Refer To: ADESH-15-173

LAUR: 15-29176

Subject: Submittal of the Inspection and Maintenance of Erosion Controls Associated with Fishladder Canyon [Solid Waste Management Unit 16-003(o)]

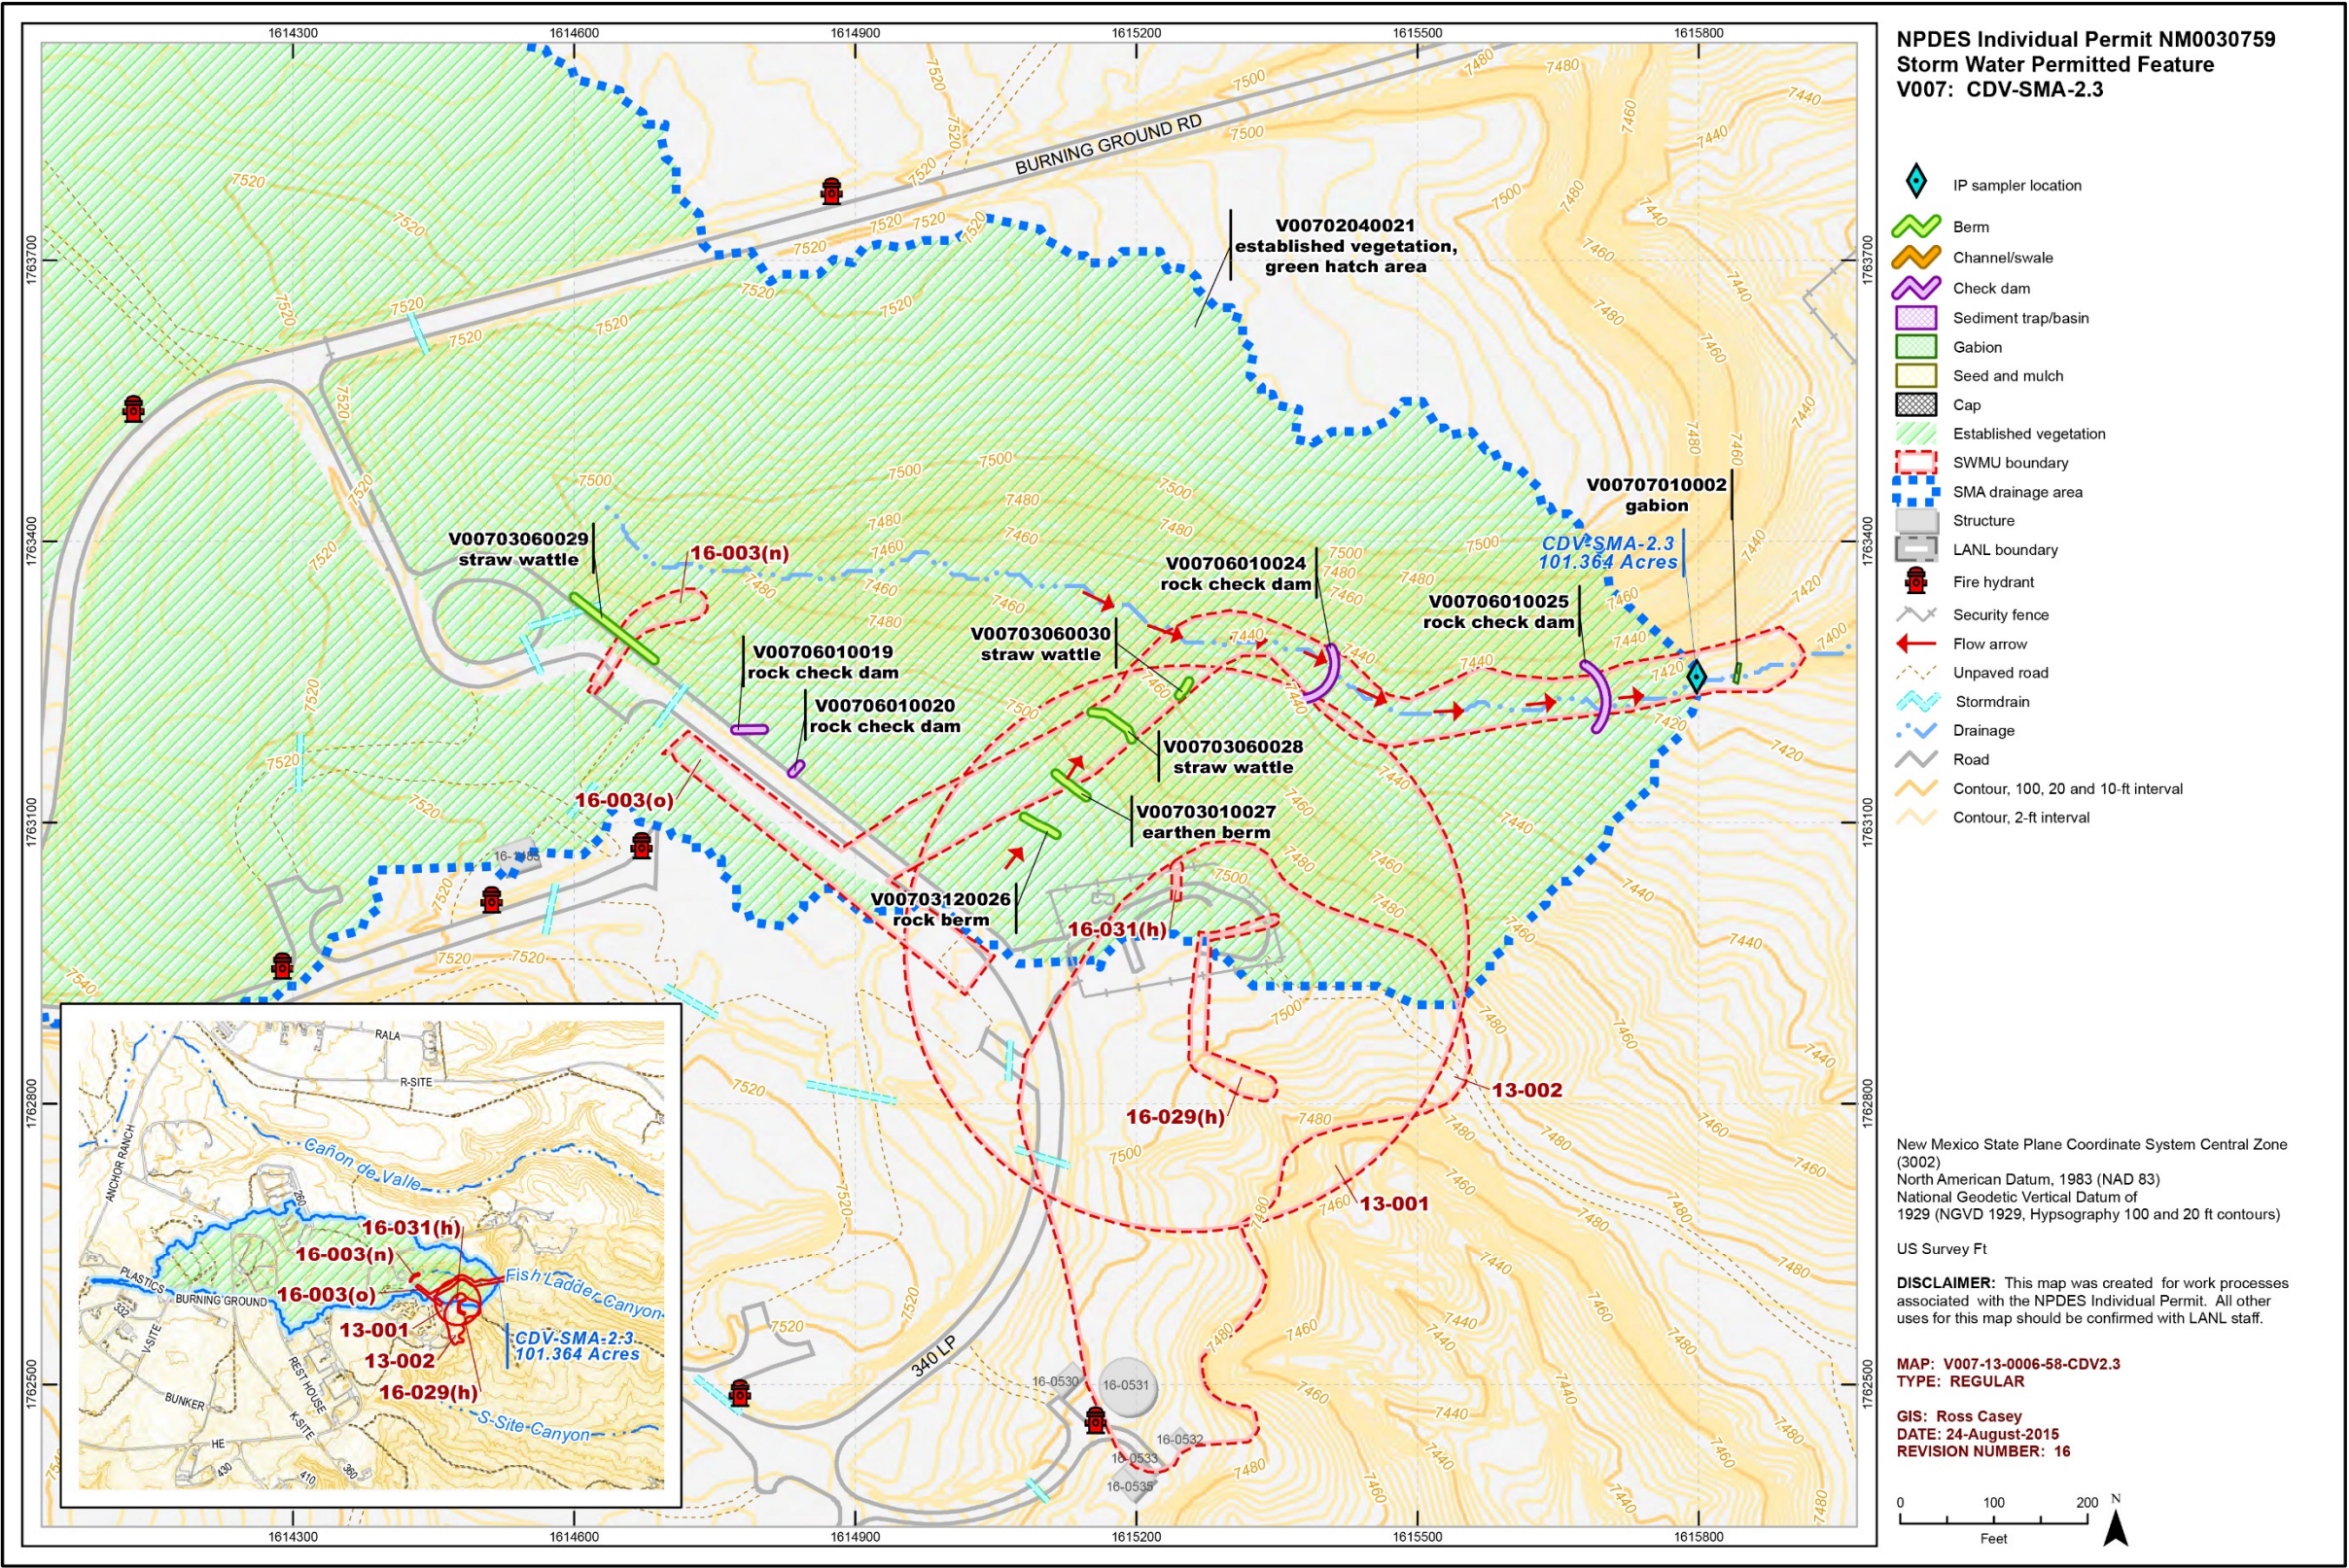
Additional controls designed to reduce flow velocities, erosion potential, and sediment transport have been installed per IP requirements at SWMU 16-003(o) and are shown in Figure 1, which is an IP site monitoring area (SMA) map showing the IP sampler location, IP storm water controls, and SWMUs associated with the SMA. Storm water controls associated with Fishladder Canyon [SWMU 16-003(o)] consist of a small gabion structure (-0002), earthen berm (-0027), straw wattles (-0023 and -0028), and rock check dams (-0024, -0025, and -0026), as shown in Figures 2 through 6. Figure 7 shows the former access road. Other storm water controls in this SMA are not associated with SWMU 16-003(o) and are not discussed.

Figure 1 Locations of the IP sampler, IP storm water controls, and SWMUs associated with the IP site monitoring area

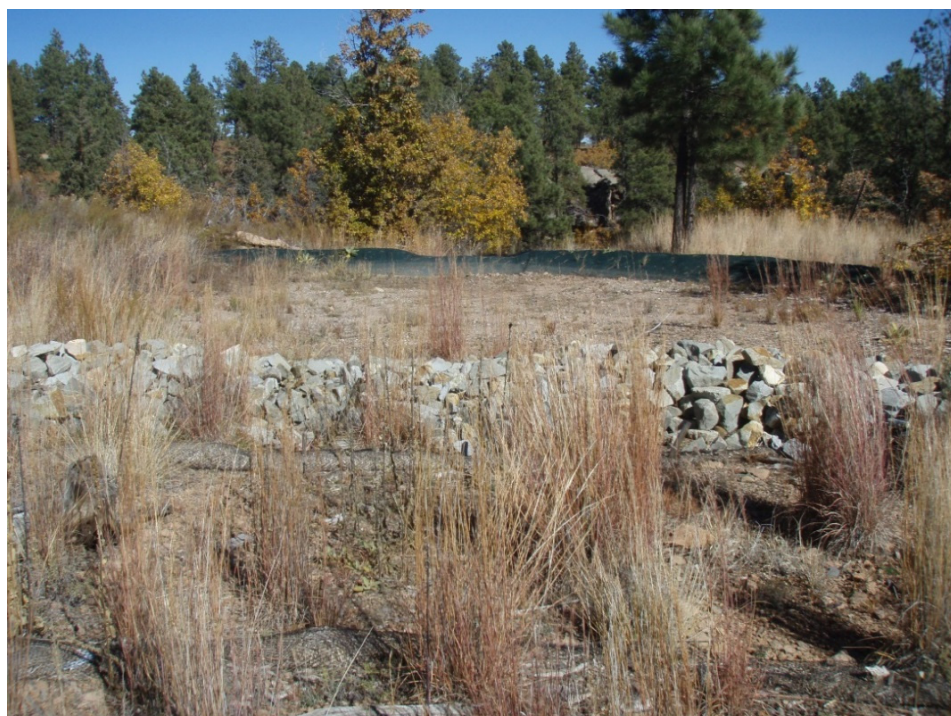
Figure 2 Rock berm (V00703120026) and earth berm (V00703010027) at the top of drainage into Fishladder Canyon (11/4/2015)

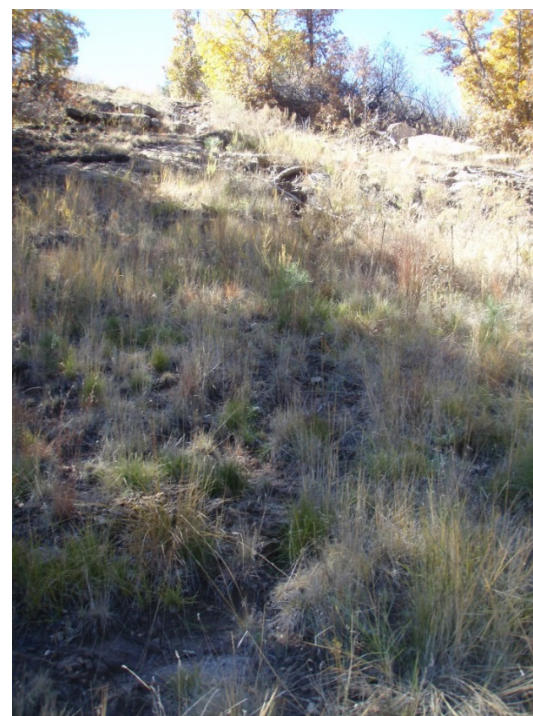
6. The IP annual erosion evaluation was completed on October 28, 2015. Inspection findings recommended replacing straw wattle (-0028); a follow-up inspection was completed on November 4, 2015, and determined the area below wattle (-0028) is stable and well vegetated. No additional action needs to be completed.

Figure 3 View looking upslope out of Fishladder Canyon (11/4/2015). Straw wattle (V007030600028) is located in middle of photo.

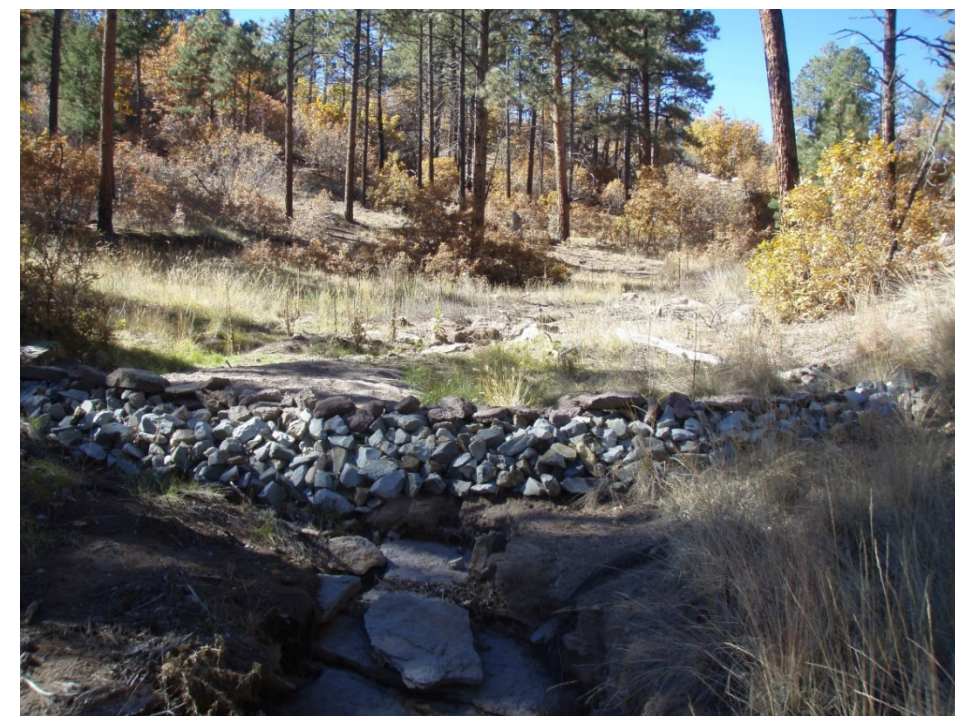
Figure 4 Rock check dam (V00706010024) in Fishladder Canyon (11/4/2015)

3. A third rain event inspection was completed on August 10, 2015, for the rain events occurring on July 29, July 31, August 1, and August 2, 2015. Inspection findings recommended adding additional rock to rock check dam (-0024). On August 25, 2015, additional rock was added to check dam (-0024).

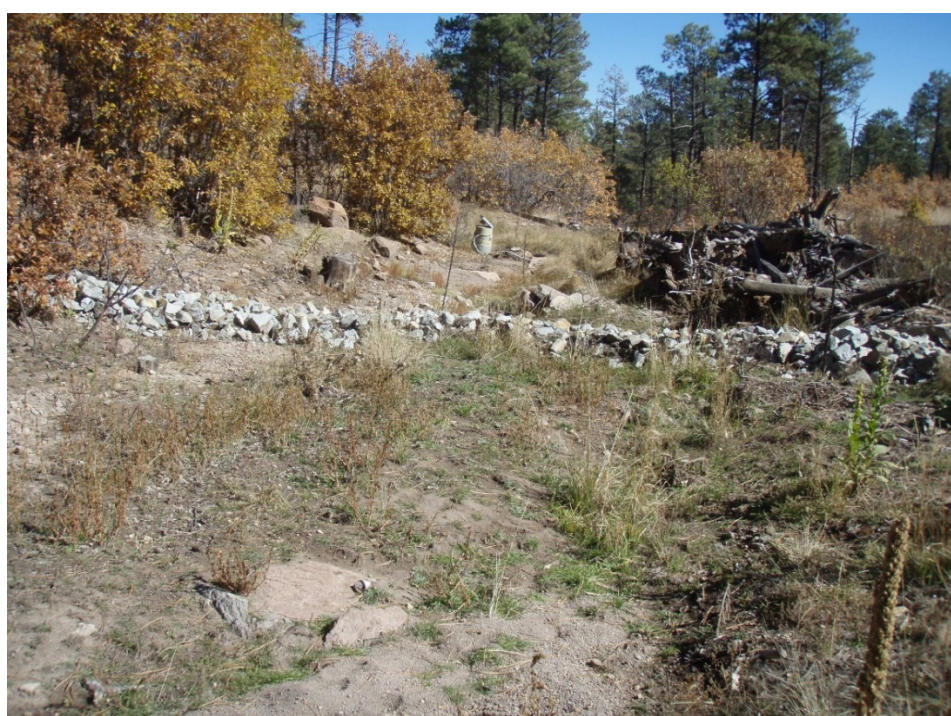
Figure 5 Rock check dam (V00706010025) in Fishladder Canyon (11/4/2015)

2. A second rain event inspection was completed on July 27, 2015, for rain events occurring on July 12 and July 20, 2015. Inspection findings recommended replacing the straw wattle (-0023) and removing leaf litter from rock check dam (-0025). On August 11, 2015, a new wattle (-0030) was installed directly upgradient of the existing wattle (-0023), and leaf litter was removed from rock check dam (-0025). Wattle (-0023) was retired and replaced with wattle (-0030), shown in Figure 1.

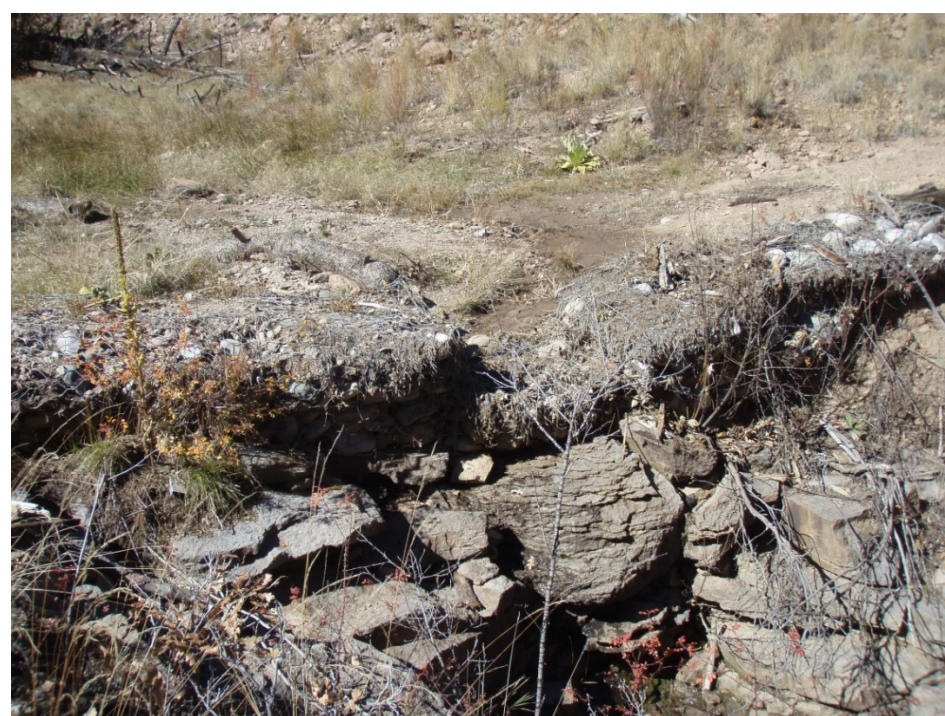
Figure 6 Gabion (V00707010002) at access road crossing in Fishladder Canyon (11/4/2015)

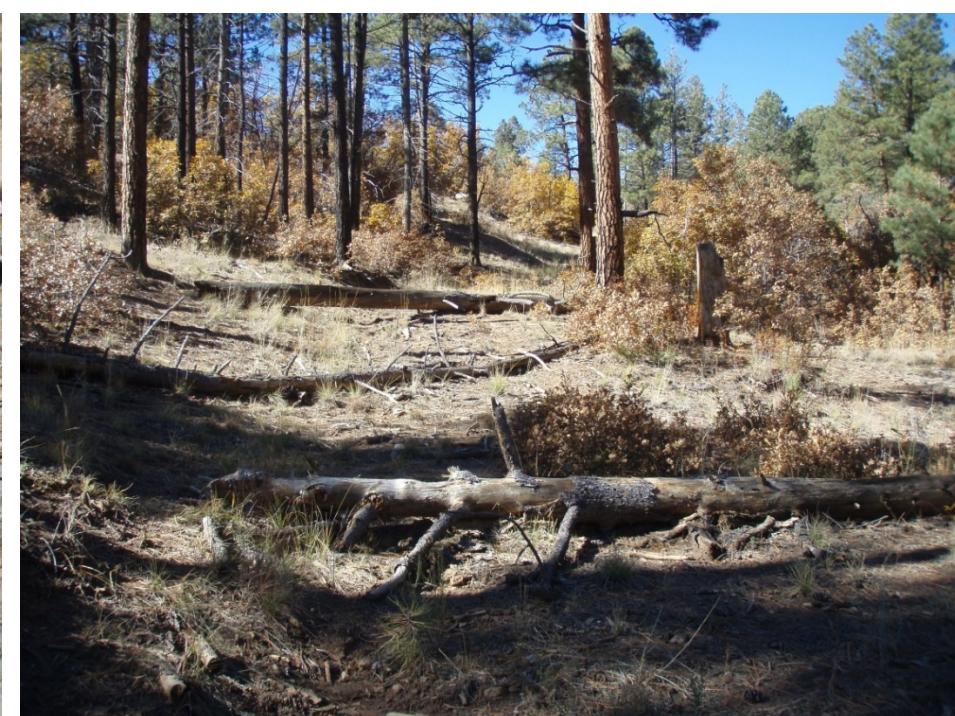
Figure 7 View west of former access road in Fishladder Canyon (11/4/2015). Straw wattle (V007030600030) is located at the western end of the former road.
