**CERRO GRANDE FIRE: AFTERMATH
ER ACTIVITIES TO REDUCE THE POTENTIAL
MOVEMENT OF CONTAMINATION AT
POTENTIAL RELEASE SITES**

VEENIS, STEVEN J.

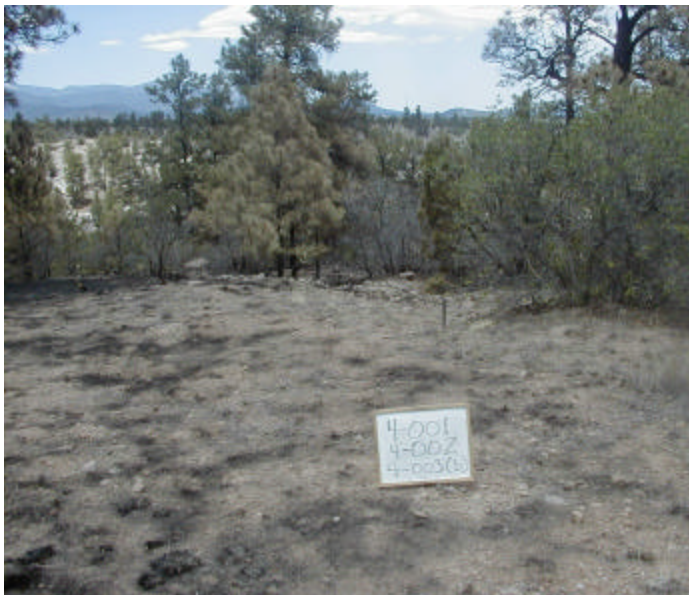
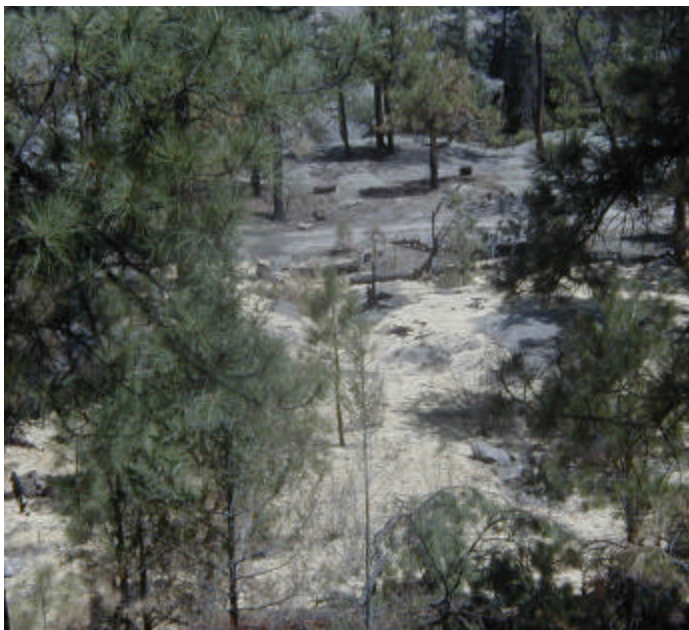
4-003(b) - *Erosion Matrix Score 51.5*. Drain outfall connected to the laboratory control building (former TA-4-3). A 6-inch diameter vitrified clay pipe discharged through a waste outfall 20 feet north. The outfall was inactive when TA-4-3 was abandoned in 1946, and partially removed in 1956.

This site is located on the south rim of Ten Site Canyon within the Upper Canada del Buey Watershed Aggregate. The fire damage was minor to moderate with a majority of the damage to the ground cover and undergrowth.

Straw wattles were installed above the site for run-on diversion, at the mesa's edge, within the north facing drainage and on the lower bench for sediment retention. Spot hand raking, reseeding and straw mulch were also applied.

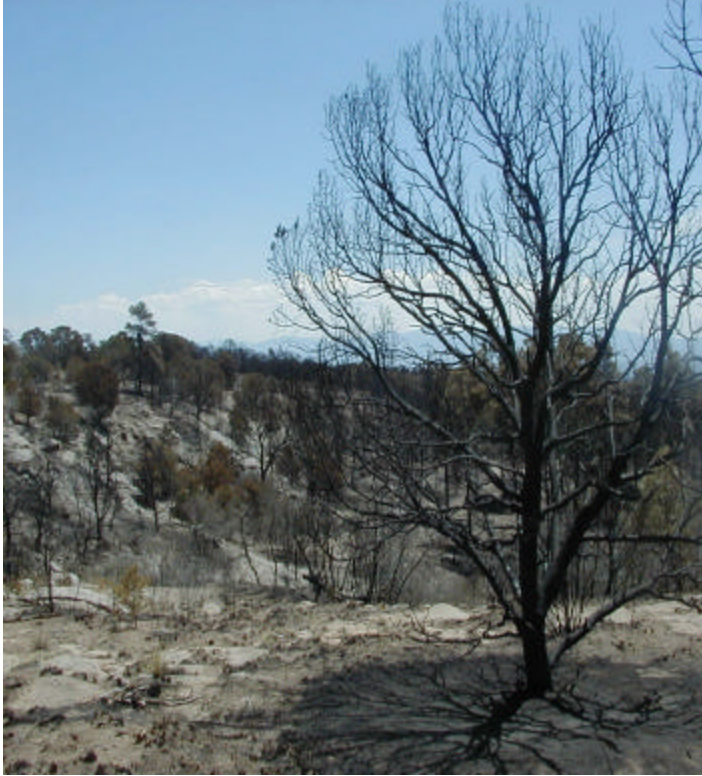
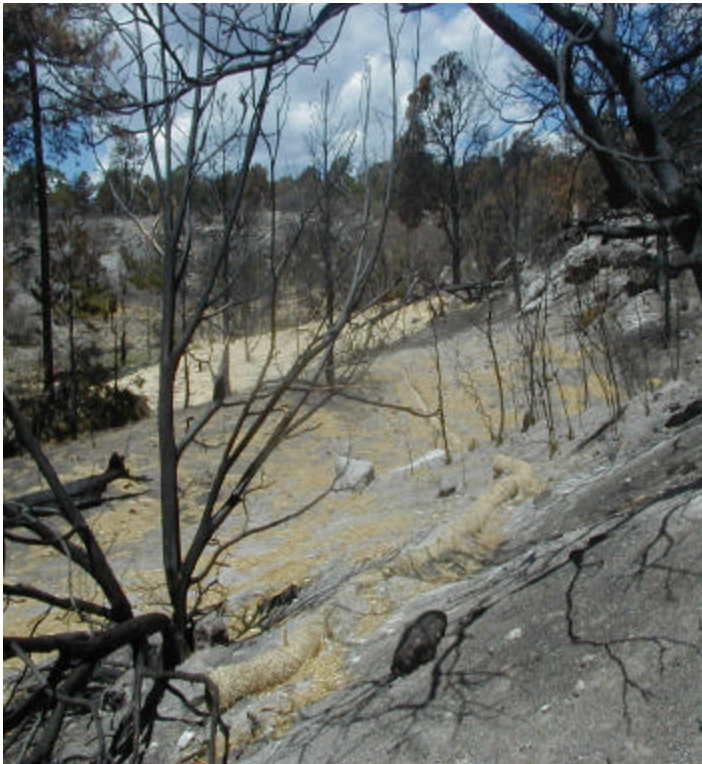
5-006(c) - *Erosion Matrix Score 27.0*. Soil contamination beneath former building TA-5-5 known to have used high explosives and photo processing chemicals. Building TA-5-5 was removed in 1960.

This site is located on the south rim of a tributary to Mortandad Canyon within the Upper Canada del Buey Watershed Aggregate. The fire damage was moderate to severe with nearly complete damage to the ground cover and canopy.

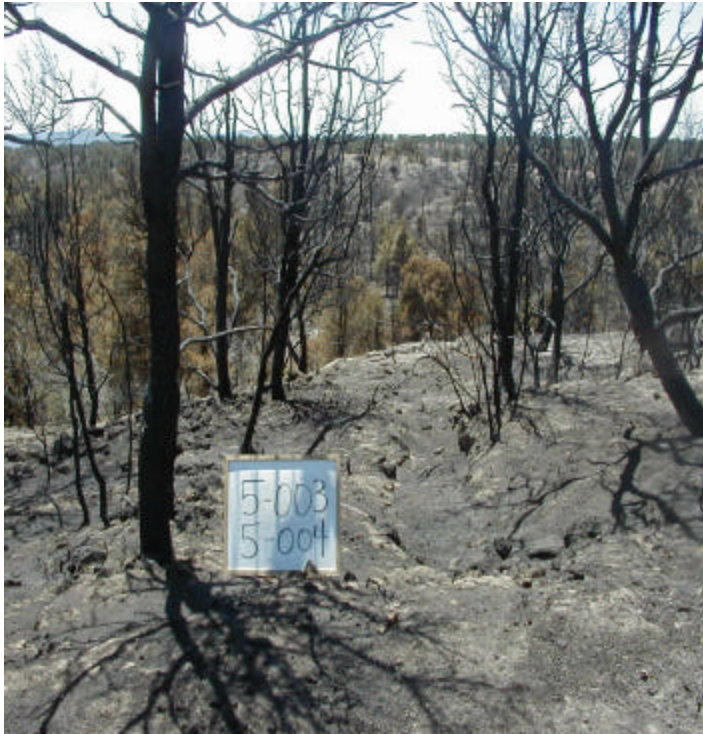
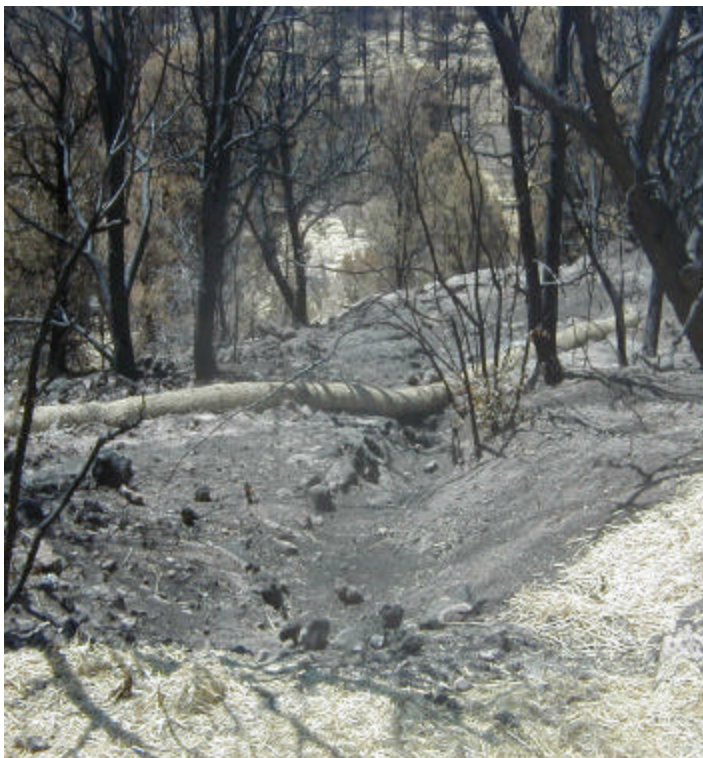
5-004 - Erosion Matrix Score 49.7. An inactive septic system (TA-5-13) that received industrial waste. The septic system was removed prior to 1985. As built drawings indicate a discharge line running from TA-5-1 near the TA-5-16 barricade to TA-5-13 and south toward the canyon.

This site is located on the south rim of a tributary to Mortandad Canyon within the Upper Canada del Buey Watershed Aggregate. The fire damage was moderate to severe with nearly complete damage to the ground cover and canopy.

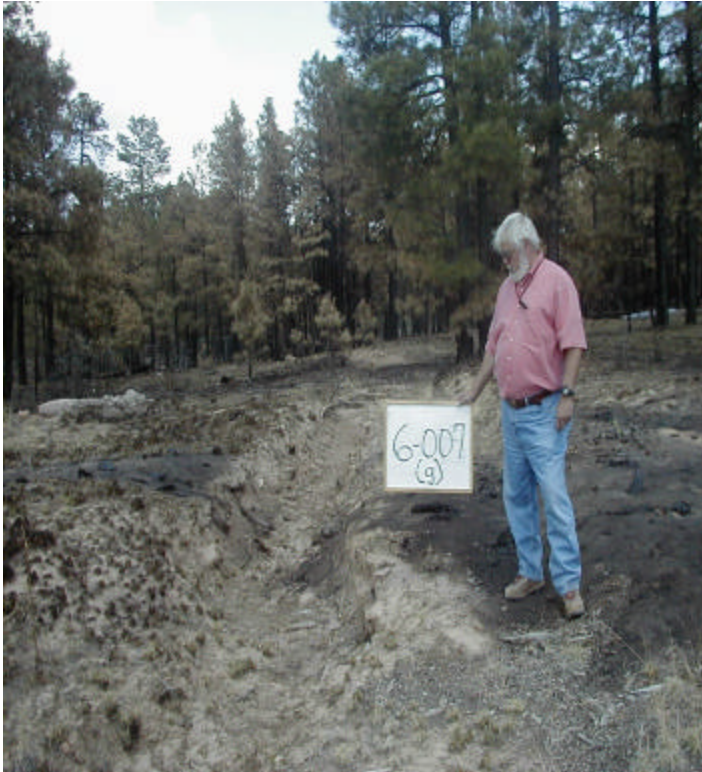
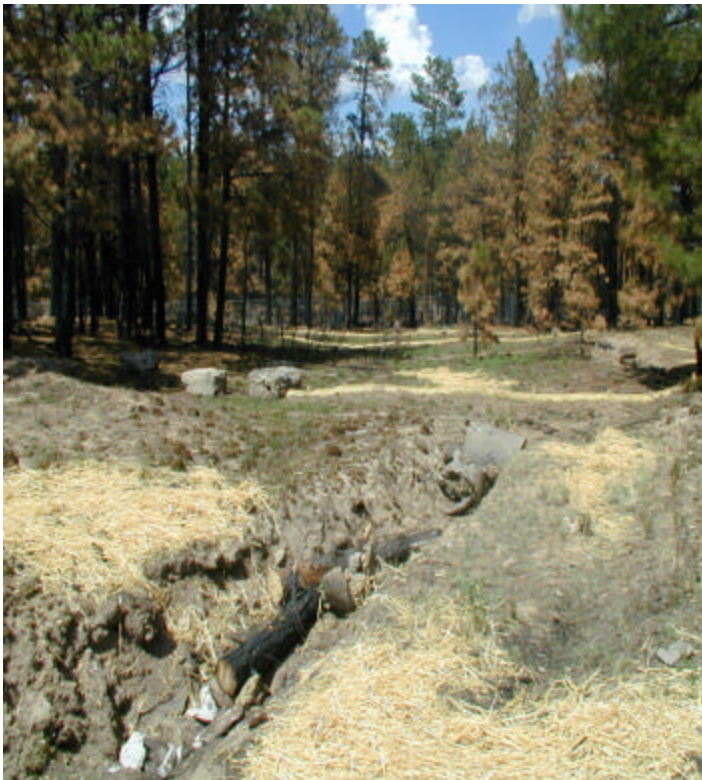
6-007(g) – *Erosion Matrix Score 50.8*. Formerly Area Of Concern C-6-004, the site of building TA-6-12. Explosives, particularly PETN, were pressed in this building, which was removed from this site in 1949.

This site is located on the south side of Pajarito Canyon within the Two Mile Canyon Watershed Aggregate. The drainage channel east of building TA-6-6 has minor evidence of fire damage. Miscellaneous debris was observed around the area including concrete, rebar and old building wood. A pre-existing erosional feature was observed.

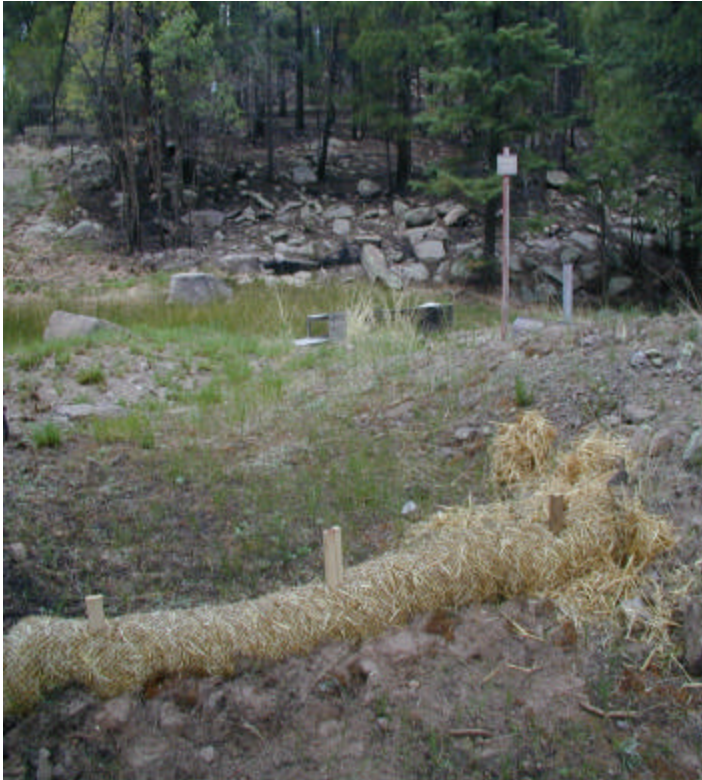
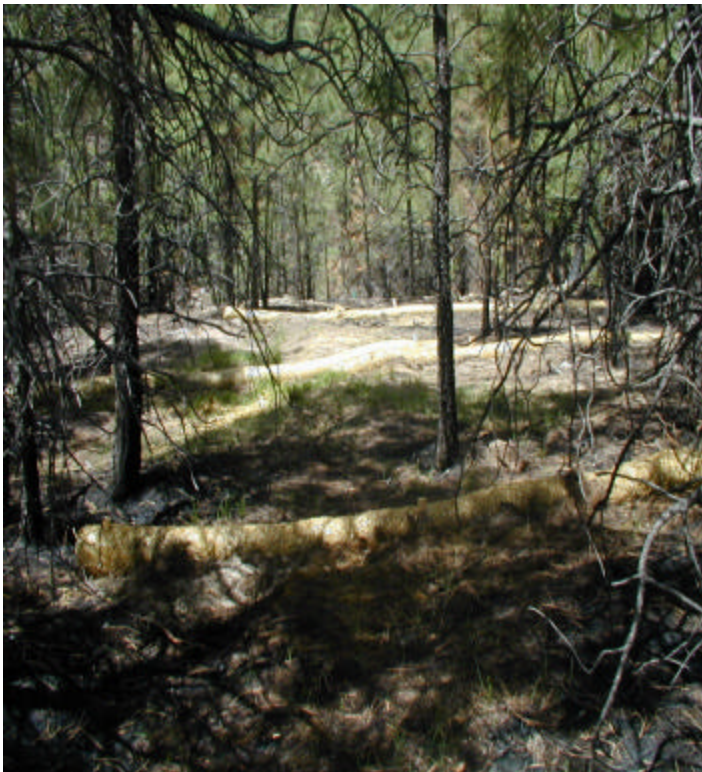
9-004(o) - *Erosion Matrix Score 43.8*. Inactive NPDES outfall associated with a sump and settling tank within building TA-9-48.

This site is located south of Pajarito Canyon within the Starmer/Upper Pajarito Watershed Aggregate. The area received minor to moderate fire damage. The ground cover was completely burned but the canopy cover was only partially affected. The grasses have recovered quickly in most of the area.

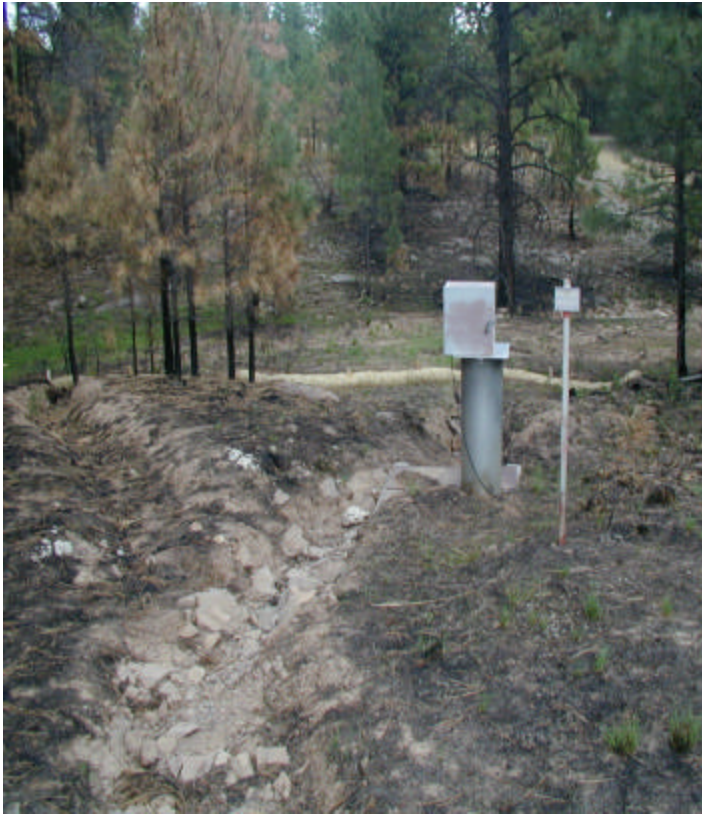
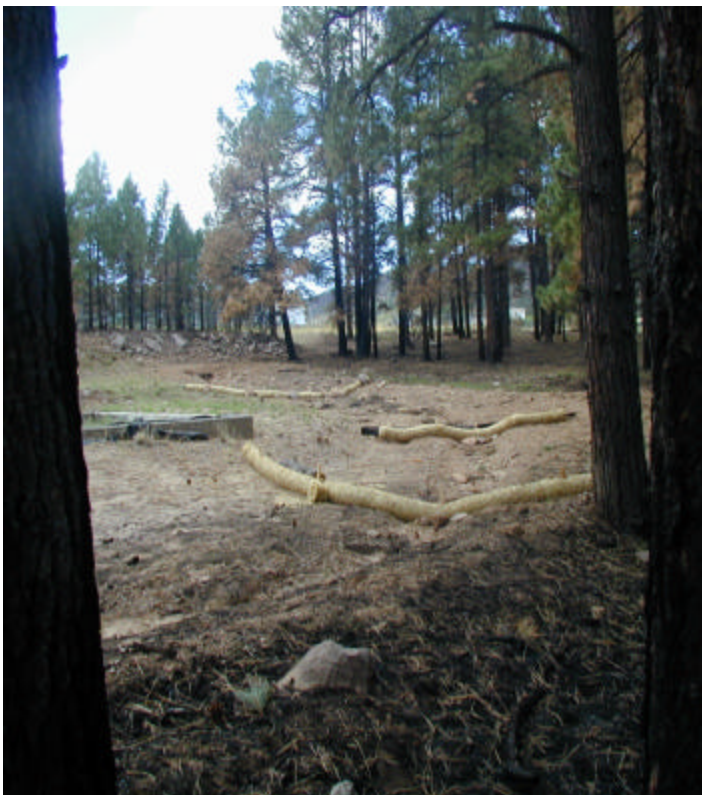
9-009 - Erosion Matrix Score 58.8. A lagoon and sand filters used to treat sanitary waste. After flowing through the sand filters, effluent discharged to a currently inactive NPDES outfall (555 02S).

This site is located south of Pajarito Canyon within the Starmer/Upper Pajarito Watershed Aggregate. The PRS is the former Sanitary Wastewater Treatment Facility north of TA-9. Site has moderate fire damage with ground and canopy cover being impacted. The erosional feature below the site that previously existed is at the greatest risk.

Straw wattles were installed in the drainage swales and rock check dams were placed in the channels to dissipate flow (using existing materials found on-site). Wattles were also provided upslope for run-on diversion.

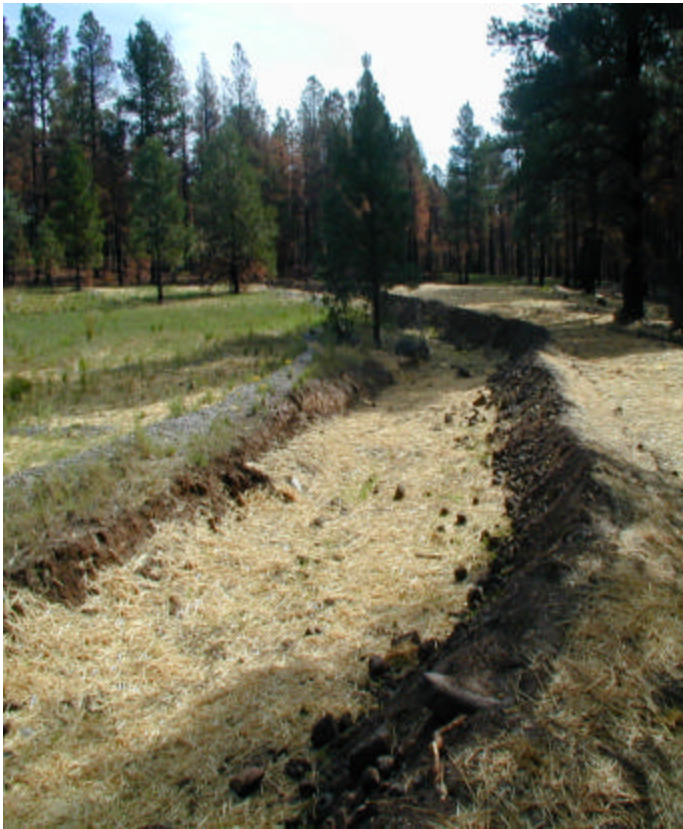
9-013 - *Erosion Matrix Score 56.0*. Material Disposal Area (MDA) M, was a surface disposal area located within TA-9. MDA-M occupied approximately 3.2 acres and was roughly circular in shape. Construction debris and solid wastes were disposed there from 1948 to 1965

This site is located south of Pajarito Canyon within the Starmer/Upper Pajarito Watershed Aggregate. The area surrounding MDA M was moderately to severely burned as was a majority of the upper Pajarito Watershed. All of the existing erosion controls at the site were destroyed.

Run-on controls were replaced as shown below. The entire site was hand raked, reseeded and mulched. A retention basin was installed at the bottom of the slope to create a “zero discharge” area.

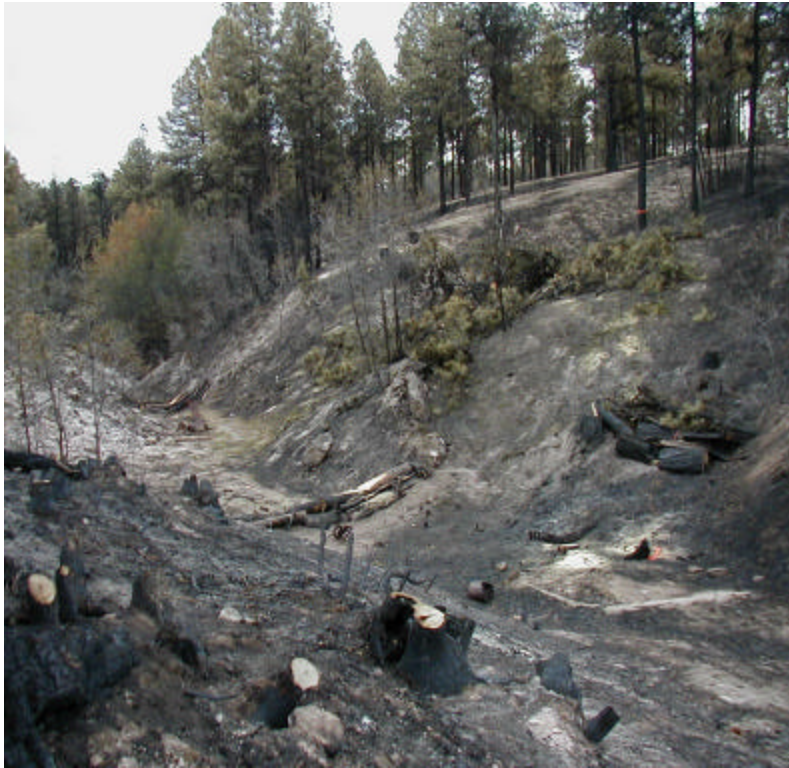
This site is located north of Water Canyon within the S-Site Watershed Aggregate. The site has moderate to severe fire damage in the area surrounding the TA-11 Drop Tower. Log check dams within the major drainages received partial damage. All straw barriers installed around site were destroyed.

The log check dams (on-site materials used) were replaced within the adjacent drainages. Straw wattles were placed on the slopes and geotextile was installed in the areas with the most erosion potential. The area surrounding the Drop Tower was hydromulched to enhance the revegetation process.

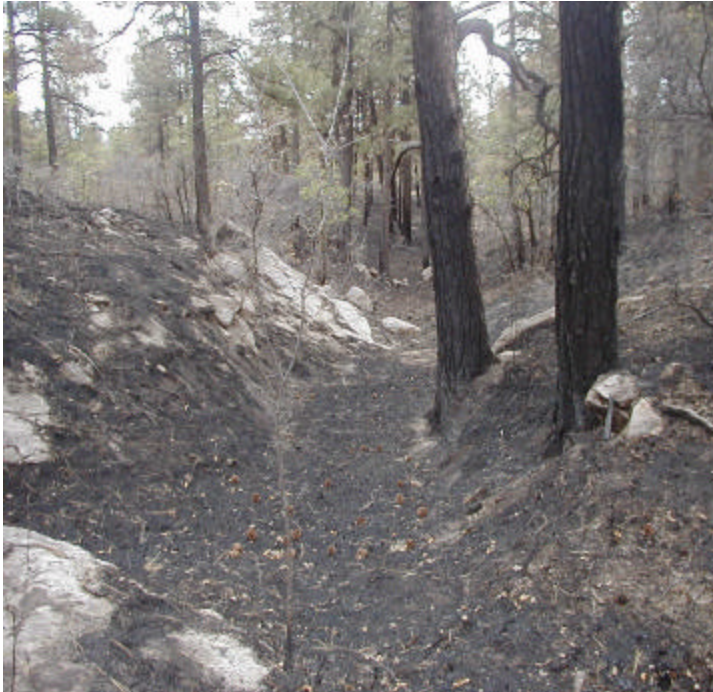
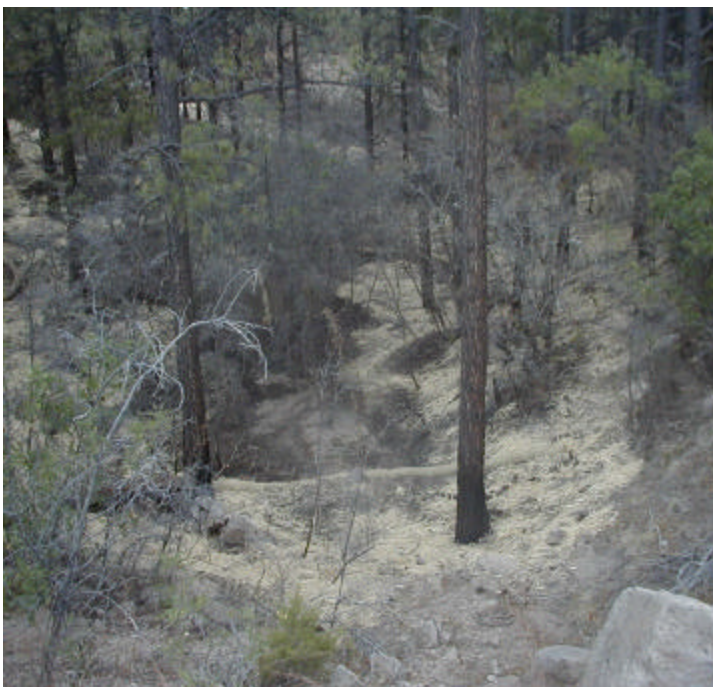
14-002(e) - Erosion Matrix Score 47.8. Firing pad on which explosive tests were photographed. Shots were small (up to 15 pounds) and some contained uranium.

This site is located north of Canon de Valle within the Canon de Valle Watershed Aggregate. The eastern portion of TA-14 was moderately burned with substantial damage to the groundcover.

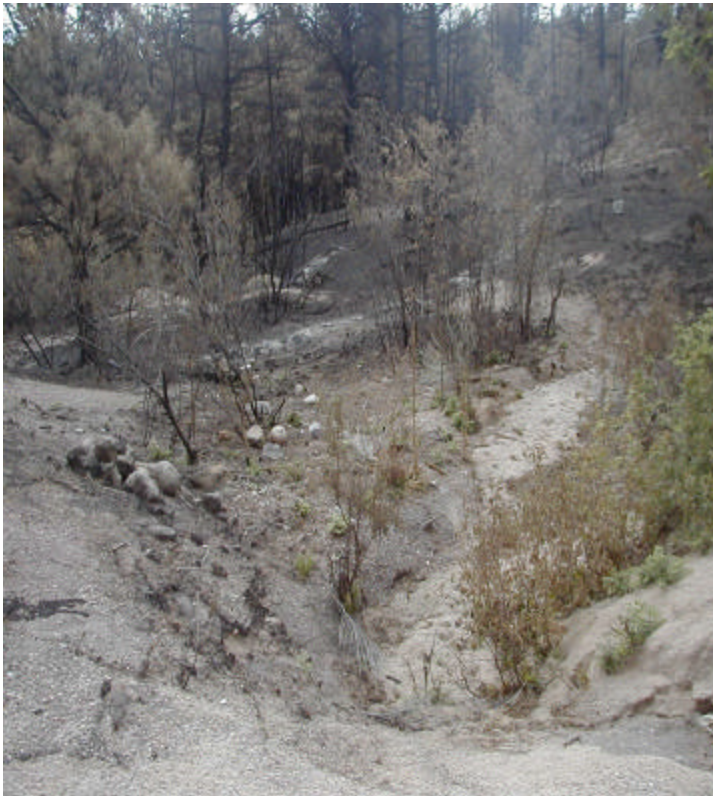
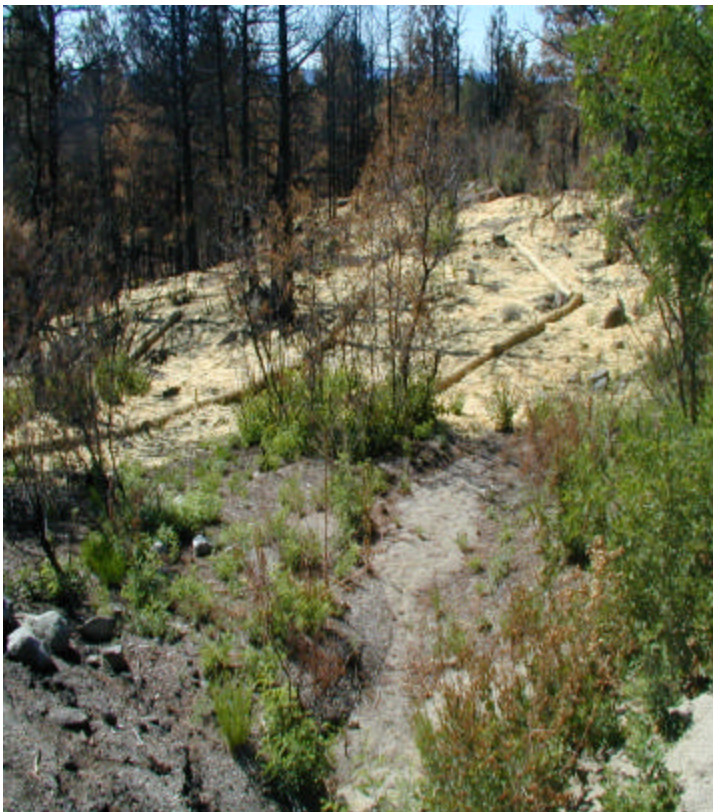
14-006 - Erosion Matrix Score 47.1. This PRS consists of a sump, drain line, and outfall. It was used to separate pieces of HE from liquid. The sump is now plugged and the only discharge to the outfall is rain water. HE and toxic chemicals may be present.

This site is located north of Canon de Valle within the Canon de Valle Watershed Aggregate. The central portion of TA-14 was moderately burned with substantial damage to the groundcover.

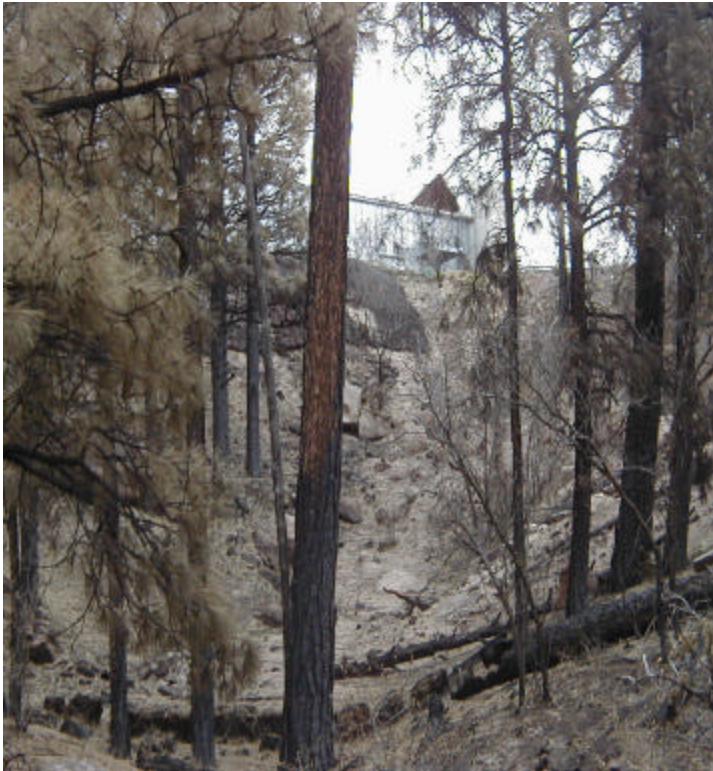
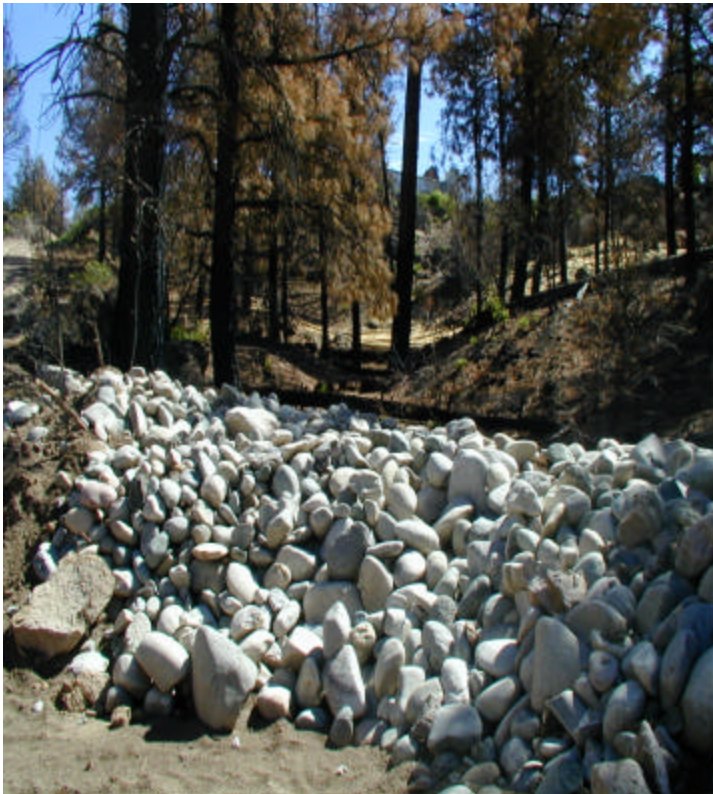
14-009 - Erosion Matrix Score 53.7. Surface disposal area consisting of ruptured sand bags which were used for containment during explosives testing activity. Sand could be contaminated with lead, uranium, HE and beryllium.

This site is located north of Canon de Valle within the Canon de Valle Watershed Aggregate. The western portion of TA-14 was moderately to severely burned with substantial damage to the canopy and groundcover.

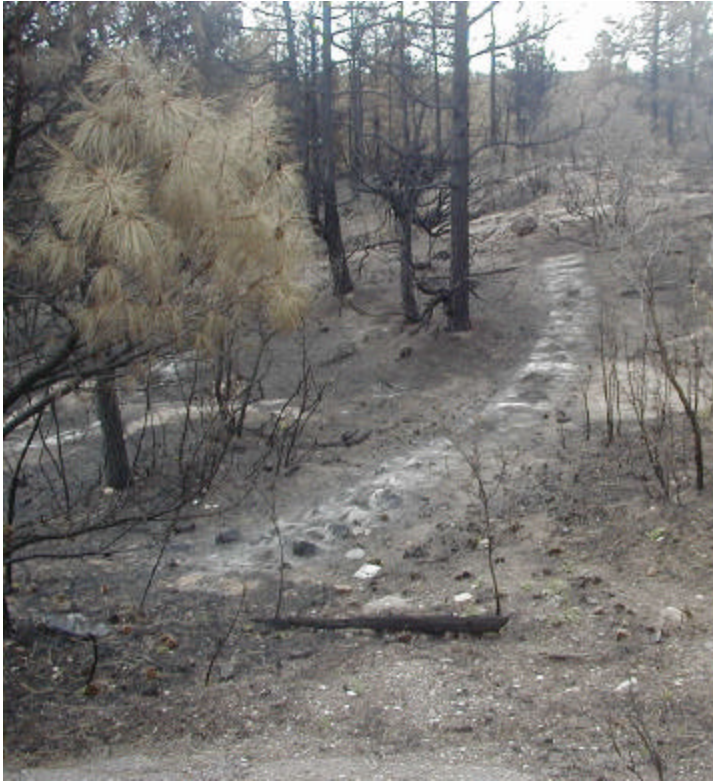
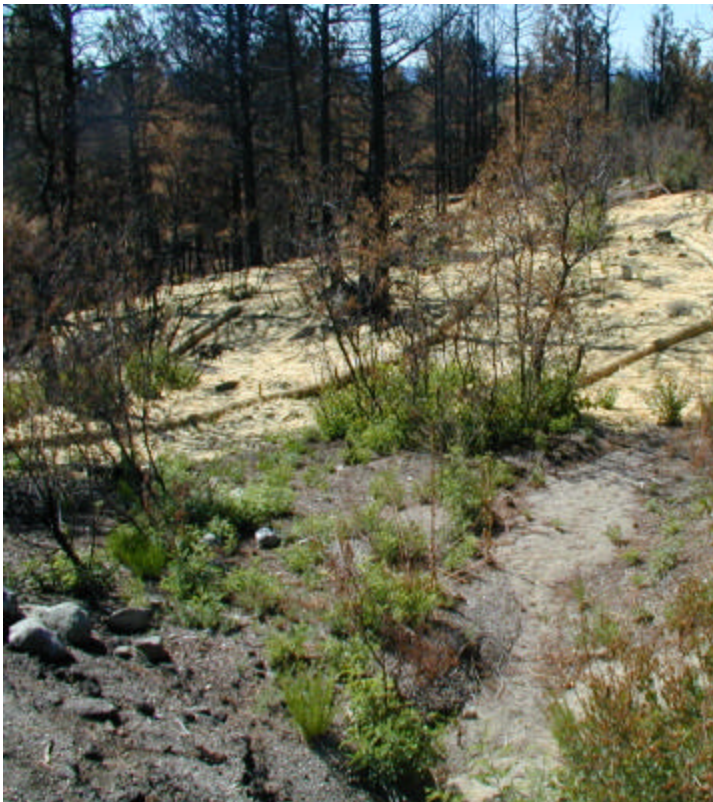
14-010 - *Erosion Matrix Score 51.5*. High explosive waste sump adjacent to TA-14-2. The site may have contained HE and other chemicals. The sump and drain-line were removed.

This site is located north of Canon de Valle within the Canon de Valle Watershed Aggregate. The western portion of TA-14 was moderately to severely burned with substantial damage to the canopy and groundcover. Most of the existing BMPs at the site were destroyed. As a result, the erosion potential for the site is moderate to high.

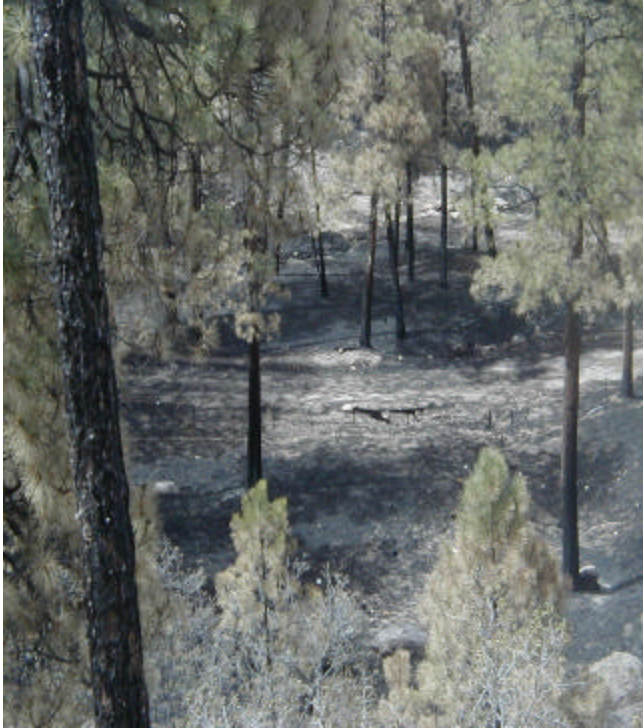
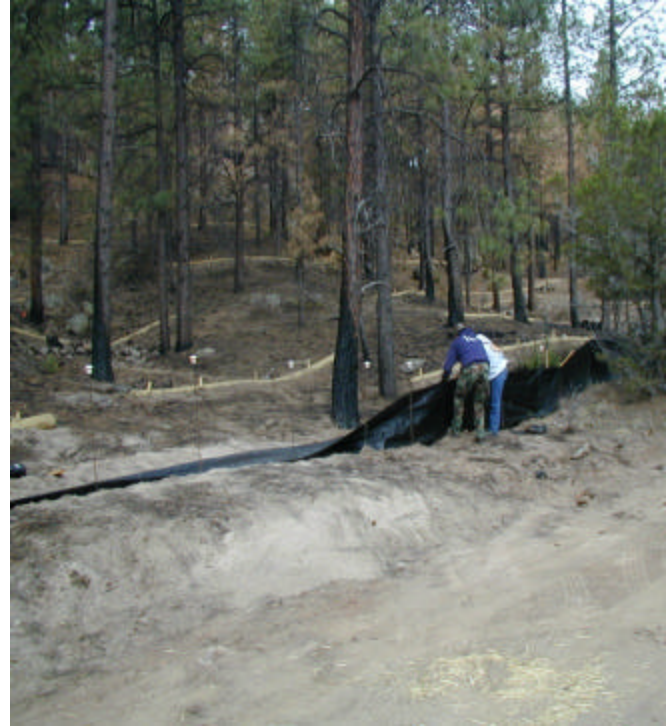
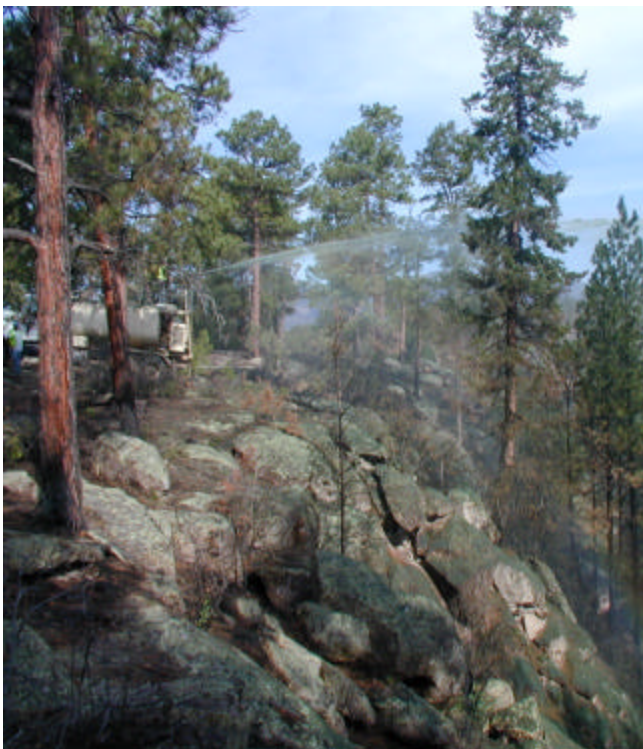
15-008(b) - *Erosion Matrix Score 67.2*. Surface disposal area north of PRS 15-006(c), R-44 Firing Site. Remnants and debris from tests were pushed over the edge of the canyon.

This site is located on the south rim of Three Mile Canyon within the Three Mile Watershed Aggregate. 15-006(c) has moderate to severe burn damage with most of the damage adjacent to the former R-44 Firing Pad. A large amount of firing site related debris has been exposed throughout the site (especially towards the east).

Straw wattles, rock check dams and silt fencing were installed throughout the burned areas. Over 20 cubic yards of firing site debris was removed from the surrounding area. The area was then hydromulched to enhance the revegetation process.

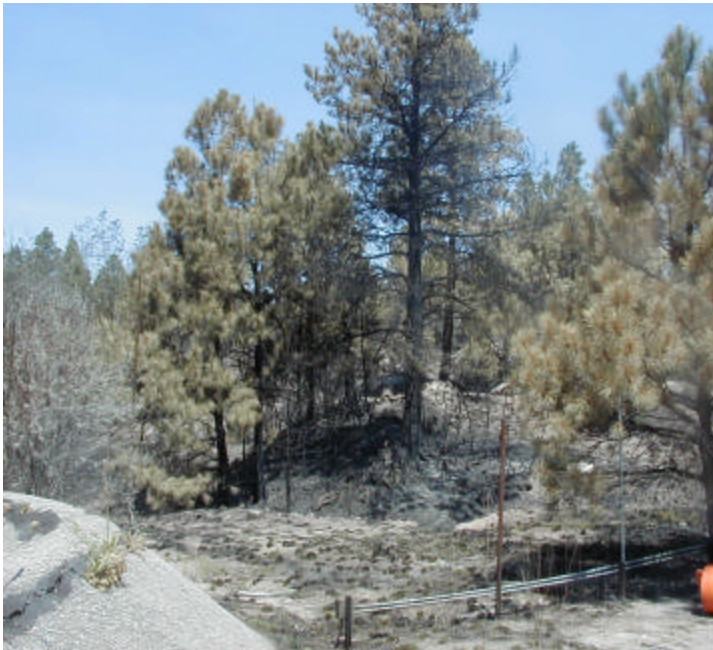
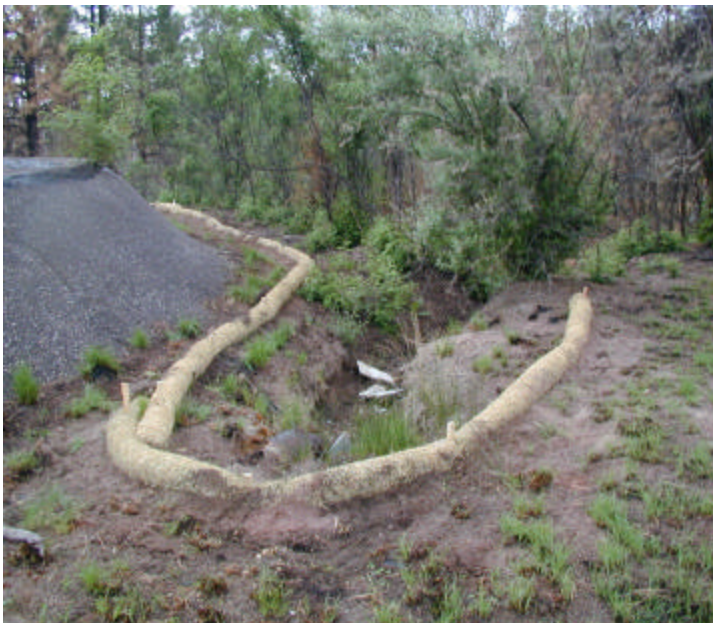
15-014(j) - *Erosion Matrix Score 61.3*. PRS 15-014(j) consists of three outfalls from Building R-50 and a drainage channel that is partially asphalt just below the outfall leading towards the canyon.

This site is located near the confluence of Canon de Valle and Water Canyon within the Canon de Valle Watershed Aggregate. The site was moderately to severely damaged including several burned structures. The ground cover and canopy surrounding the site was extensively damaged. Runoff from the entire Hollow site discharges into a small tributary (to Canon de Valle) west/southwest of the site near oil storage tank (15-011(b)).

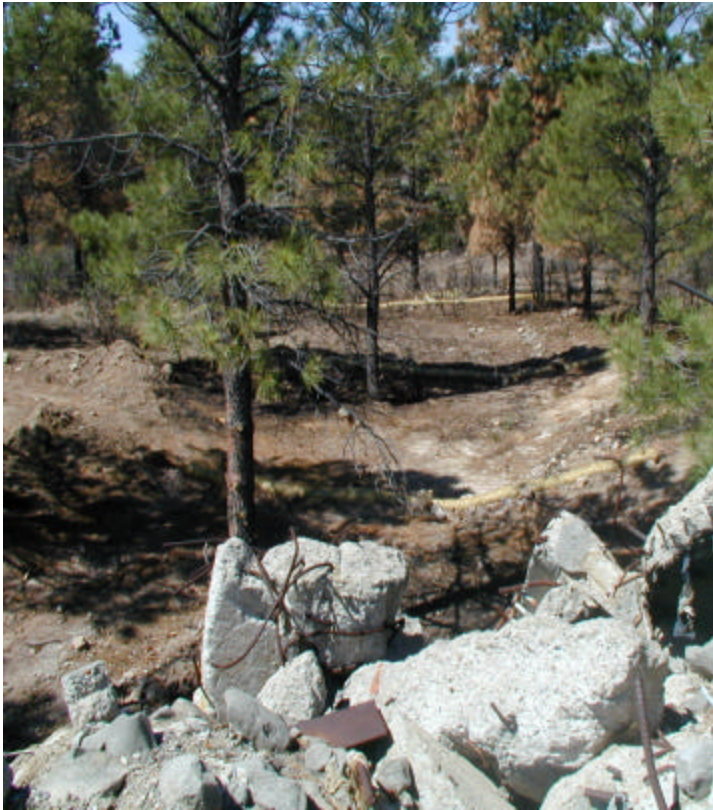
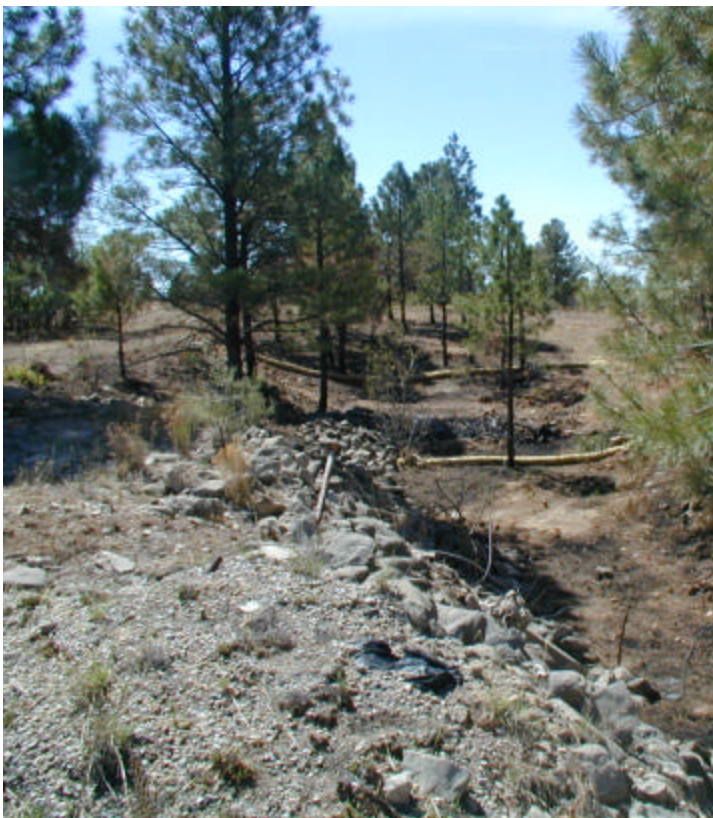
15-007(b) – *Erosion Matrix Score 40.2*. MDA Z is an inactive disposal area that was used from 1965 to 1981 for construction debris, steel blast matting from PHERMEX, and other debris.

This site is located near the confluence of Canon de Valle and Water Canyon within the Canon de Valle Watershed Aggregate. The area received minor burn damage primarily to the ground cover.

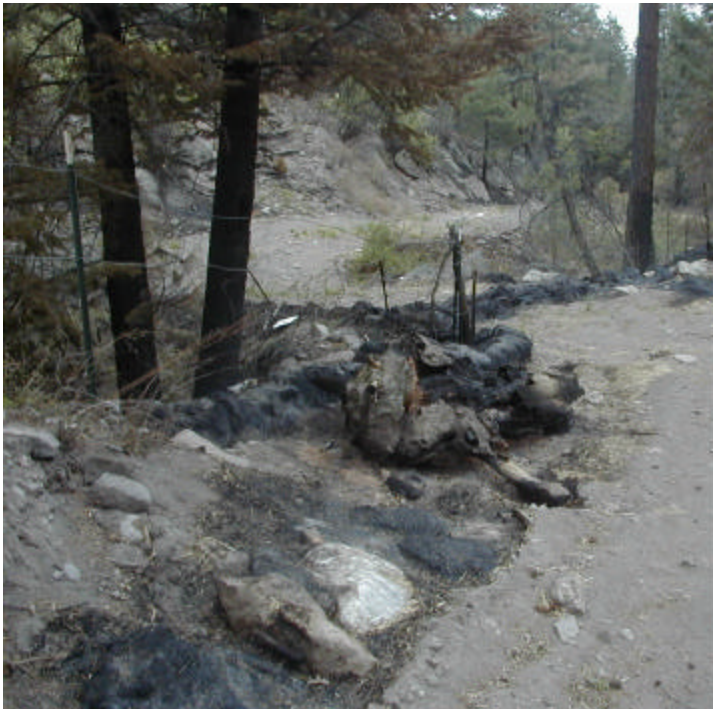
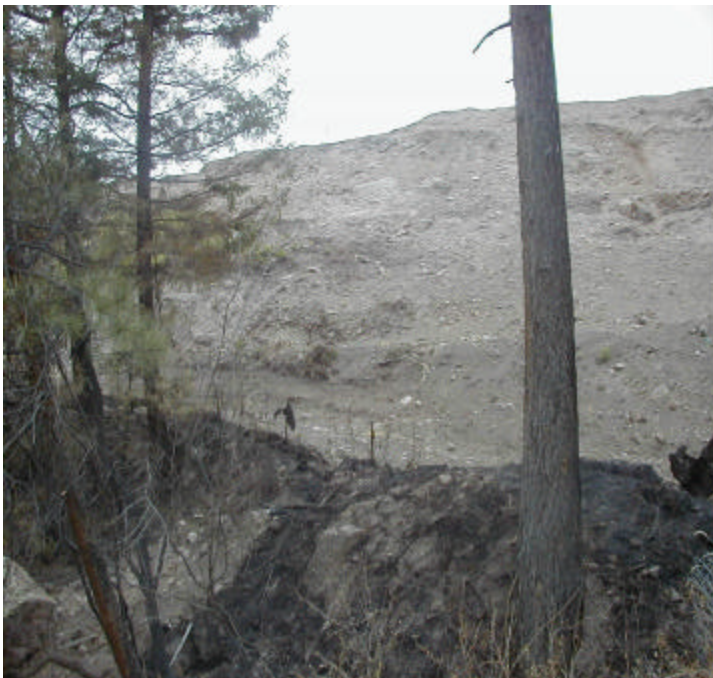
This site is located on the edge of Canon de Valle within the Canon de Valle Watershed Aggregate. MDA-P received only peripheral fire damage on the lower portion of the site. The existing straw barriers and silt fencing were destroyed. No construction equipment and project infrastructure were damaged.

The straw barriers and silt fencing were replaced and fortified with an earthen berm below the site. Soil-Sement (polymer based emulsion) was applied to exposed slopes to reduce sediment transport potential.

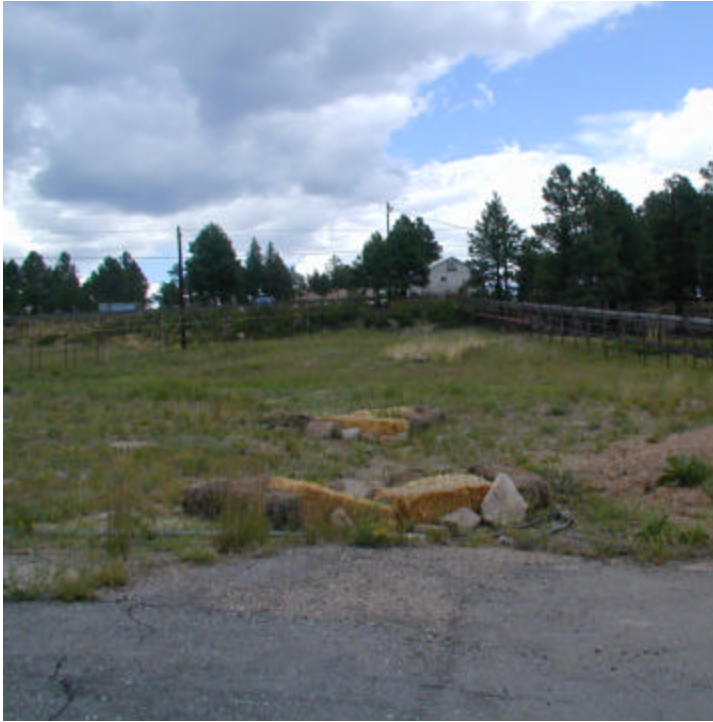
16-028(a) – *Erosion Matrix Score 51.5*. An active outfall associated with TA-16-228 High Explosive Wastewater Treatment Facility. The discharge enters the canyon between TA-16-228 and the liquid impoundment SWMU (16-008(b)).

This site is located near a tributary of Water Canyon within the Canon de Valle Watershed Aggregate. The site has minimal fire damage to the west and south. Some minor burning occurred within the SWMU boundary, but consisted mostly of destroyed grasses. The HEWTF remains operational.

Straw barriers and rock check dams (existing materials found on site) were placed within the drainage swale to reduce sediment transport potential.

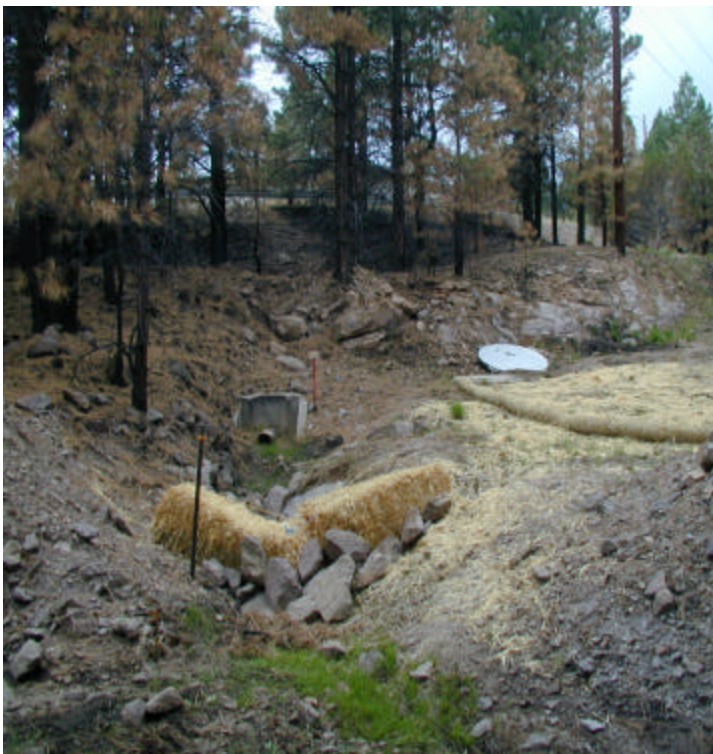
16-003(f) – *Erosion Matrix Score 8.8*. An inactive HE sump associated with TA-16-304. No HE is currently used and the probability of HE in the sump is low.

Site is located in a small tributary drainage to Water Canyon within the S-Site Watershed Aggregate. Site has minor to moderate fire damage within the outfall drainage. Ground cover has begun to re-establish itself.

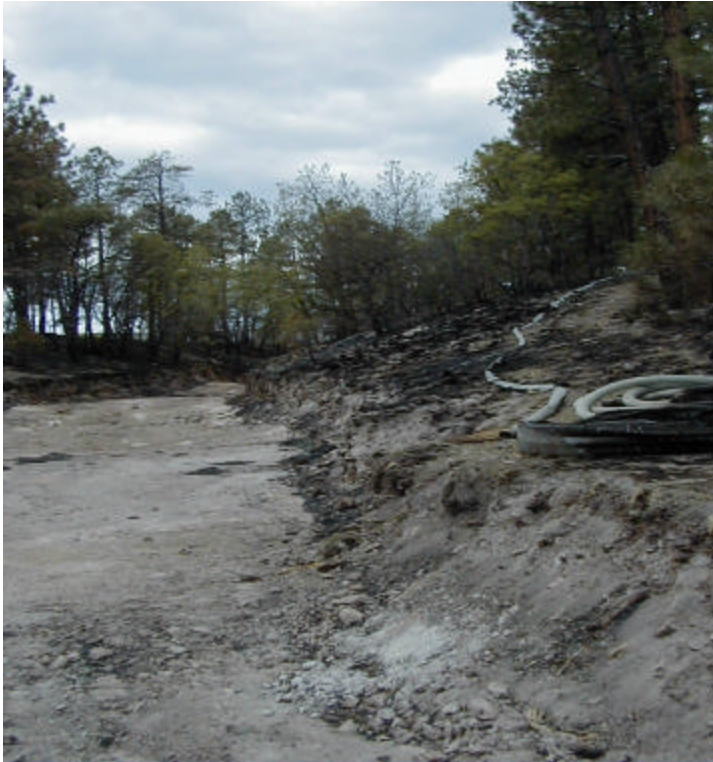
This site is located in a tributary drainage of Canon de Valle within the Canon de Valle Watershed Aggregate. Burn damage is minor to moderate within the SWMU boundary. All large equipment on-site was not affected by the fire; however, some hoses, drums and misc. equipment were damaged. The upper drainage pond was not burned. The lower drainage received minimal damage from the fire.

Straw barriers were replaced within the drainage channel and jute matting was installed to protect the exposed slopes. All excavated material remains covered with HDPE liners and is surrounded by an earthen berm. The storm water retention pond was unharmed and remains effective as a “zero discharge” BMP.

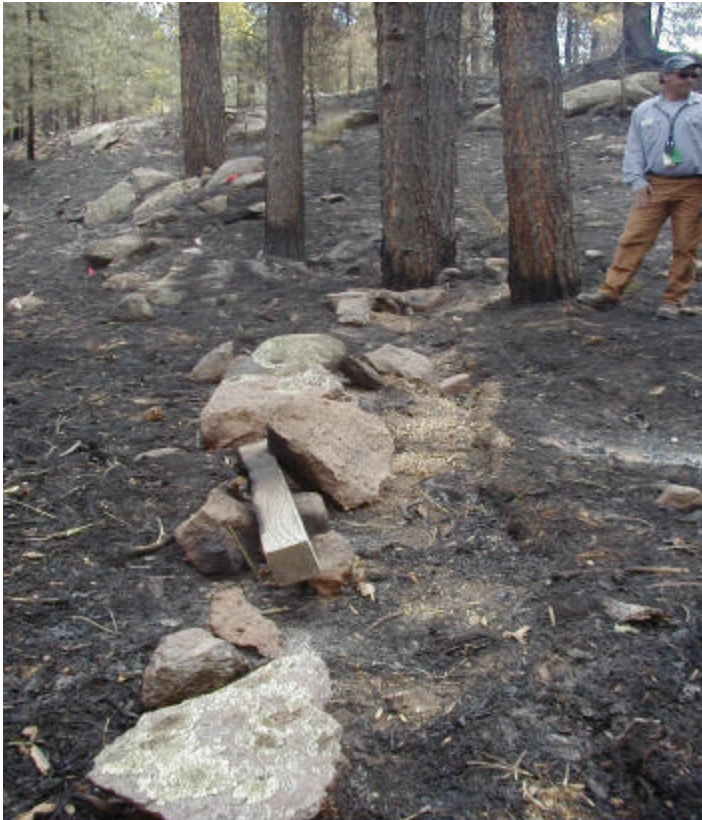
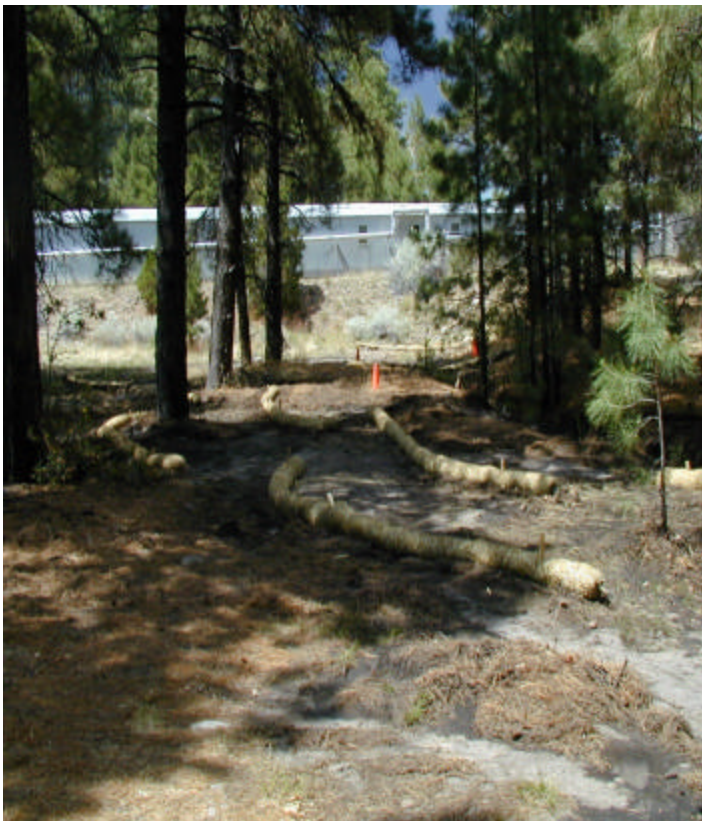
16-020 – Erosion Matrix Score 61.3. A small outfall within a drainage channel on the south side of TA-16-222 that slopes gently for approximately 295 ft. to a confluence with the main channel of Canon de Valle.

This site is located east of S-Site Road in the upper tributary of Canon de Valle within the Canon de Valle Watershed Aggregate. No damage was observed from the outfall to the first rock check dam. Below the second rock check dam, fire damaged much of the ground cover and several of the ponderosa pine trees. All straw were destroyed.
