**CERRO GRANDE FIRE: AFTERMATH
ER ACTIVITIES TO REDUCE THE POTENTIAL
MOVEMENT OF CONTAMINATION AT
POTENTIAL RELEASE SITES**

VEENIS, STEVEN J.

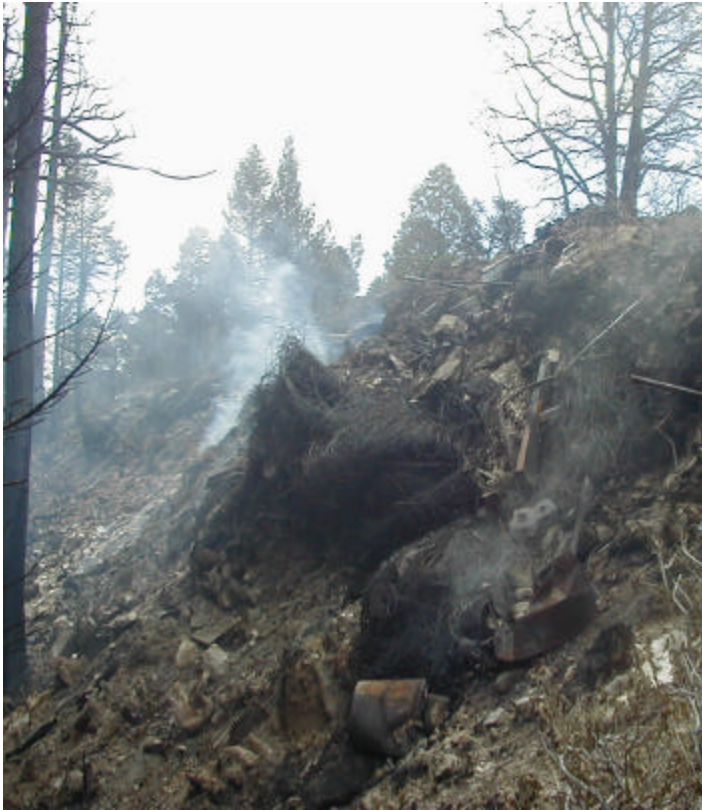
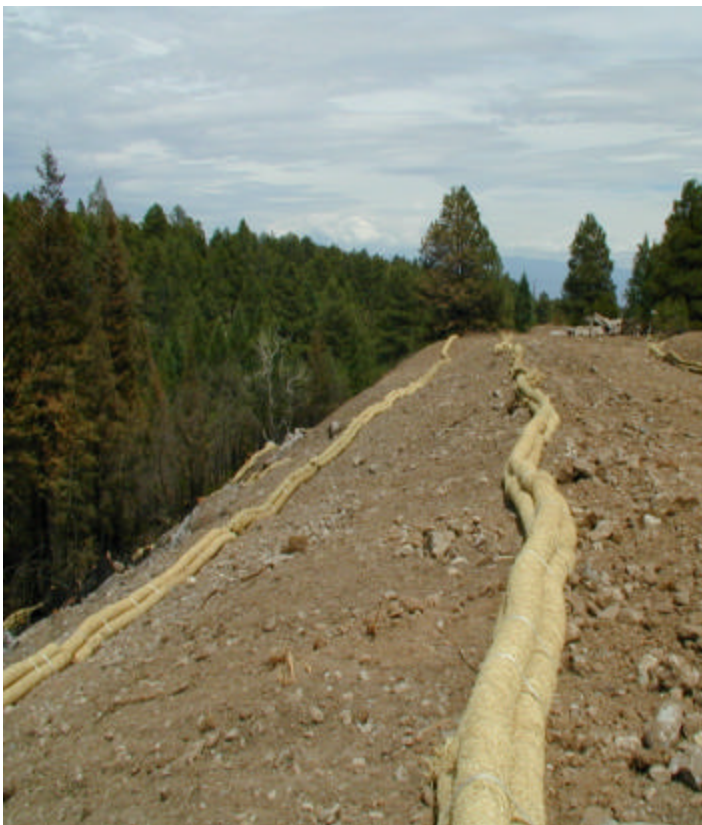
16-019 – Erosion Matrix Score 83.0. A material disposal area (MDA R) that consists of the WW II S-Site burning ground and its waste disposal site. This site was found smoldering on May 18th, 2000.

This site is located near building TA-16-260 above Canon de Valle within the Canon de Valle Watershed Aggregate. The site has moderate to severe fire damage over a majority of the area. Miscellaneous debris was exposed on the mesa and slope above canyon channel. The dissipation controls installed within the eastern drainage were destroyed. The ground and canopy cover was completely destroyed. Ash is up to 12" deep in some areas at the toe of slope. Burning occurred in the Canon de Valle leaving severe erosion potential behind.

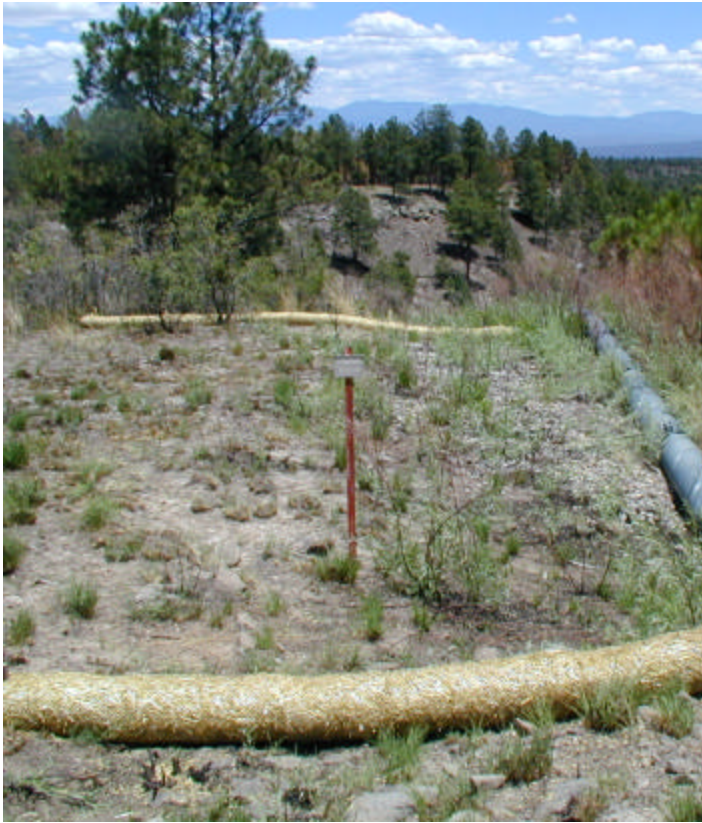
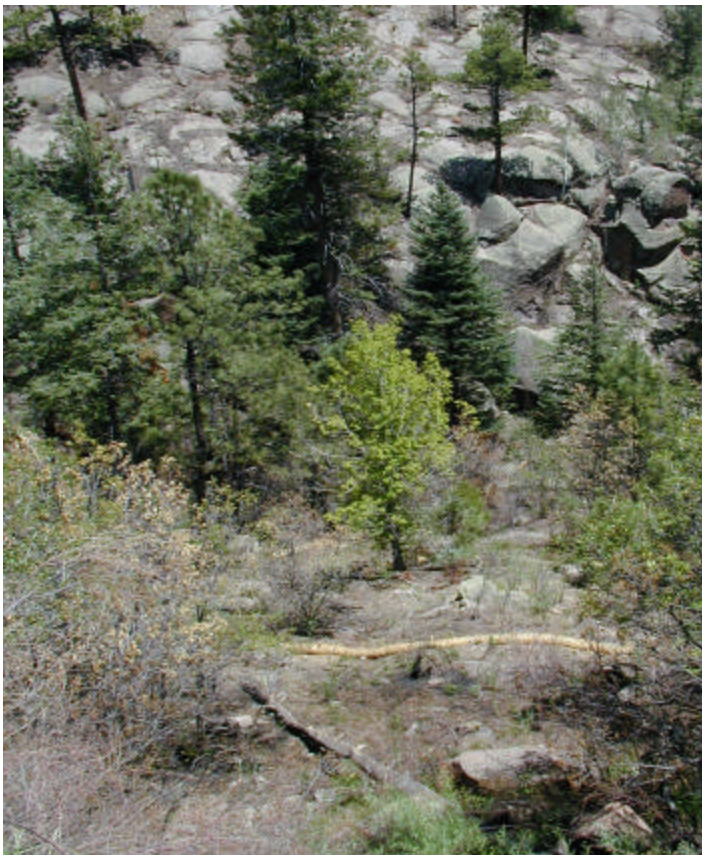
16-003(a) – *Erosion Matrix Score 55.5*. A single inactive HE sump and an outfall associated with TA-16-410.

Site is located near a tributary in upper Water Canyon within the Upper Water Canyon Watershed Aggregate. The site has minor to moderate fire damage within the outfall drainage.

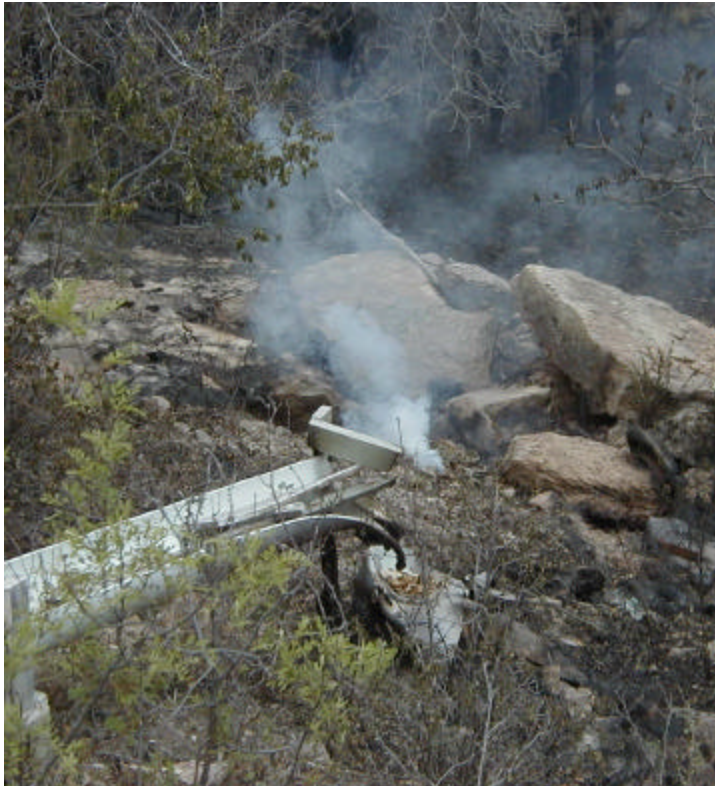
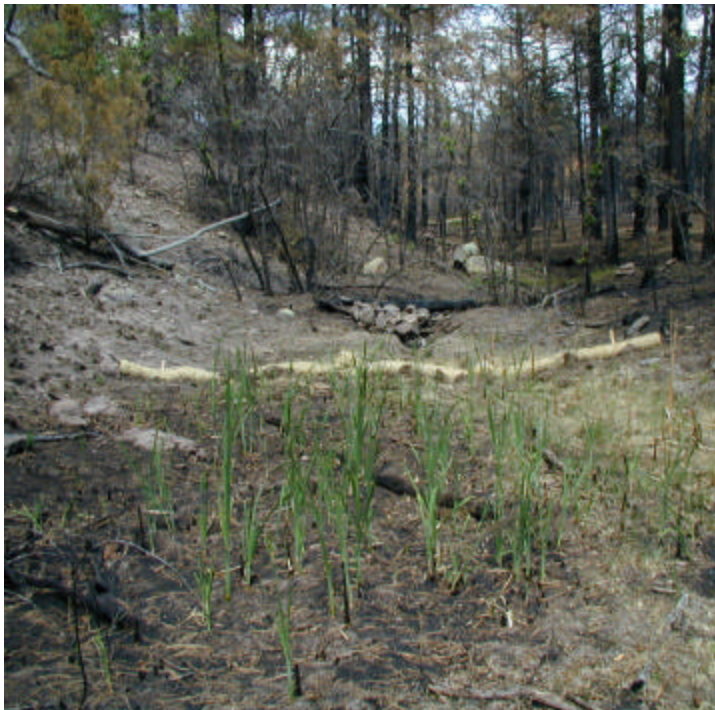
16-003(o) – *Erosion Matrix Score 27.3*. Six active HE sumps associated with TA-16-340. The outfall, EPA 05A054, discharges effluent from the six HE sumps on the northeast side of TA-16-340. The effluent flows into a common drain line that discharges into a short tributary of Canon de Valle.

The site is located in a tributary drainage of Water Canyon within the Canon de Valle Watershed Aggregate. The “fish ladder” was destroyed by the fire. The remainder of the site has minor to moderate fire damage within the drainage channel down to the existing wetlands located approximately ¼ mile downstream.

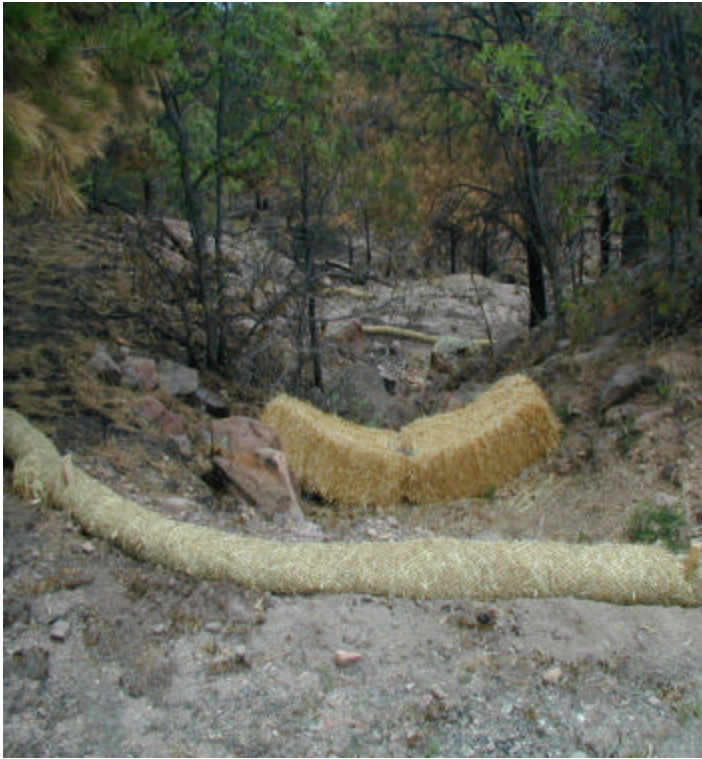
16-026(h2) – *Erosion Matrix Score 61.0*. An outfall associated with the HE sump at TA-16-360.

The site is located in a tributary drainage of Water Canyon within the Upper Water Canyon Watershed Aggregate. The site has minor to moderate fire damage within drainage channel.

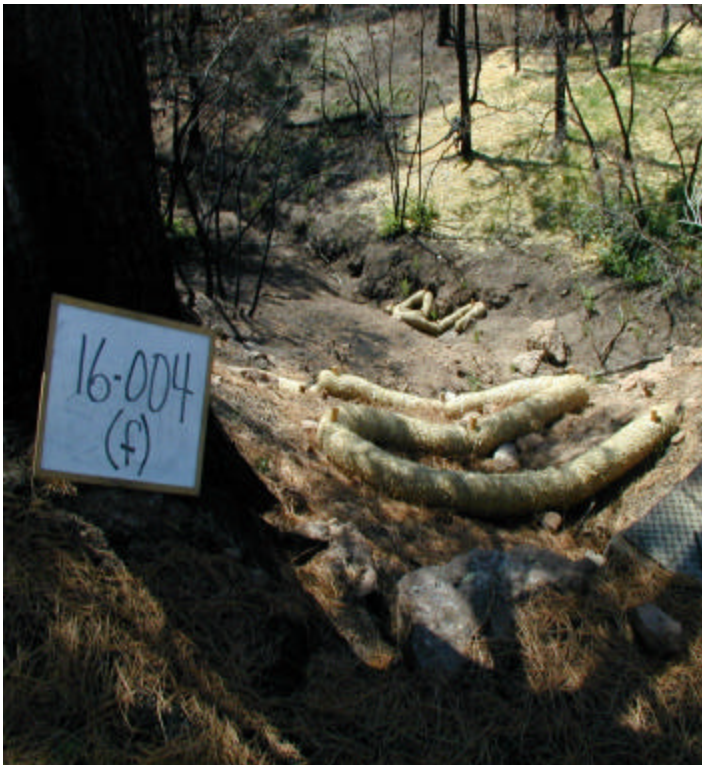
16-004(f) – *Erosion Matrix Score 31.0*. Sludge drying bed and associated outfall near Sanitary Wastewater Treatment Facility at 16-535.

The site is located in a tributary drainage of Water Canyon within the S-Site Canyon Watershed Aggregate. The site has minor to moderate fire damage within drainage channel.

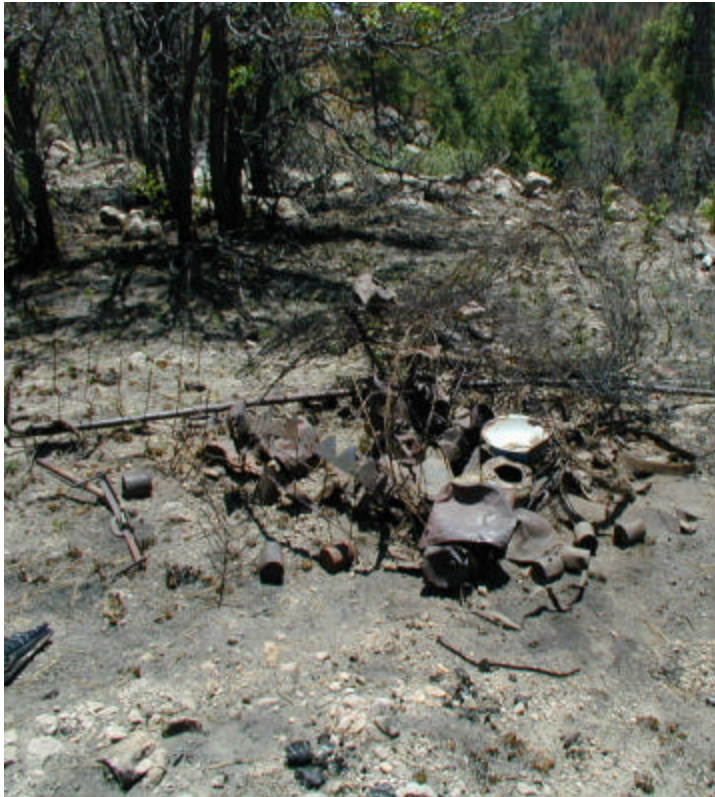
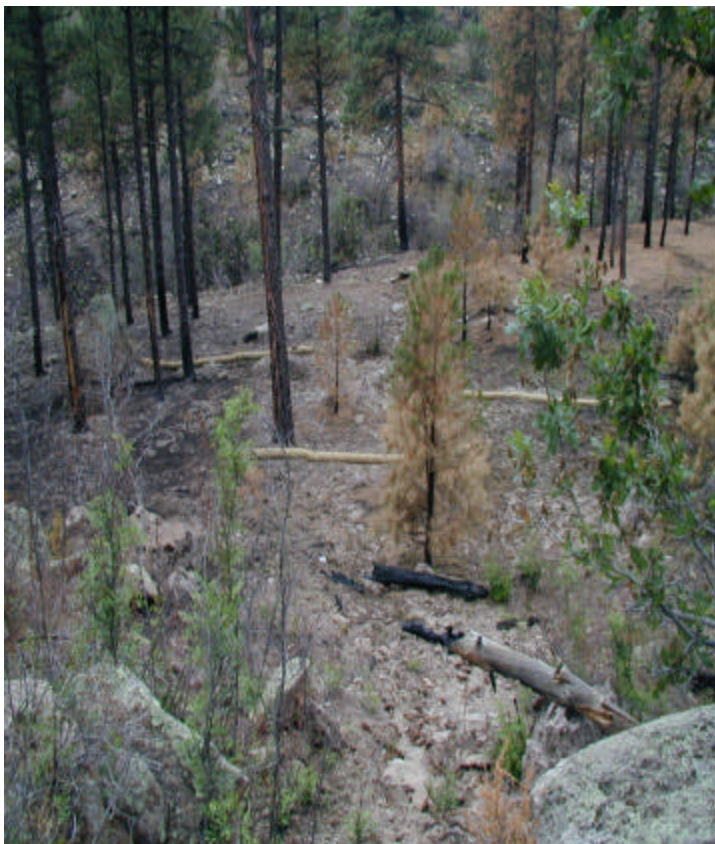
16-028(b) – *Erosion Matrix Score 83.0*. Potentially contaminated soil from a permitted outfall at TA-16-370. The outfall drains from the west side of the building and daylights approximately 50 ft. south of the building in a steep, rocky area of Water Canyon.

The site is located in a tributary drainage of Water Canyon within the Canon de Valle Watershed Aggregate. The site has minor to moderate fire damage within drainage channel. Debris was exposed within channel near the inactive outfall.

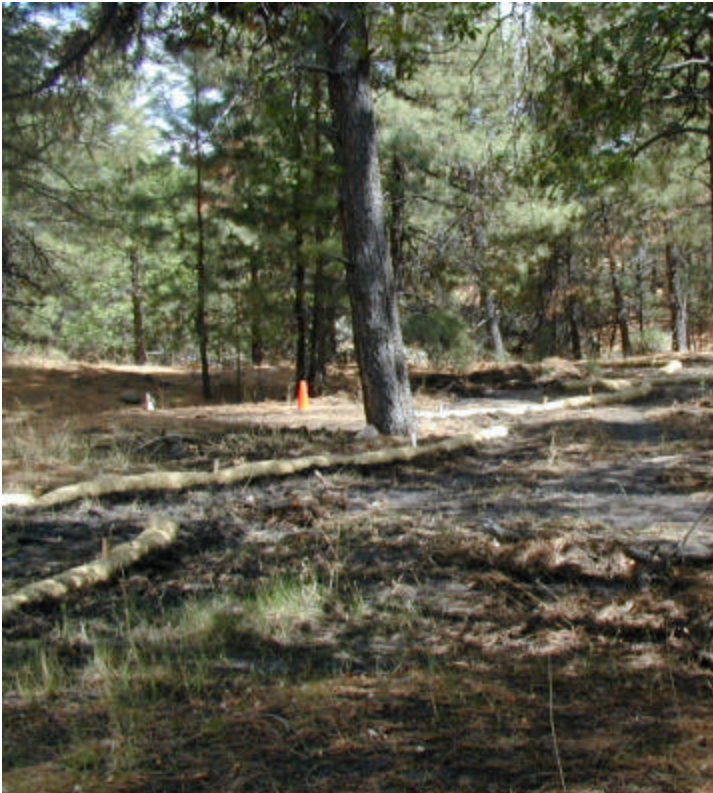
16-029(g) – *Erosion Matrix Score 21.5*. An active HE sump associated with TA-16-450. The outfall, EPA 04A091 located to the southeast of TA-16-450, receives effluent from the sump.

The site is located in a tributary drainage of Water Canyon within the Upper Water Canyon Watershed Aggregate. The site has moderate fire damage of the ground cover with minor canopy damage.

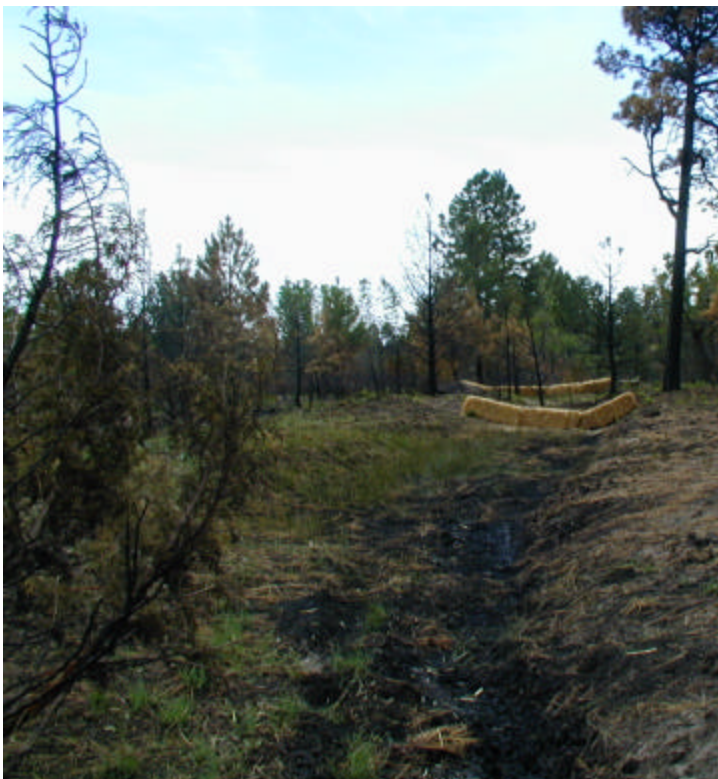
16-030(h) – *Erosion Matrix Score 29.1*. Building TA-16-430 functions as a high explosives pressing facility. Plastic-bonded explosives and mock HE powders are pressed to shape. The site consists of three outfalls associated with the three HE sumps at TA-16-430.

The site is located in a tributary drainage of Water Canyon within the Upper Water Canyon Watershed Aggregate. The site has moderate fire damage of the ground cover with minor canopy damage.

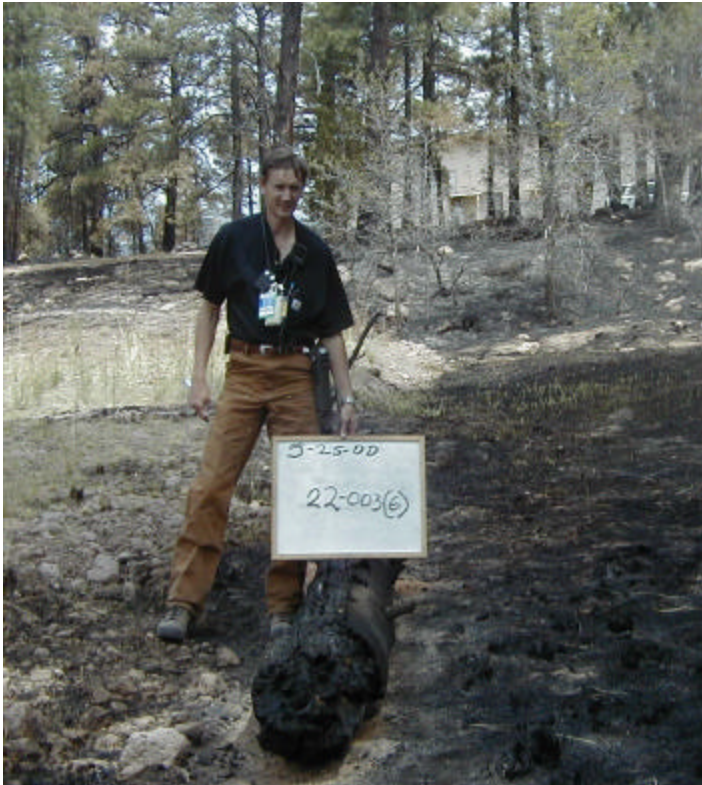
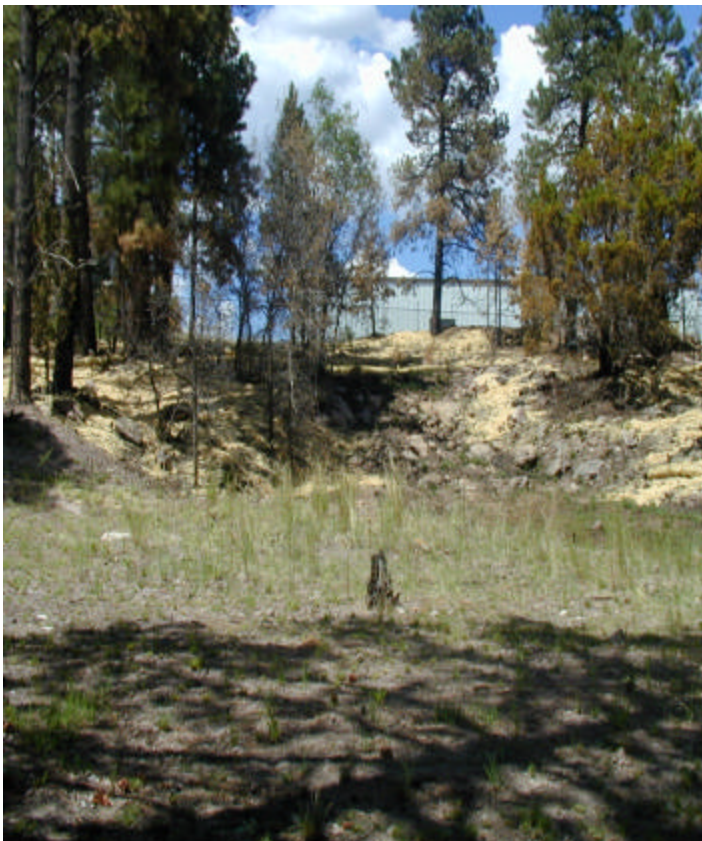
22-015(c) – *Erosion Matrix Score 51.5*. Former outfall from plating & etching operation.

The site is located in a tributary drainage of Pajarito Canyon within the Starmer's/Pajarito Canyon Watershed Aggregate. Moderate fire damage was found at 22-015(c) including the drainage swale below the inactive outfall, the pond area and stained areas leading to the mesa edge. The ground cover was severely damaged leaving little or no protection.

*Photograph is mislabeled.

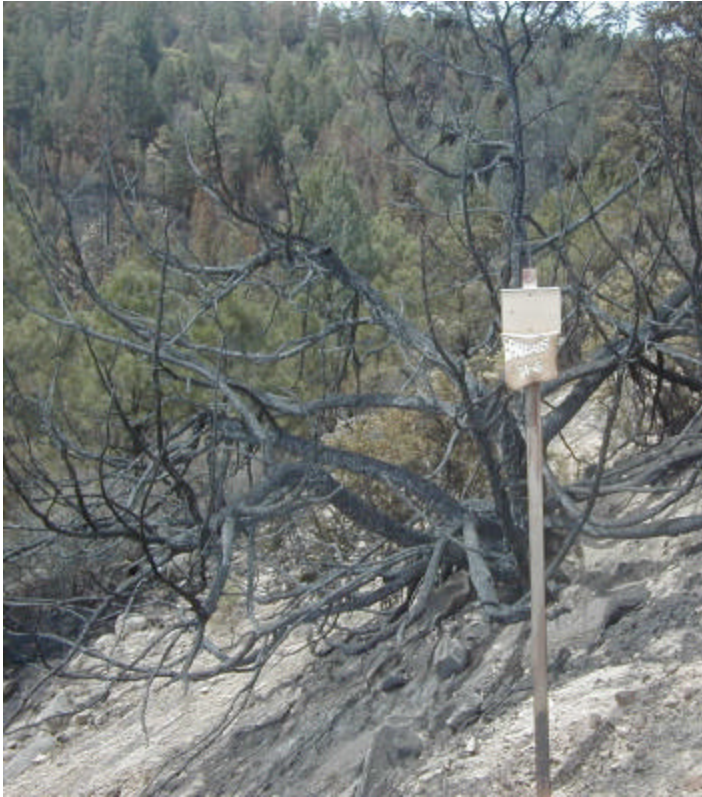
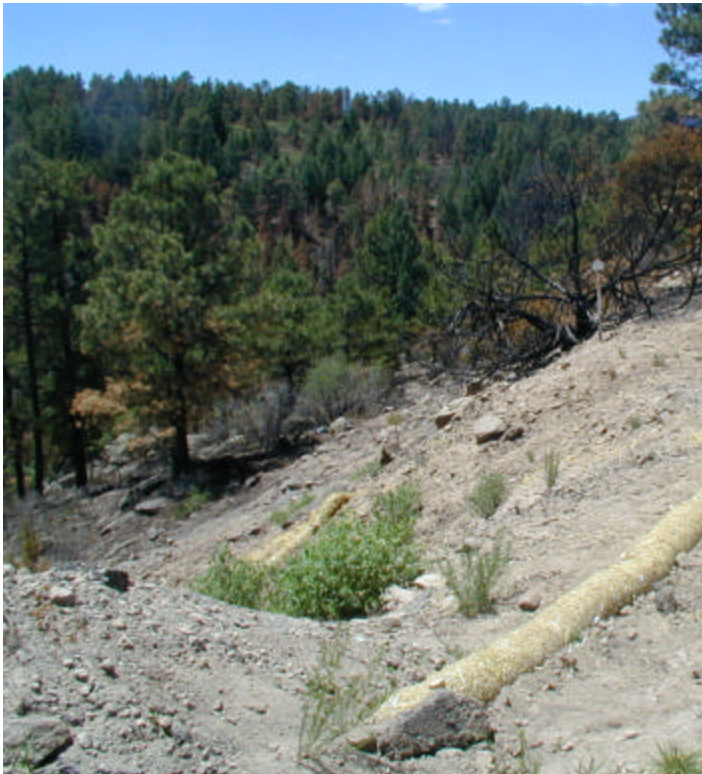
40-006(b) – *Erosion Matrix Score 62.0*. Active firing site used only for testing and development of small explosive devices and not for waste disposal. An inactive NPDES outfall (06A081) is shown.

The site is located on the edge of Pajarito Canyon within the Starmer's/Pajarito Canyon Watershed Aggregate. The fire damage was moderate to severe with several buildings destroyed near this site.

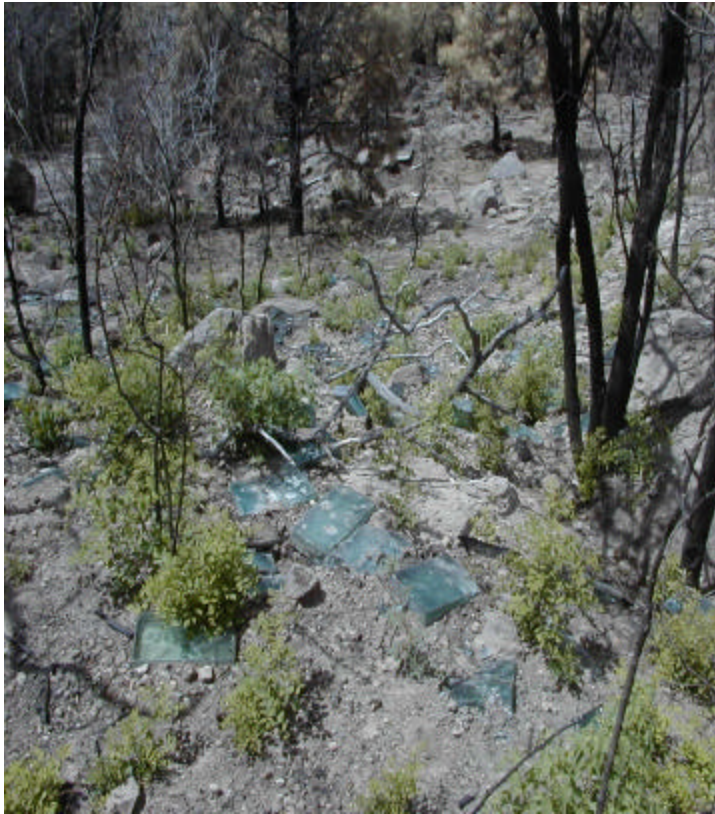
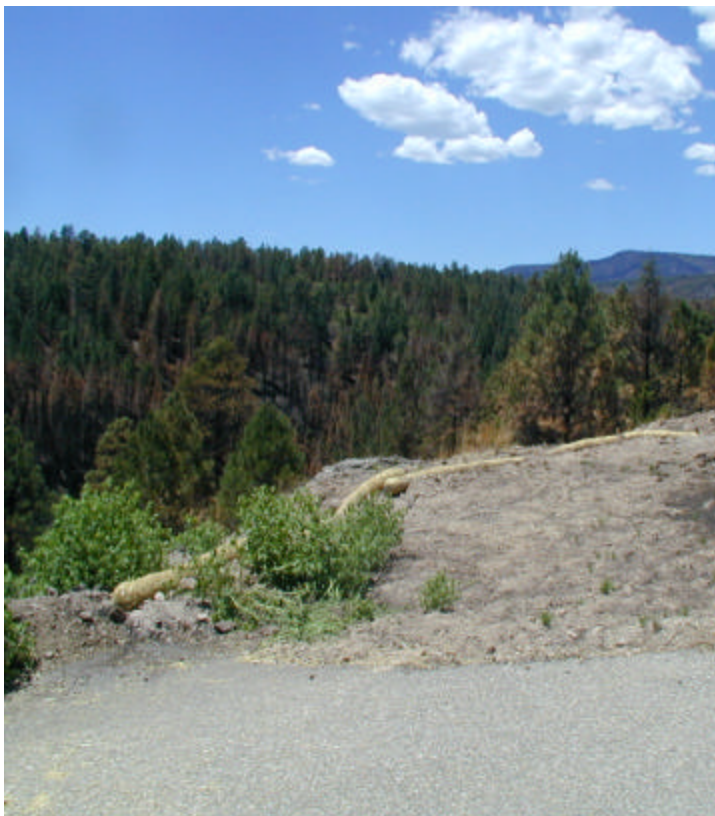
40-006(c) - Erosion Matrix Score 62.0. Active firing site used only for testing and development of small explosive devices and not for waste disposal. An inactive NPDES outfall (06A080) is shown at the site.

Site is located on the edge of Pajarito Canyon within the Starmer's/Pajarito Canyon Watershed Aggregate. The fire damage was moderate to severe with several buildings destroyed near this site.

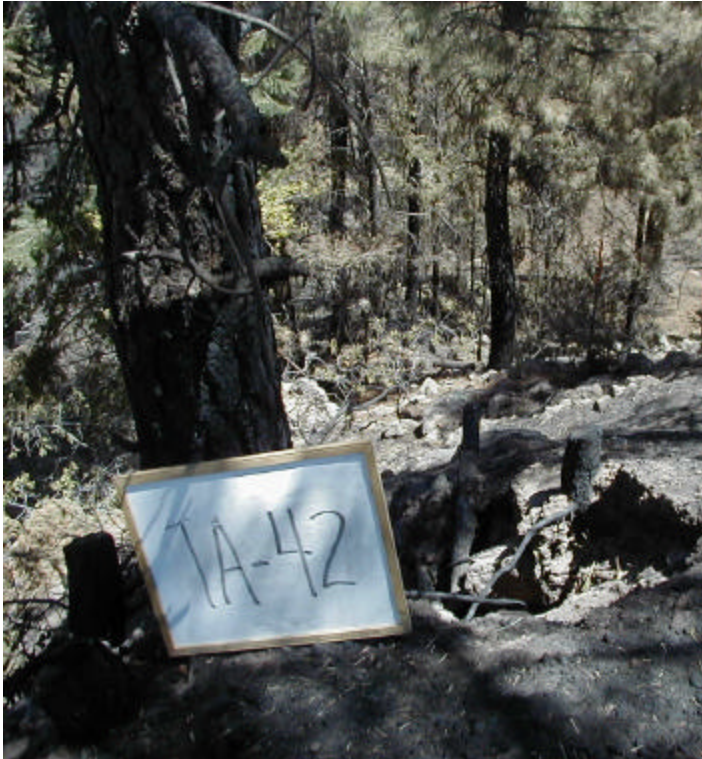
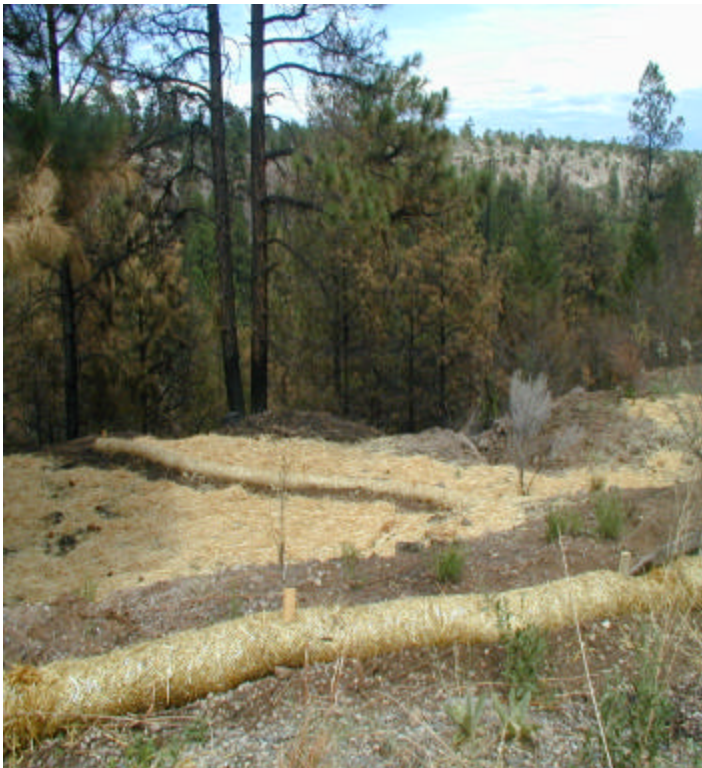
The site is located on a tributary drainage to Mortandad Canyon within the Upper Mortandad Canyon Watershed Aggregate. The entire north facing slope below former TA-42 was moderately burned. Debris on the slope was exposed as a result of the fire. Two distinct drainage channels bisect the area behind the new building constructed near TA-55. The run-on to the western most drainage has been diverted away from the area of concern. The other drainage receives only direct rainfall, with minimal upslope sources.

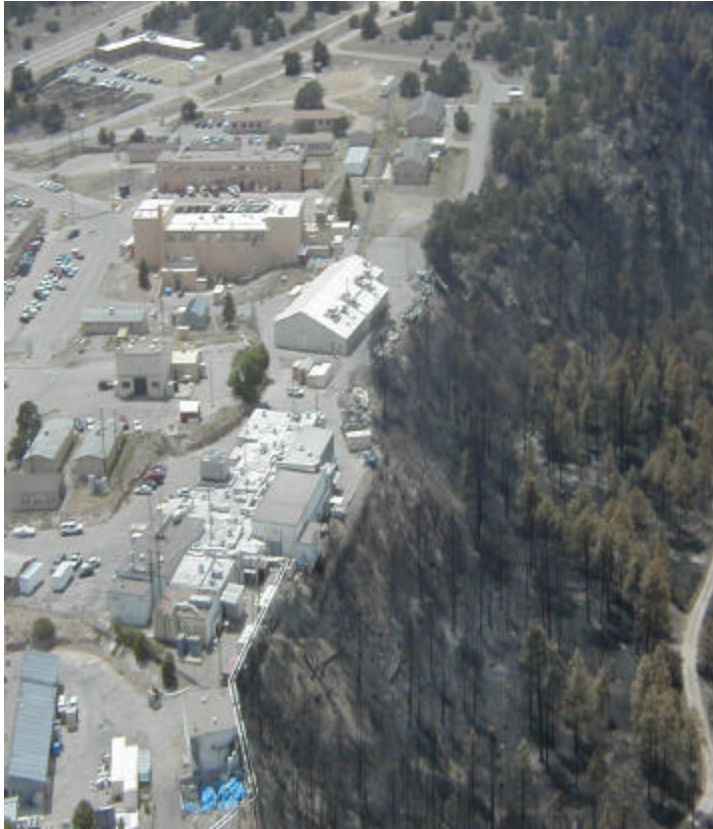
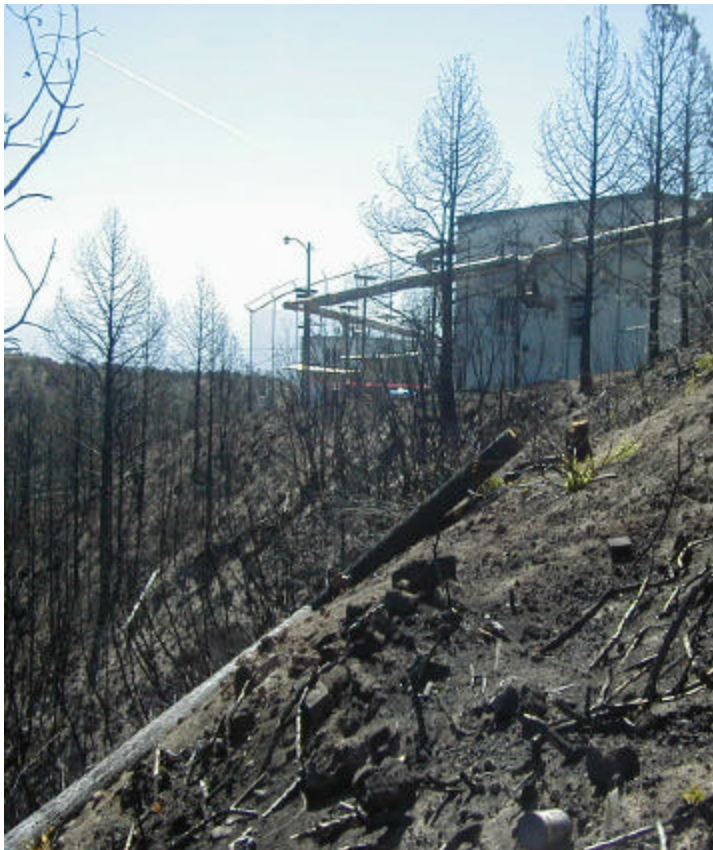
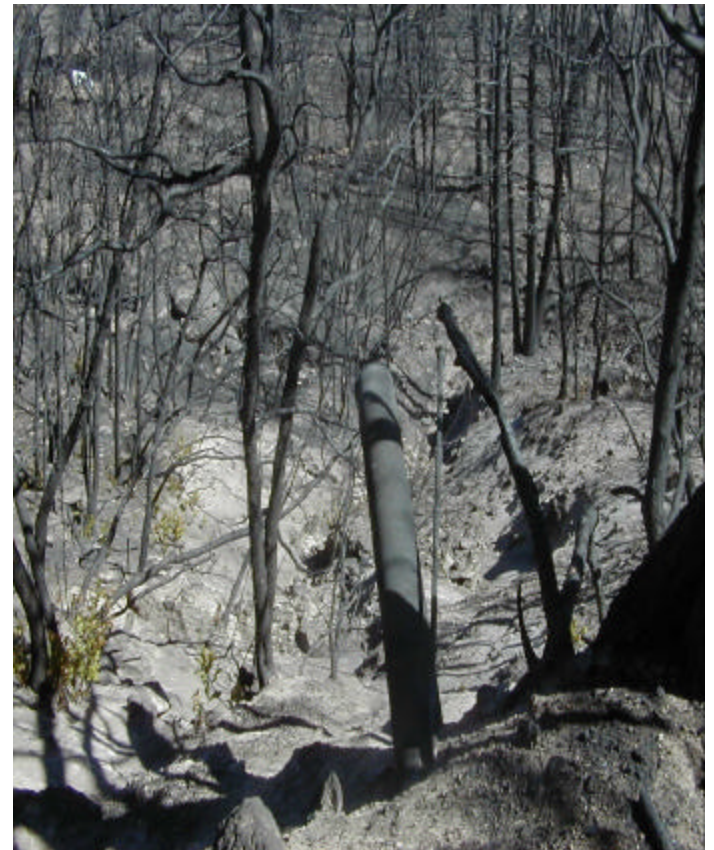
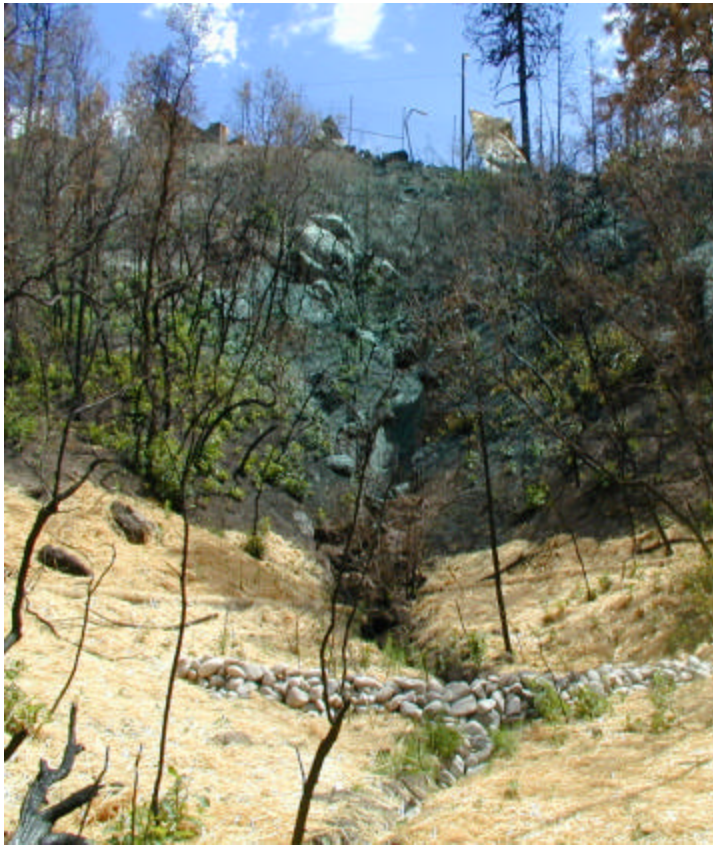
The site is located on the northern edge of Canada del Buey within the Middle Mortandad/Canada del Buey Watershed Aggregate. The entire north-facing slope behind TA-46 was moderately to severely burned. Several buildings along the mesa edge were destroyed. The canopy and ground cover was mostly destroyed. The northern slope is extremely steep with several inactive outfalls, pipes and old infrastructure parts exposed.

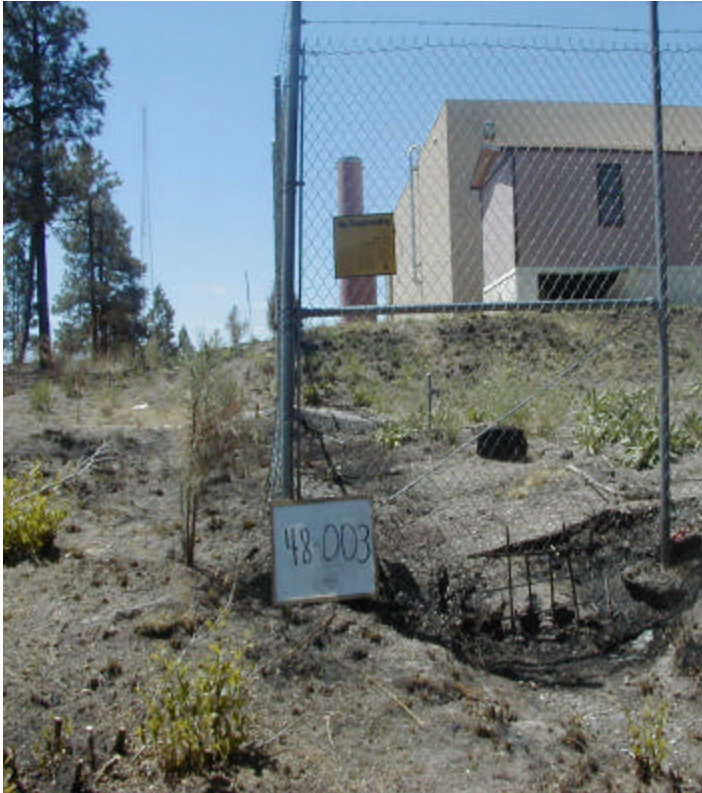
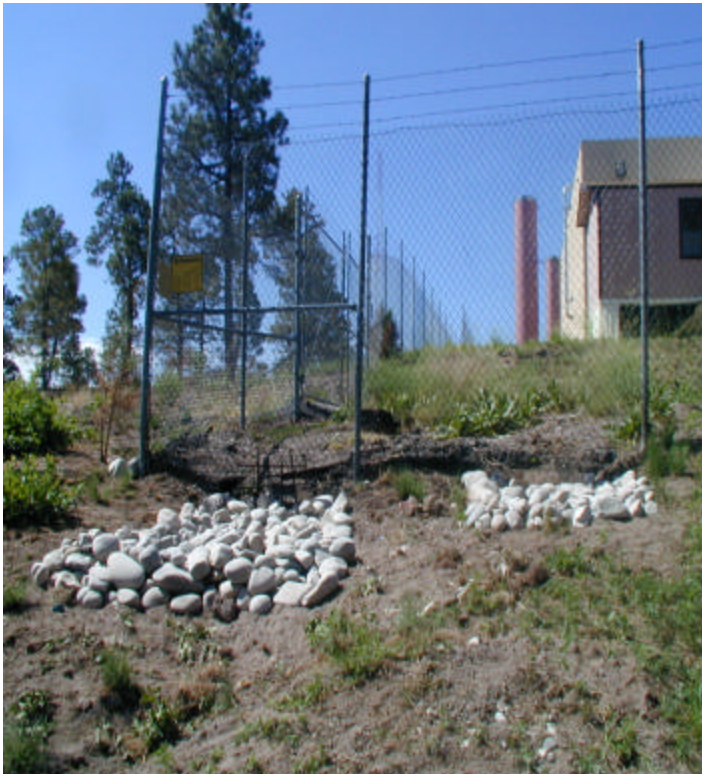
This site is located on the northern edge of Mortandad Canyon within the Upper Mortandad Watershed Aggregate. The northern part of TA-48 was moderately burned, with damage to ground cover and canopy.

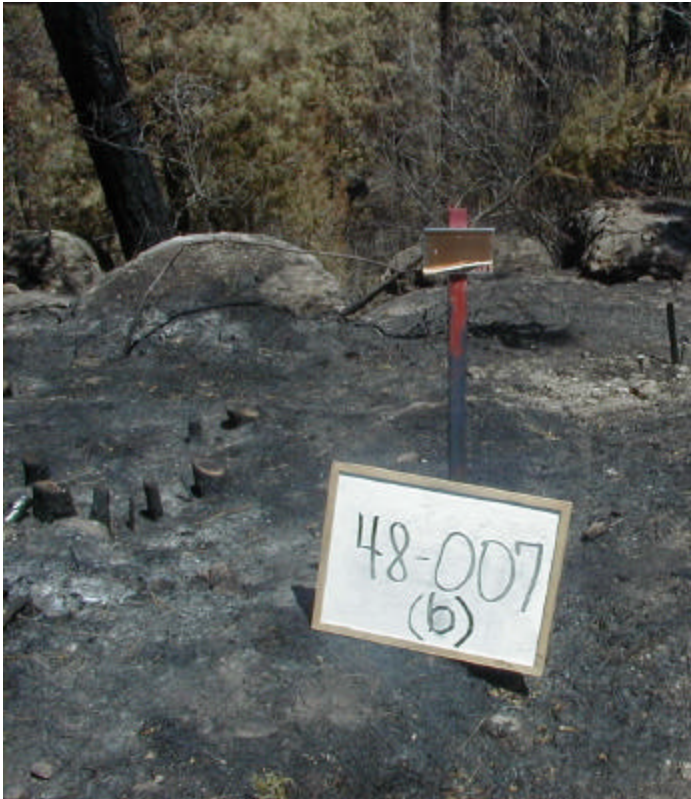
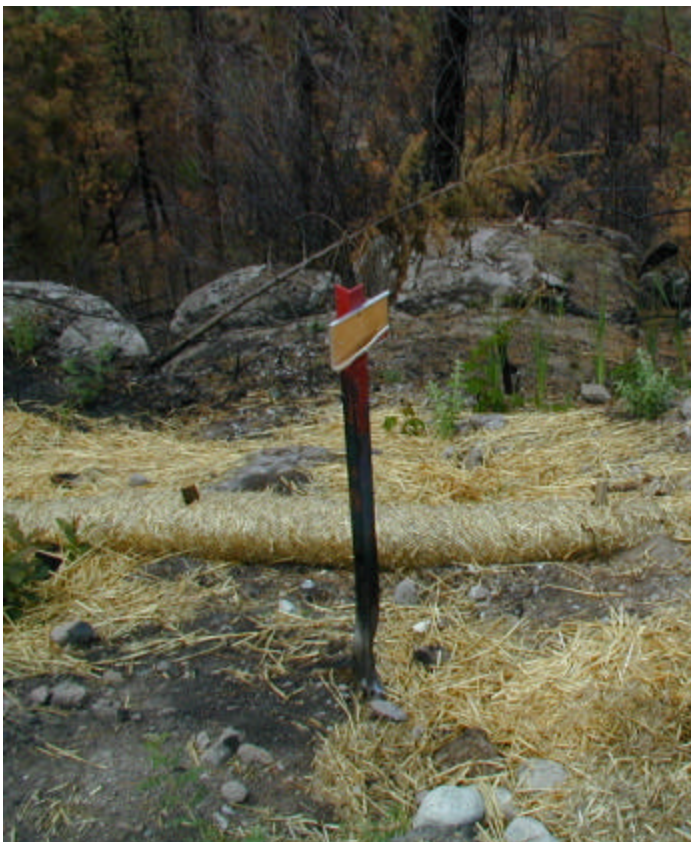
This site is located on the northern edge of Mortandad Canyon within the Upper Mortandad Watershed Aggregate. The northern part of TA-48 was moderately burned, with damage to ground cover and canopy.

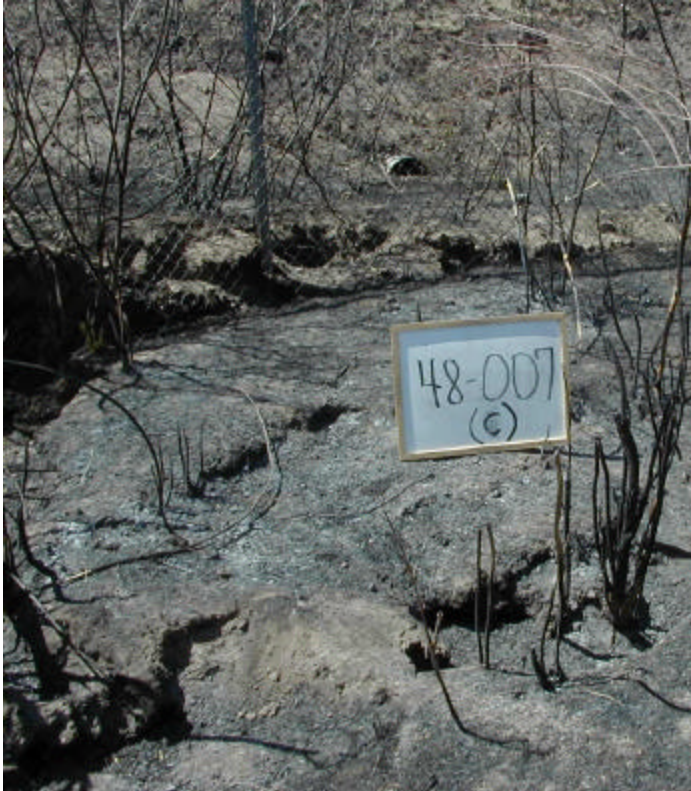
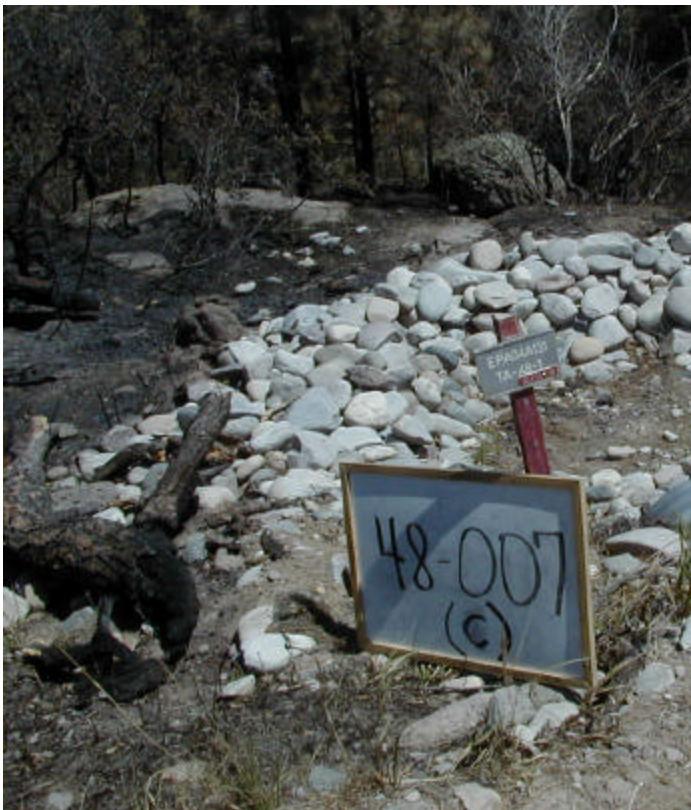
This site is located on the northern edge of Mortandad Canyon within the Upper Mortandad Watershed Aggregate. The northern part of TA-48 was moderately burned, with damage to ground cover and canopy.

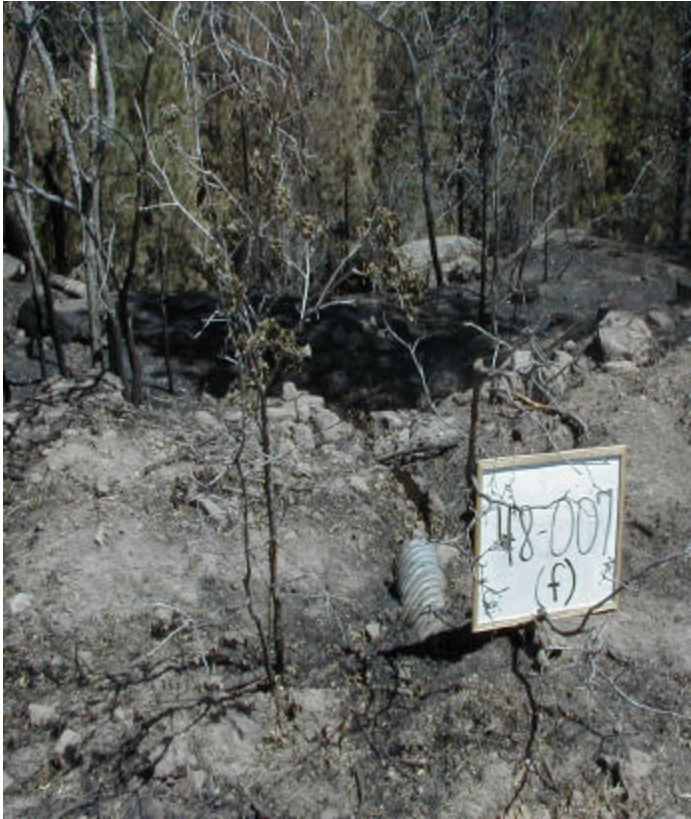
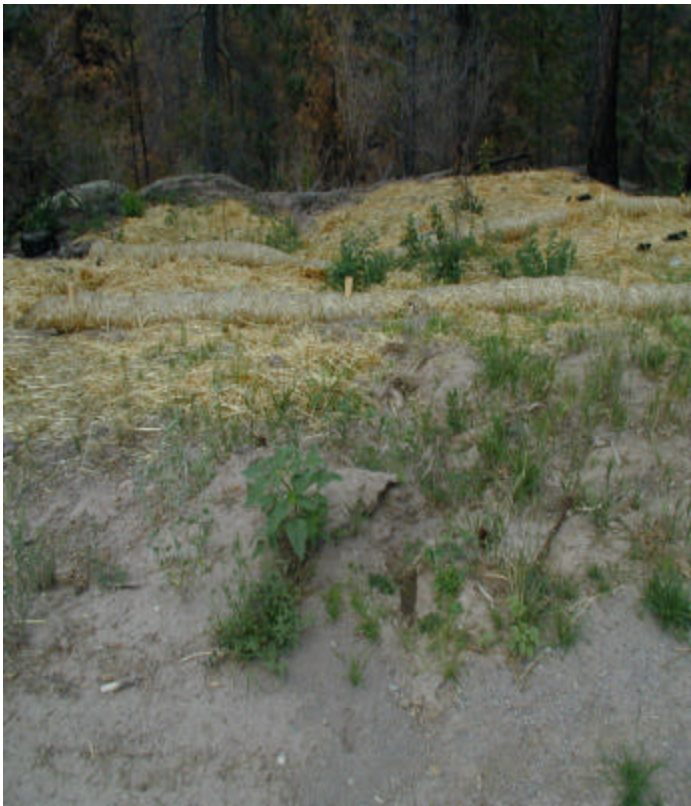
This site is located on the northern edge of Mortandad Canyon within the Upper Mortandad Watershed Aggregate. The northern part of TA-48 was moderately burned, with damage to ground cover and canopy.

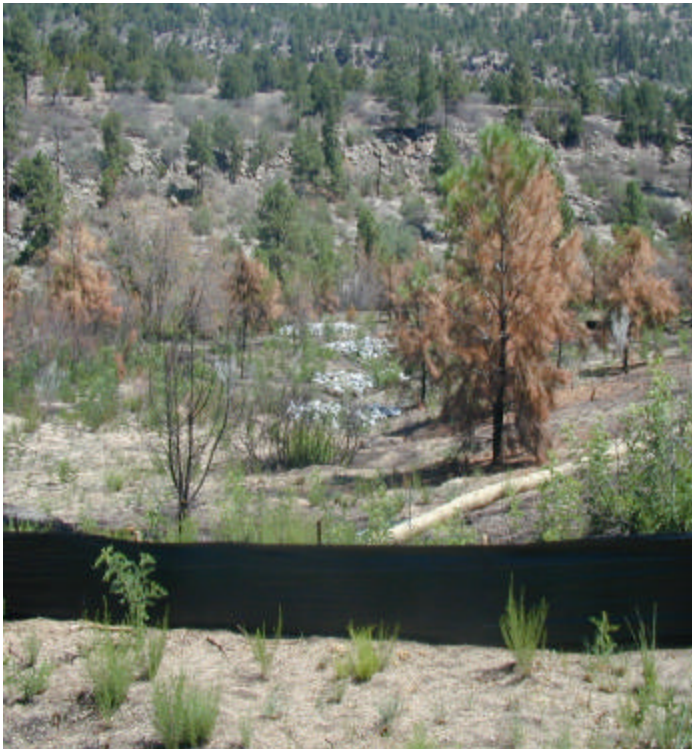
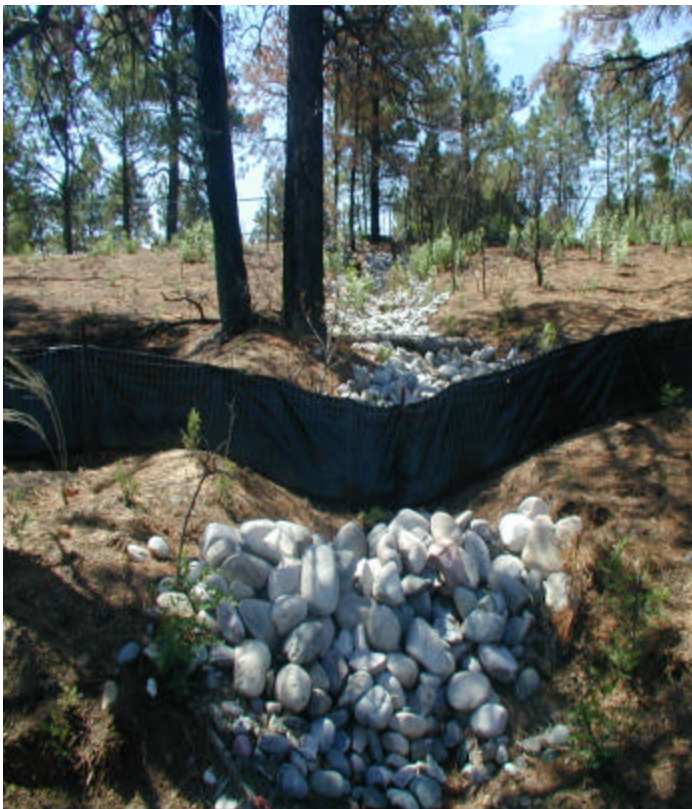
This site is located on a tributary to Water Canyon within the Lower Water/Indio Watershed Aggregate. The area was lightly to moderately burned from MDA AB towards the canyon edge. All existing BMPs were destroyed
