# 2017 Update to the Site Discharge Pollution Prevention Plan, Revision 1

Los Alamos National Laboratory  
NPDES Permit No. NM0030759  
LA-UR-18-22934 • May 1, 2018

## Sandia/Mortandad Watershed

**Volume 2**

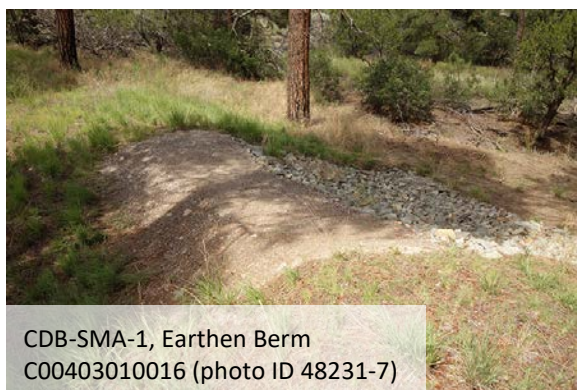
CDB-SMA-1, Earthen Berm  
C00403010016 (photo ID 48231-7)

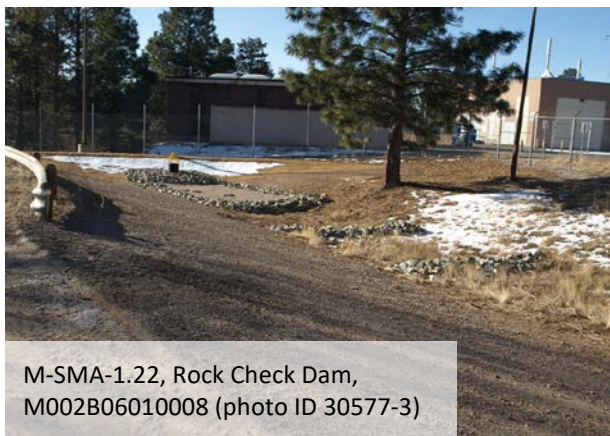
M-SMA-1.22, Rock Check Dam, M002B06010008 (photo ID 30577-3)

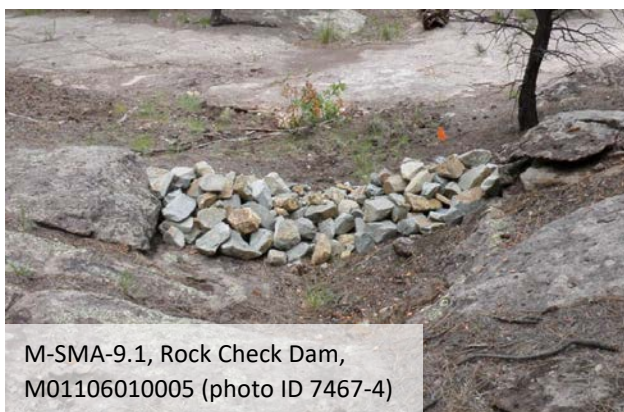
M-SMA-9.1, Rock Check Dam, M01106010005 (photo ID 7467-4)
