Title: Groundwater Discharge Plan Quarterly Report, First Quarter 2011,
Sanitary Wastewater Systems Plant (DP-857)

SUBJECT: GROUNDWATER DISCHARGE PLAN QUARTERLY REPORT, FIRST QUARTER 2011, SANITARY WASTEWATER SYSTEMS PLANT (DP-857)

SERF Evaporation Basins and Leak Inspection Pipes

EVAPORATION POND INSPECTION RECORD JANUARY 13, 2011

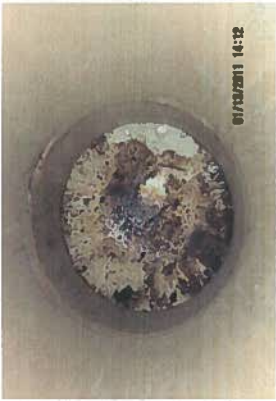
West basin, West inspection Pipe. (1-13-2011)

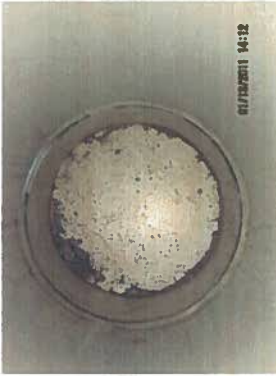
West basin, East inspection Pipe. (1-13-2011)

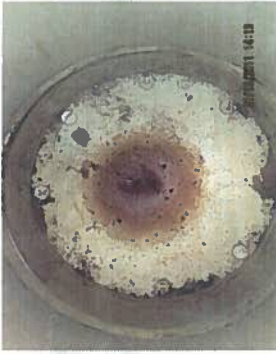
East basin, West inspection Pipe. (1-13-2011)

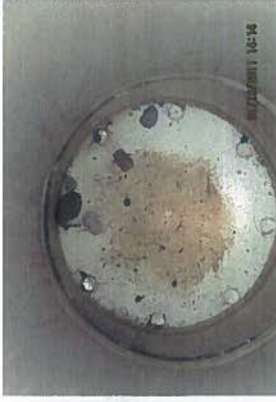
East basin, East inspection Pipe. (1-13-2011)

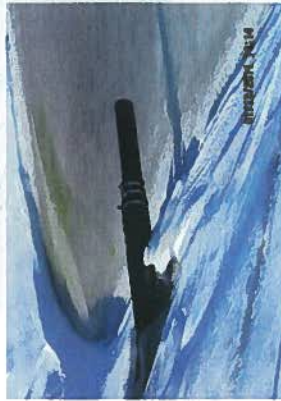
East basin influent pipe (1-13-2011)

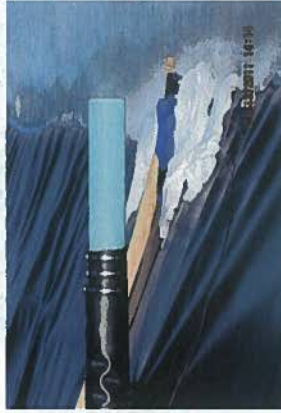
East basin overflow pipe. (1-13-2011)

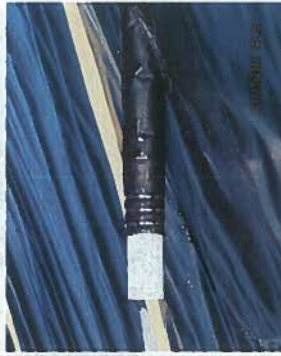
West basin overflow pipe (1-13-2011)

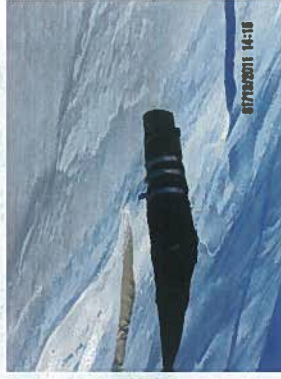
West basin influent pipe. (1-13-2011)

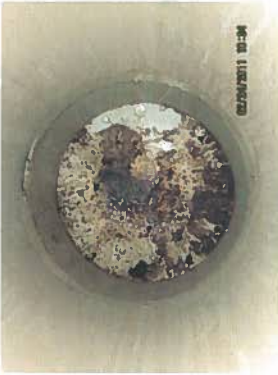
West basin, west inspection
Pipe. (2/24/2011)

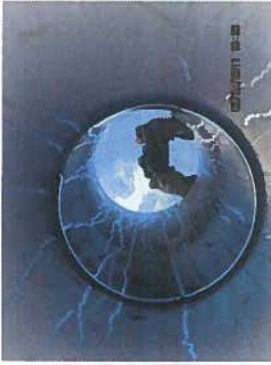
Water was discovered in the west basin's east inspection pipe at a depth of approximately 2 ft on February 24, 2011. The water level in the west SERF evaporation basin on February 24th was very low; roughly, only one-third (1/3) of the of the basin's floor was covered with water. No wastewater from the SERF or from any other Laboratory sources was discharge to either of the SERF basins in 2010. The only source of water to the SERF basins in 2010 was precipitation. Since the discovery, the following corrective actions have been taken:

West basin, East inspection
Pipe. (2/24/2011)

1. On February 28, 2011, the west basin's east inspection pipe was pumped dry. The water removed, approximately XX gal was transferred to the east SERF basin.
2. The west basin's east inspection pipe was monitored daily for the next XX days. A minimal amount of water returned to the pipe; measurements taken with a rod showed <1-inch of standing water in the pipe. A measurement taken on April 8th shows the level unchanged.
3. On two occasions—March 10th and April 1st—air was injected into the west basin's inspection ports in an attempt to produce bubbles or air leaks in the liner; both attempts failed to identify any breaches in the primary liner.

Considering that action no. 3 above did not identify any breach in the liner, the Laboratory will implement the procedures for locating a liner leak provided by the Snow Co., the installer of the liner (see Attachment 3.0).

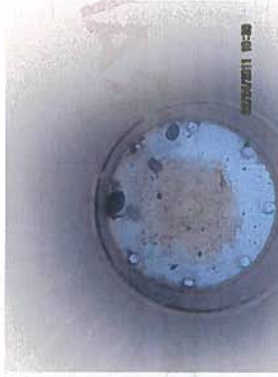
East basin, East inspection
Pipe. (2/24/2011)

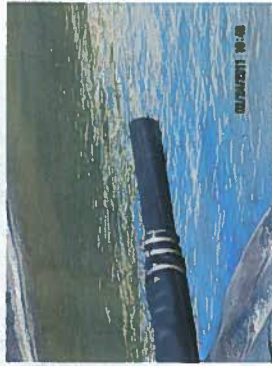
East basin influent pipe.
(2/24/2011)

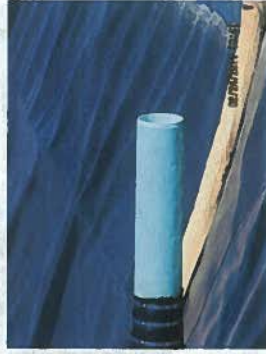
East basin overflow pipe.
(2/24/2011)

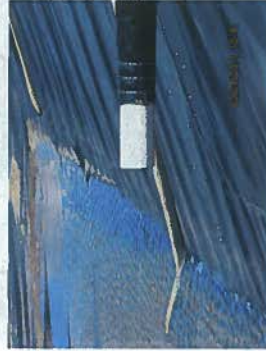
West basin overflow pipe.
(2/24/2011)

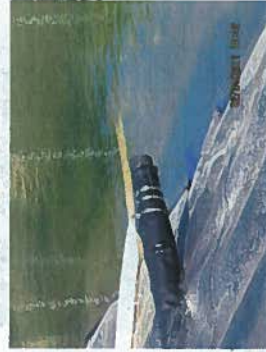
West basin influent pipe.
(2/24/2011)

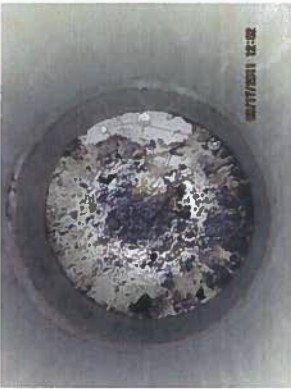
West basin, west inspection
Pipe. (3/17/2011)

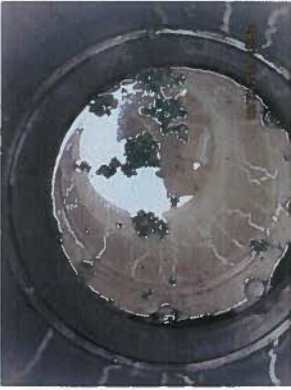
Inspection Date	Inspection Results
1/13/2011	All standpipes are dry or contain minimal amounts of water
2/24/2011	The west basin's east inspection pipe contains water. See report for details.
3/17/2011	The west basin's east inspection pipe contains less than 1" of water.

West basin, east inspection
Pipe (3/17/2011)

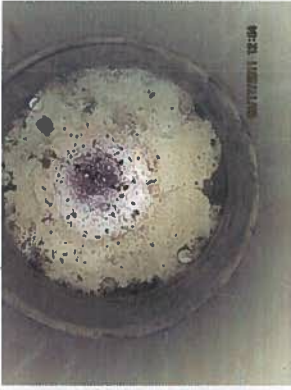
East basin, west inspection
Pipe (3/17/2011)

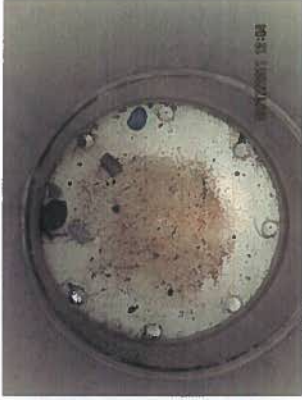
East basin, east inspection
Pipe. (3/17/2011)

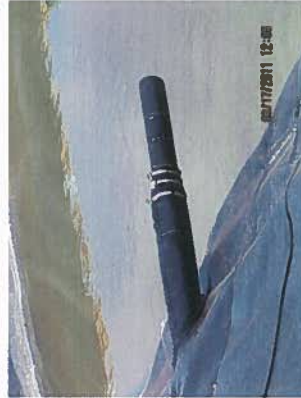
East basin influent pipe.
(3/17/2011)

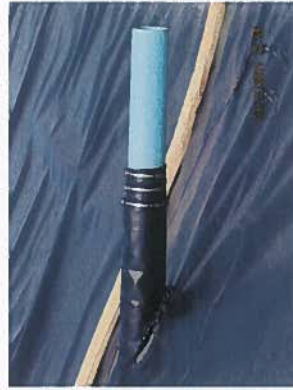
East basin overflow pipe.
(3/17/2011)

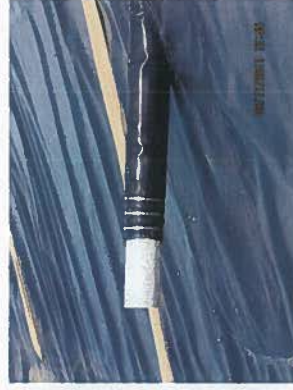
West basin overflow pipe.
(3/17/2011)

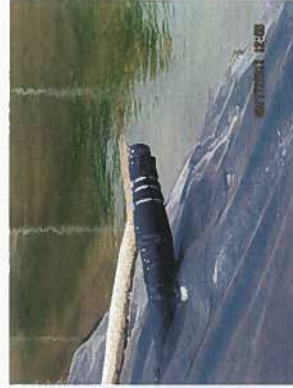
West basin influent pipe.
(3/17/2011)
