Historic Building Assessment

for the Department of Energy Conveyance and Transfer Project

Historic Building Survey Report No. 178

Los Alamos National Laboratory

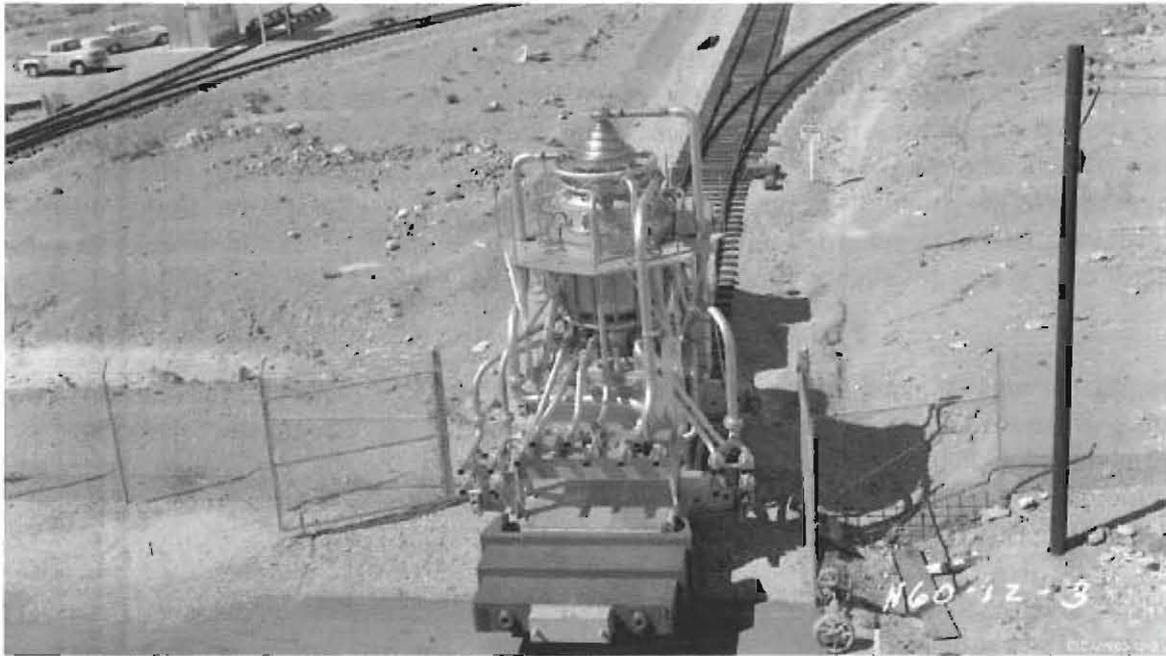
Figure 39. A Los Alamos Kiwi reactor at the Nuclear Rocket Development Station in Nevada.

The design of the reactor’s fuel element was a long process, one that used a lot of the Laboratory’s Project Rover resources (LASL 1964). Fuel elements contain fissile material and are the central part of the reactor core. The fissile material is usually mixed with a matrix material and then coated to prevent corrosion (LASL 1969). Several different types of fuel elements were developed: one was a mixture of uranium dioxide with metal and another was a mixture of uranium carbide and graphite. The reactor fuel elements were designed with holes in them for hydrogen to pass through. The holes were coated with high-temperature carbides for protection against the intense heat of the reactor (LANL 1983).

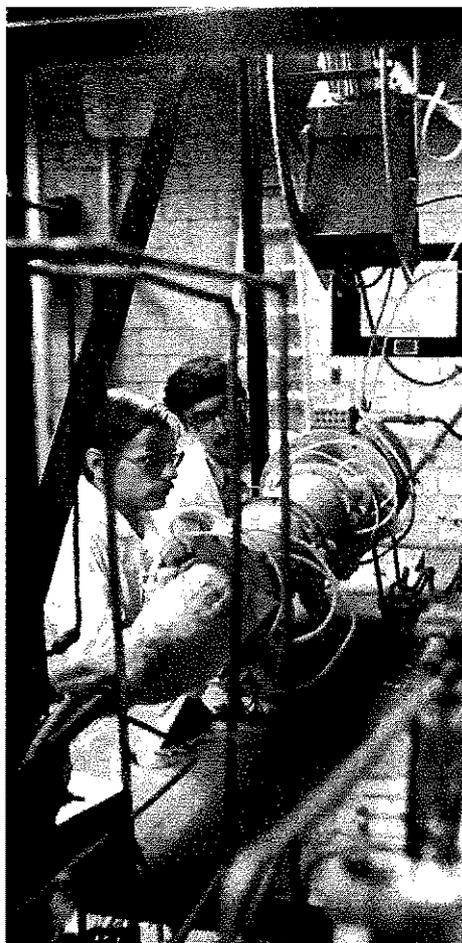
Figure 43. Workers at DP East operate the vapor deposition device constructed, in part, with components from the defunct Project Rover.

Using surplus Project Rover equipment, chemists from CMB-3 conducted vapor deposition experiments at DP East related to superconducting transmission research (Figure 43). The work at DP Site drew on advances in coating methods developed during Project Rover. Vapor deposition techniques were originally developed to protect reactor components from corrosion. Chemical vapor deposition causes gaseous materials to react and form a solid compound on a surface. The vapor deposition method used in the superconducting experiments allowed the buildup of a niobium and germanium compound in 50-micron-thick films that carried very large currents with no resistive losses at high temperatures. These films began superconducting at temperatures produced by using hydrogen slush as a coolant. This was an important development since hydrogen slush is inexpensive and readily available (LASL 1974).

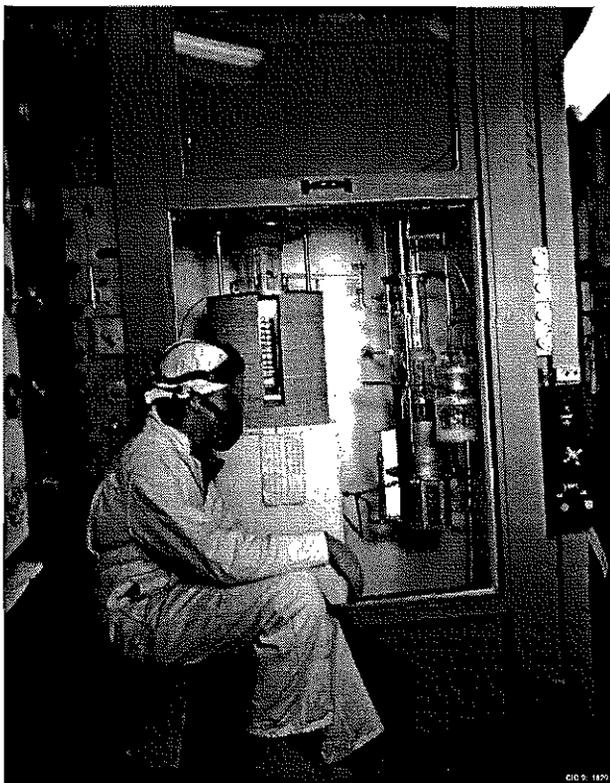
Figure 44. An early plutonium worker performs a purification operation in an open chemical hood.

Early nuclear chemistry operations were crude in comparison to today's operations (LASL 1973). Workers typically used open hoods, hood-type cabinets with sliding doors, and even unventilated gloveboxes (Maraman *et al.* 1975, LANL 1995b) (Figure 44). The prototype gloveboxes, called "dry boxes," were made of plywood and constituted a fire hazard (LANL 1983).

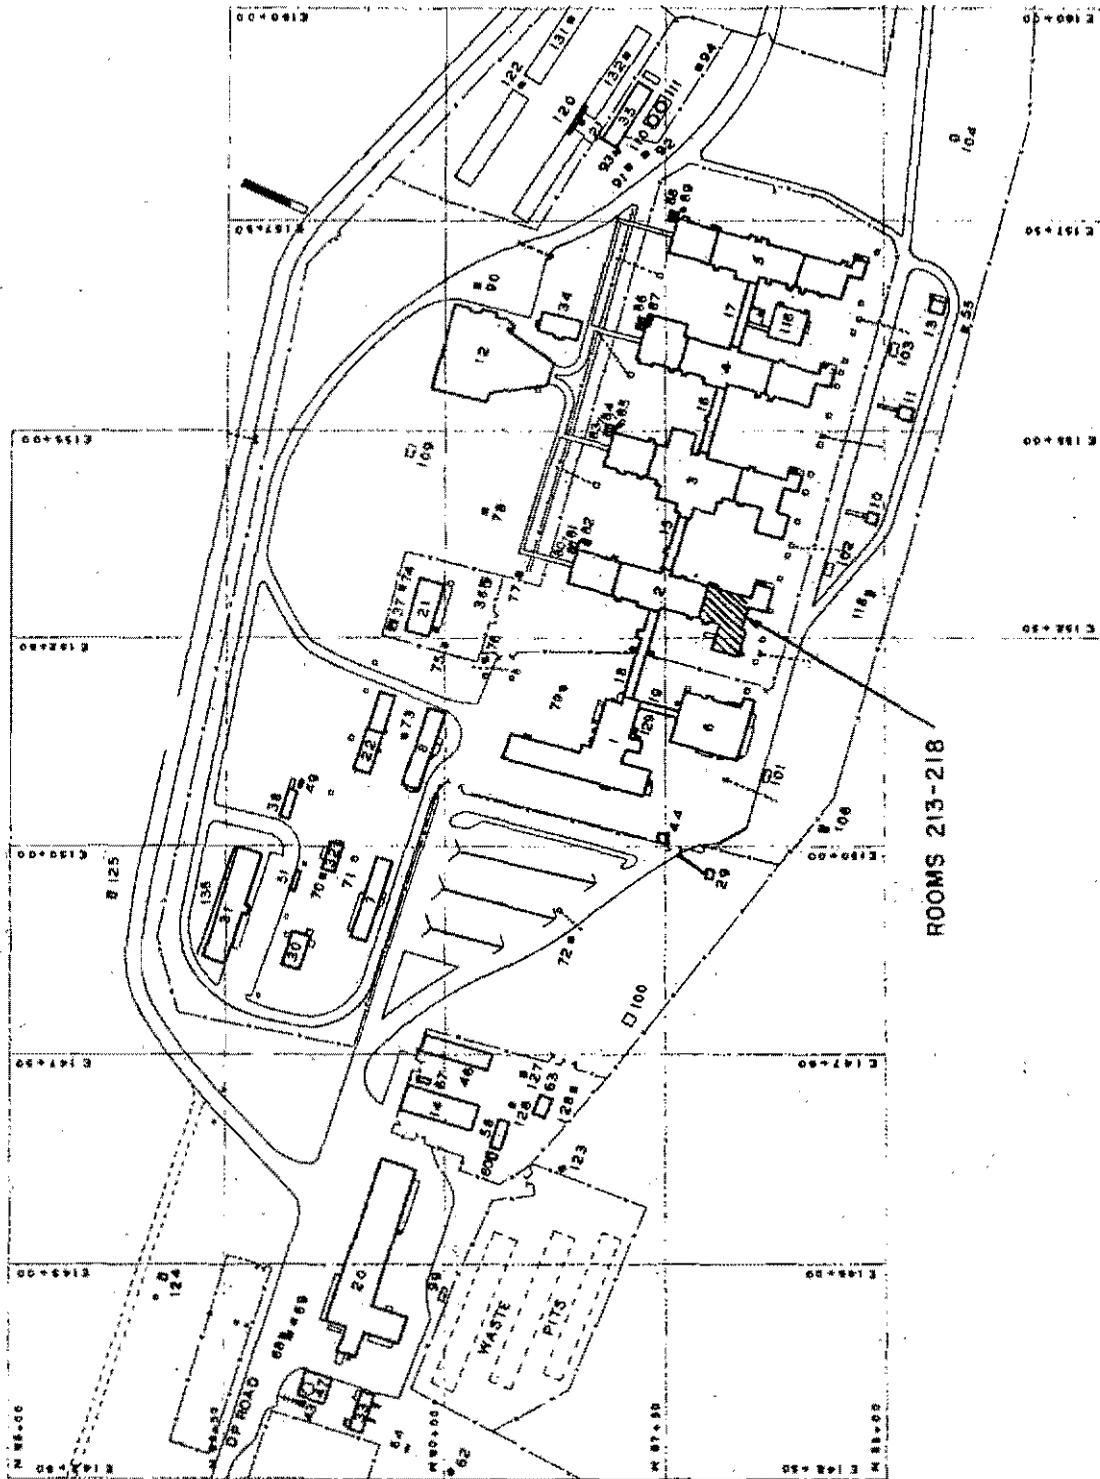
Figure 47. Map showing location of Cecil Kelley accident.

On December 30, 1958, a nuclear-criticality accident occurred in DP West's plutonium recovery operation area, Building TA-21-2 South (Figure 47). The accident involved a liquid solution of plutonium compounds and chemical reagents. This solution, containing unexpectedly high levels of plutonium, was transferred to a stainless steel tank in Building TA-21-2, Room 218 (Figures 48–50). Immediately before the accident, two layers of liquid were present in the large

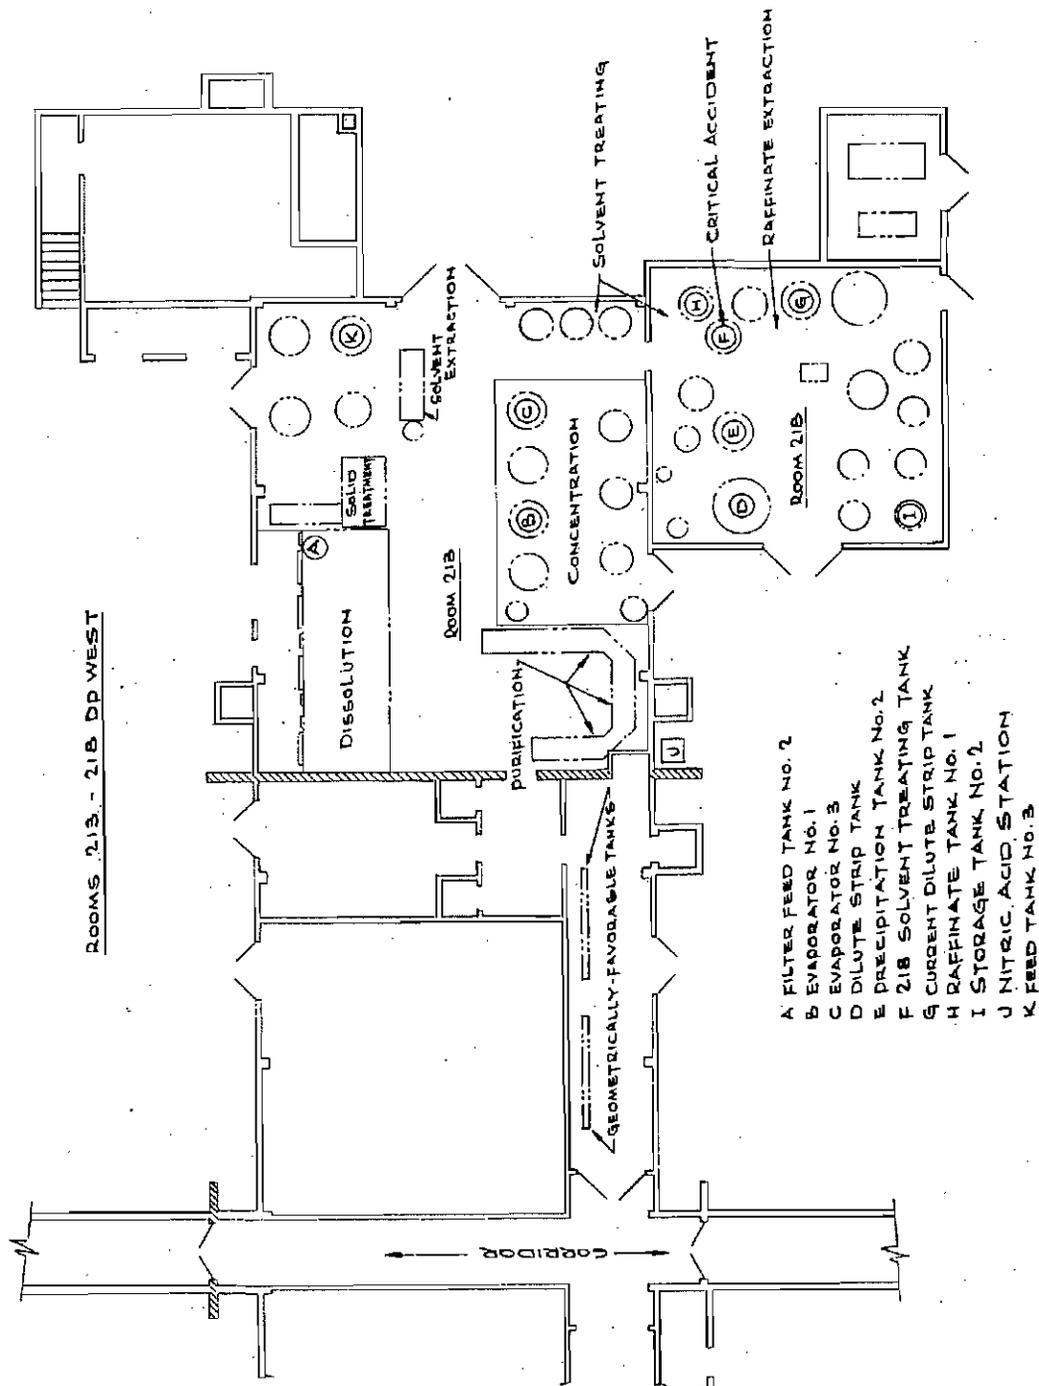
Figure 48. Layout of accident location.

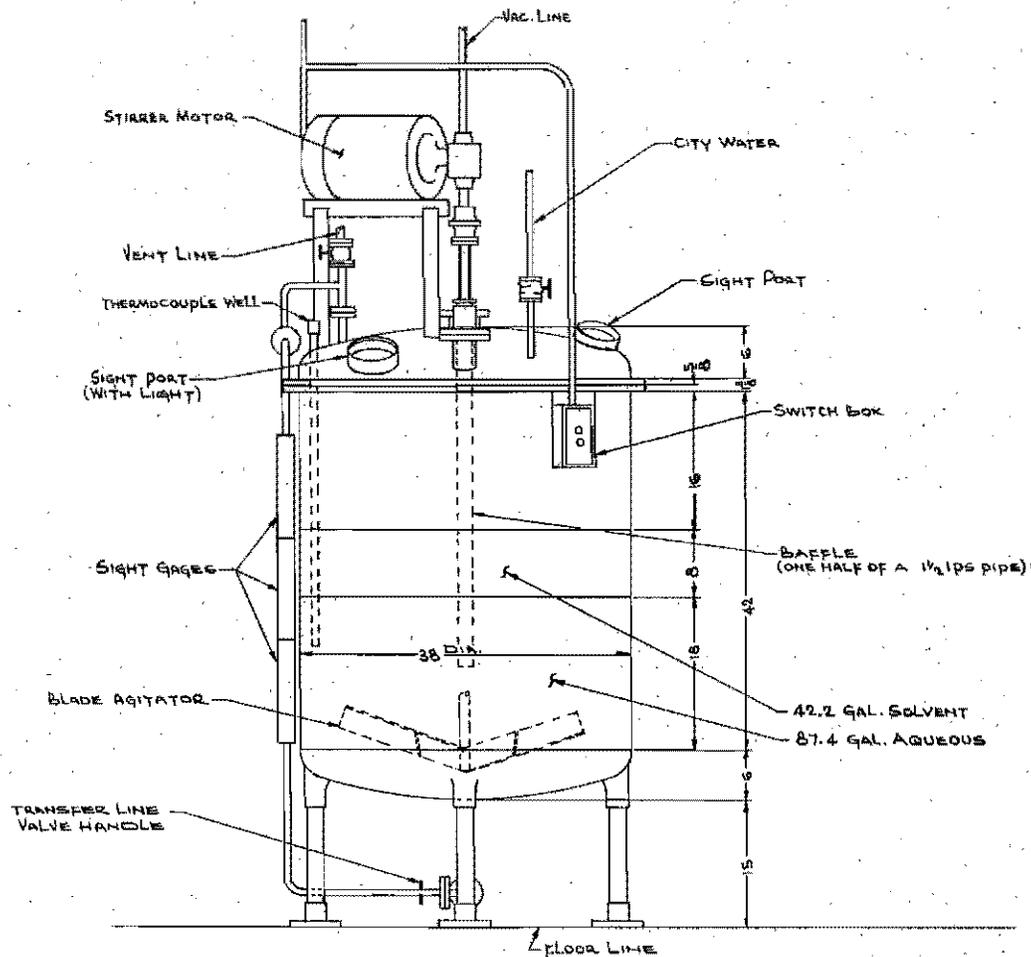
Figure 50. Diagram of solvent-treating tank, showing levels of aqueous and organic phases before stirrer was activated.

mixing tank—both contained amounts of plutonium, but the upper layer was very close to sustaining a chain reaction. The criticality occurred when the operator, Cecil Kelley, turned on the tank's stirrer. The stirring action immediately brought the bottom layer up the sides of the tank causing a thickening of the upper layer of liquid. This changed the system to 'super-prompt critical.' The resulting power excursion, a huge burst of neutrons and gamma radiation, caused Kelley's death approximately 36 hours later. His radiation dose was probably around 12,000 rem ($\pm 50\%$).

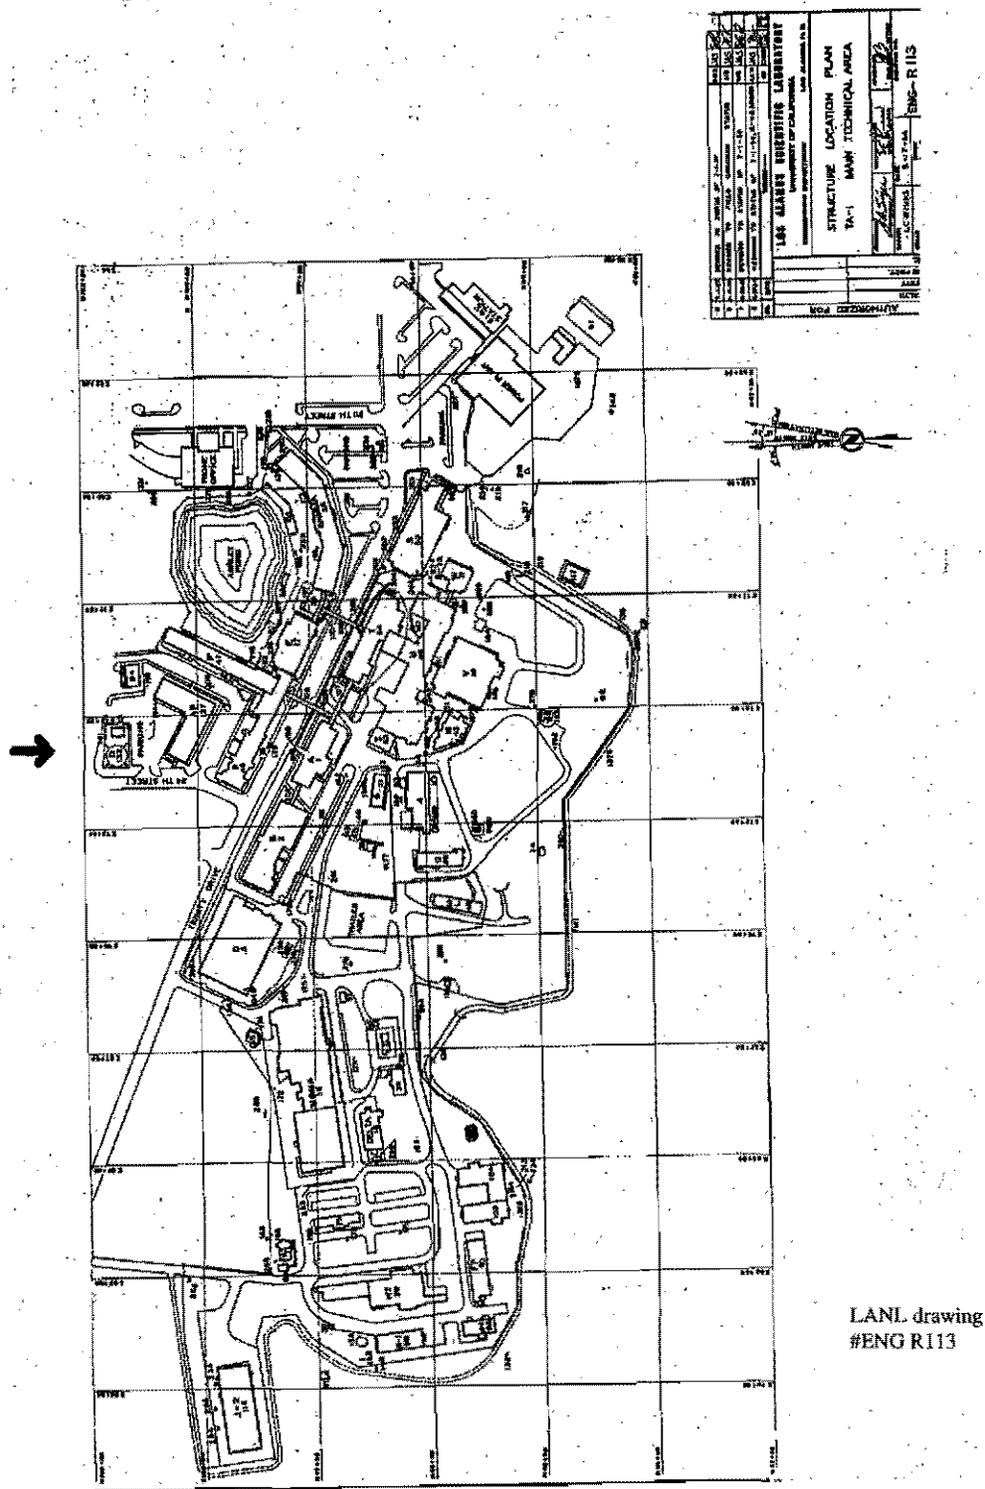
Figure 59. Structure location plan of TA-1 showing the original location of the "checkerboard" water tank (TA-21-258, formerly TA-1-132).

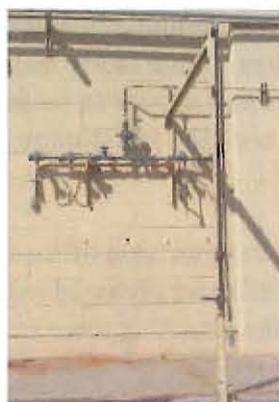
Example of small gas manifold

A gas manifold is a compressed gas distribution system. It is a centralized location where there are compressed gases (gas cylinders) connected to pipes and valves that distribute the gas to various locations.
