LA-UR-14-24617
June 2014
EP2014-0264

Results of 2013 Sediment Monitoring in the Water Canyon and Cañon de Valle Watershed

Prepared by the Environmental Programs Directorate

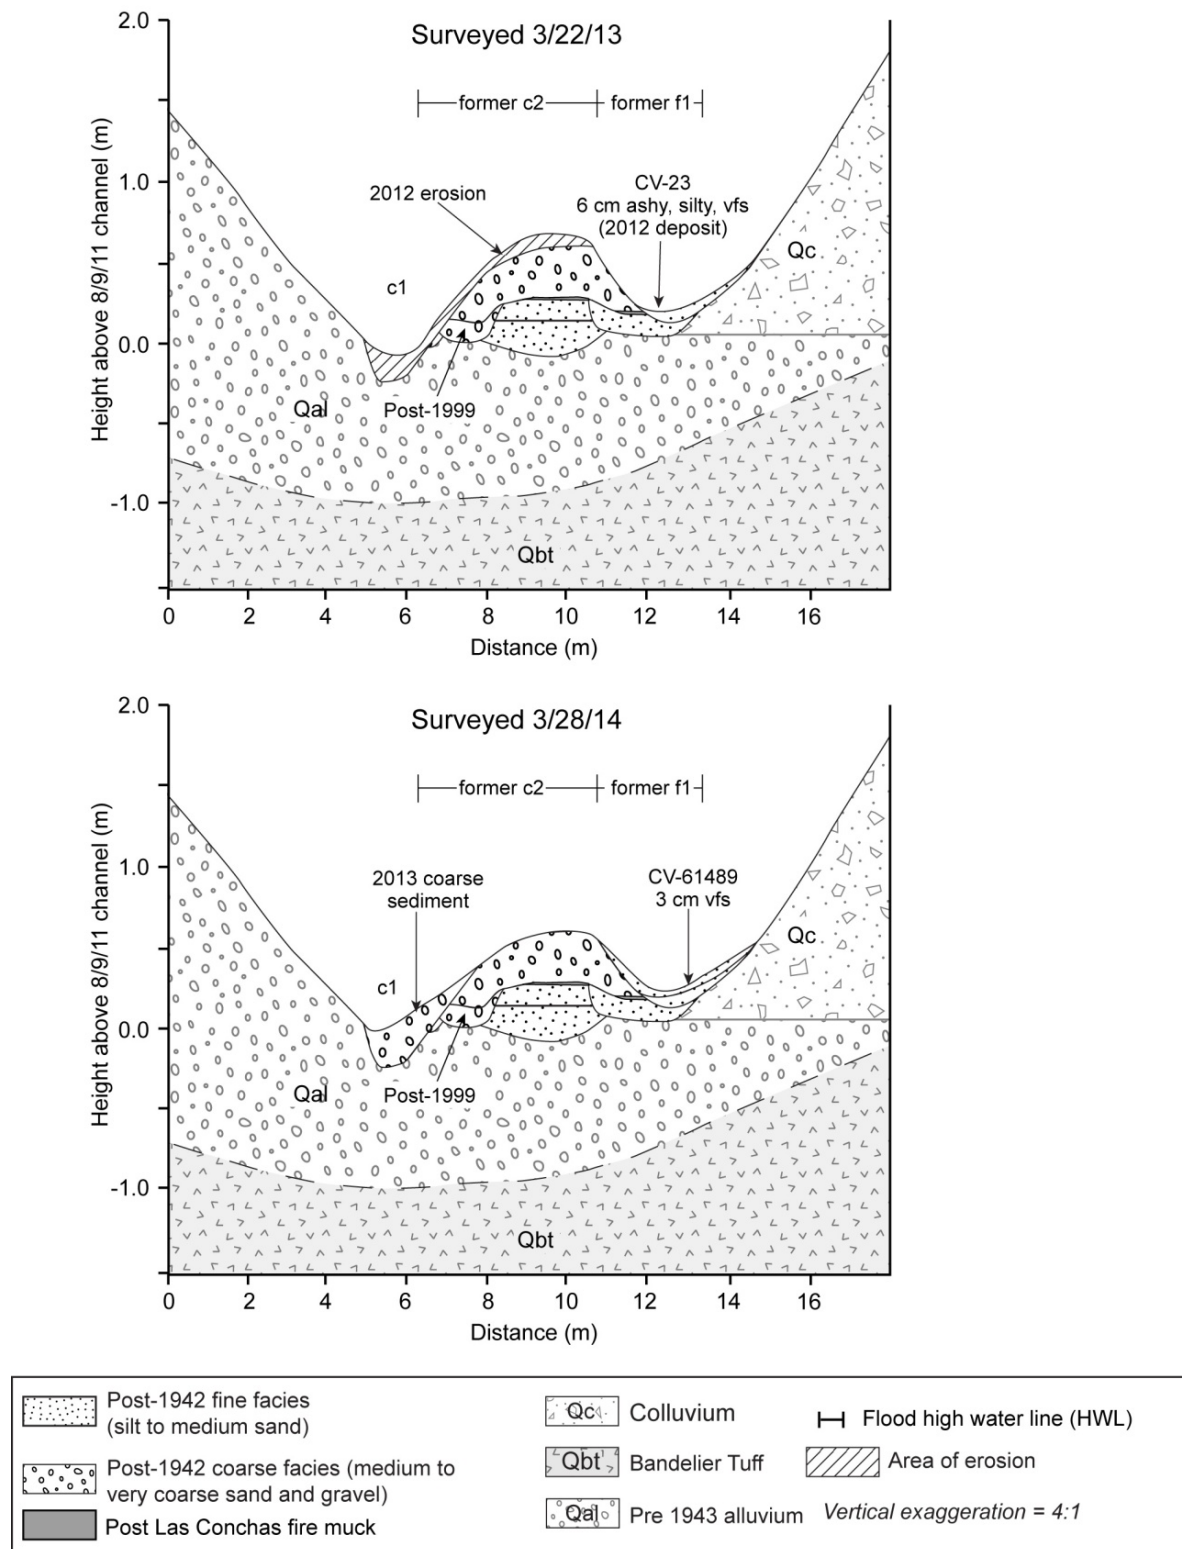
CDV-1C Cross-Section #1

Figure 2.2-1 Geomorphic cross-sections showing 2012 and 2013 erosion and deposition in reach CDV-1C

Cross-sections were surveyed at or near sampling locations in reaches CDV-1C, CDV-2E, CDV-3, CDV-4, WA-3, and WA-4. All cross-sections reoccupied previous cross-section locations. These cross-sections provide a transect of the Cañon de Valle/Water Canyon drainages from below NM 501 to the Laboratory boundary above NM 4. The cross-section located farthest upstream in the Cañon de Valle/Water Canyon drainage, in reach CDV-1C, shows deposition of coarse-grained 2013 sediments in the active channel and deposition of thin, fine-grained sediment deposits on the former f1 surface (Figure 2.2-1). This area experienced erosion within the active channel, scouring of a 2011 gravel bar and minor fine-grained sediment deposition in 2012. The cross-sections in reach CDV-2E show deposition of 2013 coarse-gravel bars on lower geomorphic surfaces, less extensive fine-grained sediment deposition primarily on higher geomorphic surfaces, and minor erosion associated with channel scouring (Figures 2.2-2 and 2.2-3). This area also experienced deposition on post-1942 geomorphic surfaces and on a former pre-1943 fluvial terrace surface, along with minor erosion of pre-1943 alluvium and post-1942 sediment deposits in 2011 and/or 2013 floods. Reach CDV-3 experienced extensive erosion during 2011 monsoonal floods (LANL 2012, 223032). CDV-3 cross-sections from November 2013 show additional erosion, primarily of pre-1943 alluvium associated with channel scouring and widening (Figures 2.2-4 through 2.2-6). Some relatively minor deposition also occurred at cross sections in reach CDV-3, primarily consisting of coarse sediment deposits within the main or side channel, and secondarily consisting of fine-gradient sediment deposits on higher post-1942 geomorphic surfaces (Figures 2.2-5 and 2.2-6). The reach CDV-4 cross-section shows erosion of post-1942 channel (c2) and flood plain (f1) deposits and deposition of coarse-grained 2013 sediment deposits on an f1 surface and within the active channel (Figure 2.2-7). In 2012, this area did not experience erosion, with the exception of localized scouring

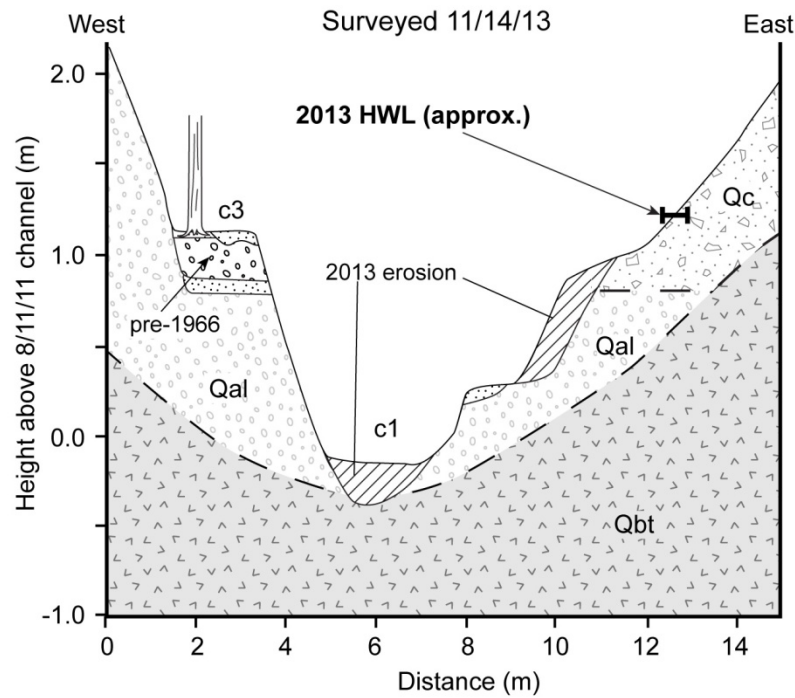
Figure 2.2-4 Geomorphic cross-sections showing 2011 and 2013 erosion and deposition in reach CDV-3 at CDV3 cross-section #1, upstream part of reach

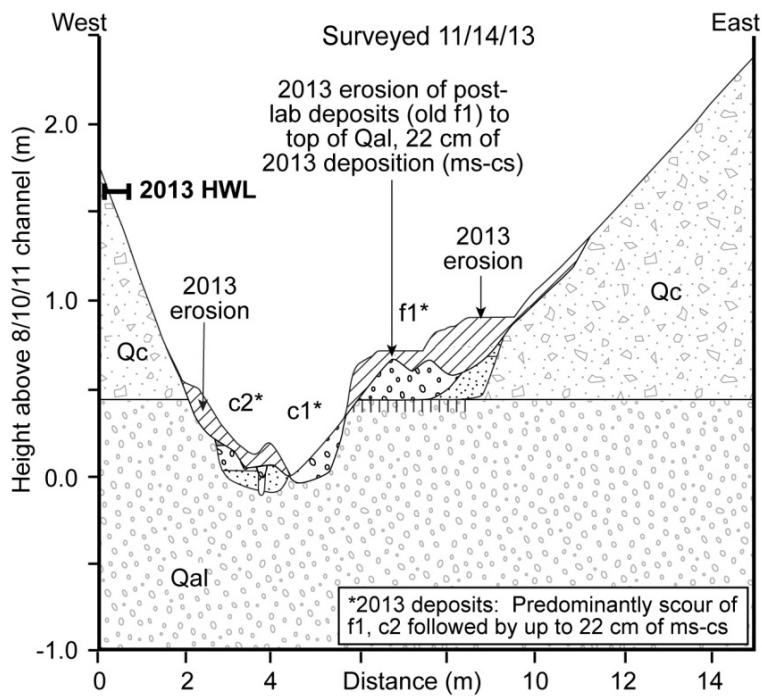
Figure 2.2-7 Geomorphic cross-sections showing 2012 and 2013 erosion and deposition in reach CDV-4

outside the active channel, and had thin, fine sediment deposition on flood plain surfaces (Figure 2.2-7). The reach WA-3 cross-section shows deposition across most of the section, with 30–40 cm of mostly coarse 2013 sediment within a broad channel area that has buried the post-1942, pre-Las Conchas deposits and adjacent pre-1943 alluvium (Figure 2.2-8). Some minor erosion of pre-1943 alluvium and post-Las Conchas sediment deposits has also occurred. This pattern of deposition across most of the cross-section and minor erosion was also observed following the 2012 monsoon season (Figure 2.2-8). The deposition along the cross-section in reach WA-3 is likely the result of its location above a prominent log jam noted in the post-2011 monsoon investigation (LANL 2012, 223032). The reach WA-4 cross-sections show erosion of post-1942 channel (c1, c2) and floodplain (f1) deposits and erosion of pre-1943 alluvium across large areas of each cross section (Figures 2.2-9 and 2.2-10). A coarse-grained 2013 gravel bar was deposited where former f1 deposits were scoured and fine-grained sediments were deposited on former f1 and Qt surfaces at the downstream cross-section (Figure 2.2-10). These observations are in contrast to only minor changes observed at this location from the 2012 floods (Figure 2.2-10).

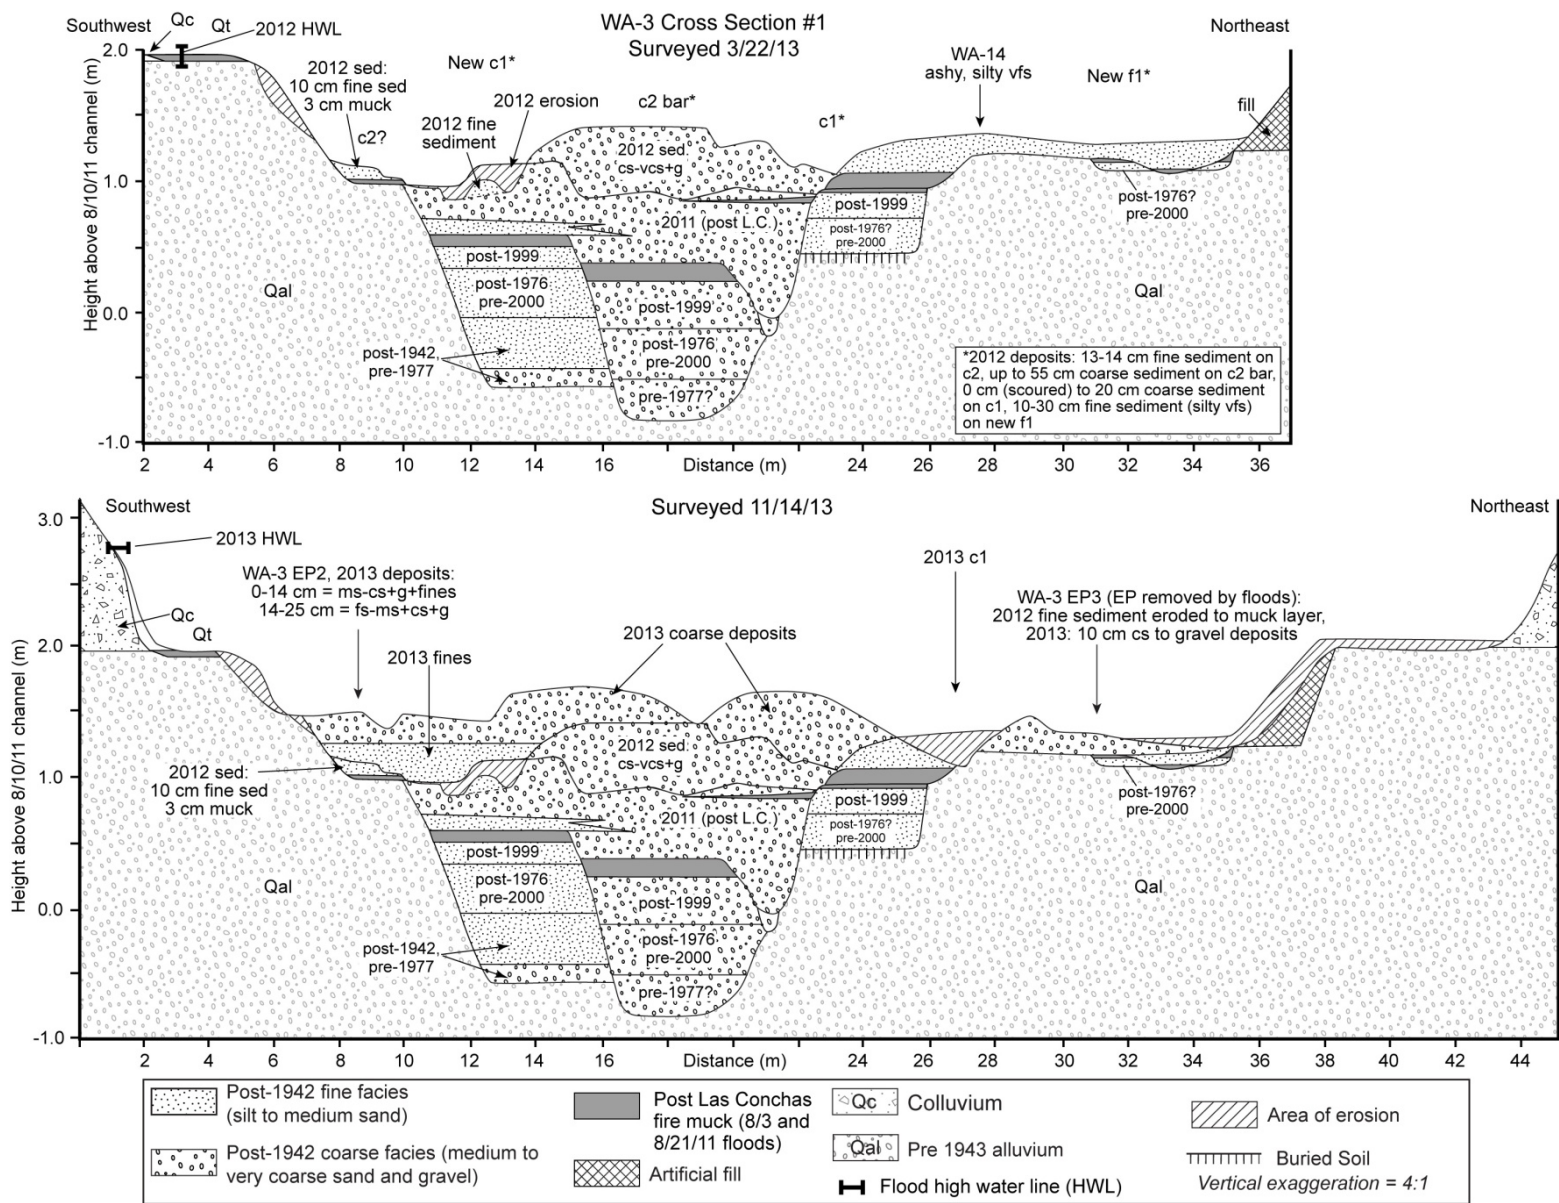
Figure 2.2-8 Geomorphic cross-sections showing 2012 and 2013 erosion and deposition in reach WA-3

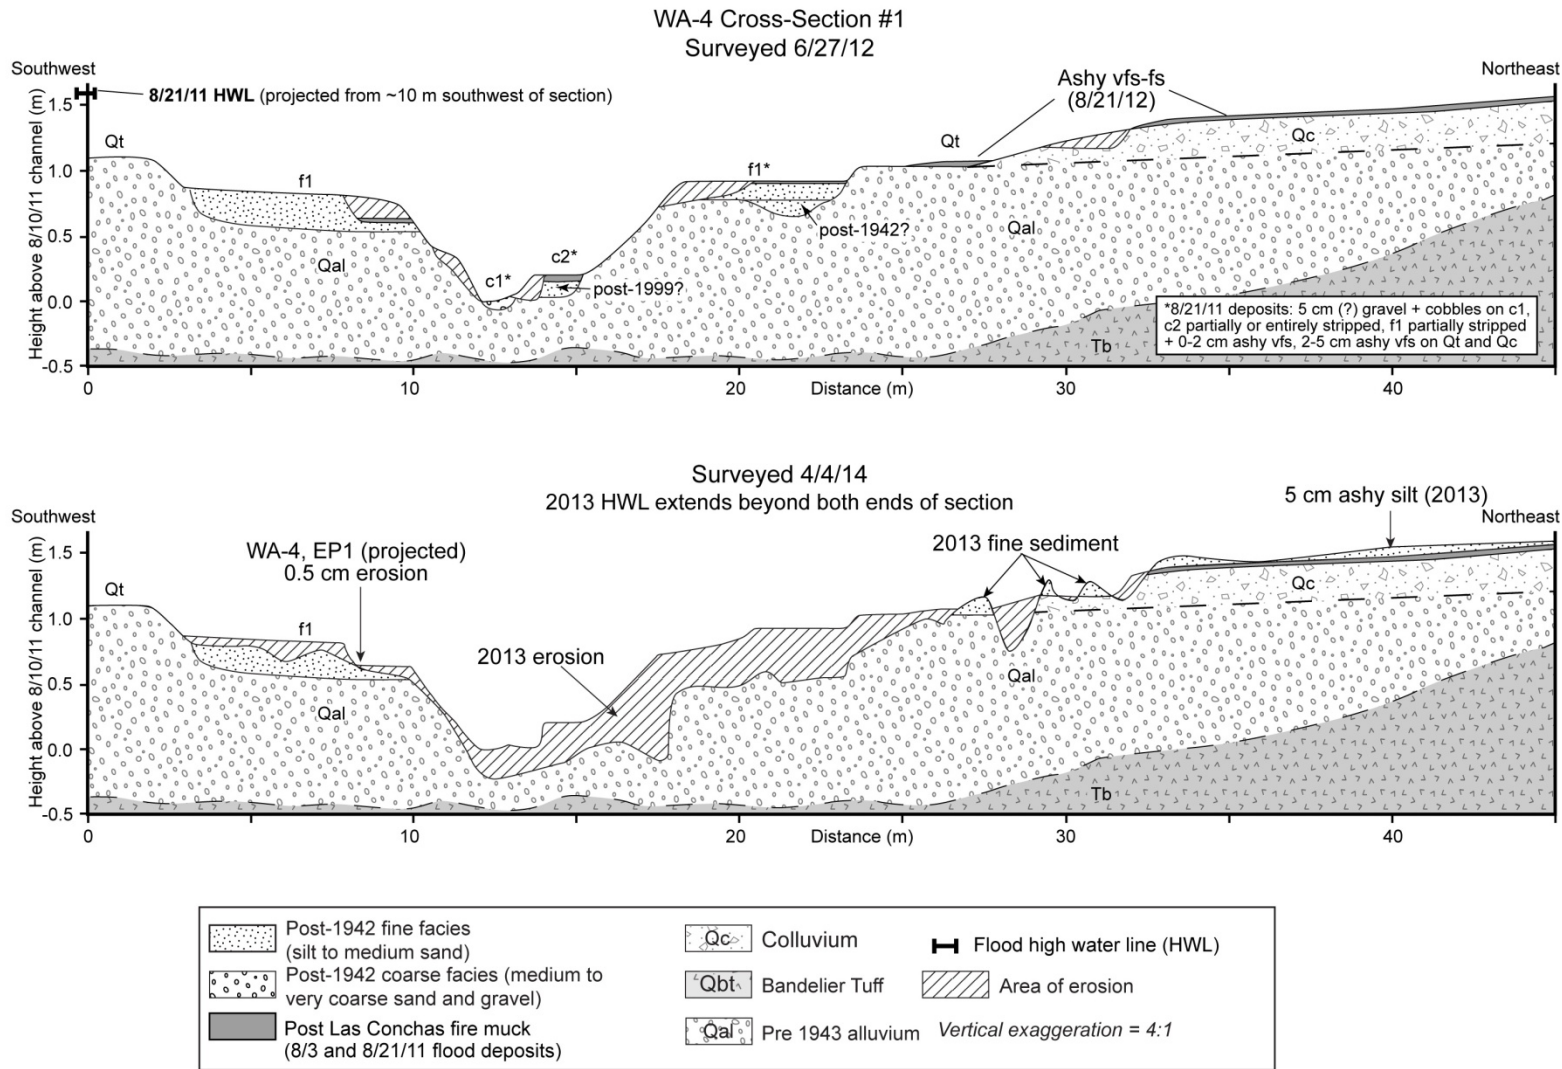
Figure 2.2-9 Geomorphic cross-sections showing 2011 and 2013 erosion and deposition in reach WA-3 at WA-4 cross-section #1, upstream part of reach

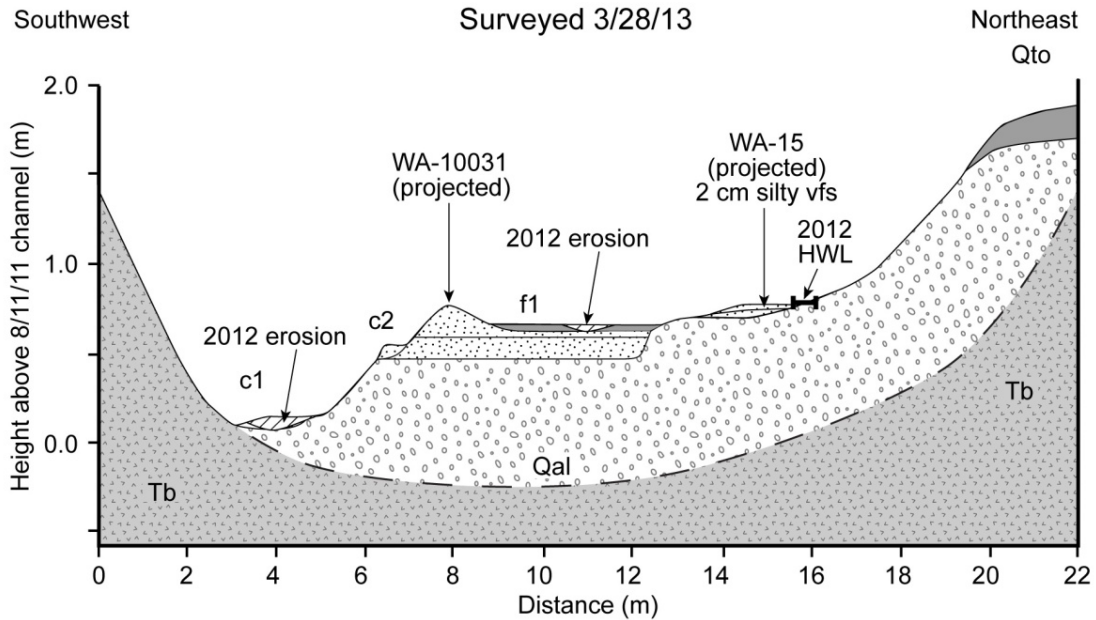
WA-4 Cross-Section #2

Figure 2.2-10 Geomorphic cross-sections showing 2012 and 2013 erosion and deposition in reach WA-3 at WA-4 cross-section #2, downstream part of reach

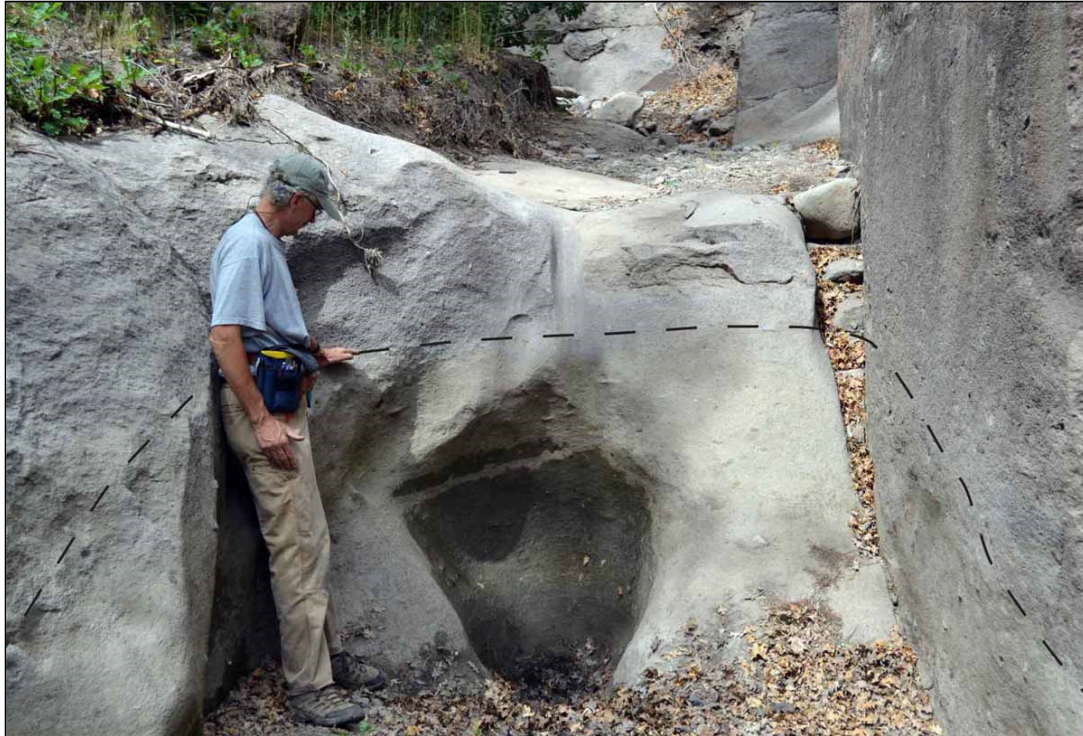
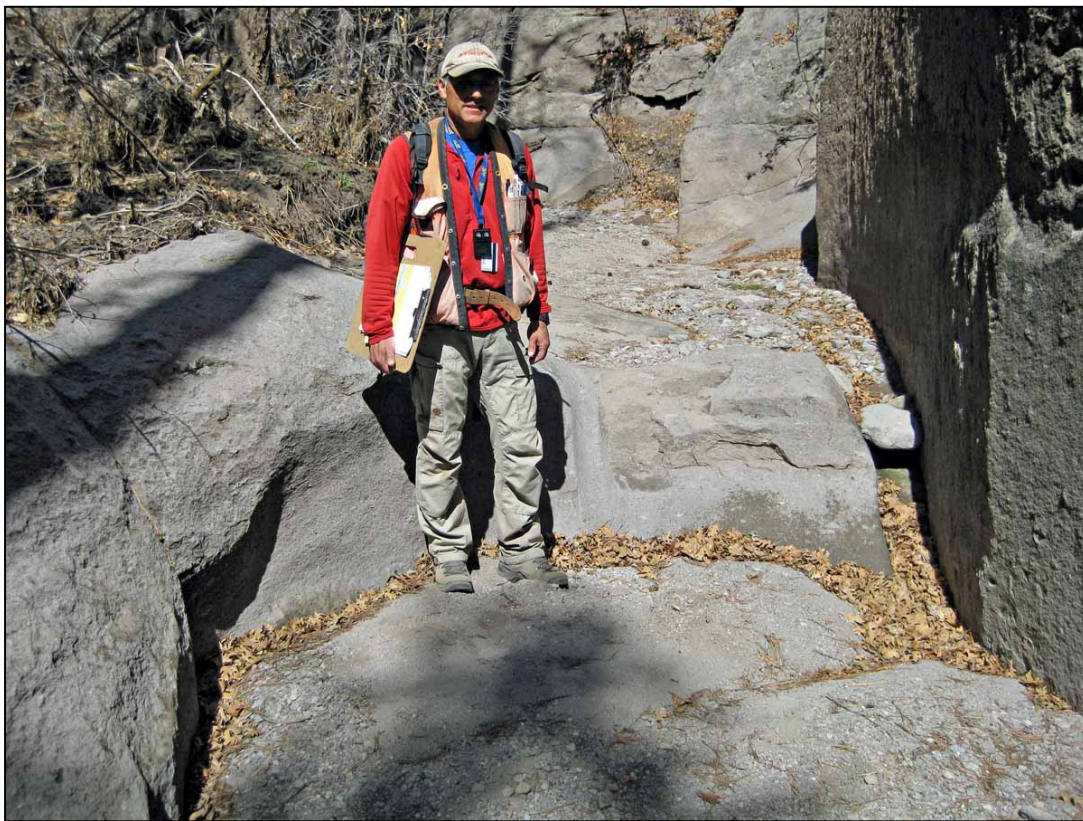
Note: Dashed line and coloration change on bedrock surface in upper photograph shows pre-flood sediment thickness.

Figure 3.2-1 Repeat photographs of former c1 surface in reach CDV-3: (a) scoured to bedrock by August 21, 2011 (b) aggraded to approximate pre-August 21, 2011, surface as of November 2013

Cross-sections from reaches sampled after the 2013 monsoon season (exclusive of baseline reaches and reaches WA-5, located downstream of NM4 and WA-6, upstream of the Water Canyon-Rio Grande confluence) depicting areas of erosion, sediment deposition, or minor bank erosion and deposition on adjacent floodplain surfaces are shown in Figures 2.2-1 to 2.2-10 and are described below. Figure 3.2-1 shows an example of sediment deposition in CDV-3 in an area scoured by the August 21, 2011, flood. Figure 3.2-2 shows a 2013 gravel bar deposited on a former f1 floodplain surface in reach CDV-2E.

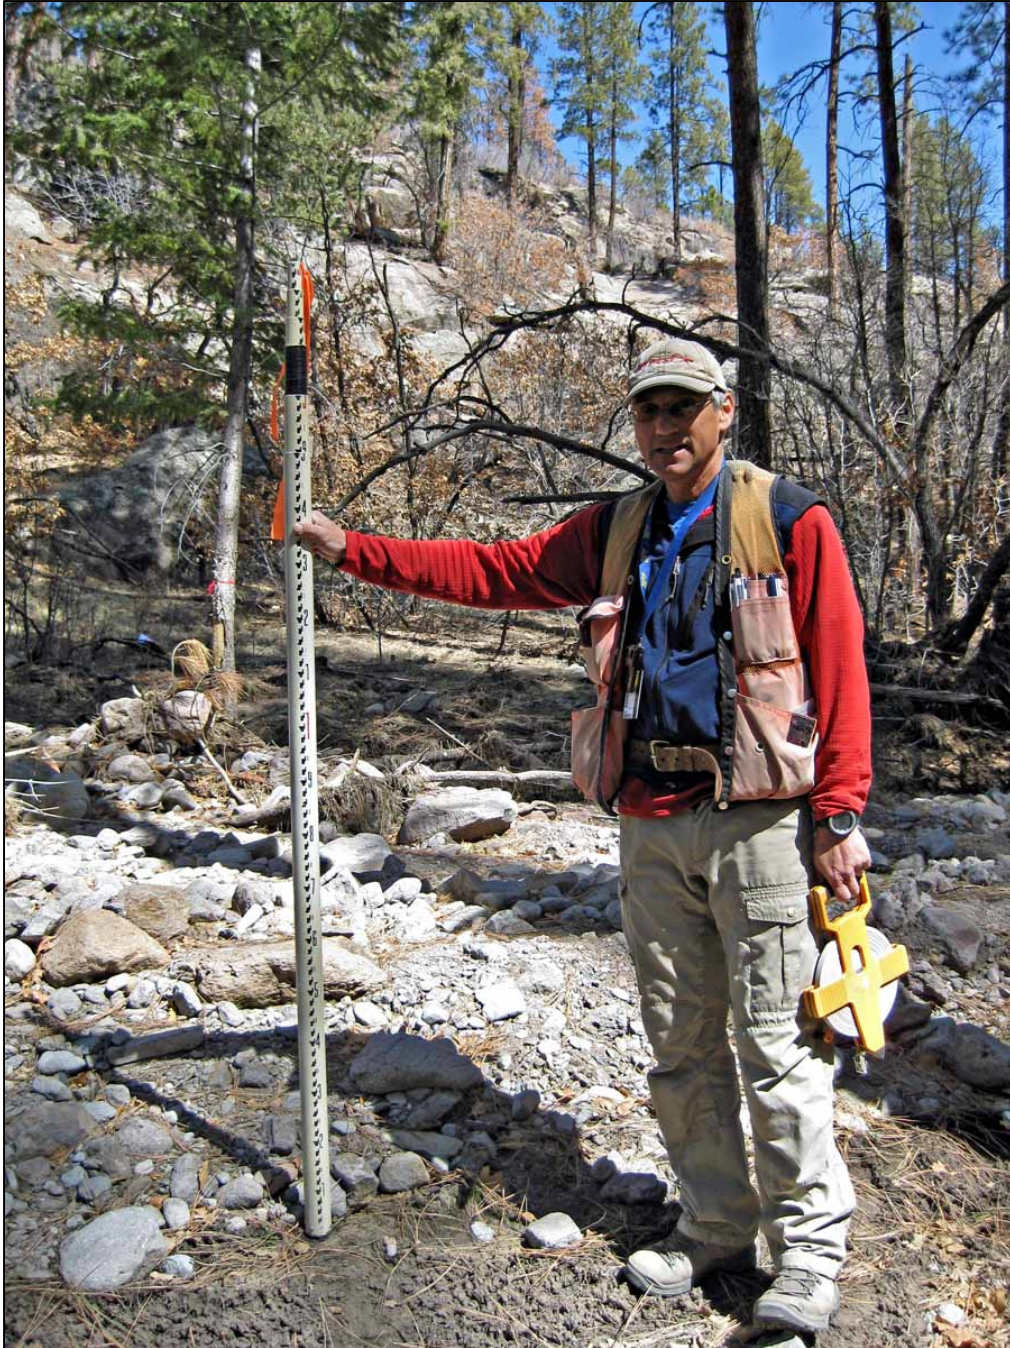
Figure 3.2-2 March 2014 photograph of 2013 gravel bar deposited on a former f1 floodplain surface in reach CDV-2E

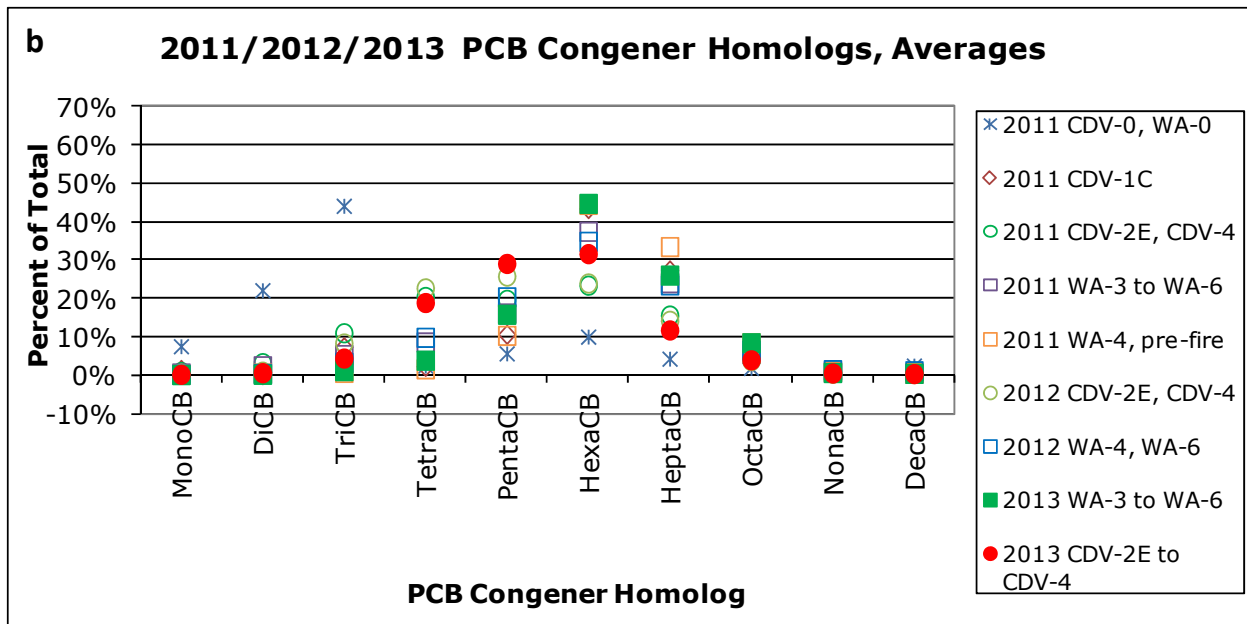
Figure 3.3-3 Plots of PCB congener homologs averages in (a) 2013 samples collected downstream from solid waste management units and areas of concern in the Water Canyon and Cañon de Valle watershed; and (b) 2011, 2012, and 2013 samples collected downstream from sites in the Water Canyon and Cañon de Valle watershed

PCB congeners from sediment or water samples can be grouped together into 10 homologs, based on the number of chlorine atoms on the biphenyl rings, which allows visual comparison of similarities or differences between samples or groups of samples (Reneau et al. 2007, 102886). Figure 3.3-3 shows average homolog percentages in each of the sediment samples from Water Canyon and Cañon de Valle collected in 2011, 2012, and 2013. The 2013 PCB congener data are consistent with the 2011, 2012, and previous sediment data, indicating several PCB sources with at least two sources in the Cañon de Valle watershed (one possibly below the 260 Outfall above reach CDV-2E and another above reach CDV-1C) and at least one other source in the Water Canyon watershed above the confluence with Cañon de Valle (LANL 2011, 207069; LANL 2012, 223032; LANL 2013, 241083).

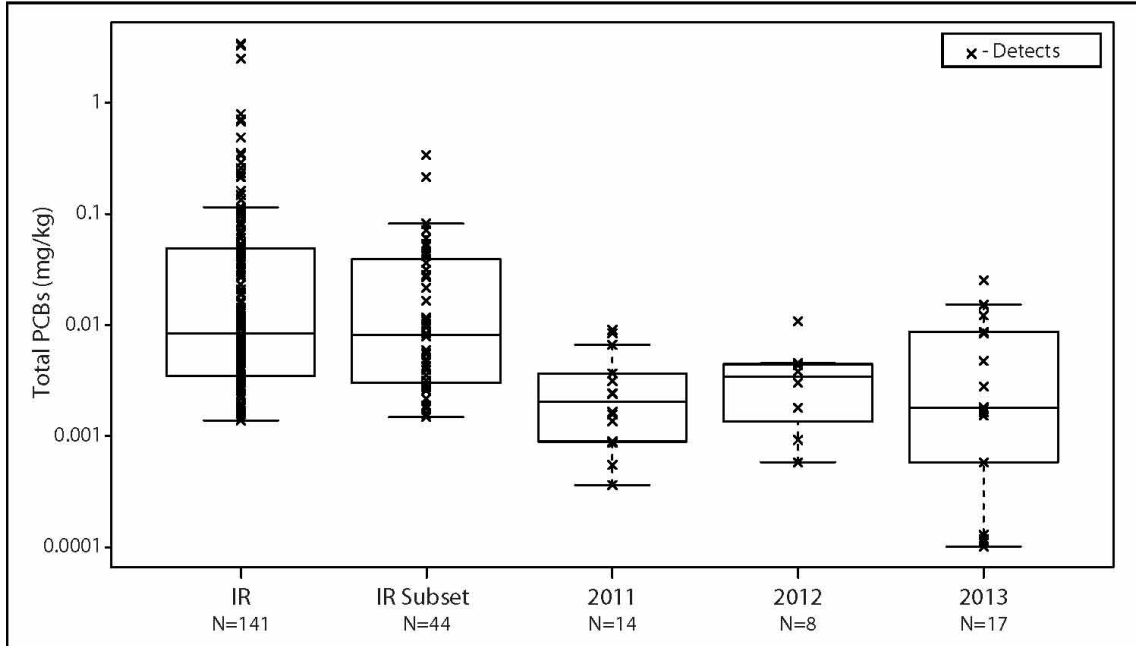
Notes: The box plots include the 25th percentile, the median, and the 75th percentile. The 10th and 90th percentiles are shown as lines above and below the boxes.

Figure 3.3-5 Total PCB concentrations in the Water Canyon and Cañon de Valle investigation report (Aroclor method), a subset of those IR data including only the reaches sampled in subsequent years (Aroclor method), 2013, 2012, and 2011 sediment samples

Total PCB concentrations are low (less than 0.004 mg/kg) in the sediment samples collected upstream of NM 501 in 2011 (reaches WA-0 and CDV-0) (Figure 3.3-4 and Table 2.1-4), reflecting baseline conditions and regional atmospheric sources. PCB concentrations increase downstream from Laboratory sources, with maximum values in single samples ranging between 0.0152 mg/kg and 0.0253 mg/kg in reaches CDV-2E, CDV-3, and WA-3 (Figure 3.3-4 and Table 2.1-4). Unlike other COPCs, total PCB concentrations are not clearly inversely related to particle size, and the highest total PCB concentration obtained (0.0253 mg/kg from CAWA-14-49271 in WA-3) was from a sample with a median particle size of coarse sand (Tables 2.1-2 and 2.1-4). Downstream of reach WA-3, the total PCB concentration decreases to less than 0.0006 mg/kg in reach WA-5 and less than 0.0002 mg/kg in reach WA-6, near the Rio Grande (Figure 3.3-4). The 2011, 2012, and 2013 total PCB concentrations are at the very low end of the concentration distribution documented in the Water Canyon/Cañon de Valle IR (LANL 2011, 207069; Figure 3.3-5), and are similar to or below baseline conditions measured in WA-0 and CDV-0 (LANL 2012, 223032).
