2014 Update to the Site Discharge Pollution Prevention Plan, Revision 1

Los Alamos National Laboratory
NPDES Permit No. NM0030759
LA-UR-15-22150 • May 1, 2015

Water/Cañon de Valle Watershed

Volume 4

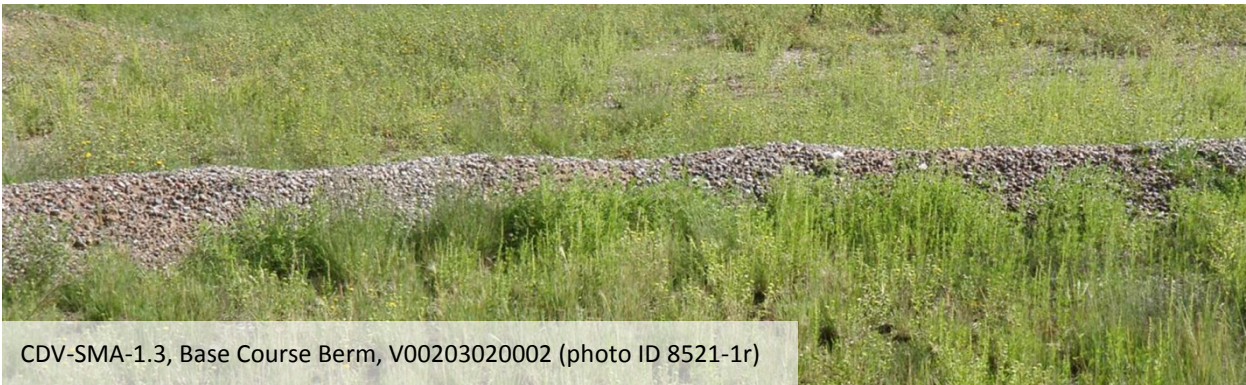
CDV-SMA-1.3, Base Course Berm, V00203020002 (photo ID 8521-1r)

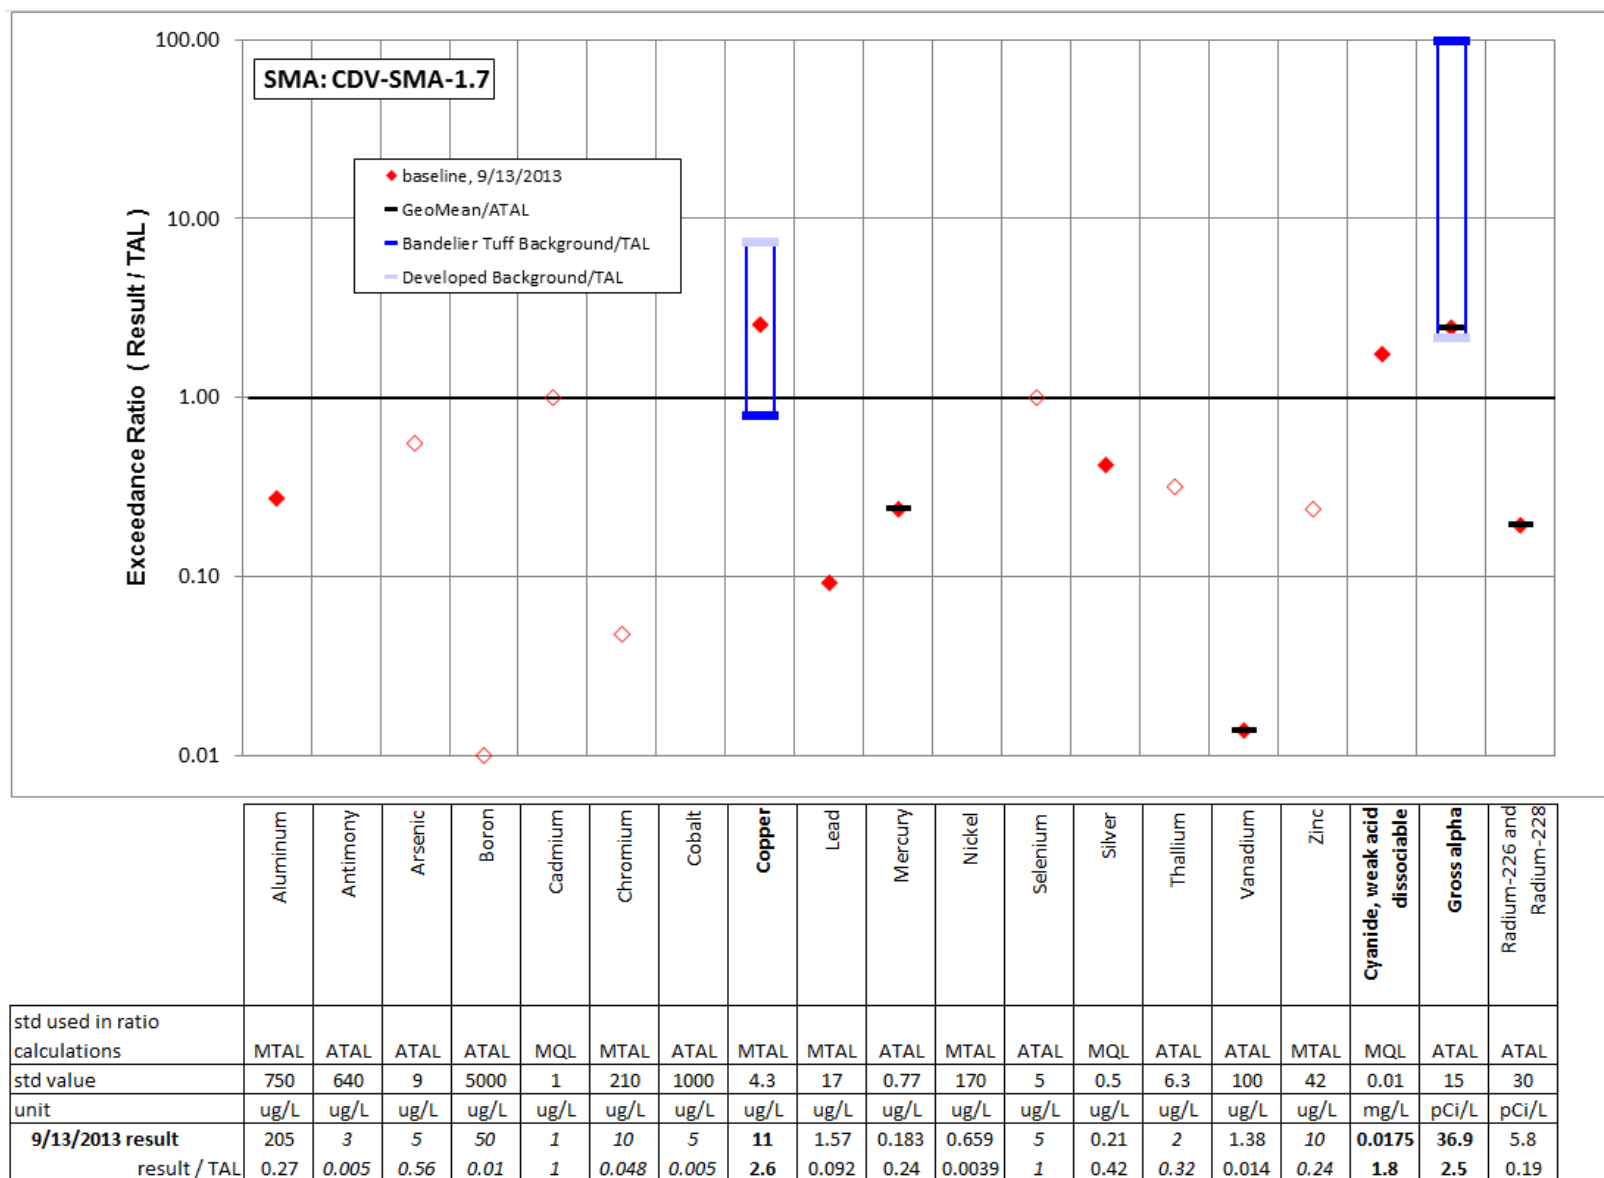
Figure 184-2 Inorganic analytical results summary plot for CDV-SMA-1.7

Bold font indicates result>TAL/MQL; italic font and hollow symbols indicate undetected results; "-" is used if no analytical results were available.

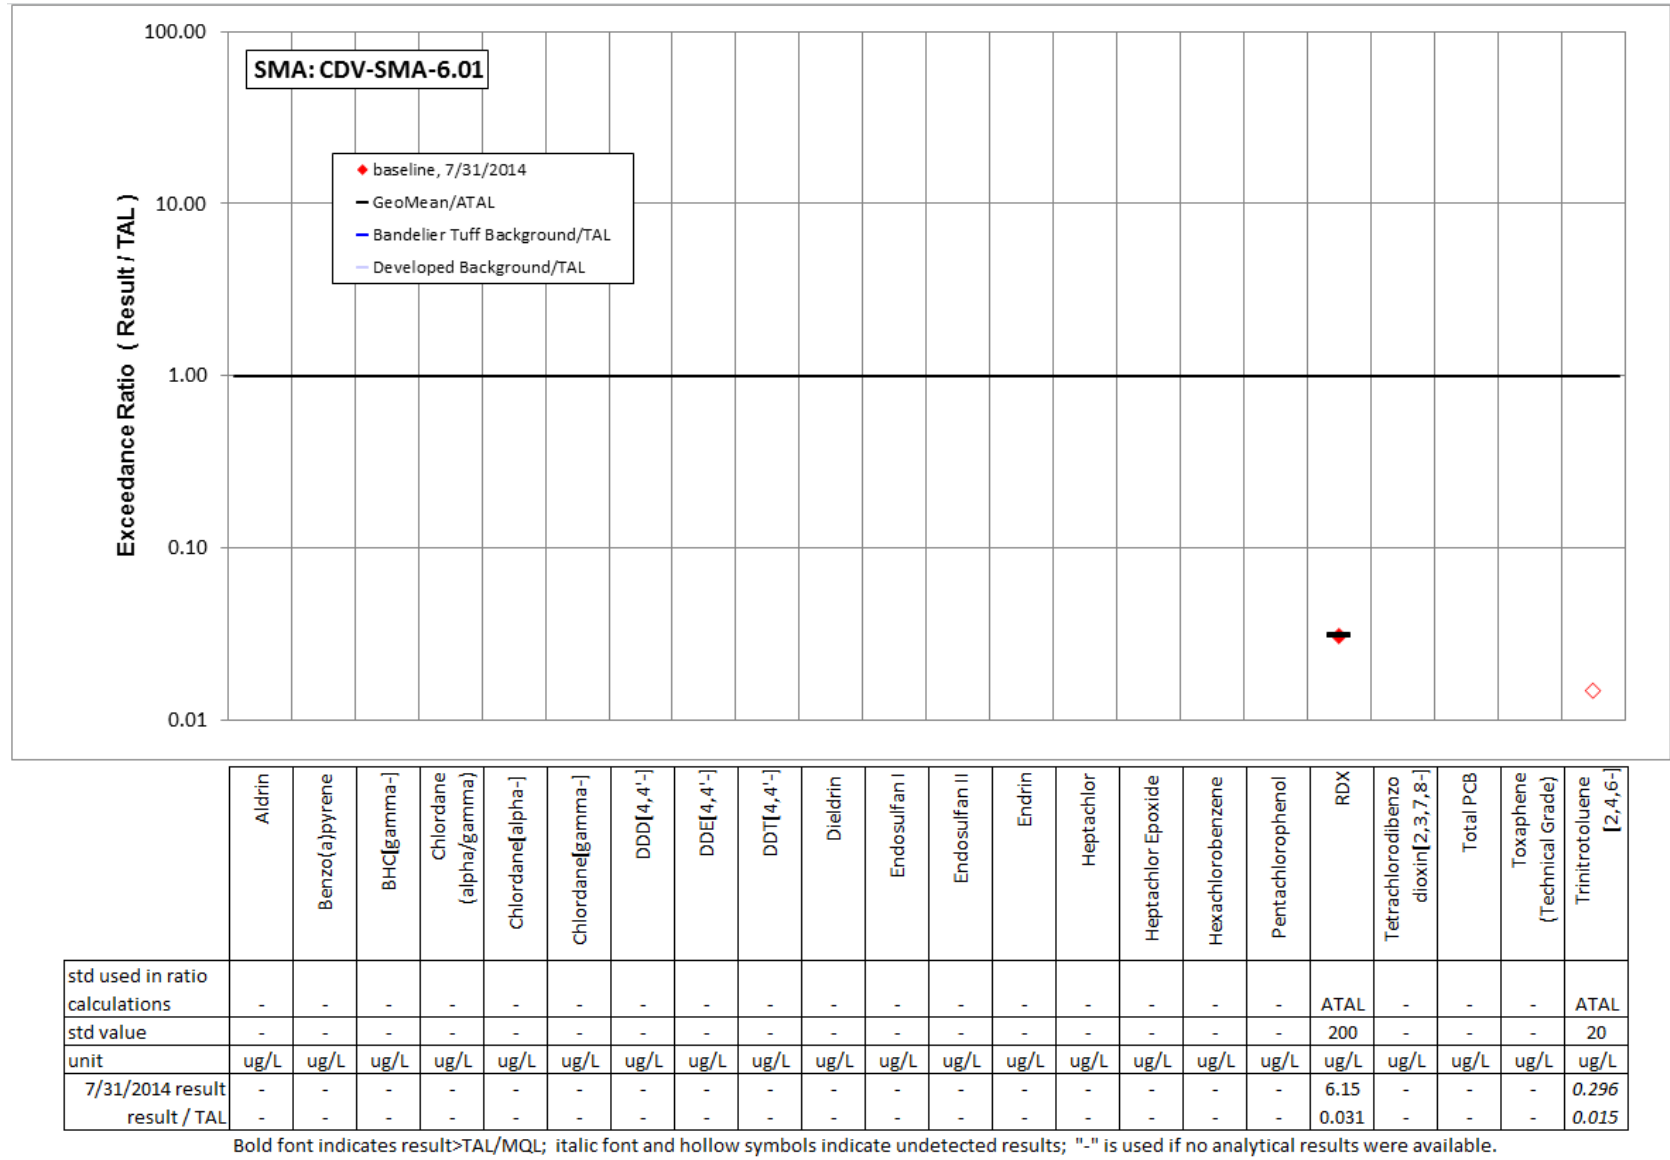
Bold font indicates result>TAL/MQL; italic font and hollow symbols indicate undetected results; "-" is used if no analytical results were available.

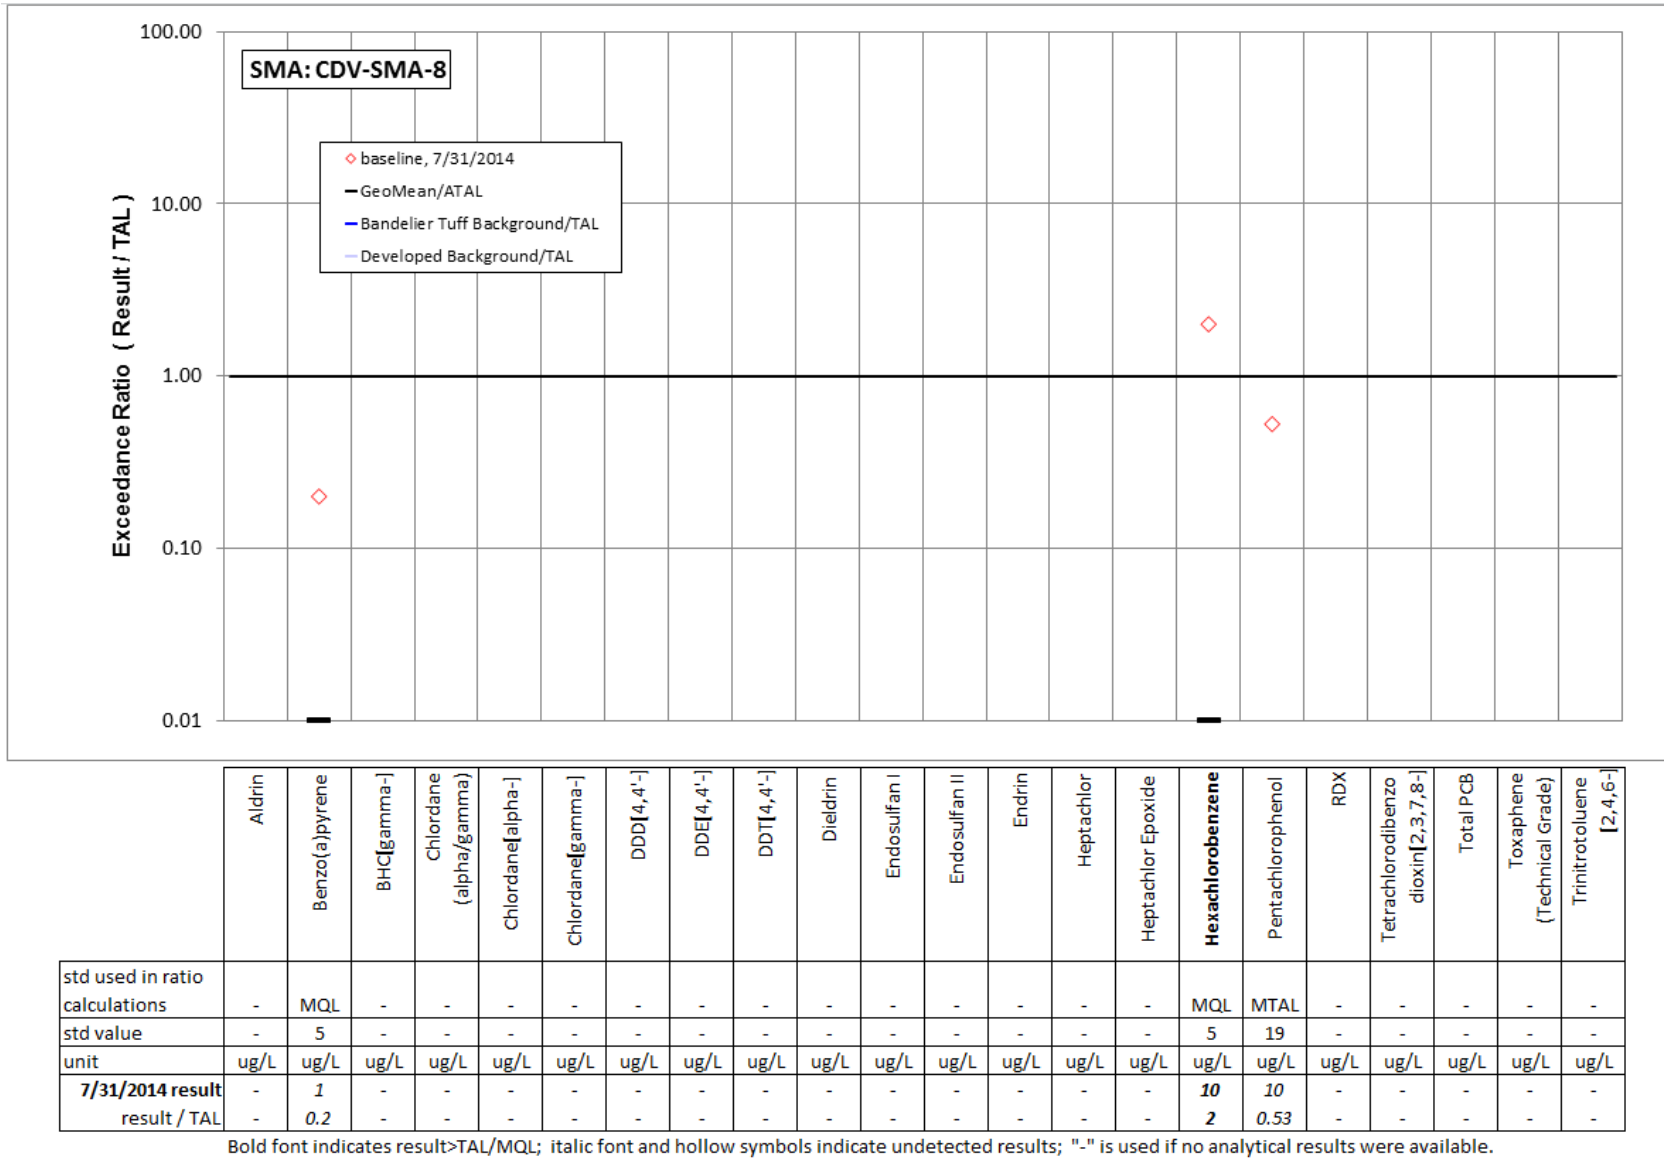
Figure 196-2 Inorganic analytical results summary plot for CDV-SMA-8

Bold font indicates result>TAL/MQL; italic font and hollow symbols indicate undetected results; "-" is used if no analytical results were available.

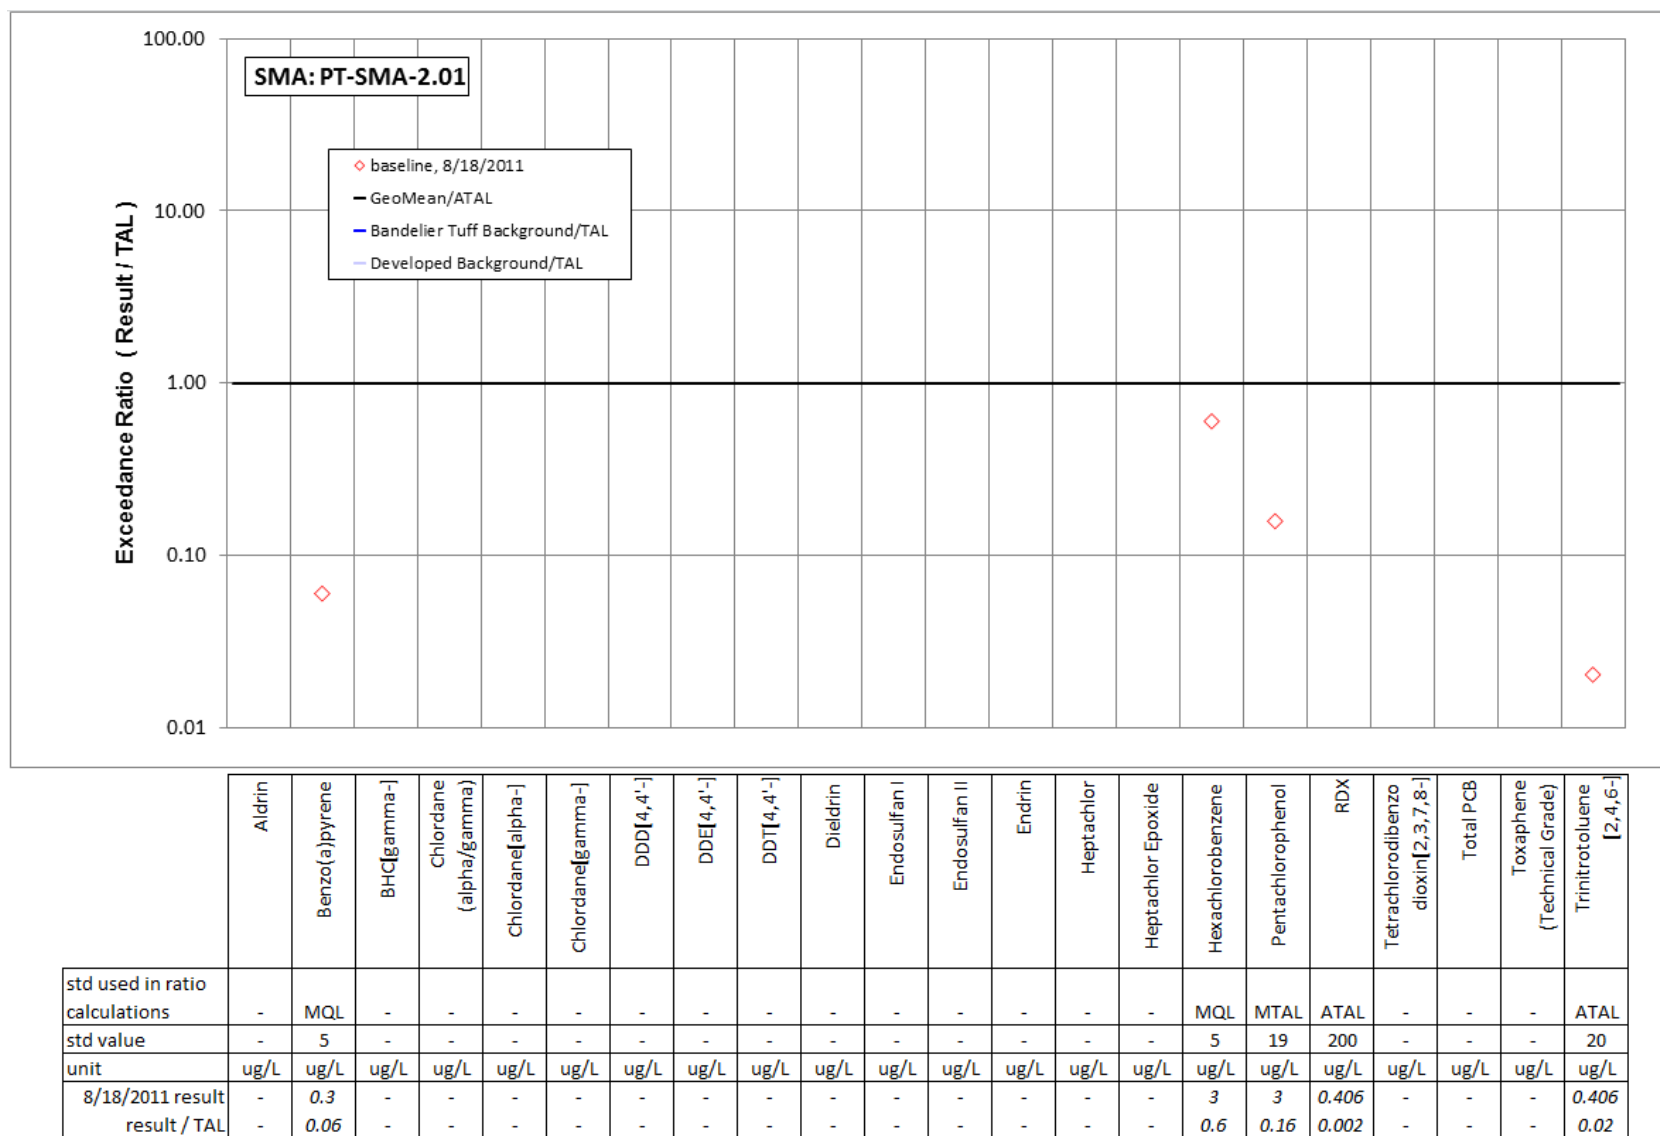
Figure 204-2 Inorganic analytical results summary plot for PT-SMA-2.01

Bold font indicates result>TAL/MQL; italic font and hollow symbols indicate undetected results; "-" is used if no analytical results were available.

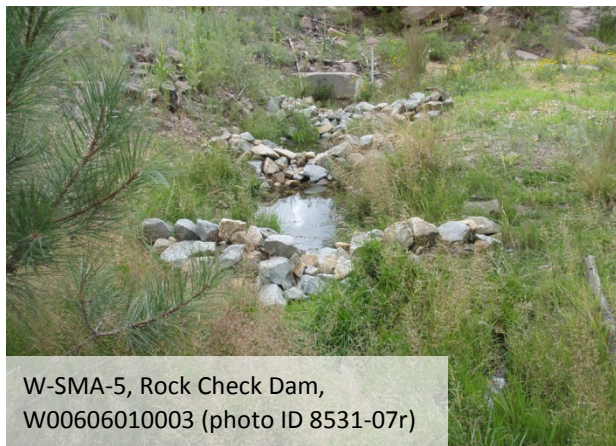
W-SMA-5, Rock Check Dam, W00606010003 (photo ID 8531-07r)

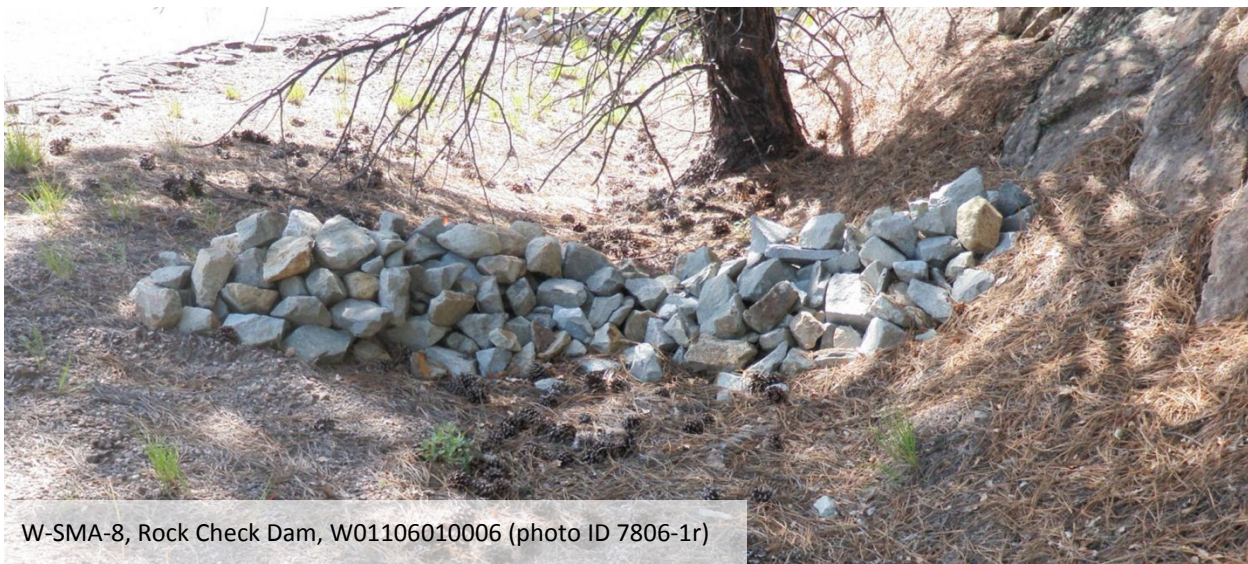
W-SMA-8, Rock Check Dam, W01106010006 (photo ID 7806-1r)
