2014 Update to the Site Discharge Pollution Prevention Plan, Revision 1

Los Alamos National Laboratory
NPDES Permit No. NM0030759
LA-UR-15-22151 • May 1, 2015

Ancho/Chaquehui Watershed

Volume 5

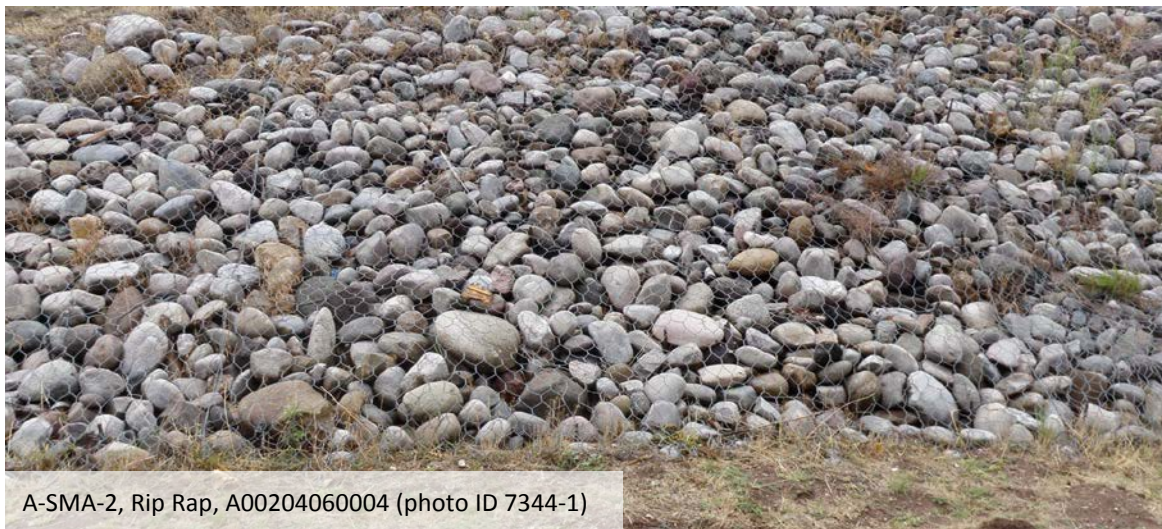
A-SMA-2, Rip Rap, A00204060004 (photo ID 7344-1)

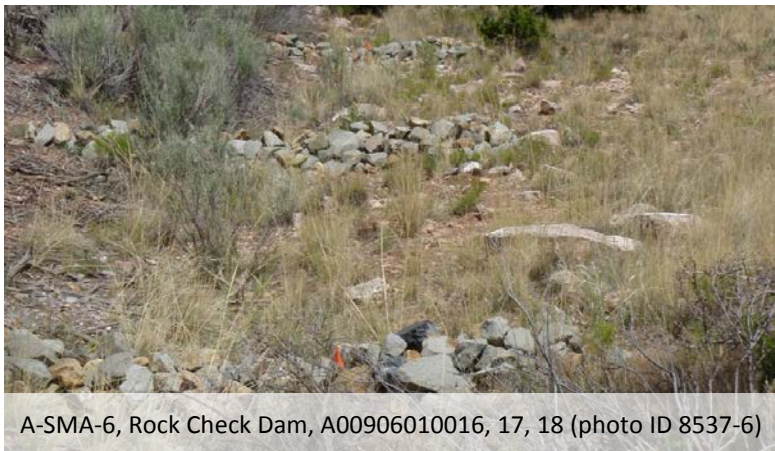
A-SMA-6, Rock Check Dam, A00906010016, 17, 18 (photo ID 8537-6)

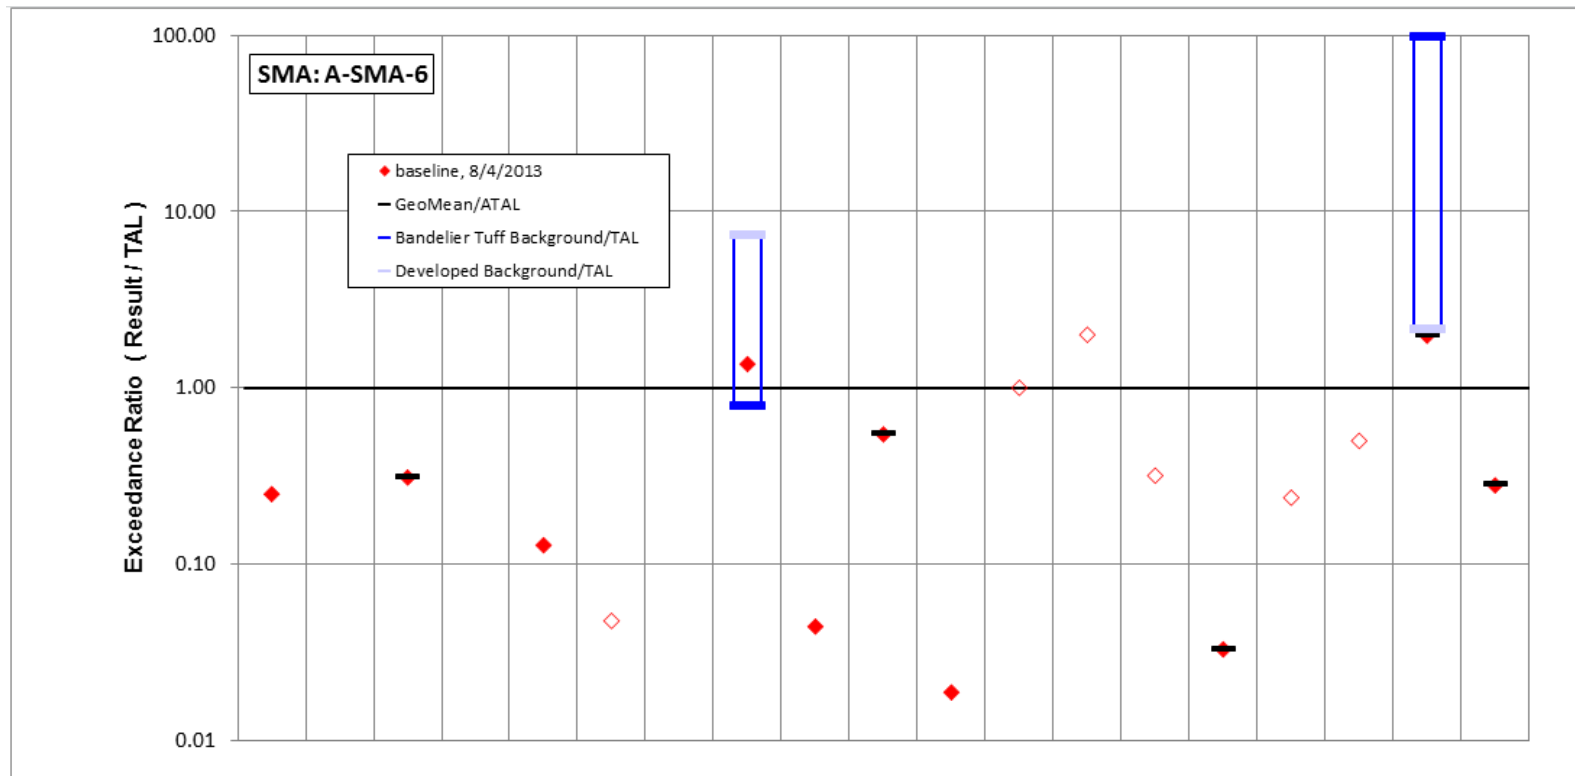
Figure 238-2 Inorganic analytical results summary plot for A-SMA-6

Aluminum	Antimony	Arsenic	Boron	Cadmium	Chromium	Cobalt	Copper	Lead	Mercury	Nickel	Selenium	Silver	Thallium	Vanadium	Zinc	Cyanide, weak acid dissociable	Gross alpha	Radium-226 and Radium-228
std used in ratio calculations	MTAL	ATAL	ATAL	ATAL	MQL	MTAL	ATAL	MTAL	MTAL	ATAL	MTAL	ATAL	MQL	ATAL	ATAL	MTAL	MQL	ATAL	ATAL
std value	750	640	9	5000	1	210	1000	4.3	17	0.77	170	5	0.5	6.3	100	42	0.01	15	30
unit	ug/L	ug/L	ug/L	ug/L	ug/L	ug/L	ug/L	ug/L	ug/L	ug/L	ug/L	ug/L	ug/L	ug/L	ug/L	ug/L	mg/L	pCi/L	pCi/L
8/4/2013 result	187	1.49	2.79	31.1	0.128	10	4.92	5.86	0.752	0.419	3.18	5	1	2	3.28	10	0.005	29.6	8.39
result / TAL	0.25	0.0023	0.31	0.0062	0.13	0.048	0.0049	1.4	0.044	0.54	0.019	1	2	0.32	0.033	0.24	0.5	2	0.28

TAL exceedances were also evaluated against the appropriate storm water BVs, that is, “Bandelier Tuff background” for undisturbed SMAs or “developed background” for urban settings. BVs are expressed as UTLs using the approved EPA method for calculating BVs. UTLs for undisturbed SMAs were derived from storm water runoff containing entrained sediments derived from Bandelier Tuff and are labeled “Bandelier Tuff Background” in Figures 238-2 and 238-3. UTLs developed for urban settings were derived from runoff from developed landscapes on the Pajarito Plateau, including buildings, parking lots, roads, and associated features, and are labeled “Developed Background” in Figures 238-2 and 238-3.

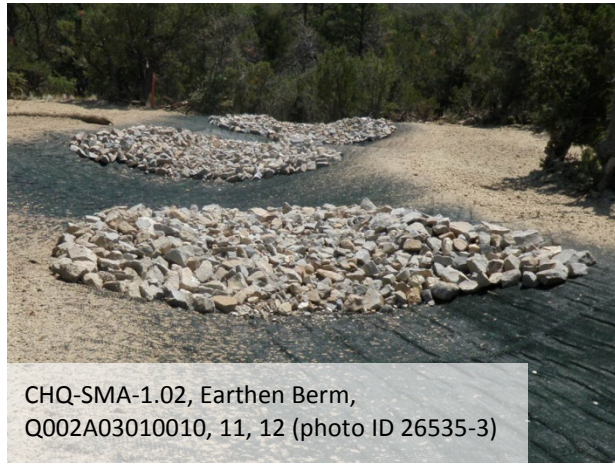
CHQ-SMA-1.02, Earthen Berm, Q002A03010010, 11, 12 (photo ID 26535-3)

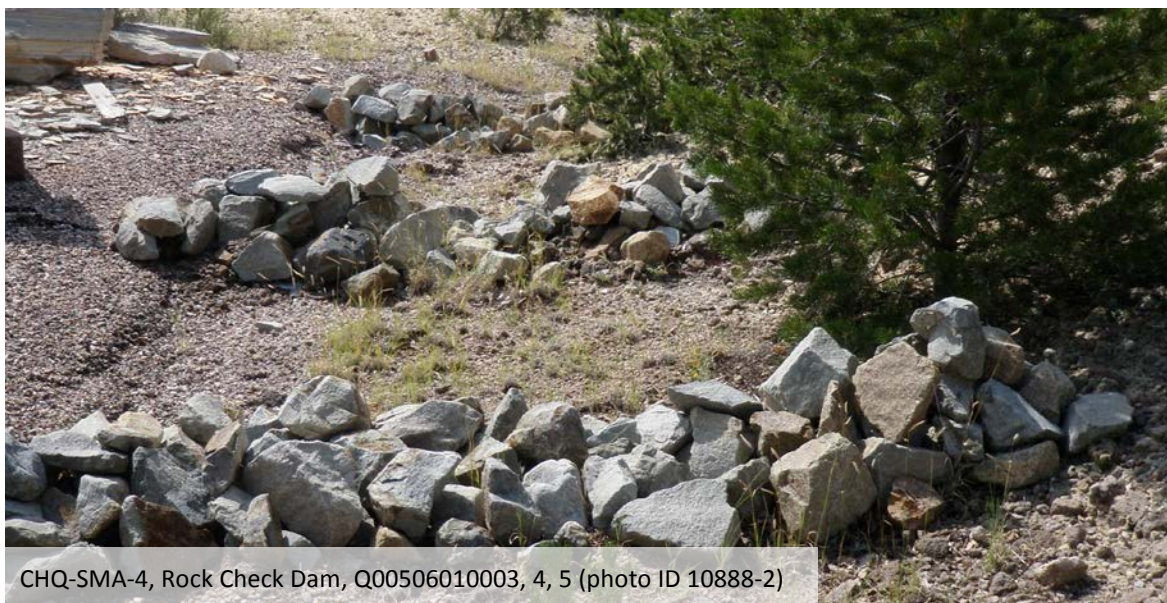
CHQ-SMA-4, Rock Check Dam, Q00506010003, 4, 5 (photo ID 10888-2)
