# 2015 Update to the Site Discharge Pollution Prevention Plan, Revision 1

Los Alamos National Laboratory  
NPDES Permit No. NM0030759  
LA-UR-16-22407 • May 1, 2016

## Ancho/Chaquehui Watershed

Volume 5

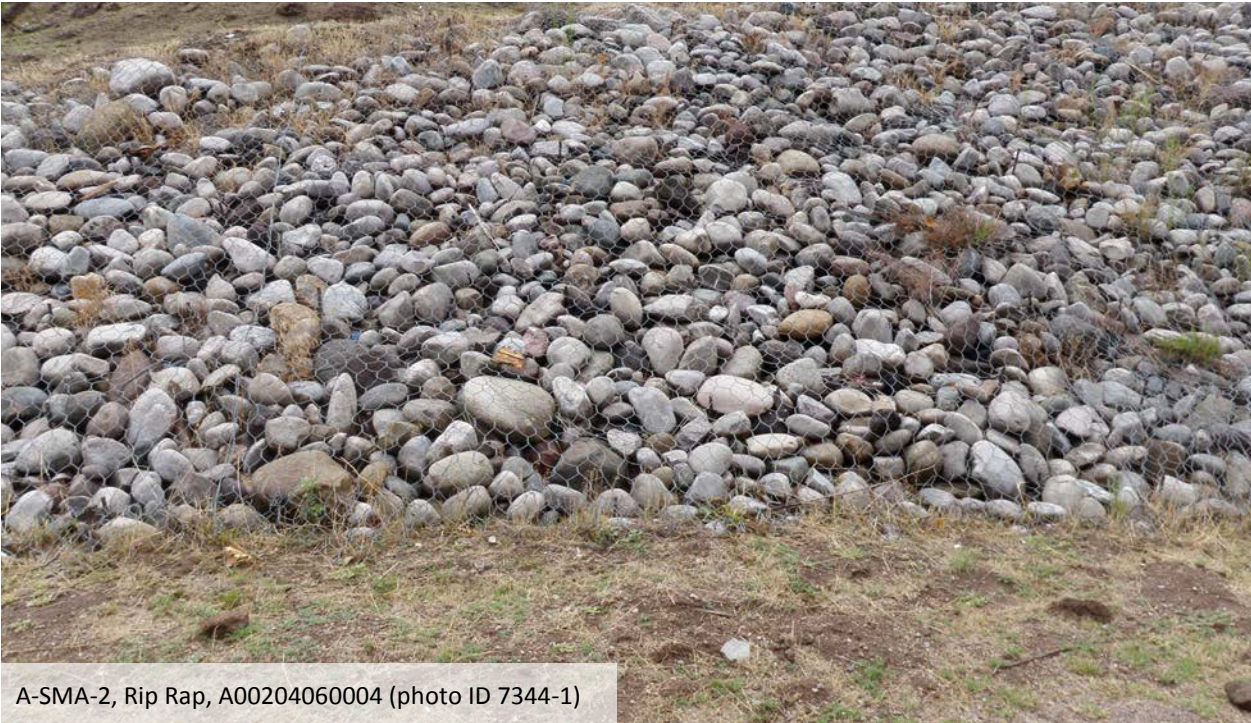
A-SMA-2, Rip Rap, A00204060004 (photo ID 7344-1)

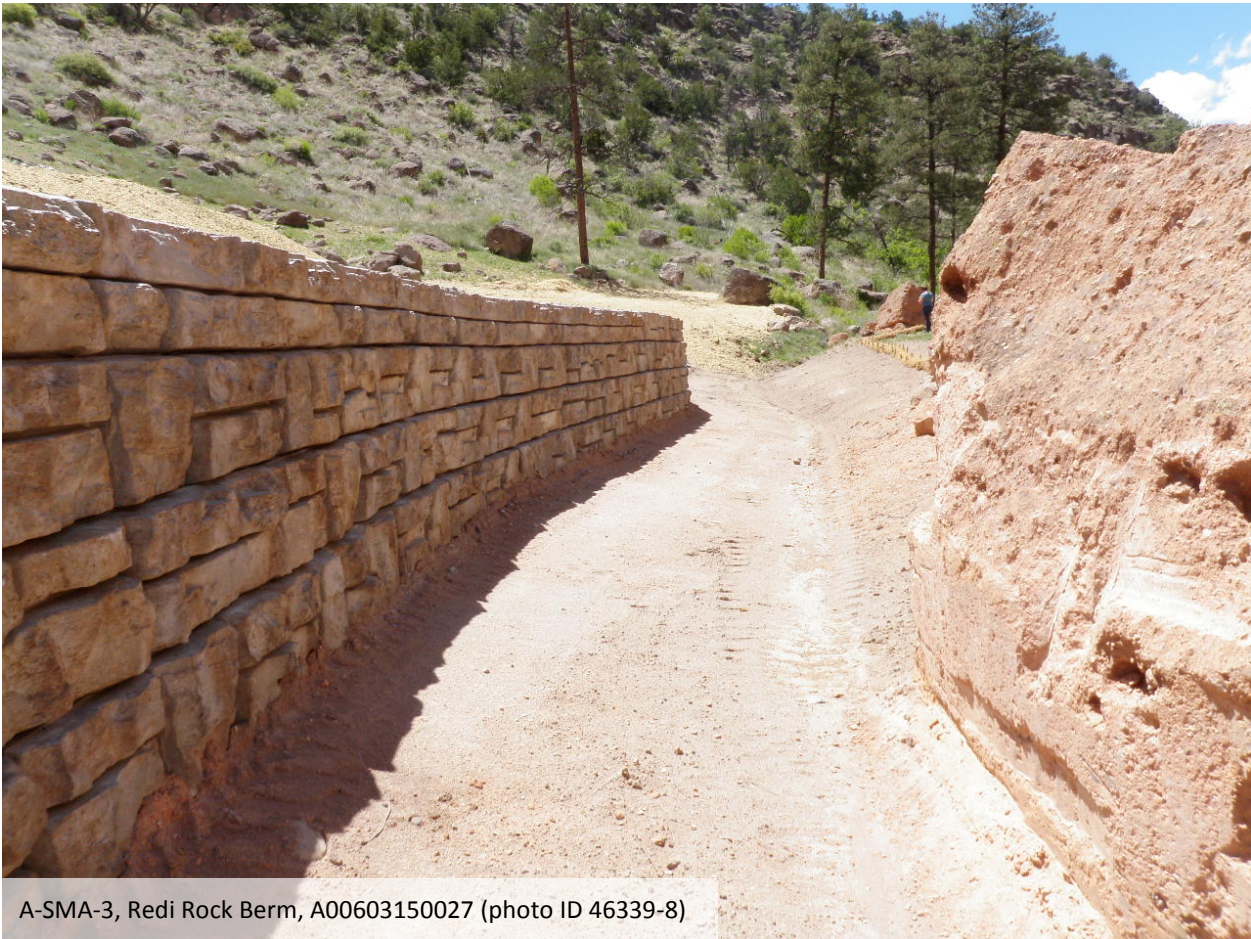
A-SMA-3, Redi Rock Berm, A00603150027 (photo ID 46339-8)

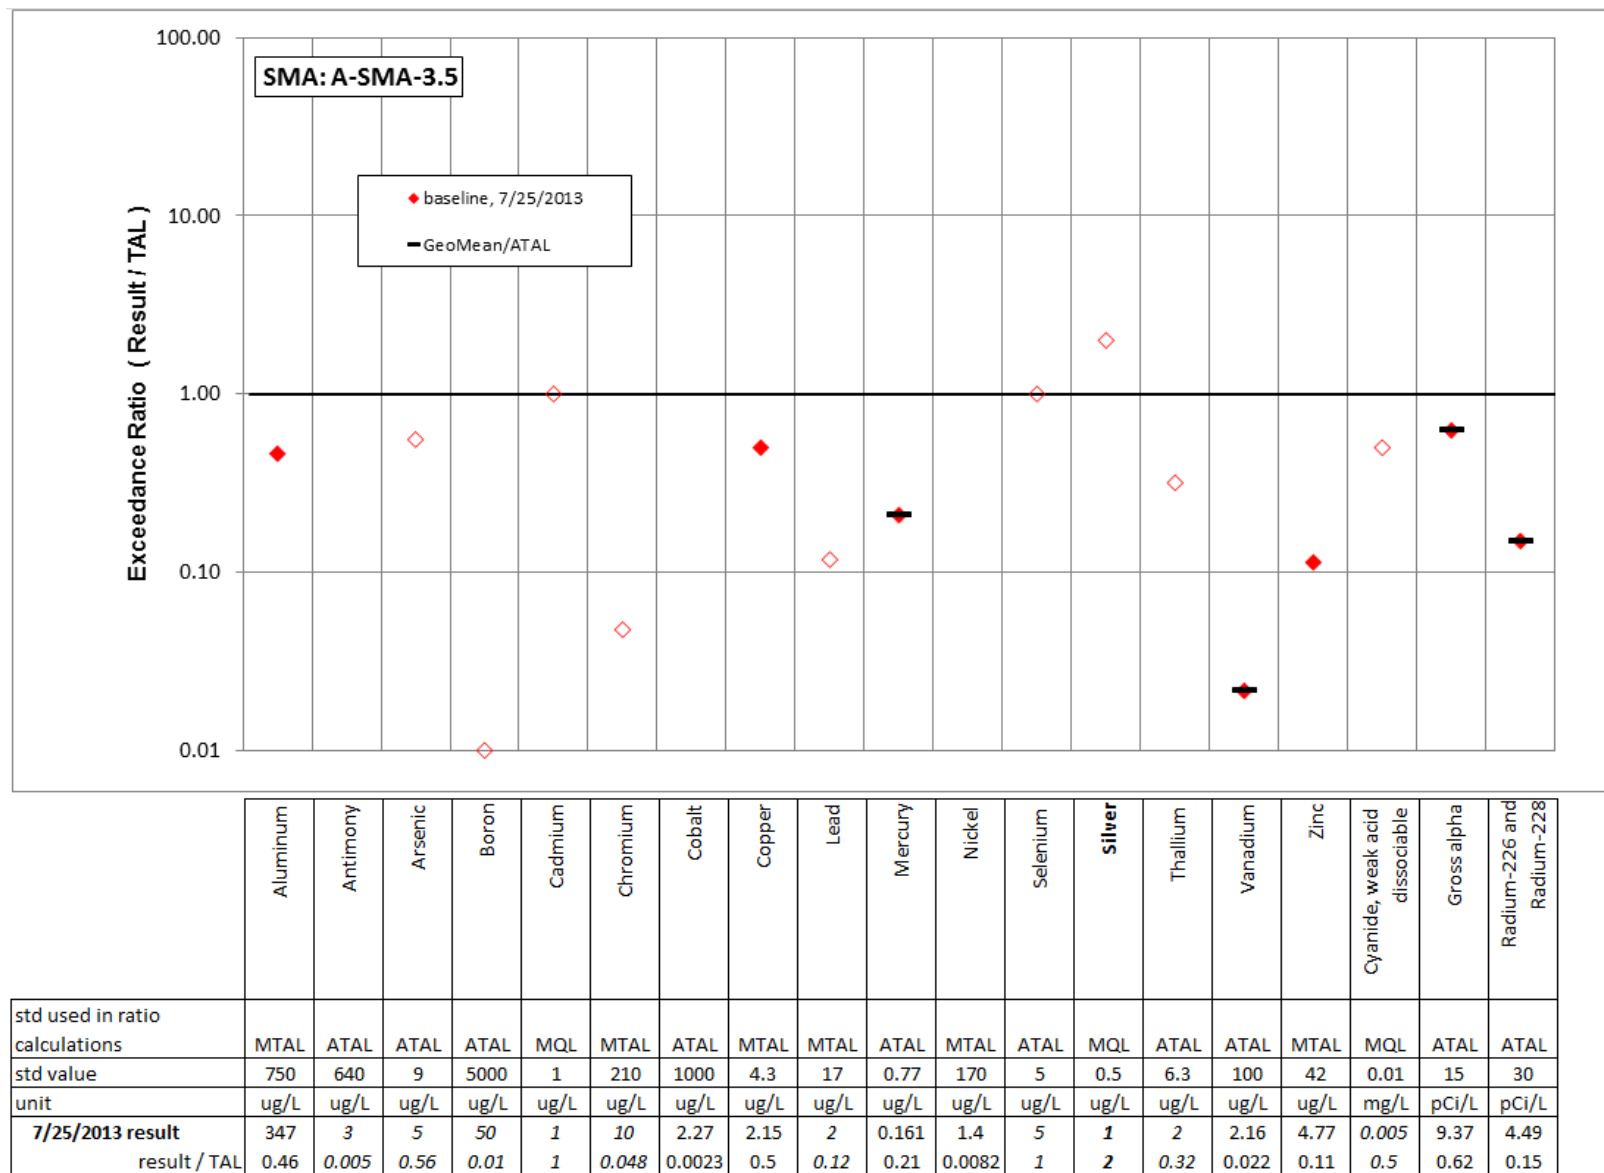
Figure 236-2 Inorganic analytical results summary plot for A-SMA-3.5

Bold font indicates result>TAL/MQL; italic font and hollow symbols indicate undetected results; "-" is used if no analytical results were available.

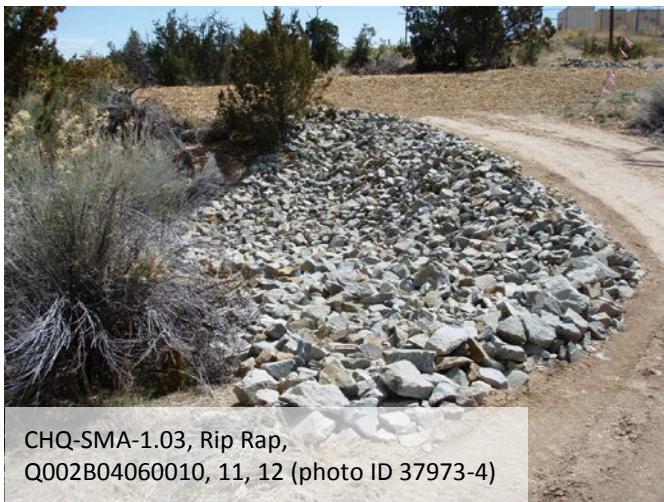
CHQ-SMA-1.03, Rip Rap, Q002B04060010, 11, 12 (photo ID 37973-4)

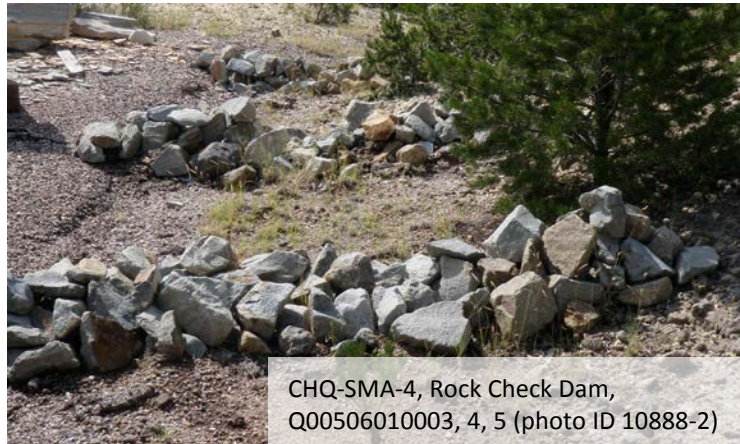
CHQ-SMA-4, Rock Check Dam, Q00506010003, 4, 5 (photo ID 10888-2)

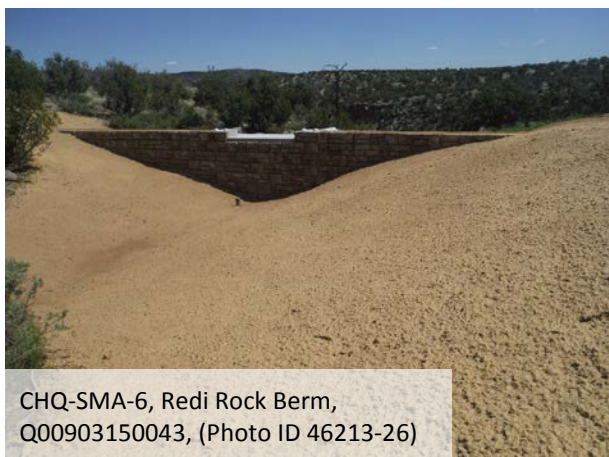
CHQ-SMA-6, Redi Rock Berm, Q00903150043, (Photo ID 46213-26)
