2016 Update to the Site Discharge Pollution Prevention Plan, Revision 1

Los Alamos National Laboratory
NPDES Permit No. NM0030759
LA-UR-17-22997 • May 1, 2017

Los Alamos/Pueblo Watershed

Receiving Waters:
Pueblo Canyon, DP Canyon, and Los Alamos Canyon

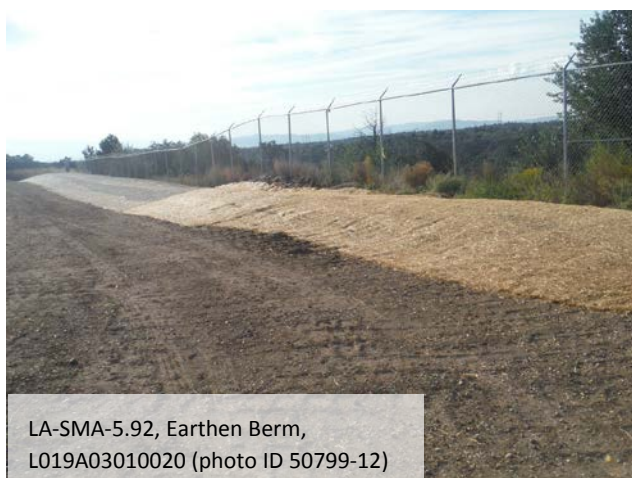
LA-SMA-5.92, Earthen Berm,
L019A03010020 (photo ID 50799-12)
