2016 Update to the Site Discharge Pollution Prevention Plan, Revision 1

Los Alamos National Laboratory
NPDES Permit No. NM0030759
LA-UR-17-23039 • May 1, 2017

Water/Cañon de Valle Watershed

Volume 4

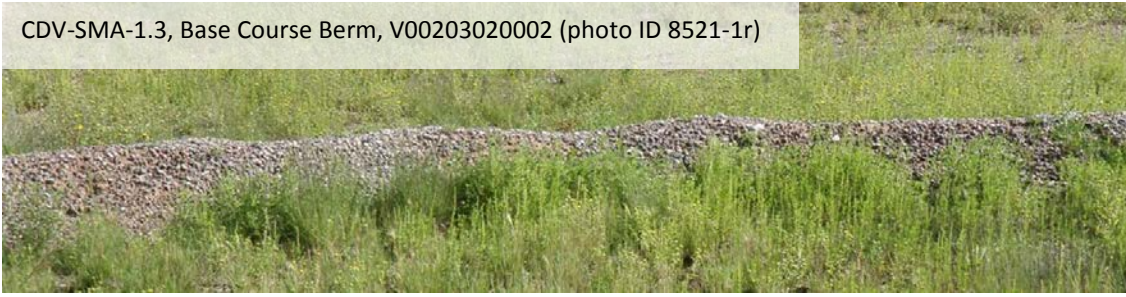
CDV-SMA-1.3, Base Course Berm, V00203020002 (photo ID 8521-1r)

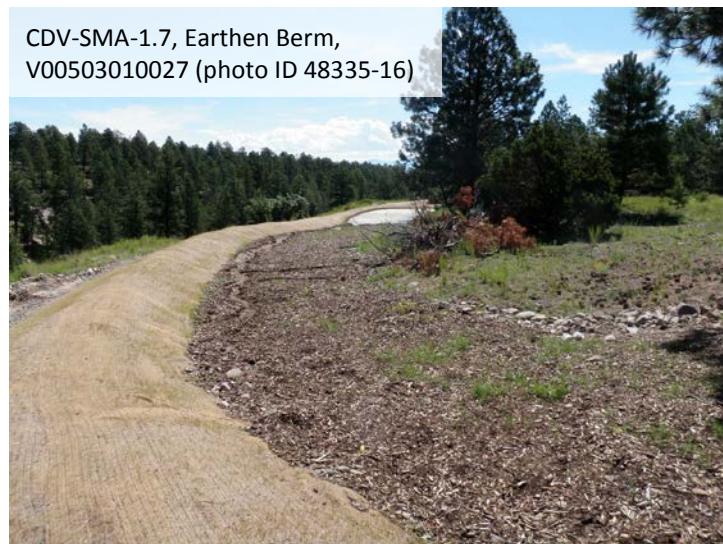
CDV-SMA-1.7, Earthen Berm,
V00503010027 (photo ID 48335-16)

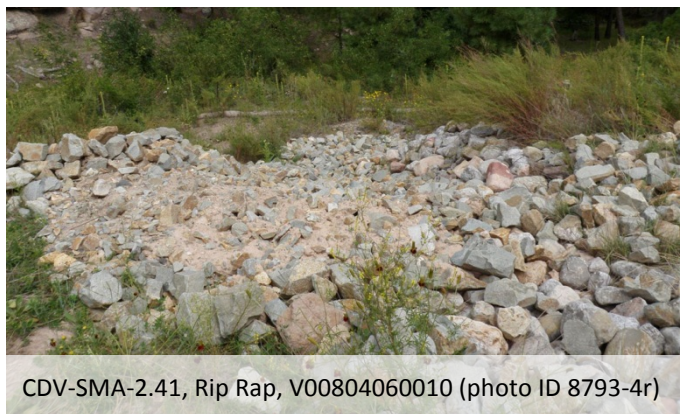
CDV-SMA-2.41, Rip Rap, V00804060010 (photo ID 8793-4r)

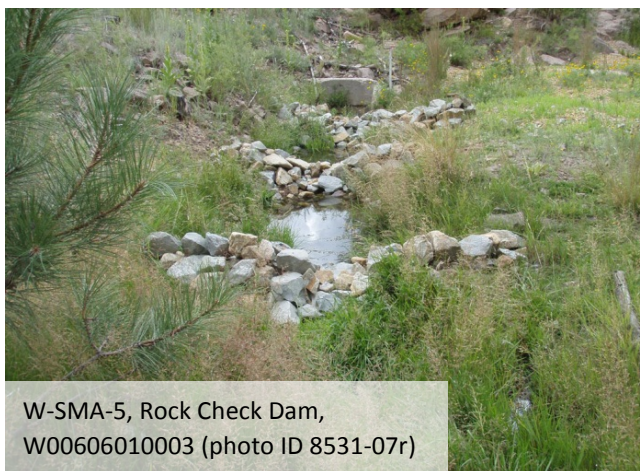
W-SMA-5, Rock Check Dam,
W00606010003 (photo ID 8531-07r)
