# 2016 Update to the Site Discharge Pollution Prevention Plan, Revision 1

Los Alamos National Laboratory  
NPDES Permit No. NM0030759  
LA-UR-17-23040 • May 1, 2017

## Ancho/Chaquehui Watershed

Receiving Waters:  
Ancho Canyon and Chaquehui Canyon

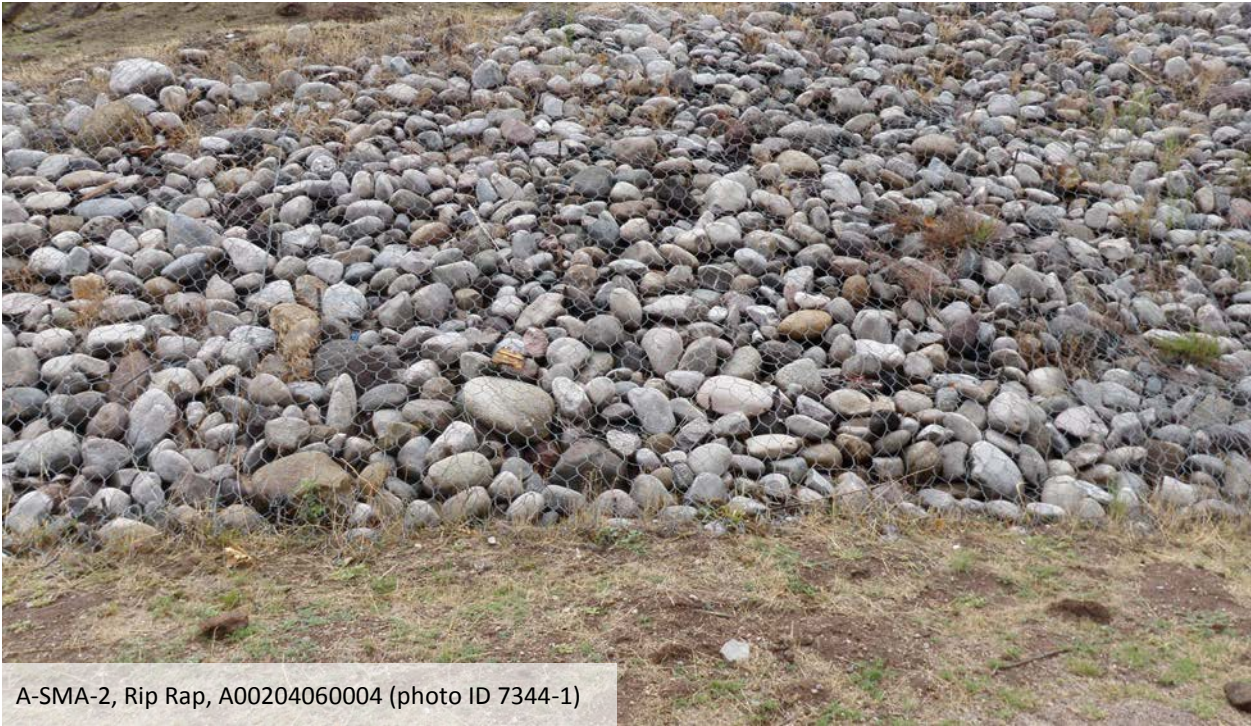
A-SMA-2, Rip Rap, A00204060004 (photo ID 7344-1)

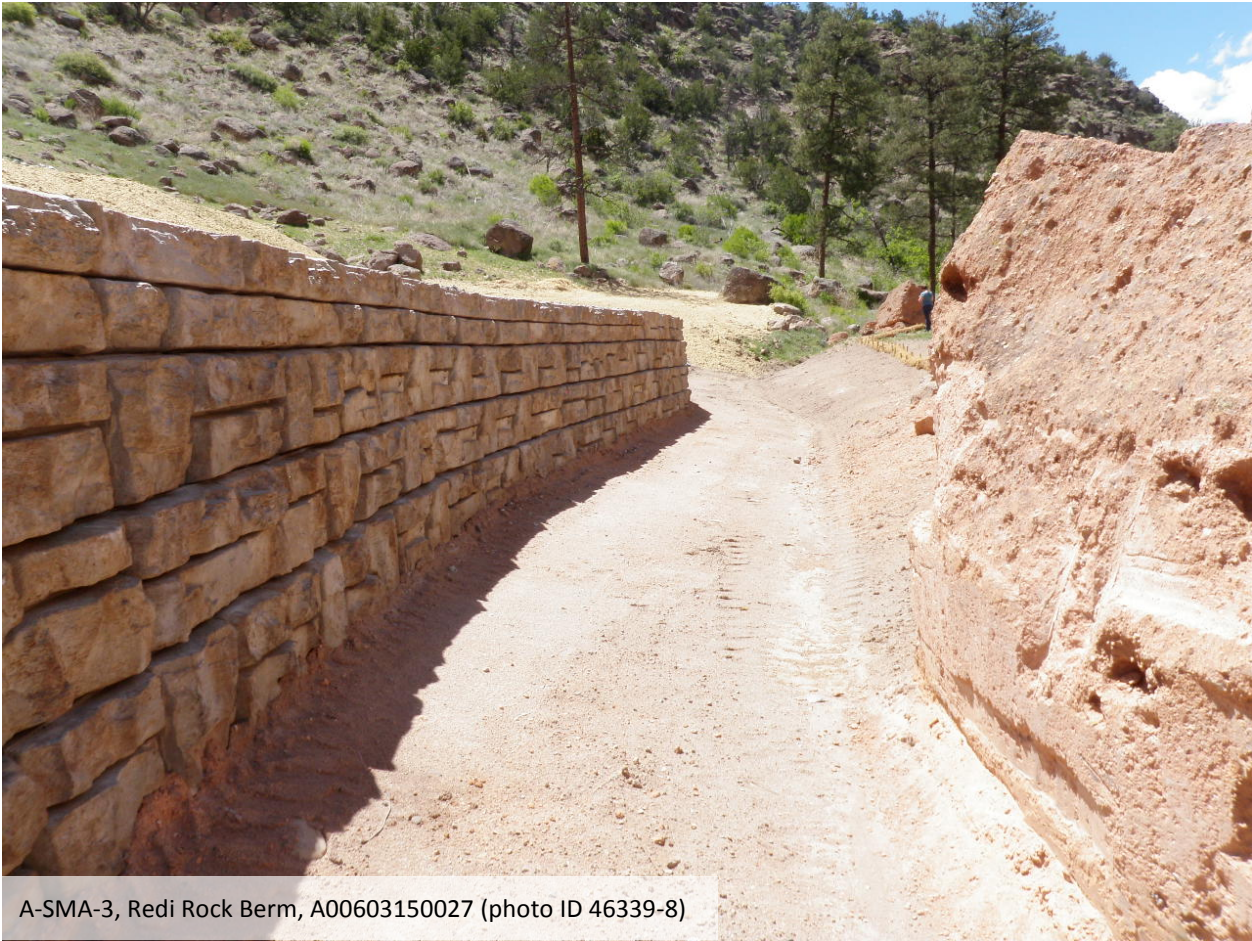
A-SMA-3, Redi Rock Berm, A00603150027 (photo ID 46339-8)

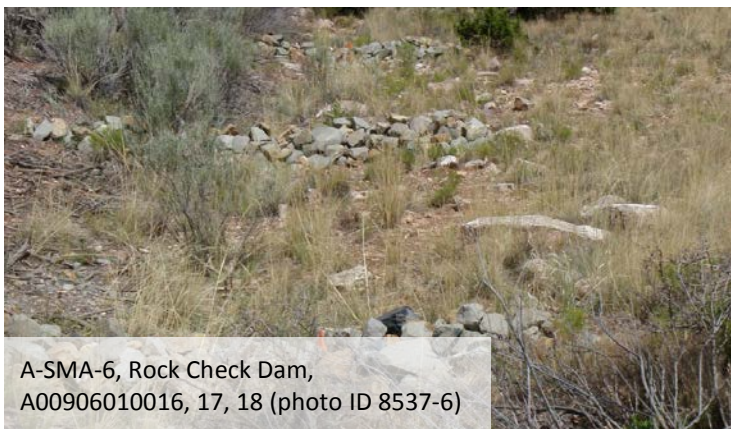
A-SMA-6, Rock Check Dam, A00906010016, 17, 18 (photo ID 8537-6)

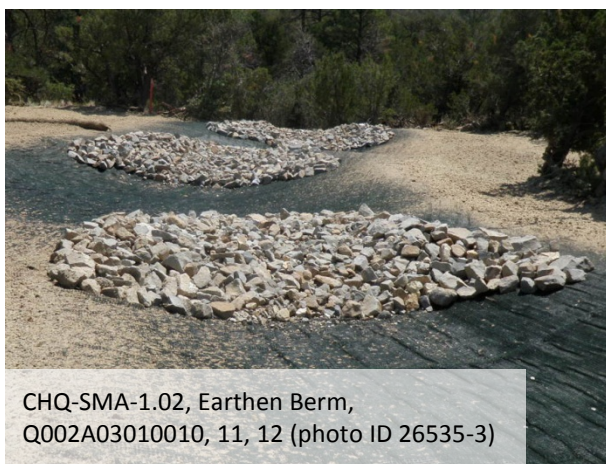
CHQ-SMA-1.02, Earthen Berm, Q002A03010010, 11, 12 (photo ID 26535-3)

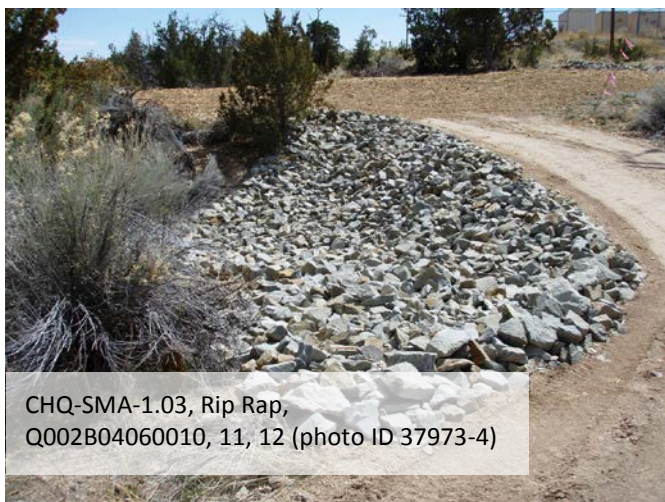
CHQ-SMA-1.03, Rip Rap,  
Q002B04060010, 11, 12 (photo ID 37973-4)

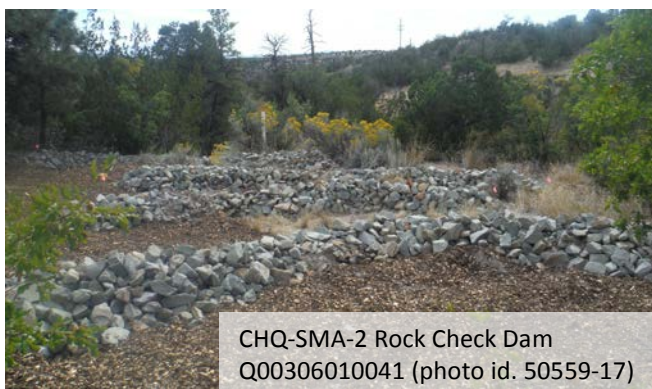
CHQ-SMA-2 Rock Check Dam  
 Q00306010041 (photo id. 50559-17)

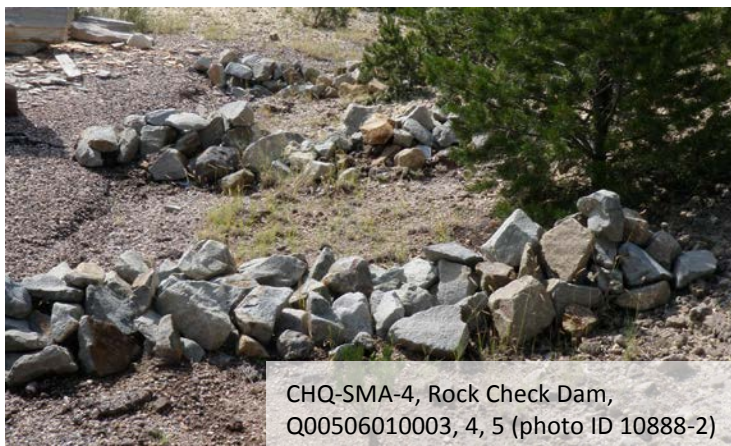
CHQ-SMA-4, Rock Check Dam, Q00506010003, 4, 5 (photo ID 10888-2)

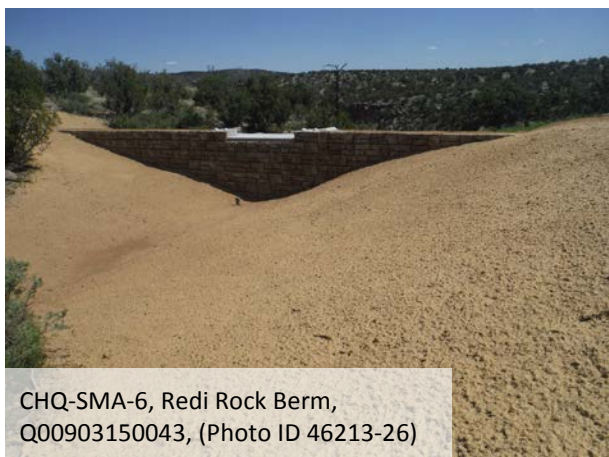
CHQ-SMA-6, Redi Rock Berm, Q00903150043, (Photo ID 46213-26)
