**Subject: 2016 Monitoring Report for Los Alamos/Pueblo Watershed Sediment Transport Mitigation Project**

April 2017

EP2017-0042

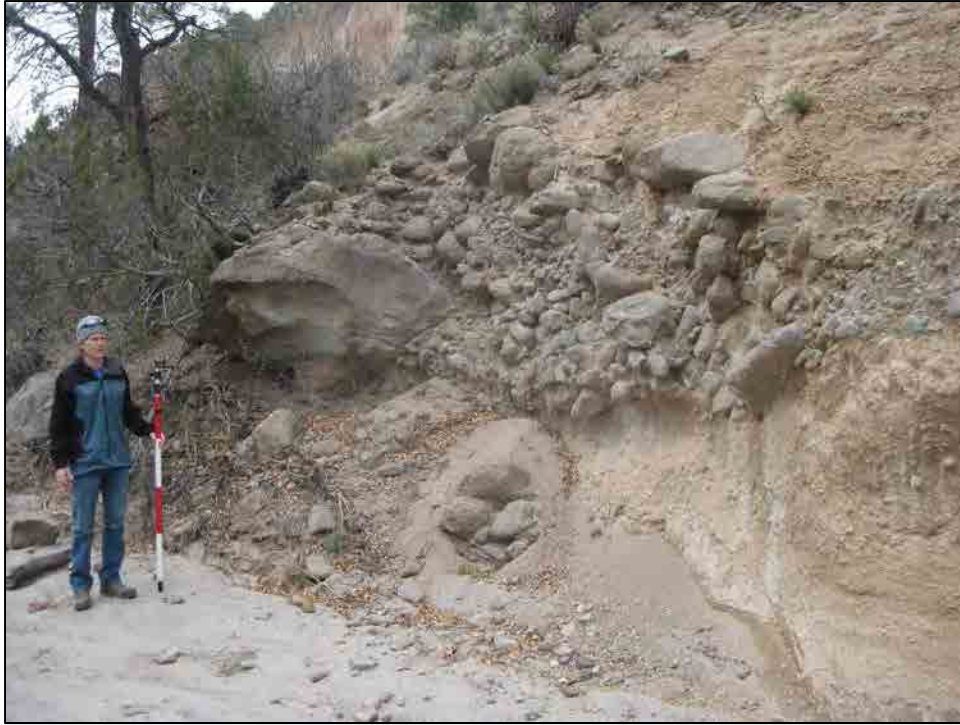
**Photo A1-2** Additional area of detected change (-5.5 ft) in Pueblo Canyon background area, looking northwest. Channel banks are eroding via rock/soil fall into the main channel.

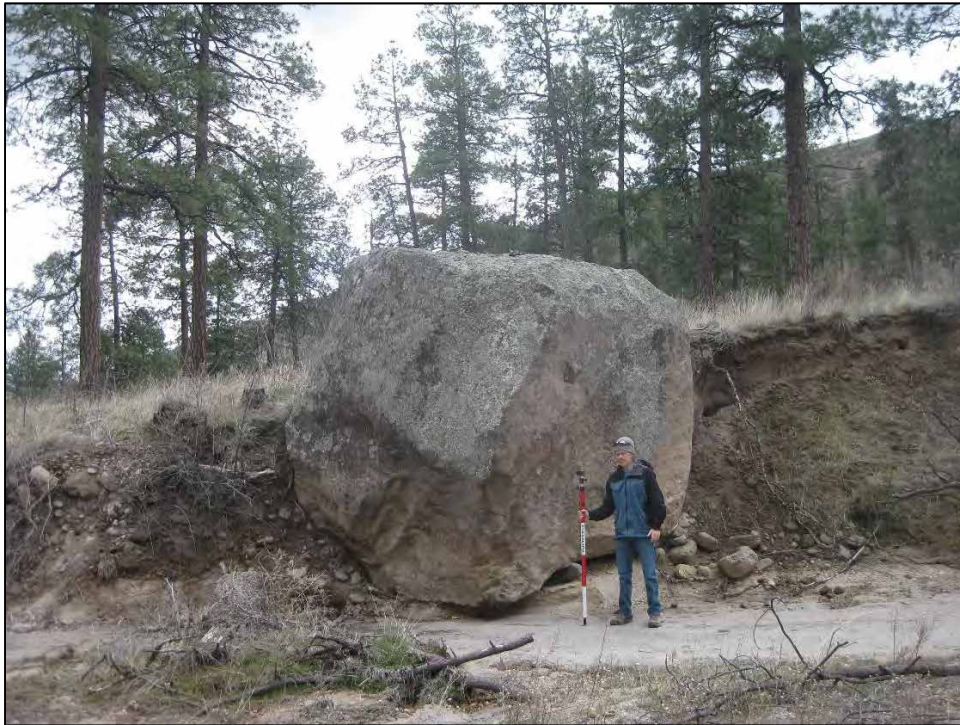
**Photo A1-3** Area of detected positive elevation change because of misclassification of light detection and ranging (LiDAR) point cloud in Pueblo Canyon background area, looking east

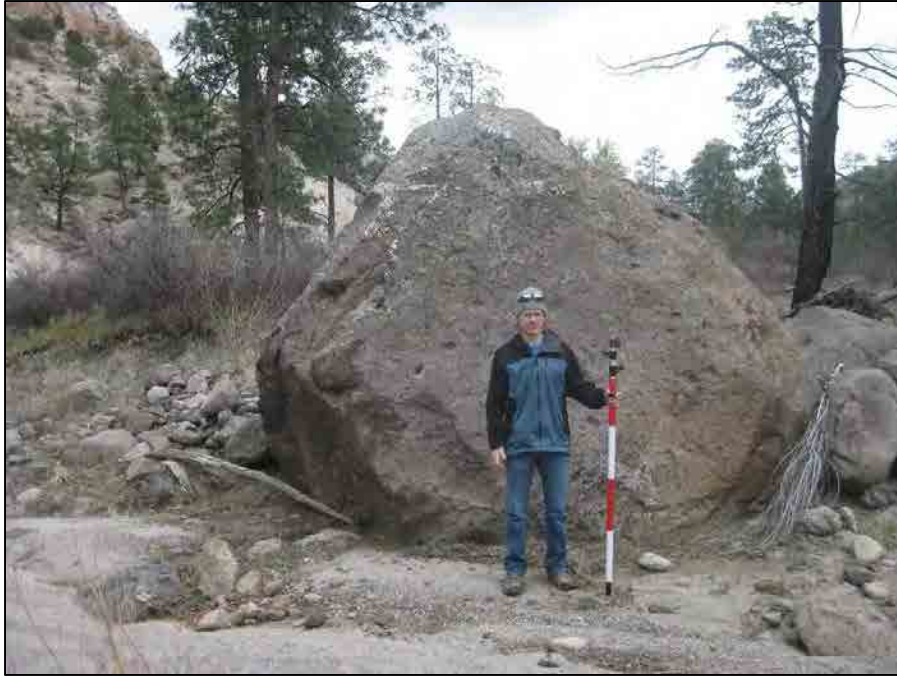
**Photo A1-4** Area of detected positive elevation change because of misclassification of LiDAR point cloud in Pueblo Canyon background area, looking east

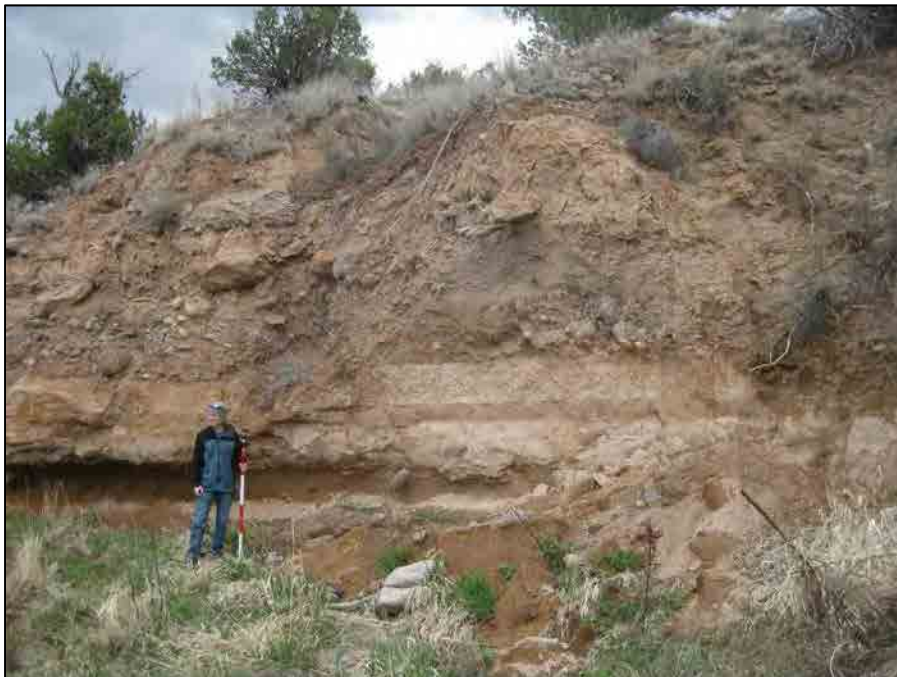
**Photo A1-5** Maximum negative elevation change (-11.3 ft) Pueblo Canyon upper willow planting area, looking east. Loss of overhanging slope sediments and rocks resulted in large magnitude of elevation change detected on this bank. Actual volume change of observed sediments at the base of the bank is minor.

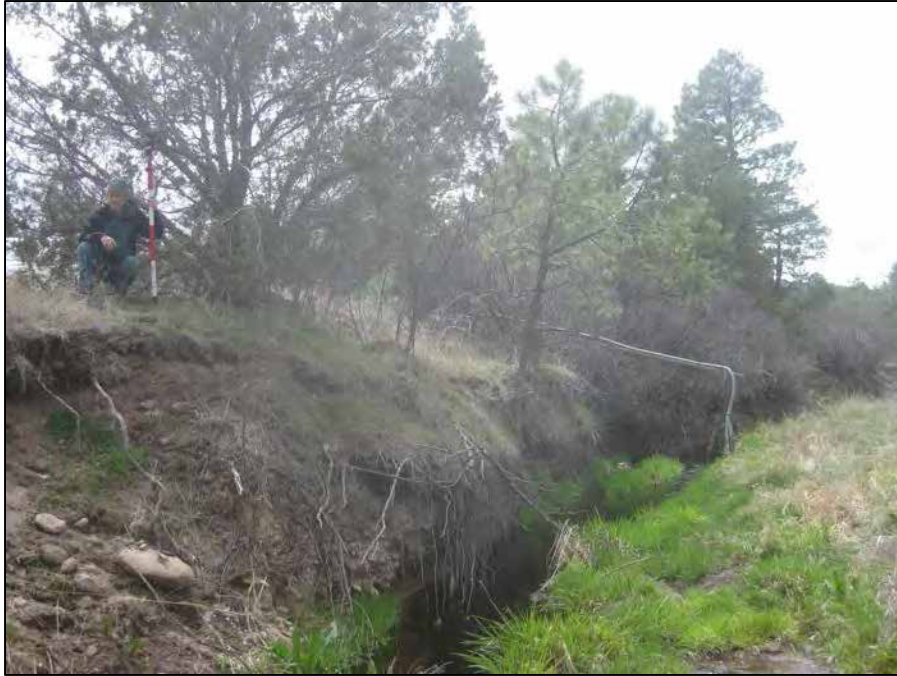
**Photo A1-6** Detected geomorphic change near stream gage E059.5 in the Pueblo Canyon upper willow planting area, looking west. Geomorphic change at this location is characterized by the slumping/creeping of unconsolidated sediment and boulders that comprise the channel bank. No channel process change is observed.

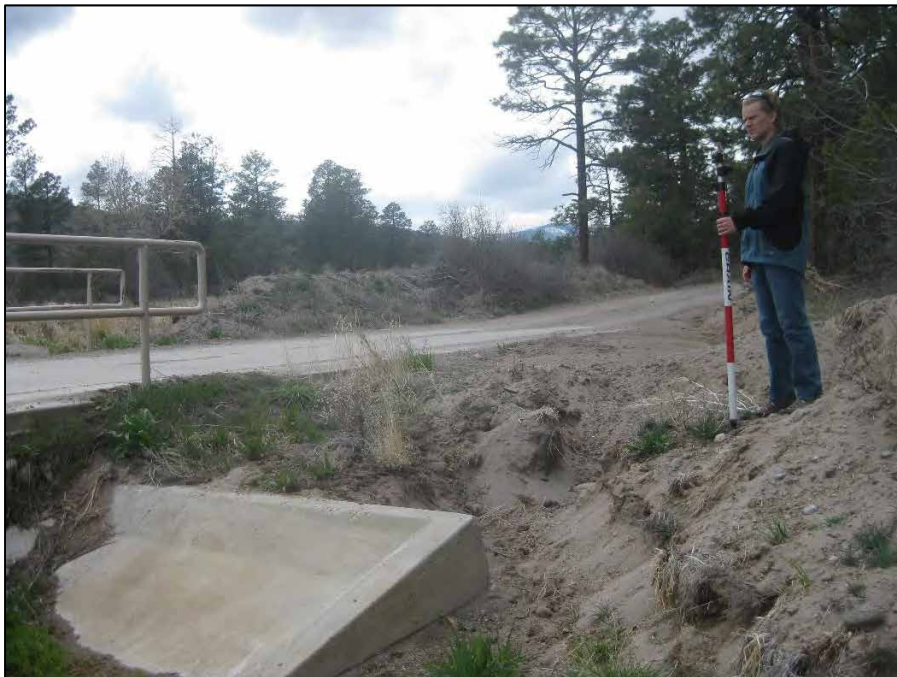
**Photo A1-7** Detected erosion (~2.4 ft) around wing ditch culverts/bridge, looking west

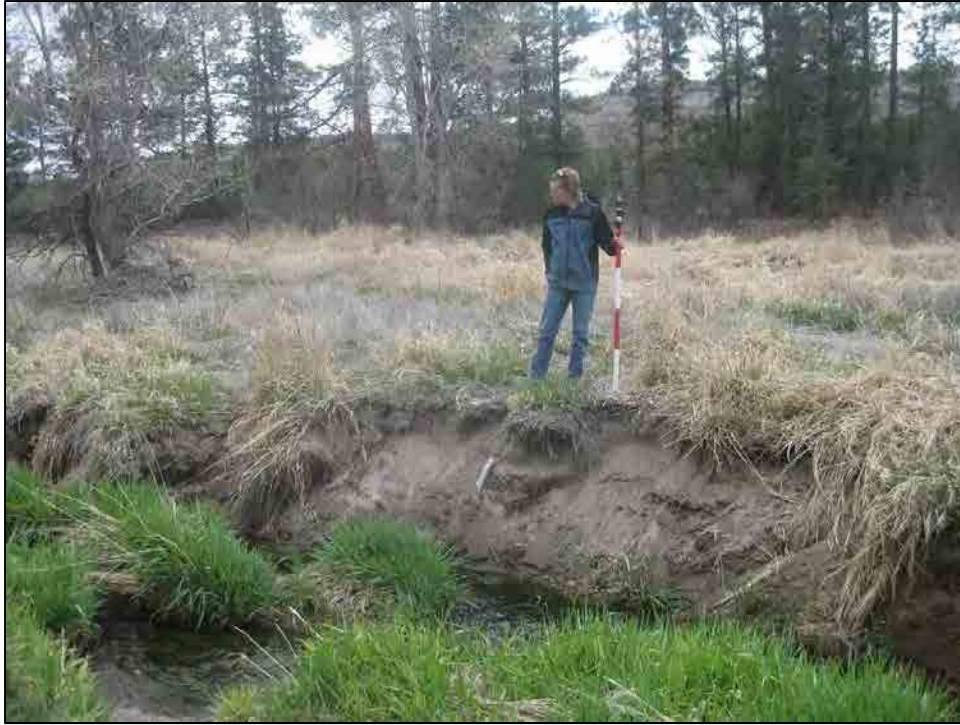
**Photo A1-8** Detected erosion (~2.39 ft) on active channel banks at upstream area of wing ditch, looking south

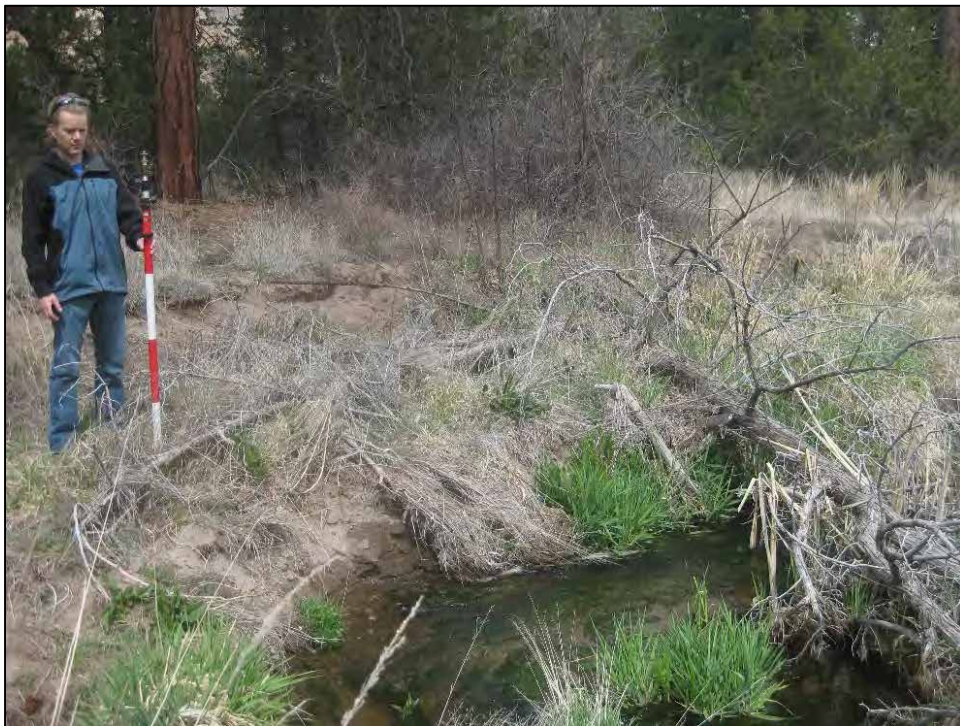
**Photo A1-9** Detected erosion (~1.9 ft) on active channel banks at upstream area of wing ditch, looking northeast

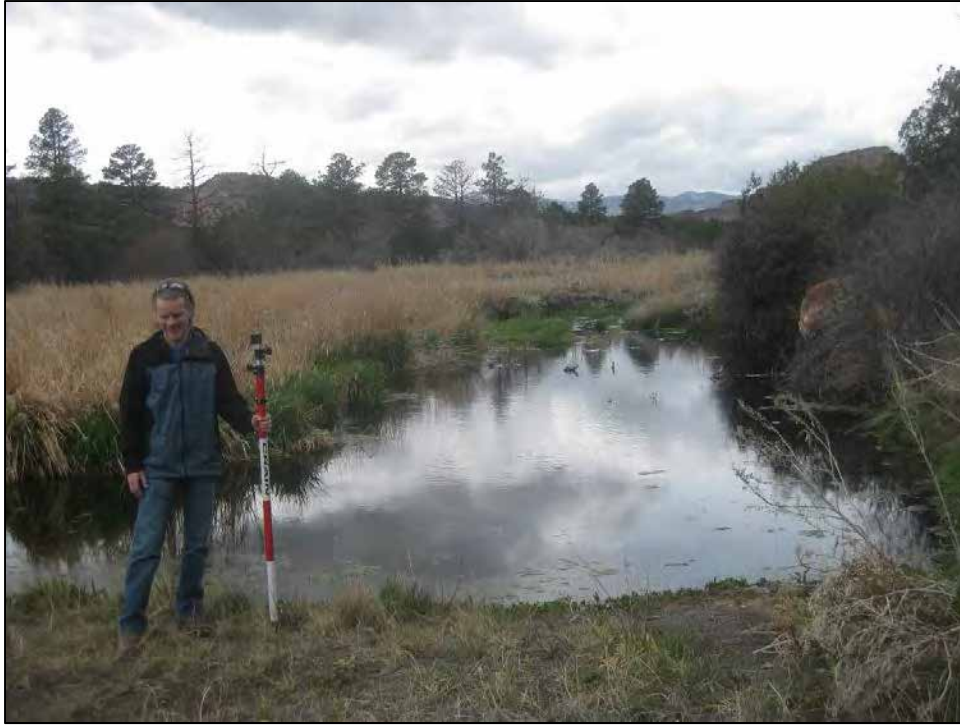
**Photo A1-10** Detected change ( $\sim 3.2$  ft) at the ponded area above Pueblo Canyon drop structure. No significant geomorphic change was observed at this area. View is west.

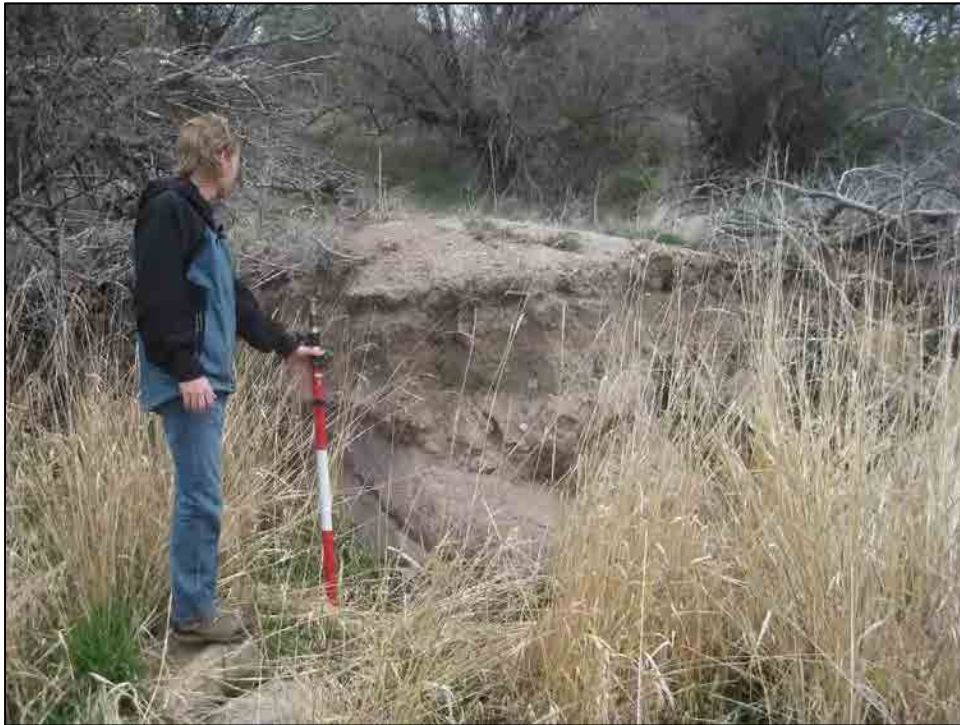
**Photo A1-11** Detected change ( $\sim 3.9$  ft) in Pueblo Canyon lower willow planting area of unconsolidated bank material. View is northeast.

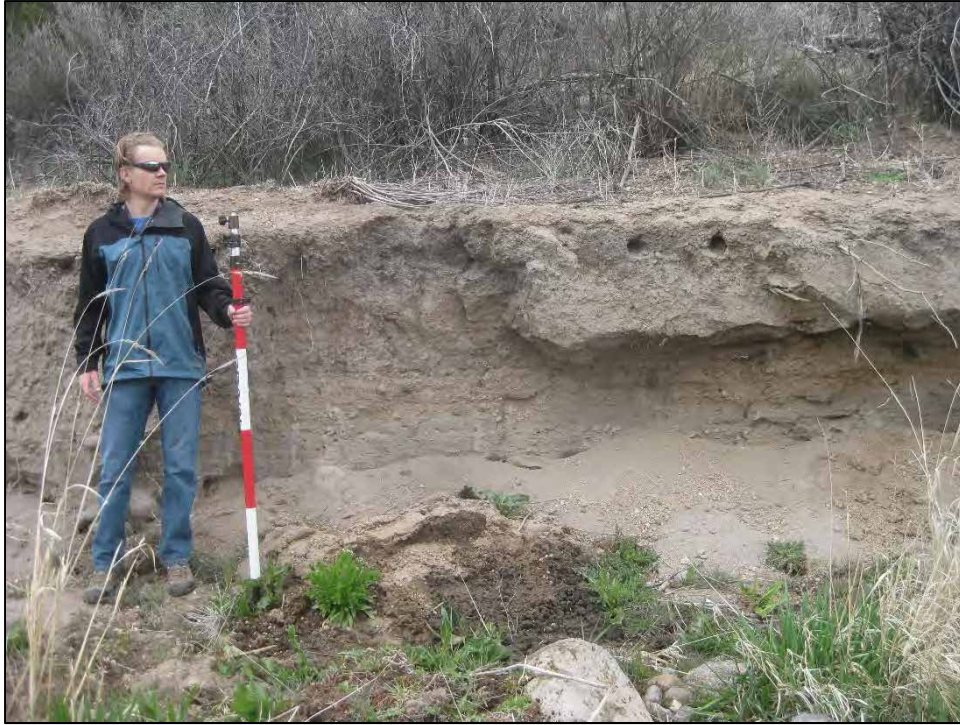
**Photo A1-12** Detected change (+2.1 ft) from collapse of channel bank sediments in Pueblo Canyon lower willow planting area, looking north

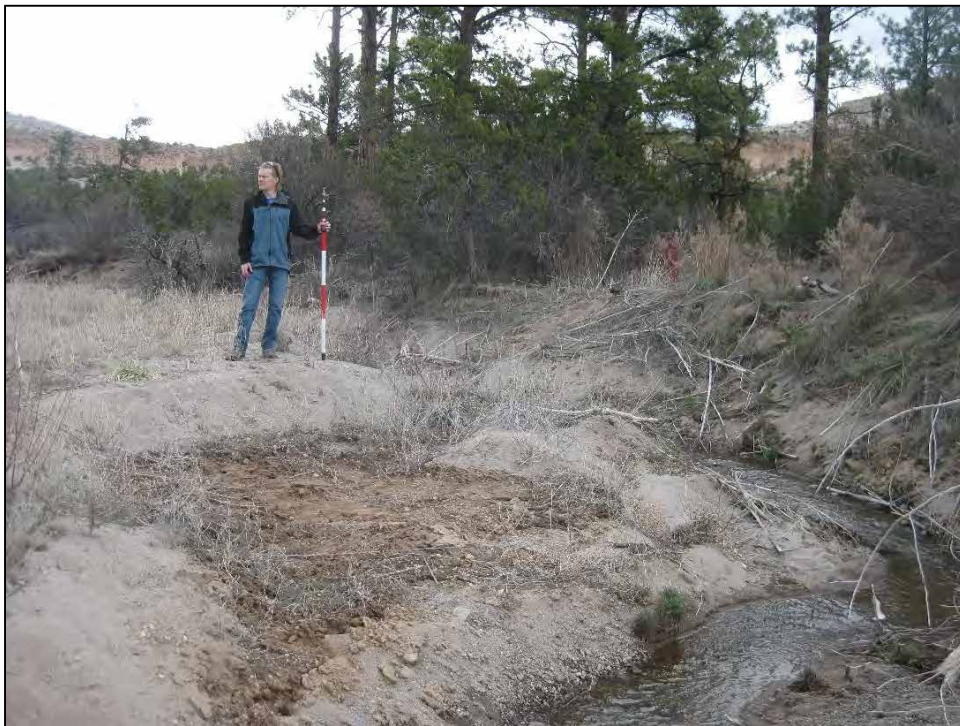
**Photo A1-13** Lateral channel migration and incision (-1.26 ft) detected near the western edge of reach P-4 Central in Pueblo Canyon grade-control structure (GCS) area, looking northwest

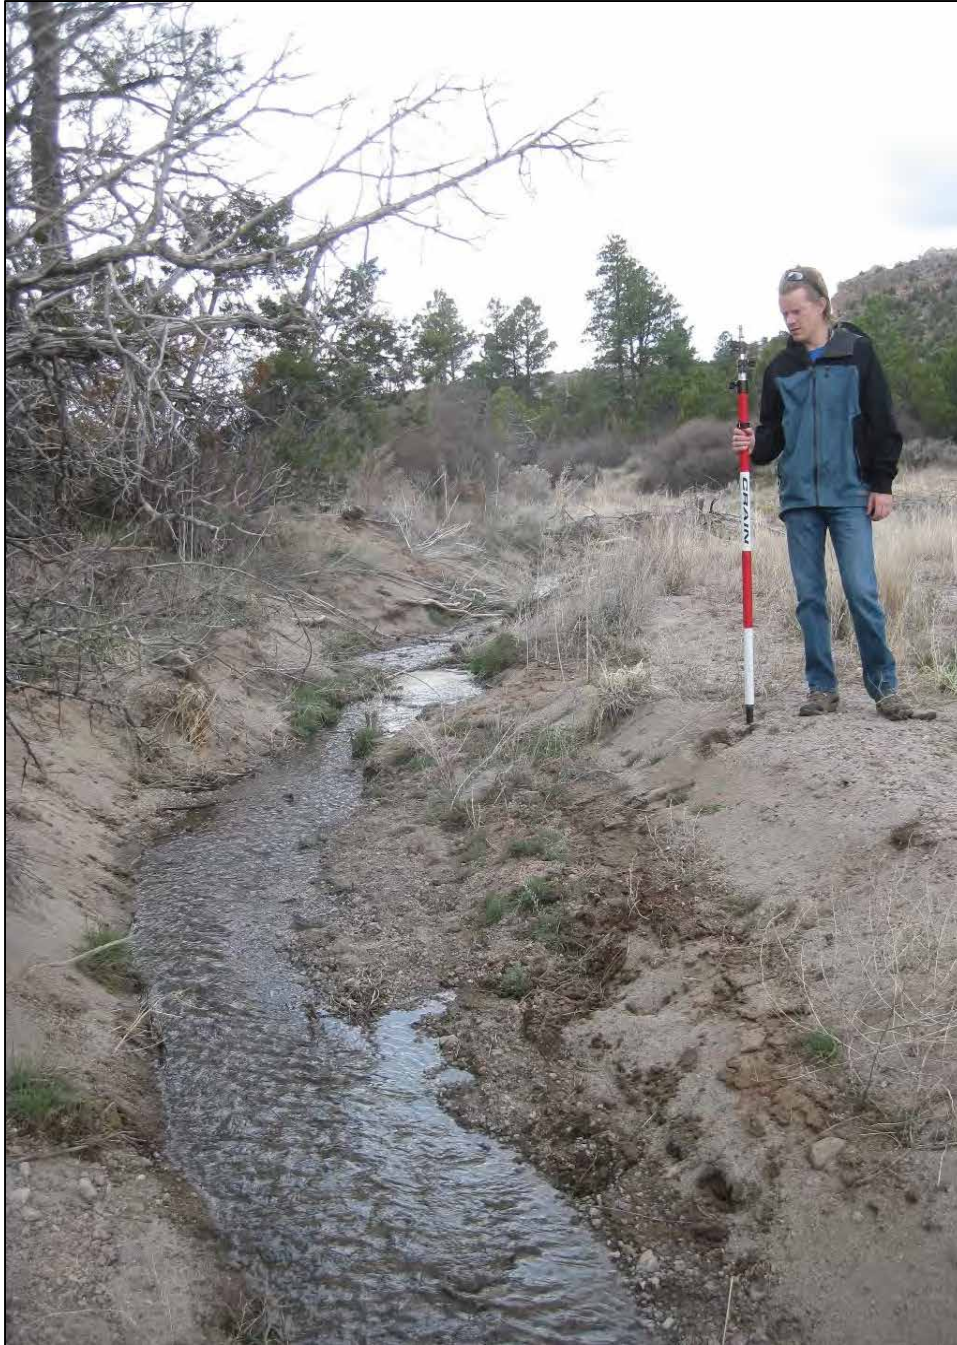
**Photo A1-14 Channel incision (~1.26 ft) detected near the western edge of reach P-4 Central in Pueblo Canyon GCS area, looking east**

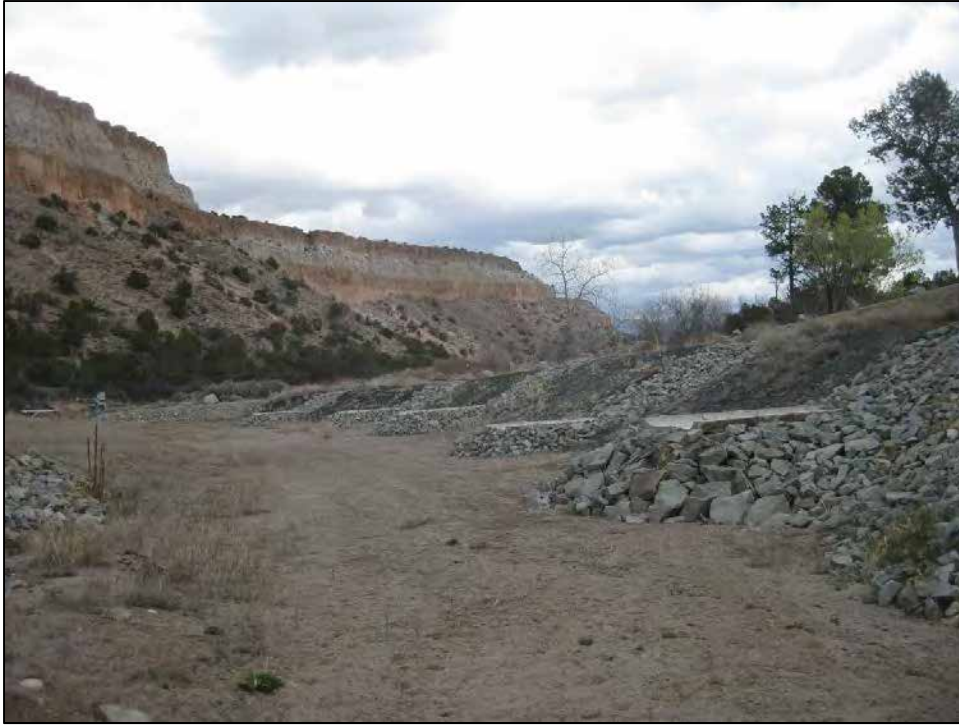
**Photo A1-15** Change-detection analyses highlighted the results of construction and grading activities below Pueblo Canyon GCS, looking east

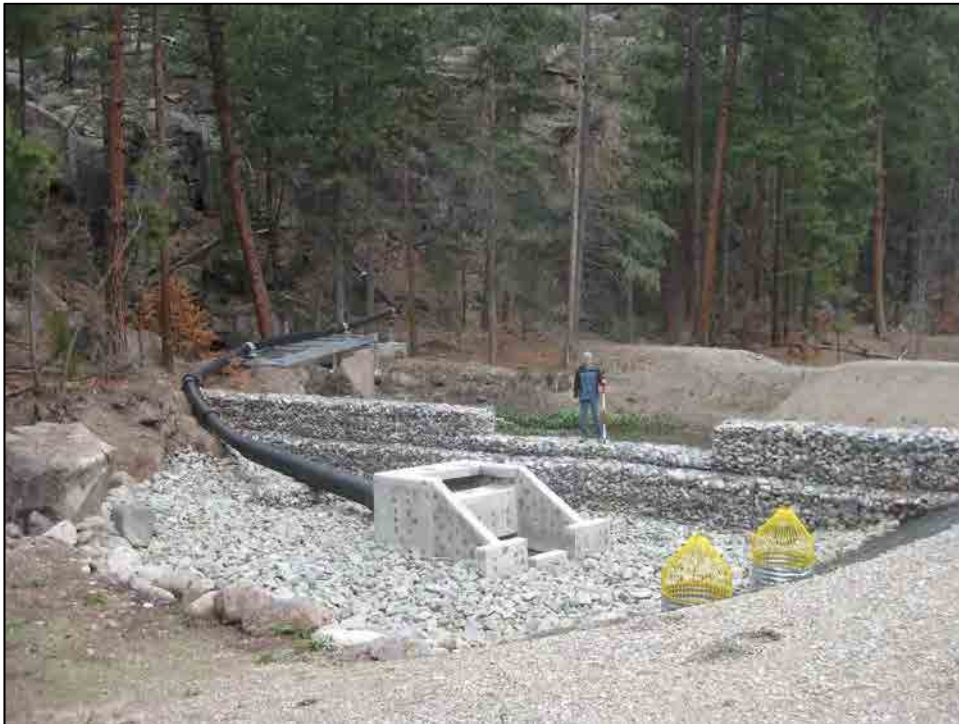
**Photo A1-16** Change detection analyses highlighted the results of construction and installation of storm water runoff mitigation structures, looking northeast

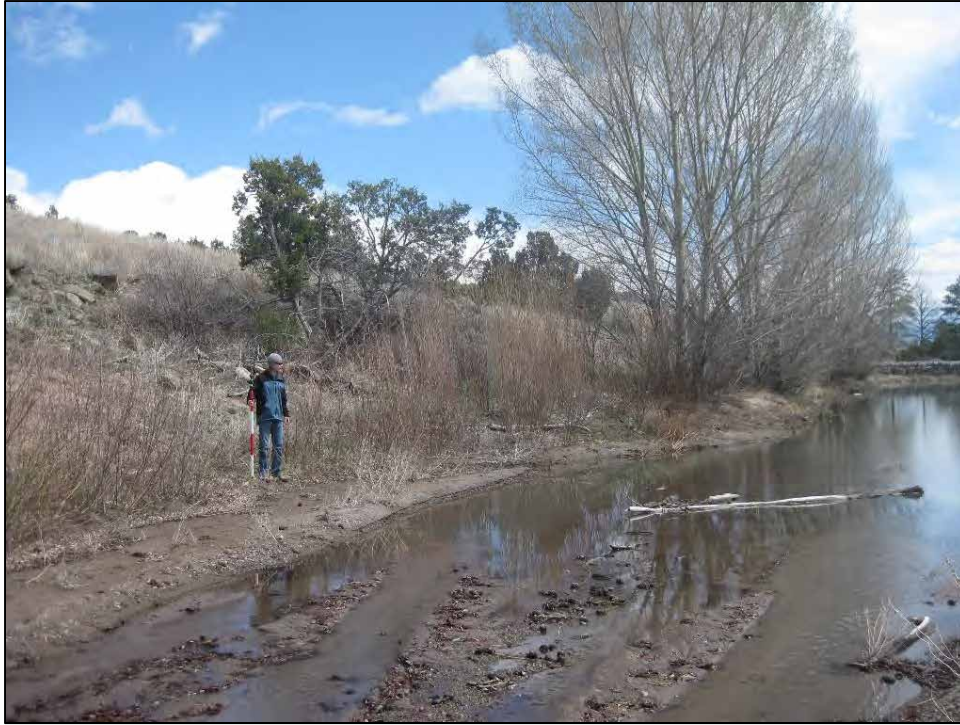
**Photo A1-17** Erosion ( $\sim 0.8$  ft) on cut bank in Basin 3 above Los Alamos Canyon low-head weir, looking east

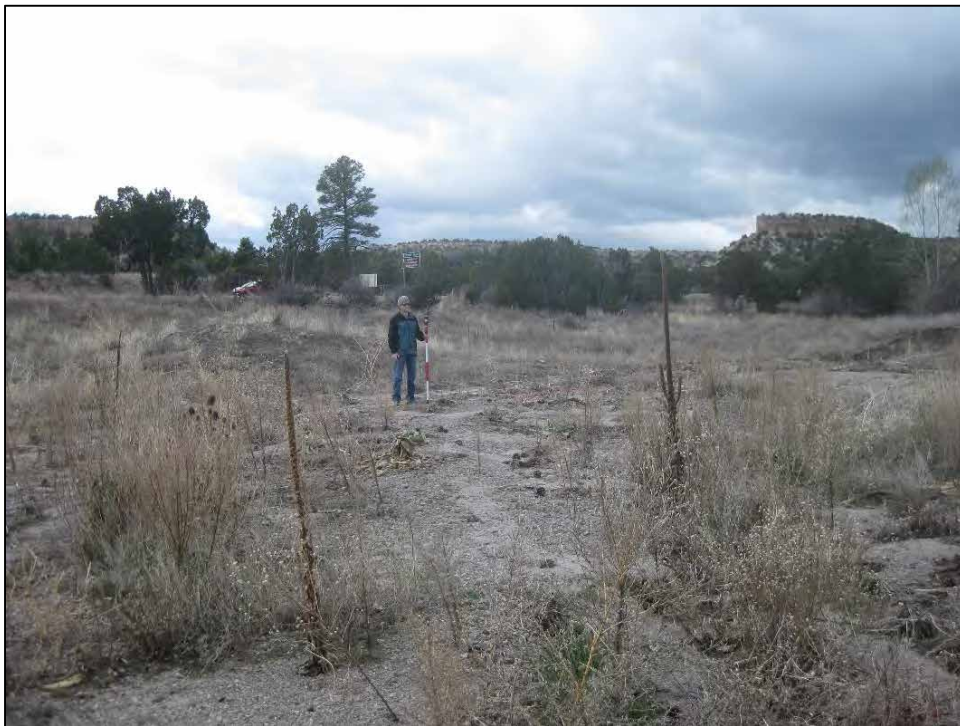
**Photo A1-18** Deposition ( $+1.0$  ft) in channel of Basin 2 above Los Alamos Canyon low-head weir, looking west

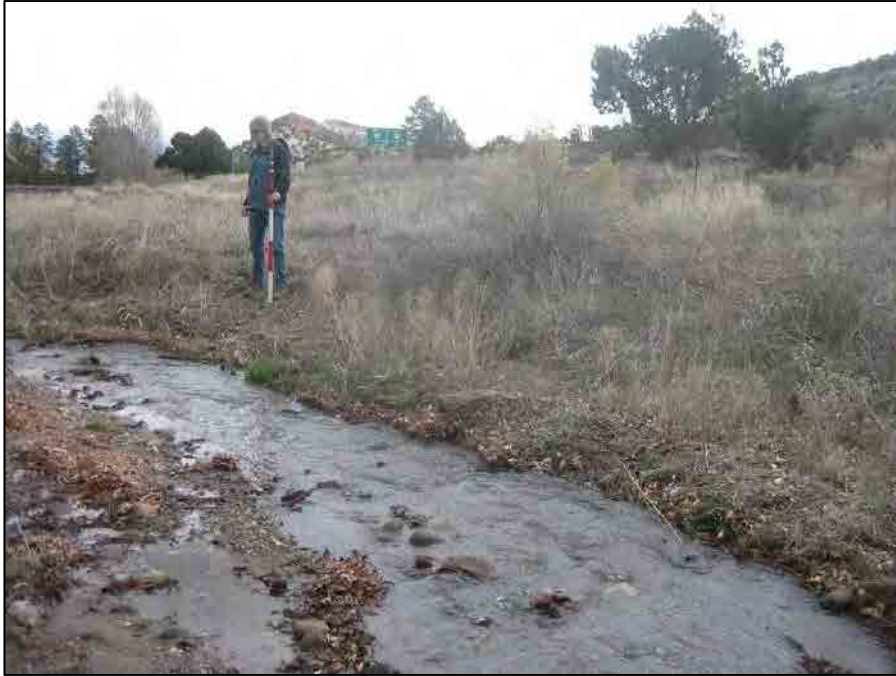
**Photo A1-19** Deposition (+0.97 ft) of overbank materials in Basin 1 above Los Alamos Canyon low-head weir

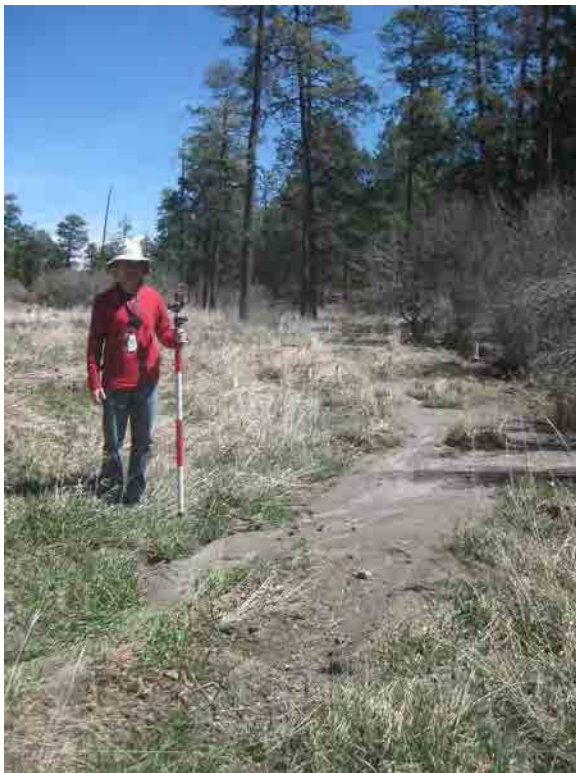
**Photo A1-20** Deposition (+1.21 ft) of channel fill materials detected in area of braided channels above DP Canyon GCS, looking east

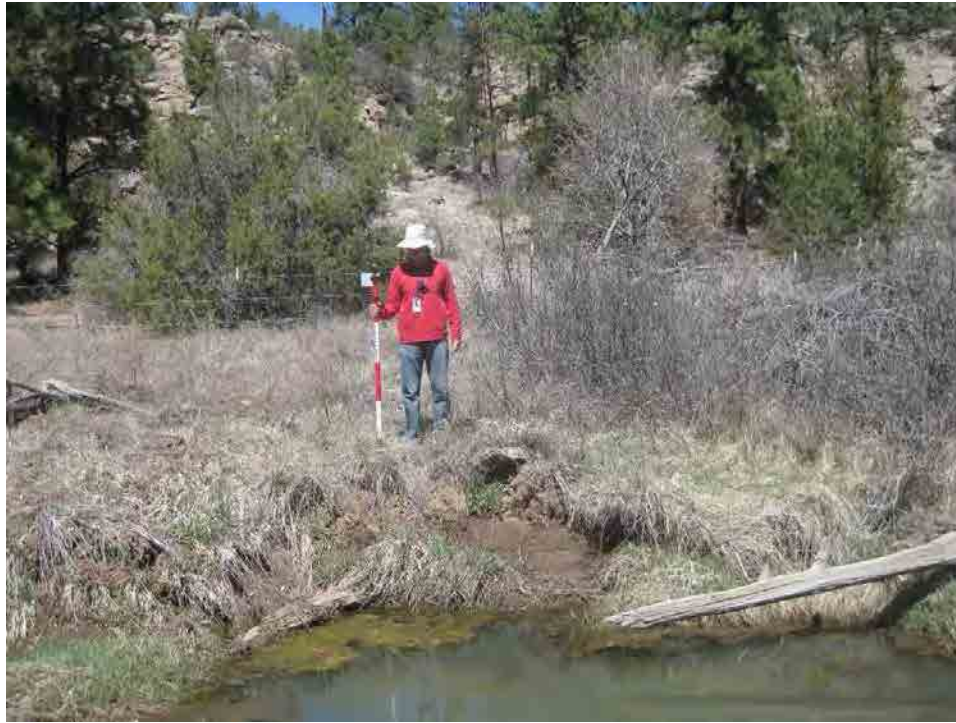
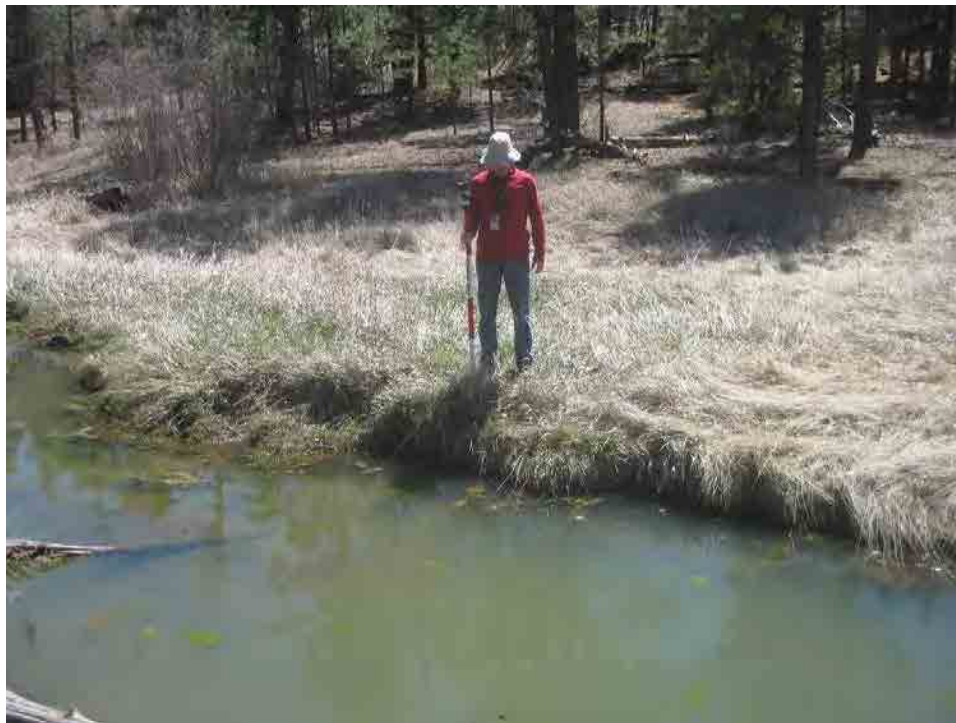
**Photo A1-21** Erosion (~1.0 ft) of bank materials detected in area of well-defined channel directly upstream of DP Canyon GCS: (a) looking north at left bank and (b) looking south at right bank

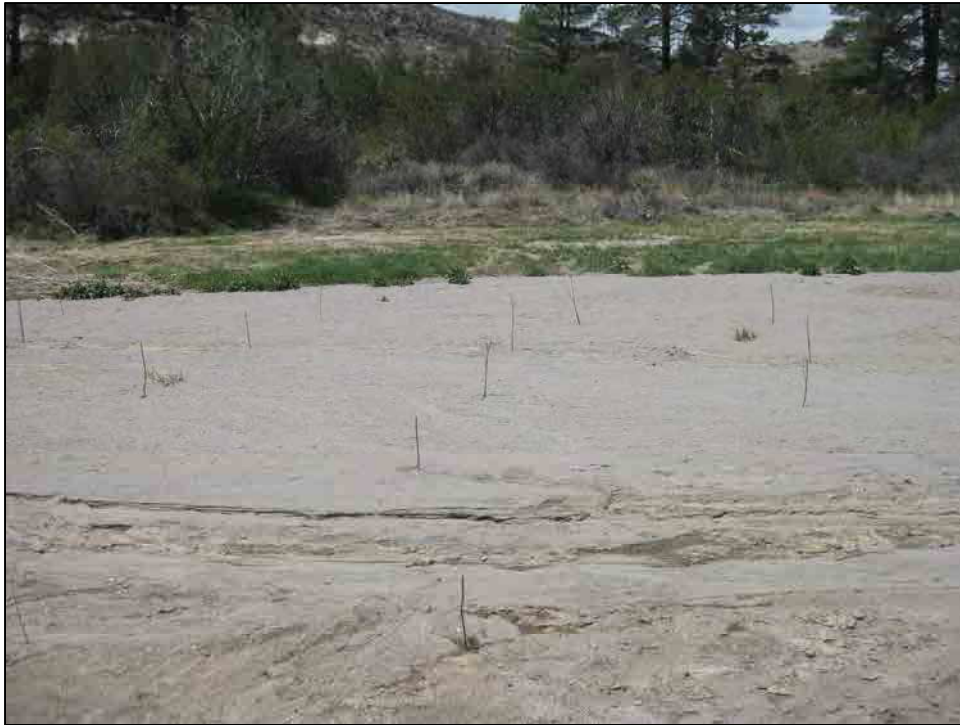
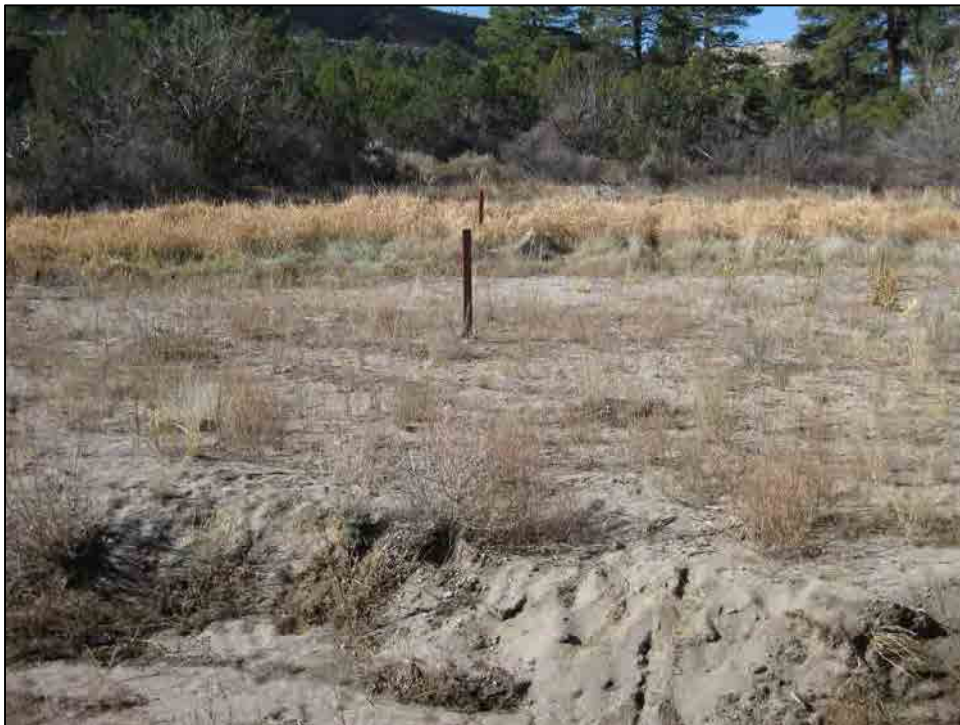
**Photo A1-22** Willows planted in 2014 in Pueblo Canyon lower willow-planting area, from northern stake at P4C+800: (a) in April 2014 and (b) short-height, spatially dispersed community (P-1) example in November 2016

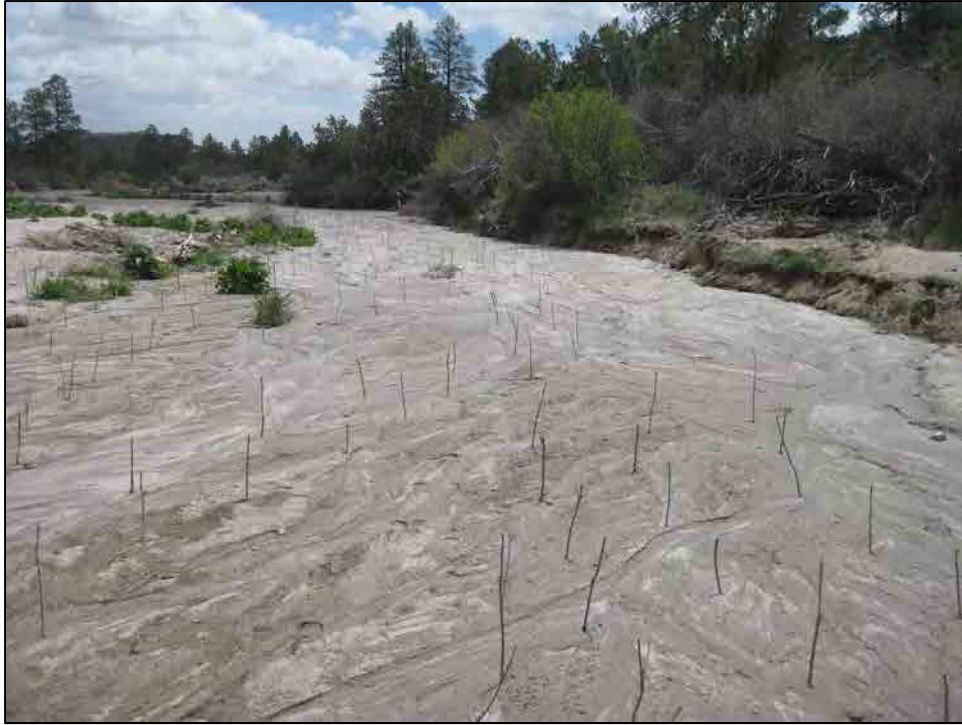
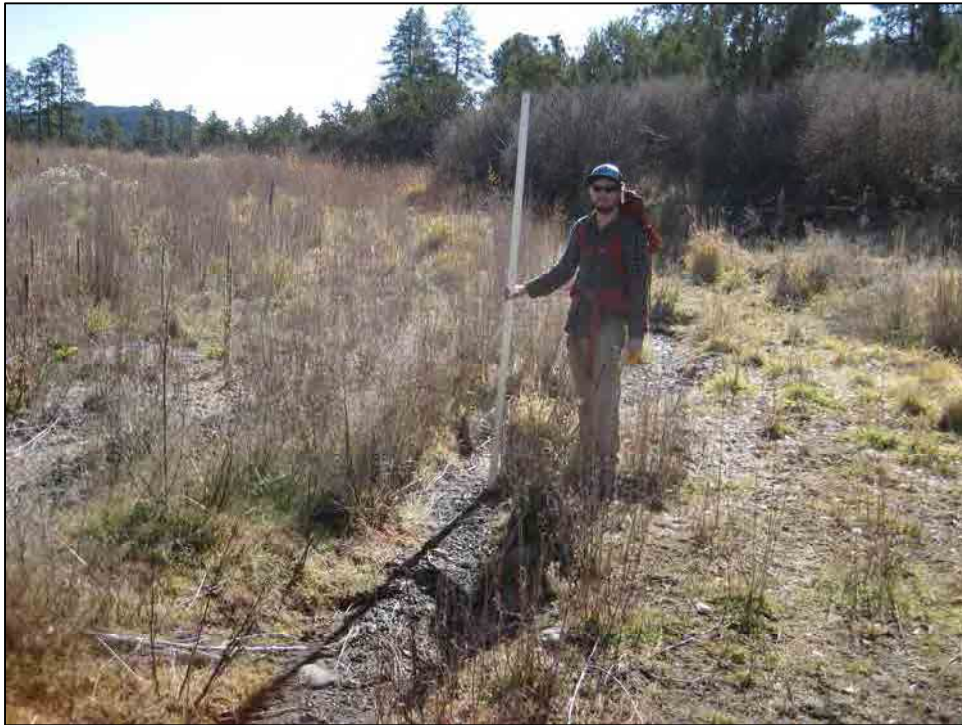
**Photo A1-23** Willows planted in 2014 in Pueblo Canyon lower willow planting area, looking downstream from PU+1100: (a) April 2014 and (b) short-height, spatially continuous community (P-2) example in November 2016

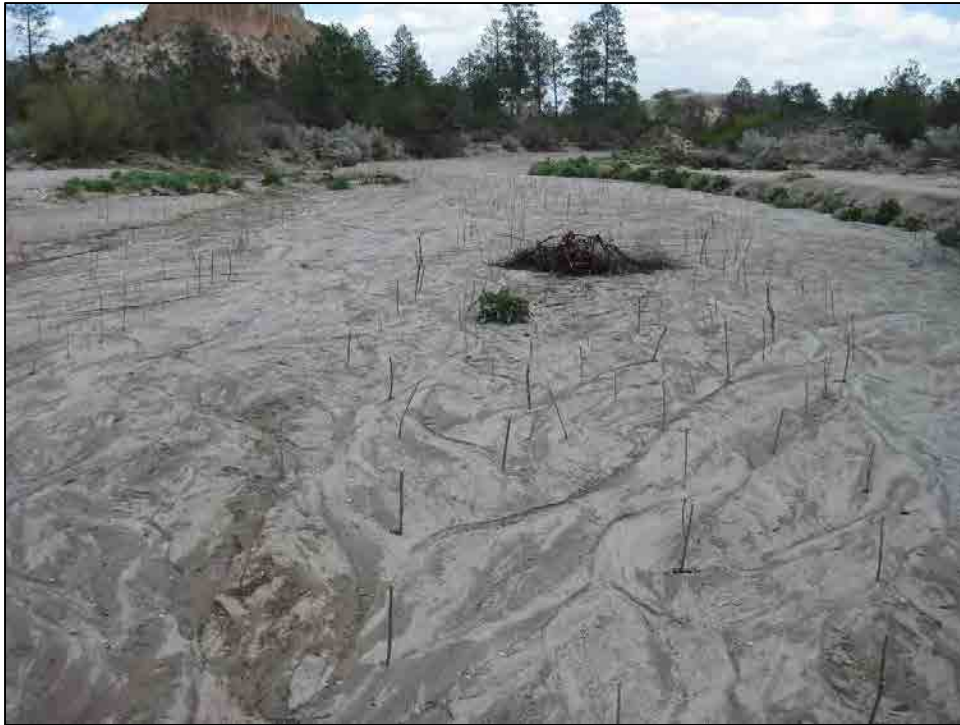
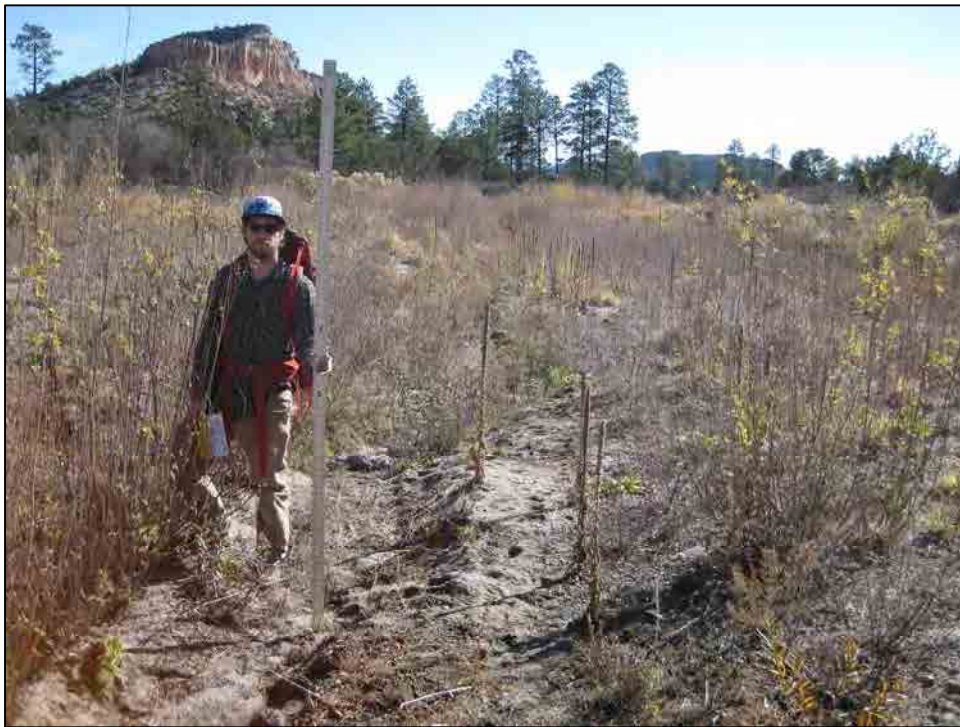
**Photo A1-24** Willows planted in 2014 in Pueblo Canyon lower willow planting area, looking downstream from P4C+200: (a) in April 2014 and (b) medium-height, spatially dispersed community (P-3) example in November 2016

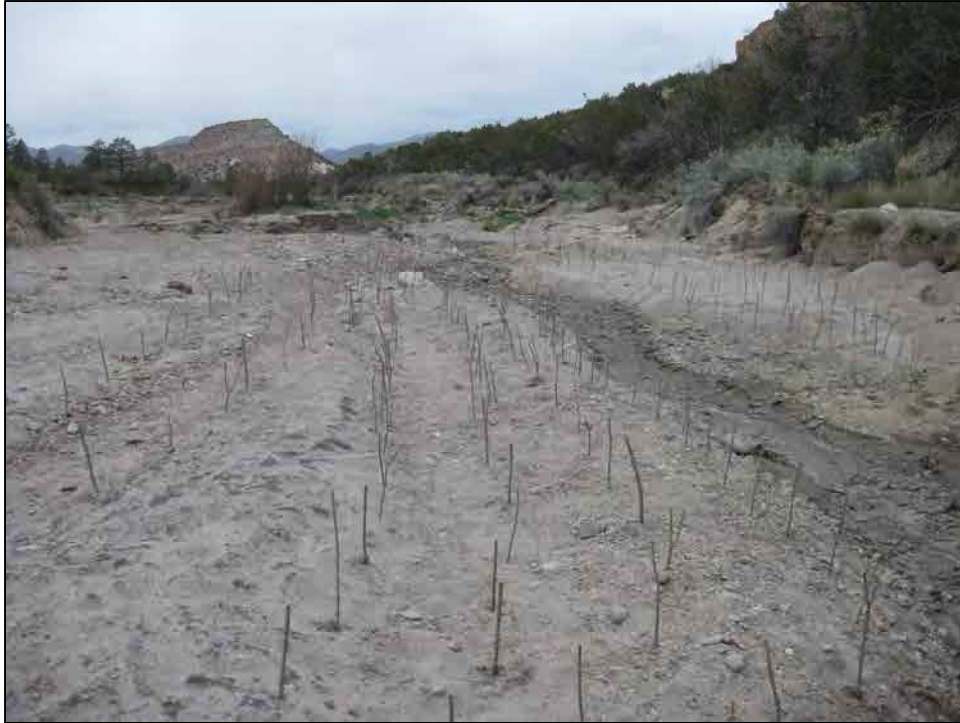
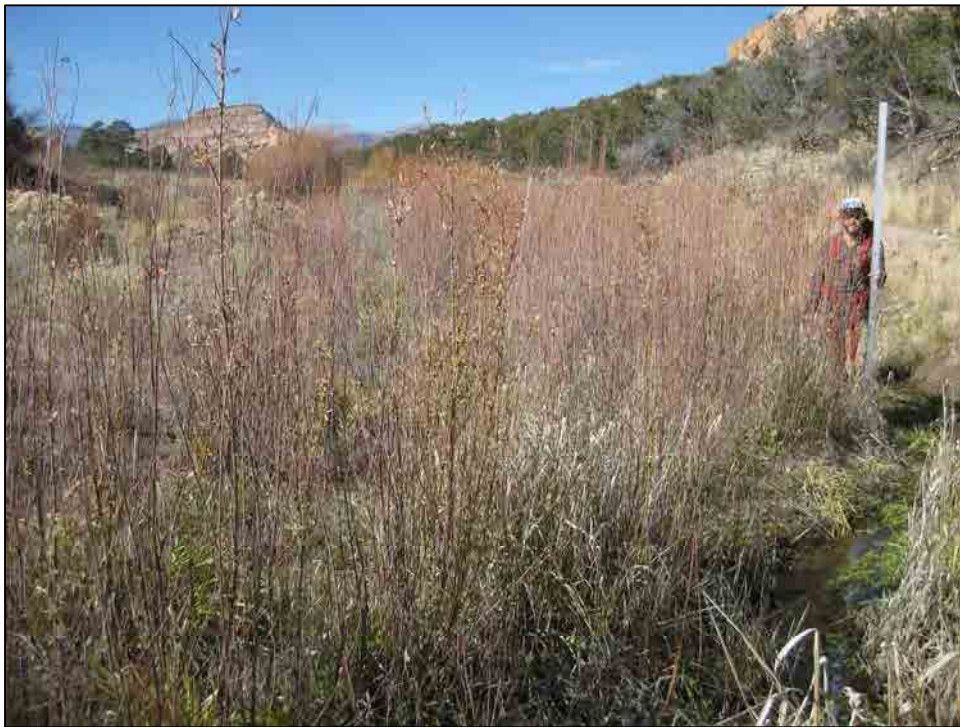
**Photo A1-25** Willows planted in 2014 in Pueblo Canyon lower willow planting area, looking upstream from P4C+300: (a) in April 2014 and (b) example of medium-height, spatially continuous community (P-4) in November 2016

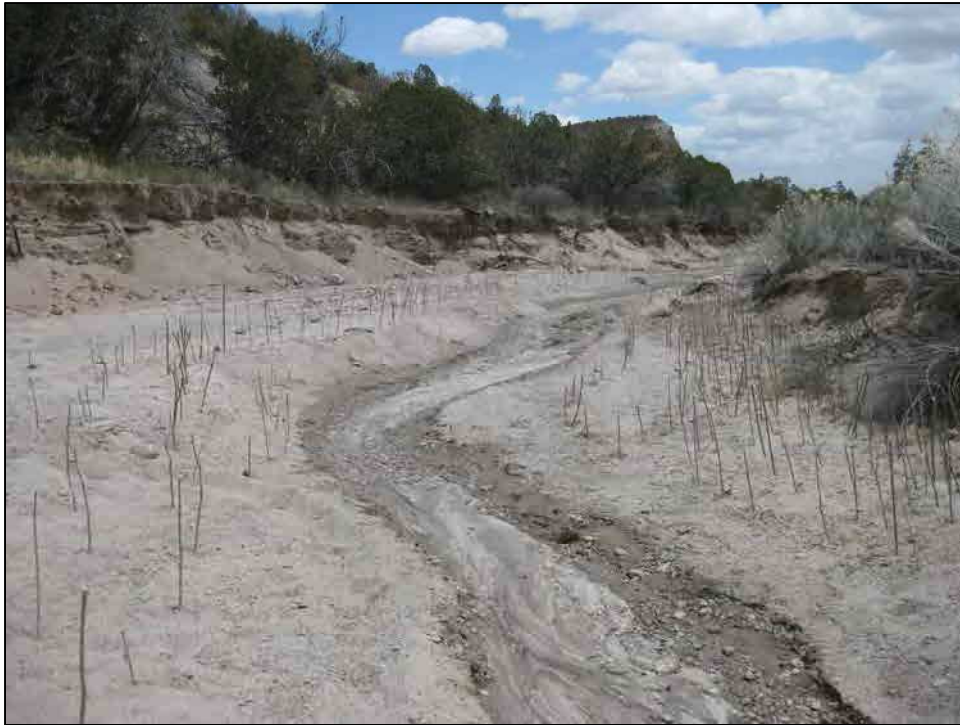
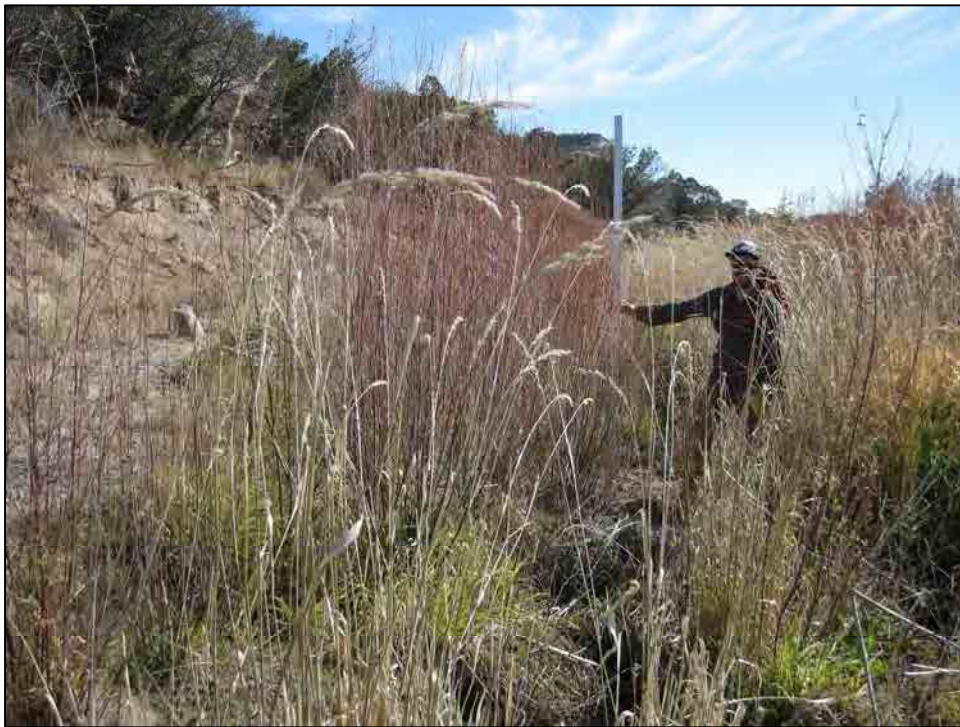
**Photo A1-26** Willows planted in 2014 in Pueblo Canyon lower willow planting area, looking downstream from PU+400: (a) in April 2014 and (b) example of tall-height, spatially continuous community (P-5) (center) in November 2016
