**Subject: 2016 Monitoring Report for Los Alamos/Pueblo Watershed Sediment Transport Mitigation Project**

April 2017

EP2017-0042

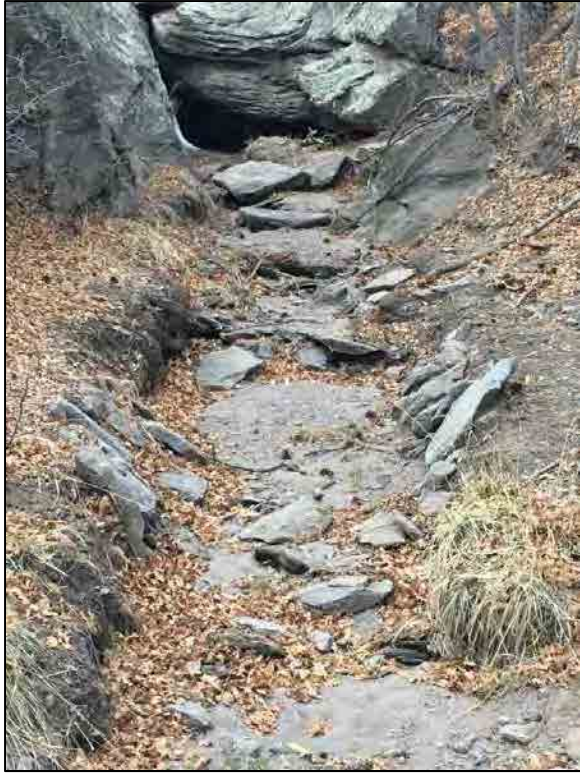
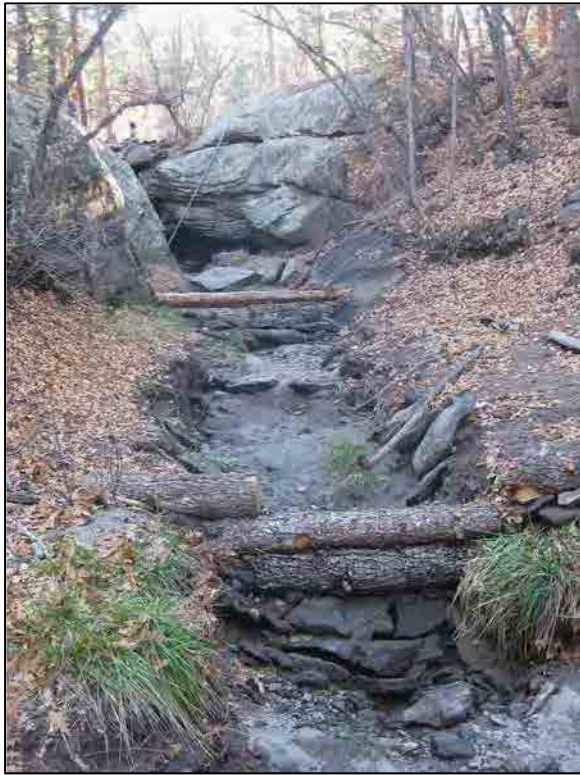
**Photo A1-27** Rock armoring along stream banks in the south fork of Acid Canyon: (a) looking upstream in April 2016 and (b) log check dams in November 2016

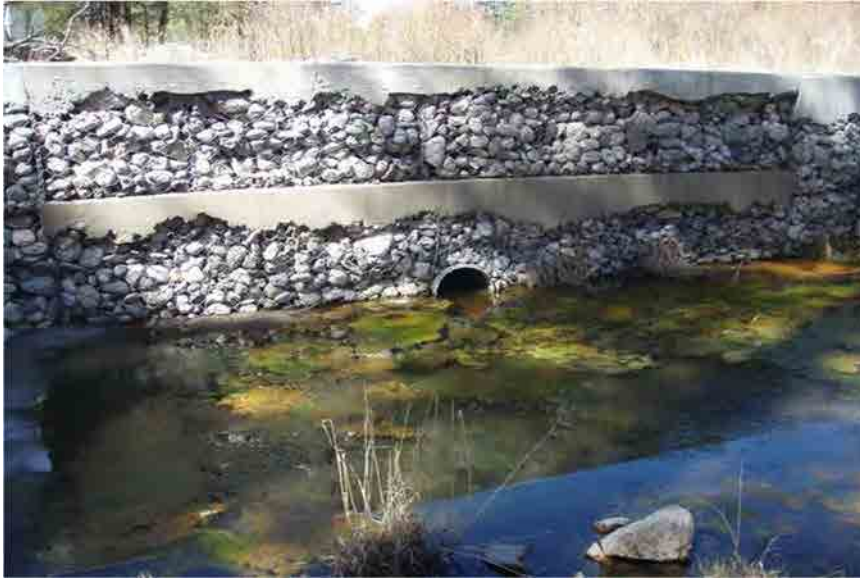
**Photo C-2.1-1** March 2016 — Downslope side shows standing water present in pond. The pipe is about  $\frac{1}{4}$  full, difficult to determine at the time if sediment is an issue. Recommend monitoring.

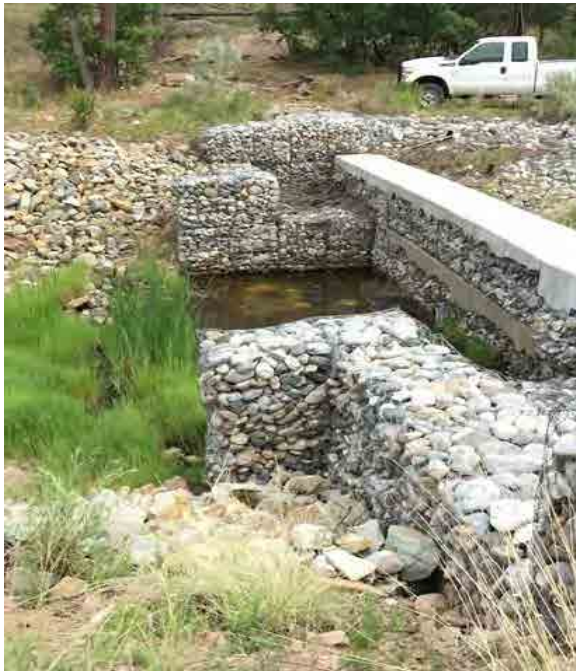
**Photo C-2.1-2** June 2016 — Standing water in downslope side pond still shows standing water. No visible seepage or piping issue present. Pipe is about  $\frac{1}{8}$  full. Recommend monitoring.

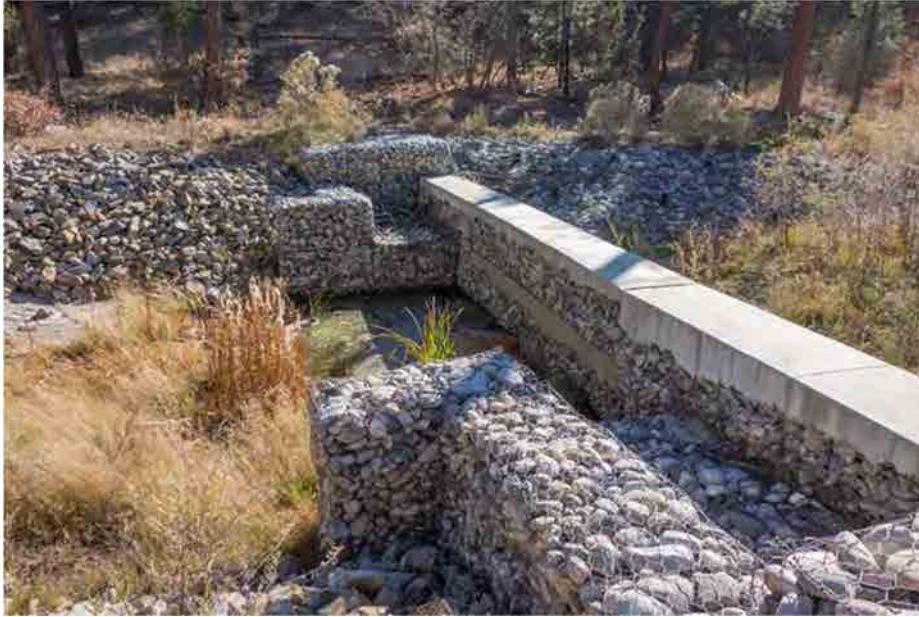
**Photo C-2.1-3** Nov 2016 — Standing water in downslope side pond still shows standing water. No visible seepage or piping issue present. Pipe is about 1/8 full and is consistent with the last inspection. Recommend monitoring.

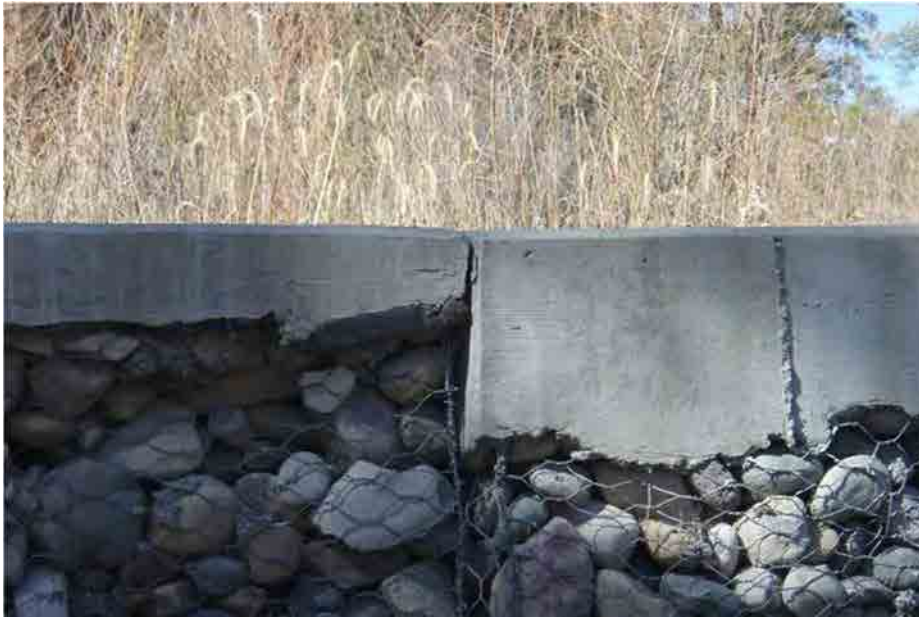
**Photo C-2.2-1** March 2016 — The joint located on the northern portion of the crest directly above the bulging gabion basket shows signs of separation (approximately 0.25 in.). No change in condition from the last inspection (Q3 2015). Recommend monitoring.

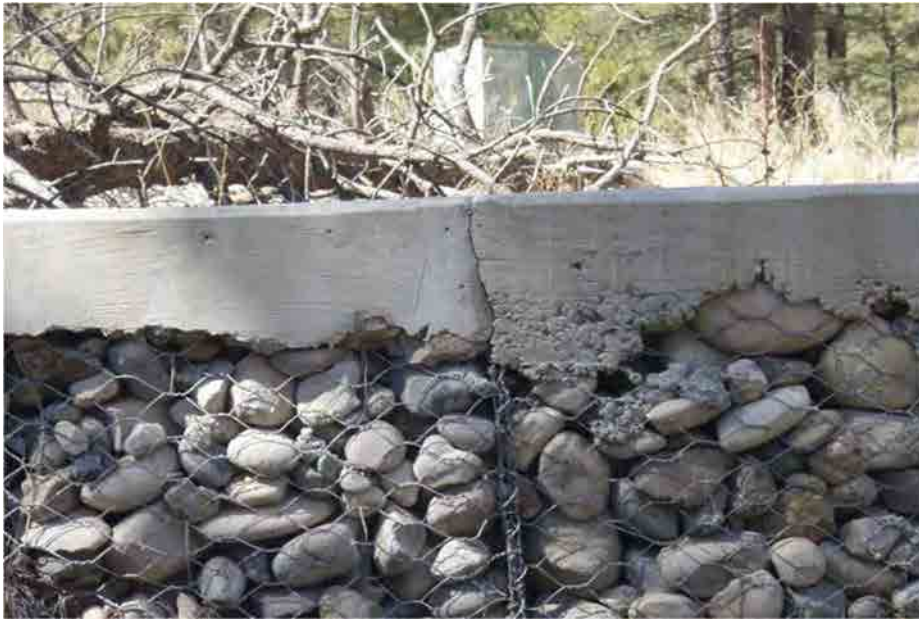
**Photo C-2.3-1** March 2016 — Cracks are consistent with previous inspection. Recommend monitoring.

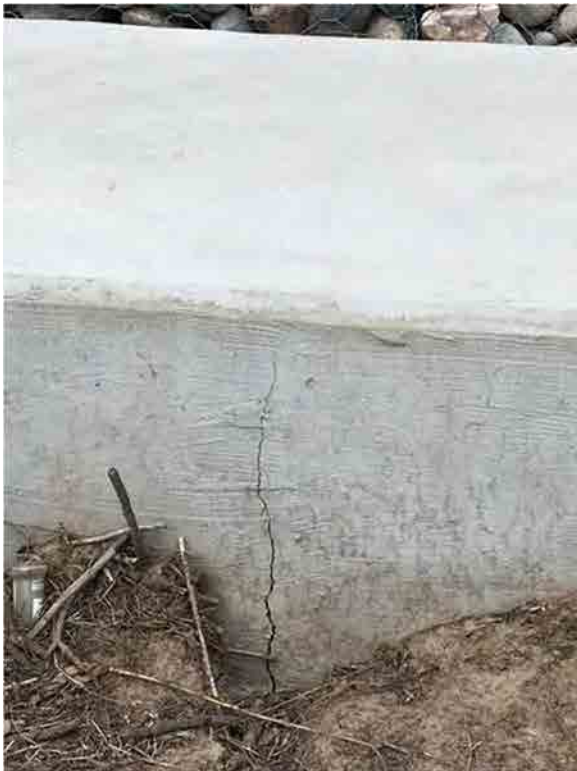
**Photo C-2.3-2** June 2016 — Cracks are consistent with previous inspection. Recommend monitoring.

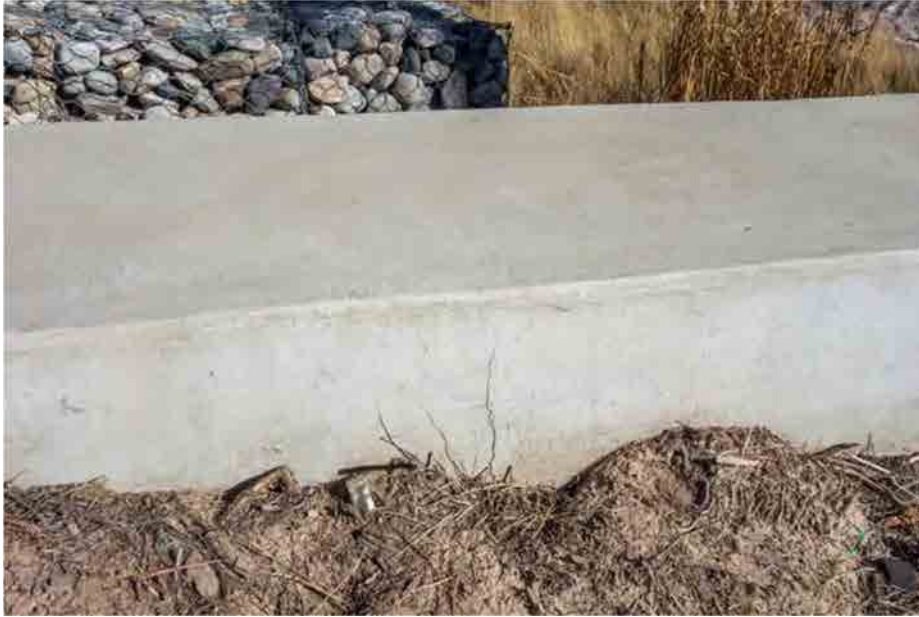
**Photo C-2.3-3** Nov 2016 — Cracks are consistent with previous inspection. Recommend monitoring.

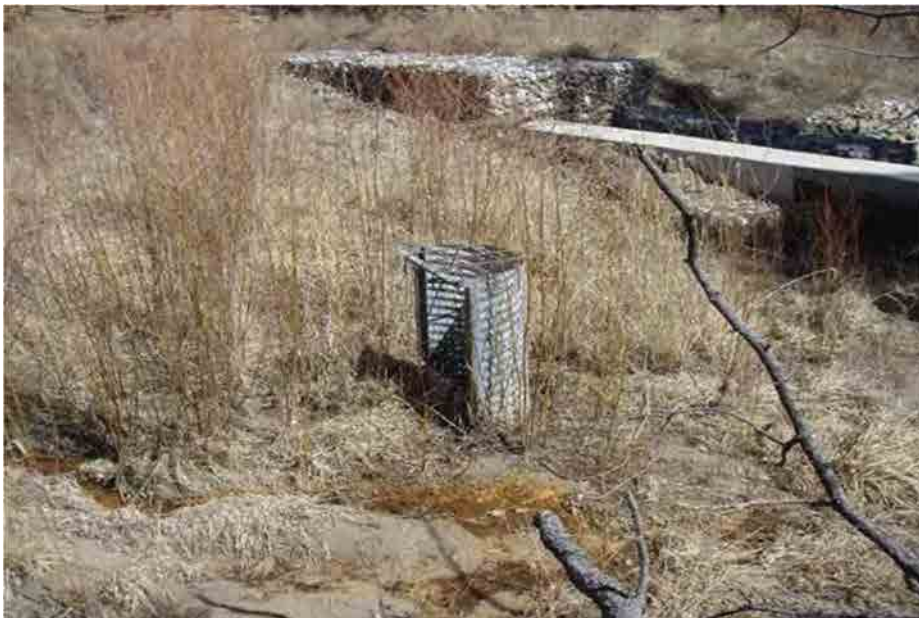
**Photo C-2.4-1** March 2016 — Approximate height between channel bed and top of weir is 3.5 ft (no change from the last inspection [Q4 2015]). The height of the standpipe inlet is approximately 1 ft above the soil profile in front of the weir. This may represent a lower height than was present during the last inspection when 1.45 ft was reported. Tire present in standpipe. Recommend monitoring and removal of tire.

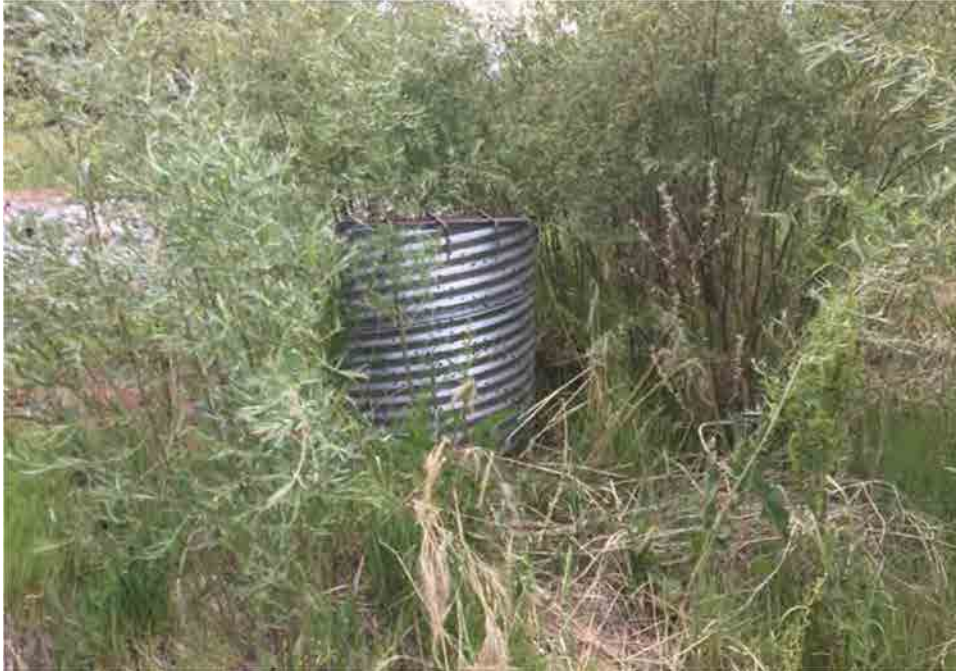
**Photo C-2.4-2** June 2016 — Approximate height between channel bed and top of weir is 3.5 ft (no change from previous inspection [Q1 2016]). Tire is still present in the standpipe. Recommend monitoring and removal of tire.

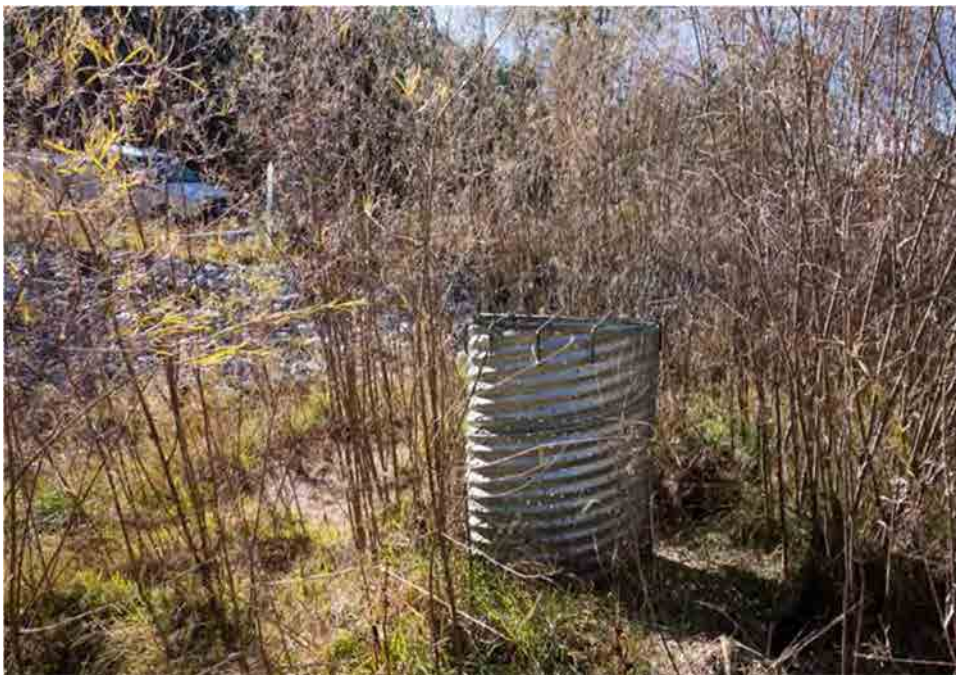
**Photo C-2.4-3** Nov 2016 — Approximate height between channel bed and top of weir is 3.5 ft (unchanged from last inspection [Q2 2016]). Tire is still present in the standpipe. Recommend monitoring and removal of tire.

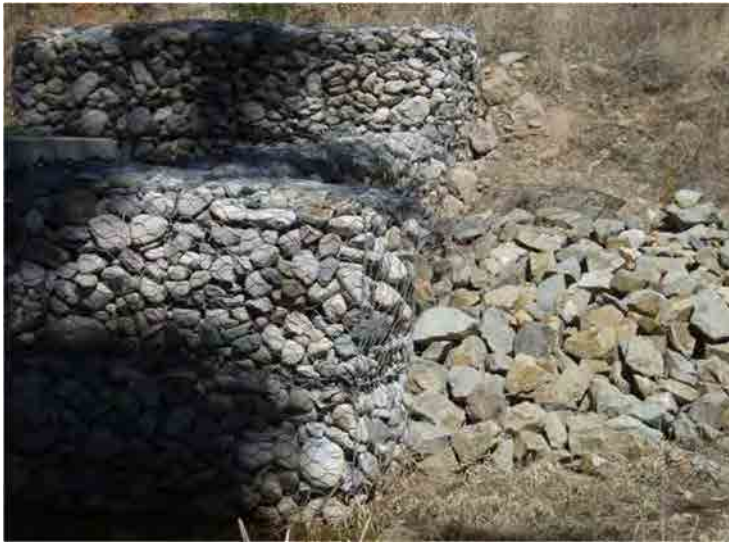
**Photo C-2.5-1 March 2016 — Bulging gabion basket located on the downstream face and below crest of weir. Consistent with previous inspection.**

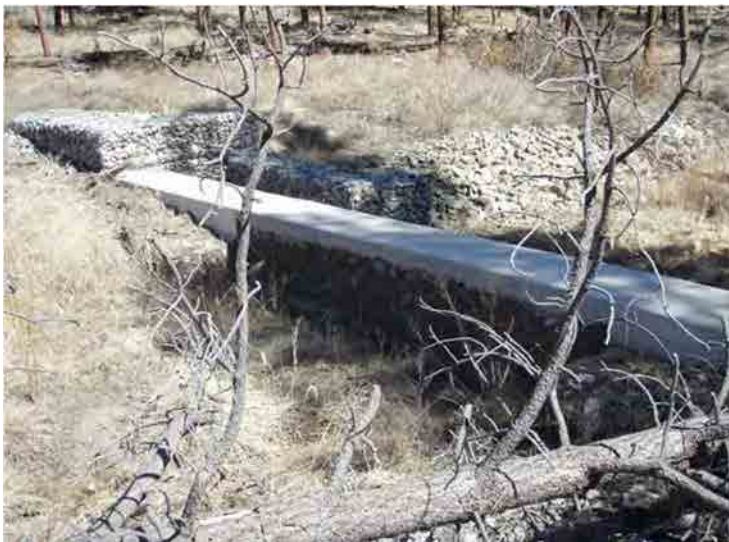
**Photo C-2.6-1 March 2016 — Large tree and woody debris shown on upstream slope face of weir. Recommend removal of tree.**

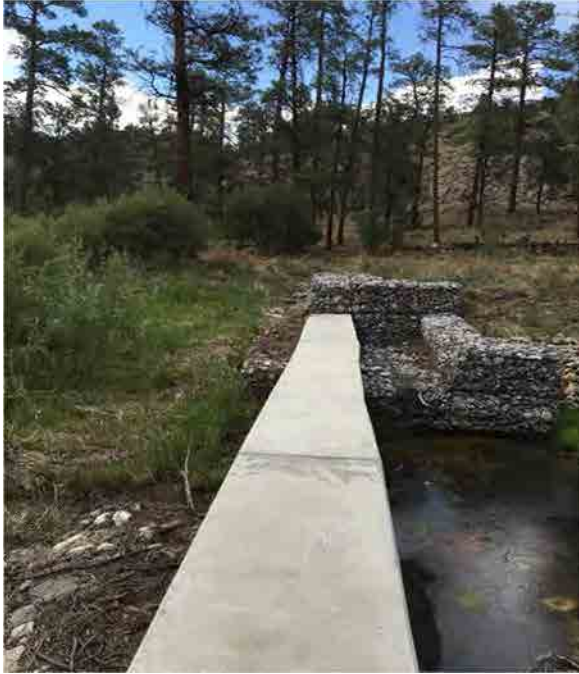
**Photo C-2.6-2** June 2016 — Debris (trash and sticks) shown on upstream slope face of weir. Recommend monitoring.

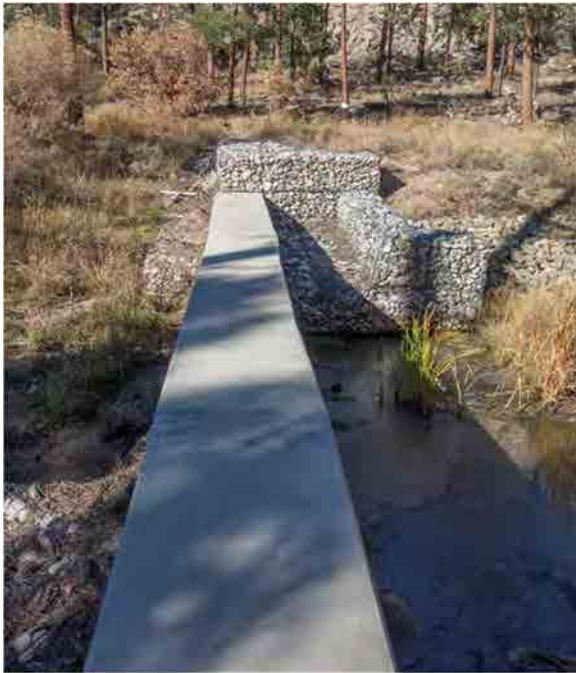
**Photo C-2.6-3** Nov 2016 — Minor trash and woody debris present on upstream slope face of weir. Recommend monitoring.

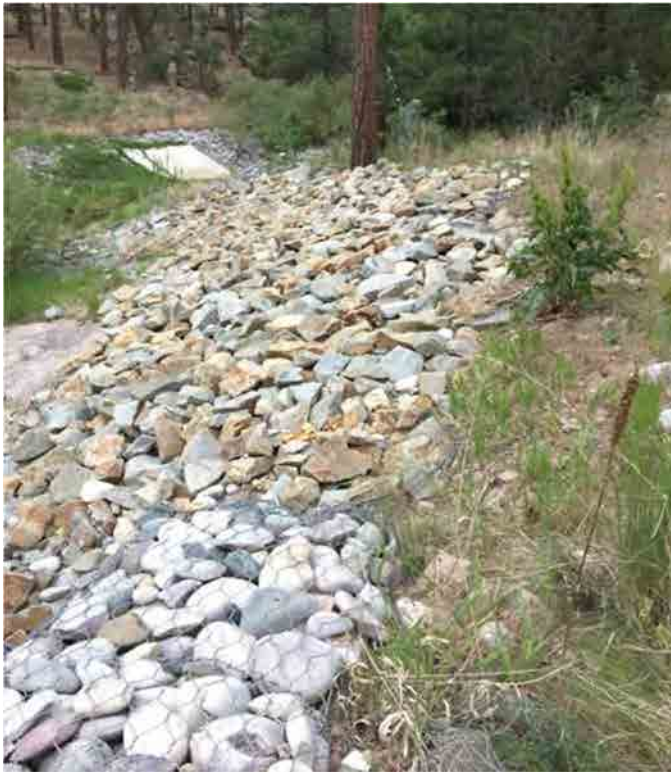
**Photo C-2.7-1** June 2016 — Downstream embankments with burrows present. Recommend monitoring.

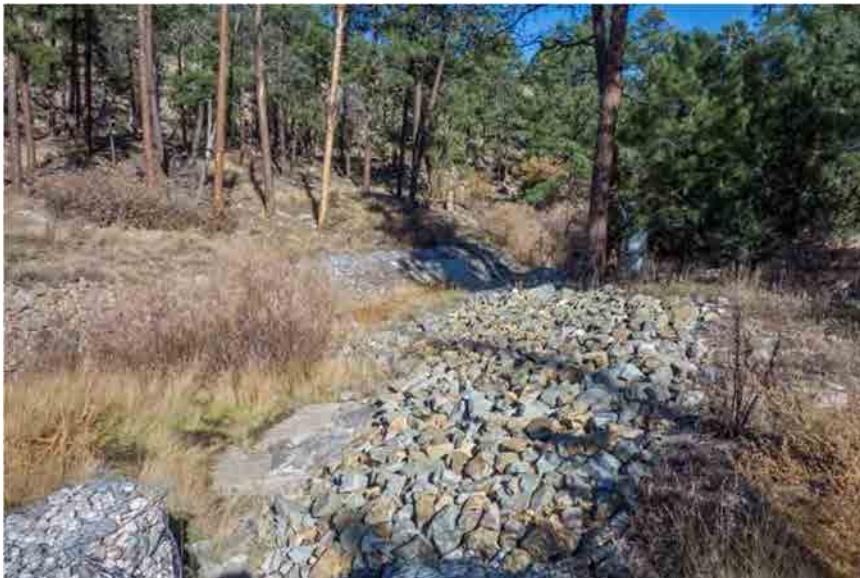
**Photo C-2.7-2** Nov 2016 — Presence of rodent burrows consistent with previous inspection. Burrows do not appear to be active. Recommend monitoring.

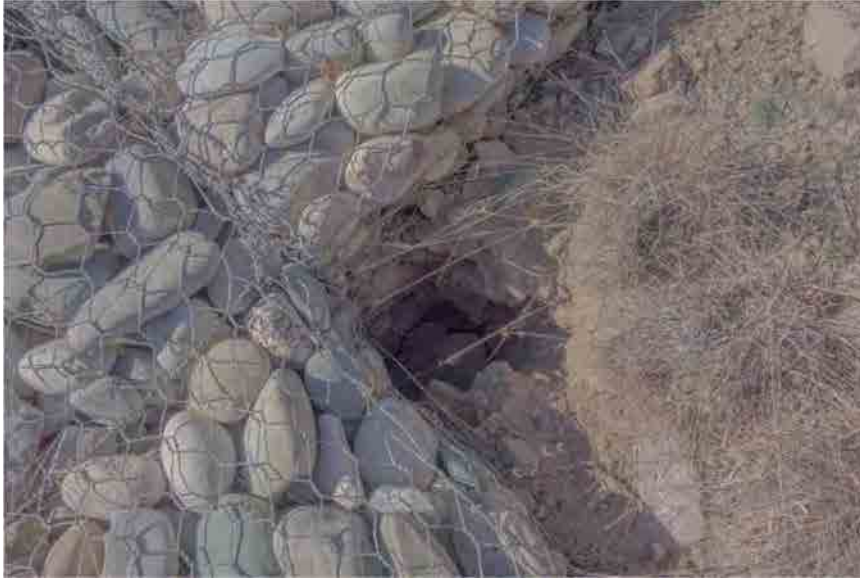
**Photo C-2.8-1** Nov 2016 — Erosion feature near northeast corner of spillway. Hole is approximately 2 ft deep and is not described in previous inspection reports.

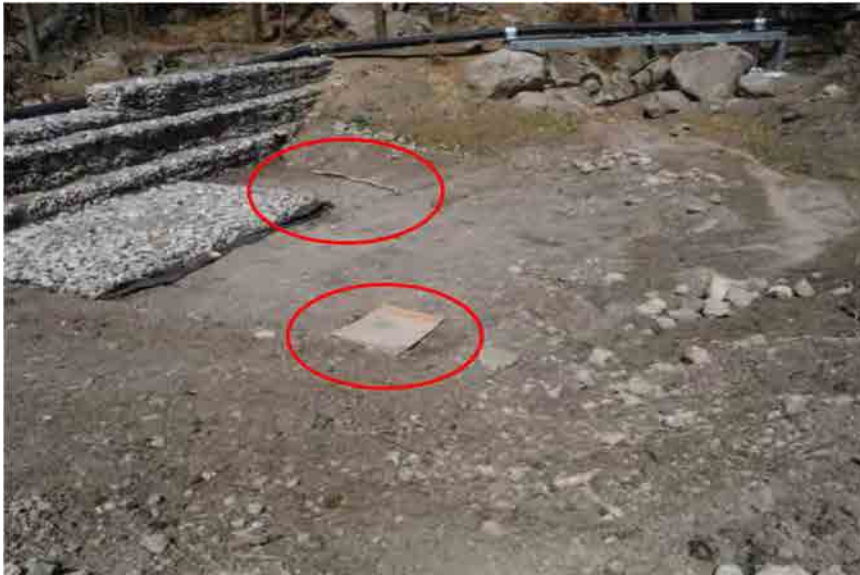
**Photo C-3.1-1** March 2016 — Floatable debris found in upper basin marked by red circles. Recommend removal and disposal of debris. Sloughing on north bank not pictured. Recommend monitoring sloughing.

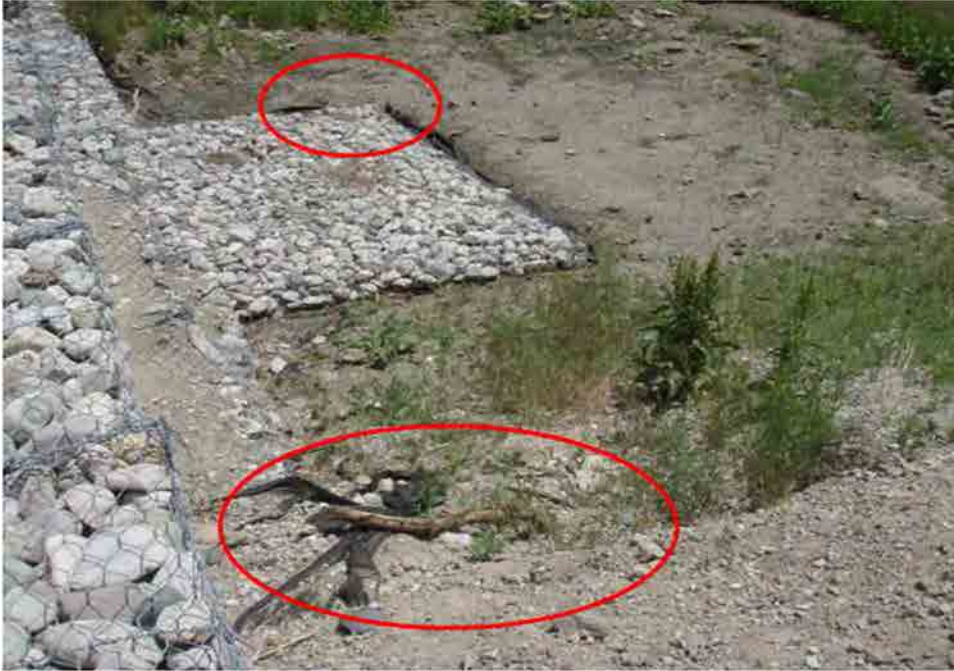
**Photo C-3.1-2** June 2016 — Floatable debris found in upper basin marked by red circles. Sloughing on north bank not pictured. Recommend monitoring both.

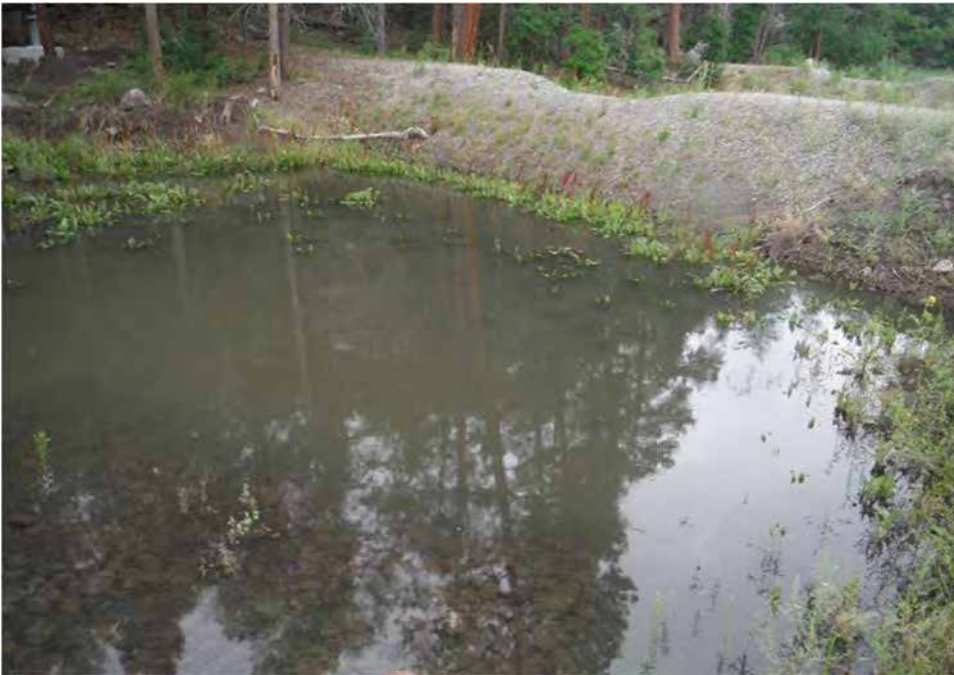
**Photo C-3.1-3** Flow Event on August 3, 2016 — Upper basin shows ponding due to recent rain events.

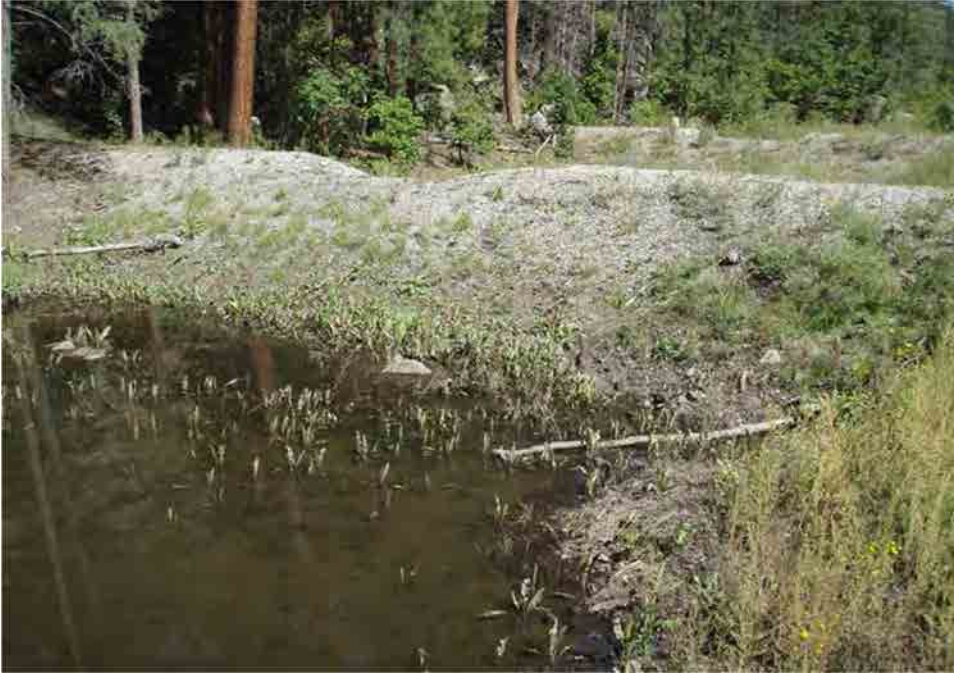
**Photo C-3.1-4** Sept 2016 — Floatable debris present in ponded water (consistent with last inspection).

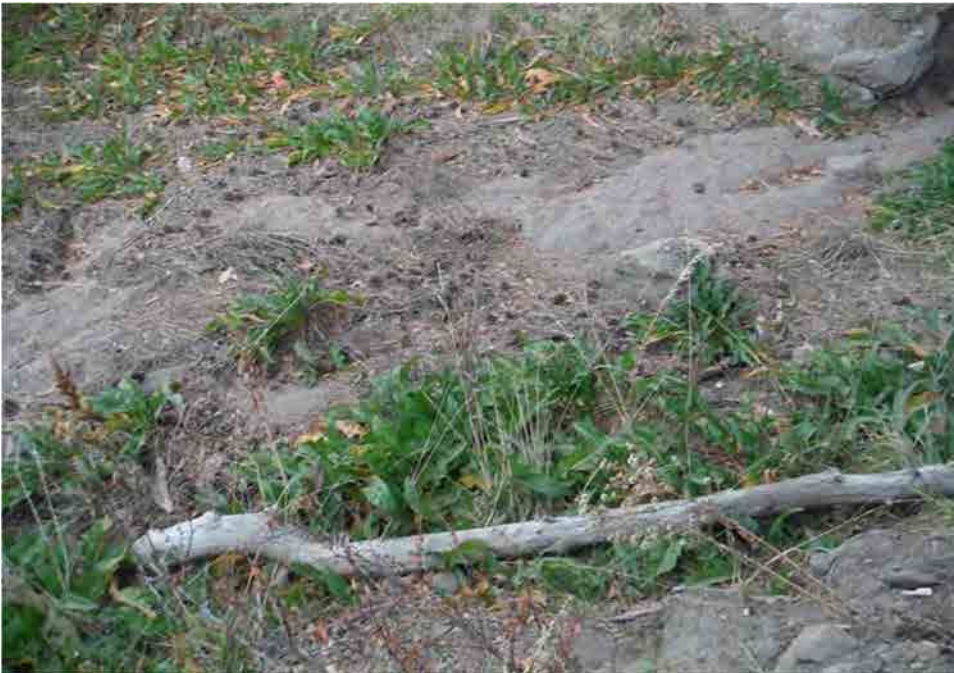
**Photo C-3.1-5** Nov 2016 — Floatable debris encountered in upper basin. Bottom of basin is wet.

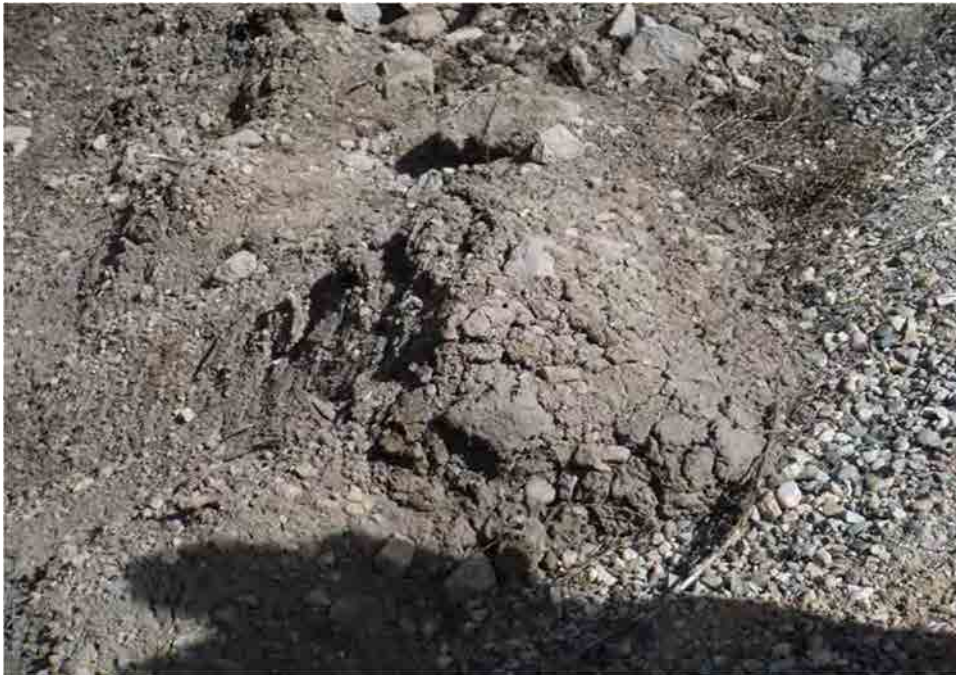
**Photo C-3.2-1 March 2016 — Construction excavation spoils found in upper basin. Construction spoils decrease basin capacity. Recommend removal of construction spoils.**

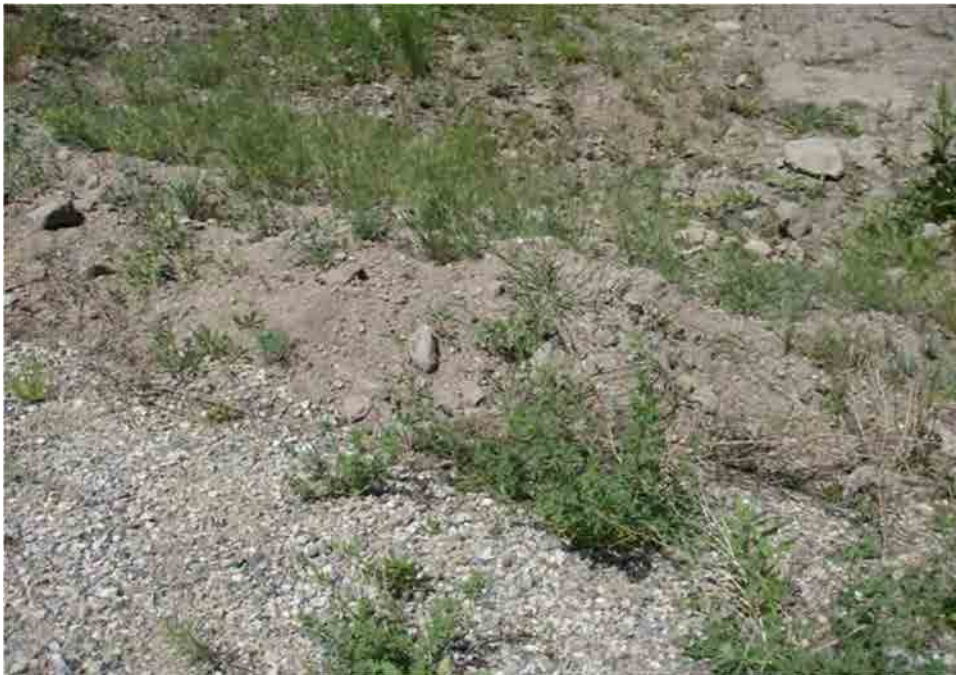
**Photo C-3.2-2 June 2016 — Construction spoils remaining from pipeline construction still present. Recommend removal of construction spoils.**

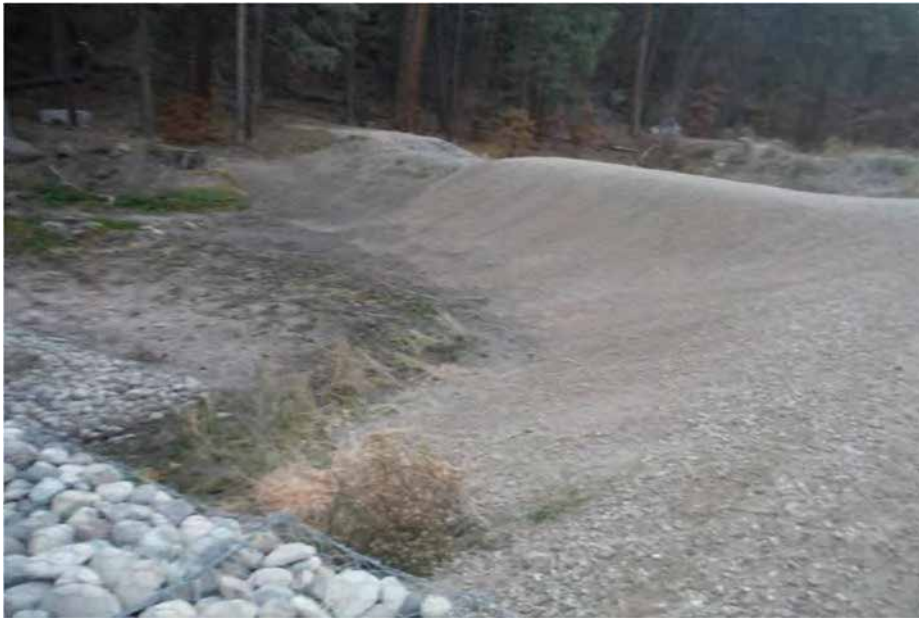
**Photo C-3.2-4 Sept 2016 — Recent maintenance removed pipeline construction spoils and placed north of pond with seed and mulch.**

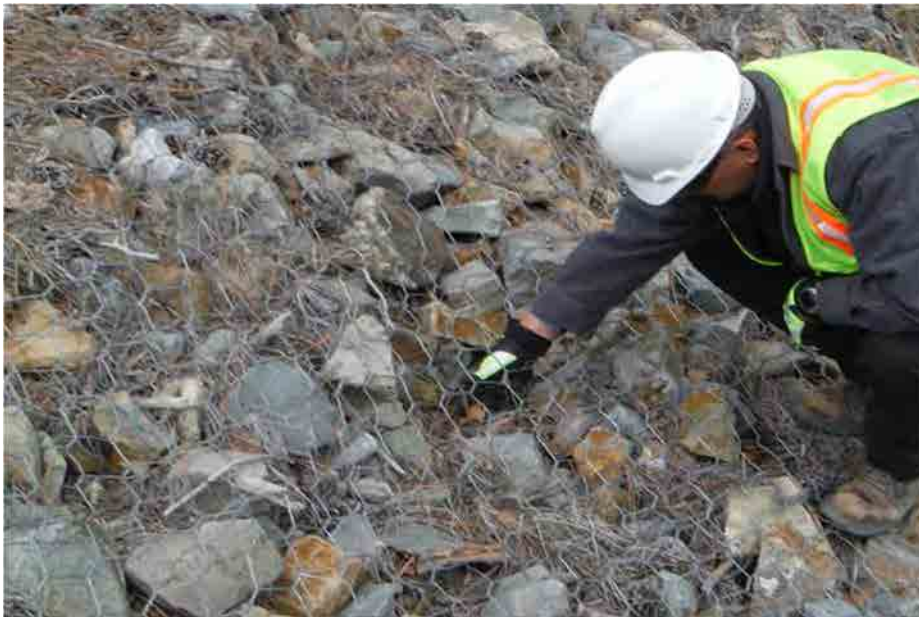
**Photo C-3.3-1 March 2016 — Slumping failure of riprap below wire mesh resulting from insufficient number of wire ties to bottom mesh. Recommend repair slumping.**

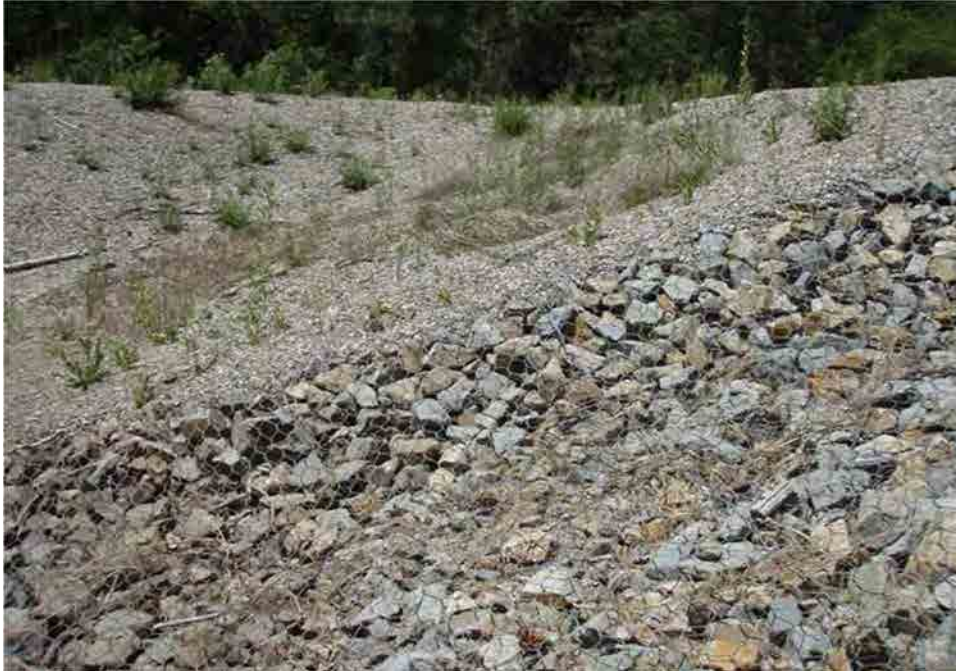
**Photo C-3.3-2 June 2016 — Slumping failure of riprap still present. Newly noted animal burrows present. Recommend repair burrows and slumping.**

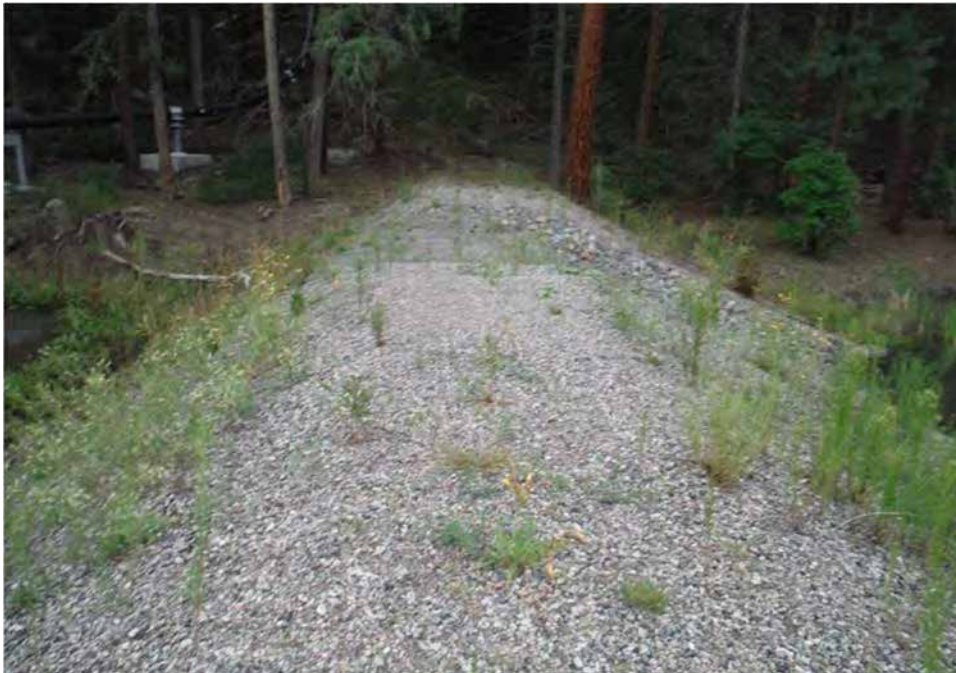
**Photo C-3.3-3 Flow Event on August 3, 2016 — Animal burrows present. Slumping failure still present. Recommend repair burrows and slumping.**

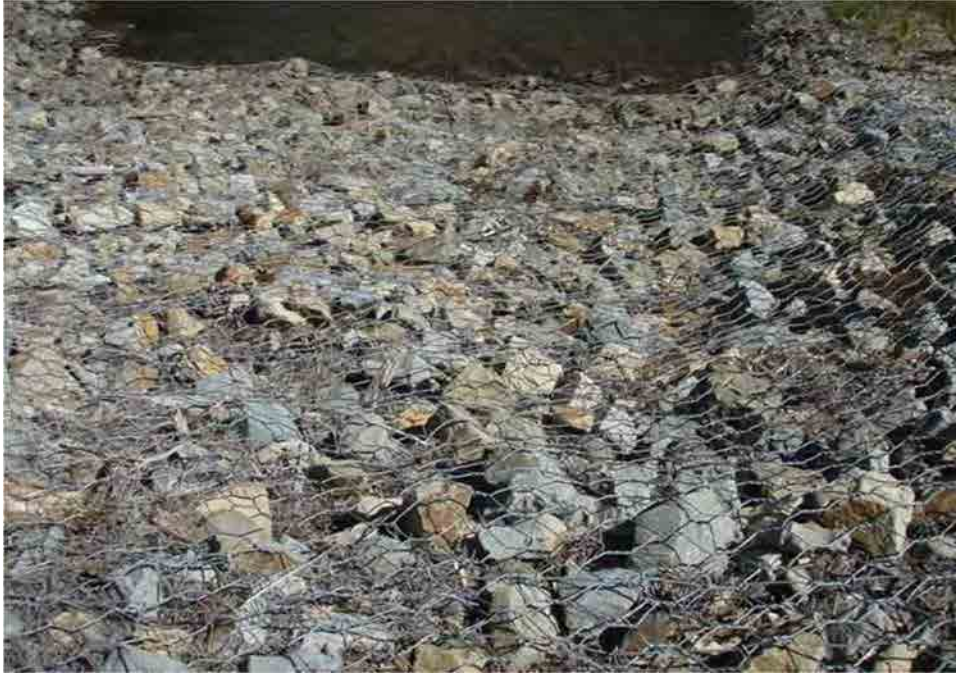
**Photo C-3.3-4** Sept 2016 — Slumping on upper portion of spillway still present (consistent with previous inspection). Animal burrows present (consistent with previous inspection). Recommend repair burrows and slumping.

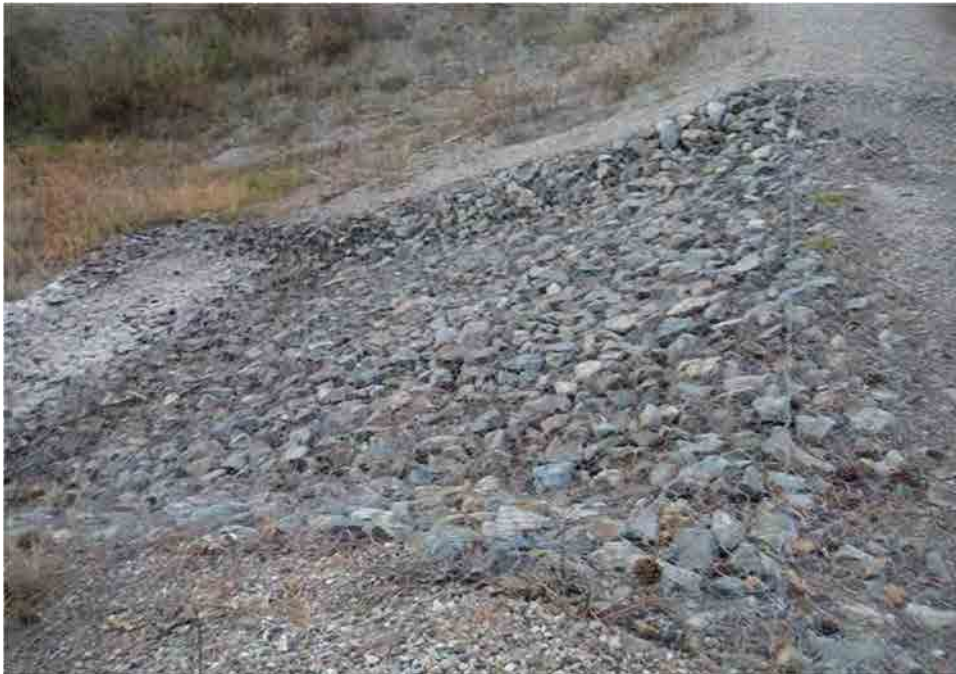
**Photo C-3.3-5** Nov 2016 — Spillway wire enclosed riprap repair recently completed under maintenance work order.

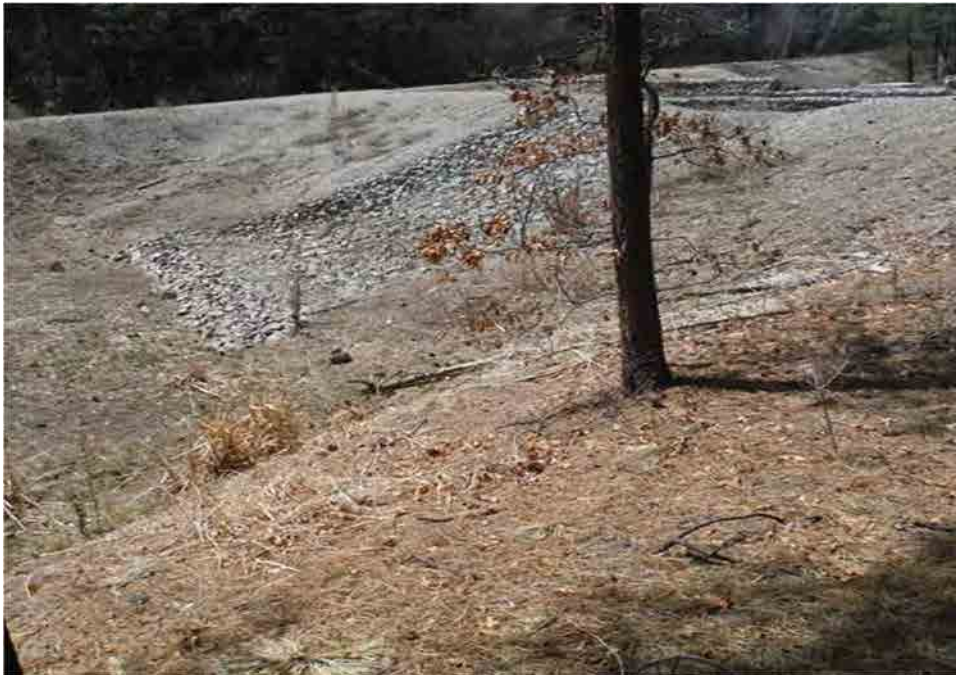
**Photo C-3.4-1 March 2016 — Lower basin has sloughing on north bank.**

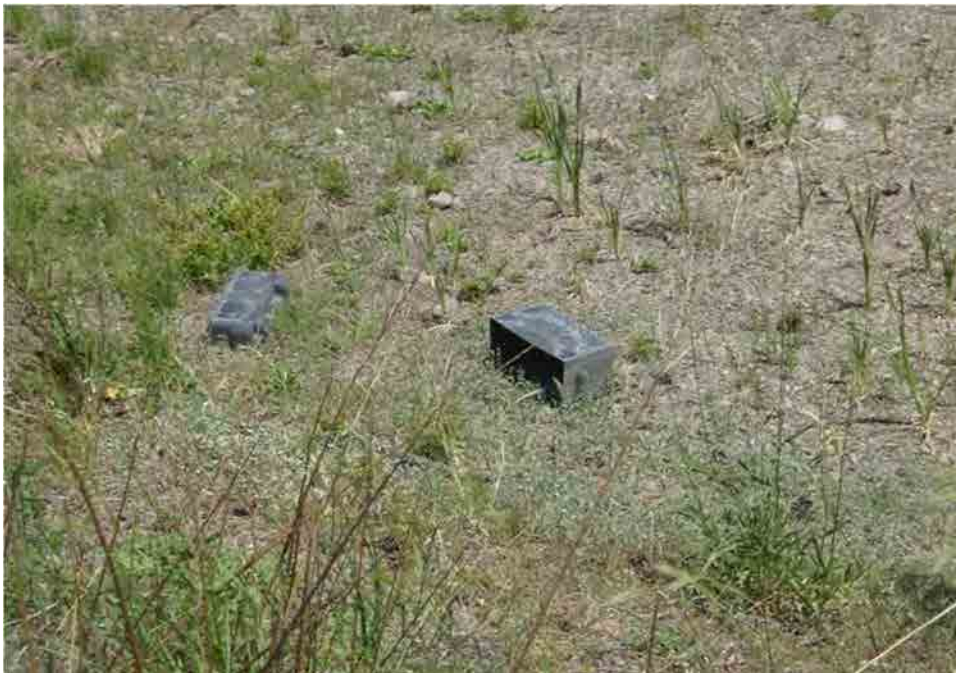
**Photo C-3.4-2 June 2016 — Battery boxes in lower basin. Sloughing on north bank present but minimal (not pictured). Recommend removal of debris.**

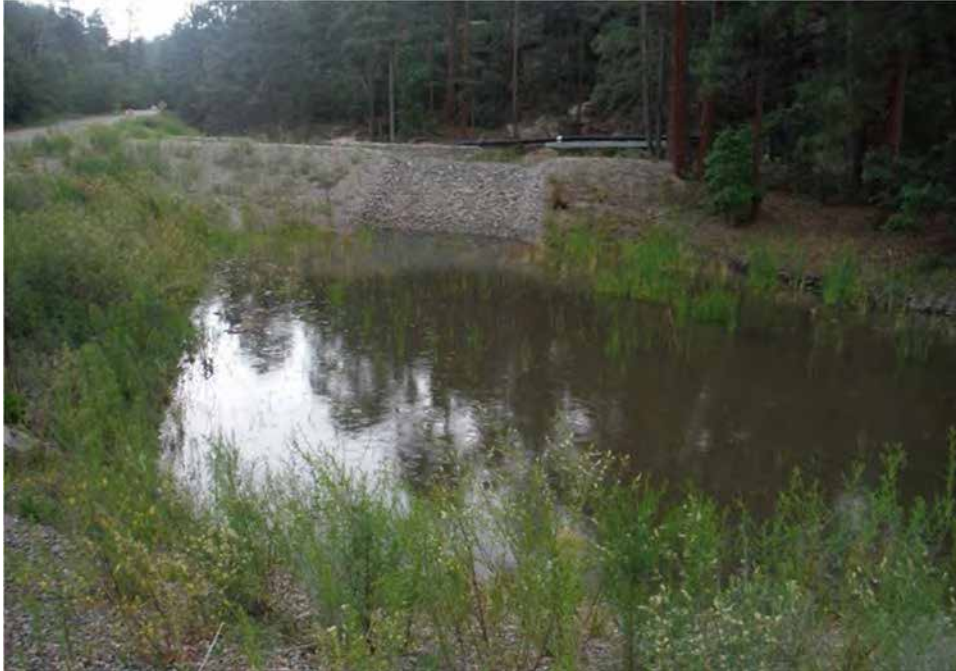
**Photo C-3.4-3** Flow Event on August 3, 2016 — Floating battery boxes found (not pictured). No other floating debris present. Basin filled with water due to recent rain events. Recommend removal of debris

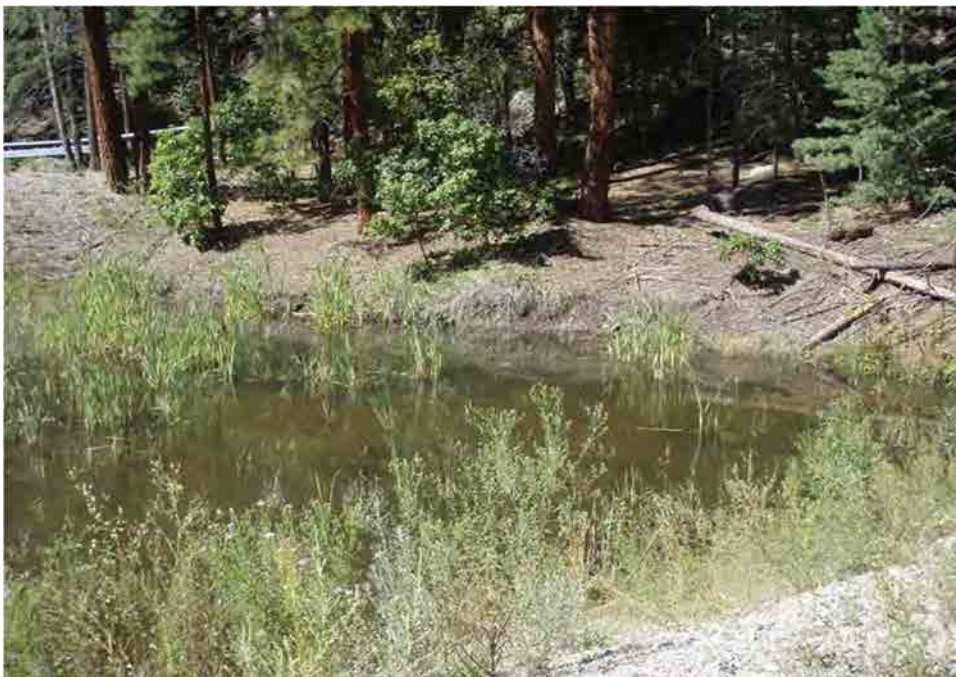
**Photo C-3.4-4** Sept 2016 — Sloughing on north bank present (unchanged from previous inspections). Pounded water still present. Battery boxes still present in pond. Recommend removal of debris

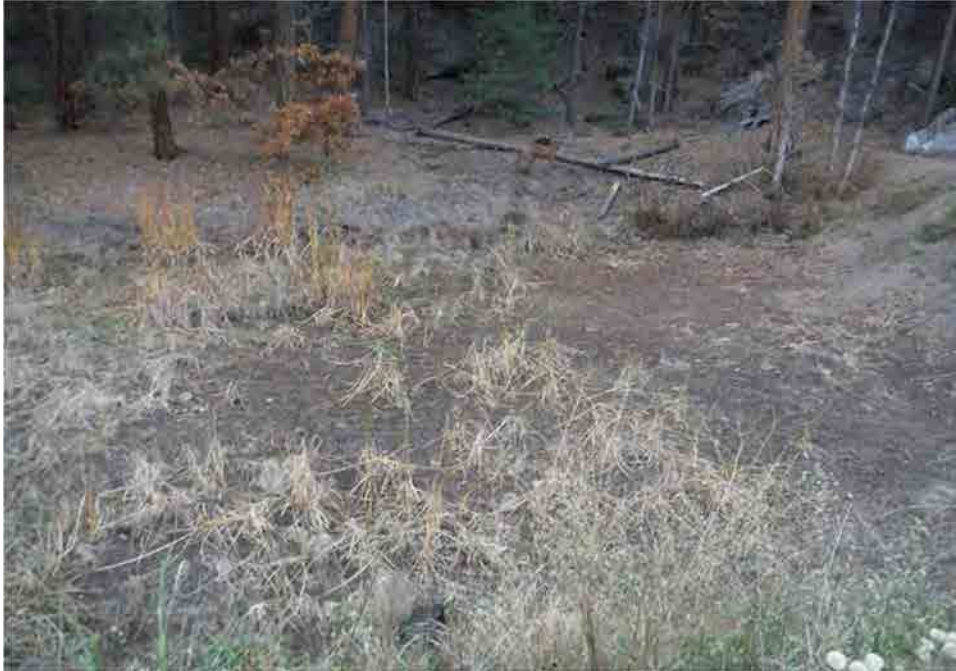
**Photo C-3.4-5** Nov 2016 — Debris present in lower basin. Bottom of basin damp from previous flow events. Recommend removal of debris.

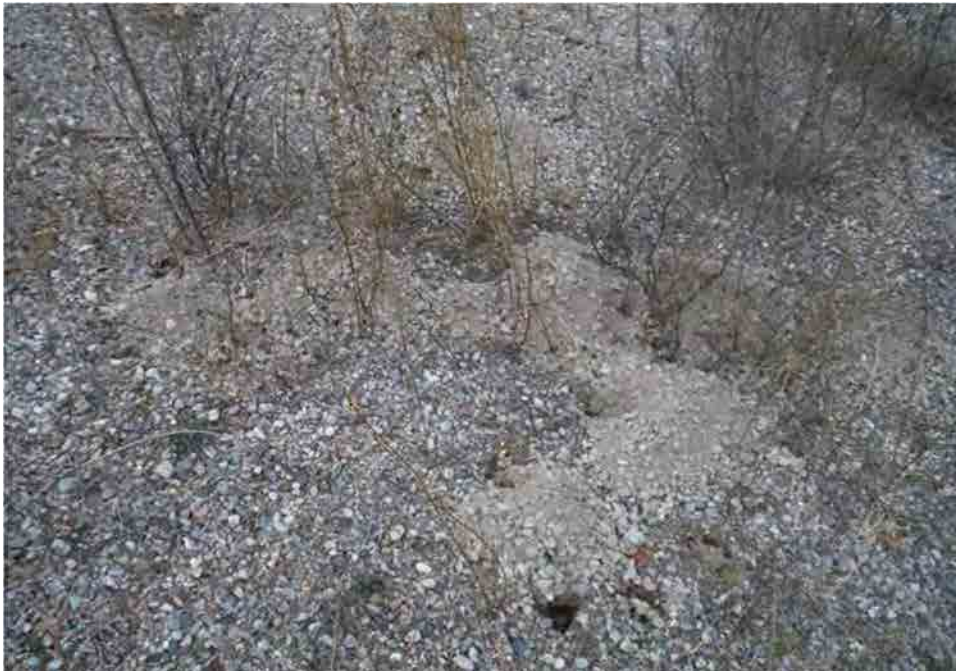
**Photo C-3.5-1** March 2016 — Animal burrows in lower embankment south of spillway. Recommend repair of animal burrows.
