**Subject: 2016 Monitoring Report for Los Alamos/Pueblo Watershed Sediment Transport Mitigation Project**

April 2017

EP2017-0042

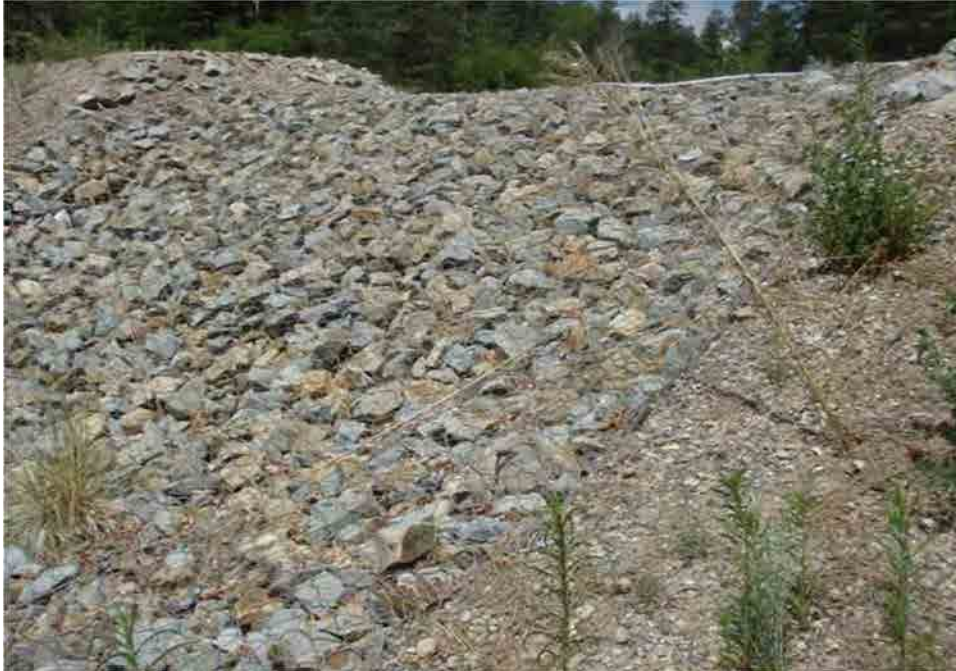
**Photo C-3.5-2** June 2016 — Animal burrows on lower basin spillway. Based on visual inspection, number and size of holes appear to be consistent with last inspection (Q1 2016). Recommend repair of animal burrows.

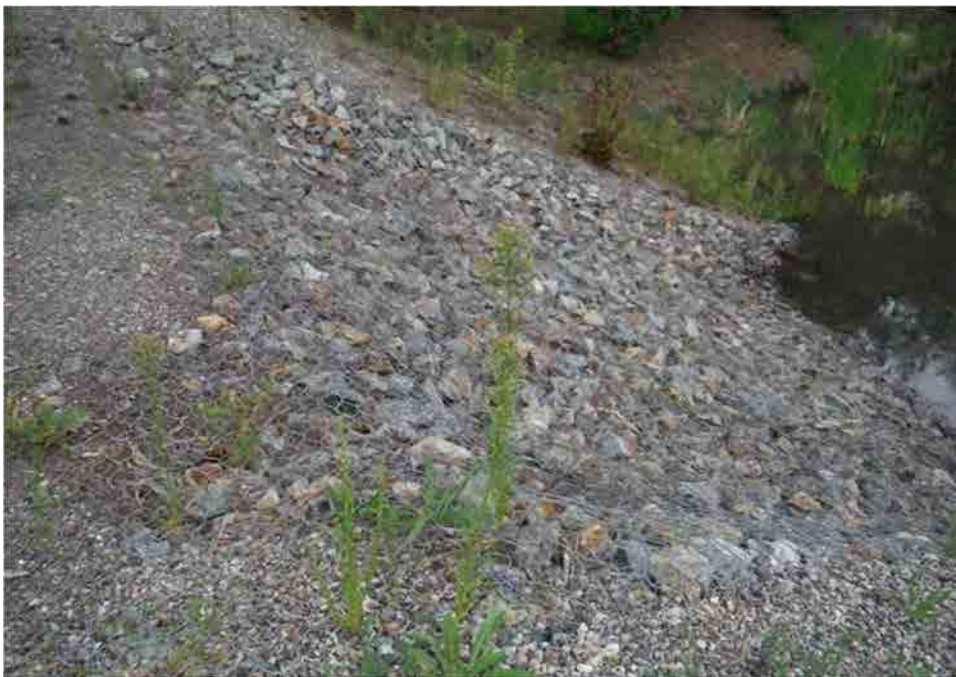
**Photo C-3.5-3** Flow Event August 3, 2016 — Animal burrows still present. No change in size and shape since last inspection (Q2 2016). No evidence of flow. Recommend repair of animal burrows.

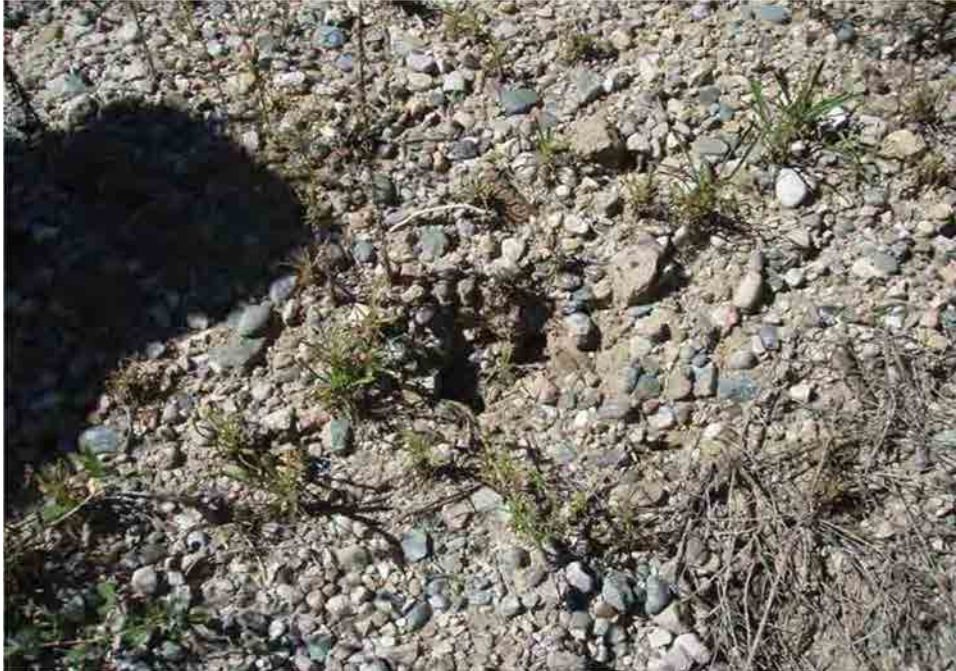
**Photo C-3.5-4** Sept 2016 — Animal burrows still present. No change in size and shape since last inspection (flow event on August 3, 2016). No evidence of flow. Recommend repair of animal burrows.

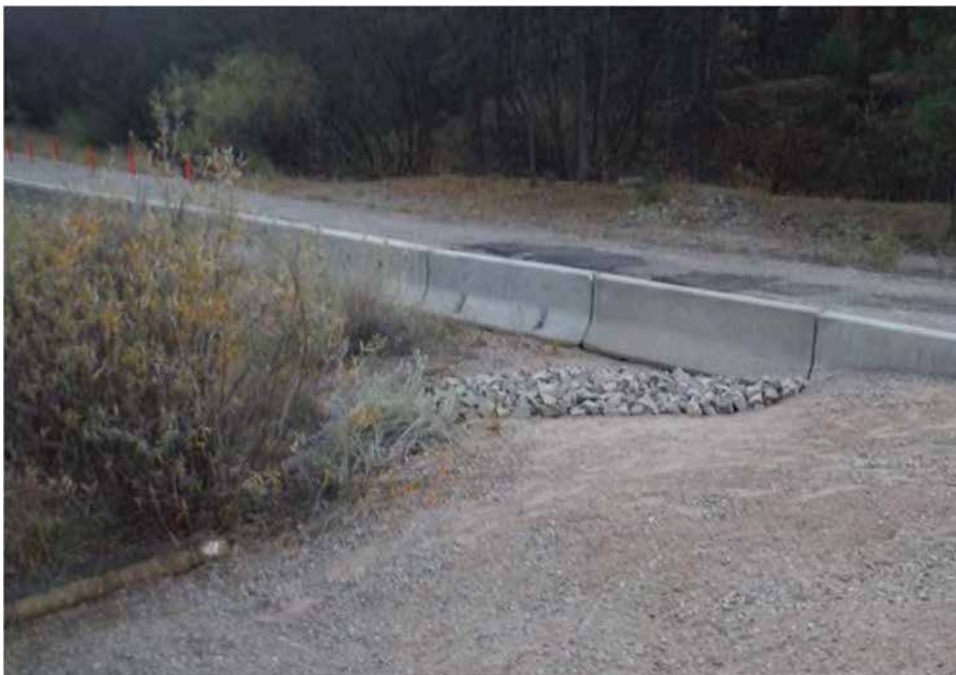
**Photo C-3.5-5** Nov 2016 — Lower basin spillway looking east. Animal burrows recently repaired under maintenance work order.

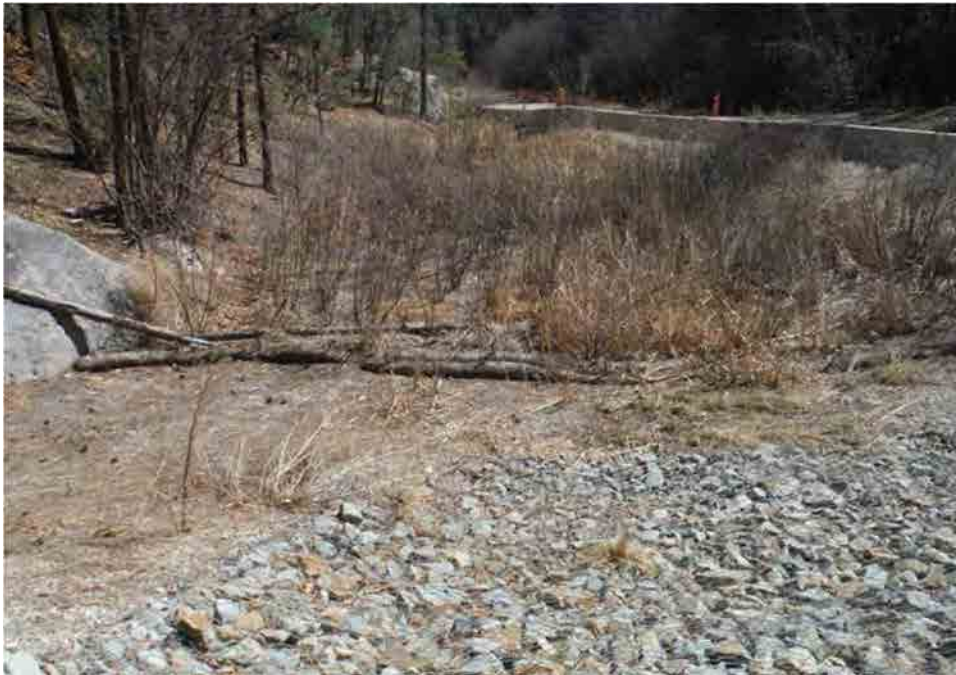
**Photo C-3.6-1 March 2016 — Wetland shows well-established vegetation downstream of coir log. Monitor vegetation and level of sediment.**

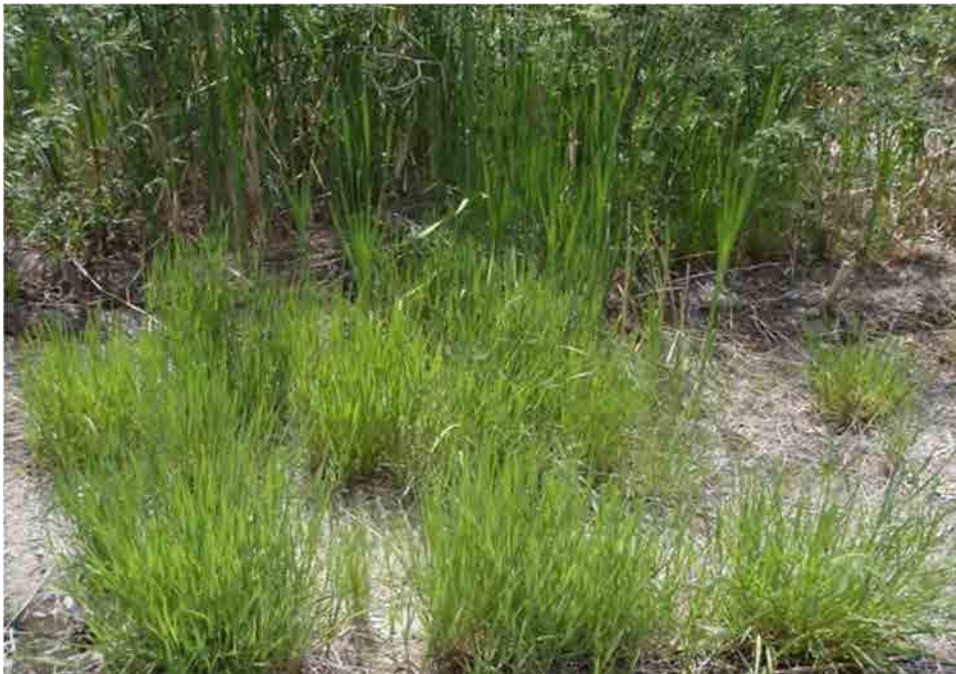
**Photo C-3.6-2 June 2016 — Wetland shows well-established vegetation. Consistent with previous inspections. Monitor vegetation and level of sediment.**

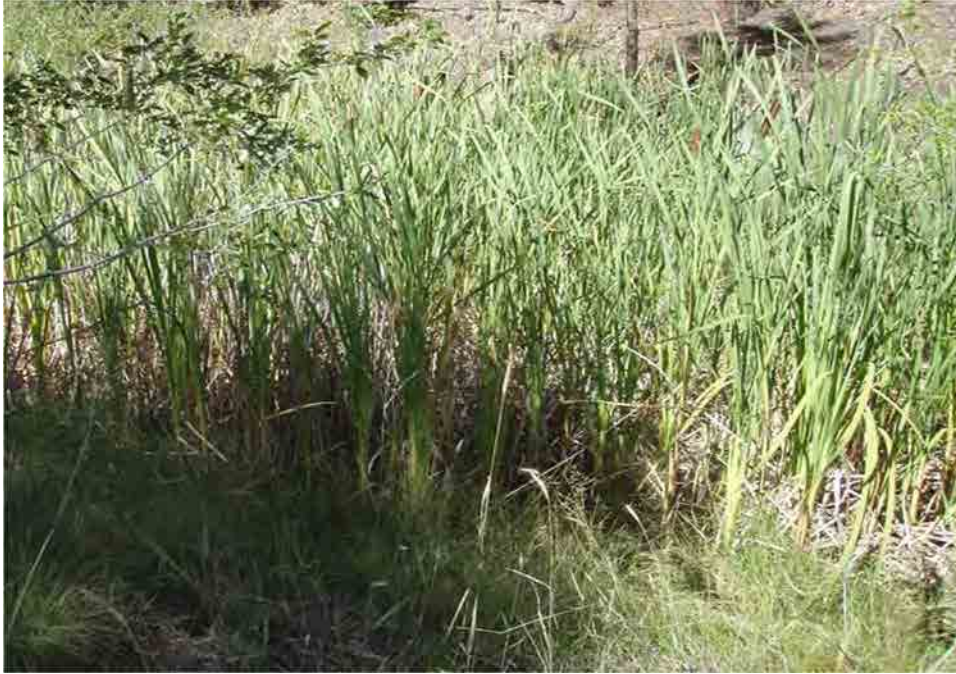
**Photo C-3.6-3** Sept 2016 — Wetland shows well-established vegetation. Monitor vegetation and level of sediment.

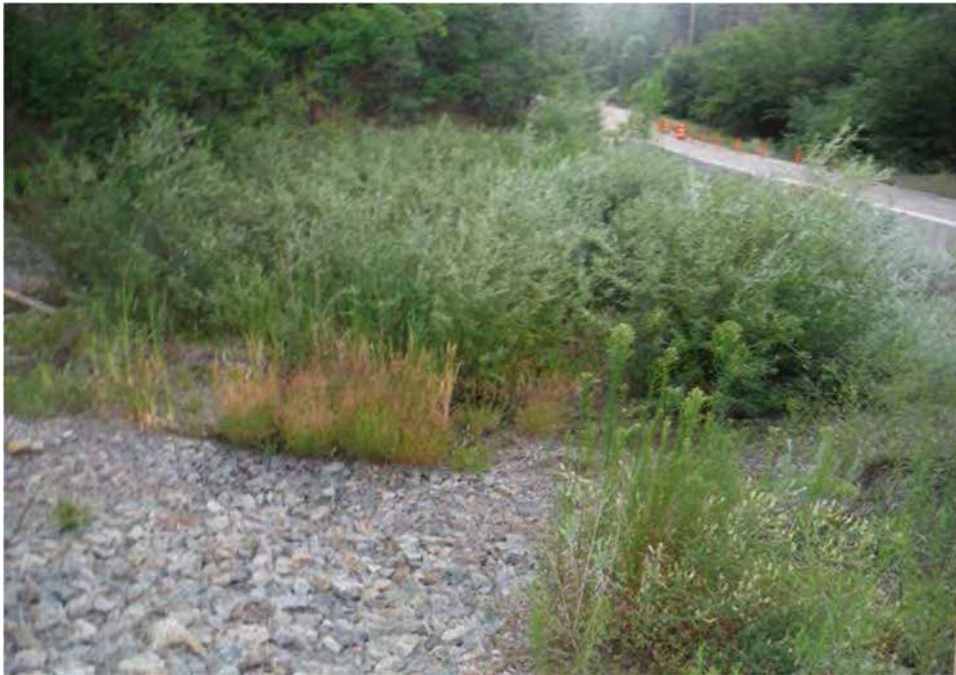
**Photo C-3.6-4** Flow Event on August 3, 2016 — Wetland shows well-established vegetation. Monitor vegetation and level of sediment.

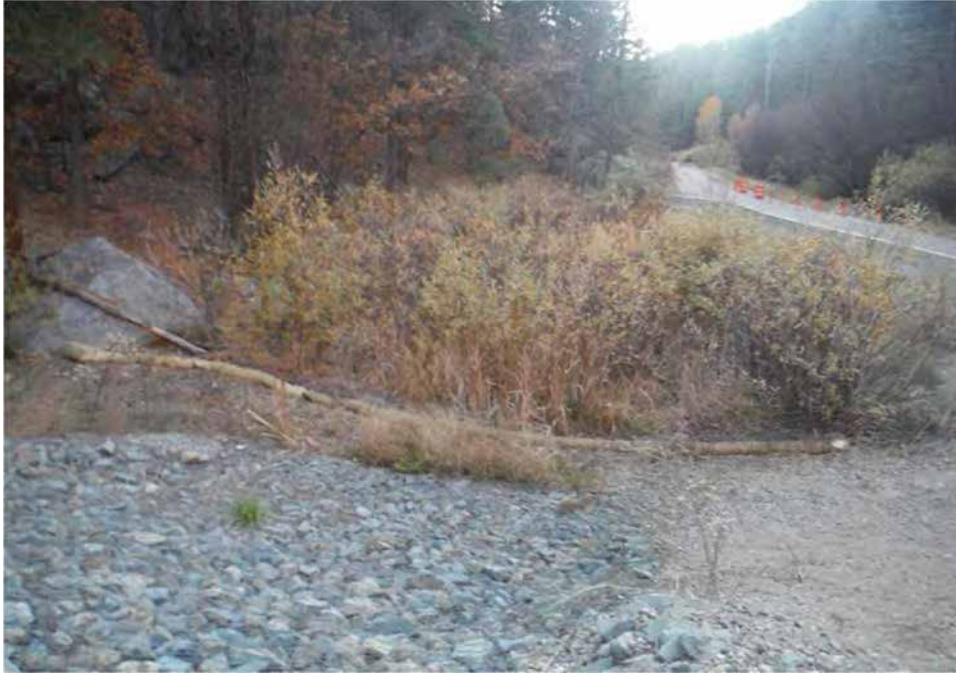
**Photo C-3.6-5** Nov 2016 — Wetland shows well-established vegetation. Monitor vegetation and level of sediment.

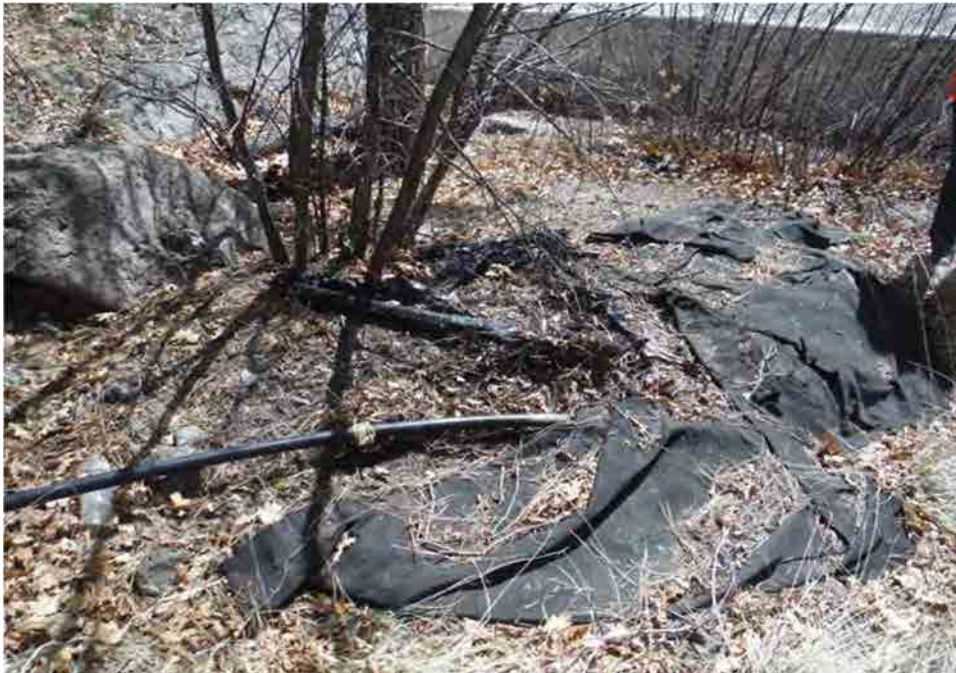
**Photo C-3.7-1** March 2016 — Silt fence and pipe materials (construction debris) at southeast side of the wetland pond, near sampler. Recommend removing debris and monitor geotextile.

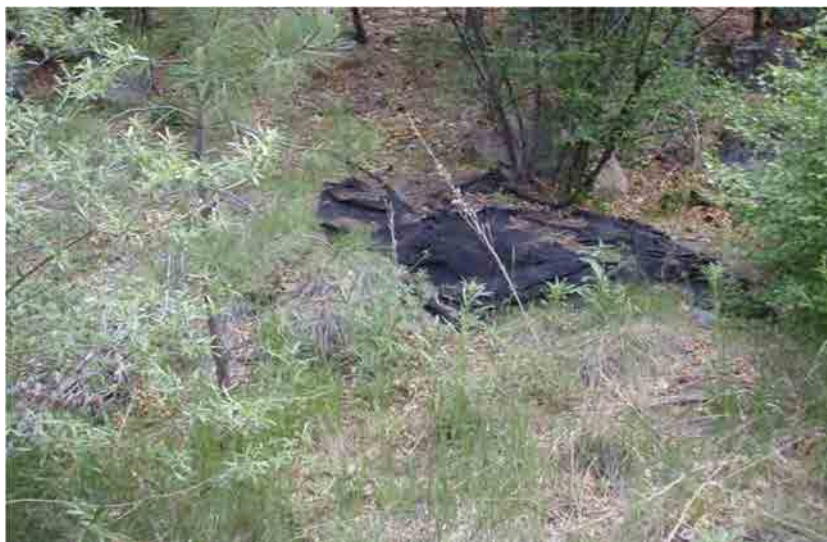
**Photo C-3.7-2 June 2016 — Debris (silt fence and geotextile debris) on north bank in wetland. Recommend removing debris and monitor geotextile.**

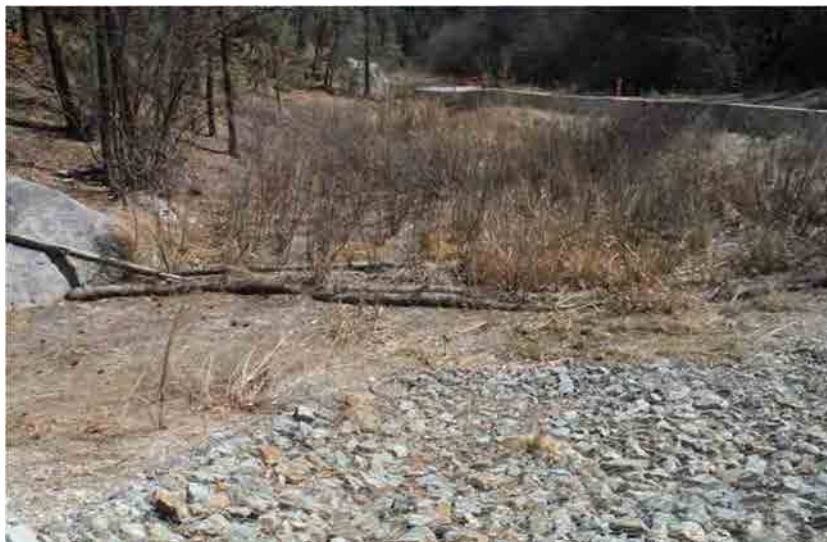
**Photo C-3.8-1 March 2016 — Deteriorating wattles downstream of lower spillway at entrance to wetlands. Recommend repairing deteriorated wattles.**

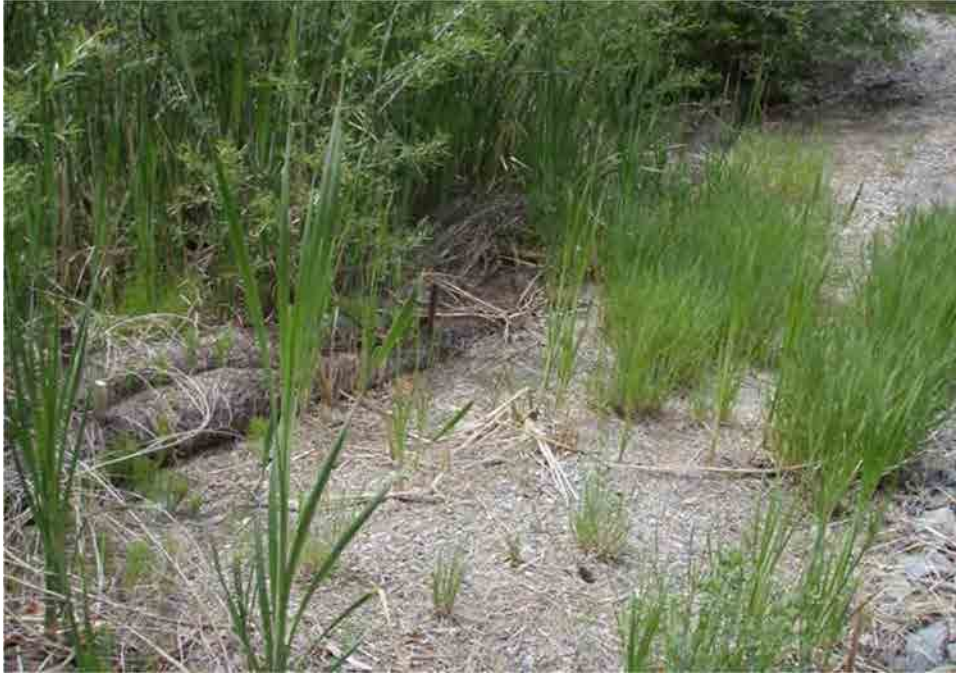
**Photo C-3.8-2** June 2016 — Deteriorating wattles downstream of lower spillway at entrance to wetlands. Recommend repairing deteriorated wattles.

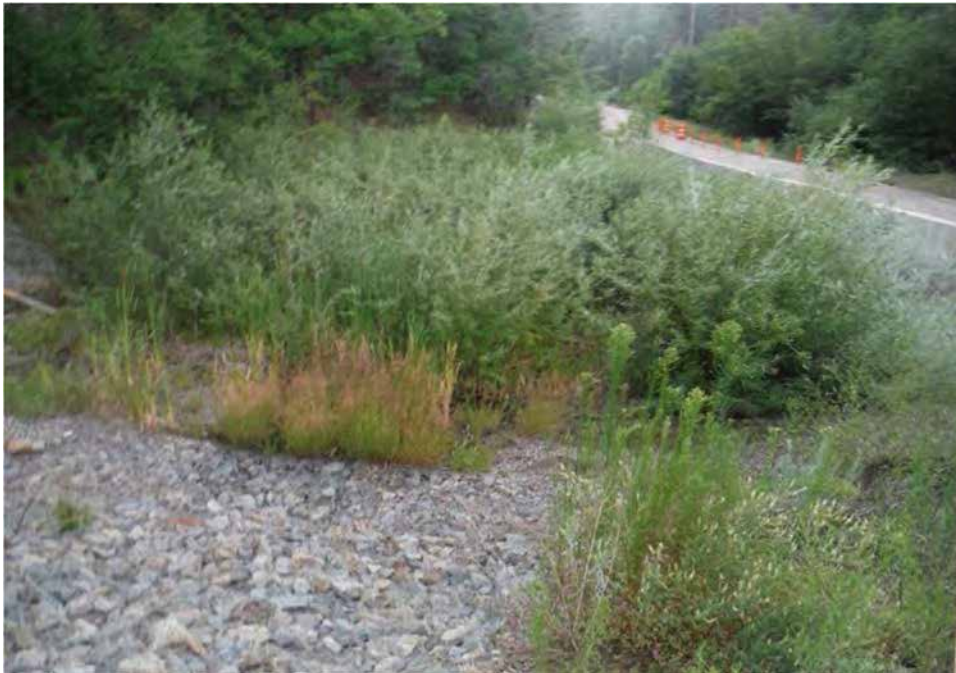
**Photo C-3.8-3** Flow Event on August 3, 2016 — Deteriorated wattles. Recommend repairing deteriorated wattles.

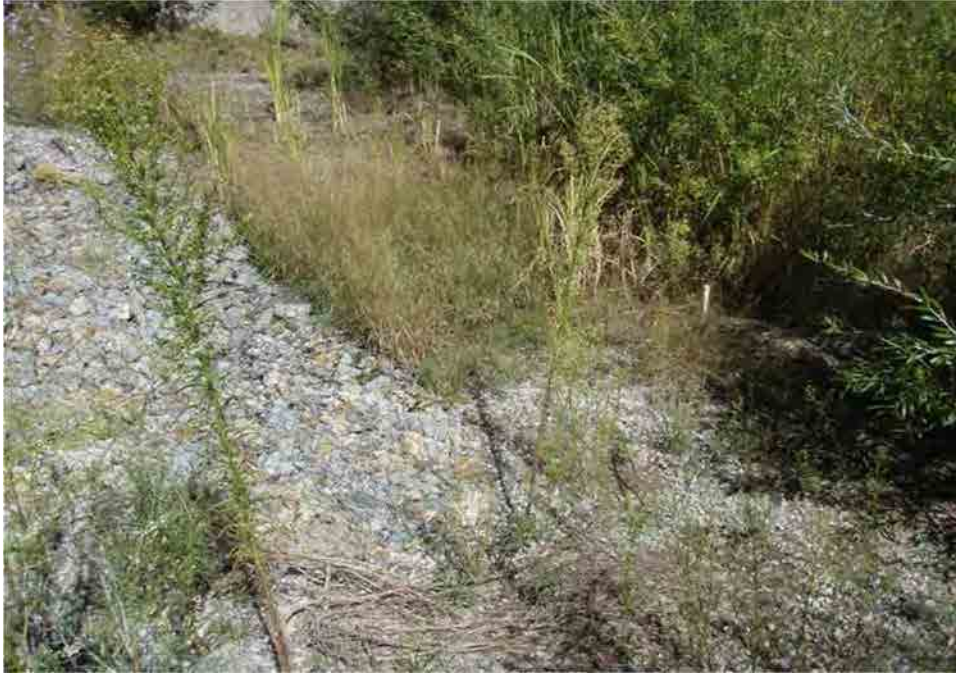
**Photo C-3.8-4** Sept 2016 — Deteriorated wattles downstream of lower spillway (consistent with previous inspection). Recommend repairing deteriorated wattles.

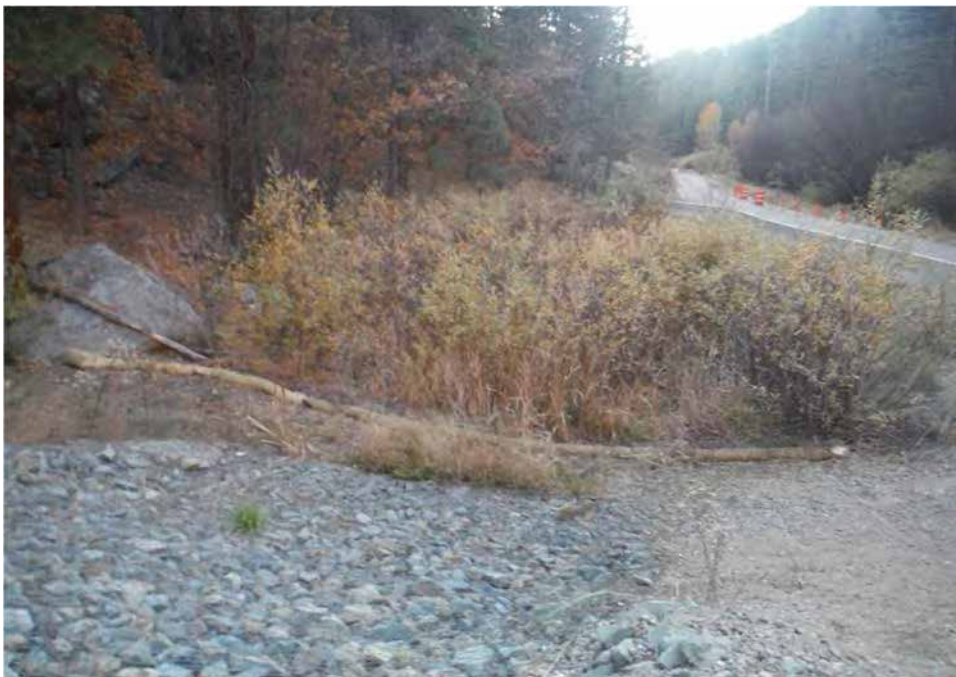
**Photo C-3.8-5** Nov 2016 — Straw wattles recently replaced under maintenance work order.

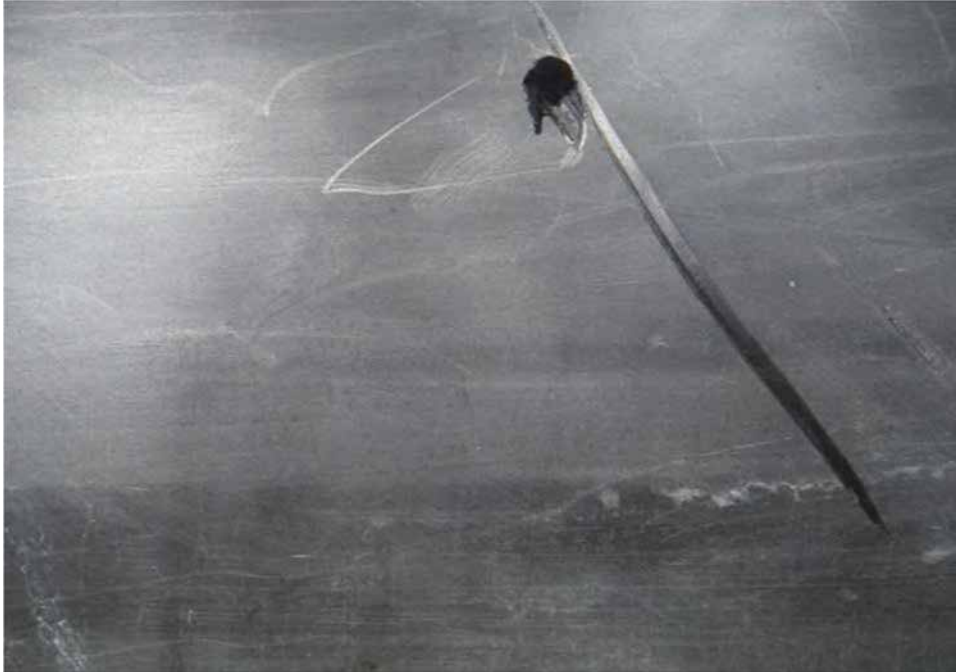
**Photo C-3.9-1** March 2016 — Nick in pipe 6 ft east of pipe bridge structure. Recommend monitoring nick.

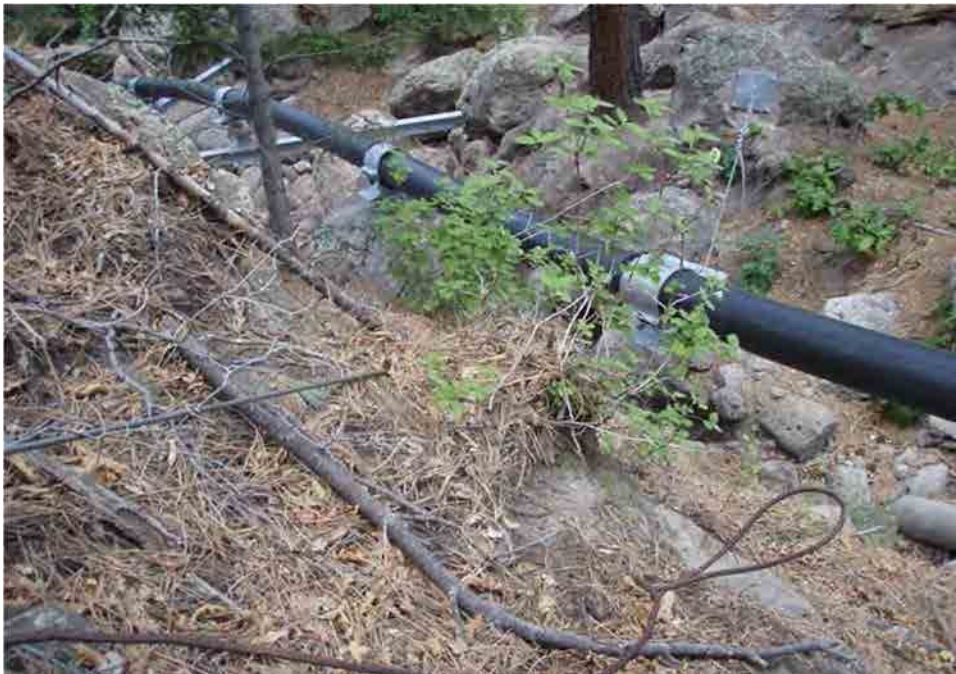
**Photo C-3.9-2** June 2016 — Pipeline and supports (nick not pictured). Recommend monitoring nick.

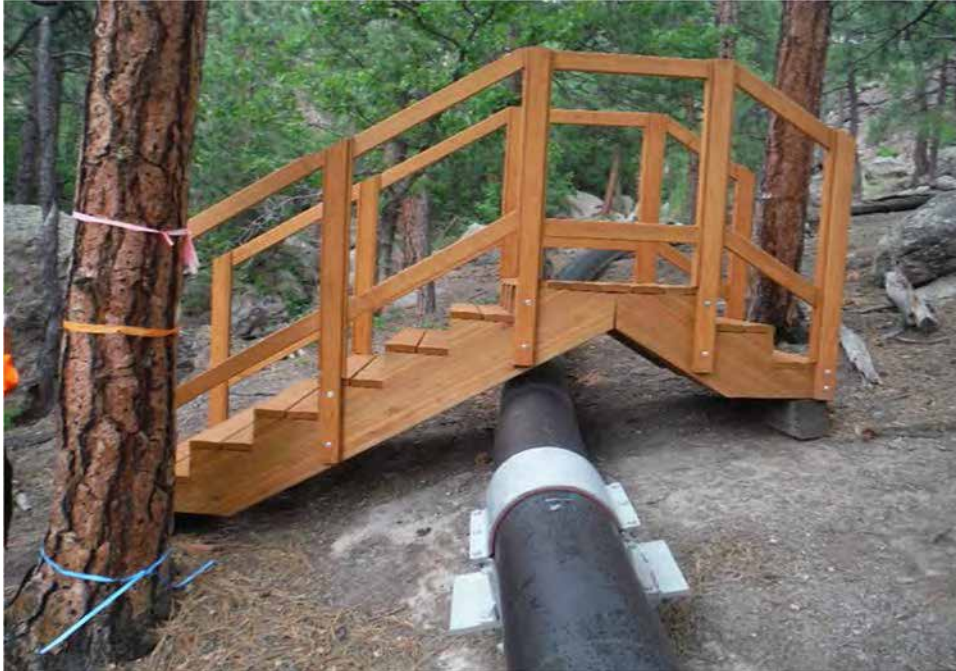
**Photo C-3.9-3** Flow Event on August 3, 2016 — Nick on pipe (circled in red above). Recommend monitoring nick.

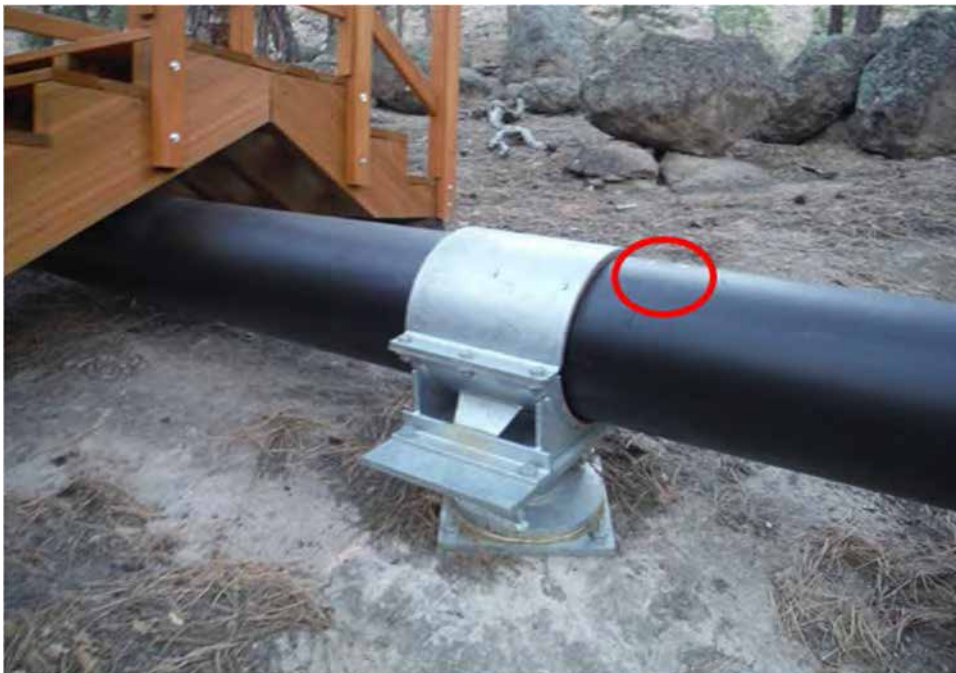
**Photo C-3.9-5** Q4 — Nick in pipe found 6 ft east of pipe bridge structure (circled in red). Recommend monitoring nick.

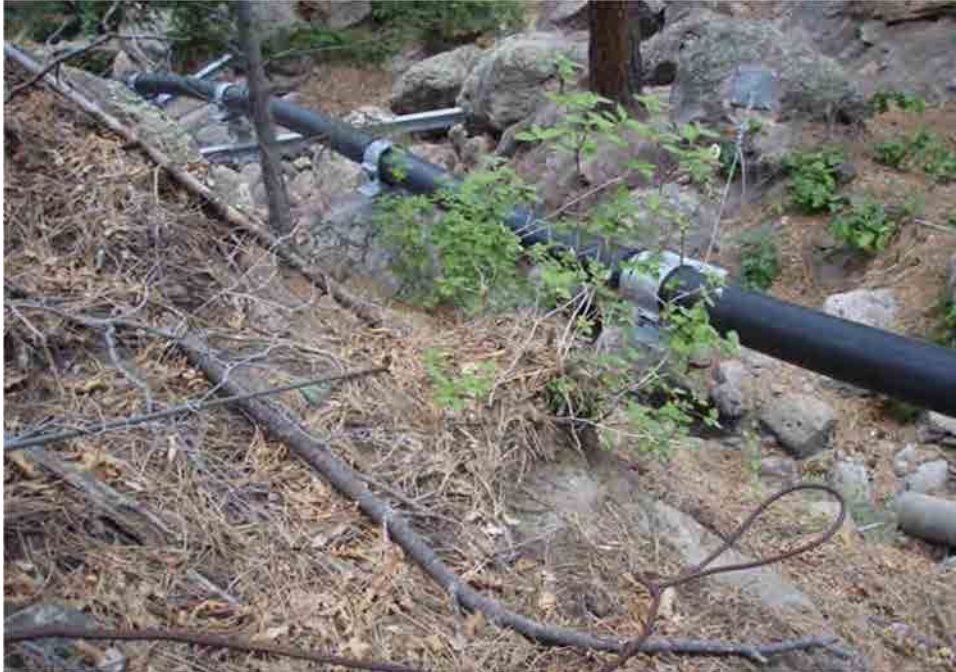
**Photo C-3.10-1 June 2016 — Uppermost support cable shows fraying and corrosion (fraying not pictured). Recommend monitoring cables.**

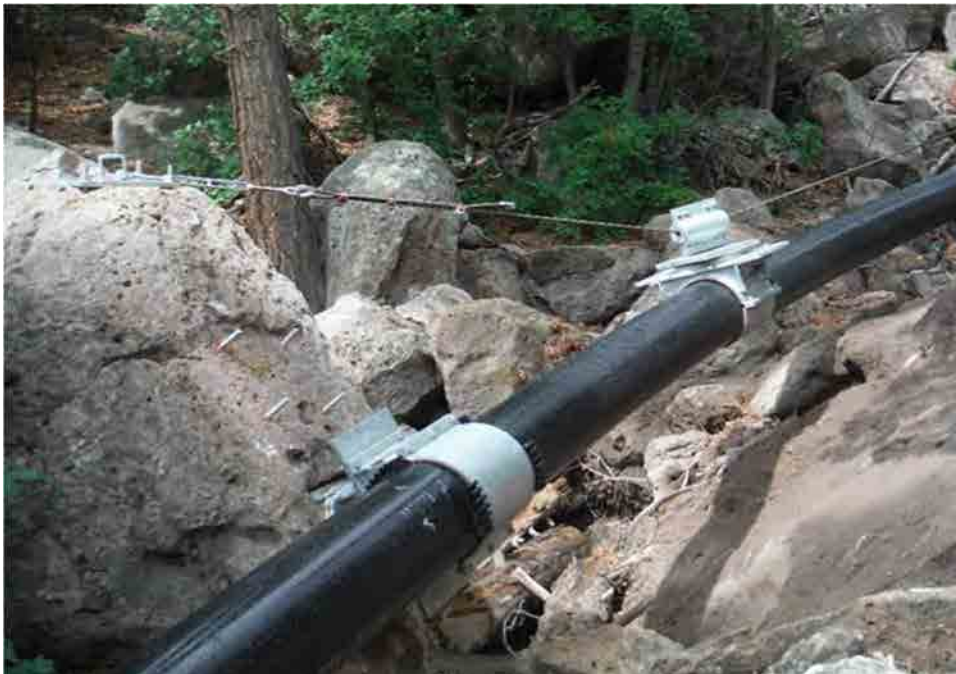
**Photo C-3.10-2 Flow Event on August 3, 2016 — Uppermost support cable with fraying and corrosion. Recommend monitoring cables.**

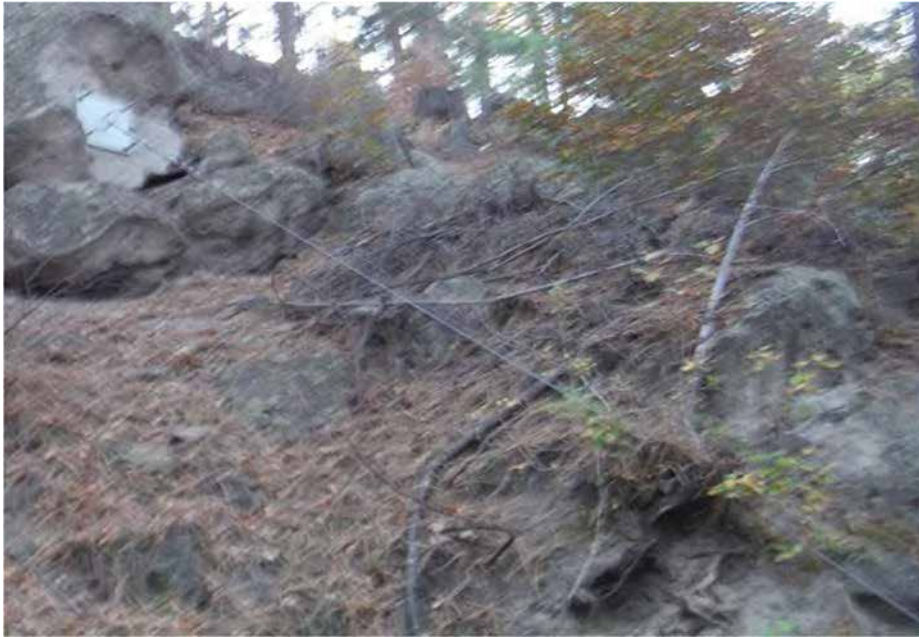
**Photo C-3.10-4    Nov 2016 — Uppermost pipe cable anchor fraying and corrosion where it rubs against the canyon rocks. Recommend monitoring cables.**

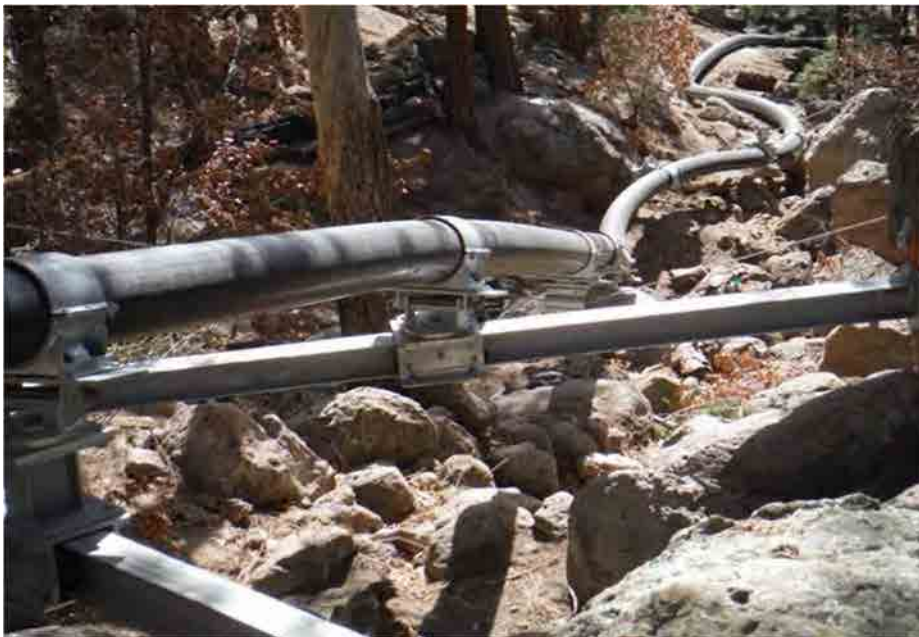
**Photo C-3.11-1    March 2016 — Rolling pipe support on lower I-beam (upstream of vacuum breaker) has skewed alignment and is bearing incorrectly. Recommend monitoring I-beam.**

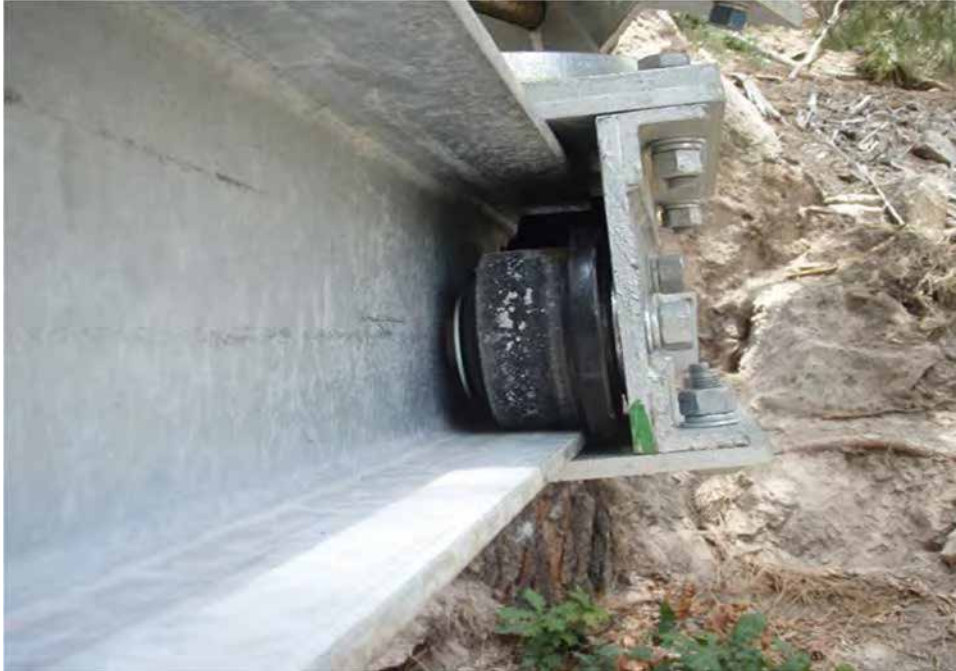
**Photo C-3.11-2** June 2016 — Lower rolling pipe support on I-beam with skewed alignment and incorrect bearing. Recommend monitoring I-beam.

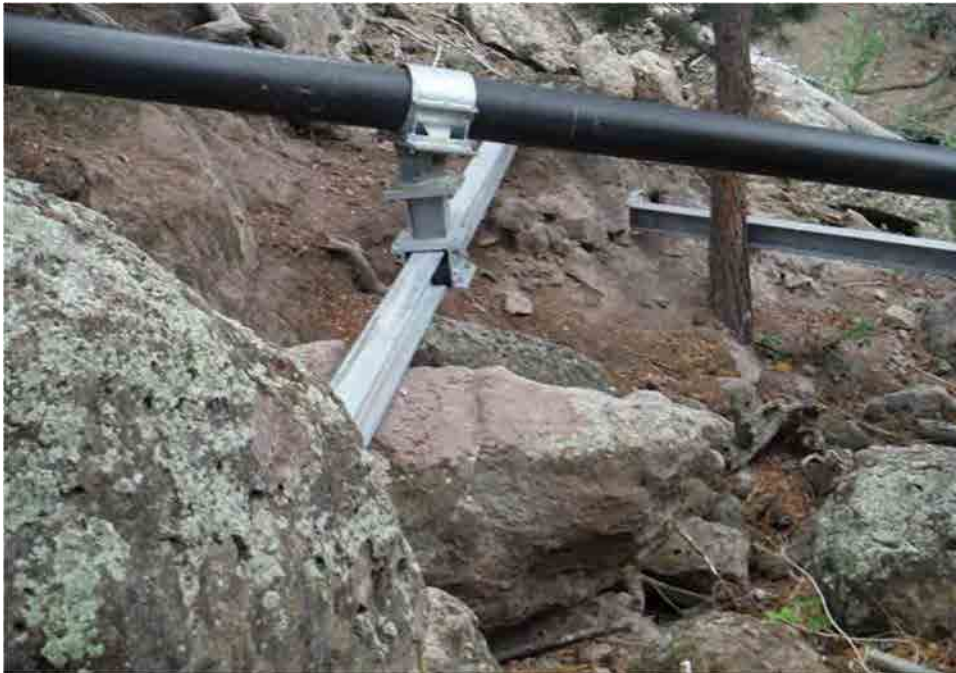
**Photo C-3.11-3** Flow Event on August 3, 2016 — Lower rolling pipe support on I-beam with skewed alignment and incorrect bearing. Recommend monitoring I-beam.

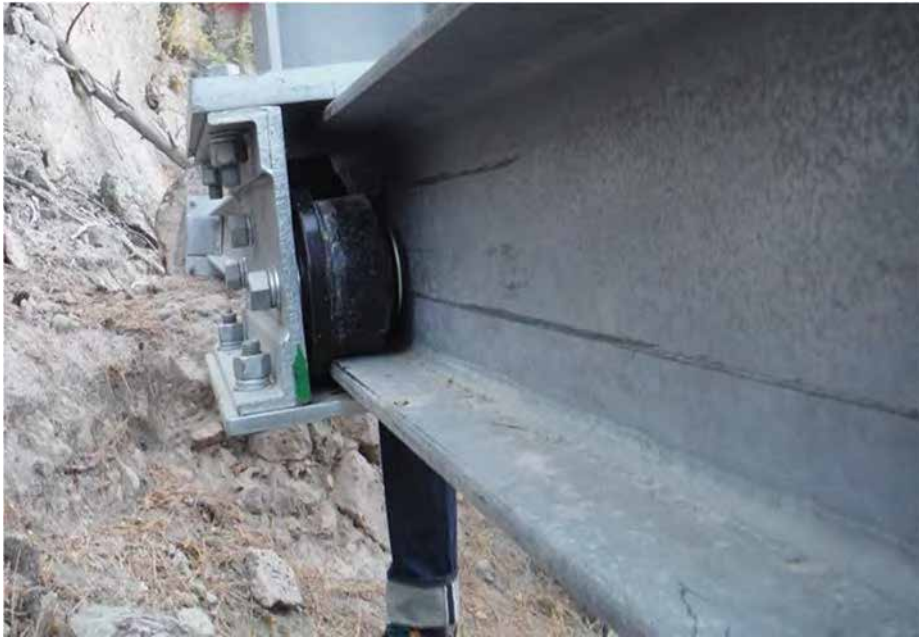
**Photo C-3.11-5** Nov 2016 — Lower rolling pipe support on I-beam with skewed alignment and incorrect bearing. Recommend monitoring I-beam.

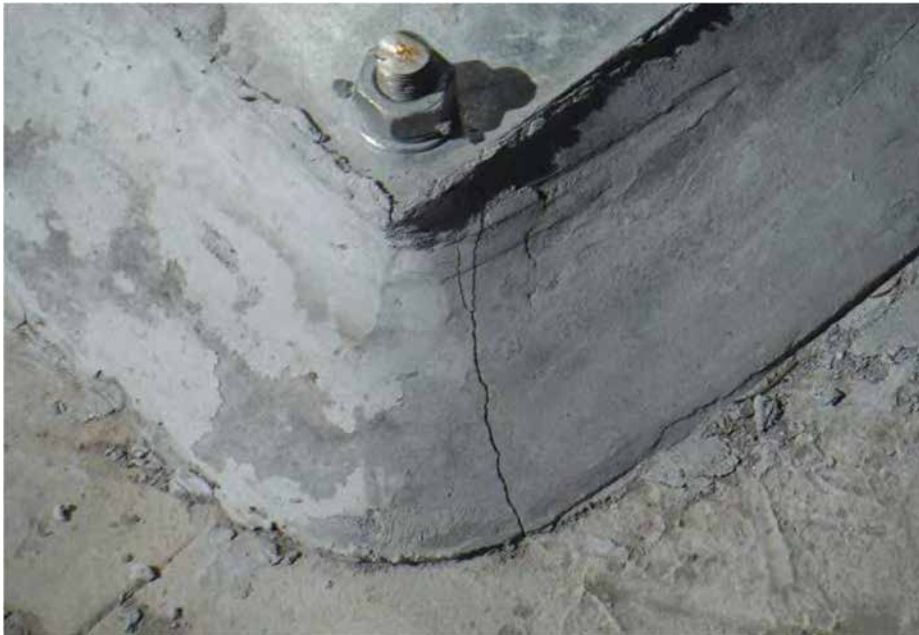
**Photo C-3.12-1** March 2016 — Crack found in mortar on southeast corner pipe bridge support. Recommend monitoring crack.

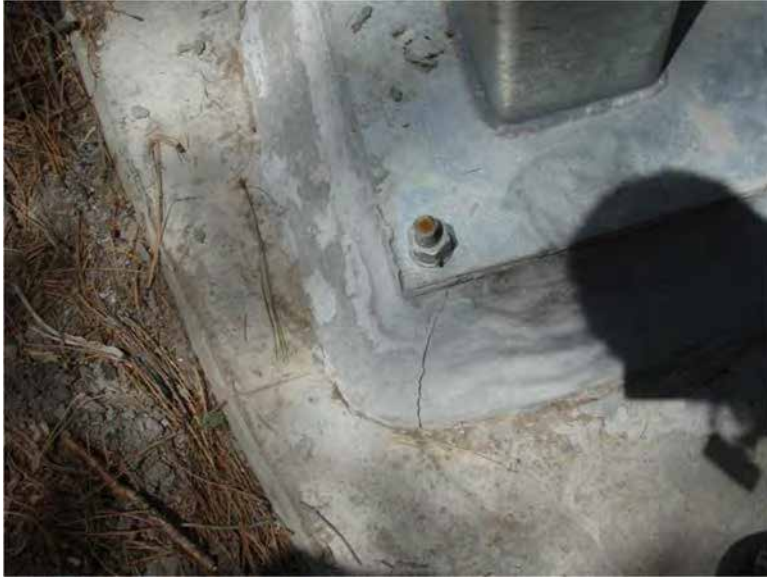
**Photo C-3.12-2 June 2016 — Crack found in mortar on southeast corner pipe bridge support. Recommend monitoring crack.**

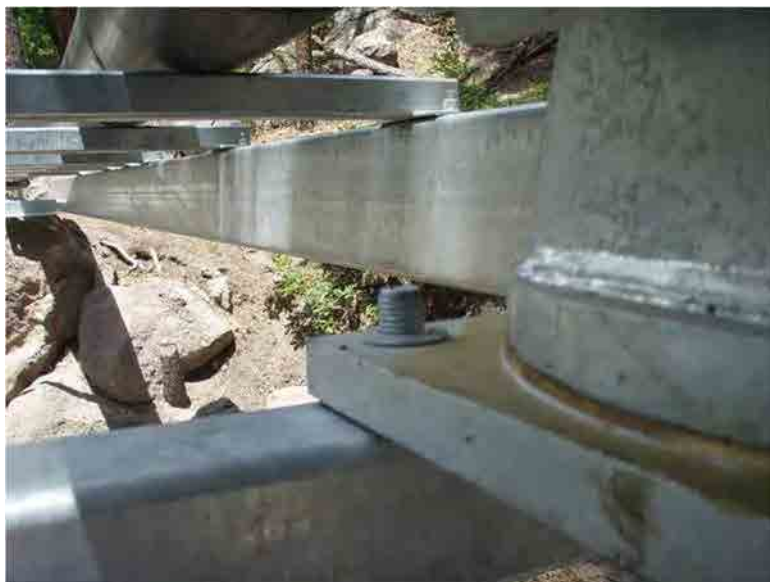
**Photo C-3.13-1 June 2016 — Pipe support bolt with missing nut. Recommend installing missing nut.**

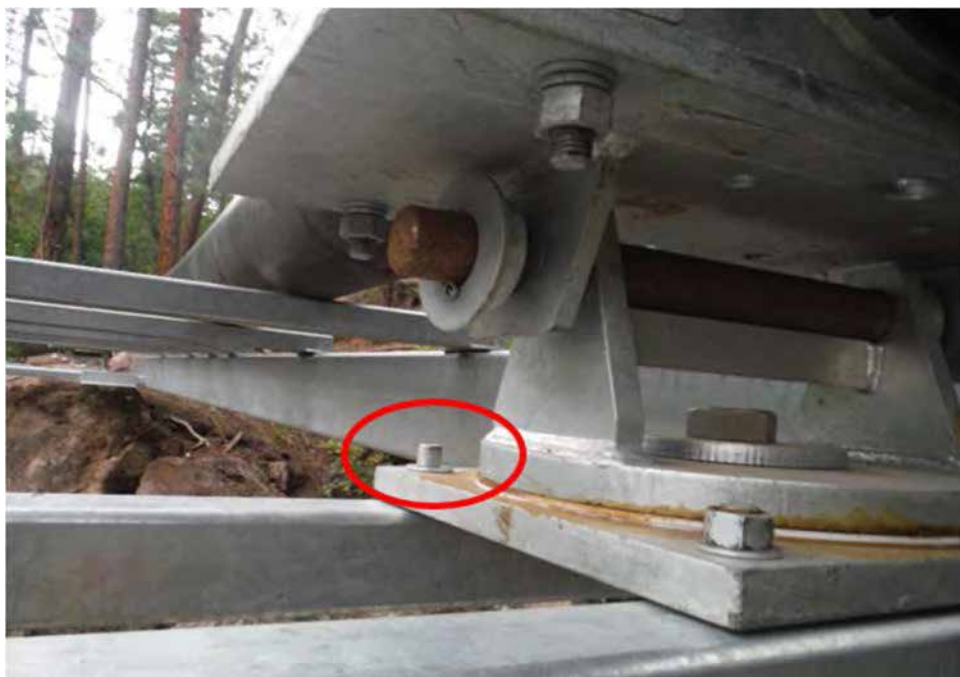
**Photo C-3.13-2 Flow Event on August 3, 2016: Pipe support bolt with missing nut (circled in red) consistent with previous inspection. Recommend installing missing nut.**

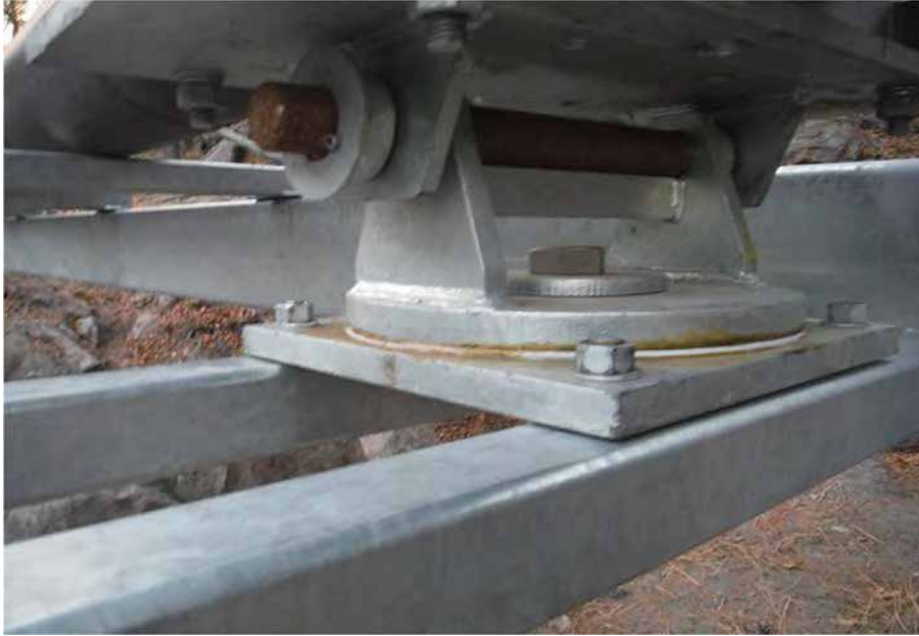
**Photo C-3.13-4** Nov 2016 — Previously missing nut recently installed at southwest corner top of plate under maintenance work order.

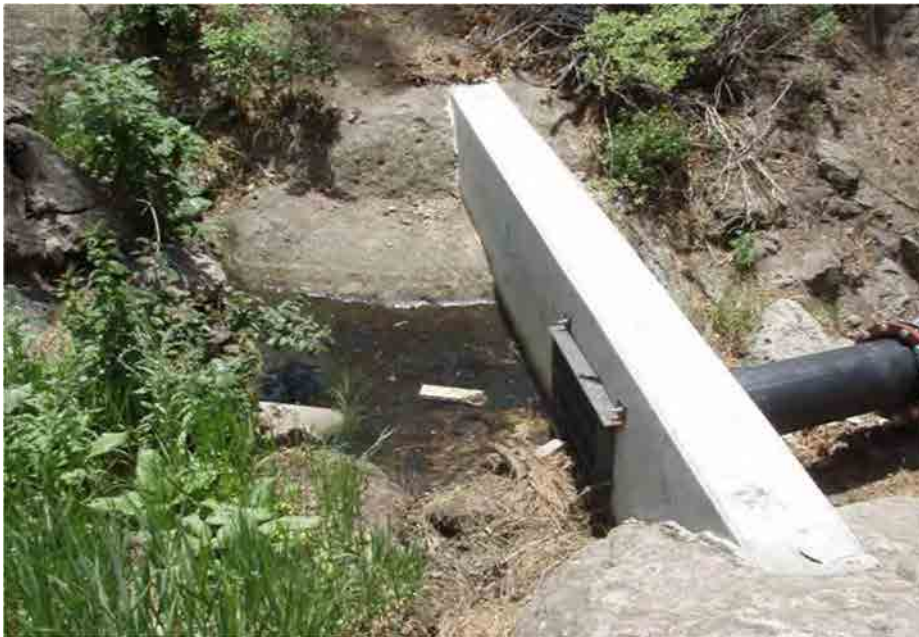
**Photo C-3.14-2** June 2016 — Debris present upstream of pipe inlet. Recommend removal of debris.

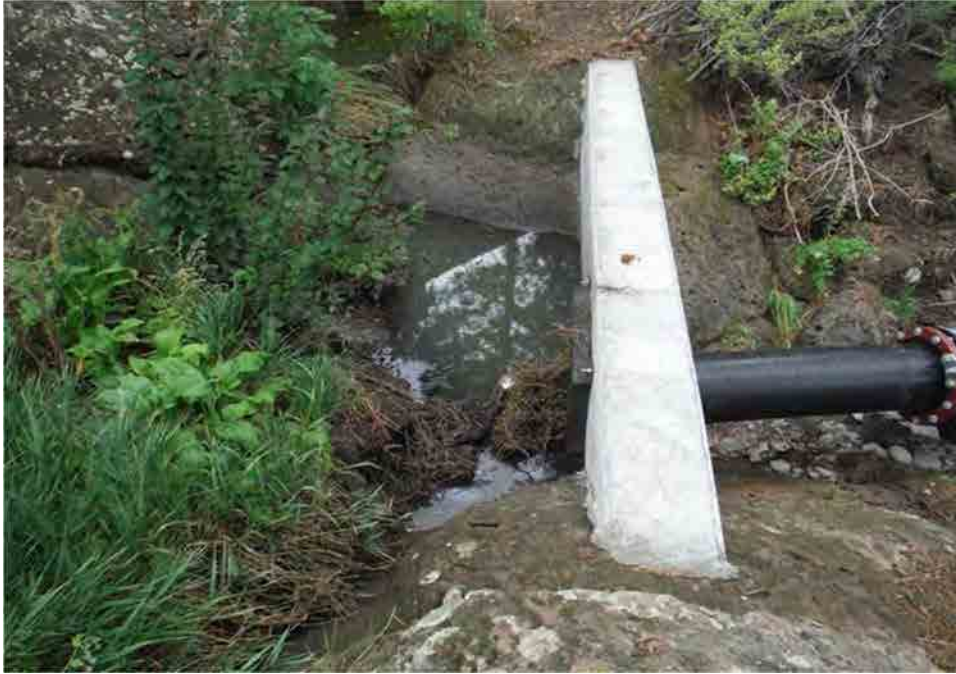
**Photo C-3.14-3** Flow Event on August 3, 2016 — Pipe inlet plugged with debris from recent rain event. Recommend removal of debris.

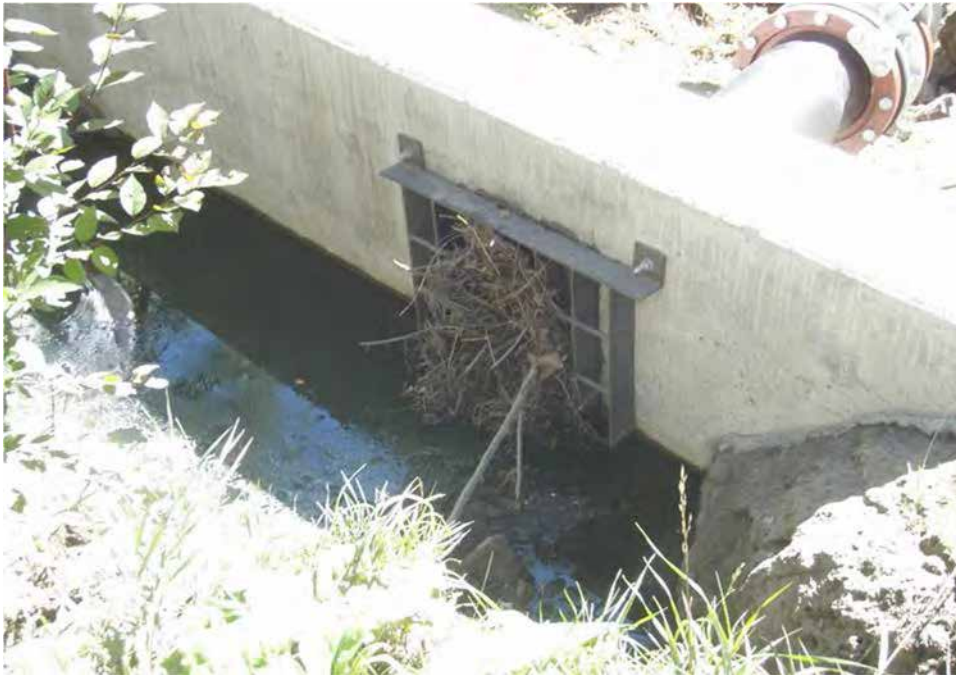
**Photo C-3.14-4** Sept 2016 — Pipe inlet still plugged with debris. Recommend removal of debris.
