**Subject: 2016 Monitoring Report for Los Alamos/Pueblo Watershed Sediment Transport Mitigation Project**

April 2017

EP2017-0042

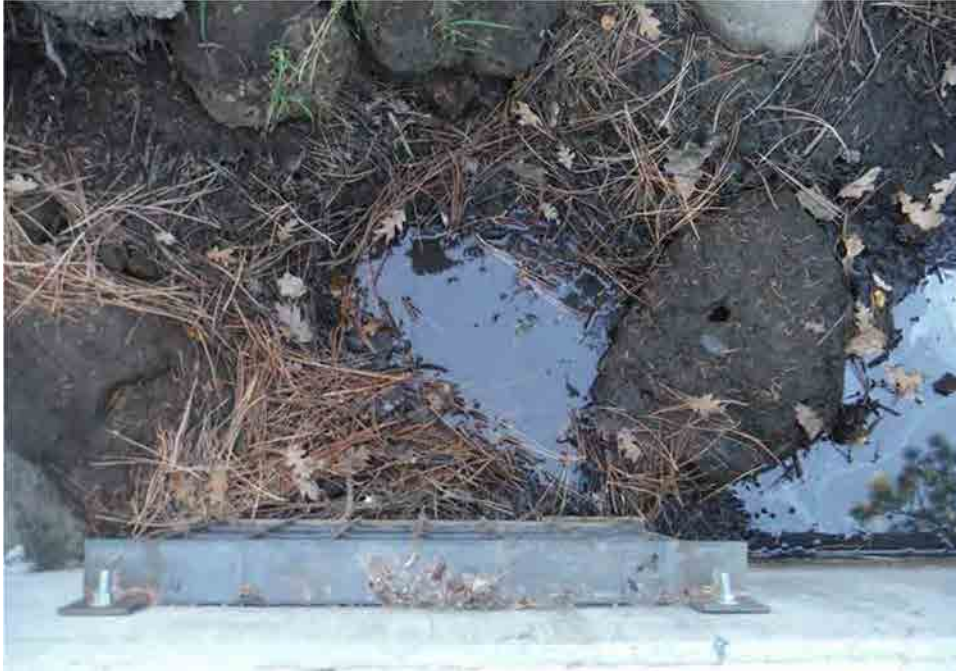
**Photo C-3.14-5** Nov 2016 — Debris present at pipe inlet. Recommend removal of debris.

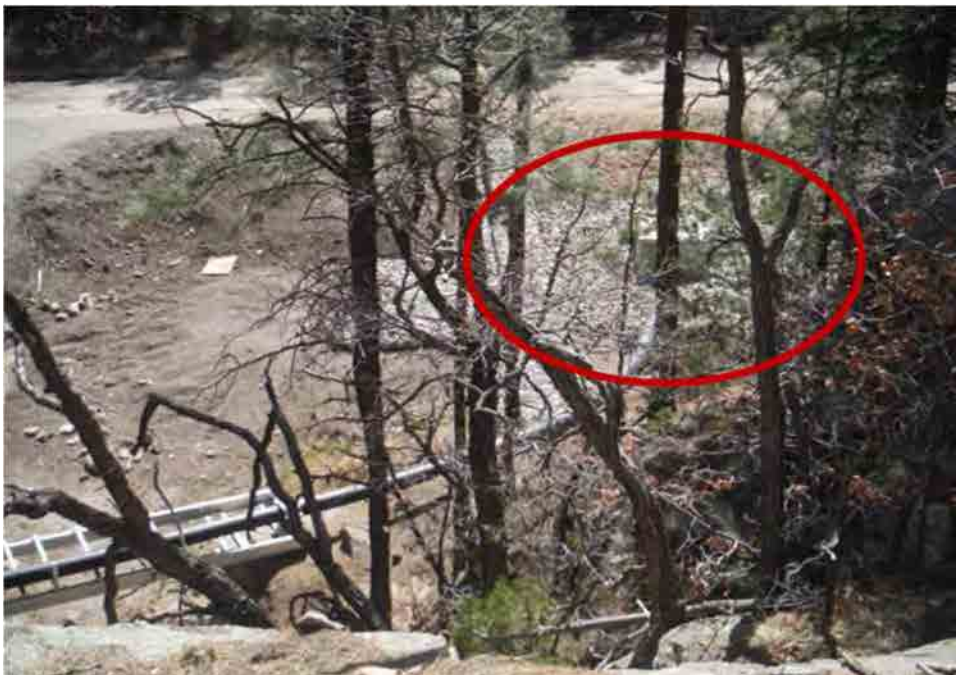
**Photo C-3.15-1** March 2016 — Bare soils on steep slopes found on south and north bank upstream of the gabion overflow structure to upper pond. Pipe outlet circled in red above.

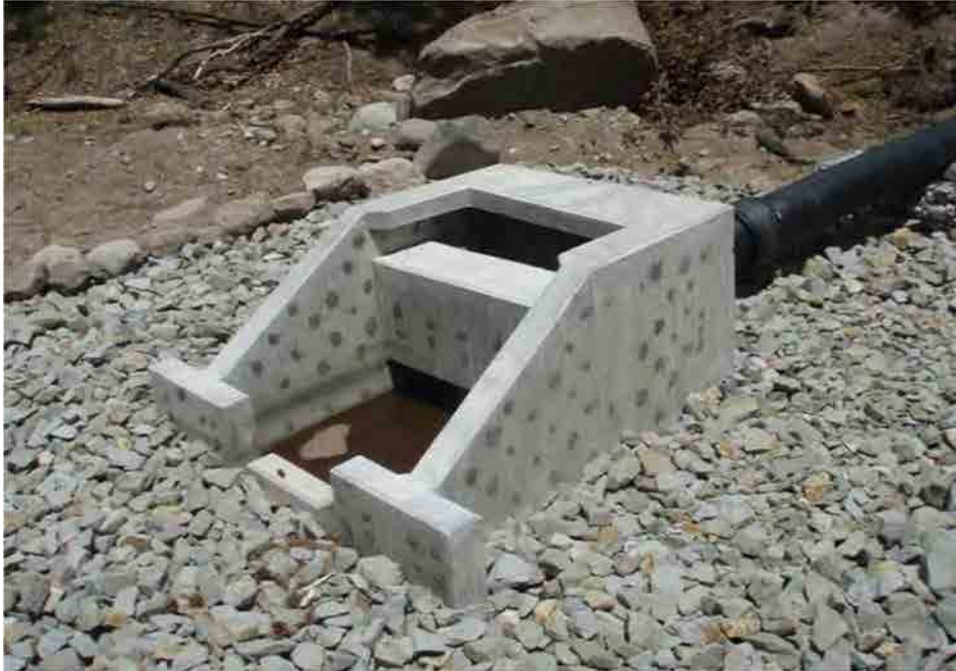
**Photo C-3.15-2** June 2016 — Debris around energy dissipater present. Bare soil on south and north banks is exposed and in need of stabilization. Recommend removal of debris.

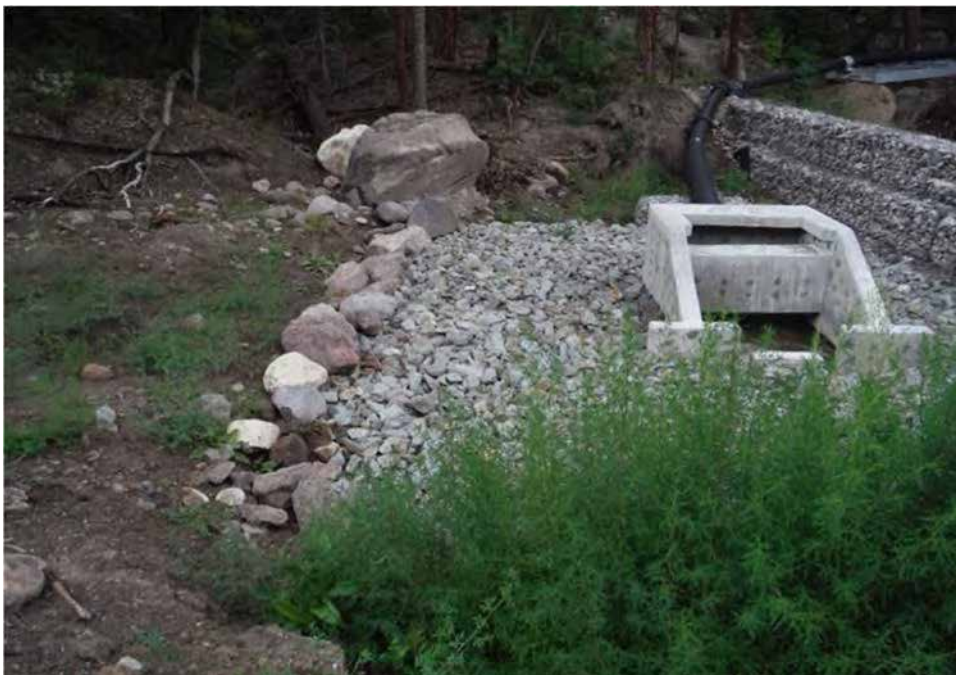
**Photo C-3.15-3** Flow Event of August 3, 2016 — Pipe outlet contains trash and debris. Standing water present due to recent rain event. Recommend removal of debris.

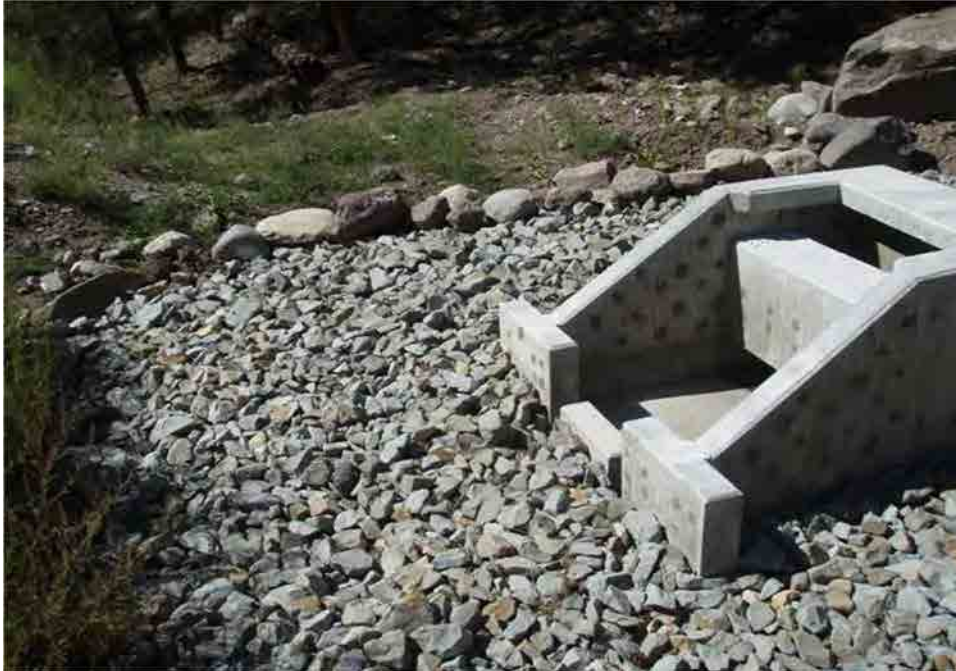
**Photo C-3.15-4** Sept 2016 — Banks near pipeline outlet in need of stabilization (consistent with previous inspections). No standing water present. Recommend removal of debris.

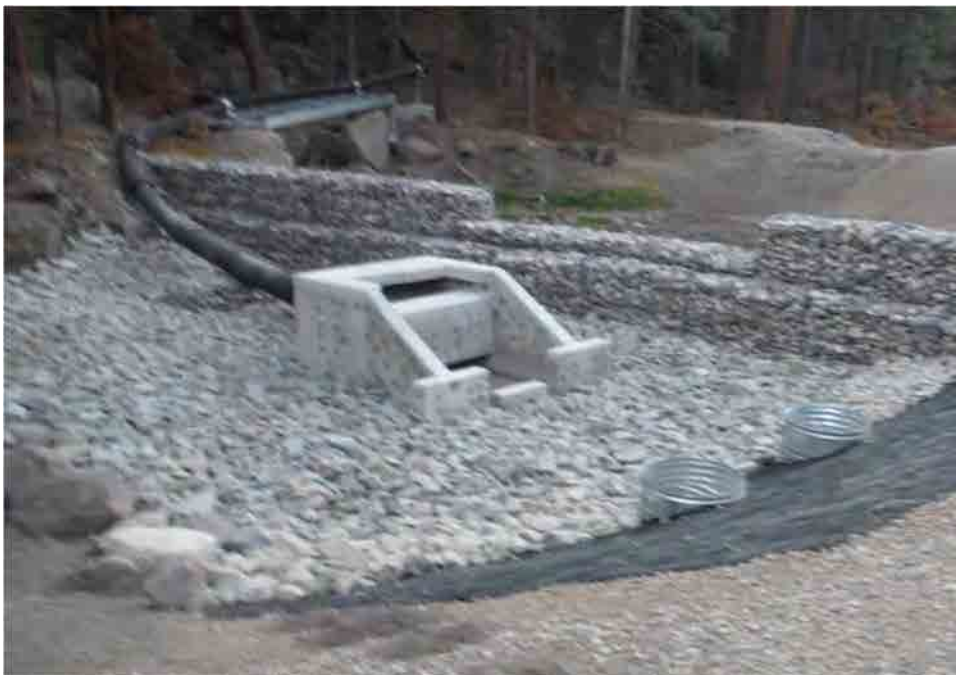
**Photo C-3.15-5** Nov 2016 — Pipe outlet looking northeast. Riprap on banks recently installed under maintenance work order. Recent rodent activity on south bank.

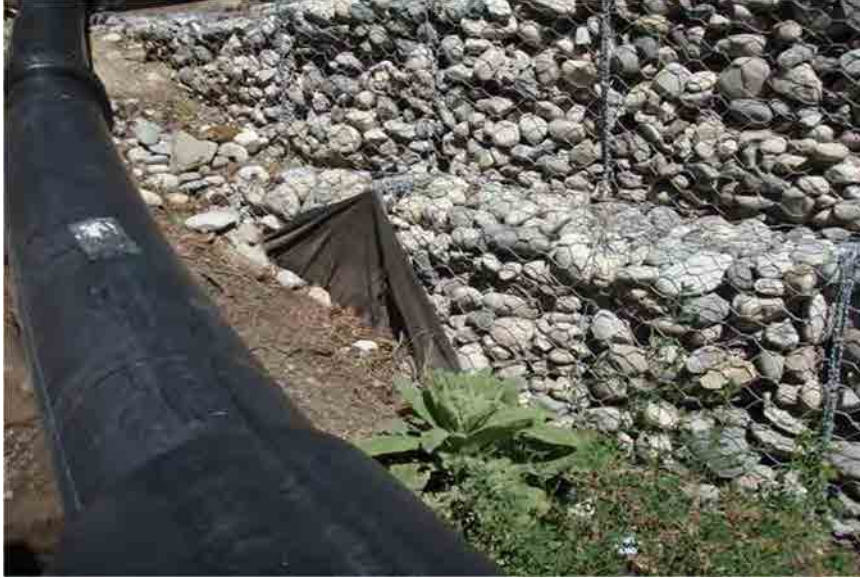
**Photo C-3.16-3** Sept 2016 — Filter fabric left after construction. North and south banks of overflow structure still exposed (consistent with previous inspection). Sediment deposition encountered below top of gabion spillway into upper pond indicating water levels in the diversion area did not reach a level to spill into the upper pond. Recommend removal of debris.

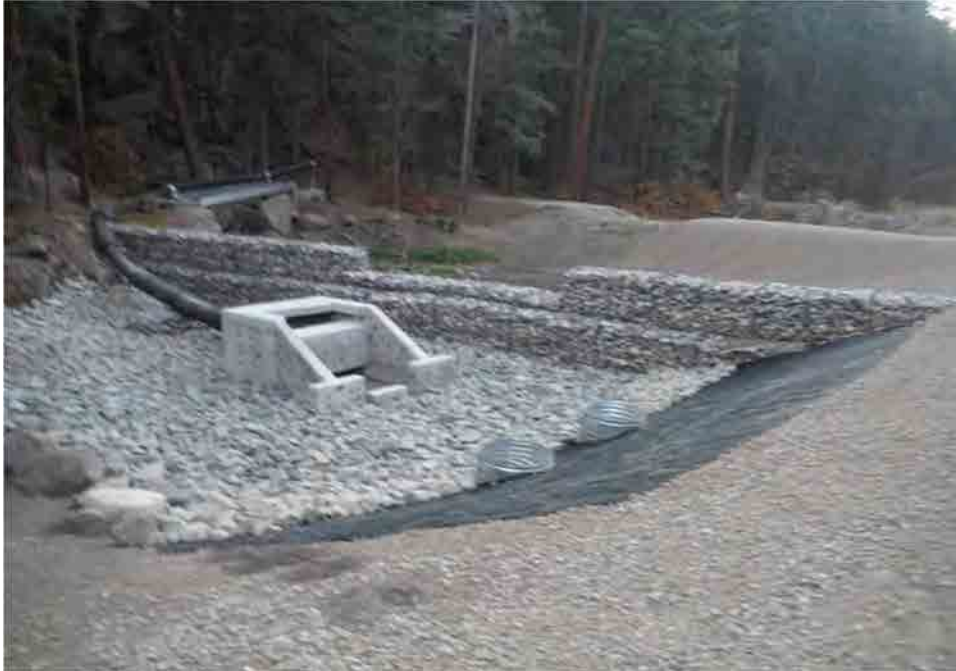
**Photo C-3.16-4 Nov 2016 — Filter fabric removed.**

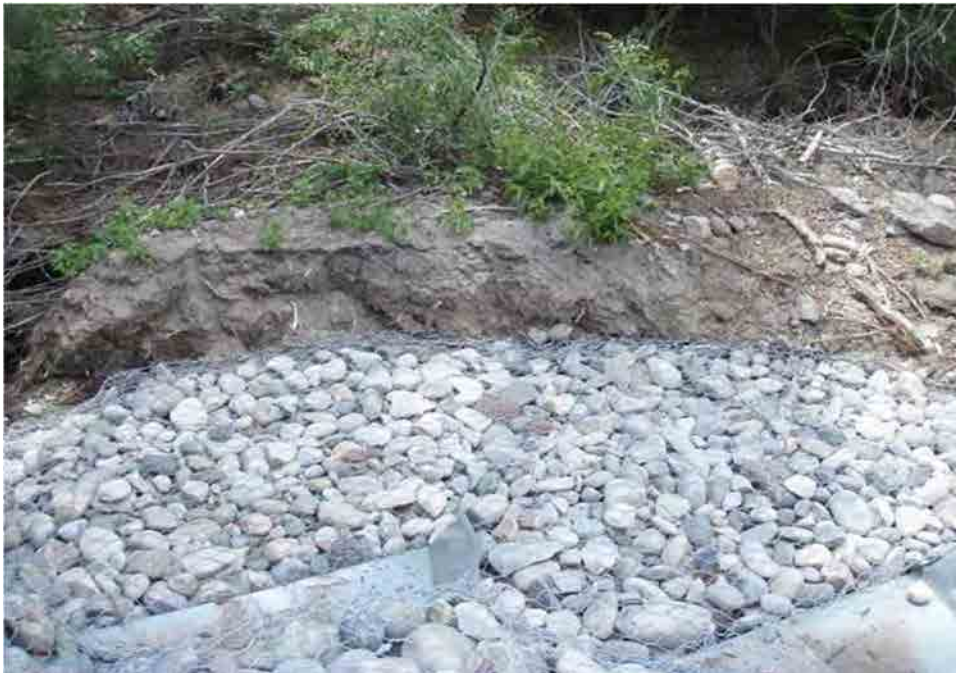
**Photo C-3.17-2 June 2016 — Basin outlet area with exposed, unstable bank.**

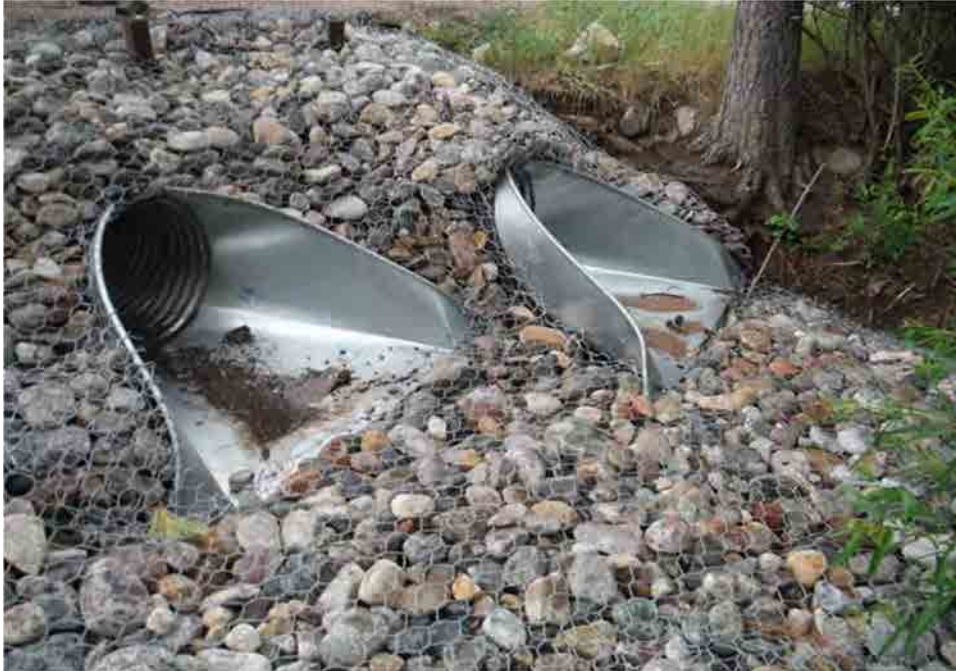
**Photo C-3.17-3** Flow Event on August 3, 2016 — Basin outlet with evidence of flow from recent rain event.

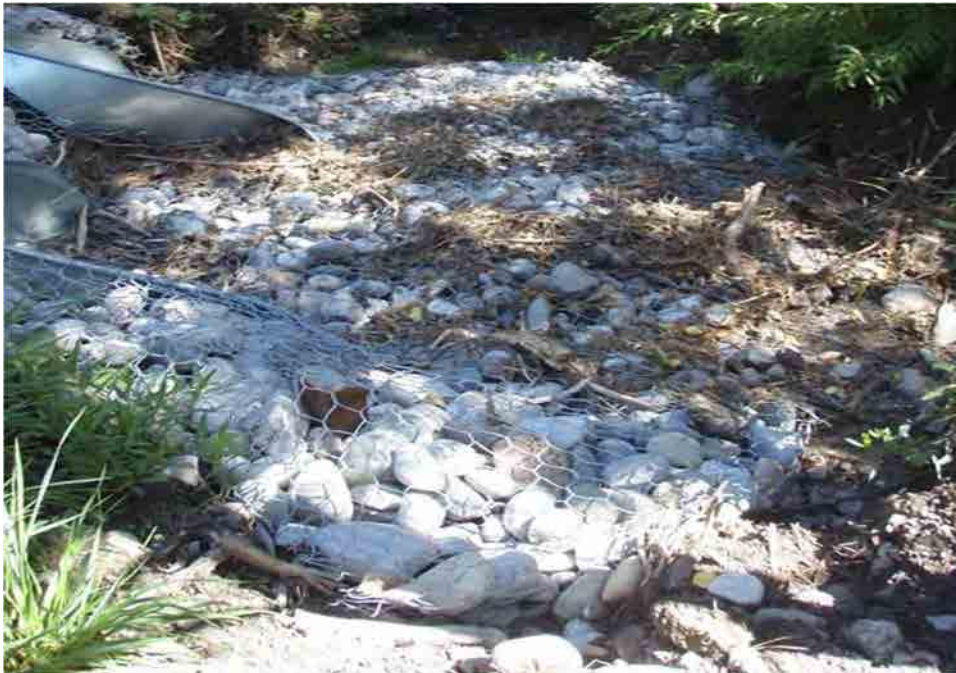
**Photo C-3.17-4** Sept 2016 — Bare soil areas on opposite bank of discharge culvert outlet. Evidence of flow at culvert discharge. Consistent with previous inspections.

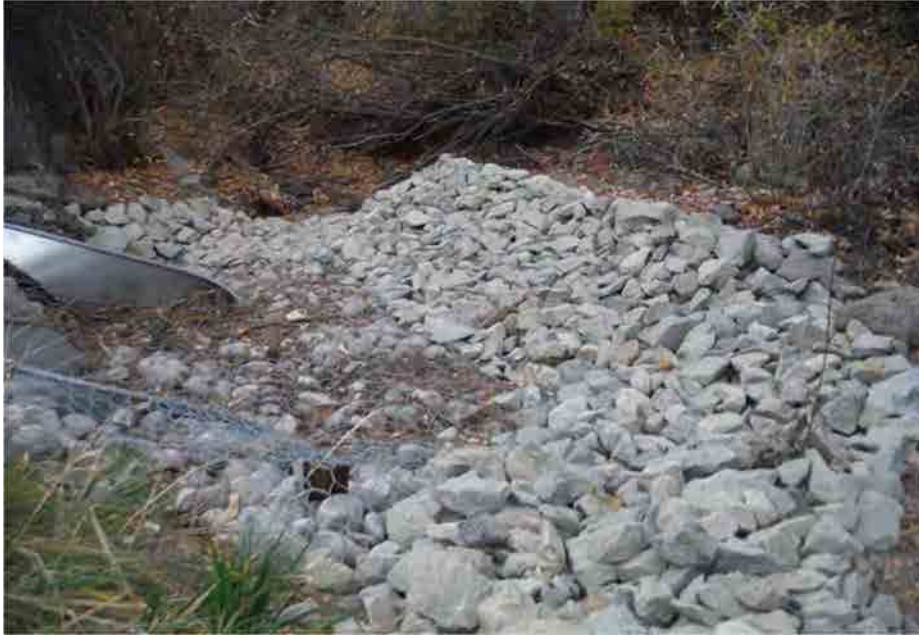
**Photo C-3.17-5** Nov 2016 — Culvert outlet riprap extension completed under maintenance order.

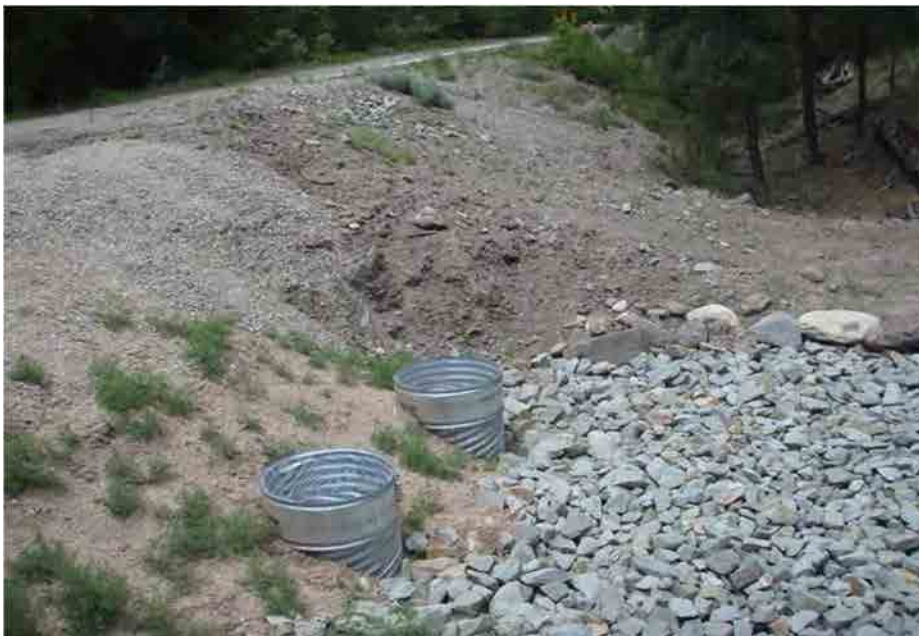
**Photo C-3.18-2** June 2016 — Recommend installing trash racks and 3-in.-diameter holes on riser pipes. Bank erosion present.

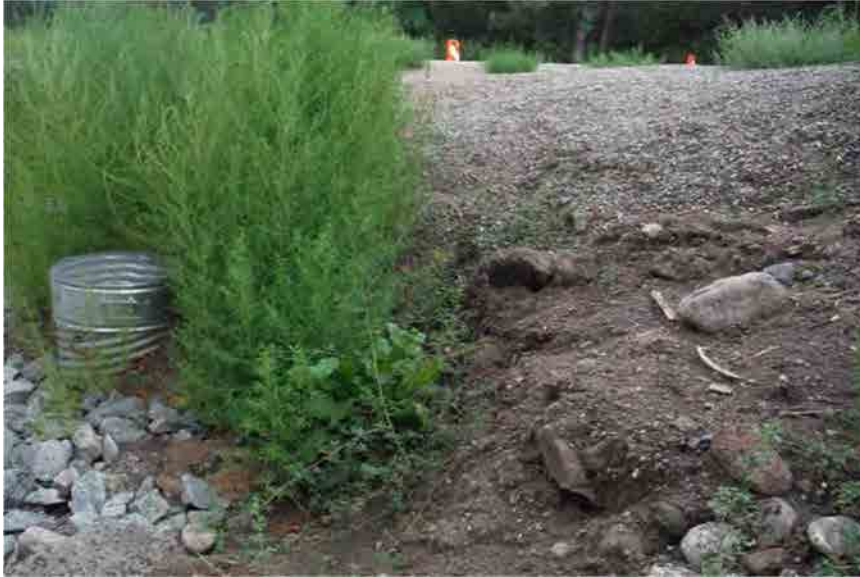
**Photo C-3.18-3** Flow Event on August 3, 2016 — Tall vegetation encountered near new culvert pipe inlet risers. Bank erosion present. Recommend installing trash racks and 3-in.-diameter holes on riser pipes.

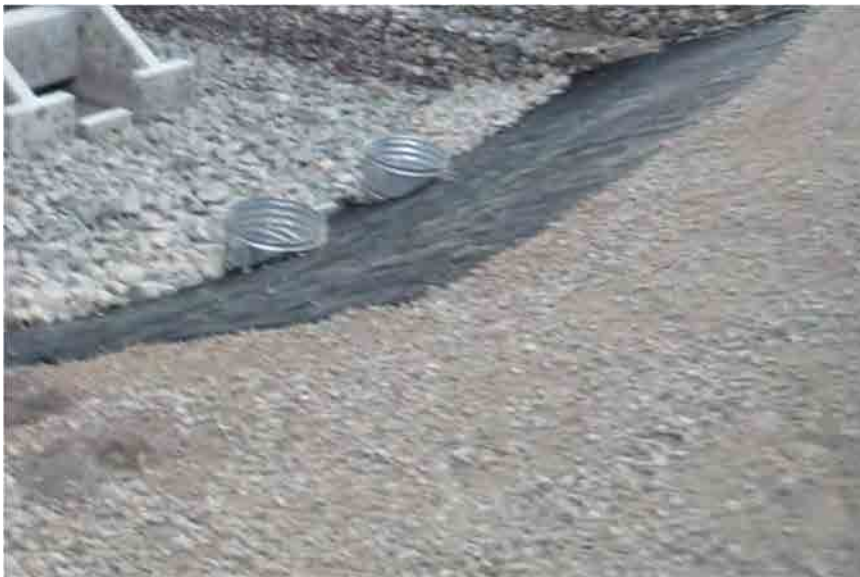
**Photo C-3.18-5** Nov 2016 — Riser pipes consistent with previous inspection. Recommend installing trash racks and 3-in.-diameter holes on riser pipes.

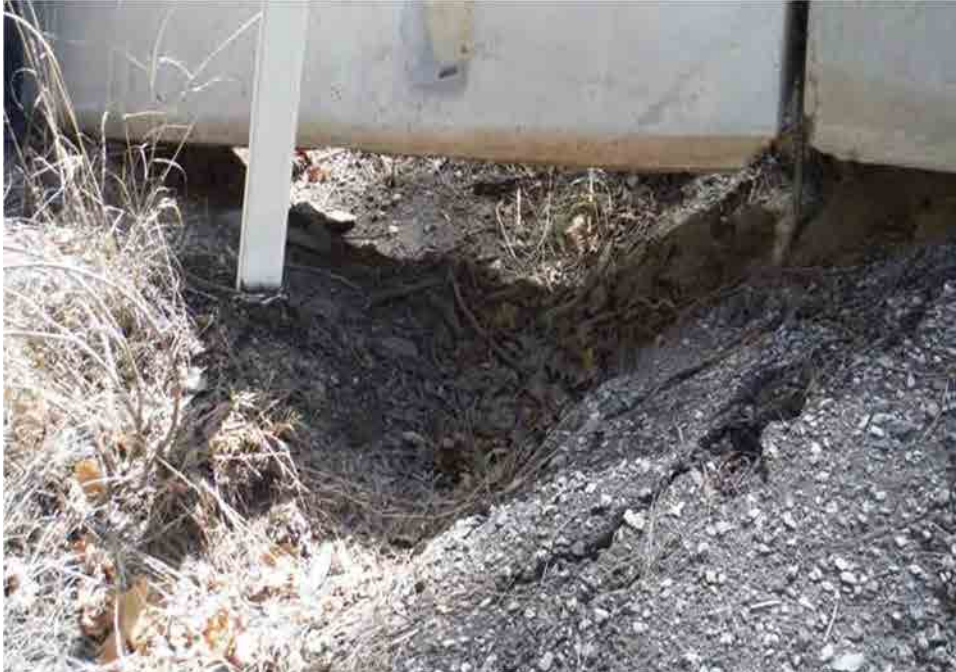
**Photo C-3.19-1** March 2016 — Road collapse under Jersey barrier at southeast end of wetland. Recommend repair of road.

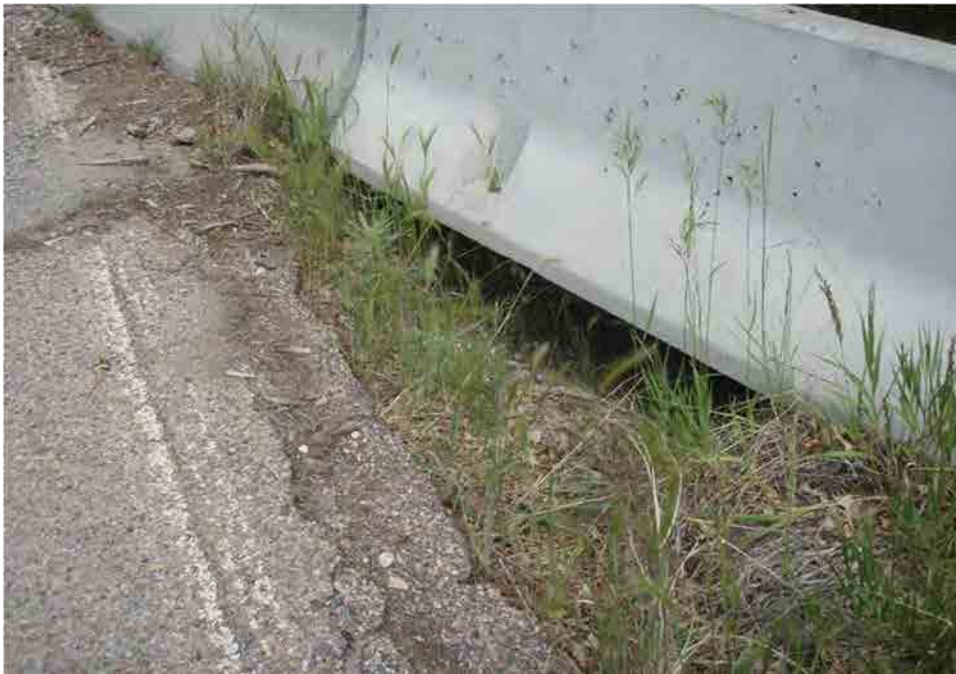
**Photo C-3.19-2** June 2016 — Road collapse under Jersey barrier. Recommend repair of road.

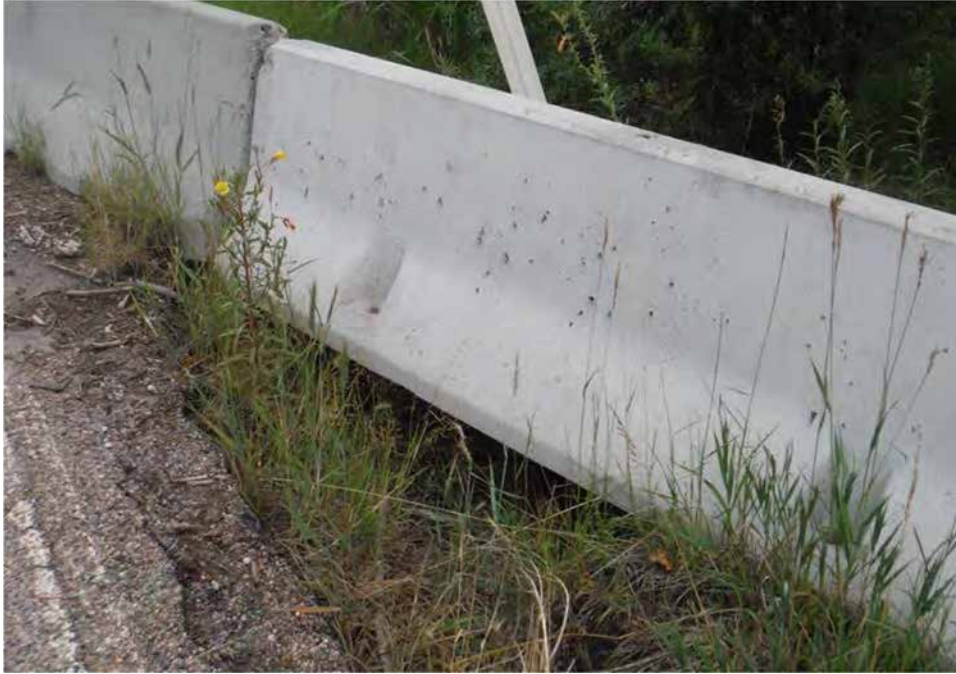
**Photo C-3.19-3** Flow Event August 3, 2016 — Road collapse under Jersey barrier. Recommend repair of road.

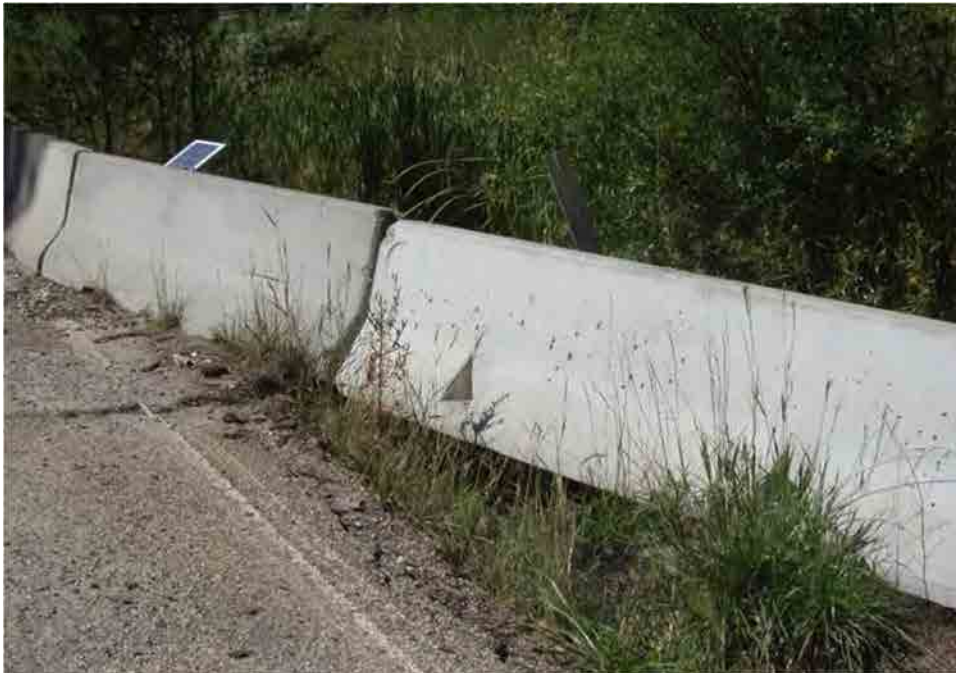
**Photo C-3.19-4** Sept 2016 — Road collapse under Jersey barrier (consistent with previous inspection). Recommend repair of road.

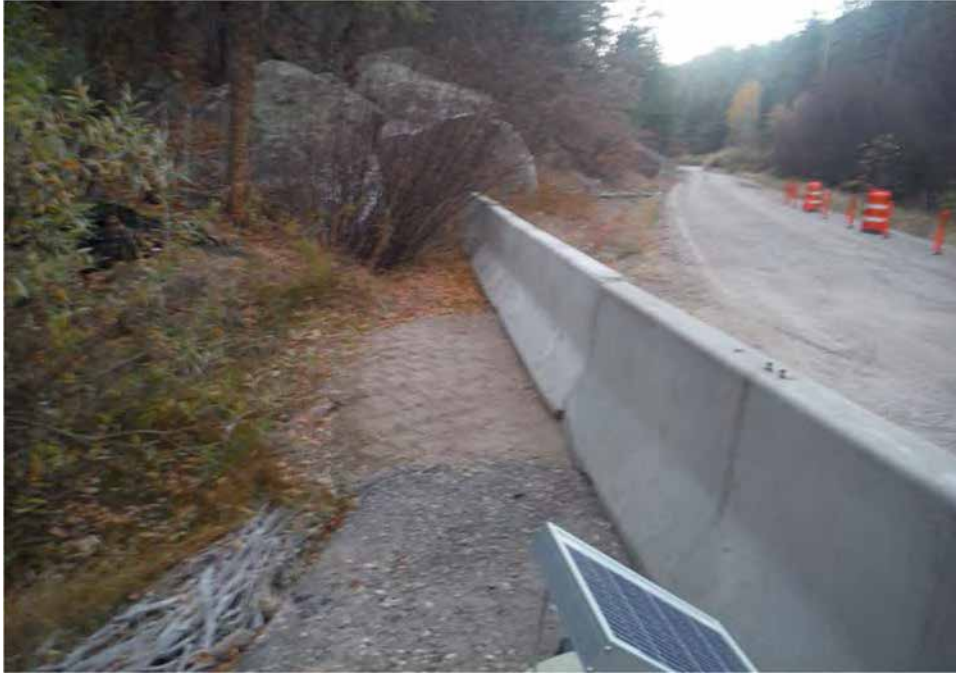
**Photo C-3.19-5** Nov 2016 — Road collapse repair recently completed under maintenance work order.

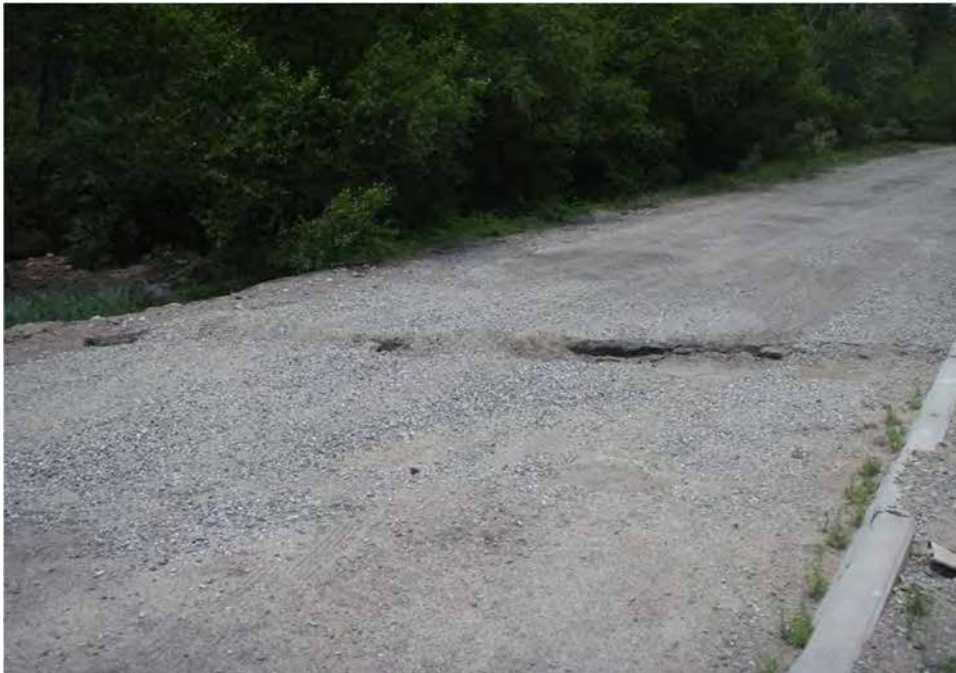
**Photo C-3.20-1** June 2016 — Road with visible holes and damage. Recommend repair of road.

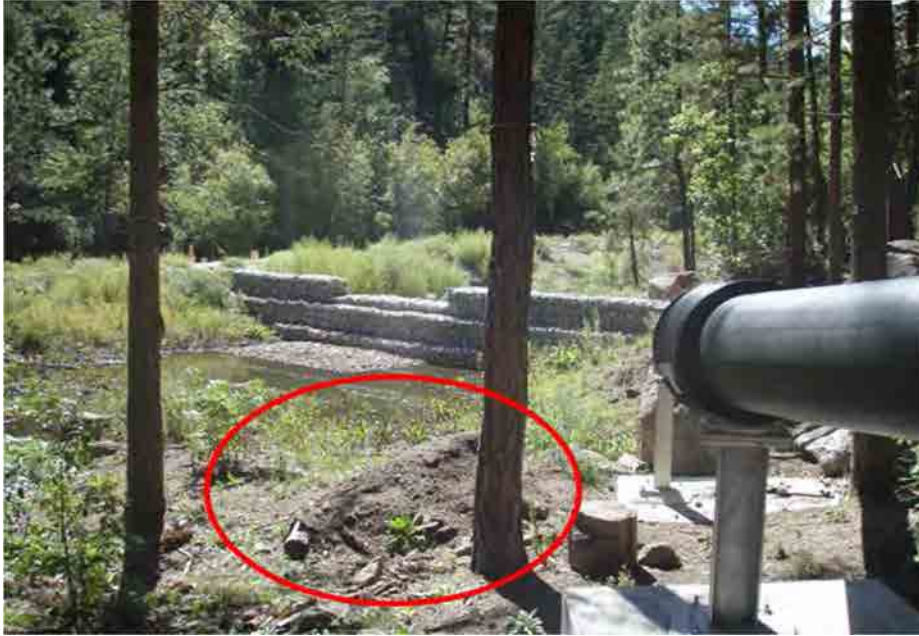
**Photo C-3.20-2** Sept 2016 — Construction spoils circled in red. Recommend removal of spoils.

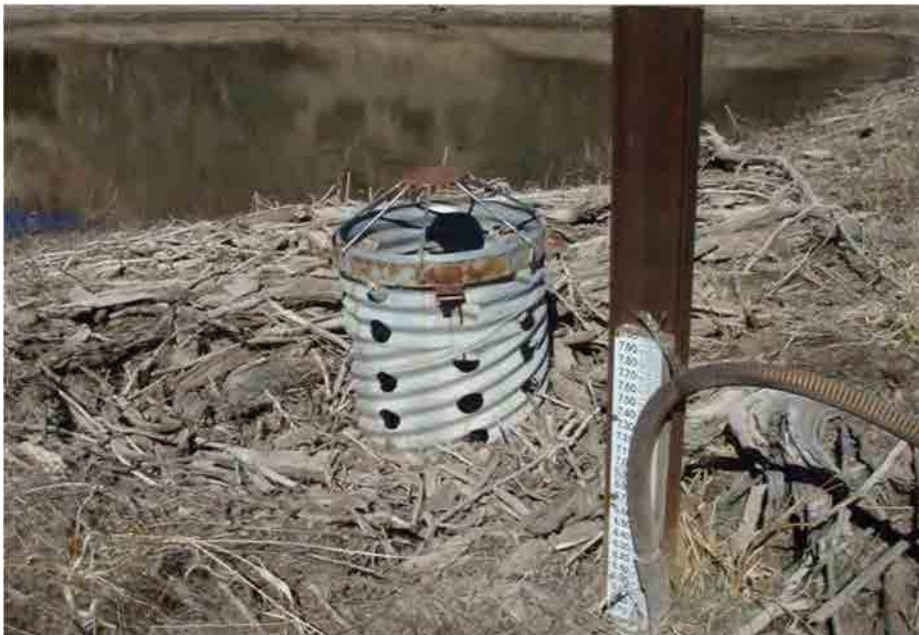
**Photo C-4.1-1** March 2016 — Standpipe is unobstructed for top four holes, five holes buried. Staff gage reads 5.7 ft.

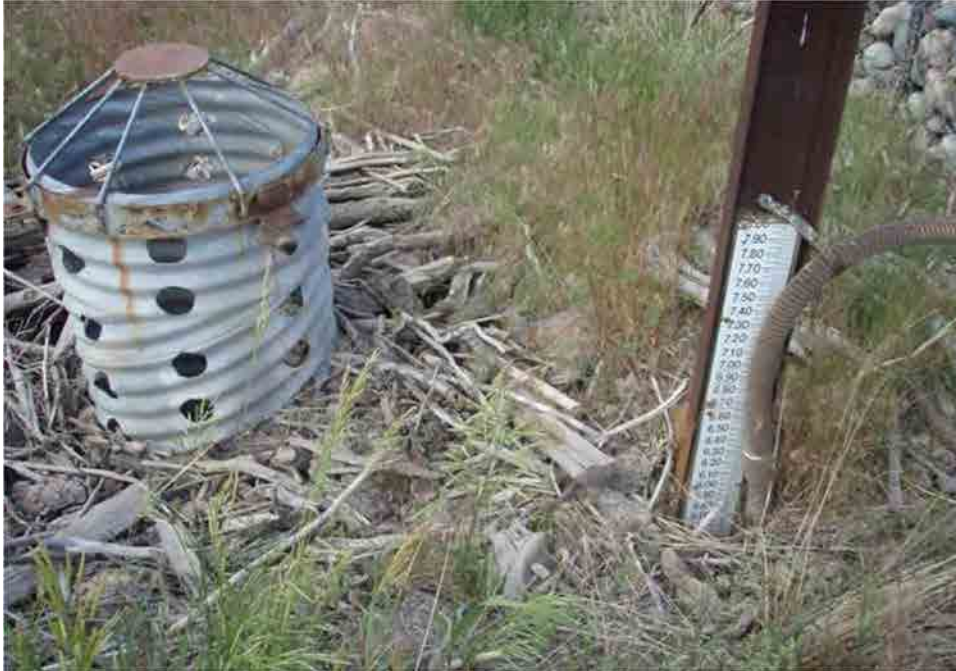
**Photo C-4.1-2** June 2016 — Standpipe is unobstructed for top four holes. Staff gage reads 5.7 ft.

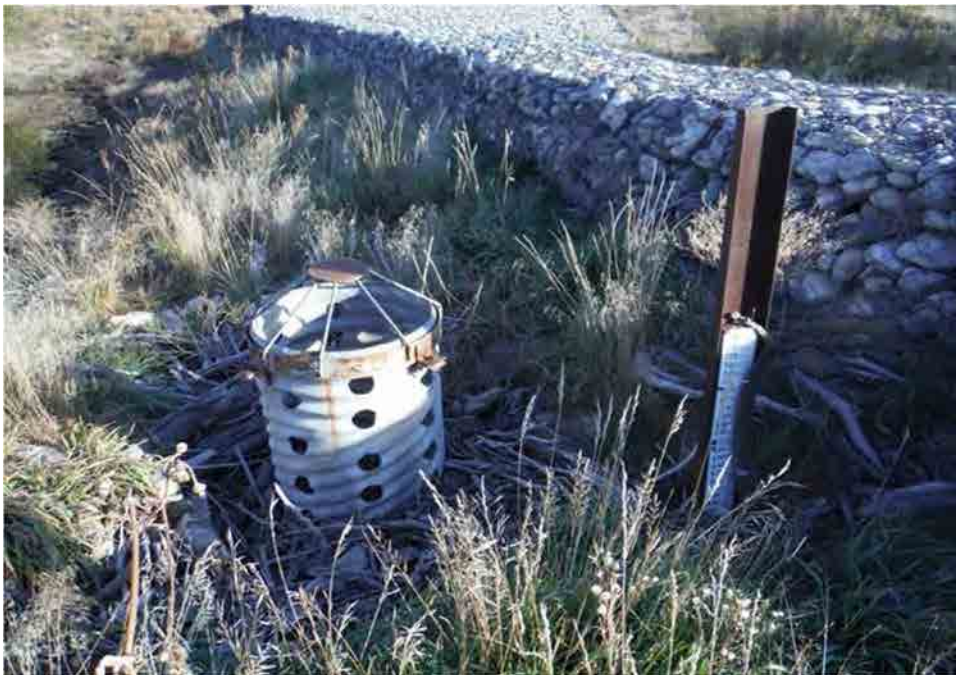
**Photo C-4.1-3** Oct 2016 — Standpipe is unobstructed for top four holes. Staff gage reads 5.8 ft. Note: Though piping could be discouraged by clearing debris from around the standpipe, the New Mexico Environment Department wants all water upstream of the weir to filter through the gabions.

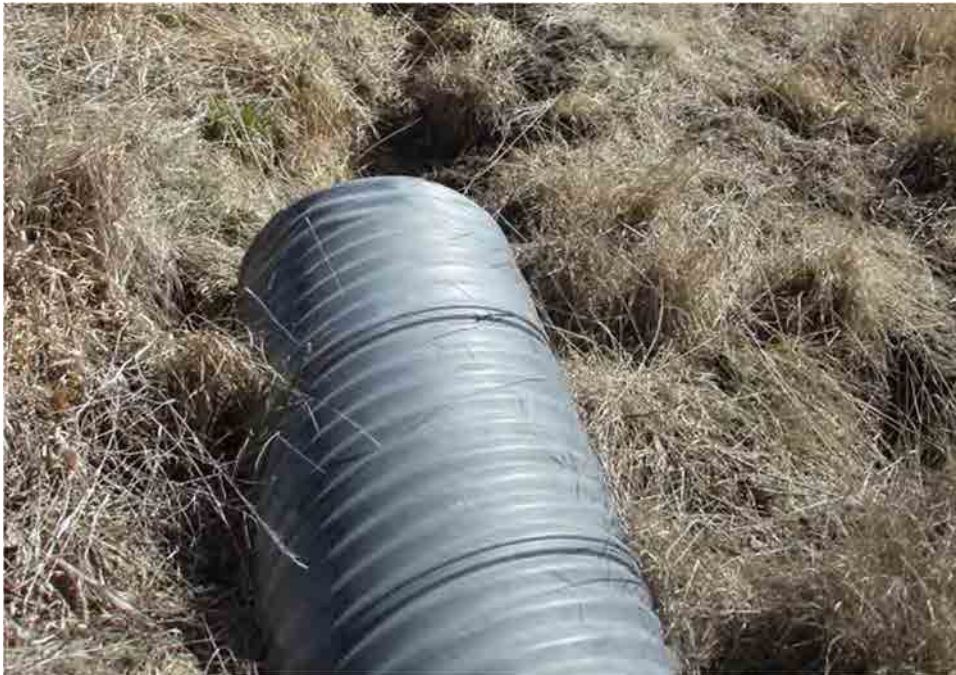
**Photo C-4.2-1 March 2016 — Outlet pipe shows evidence of erosion. Recommend monitoring.**

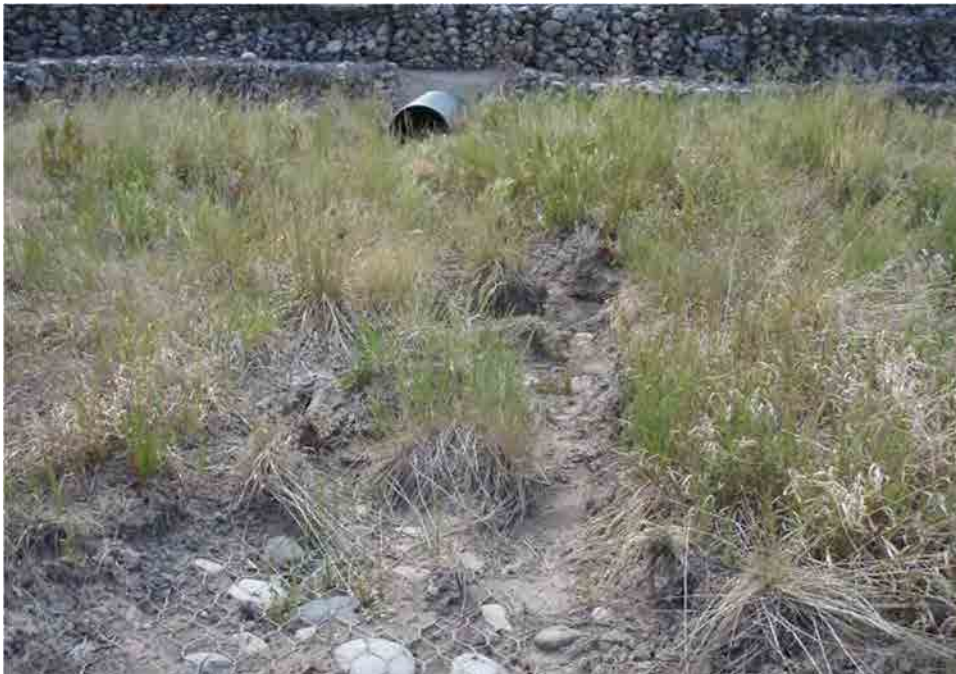
**Photo C-4.2-2 June 2016 — Downstream side of outlet pipe shows evidence of erosion. Recommend monitoring.**

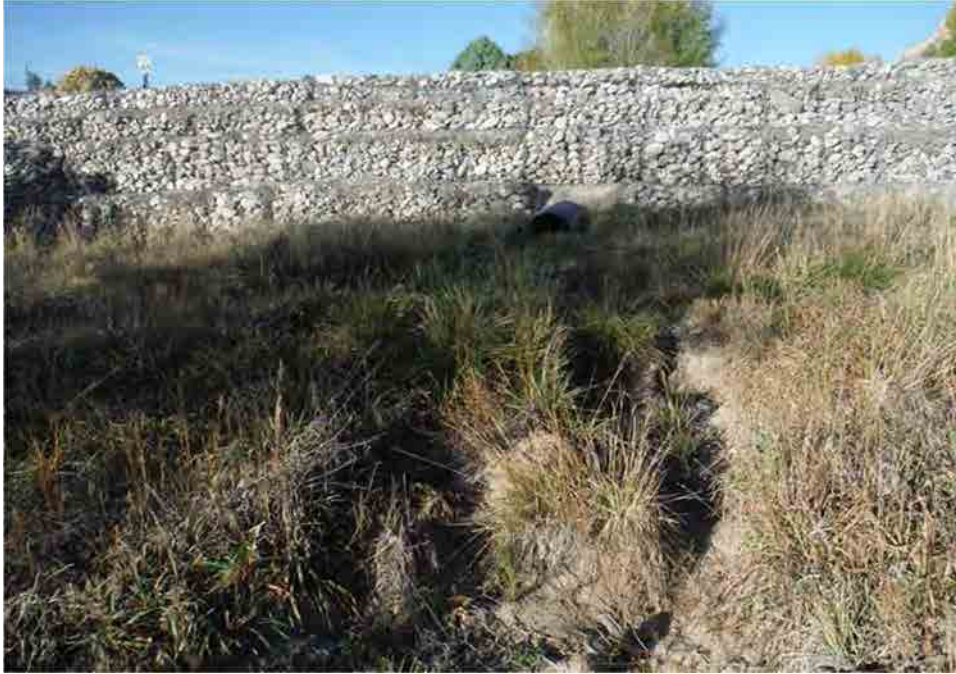
**Photo C-4.2-3** Oct 2016 — Downstream side of outlet pipe shows signs of erosion. Recommend monitoring.

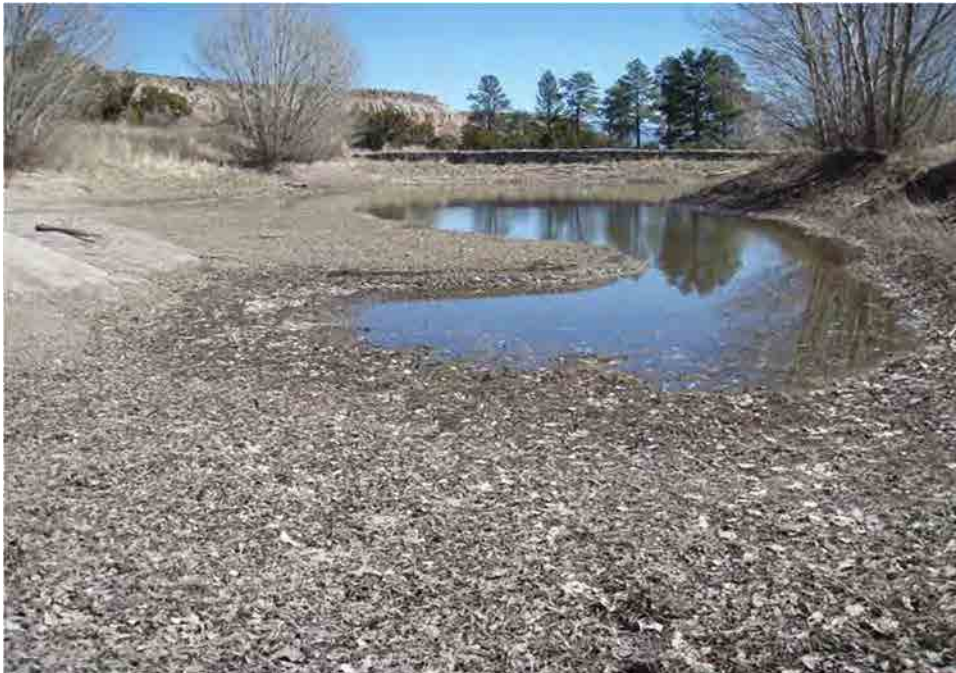
**Photo C-4.3-1** March 2016 — Lower pond filled with estimated 2–3 ft of standing water.

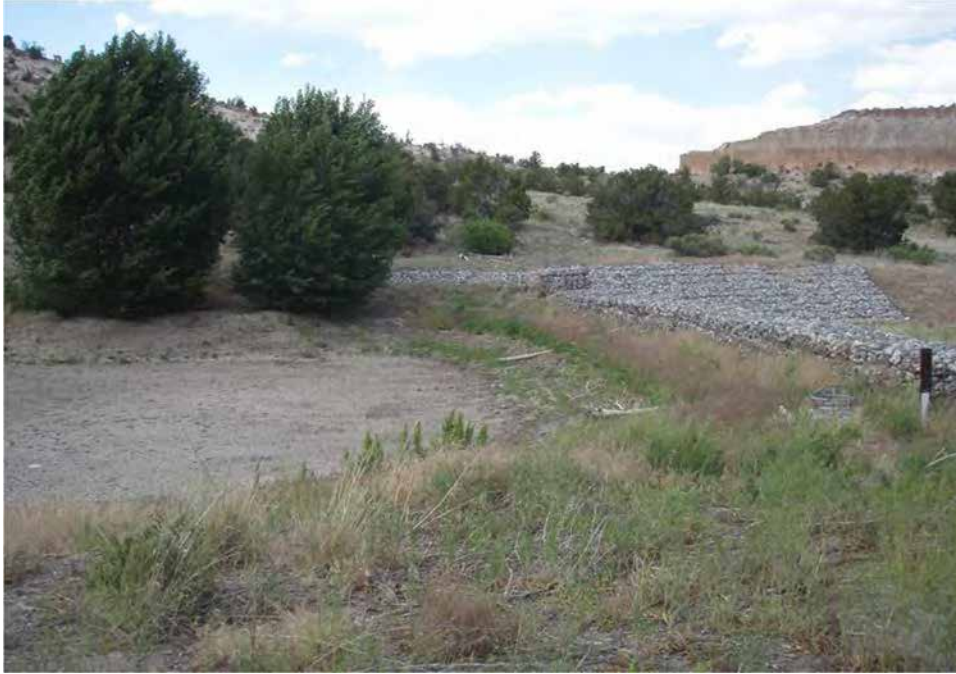
**Photo C-4.3-2 June 2016 — Lower pond with estimated 5–6 ft of sediment below top of spillway.**

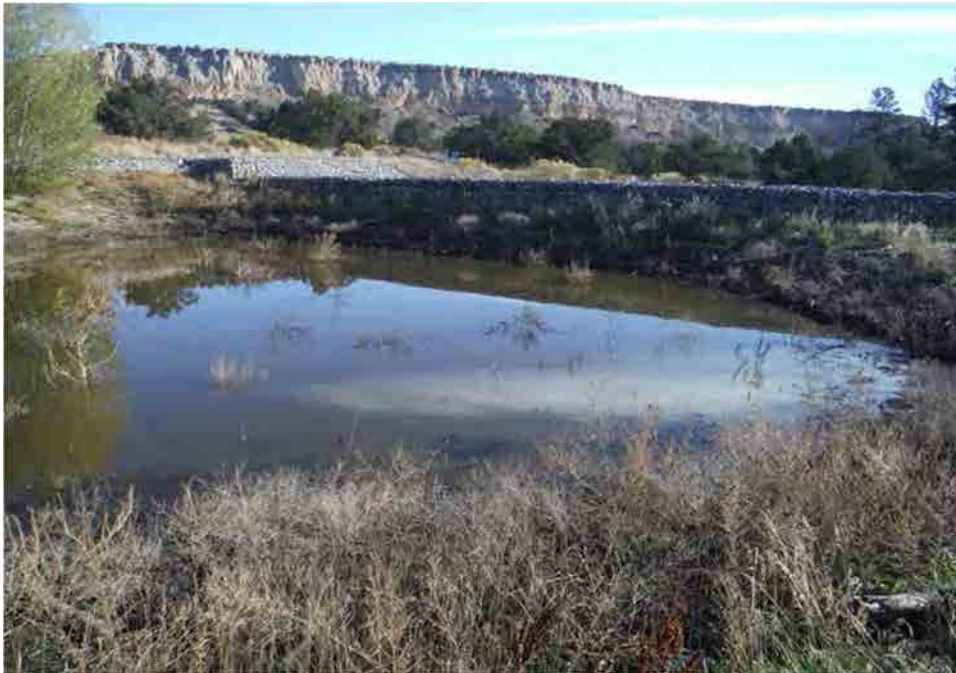
**Photo C-4.3-3 Oct 2016 — Lower pond with estimated 5–6 ft of standing water below top of spillway.**

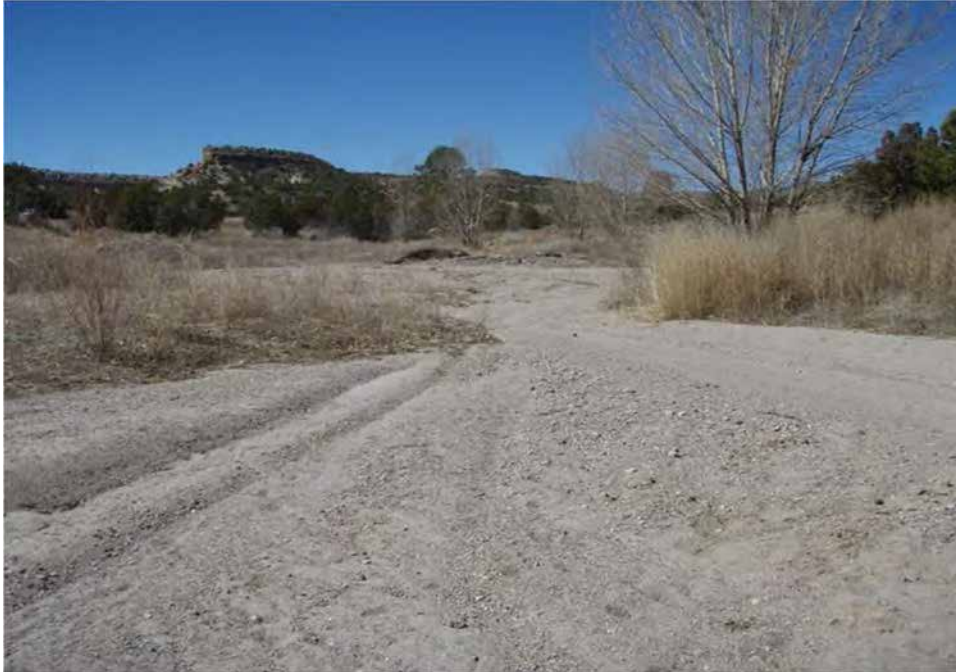
**Photo C-4.4-1 March 2016 — Sediment levels at middle and upper ponds at unknown depth.**

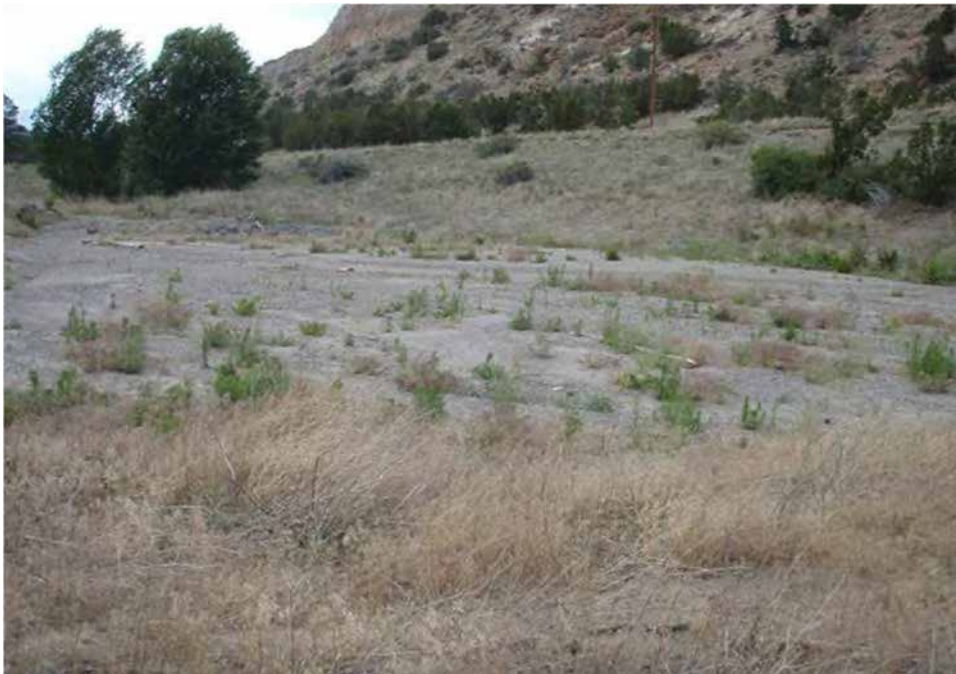
**Photo C-4.4-2 June 2016 — Sediment levels in middle and upper ponds at unknown depth. Consistent with previous inspection.**

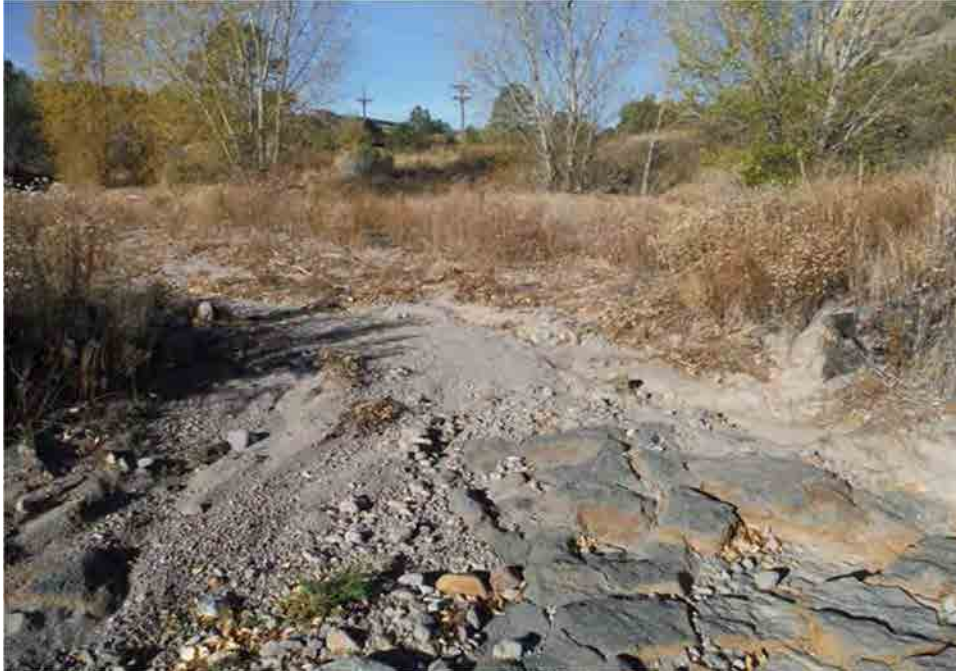
**Photo C-4.4-3 Oct 2016 — Sediment levels consistent with previous inspection.**

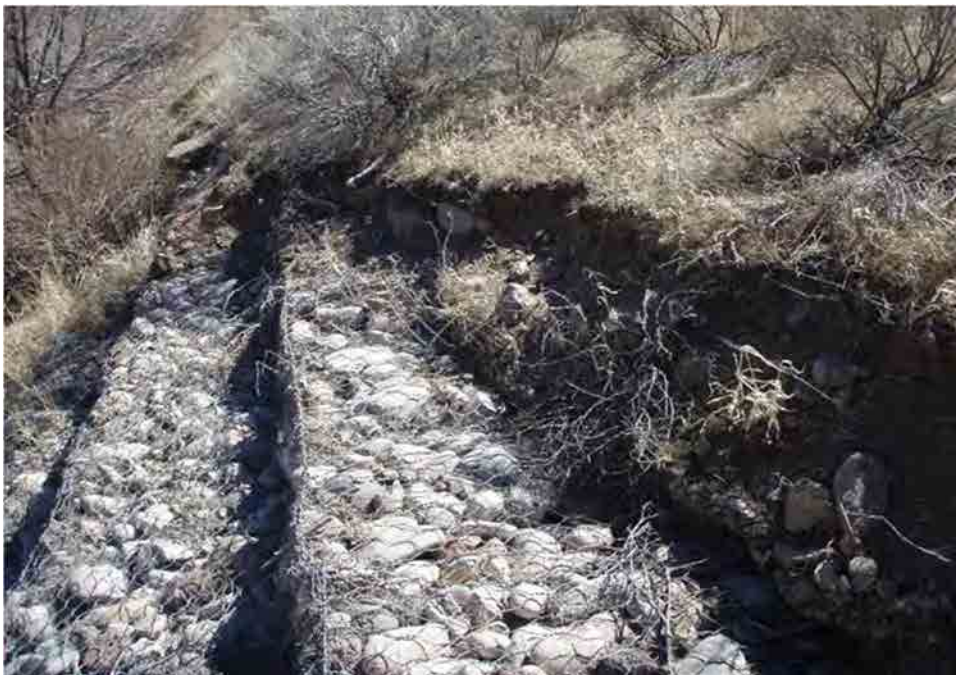
**Photo C-4.5-1 March 2016 — Downstream embankments with erosion under former erosion-control blanket (ECB). Erosion could be creeping toward New Mexico Department of Transportation (NMDOT) right of way (ROW).**
