**Subject: 2016 Monitoring Report for Los Alamos/Pueblo Watershed Sediment Transport Mitigation Project**

April 2017

EP2017-0042

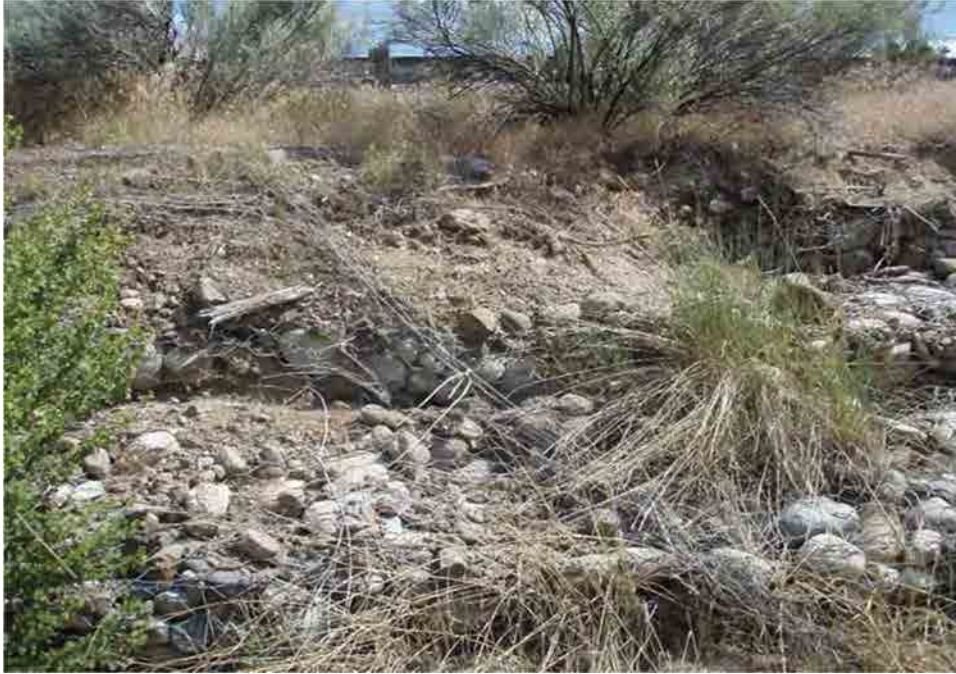
**Photo C-4.5-2 June 2016 — Southside of embankment shows erosion approaching NMDOT ROW.**

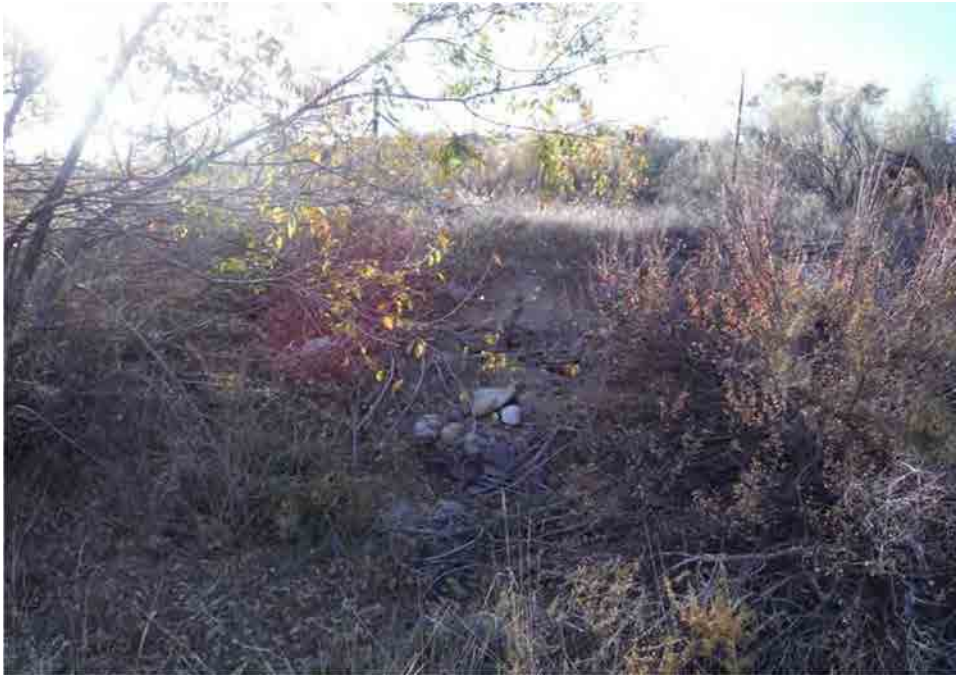
**Photo C-4.5-3 Q4 — South bank continues to show erosion.**

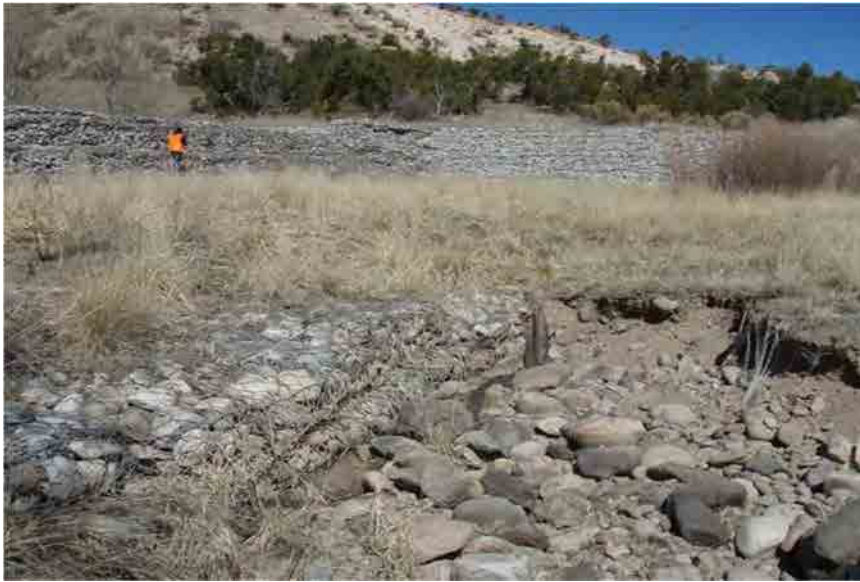
**Photo C-4.6-1 March 2016 — Downstream end of gabion basket shows minor erosion and undercutting. Recommend monitoring.**

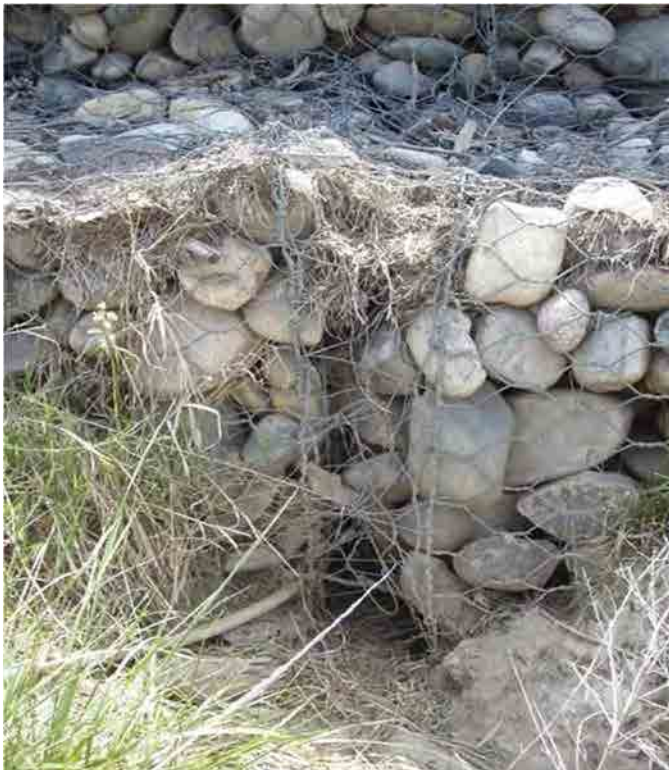
**Photo C-4.6-2 June 2016 — Gabion baskets on stream face of weir appear to have undercutting with erosion immediately downstream. Recommend monitoring.**

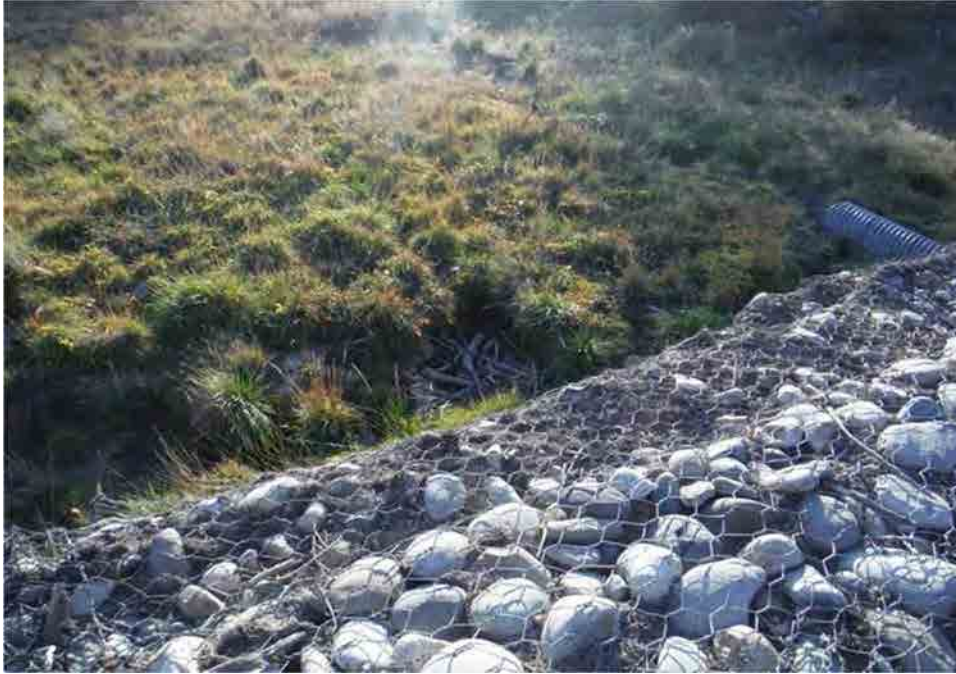
**Photo C-4.6-3** Oct 2016 — Gabion baskets show undercutting and erosion immediately downstream. Conditions similar to previous inspections. Recommend monitoring.

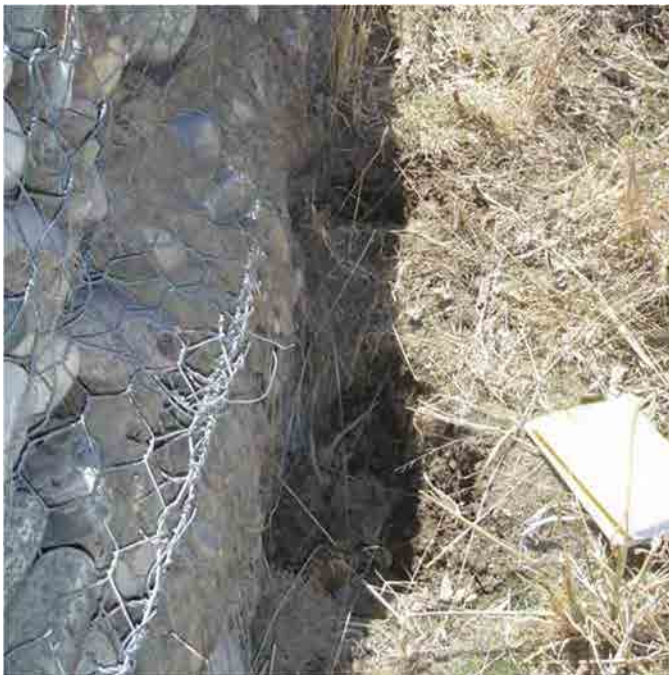
**Photo C-4.7-1** March 2016 — Piping on upstream side of weir consistent with previous inspection. Recommend monitoring.

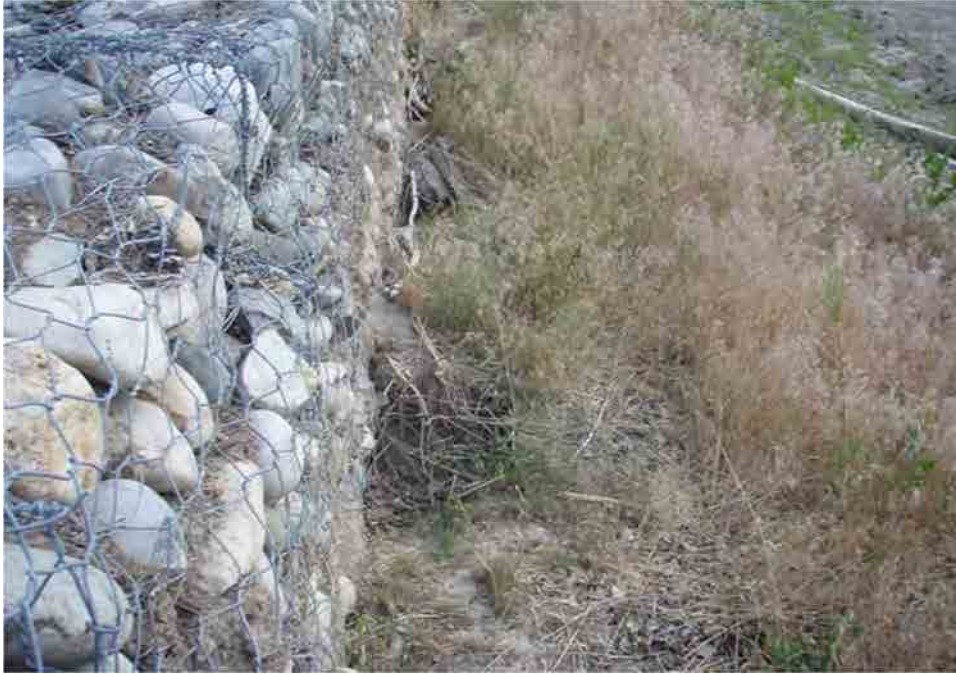
**Photo C-4.7-2** June 2016 — Piping erosion consistent with previous inspections. Recommend monitoring.

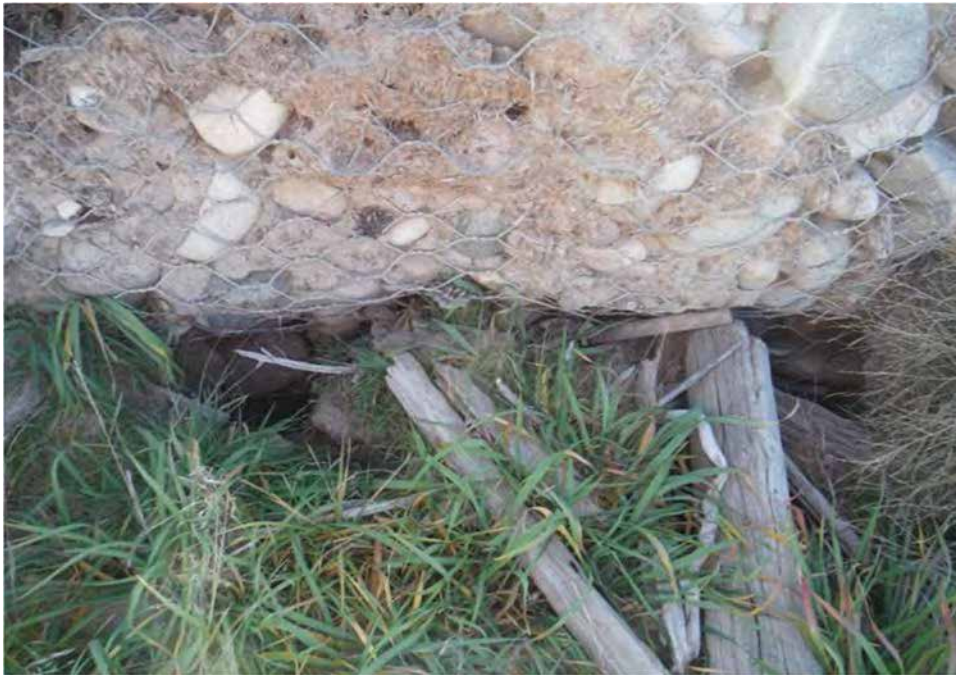
**Photo C-4.7-3** Oct 2016 — Occurrences of piping have increased since last inspection. Piping appears to be occurring above the bottom of the weir's lowest level of gabion baskets and mattresses. Estimated 11 locations of piping along the weir. Large voids in gabions could allow fine sediment transport downstream. Recommend monitoring.

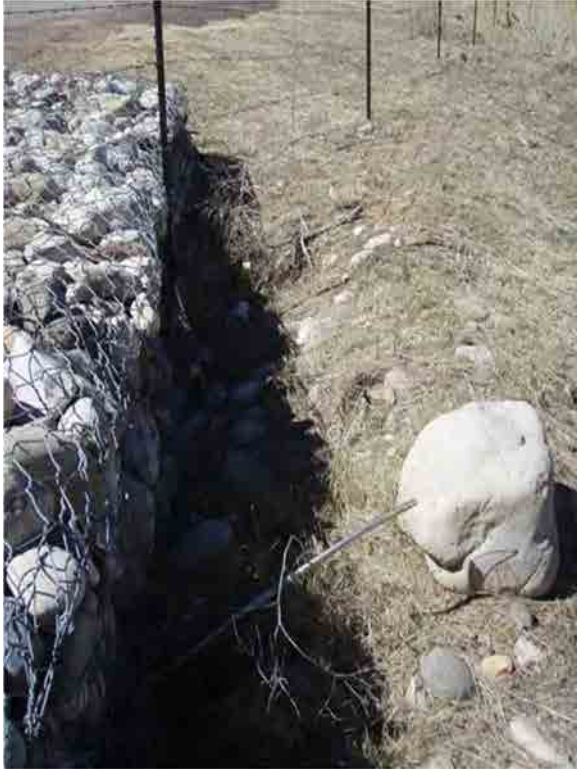
**Photo C-4.8-1 March 2016 — Preferential flow path developing on upstream south embankment near the fence. Recommend monitoring.**

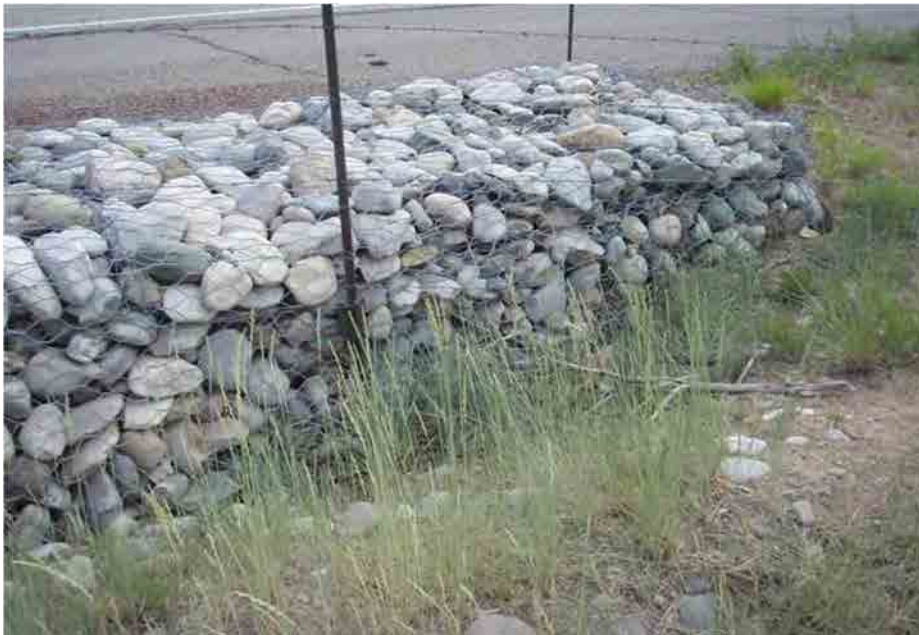
**Photo C-4.8-2 June 2016 — Preferential flow path continuing to develop on upstream south embankment near the fence.**

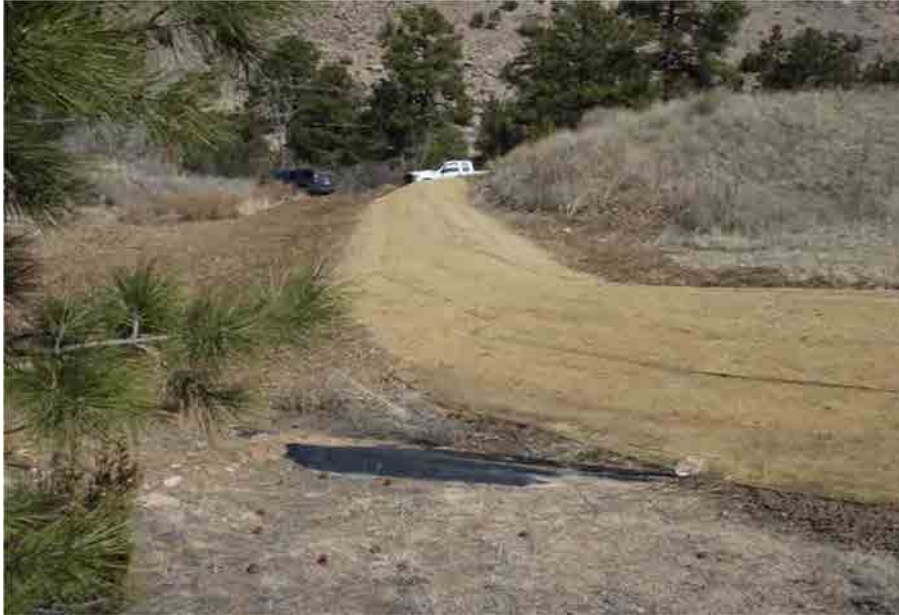
**Photo C-4.9-1** March 2016: Borrow pit runoff control berm looking north. The borrow pit runoff control berm appears to be in good hydrologic condition and is functioning correctly to reduce runoff and sediment migration from the area. Recommend monitoring.

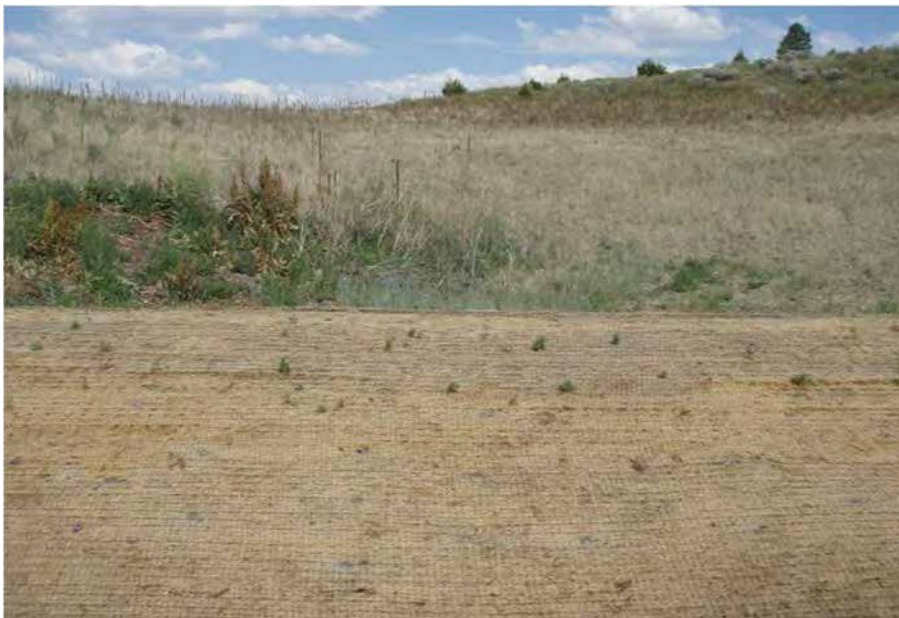
**Photo C-4.9-2** June 2016 — Borrow pit runoff control in good condition and is functioning correctly. Recommend monitoring.

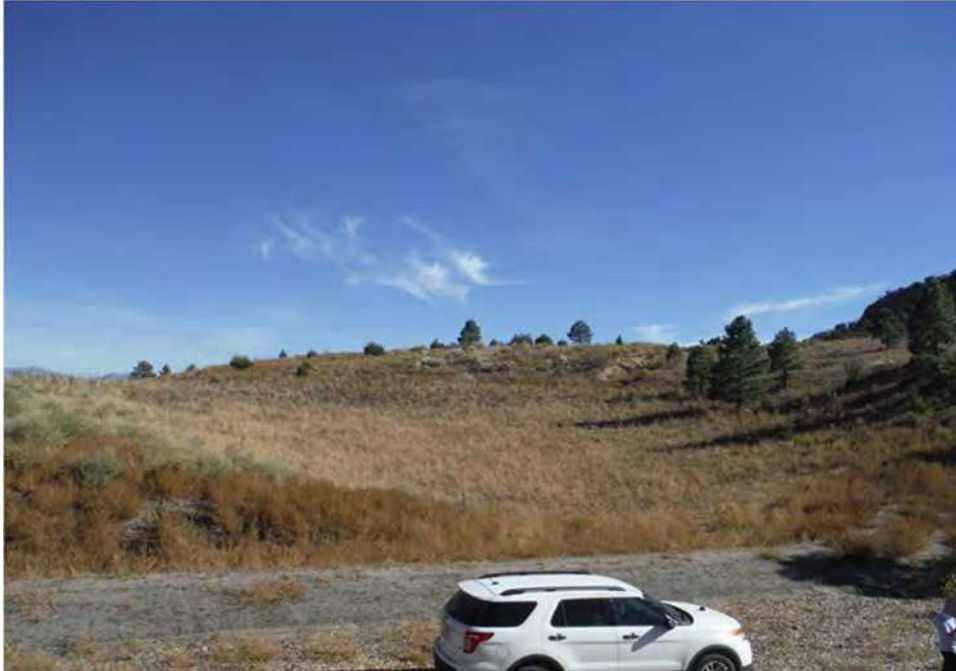
**Photo C-4.9-3** Oct 2016 — Borrow pit runoff control in good condition. Recommend monitoring.

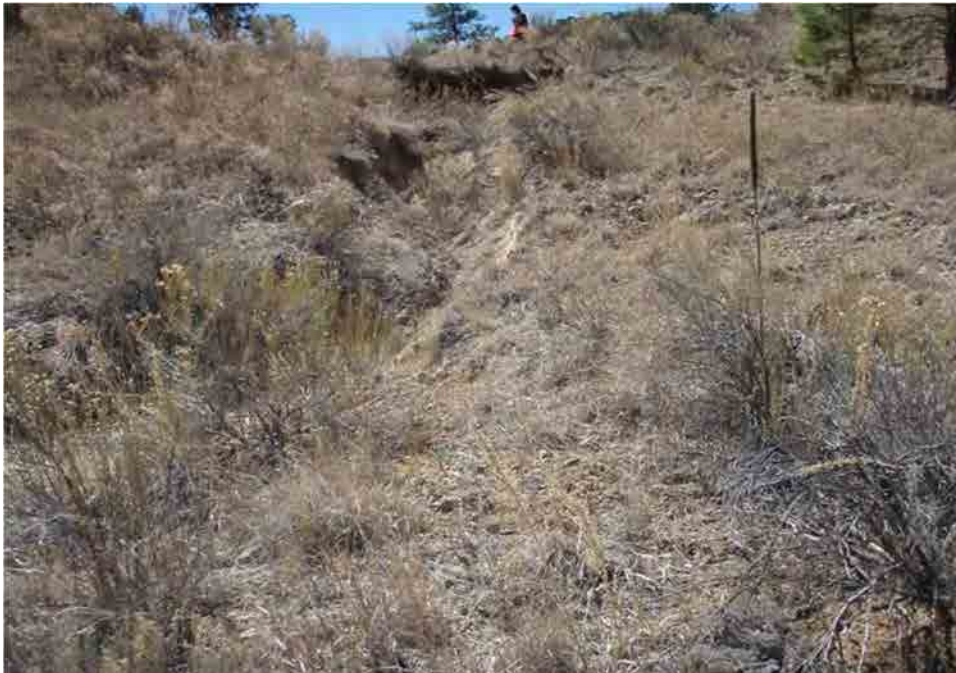
**Photo C-4.10-1** March 2016 — Erosion feature located outside of borrow pit sediment storage area to the west. Recommend monitoring.

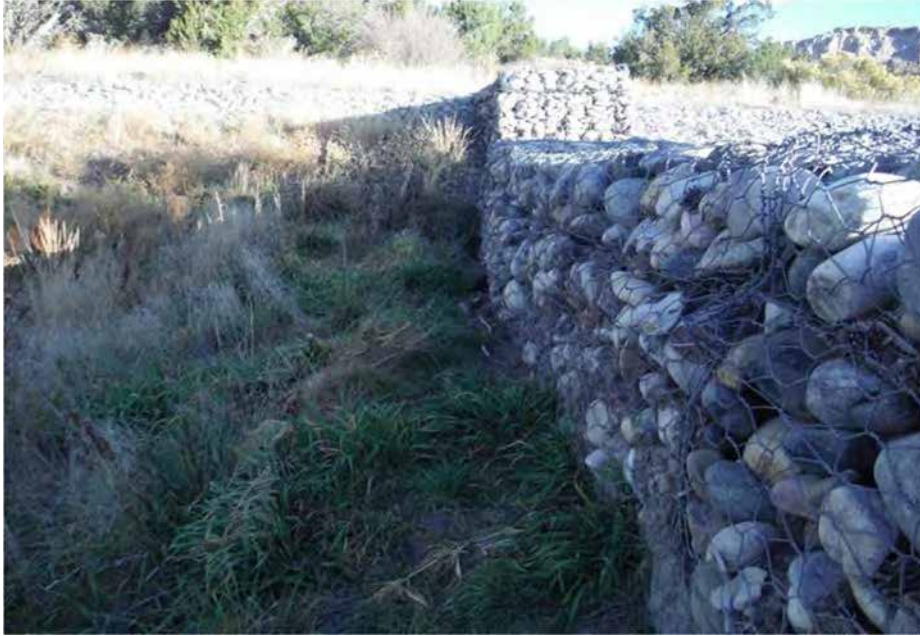
**Photo C-4.10-2** Oct 2016 — Bulging gabion baskets found near areas with piping. Recommend monitoring.

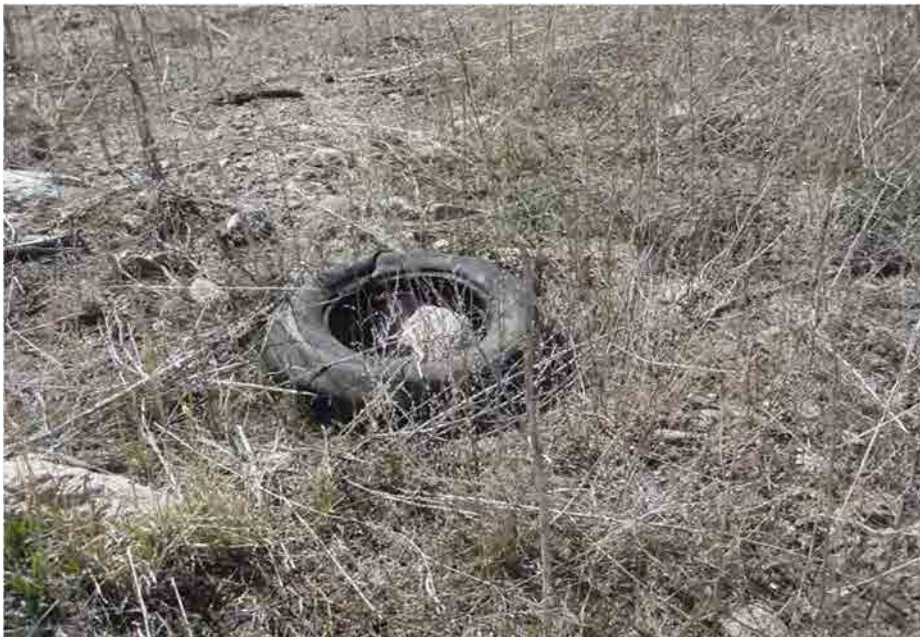
**Photo C-5.1-1** March 2016 — Tire in channel upstream of flow way. Recommend removal of tire.

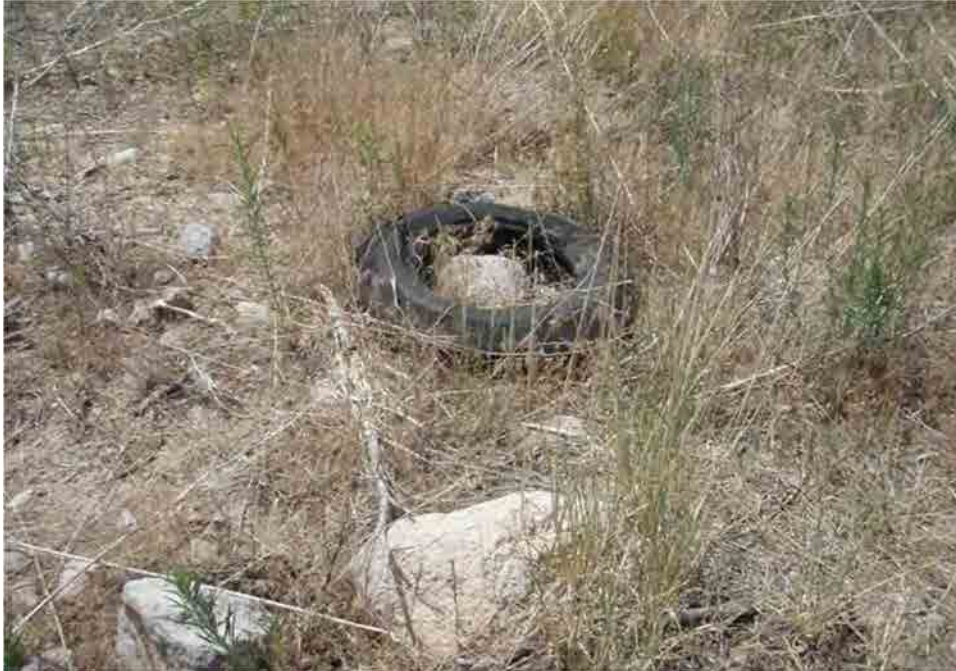
**Photo C-5.1-2 June 2016 — Tire present in channel upstream of flow way. Recommend removal of tire.**

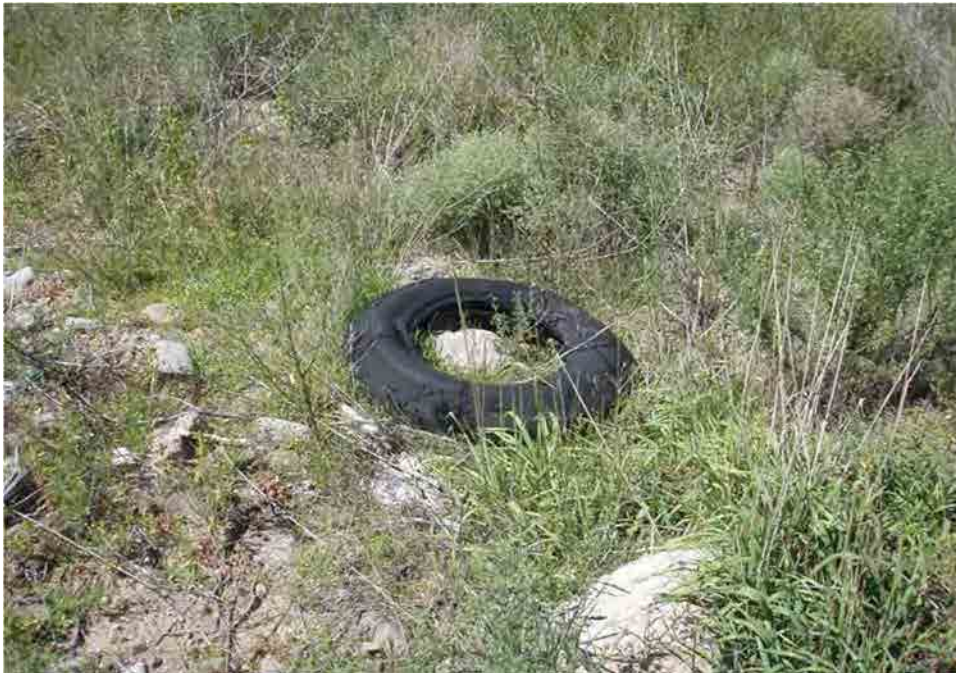
**Photo C-5.1-3 Sept 2016 — Tire present in channel upstream of flow way. Recommend removal of tire.**

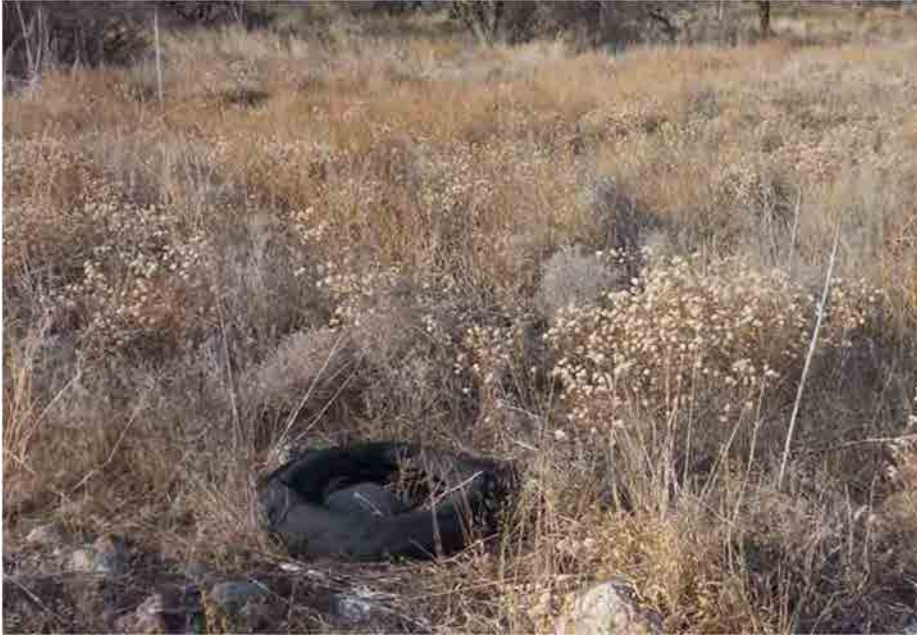
**Photo C-5.1-4** Nov 2016 — Tire present in channel upstream of flow way. Recommend removal of tire.

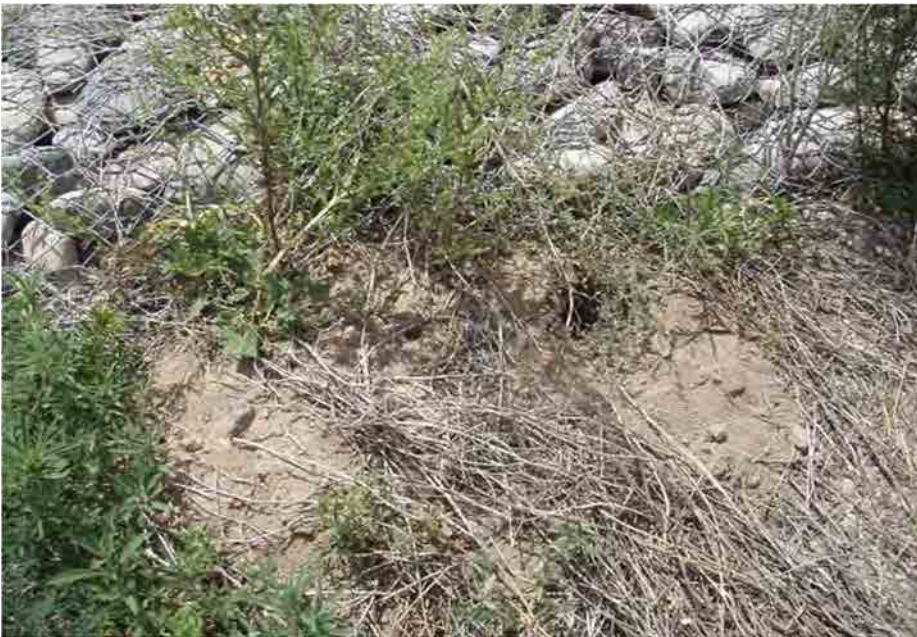
**Photo C-5.2-2** June 2016 — Rodent holes on downstream side of embankments. No change from previous inspection. Recommend monitoring rodent holes.

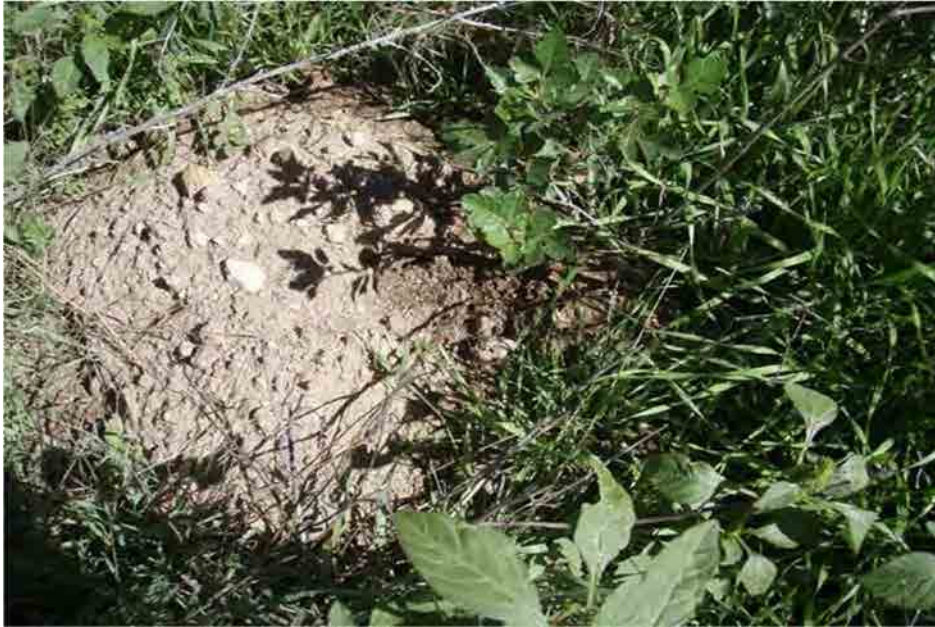
**Photo C-5.2-3** Sept 2016 — Rodent holes consistent with previous inspection. Recommend monitoring rodent holes.

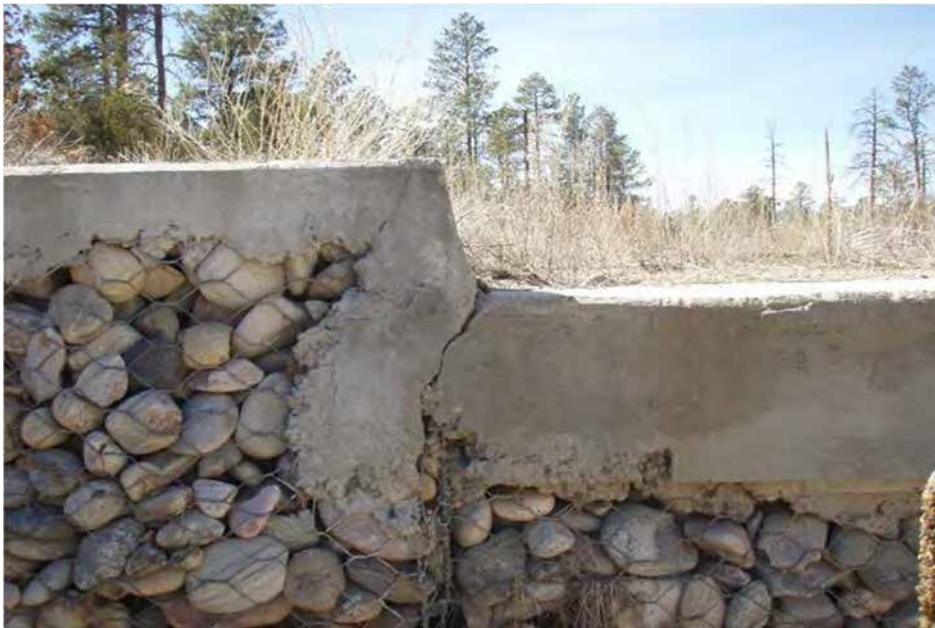
**Photo C-5.3-1** March 2016 — Cracking apparent on joints of spillway. No change from previous inspections. Recommend monitoring.

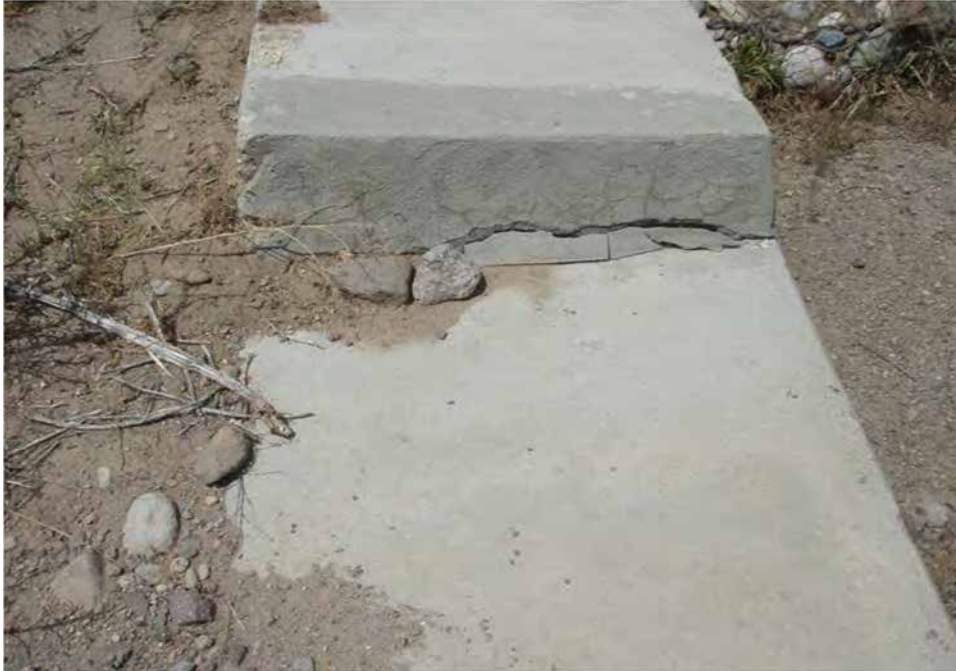
**Photo C-5.3-2 June 2016 — Cracking occurring at the joints on the spillway. No change from previous inspection. Recommend monitoring.**

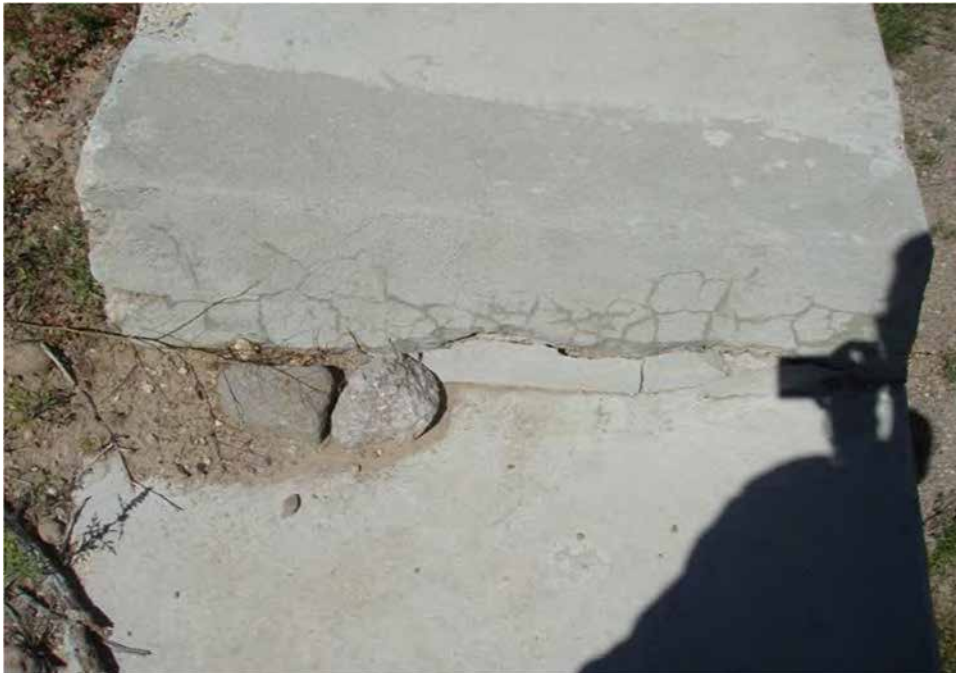
**Photo C-5.3-3 Sept 2016 — Cracking occurring at the joints along the spillway. Consistent with previous inspection. Recommend monitoring.**

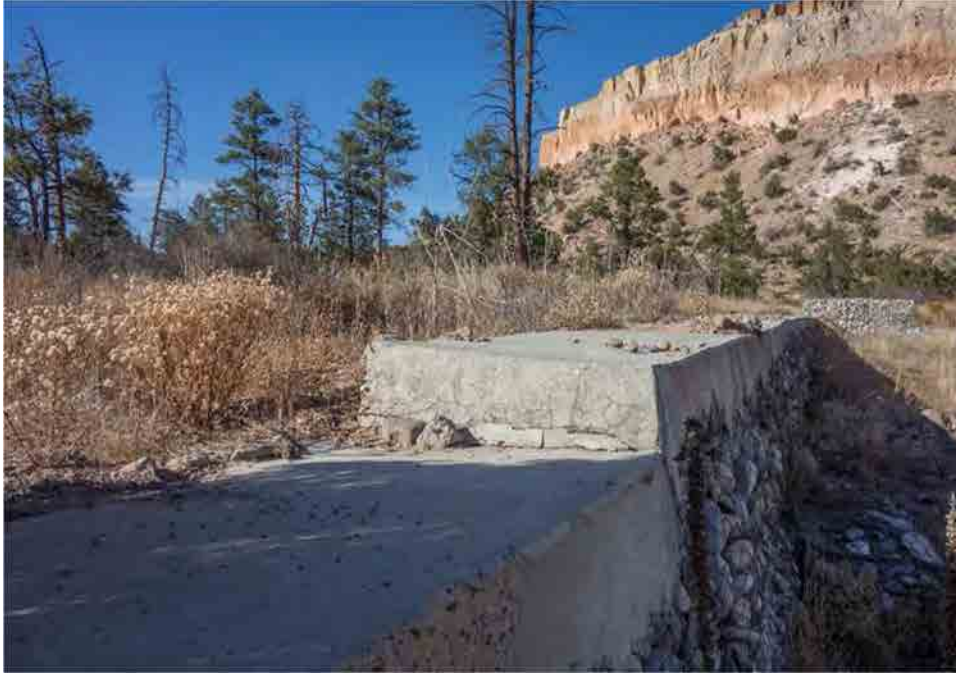
**Photo C-5.3-4** Nov 2016 — Joint cracking consistent with previous inspection. Recommend monitoring.

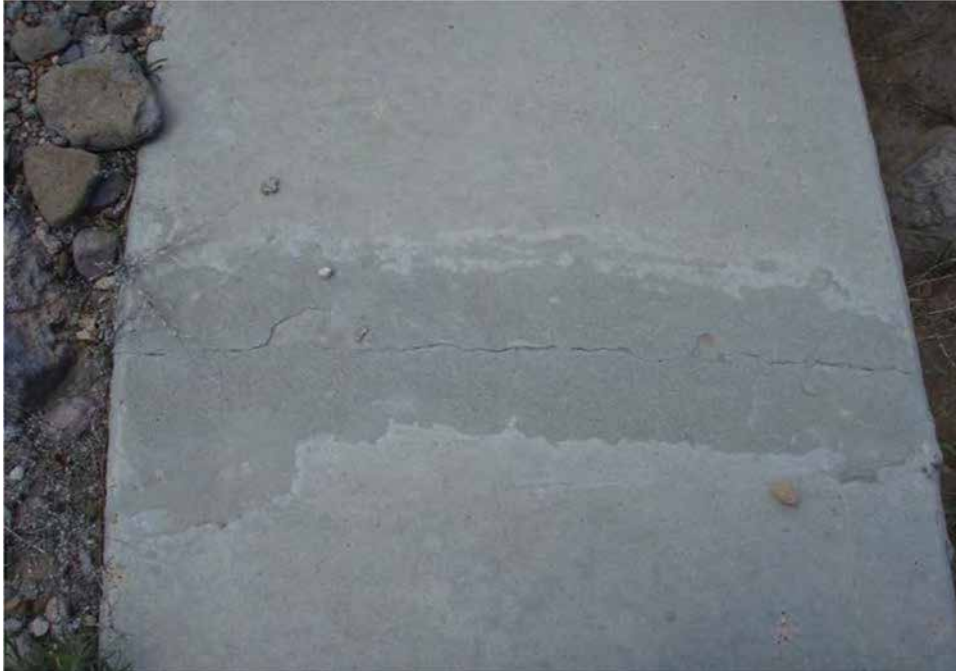
**Photo C-5.4-2** June 2016 — Cracking/spalling occurring across the crest in several locations. One significant crack is present; however, no apparent settlement of the crest is noted. Consistent with previous inspection. Recommend monitoring.

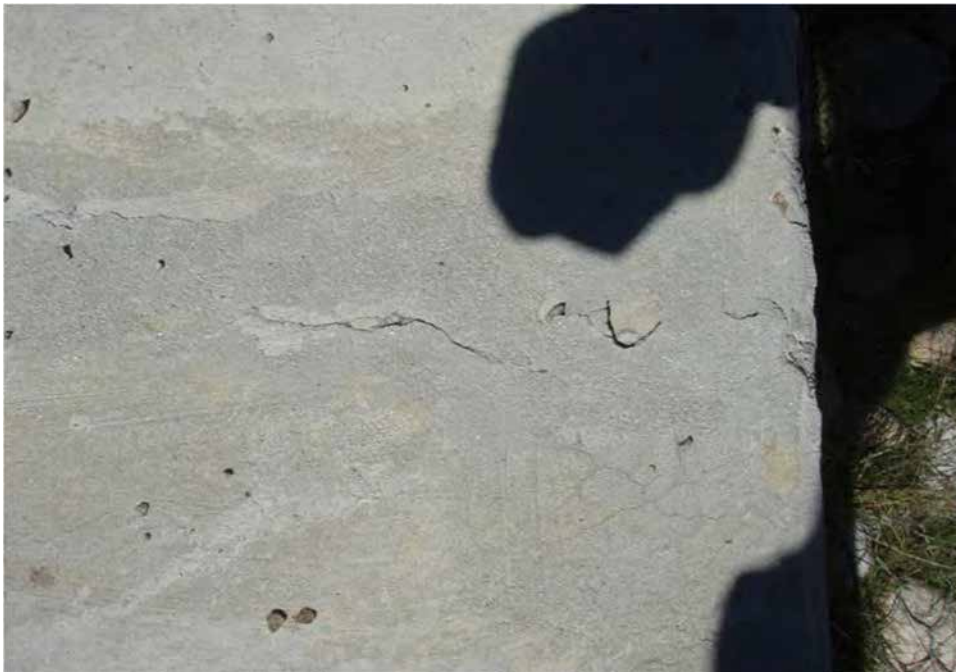
**Photo C-5.4-3** Sept 2016 — Cracking across crest in several locations. Consistent with previous inspection. Recommend monitoring.

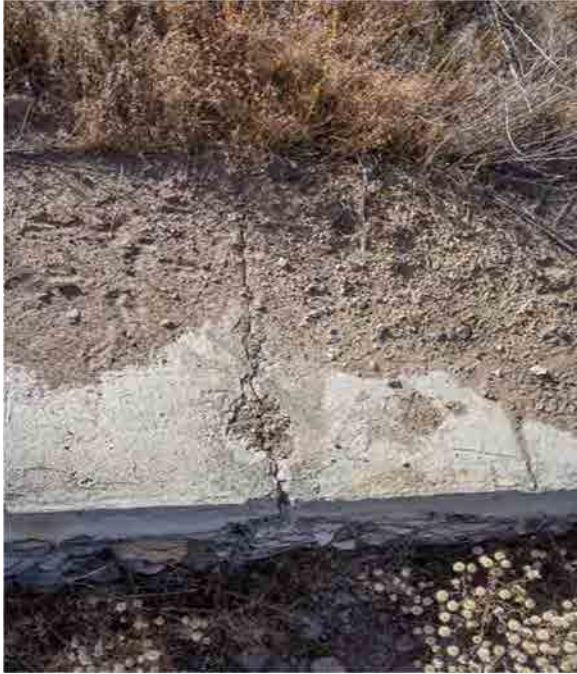
**Photo C-5.4-4** Nov 2016 — Cracking across crest in several locations. Consistent with previous inspection. Recommend monitoring.

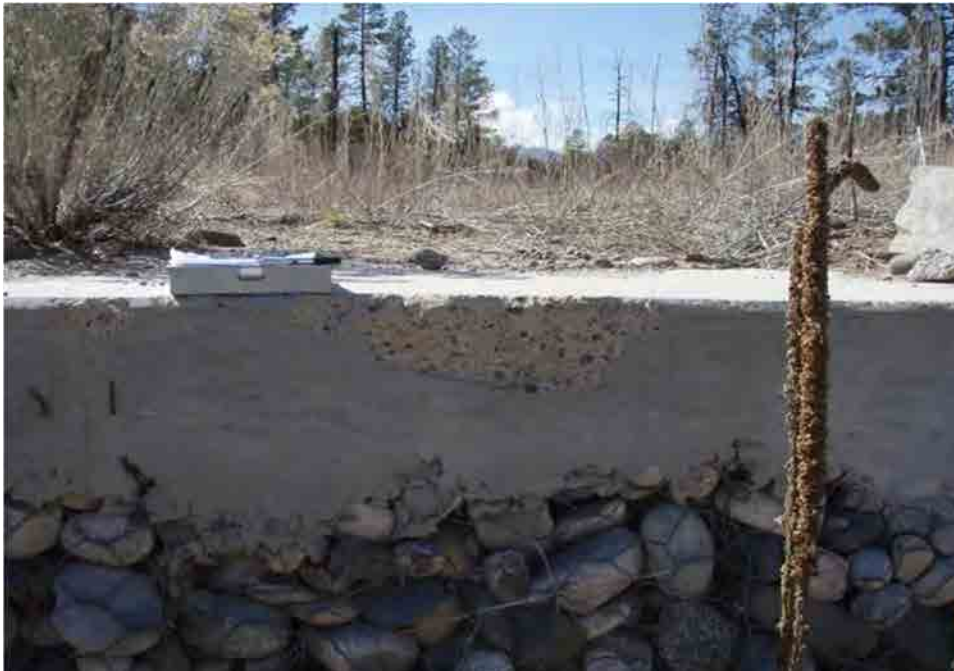
**Photo C-5.5-1** March 2016 — Spalling present on the downstream side of the spillway crest. Recommend monitoring.

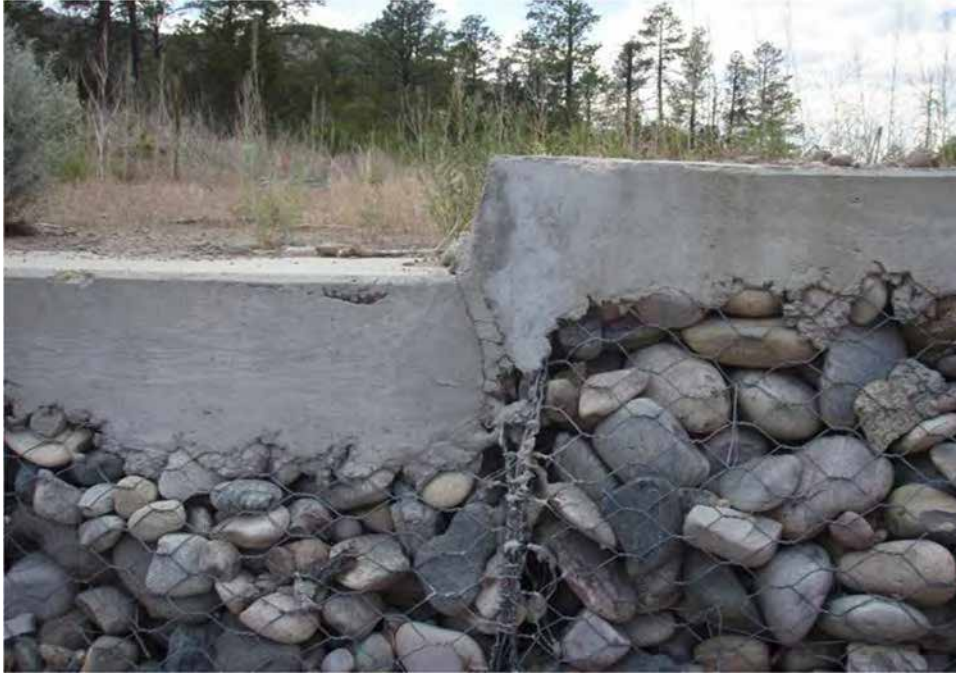
**Photo C-5.5-2** June 2016 — Spalling and cracks present on the downstream side of the spillway crest. Consistent with previous inspection. Recommend monitoring.

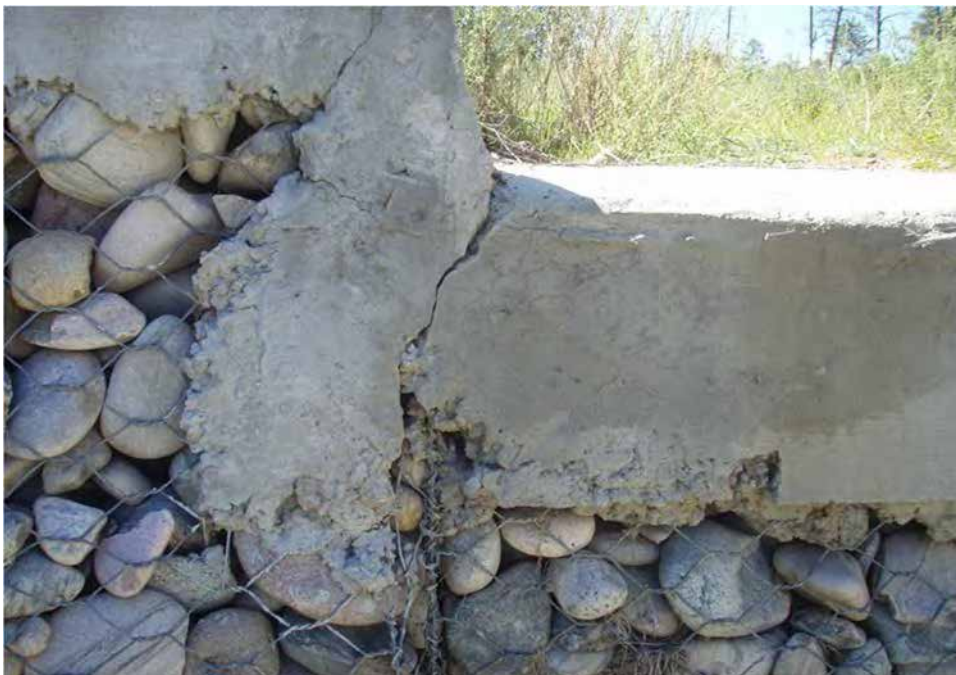
**Photo C-5.5-3** Sept 2016 — Spalling and cracks on the downstream face of the spillway. Consistent with previous inspection. Recommend monitoring.

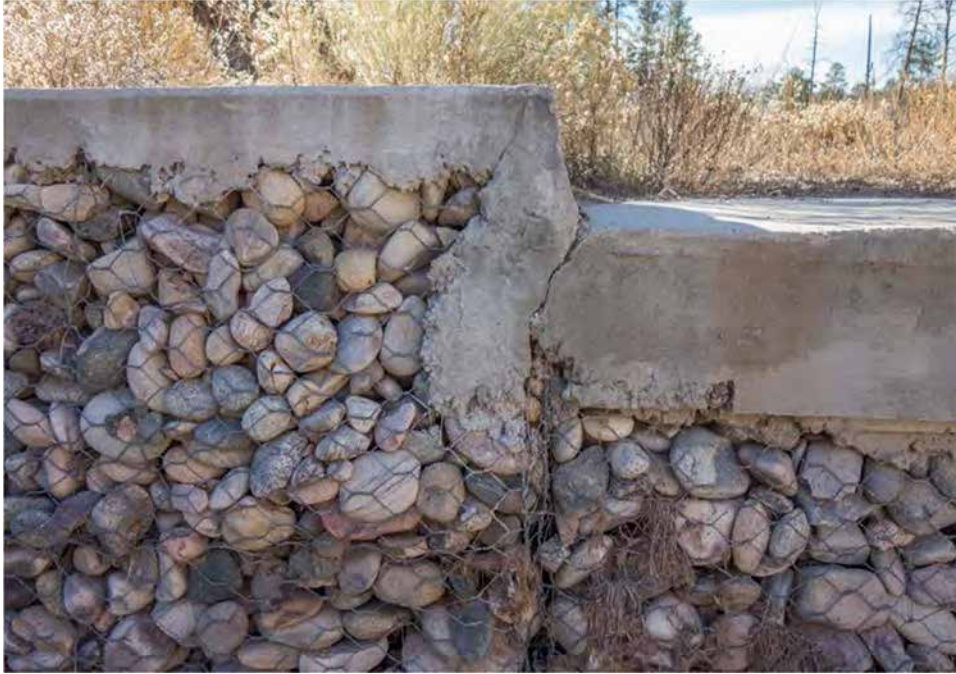
**Photo C-5.5-4** Nov 2016 — Spalling and cracks consistent with previous inspection. Recommend monitoring.

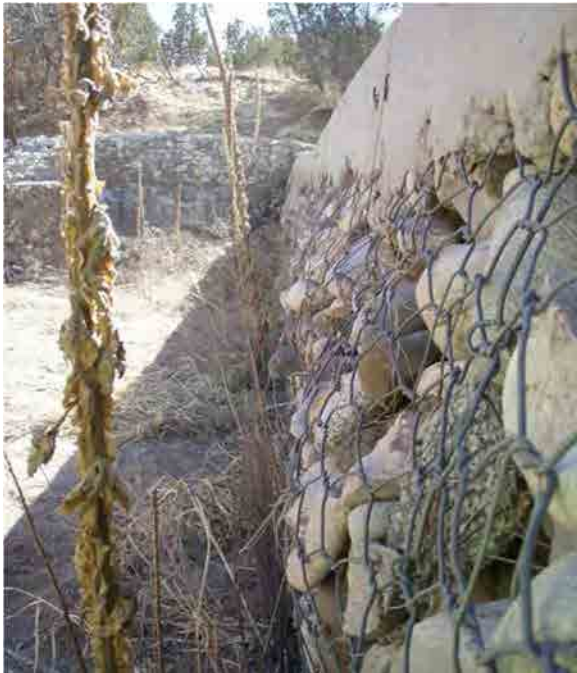
**Photo C-5.6-1** March 2016 — Gabion baskets located adjacent to the overflow catchment are bowing out of alignment. No change from last inspection (Sept 2015). Recommend monitoring.

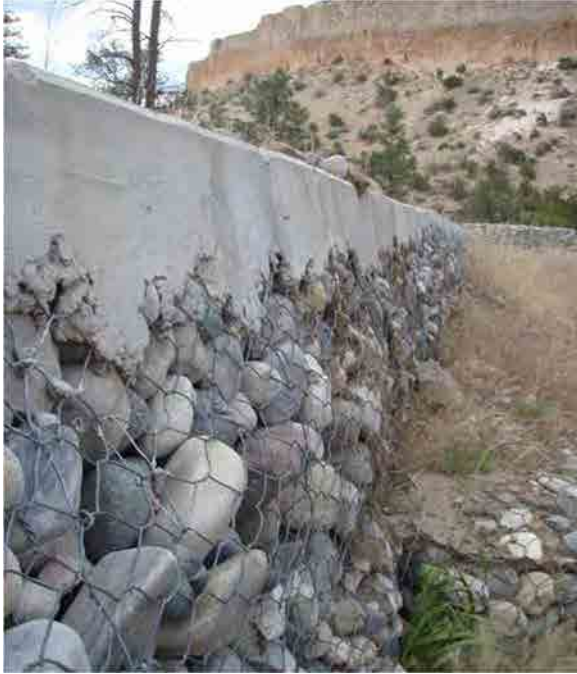
**Photo C-5.6-2 June 2016 — Gabion baskets located adjacent to the overflow catchment are bowing out of alignment. No change from last inspection. Recommend monitoring.**

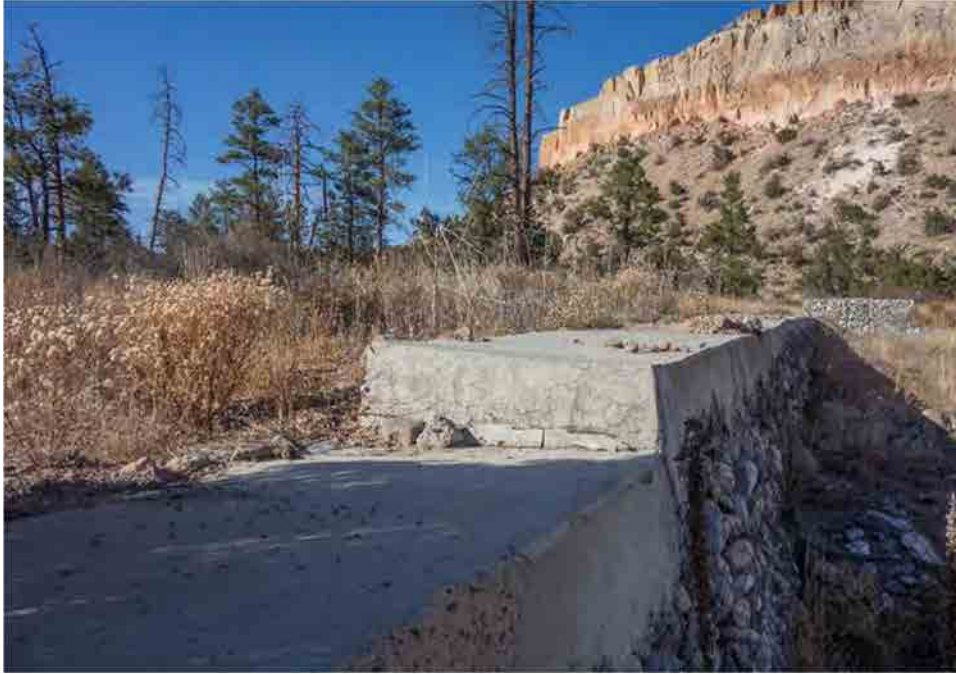
**Photo C-5.6-4** Nov 2016 — Gabion baskets adjacent to overflow catchment are bowing out. Consistent with previous inspection. Recommend monitoring.

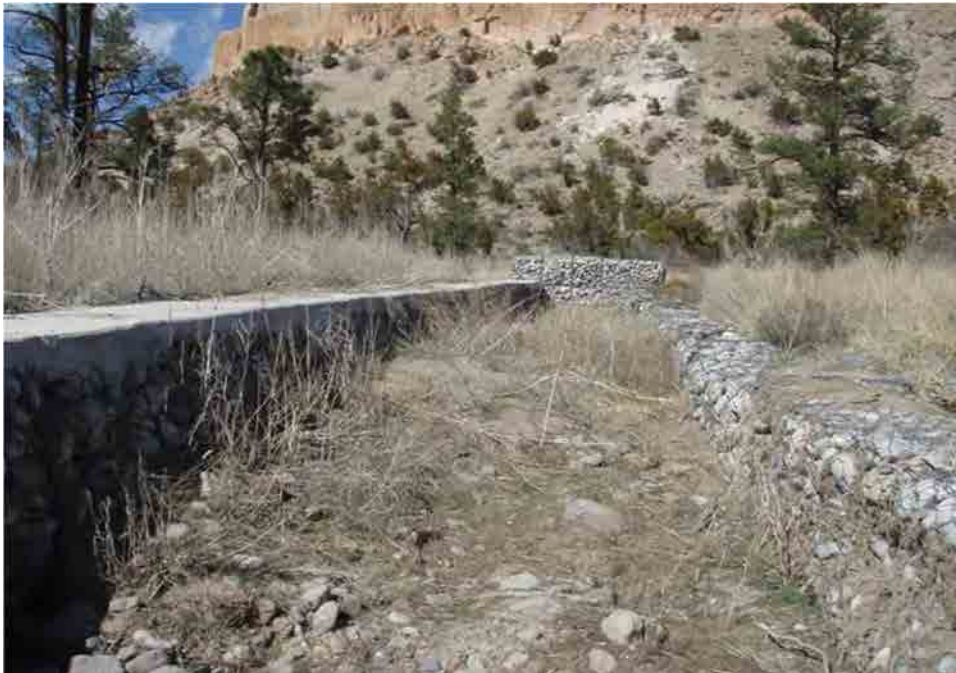
**Photo C-5.7-1** March 2016 — The north side of the flow way has sediment accumulation and evidence of standing water (vegetation). Recommend monitoring.

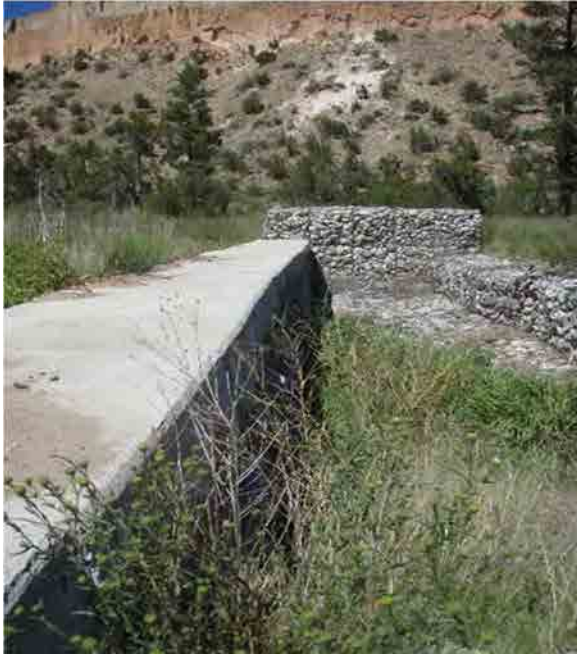
**Photo C-5.7-3    Sept 2016 — Sediment accumulation on downstream side of the spillway. Vegetation exists, which suggests standing water. Recommend monitoring.**
