**Subject: 2016 Monitoring Report for Los Alamos/Pueblo Watershed Sediment Transport Mitigation Project**

April 2017

EP2017-0042

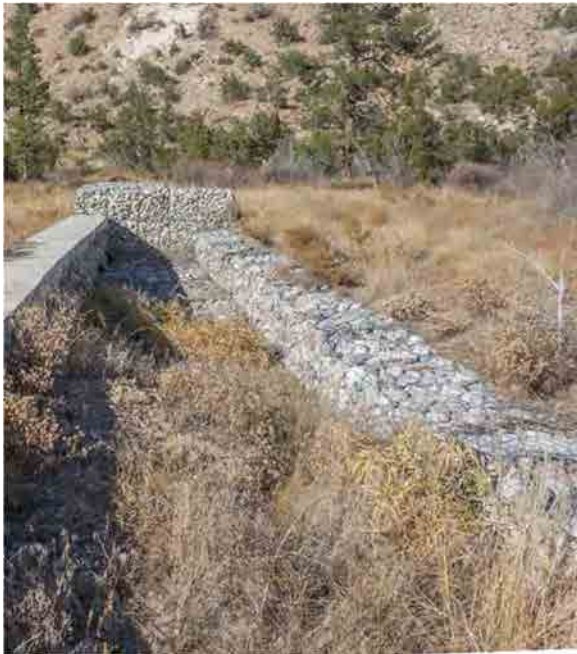
**Photo C-5.7-4    Q4 — Sediment accumulation on downstream side of the spillway. Recommend monitoring.**

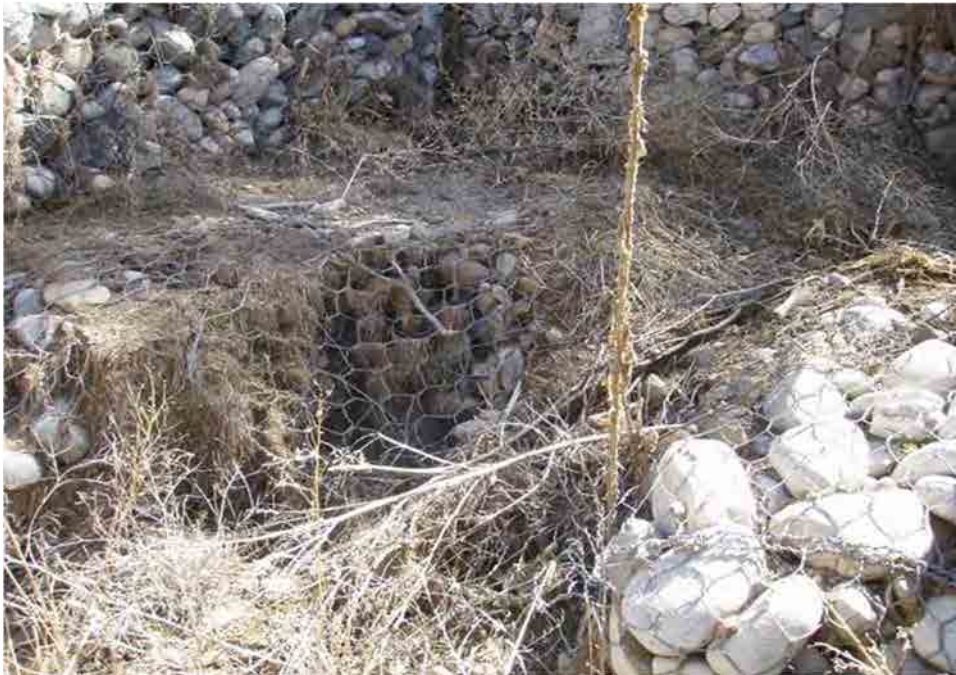
**Photo C-5.8-1 March 2016: Gabion basket (located downstream on the south side of spillway) has deteriorated and no longer contains rock supporting the basket. Condition has not changed since previous two inspections. Recommend monitoring.**

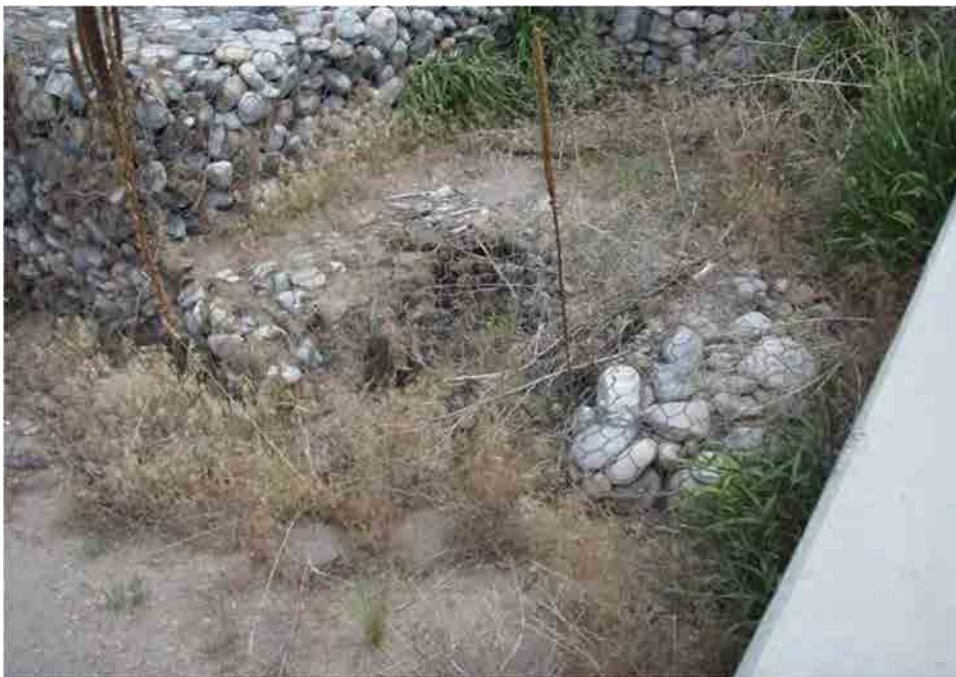
**Photo C-5.8-2 June 2016 — Gabion basket settling and missing rocks. Consistent with previous inspections. Recommend monitoring.**

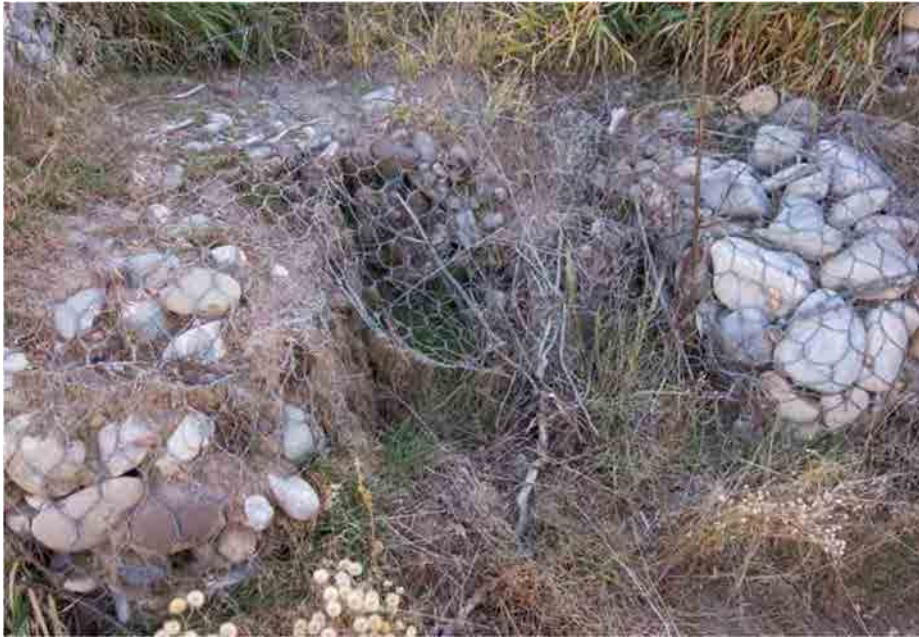
**Photo C-5.8-4    Nov 2016 — Gabion basket on south side of spillway failed and is empty of rock. Recommend maintenance.**

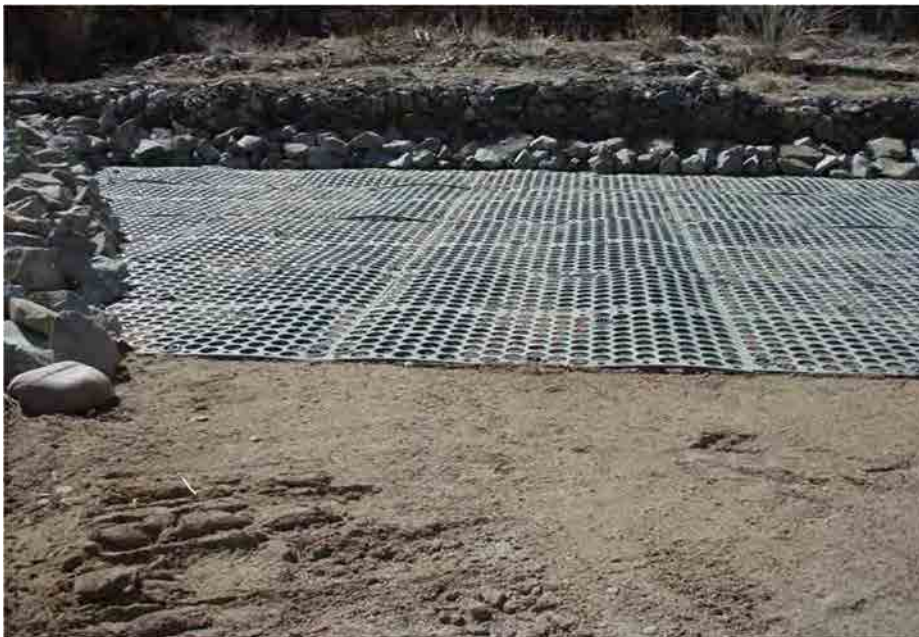
**Photo C-5.9-1    Q1 — ScourStop shows evidence of expansion with some overlap.  
Recommend monitoring.**

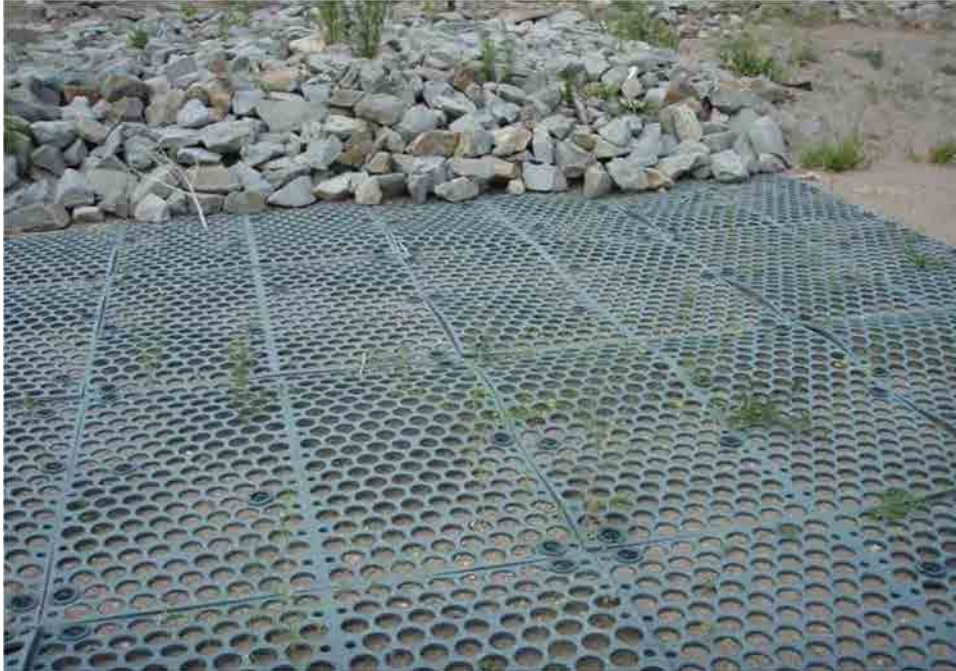
**Photo C-5.9-2** June 2016 — ScourStop shows evidence of expansion with minor vegetative growth. Because of expansion, sheets exhibit some bowing but are still anchored to the ground. Recommend monitoring.

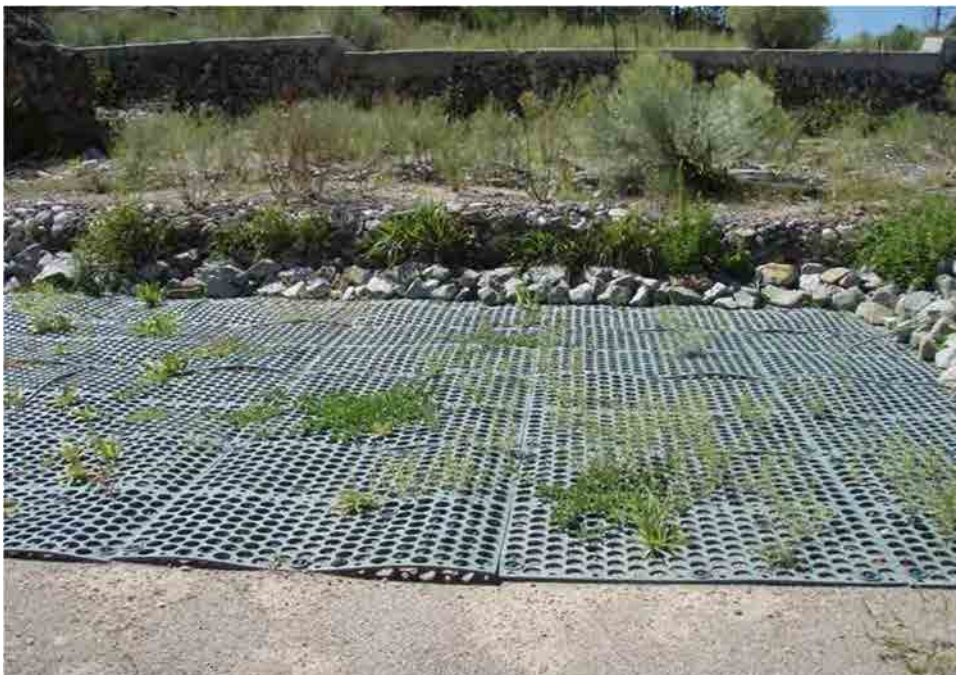
**Photo C-5.9-3** Sept 2016 — ScourStop consistent with previous inspection. Recommend monitoring.

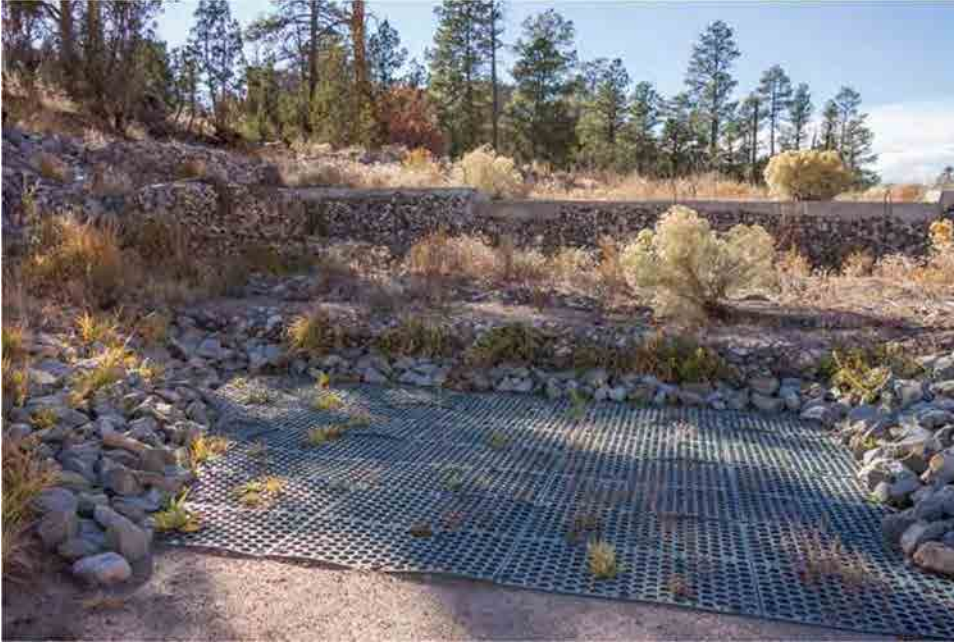
**Photo C-5.9-4 Nov 2016 — ScourStop sheets consistent with previous inspection. Recommend monitoring.**

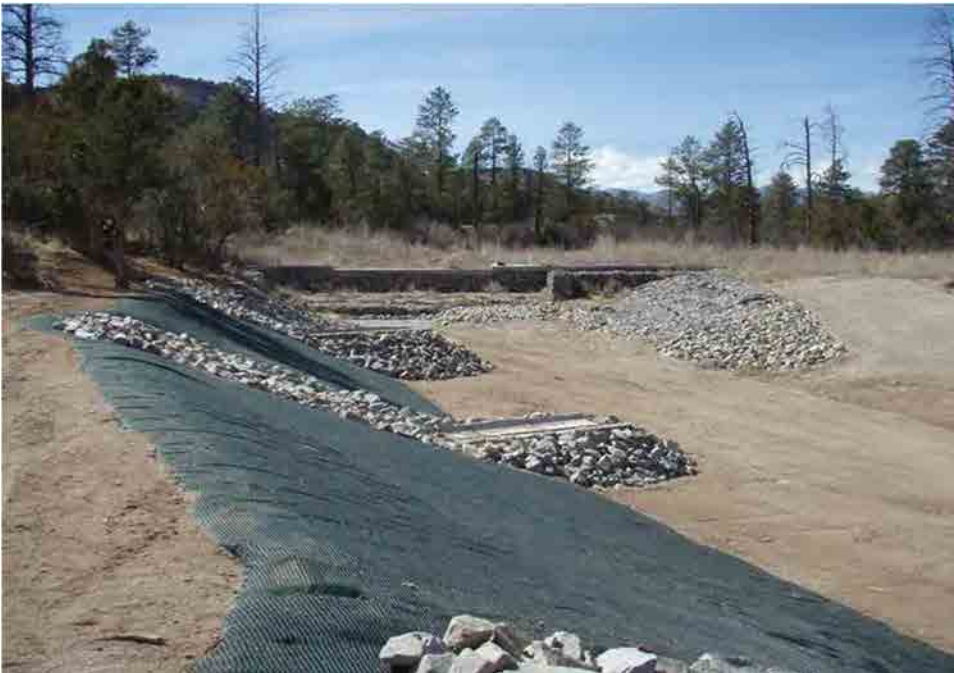
**Photo C-5.10-1 Q1 — Spurs and associated riprap have been added to inspection form.**

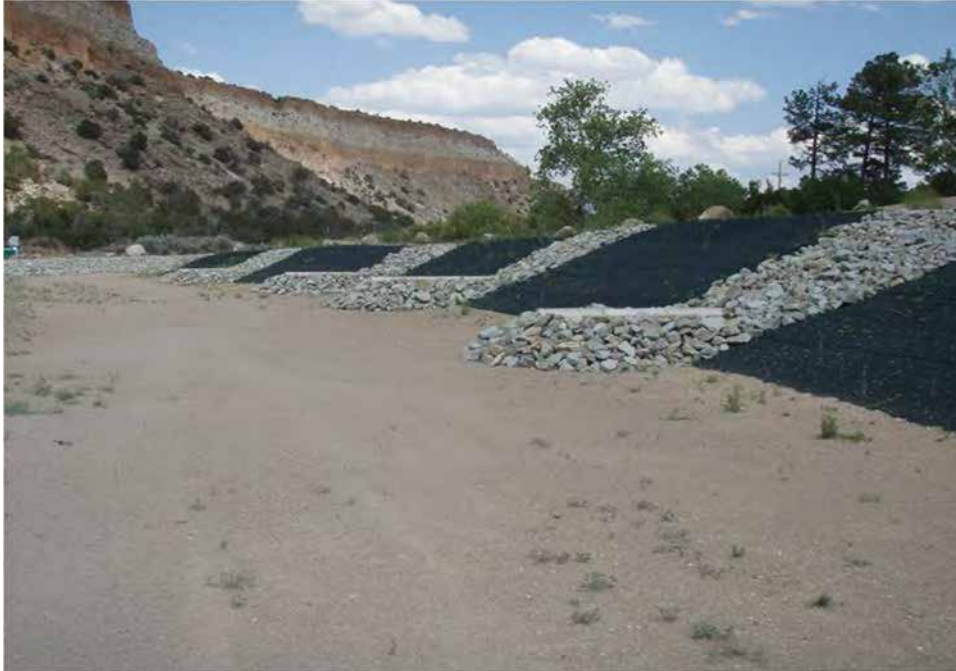
**Photo C-5.10-2 June 2016 — Spurs and associated riprap in good condition.**

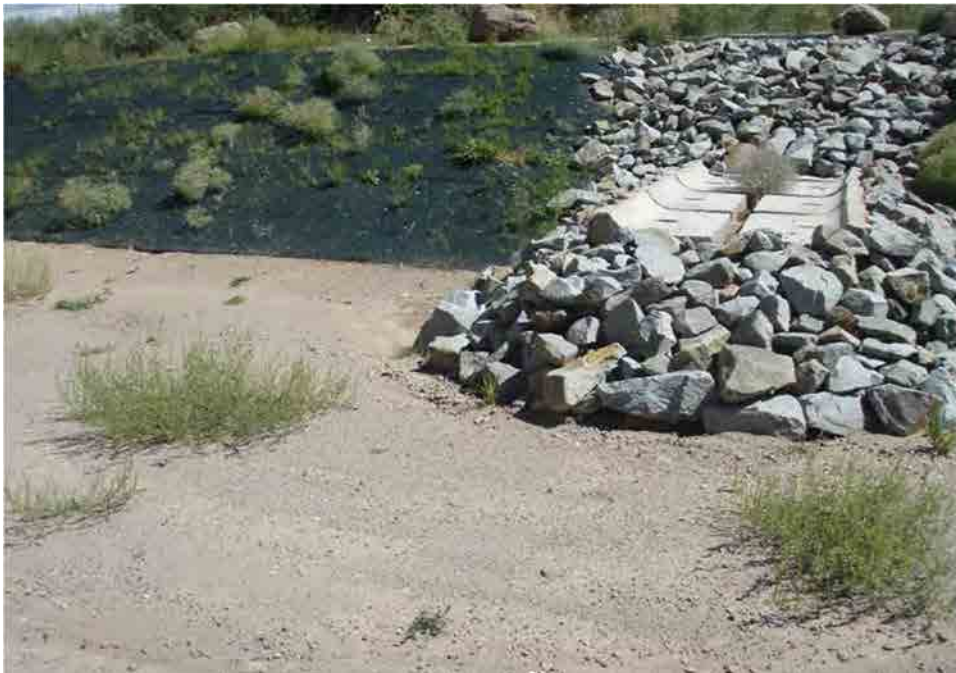
**Photo C-5.10-3 Sept 2016 — Rilling occurring at the tip of Spur 4. Recommend monitoring.**

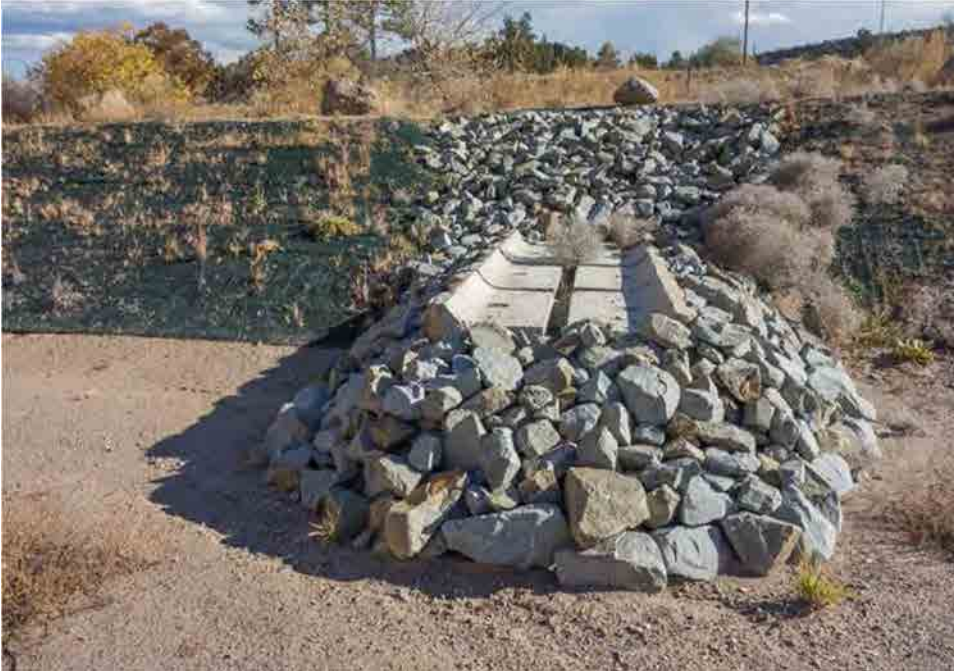
**Photo C-5.10-4 Nov 2016 — Rilling occurring at the tip of Spur 4. Consistent with previous inspection. Recommend monitoring.**

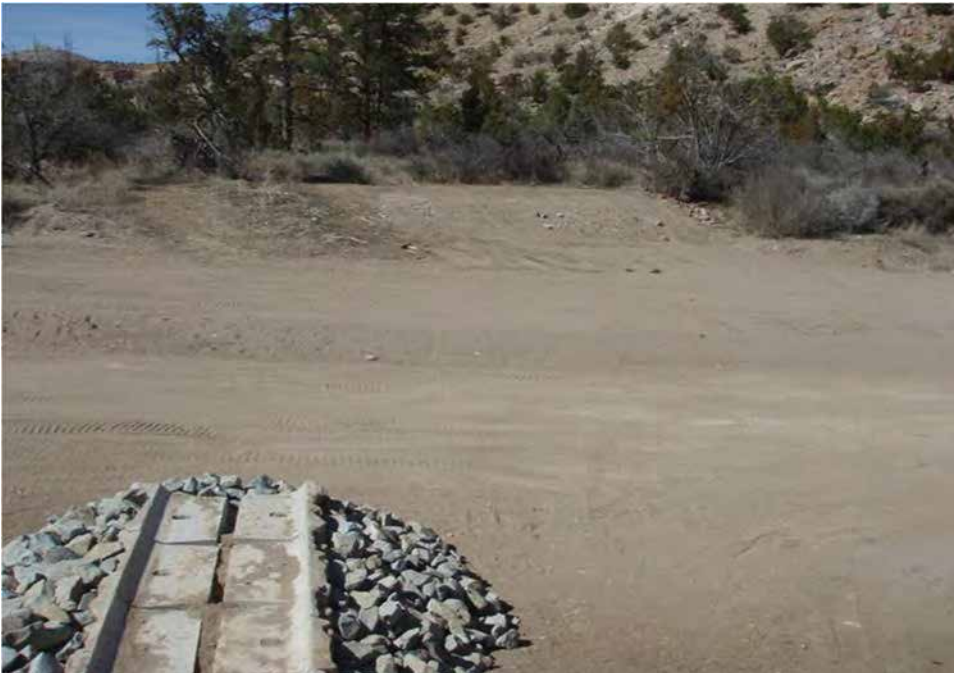
**Photo C-5.11-1 Q1 — Bank on the opposite side of the spurs requires seeding.**

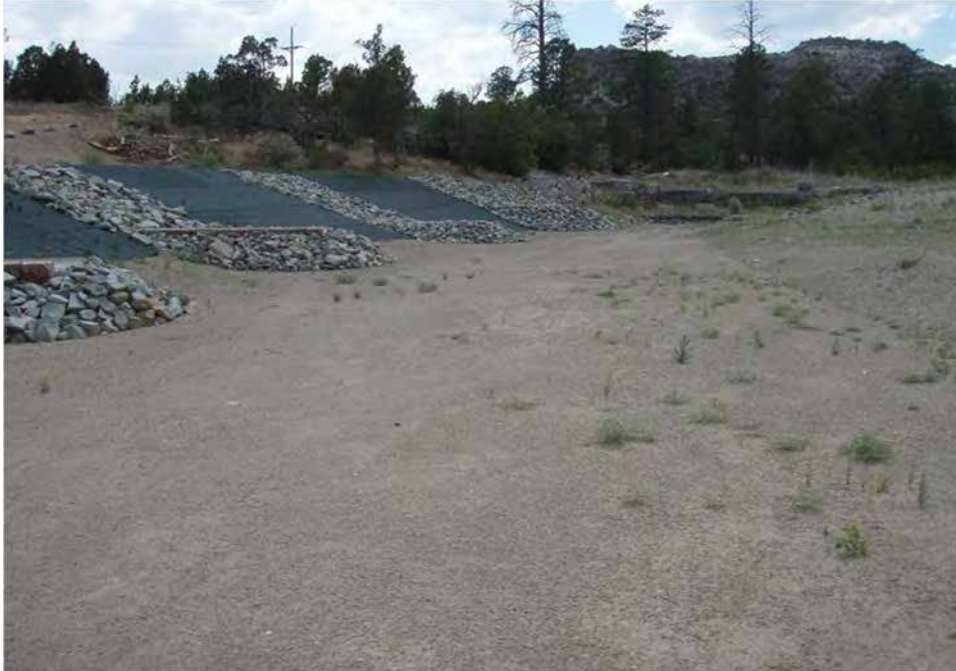
**Photo C-5.11-2 June 2016 — Disturbed area north of spurs requires seeding.**

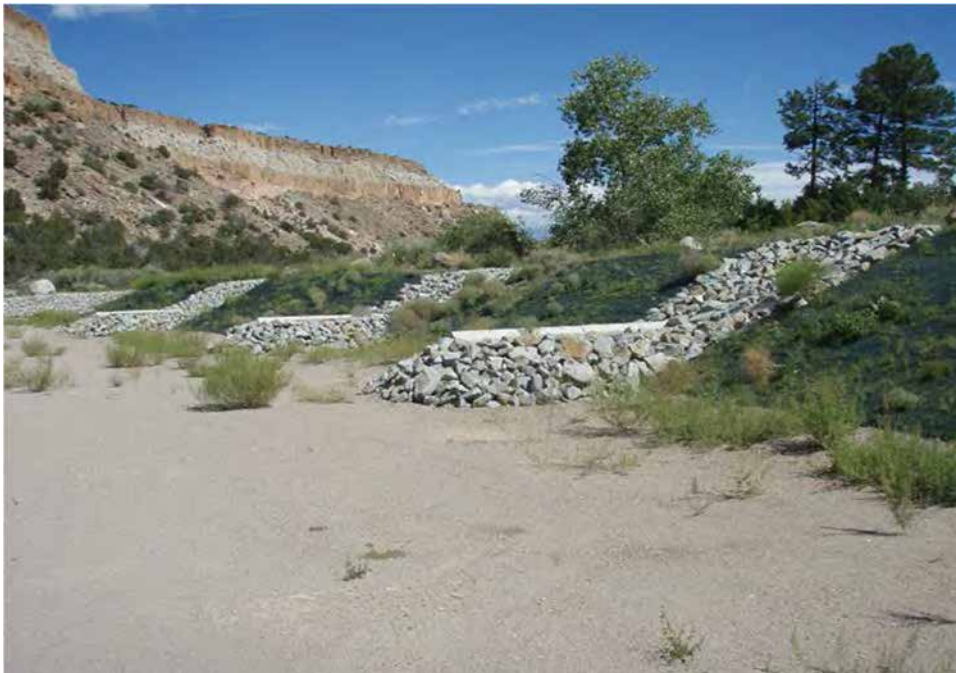
**Photo C-5.11-3 Sept 2016 — Vegetation coming in on slopes.**

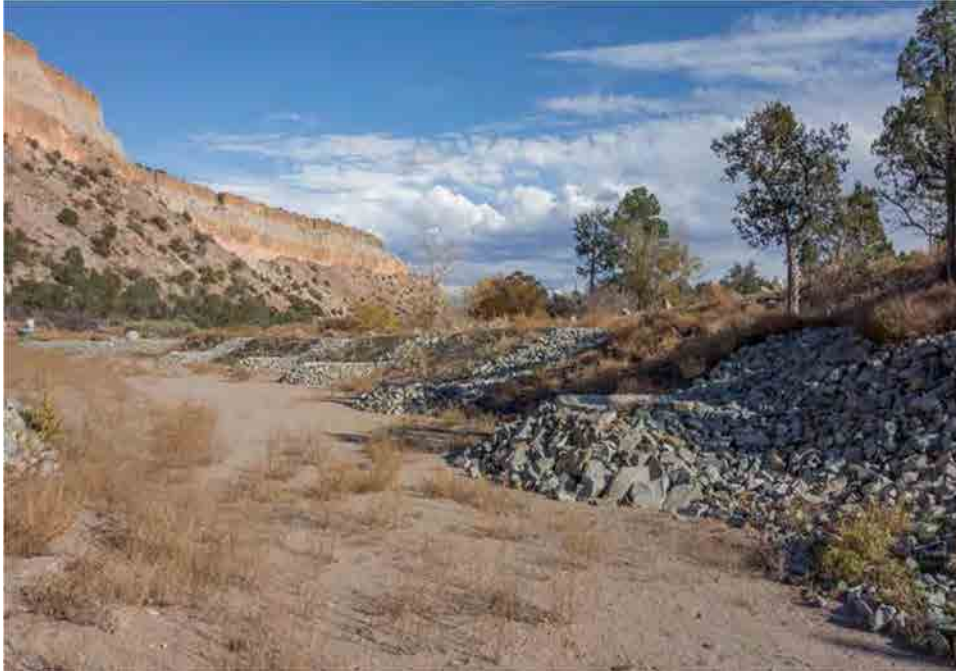
**Photo C-5.11-4** Nov 2016 — Vegetation coming in on slopes.

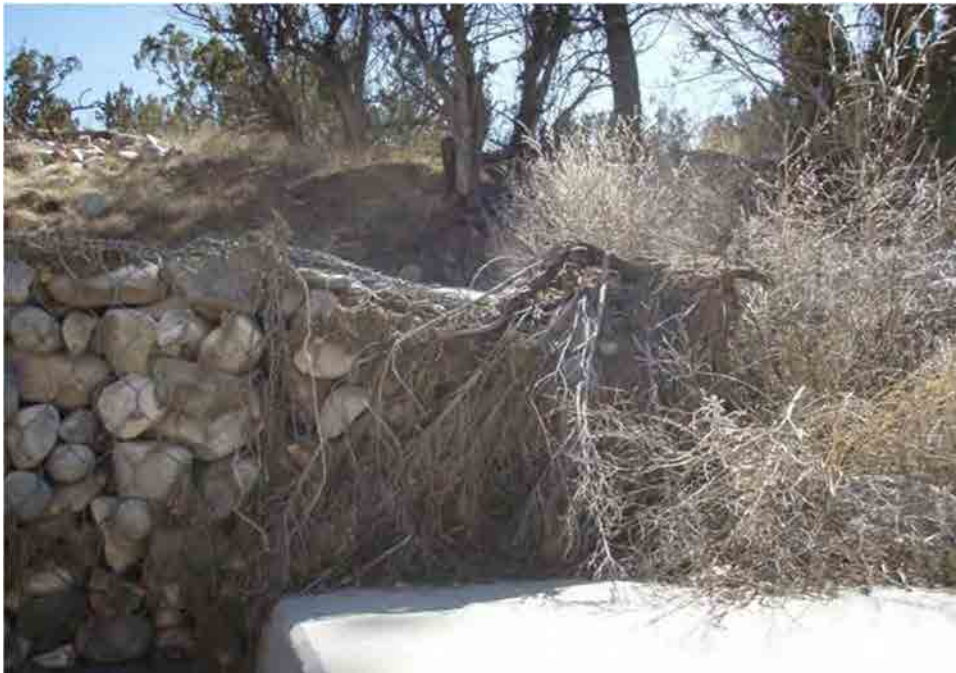
**Photo C-5.12-1** March 2016 — Gabion basket on the upstream south side of the spillway appears to be degrading. Recommend monitoring.

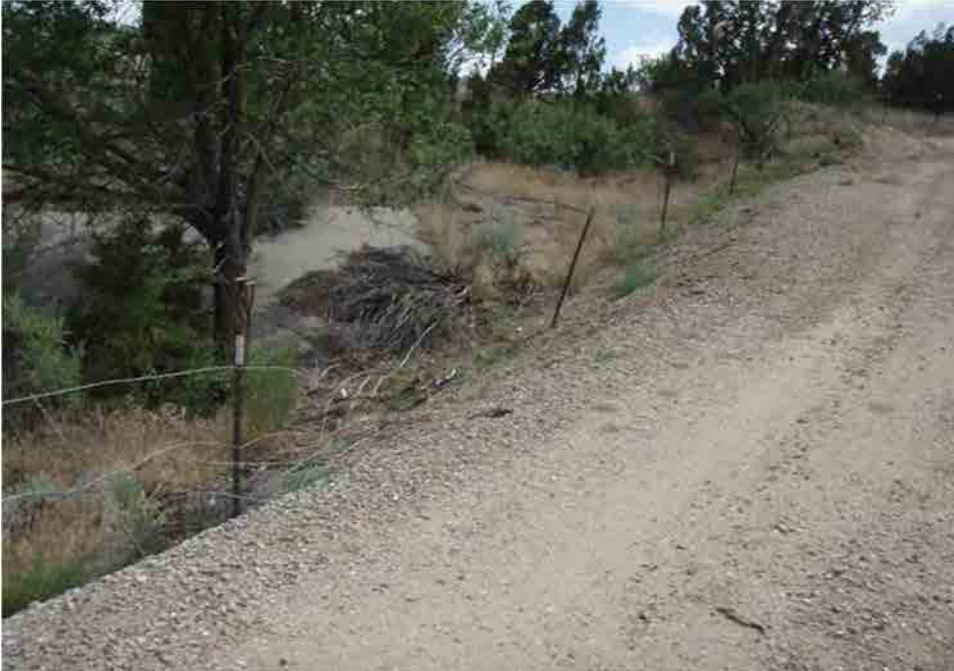
**Photo C-5.12-2 June 2016 — Broken fence. Recommend repair.**

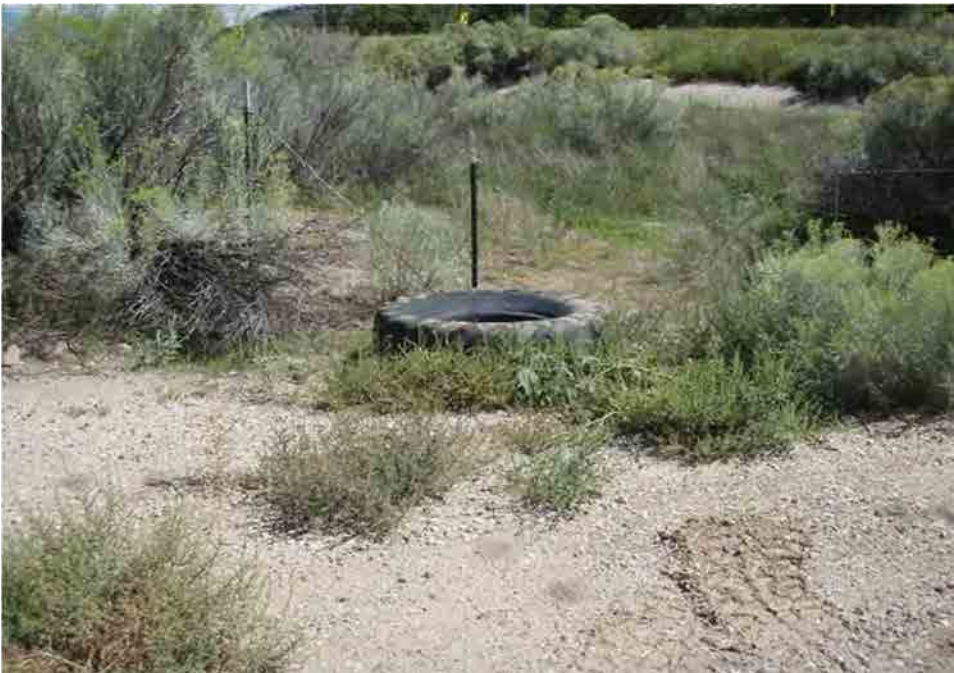
**Photo C-5.12-3 Sept 2016 — Tire found near GCS.**

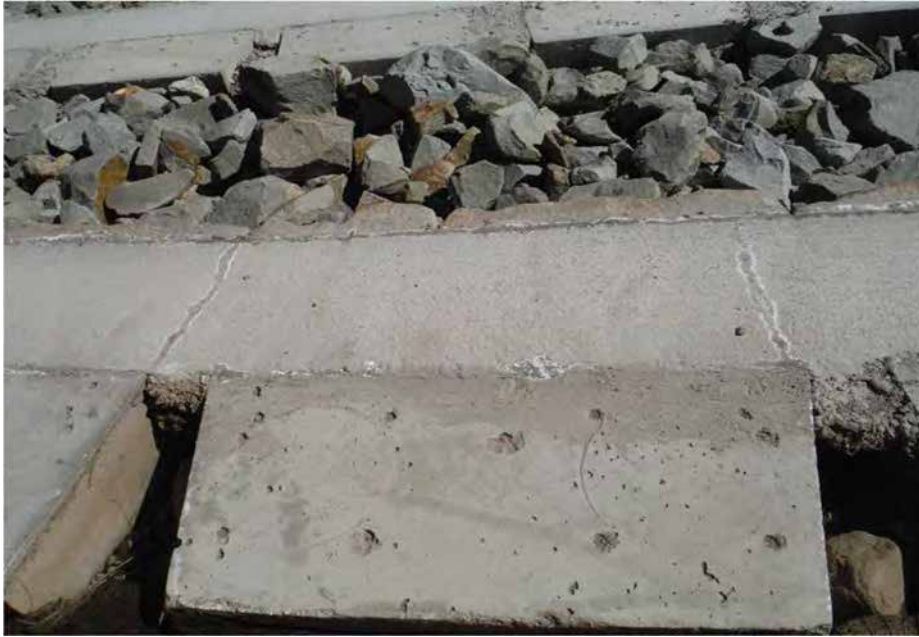
**Photo C-6.1-1** March 2016 — Redi-Rock structure shows minor cracks in the concrete. Recommend monitoring cracks.

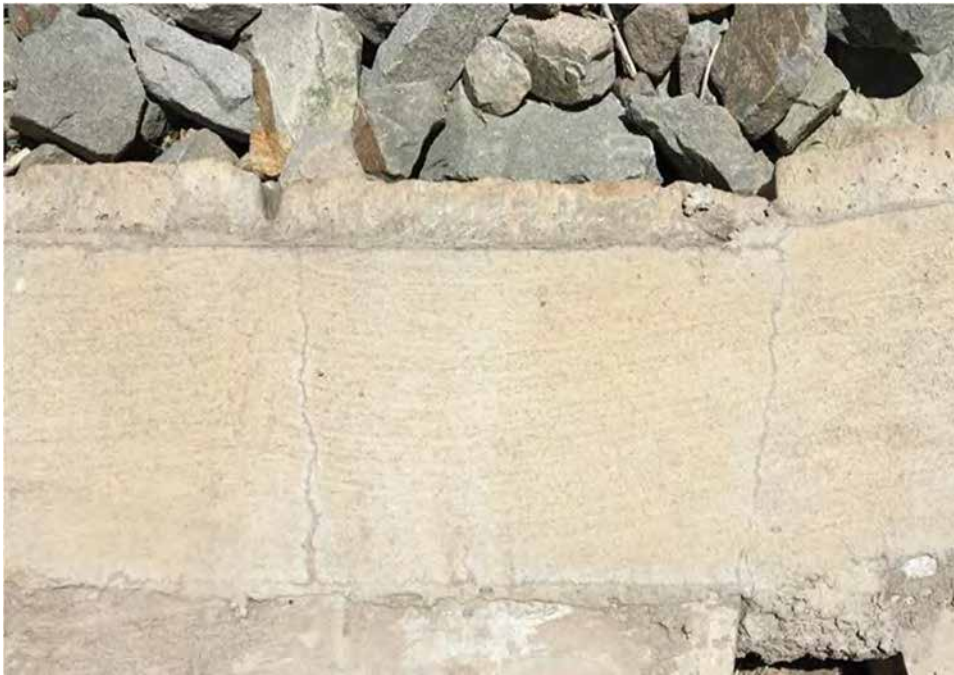
**Photo C-6.1-2** June 2016 — Redi-Rock structure shows minor shrinkage cracks. Recommend monitoring cracks.

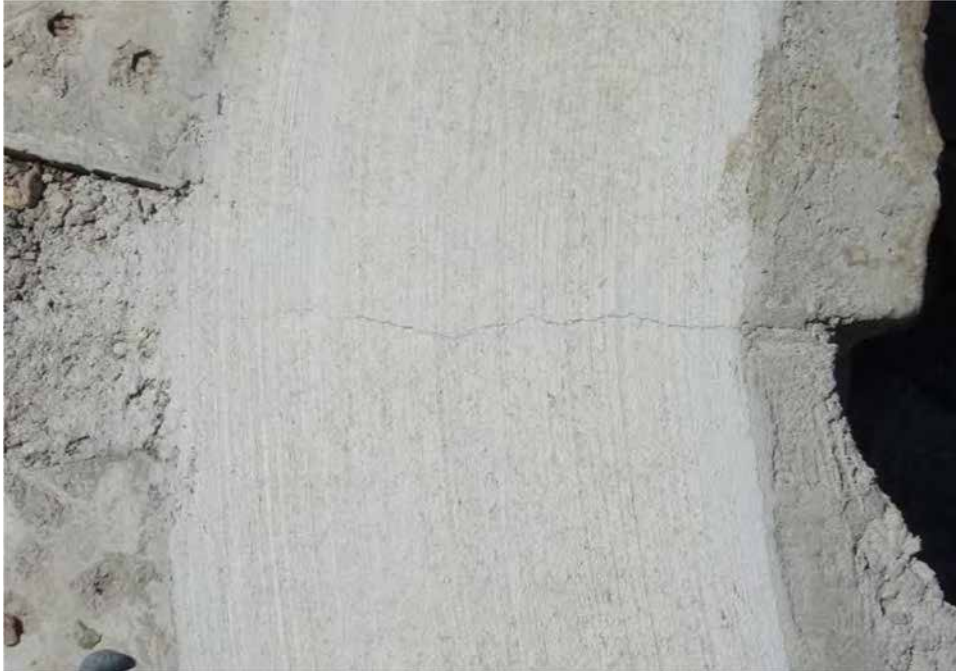
**Photo C-6.1-3** Sept 2016 — Shrinkage cracks consistent with previous inspection. Recommend monitoring cracks.

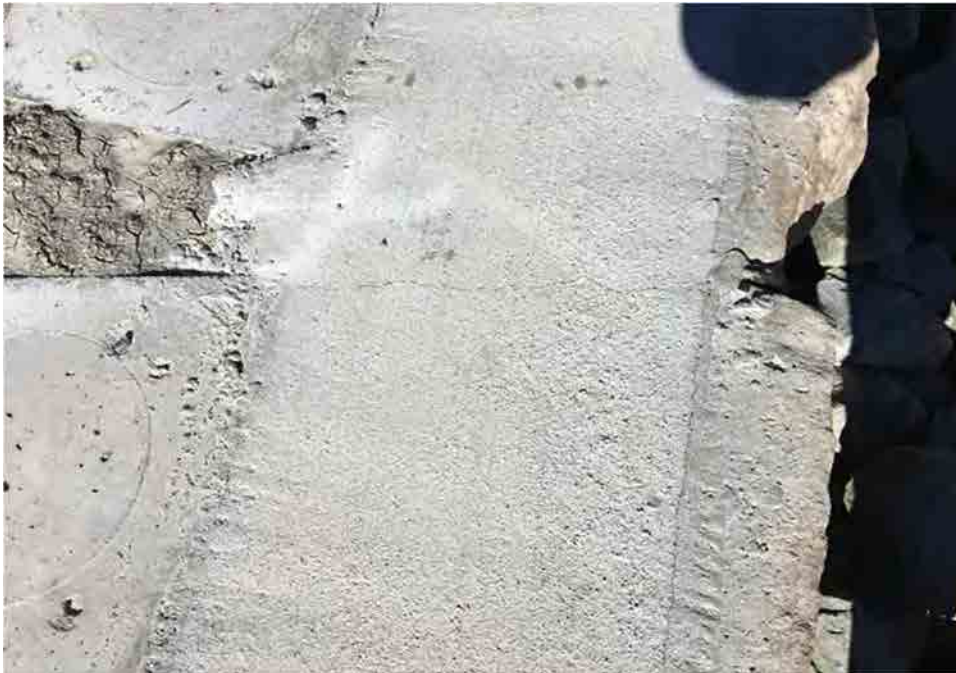
**Photo C-6.1-4** Nov 2016 — Shrinkage cracks consistent with previous inspection. Recommend monitoring cracks.

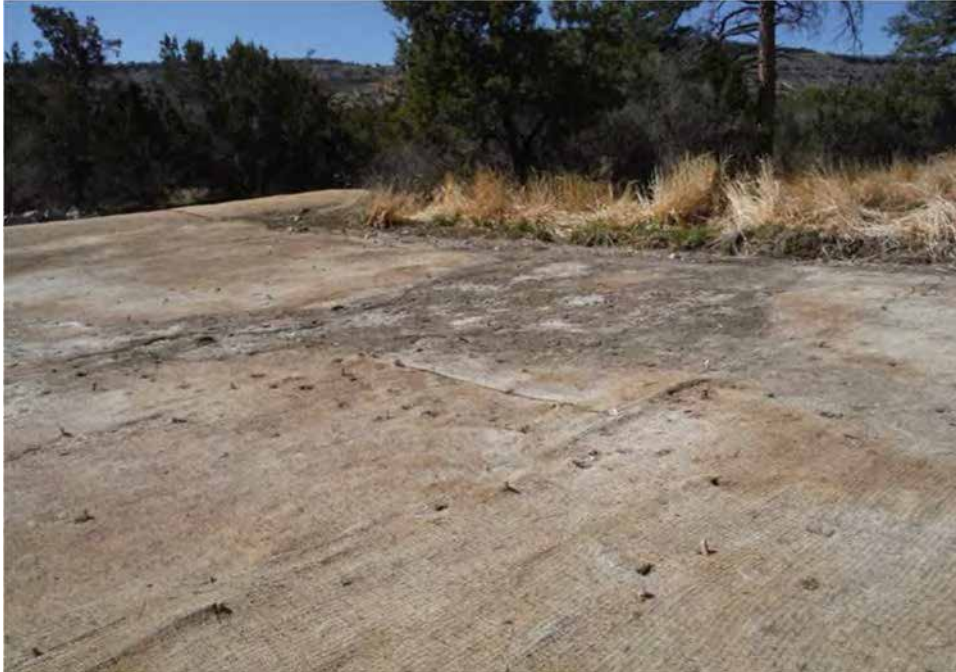
**Photo C-6.2-1** March 2016 — Limited growth due to 2015/2016 winter season. Continue to monitor for growth.

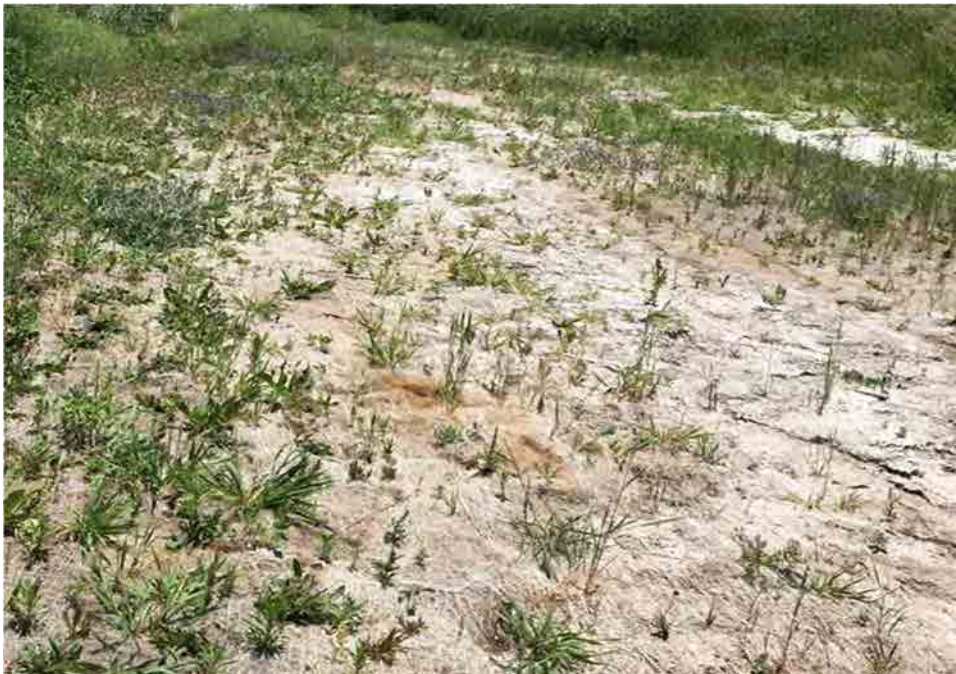
**Photo C-6.2-2** June 2016 — Sparse areas with light vegetation growing. Recommend monitoring for growth.

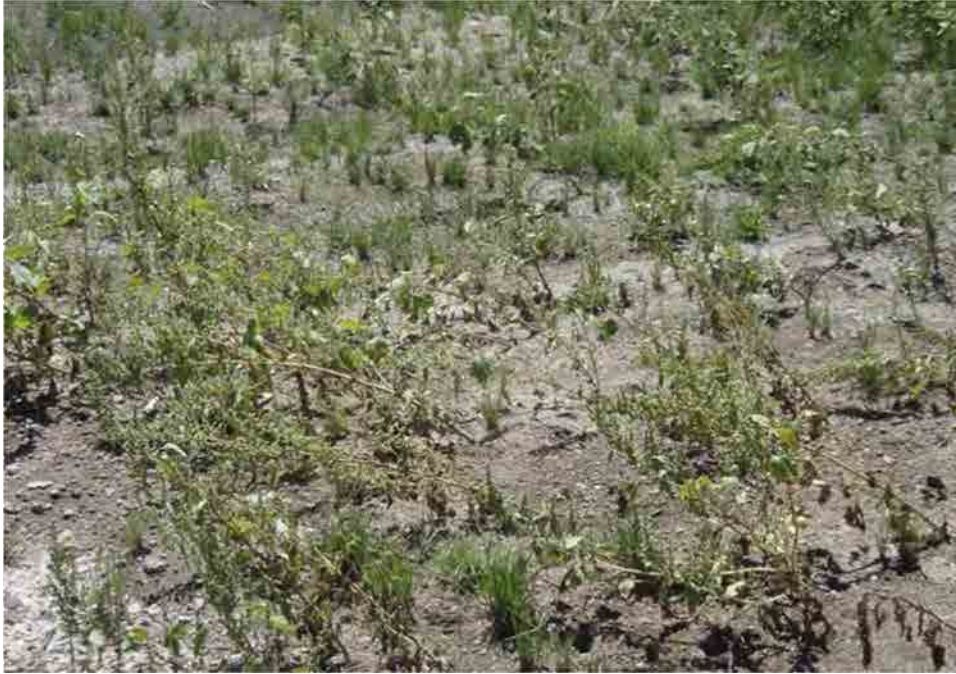
**Photo C-6.2.3** Sept 2016 — Upstream vegetation has improved since last inspection. Erosion matting has deteriorated beyond useful life. Recommend monitoring for growth.

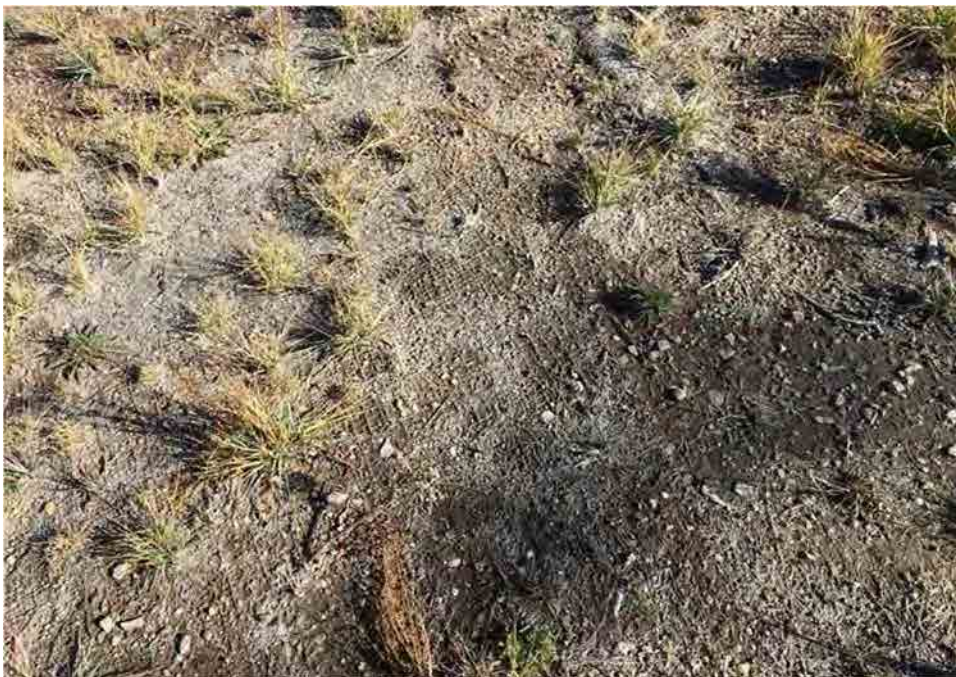
**Photo C-6.2-4** Q4 — Upstream vegetation consistent with previous inspection. Recommend monitoring for growth.

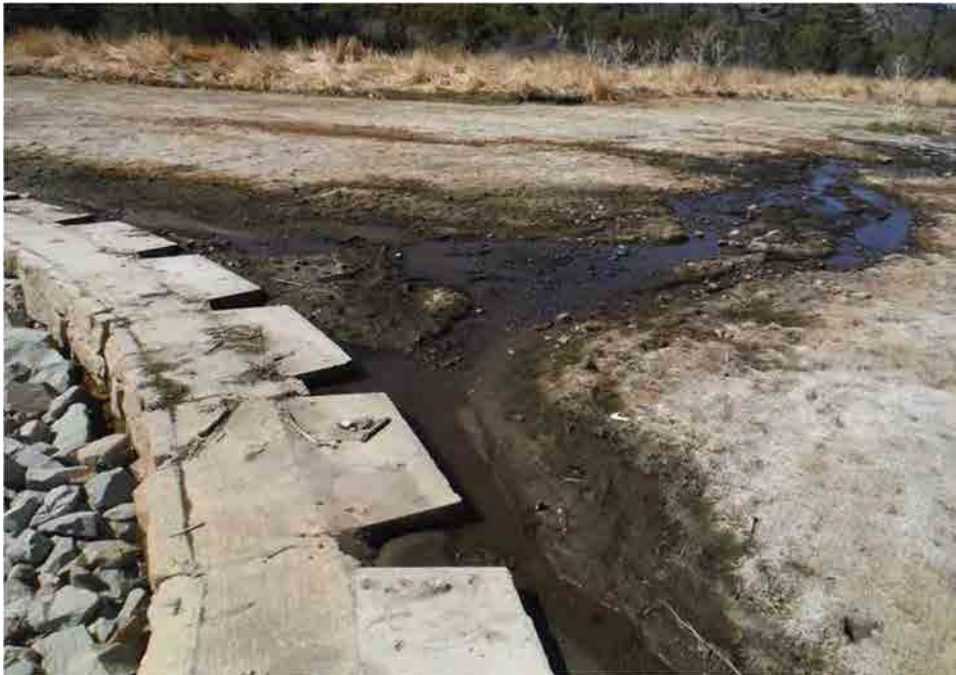
**Photo C-6.3-1** March 2016 — Channelization noted, upstream portion of the structure directly behind the Redi-Rock blocks. Recommend monitoring.

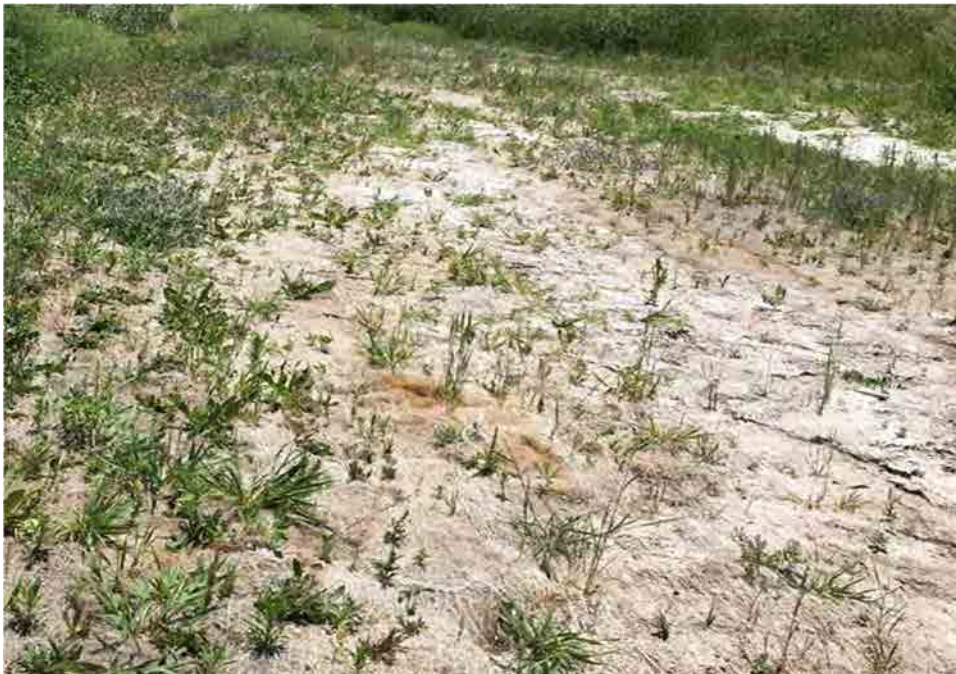
**Photo C-6.3-2** June 2016 — Channel forming at original low-flow channel outlet from wetland (upstream of structure). Suggest sand bag to better distribute flow.

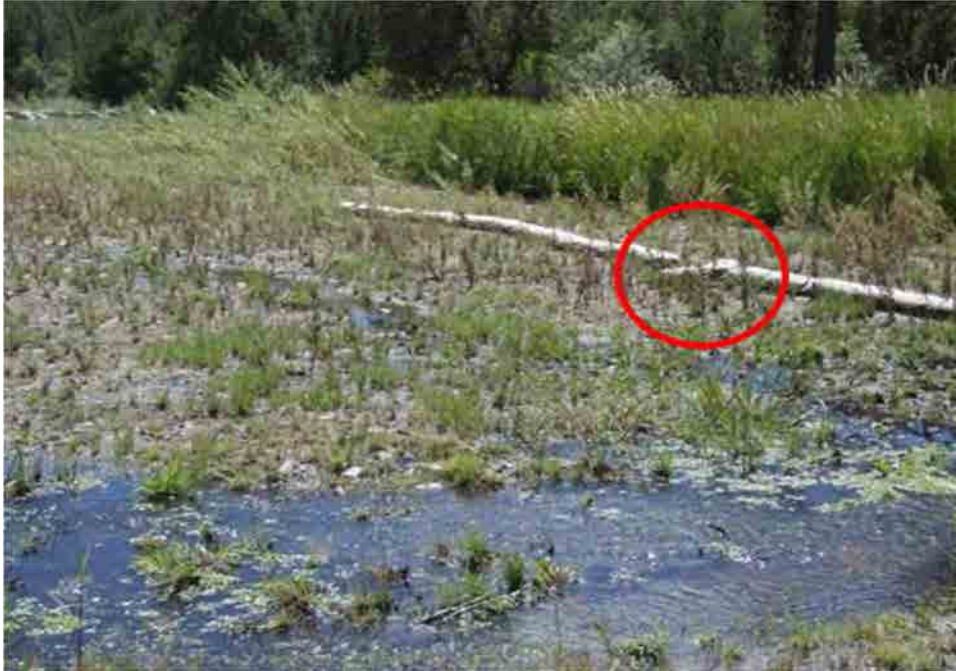
**Photo C-6.3-3** Sept 2016 — Spreader sand bags installed since last inspection. Several have been moved, allowing channelization to continue, and one is damaged (noted in red circle). There is evidence of improved sheet flow.

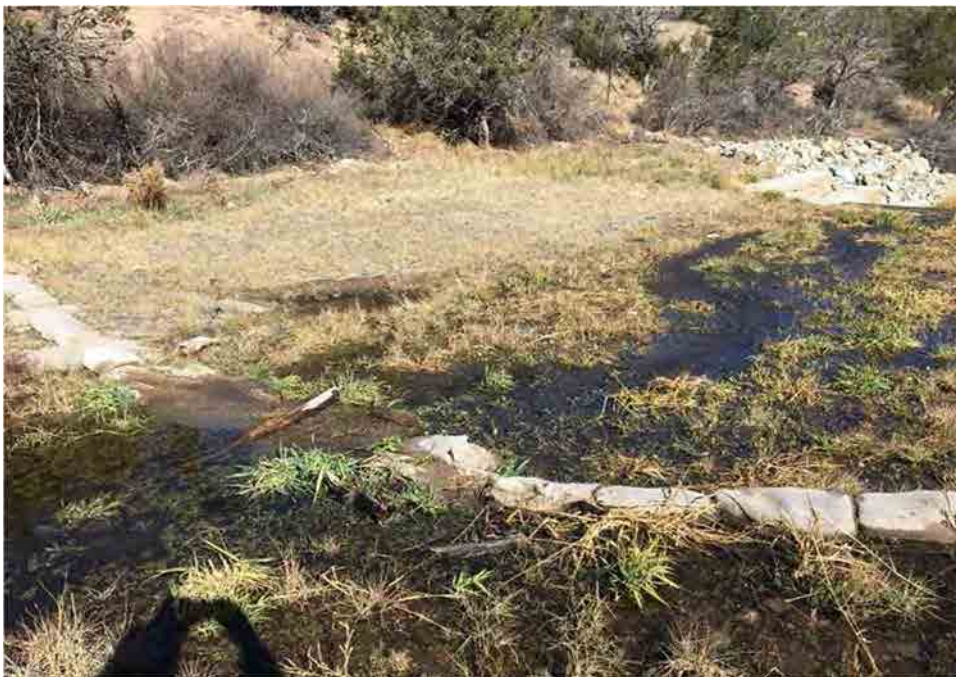
**Photo C-6.3-4** Nov 2016 — Channelization present at location of sandbags. Repair sandbags to encourage the spread of water.

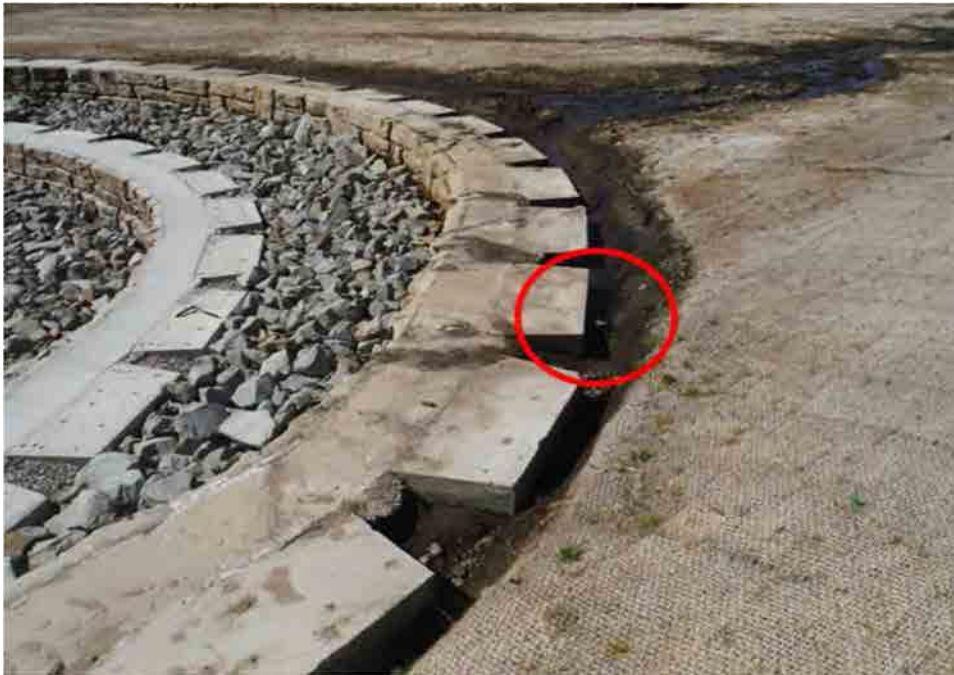
**Photo C-6.4-1** March 2016 — Metal debris in T-post section (noted in red circle). Recommend removal.

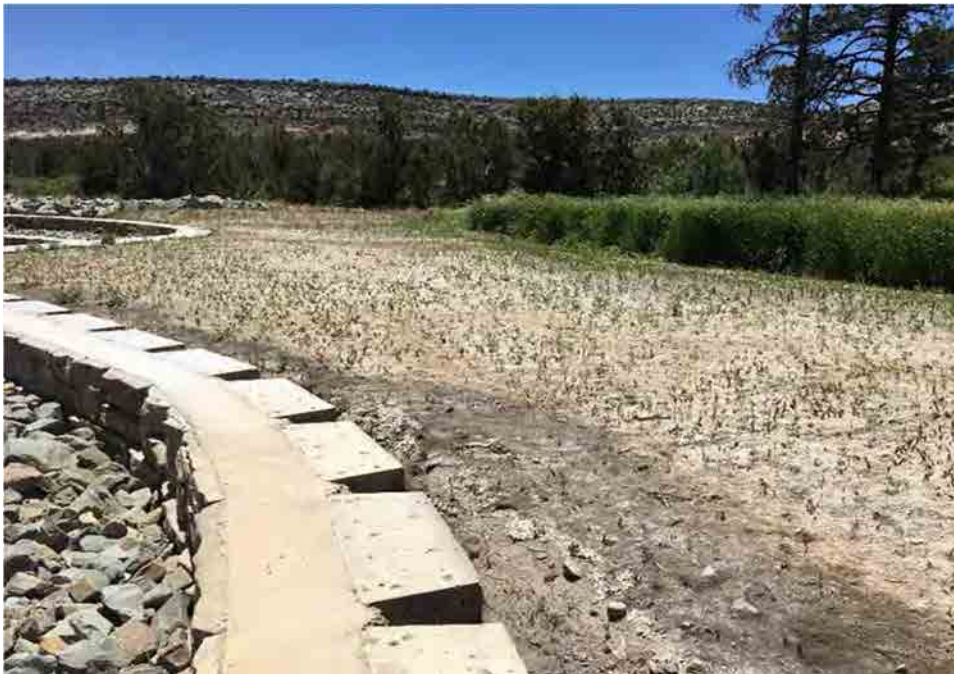
**Photo C-6.4-2** June 2016 — Upstream side of upper Redi-Rock structure with settling and erosion. Recommend repairing.

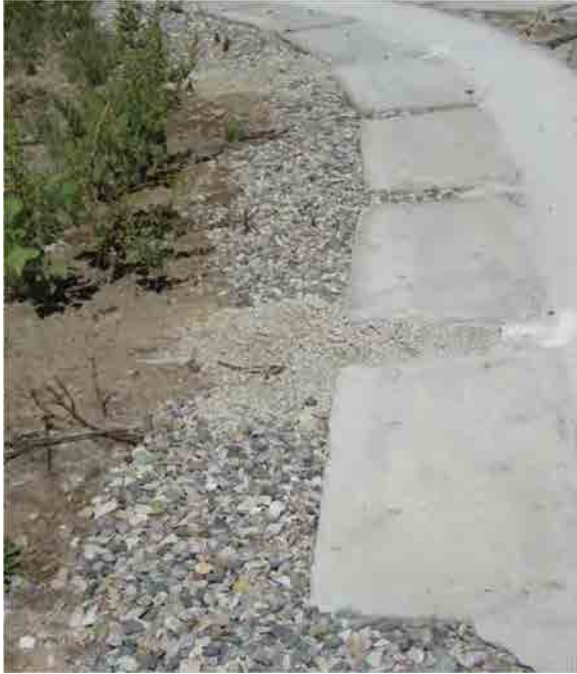
**Photo C-6.4-3** Sept 2016 — Monitor area behind Redi-Rock for future erosion. This area was repaired with a mix of gravel and bentonite plugs, which are allowing for a better distribution of flow over the wall in this area.

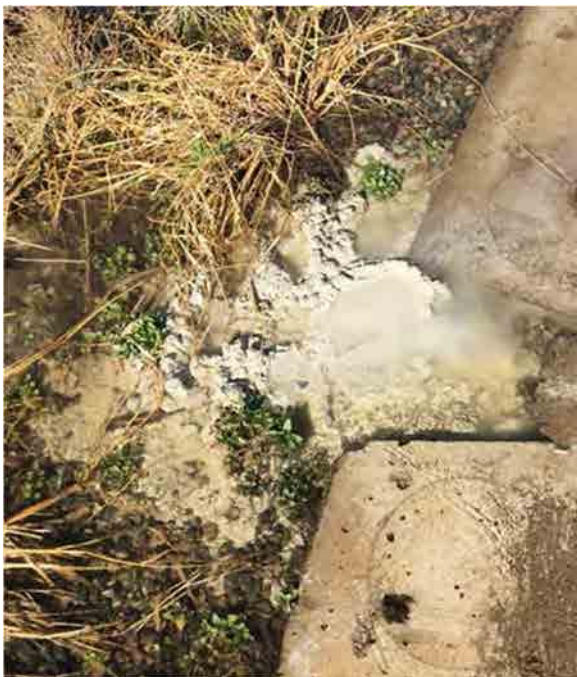
**Photo C-6.4-4** Nov 2016 — Monitor behind Redi-Rock for future erosion. Controls previously put in place are allowing for a better distribution of flow over the wall in this area.
