**Subject: 2016 Monitoring Report for Los Alamos/Pueblo Watershed Sediment Transport Mitigation Project**

April 2017

EP2017-0042

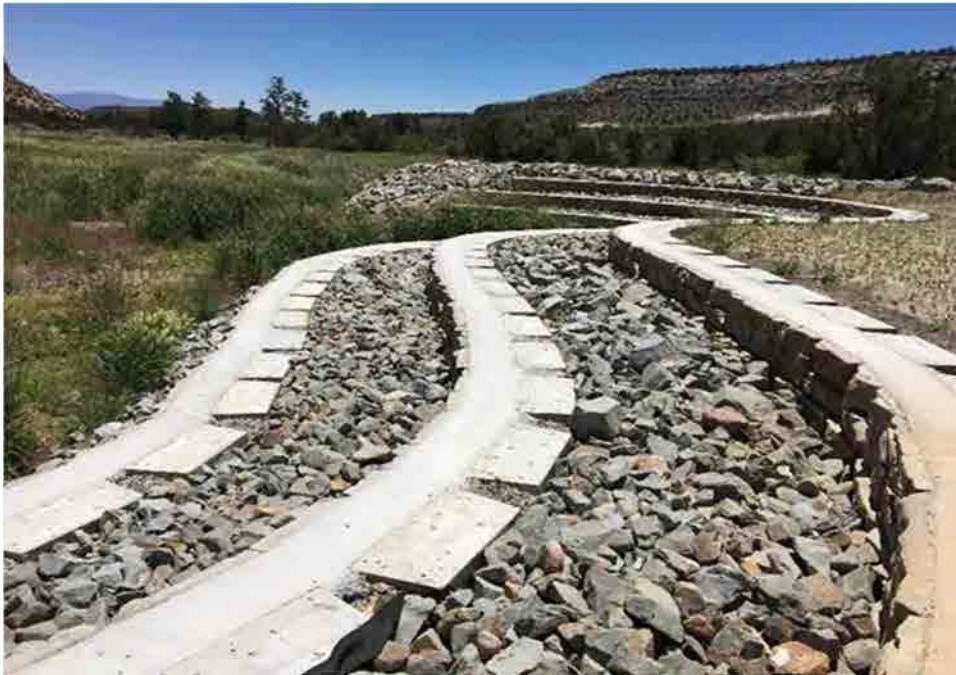
**Photo C-6.5-1 June 2016 — Geotextile covered by riprap. Recommend monitoring.**

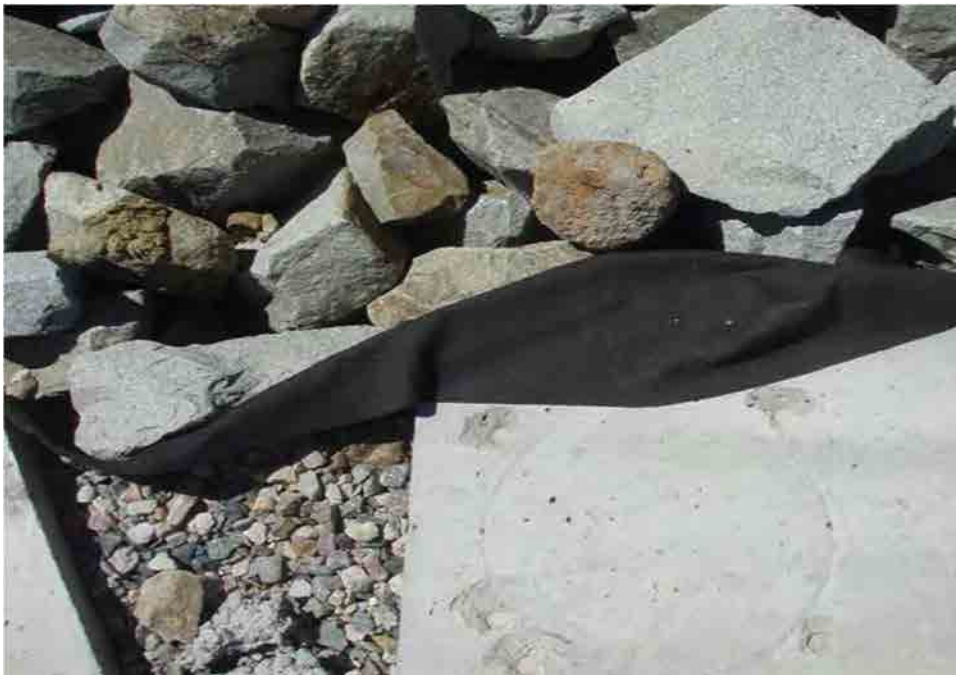
**Photo C-6.5-2 Sept 2016 — Some geotextile under riprap has been uncovered. Consistent with previous inspection. Recommend monitoring.**

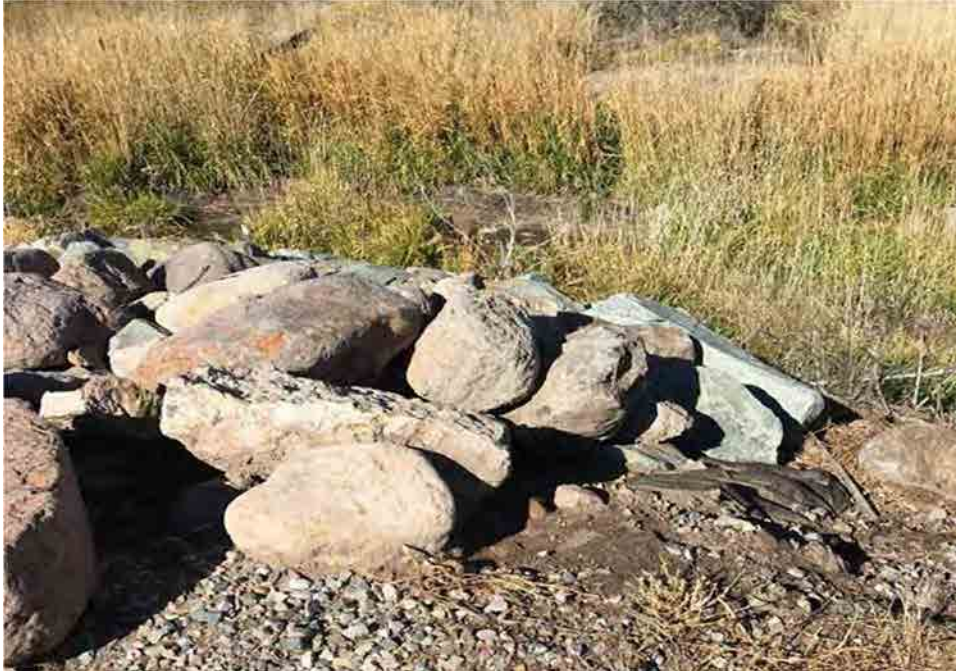
**Photo C-6.5-3** Nov 2016 — Condition of geotextile consistent with previous inspection. Recommend monitoring.

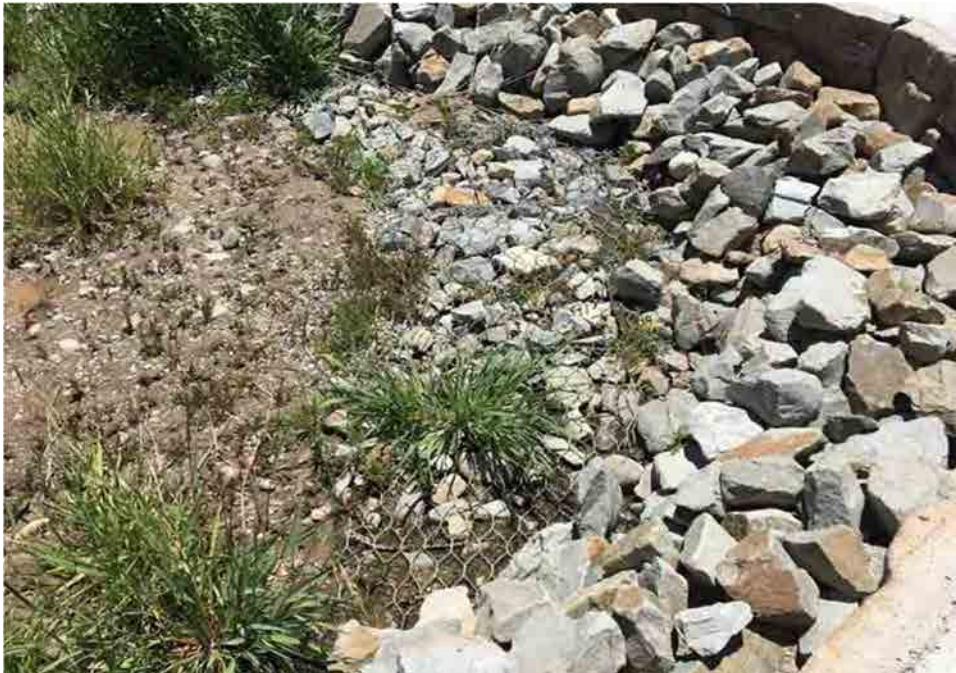
**Photo C-6.6-1** March 2016 — Gabions partially covered with sediment. Recommend monitoring.

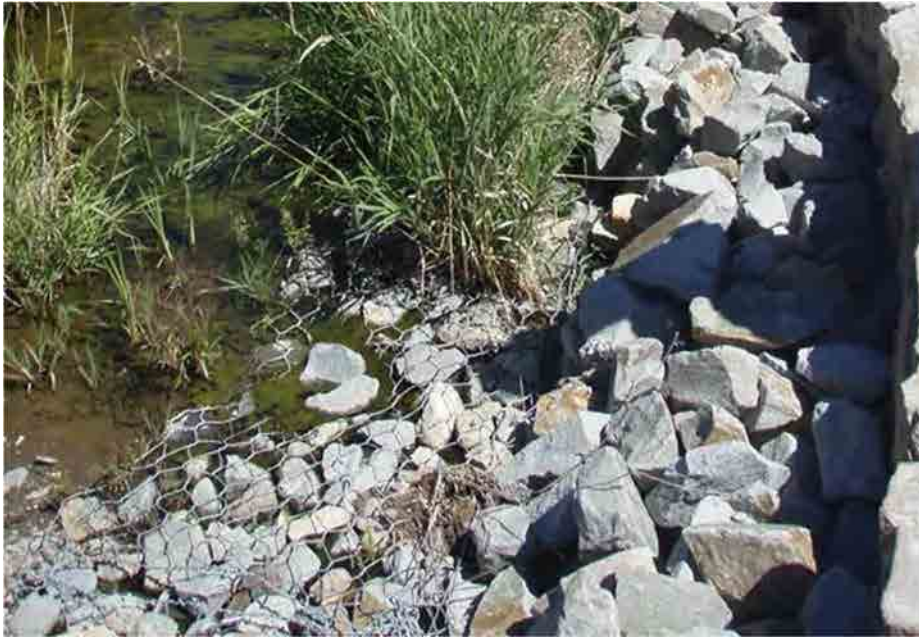
**Photo C-6.6-3    Sept 2016 — Gabions partially covered with sediment. Consistent with previous inspection. Recommend monitoring.**

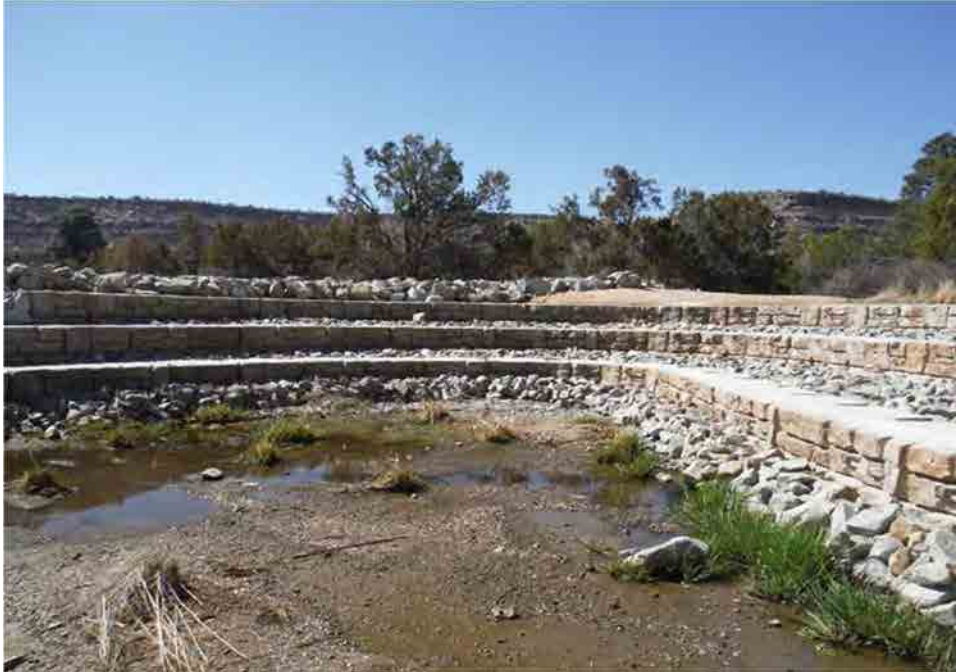
**Photo C-6.7-1 Q1 — Limited growth of vegetation due to 2015/2016 winter season. Monitor for growth in 2016.**

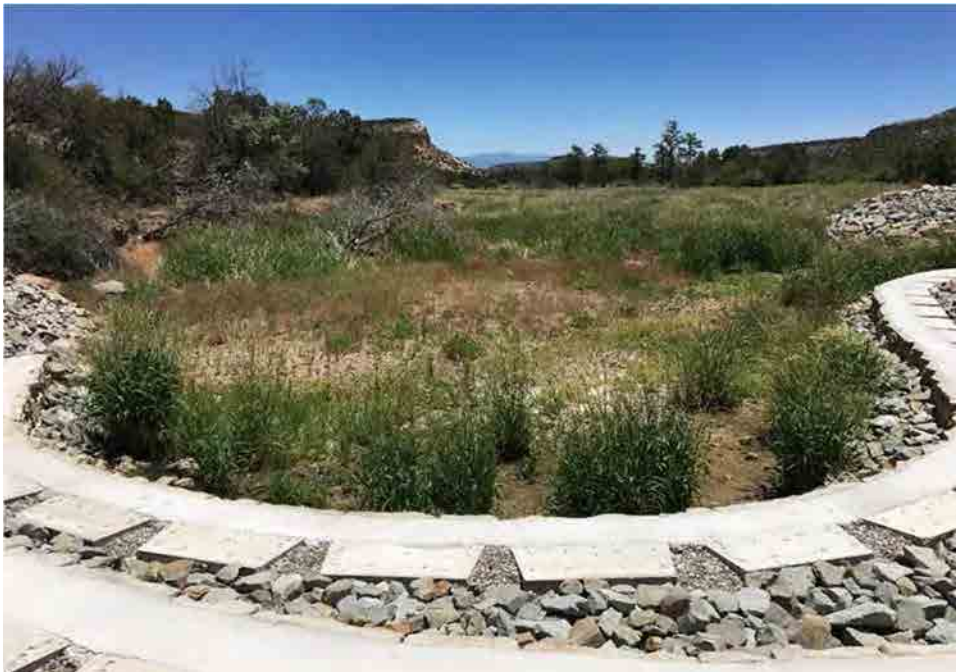
**Photo C-6.7-2 June 2016 — Replanted reed canarygrass is doing well. Recommend monitoring.**

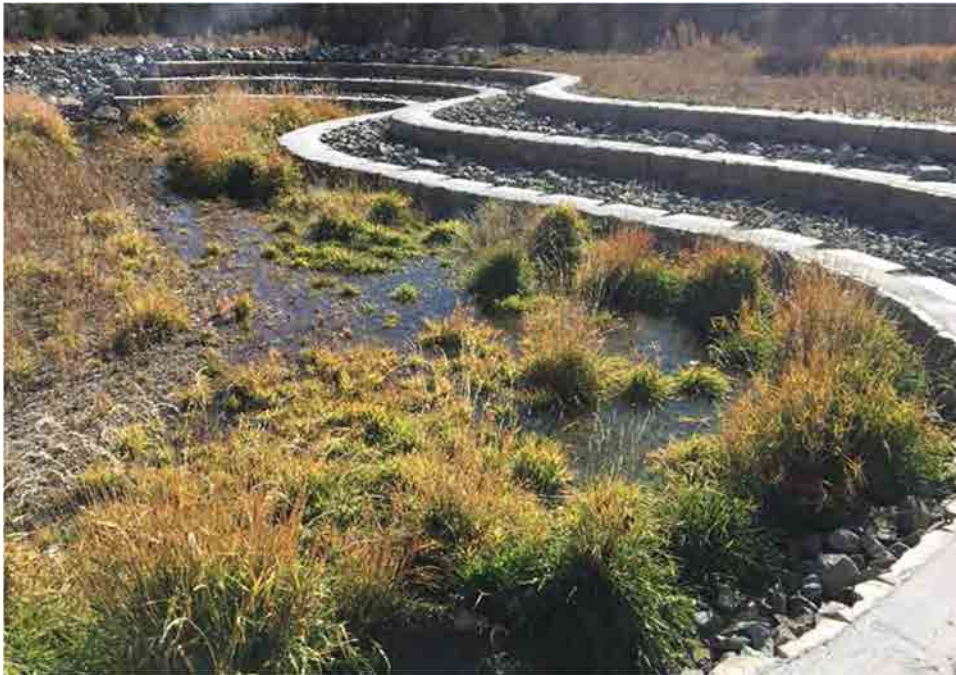
**Photo C-6.7-4** Nov 2016 — Vegetation consistent with previous inspection. Recommend monitoring.

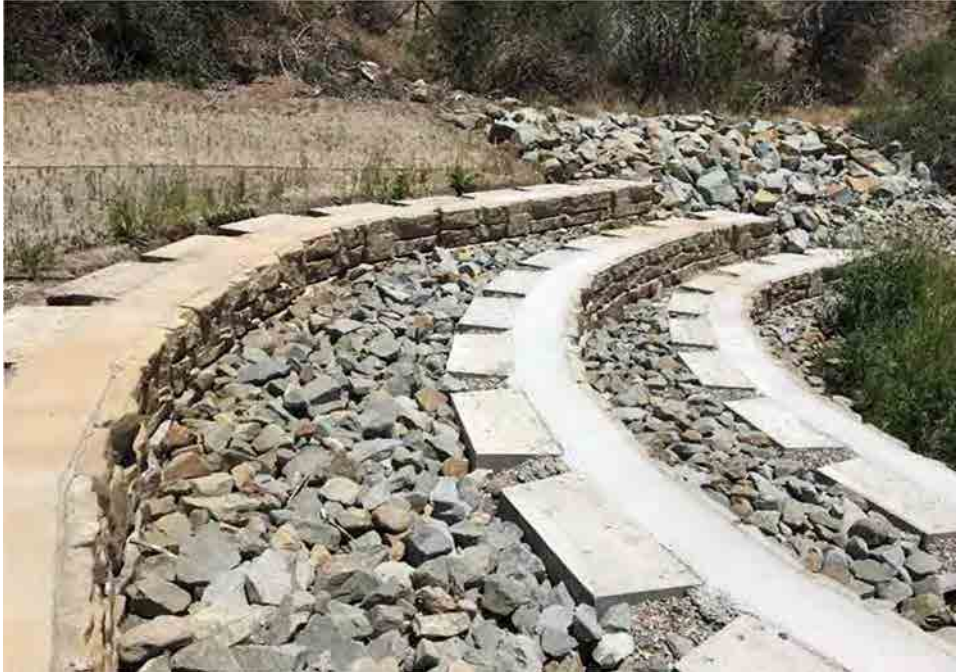
**Photo C-6.8-1 June 2016 — Geotextile is covered by riprap except for edges. Recommend monitoring.**

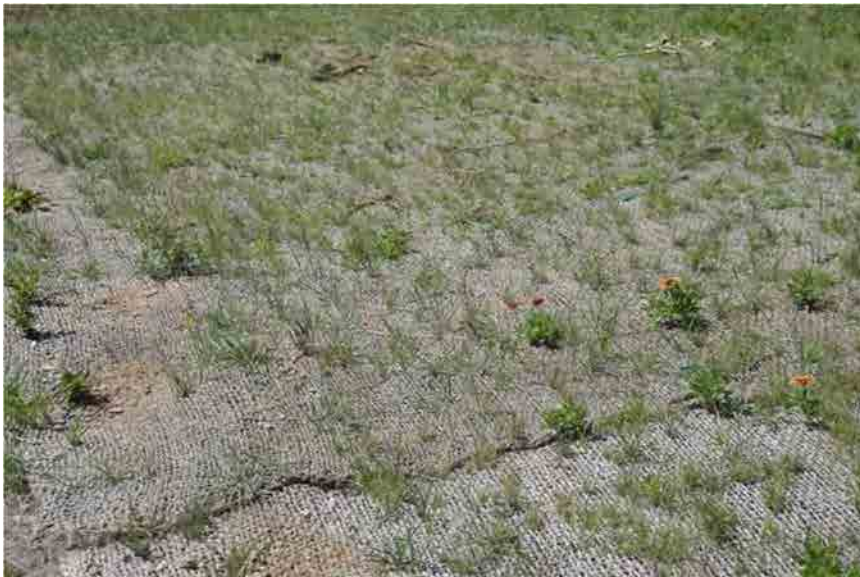
**Photo C-6.8-2 Sept 2016 — Geotextile is covered by riprap and TRM except on edges. Vegetative growth becoming established through TRM. Recommend monitoring.**

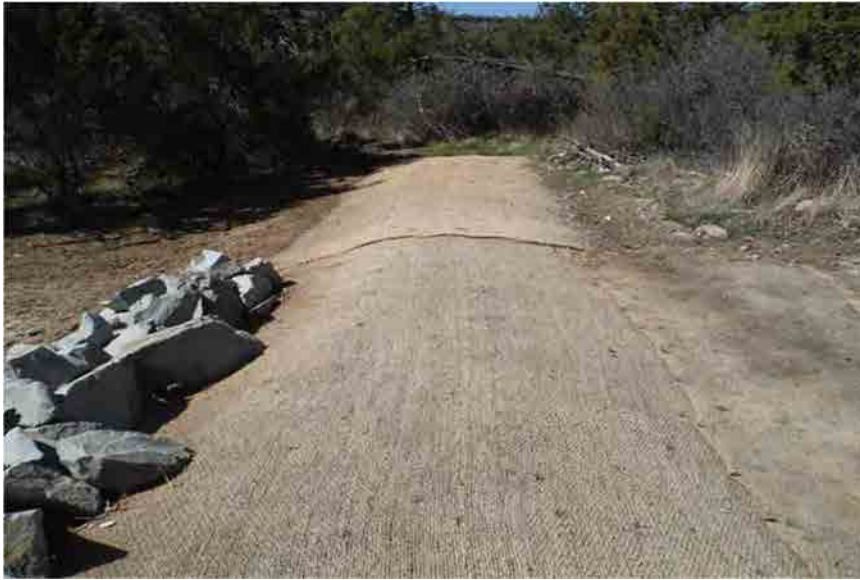
**Photo C-6.9-1 Q1 — Limited growth of vegetation due to 2015/2016 winter season. Monitor for growth in 2016.**

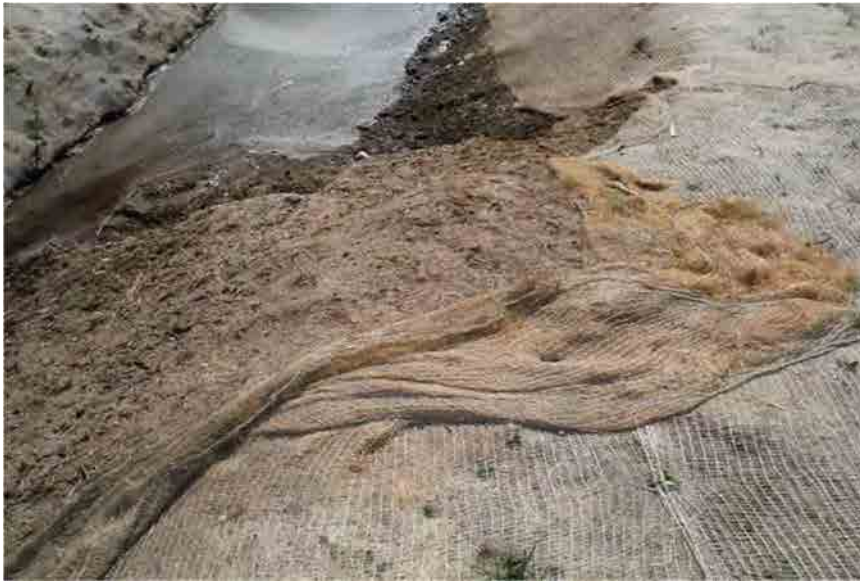
**Photo C-6.10-1** March 2016 — TRM is beginning to degrade and has unstapled in a few areas. Recommend re-stapling TRM in this area. Monitor for growth in 2016.

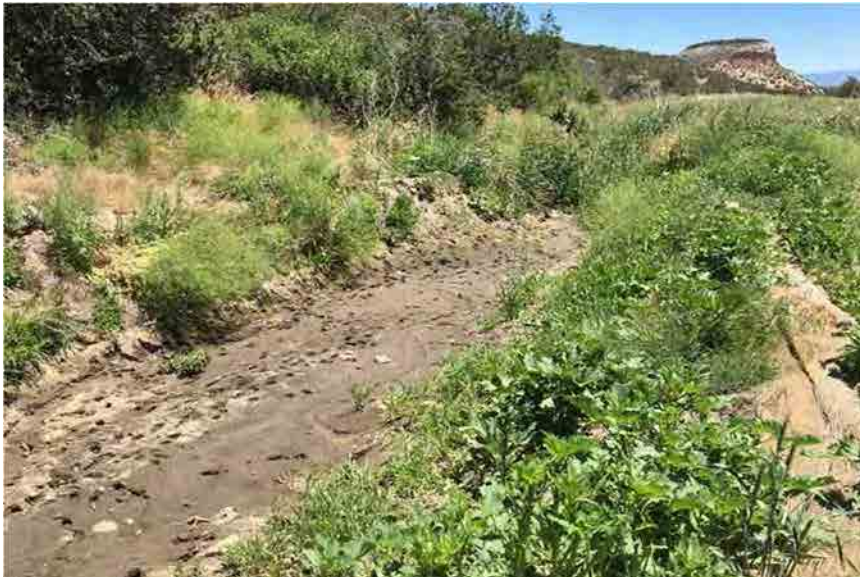
**Photo C-6.10-2** June 2016 — The pond has no water in it. ECB has deteriorated on bands and vertical “steps” are present and exposed on interior slopes. ECB is at the end of life and should be retired. Vegetation on side slopes has 100% cover due to broad-leafed foliage. Continue to monitor.

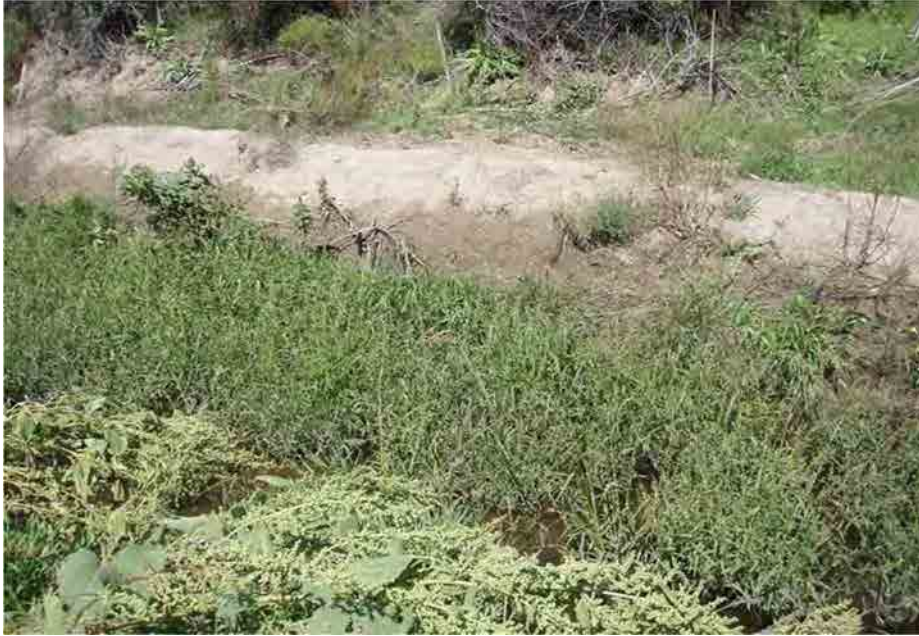
**Photo C-6.10-3** Sept 2016 — The pond has water in it. ECB condition consistent with previous inspection. Continue to monitor.

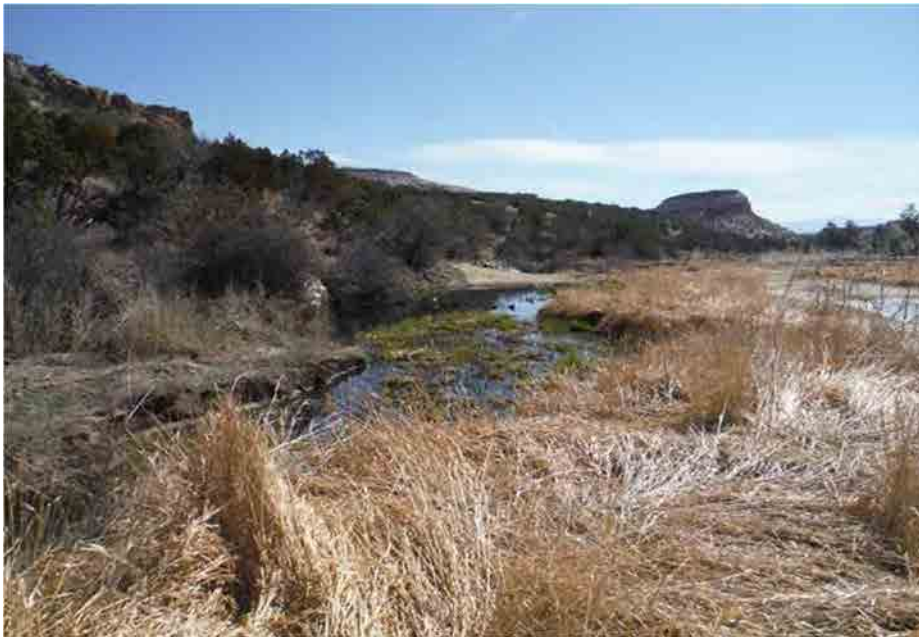
**Photo C-6.11-1** March 2016 — Some aggradation in pond and channel is evident. Recommend monitoring.

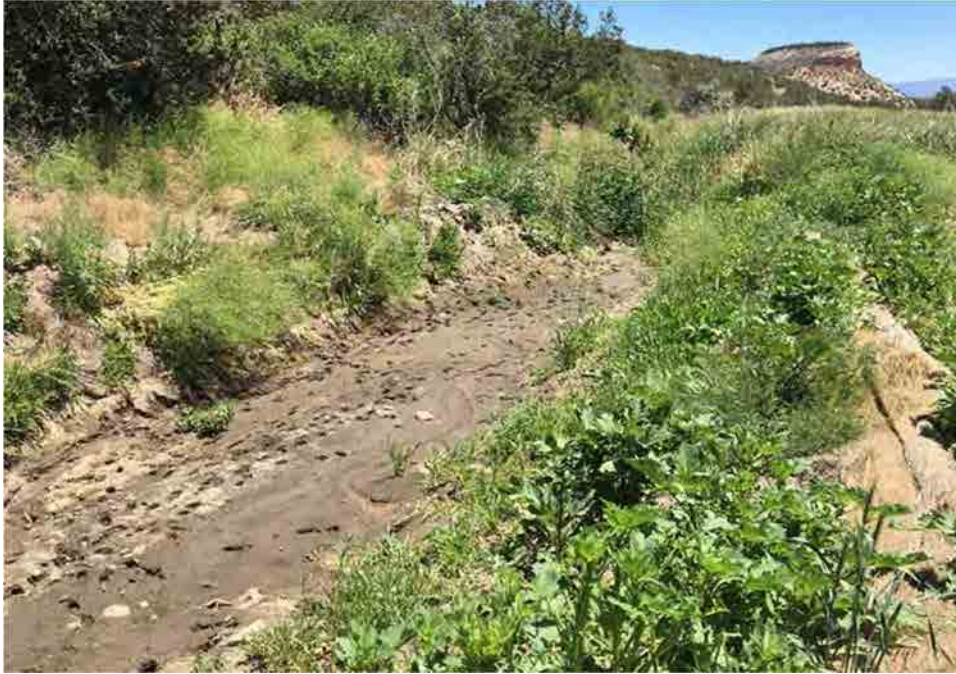
**Photo C-6.11-2 June 2016 — Sediment is present in channel and pond, but there is no way to determine the level or thickness of sediment. There is still a lot of capacity to retain low-flow sediment capture. Recommend monitoring.**

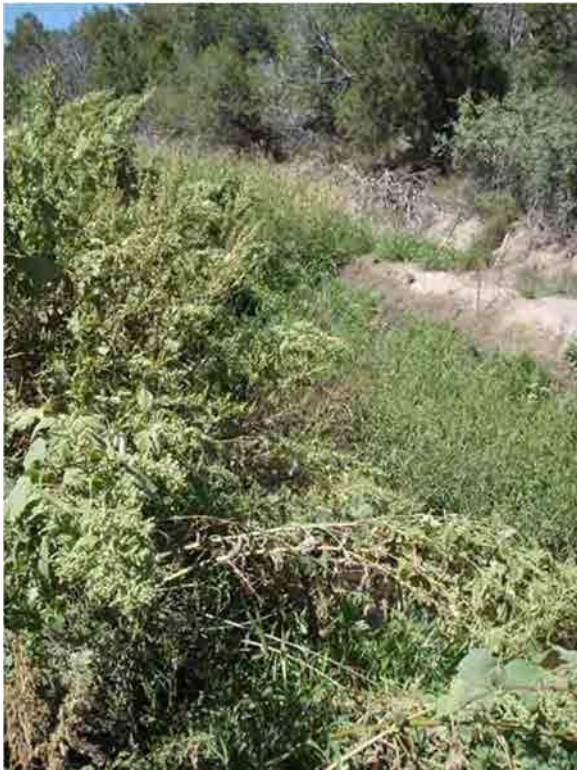
**Photo C-6.11-3 Sept 2016 — Unable to determine sediment level in pond and channel due to water present. Recommend monitoring.**

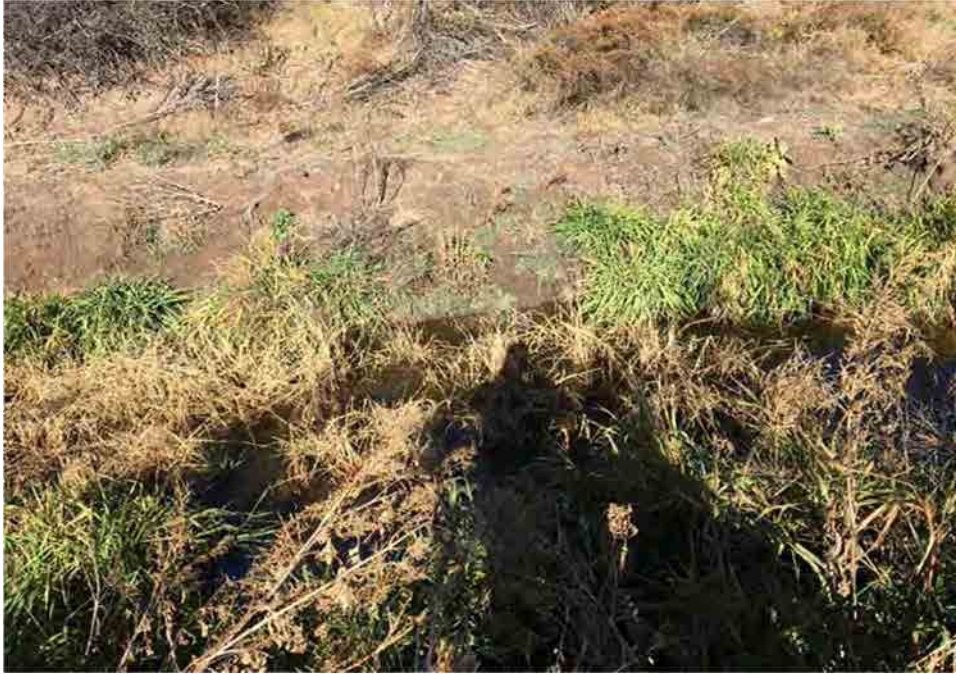
**Photo C-6.11-4** Nov 2016 — Unable to determine sediment level in pond and channel due to water present. Recommend monitoring.

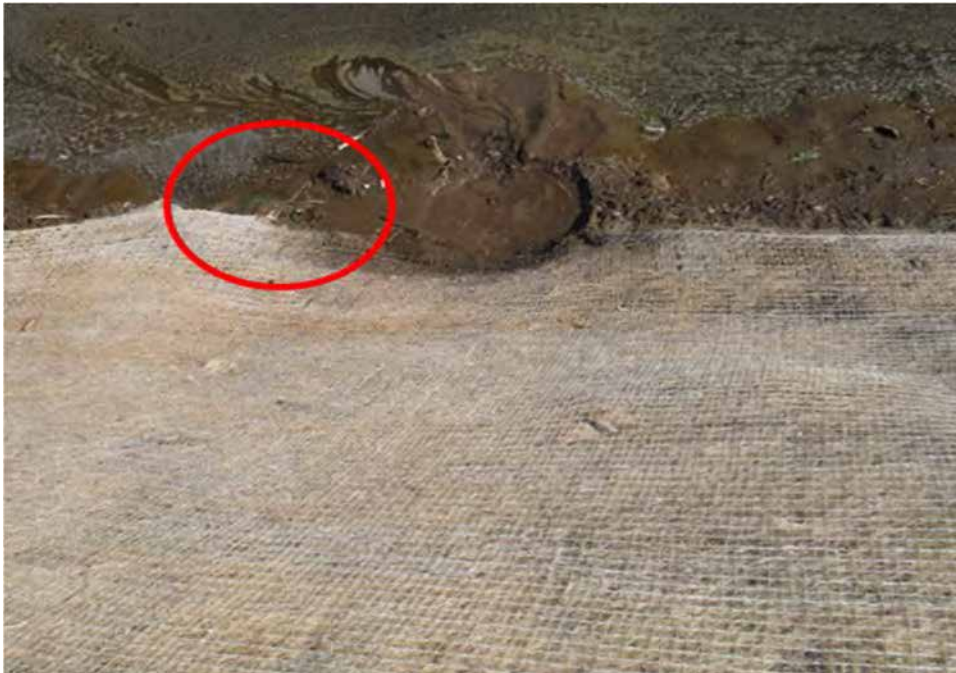
**Photo C-6.12-1** March 2016 — Small piece of trash (noted in red circle) found in pond. A piece of rubber near the channel bank and tee-post were also noted (not pictured). Recommend removal.
