Subject: 2017 Sandia Wetland Performance Report

LA-UR-18-23914
April 2018
EP2018-0013

2017 Sandia Wetland Performance Report

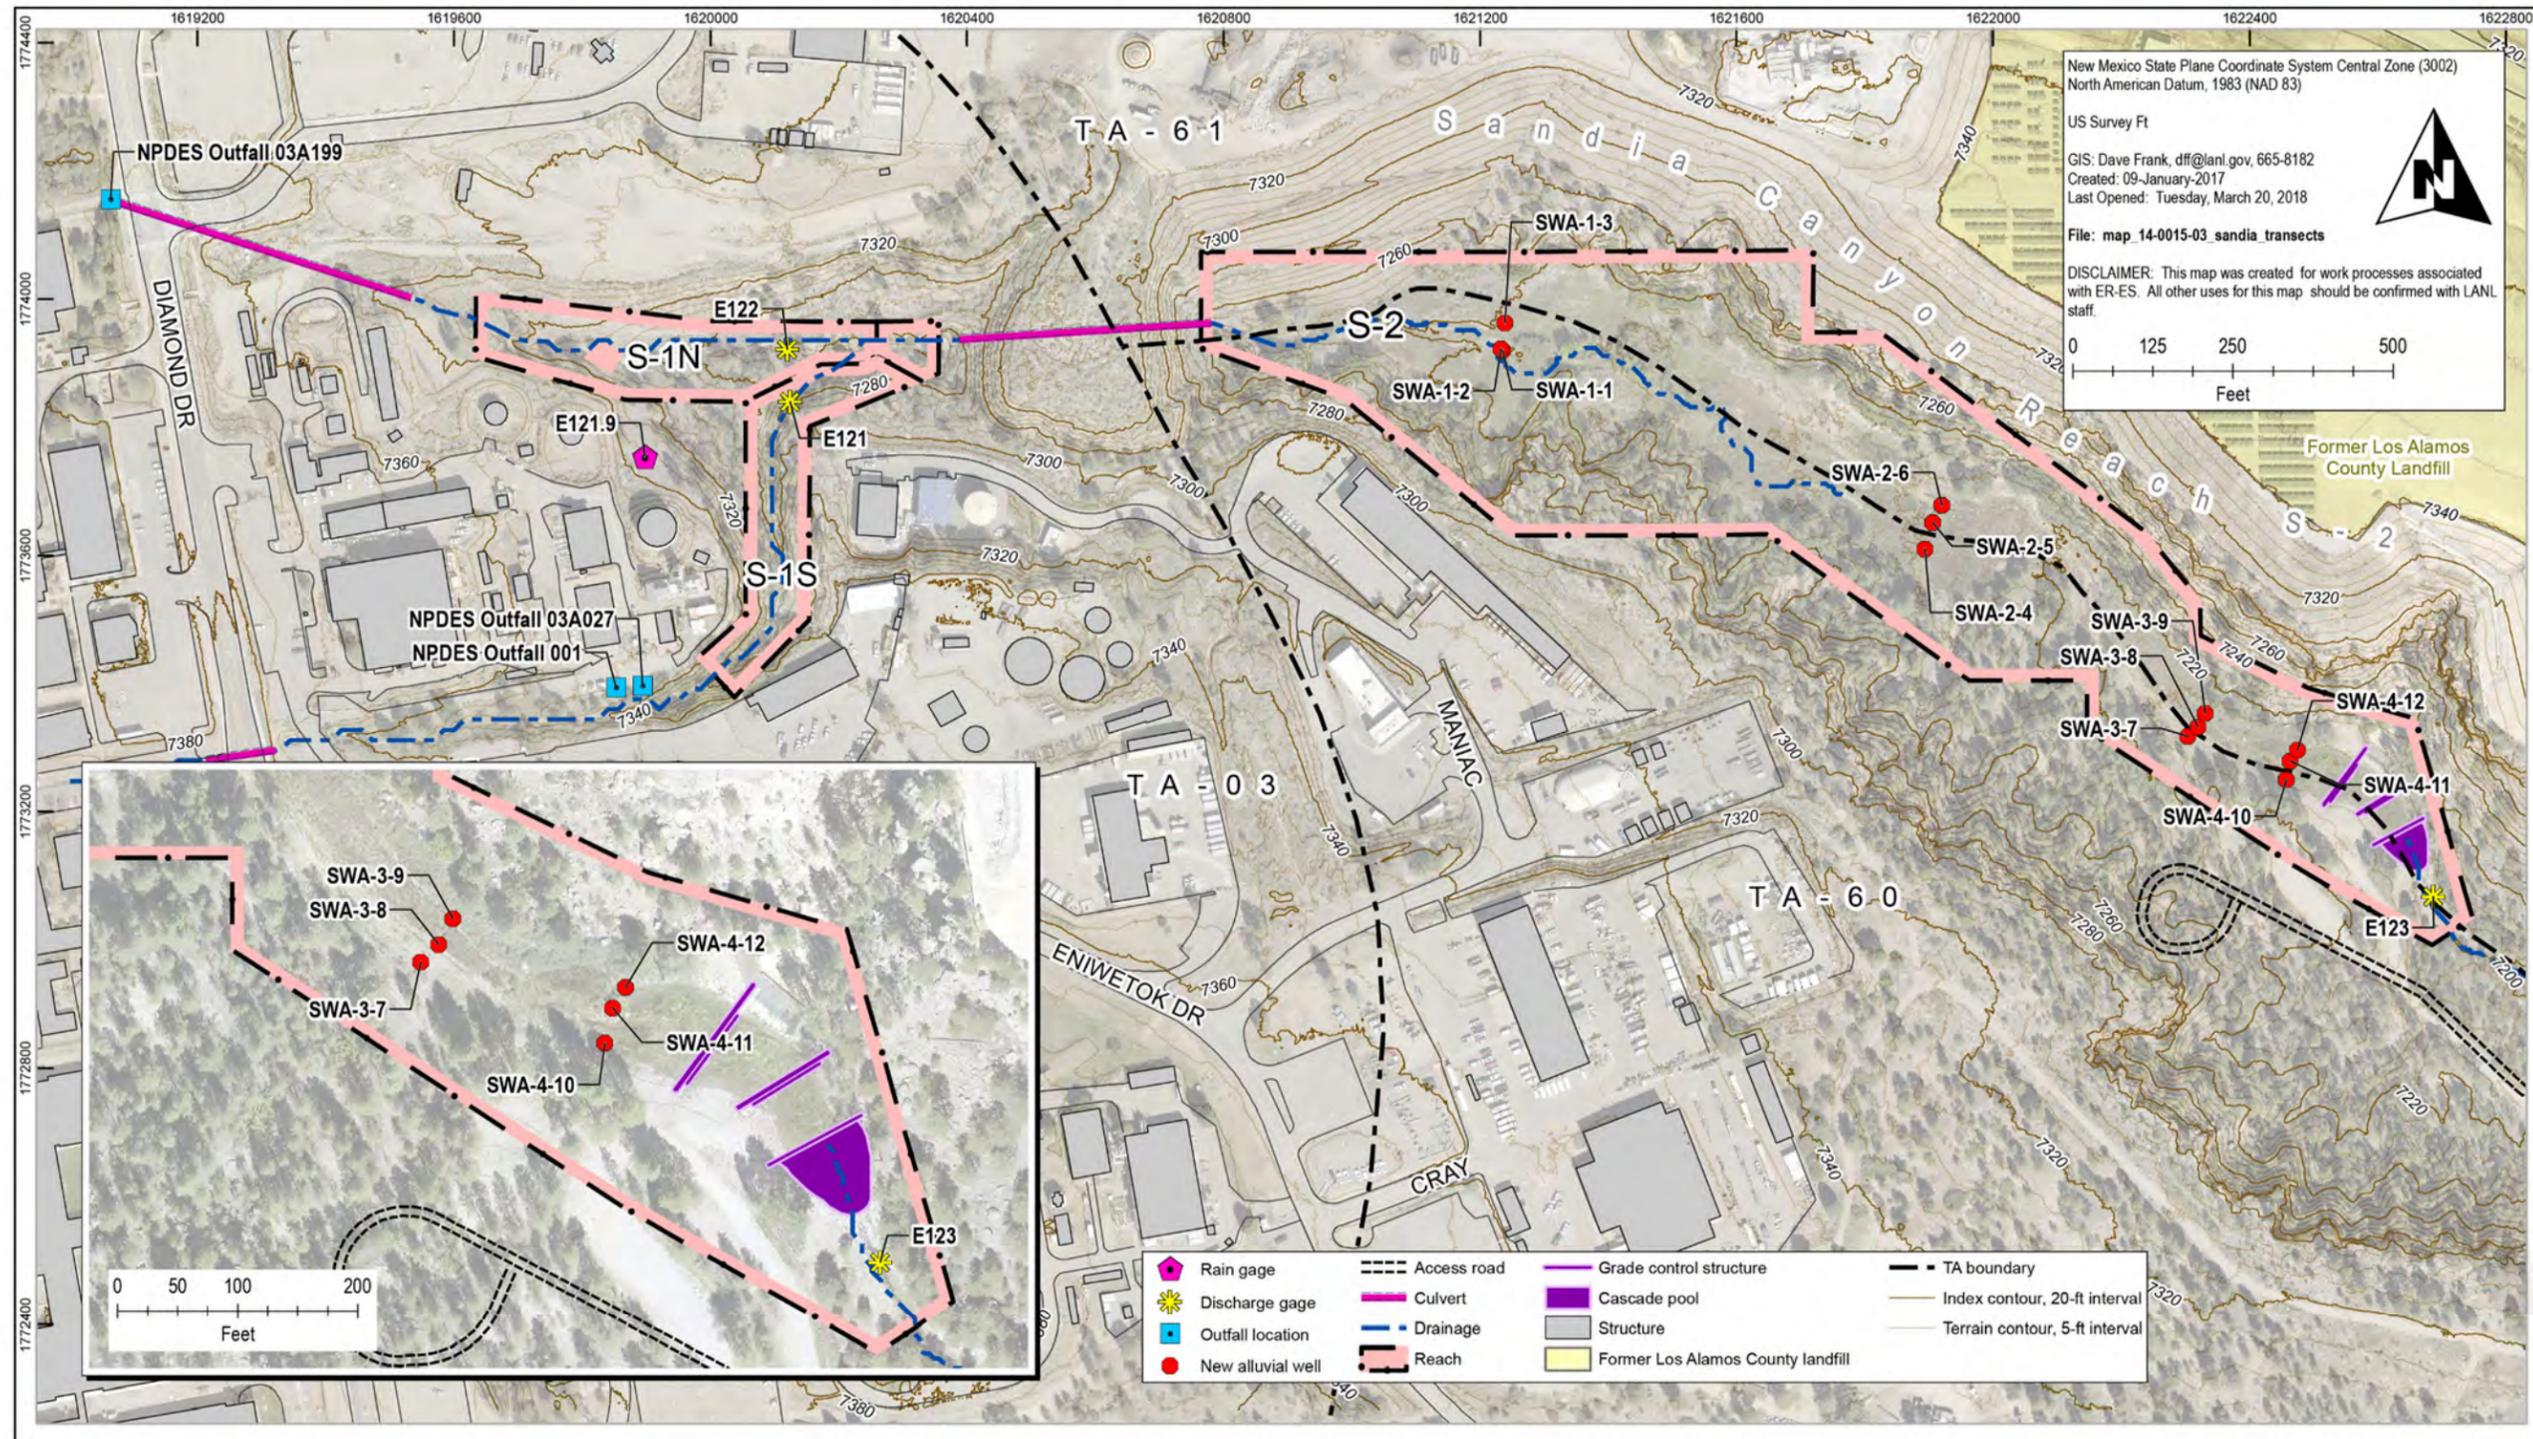
Figure 1.0-1 Locations of the Sandia GCS (headcut was located at the upper most sheet pile at the terminus of the wetland), NPDES outfalls, precipitation gage E121.9, alluvial wells, surface and storm water gaging stations, former Los Alamos County landfill, surrounding TAs, and reaches S-1N, S-1S, and S-2.

The location of the GCS is shown in Figure 1.0-1. The overall objectives of the GCS were to arrest the headcut in the lower portion of the wetland and to maintain favorable hydrologic and geochemical conditions to minimize contaminant migration (LANL 2011, 203454, Figure 2.4-2). The GCS was designed to meet the following objectives:

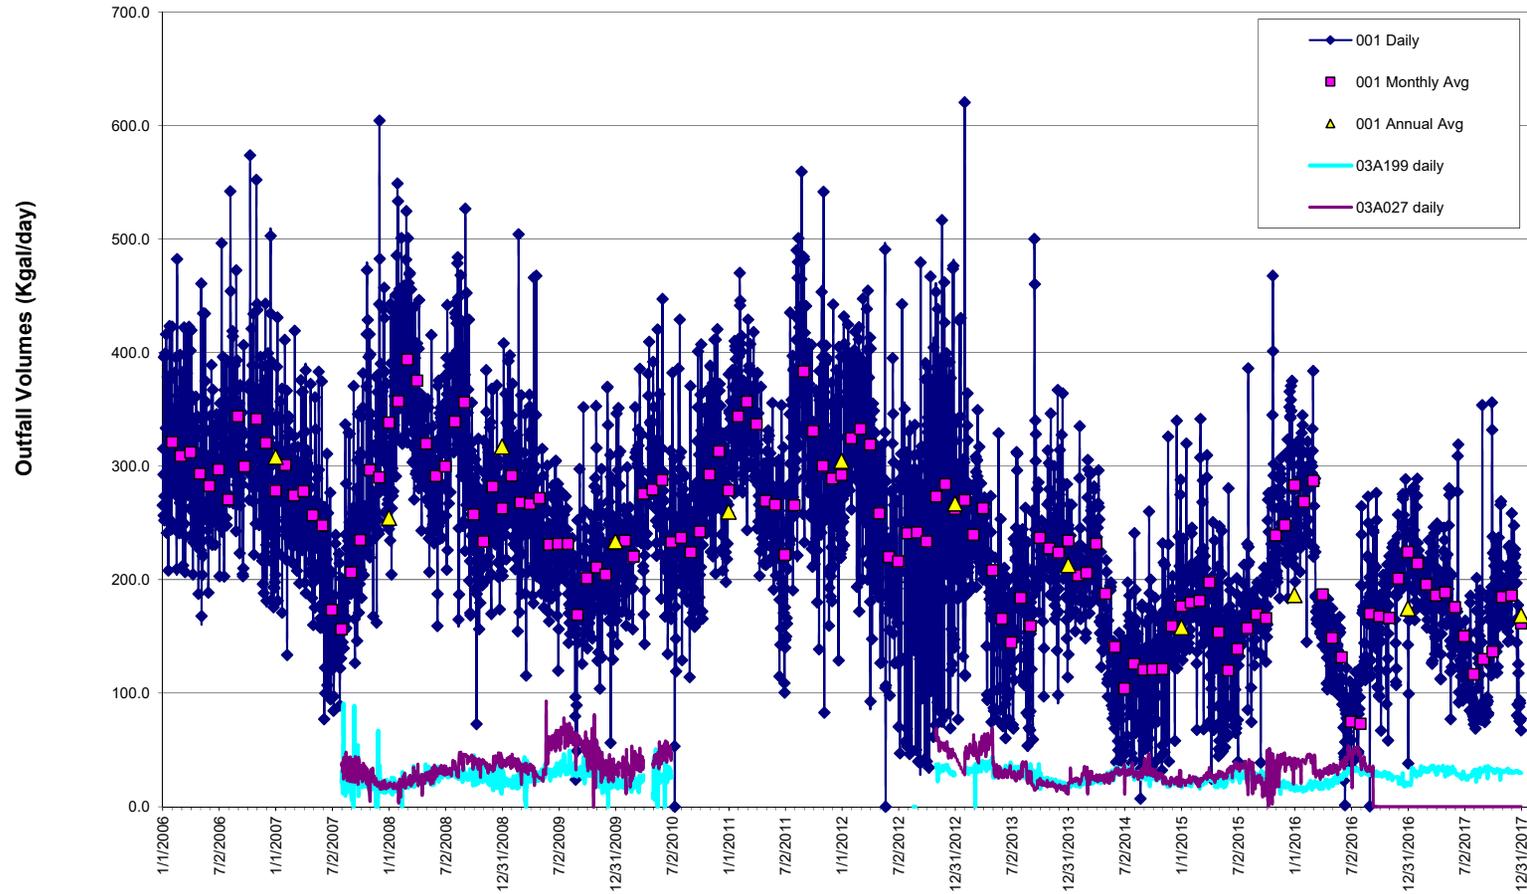
Figure 1.4-1 Daily, monthly average, and yearly average effluent release volumes (expressed as Kgal./d) for Outfall 001 from 2006 to December 2017, and daily effluent releases for Outfalls 03A027 and 03A199 from August 2007 to January 2010 and from November 2012 to December 2017. No discharges to Outfall 03A027 have occurred since September 2016.

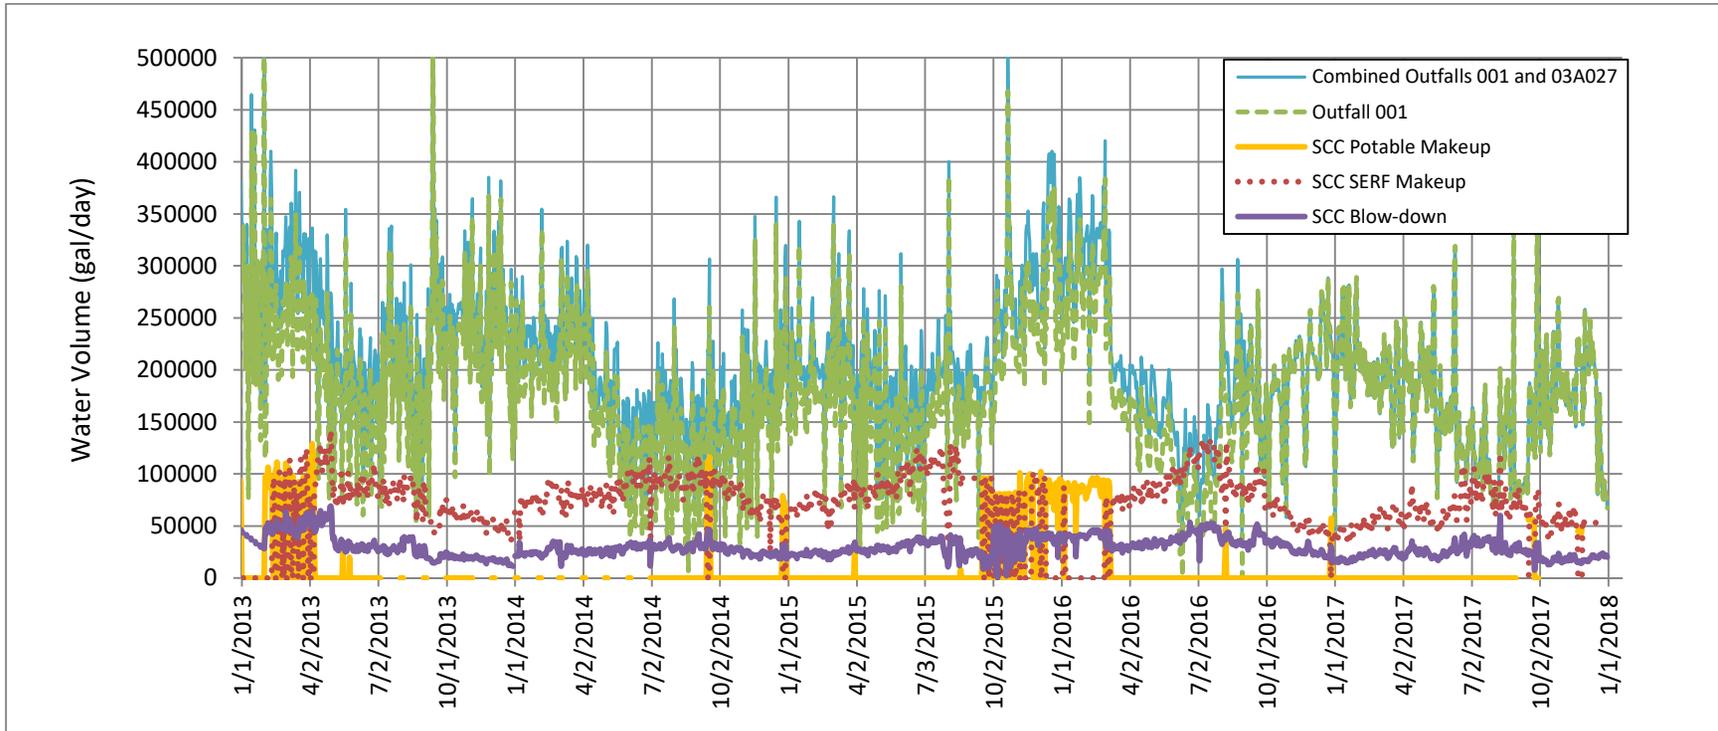
Figure 1.4-2 Daily water volumes (gpd) from November 2012 to December 2017 for effluent released from combined Outfalls 001 and 03A027 and Outfall 001 only. Also included are effluent (blowdown) volumes from the SCC cooling towers and makeup water sources (potable or SERF-blended water) used at the SCC cooling towers. The SCC cooling tower blowdown was released to Outfall 03A027 until September 8, 2016; since September 9, 2016, the blowdown has been released to Outfall 001.

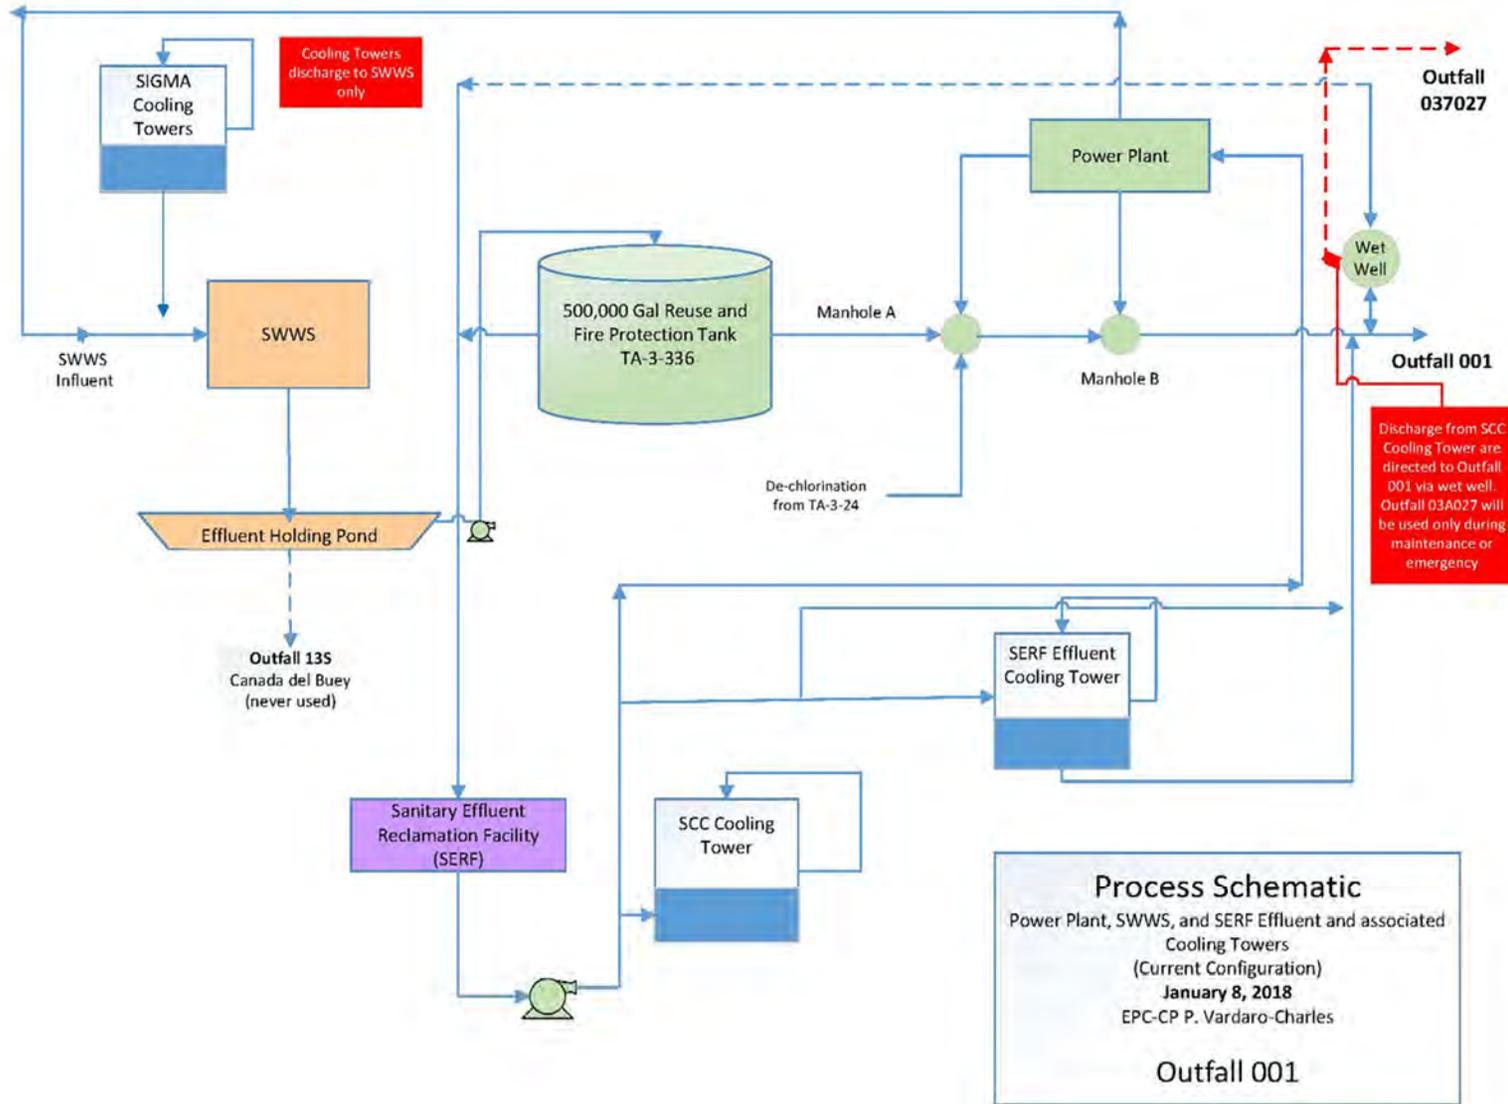
Figure 1.4-3 Updated process schematic for the power plant, SWWS, and SERF connections to Outfall 001 (current configuration)

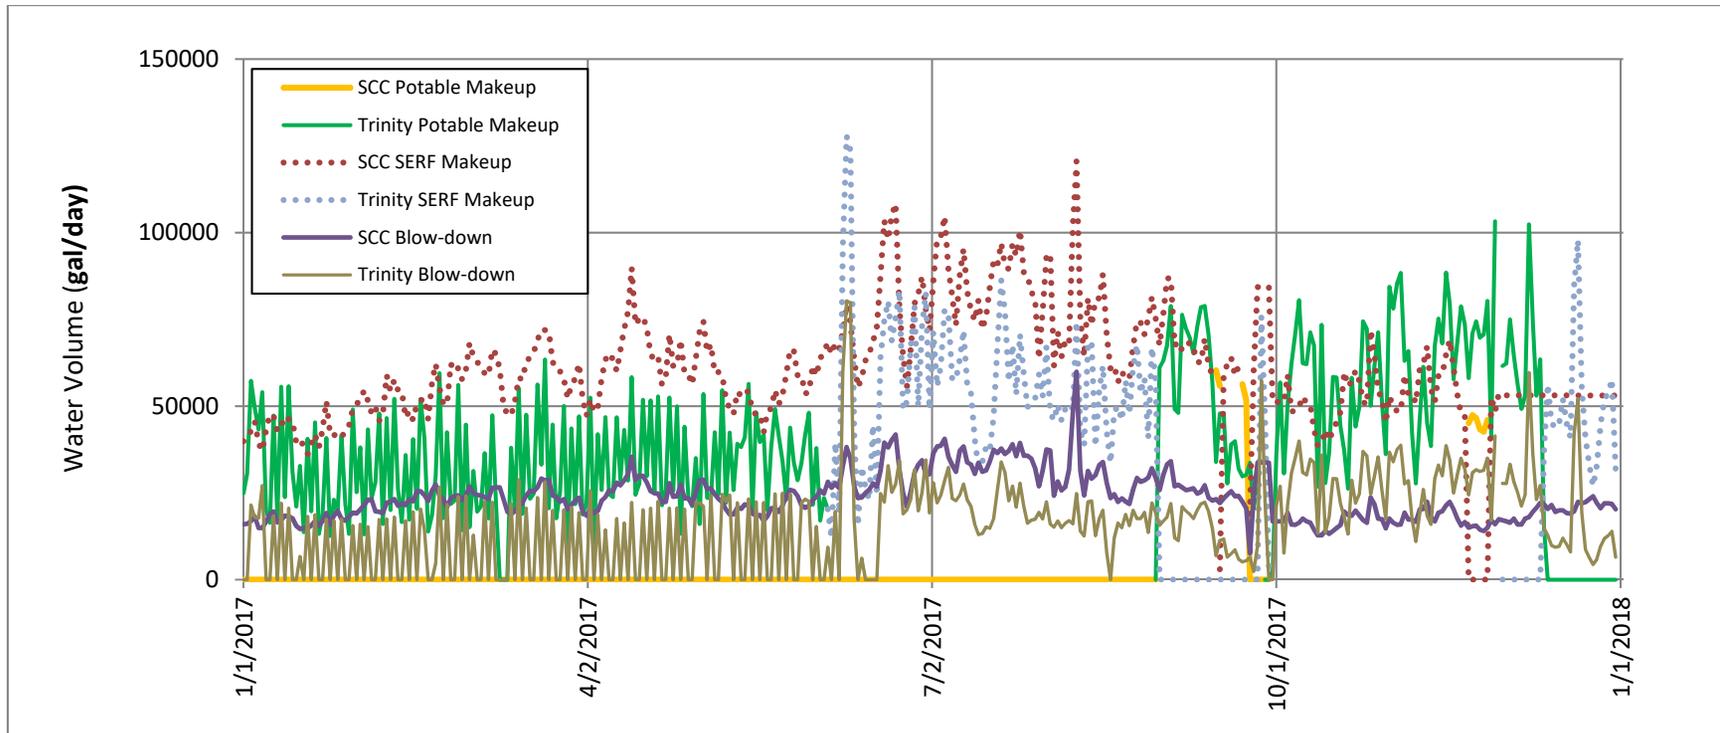
Figure 1.4-4 Daily cooling water usage and discharge information for the SCC and Trinity cooling towers during 2017. Included are effluent (blowdown) volumes from the SCC and Trinity cooling towers and makeup water sources (potable or SERF-blended water) used at the SCC and Trinity cooling towers. During 2017, all SCC and Trinity cooling tower blowdown was released to Outfall 001.

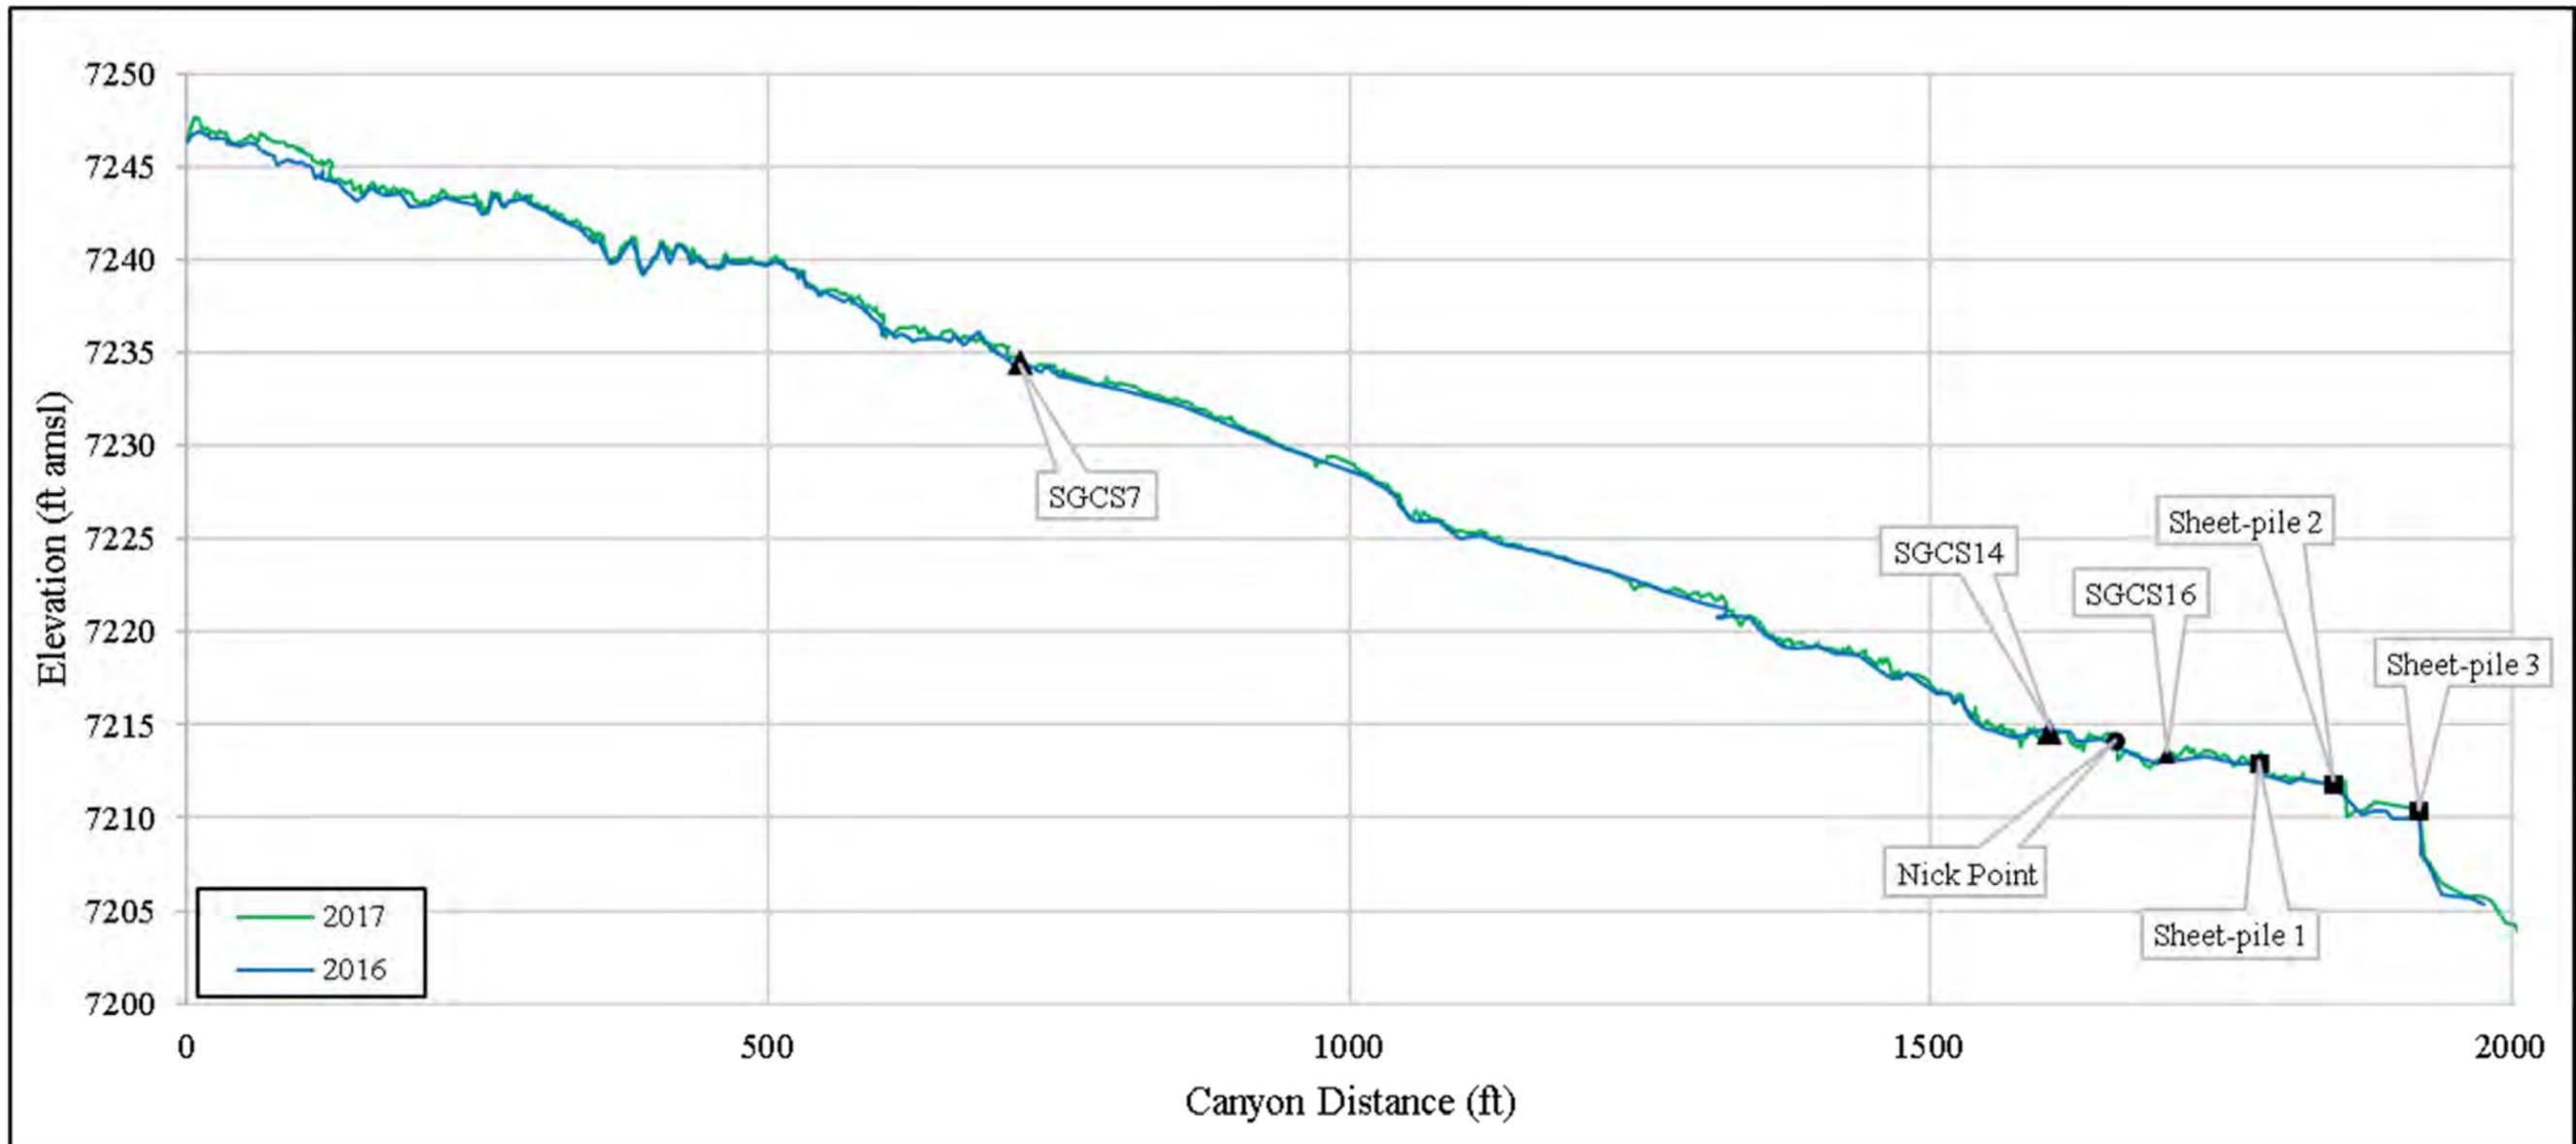
Figure B-4.1-1 Thalweg profile in Sandia Canyon comparing 2016 and 2017 survey data

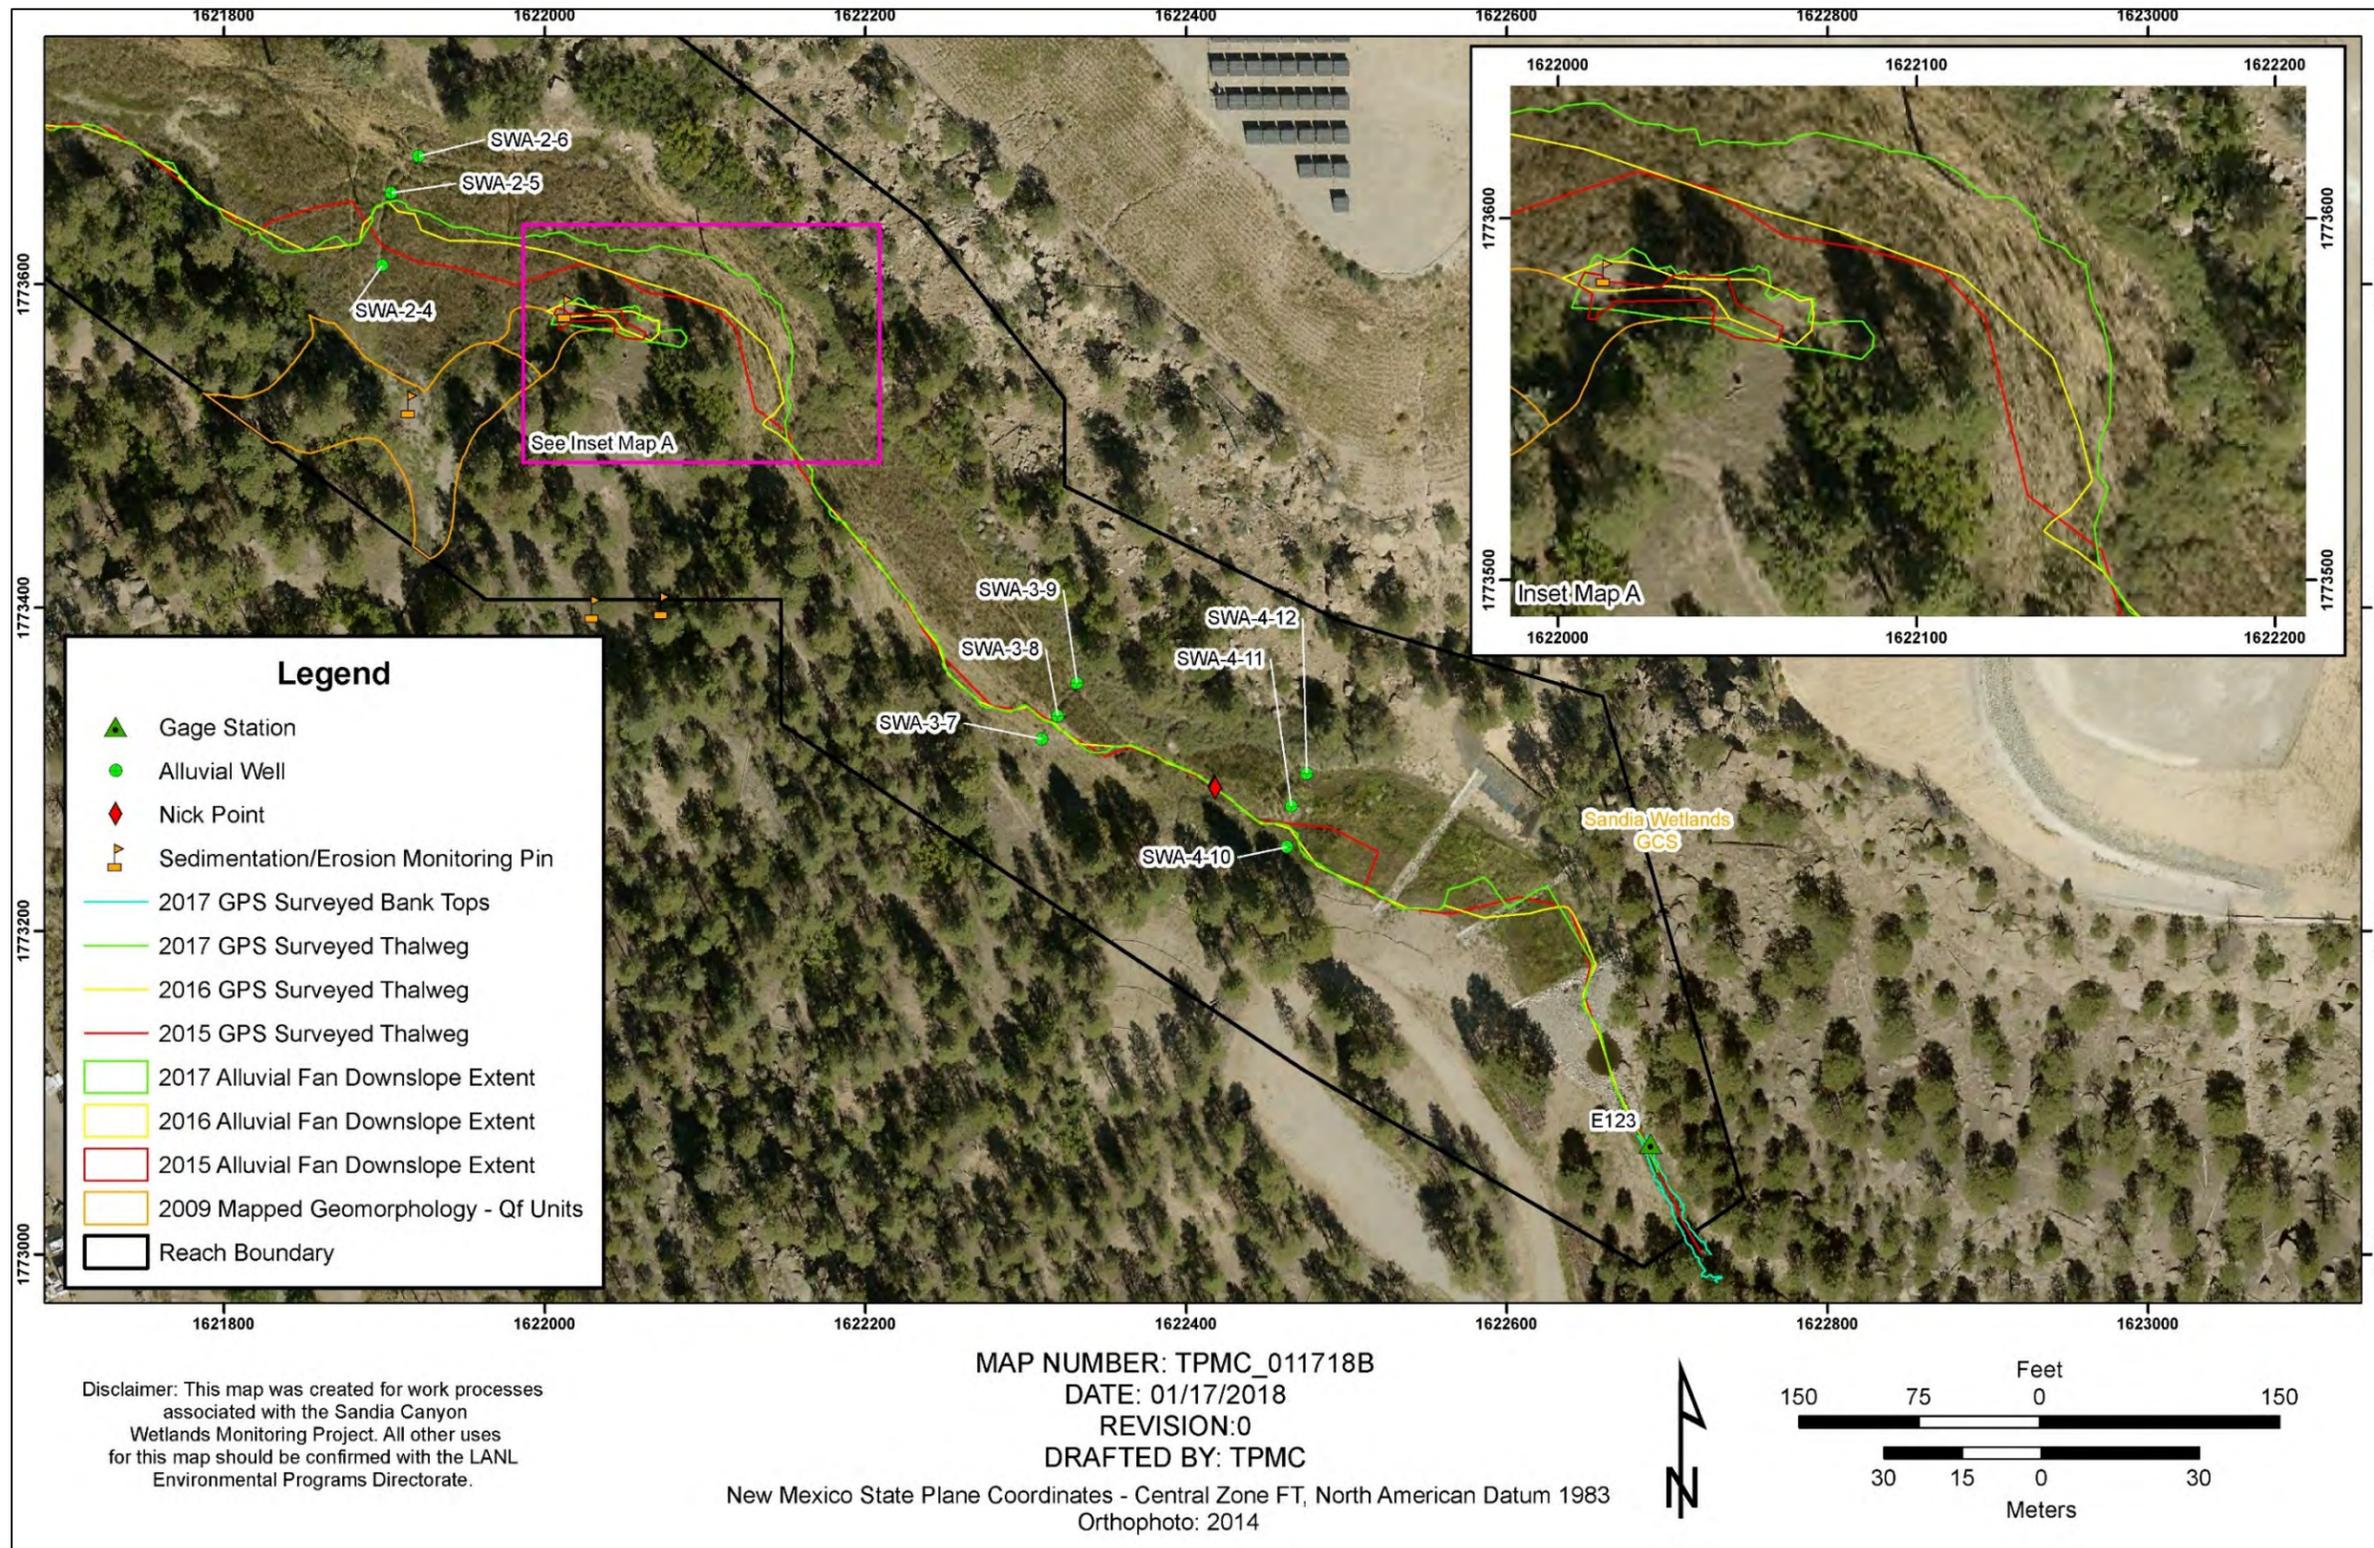
Figure B-4.1-2 Lower end of reach S-2 highlighting position of thalweg in relation to alluvial fan extent

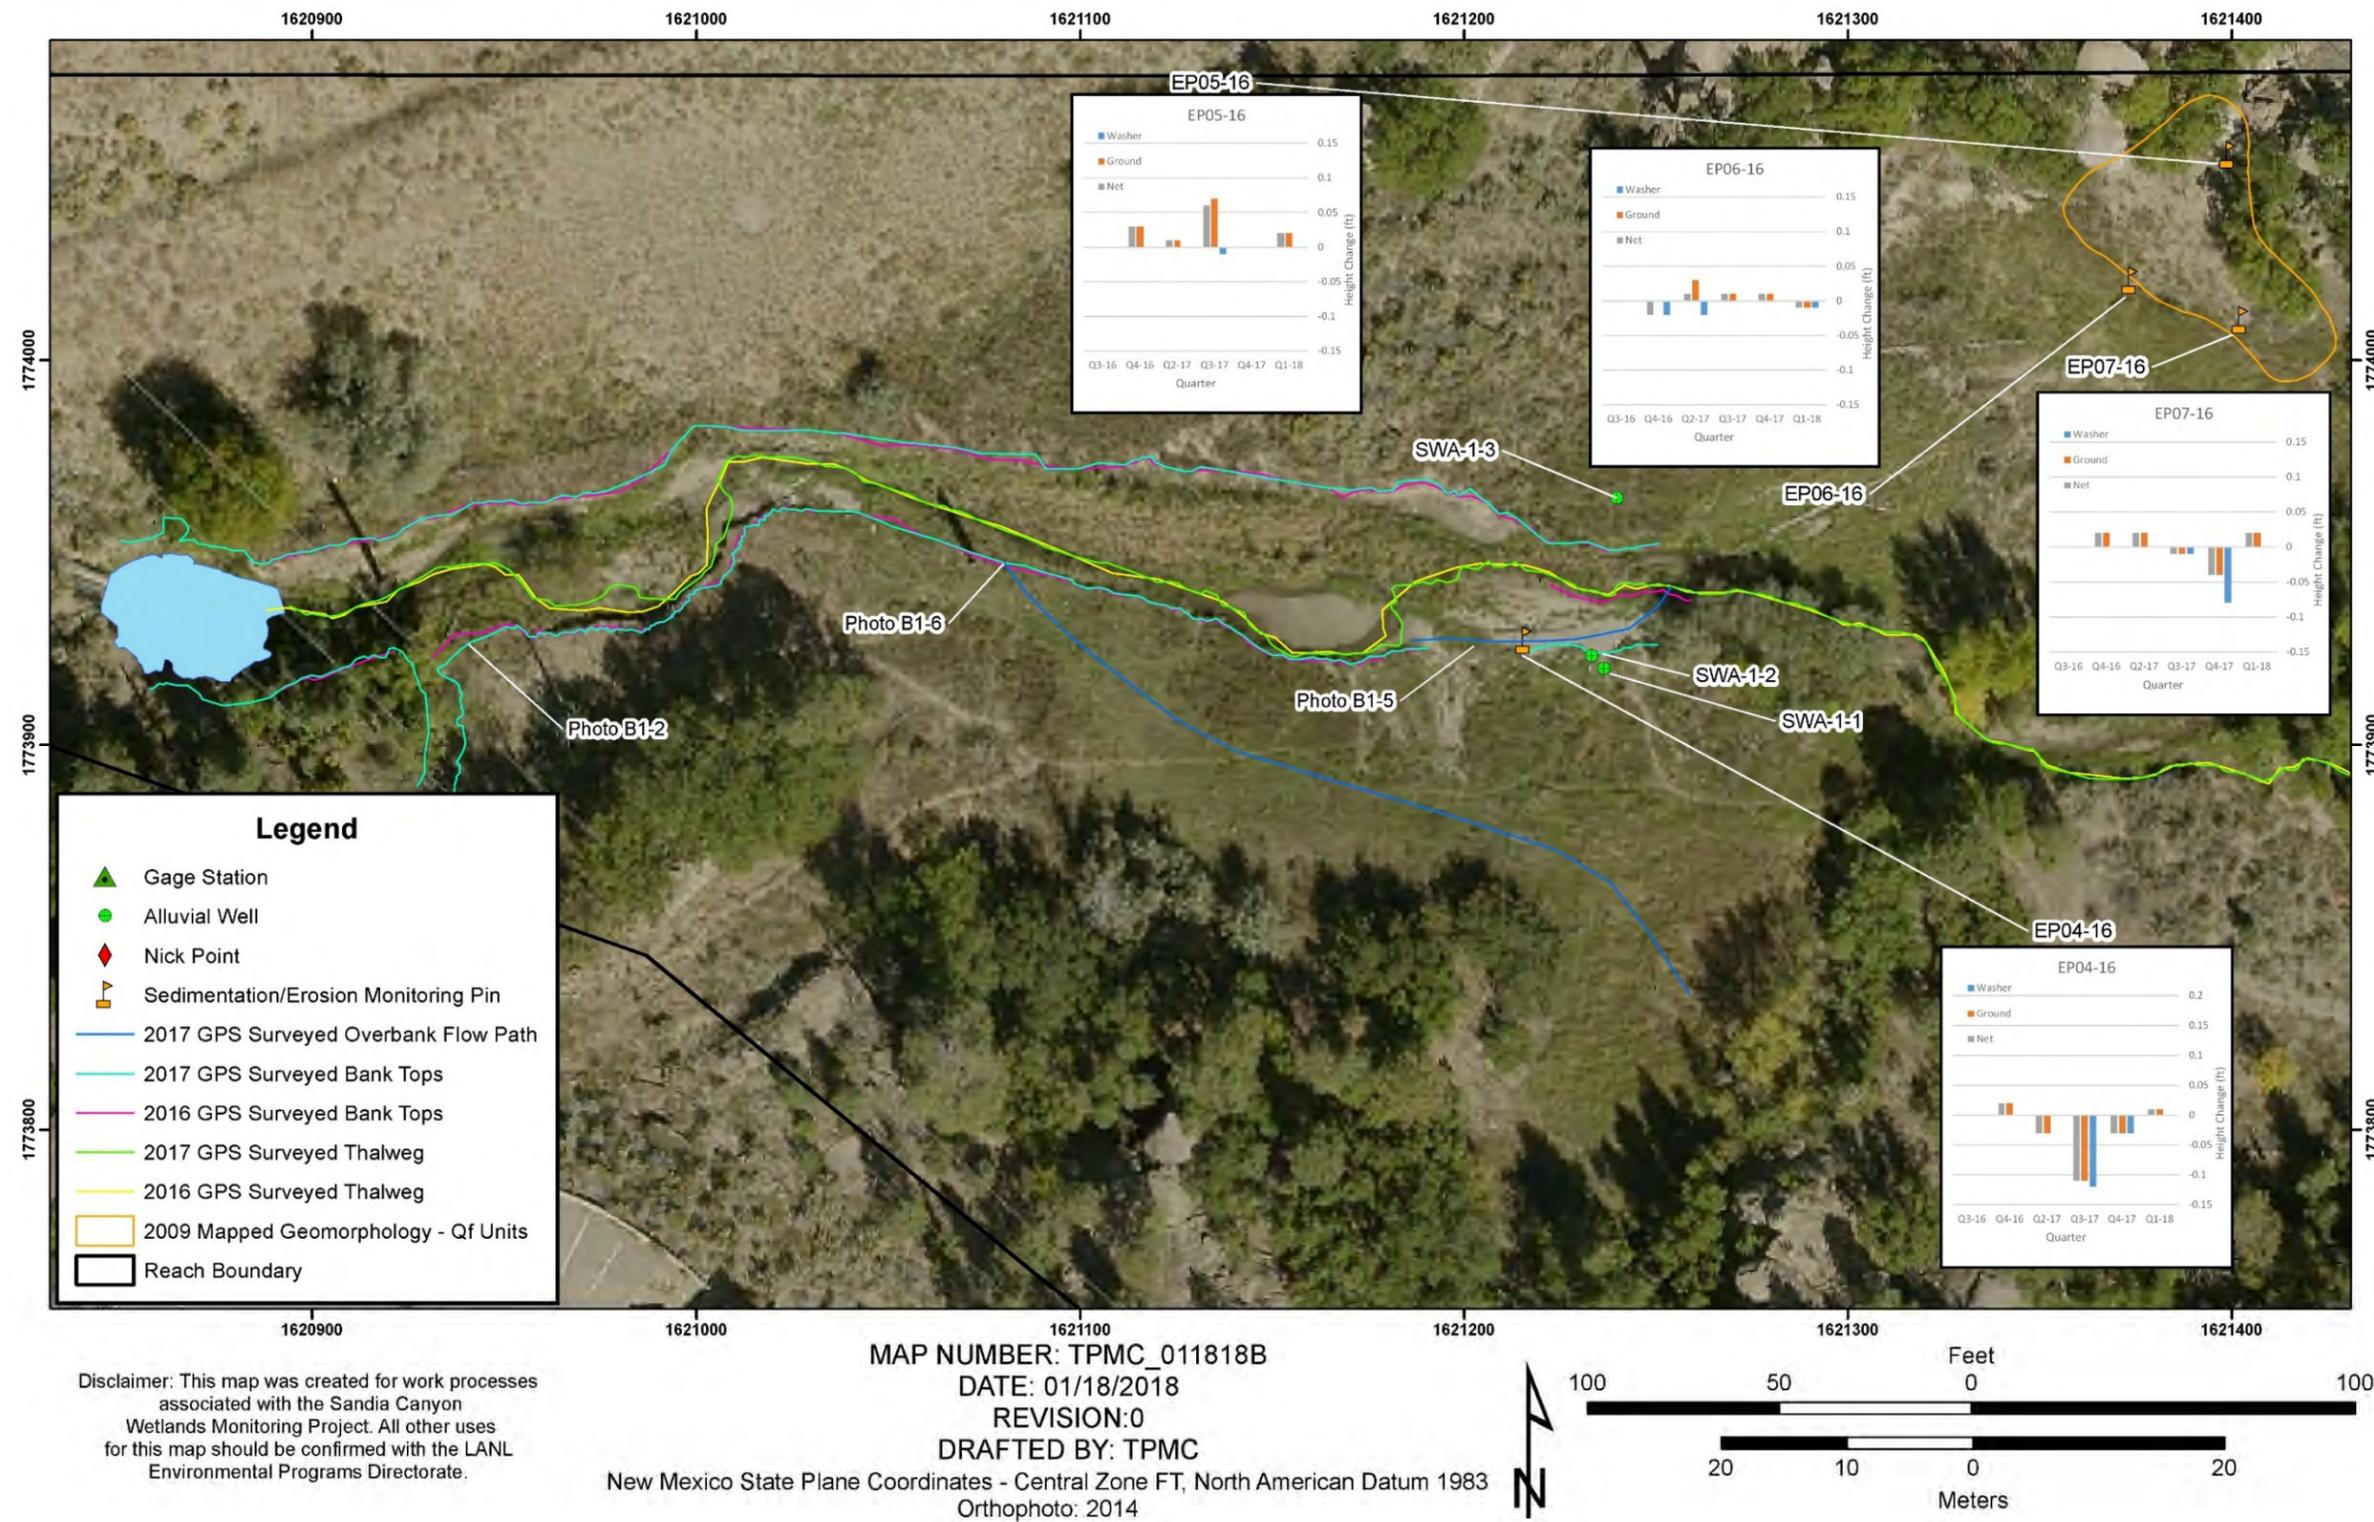
Figure B-4.3-1 Upper portion of reach S-2 displaying 1 yr bank and thalweg comparisons, path of overbank flows, and erosion pin data
