Subject: 2017 Sandia Wetland Performance Report

LA-UR-18-23914
April 2018
EP2018-0013

2017 Sandia Wetland Performance Report

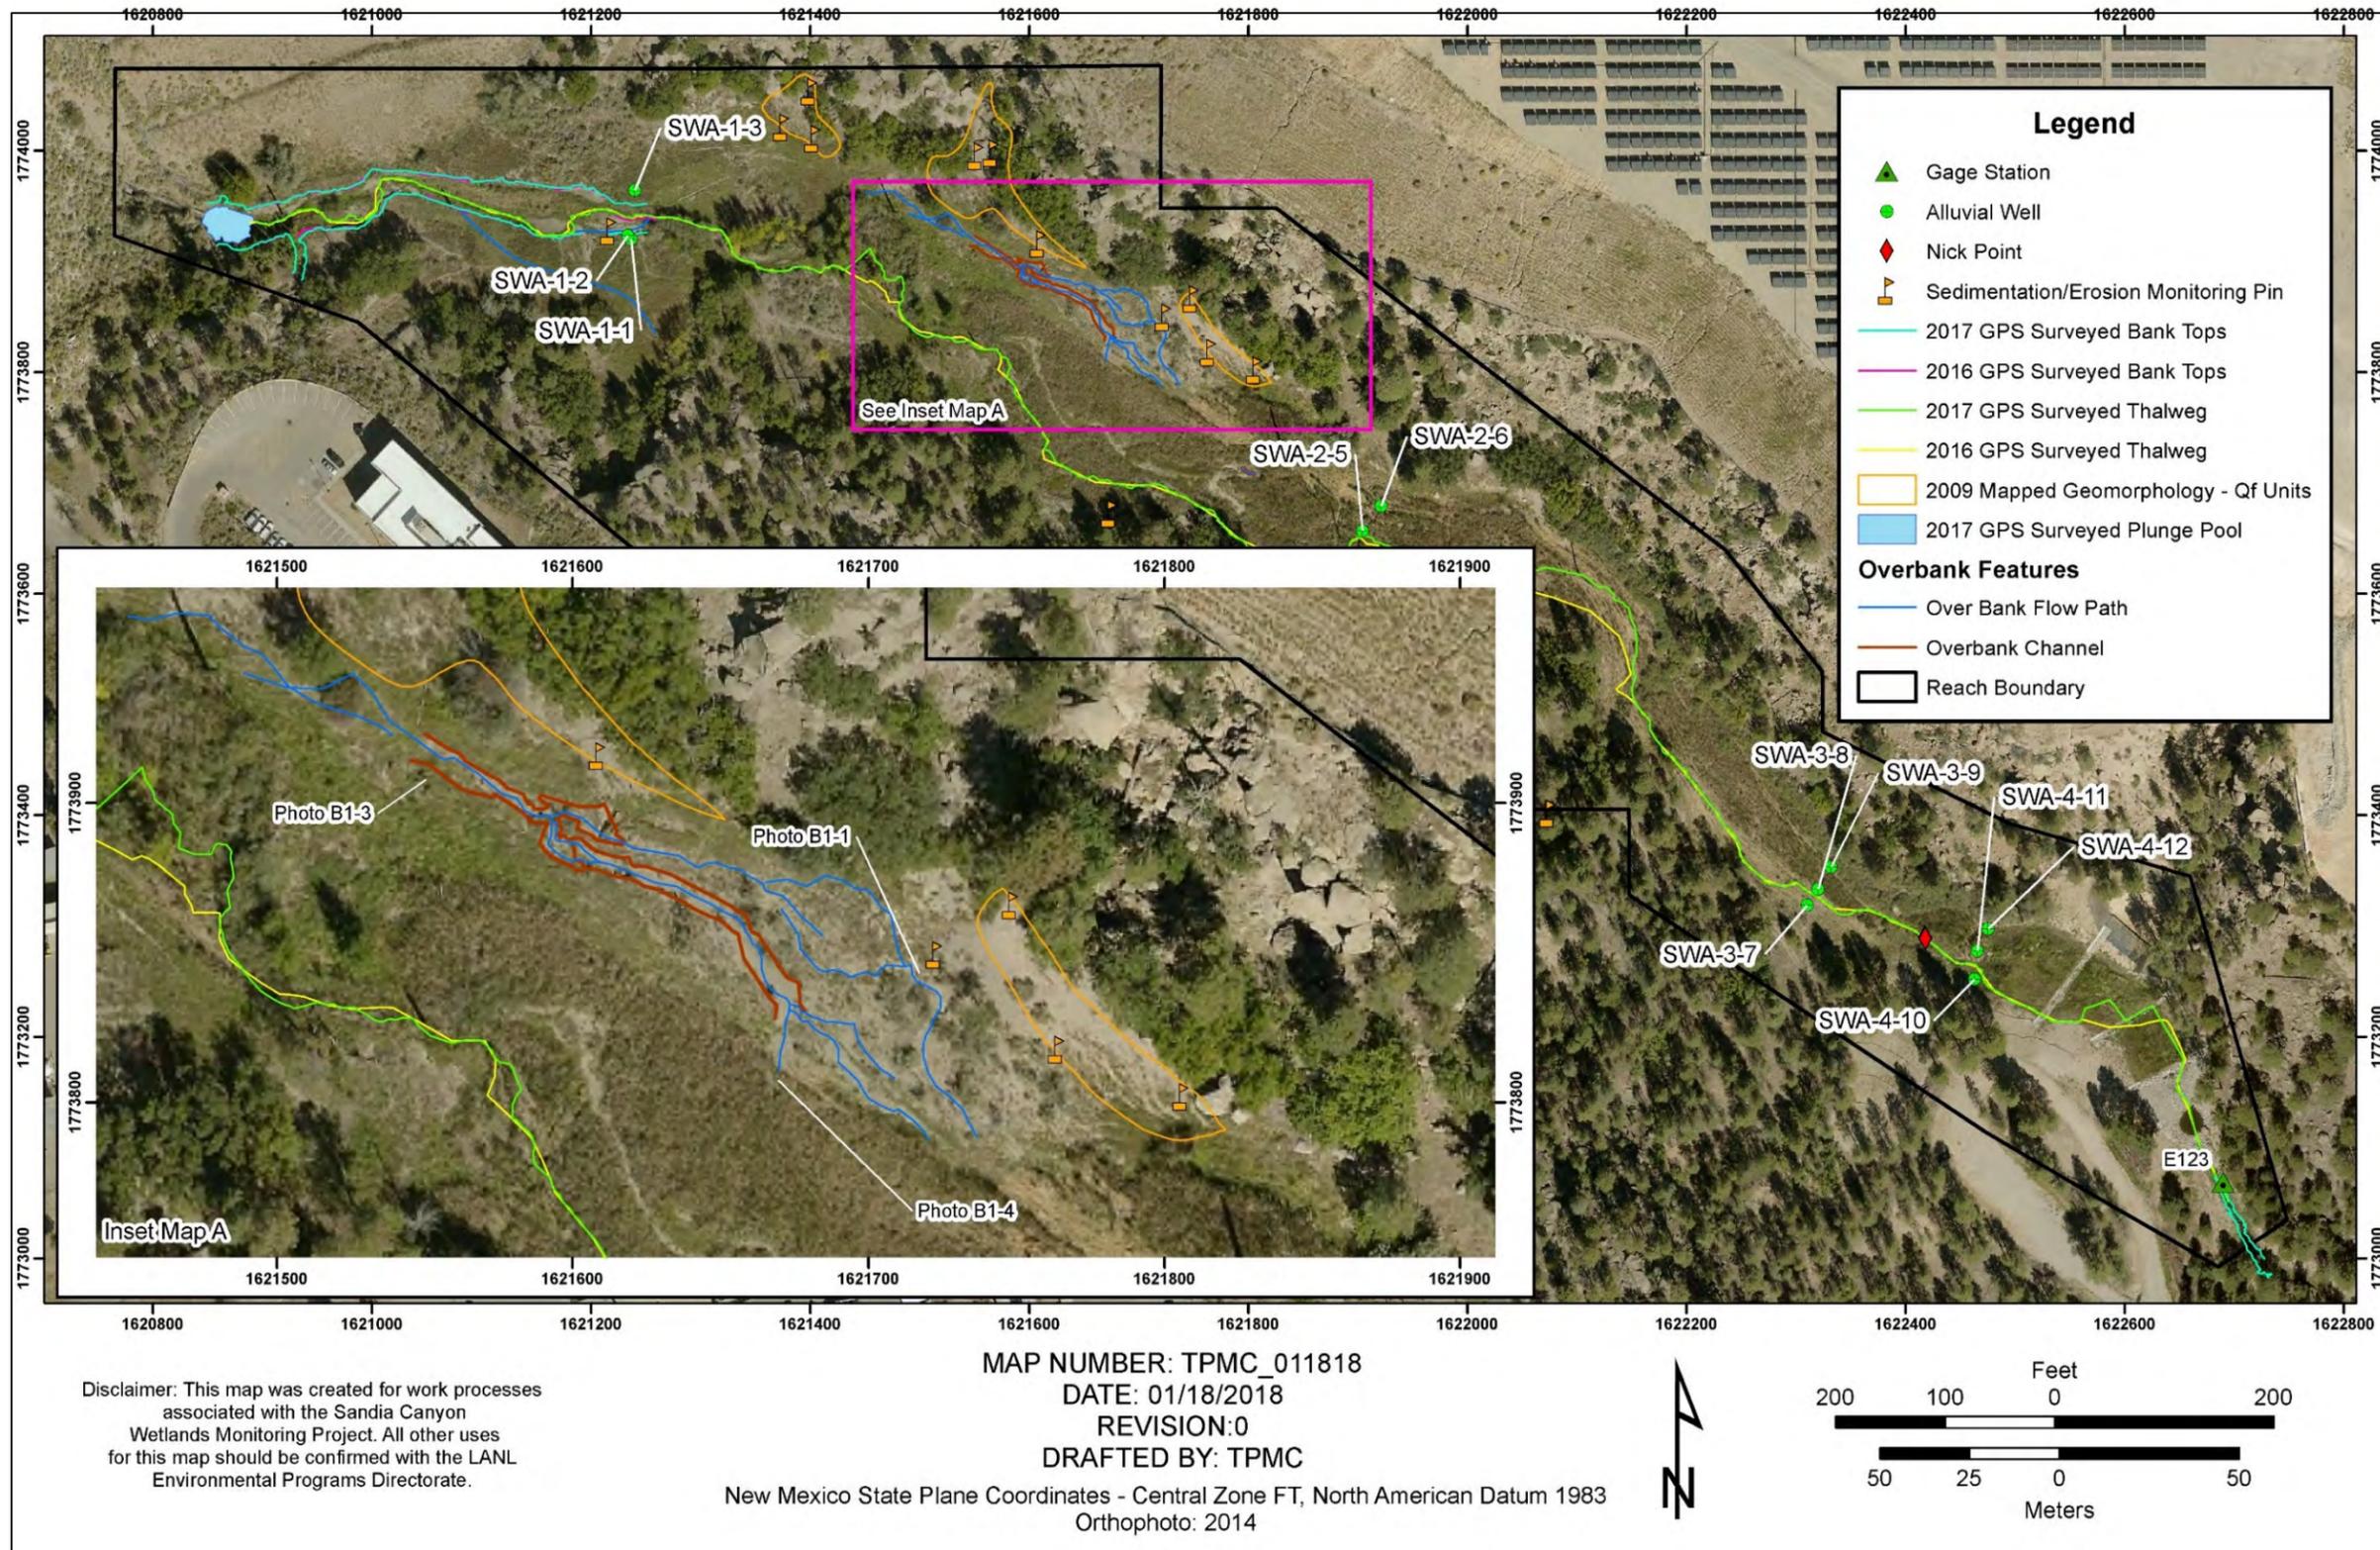
Figure B-4.3-2 Map of reach S-2 highlighting overbank flow features in the northcentral portion of the reach

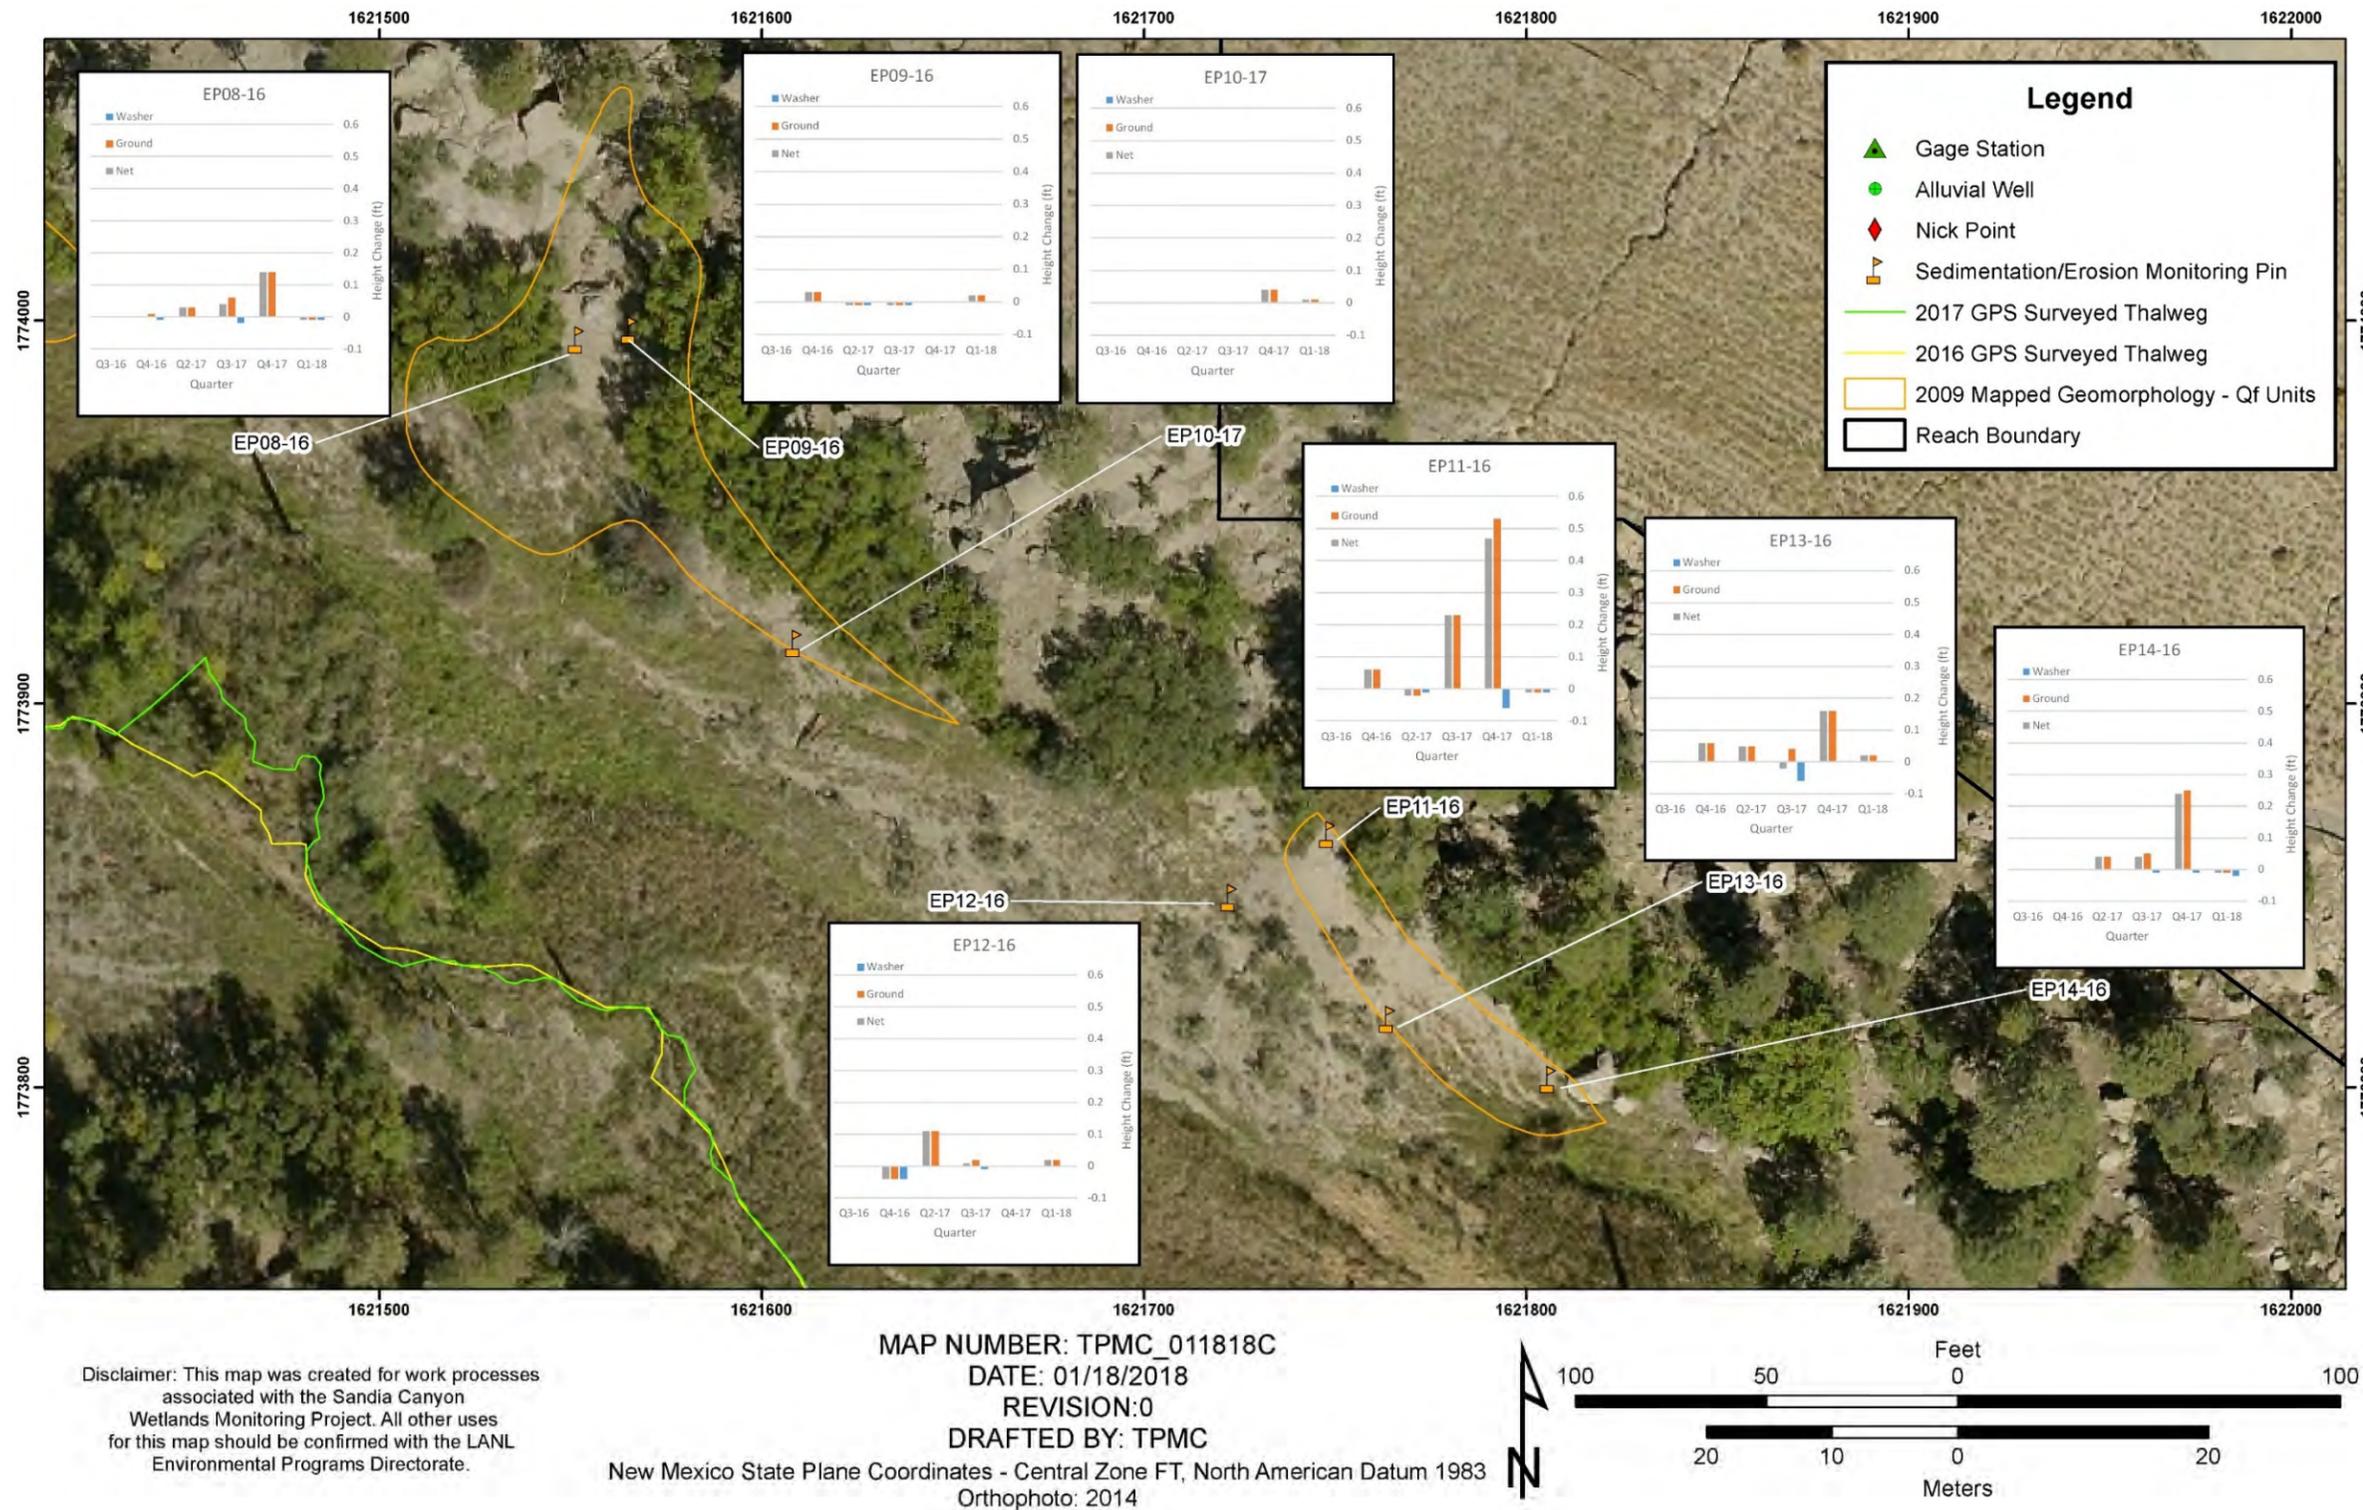
Figure B-4.4-1 Map of reach S-2 highlighting two alluvial fans in the northcentral part of the reach

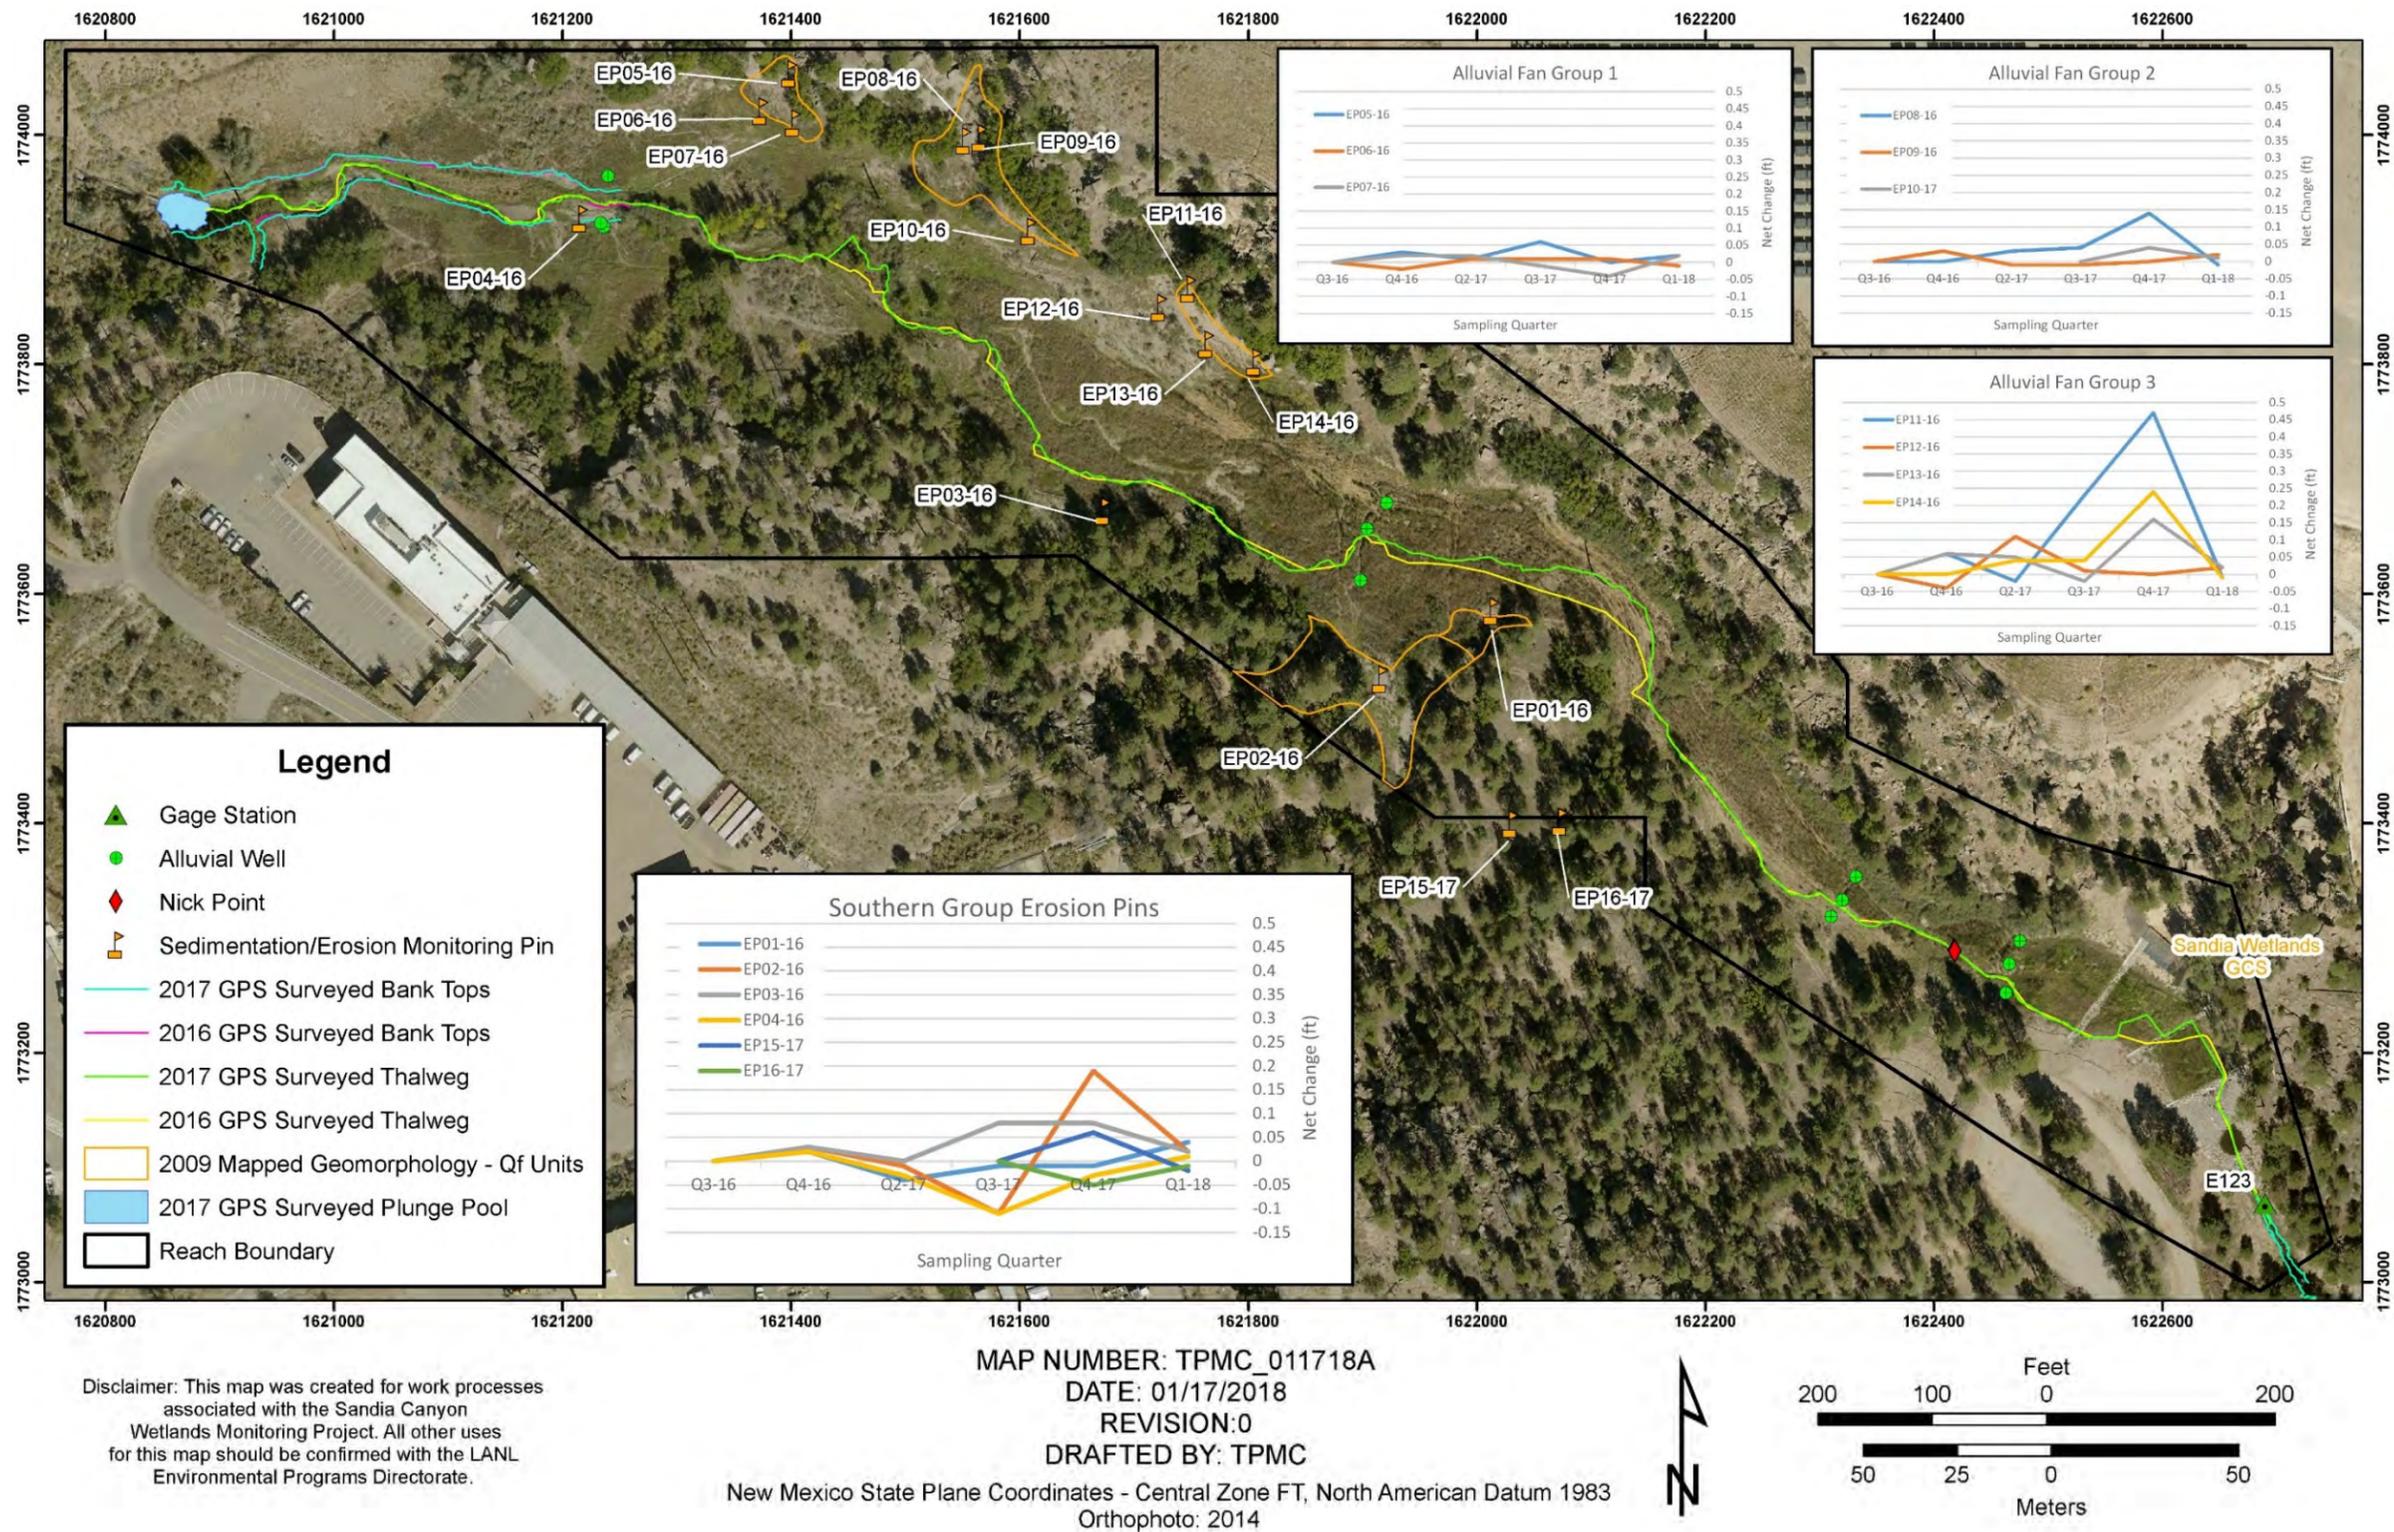
Figure B-4.4-2 Map of reach S-2 highlighting net change documented at erosion pins in their respective groups

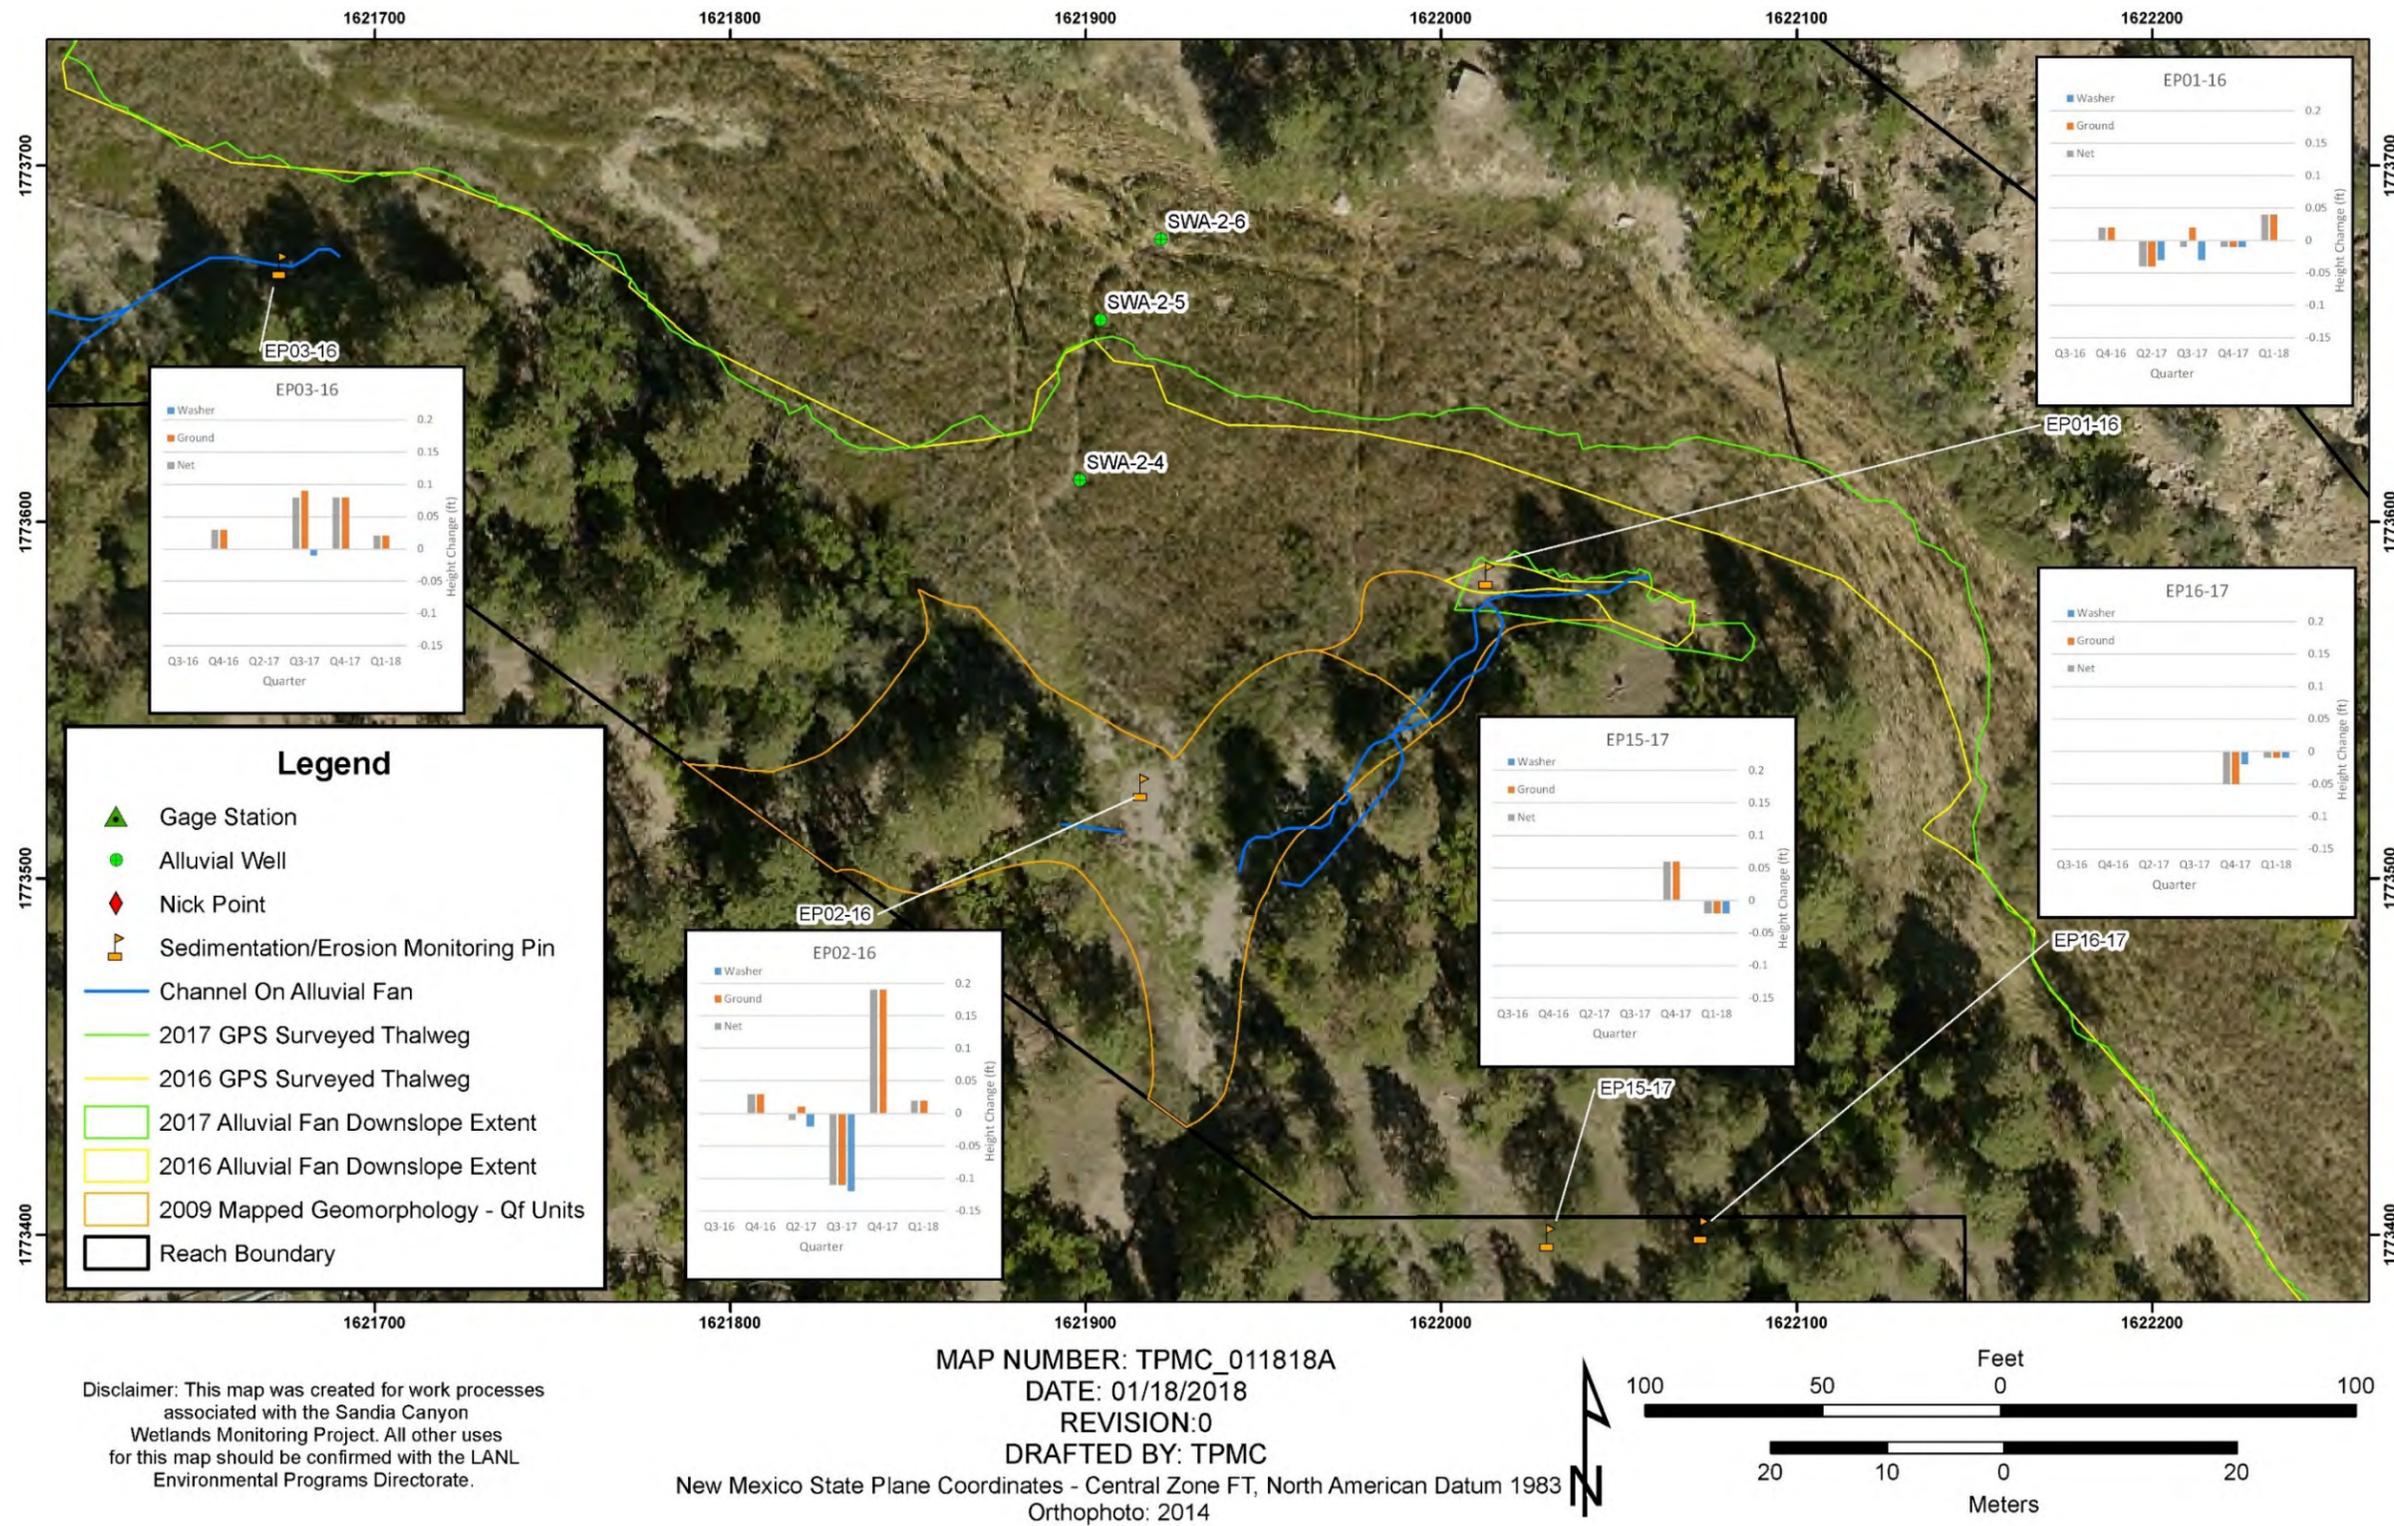
Figure B-4.4-3 Map of reach S-2 highlighting alluvial fan extent and erosion pin data for locations on the southeastern side of the Sandia wetlands

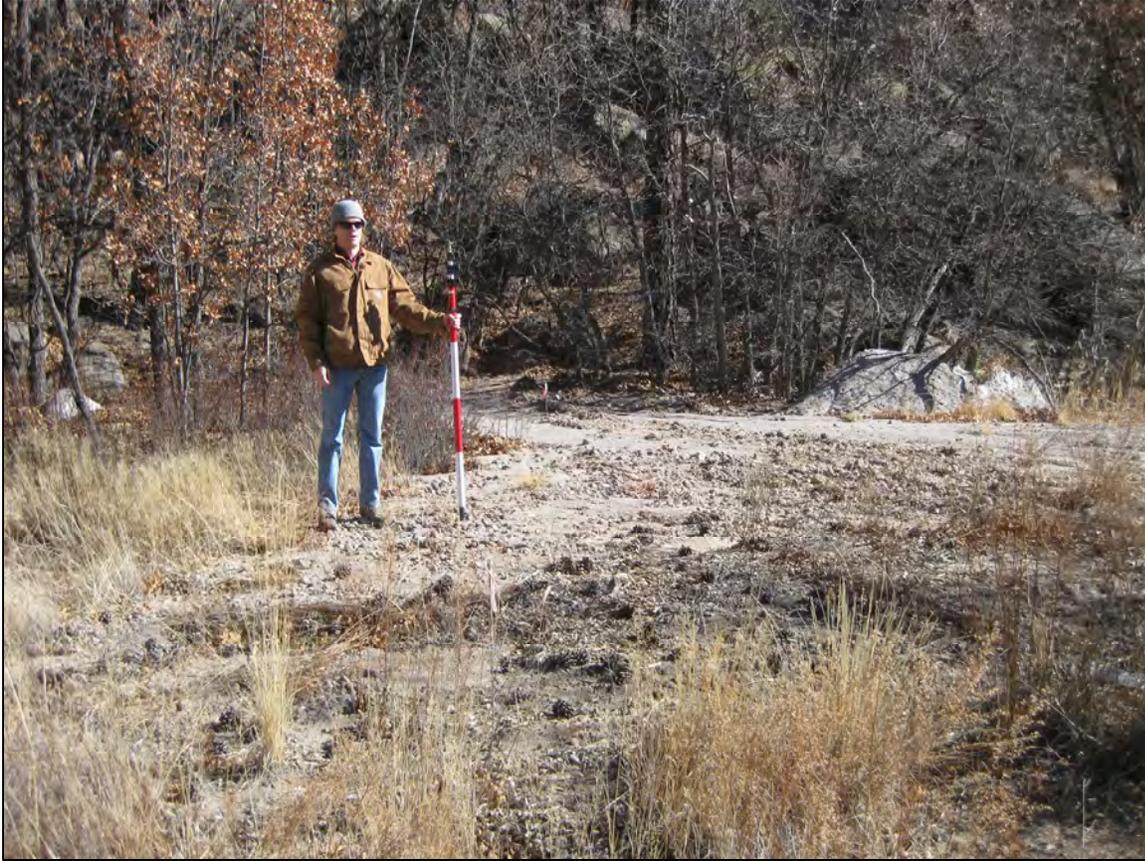
Photo B1-1 Example of erosion pin placement in reach S-2. February 2018 photo looking to north.

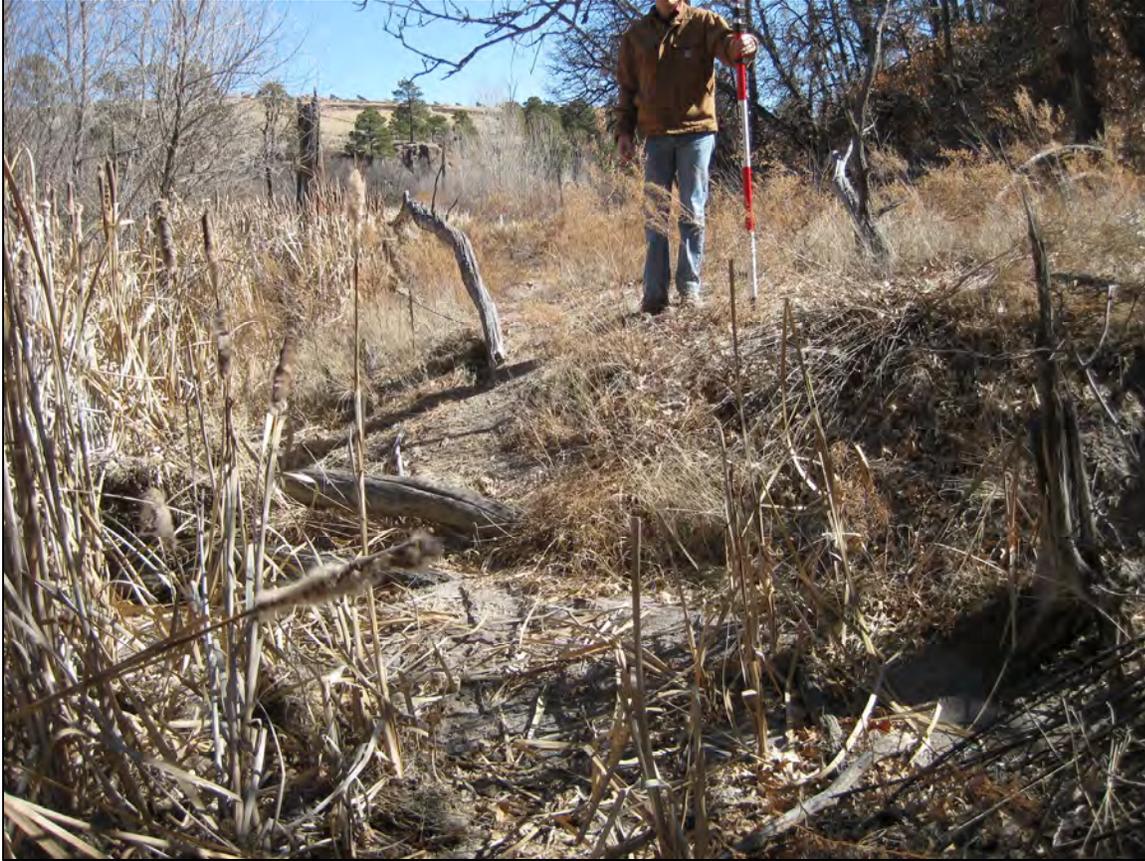
Photo B1-2 Example of bank survey interpretation of break in slope. No evidence of erosion based on field check. February 2017 photo looking northeast.

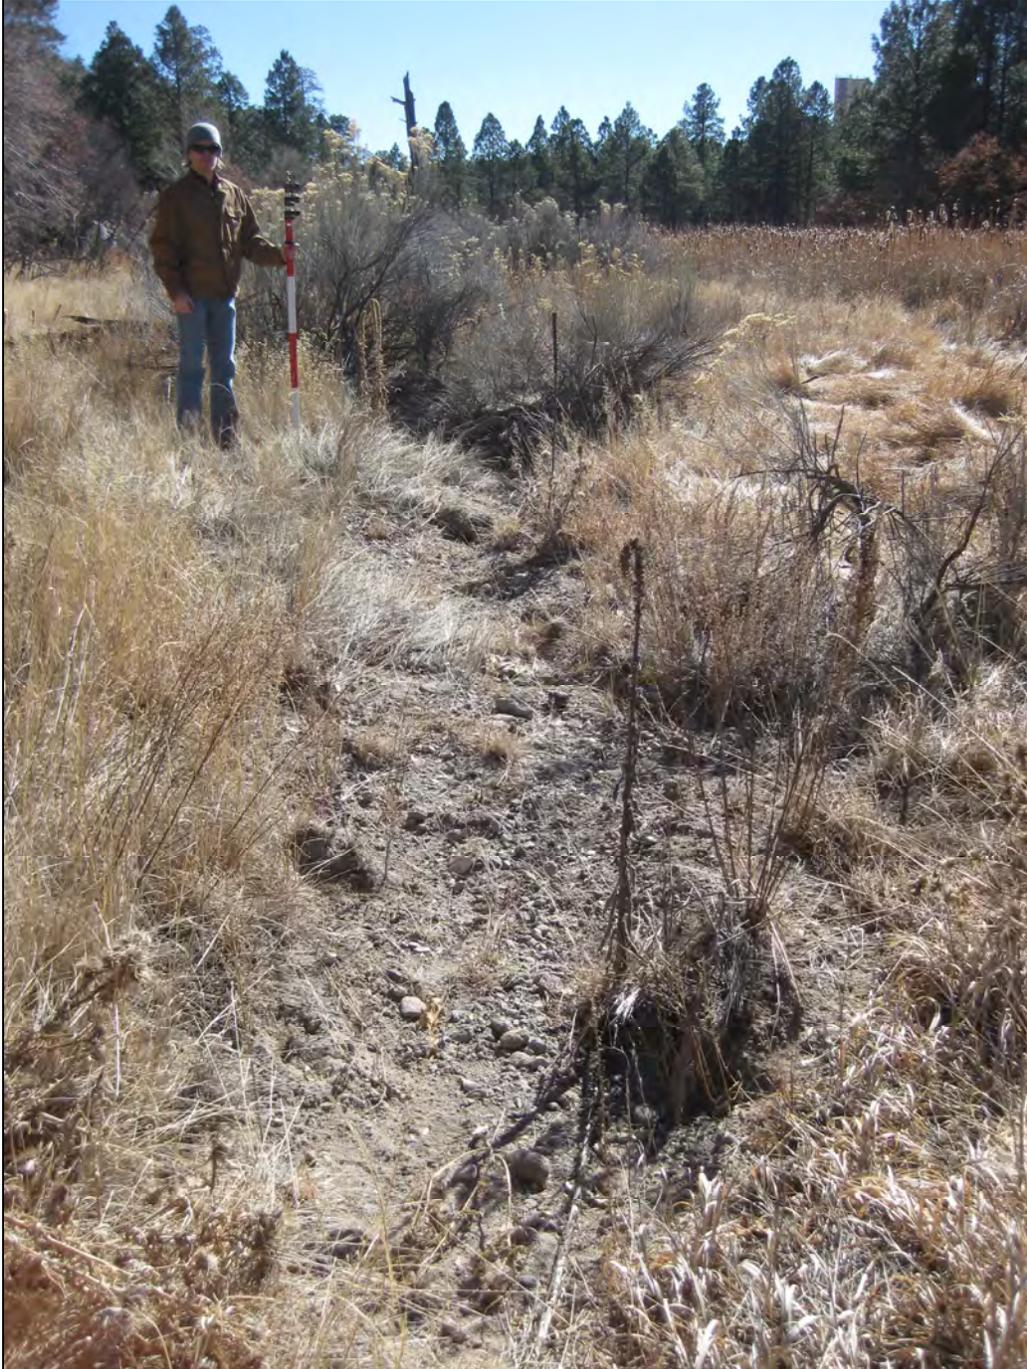
Photo B1-3 Overbank flow in previously abandoned channel between northern alluvial fans and wetland. February 2017 photo looking east.

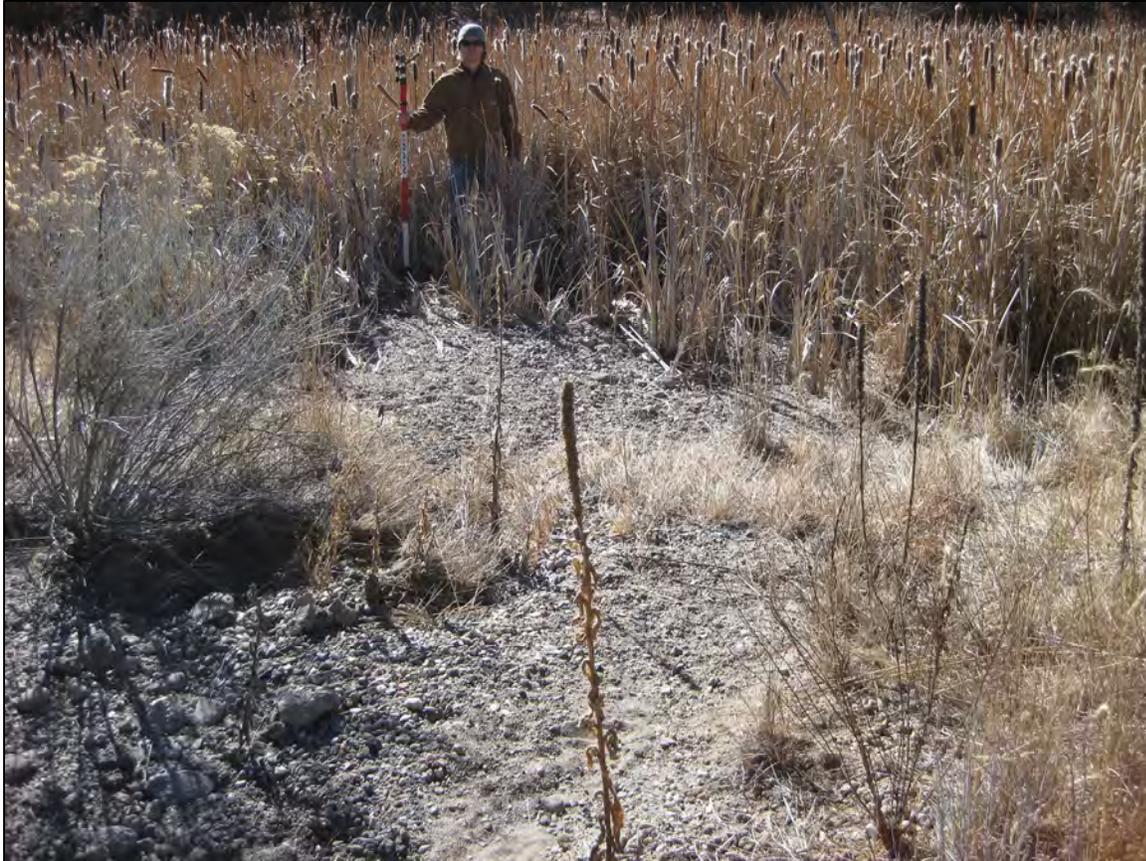
Photo B1-4 Deposition of gravels at eastern termination of side channel (Photo B1-3) into wetland. February 2017 photo looking southeast.

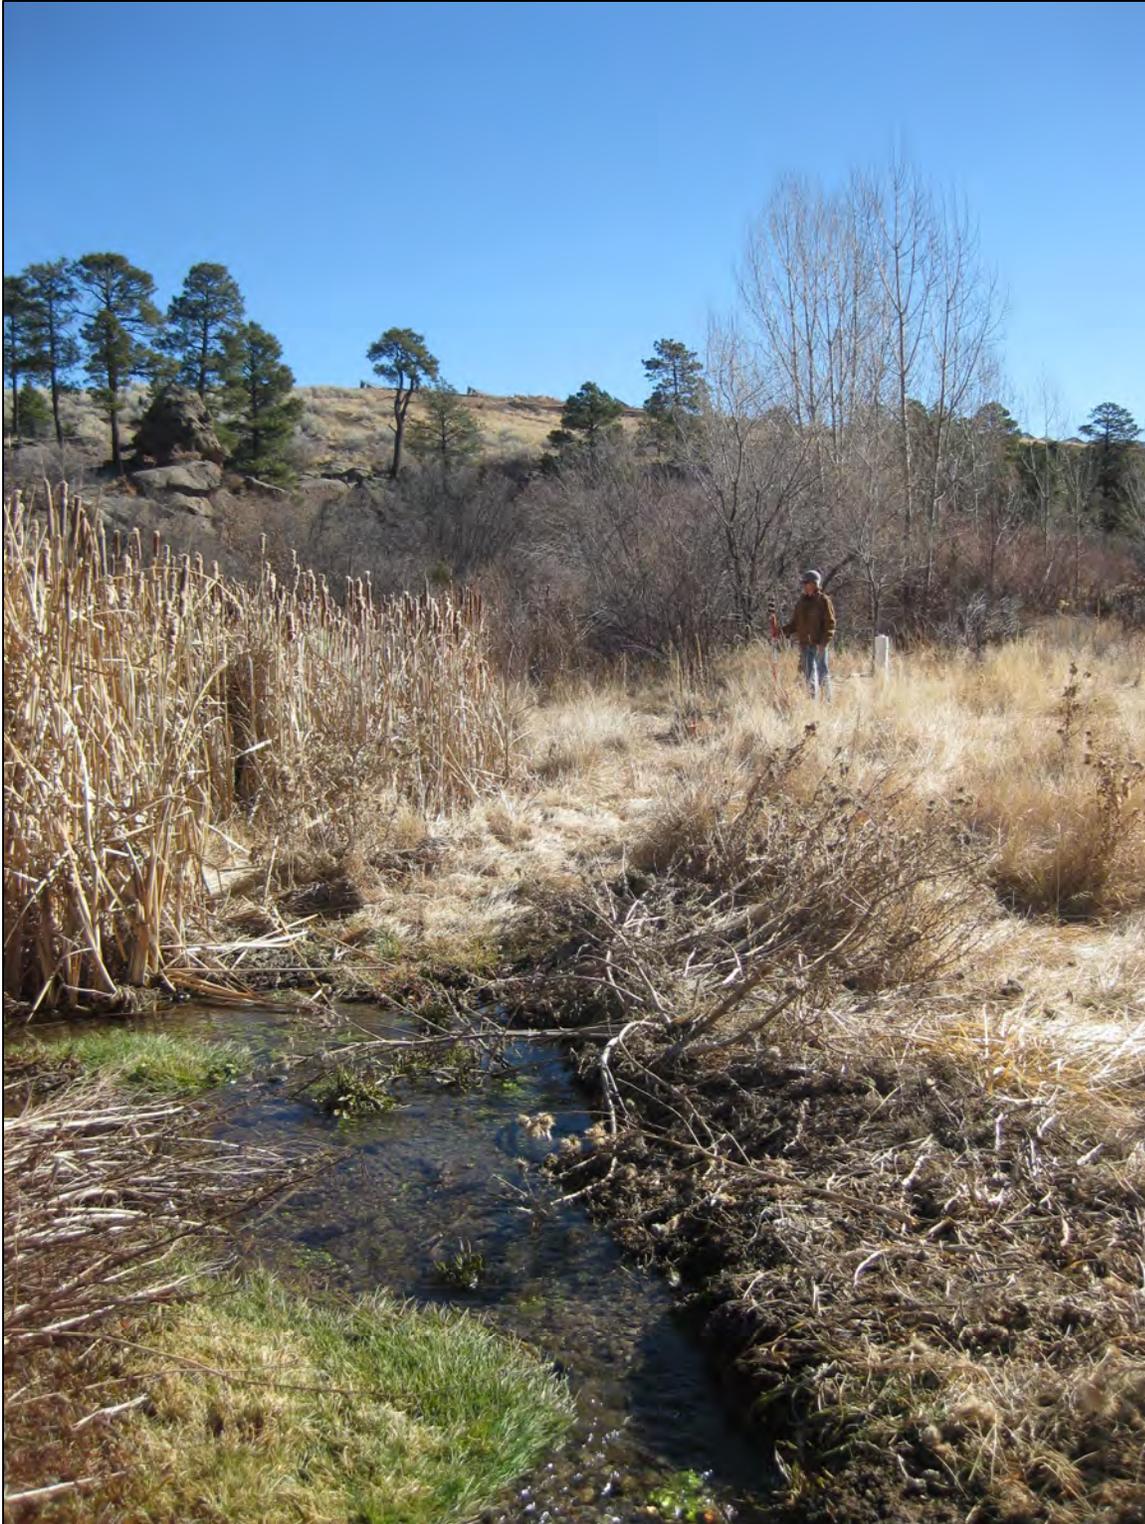
Photo B1-5 Example of 2017 overbank flow into a side channel. Erosion pin (orange cap) located in center of picture detected 0.25 in of net change (erosion) February 2018 photo looking east parallel to side channel flow.

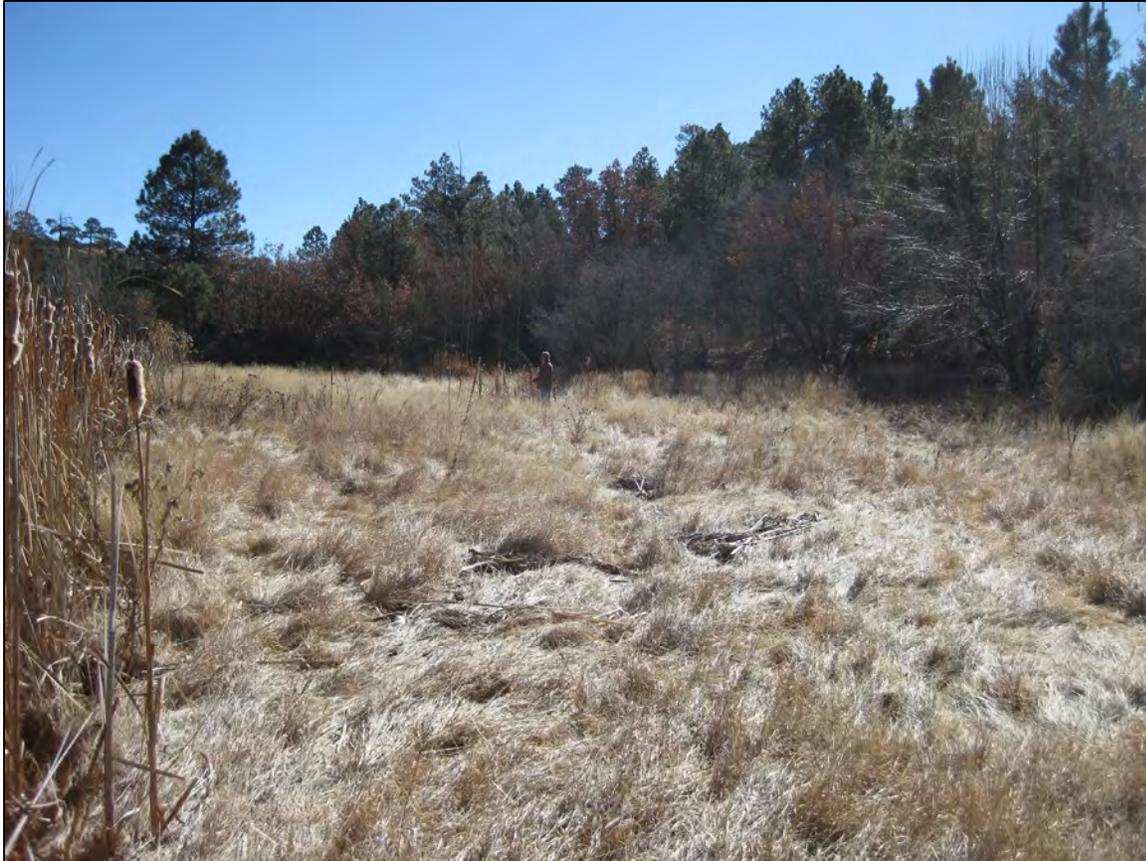
Photo B1-6 Debris piles as evidence of overbank flow that has continued to provide water to the cattail islands in the redtop grass meadow south of the wetland (See Appendix C Figure 3.1-1). February 2018 photo looking southeast parallel to side channel flow toward cattail island populations.
