Subject: 2017 Sandia Wetland Performance Report

LA-UR-18-23914
April 2018
EP2018-0013

2017 Sandia Wetland Performance Report

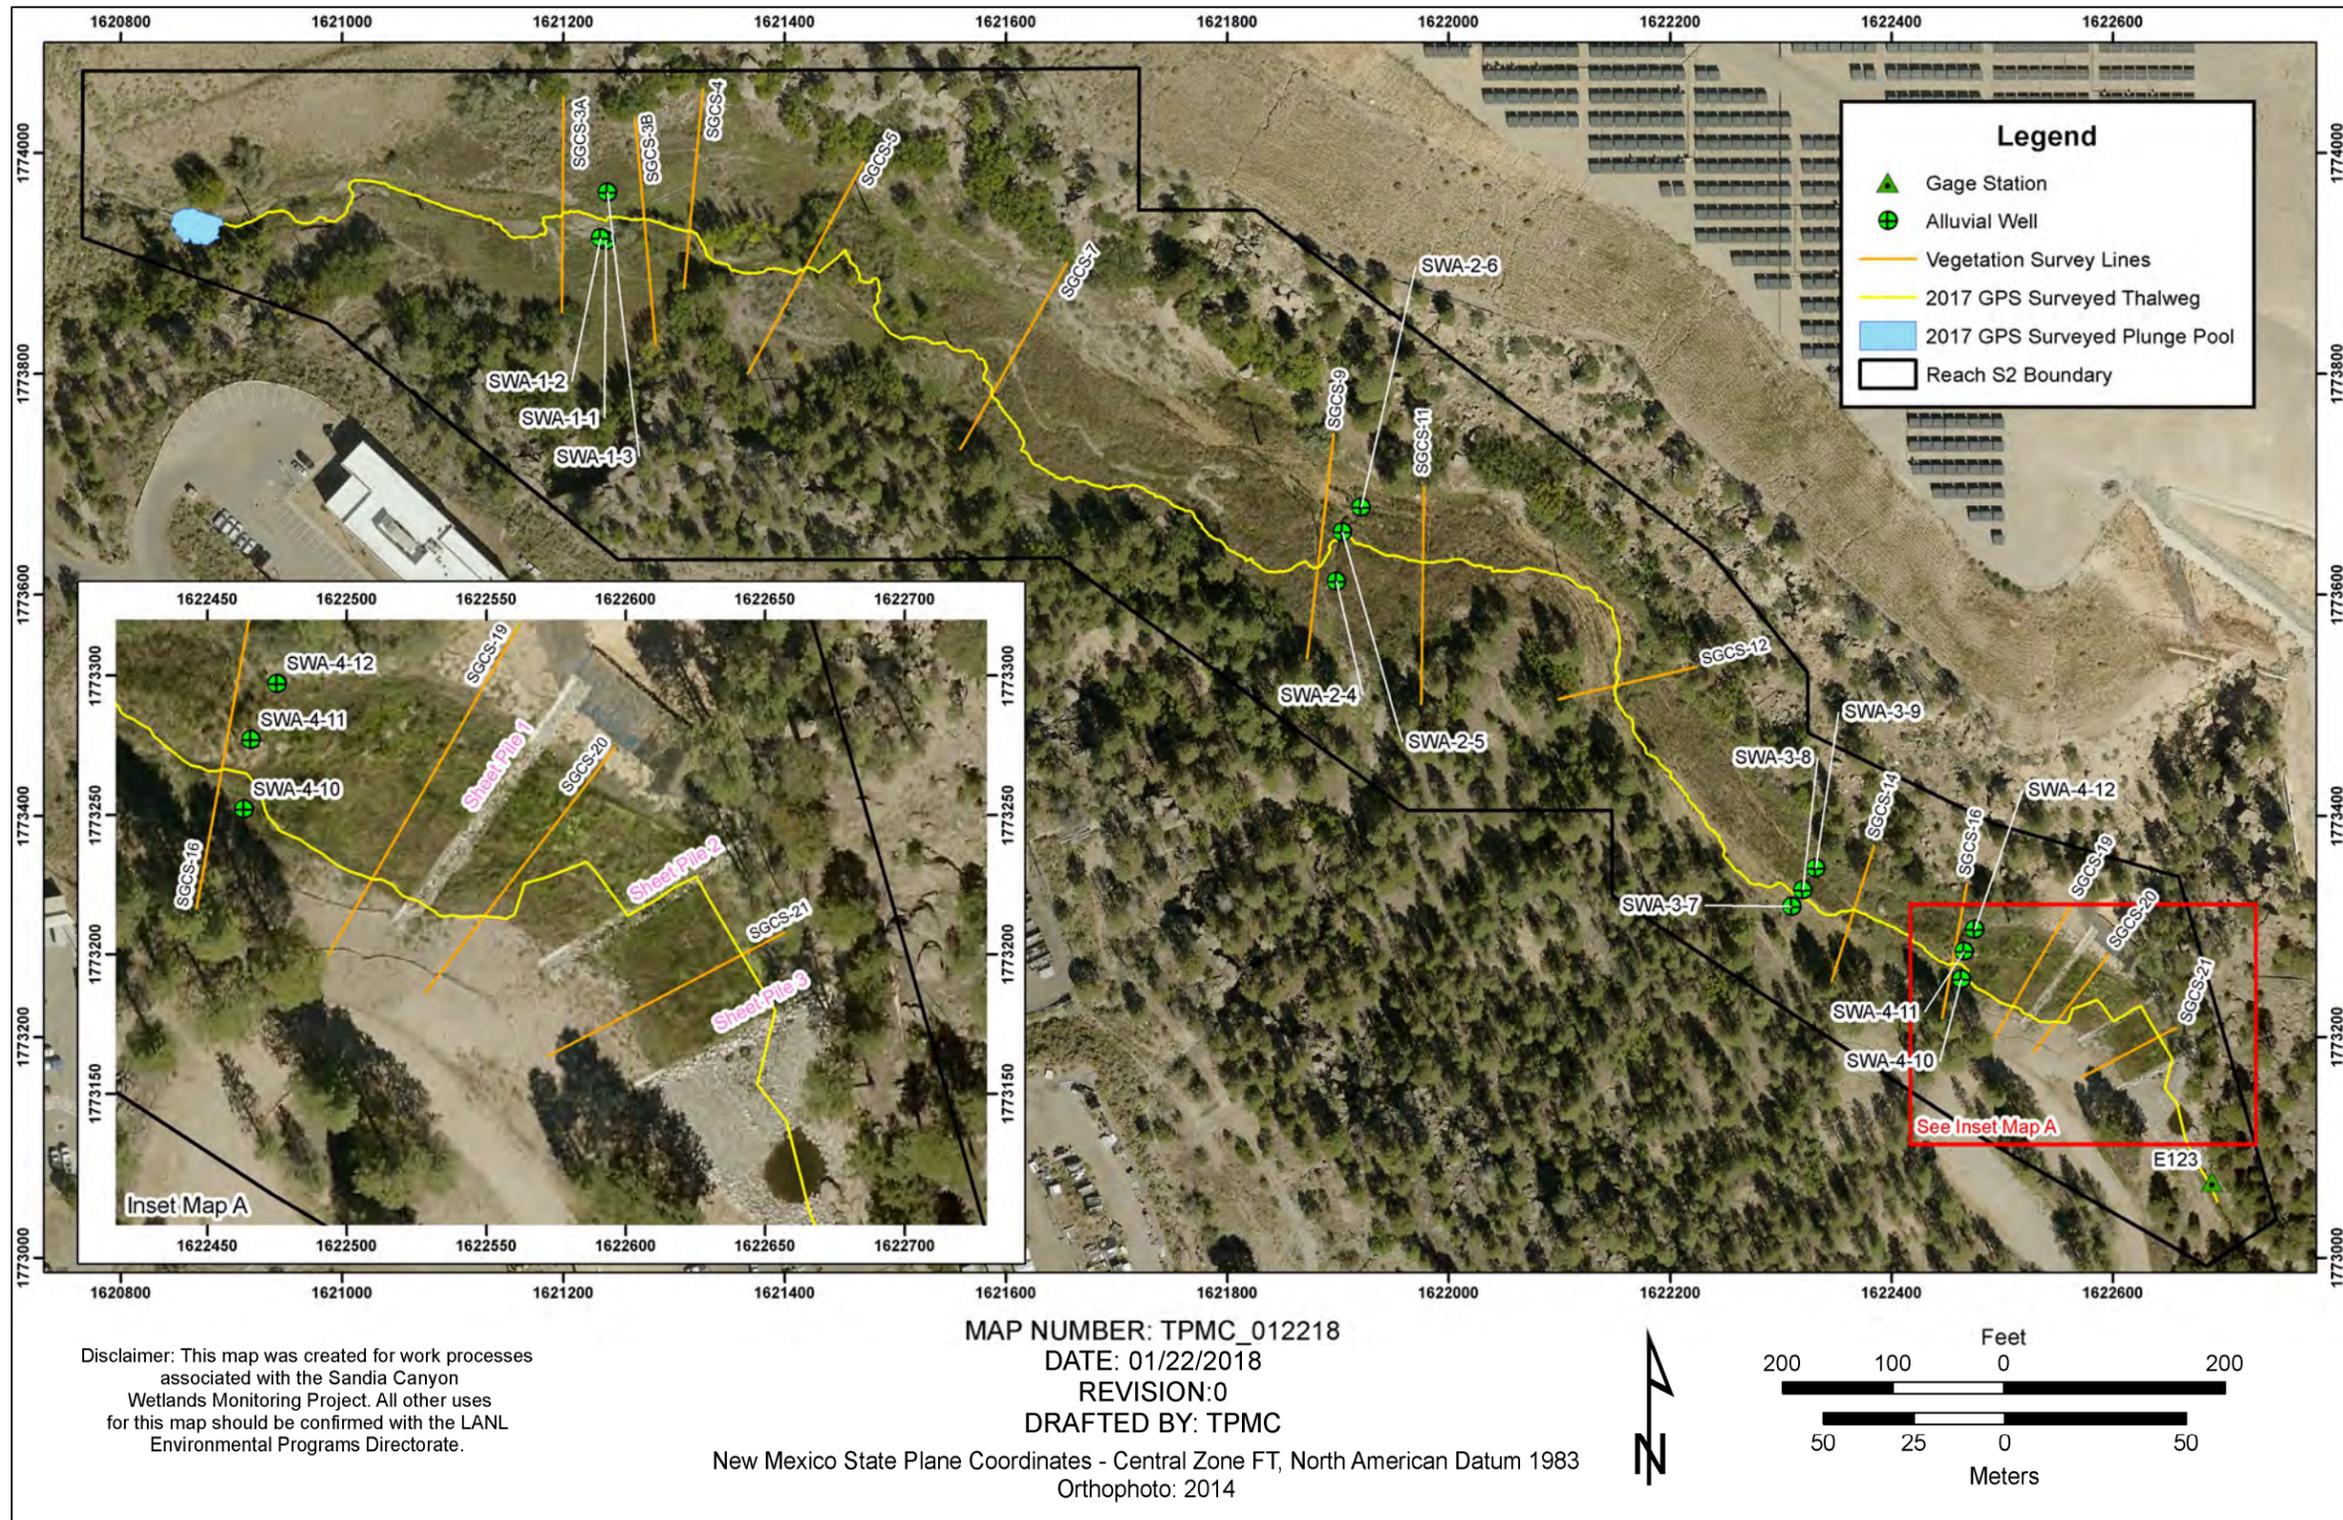
Figure C-1.0-1 Locations of cross-sections, piezometers, sheet piles, and thalweg profiles in Sandia Canyon reach S-2

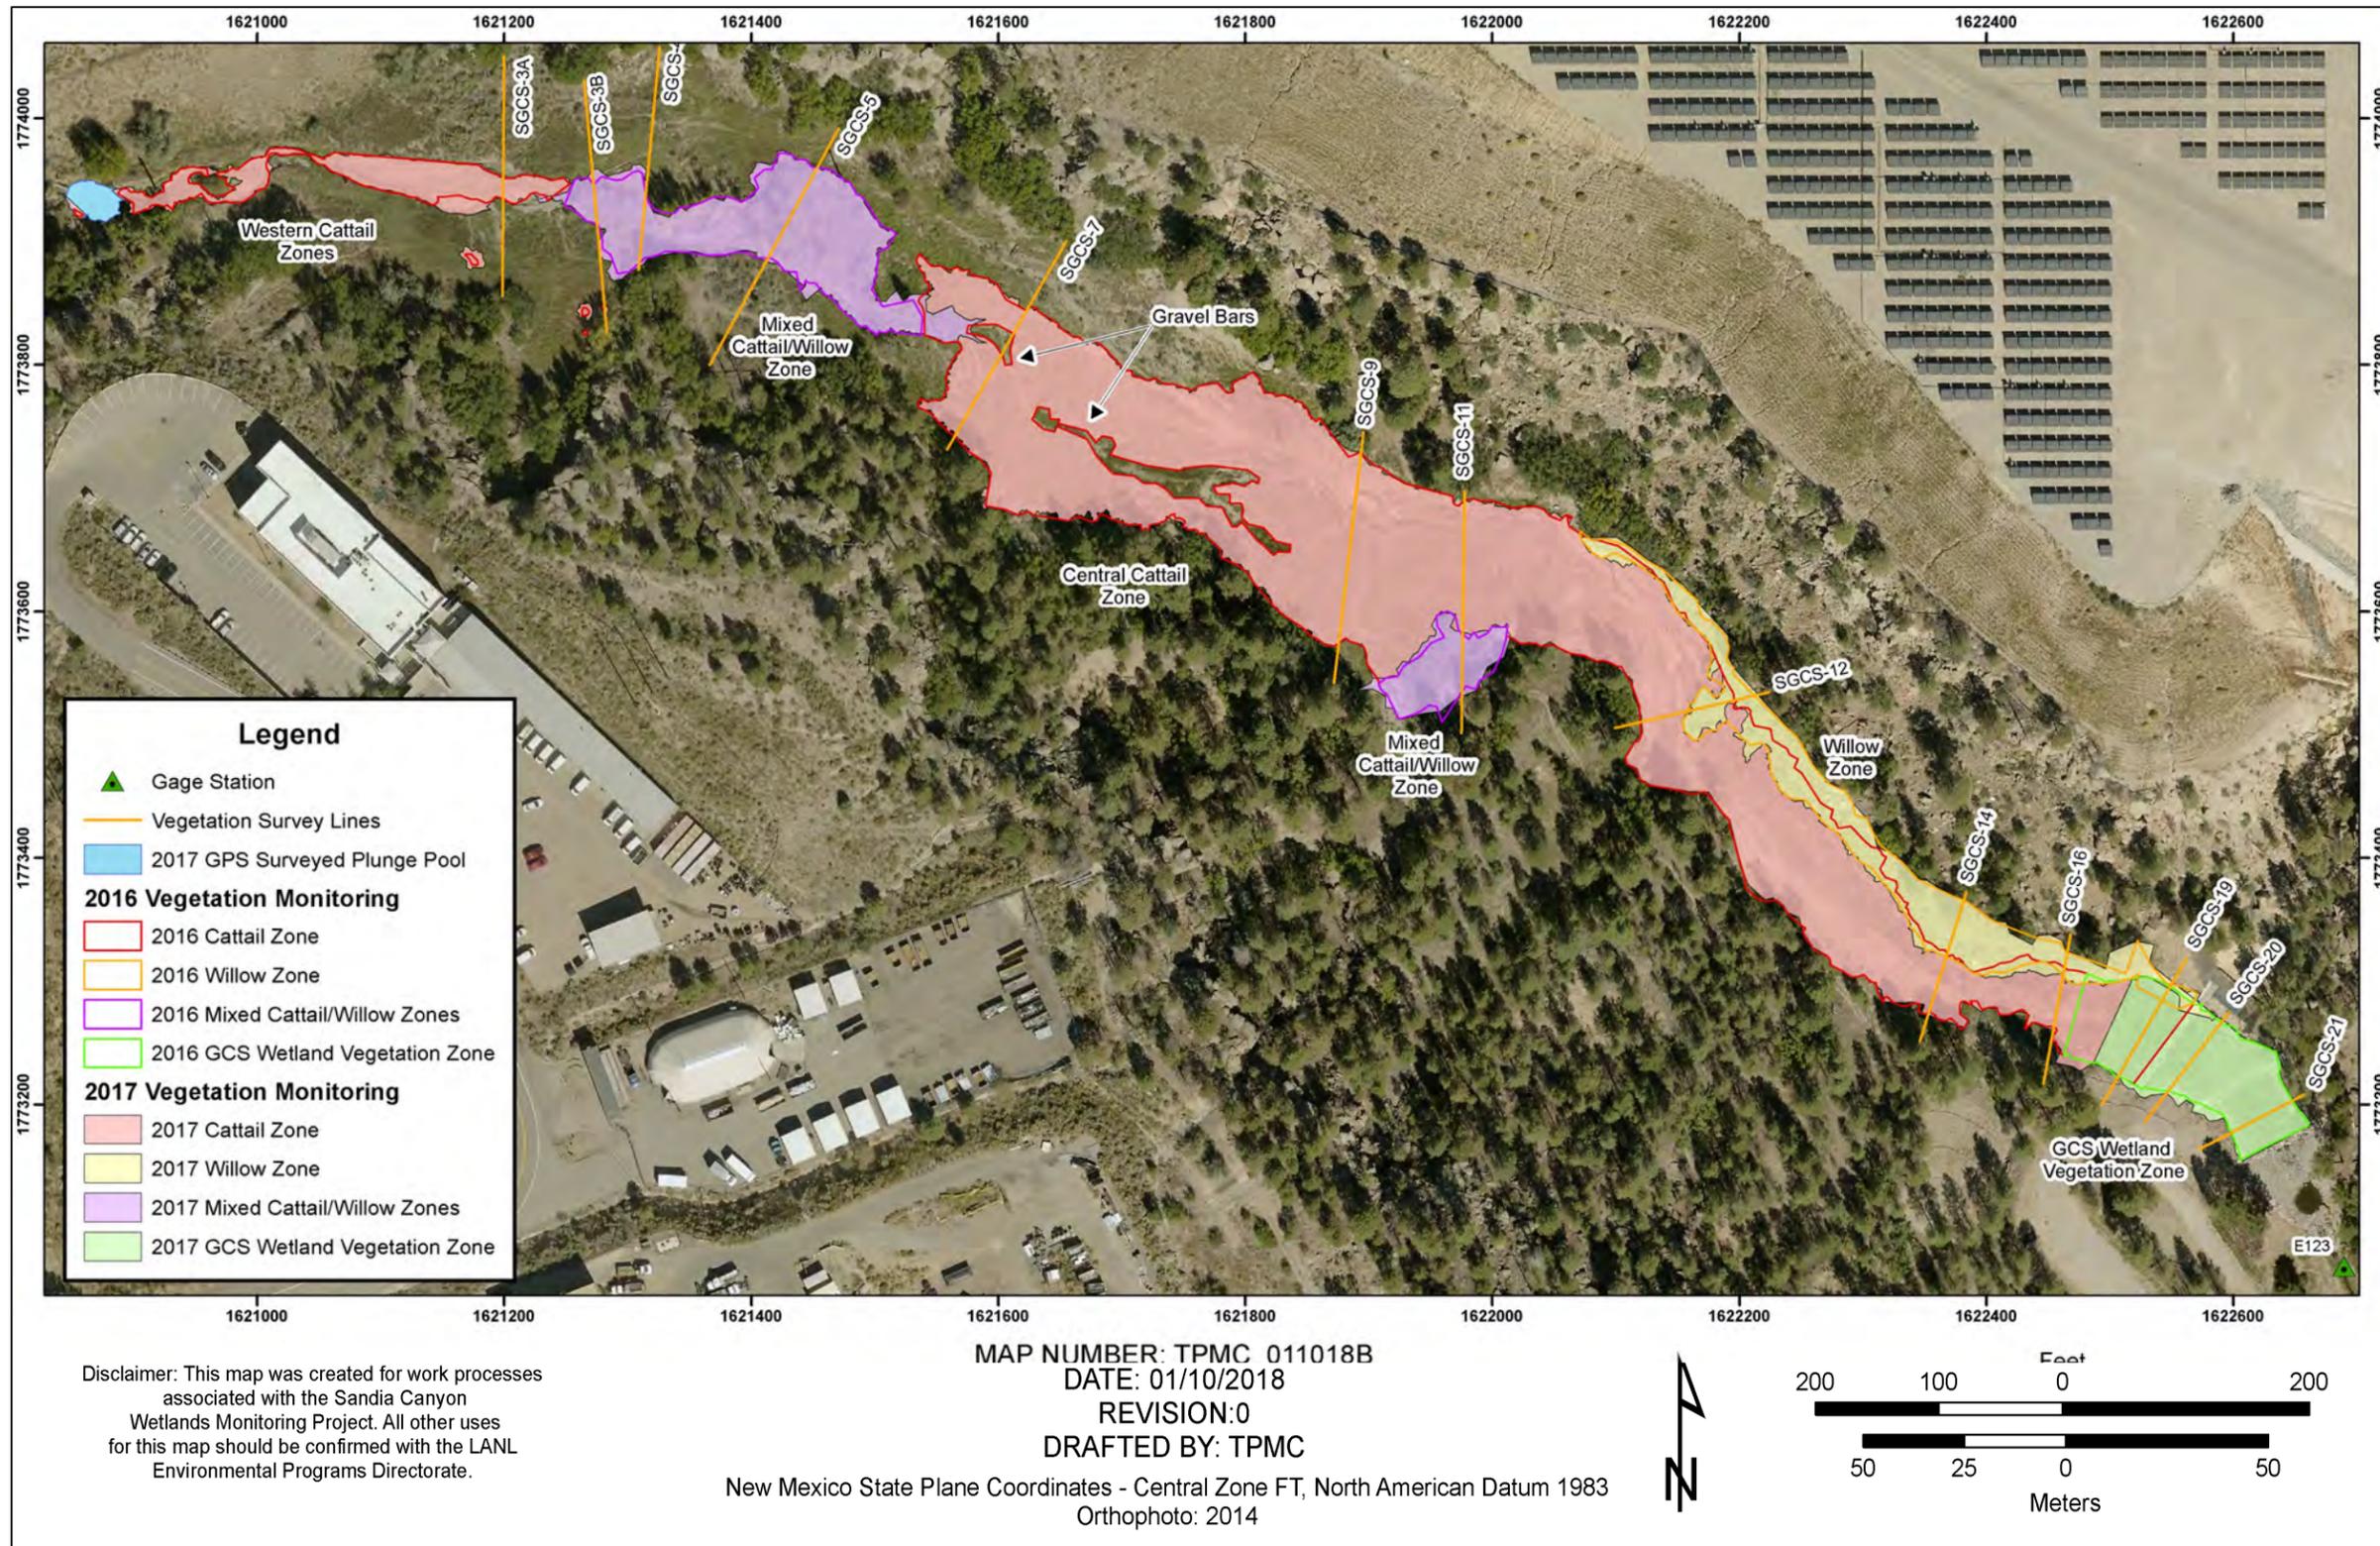
Figure C-3.0-1 2017 and 2016 vegetation perimeter mapping comparison results at Sandia Canyon reach S-2

Between 2016 and 2017, the wetland vegetation remains stable with a 2.5% overall expansion of obligate wetland species over the whole study area. The largest expansion was observed in the western-end of the wetland, with noticeable increases occurring in the satellite cattail populations by the plunge pool and in the field south of the channel in the Western Cattail Zone. The Northern Willow Zone continues to expand but the Central Cattail Zone remains generally unaffected with a stable and homogenous stand of cattails, which are only minimally affected by the deposition of sediment from the southern drainage. A slight decrease of GCS vegetation is observed in the GCS Wetland Vegetation Zone due to the spread of native cattails into that zone suggesting a further stabilization of the native Sandia wetland vegetation.

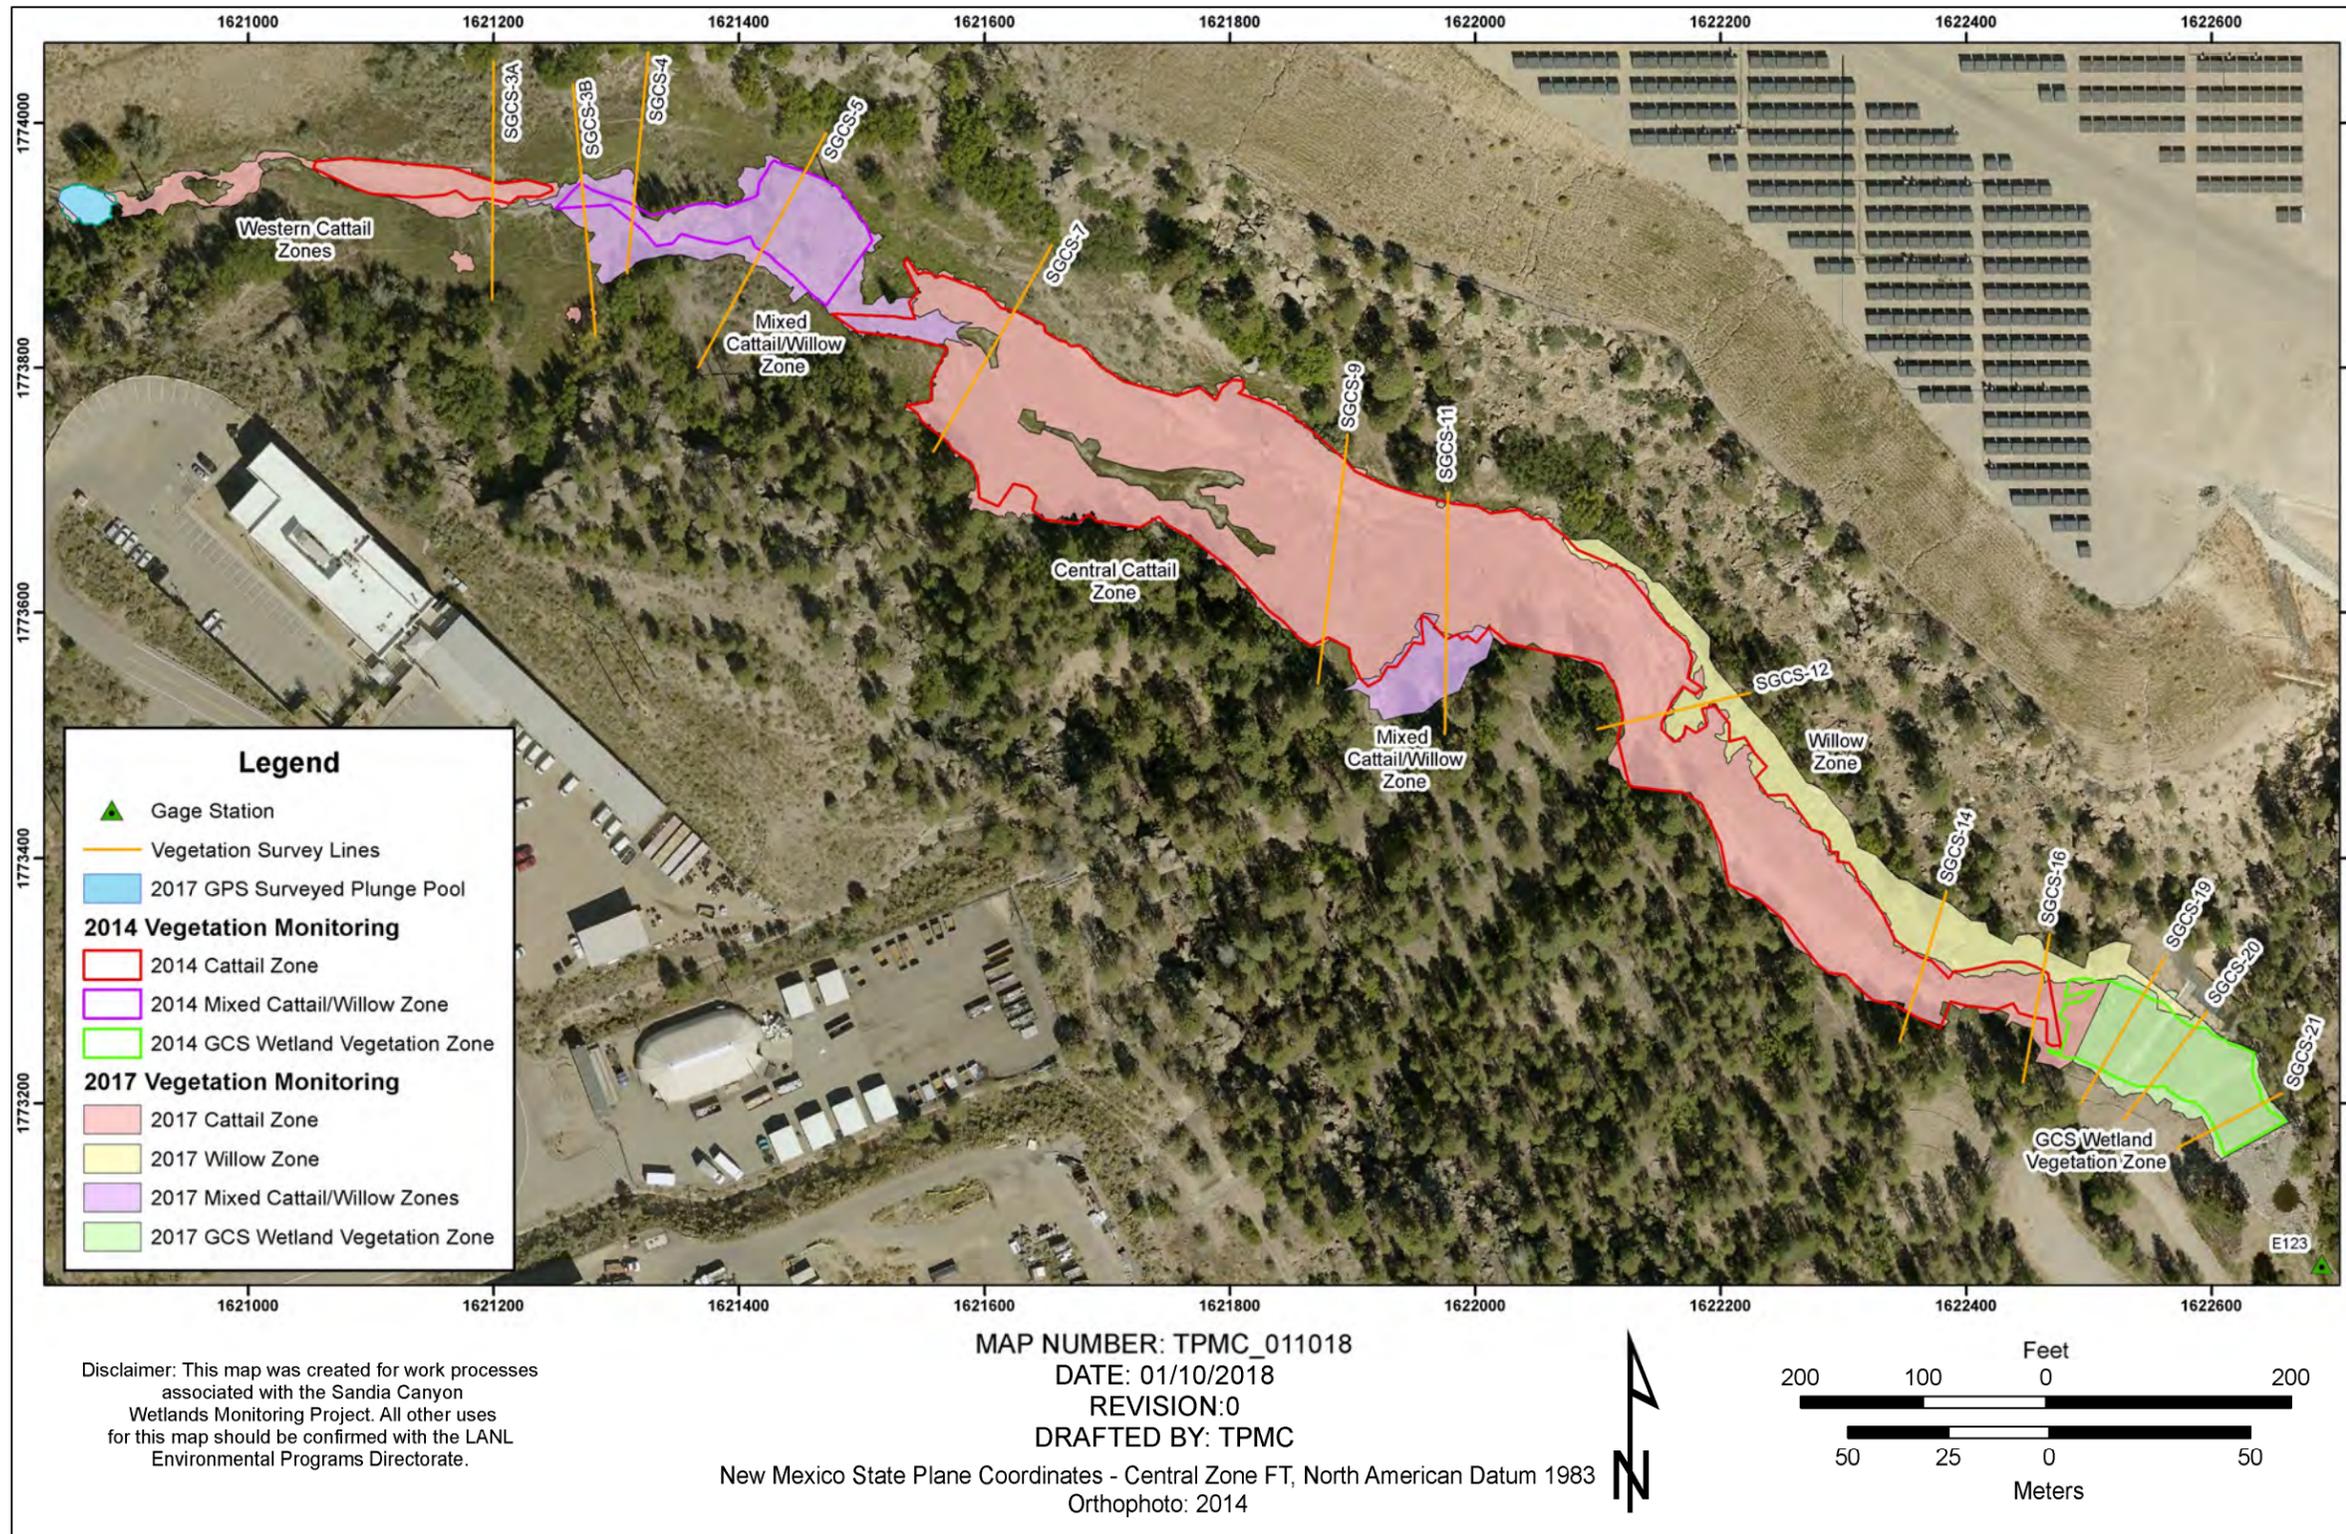
Figure C-3.4-1 Three-year (2014–2017) comparison of wetland vegetation perimeters

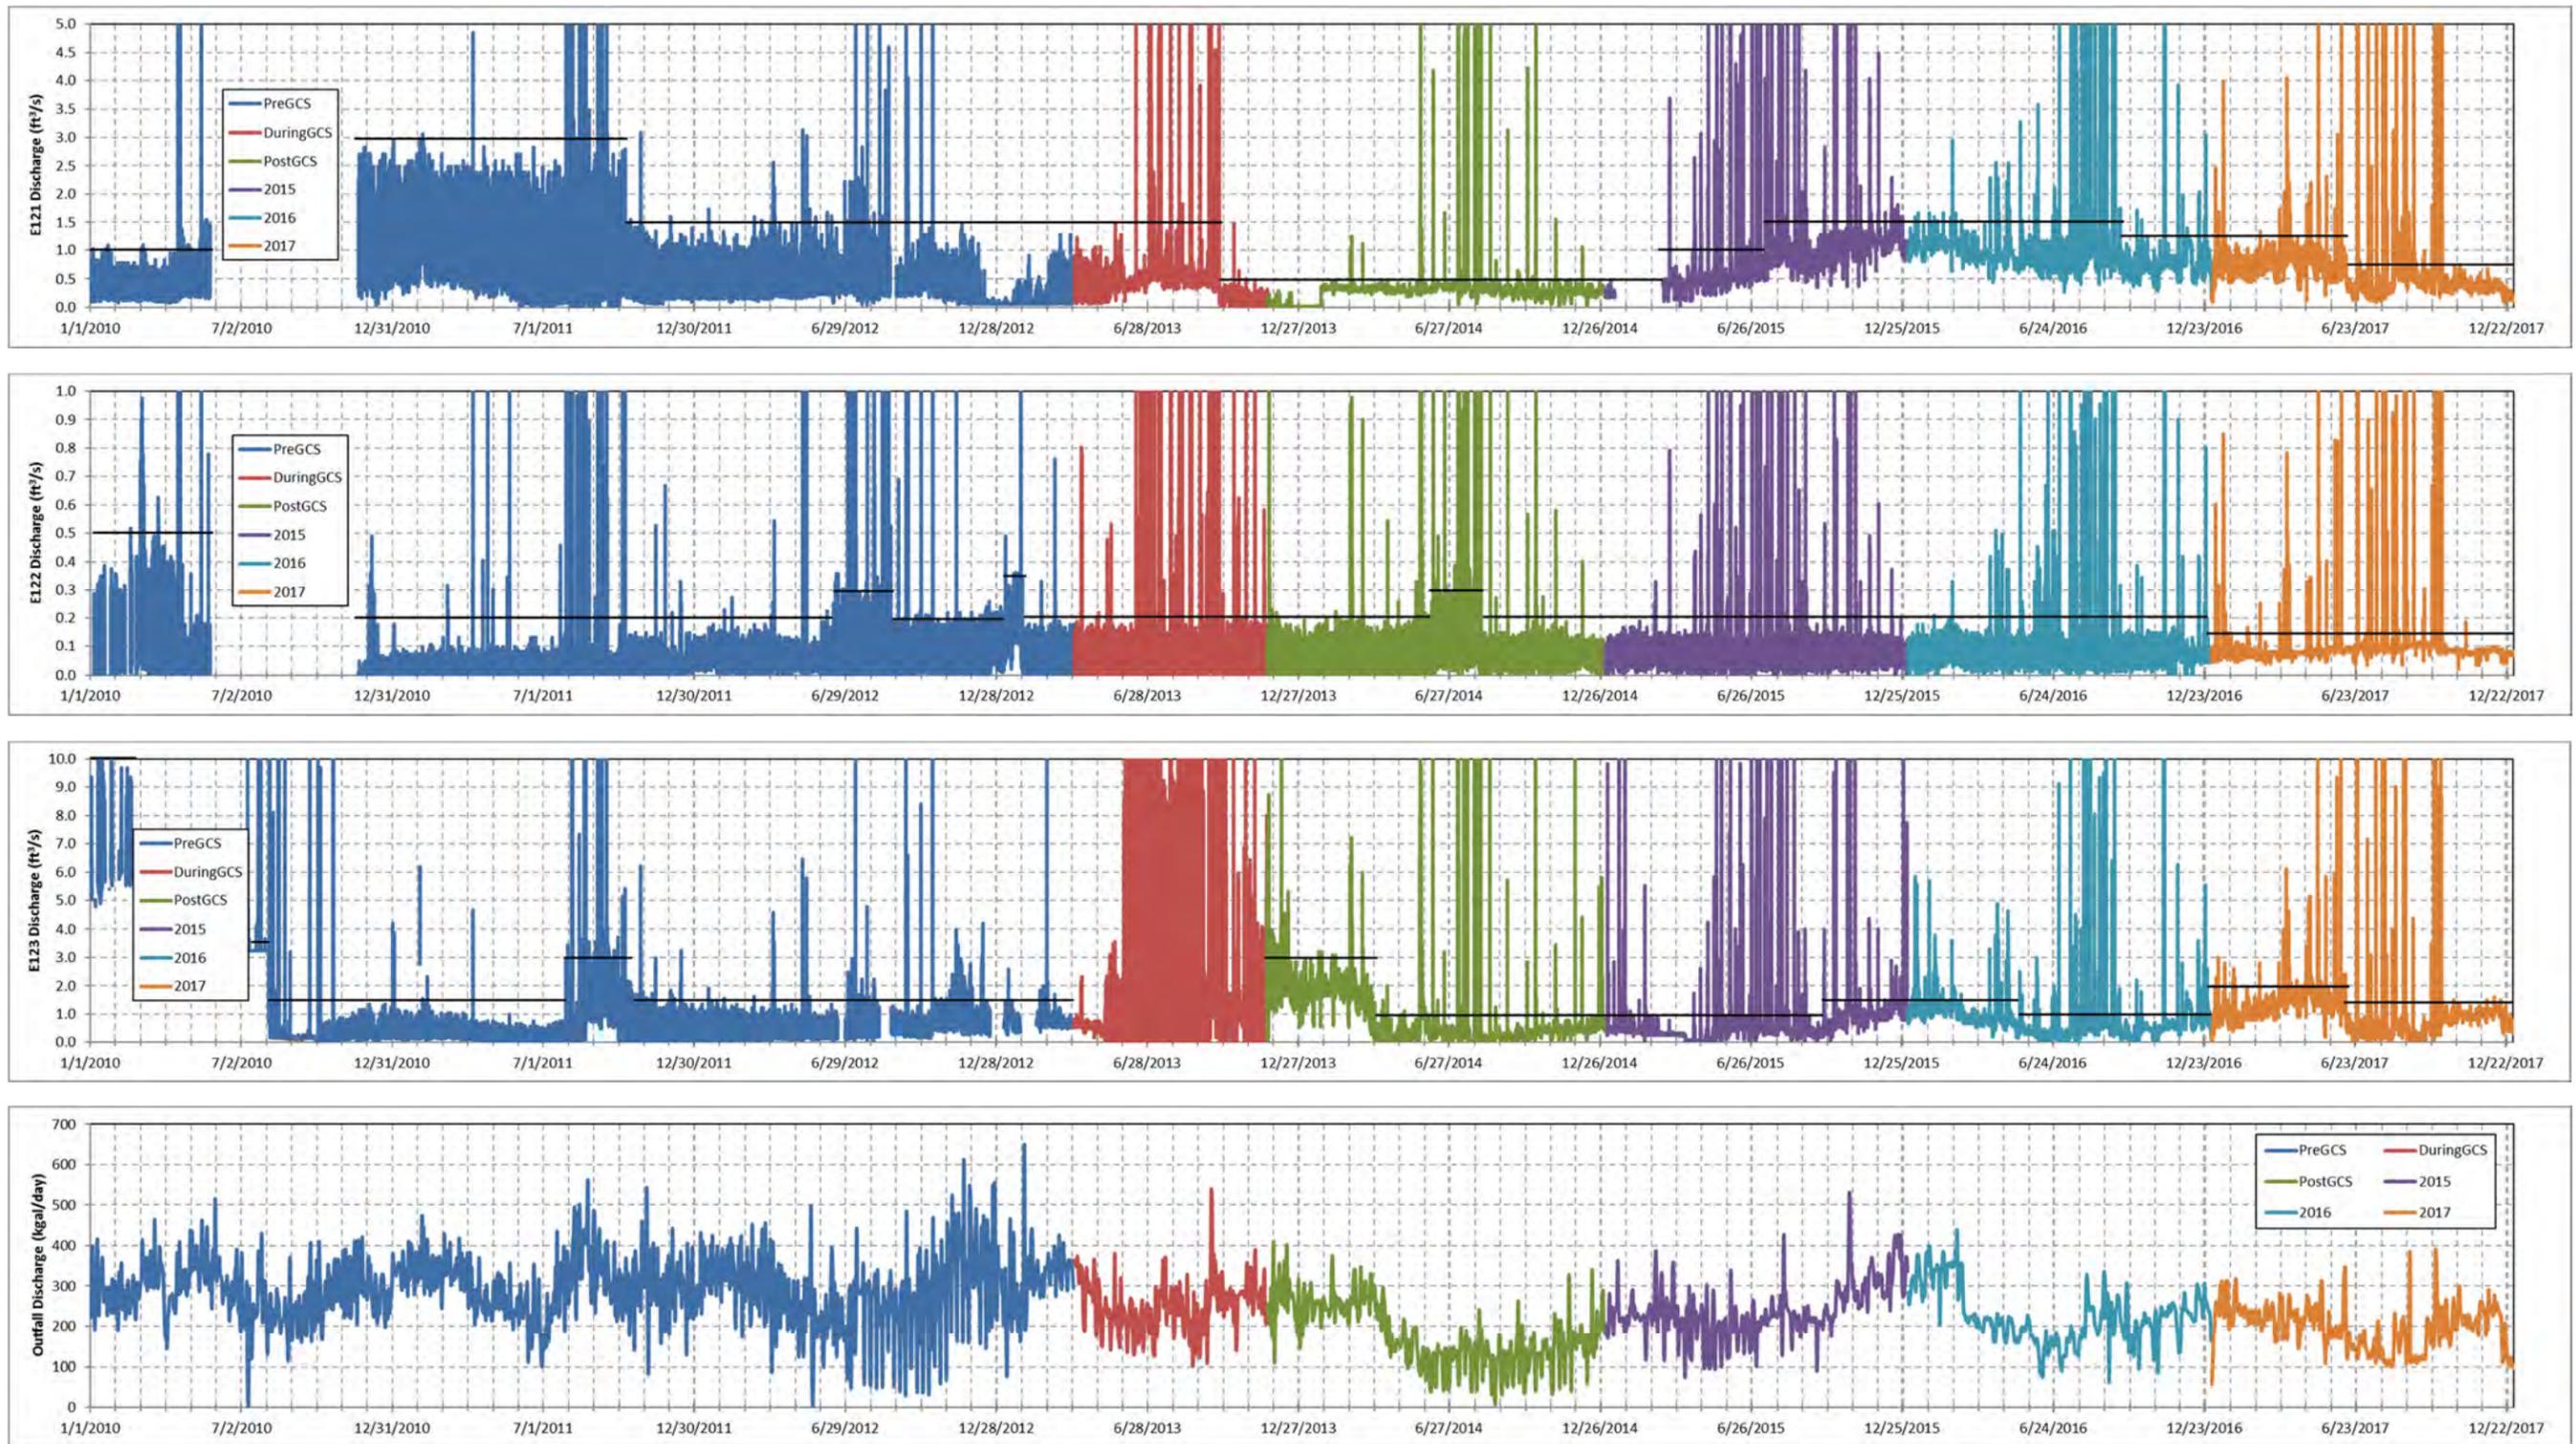
Figure D-2.0-6 Time-series plots from 2010 to 2017 showing discharge at E121, E122, and E123 and total discharge from Outfalls 001, 03A027, and 03A199; solid black horizontal lines indicate approximate base flow discharge at the surface-water gaging stations, which vary throughout the 8-yr period

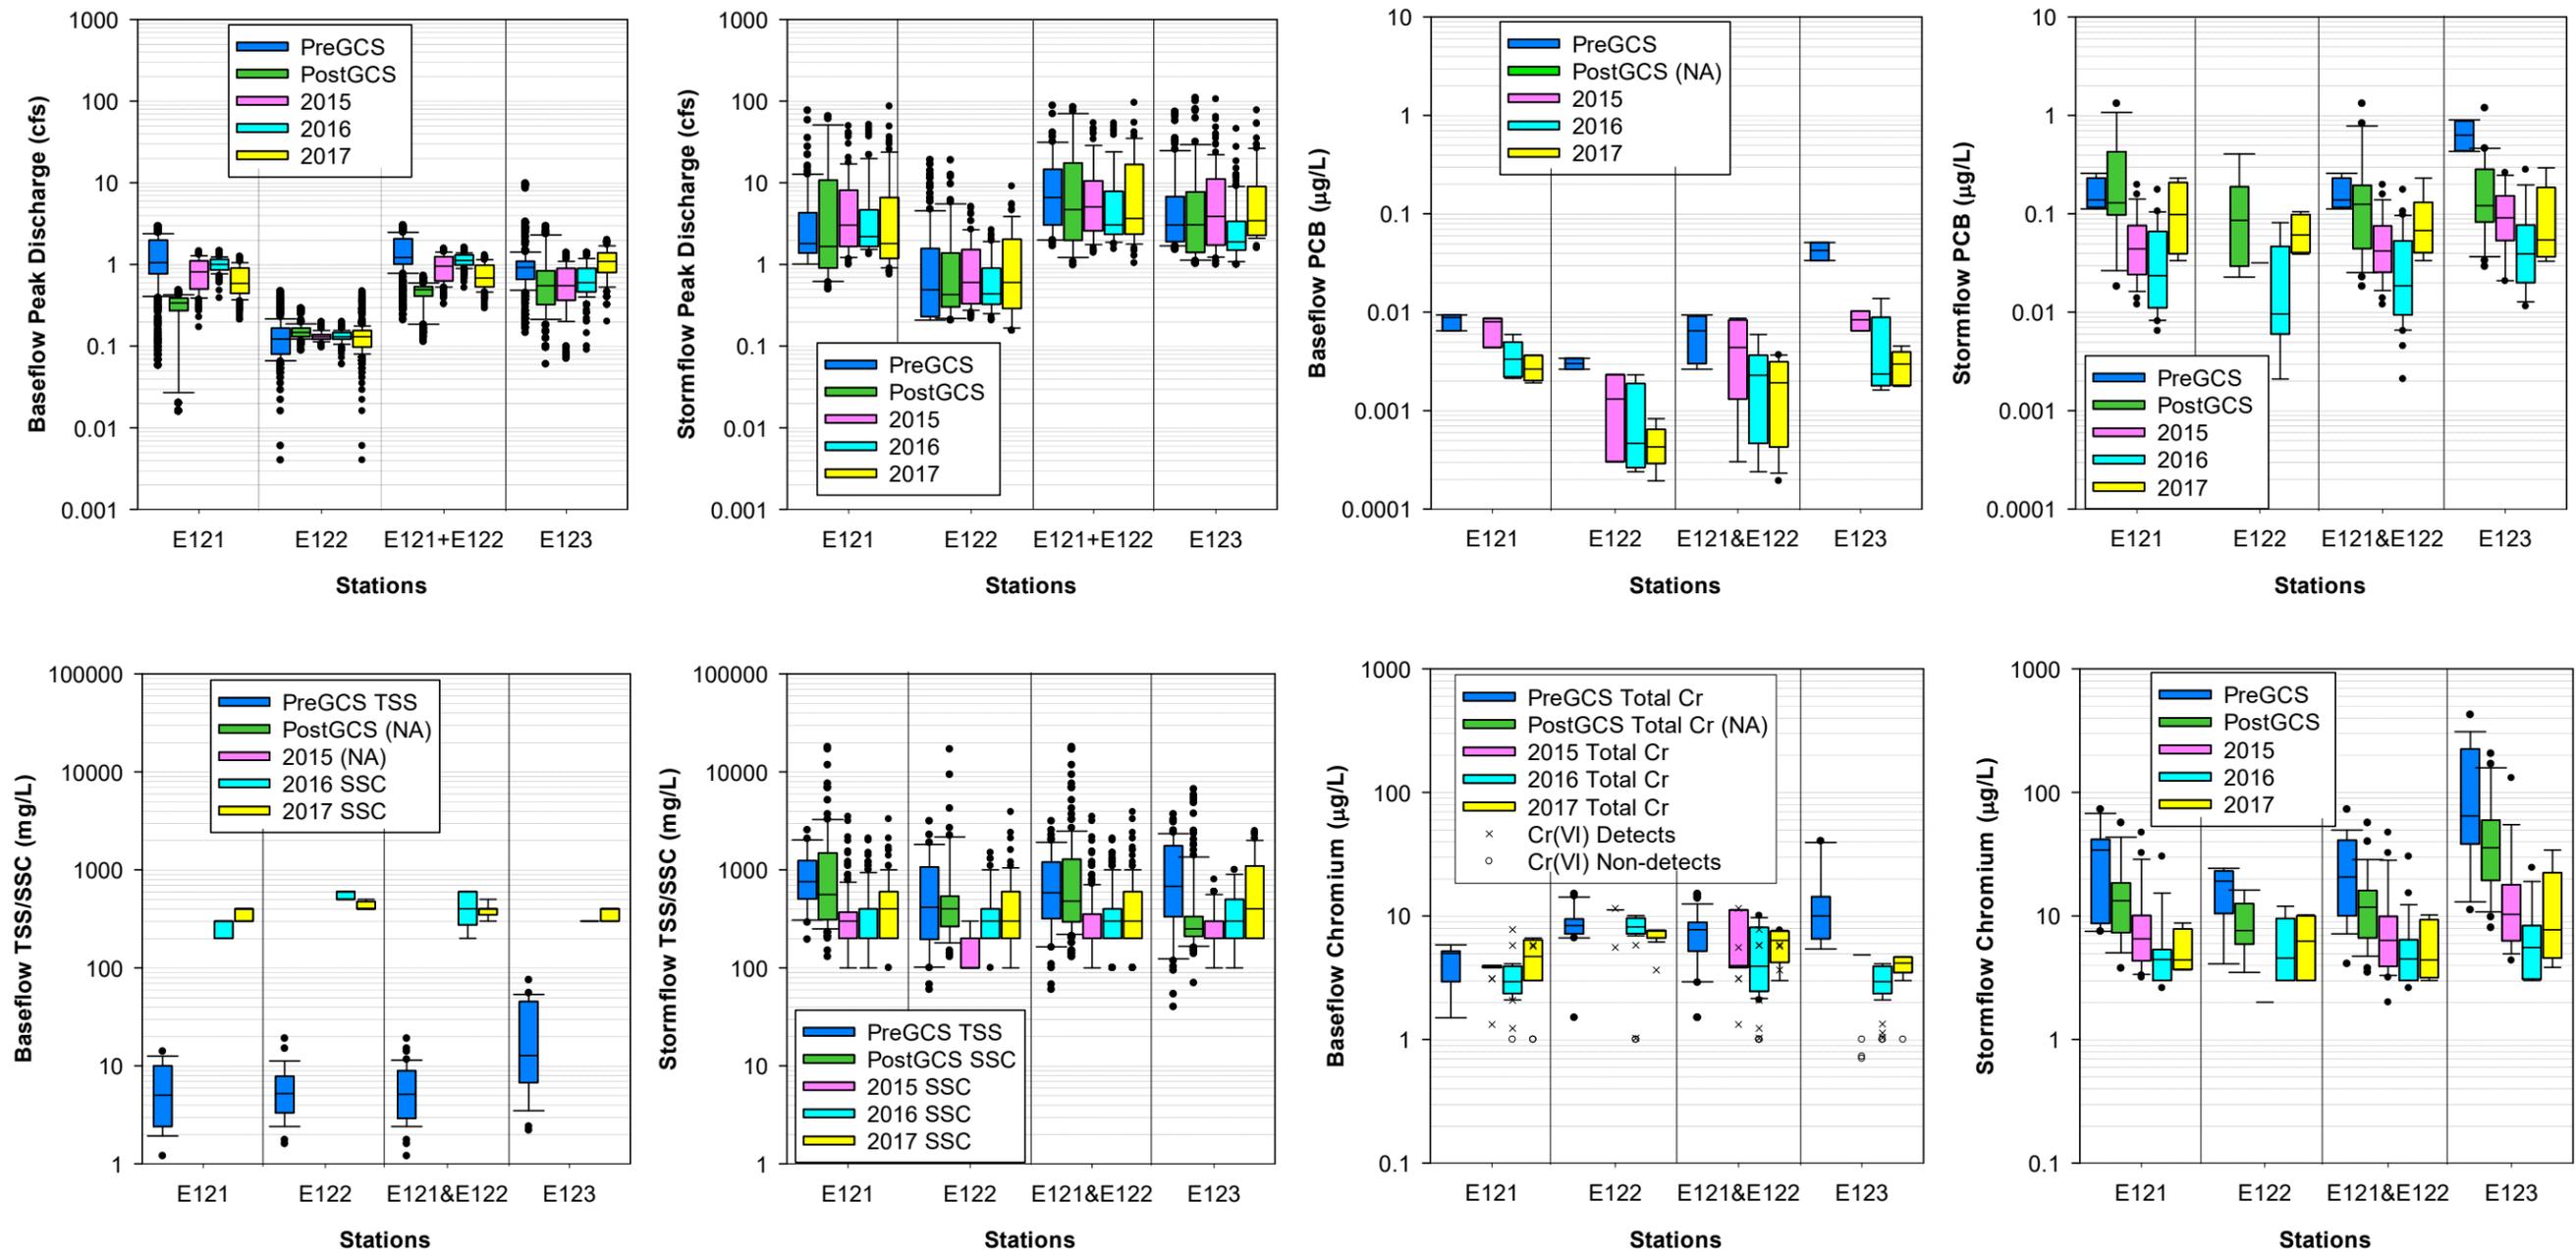
Figure D-2.0-7 Box-and-whisker plots of peak discharge, TSS/SSC, PCBs, unfiltered chromium and Cr(VI), and PAHs for base flow and storm flow at gaging stations E121, E122, and E123, pre- and post-construction of the GCS, respectively, in 2015, 2016, and 2017. (NA = Not analyzed.)

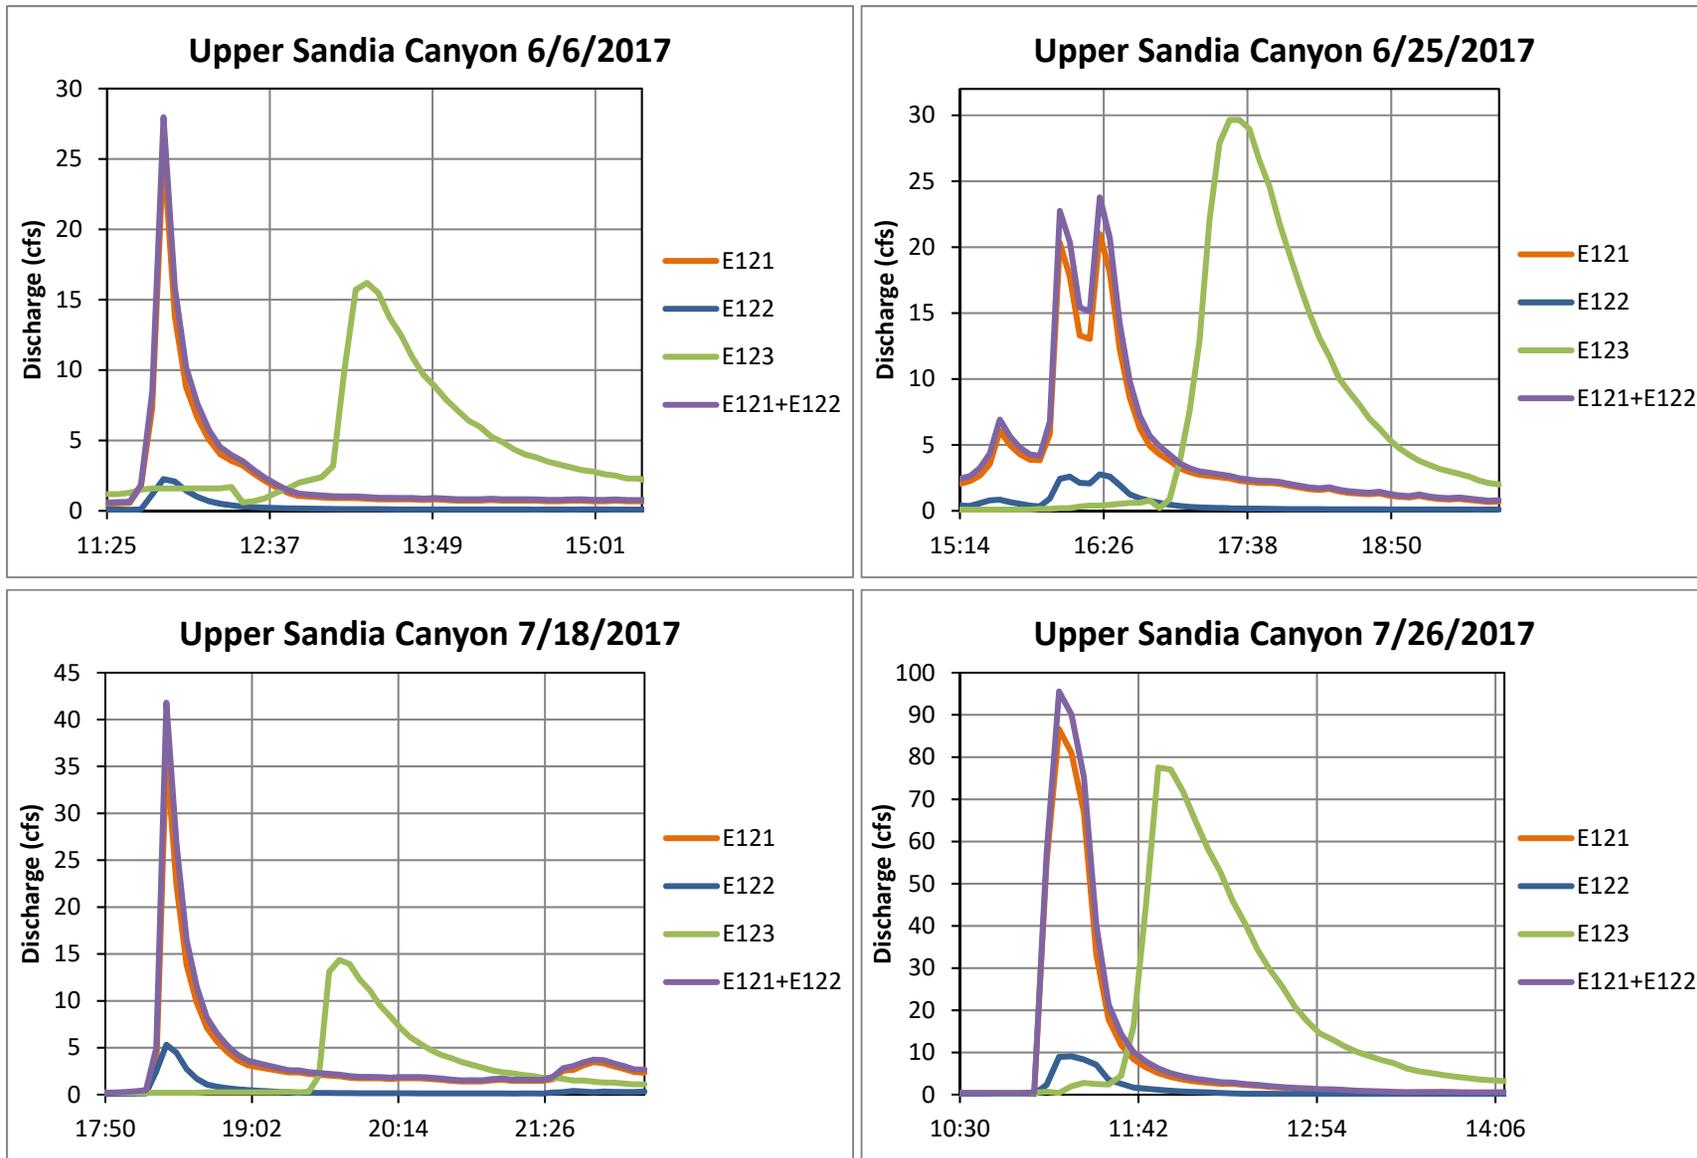
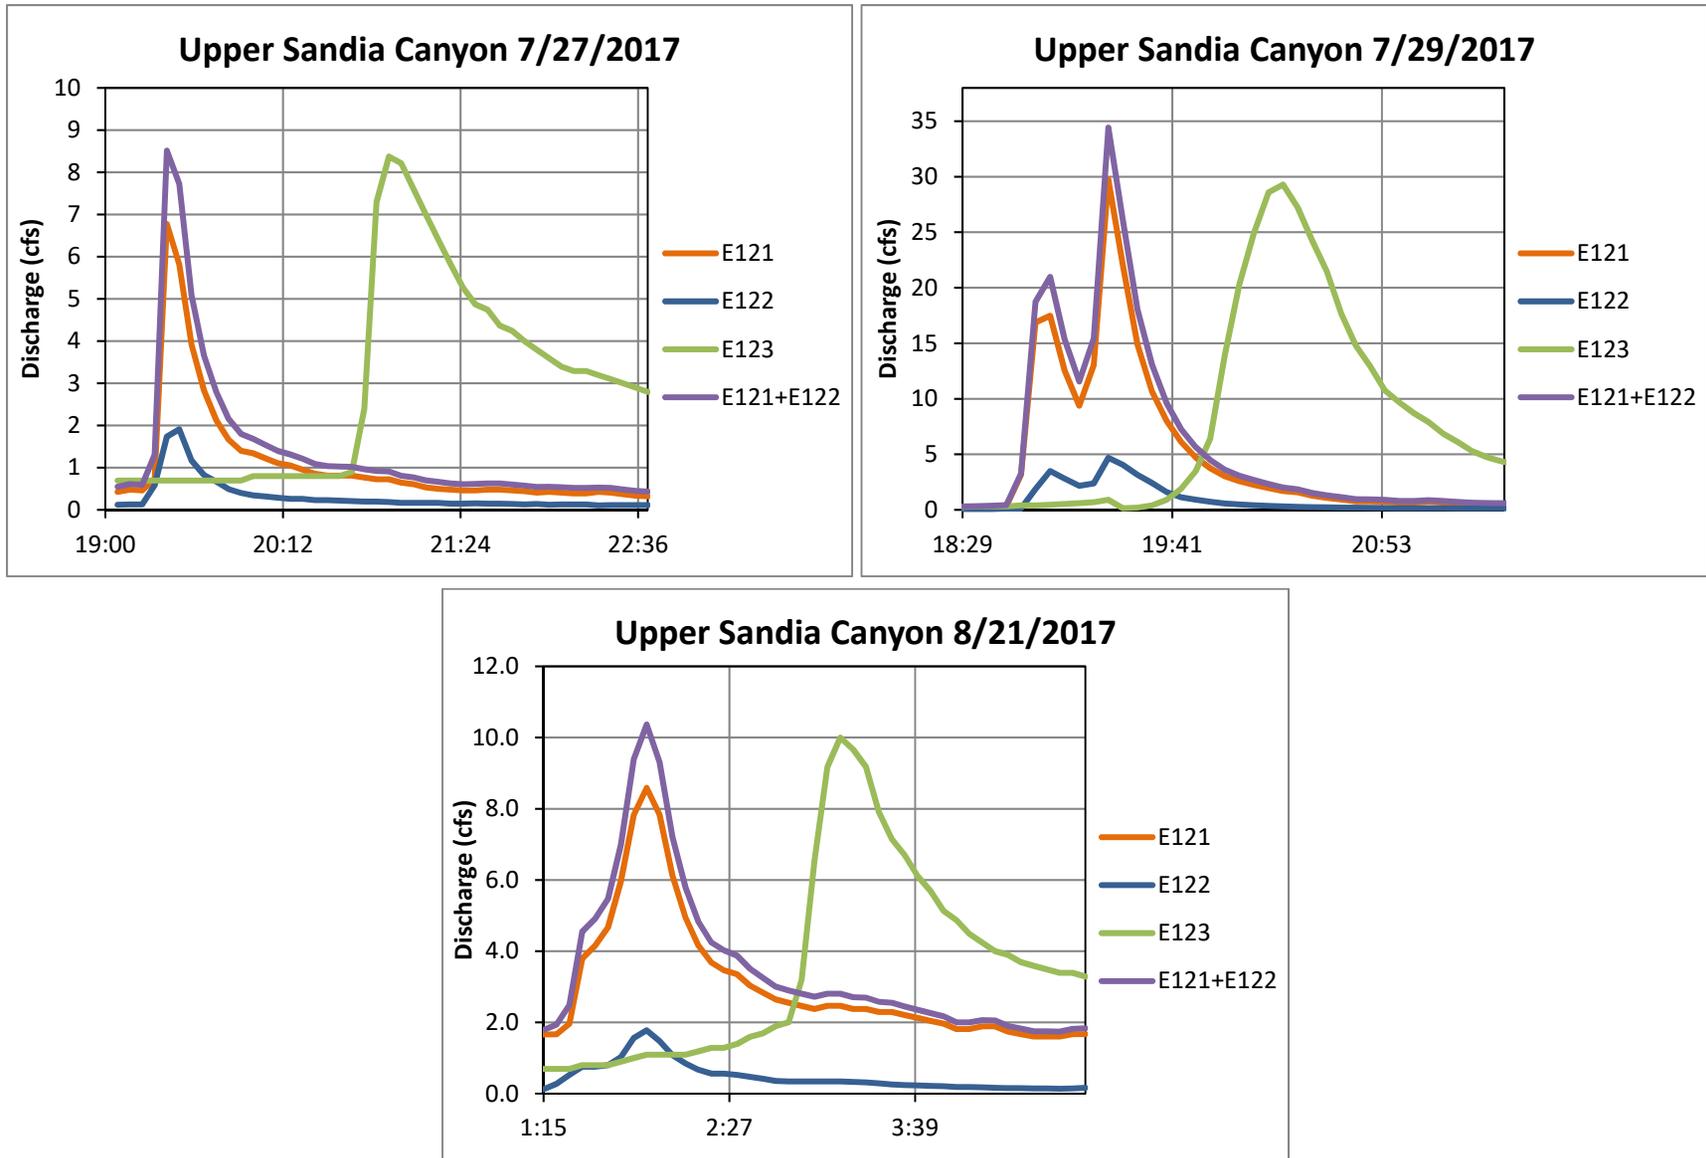
Figure D-2.0-8 Hydrographs of storm water discharge at E121, E122, and E123 during each sample-triggering storm event in 2017
