Subject: 2017 Sandia Wetland Performance Report

LA-UR-18-23914
April 2018
EP2018-0013

2017 Sandia Wetland Performance Report

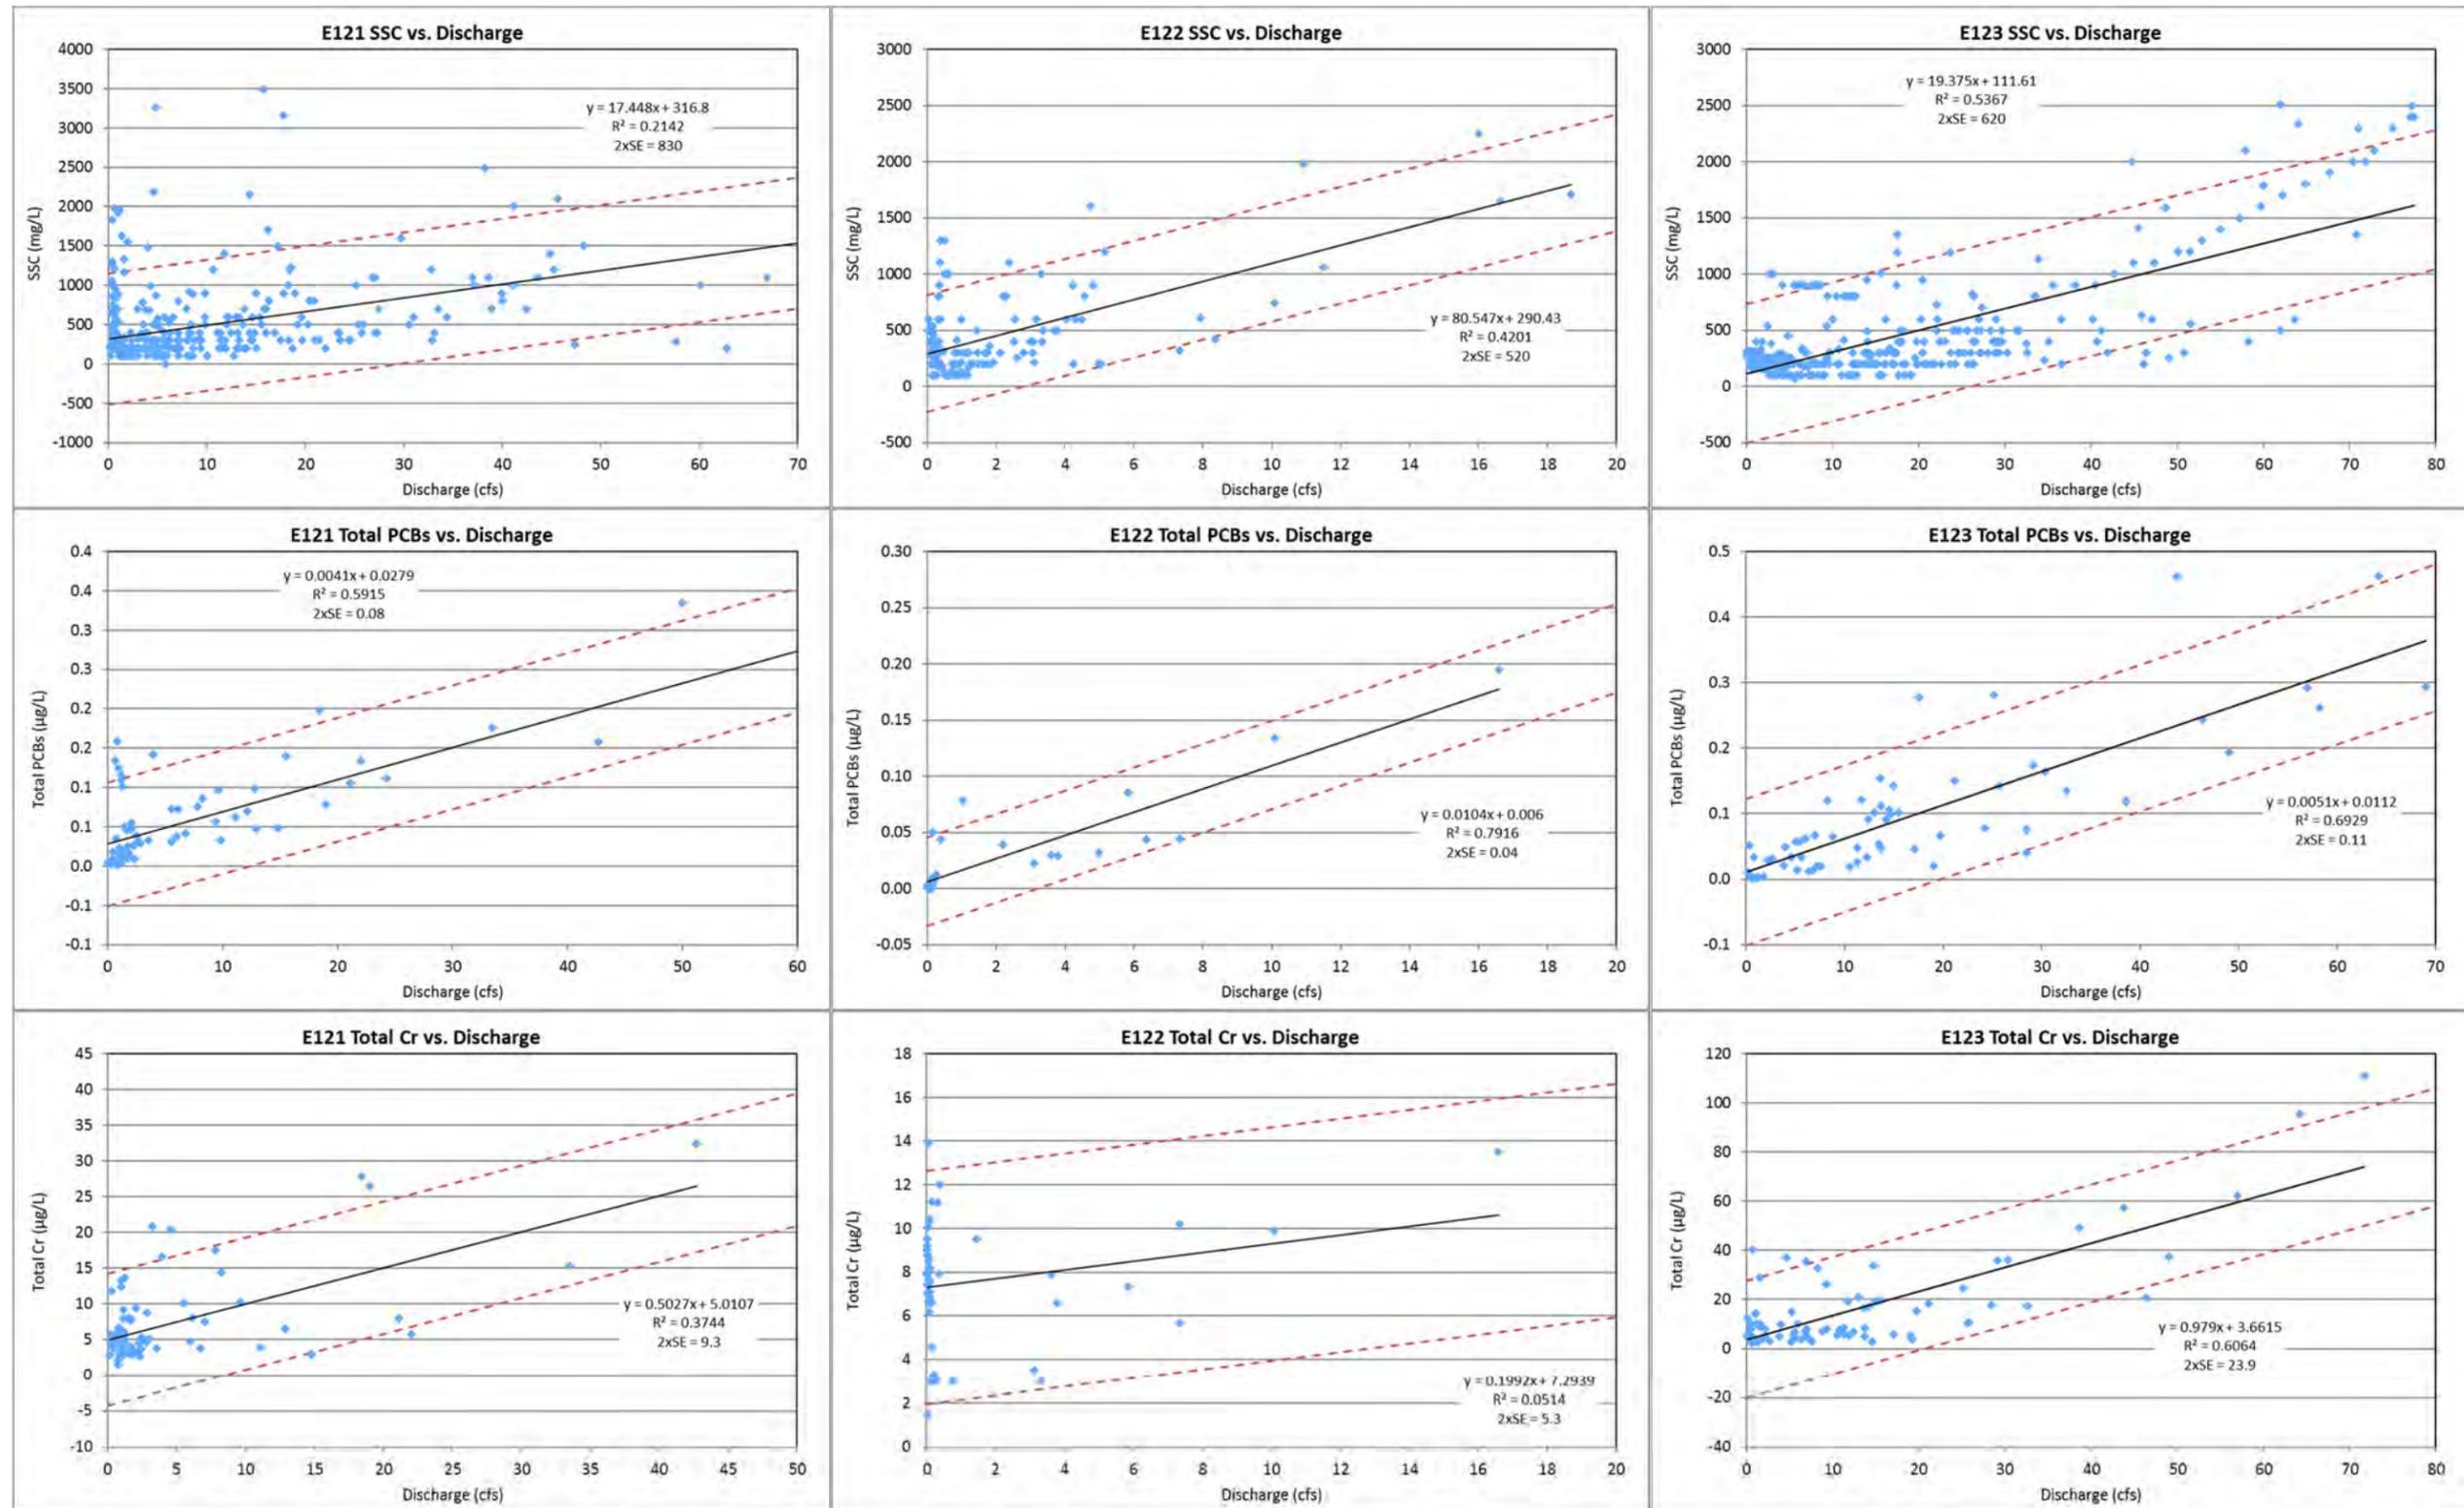
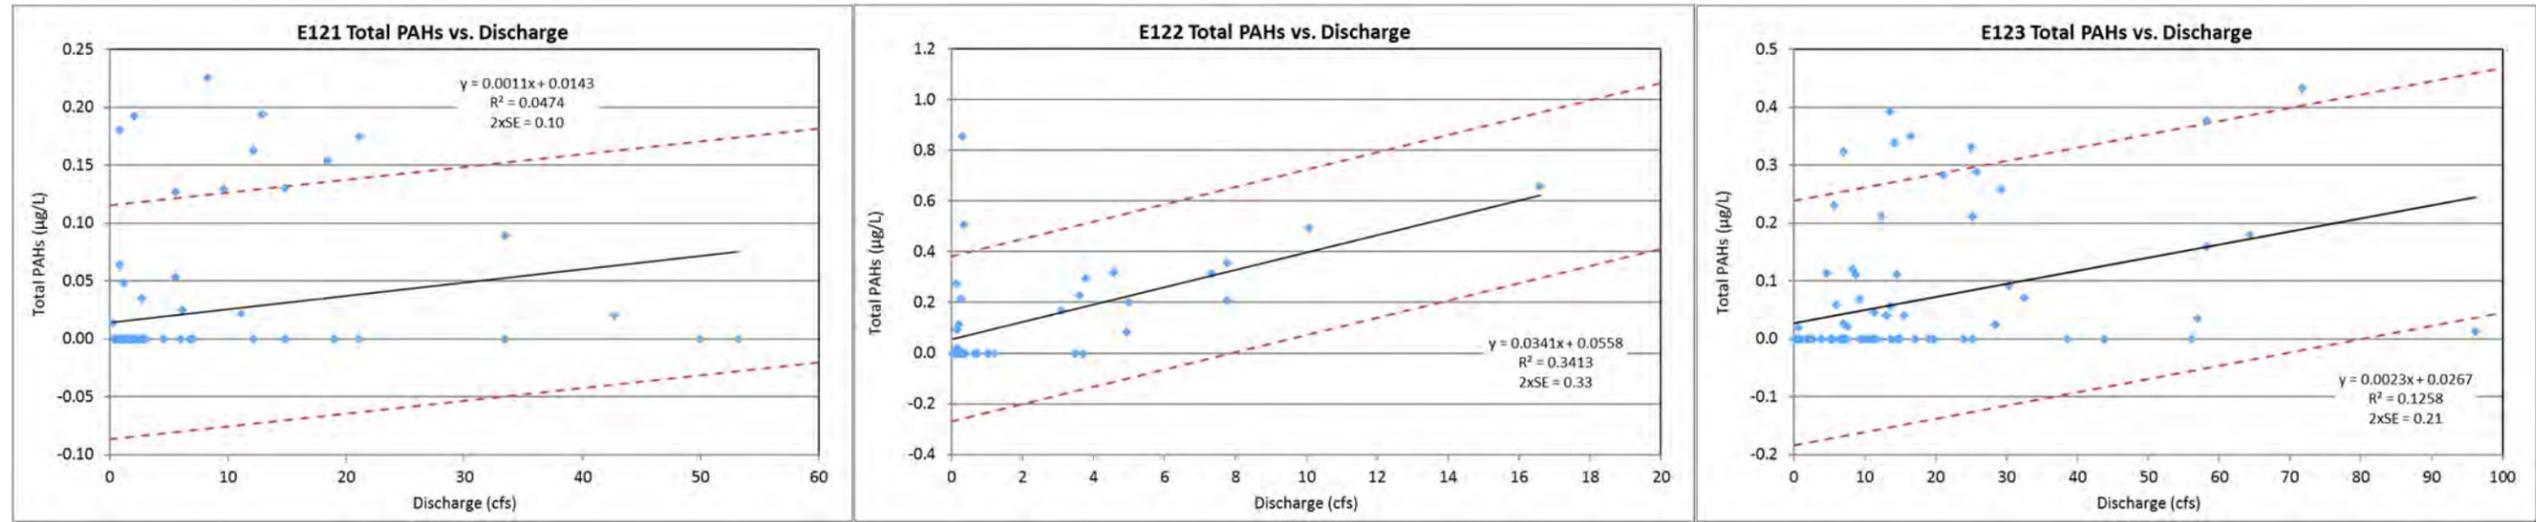
Figure D-2.0-9 Storm- and base flow discharge correlations with SSC, total PCBs, total chromium, and total PAHs from 2014 to 2017 at E121, E122, and E123 with standardized residual outliers removed; the red dashed lines are 2 times the standard error (2×SE) of the estimate, as noted with the equation of the line and the Pearson’s correlation coefficient (R²)

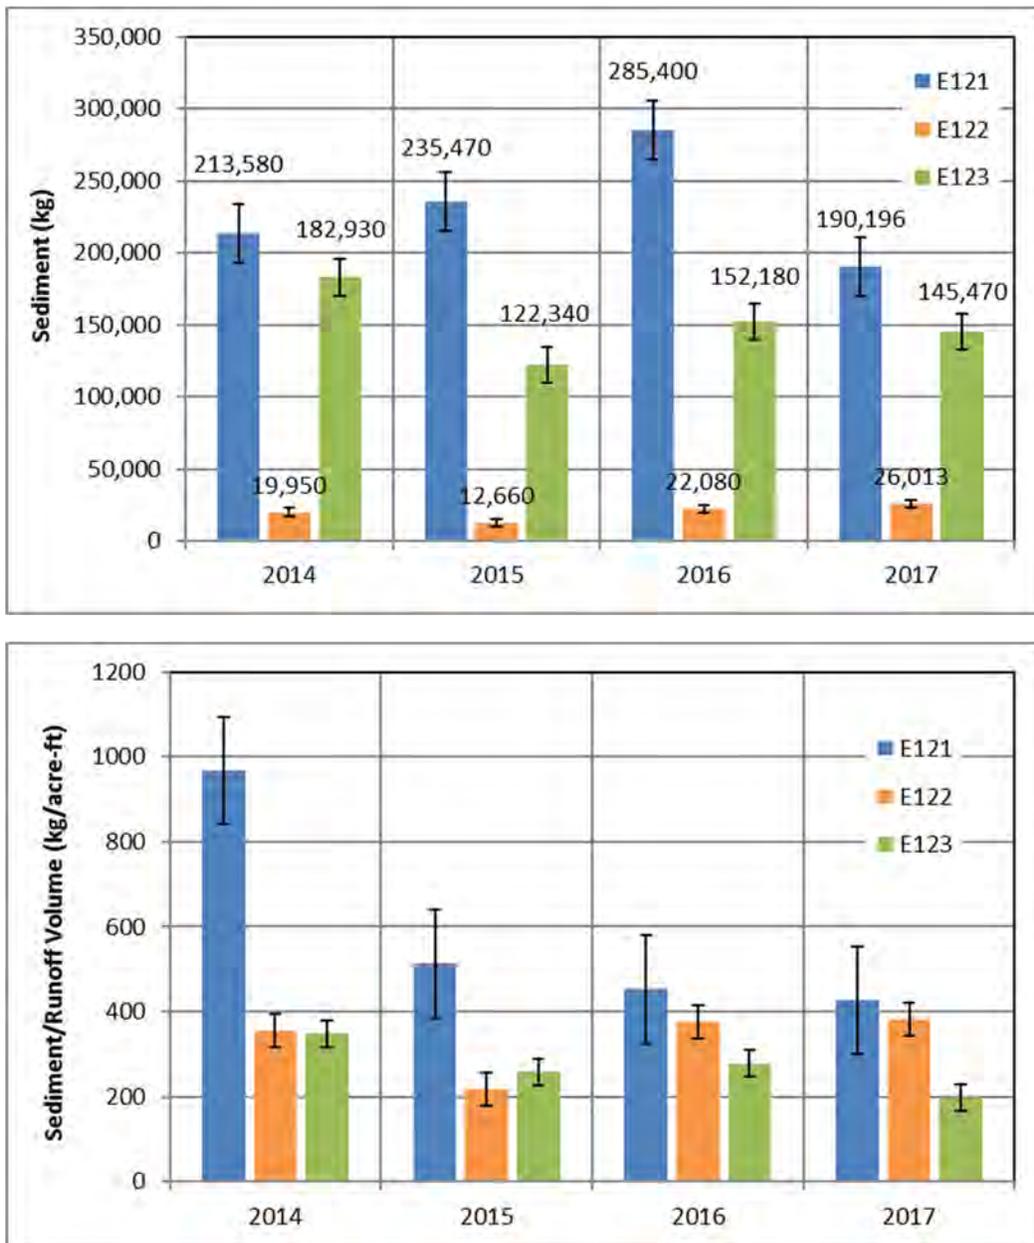
Figure D-2.0-10 Annual mass flux (top) and annual mass flux normalized by runoff volume (bottom) for sediment at gaging stations E121 (blue), E122 (orange), and E123 (green) from 2014 to 2017. Gaging stations E121 and E122 represent inputs into the wetland, and E123 represents output from the wetland. Error bars represent the standard error of the mean.

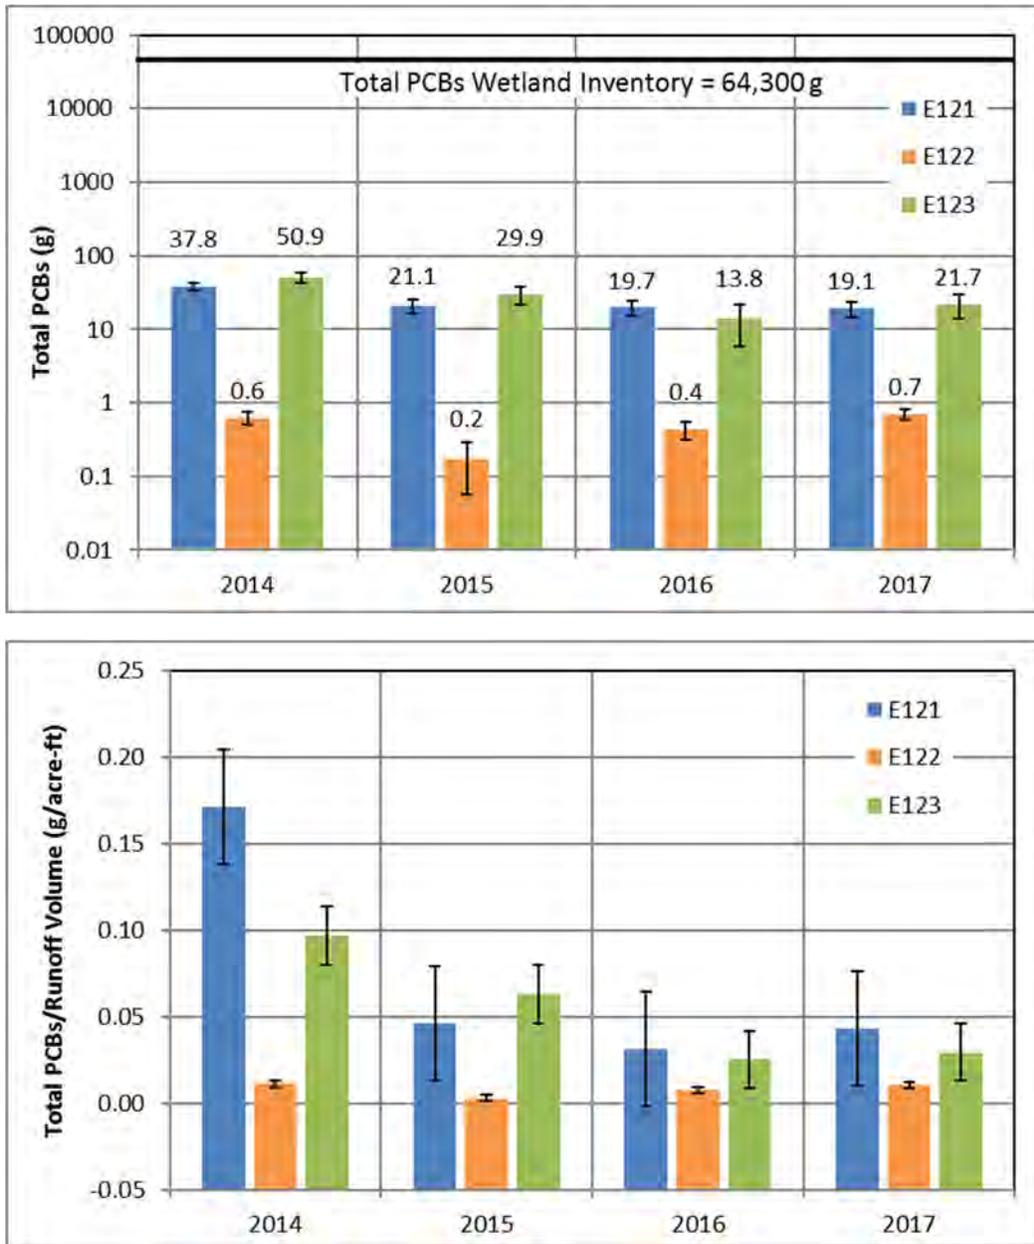
Figure D-2.0-11 Annual mass flux (top) and annual mass flux normalized by runoff volume (bottom) for total PCBs at gaging stations E121 (blue), E122 (orange), and E123 (green) from 2014 to 2017. Gaging stations E121 and E122 represent inputs into the wetland, and E123 represents output from the wetland. Error bars represent the standard error of the mean.

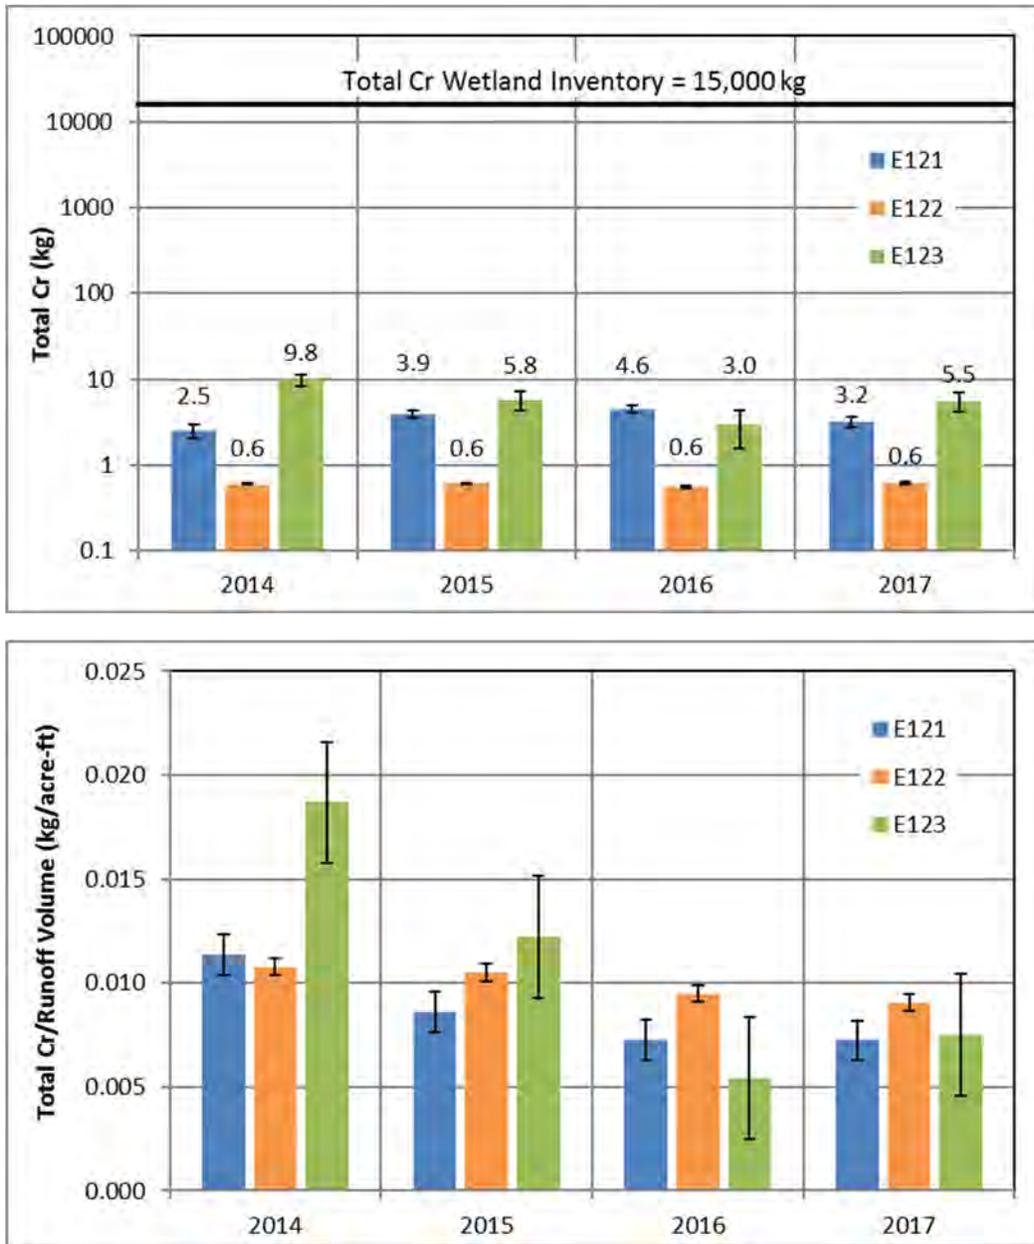
Figure D-2.0-12 Annual mass flux (top) and annual mass flux normalized by runoff volume (bottom) for total chromium at gaging stations E121 (blue), E122 (orange), and E123 (green) from 2014 to 2017. Gaging stations E121 and E122 represent inputs into the wetland, and E123 represents output from the wetland. Error bars represent the standard error of the mean.

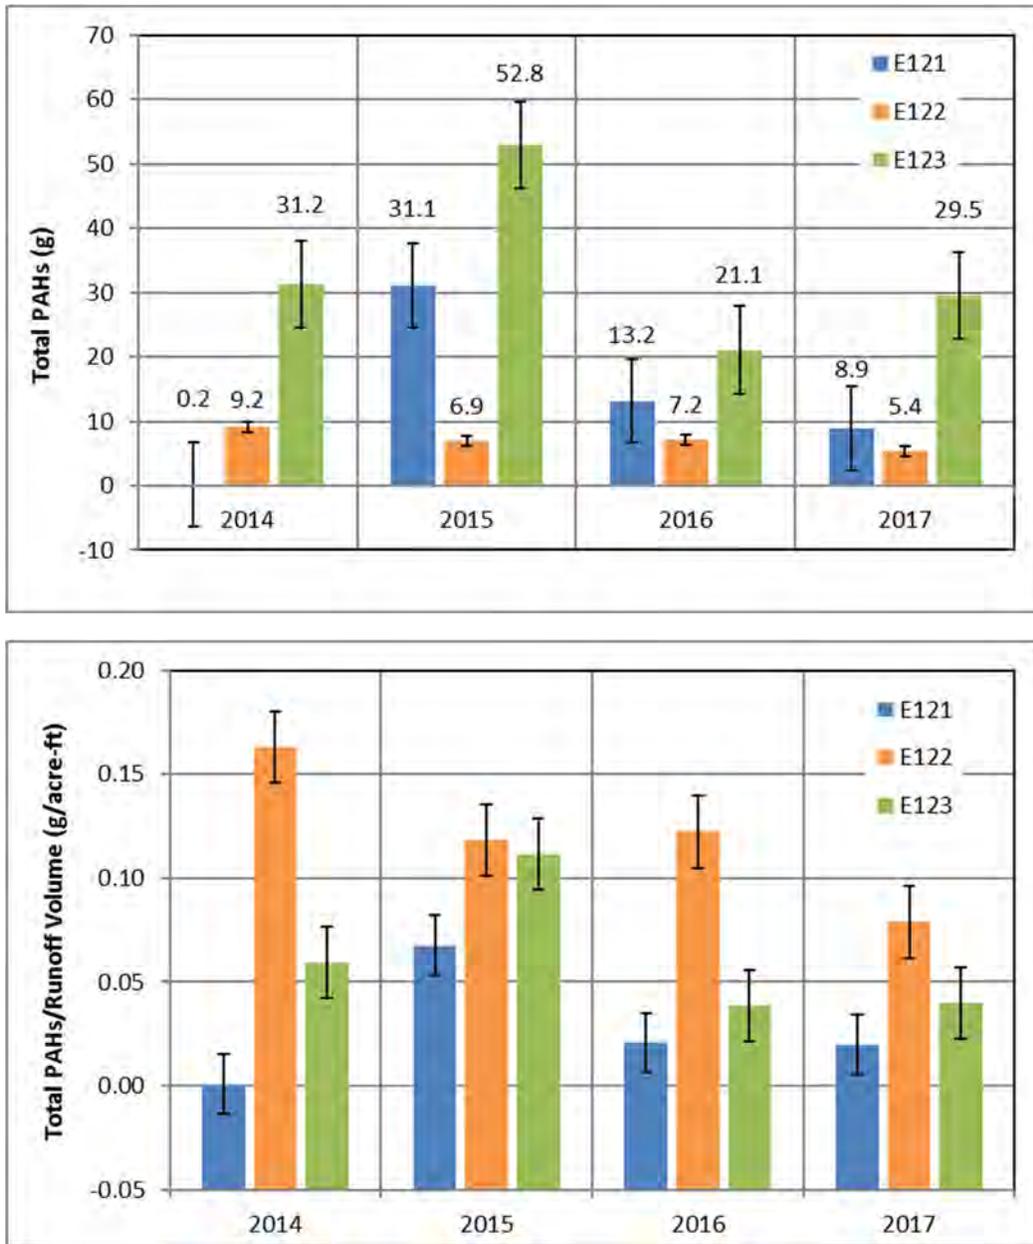
Figure D-2.0-13 Annual mass flux (top) and annual mass flux normalized by runoff volume (bottom) for total PAHs at gaging stations E121 (blue), E122 (orange), and E123 (green) from 2014 to 2017. Gaging stations E121 and E122 represent inputs into the wetland, and E123 represents output from the wetland. Error bars represent the standard error of the mean.

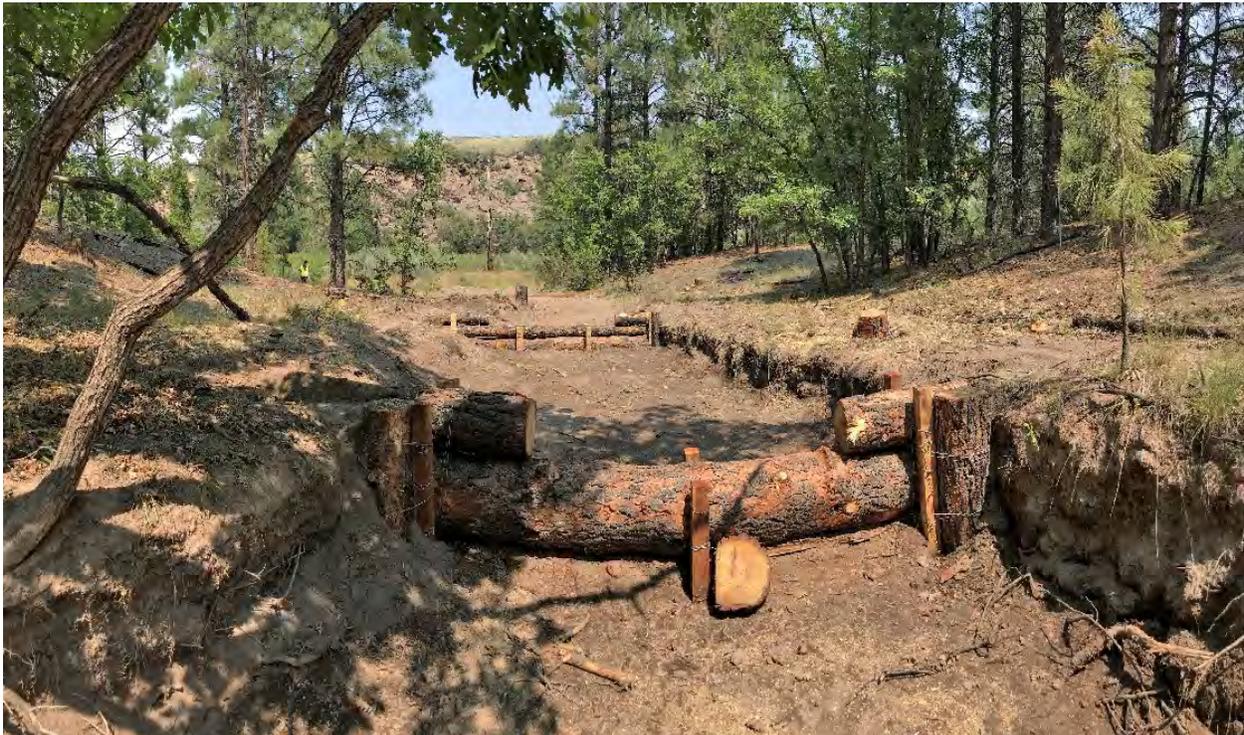
Figure E-2.1-1 September 2017: The two log check dams were installed to capture sediment originating from an erosion feature upgradient of the controls. Picture looking toward the wetland/downstream.

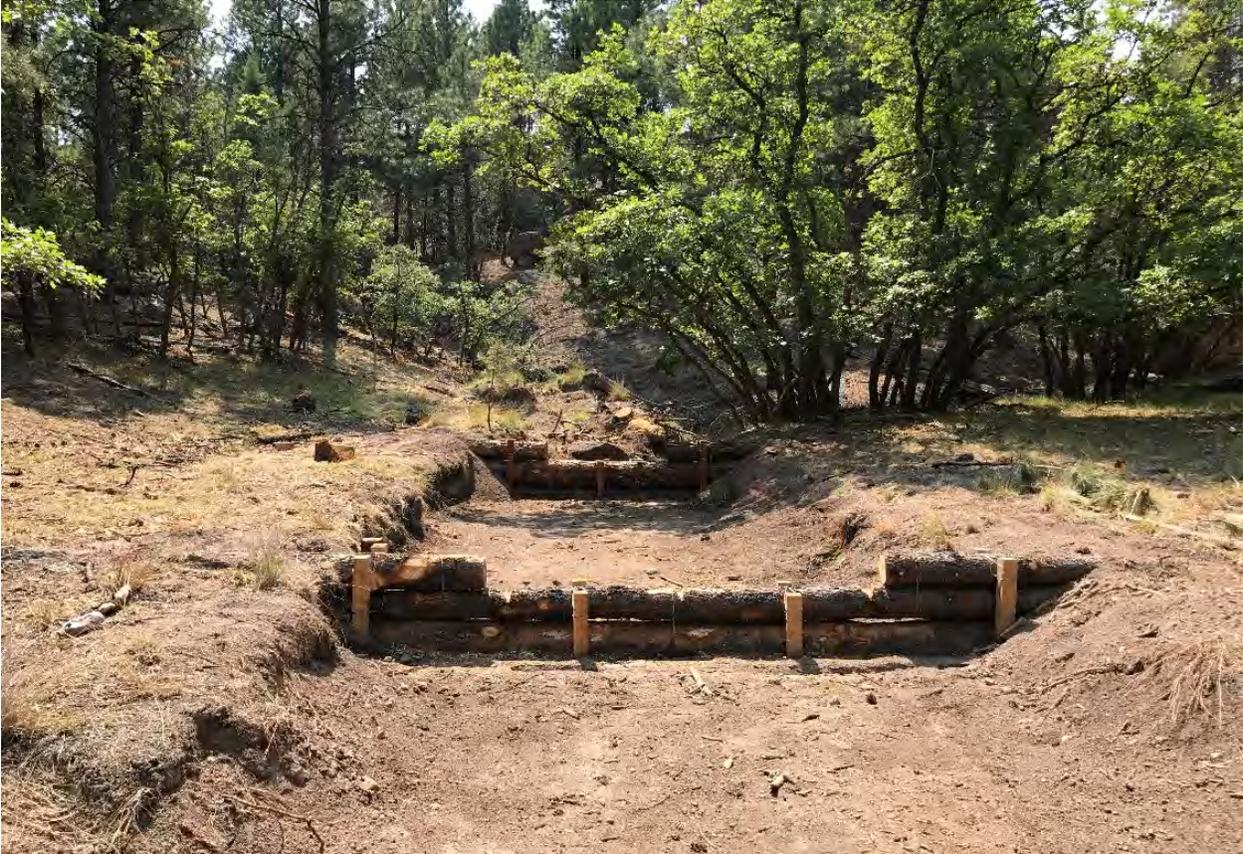
Figure E-2.1-2 September 2017: View of newly installed log check dams looking upstream

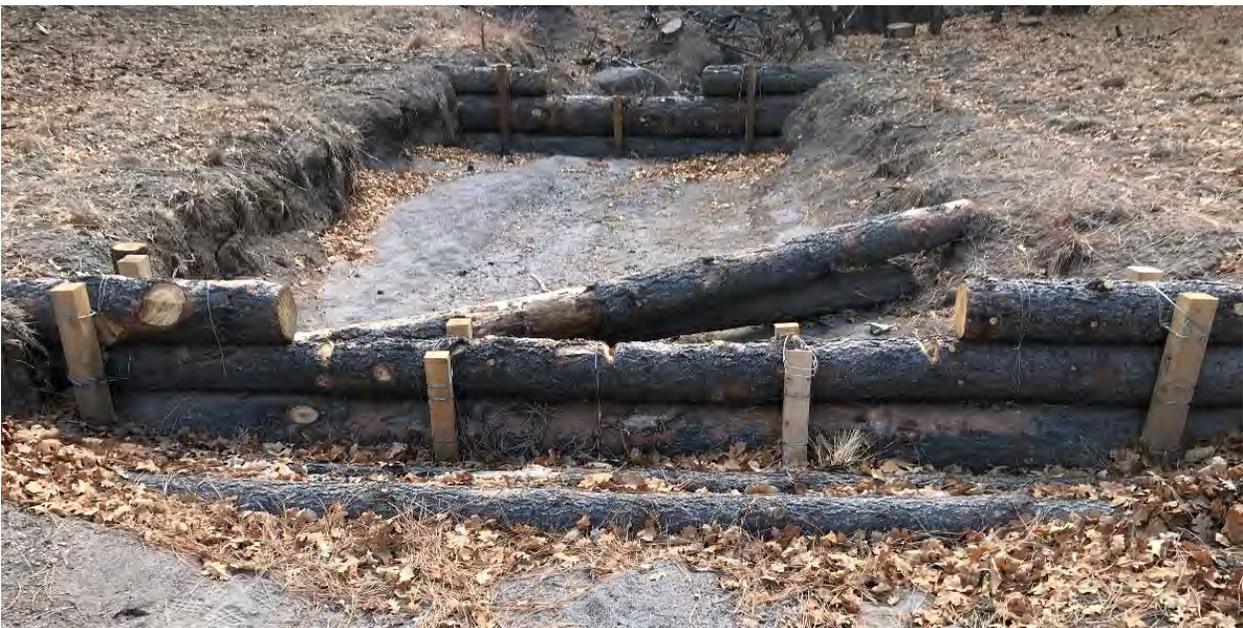
Figure E-2.1-3 December 2017: View of failed log check dams with displaced scour protection logs. Looking upstream.

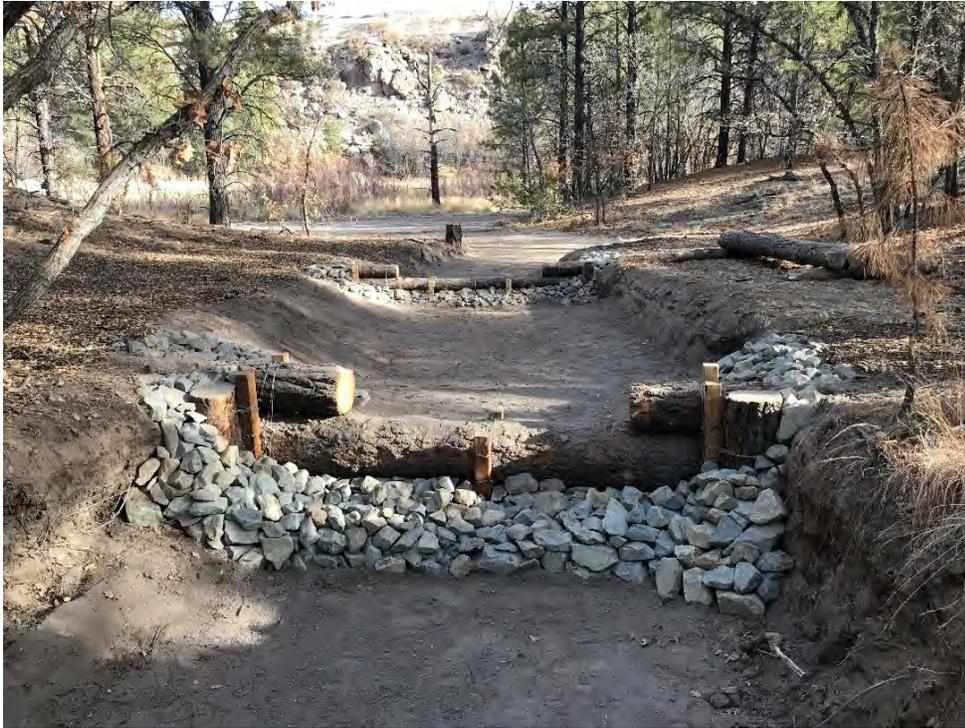
Figure E-2.1-4 January 2018: View of repaired log check dams with additional riprap erosion protection. Looking downstream.

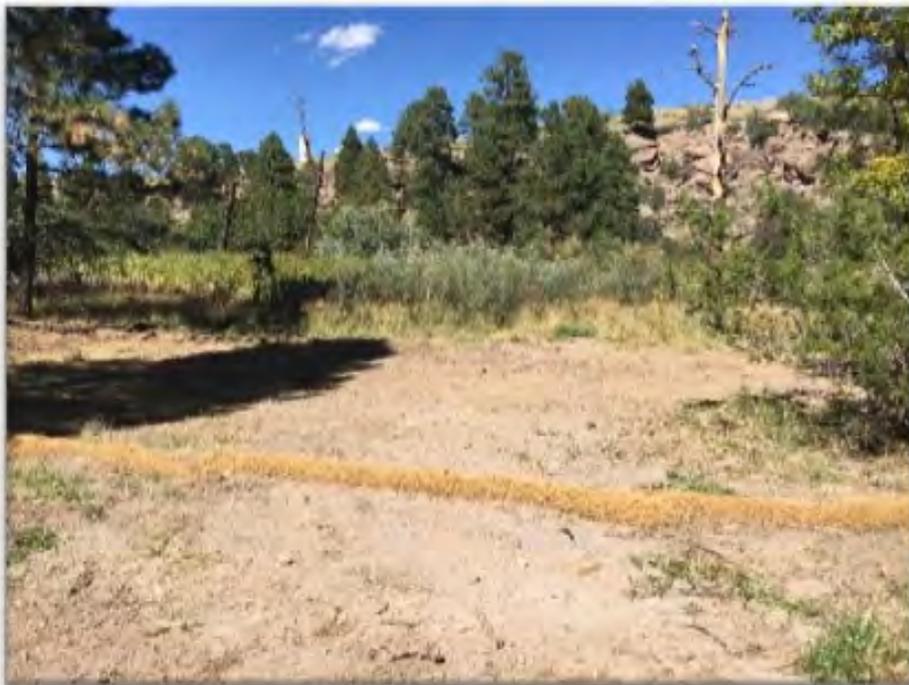
Figure E-2.1-5 September 2017: A line of coir logs were installed to allow for both velocity dissipation and sediment capture.

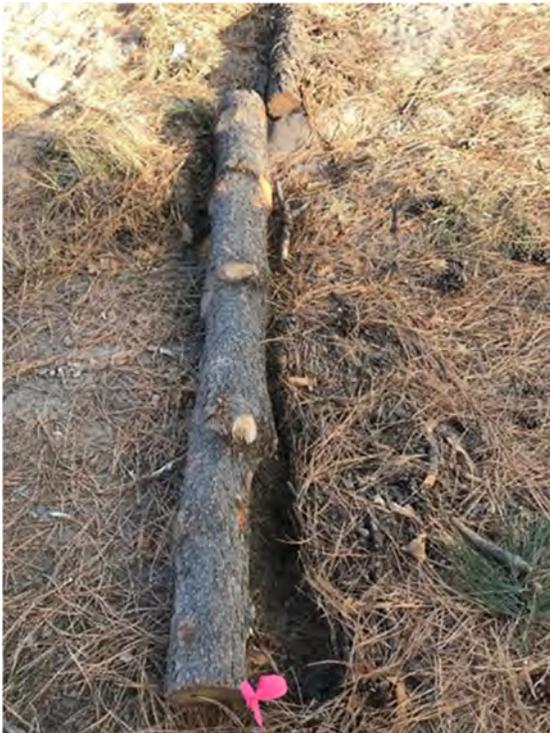
Figure E-2.1-7 December 2017: Flow spreader logs displaced during flow event. Logs were replaced and keyed in with riprap during January 2018 maintenance. Looking east.

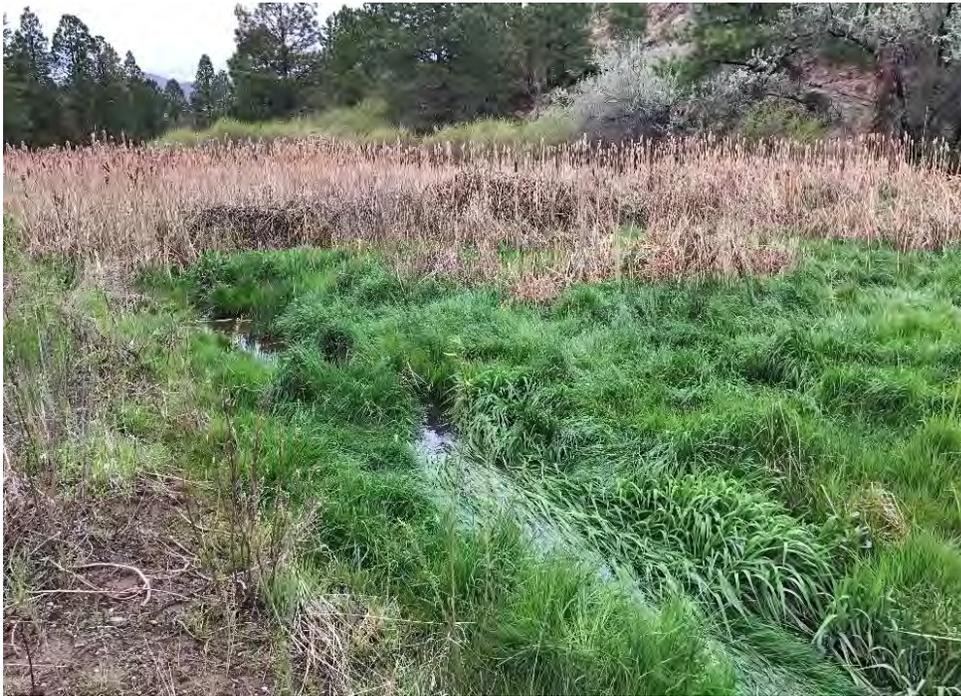
Figure E-3.3-1 May 2017: Minor channelization occurring near bank but vegetation growth has significantly increased compared to prior season. Continue to monitor. No evidence of cracking or spalling on concrete wall.

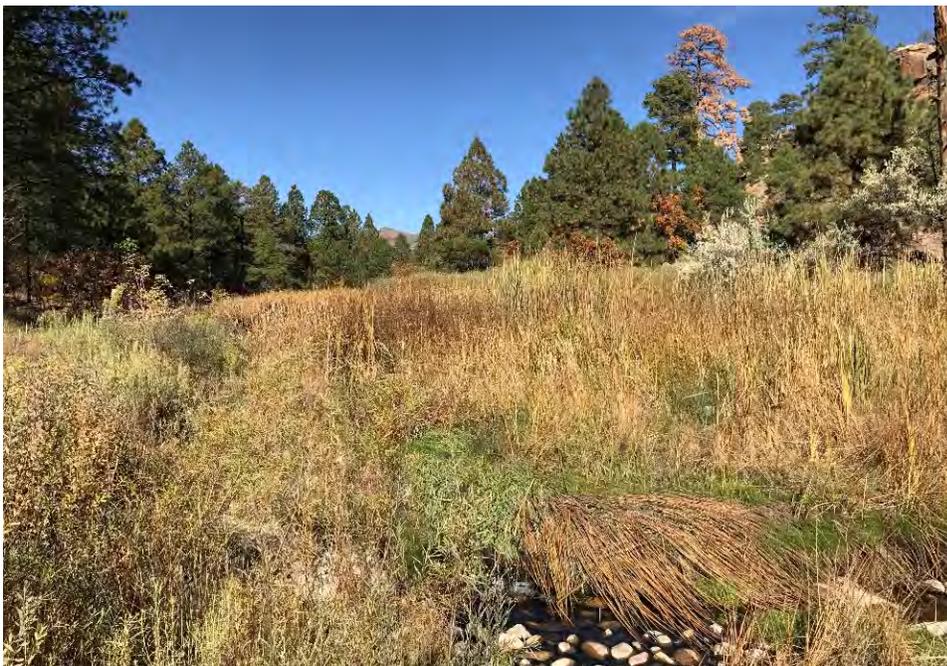
Figure E-3.3-2 October 2017: Channelization has decreased since last visit (May 2017). Wetland vegetation has aided in dispersing upstream flow throughout wetland.

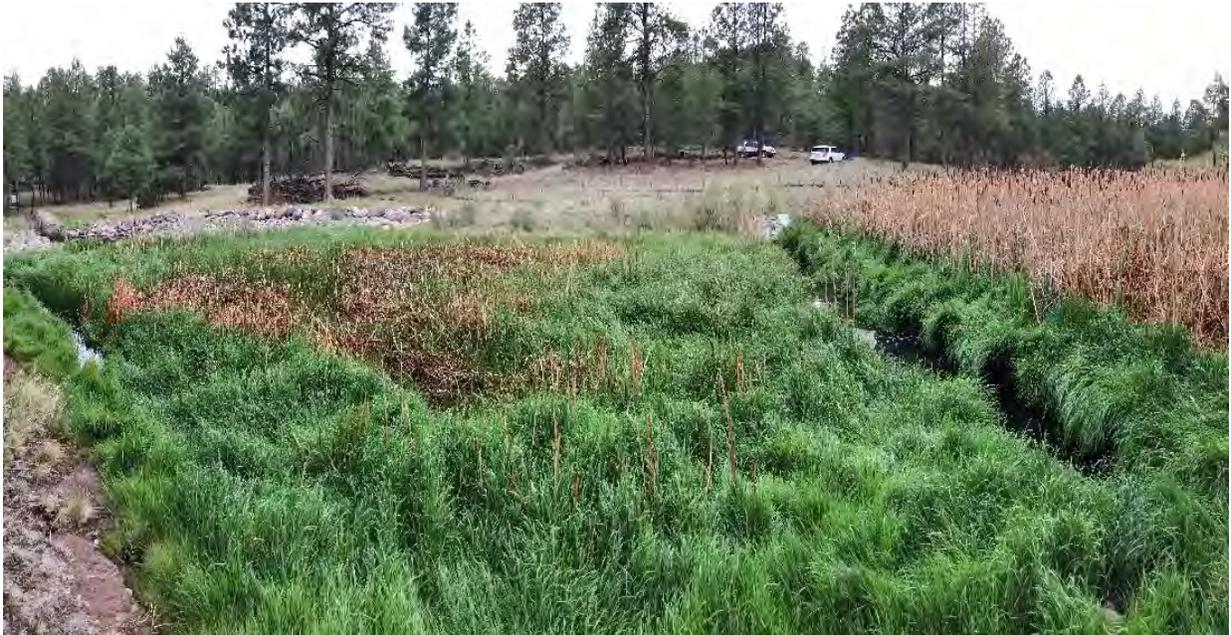
Figure E-3.5-1 May 2017: Wetland vegetation well established. Dispersing flow evenly throughout GCS. No evidence of channelization. No evidence of cracking or spalling on concrete wall.

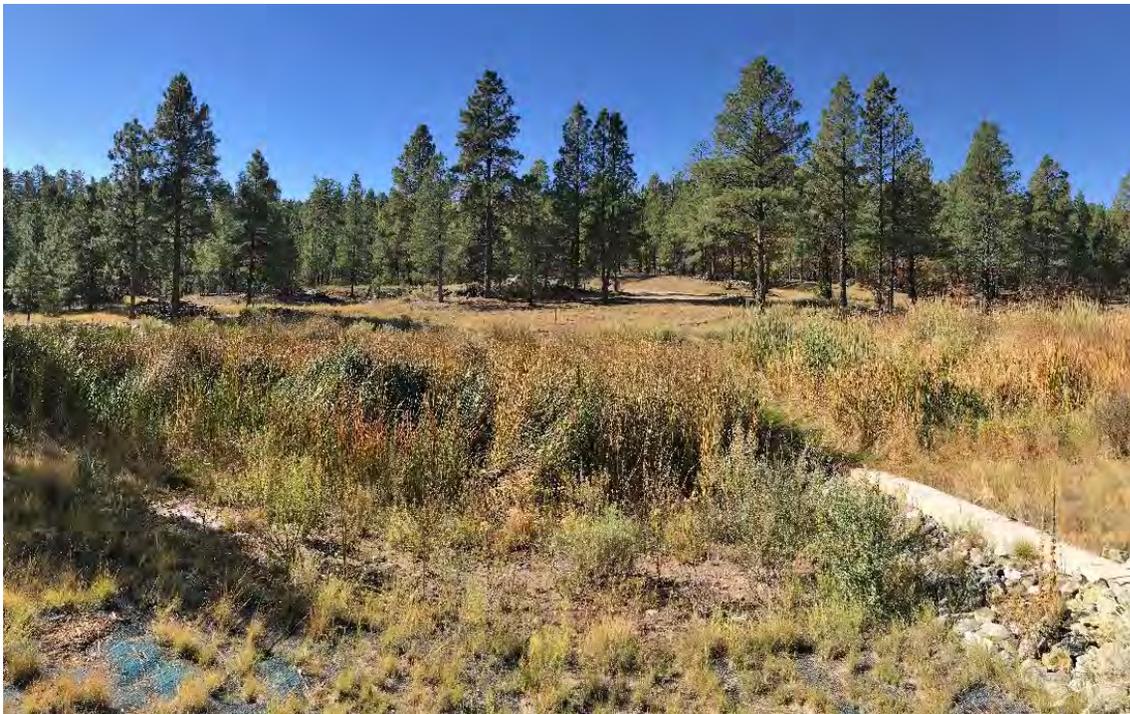
Figure E-3.5-2 October 2017: Wetland vegetation further established since last site visit (May 2017). No further changes since last site visit.

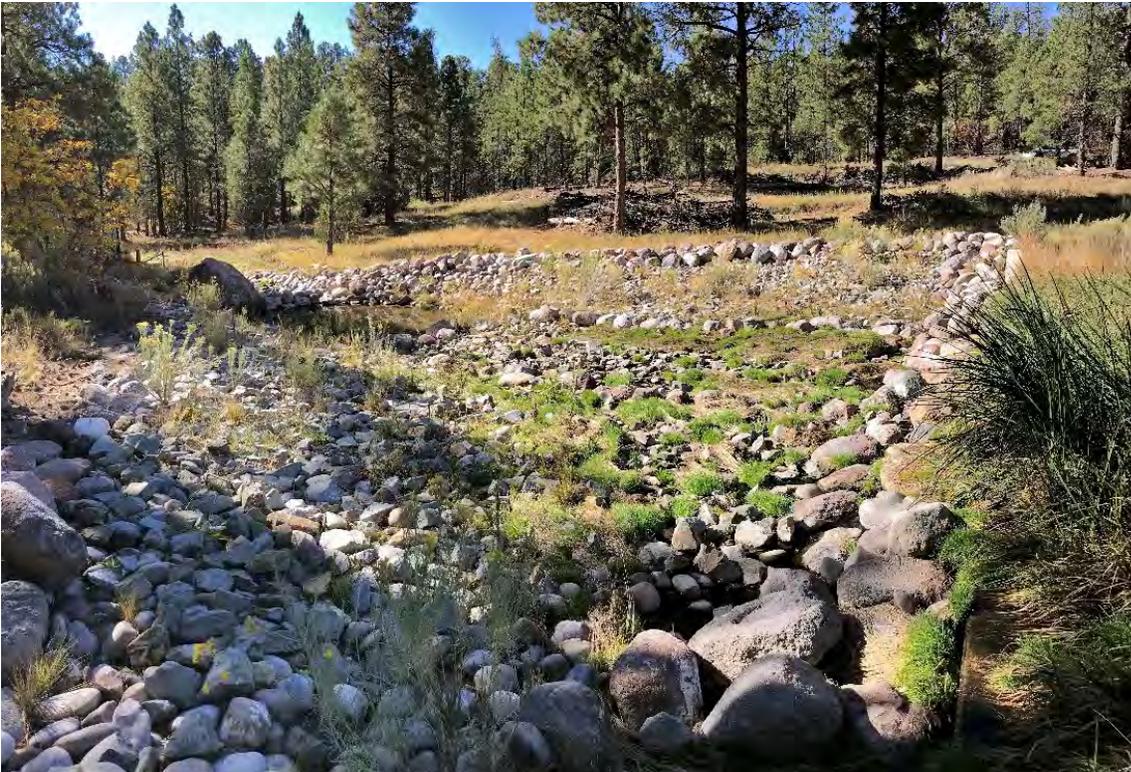
Figure E-3.6-2 October 2017: No change in site condition since last visit (May 2017).

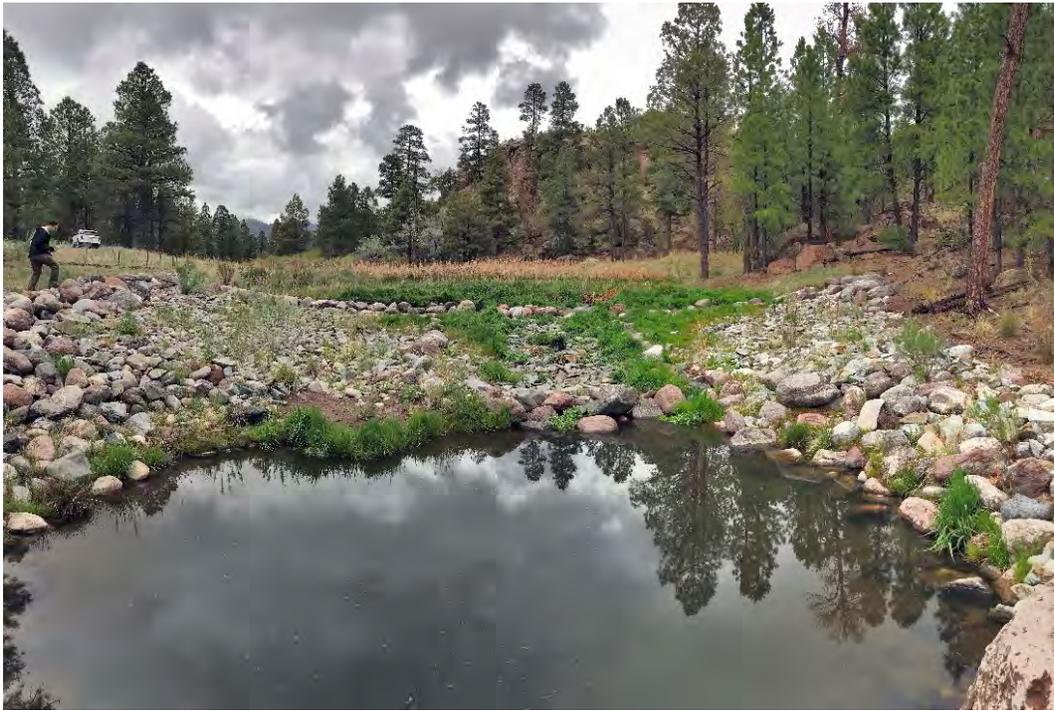
Figure E-3.7-1 May 2017: Cascade structure working as designed. No evidence of rock displacement. No evidence of erosion in/near cascade pool.

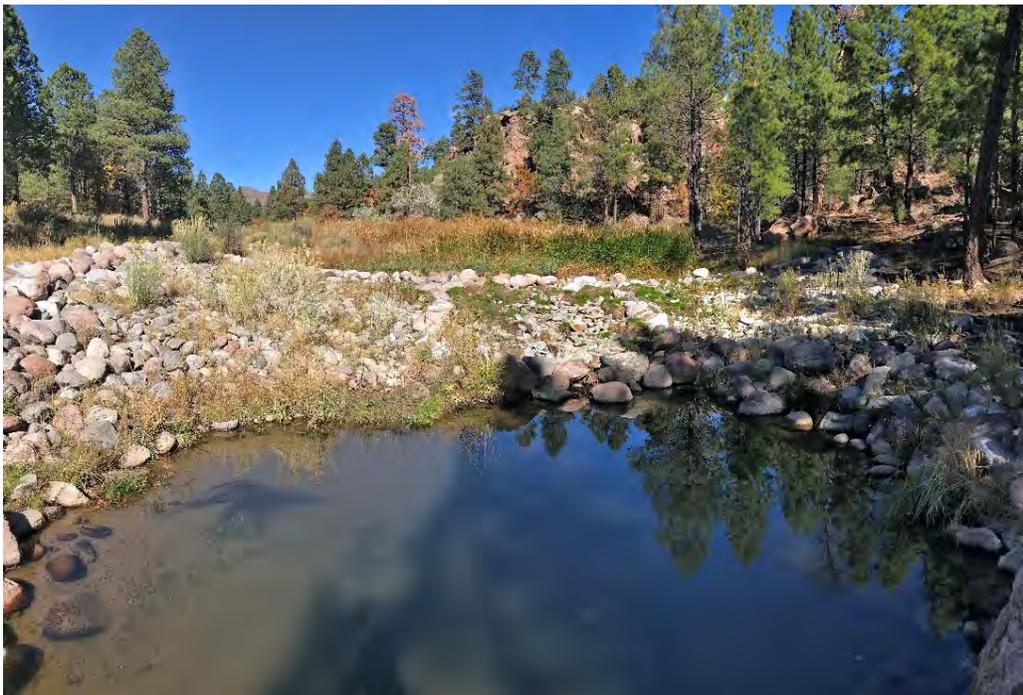
Figure E-3.7-2 October 2017: No change in site condition since last inspection (May 2017).

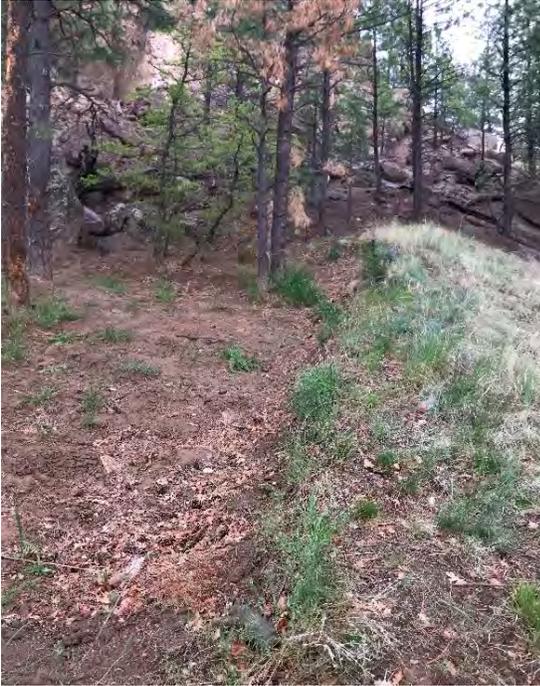
Figure E-3.8-1 May 2017: Upper defense at roughly 50 percent capacity. Los Alamos County upgradient best management practice reducing sediment flow to control. Defense cell operating as designed.
