## Site Discharge Pollution Prevention Plan

Los Alamos National Laboratory  
NPDES Permit No. NM0030759, May 1, 2012

# Ancho/Chaquehui Watershed

Receiving Waters:  
Ancho Canyon and Chaquehui Canyon

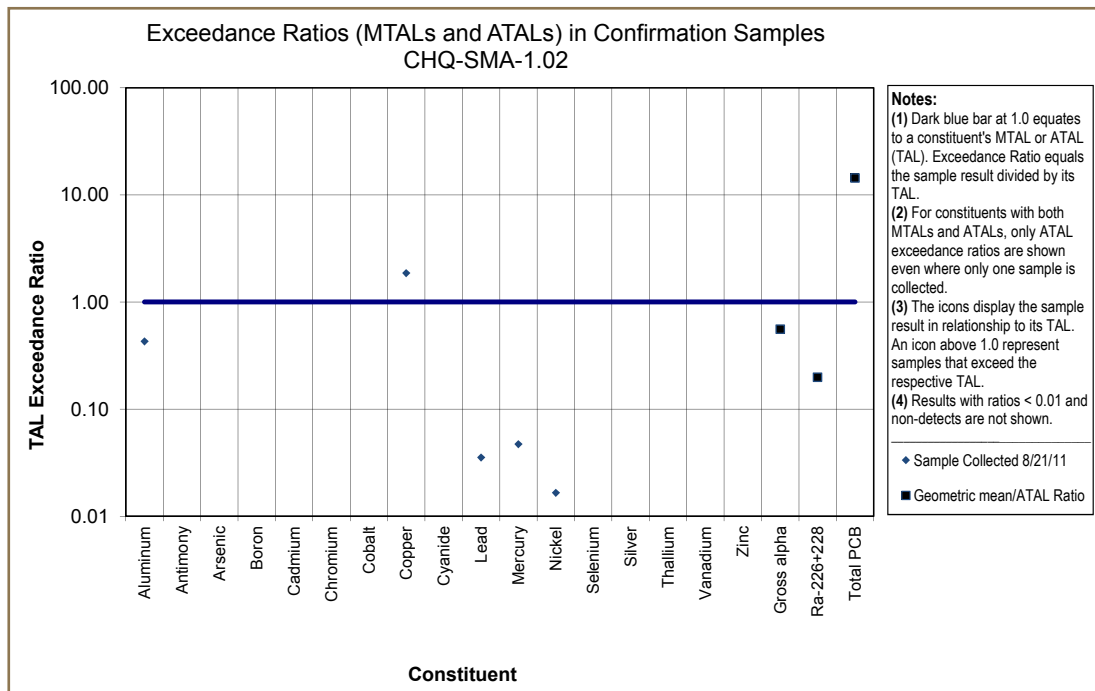
The results of this sampling effort are graphically displayed in the following chart where results are shown as a ratio of the respective MTAL or ATAL. Full data analysis and reporting of the analytical results of this sampling will be provided in the 2011 Annual Report.
