Subject: 2015 Biennial Asphalt Monitoring and Removal Report for Area of Concern C-00-041, Guaje/Barrancas/Rendija Canyons Aggregate Area

LA-UR-15-29147
December 2015
EP2015-0199

2015 Biennial Asphalt Monitoring and Removal Report for Area of Concern C-00-041, Guaje/Barrancas/Rendija Canyons Aggregate Area

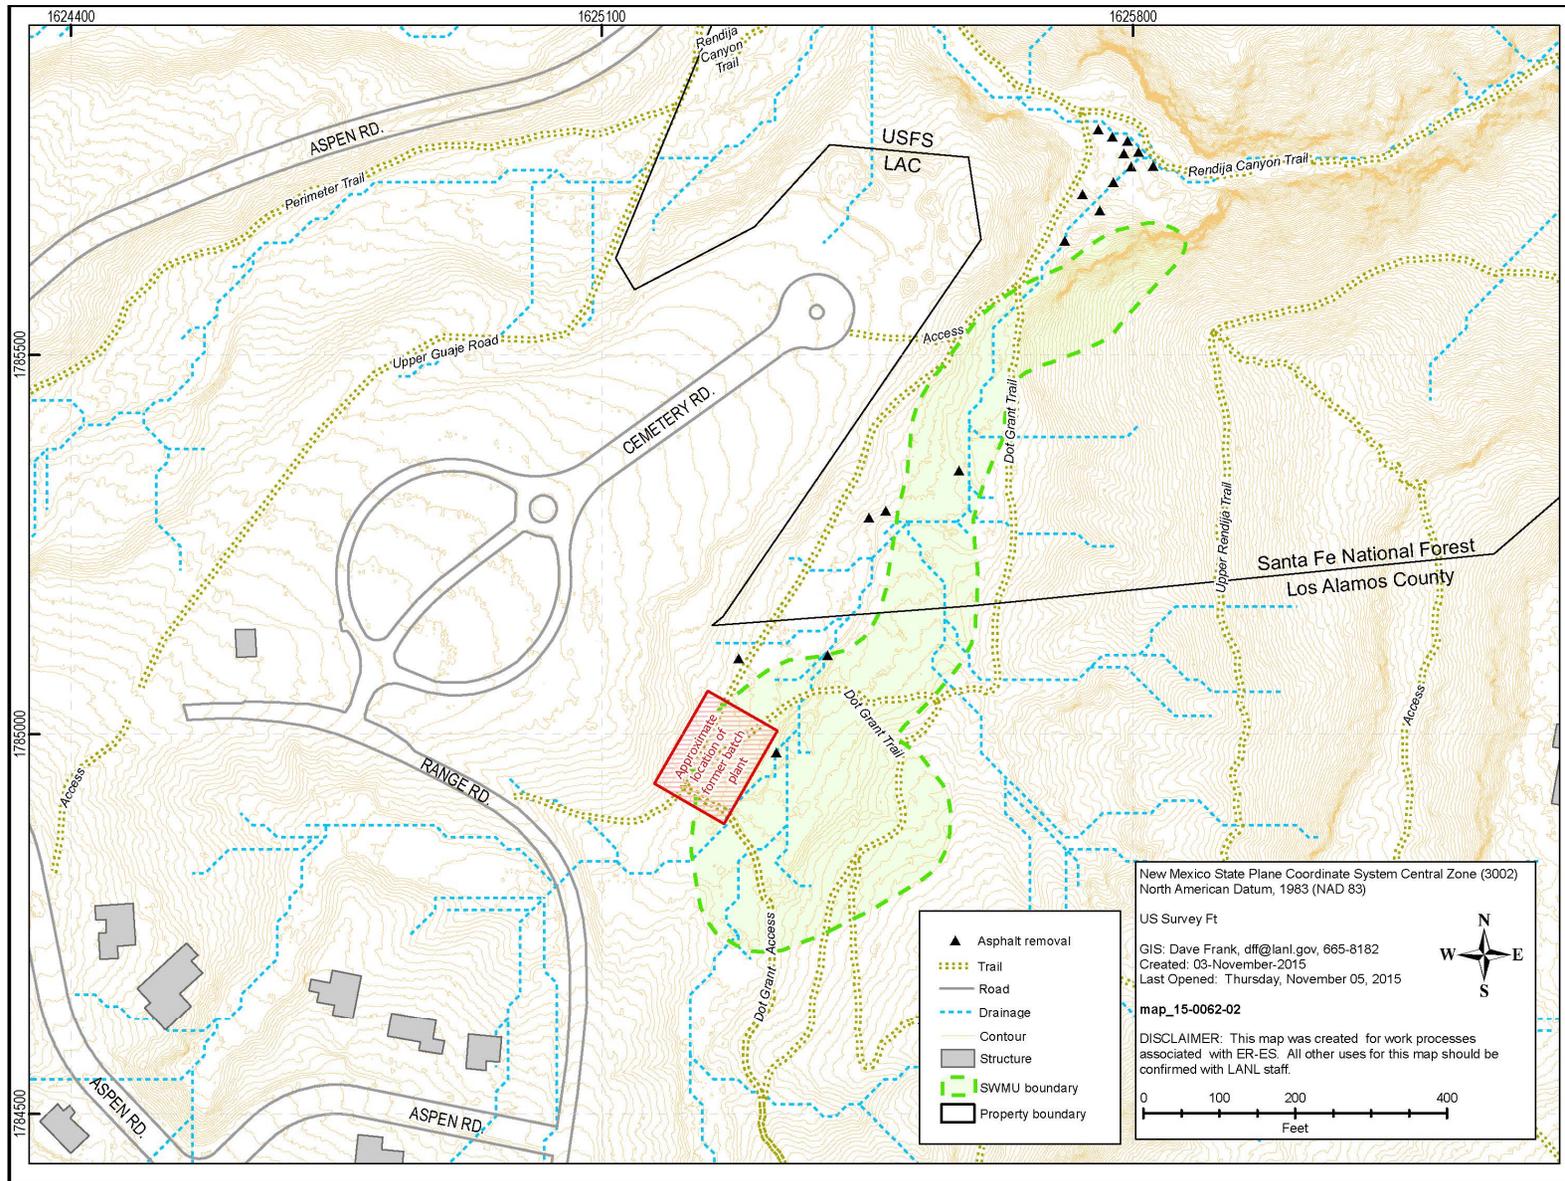
Figure 2.0-1 AOC C-00-041 site map and locations of asphalt and tar removal

Figure 2.0-1 is a site map of AOC C-00-041. Currently, the site is undeveloped and is located in a grassy open meadow bisected south to north by an ephemeral stream. A hiking trail, the Dot Grant Trail, is located to the east of AOC C-00-041, and another trail and the Guaje Pines Cemetery are located to the west.

no excavation or significant soil disturbance. The asphalt and tar pieces ranged in size from less than an inch to up to 18 in. in length and width. Asphalt and tar pieces were collected in buckets and transferred to the back of a pickup truck. A total of 1160 lb of asphalt and tar was removed from AOC C-00-041 and transferred to, and recycled at, the Los Alamos County Eco-Station. Figure 2.0-1 shows the location where visible asphalt and tar were removed from AOC C-00-041. Figures 4.2-1 through 4.2-6 are photographs of asphalt and tar collection activities.

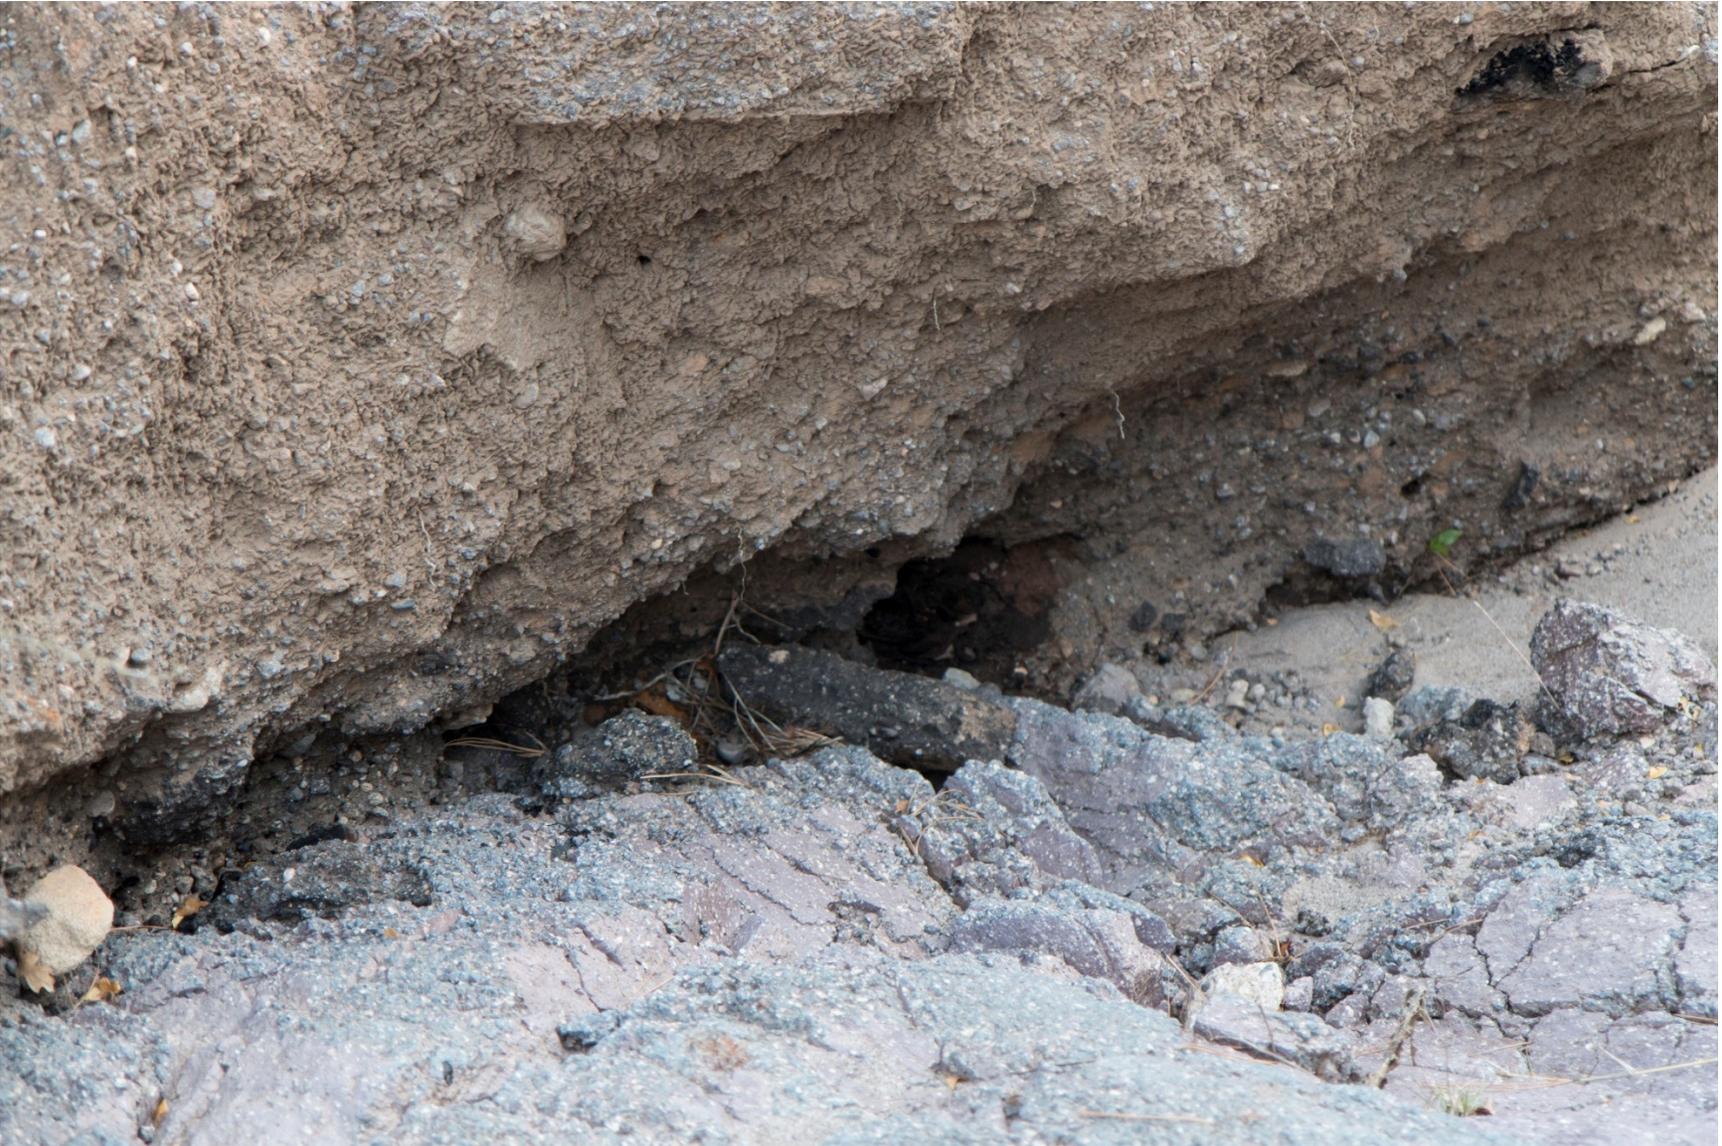
Figure 4.2-2 Asphalt debris in drainage within AOC C-00-041

On October 28, 2015, exposed asphalt and tar fragments were found and removed during the site inspection of AOC C-00-41. Asphalt or tar was removed only if it was visible at the surface and involved
