**U.S. DEPARTMENT OF ENERGY**

**Supplemental Environmental Project:  
Second Independent External Triennial Review**

**Los Alamos National Laboratory, Los Alamos, New Mexico**

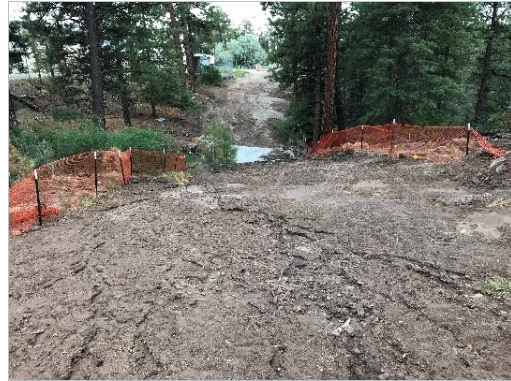
- Observation IP-001, minimize sediment in runoff during construction project: At 2M-SMA-1, the Review Team discovered a freshly graded, dirt construction road with insufficient controls to prevent the erosion of SWMU-03-010(a), a permitted feature (former outfall area from a vacuum repair shop), or to prevent sediment from entering the SMA during a storm event (see Figure 3-1). The Review Team discovered gaps in communications between N3B and Triad during construction at this Site.

Figure 3-1: Erosion at SWMU-03-010(a)
