Subject: 2017 Biennial Asphalt Monitoring and Removal Report for Area of Concern C-00-041, Guaje/Barrancas/Rendija Canyons Aggregate Area

LA-UR-17-30852
December 2017
EP2017-0147

2017 Biennial Asphalt Monitoring and Removal Report for Area of Concern C-00-041, Guaje/Barrancas/Rendija Canyons Aggregate Area

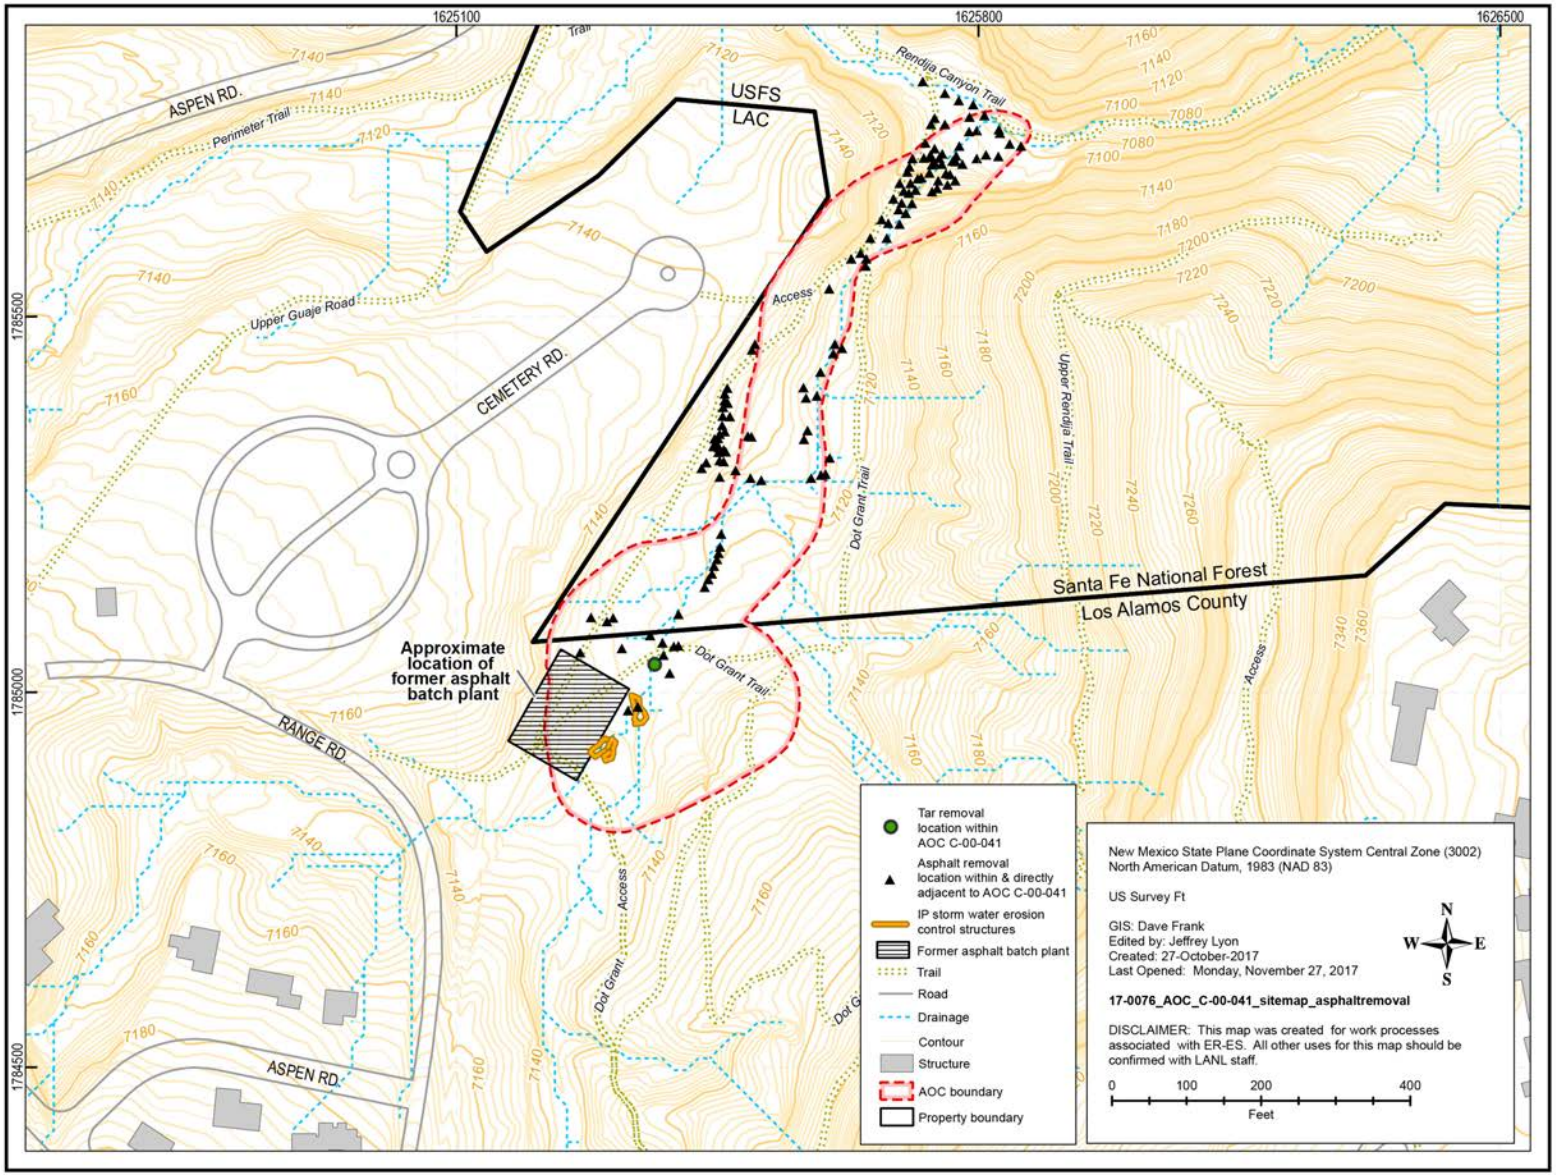
Figure 2.0-1 AOC C-00-041 site map, locations of asphalt and tar removed in 2017, and location of IP storm water erosion controls

AOC C-00-041 was inspected on October 19, 2017 per the approved asphalt monitoring and removal plan (LANL 2008, 102726; NMED 2008, 102289). The inspection was conducted to identify remnants of asphalt and tar that have been exposed at the surface by runoff or erosion since the 2015 monitoring and removal activities. The inspection was performed by traversing the site on foot and visually inspecting the ground surface. The site was divided into smaller areas, and multiple sweeps (or sweeps by multiple people) were performed in each area to ensure all newly exposed asphalt and tar were identified and removed. Several photographs were taken and a Global Positioning System unit was used to record all locations where asphalt and tar were collected within and directly adjacent to AOC C-00-041 (Figure 2.0-1).

On October 19, 2017, exposed asphalt debris and tar fragments were found and removed during the site inspection of AOC C-00-41. Asphalt or tar was removed only if it was visible at the surface and involved no excavation or significant soil disturbance. The majority of material found and removed within AOC C-00-041 was asphalt debris (Figures 2.0-1 and 4.2-2). A few pieces of tar were found and removed in only one location within AOC C-00-041 (Figures 2.0-1 and 4.2-3). The tar pieces were less than 3 in. in length, one in. in width, and less than 0.25 in. thick. The asphalt pieces ranged in size from less than an inch up to 18 in. in length and 6 in. in width. Asphalt and tar pieces were collected in buckets and transferred to the bed of a pickup truck. A total of 780 lb of primarily asphalt debris was removed from within and directly adjacent to AOC C-00-041. The asphalt and tar removed was transferred to the LAC Eco-Station and recycled. Figures 4.2-1 through 4.2-5 are photographs of asphalt and tar collection activities.
