Title: CERRO GRANDE FIRE: ONE YEAR AFTER AN UPDATE ON ER ACTIVITIES TO REDUCE THE POTENTIAL MOVEMENT OF CONTAMINATION AT POTENTIAL RELEASE SITES

Author(s): Steven J. Veenis, CPESC
Randy Johnson

Submitted to: Environmental Restoration Project
Water Quality & Hydrology Group (ESH-18)

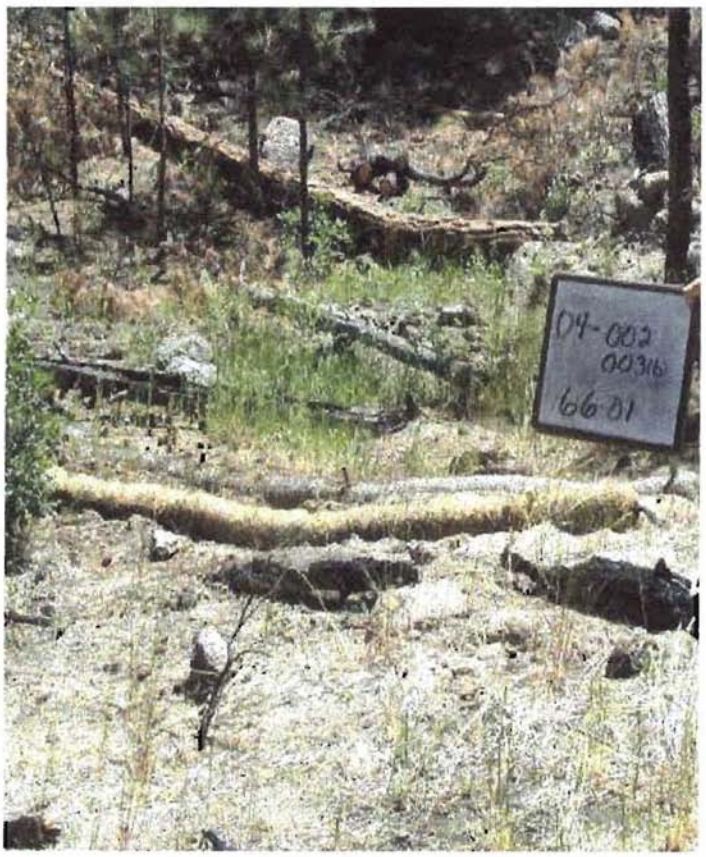
TECHNICAL AREA-4 SITES ONE YEAR AFTER THE CERRO GRANDE FIRE

Site is in good condition, with vegetative cover of greater than 50%. The area appears stable with evidence of sediment migration being minimal.

Straw wattles were installed above the site for run-on diversion at the mesa's edge, within the north facing drainage and on the lower bench for sediment retention. Spot hand raking, reseeding and straw mulch were also applied.

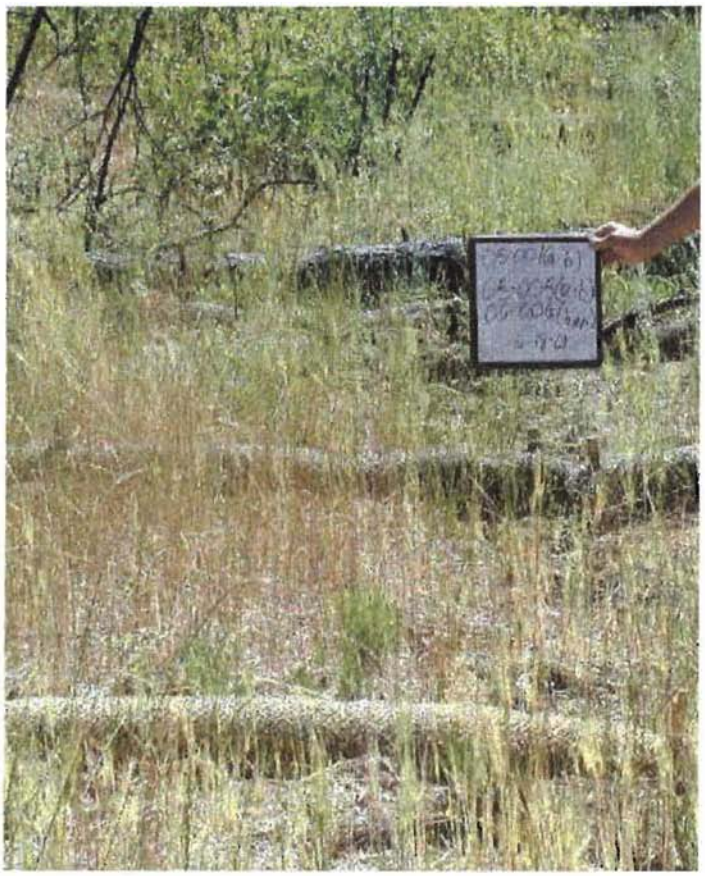
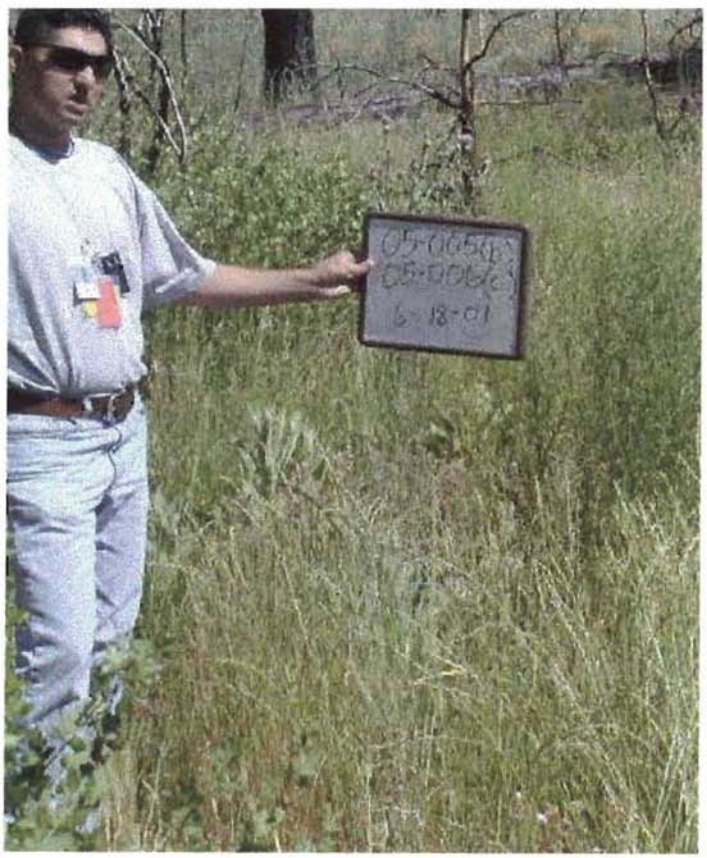
This site is located on the south rim of Mortandad Canyon within the Upper Canada del Buey Watershed Aggregate. The fire damage was moderate to severe with nearly complete damage to the ground cover and canopy.

Site is in good condition, with vegetative cover of greater than 70%. Sediment migration is occurring in the steepest part of several drainage channels, but the straw wattles on the flatter bench appear to be keeping sediment from entering into Canada del Buey.

Maintenance consisted of installation of an additional 28 wattles throughout the site. A few more trees were felled within drainages and spot reseeding and mulch were applied.

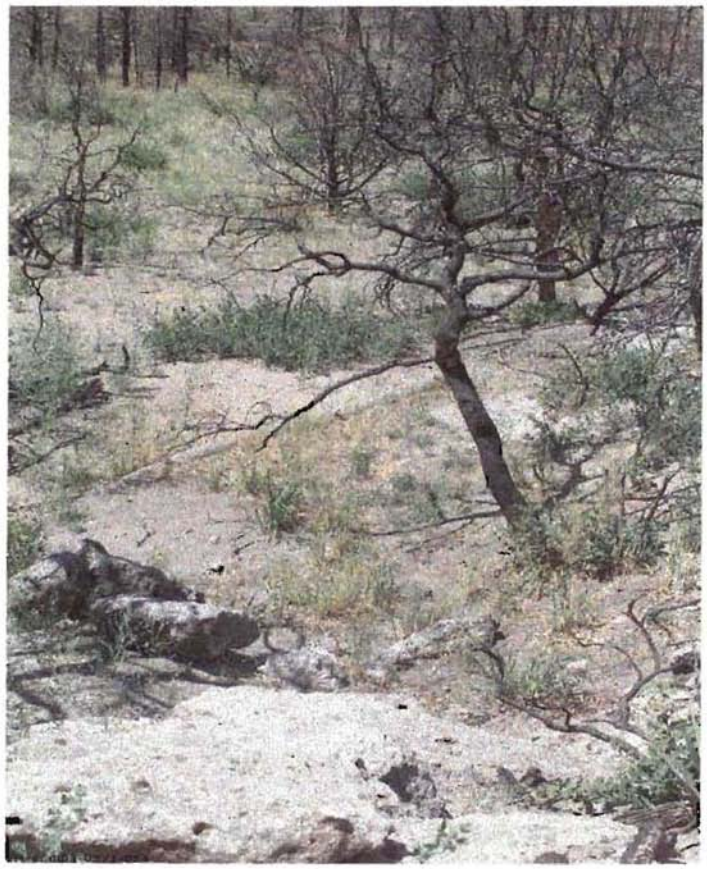
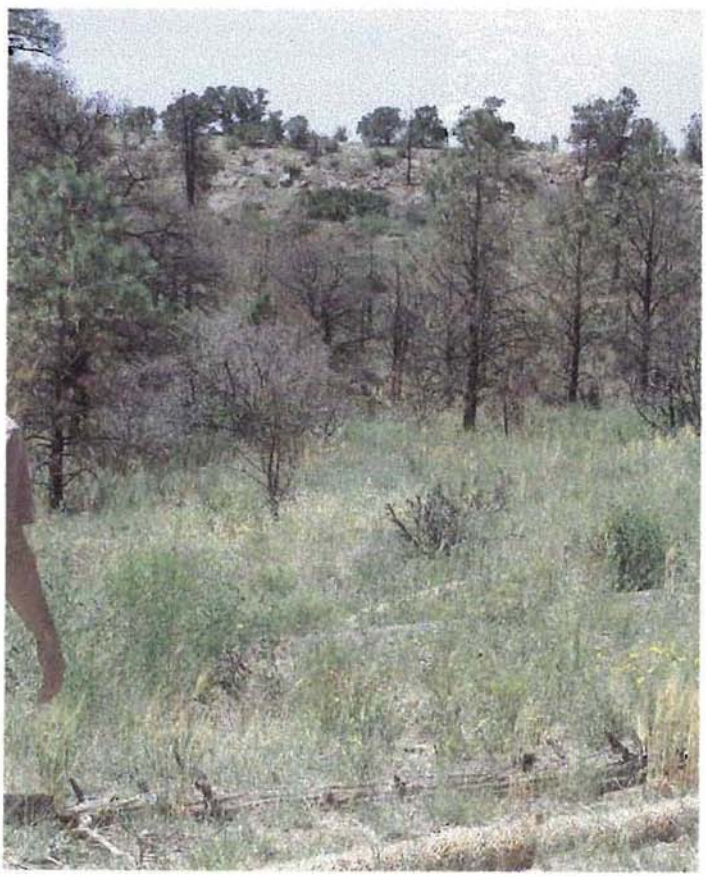
This site is located on the south rim of a tributary to Mortandad Canyon within the Upper Canada del Buey Watershed Aggregate. The fire damage was moderate to severe with nearly complete damage to the ground cover and canopy.

Site is in good condition, with vegetative cover of greater than 50%. Sediment migration is occurring in the steepest part of several drainage channels, but the straw wattles on the flatter bench appear to be keeping sediment from entering into tributary drainage.

Maintenance consisted of installation of an additional 22 wattles directly down gradient of existing wattles. Spot reseeding and mulch were applied where needed.

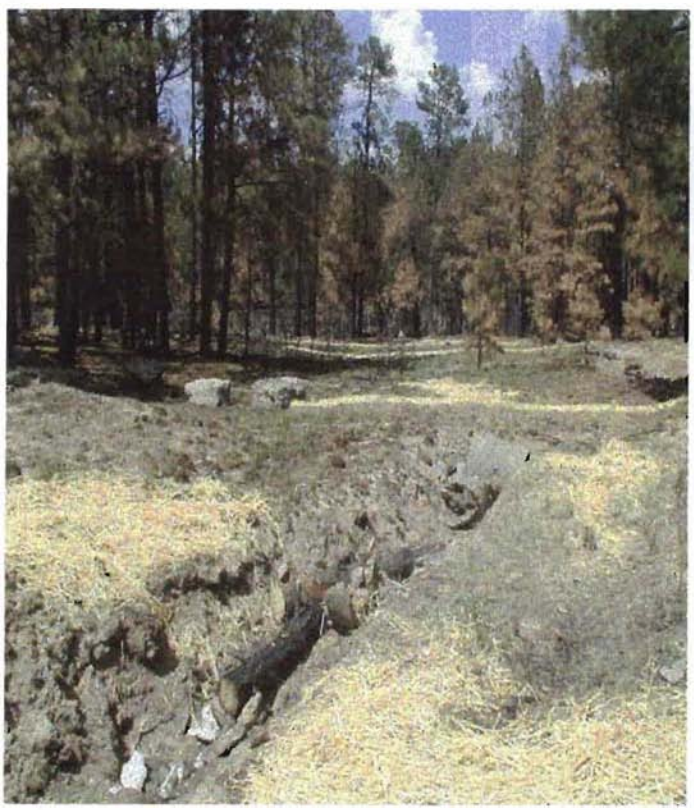
This site is located on the south side of Pajarito Canyon within the Two Mile Canyon Watershed Aggregate. The drainage channel east of building TA-6-6 has minor evidence of fire damage.

Site is in good condition, with vegetative cover of greater than 70%. The area appears stable with evidence of sediment migration being minimal.

5/10/2001	
4/05/2001	An additional 4 straw wattles were
10/30/2000	installed.
10/28/2000

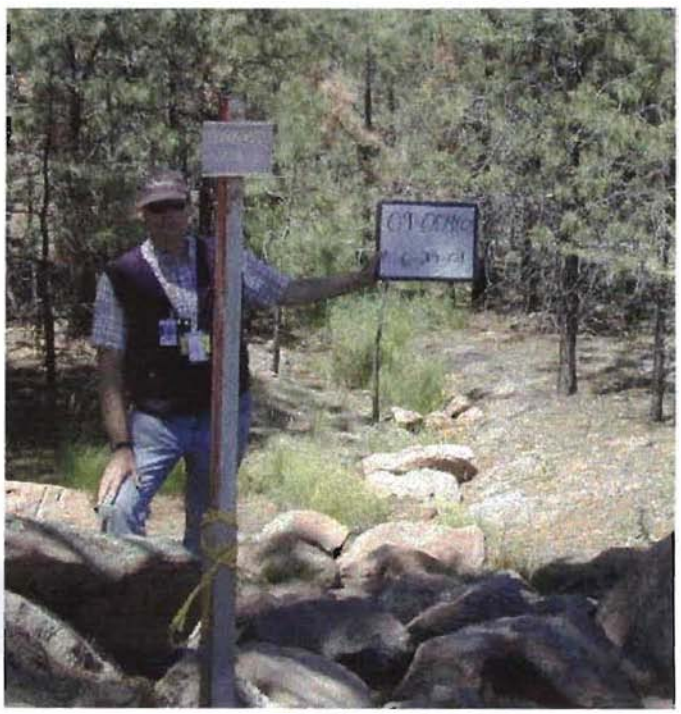
This site is located south of Pajarito Canyon within the Starmer/Upper Pajarito Watershed Aggregate. The area received minor to moderate fire damage. The ground cover was completely burned but the canopy cover was only partially affected.

Site is in good condition, with vegetative cover of greater than 70%. The area appears stable with evidence of sediment migration being minimal.

6/29/2001	
5/10/2001	
4/05/2001	An additional 2 straw wattles were
10/30/2000	installed.
6/24/2000

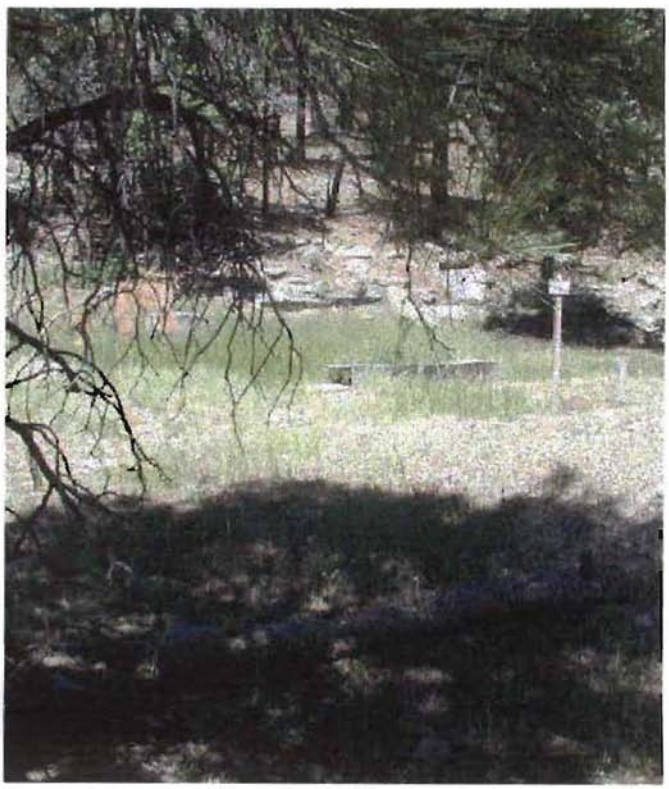
This site is located south of Pajarito Canyon within the Starmer/Upper Pajarito Watershed Aggregate. The PRS is the former Sanitary Wastewater Treatment Facility north of TA-9. Site has moderate fire damage with ground and canopy cover being impacted.

Site is in good condition, with vegetative cover of greater than 40%. The area appears stable with evidence of sediment migration being minimal.

Straw wattles were installed in the drainage swales and rock check dams were placed in the channels to dissipate flow (using existing materials found on-site). Wattles were also provided upslope for run-on diversion.

6/29/2001
5/10/2001 — An additional 2 straw wattles were
4/05/2001 — installed
10/30/2000
6/24/2000

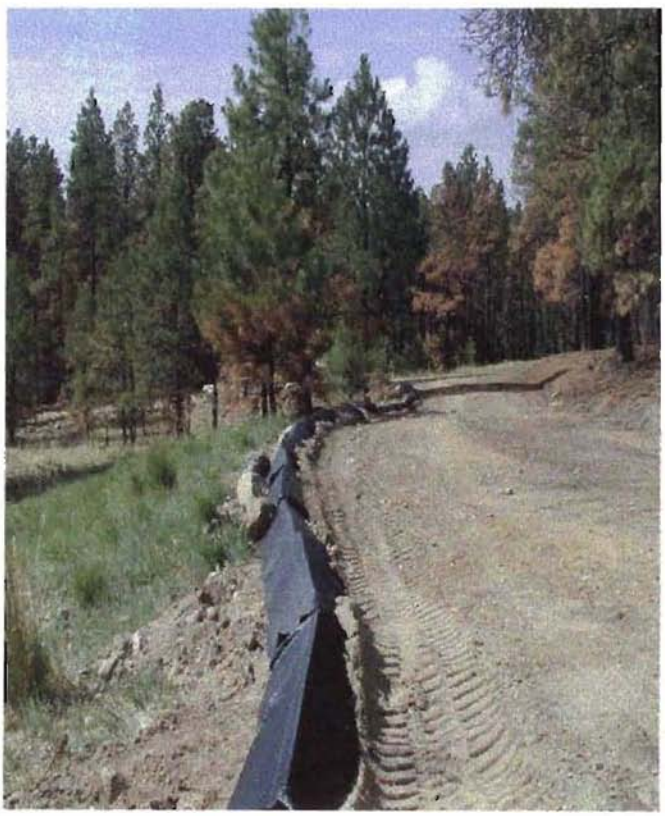
This site is located south of Pajarito Canyon within the Starmer/Upper Pajarito Watershed Aggregate. The area surrounding MDA M was moderately to severely burned as was a majority of the upper Pajarito Watershed. All of the existing erosion controls at the site were destroyed.

Run-on controls were replaced as shown below. The entire site was hand raked, reseeded and mulched. A retention basin was installed at the bottom of the slope to create a "zero discharge" area.

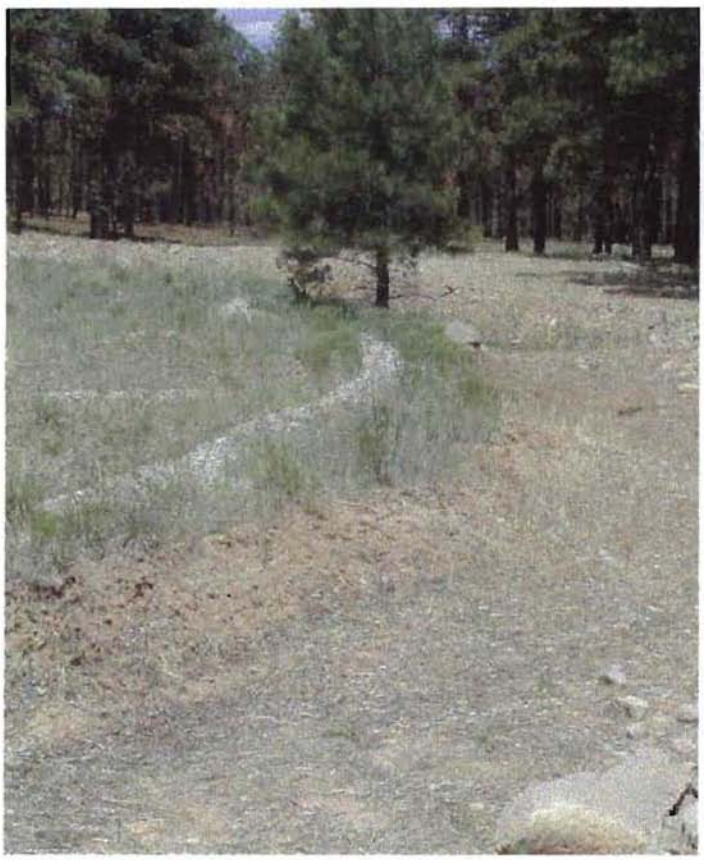
Site is in good condition, with vegetative cover of greater than 70%. The area appears stable with evidence of sediment migration being minimal.

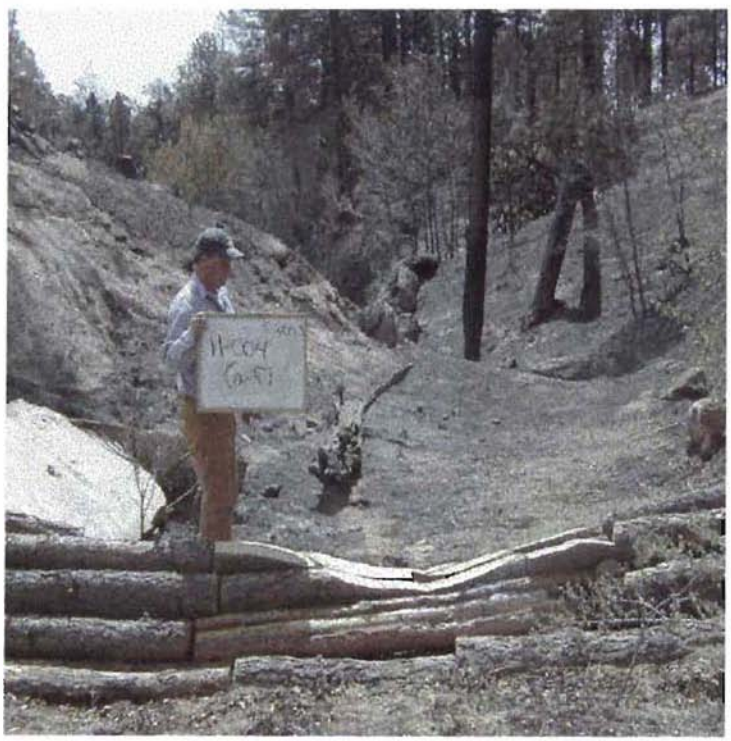
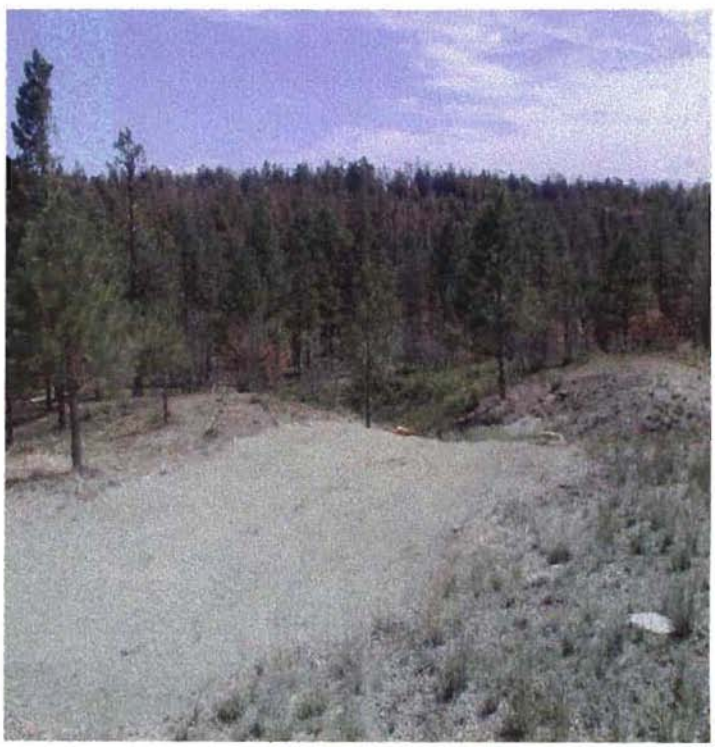
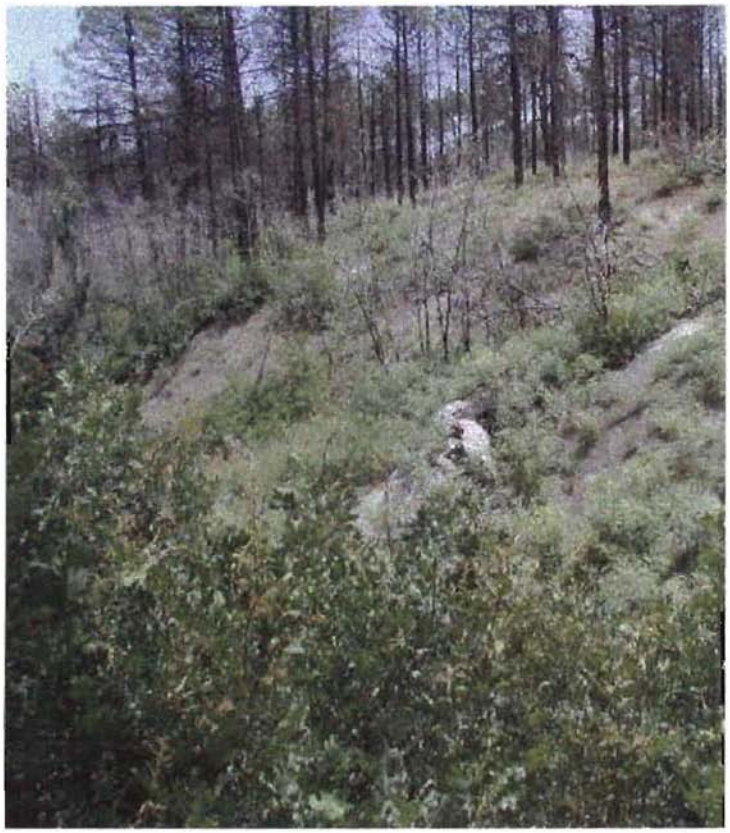
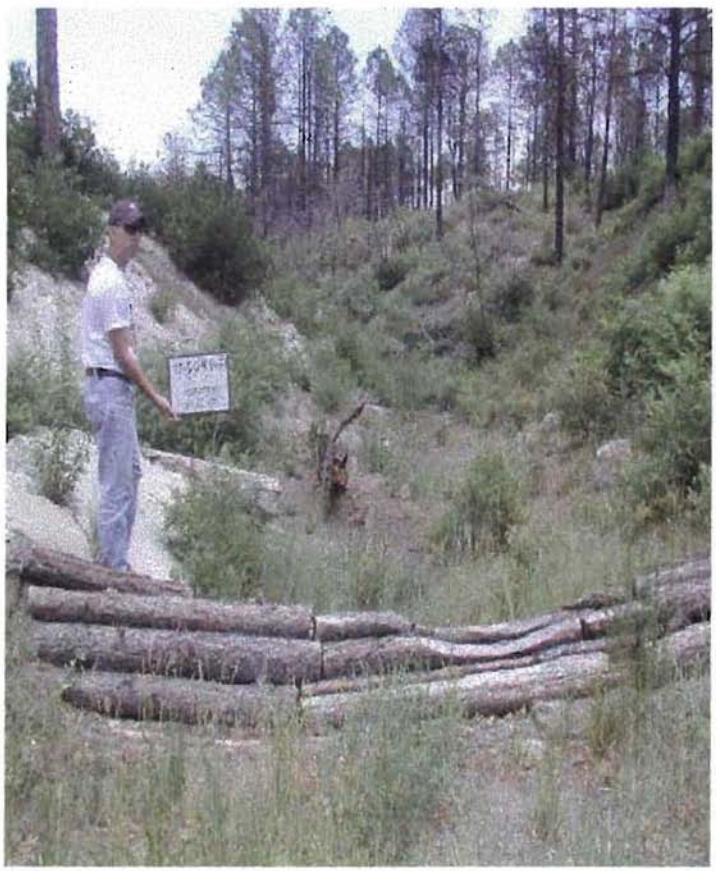
This site is located north of Water Canyon within the S-Site Watershed Aggregate. The site has moderate to severe fire damage in the area surrounding the TA-11Drop Tower. Log check dams within the major drainages received partial damage. All straw barriers installed around site were destroyed.

Site is in good condition, with vegetative cover of greater than 60%. The area appears stable with evidence of sediment migration being minimal.

The log check dams (on-site materials used) were replaced within the adjacent drainages. Straw wattles were placed on the slopes and geotextile was installed in the areas with the most erosion potential. The area surrounding the Drop Tower was hydromulched to enhance the revegetation process.

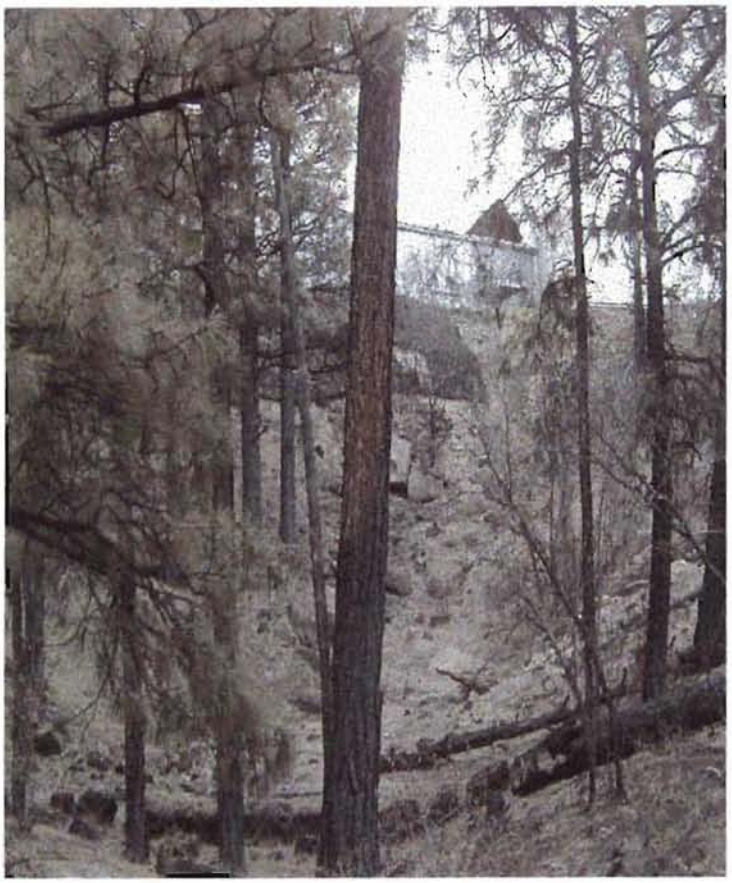
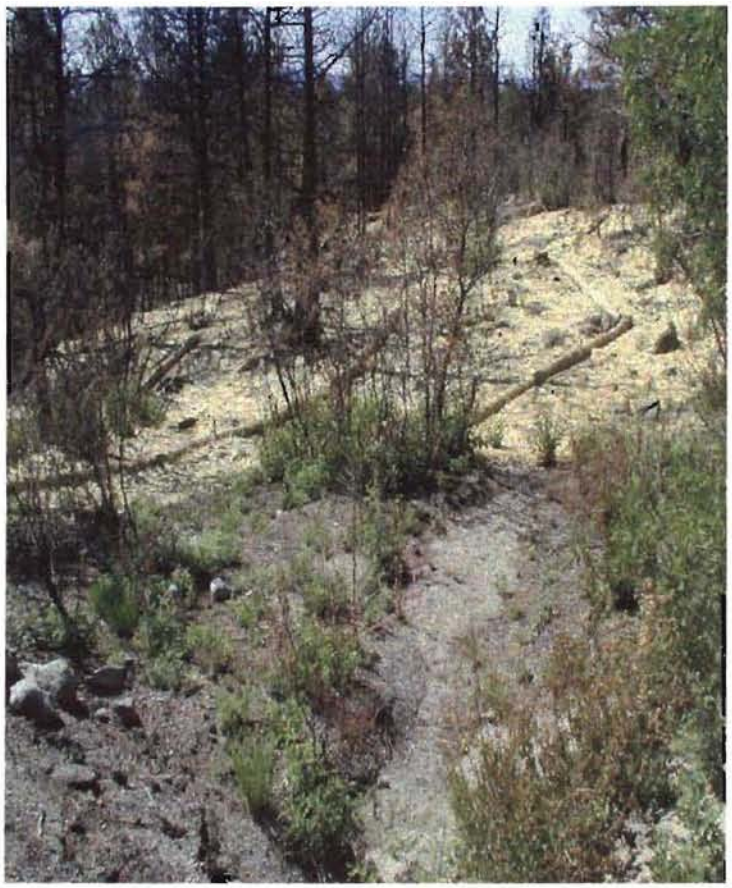
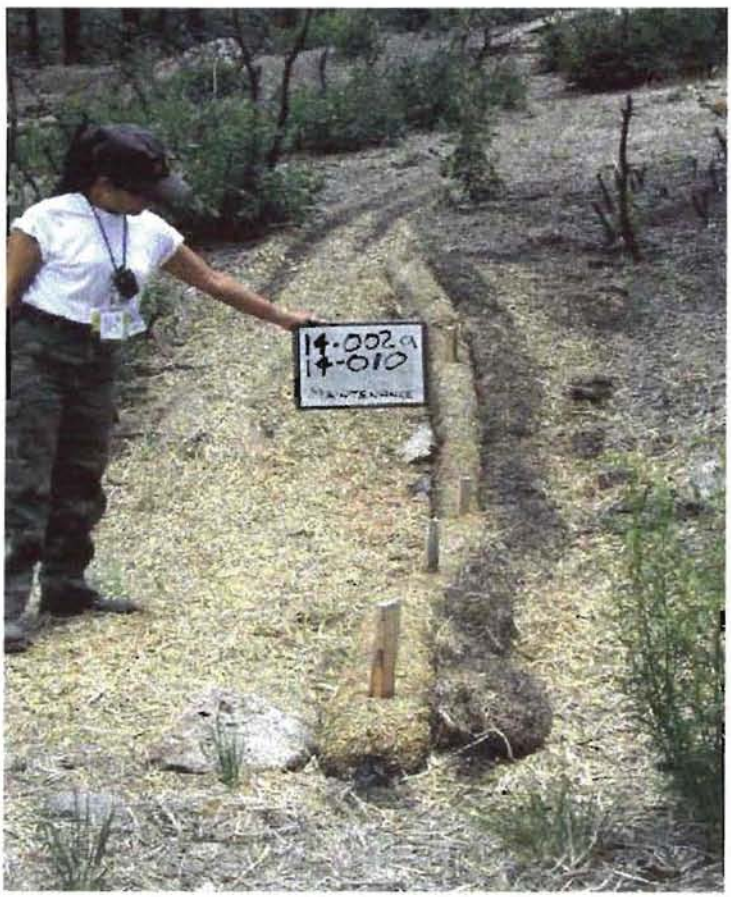
PHOTOGRAPH:

This site is located north of Canon de Valle within the Canon de Valle Watershed Aggregate. The entire south facing slope located to the south of TA-14 stuctures was moderately burned with substantial damage to the groundcover.

This photograph was taken on June 8th, 2000. The drainage shown is located below building 14-43.

Site is in good condition, with vegetative cover of greater than 70% throughout the site. The area appears stable with evidence of sediment migration being minimal.

Straw wattles were installed across the drainage swale. The area was hand raked, reseeded and mulched. A rock check dam was installed at the lowest part of the drainage.

Several more straw wattles were installed due to damage from wildlife.

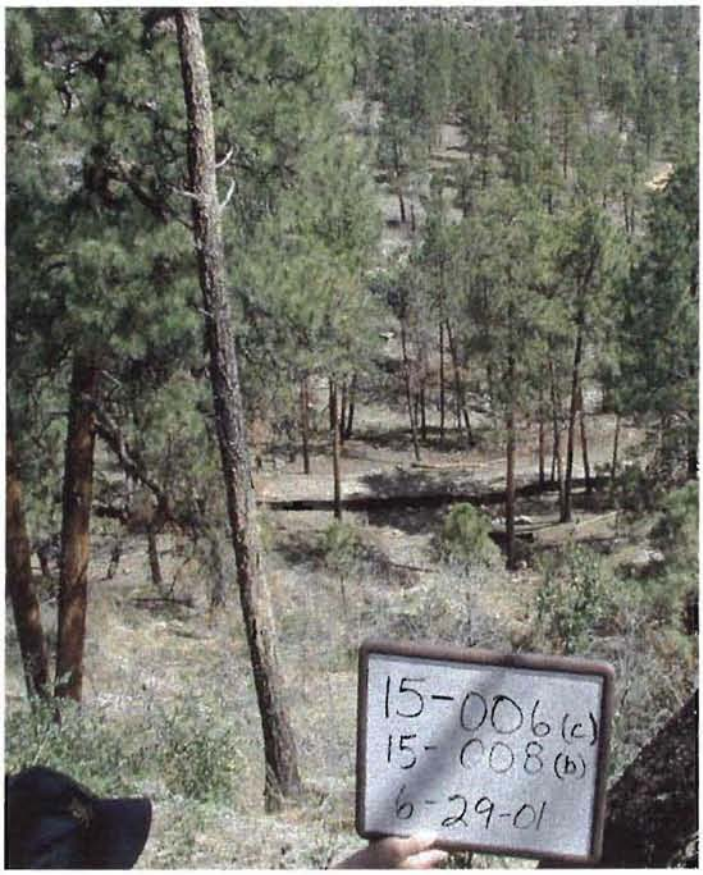
This site is located on the south rim of Three Mile Canyon within the Three Mile Watershed Aggregate. 15-006(c) has moderate to severe burn damage with most of the damage adjacent to the former R-44 Firing Pad. A large amount of firing site related debris has been exposed throughout the site (especially towards the east).

Over 20 cubic yards of firing site debris was removed from the surrounding area. Site is in good condition, with vegetative cover of greater than 70%. The area appears stable with evidence of sediment migration being minimal.

Straw wattles, rock check dams and silt fencing were installed throughout the burned areas. The area was then hydrolmulched to enhance the revegetation process.

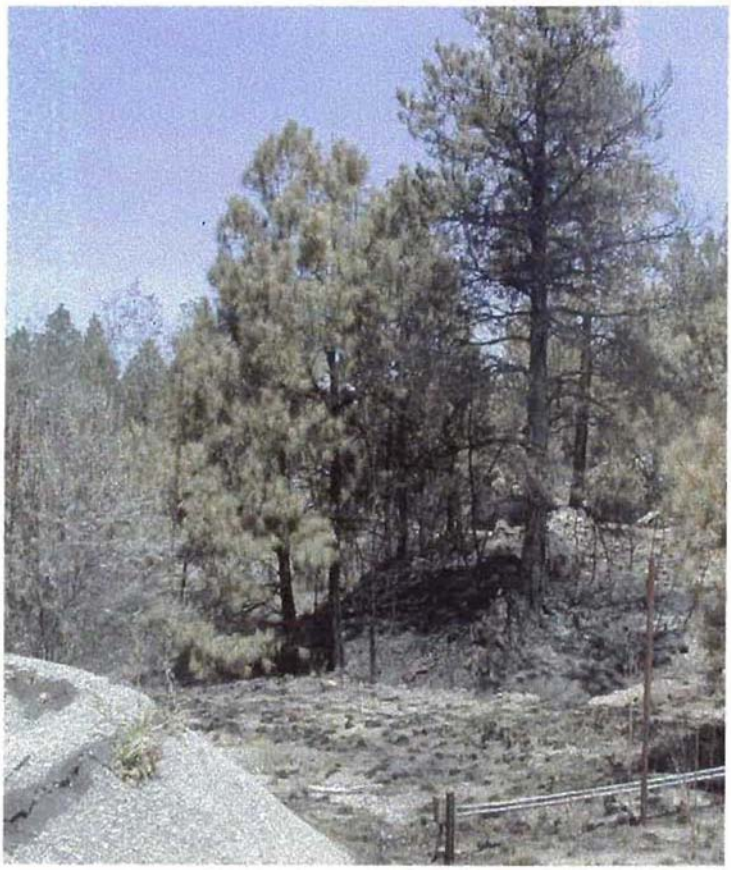
TECHNICAL AREA-15 – HOLLOW SITE BEFORE AND AFTER THE CERRO GRANDE FIRE

C-15-007 - *Erosion Matrix Score 51.5.* Stained soil noted during a 1988 ER site reconnaissance visit. A transportable building was placed over it. The area was sampled in 1997. **C-15-010** - *Erosion Matrix Score 8.8.* Removed inactive underground fuel storage tank. **15-014(k)** - *Erosion Matrix Score 3.6.* Concrete open trench drains. **15-011(a)** - *Erosion Matrix Score 3.6.* Concrete trench drains. **15-014(i)** – *Erosion Matrix Score* 3.6. Drain line from roof of building TA-15-194. **15-011(b)** - *Erosion Matrix Score 87.0.* Dirt drainage ditch located southwest of Building R-194. Drainage may have received degreasers, solvents containing sulfuric acid, and/or hydrochloric acid. **15-011(c)** - *Erosion Matrix Score 87.0.* Drainage, PRS 15-011(c), serves the outfalls from buildings within The Hollow that have had various uses as assembly building, laboratories, and shops. **15-014(j)** - *Erosion Matrix Score 61.3.* PRS 15-014(j) consists of three outfalls from Building R-50 and a drainage channel that is partially asphalt just below the outfall leading towards the canyon.

This site is located near the confluence of Canon de Valle and Water Canyon within the Canon de Valle Watershed Aggregate. The site was moderately to severely damaged including several burned structures.

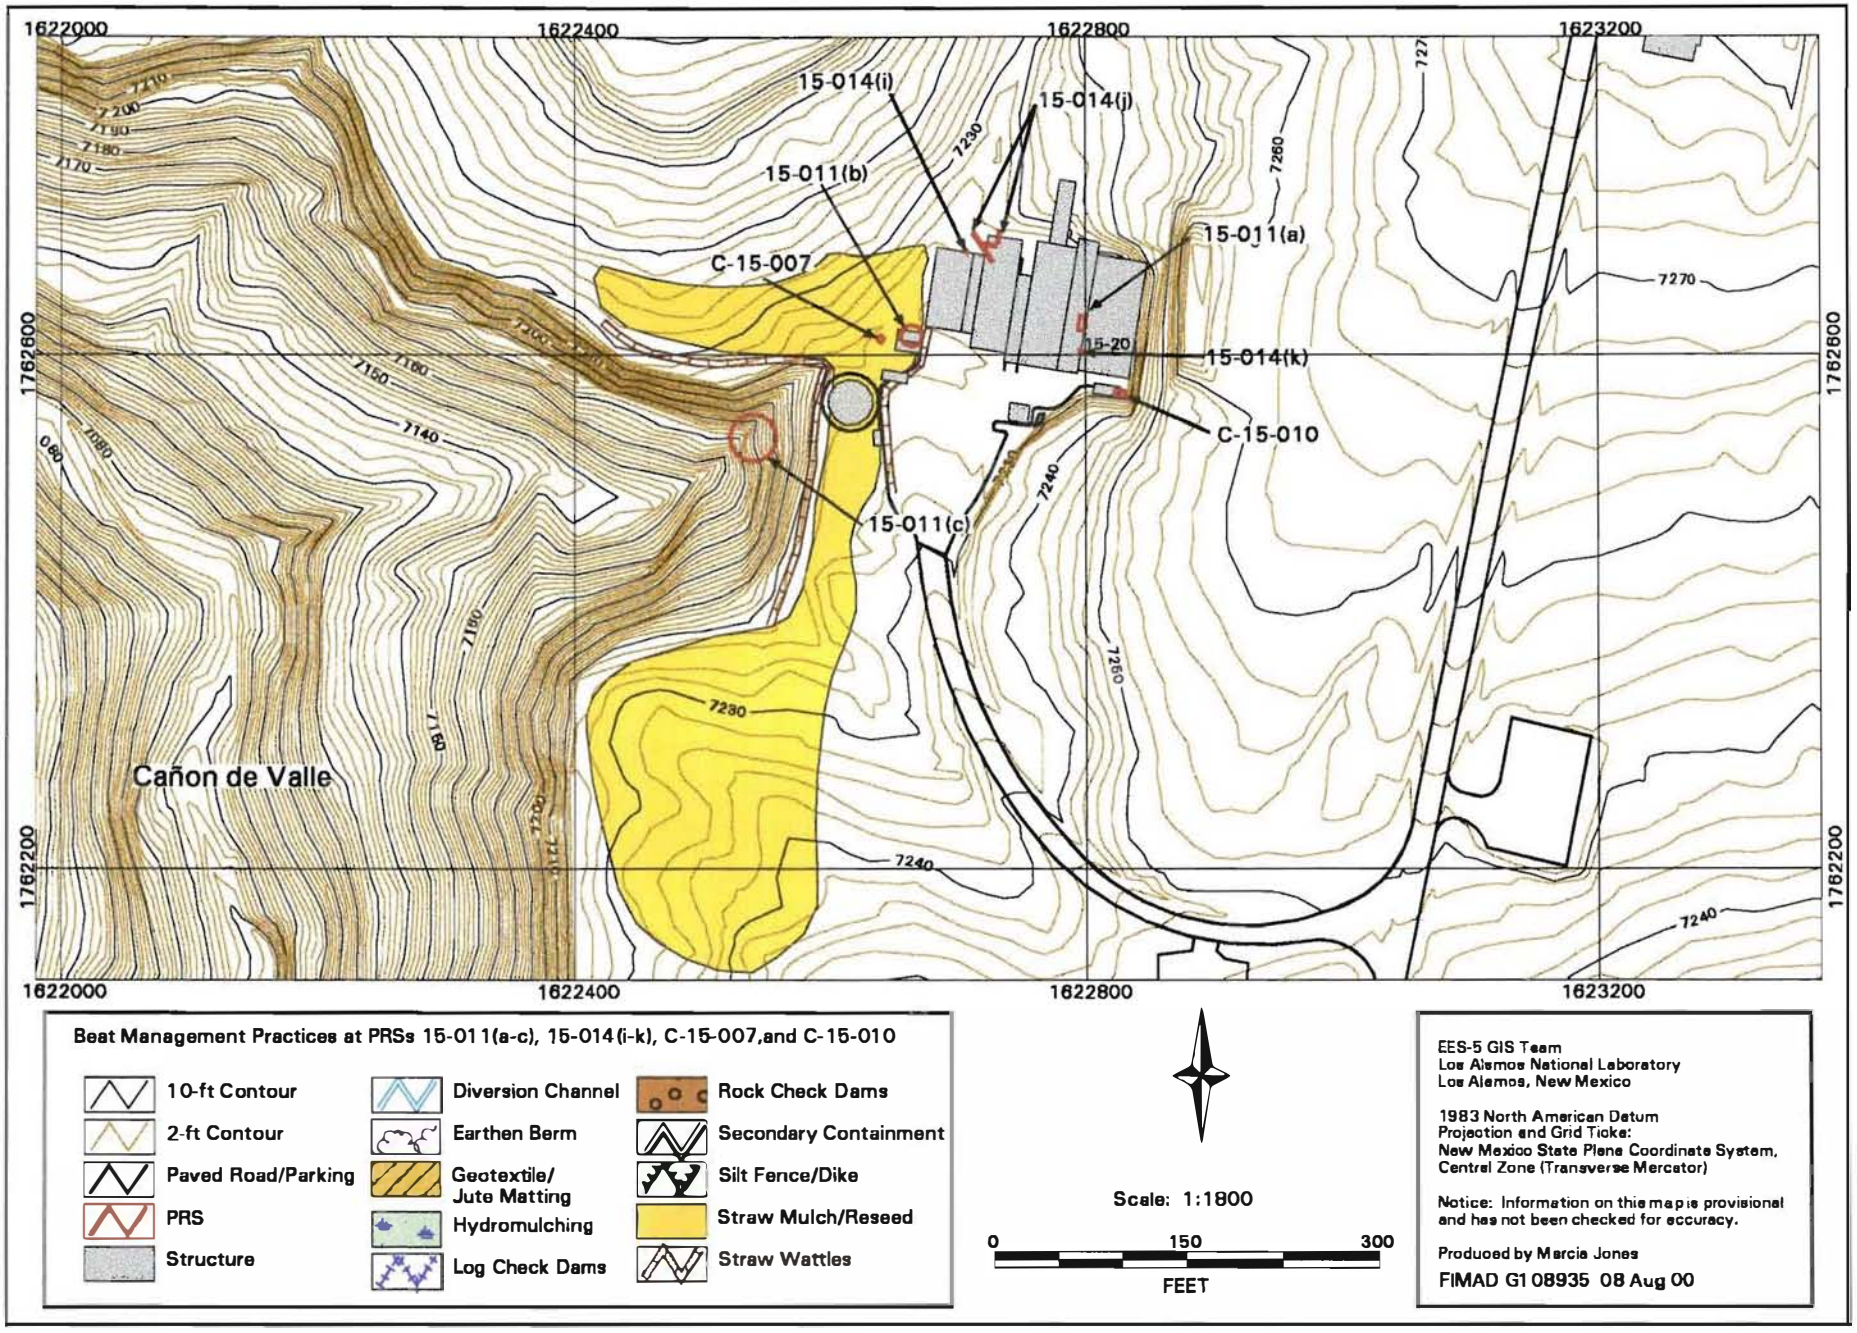
Beat Management Practices at PRSs 15-011(a-c), 15-014(i-k), C-15-007,and C-15-010

Site is in good condition, with vegetative cover of greater than 70%. The area appears stable with evidence of sediment migration being minimal.

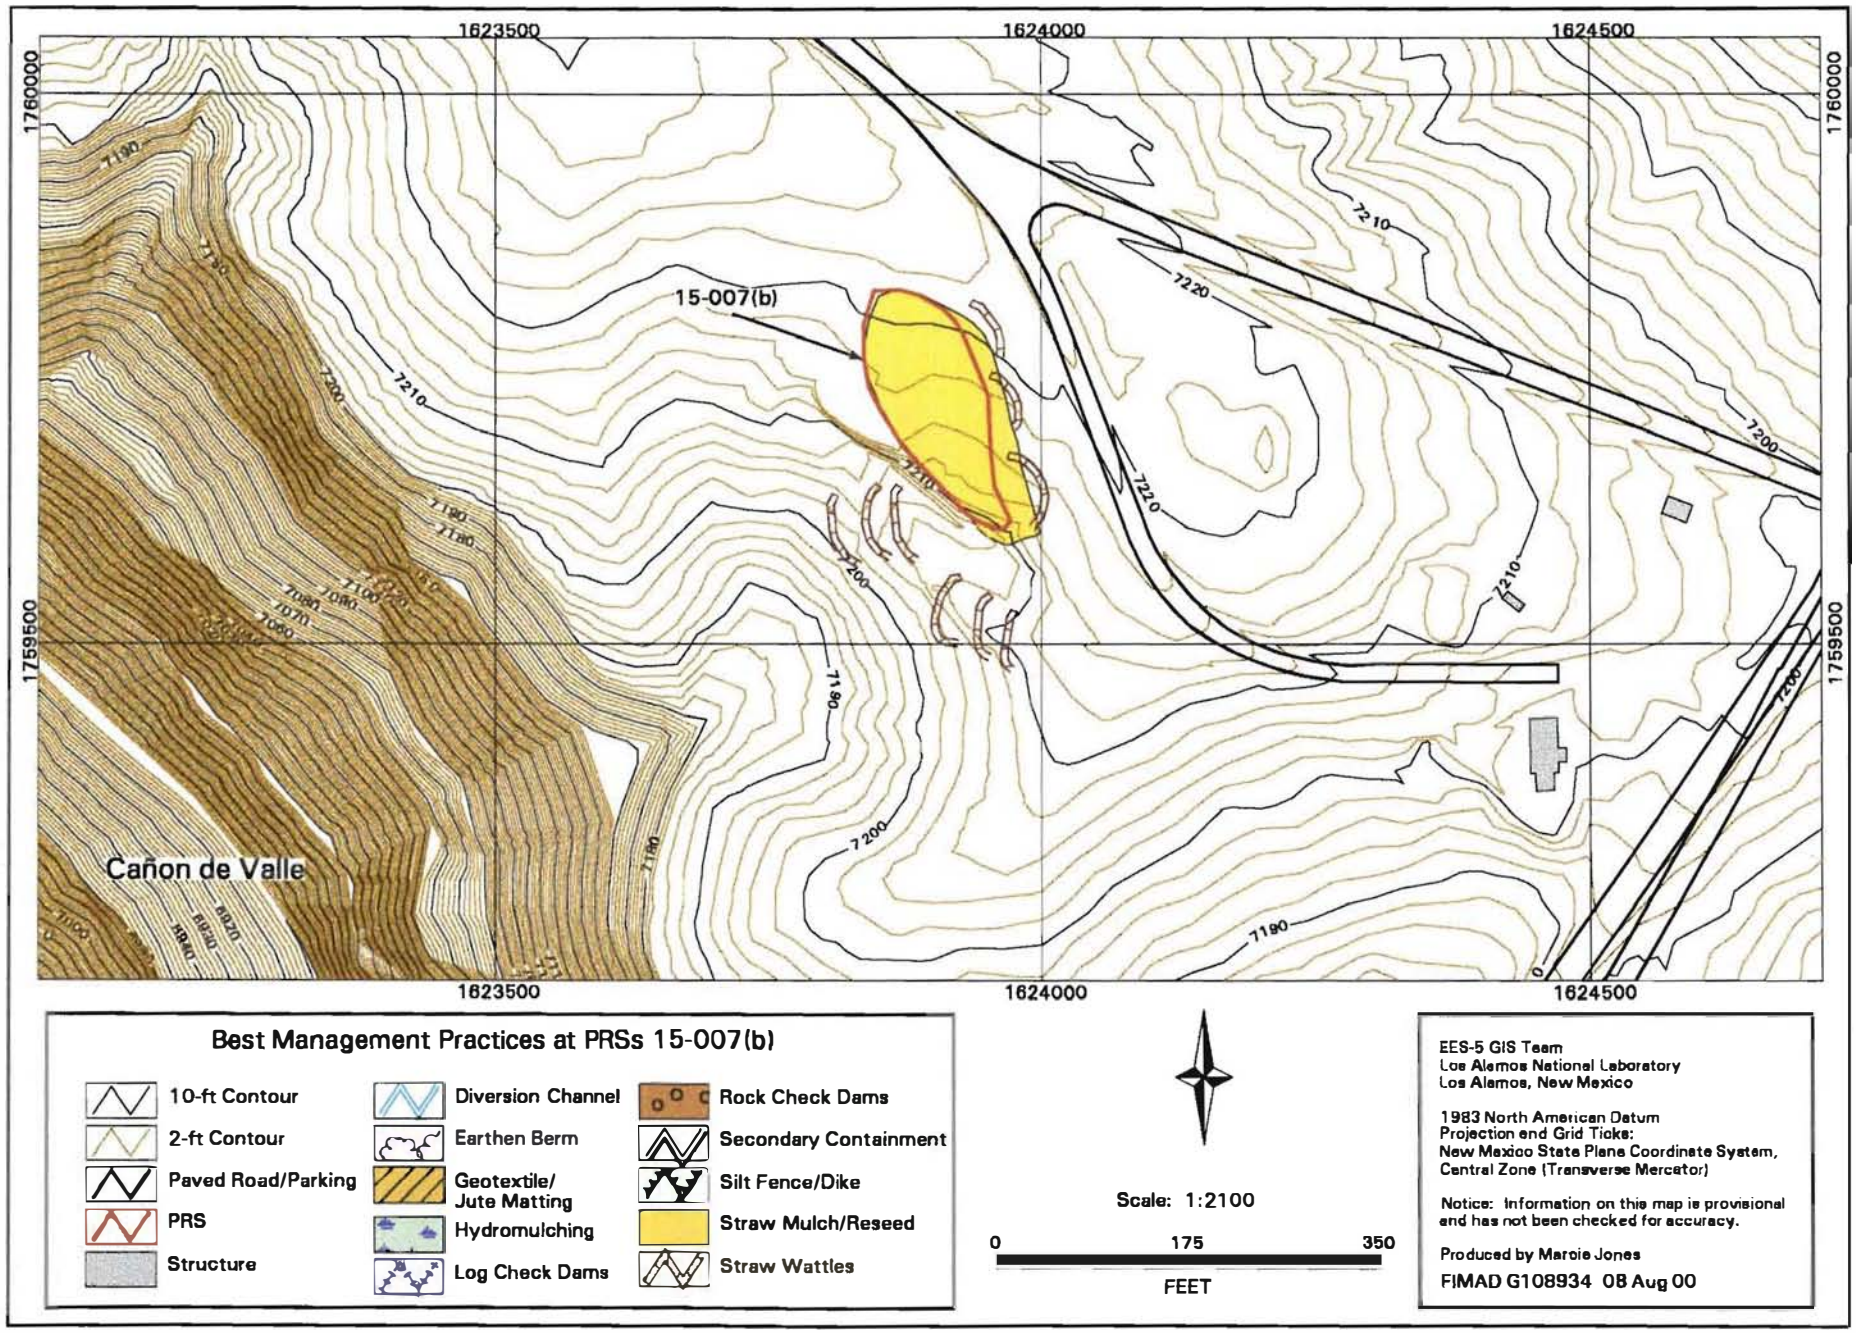
Site is in good condition, with vegetative cover of greater than 50%. The area appears stable with evidence of sediment migration being minimal.

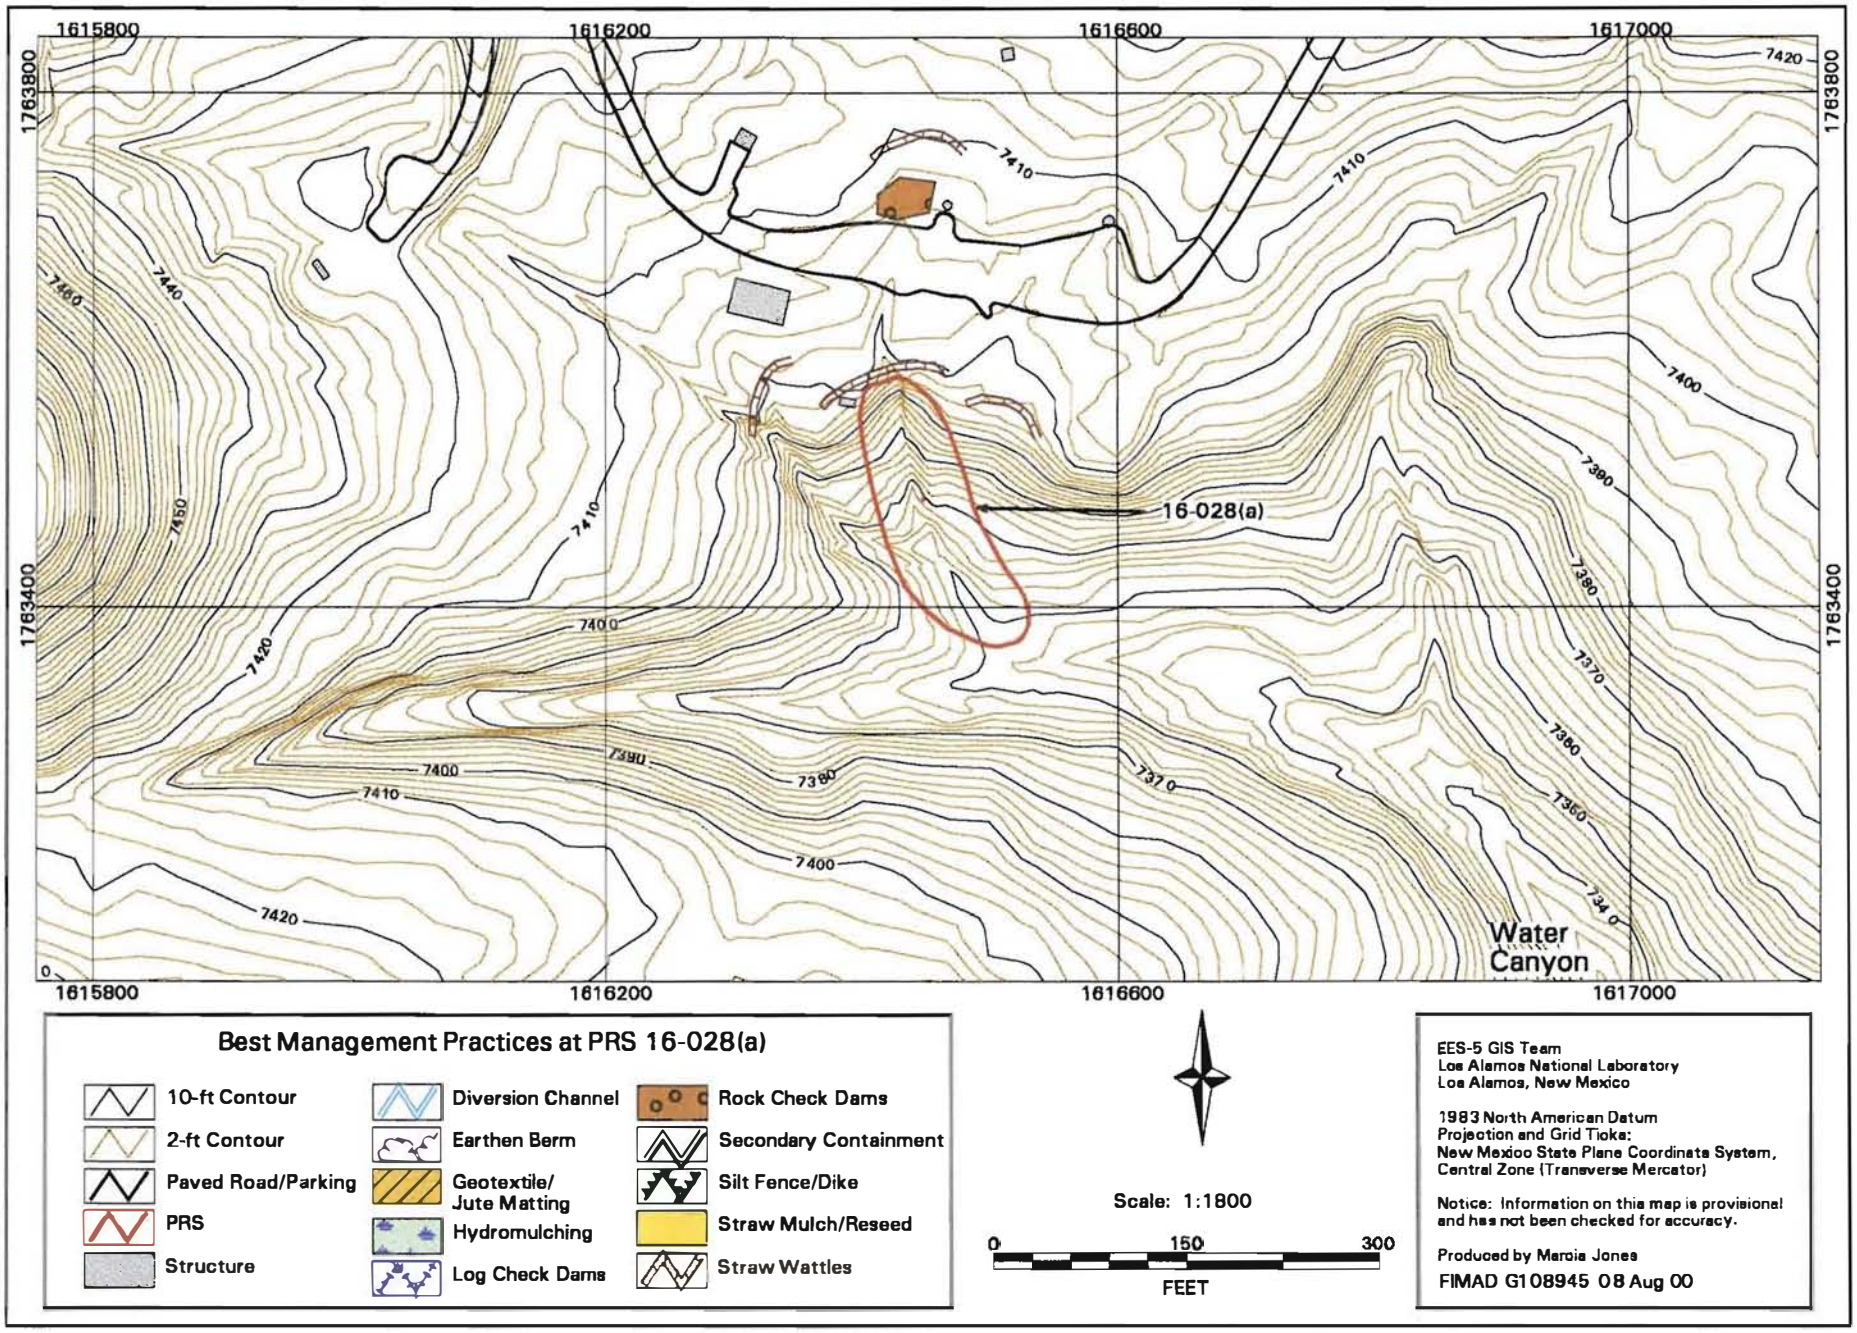
This site is located near a tributary of Water Canyon within the Canon de Valle Watershed Aggregate. The site has minimal fire damage to the west and south. Some minor burning occurred within the SWMU boundary, but consisted mostly of destroyed grasses. The HEWTF remains operational.

Site is in good condition, with vegetative cover of greater than 50%. The area appears stable with evidence of sediment migration being minimal.

Straw barriers and rock check dams (existing materials found on site) were placed within the drainage swale to reduce sediment transport potential.
