Title: CERRO GRANDE FIRE: ONE YEAR AFTER AN UPDATE ON ER ACTIVITIES TO REDUCE THE POTENTIAL MOVEMENT OF CONTAMINATION AT POTENTIAL RELEASE SITES

Author(s): Steven J. Veenis, CPESC
Randy Johnson

Submitted to: Environmental Restoration Project
Water Quality & Hydrology Group (ESH-18)

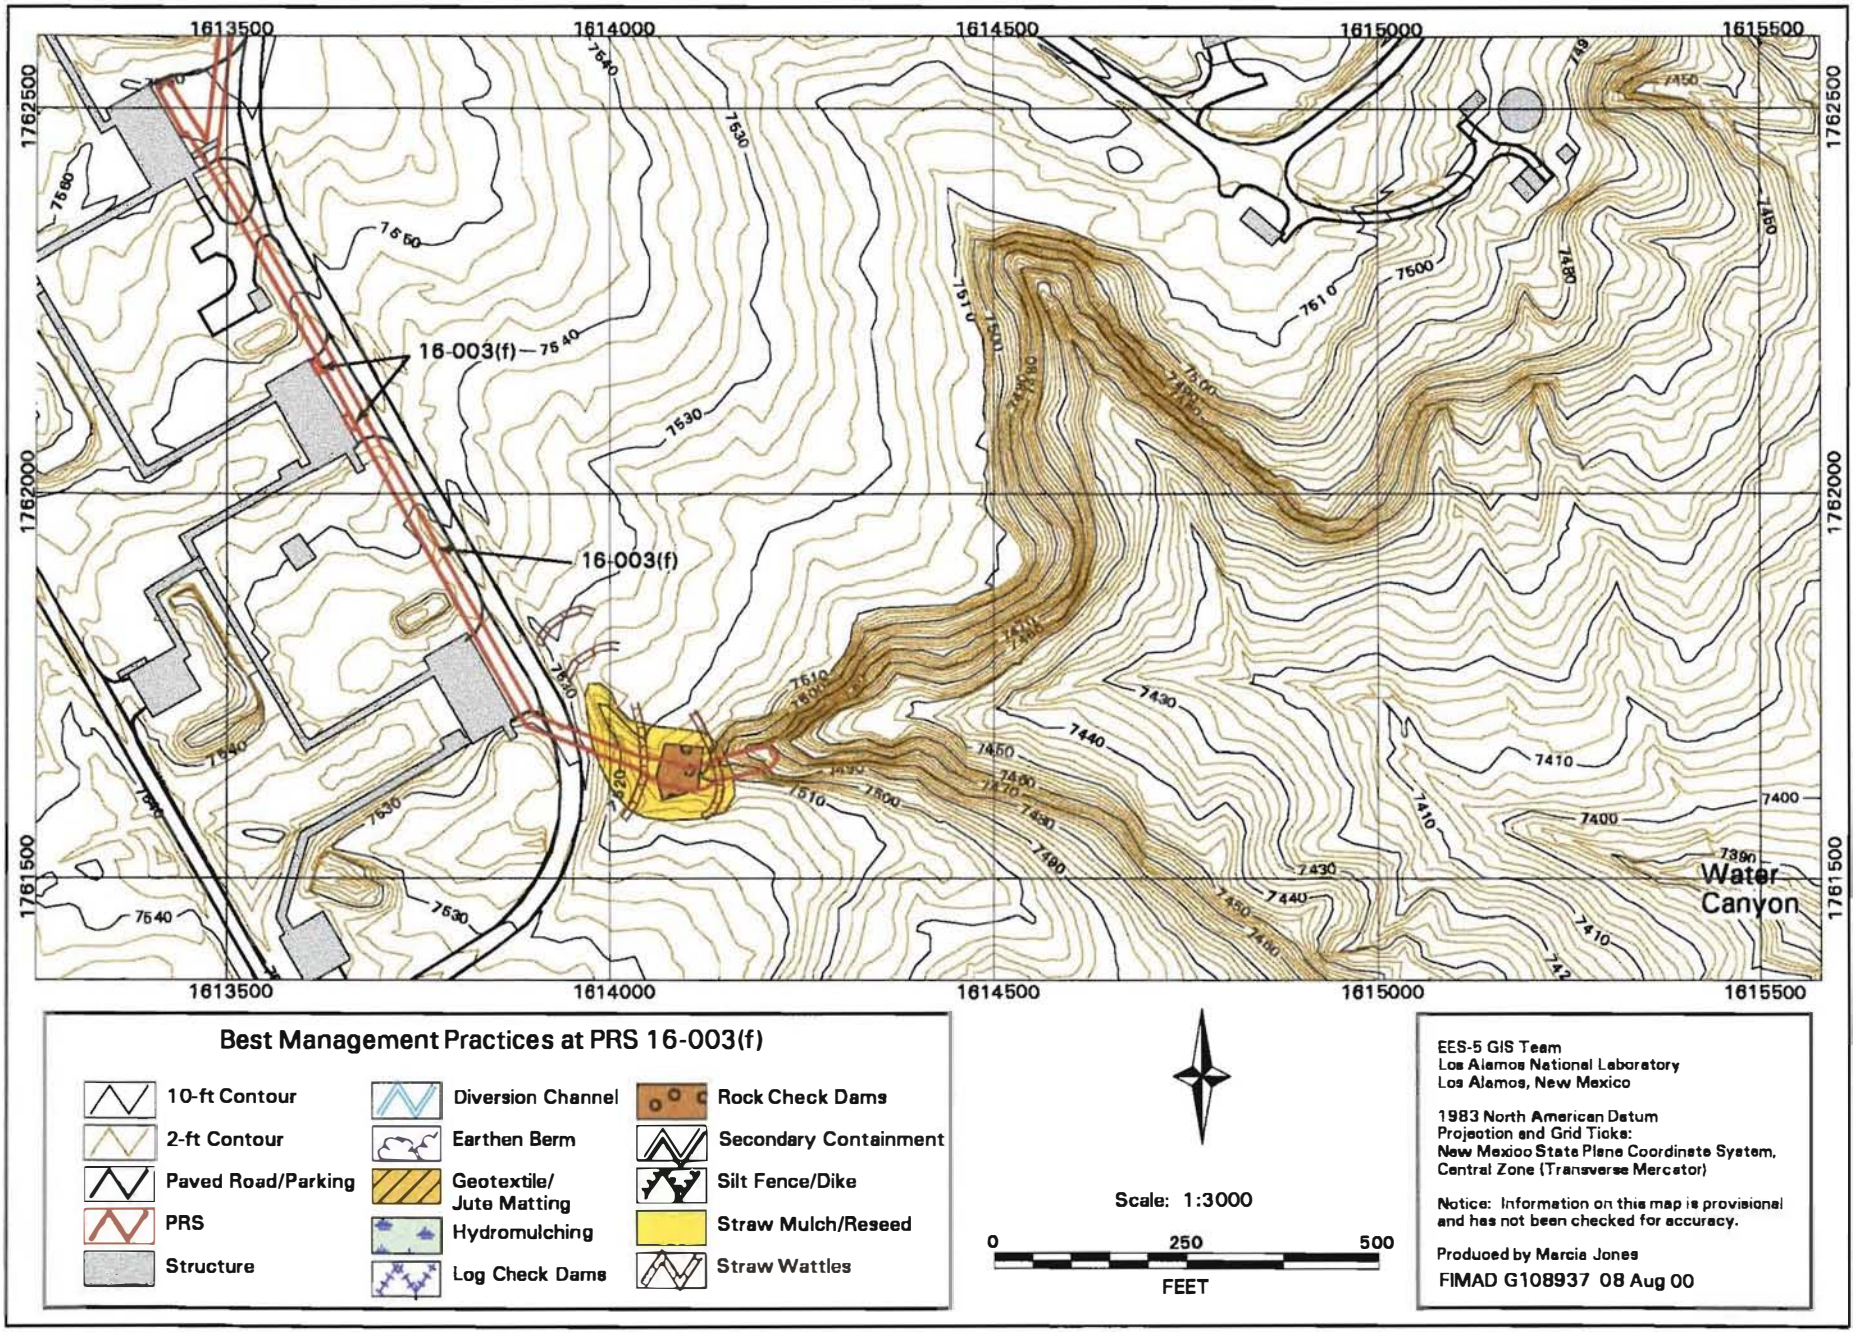
Site is located in a small tributary drainage to Water Canyon within the S-Site Watershed Aggregate. Site has minor to moderate fire damage within the outfall drainage.

Site is in good condition, with vegetative cover of greater than 70%. The area appears stable with evidence of sediment migration being minimal.

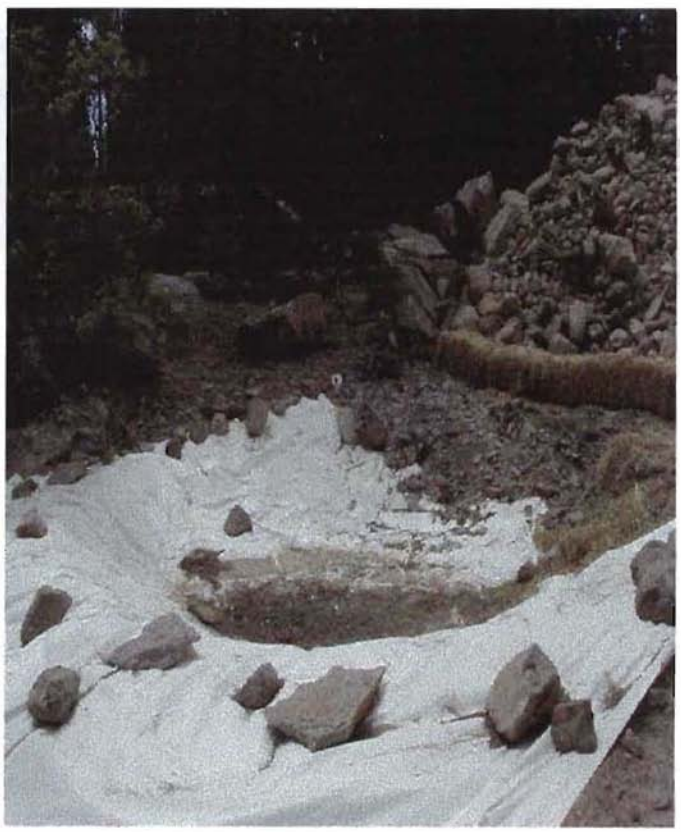
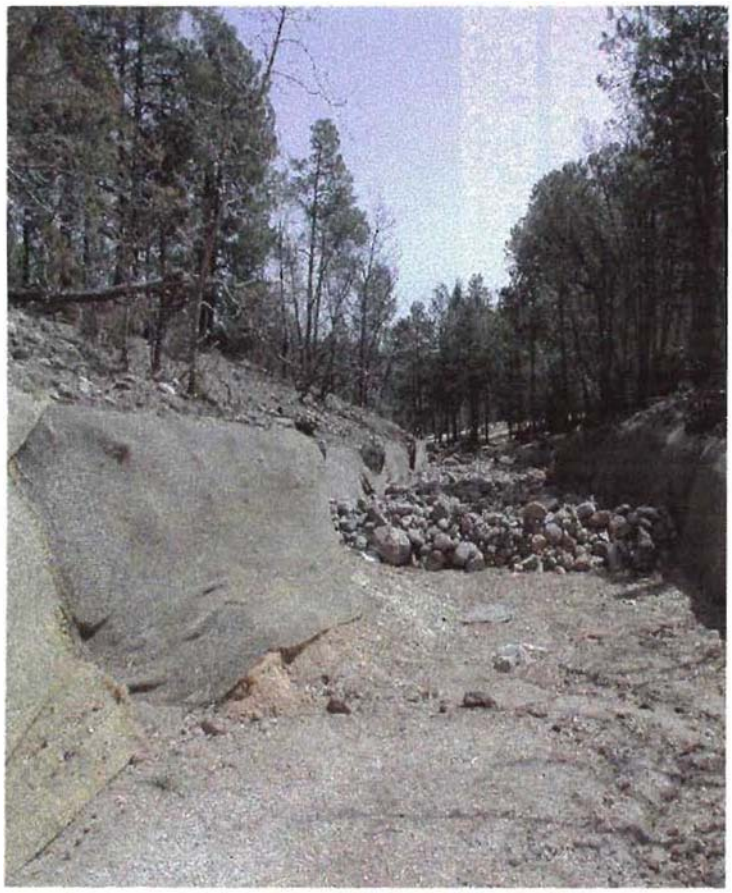
This site is located in a tributary drainage of Canon de Valle within the Canon de Valle Watershed Aggregate. Burn damage is minor to moderate within the SWMU boundary. Heavy equipment on-site was not affected by the fire, although some hoses, drums and misc. equipment were damaged. The upper drainage pond was not burned. The lower drainage received minimal damage from the fire.

Straw barriers were replaced within the drainage channel and jute matting was installed to protect the exposed slopes. All excavated material remains covered with HDPE liners and is surrounded by an earthen berm. The storm water retention pond was unharmed and remains effective as a "zero discharge" BMP.

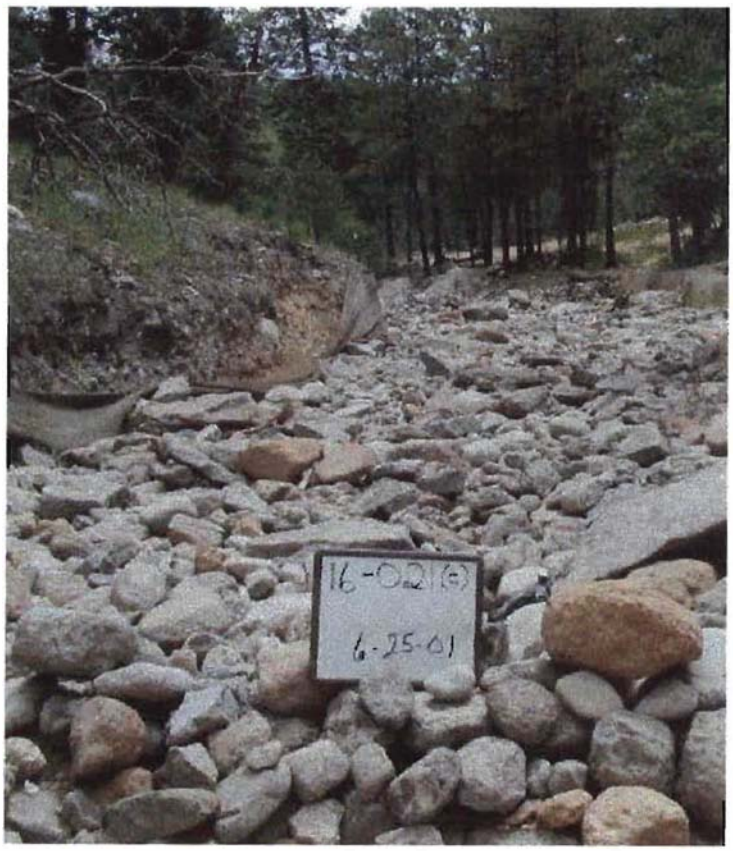
Site is in good condition, with vegetative cover of greater than 70% along the channel banks. The channel has been completely excavated of contaminated soil and river rock was placed to dissipate any future storm water runoff.

An interim measure was recently completed at the site to remove several hundred cubic yards of HE contaminated soil from the drainage channel. The excavation is complete and site restoration activities are ongoing. The site will be inspected and maintained until final stabilization is completed.

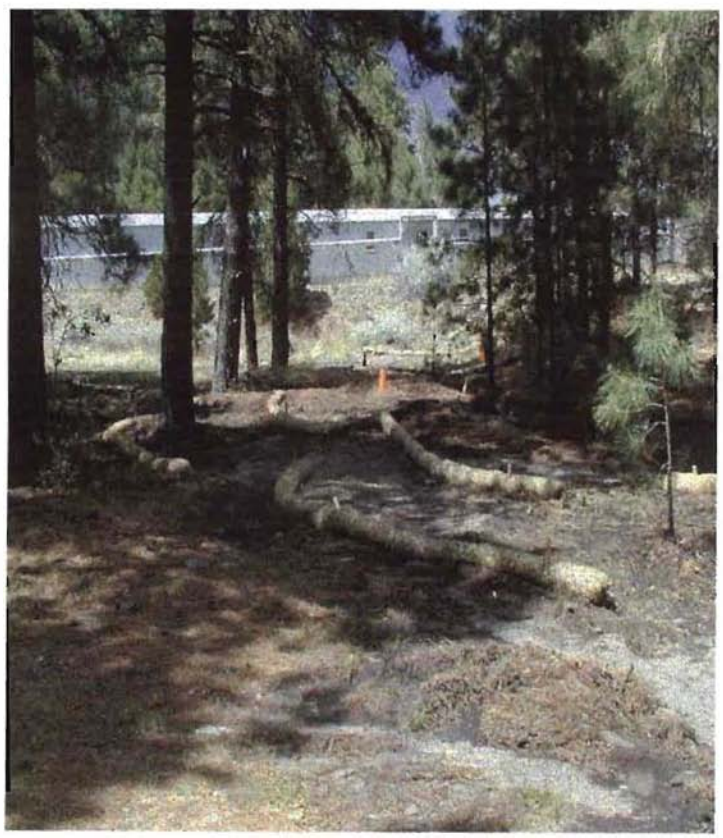
This site is located east of S-Site Road in the upper tributary of Canon de Valle within the Canon de Valle Watershed Aggregate. No damage was observed from the outfall to the first rock check dam. Below the second rock check dam, fire damaged much of the ground cover and several of the ponderosa pine trees. All straw were destroyed.

Straw wattles were installed throughout the outfall area to dissipate run-on. Ashflow from run-on events have been and will continue to be a problem in this area. This site is being considered for an accelerated cleanup.

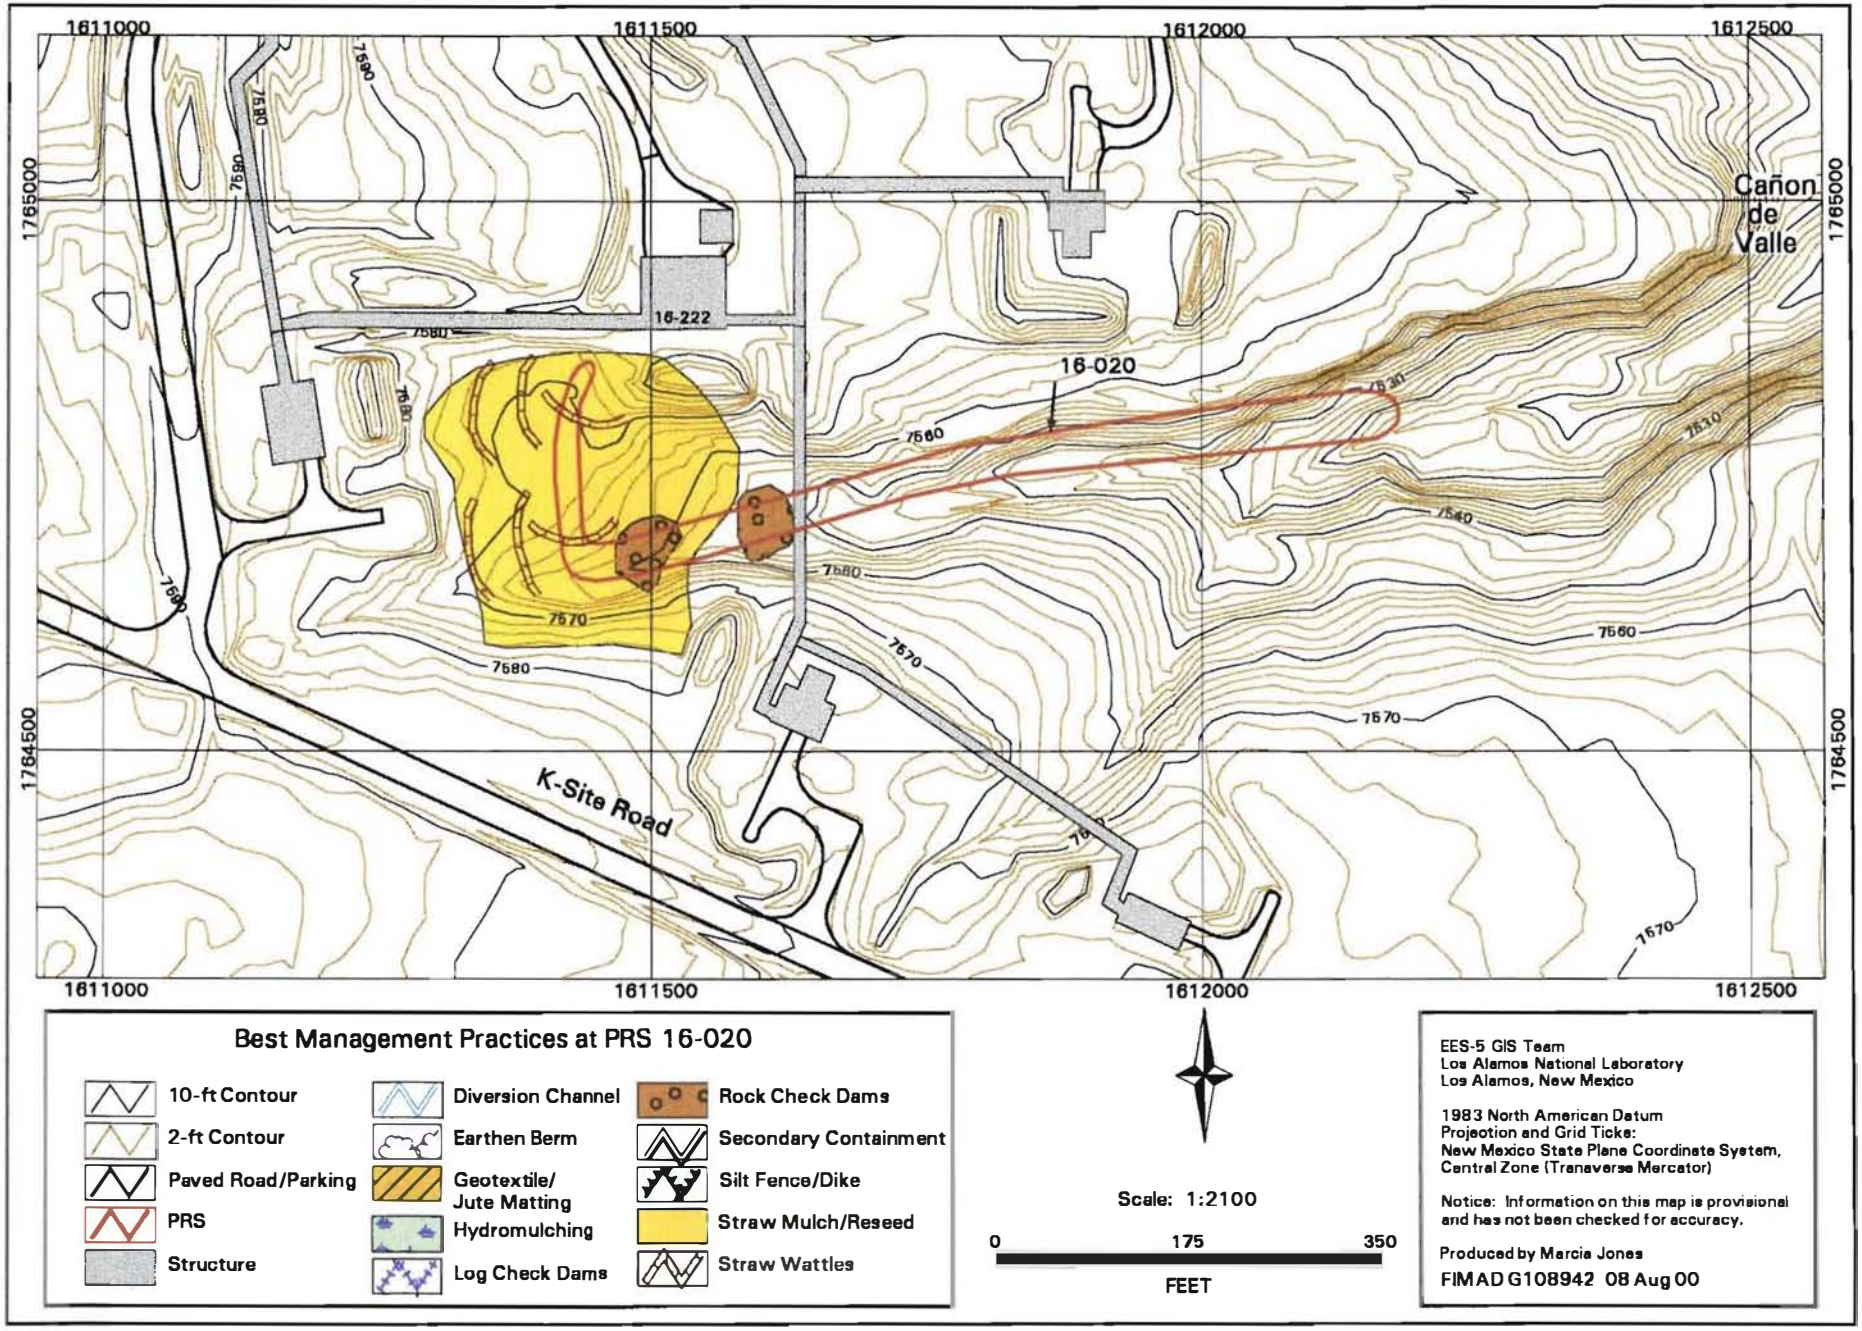
The site has a vegetative cover of around 60% and appears stable with evidence of sediment migration being minimal. Upstream flood control efforts have reduced the flood potential at the site.

Approximately 6 to 12 inches of soil was removed from the defined drainage channel beginning at the start of the outfall and continuing to a distance of approximately 738 feet down drainage as part of the Flood Control Immediate Action Cleanup.

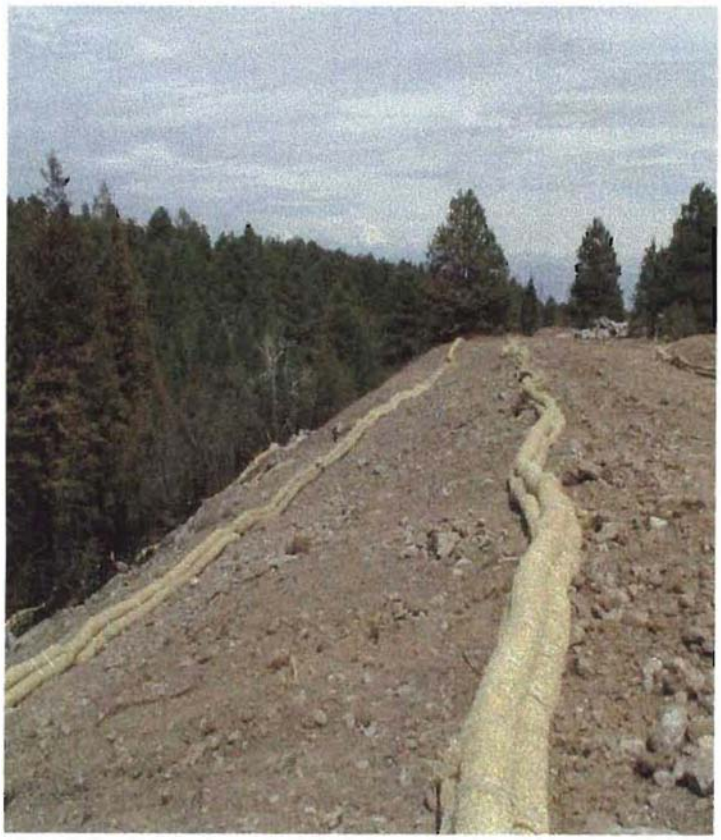
This site is located near building TA-16-260 above Canon de Valle within the Canon de Valle Watershed Aggregate. The site has moderate to severe fire damage over a majority of the area. Miscellaneous debris was exposed on the mesa and slope above canyon channel. The dissipation controls installed within the eastern drainage were destroyed. The ground and canopy cover was completely destroyed. Ash is up to 12" deep in some areas at the toe of slope. Burning occurred in the Canon de Valle leaving severe erosion potential behind.

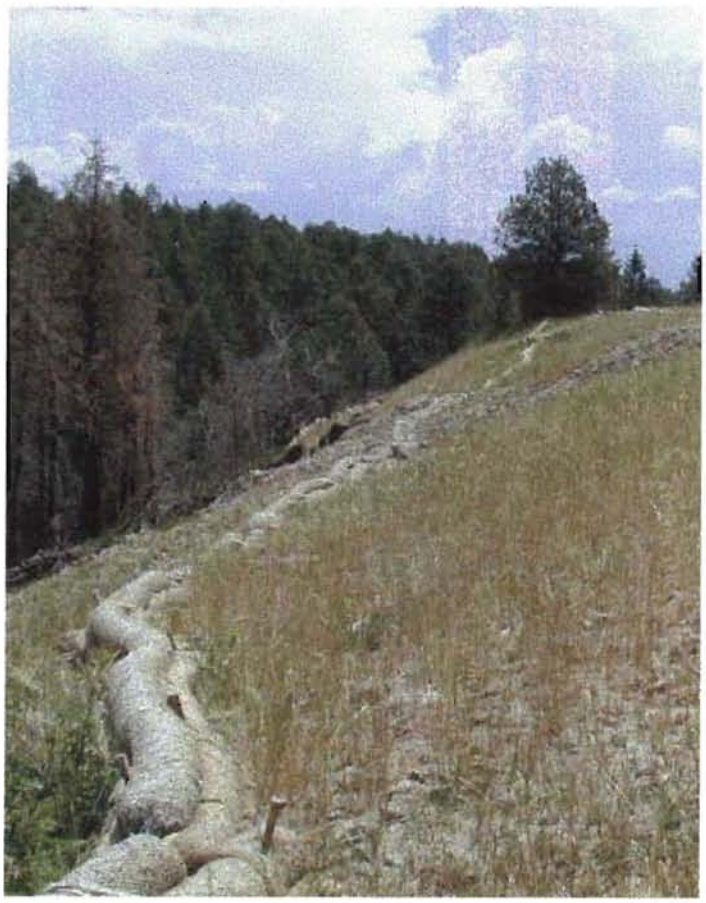
All excavated soil and debris have been removed from the site. The controls installed at the site have been very effective in stabilization of the slope. The run-on diversion trench has reduced storm water flow onto the site by more than 75%. The vegetative groundcover has reduced erosion potential on the slope and the migration of sediment at the site is minimal.

The excavated soils were staged on top of the mesa. Approximately 1500 cubic yards of soil and debris were removed from the hillside. A 3-foot high clean fill earthen berm was installed around the material. Straw wattles were also placed around the berm for added protection.

Several straw wattles were replaced due to wildlife damage. After the excavated soils staged on top of the mesa were removed, the area was reseeded and covered with several inches of straw mulch.

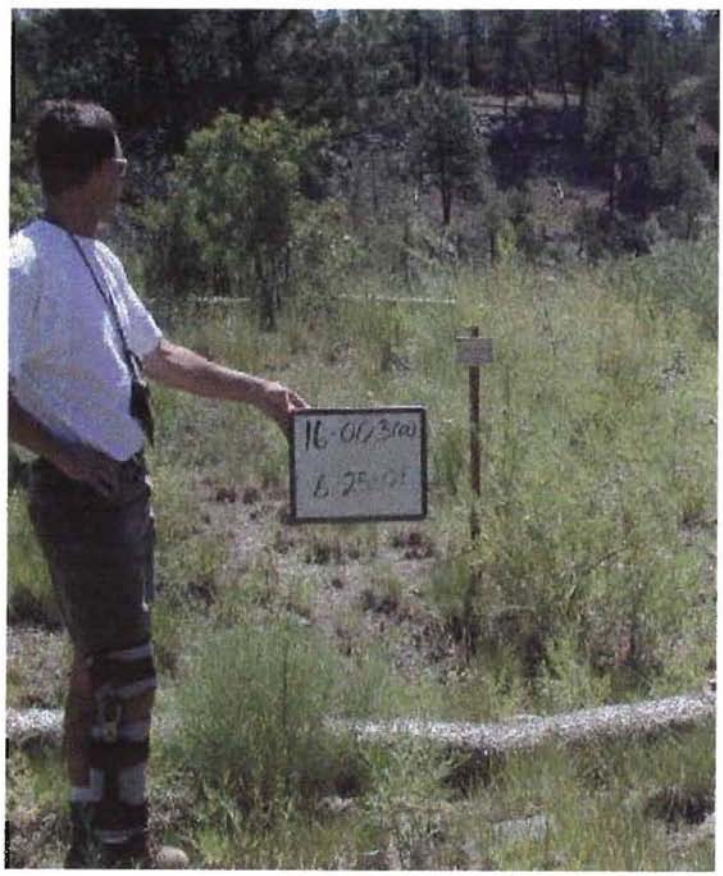
Site is located near a tributary in upper Water Canyon within the Upper Water Canyon Watershed Aggregate. The site has minor to moderate fire damage within the outfall drainage.

Straw wattles were installed near the outfall pipe and below the mesa's edge within the bottom of the tributary drainage. The area around the outfall was hand-raked, reseeded and straw mulched.

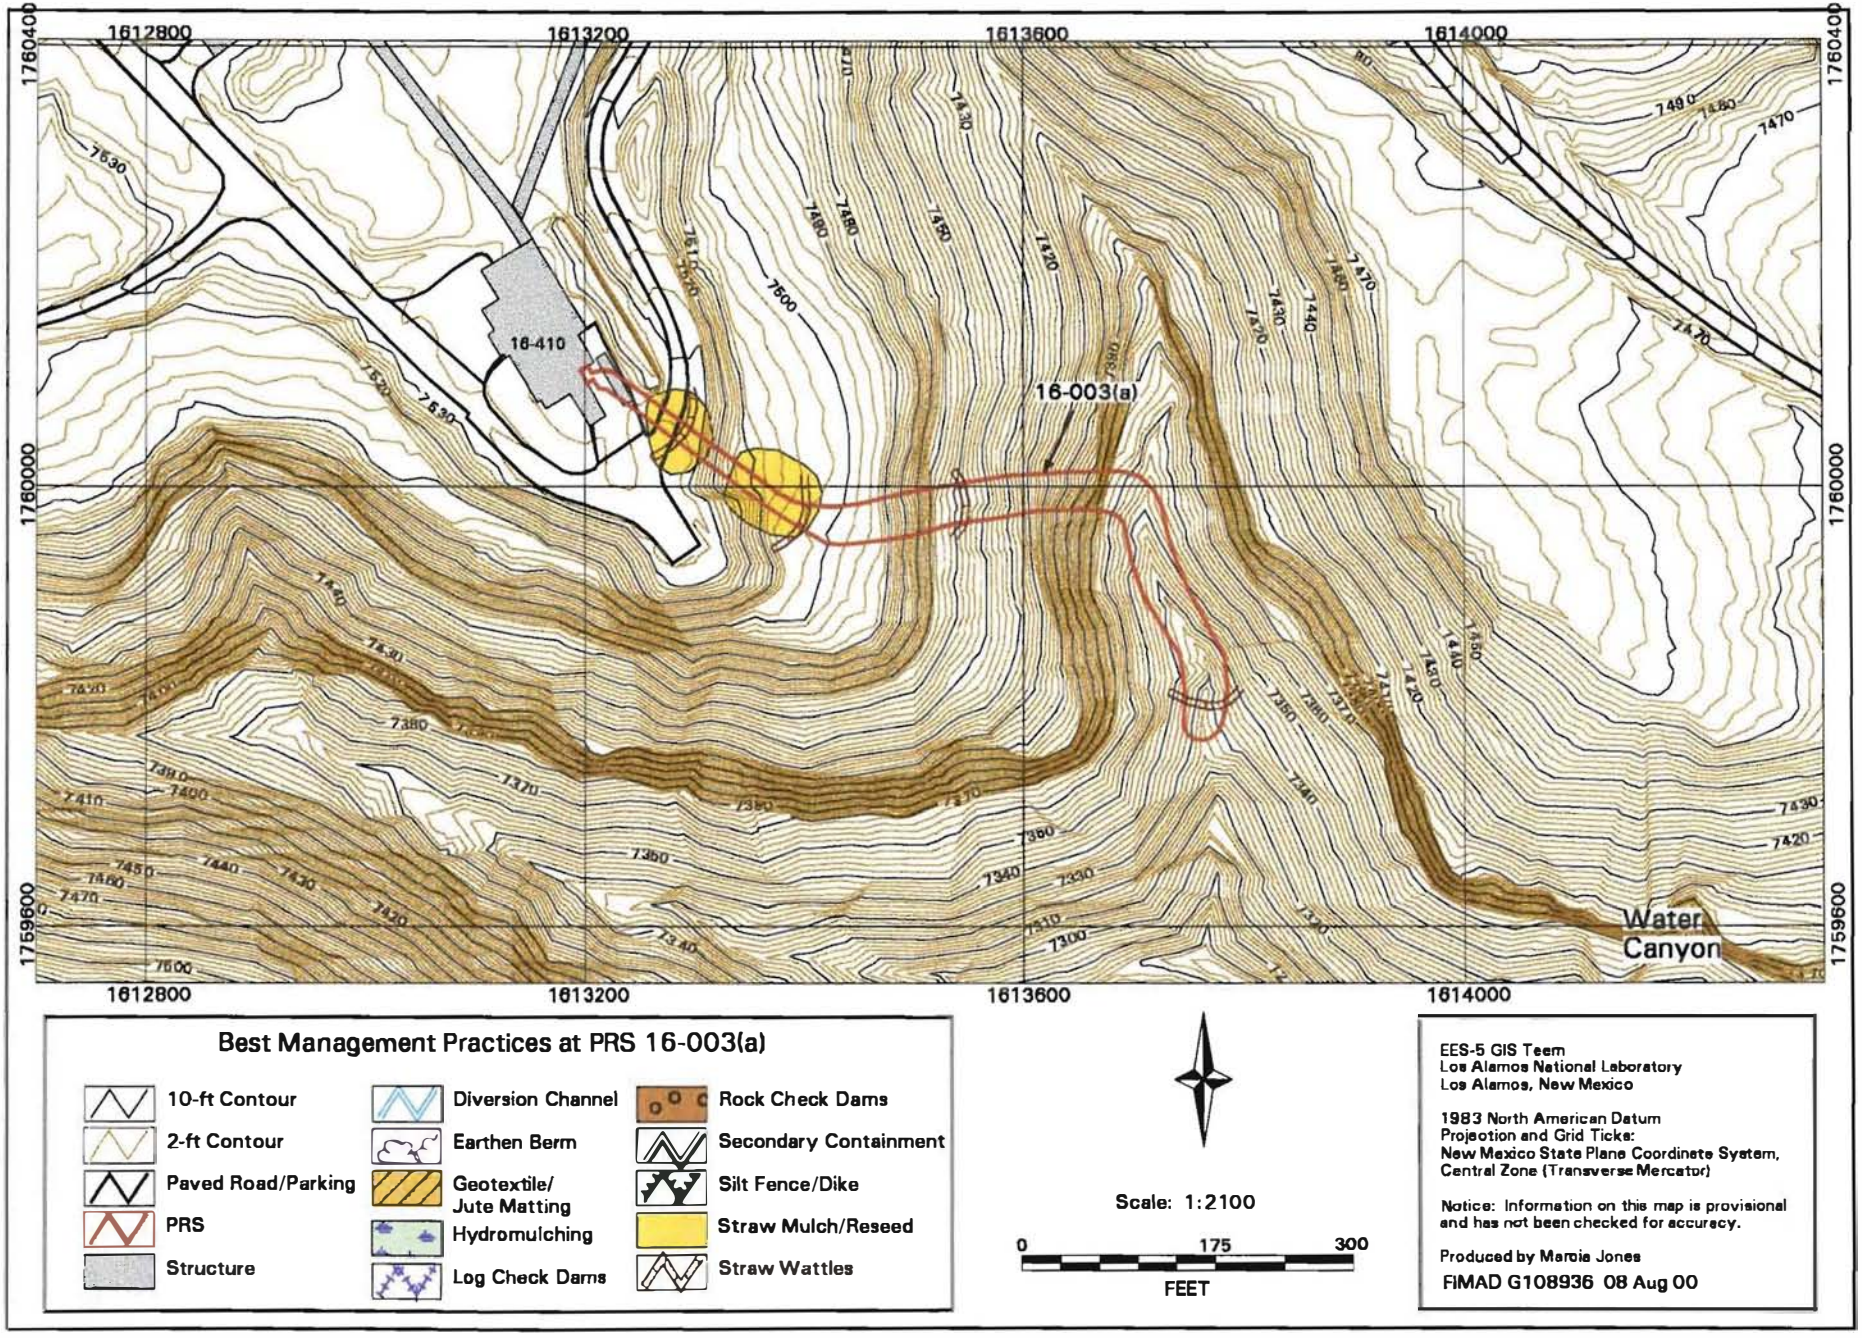
Site is in good condition, with vegetative cover of greater than 70%. The area appears stable with evidence of sediment migration being minimal.

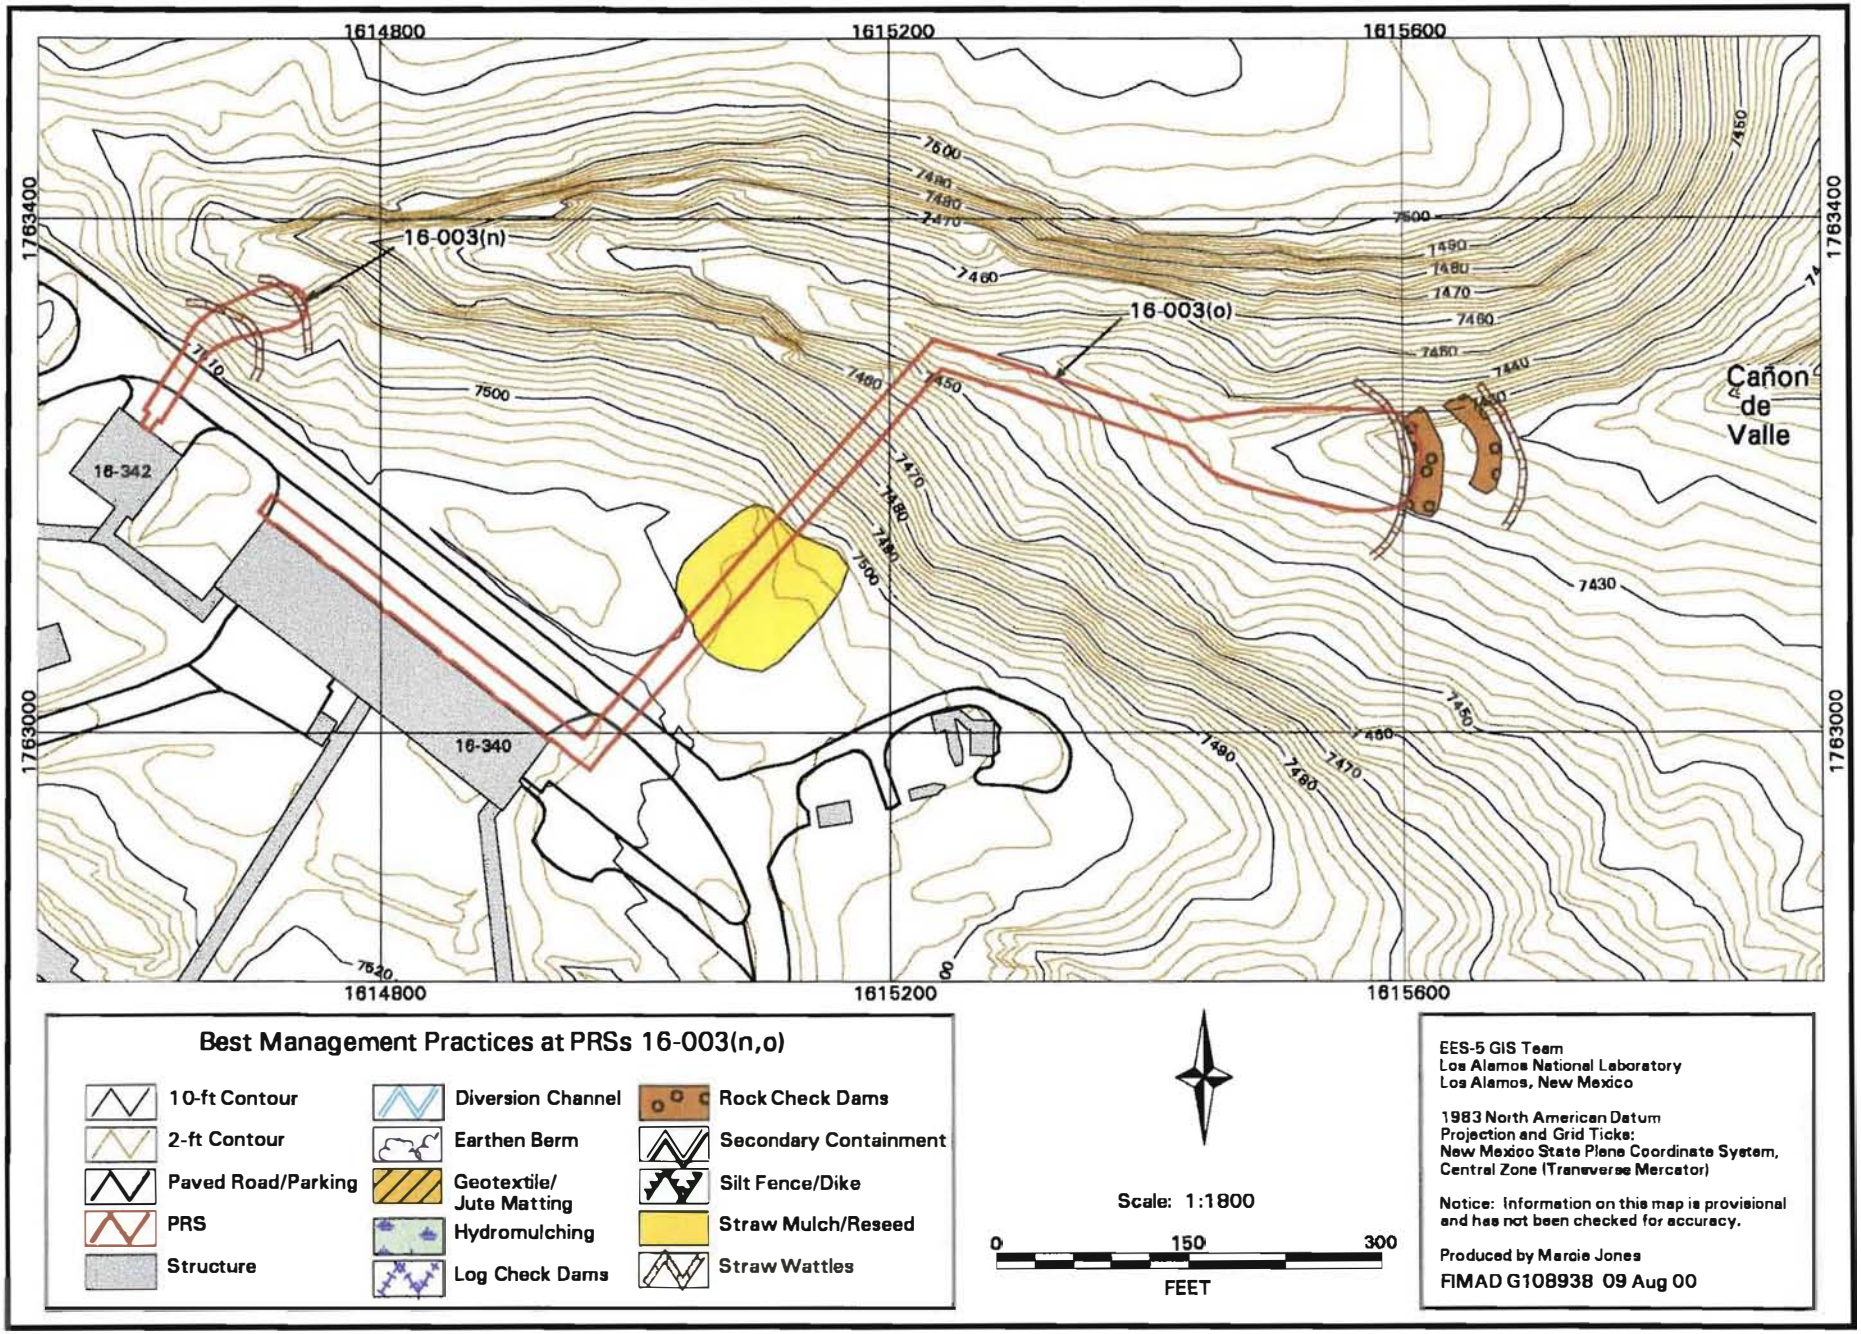
The site is located in a tributary drainage of Water Canyon within the Canon de Valle Watershed Aggregate. The site has minor to moderate fire damage within the drainage channel down to the existing wetlands located approximately ¼ mile downstream.

Revegetation efforts within the tributary drainage have been successful. The wetland grasses as well as the surrounding channel bank grasses have achieved a greater than 70% cover. The site appears stable and sediment migration at the site is minimal.

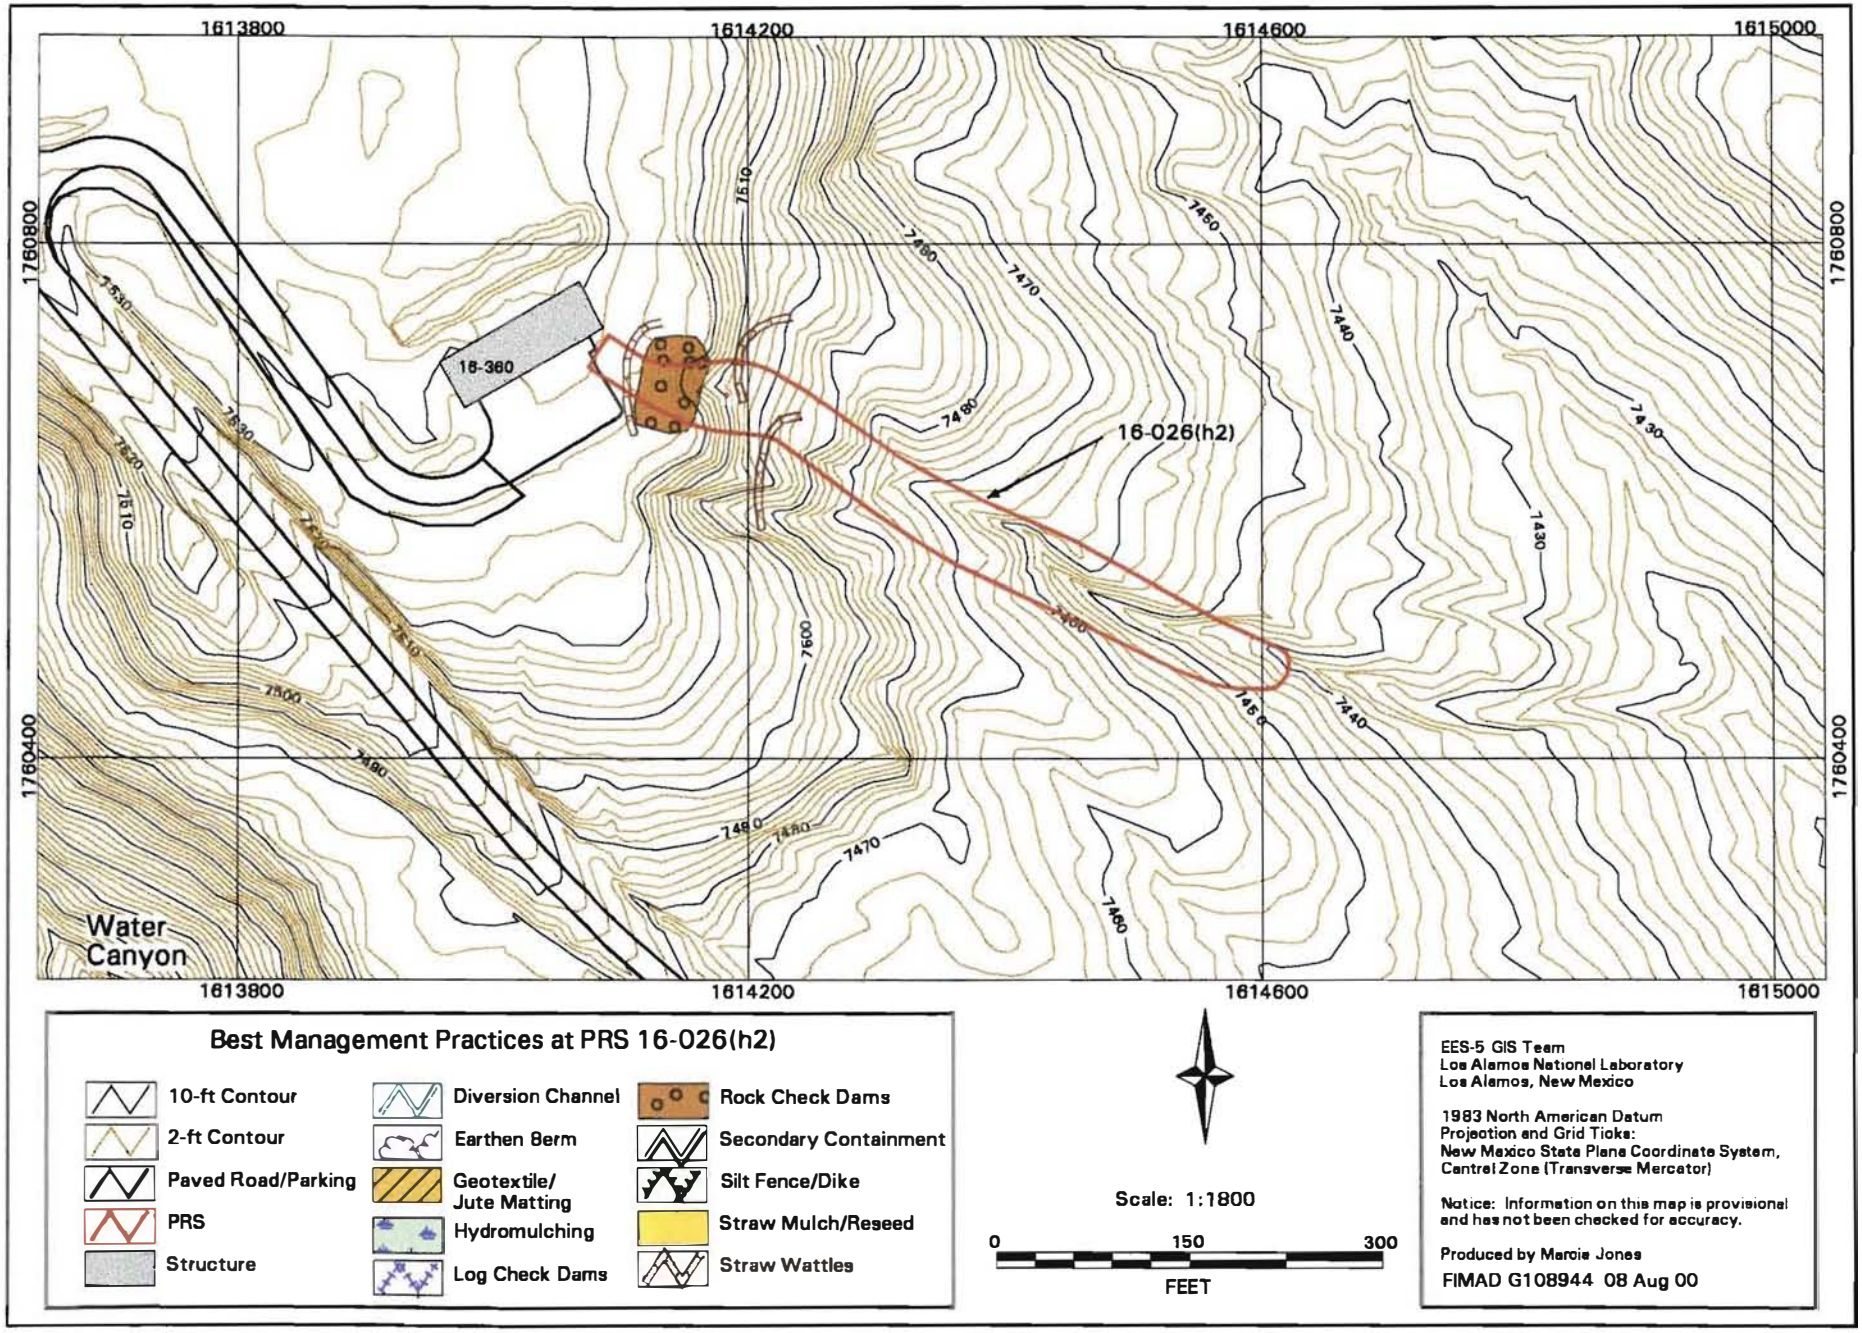
The site is located in a tributary drainage of Water Canyon within the Upper Water Canyon Watershed Aggregate. The site has minor to moderate fire damage within drainage channel.

Revegetation efforts within the tributary drainage have been successful. The wetland grasses as well as the surrounding channel bank grasses have achieved a greater than 70% cover. The site appears stable and sediment migration at the site is minimal.

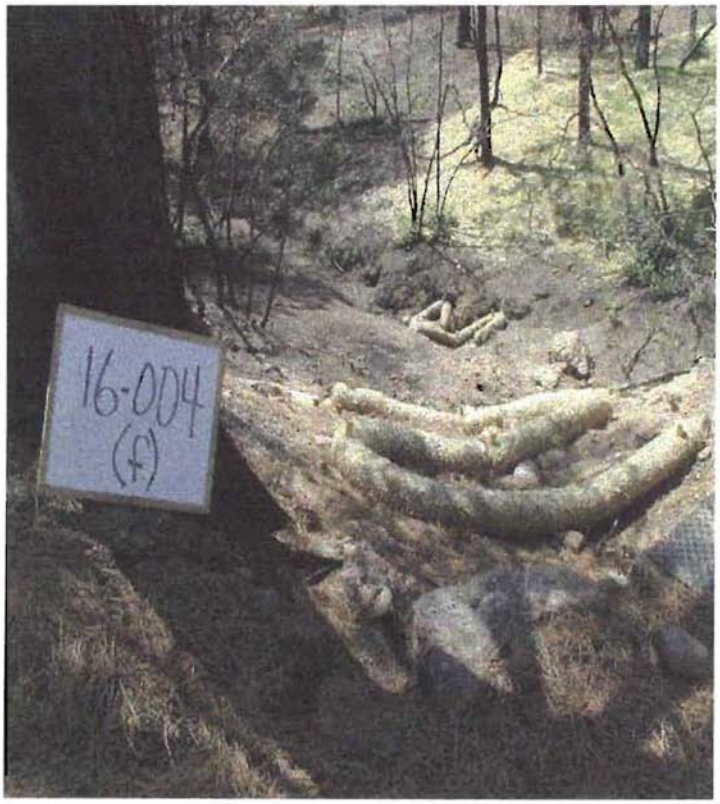
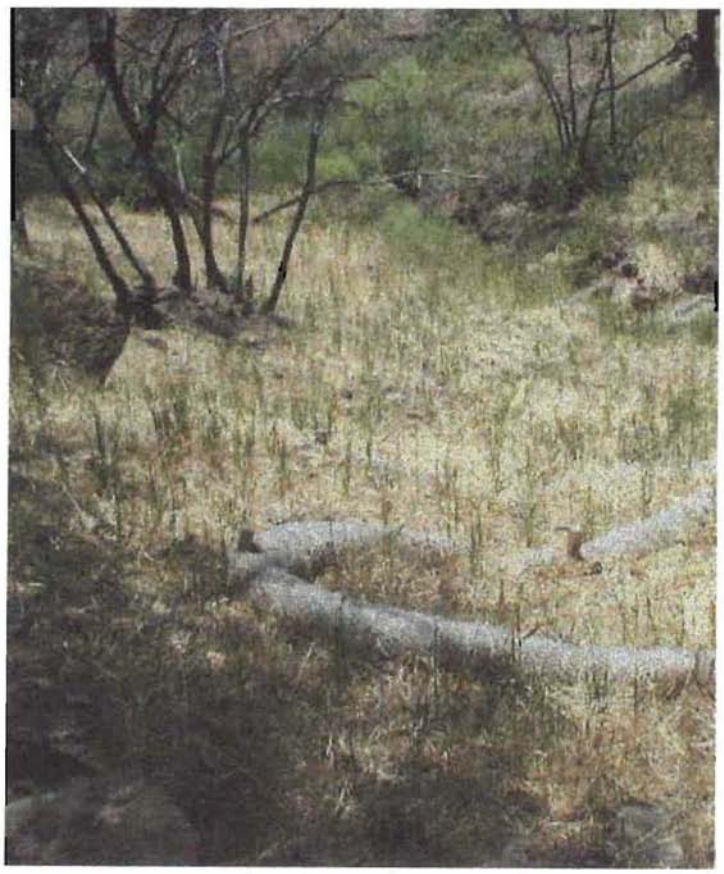
The site is located in a tributary drainage of Water Canyon within the S-Site Canyon Watershed Aggregate. The site has minor to moderate fire damage within drainage channel.

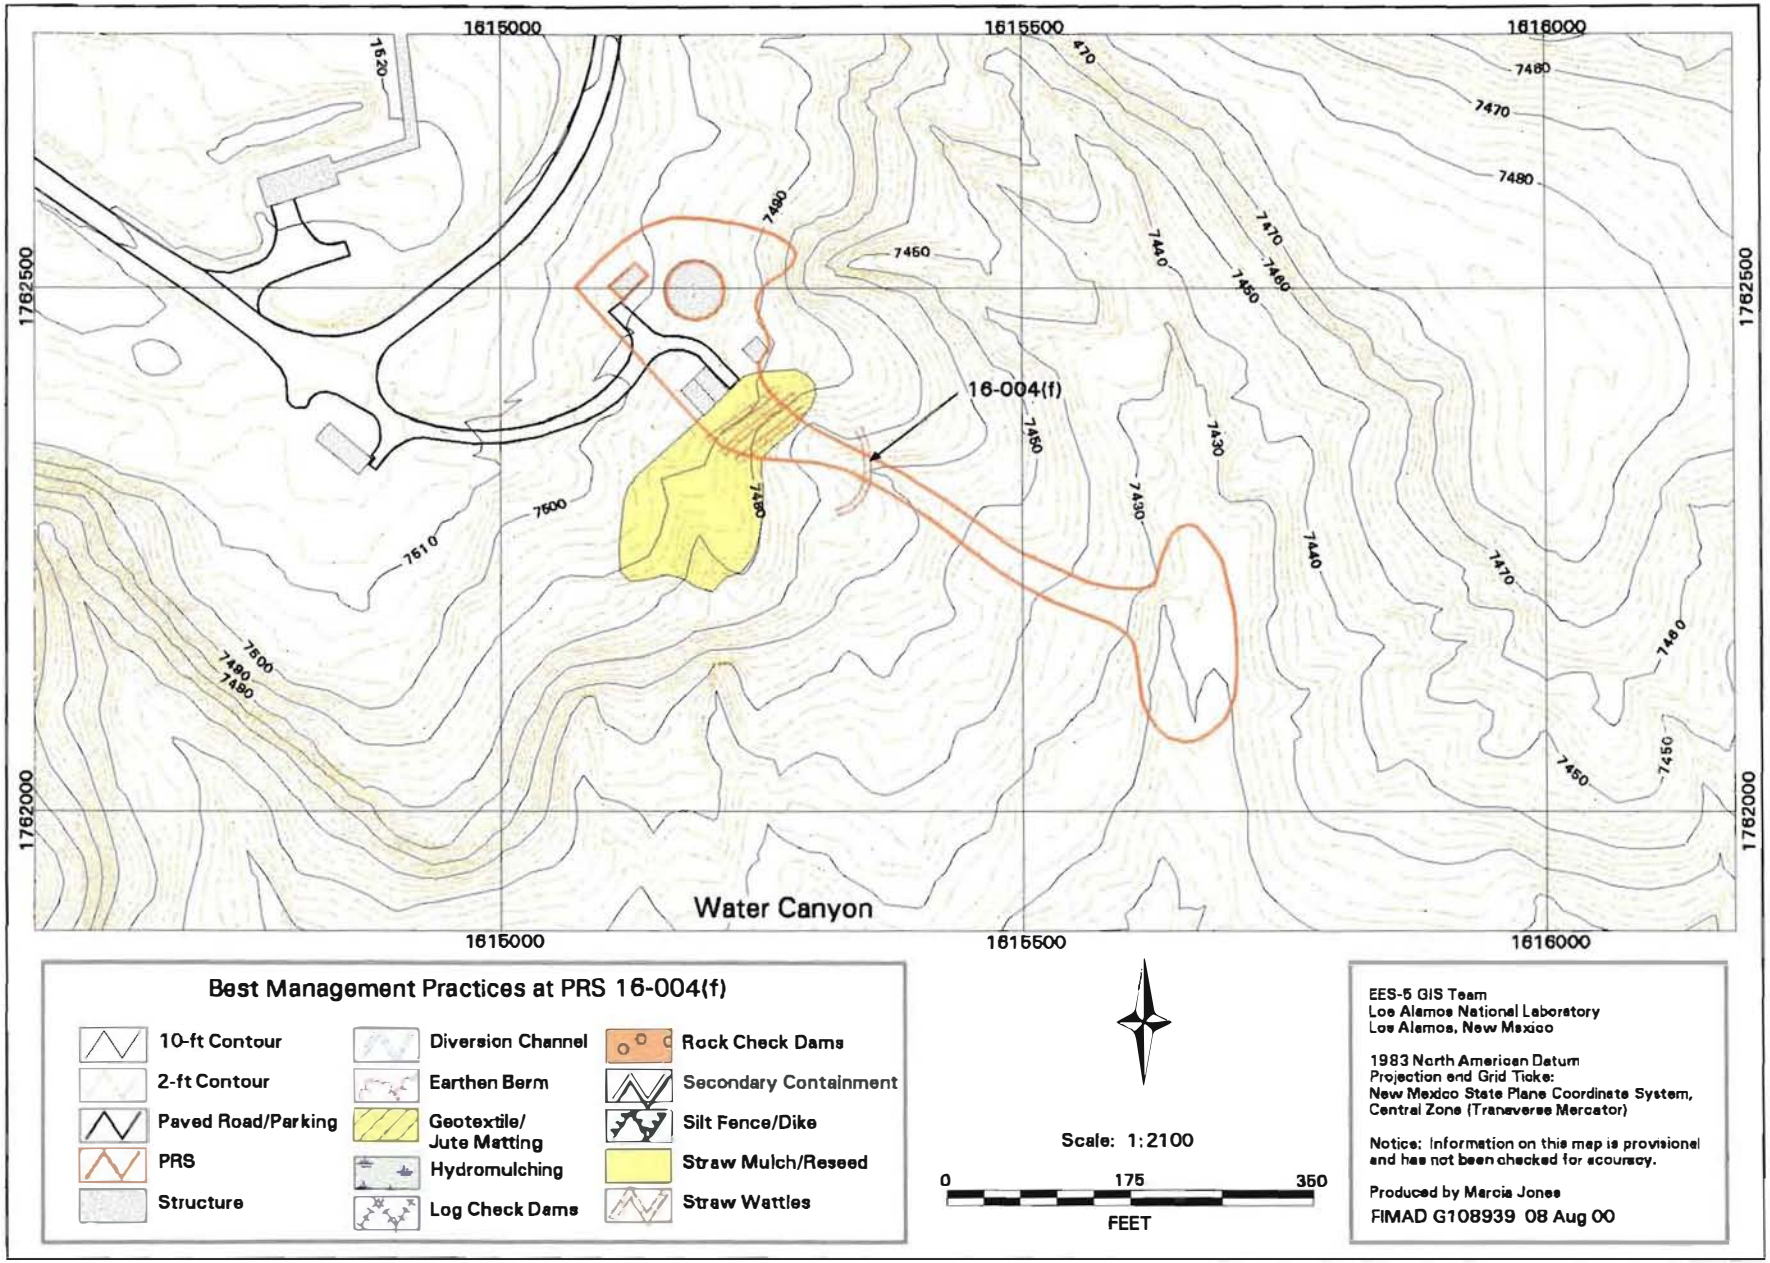
Revegetation efforts within the tributary drainage have been successful. The surrounding channel bank grasses have achieved a greater than 70% cover. The site appears stable and sediment migration at the site is minimal.

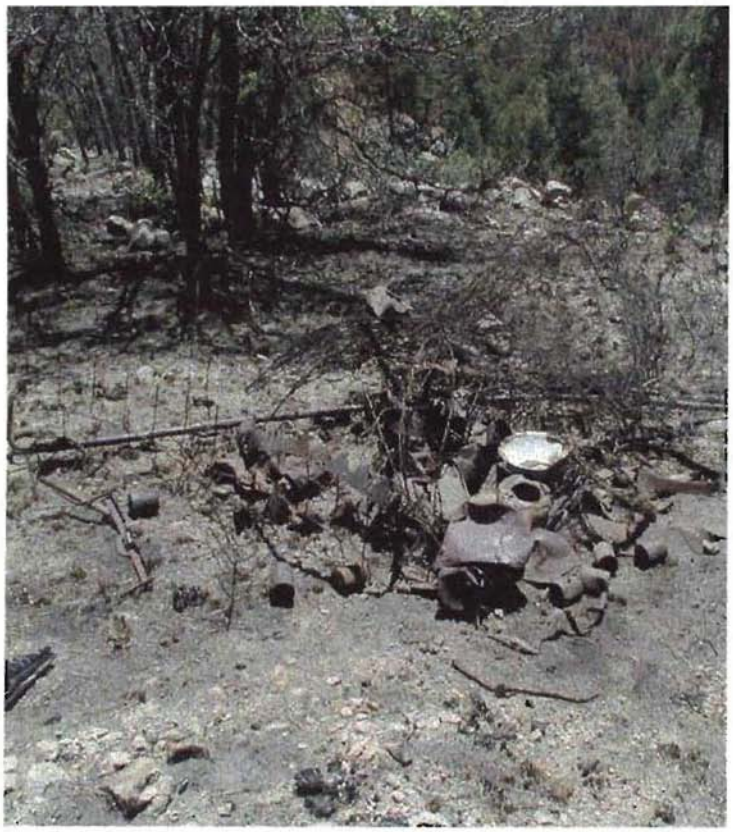
The site is located in a tributary drainage of Water Canyon within the Canon de Valle Watershed Aggregate. The site has minor to moderate fire damage within drainage channel. Debris was exposed within channel near the inactive outfall.
