Title: CERRO GRANDE FIRE: ONE YEAR AFTER AN UPDATE ON ER ACTIVITIES TO REDUCE THE POTENTIAL MOVEMENT OF CONTAMINATION AT POTENTIAL RELEASE SITES

Author(s): Steven J. Veenis, CPESC
Randy Johnson

Submitted to: Environmental Restoration Project
Water Quality & Hydrology Group (ESH-18)

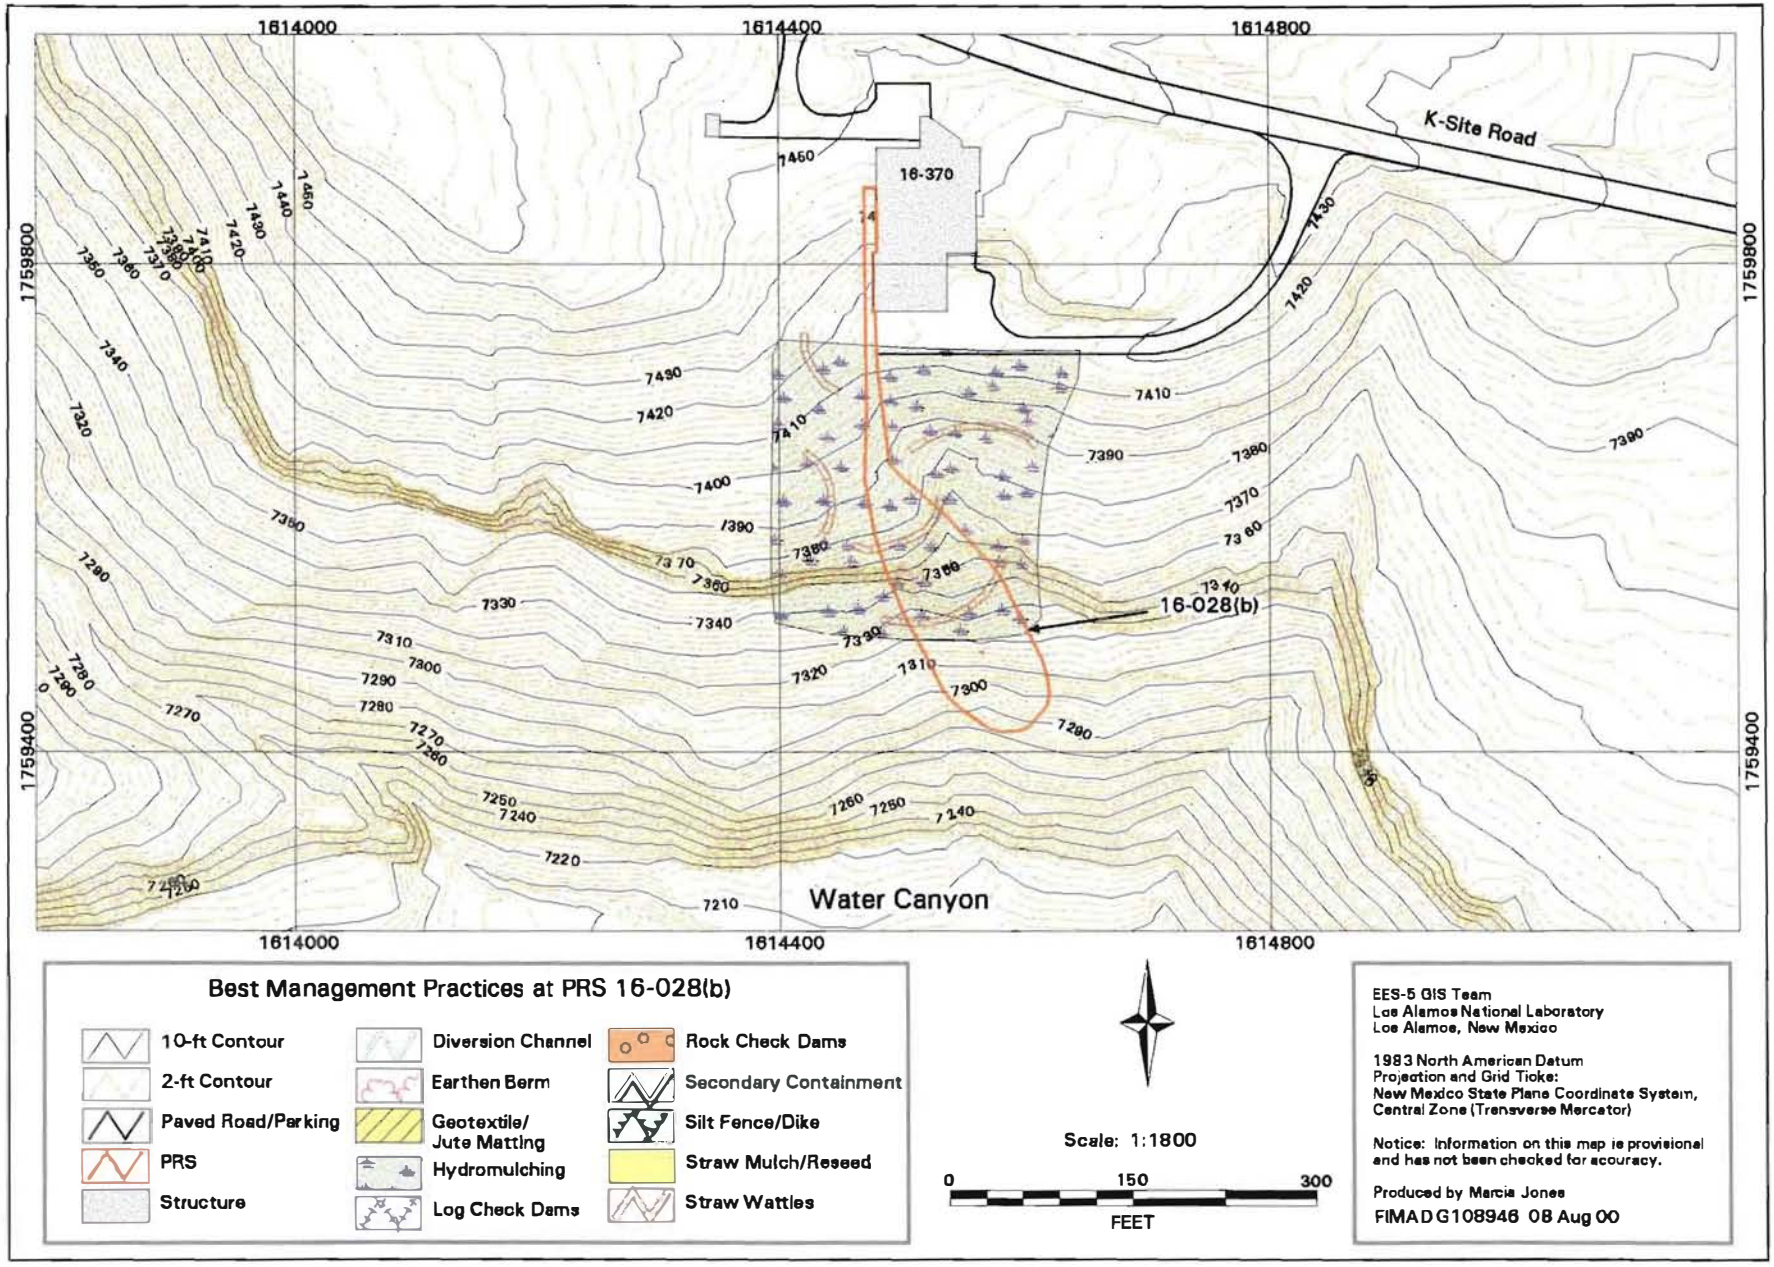
Revegetation efforts within the tributary drainage have been successful. The surrounding channel bank grasses have achieved a greater than 70% cover. The site appears stable and sediment migration at the site is minimal.

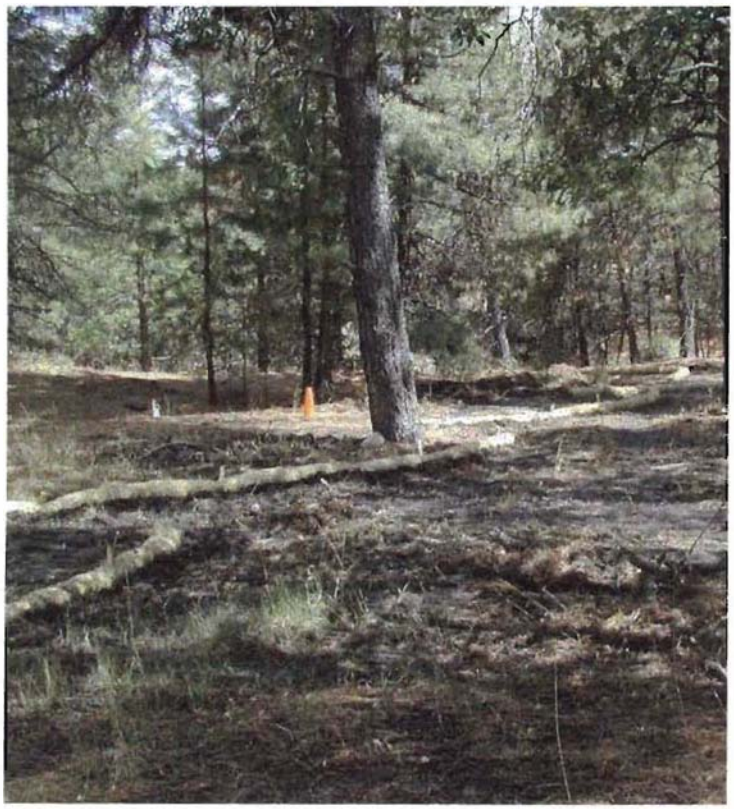
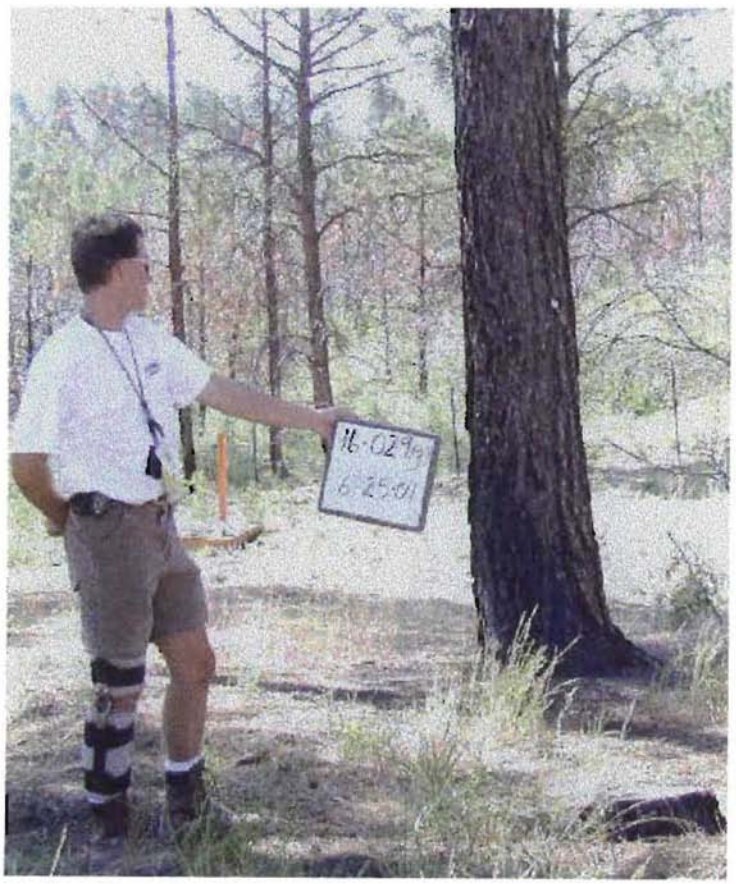
16-029(g) – *Erosion Matrix Score 21.5.* An active HE sump associated with TA-16-450. The outfall, EPA 04A091 located to the southeast of TA-16-450, receives effluent from the sump.

The site is located in a tributary drainage of Water Canyon within the Upper Water Canyon Watershed Aggregate. The site has moderate fire damage of the ground cover with minor canopy damage.

Straw wattles were installed throughout the site for sediment retention. The area was then hand-raked, reseeded and straw mulched.

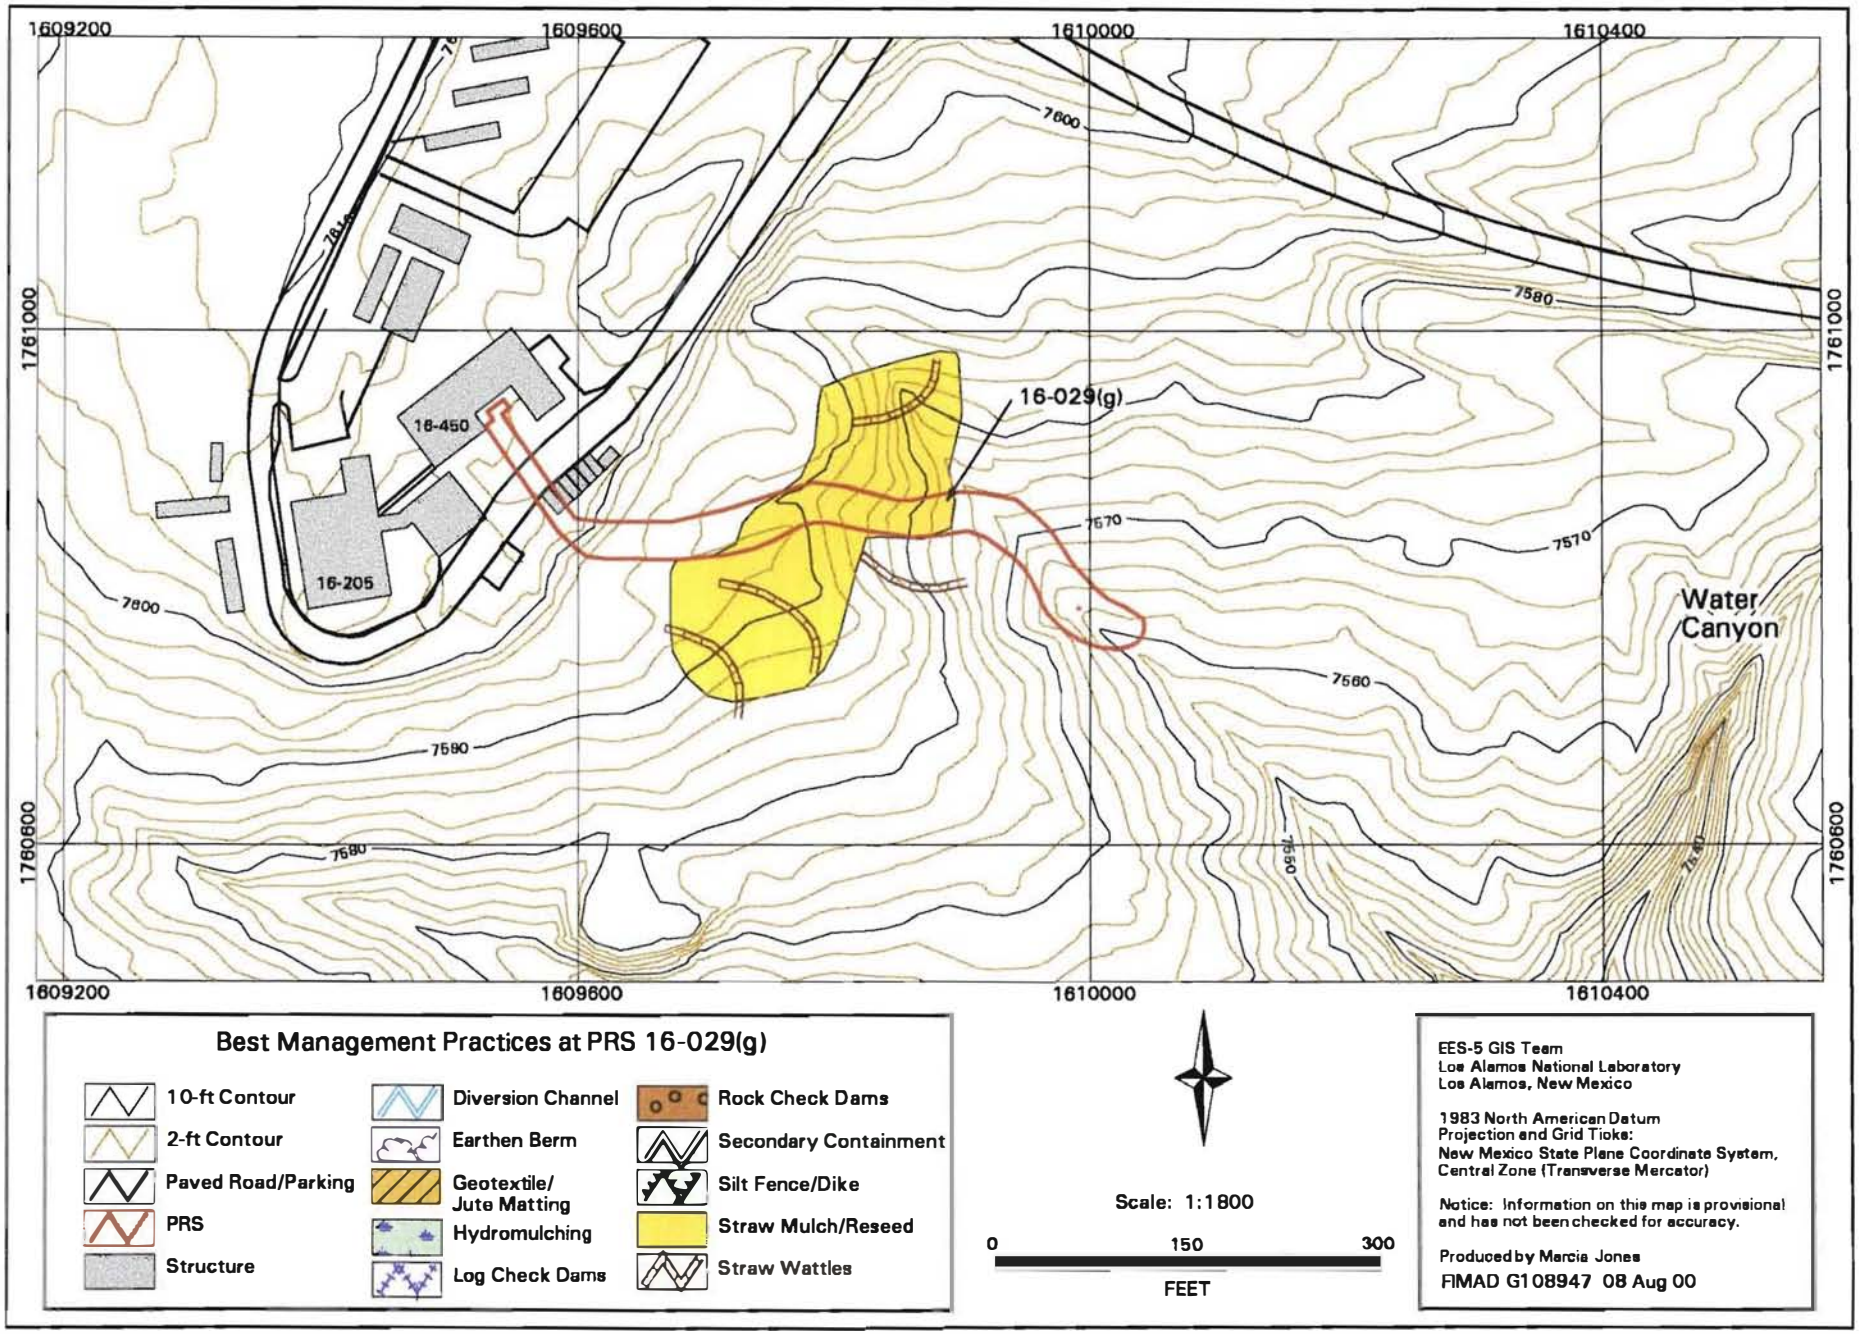
Revegetation efforts throughout the site have been successful. The surrounding grasses have achieved a greater than 70% cover. The site appears stable and sediment migration at the site is minimal.

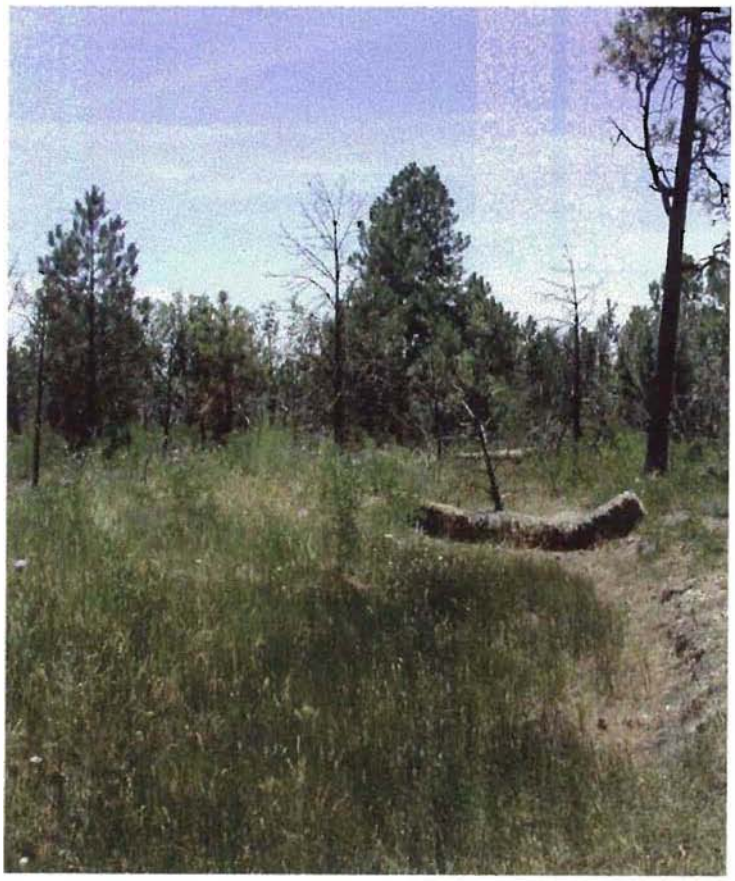
16-030(h) – *Erosion Matrix Score 29.1.* Building TA-16-430 functions as a high explosives pressing facility. Plastic-bonded explosives and mock HE powders are pressed to shape. The site consists of three outfalls associated with the three HE sumps at TA-16-430.

The site is located in a tributary drainage of Water Canyon within the Upper Water Canyon Watershed Aggregate. The site has moderate fire damage of the ground cover with minor canopy damage.

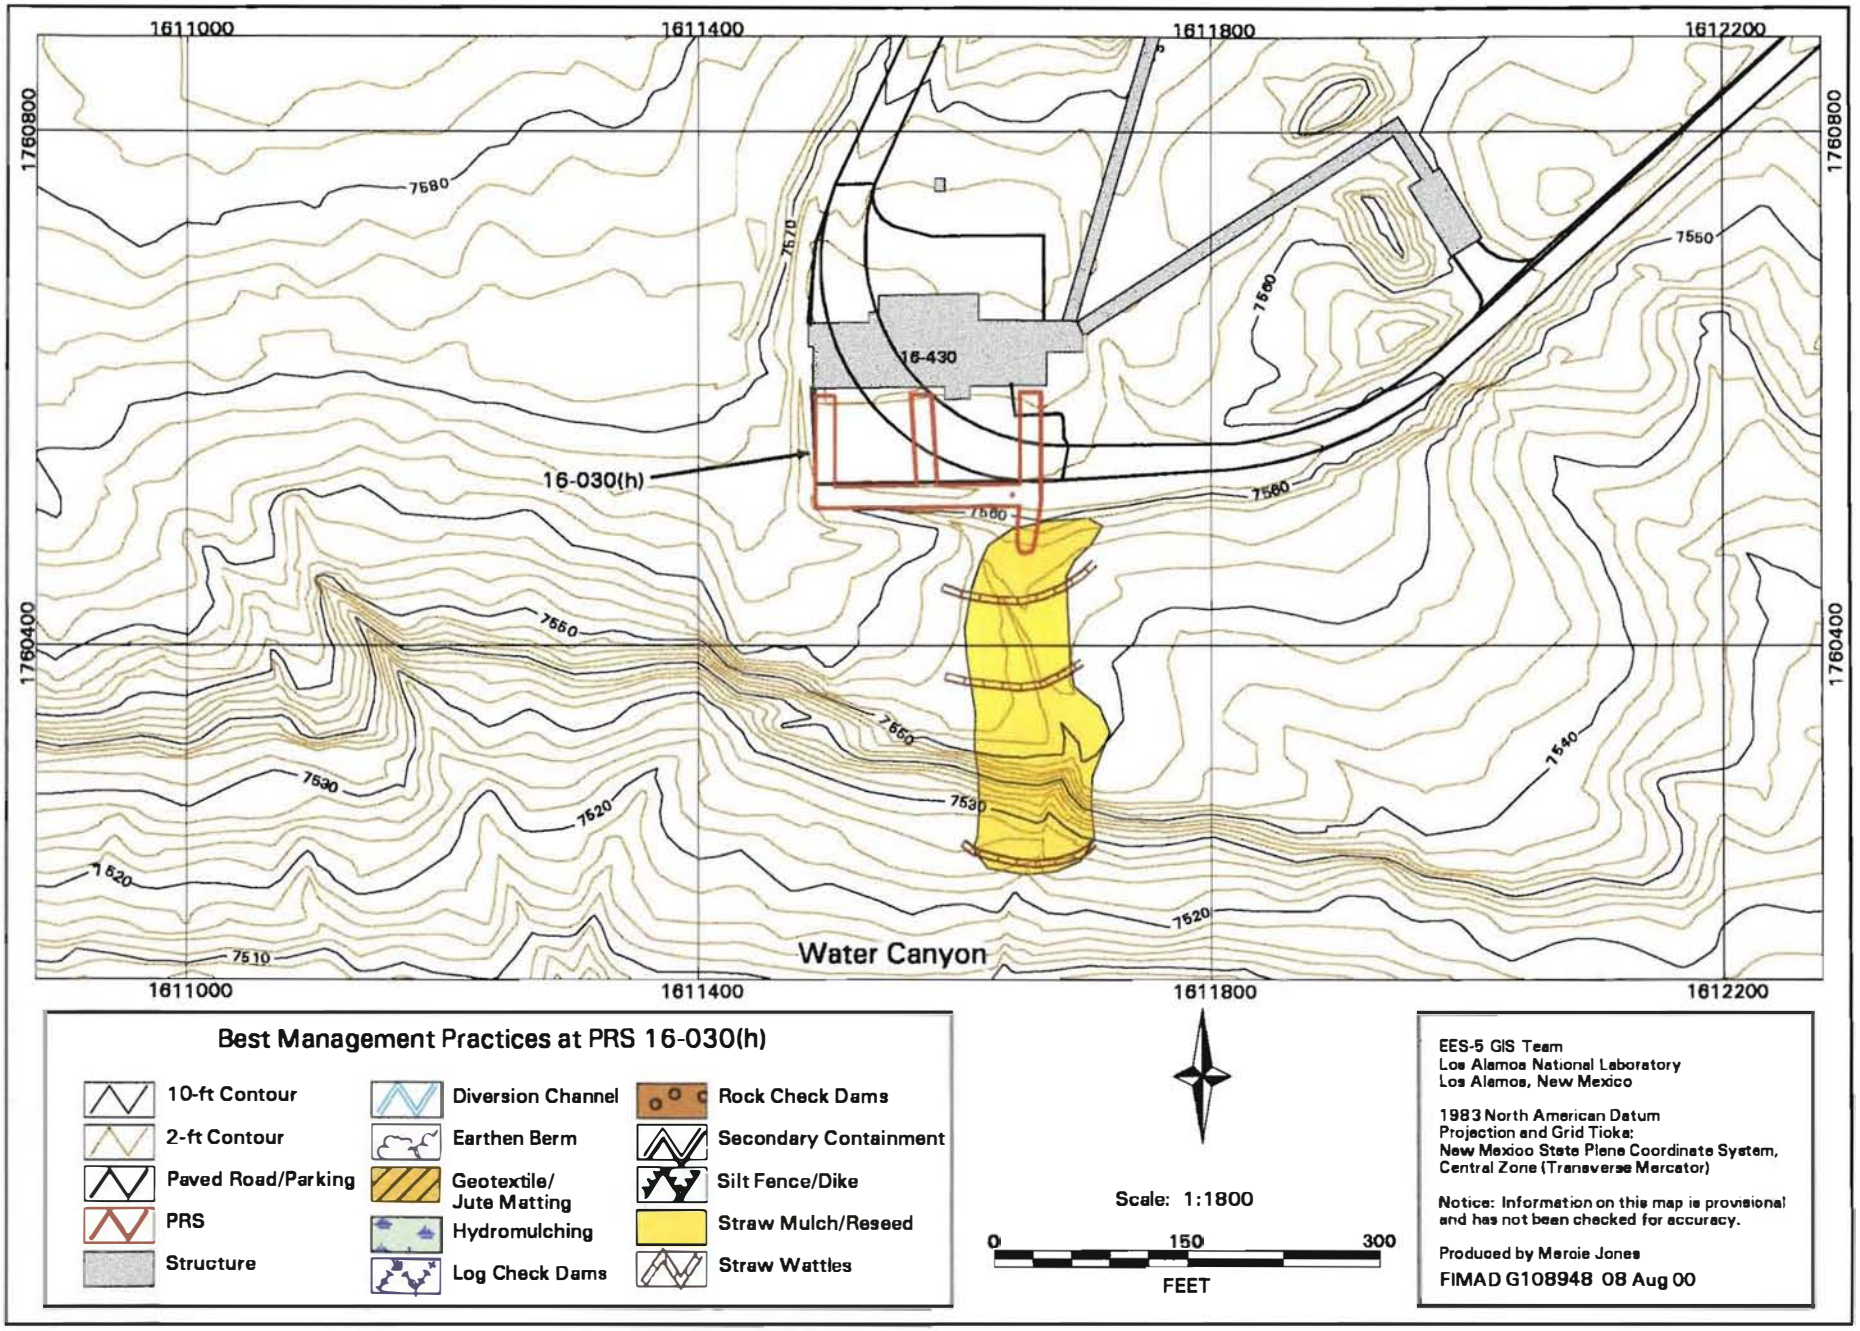
Revegetation efforts within the tributary drainage have been successful. The surrounding channel bank grasses have achieved a greater than 70% cover. The site appears stable and sediment migration at the site is minimal.

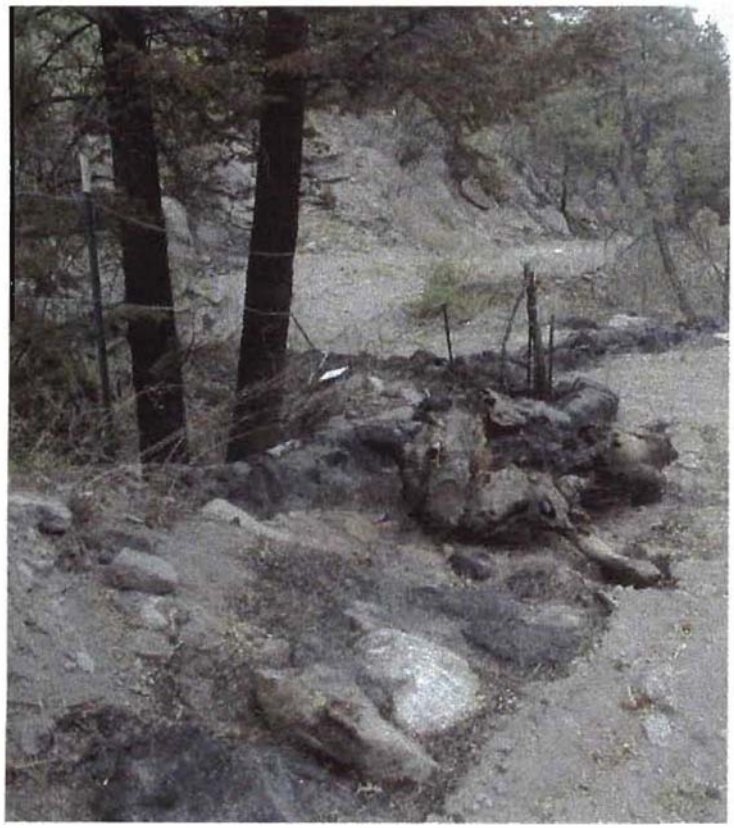
TECHNICAL AREA 16 -MDA P BEFORE AND AFTER THE CERRO GRANDE FIRE

16-018 – *Erosion Matrix Score 69.3.* A landfill that contains rubble and debris generated by the burning of HE, HE contaminated equipment and material, barium nitrate sands, building material, empty drums, bottles and trash. (MDA P). It is located in TA-16 near the south rim of Canon de Valle, just north of flash pad (TA-16-387).

This site is located on the edge of Canon de Valle within the Canon de Valle Watershed Aggregate. MDA-P received only peripheral fire damage on the lower portion of the site. The existing straw barriers and silt fencing were destroyed. No construction equipment and project infrastructure were damaged.

The straw barriers and silt fencing were replaced and fortified with an earthen berm below the site. Soil-Sement (polymer based emulsion) was applied to exposed slopes to reduce sediment transport potential.

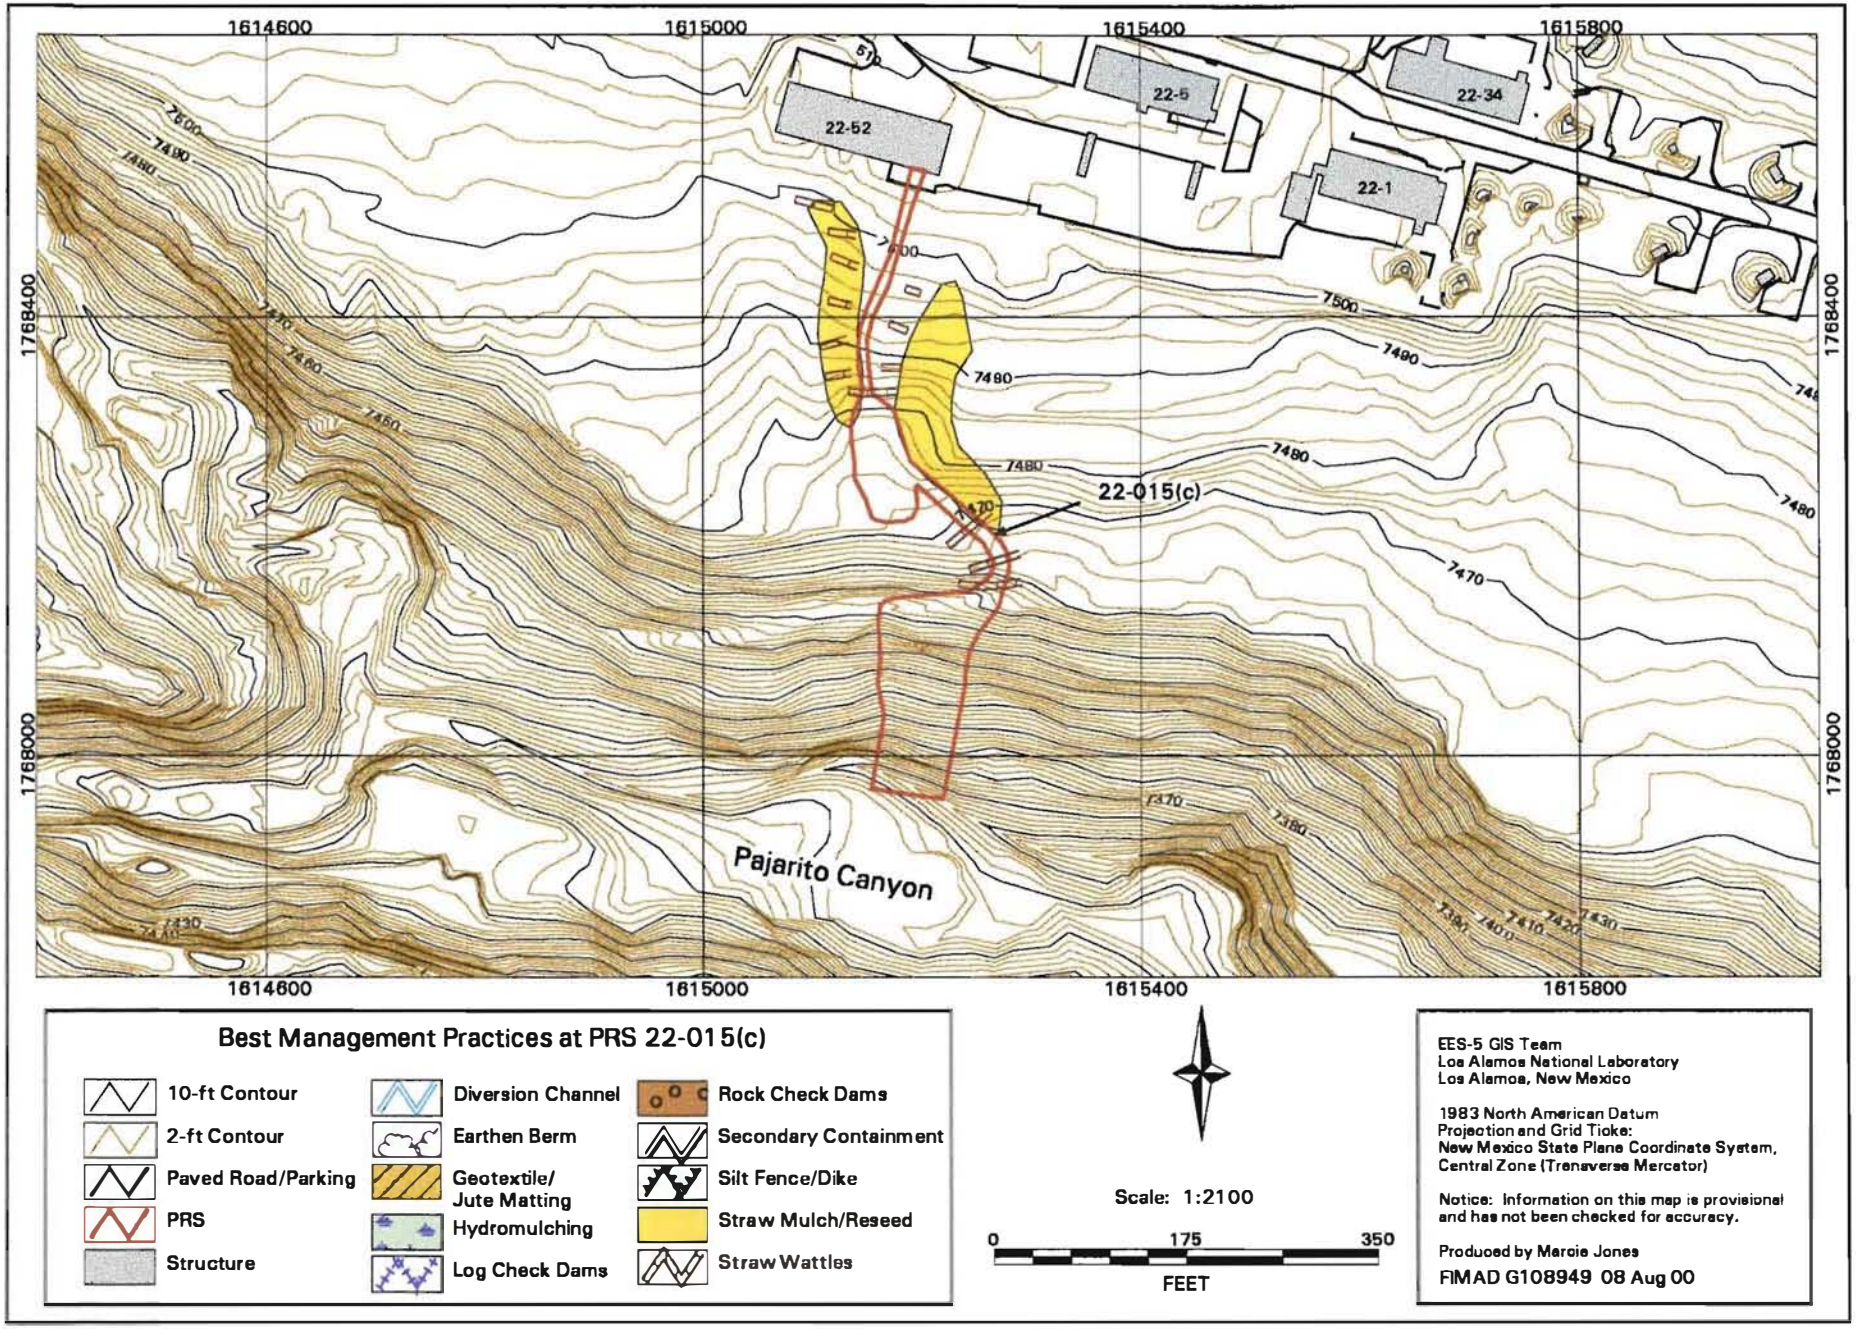
Revegetation efforts throughout the site have been successful. The surrounding channel bank grasses have achieved a greater than 70% cover. The site appears stable and sediment migration at the site is minimal.

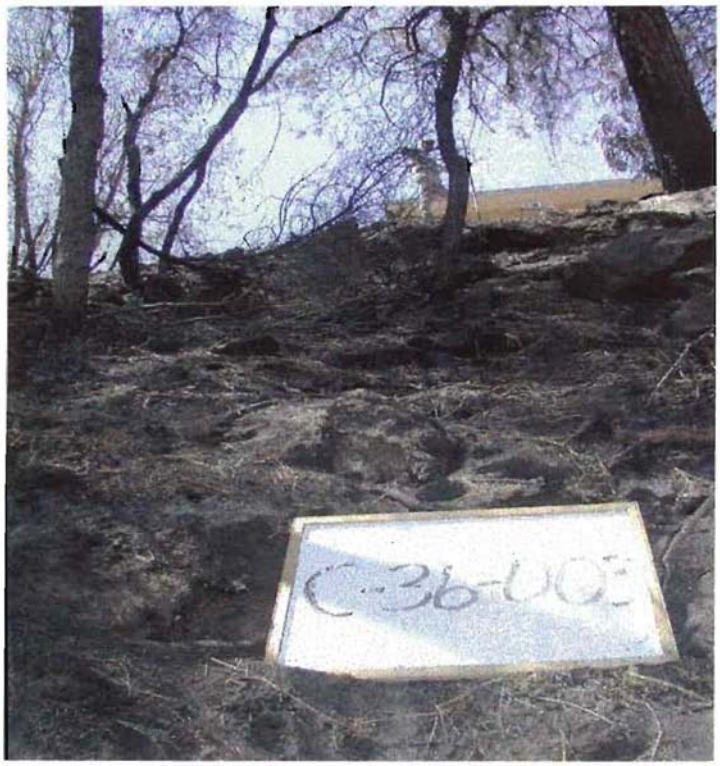
TECHNICAL AREA-36 SITE BEFORE AND AFTER THE CERRO GRANDE FIRE

C-36-003 – *Erosion Matrix Score 52.0.* This is an inactive permitted (06A106) outfall that received chemicals from a photo lab within Building TA-36-1. It discharges over the steep edge of Three Mile Canyon. It became operational in 1950. The debris that was exposed adjacent to the outfall was later identified as **PRS 36-008** - *Erosion Matrix Score 52.0* a land disposal area.

Straw wattles were installed on the mesa's edge to divert storm water run-on from the parking area, within the drainage channels on the slope and at the toe of the slope The debris that was exposed by the fire has been removed, and the area was hand-raked, reseeded and straw mulched.

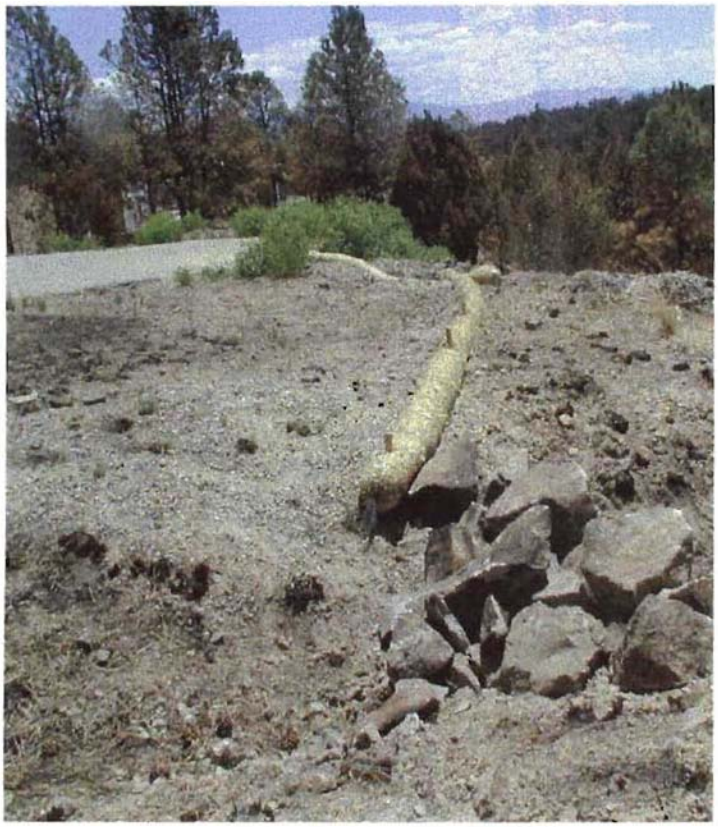
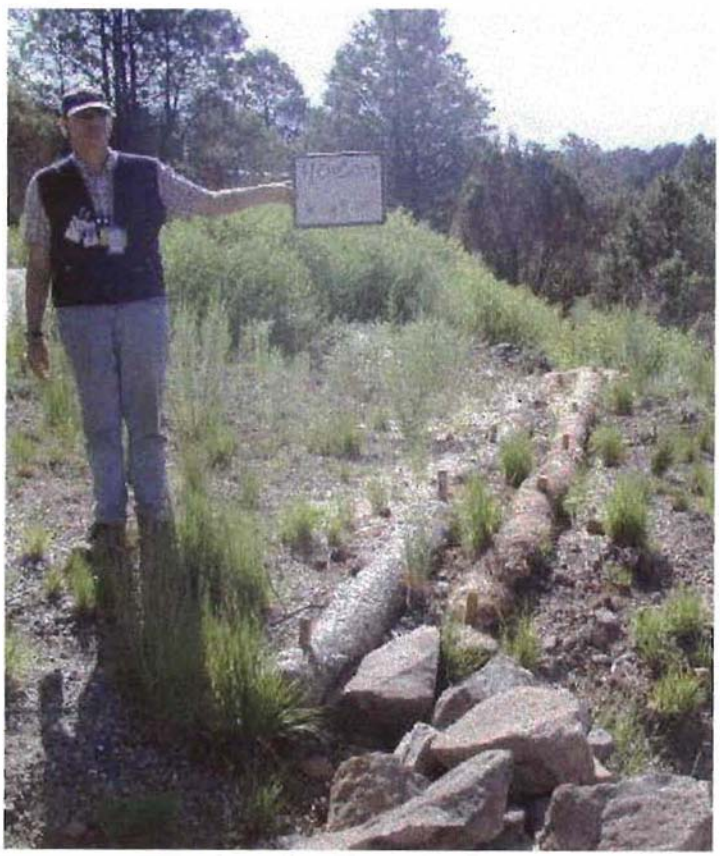
40-009 - *Erosion Matrix Score 54.5.* Landfill adjacent to firing site at TA-40-9. The landfill contains debris from decommissioning of buildings at TA-15. An inactive NPDES outfall (04A101) is located nearby.

The site is located on the edge of Pajarito Canyon within the Starmer's/Pajarito Canyon Watershed Aggregate. The erosion potential on this slope increased due to lack of vegetative cover as a result of the fire.

Straw wattles were installed along the mesa edge to divert run-on from the slope. Rock check dams (on-site materials used) were provided to dissipate flow within the drainage channels on both the east and west ends of the site.

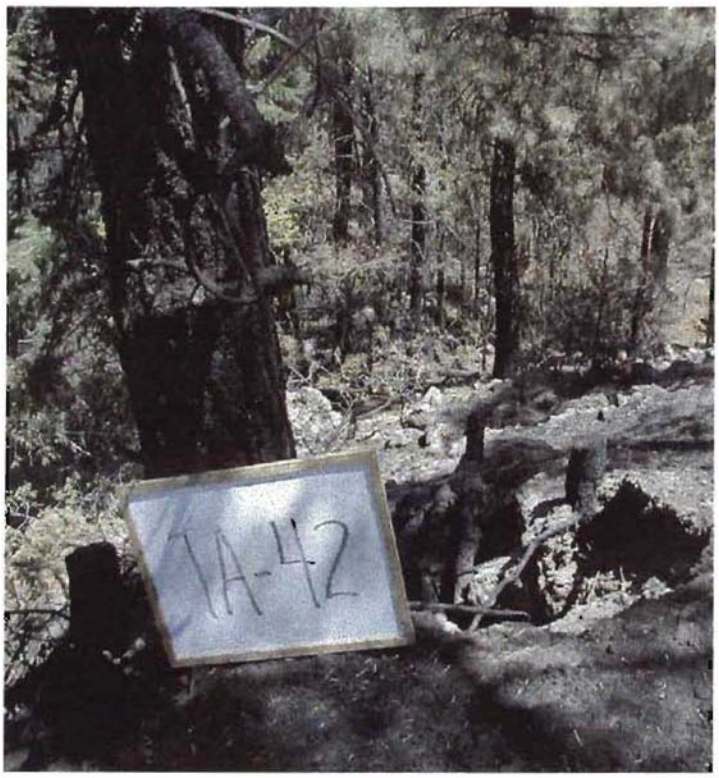
Revegetation efforts around the site have been successful. The surrounding channel bank grasses have achieved a greater than 50% cover. The site appears stable and sediment migration at the site is minimal. The debris near the mesa's edge was removed from the area and disposed of as solid waste.

Installation of two additional straw wattles for sediment retention.

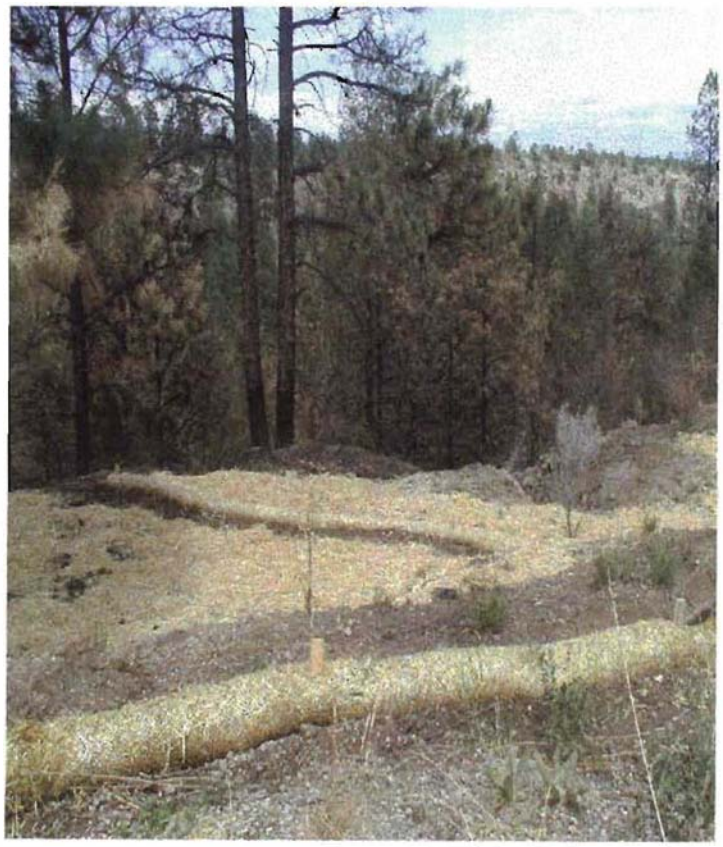
42-004 – *Erosion Matrix Score 93.5.* A canyon disposal area at former TA-42. Some building debris including pipes, were discarded over the canyon edge north of TA-42. The canyon disposal area is also designated as PRS No. C-42-001. Soil samples collected in 1991 as part of a survey found no contaminants of concern at the site.

The site is located on a tributary drainage to Mortandad Canyon within the Upper Mortandad Canyon Watershed Aggregate. The entire north facing slope below former TA-42 was moderately burned. Two distinct drainage channels bisect the area behind the new building constructed near TA-55. The run-on to the western most drainage has been diverted away from the area of concern. The other drainage receives only direct rainfall, with minimal upslope sources.

Straw wattles were installed around the area to divert run-on and to impede sediment transport potential. The area was hand-raked, reseeded and straw mulched.

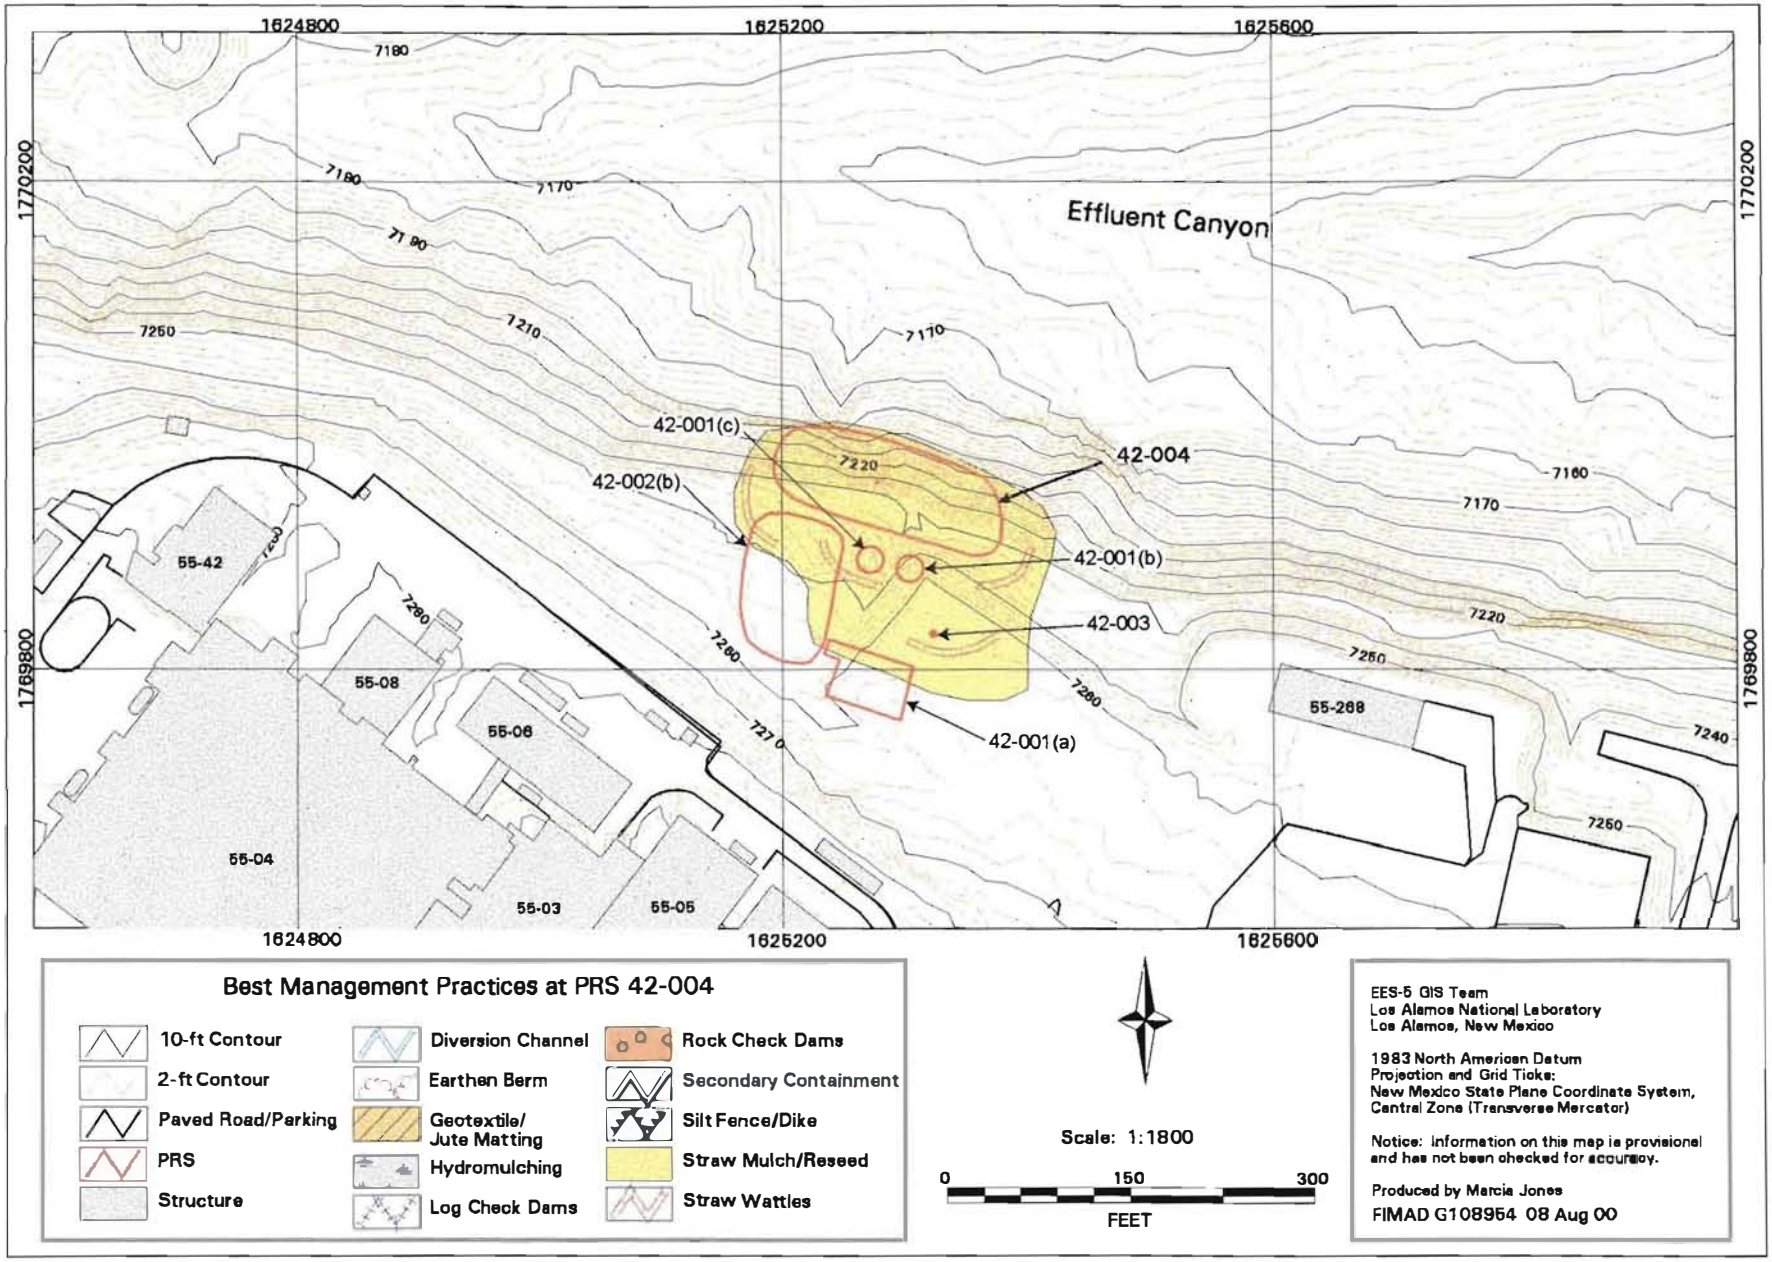
Revegetation efforts around the site have been mostly successful. The surrounding channel bank grasses have achieved a greater than 50% cover. The site appears stable and sediment migration at the site is minimal.

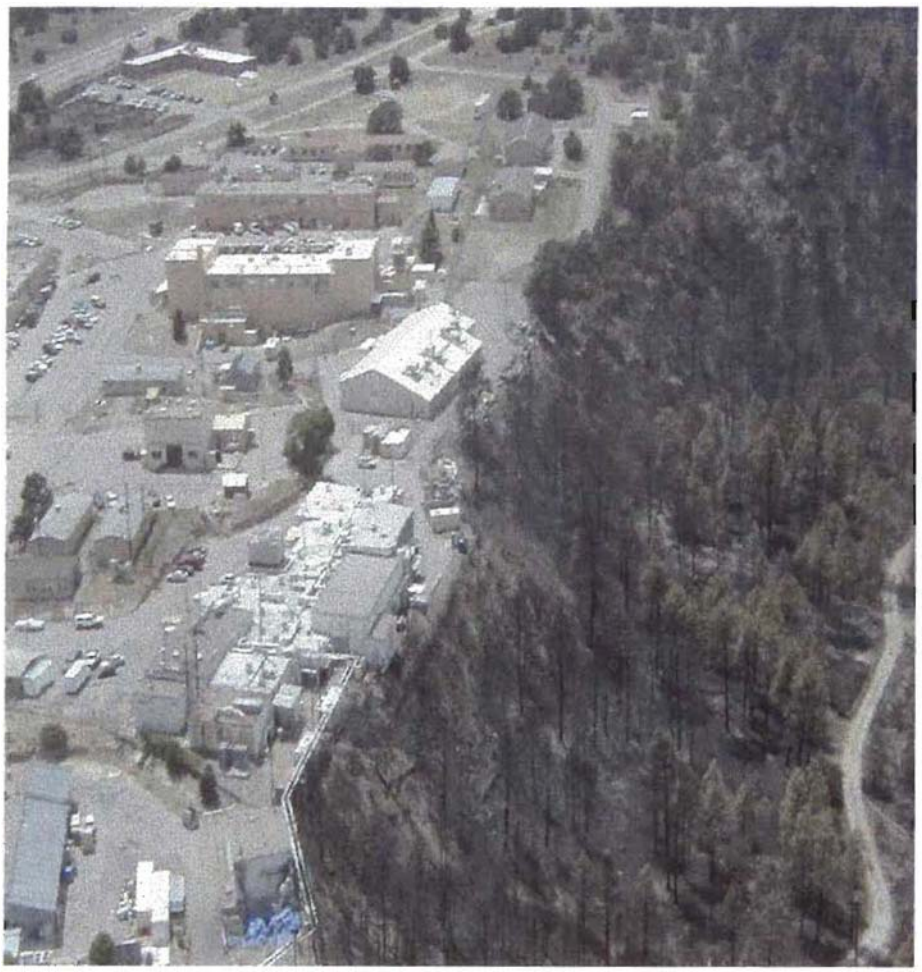
46-004(z) - *Erosion Matrix Score 30.5.* (Outall L) is the outfall from a second industrial drain servicing Rooms 160 through 172 in TA-46-31. The outfall is a 6-inch cast iron pipe, located northwest of building that discharges into Canada del Buey. Both floor drains and roof drains are connected to the outfall.

The area impacted is located on the northern edge of Canada del Buey within the Middle Mortandad/Canada del Buey Watershed Aggregate. The entire north-facing slope below TA-46 was moderately to severely burned. Several buildings along the mesa edge were destroyed. The canopy and ground cover was mostly destroyed. The northern slope is extremely steep with several inactive outfalls, pipes and old infrastructure parts exposed.

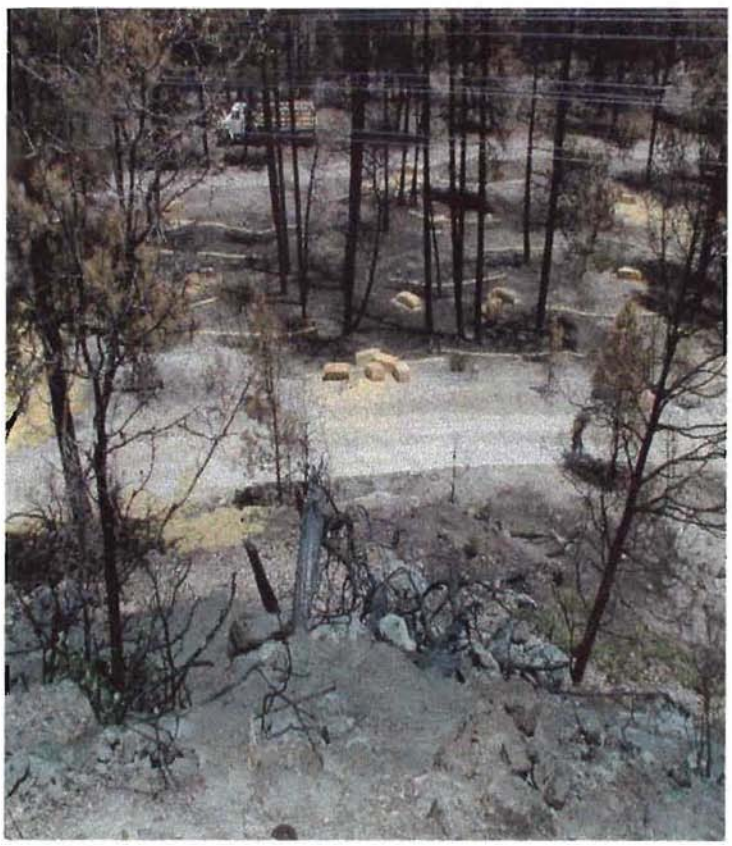
This photograph was taken on June 14, 2000. It shows the eastern most corner of the impacted northern slope behind building 46-58. Several trees and power poles were cut down to protect the existing structures.

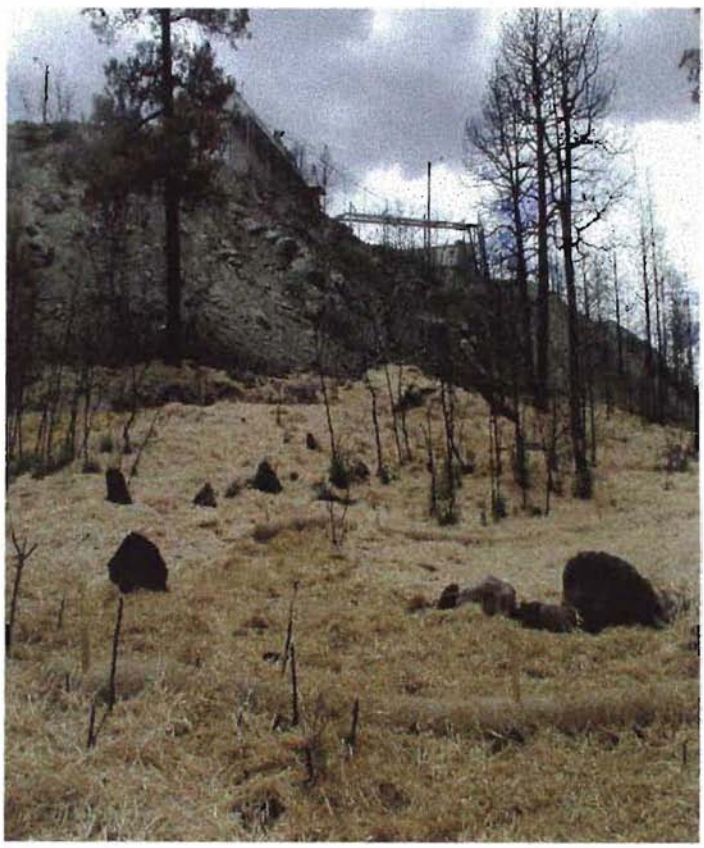
This photograph was taken on June 14, 2000. It shows one of the many inactive outfalls that discharged onto the slope below.

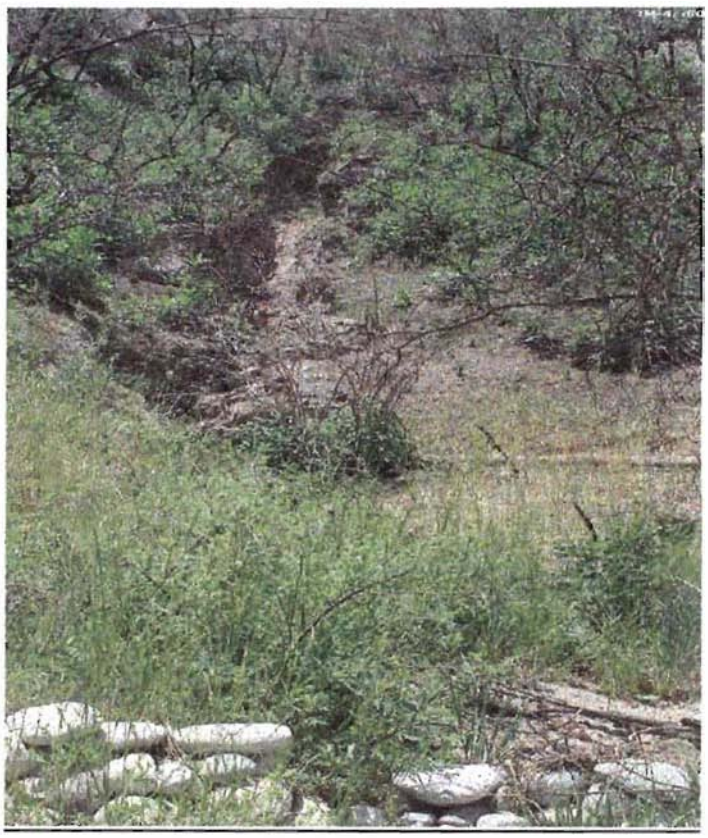
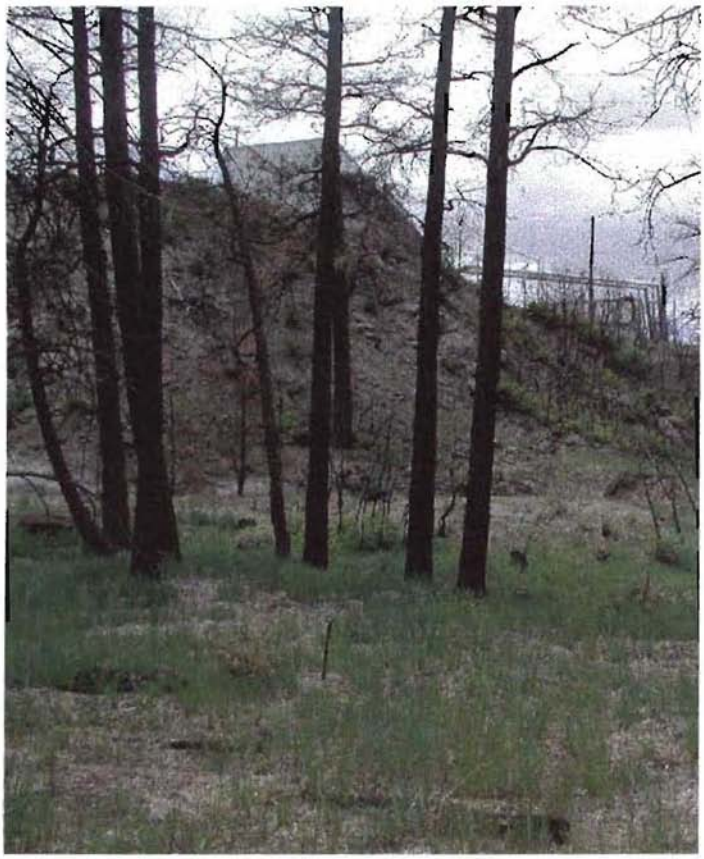
These photographs were taken during the April 2001 and June 2001 field inspections.

In April 2001, the earthen berm at northern boundary of the site was patched in one location. Several additional straw wattles have been placed in various locations to reduce sediment migration potential.
