Title: CERRO GRANDE FIRE: ONE YEAR AFTER AN UPDATE ON ER ACTIVITIES TO REDUCE THE POTENTIAL MOVEMENT OF CONTAMINATION AT POTENTIAL RELEASE SITES

Author(s): Steven J. Veenis, CPESC
Randy Johnson

Submitted to: Environmental Restoration Project
Water Quality & Hydrology Group (ESH-18)

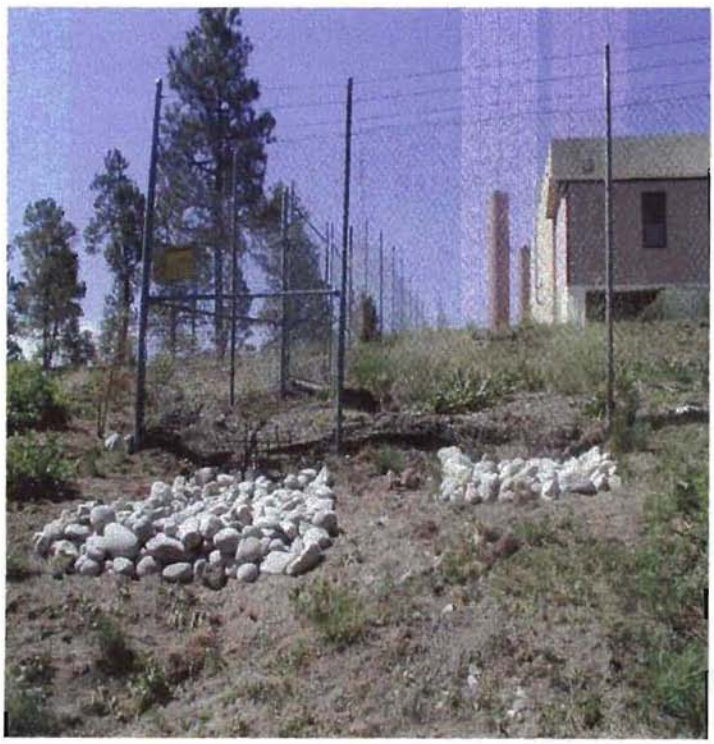
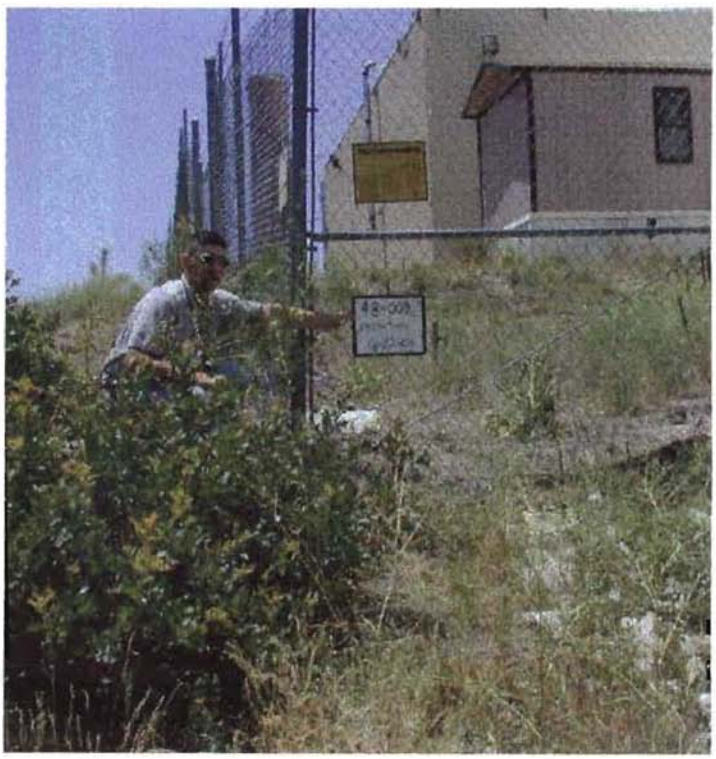
Site is in good condition, with vegetative cover of greater than 50%. The area appears stable with evidence of sediment migration being minimal.

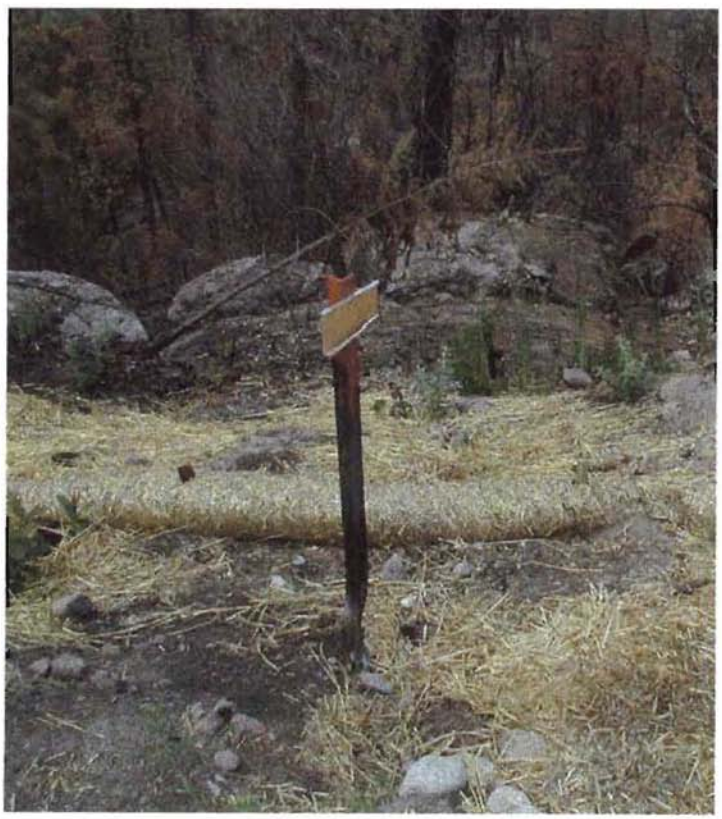
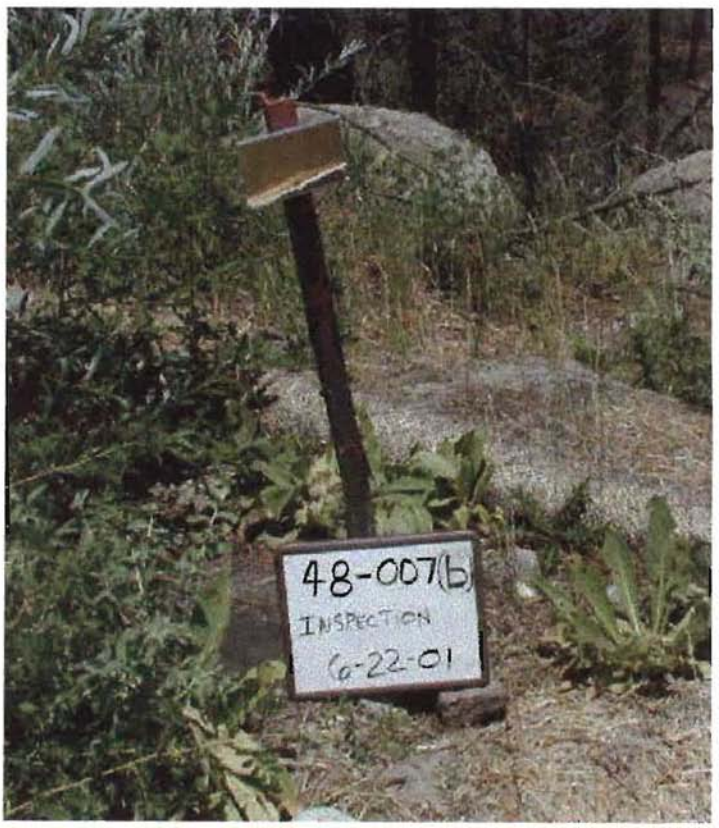
Site is in good condition, with vegetative cover of greater than 70%. The area appears stable with evidence of sediment migration being minimal.

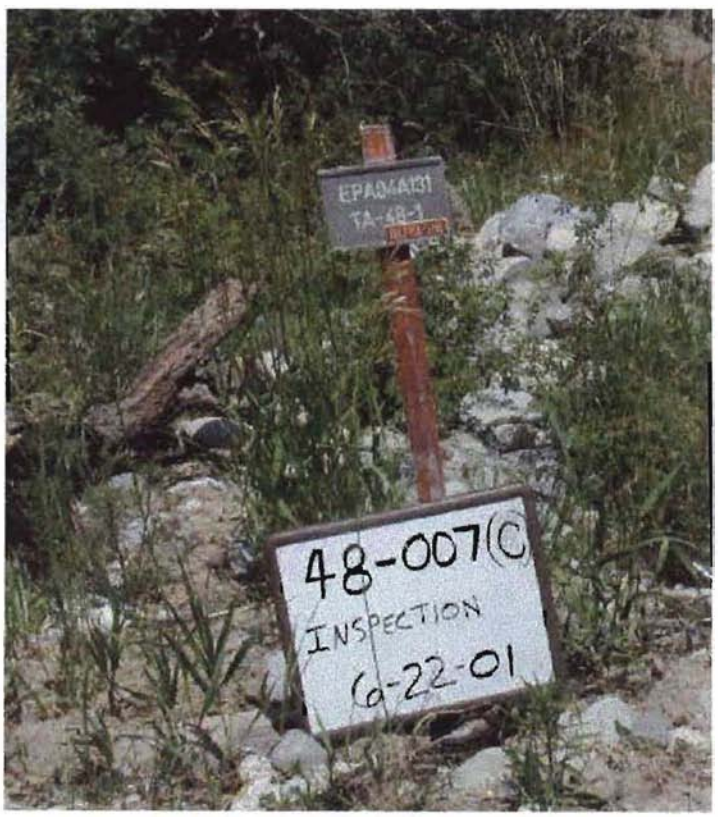
Site is in good condition, with vegetative cover of greater than 70%. The area appears stable with evidence of sediment migration being minimal.

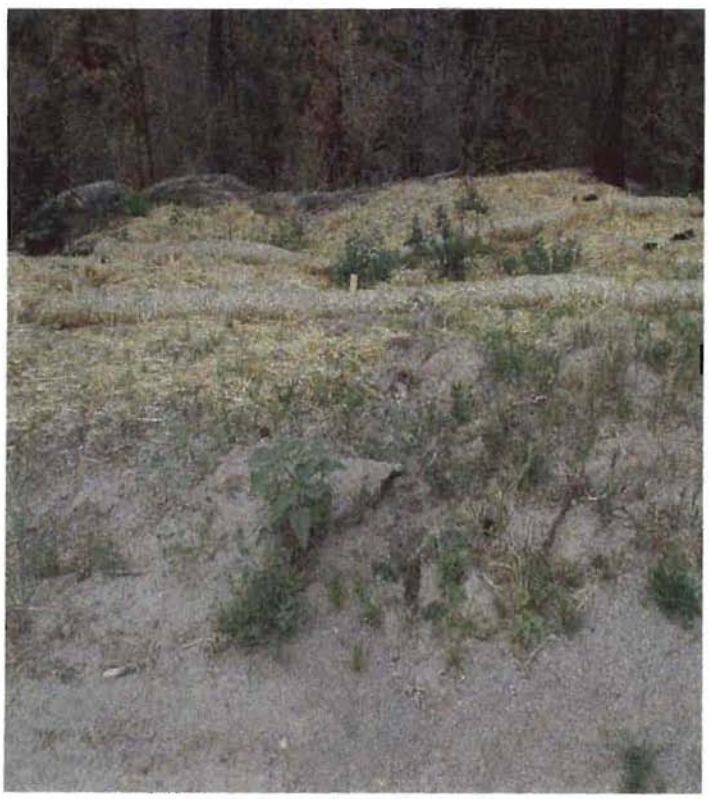
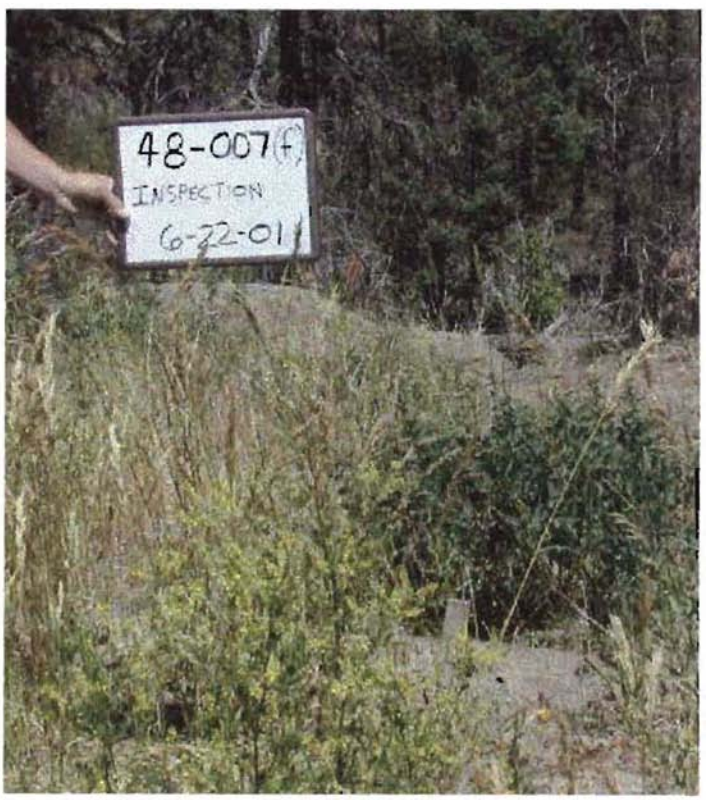
Site is in good condition, with vegetative cover of greater than 70%. The area appears stable with evidence of sediment migration being minimal.

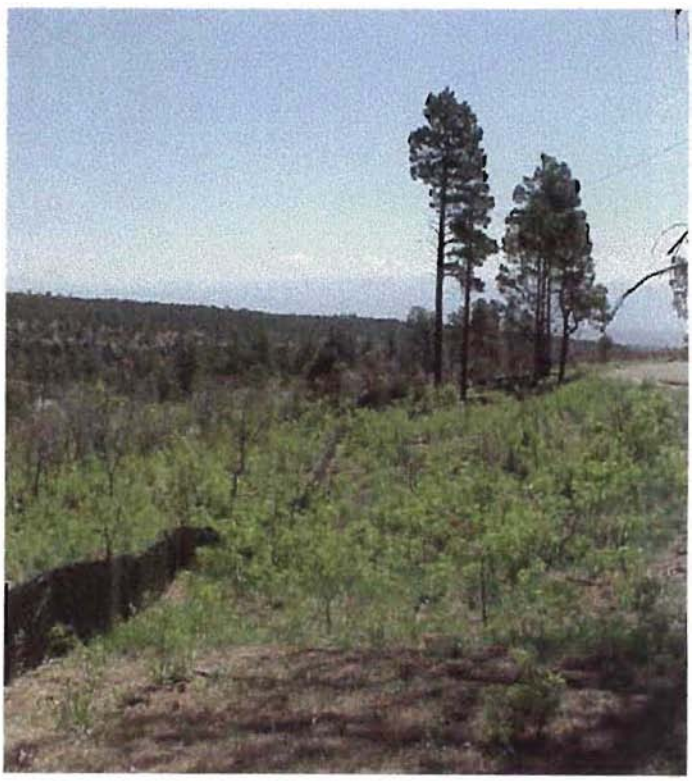
Site is in good condition, with vegetative cover of greater than 70%. The area appears stable with evidence of sediment migration being minimal.
