# 2017 Update to the Site Discharge Pollution Prevention Plan, Revision 1

Los Alamos National Laboratory  
NPDES Permit No. NM0030759  
LA-UR-18-22934 • May 1, 2018

## Sandia/Mortandad Watershed

**Volume 2**

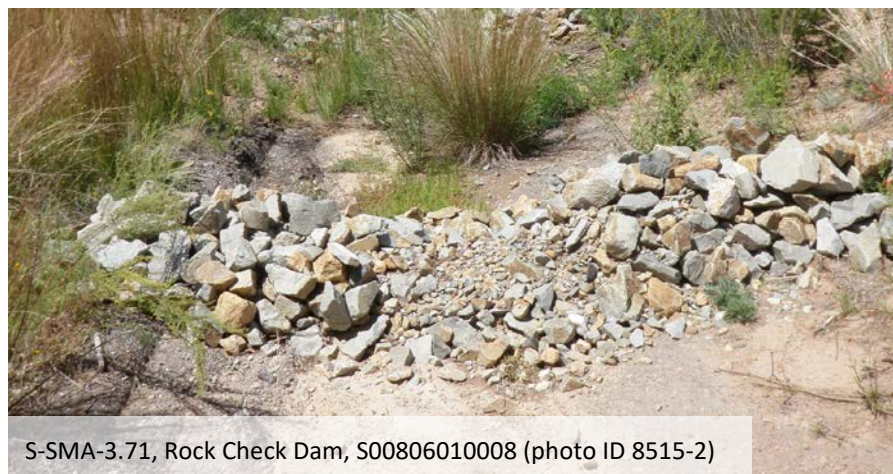
S-SMA-3.71, Rock Check Dam, S00806010008 (photo ID 8515-2)

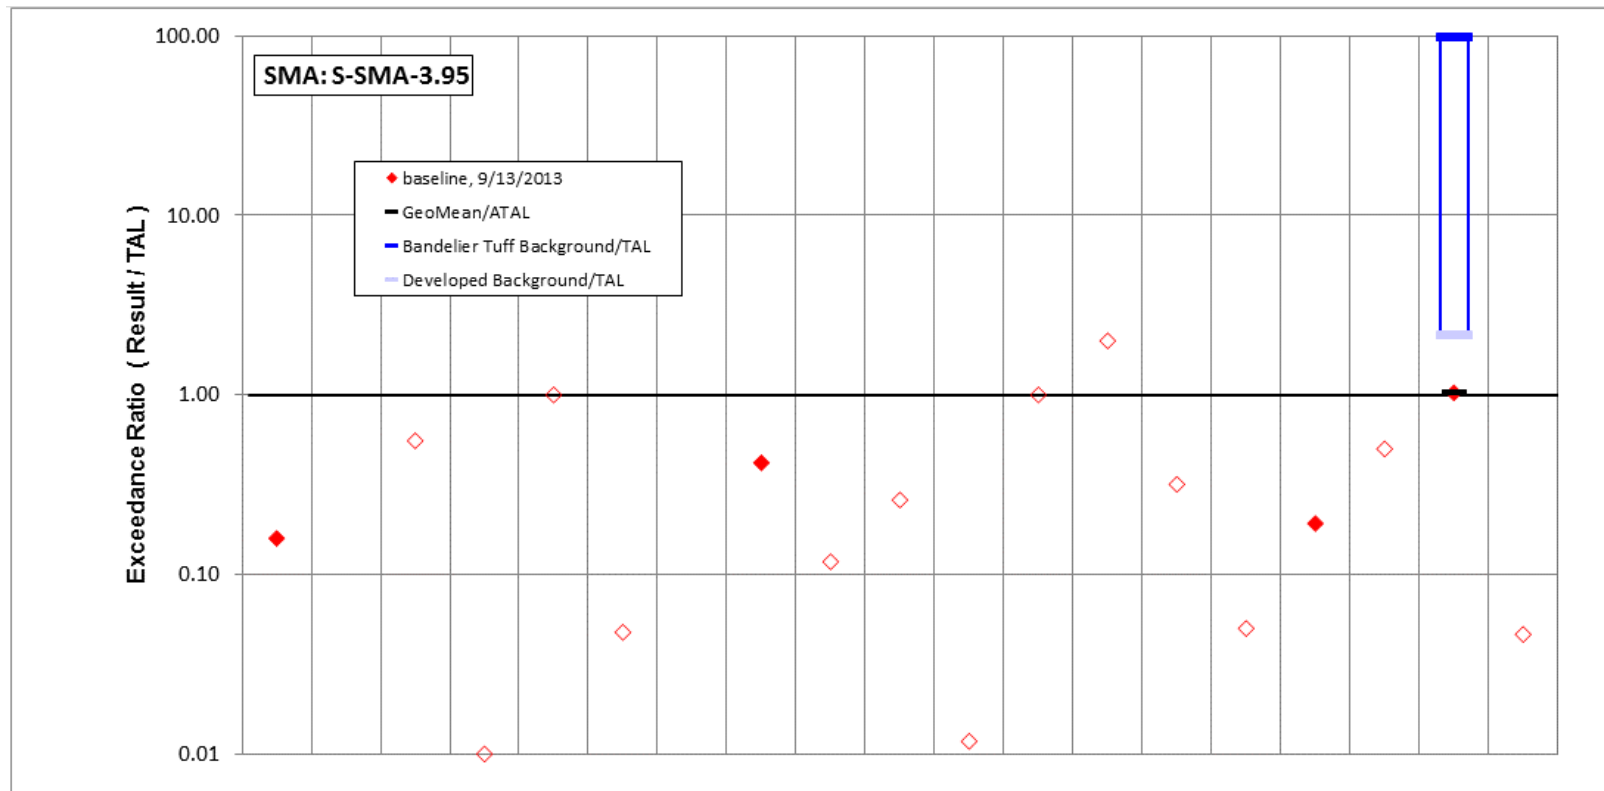
**Figure 77-2 Inorganic analytical results summary plot for S-SMA-3.95**

SWMU 20-002(a) is monitored within S-SMA-3.95. Following the installation of baseline control measures, a baseline storm water sample was collected on September 13, 2013 (Figures 77-2 and 77-3). In Figures 77-2 and 77-3, cadmium, selenium, silver, and hexachlorobenzene are reported as nondetectable results equal to or greater than their respective TALs. These values are reported at the PQL; however, the MDLs for these analytes are below the TALs. Analytical results from this sample yielded the following exceedance:

TAL exceedances were also evaluated against the appropriate storm water BVs, that is, “Bandelier Tuff background” for undisturbed SMAs or “developed background” for urban settings. BVs are expressed as UTLs using the approved EPA method for calculating BVs. UTLs for undisturbed SMAs were derived from storm water runoff containing entrained sediments derived from Bandelier Tuff and are labeled “Bandelier Tuff Background” in Figures 77-2 and 77-3. UTLs developed for urban settings were derived from runoff from developed landscapes on the Pajarito Plateau, including buildings, parking lots, roads, and associated features, and are labeled “Developed Background” in Figures 77-2 and 77-3.

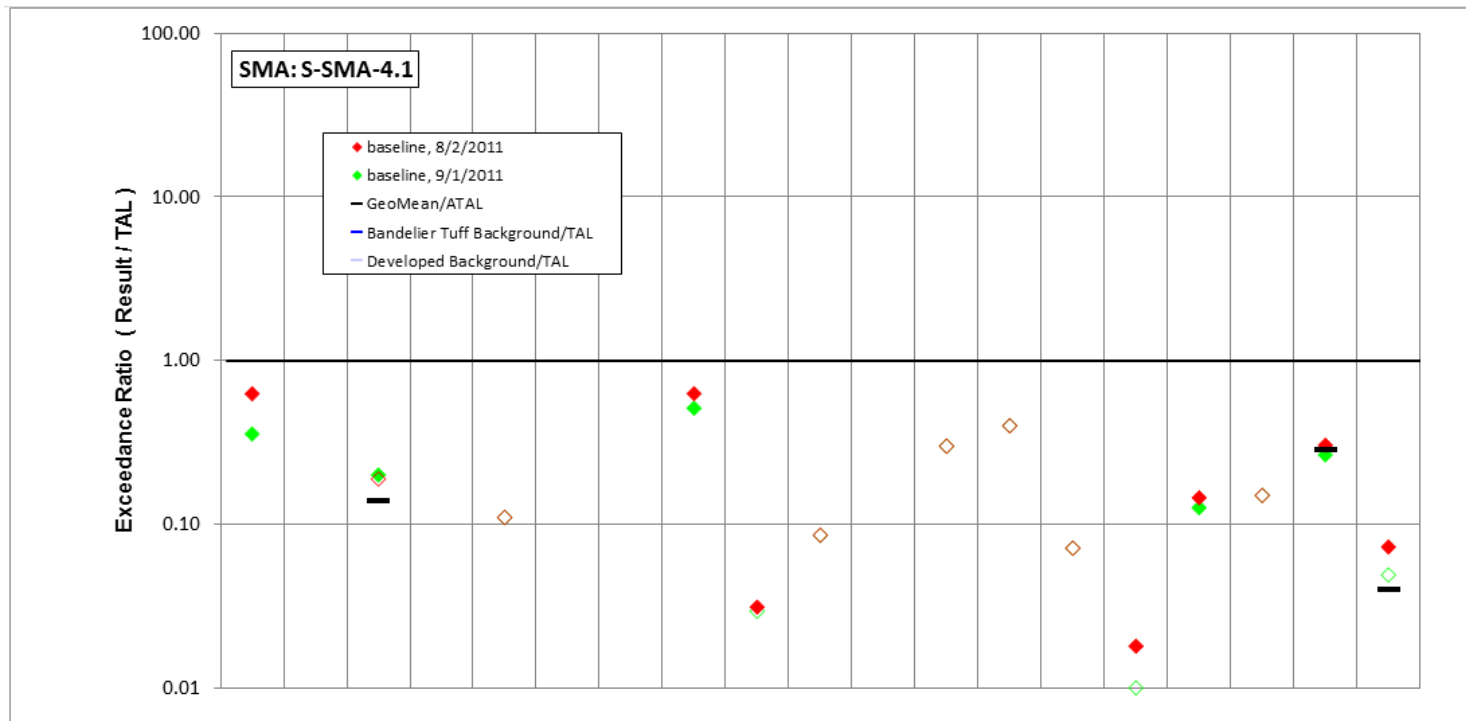
**Figure 78-2 Inorganic analytical results summary plot for S-SMA-4.1**

AOC 53-014 was monitored within S-SMA-4.1. Following the installation of baseline control measures, baseline storm water samples were collected on August 2, 2011, and September 1, 2011 (Figures 78-2 and 78-3). In July 2013, NMED issued a COC for SWMU 53-014. This Site is now certified as corrective action complete, and monitoring of storm water discharges has ceased at S-SMA-4.1. No further sampling is required for S-SMA-4.1 for the remainder of the IP. Analytical results from these samples yielded the following TAL exceedances:

TAL exceedances were also evaluated against the appropriate storm water BVs, that is, “Bandelier Tuff background” for undisturbed SMAs or “developed background” for urban settings. BVs are expressed as UTLs using the approved EPA method for calculating BVs. UTLs for undisturbed SMAs were derived from storm water runoff containing entrained sediments derived from Bandelier Tuff and are labeled “Bandelier Tuff Background” in Figures 78-2 and 78-3. UTLs developed for urban settings were derived from runoff from developed landscapes on the Pajarito Plateau, including buildings, parking lots, roads, and associated features, and are labeled “Developed Background” in Figures 78-2 and 78-3.

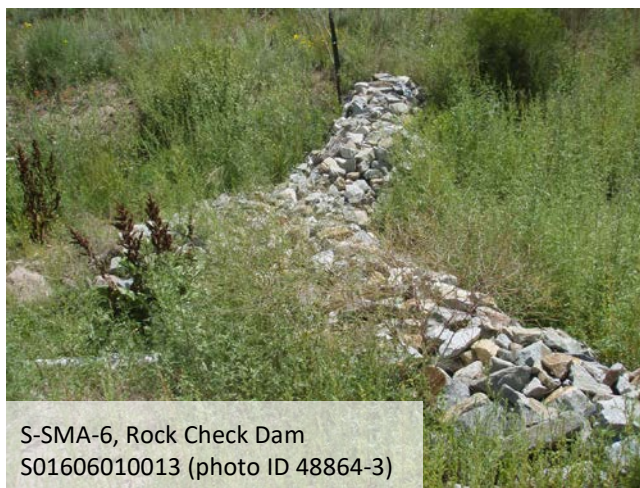
S-SMA-6, Rock Check Dam  
 S01606010013 (photo ID 48864-3)

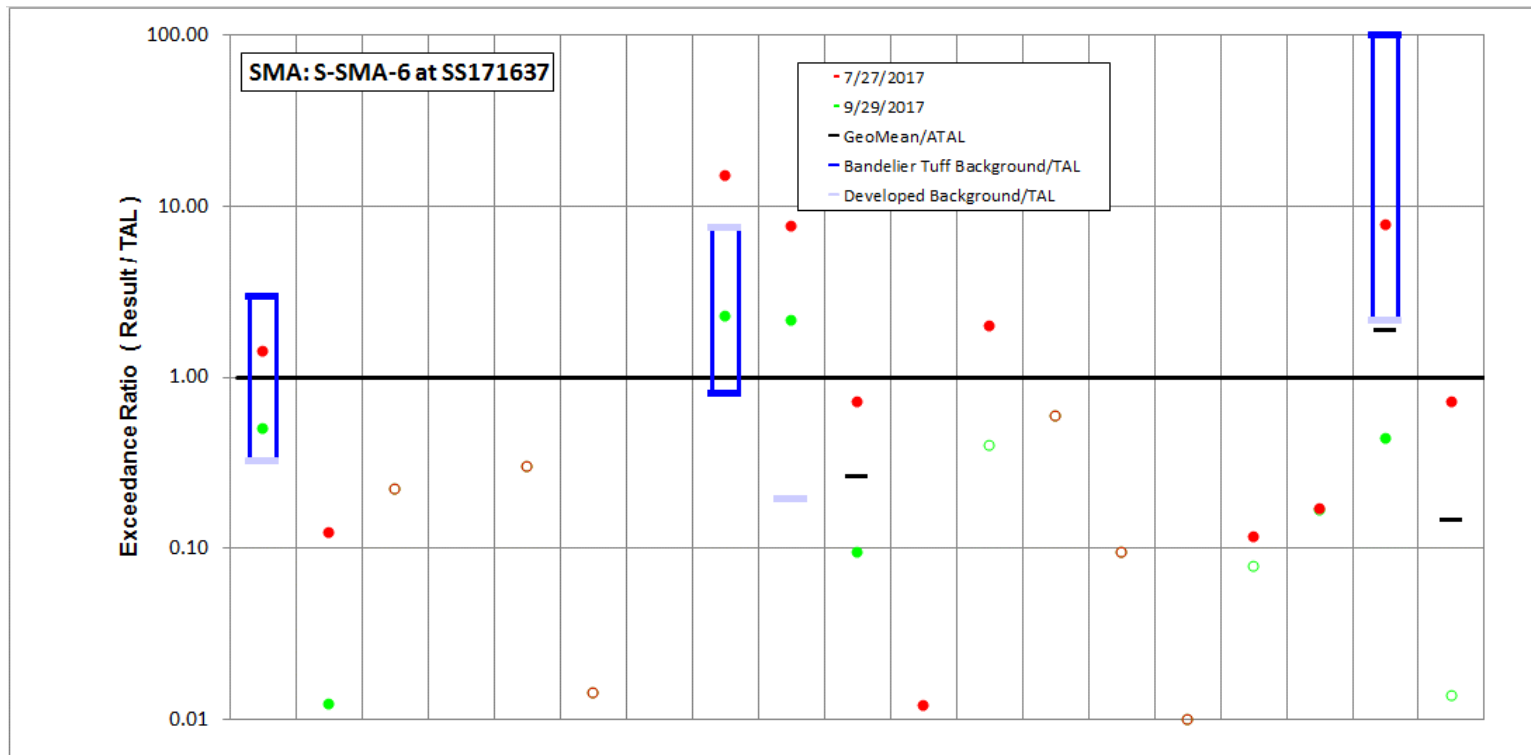
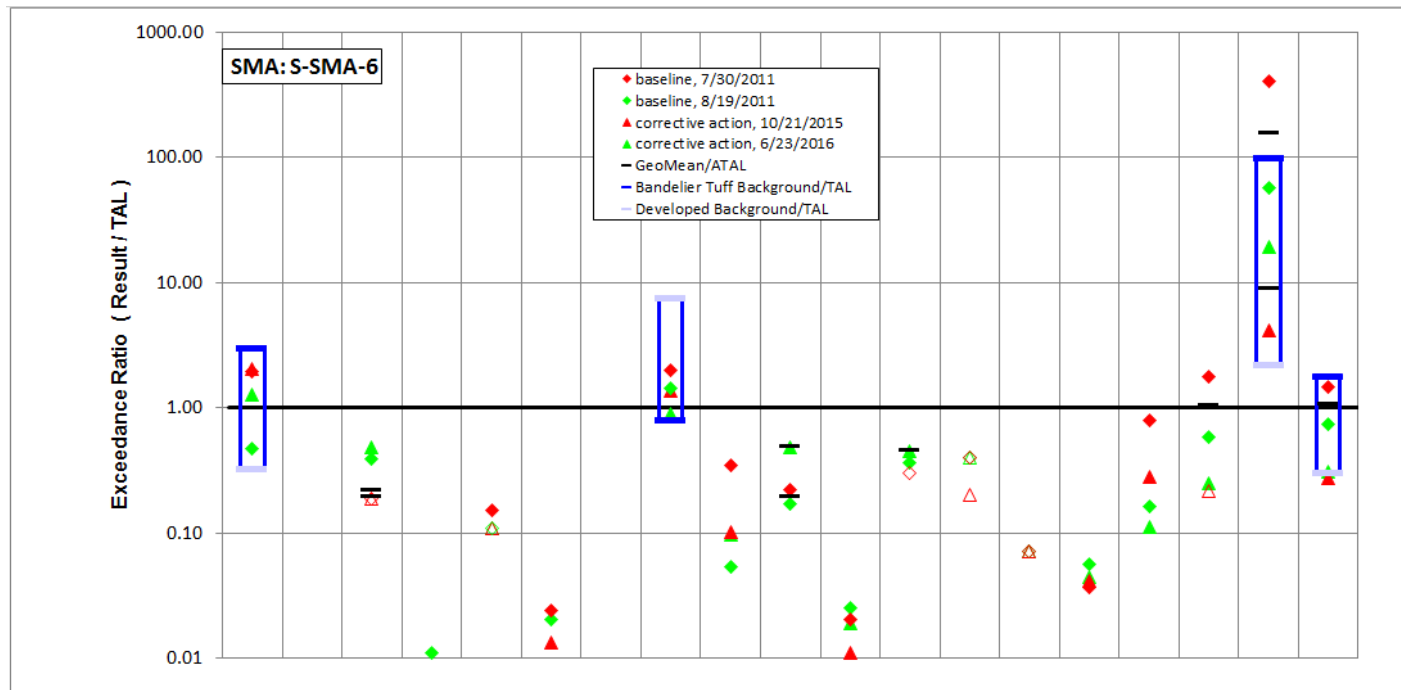
- Gross alpha—The gross-alpha UTL from developed landscape storm water run-on is 32.5 pCi/L; the gross-alpha UTL for storm water containing sediments derived from Bandelier Tuff is 1490 pCi/L. One of the 2011 gross-alpha results is greater than both of these values, and the other result is between them. The 2015, 2016, and 2017 gross-alpha results are between these values.

- Radium-226 and radium-228—The radium-226 and radium-228 activity UTLs from developed landscape storm water run-on and for storm water containing sediments derived from Bandelier Tuff were not calculated because an insufficient number of detected values was available to calculate the UTL values in the baseline metals background study. Thus, comparison to background storm water activity of radium-226 and radium-228 could not be made.

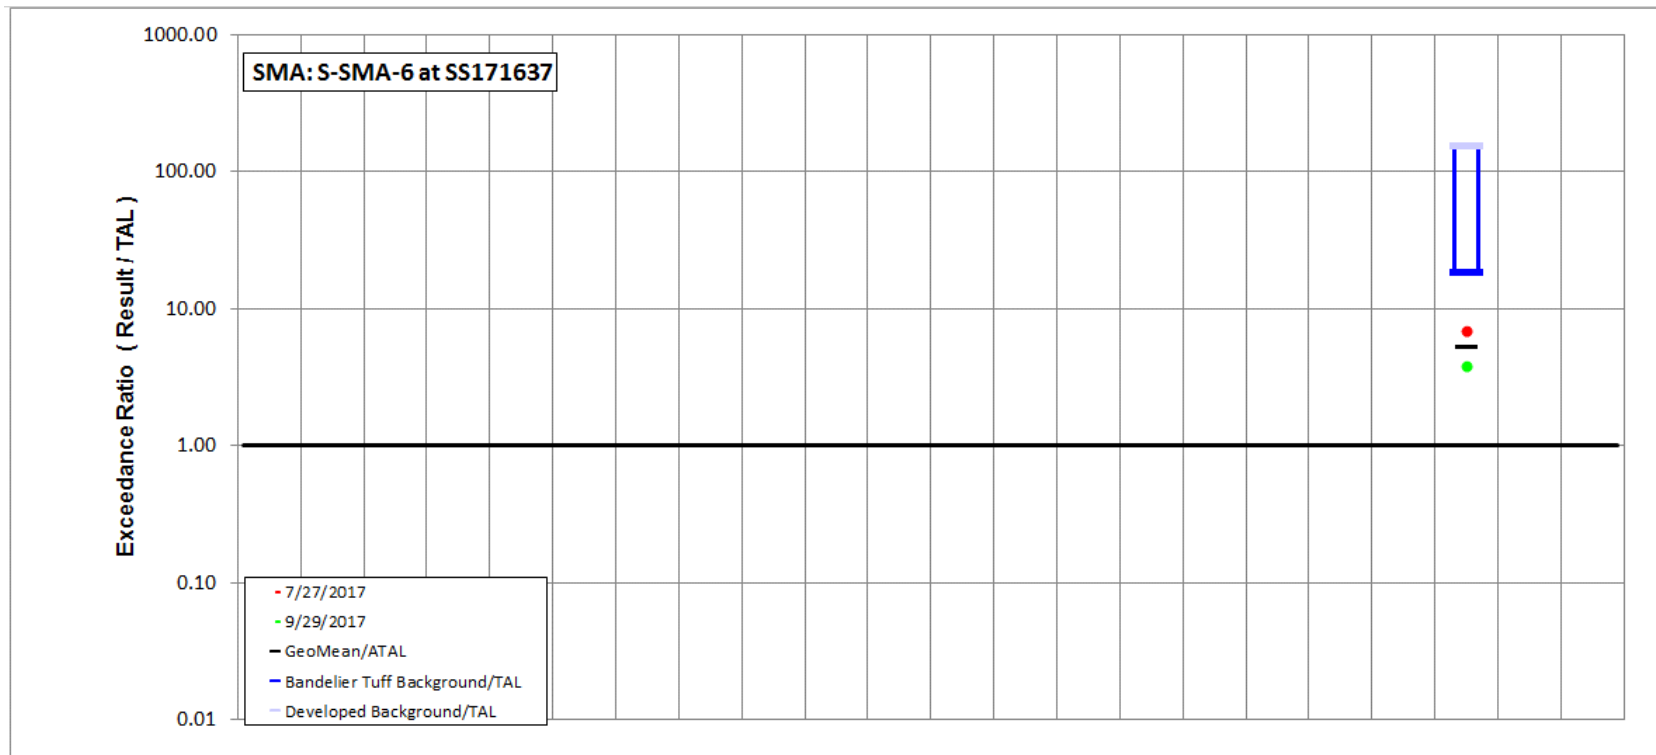
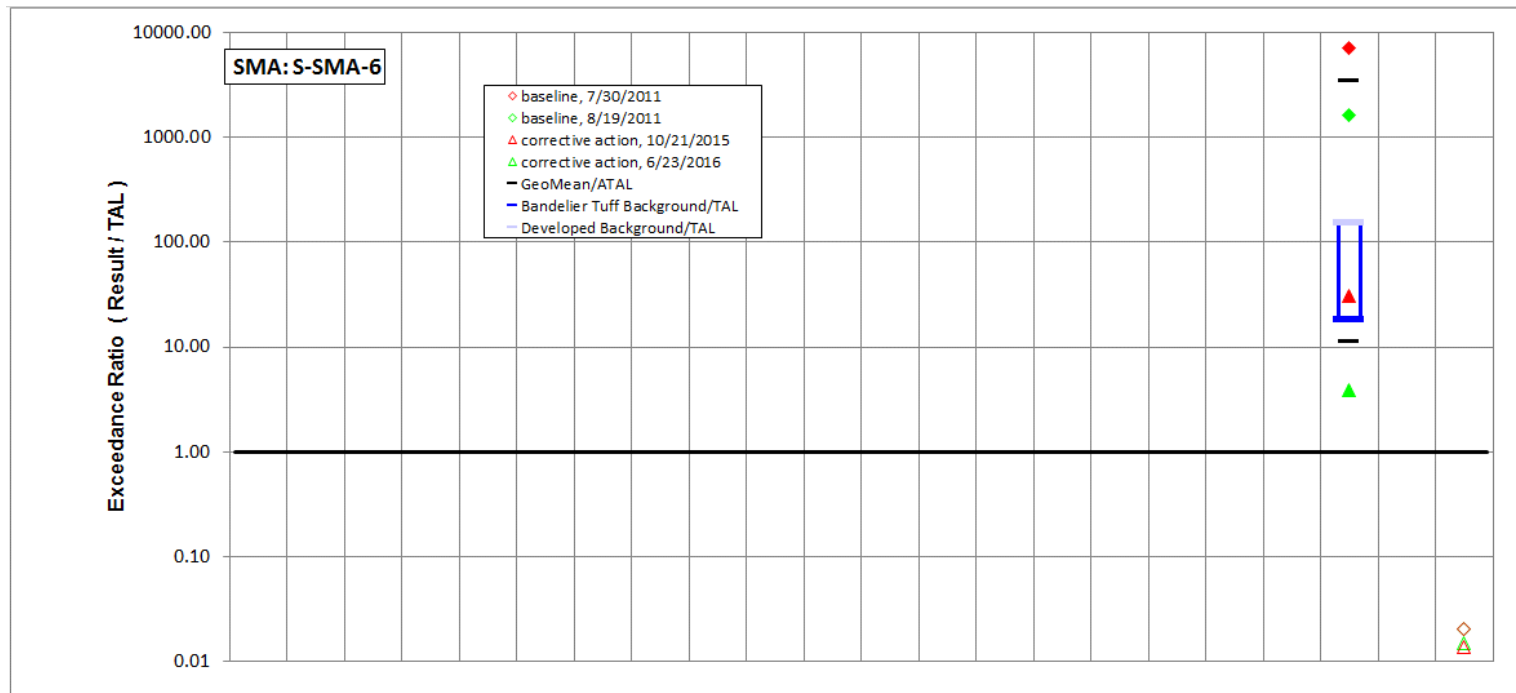
- PCBs—The PCB UTL from developed landscape storm water run-on is 98 ng/L; the PCB UTL for storm water containing sediments derived from Bandelier Tuff is 11.7 ng/L. The PCB results from 2011 are both greater than these two values. The PCB result from 2015 is between these two values. The PCB results from 2016 and 2017 are less than both of these values.

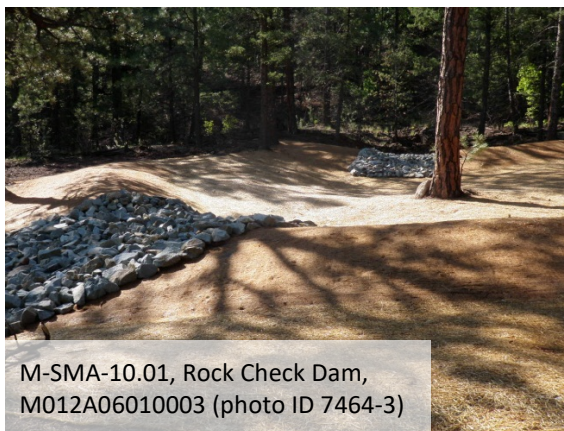
M-SMA-10.01, Rock Check Dam, M012A06010003 (photo ID 7464-3)

Monitoring location M-SMA-10.01 receives storm water run-on from landscape consisting of Bandelier Tuff sediment. Gross alpha in Bandelier Tuff is associated with naturally occurring radioactive uranium- and thorium-bearing minerals.

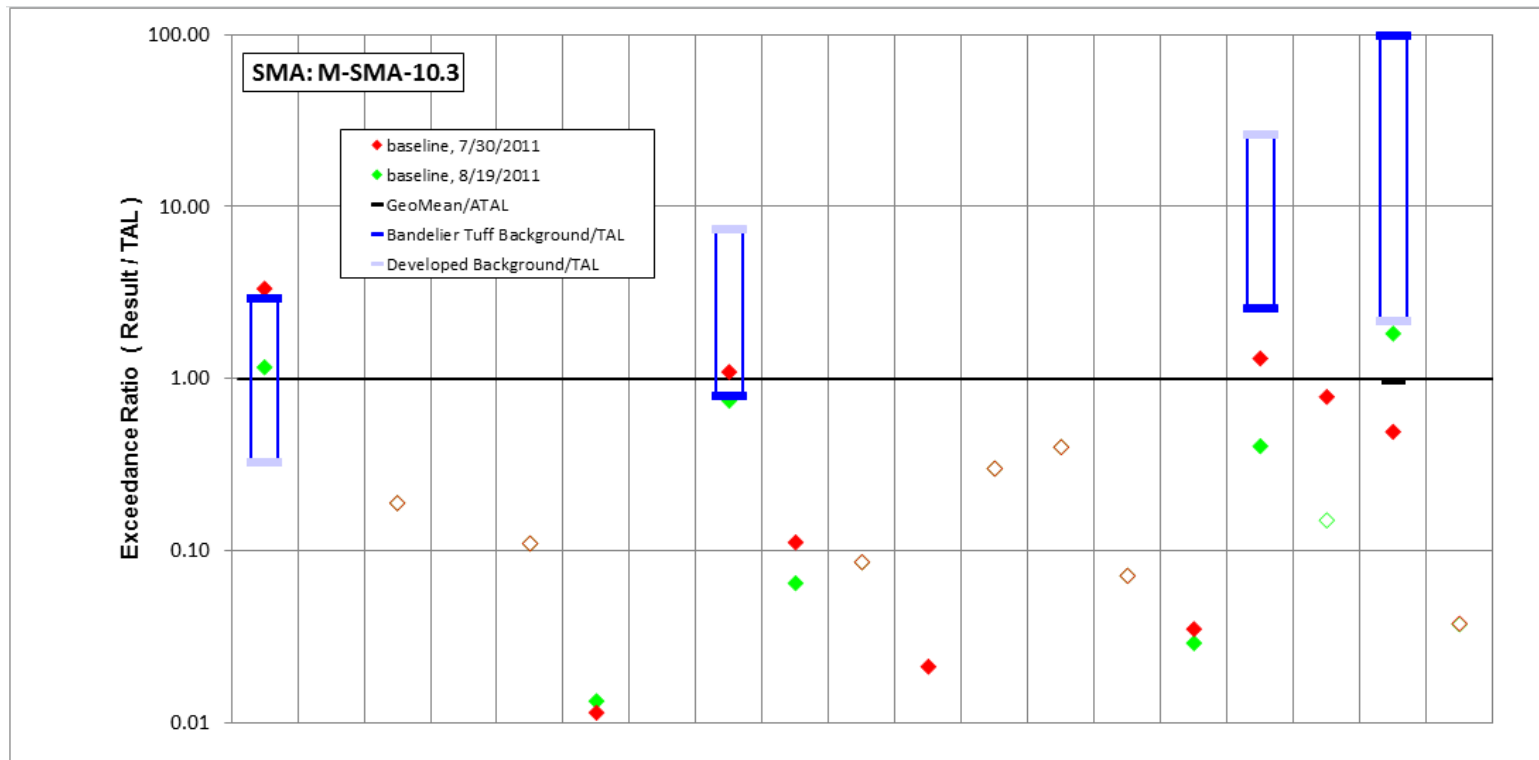
**Figure 109-2 Inorganic analytical results summary plot for M-SMA-10.3**

7/30/2011 result	<b>2500</b>	<i>1</i>	<i>1.7</i>	<i>20.9</i>	<i>0.11</i>	<i>2.4</i>	<i>1.3</i>	<b>4.7</b>	<i>1.9</i>	<i>0.066</i>	<i>3.6</i>	<i>1.5</i>	<i>0.2</i>	<i>0.45</i>	<i>3.5</i>	<b>55</b>	<i>0.0078</i>	<i>7.36</i>	<i>1.13</i>
result / TAL	<b>3.3</b>	<i>0.002</i>	<i>0.19</i>	<i>0.0042</i>	<i>0.11</i>	<i>0.011</i>	<i>0.0013</i>	<b>1.1</b>	<i>0.11</i>	<i>0.086</i>	<i>0.021</i>	<i>0.3</i>	<i>0.4</i>	<i>0.071</i>	<i>0.035</i>	<b>1.3</b>	<i>0.78</i>	<i>0.49</i>	<i>0.038</i>

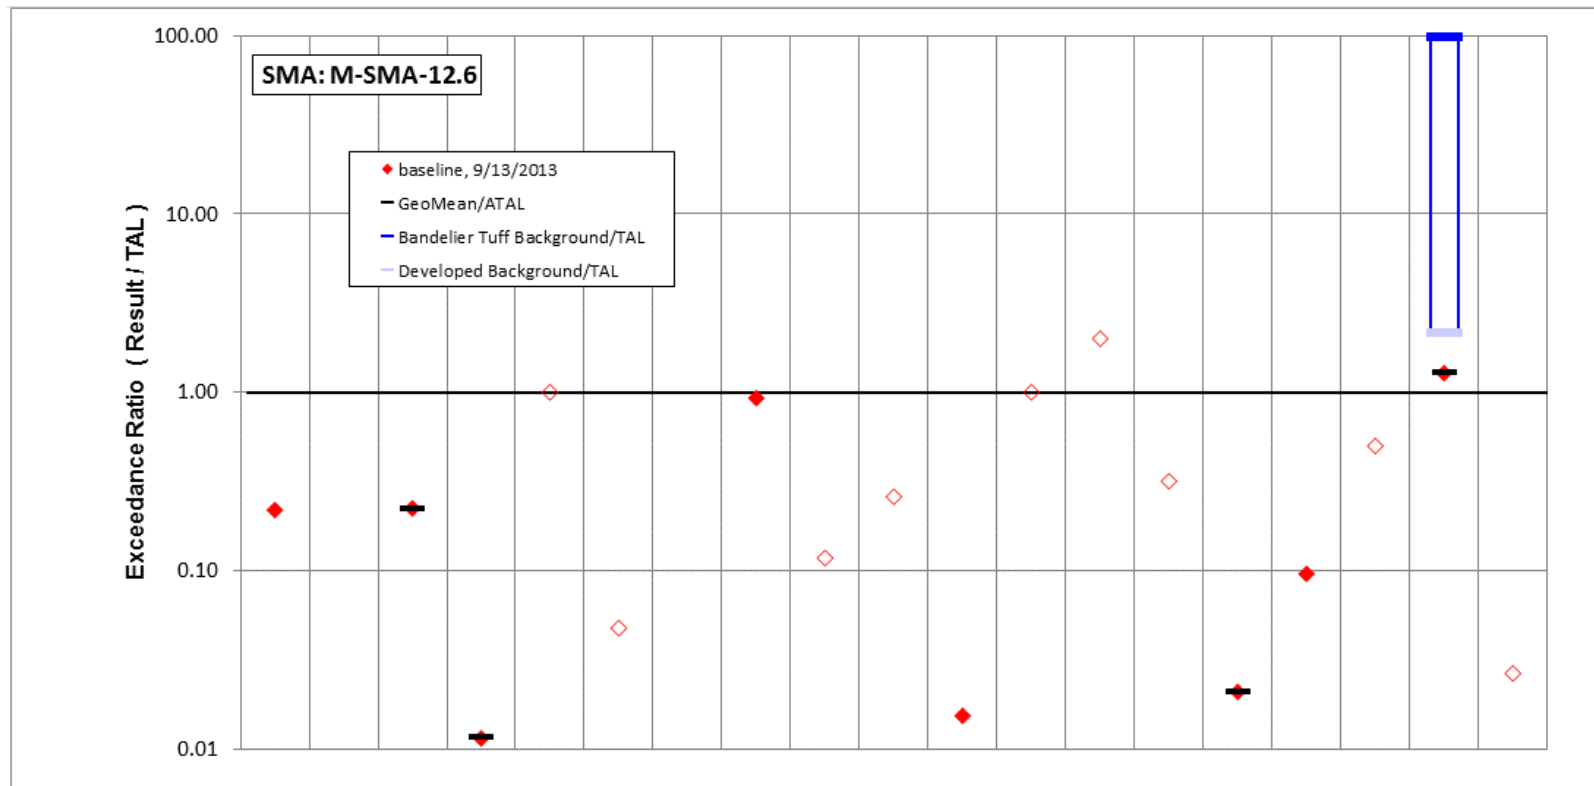
Figure 113-2 Inorganic analytical results summary plot for M-SMA-12.6

SWMU 05-004 is monitored within M-SMA-12.6. Following the installation of baseline control measures, a baseline storm water sample was collected on September 13, 2013 (Figures 113-2 and 113-3). In Figures 113-2 and 113-3, cadmium, selenium, silver, and hexachlorobenzene are reported as nondetectable results equal to or greater than their respective TALs. These values are reported at the PQL; however, the MDLs for these analytes are below the TALs. Analytical results from this sample yielded the following TAL exceedance:

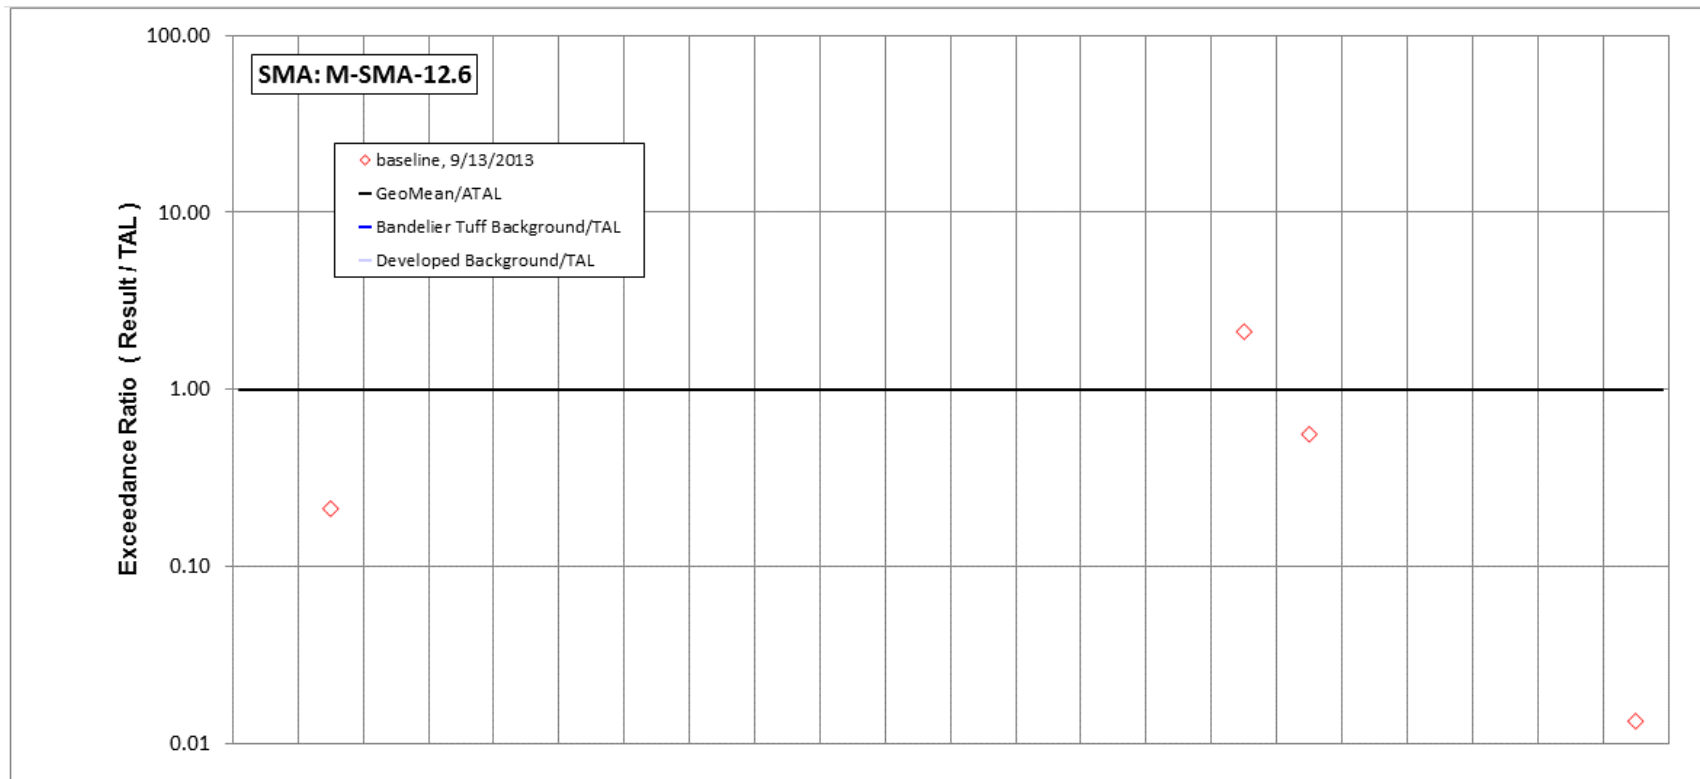
Aldrin	Benzo(a)pyrene	BHC[gamma-]	Chlordane (alpha/gamma)	Chlordane[alpha-]	Chlordane[gamma-]	DDD[4,4'-]	DDE[4,4'-]	DDT[4,4'-]	Dieldrin	Endosulfan I	Endosulfan II	Endrin	Heptachlor	Heptachlor Epoxide	<b>Hexachlorobenzene</b>	Pentachlorophenol	RDX	Tetrachlorodibenzo dioxin[2,3,7,8-]	Total PCB	Toxaphene (Technical Grade)	Trinitrotoluene [2,4,6-]	
std used in ratio calculations	-	MQL	-	-	-	-	-	-	-	-	-	-	-	-	-	MQL	MTAL	ATAL	-	-	-	-	ATAL
std value	-	5	-	-	-	-	-	-	-	-	-	-	-	-	-	5	19	200	-	-	-	-	20
unit	ug/L	ug/L	ug/L	ug/L	ug/L	ug/L	ug/L	ug/L	ug/L	ug/L	ug/L	ug/L	ug/L	ug/L	ug/L	ug/L	ug/L	ug/L	ug/L	ug/L	ug/L	ug/L	ug/L
9/13/2013 result	-	1.06	-	-	-	-	-	-	-	-	-	-	-	-	-	<b>10.6</b>	10.6	0.267	-	-	-	-	0.267
result / TAL	-	0.21	-	-	-	-	-	-	-	-	-	-	-	-	-	<b>2.1</b>	0.56	0.001	-	-	-	-	0.013

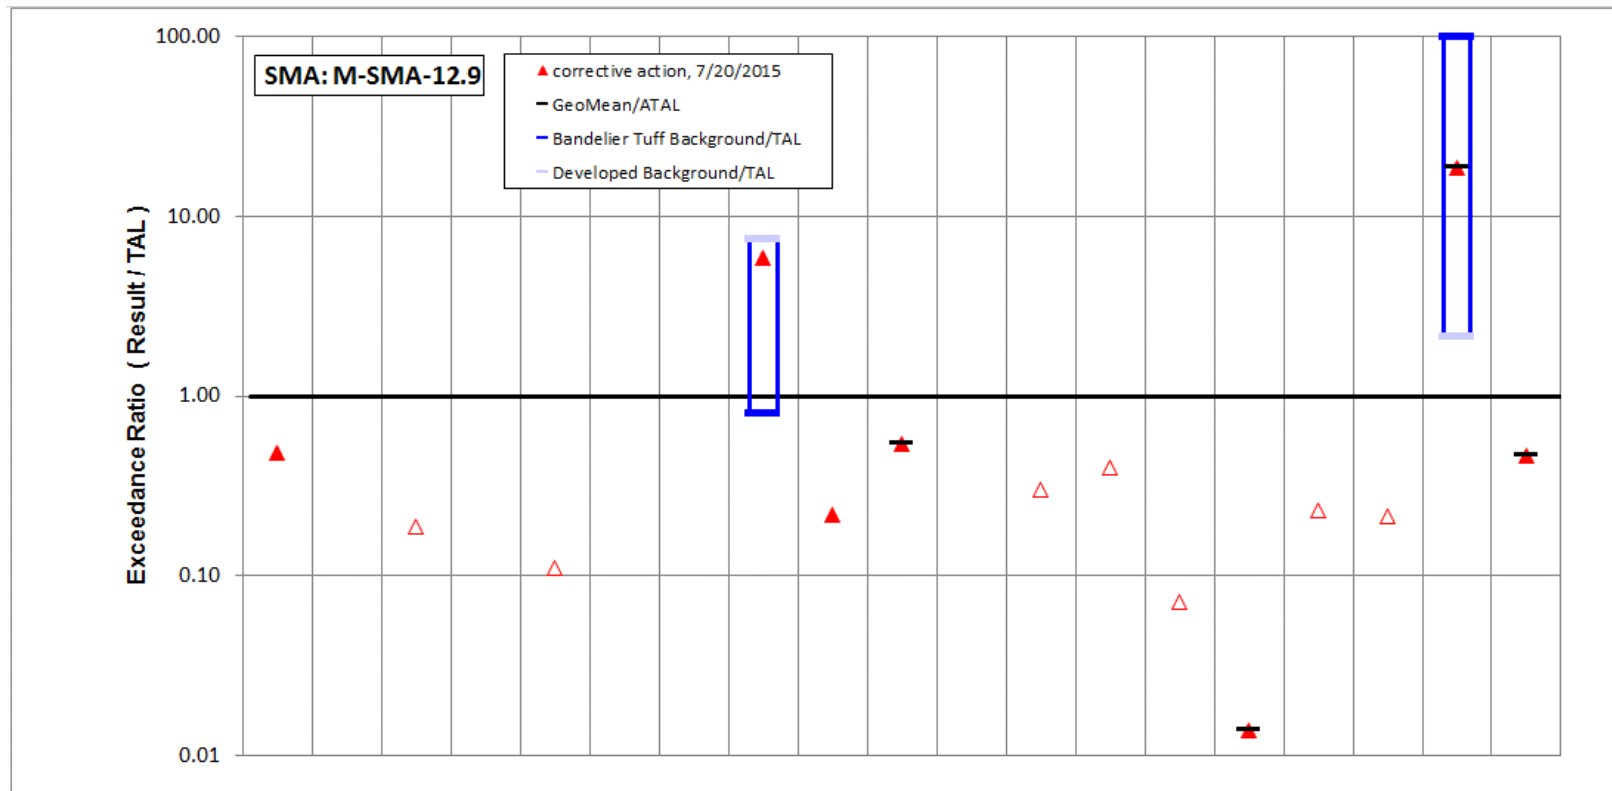
Figure 116-2 Inorganic analytical results summary plot for M-SMA-12.9

Aluminum	Antimony	Arsenic	Boron	Cadmium	Chromium	Cobalt	<b>Copper</b>	Lead	Mercury	Nickel	Selenium	Silver	Thallium	Vanadium	Zinc	Cyanide, weak acid dissociable	<b>Gross alpha</b>	Radium-226 and Radium-228
std used in ratio calculations	MTAL	ATAL	ATAL	ATAL	MTAL	MTAL	ATAL	MTAL	MTAL	ATAL	MTAL	ATAL	MTAL	ATAL	ATAL	MTAL	ATAL	ATAL	ATAL
std value	750	640	9	5000	1	210	1000	4.3	17	0.77	170	5	0.5	6.3	100	42	0.01	15	30
unit	ug/L	ug/L	ug/L	ug/L	ug/L	ug/L	ug/L	ug/L	ug/L	ug/L	ug/L	ug/L	ug/L	ug/L	ug/L	ug/L	mg/L	pCi/L	pCi/L
<b>7/20/2015 result</b>	363	1	1.7	16.4	0.11	2	1	<b>25.1</b>	3.71	0.42	0.5	1.5	0.2	0.45	1.39	9.78	0.002	<b>276</b>	13.9
result / TAL	0.48	0.002	0.19	0.0033	0.11	0.01	0.001	<b>5.8</b>	0.22	0.55	0.003	0.3	0.4	0.071	0.014	0.23	0.21	<b>18</b>	0.46

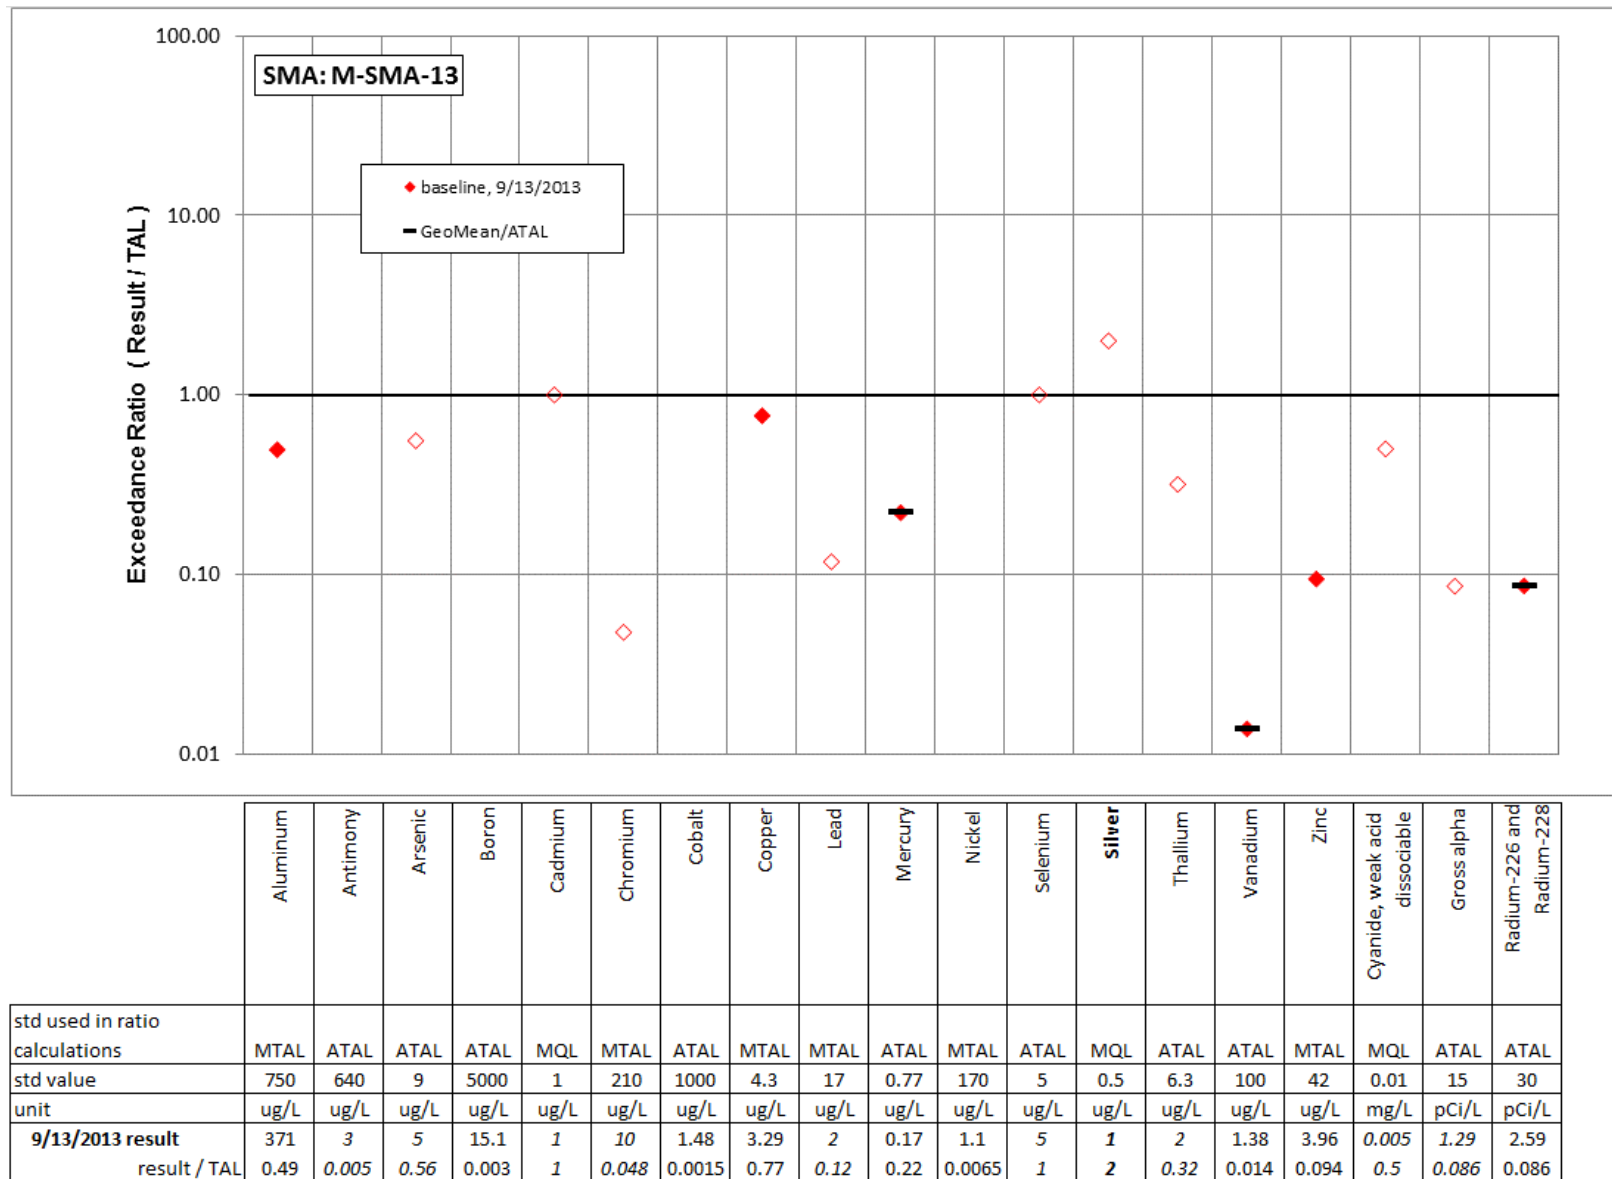
Figure 118-2 Inorganic analytical results summary plot for M-SMA-13

AOC 05-001(c) is monitored within M-SMA-13. Following the installation of baseline control measures, a baseline storm water sample was collected on September 13, 2013 (Figures 118-2 and 118-3). In Figure 118-2, cadmium, selenium, and silver are reported as nondetectable results equal to or greater than their respective TALs. These values are reported at the PQL; however, the MDLs for these analytes are below the TALs. Analytical results from this sample yielded no TAL exceedances. Baseline confirmation is complete for M-SMA-13 and the associated AOC 05-001(c) because all applicable sampling results are below the applicable MTAL or ATAL. No further sampling is required for M-SMA-13 for the duration of the IP.

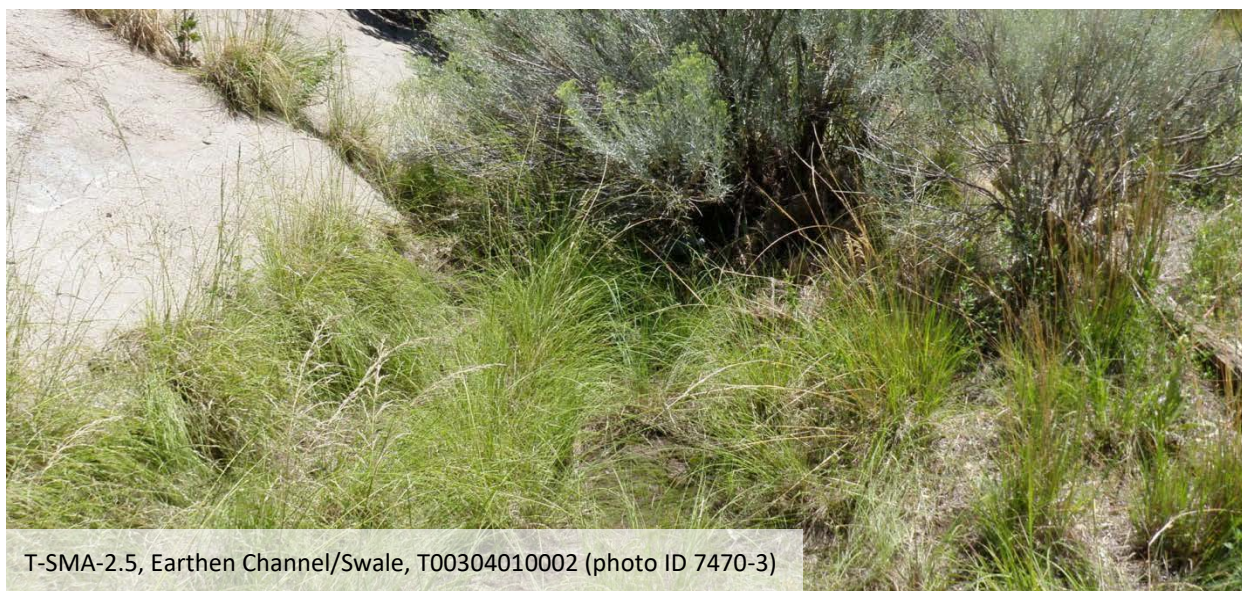
T-SMA-2.5, Earthen Channel/Swale, T00304010002 (photo ID 7470-3)

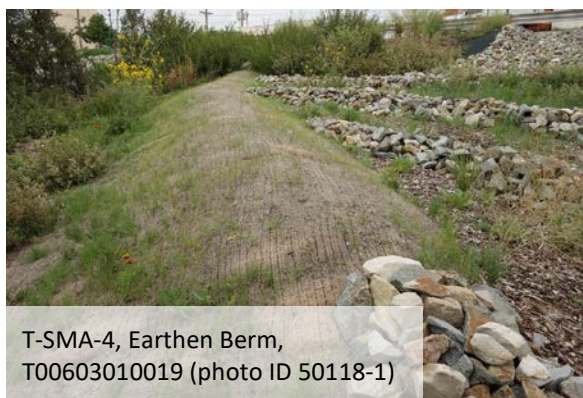
T-SMA-4, Earthen Berm, T00603010019 (photo ID 50118-1)
