**CERRO GRANDE FIRE: AFTERMATH
ER ACTIVITIES TO REDUCE THE POTENTIAL
MOVEMENT OF CONTAMINATION AT
POTENTIAL RELEASE SITES**

VEENIS, STEVEN J.

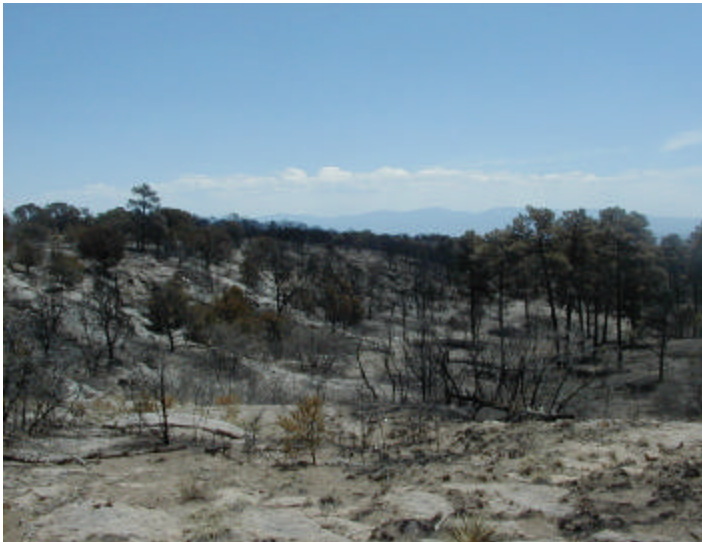
CERRO GRANDE FIRE:

This site is located on the south rim of Mortandad Canyon within the Upper Canada del Buey Watershed Aggregate. The fire damage was moderate to severe with nearly complete damage to the ground cover and canopy.

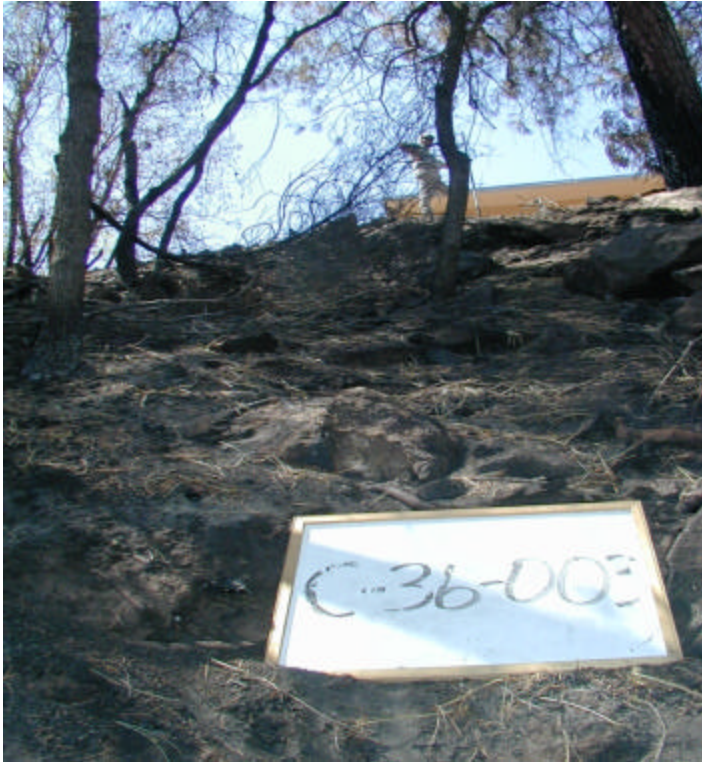
CERRO GRANDE FIRE:

The site is located on the edge of Three Mile Canyon within the Three Mile Canyon Watershed Aggregate. A backfire was set near C-36-003 to help protect TA-18. This fire exposed miscellaneous debris on the slope behind building TA-36-1.

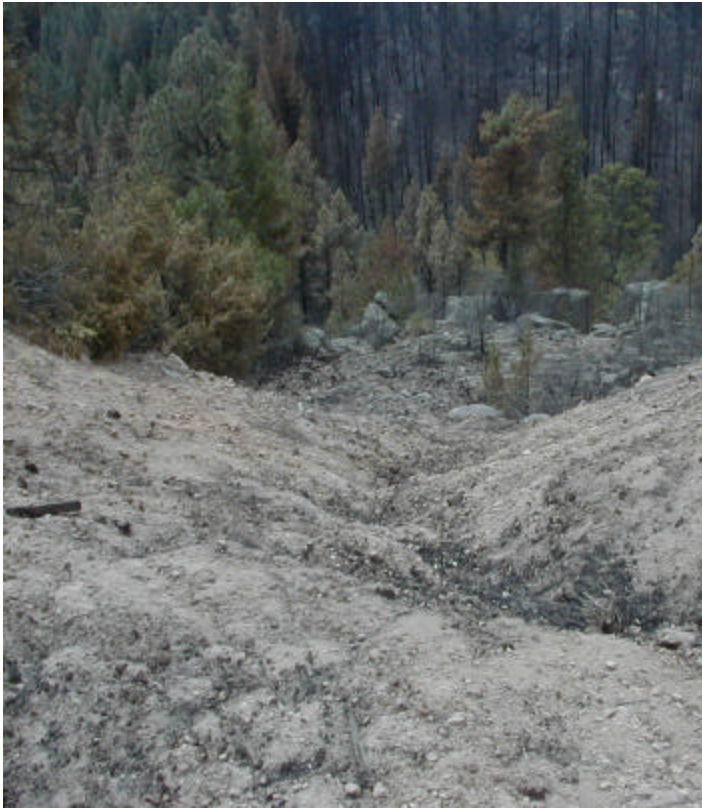
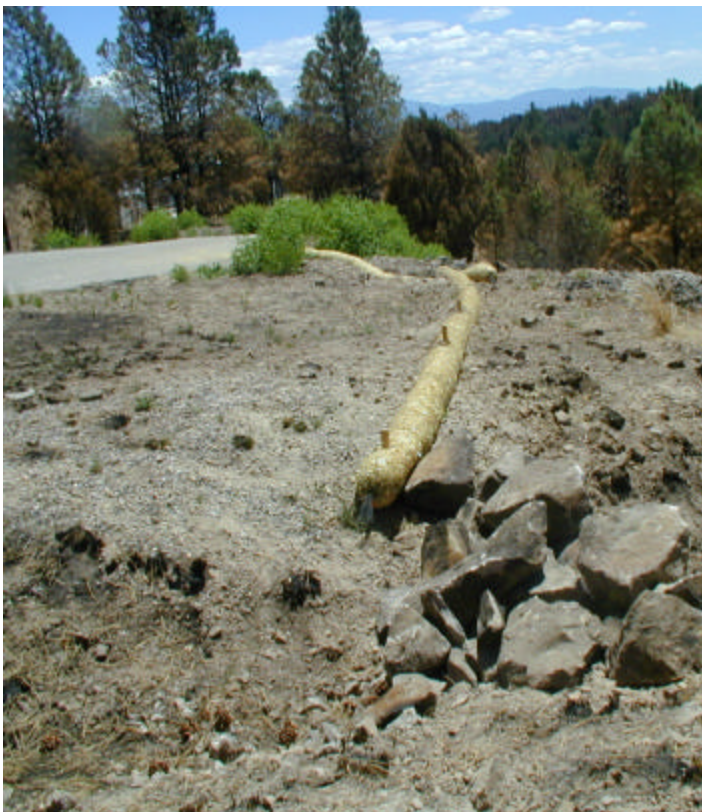
40-009 - Erosion Matrix Score 54.5. Landfill adjacent to firing site at TA-40-9. The landfill contains debris from decommissioning of buildings at TA-15. An inactive NPDES outfall (04A101) is located nearby.

The site is located on the edge of Pajarito Canyon within the Starmer's/Pajarito Canyon Watershed Aggregate. The erosion potential on this slope increased due to lack of vegetative cover as a result of the fire.

Straw wattles were installed along the mesa edge to divert run-on from the slope. Rock check dams (on-site materials used) were provided to dissipate flow within the drainage channels on both the east and west ends of the site.

1 acre treated
20 straw wattles

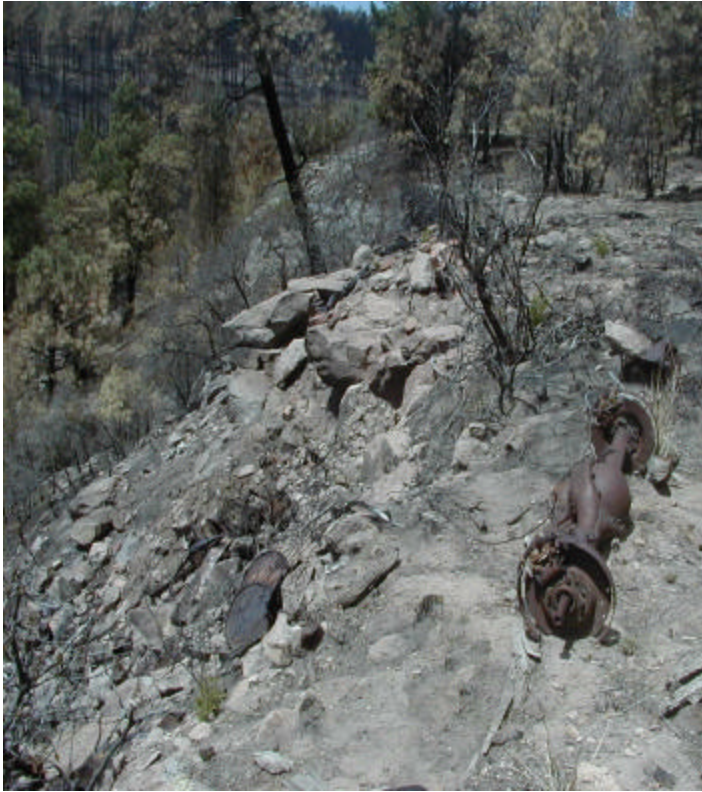
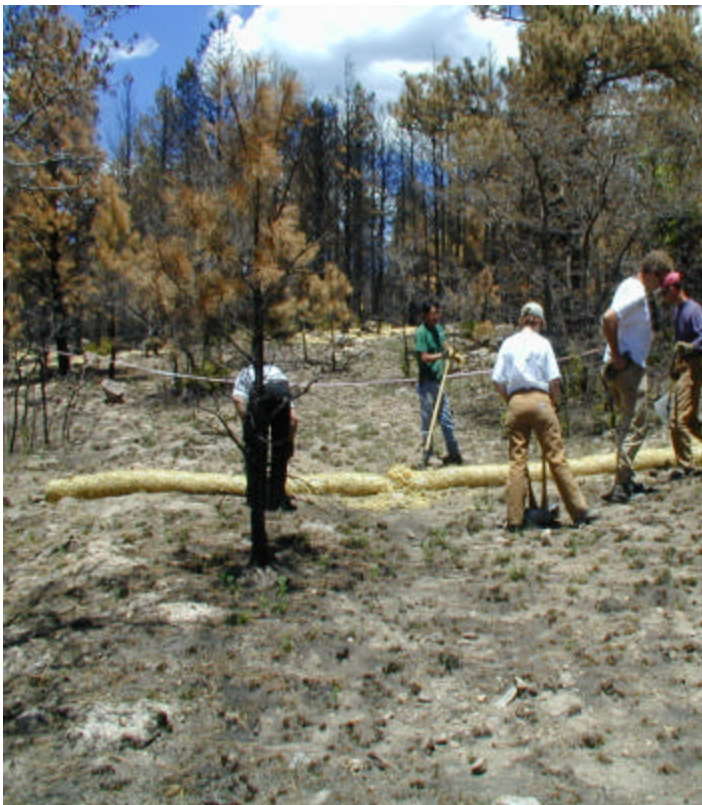
40-010 - Erosion Matrix Score 40.2. An area on the edge of Pajarito Canyon extending about 50-feet along the canyon edge and about 50 feet down the canyon. Debris in this area includes farm and home implements that probably predate the Manhattan Project.

The site is located on the edge of Pajarito Canyon within the Starmer's/Pajarito Canyon Watershed Aggregate. Land disposal area 40-010 was exposed due to the fire, with debris consisting of industrial waste.

Straw wattles were installed upslope from the landfill to reduce run-on impact. Large trees were contour felled to provide run-on diversion. The area was hand-raked, reseeded and straw mulched. The debris near the mesa's edge was removed from the area and disposed of as solid waste.

1.5 acres treated
40 straw wattles
20 straw bales
10 pounds seed

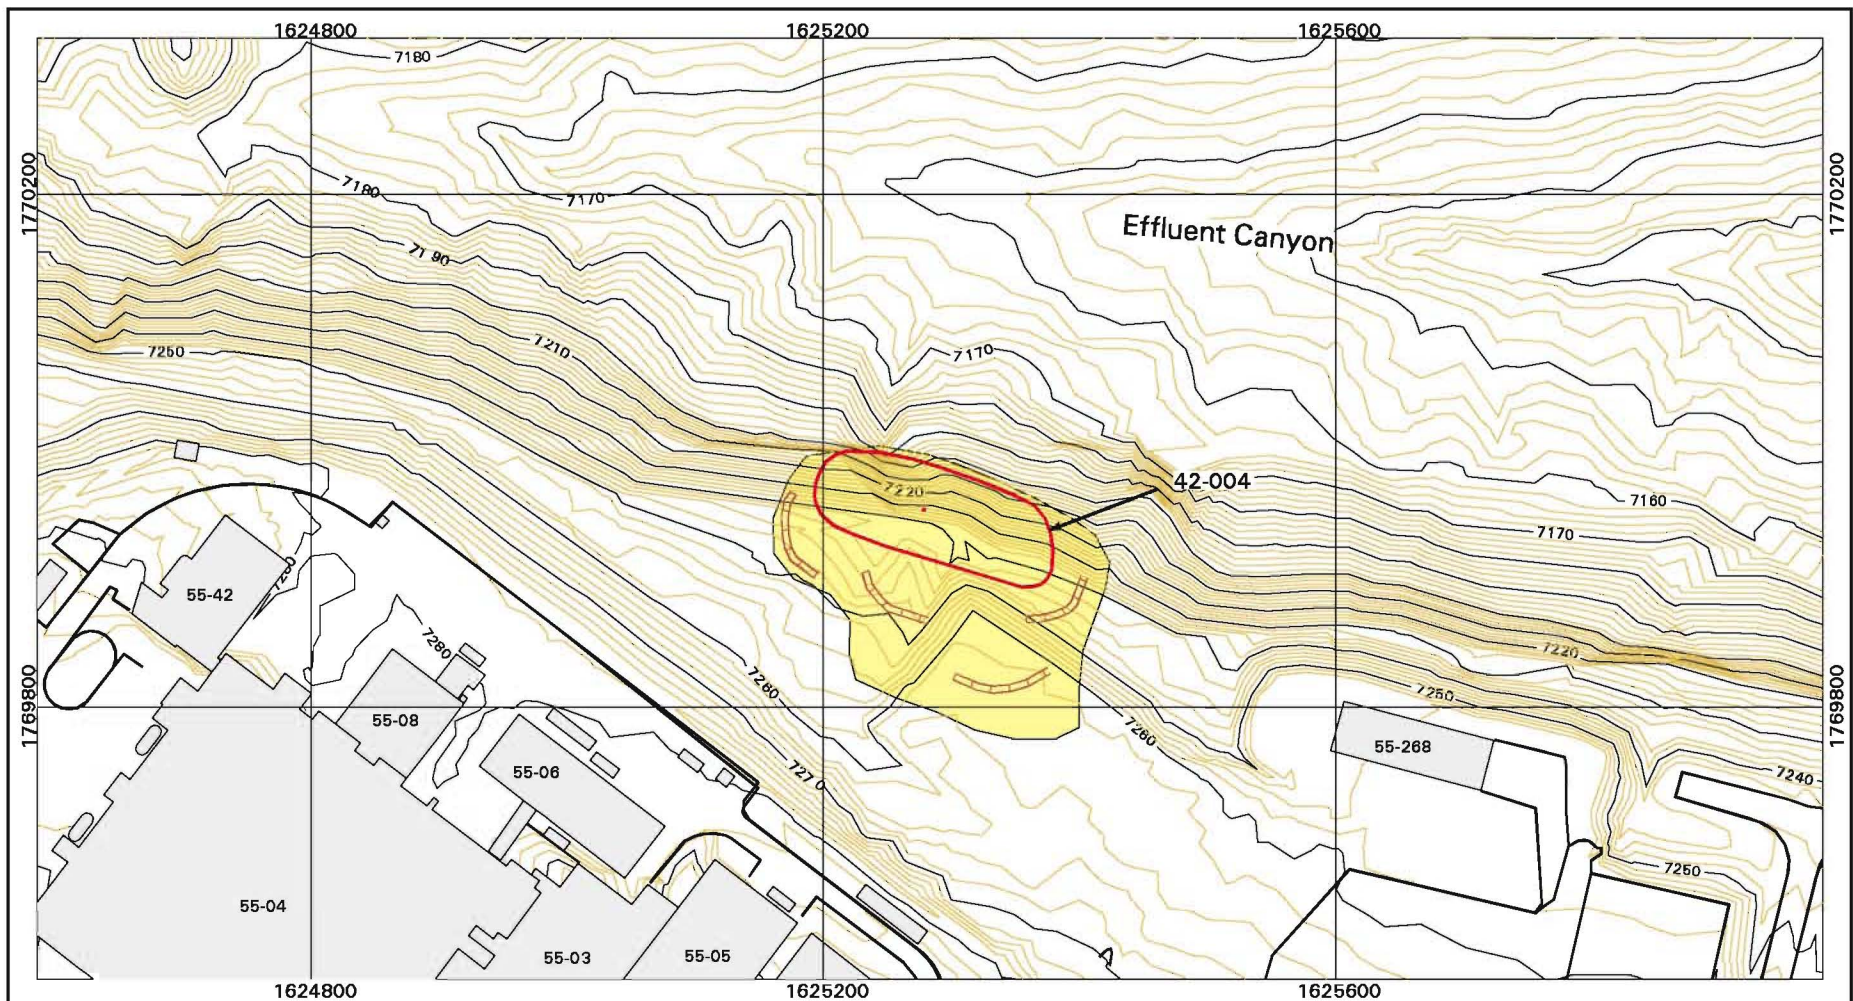
Best Management Practices at PRS 42-004

42-004 – Erosion Matrix Score 93.5. A canyon disposal area at former TA-42. Some building debris including pipes, were discarded over the canyon edge north of TA-42. The canyon disposal area is also designated as PRS No. C-42-001. Soil samples collected in 1991 as part of a survey found no contaminants of concern at the site.

The site is located on a tributary drainage to Mortandad Canyon within the Upper Mortandad Canyon Watershed Aggregate. The entire north facing slope below former TA-42 was moderately burned. Debris on the slope was exposed as a result of the fire. Two distinct drainage channels bisect the area behind the new building constructed near TA-55. The run-on to the western most drainage has been diverted away from the area of concern. The other drainage receives only direct rainfall, with minimal upslope sources.

1 acre treated
20 straw wattles
20 straw bales
10 pounds seed

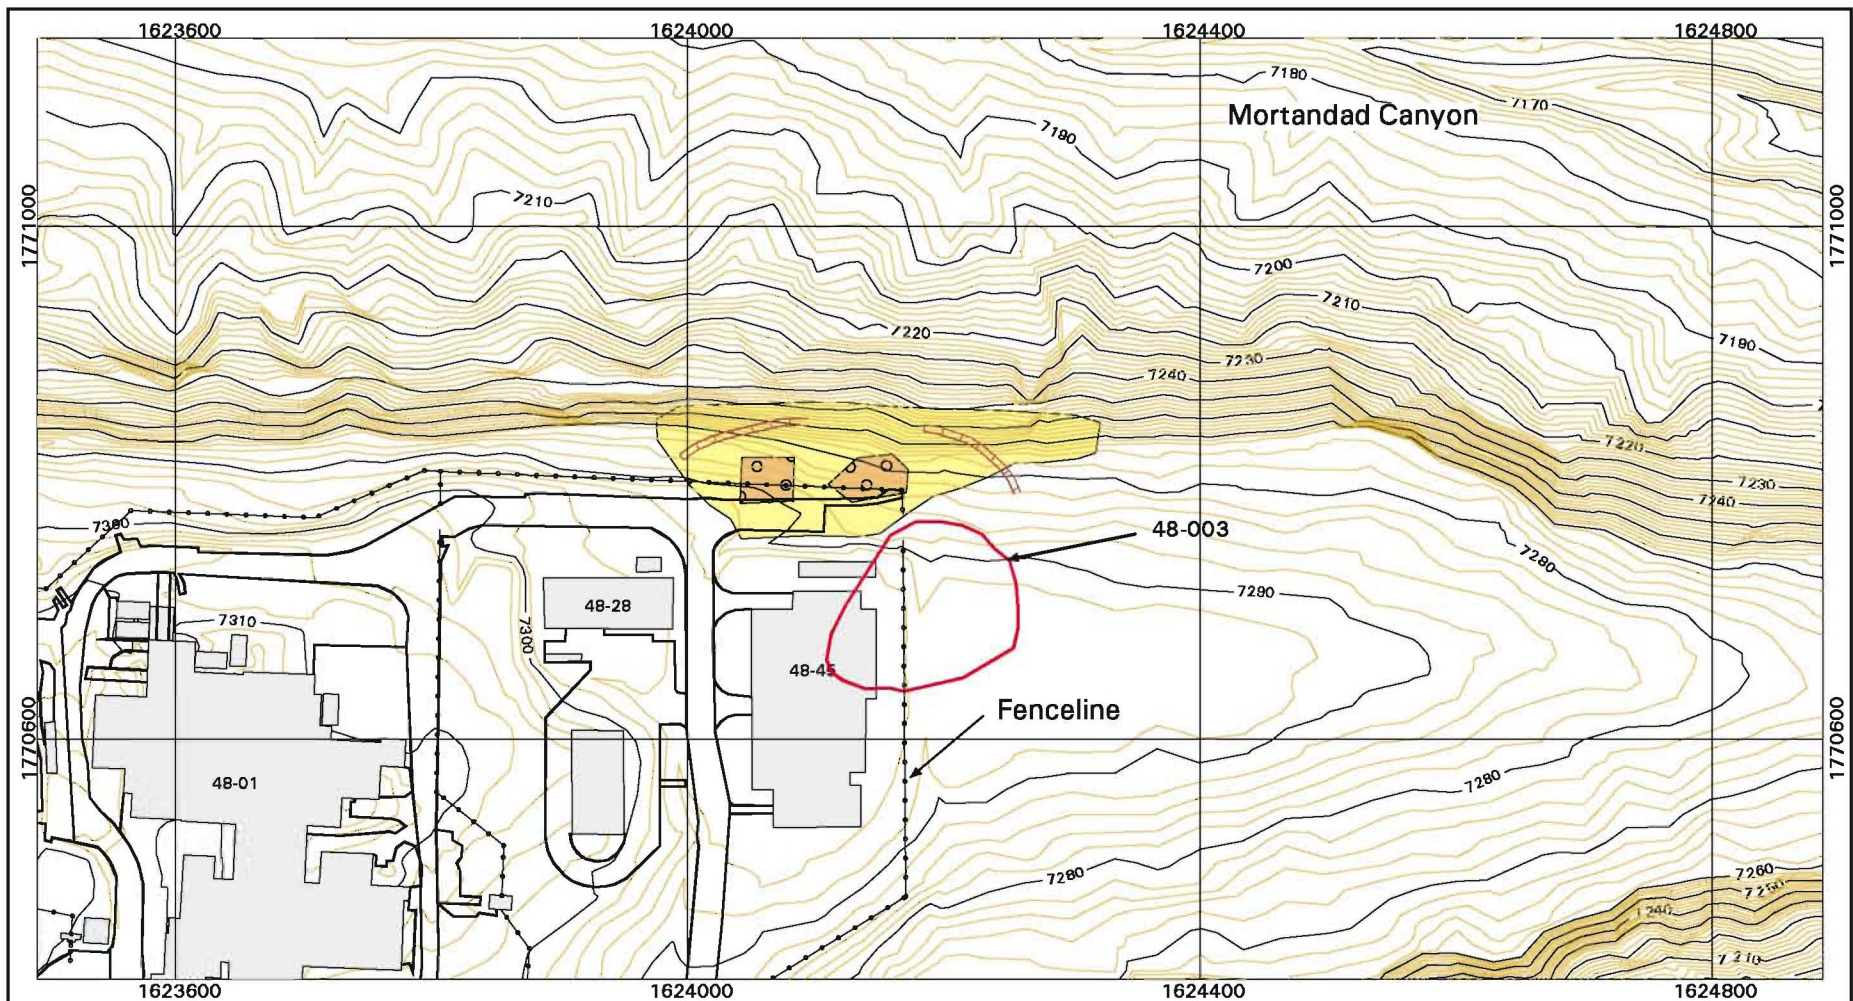
Best Management Practices at PRSs 48-003

48-003 – *Erosion Matrix Score 40.7*. Inactive septic system. The system served TA-48 from 1957 through January 1986 when it was removed from service. The septic tank and filter bed were decommissioned and removed in 1986.

This site is located on the northern edge of Mortandad Canyon within the Upper Mortandad Watershed Aggregate. The northern part of TA-48 was moderately burned, with damage to ground cover and canopy.

- .5 acre treated
- 10 straw wattles
- 10 pounds seed
- 5 straw bales
- 3 cubic yards of river rock

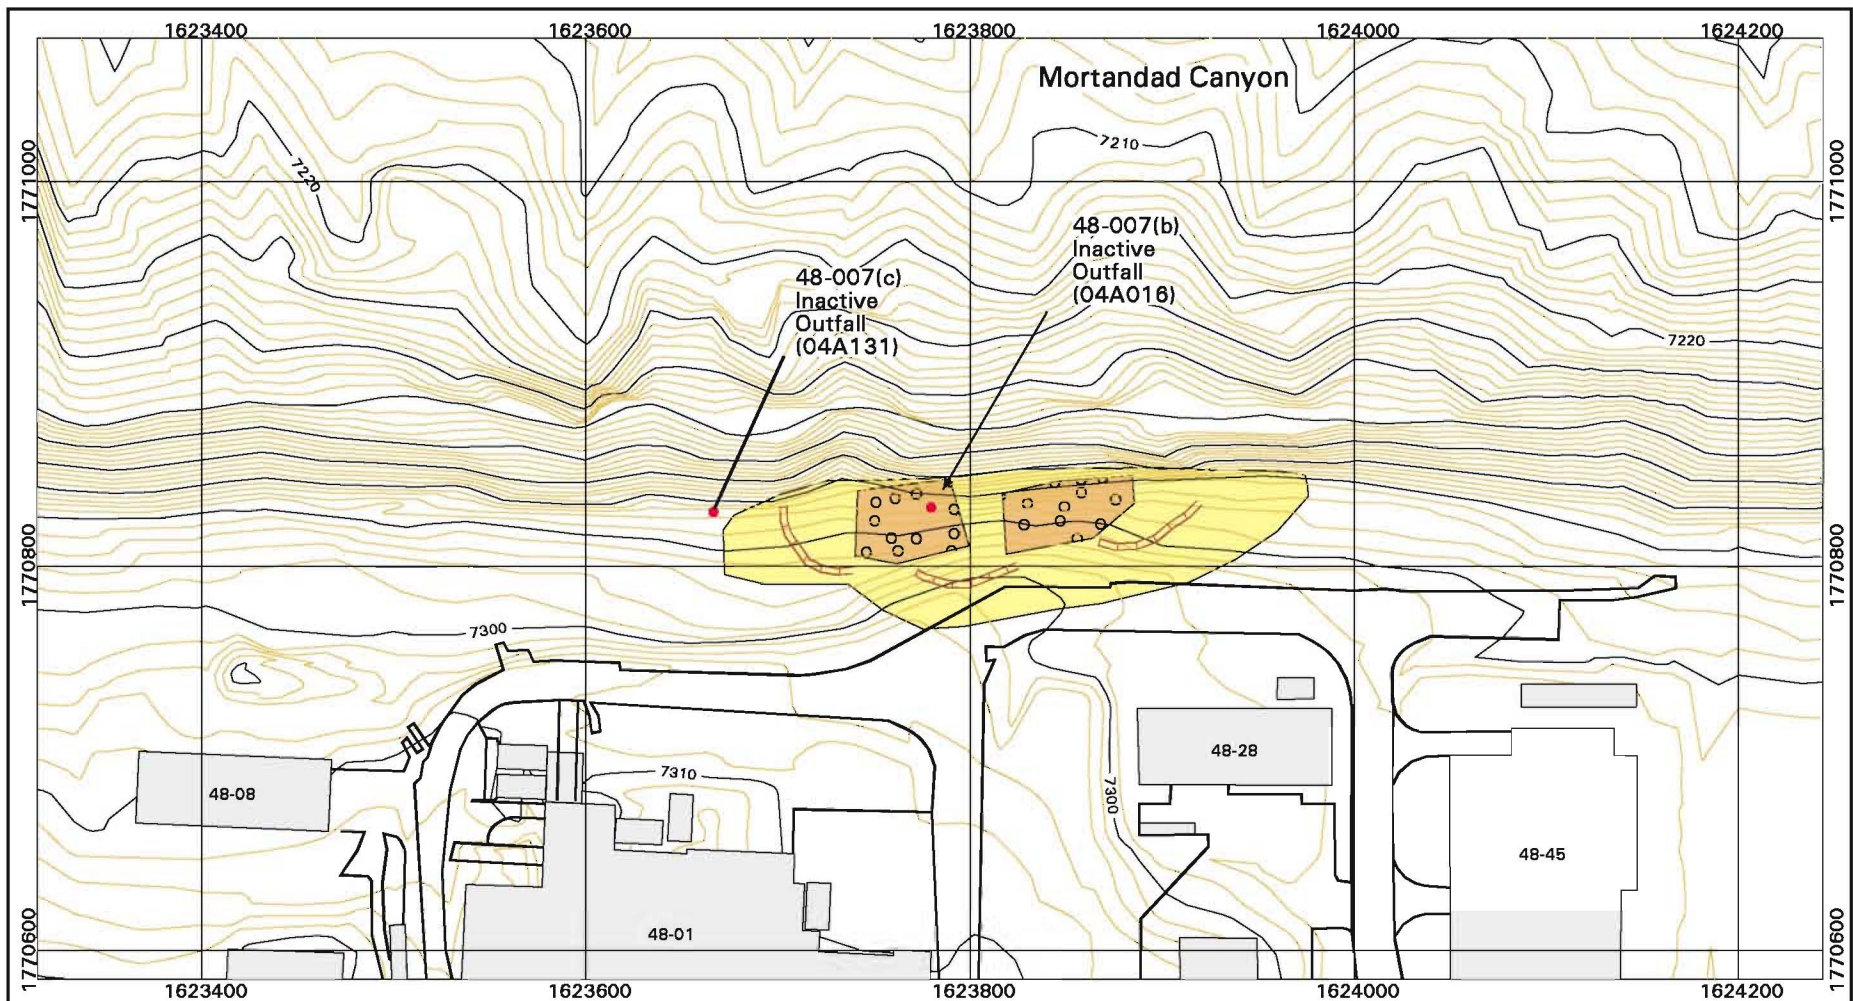
Best Management Practices at PRSs 48-007(b,c)

This site is located on the northern edge of Mortandad Canyon within the Upper Mortandad Watershed Aggregate. The northern part of TA-48 was moderately burned, with damage to ground cover and canopy.

.5 acre treated
5 straw wattles
3 cubic yards of river rock
10 pounds seed
5 straw bales

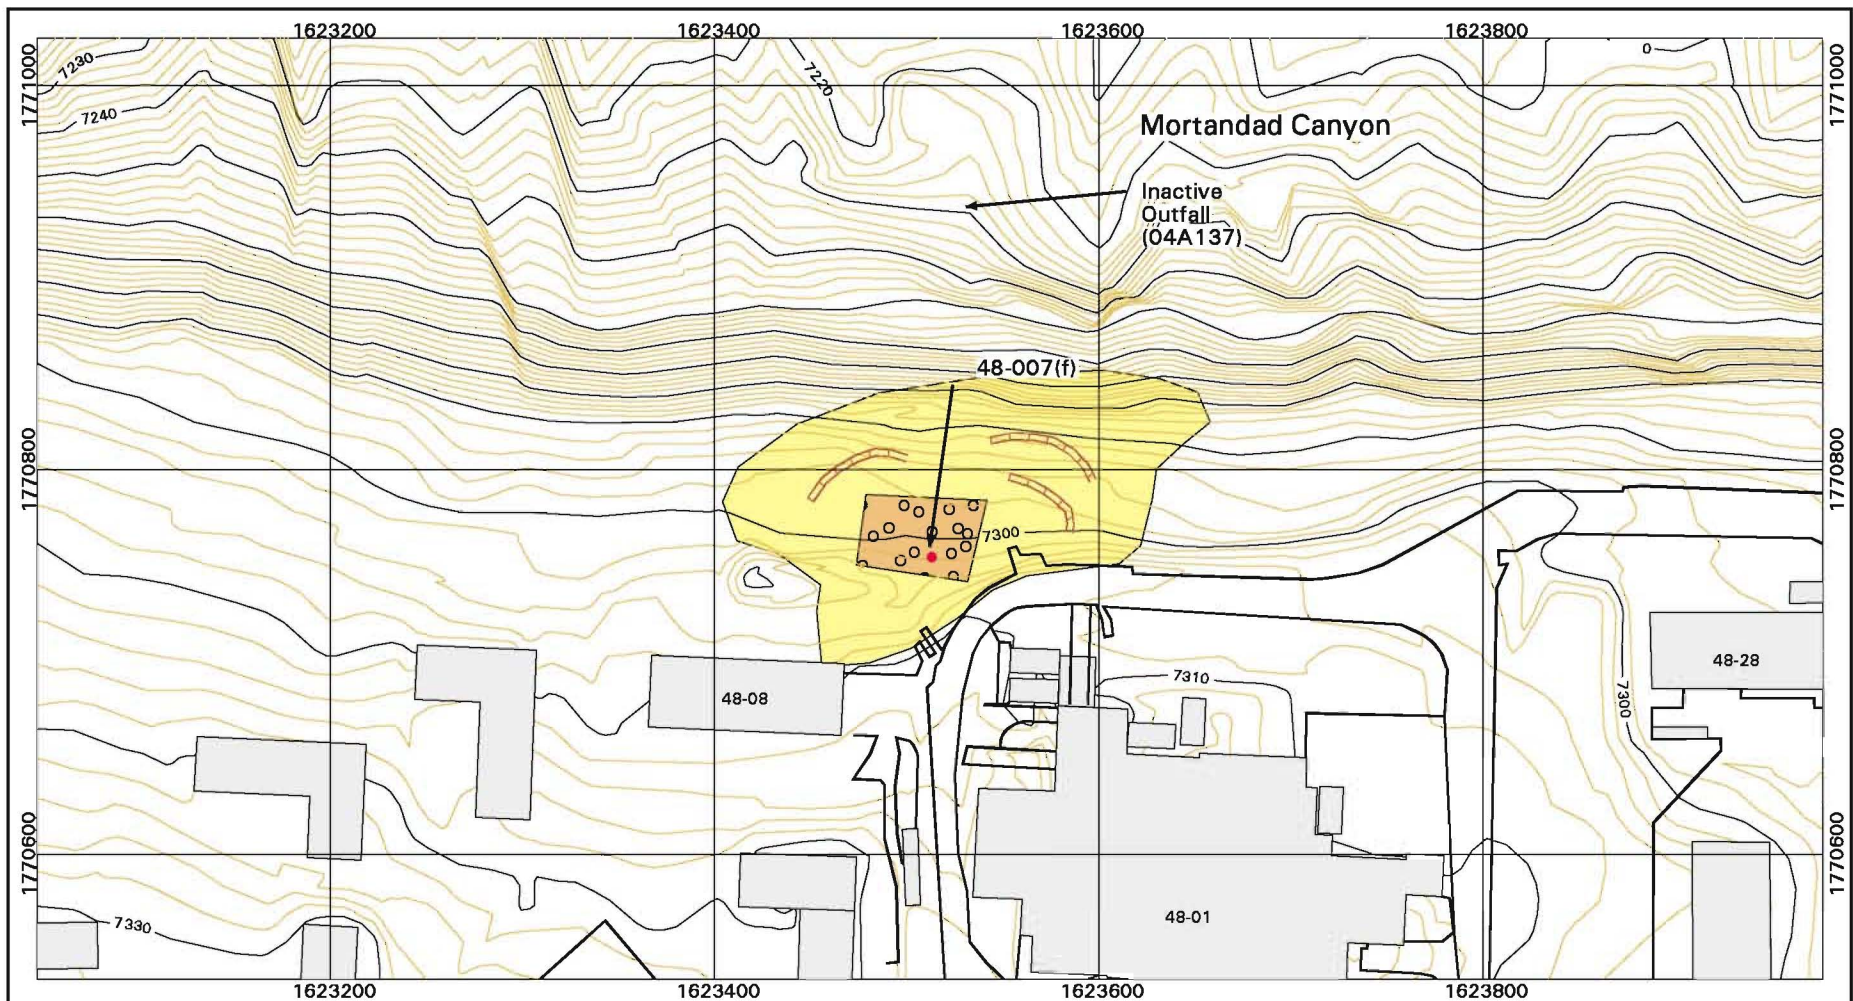
Best Management Practices at PRSs 48-007(f)

This site is located on the northern edge of Mortandad Canyon within the Upper Mortandad Watershed Aggregate. The northern part of TA-48 was moderately burned, with damage to ground cover and canopy.

.5 acre treated
10 straw wattles
5 straw bales
10 pounds seed

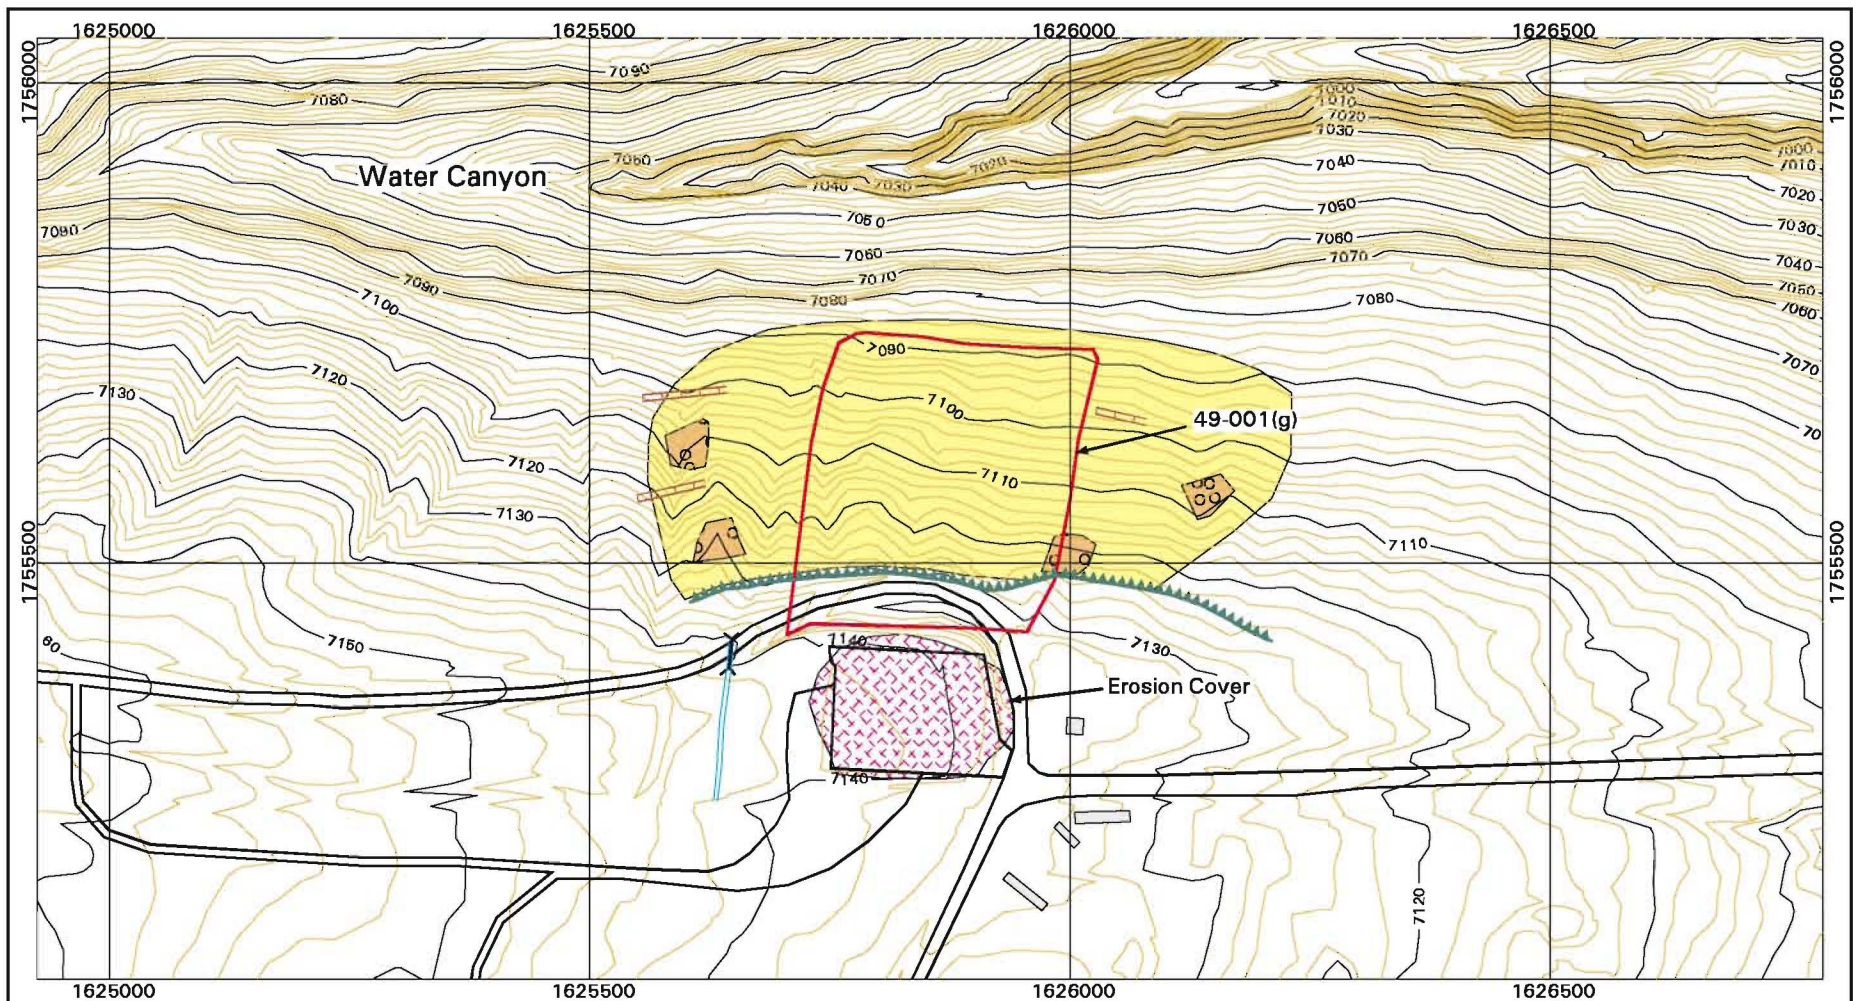
Best Management Practices at PRS 49-001(g)

This site is located on a tributary to Water Canyon within the Lower Water/Indio Watershed Aggregate. The area was lightly to moderately burned from MDA AB towards the canyon edge. All existing BMPs were destroyed

2 acres treated
50 straw wattles
16 cubic yards river rock
40 pounds seed
400 linear feet silt fence
30 straw bales
