LA-UR-98-3493
August 1998

RFI Report for Potential Release Sites

09-002
09-011(b)

Environmental Restoration Project
A Department of Energy Environmental Cleanup Program

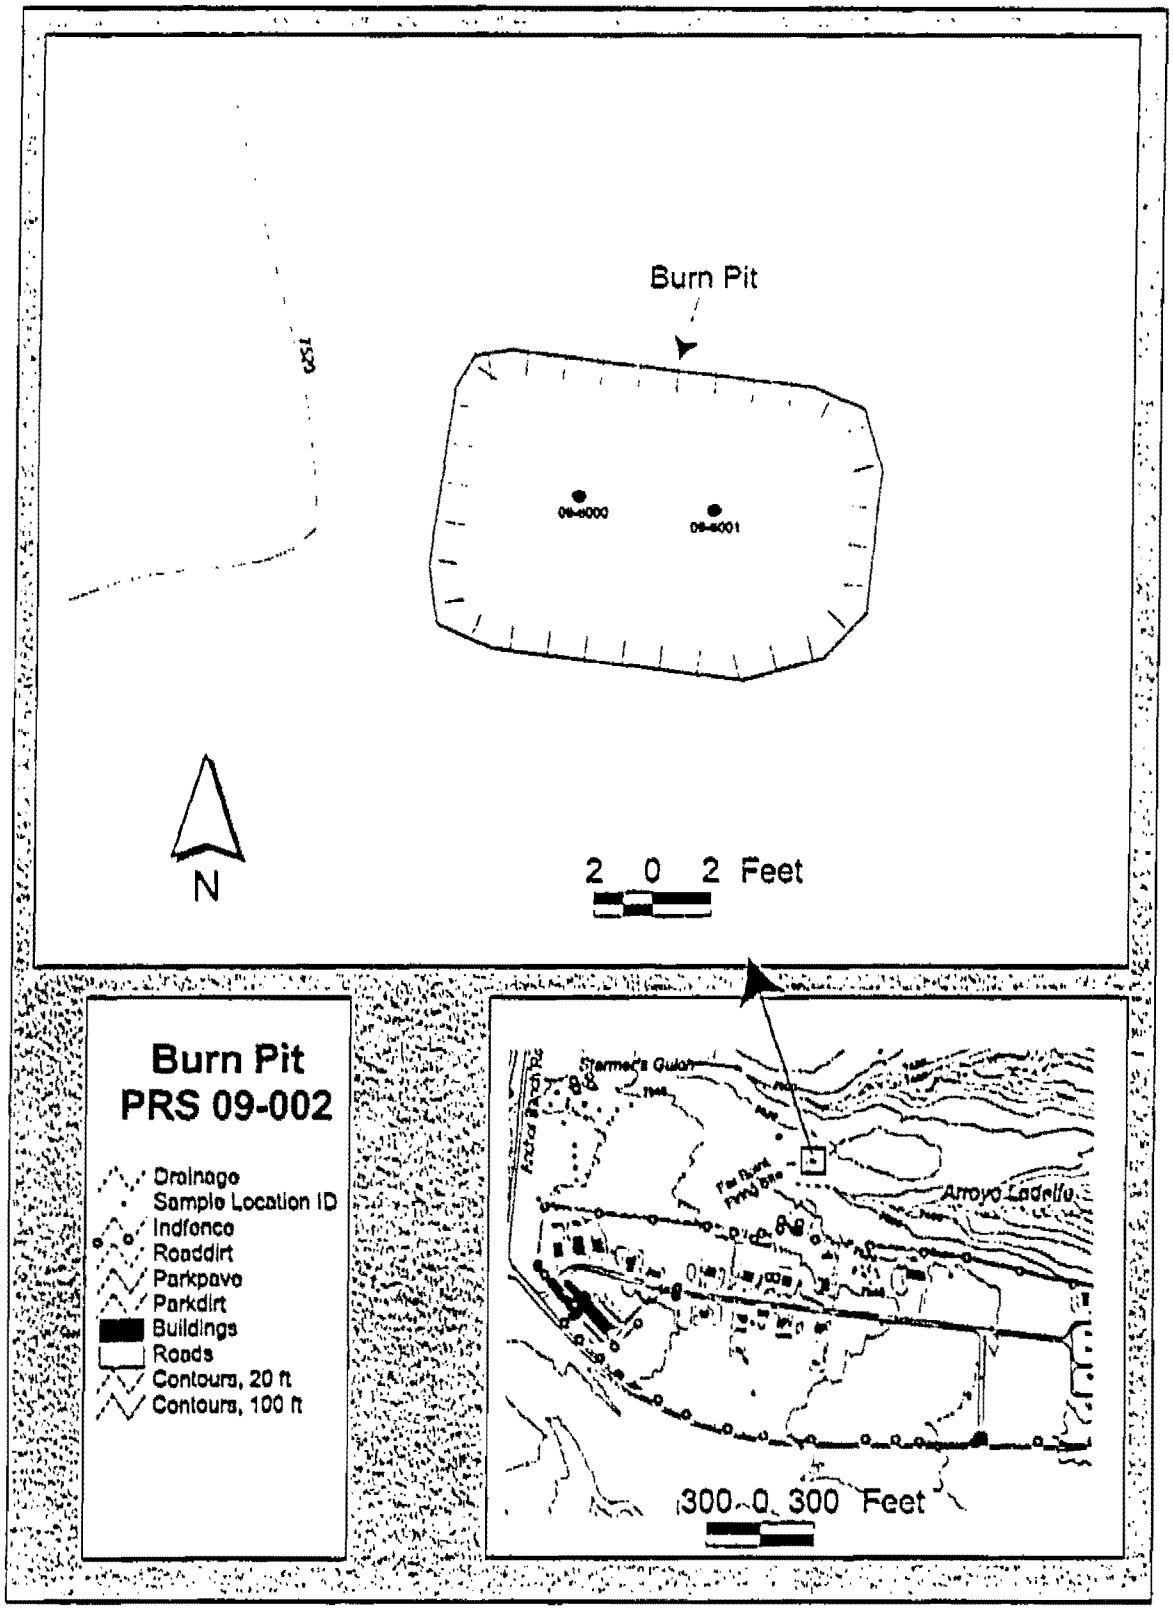
Figure 2.2-1. Sampling locations at PRS 09-002.

Two sampling sites were selected at the bottom of the surface depression identified by former TA-9 employees as the probable location of the burn pit. The bottom of the pit was selected for biased sampling because the sides of the pit were found to be intact and natural precipitation would have tended to concentrate any remaining residues from the burning down into the pit bottom. On May 10, 1994, two 0 to 0.5 ft surface soil samples (AAB0896 and AAB0897) were collected at locations 09-6000 and 09-6001 (See Figure 2.2-1 for sample locations). Soil moisture at the time of sampling was normal, that is, dry to slightly moist; the weather was cool and the skies were overcast. No ash or burned debris were observed in the soil sampling locations. Personnel from the ESH-19 Waste Site Studies Team collected samples using the Spade and Scoop method (ER SOP 6.09 [LANL, ER ID 51575]). The samples were analyzed for metals. A summary of samples collected is shown in Table 2.3-1.

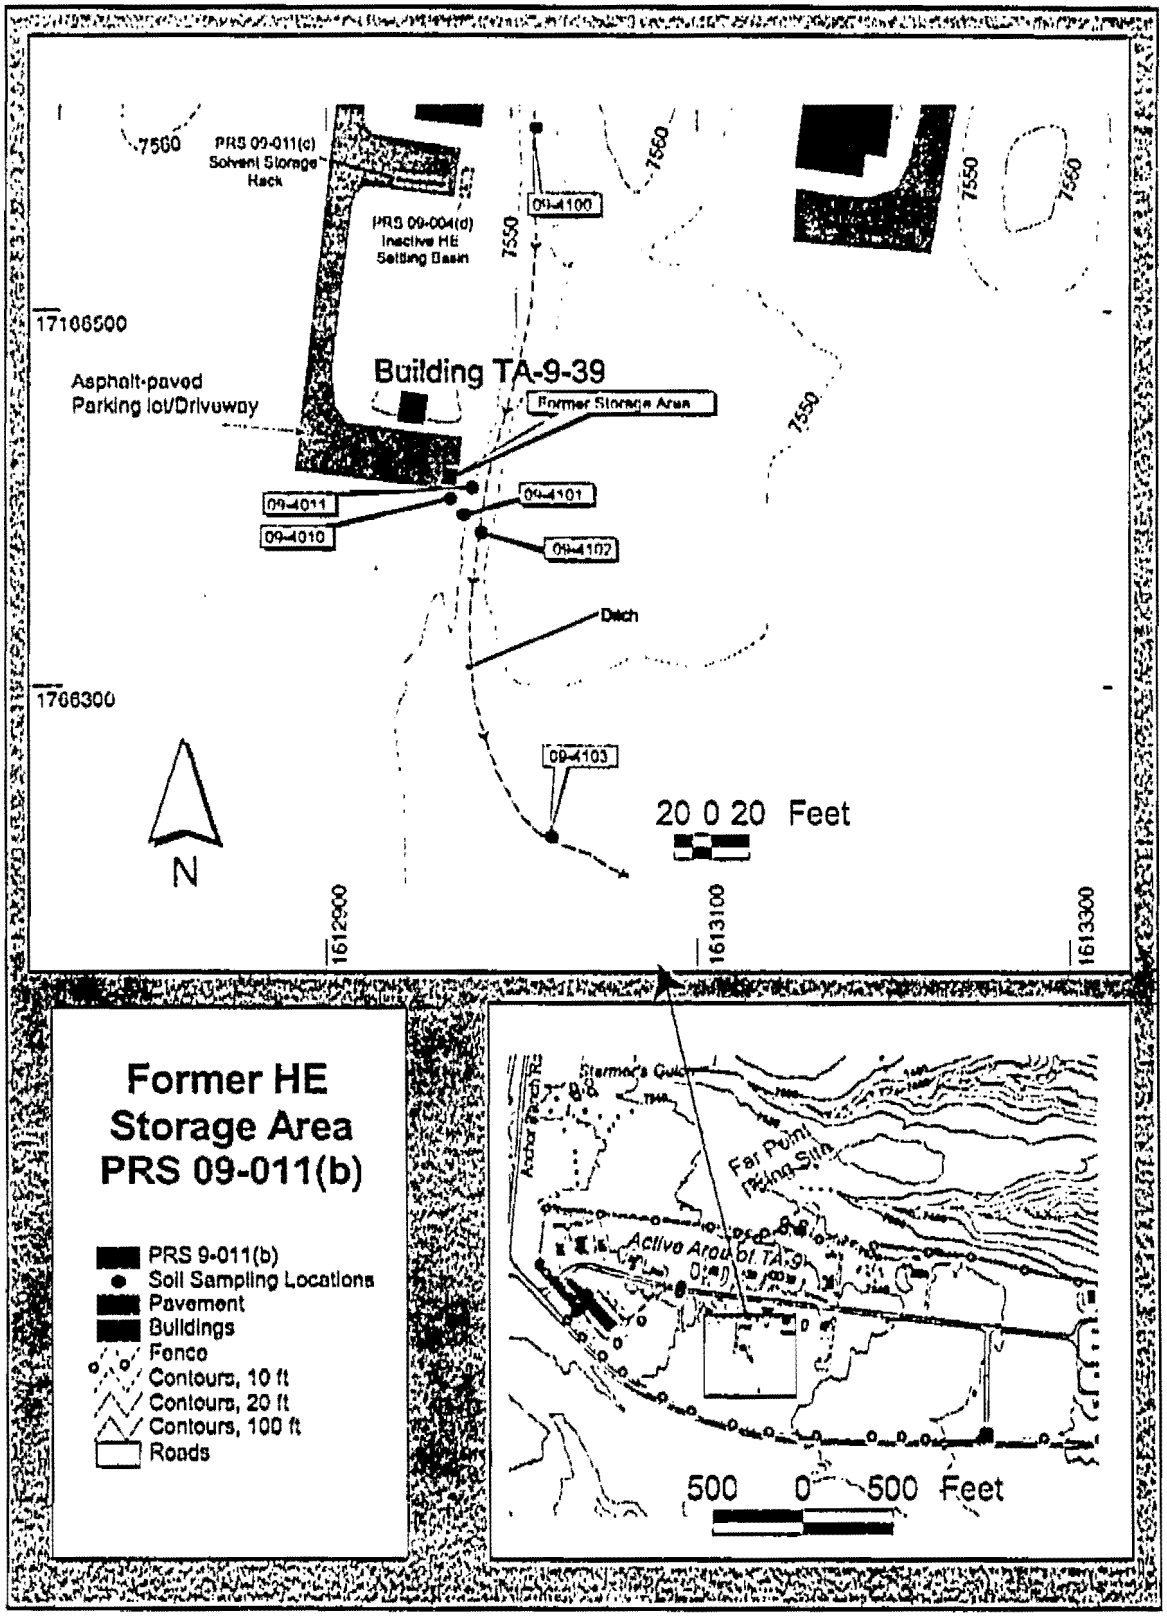
Figure 3.2-1. Sampling locations at PRS 09-011(b).

Surface soil samples (0- to 6-in. depth interval) were collected on April 28, 1994 from two locations adjacent to the asphalt-paved storage area. These sampling locations (09-4010 and 09-4011) are shown in Figure 3.2-1. Personnel from the ESH-19 Waste Site Studies Team conducted the fieldwork. Climatic conditions at the time of sampling were clear skies, moderate temperatures, and little or no precipitation. The soil was dry to slightly moist and no atypical soil discoloration or contaminant-related odors were noted during the sampling. The Spade and Scoop Method (ER-SOP-6.09) was used to collect the samples (LANL 51575). The samples were analyzed for HE and were intended to characterize the area reasonably assumed to have been most impacted by site activities (i.e., the soils immediately surrounding the pad). A summary of samples collected is shown in Table 3.3-1.
