# 2013 Update to the Site Discharge Pollution Prevention Plan, Revision 1

Los Alamos National Laboratory  
NPDES Permit No. NM0030759  
LA-UR-14-22681 • May 1, 2014

## Sandia/Mortandad Watershed

**Volume 2**

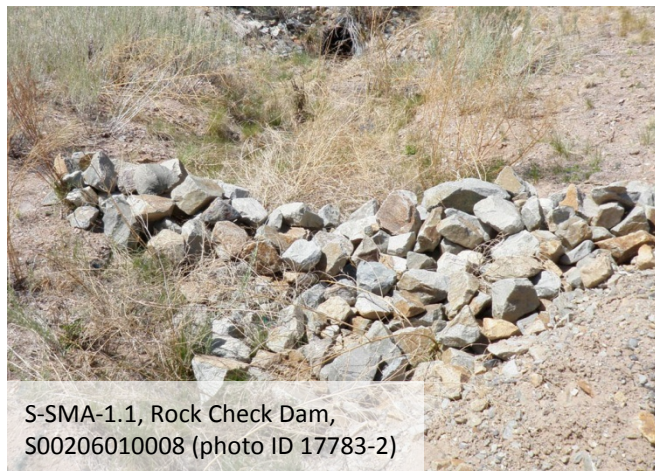
S-SMA-1.1, Rock Check Dam, S00206010008 (photo ID 17783-2)

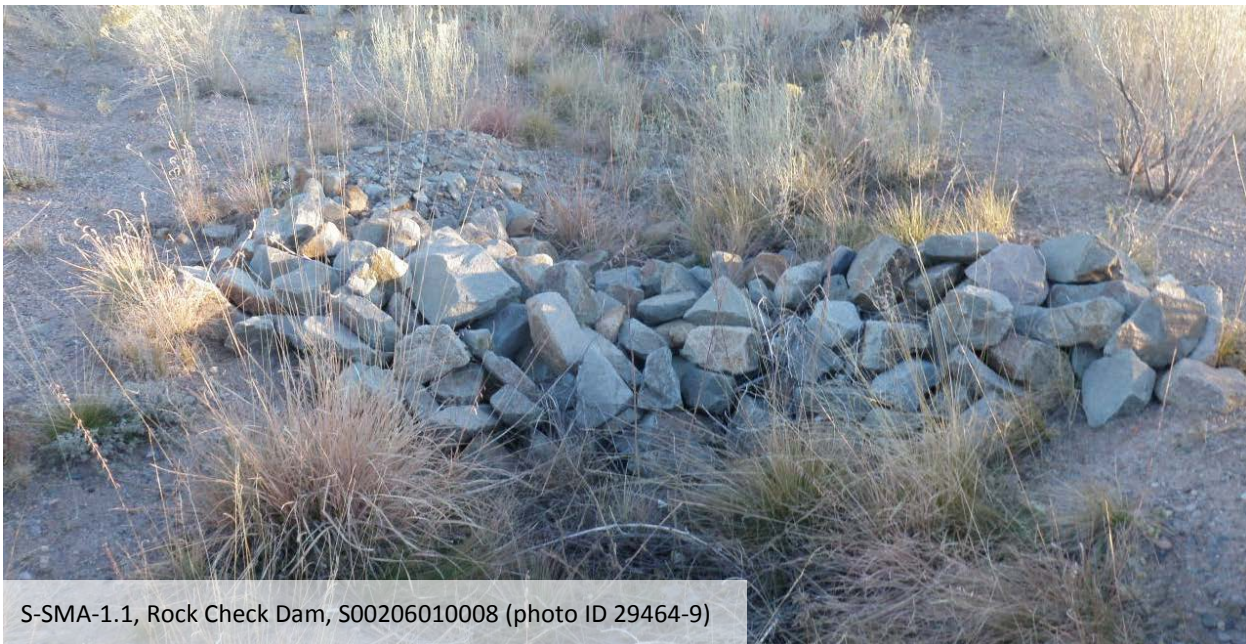
S-SMA-1.1, Rock Check Dam, S00206010008 (photo ID 29464-9)

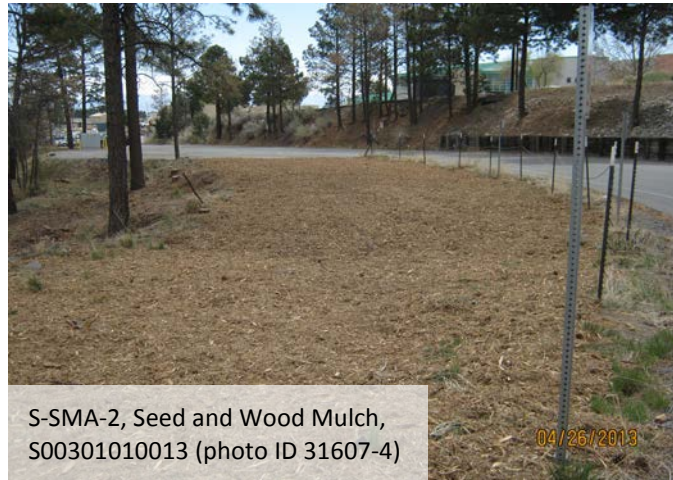
S-SMA-2, Seed and Wood Mulch, S00301010013 (photo ID 31607-4)

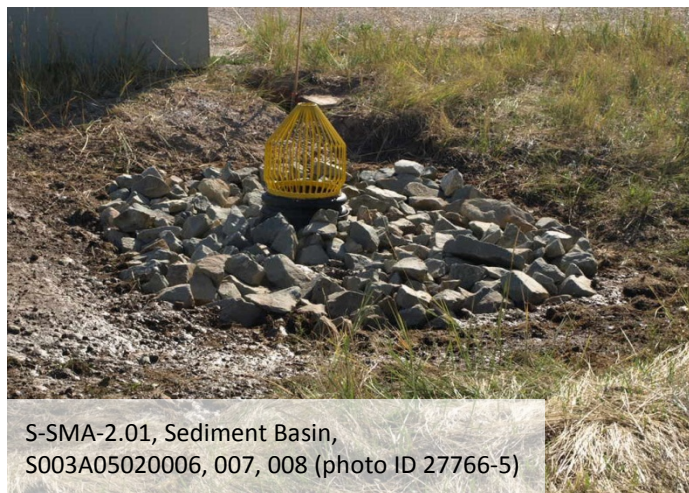
S-SMA-2.01, Sediment Basin, S003A05020006, 007, 008 (photo ID 27766-5)

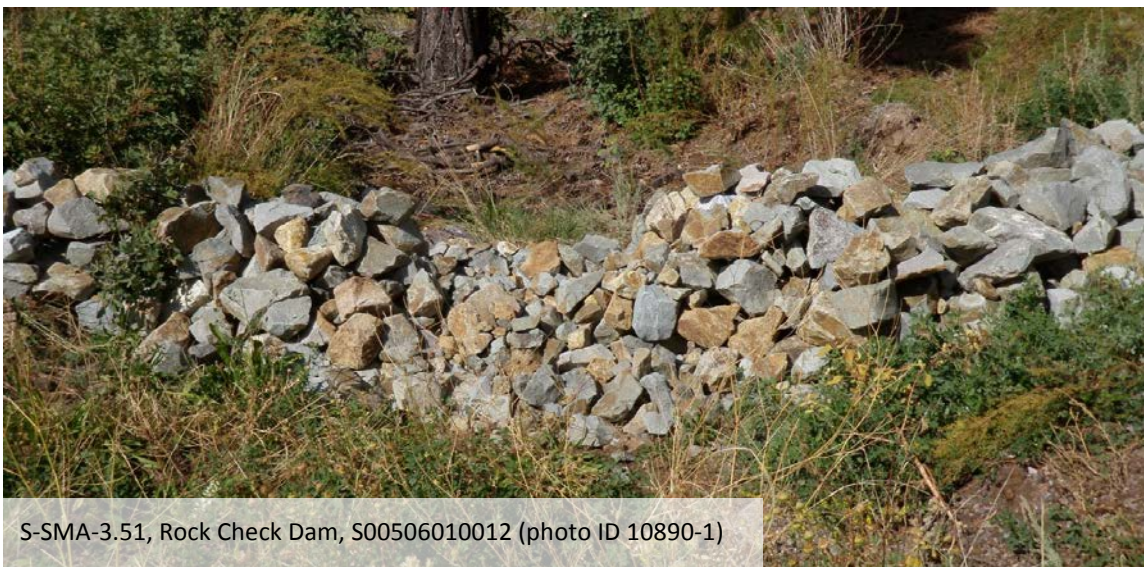
S-SMA-3.51, Rock Check Dam, S00506010012 (photo ID 10890-1)

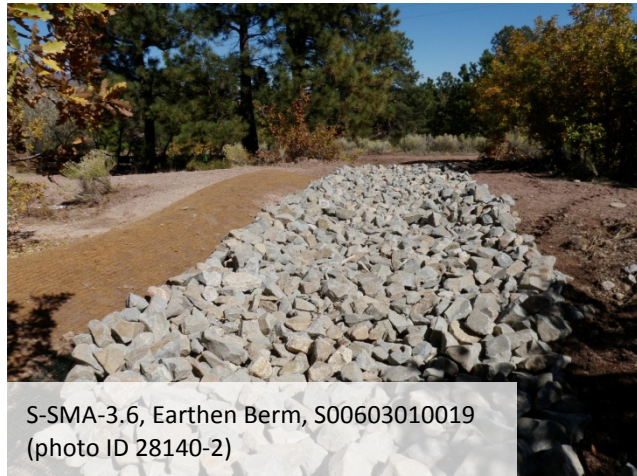
S-SMA-3.6, Earthen Berm, S00603010019  
(photo ID 28140-2)

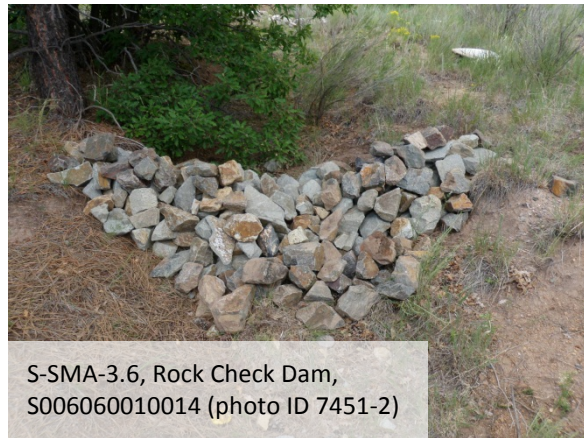
S-SMA-3.6, Rock Check Dam, S006060010014 (photo ID 7451-2)

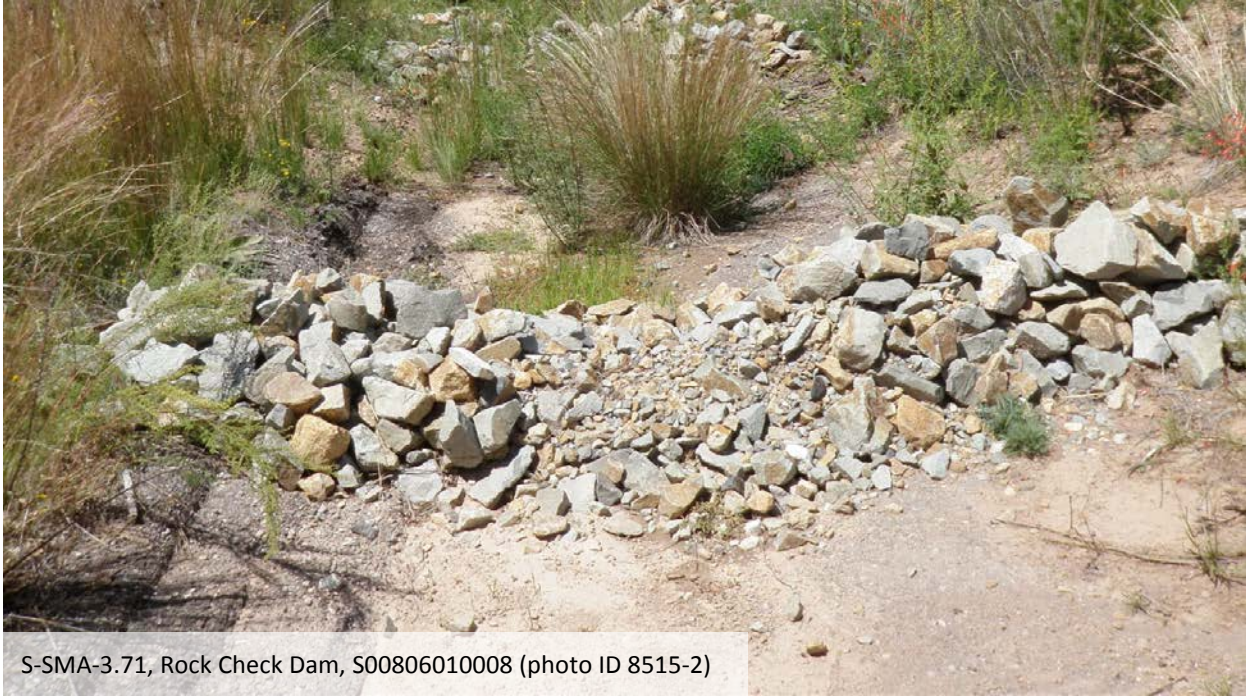
S-SMA-3.71, Rock Check Dam, S00806010008 (photo ID 8515-2)

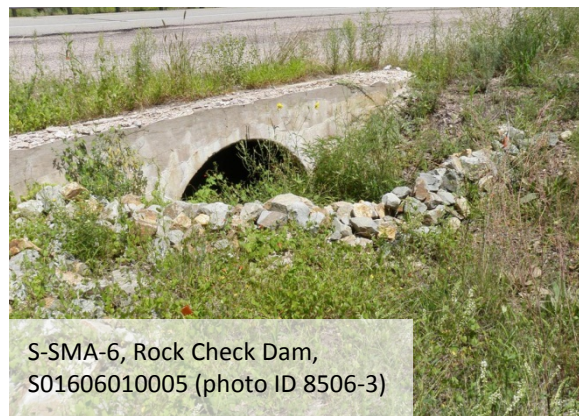
S-SMA-6, Rock Check Dam,  
S01606010005 (photo ID 8506-3)

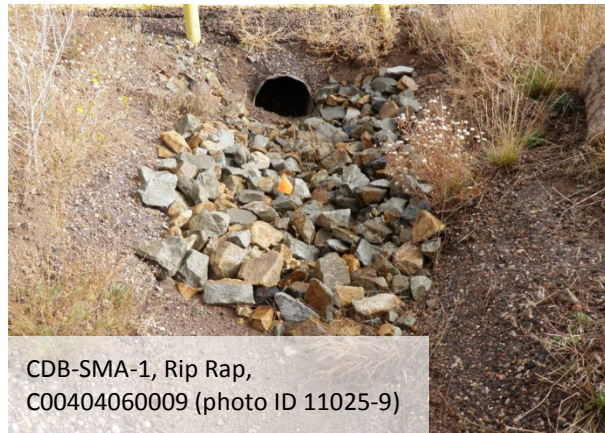
CDB-SMA-1, Rip Rap,  
C00404060009 (photo ID 11025-9)

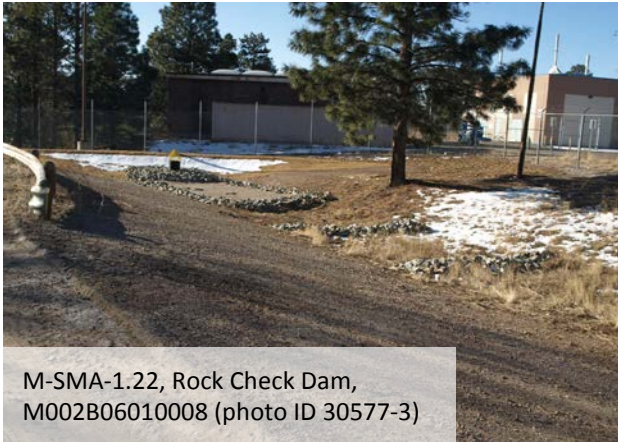
M-SMA-1.22, Rock Check Dam, M002B06010008 (photo ID 30577-3)

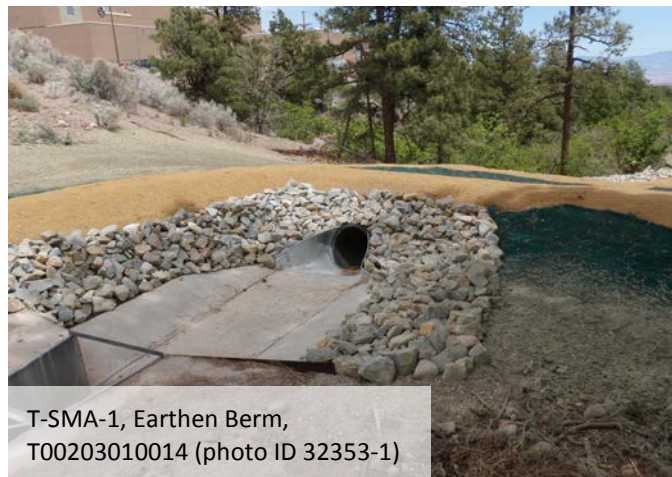
T-SMA-1, Earthen Berm, T00203010014 (photo ID 32353-1)

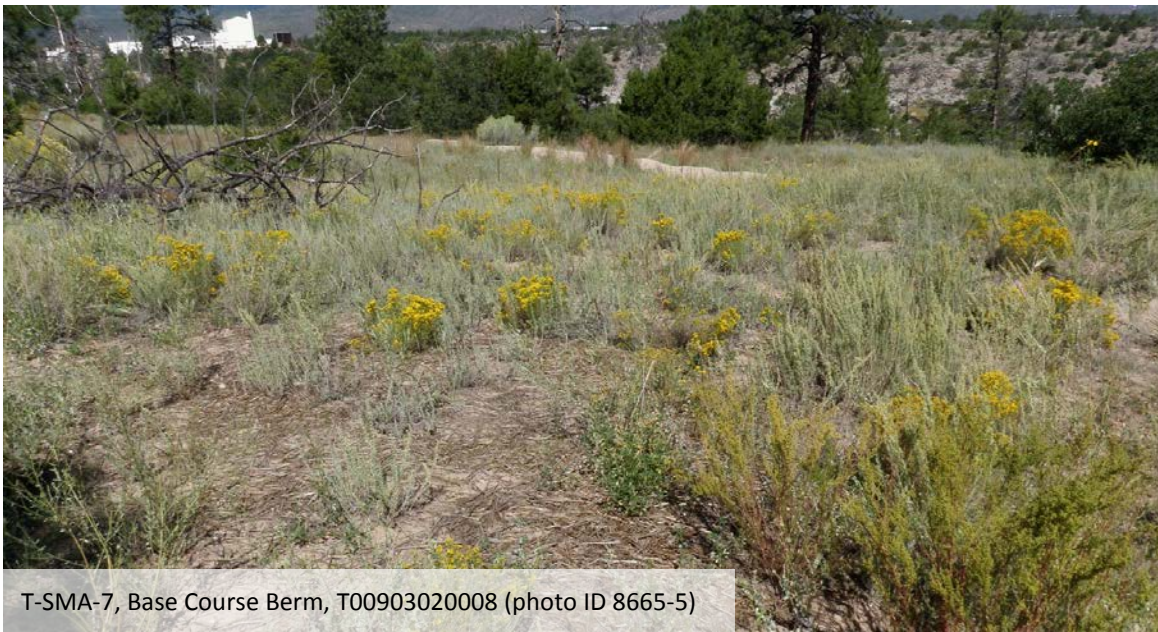
T-SMA-7, Base Course Berm, T00903020008 (photo ID 8665-5)
