2014 Update to the Site Discharge Pollution Prevention Plan, Revision 1

Los Alamos National Laboratory
NPDES Permit No. NM0030759
LA-UR-15-22148 • May 1, 2015

Sandia/Mortandad Watershed

Volume 2

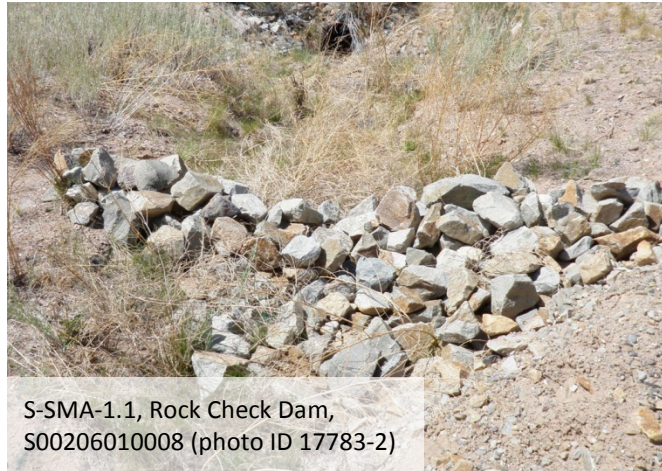
S-SMA-1.1, Rock Check Dam, S00206010008 (photo ID 17783-2)

BMP-41117	Added angular rock to rock check dam S00206010008 to build up height and extend both ends. Installed a rock check dam between existing rock check dam S00206010008 and riprap S00204060006. Added angular rock to fill in gullies at lower end of riprap area.	7-31-2014	16 day(s)	Maintenance conducted as soon as practicable.
BMP-42092	Repaired downgradient side of sediment basin S00205020013 berm by filling in erosion with base-course mix. Assessed standpipe for structural integrity.	8-29-2014	18 day(s)	Maintenance conducted as soon as practicable.
BMP-43875	Added angular rock to extend south end of riprap S00204060014 area approximately 8 ft.	11-5-2014	15 day(s)	Maintenance conducted as soon as practicable.

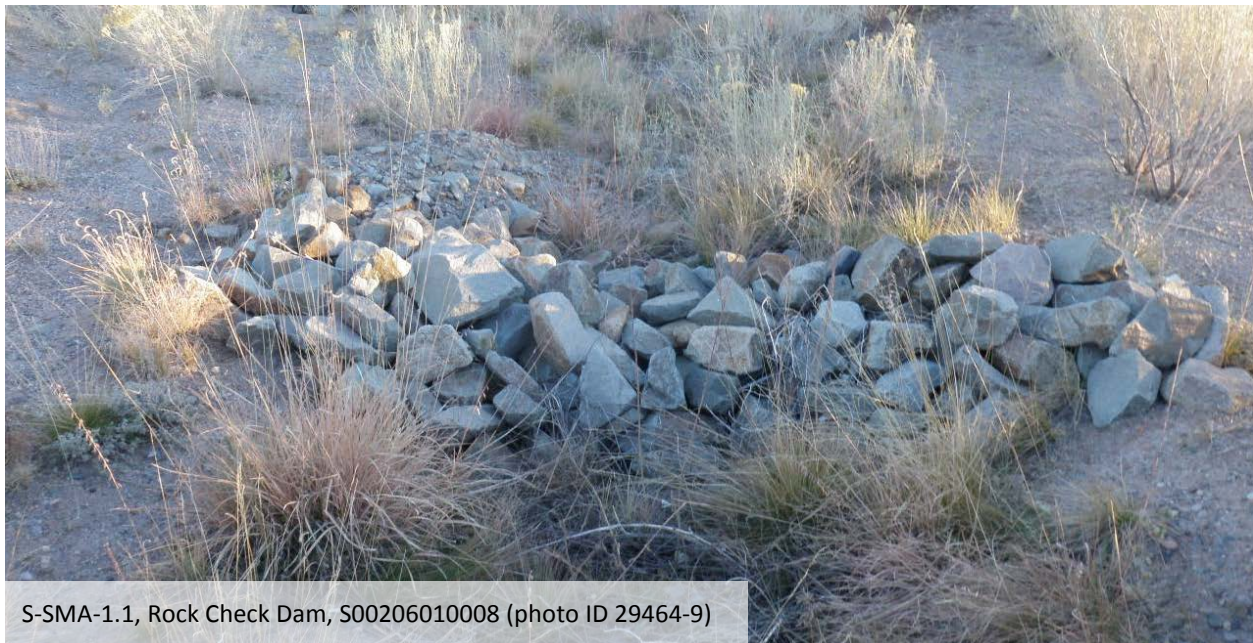
S-SMA-1.1, Rock Check Dam, S00206010008 (photo ID 29464-9)

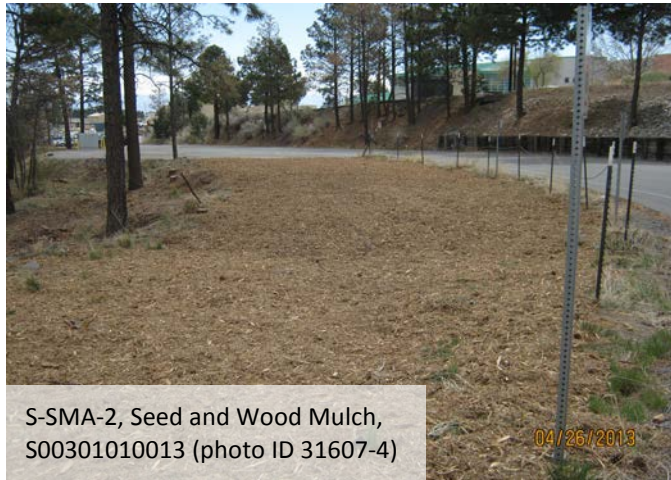
S-SMA-2, Seed and Wood Mulch, S00301010013 (photo ID 31607-4)

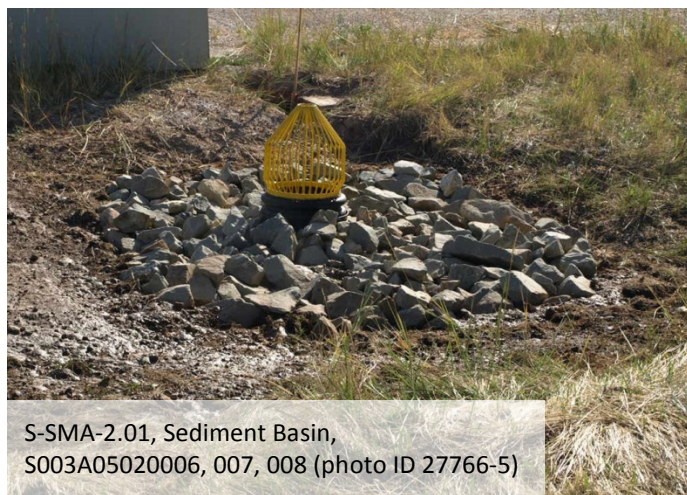
S-SMA-2.01, Sediment Basin, S003A05020006, 007, 008 (photo ID 27766-5)

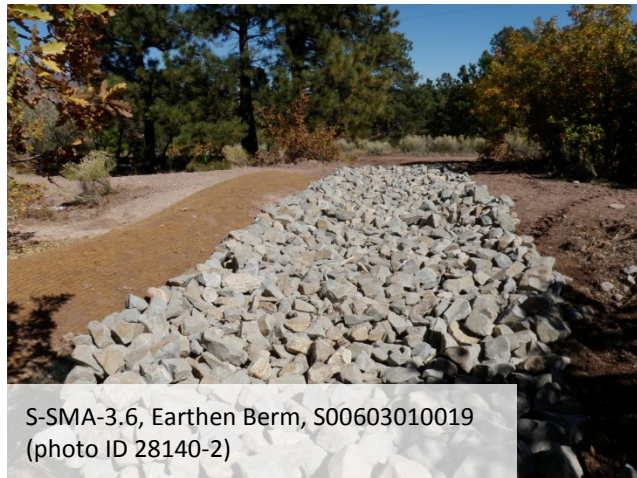
S-SMA-3.6, Earthen Berm, S00603010019 (photo ID 28140-2)

Enhanced controls were installed and certified on December 13, 2012, as part of corrective action. Photographs of the enhanced controls are available at <http://www.lanl.gov/community-environment/environmental-stewardship/protection/compliance/individual-permit-stormwater/construction-certifications.php>.

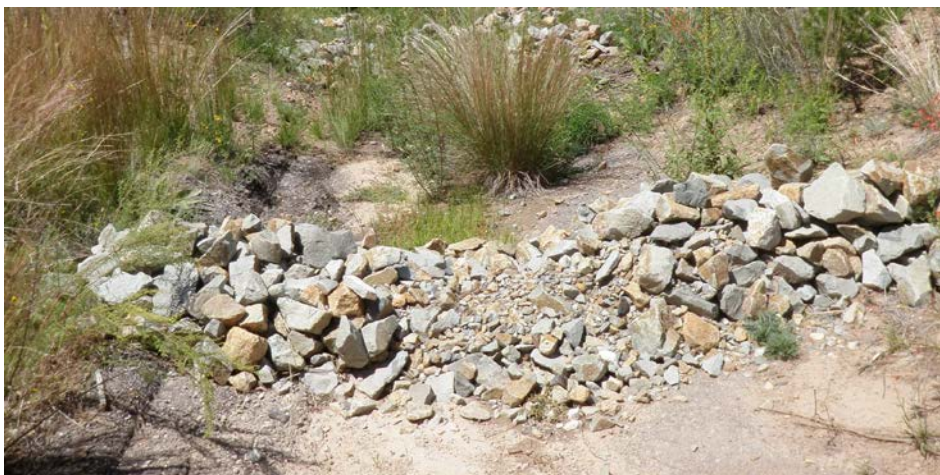
S-SMA-3.71, Rock Check Dam, S00806010008 (photo ID 8515-2)

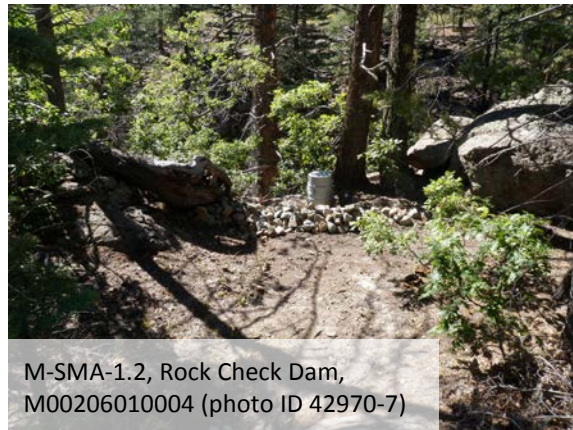
M-SMA-1.2, Rock Check Dam, M00206010004 (photo ID 42970-7)

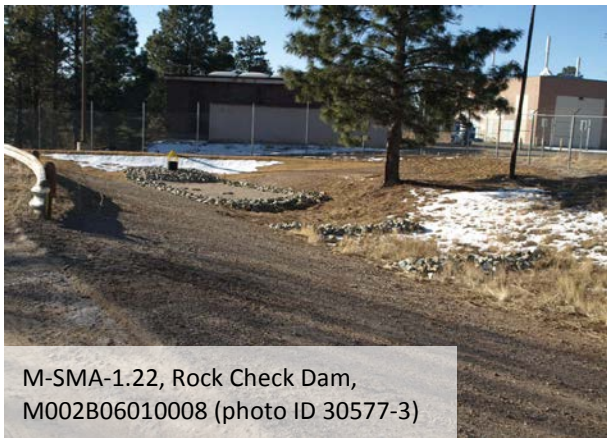
M-SMA-1.22, Rock Check Dam, M002B06010008 (photo ID 30577-3)

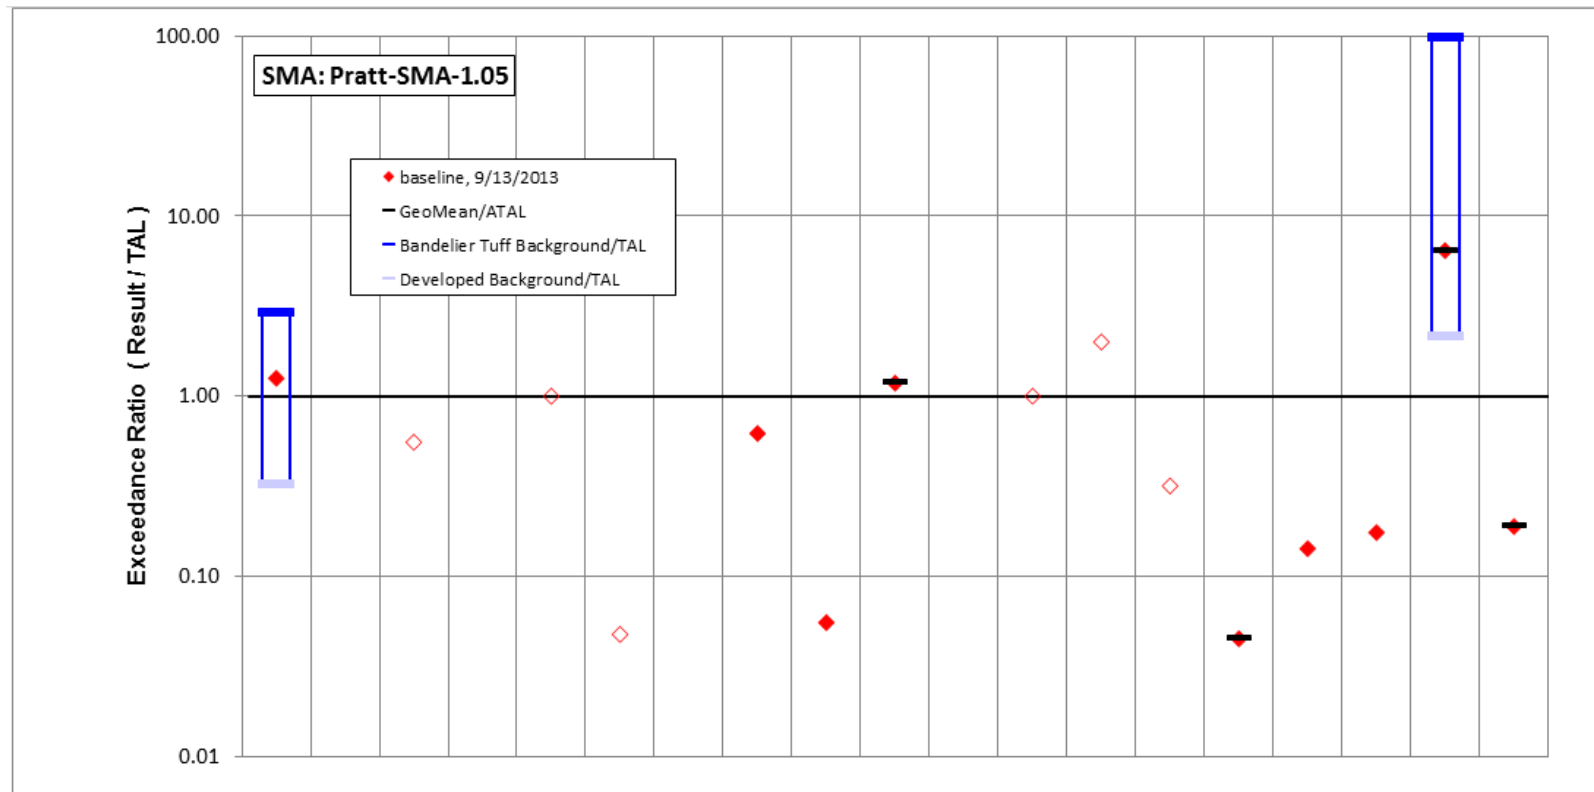
Aluminum	Antimony	Arsenic	Boron	Cadmium	Chromium	Cobalt	Copper	Lead	Mercury	Nickel	Selenium	Silver	Thallium	Vanadium	Zinc	Cyanide, weak acid dissociable	Gross alpha	Radium-226 and Radium-228
std used in ratio calculations	MTAL	ATAL	ATAL	ATAL	MQL	MTAL	ATAL	MTAL	MTAL	ATAL	MTAL	ATAL	MQL	ATAL	ATAL	MTAL	MQL	ATAL	ATAL
std value	750	640	9	5000	1	210	1000	4.3	17	0.77	170	5	0.5	6.3	100	42	0.01	15	30
unit	ug/L	ug/L	ug/L	ug/L	ug/L	ug/L	ug/L	ug/L	ug/L	ug/L	ug/L	ug/L	ug/L	ug/L	ug/L	ug/L	mg/L	pCi/L	pCi/L
9/13/2013 result	943	<i>3</i>	<i>5</i>	17.8	<i>1</i>	<i>10</i>	1.98	2.67	0.942	0.91	1.23	<i>5</i>	1	2	4.5	5.98	0.0018	96.5	5.67
result / TAL	1.3	<i>0.005</i>	<i>0.56</i>	0.0036	<i>1</i>	<i>0.048</i>	0.002	0.62	0.055	1.2	0.0072	<i>1</i>	2	0.32	0.045	0.14	0.18	6.4	0.19

Bold font indicates result>TAL/MQL; italic font and hollow symbols indicate undetected results; "-" is used if no analytical results were available.

Figure 119-2 Inorganic analytical results summary plot for Pratt-SMA-1.05

TAL exceedances were also evaluated against the appropriate storm water BVs, that is, “Bandelier Tuff background” for undisturbed SMAs or “developed background” for urban settings. BVs are expressed as UTLs using the approved EPA method for calculating BVs. UTLs for undisturbed SMAs were derived from storm water runoff containing entrained sediments derived from Bandelier Tuff and are labeled “Bandelier Tuff Background” in Figures 119-2 and 119-3. UTLs developed for urban settings were derived from runoff from developed landscapes on the Pajarito Plateau, including buildings, parking lots, roads, and associated features, and are labeled “Developed Background” in Figures 119-2 and 119-3.

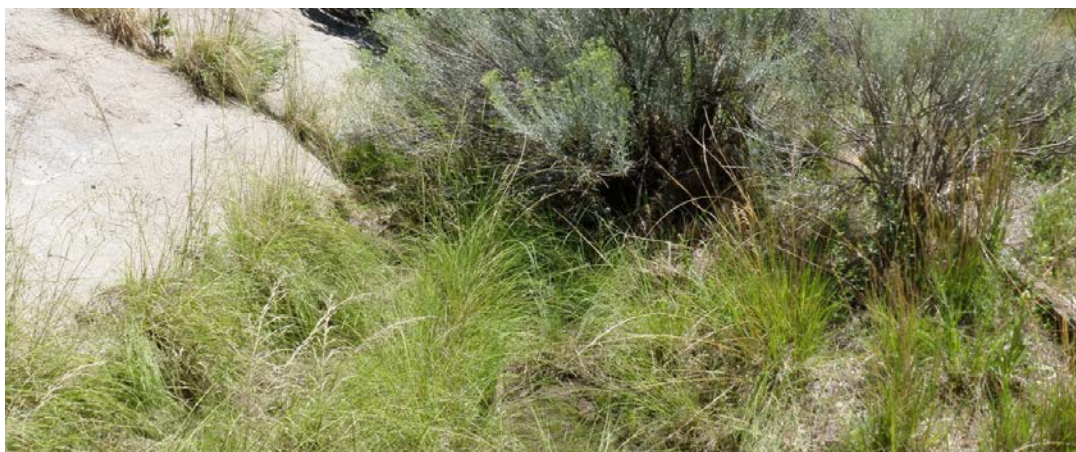
T-SMA-2.5, Earthen Channel/Swale, T00304010002 (photo ID 7470-3)

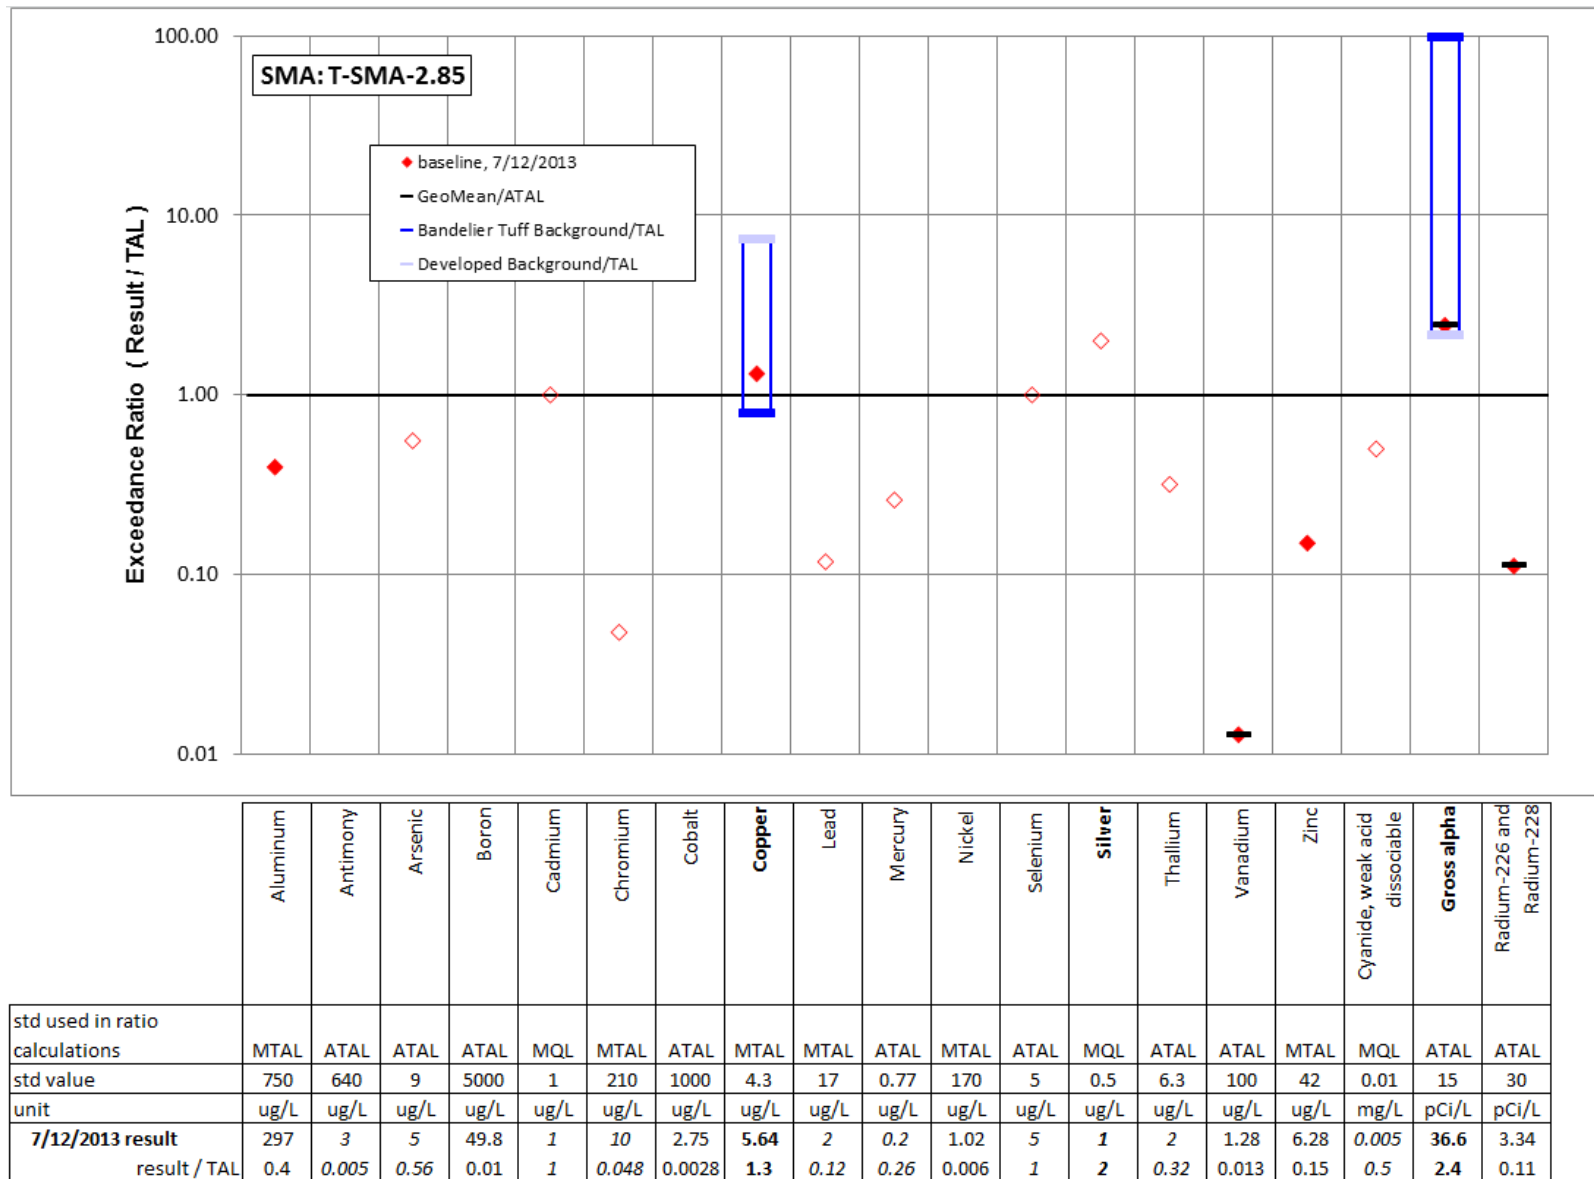
Bold font indicates result>TAL/MQL; italic font and hollow symbols indicate undetected results; "-" is used if no analytical results were available.

Figure 122-2 Inorganic analytical results summary plot for T-SMA-2.85

SWMU 35-014(g) and AOC 35-016(n) are monitored within T-SMA-2.85. Following the installation of baseline control measures, a baseline storm water sample was collected on July 12, 2013 (Figure 122-2). Analytical results from this sample yielded the following TAL exceedances:

TAL exceedances were also evaluated against the appropriate storm water BVs, that is, “Bandelier Tuff background” for undisturbed SMAs or “developed background” for urban settings. BVs are expressed as UTLs using the approved EPA method for calculating BVs. UTLs for undisturbed SMAs were derived from storm water runoff containing entrained sediments derived from Bandelier Tuff and are labeled “Bandelier Tuff Background” in Figure 122-2. UTLs developed for urban settings were derived from runoff from developed landscapes on the Pajarito Plateau, including buildings, parking lots, roads, and associated features, and are labeled “Developed Background” in Figure 122-2.
