# 2017 Update to the Site Discharge Pollution Prevention Plan, Revision 1

Los Alamos National Laboratory  
NPDES Permit No. NM0030759  
LA-UR-18-22935 • May 1, 2018

## Pajarito Watershed

**Volume 3**

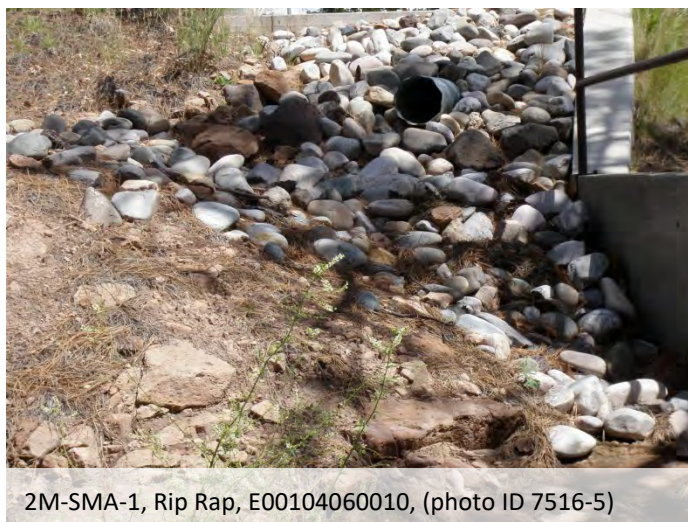
2M-SMA-1, Rip Rap, E00104060010, (photo ID 7516-5)

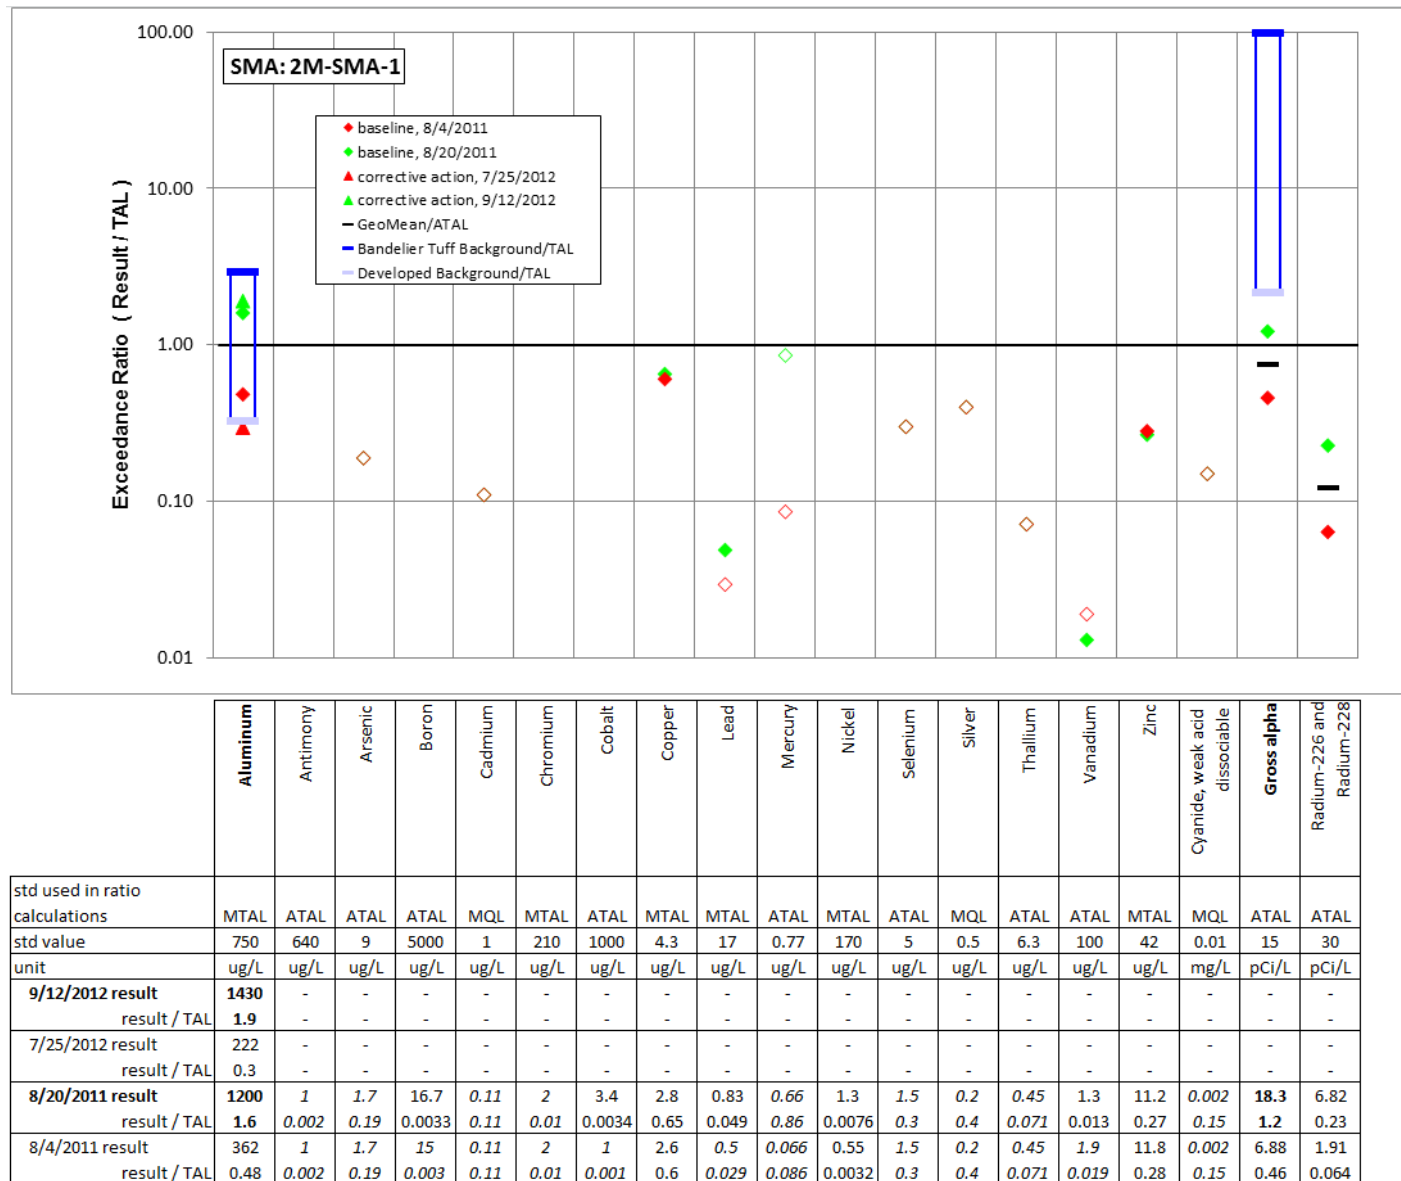
**Figure 129-2 Inorganic analytical results summary plot for 2M-SMA-1**

Bold font indicates result>TAL/MQL; italic font and hollow symbols indicate undetected results; "-" is used if no analytical results were available.

SWMU 03-010(a) is monitored within 2M-SMA-1. Following the installation of baseline control measures, two baseline storm water samples were collected on August 4, 2011, and August 20, 2011 (Figure 129-2). Analytical results from these baseline monitoring samples yielded the following TAL exceedances:

Following the installation of enhanced control measures, two corrective action storm water samples were collected on July 25, 2012, and September 12, 2012 (Figure 129-2). Analytical results from these corrective action monitoring samples yielded the following TAL exceedance:

TAL exceedances were also evaluated against the appropriate storm water BV, that is, “Bandelier Tuff background” for undisturbed SMAs or “developed background” for urban settings. BVs are expressed as UTLs using the approved EPA method for calculating BVs. UTLs for undisturbed SMAs were derived from storm water runoff containing entrained sediments derived from Bandelier Tuff and are labeled “Bandelier Tuff Background” in Figure 129-2. UTLs developed for urban settings were derived from runoff from developed landscapes on the Pajarito Plateau, including buildings, parking lots, roads, and associated features, and are labeled “Developed Background” in Figure 129-2.

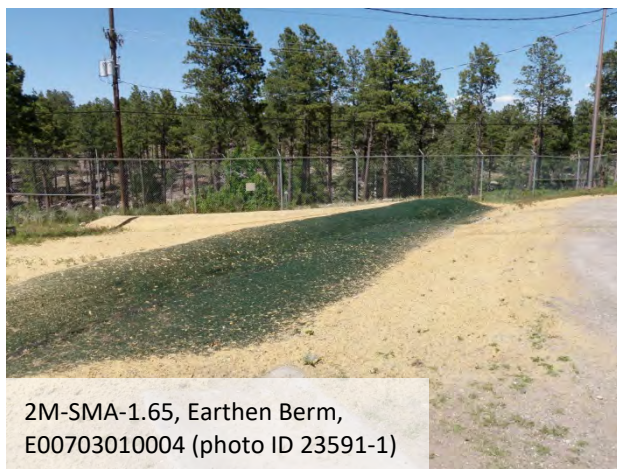
2M-SMA-1.65, Earthen Berm, E00703010004 (photo ID 23591-1)

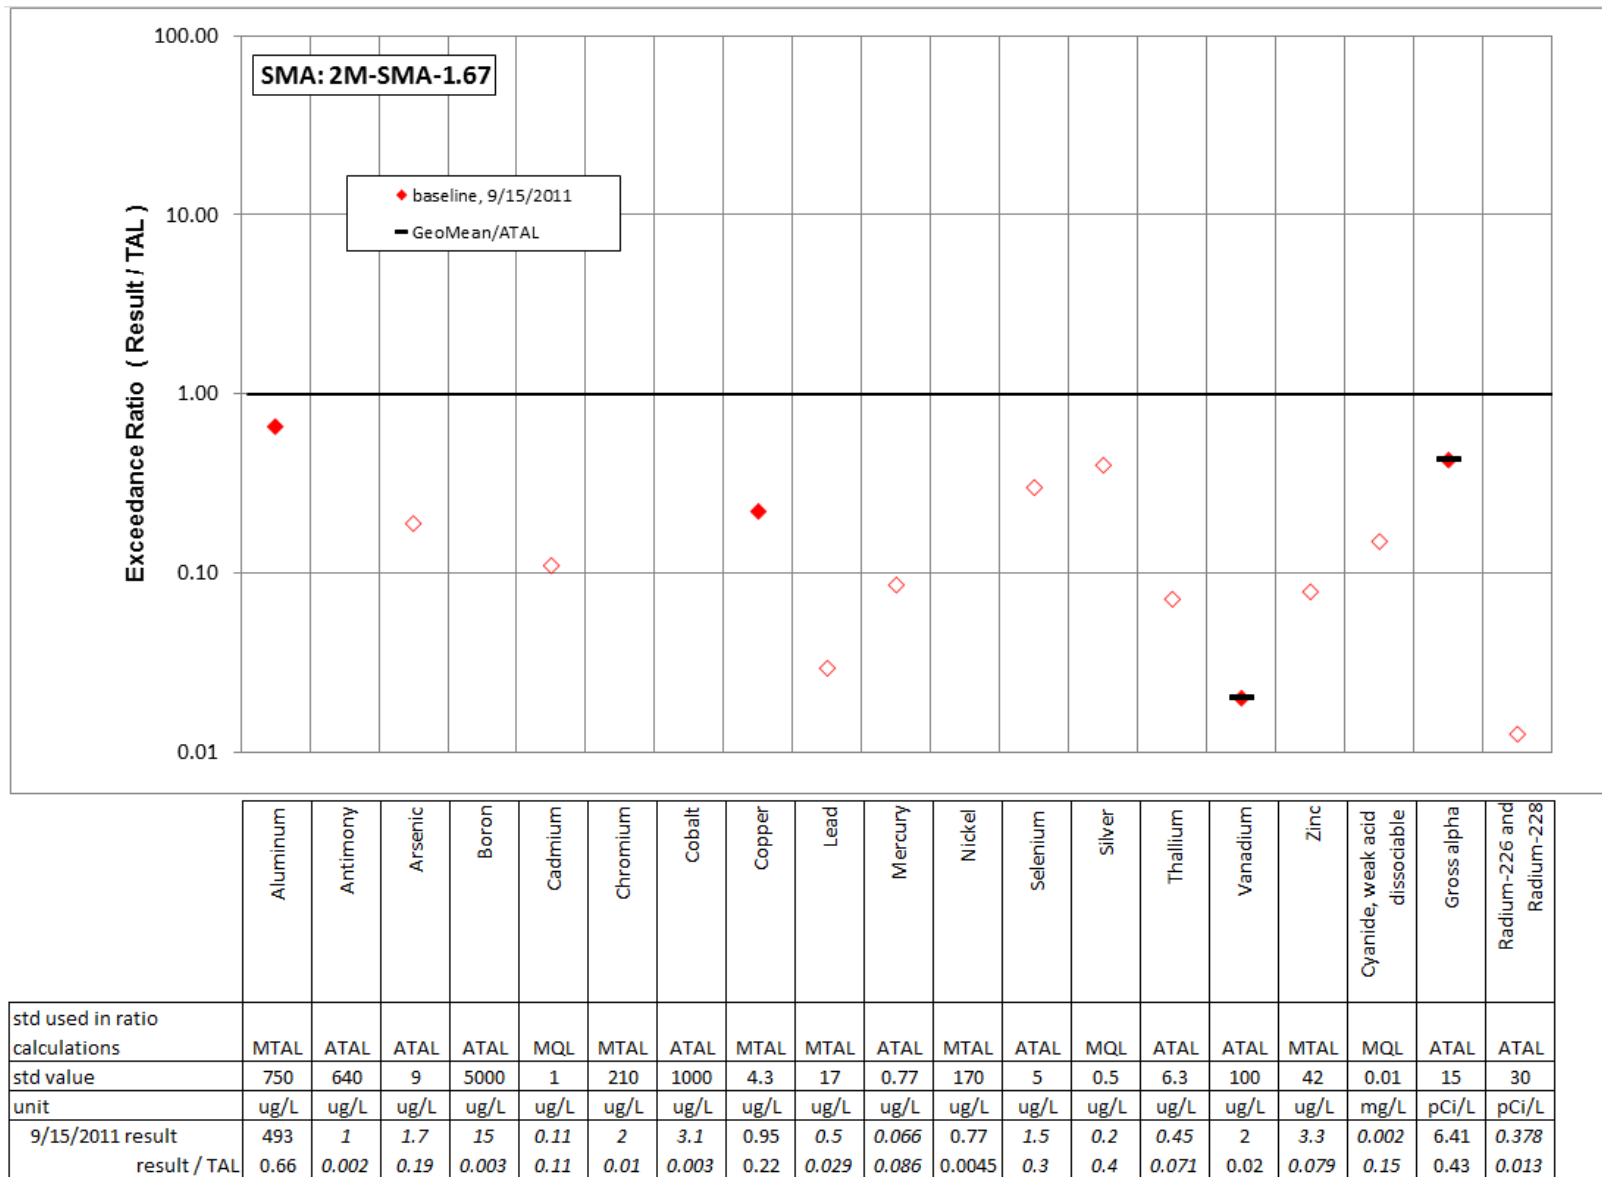
Figure 136-2 Inorganic analytical results summary plot for 2M-SMA-1.67

Bold font indicates result>TAL/MQL; italic font and hollow symbols indicate undetected results; "-" is used if no analytical results were available.

SWMU 06-003(h) is monitored within 2M-SMA-1.67. Following the installation of baseline control measures, a baseline storm water sample was collected on September 15, 2011 (Figures 136-2 and 136-3). Analytical results from this sample yielded no TAL exceedances. The HE sample collected on September 15, 2011, was extracted or analyzed beyond the appropriate holding time and thus may have a low bias and potentially under report the concentration of HE in this sample. Consequently, the results for this analysis cannot be used to confirm that HE is present at a concentration greater or less than the TAL. Therefore, 2M-SMA-1.67 will remain in the baseline monitoring extended phase until a viable baseline confirmation monitoring sample can be collected and analyzed with fully usable results.

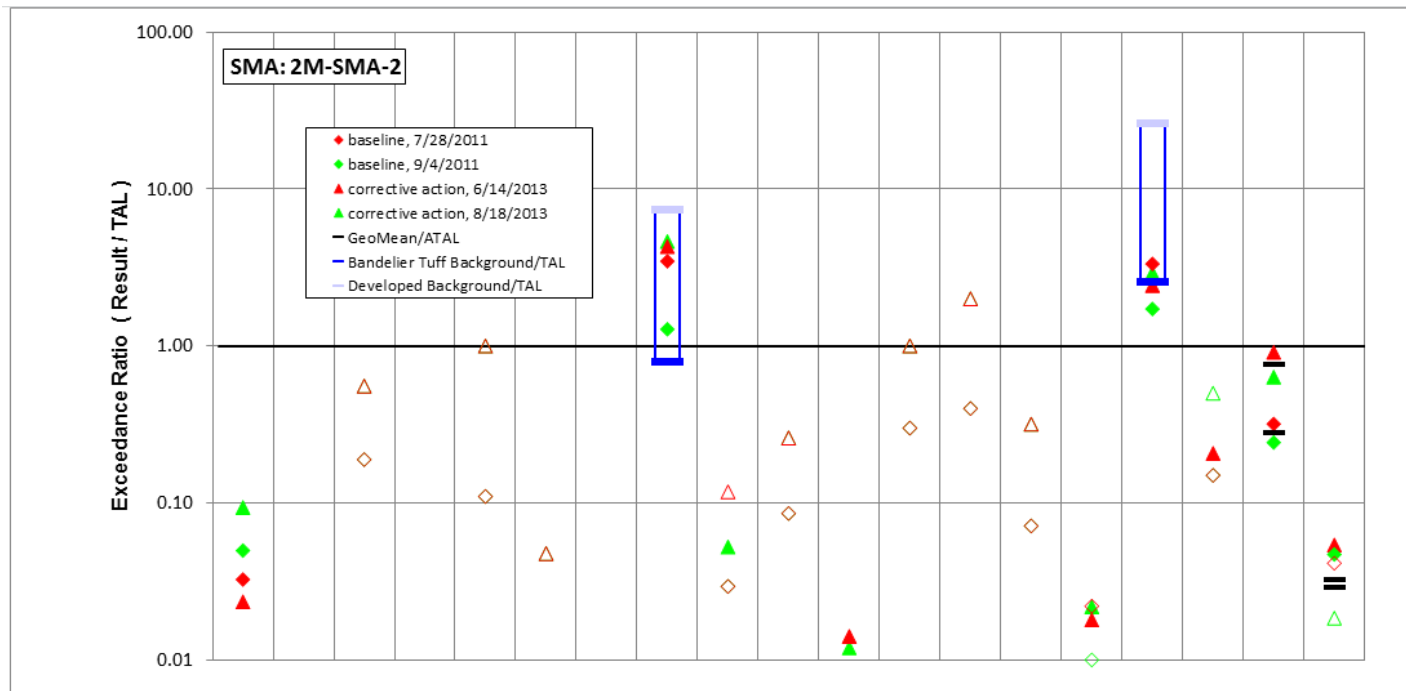
**Figure 140-2 Inorganic analytical results summary plot for 2M-SMA-2**

Aluminum	Antimony	Arsenic	Boron	Cadmium	Chromium	Cobalt	<b>Copper</b>	Lead	Mercury	Nickel	Selenium	<b>Silver</b>	Thallium	Vanadium	Zinc	Cyanide, weak acid dissociable	Gross alpha	Radium-226 and Radium-228
std used in ratio calculations	MTAL	ATAL	ATAL	ATAL	MQL	MTAL	ATAL	MTAL	MTAL	ATAL	MTAL	ATAL	MQL	ATAL	ATAL	MTAL	MQL	ATAL	ATAL
std value	750	640	9	5000	1	210	1000	4.3	17	0.77	170	5	0.5	6.3	100	42	0.01	15	30
unit	ug/L	ug/L	ug/L	ug/L	ug/L	ug/L	ug/L	ug/L	ug/L	ug/L	ug/L	ug/L	ug/L	ug/L	ug/L	ug/L	mg/L	pCi/L	pCi/L
<b>8/18/2013 result</b>	70.2	1.25	5	29.5	1	10	5	<b>19.9</b>	0.891	0.2	2.03	5	<b>1</b>	2	2.18	<b>123</b>	0.005	9.51	0.554
result / TAL	0.094	0.002	0.56	0.0059	1	0.048	0.005	<b>4.6</b>	0.052	0.26	0.012	1	<b>2</b>	0.32	0.022	<b>2.9</b>	0.5	0.63	0.018
<b>6/14/2013 result</b>	17.6	1.84	5	36.1	1	10	2.43	<b>18.5</b>	2	0.2	2.4	5	<b>1</b>	2	1.8	<b>102</b>	0.0021	13.7	1.62
result / TAL	0.023	0.0029	0.56	0.0072	1	0.048	0.0024	<b>4.3</b>	0.12	0.26	0.014	1	<b>2</b>	0.32	0.018	<b>2.4</b>	0.21	0.91	0.054

<b>9/4/2011 result</b>	37.3	1.8	1.7	15	0.11	2	2.7	<b>5.5</b>	0.5	0.066	0.55	1.5	0.2	0.45	1	<b>72.3</b>	0.002	3.64	1.41
result / TAL	0.05	0.003	0.19	0.003	0.11	0.01	0.0027	<b>1.3</b>	0.029	0.086	0.0032	0.3	0.4	0.071	0.001	<b>1.7</b>	0.15	0.24	0.047
<b>7/28/2011 result</b>	24.4	6.2	1.7	18.2	0.11	2	1.6	<b>14.9</b>	0.5	0.066	1.3	1.5	0.2	0.45	2.2	<b>140</b>	0.002	4.78	1.24
result / TAL	0.033	0.0097	0.19	0.0036	0.11	0.01	0.002	<b>3.5</b>	0.029	0.086	0.0076	0.3	0.4	0.071	0.022	<b>3.3</b>	0.15	0.32	0.041

Bold font indicates result>TAL/MQL; italic font and hollow symbols indicate undetected results; "-" is used if no analytical results were available.

SWMUs 03-050(d) and 03-054(b) are monitored within 2M-SMA-2. Following the installation of baseline control measures, two baseline storm water samples were collected on July 28, 2011, and September 4, 2011 (Figures 140-2 and 140-3). In Figure 140-2, cadmium, selenium, and silver are reported as nondetectable results equal to or greater than their respective TALs. These values are reported at the PQL; however, the MDLs for these analytes are below the TALs. Analytical results from these samples yielded the following TAL exceedances:

Following the installation of enhanced control measures at 2M-SMA-2, corrective action storm water samples were collected on June 1, 2013, and September 4, 2013 (Figures 140-2 and 140-3). Analytical results from these corrective action monitoring samples yielded the following TAL exceedances:

TAL exceedances were also evaluated against the appropriate storm water BV, that is, “Bandelier Tuff background” for undisturbed SMAs or “developed background” for urban settings. BVs are expressed as UTLs using the approved EPA method for calculating BVs. UTLs for undisturbed SMAs were derived from storm water runoff containing entrained sediments derived from Bandelier Tuff and are labeled “Bandelier Tuff Background” in Figures 140-2 and 140-3. UTLs developed for urban settings were derived from runoff from developed landscapes on the Pajarito Plateau, including buildings, parking lots, roads, and associated features, and are labeled “Developed Background” in Figures 140-2 and 140-3.

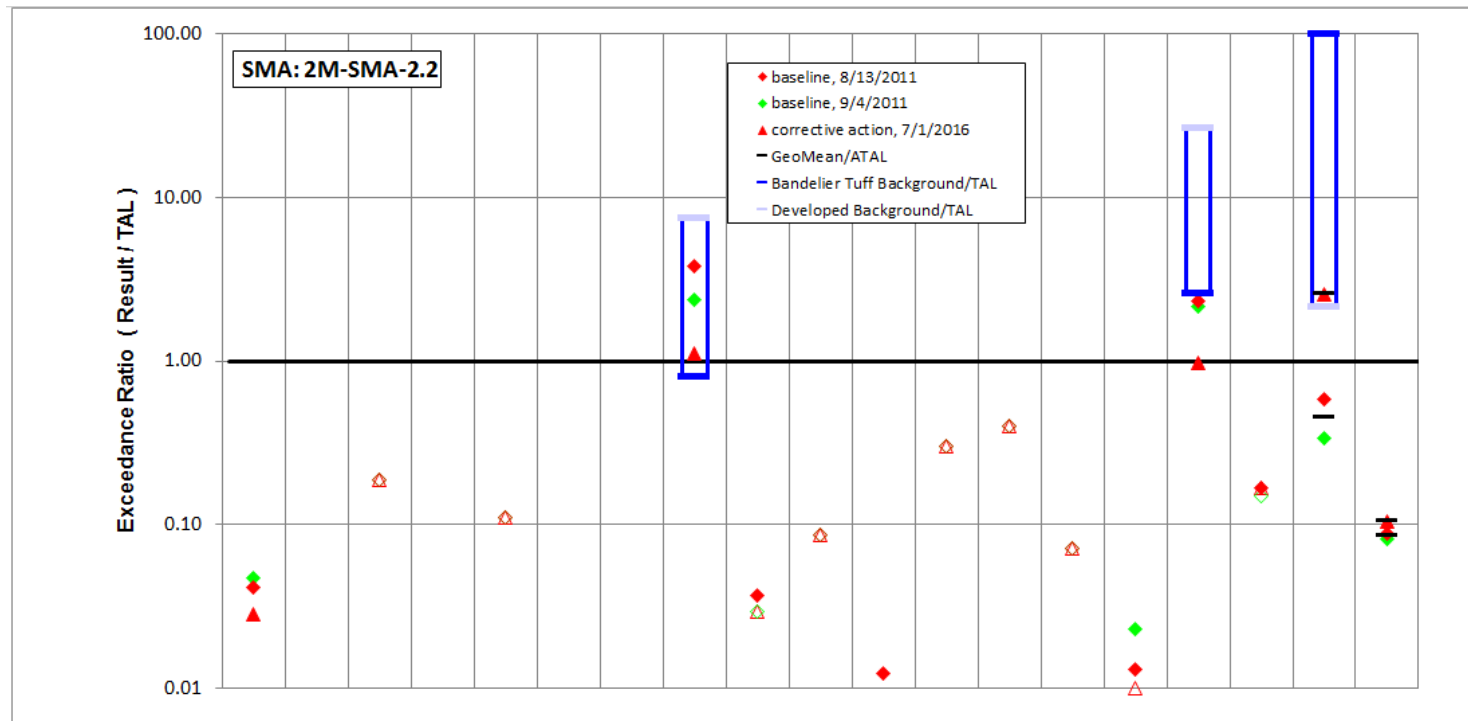
**Figure 141-2 Inorganic analytical results summary plot for 2M-SMA-2.2**

Aluminum	Antimony	Arsenic	Boron	Cadmium	Chromium	Cobalt	<b>Copper</b>	Lead	Mercury	Nickel	Selenium	Silver	Thallium	Vanadium	<b>Zinc</b>	Cyanide, weak acid dissociable	<b>Gross alpha</b>	Radium-226 and Radium-228
std used in ratio calculations	MTAL	ATAL	ATAL	ATAL	MTAL	MTAL	ATAL	MTAL	MTAL	ATAL	MTAL	ATAL	MTAL	ATAL	ATAL	MTAL	ATAL	ATAL	ATAL
std value	750	640	9	5000	1	210	1000	4.3	17	0.77	170	5	0.5	6.3	100	42	0.01	15	30
unit	ug/L	ug/L	ug/L	ug/L	ug/L	ug/L	ug/L	ug/L	ug/L	ug/L	ug/L	ug/L	ug/L	ug/L	ug/L	ug/L	mg/L	pCi/L	pCi/L
<b>7/1/2016 result</b>	21.1	1	1.7	15	0.11	2	1	<b>4.8</b>	0.5	0.067	0.5	1.5	0.2	0.45	1	40.8	0.002	<b>37.9</b>	3.16
result / TAL	0.028	0.002	0.19	0.003	0.11	0.01	0.001	<b>1.1</b>	0.029	0.087	0.003	0.3	0.4	0.071	0.01	0.97	0.17	2.5	0.11
<b>9/4/2011 result</b>	35.3	1	1.7	15	0.11	2	2	<b>10.1</b>	0.5	0.066	1.2	1.5	0.2	0.45	2.3	<b>90.1</b>	0.002	5.09	2.43
result / TAL	0.047	0.002	0.19	0.003	0.11	0.01	0.002	<b>2.3</b>	0.029	0.086	0.0071	0.3	0.4	0.071	0.023	<b>2.1</b>	0.15	0.34	0.081

<b>8/13/2011 result</b>	30.9	1	1.7	19.3	0.11	2	2.1	<b>16.4</b>	0.63	0.066	2.1	1.5	0.2	0.45	1.3	<b>97.2</b>	0.0017	8.76	2.63
result / TAL	0.041	0.002	0.19	0.0039	0.11	0.01	0.0021	<b>3.8</b>	0.037	0.086	0.012	0.3	0.4	0.071	0.013	<b>2.3</b>	0.17	0.58	0.088

Bold font indicates result>TAL or MQL; italic font and hollow symbols indicate undetected results; "-" is used if no analytical results were available.

AOC 03-003(k) is monitored within 2M-SMA-2.2. Following the installation of baseline control measures, two baseline storm water samples were collected on August 13, 2011, and September 4, 2011 (Figures 141-2 and 141-3). This Site is now certified as corrective action complete under no exposure. Analytical results from these samples yielded the following TAL exceedances:

Following certification of no exposure, a corrective action investigation storm water sample was collected on July 1, 2016 (Figures 141-2 and 141-3). Analytical results from this sample yielded the following TAL exceedances:

TAL exceedances were also evaluated against the appropriate storm water BV, that is, “Bandelier Tuff background” for undisturbed SMAs or “developed background” for urban settings. BVs are expressed as UTLs using the approved EPA method for calculating BVs. UTLs for undisturbed SMAs were derived from storm water runoff containing entrained sediments derived from Bandelier Tuff and are labeled “Bandelier Tuff Background” in Figures 141-2 and 141-3. UTLs developed for urban settings were derived from runoff from developed landscapes on the Pajarito Plateau, including buildings, parking lots, roads, and associated features, and are labeled “Developed Background” in Figures 141-2 and 141-3.

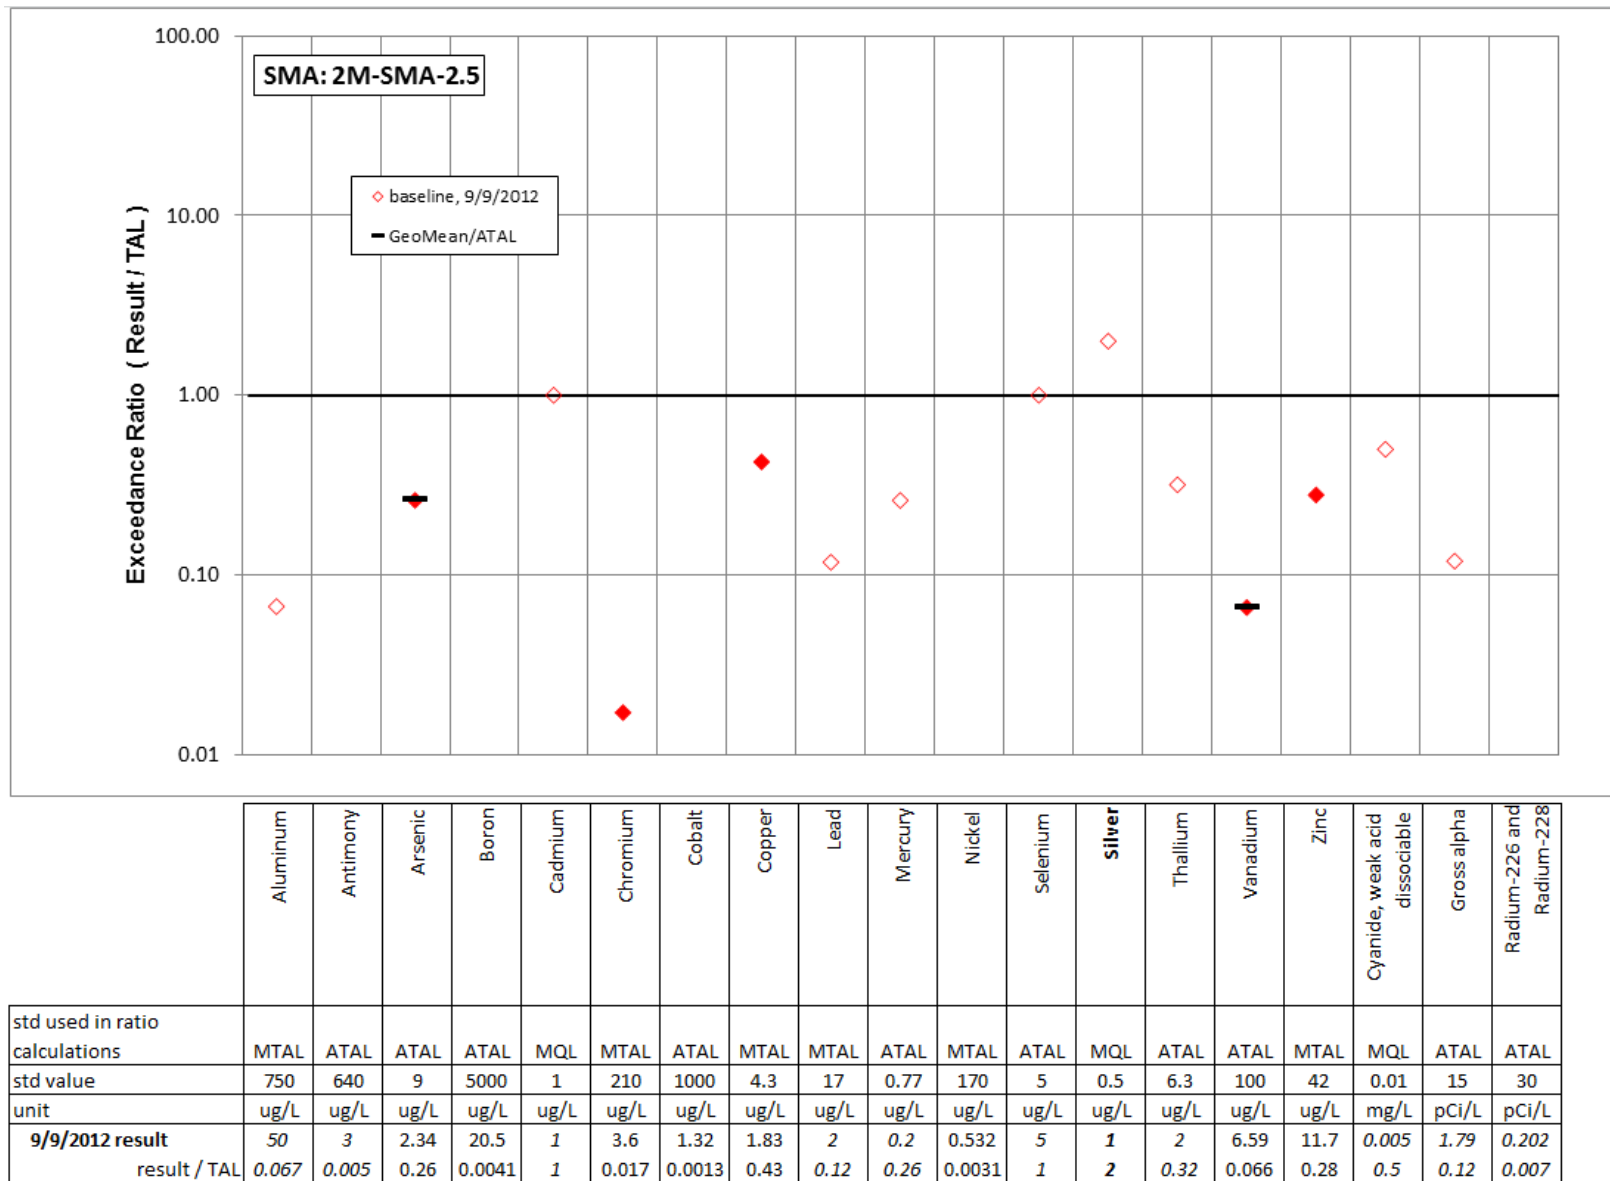
**Figure 142-2 Inorganic analytical results summary plot for 2M-SMA-2.5**

Bold font indicates result>TAL/MQL; italic font and hollow symbols indicate undetected results; "-" is used if no analytical results were available.

SWMU 40-001(c) is monitored within 2M-SMA-2.5. Following the installation of baseline control measures, a baseline storm water sample was collected on September 9, 2012 (Figure 142-2). In Figure 142-2, cadmium, selenium, and silver are reported as nondetectable results equal to or greater than their respective TALs. These values are reported at the PQL; however, the MDLs for these analytes are below the TALs. Analytical results from this sample yielded no TAL exceedances. Baseline confirmation is complete for 2M-SMA-2.5 and the associated SWMU 40-001(c) because all applicable sampling results are below the applicable MTAL or ATAL. No further sampling is required for 2M-SMA-2.5 for the duration of the IP.

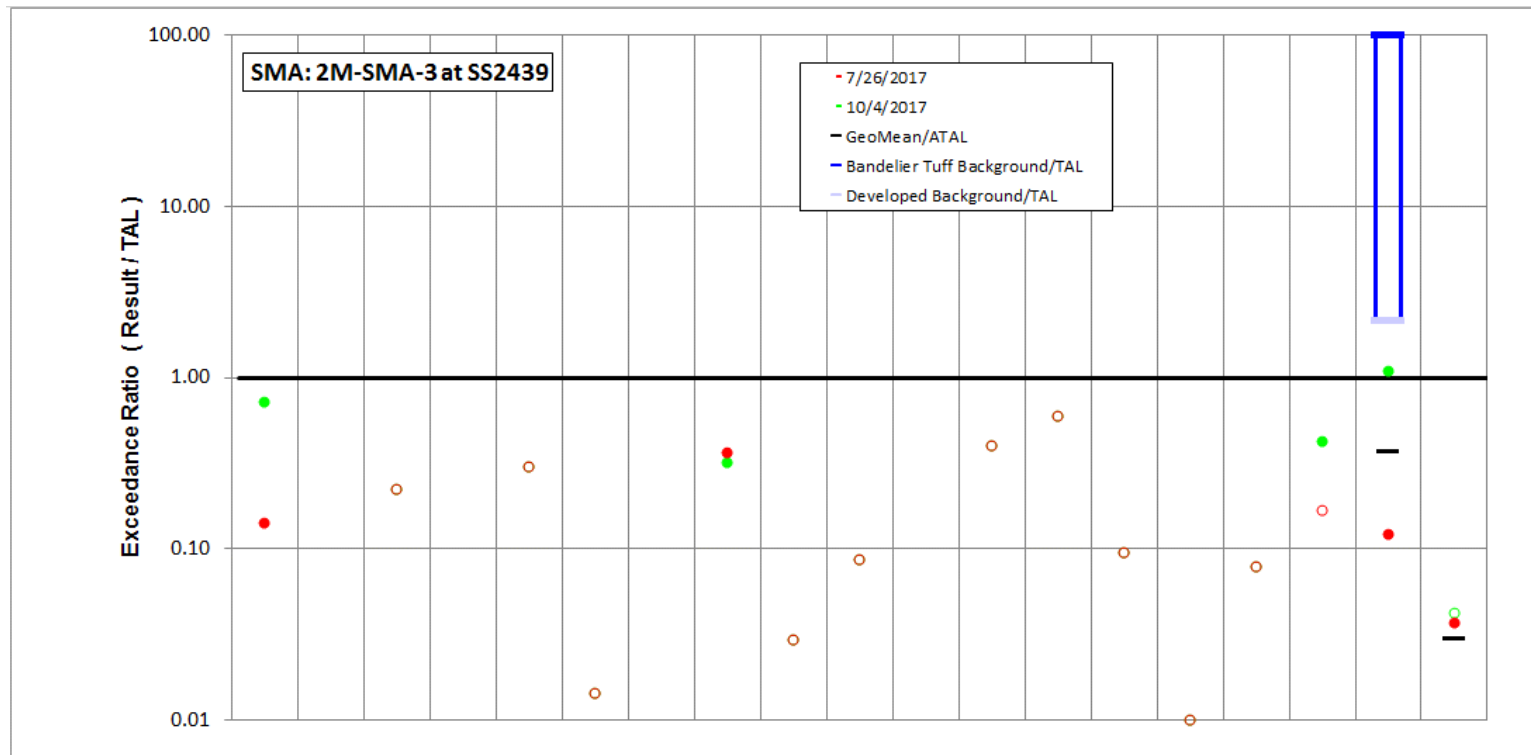
**Figure 143-2a Inorganic analytical results summary plot for 2M-SMA-3**

Aluminum	Antimony	Arsenic	Boron	Cadmium	Chromium	Cobalt	Copper	Lead	Mercury	Nickel	Selenium	Silver	Thallium	Vanadium	Zinc	Cyanide, weak acid dissociable	<b>Gross alpha</b>	Radium-226 and Radium-228
std used in ratio calculations	MTAL	ATAL	ATAL	ATAL	MTAL	MTAL	ATAL	MTAL	MTAL	ATAL	MTAL	ATAL	MTAL	ATAL	ATAL	MTAL	ATAL	ATAL	ATAL
std value	750	640	9	5000	1	210	1000	4.3	17	0.77	170	5	0.5	6.3	100	42	0.01	15	30
unit	ug/L	ug/L	ug/L	ug/L	ug/L	ug/L	ug/L	ug/L	ug/L	ug/L	ug/L	ug/L	ug/L	ug/L	ug/L	ug/L	mg/L	pCi/L	pCi/L
<b>10/4/2017 result</b>	539	<i>1</i>	<i>2</i>	<i>15</i>	<i>0.3</i>	<i>3</i>	<i>1</i>	1.36	<i>0.5</i>	<i>0.067</i>	0.623	<i>2</i>	<i>0.3</i>	<i>0.6</i>	<i>1</i>	<i>3.3</i>	0.0042	<b>16.2</b>	1.26
result / TAL	0.72	<i>0.002</i>	<i>0.22</i>	<i>0.003</i>	<i>0.3</i>	<i>0.014</i>	<i>0.001</i>	0.32	<i>0.029</i>	<i>0.087</i>	0.0037	<i>0.4</i>	<i>0.6</i>	<i>0.095</i>	<i>0.01</i>	<i>0.079</i>	0.42	<b>1.1</b>	<i>0.042</i>

<b>7/26/2017 result</b>	105	<i>1</i>	<i>2</i>	<i>15</i>	<i>0.3</i>	<i>3</i>	<i>1</i>	1.56	<i>0.5</i>	<i>0.067</i>	0.673	<i>2</i>	<i>0.3</i>	<i>0.6</i>	<i>1</i>	<i>3.3</i>	0.002	1.83	1.11
result / TAL	0.14	<i>0.002</i>	<i>0.22</i>	<i>0.003</i>	<i>0.3</i>	<i>0.014</i>	<i>0.001</i>	0.36	<i>0.029</i>	<i>0.087</i>	0.004	<i>0.4</i>	<i>0.6</i>	<i>0.095</i>	<i>0.01</i>	<i>0.079</i>	0.17	0.12	0.037

Bold font indicates result>TAL or MQL; italic font and hollow symbols indicate undetected results; "-" is used if no analytical results were available.

Enhanced control confirmation monitoring storm water samples were collected on July 26, 2017, and October 4, 2017 (Figures 143-2 and 143-3). Analytical results from these samples yielded no TAL exceedances.

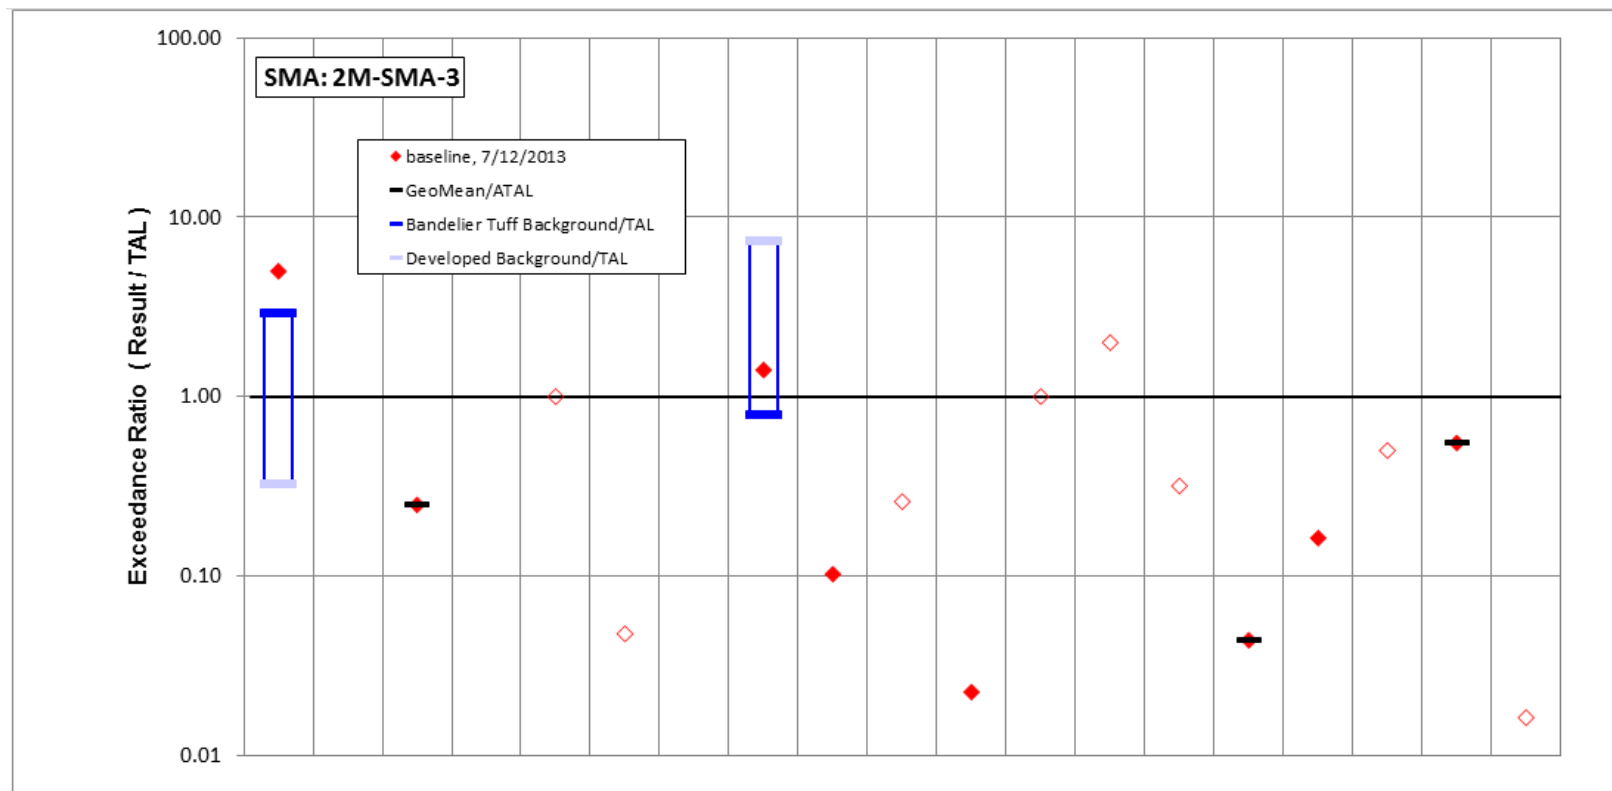
**Figure 143-2b Inorganic analytical results summary plot for 2M-SMA-3**

<b>Aluminum</b>	Antimony	Arsenic	Boron	Cadmium	Chromium	Cobalt	<b>Copper</b>	Lead	Mercury	Nickel	Selenium	<b>Silver</b>	Thallium	Vanadium	Zinc	Cyanide, weak acid dissociable	Gross alpha	Radium-226 and Radium-228
std used in ratio calculations	MTAL	ATAL	ATAL	ATAL	MQL	MTAL	ATAL	MTAL	MTAL	ATAL	MTAL	ATAL	MQL	ATAL	ATAL	MTAL	MQL	ATAL	ATAL
std value	750	640	9	5000	1	210	1000	4.3	17	0.77	170	5	0.5	6.3	100	42	0.01	15	30
unit	ug/L	ug/L	ug/L	ug/L	ug/L	ug/L	ug/L	ug/L	ug/L	ug/L	ug/L	ug/L	ug/L	ug/L	ug/L	ug/L	mg/L	pCi/L	pCi/L
<b>7/12/2013 result</b>	<b>3750</b>	3	2.24	25.1	1	10	4.06	<b>6.05</b>	1.74	0.2	3.83	5	<b>1</b>	2	4.38	6.83	0.005	8.27	0.487
result / TAL	<b>5</b>	0.005	0.25	0.005	1	0.048	0.004	<b>1.4</b>	0.1	0.26	0.023	1	<b>2</b>	0.32	0.044	0.16	0.5	0.55	0.016

Bold font indicates result>TAL/MQL; italic font and hollow symbols indicate undetected results; "-" is used if no analytical results were available.

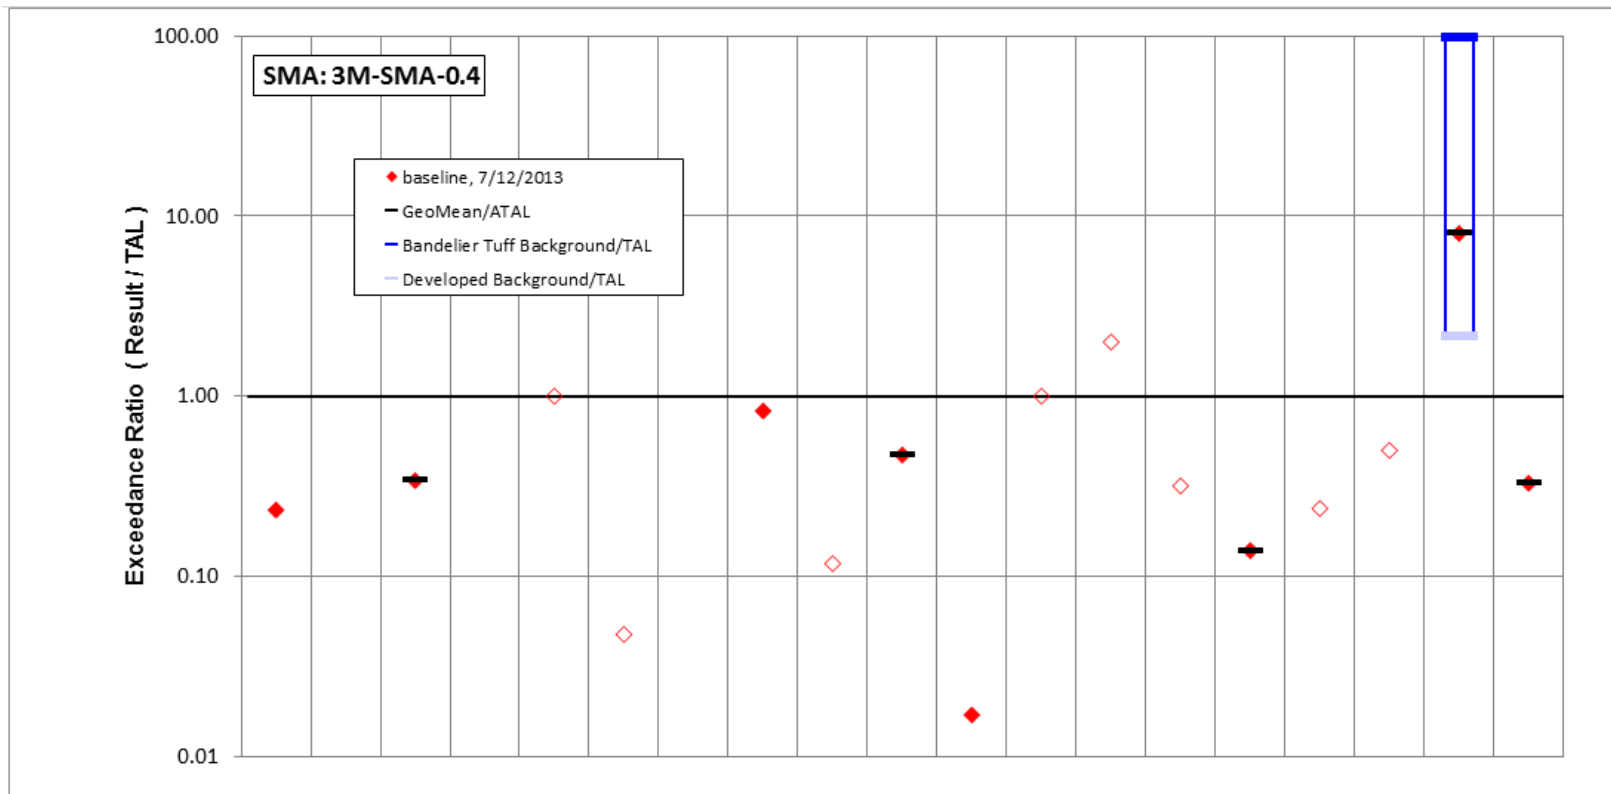
**Figure 145-2 Inorganic analytical results summary plot for 3M-SMA-0.4**

Aluminum	Antimony	Arsenic	Boron	Cadmium	Chromium	Cobalt	Copper	Lead	Mercury	Nickel	Selenium	Silver	Thallium	Vanadium	Zinc	Cyanide, weak acid dissociable	Gross alpha	Radium-226 and Radium-228
std used in ratio calculations	MTAL	ATAL	ATAL	ATAL	MQL	MTAL	ATAL	MTAL	MTAL	ATAL	MTAL	ATAL	MQL	ATAL	ATAL	MTAL	MQL	ATAL	ATAL
std value	750	640	9	5000	1	210	1000	4.3	17	0.77	170	5	0.5	6.3	100	42	0.01	15	30
unit	ug/L	ug/L	ug/L	ug/L	ug/L	ug/L	ug/L	ug/L	ug/L	ug/L	ug/L	ug/L	ug/L	ug/L	ug/L	ug/L	mg/L	pCi/L	pCi/L
<b>7/12/2013 result</b>	175	3	3.06	32.3	1	10	1.46	3.56	2	0.363	2.89	5	1	2	13.9	10	0.005	120	9.86
result / TAL	0.23	0.005	0.34	0.0065	1	0.048	0.0015	0.83	0.12	0.47	0.017	1	2	0.32	0.14	0.24	0.5	8	0.33

Bold font indicates result>TAL/MQL; italic font and hollow symbols indicate undetected results; "-" is used if no analytical results were available.

SWMU 15-006(b) is monitored within 3M-SMA-0.4. Following the installation of baseline control measures, a baseline storm water sample was collected on July 12, 2013 (Figures 145-2 and 145-3). In Figure 145-2, cadmium, selenium, and silver are reported as nondetectable results equal to or greater than their respective TALs. These values are reported at the PQL; however, the MDLs for these analytes are below the TALs. Analytical results from this sample yielded the following TAL exceedance:

TAL exceedances were also evaluated against the appropriate storm water BVs, that is, “Bandelier Tuff background” for undisturbed SMAs or “developed background” for urban settings. BVs are expressed as UTLs using the approved EPA method for calculating BVs. UTLs for undisturbed SMAs were derived from storm water runoff containing entrained sediments derived from Bandelier Tuff and are labeled “Bandelier Tuff Background” in Figures 145-2 and 145-3. UTLs developed for urban settings were derived from runoff from developed landscapes on the Pajarito Plateau, including buildings, parking lots, roads, and associated features, and are labeled “Developed Background” in Figures 145-2 and 145-3.

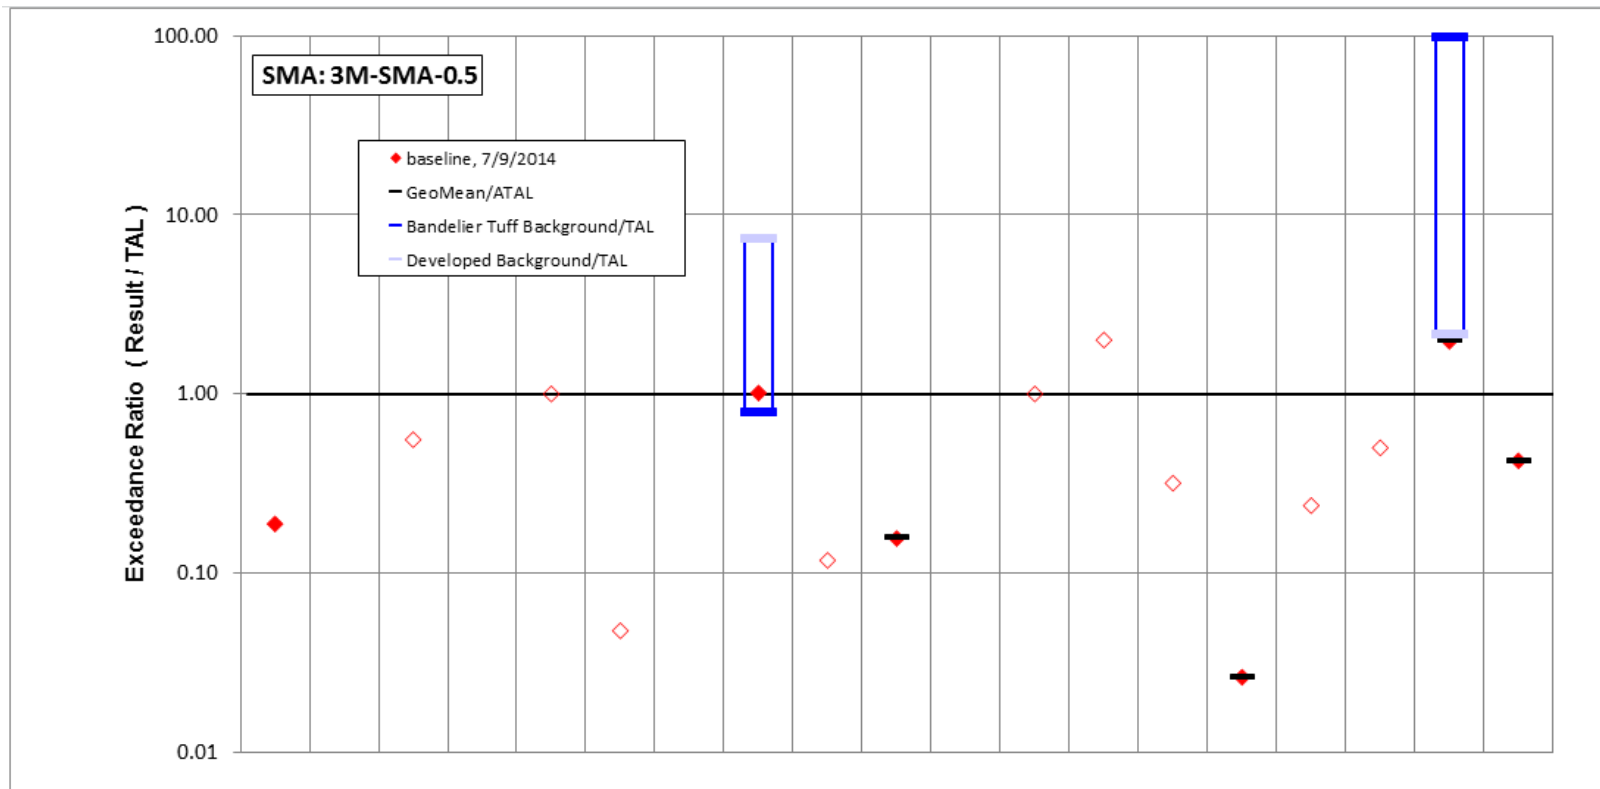
Figure 146-2 Inorganic analytical results summary plot for 3M-SMA-0.5

Aluminum	Antimony	Arsenic	Boron	Cadmium	Chromium	Cobalt	<b>Copper</b>	Lead	Mercury	Nickel	Selenium	<b>Silver</b>	Thallium	Vanadium	Zinc	Cyanide, weak acid dissociable	<b>Gross alpha</b>	Radium-226 and Radium-228
std used in ratio calculations	MTAL	ATAL	ATAL	ATAL	MQL	MTAL	ATAL	MTAL	MTAL	ATAL	MTAL	ATAL	MQL	ATAL	ATAL	MTAL	MQL	ATAL	ATAL
std value	750	640	9	5000	1	210	1000	4.3	17	0.77	170	5	0.5	6.3	100	42	0.01	15	30
unit	ug/L	ug/L	ug/L	ug/L	ug/L	ug/L	ug/L	ug/L	ug/L	ug/L	ug/L	ug/L	ug/L	ug/L	ug/L	ug/L	mg/L	pCi/L	pCi/L
<b>7/9/2014 result</b>	141	3	5	16.5	1	10	5	<b>4.35</b>	2	0.12	1.39	5	<b>1</b>	2	2.62	10	0.005	<b>29.5</b>	12.7
result / TAL	0.19	0.005	0.56	0.0033	1	0.048	0.005	<b>1</b>	0.12	0.16	0.0082	1	<b>2</b>	0.32	0.026	0.24	0.5	<b>2</b>	0.42

Bold font indicates result>TAL/MQL; italic font and hollow symbols indicate undetected results; "-" is used if no analytical results were available.

SWMUs 15-006(c) and 15-009(c) are monitored within 3M-SMA-0.5. Following the installation of baseline control measures, a baseline storm water sample was collected on July 9, 2014 (Figures 146-2 and 146-3). In Figure 146-2, cadmium, selenium, and silver are reported as nondetectable results equal to or greater than their respective TALs. These values are reported at the PQL; however, the MDLs for these analytes are below the TALs. Analytical results from this sample yielded the following TAL exceedances:

TAL exceedances were also evaluated against the appropriate storm water BVs, that is, “Bandelier Tuff background” for undisturbed SMAs or “developed background” for urban settings. BVs are expressed as UTLs using the approved EPA method for calculating BVs. UTLs for undisturbed SMAs were derived from storm water runoff containing entrained sediments derived from Bandelier Tuff and are labeled “Bandelier Tuff Background” in Figures 146-2 and 146-3. UTLs developed for urban settings were derived from runoff from developed landscapes on the Pajarito Plateau, including buildings, parking lots, roads, and associated features, and are labeled “Developed Background” in Figures 146-2 and 146-3.

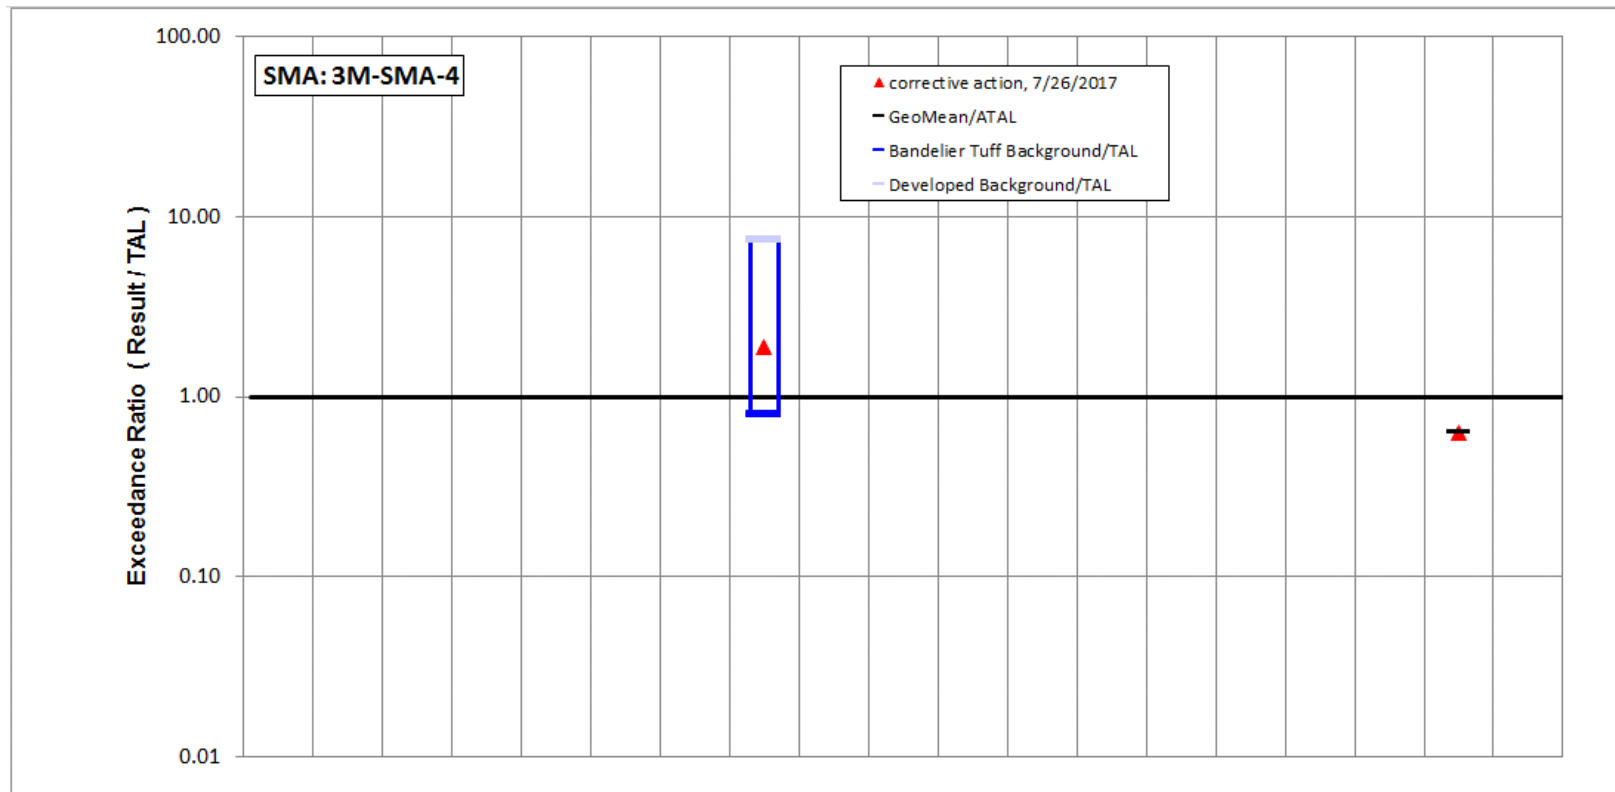
Figure 149-2a Inorganic analytical results summary plot for 3M-SMA-4

Aluminum	Antimony	Arsenic	Boron	Cadmium	Chromium	Cobalt	<b>Copper</b>	Lead	Mercury	Nickel	Selenium	Silver	Thallium	Vanadium	Zinc	Cyanide, weak acid dissociable	Gross alpha	Radium-226 and Radium-228
std used in ratio calculations	-	-	-	-	-	-	-	MTAL	-	-	-	-	-	-	-	-	-	ATAL	-
std value	-	-	-	-	-	-	-	4.3	-	-	-	-	-	-	-	-	-	15	-
unit	ug/L	ug/L	ug/L	ug/L	ug/L	ug/L	ug/L	ug/L	ug/L	ug/L	ug/L	ug/L	ug/L	ug/L	ug/L	ug/L	mg/L	pCi/L	pCi/L
7/26/2017 result	-	-	-	-	-	-	-	<b>8.11</b>	-	-	-	-	-	-	-	-	-	9.4	-
result / TAL	-	-	-	-	-	-	-	<b>1.9</b>	-	-	-	-	-	-	-	-	-	0.63	-

Bold font indicates result>TAL or MQL; italic font and hollow symbols indicate undetected results; "-" is used if no analytical results were available.

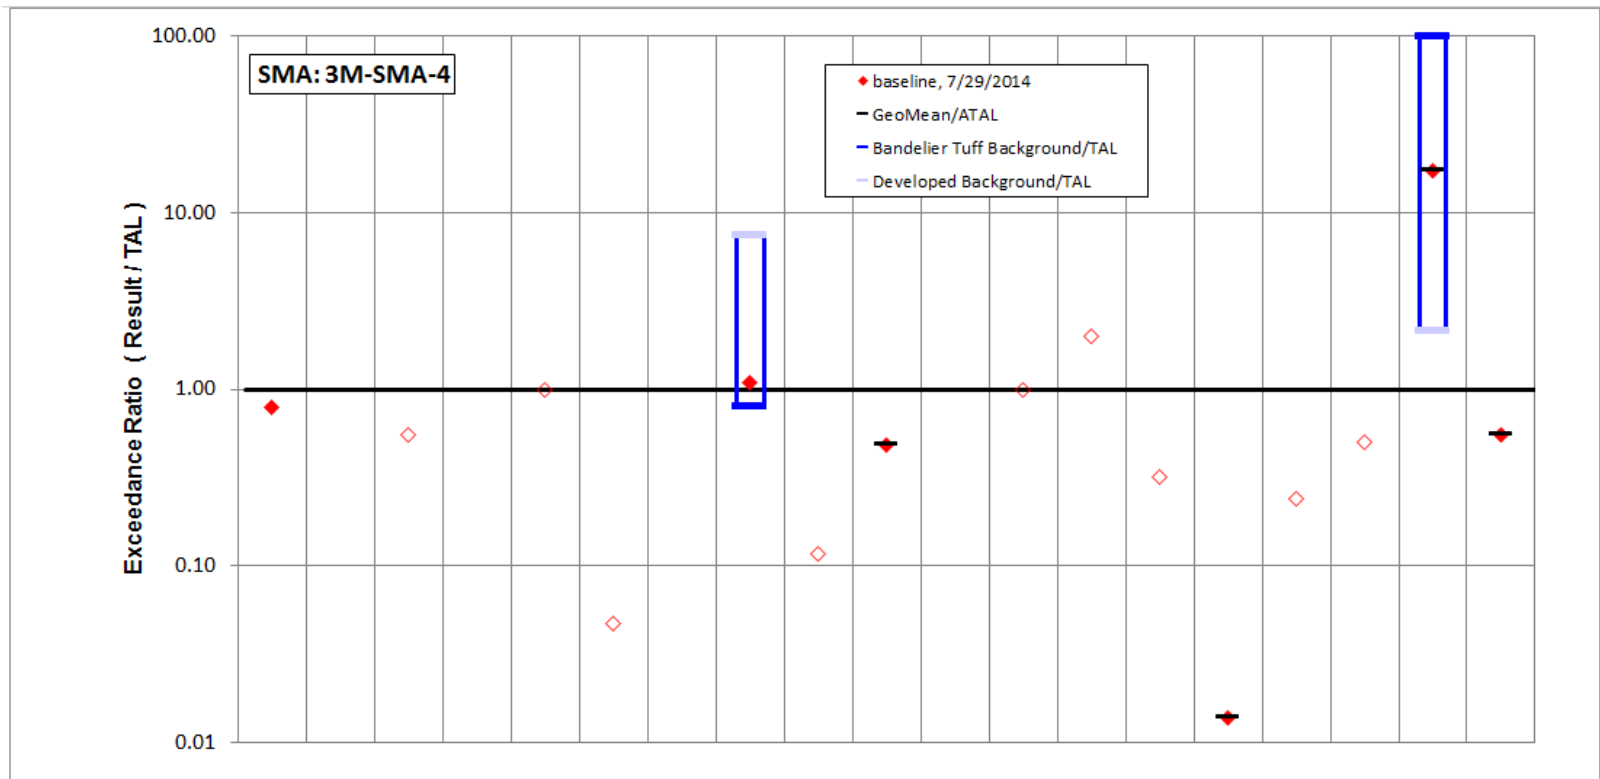
**Figure 149-2b Inorganic analytical results summary plot for 3M-SMA-4**

Aluminum	Antimony	Arsenic	Boron	Cadmium	Chromium	Cobalt	<b>Copper</b>	Lead	Mercury	Nickel	Selenium	<b>Silver</b>	Thallium	Vanadium	Zinc	Cyanide, weak acid dissociable	<b>Gross alpha</b>	Radium-226 and Radium-228
std used in ratio calculations	MTAL	ATAL	ATAL	ATAL	MTAL	MTAL	ATAL	MTAL	MTAL	ATAL	MTAL	ATAL	MTAL	ATAL	ATAL	MTAL	ATAL	ATAL	ATAL
std value	750	640	9	5000	1	210	1000	4.3	17	0.77	170	5	0.5	6.3	100	42	0.01	15	30
unit	ug/L	ug/L	ug/L	ug/L	ug/L	ug/L	ug/L	ug/L	ug/L	ug/L	ug/L	ug/L	ug/L	ug/L	ug/L	ug/L	mg/L	pCi/L	pCi/L
<b>7/29/2014 result</b>	593	3	5	18.3	1	10	2.05	<b>4.72</b>	2	0.372	1.31	5	<b>1</b>	2	1.37	10	<b>0.005</b>	<b>259</b>	16.4
result / TAL	0.79	<i>0.005</i>	<i>0.56</i>	0.0037	1	<i>0.048</i>	0.002	<b>1.1</b>	0.12	0.48	0.0077	1	<b>2</b>	0.32	0.014	0.24	0.5	<b>17</b>	0.55

Bold font indicates result>TAL; italic font indicates undetected results; "-" is used if no analytical results were available.
