# 2017 Update to the Site Discharge Pollution Prevention Plan, Revision 1

Los Alamos National Laboratory  
NPDES Permit No. NM0030759  
LA-UR-18-22935 • May 1, 2018

## Pajarito Watershed

**Volume 3**

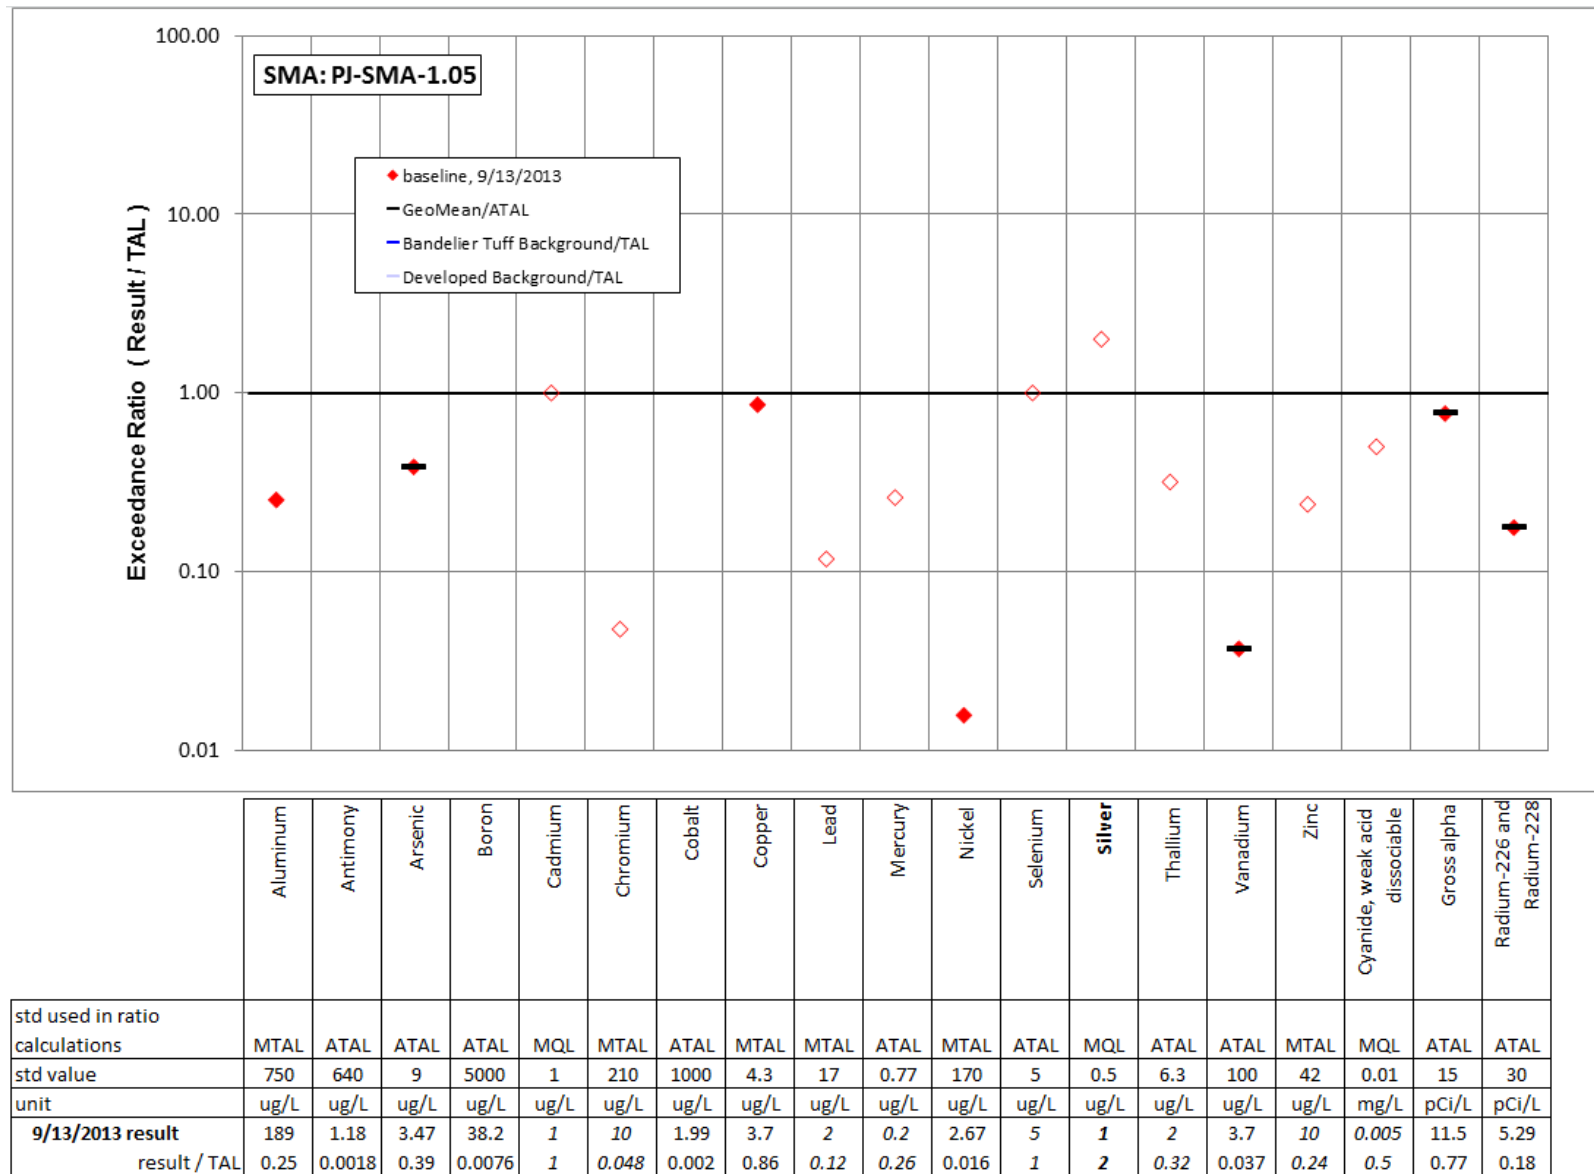
**Figure 150-2 Inorganic analytical results summary plot for PJ-SMA-1.05**

Bold font indicates result>TAL/MQL; italic font and hollow symbols indicate undetected results; "-" is used if no analytical results were available.

SWMU 09-013 is monitored within PJ-SMA-1.05. Following the installation of baseline control measures, a baseline storm water sample was collected on September 13, 2013 (Figures 150-2 and 150-3). In Figure 150-2, cadmium, selenium, and silver are reported as nondetectable results equal to or greater than their respective TALs. These values are reported at the PQL; however, the MDLs for these analytes are below the TALs. Analytical results from this sample yielded the following TAL exceedance:

TAL exceedances were also evaluated against the appropriate storm water BVs, that is, “Bandelier Tuff background” for undisturbed SMAs or “developed background” for urban settings. BVs are expressed as UTLs using the approved EPA method for calculating BVs. UTLs for undisturbed SMAs were derived from storm water runoff containing entrained sediments derived from Bandelier Tuff and are labeled “Bandelier Tuff Background” in Figures 150-2 and 150-3. UTLs developed for urban settings were derived from runoff from developed landscapes on the Pajarito Plateau, including buildings, parking lots, roads, and associated features, and are labeled “Developed Background” in Figures 150-2 and 150-3.

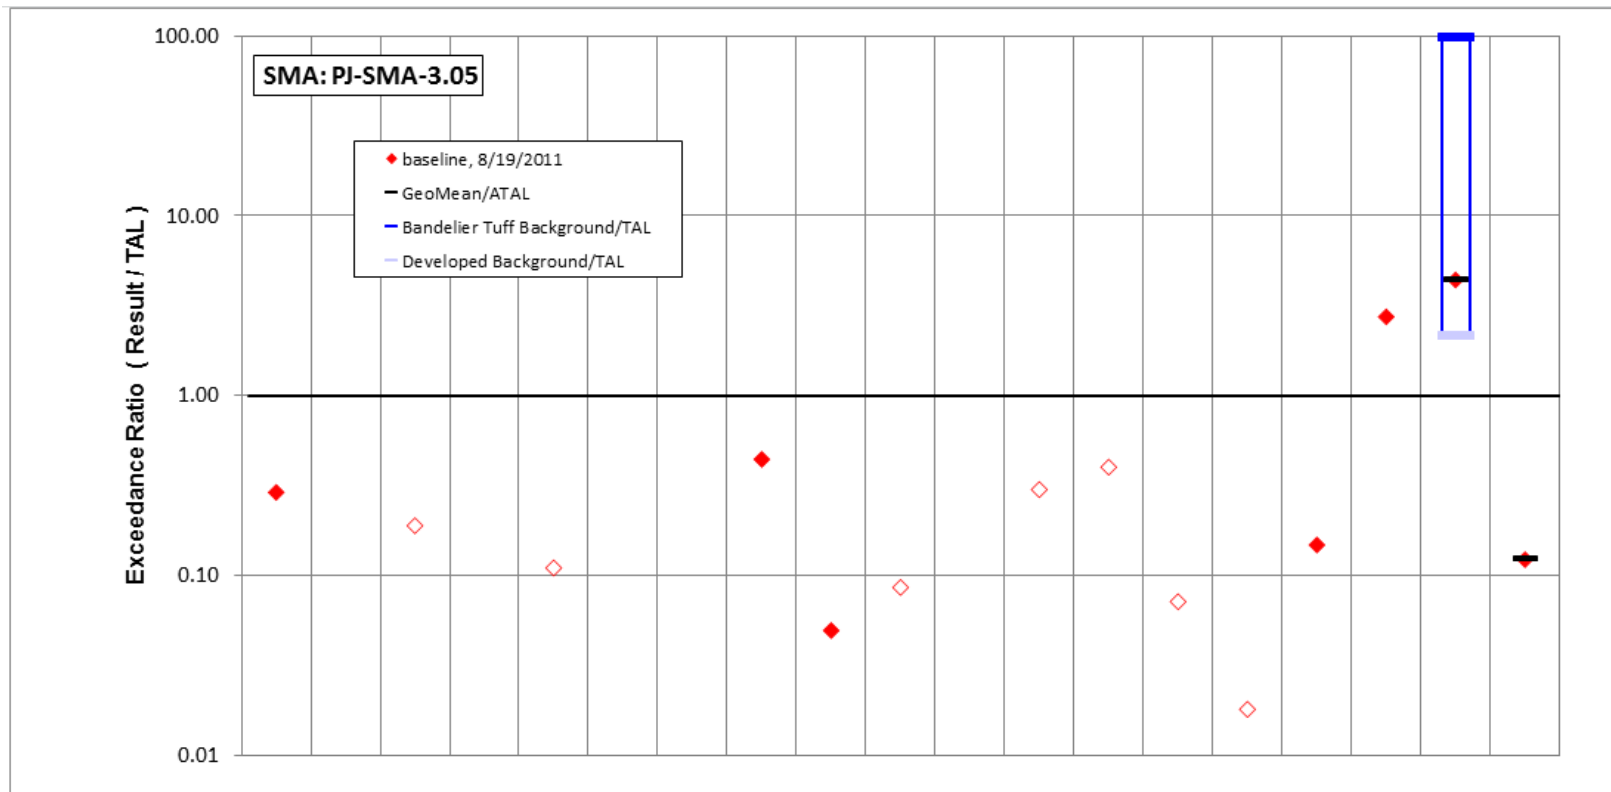
Aluminum	Antimony	Arsenic	Boron	Cadmium	Chromium	Cobalt	Copper	Lead	Mercury	Nickel	Selenium	Silver	Thallium	Vanadium	Zinc	Cyanide, weak acid dissociable	Gross alpha	Radium-226 and Radium-228
std used in ratio calculations	MTAL	ATAL	ATAL	ATAL	MQL	MTAL	ATAL	MTAL	MTAL	ATAL	MTAL	ATAL	MQL	ATAL	ATAL	MTAL	MQL	ATAL	ATAL
std value	750	640	9	5000	1	210	1000	4.3	17	0.77	170	5	0.5	6.3	100	42	0.01	15	30
unit	ug/L	ug/L	ug/L	ug/L	ug/L	ug/L	ug/L	ug/L	ug/L	ug/L	ug/L	ug/L	ug/L	ug/L	ug/L	ug/L	mg/L	pCi/L	pCi/L
<b>8/19/2011 result</b>	217	1	1.7	15	0.11	2	1.8	1.9	0.84	0.066	0.61	1.5	0.2	0.45	1.8	6.2	<b>0.0274</b>	<b>65.9</b>	3.67
result / TAL	0.29	0.002	0.19	0.003	0.11	0.01	0.002	0.44	0.049	0.086	0.0036	0.3	0.4	0.071	0.018	0.15	2.7	4.4	0.12

Bold font indicates result>TAL/MQL; italic font and hollow symbols indicate undetected results; "-" is used if no analytical results were available.

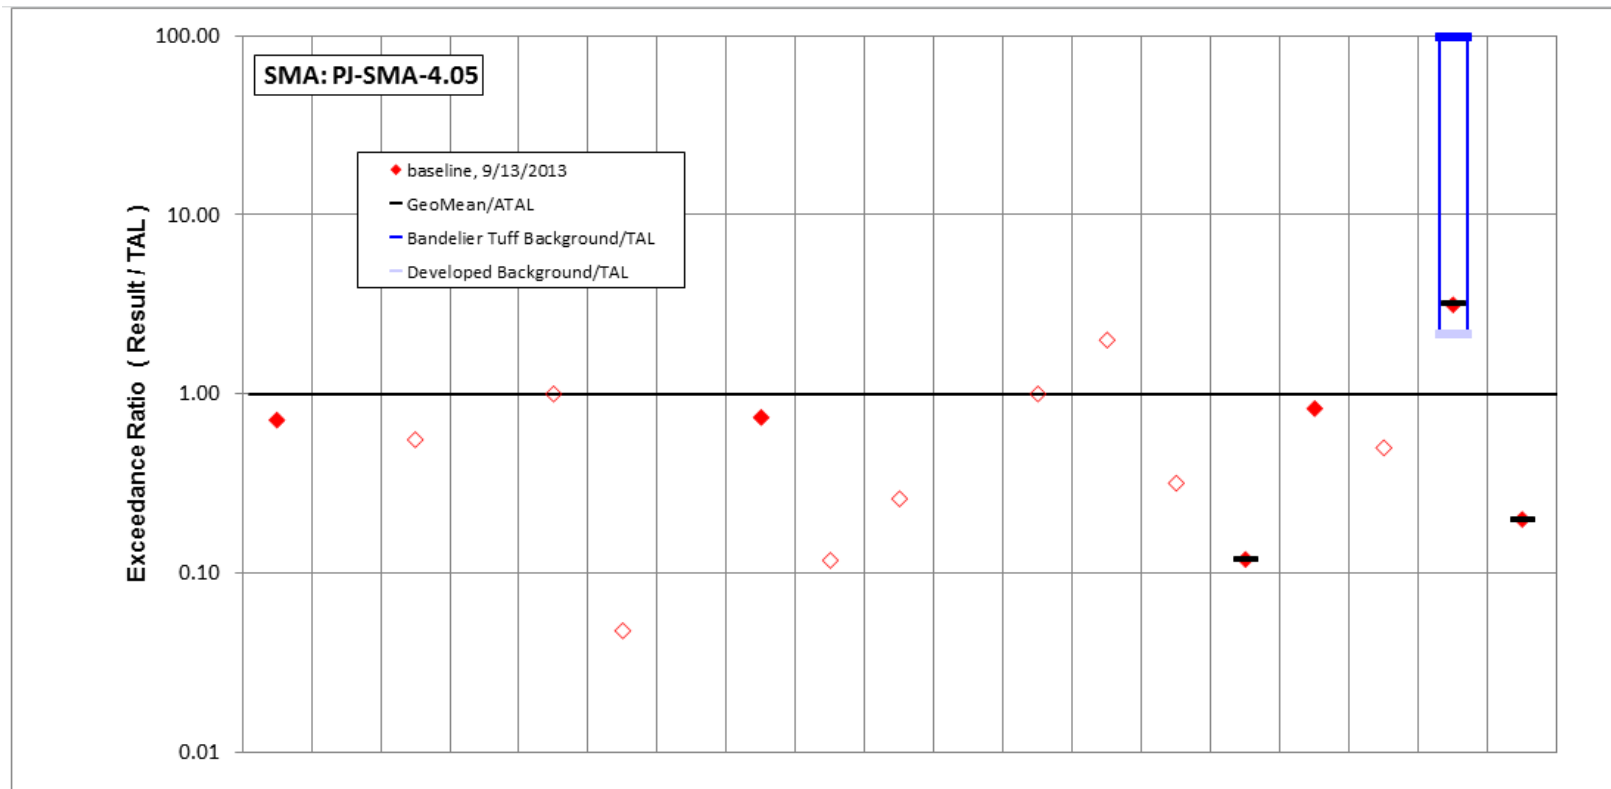
Aluminum	Antimony	Arsenic	Boron	Cadmium	Chromium	Cobalt	Copper	Lead	Mercury	Nickel	Selenium	Silver	Thallium	Vanadium	Zinc	Cyanide, weak acid dissociable	Gross alpha	Radium-226 and Radium-228
std used in ratio calculations	MTAL	ATAL	ATAL	ATAL	MQL	MTAL	ATAL	MTAL	MTAL	ATAL	MTAL	ATAL	MQL	ATAL	ATAL	MTAL	MQL	ATAL	ATAL
std value	750	640	9	5000	1	210	1000	4.3	17	0.77	170	5	0.5	6.3	100	42	0.01	15	30
unit	ug/L	ug/L	ug/L	ug/L	ug/L	ug/L	ug/L	ug/L	ug/L	ug/L	ug/L	ug/L	ug/L	ug/L	ug/L	ug/L	mg/L	pCi/L	pCi/L
<b>9/13/2013 result</b>	536	3	5	38.2	1	10	1.26	3.18	2	0.2	1.27	5	1	2	11.9	34.8	0.005	47.2	5.98
result / TAL	0.71	0.005	0.56	0.0076	1	0.048	0.0013	0.74	0.12	0.26	0.0075	1	2	0.32	0.12	0.83	0.5	3.1	0.2

Bold font indicates result>TAL/MQL; italic font and hollow symbols indicate undetected results; "-" is used if no analytical results were available.

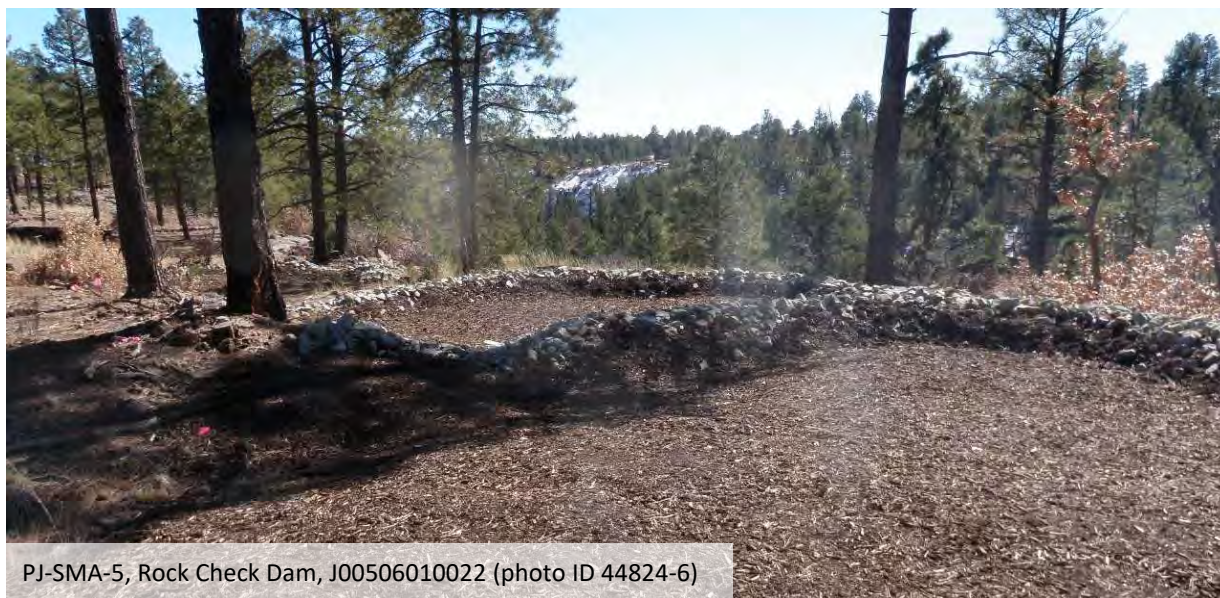
PJ-SMA-5, Rock Check Dam, J00506010022 (photo ID 44824-6)

Enhanced controls were installed and certified on July 18, 2015, and submitted to EPA on August 17, 2015, as part of corrective action. Photographs of the enhanced controls are available at <http://www.lanl.gov/environment/protection/compliance/individual-permit-stormwater/construction-certifications.php>.

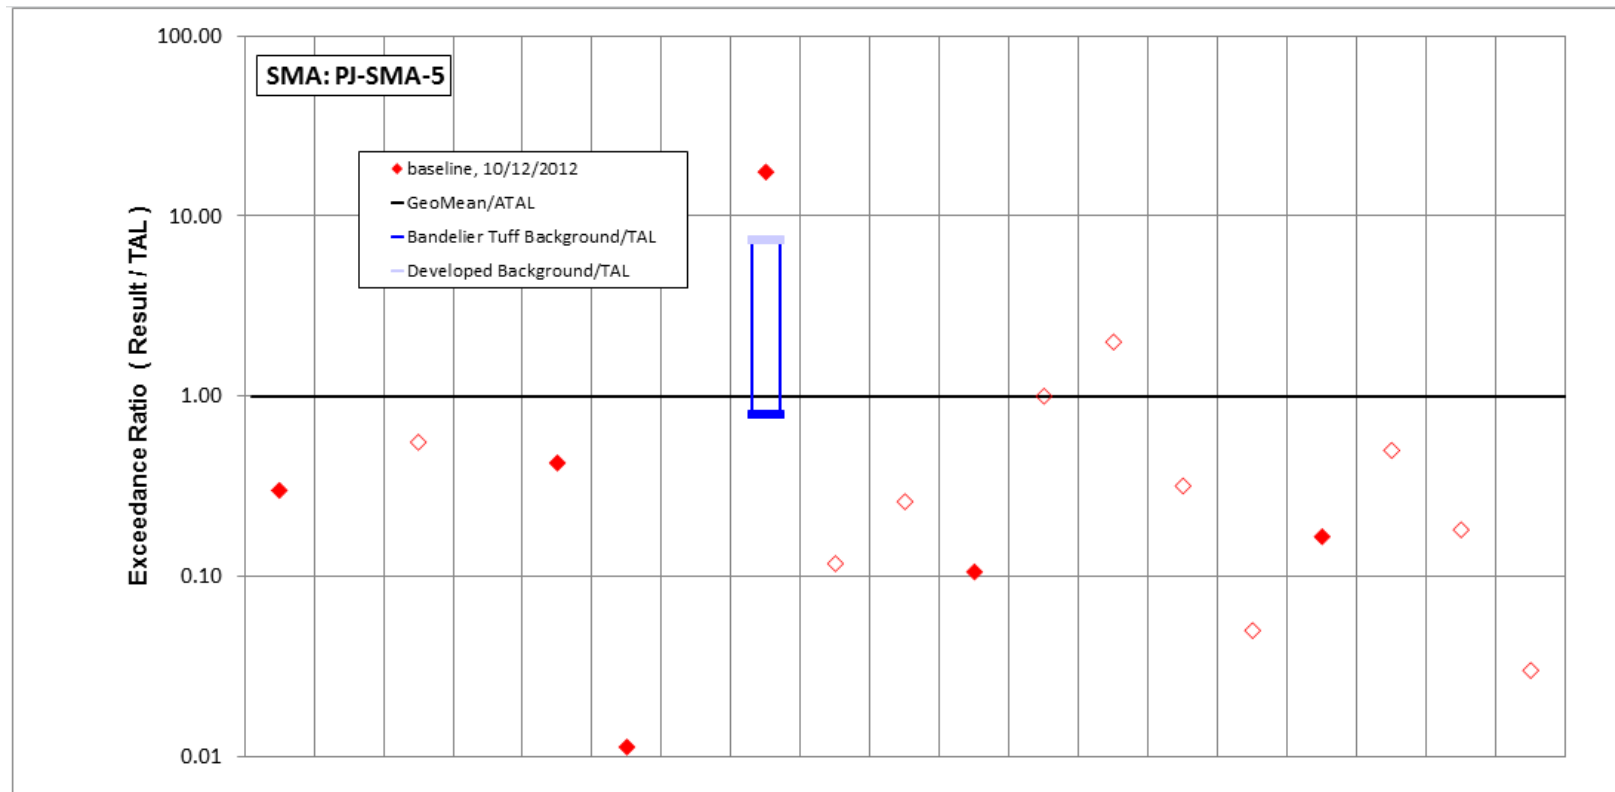
**Figure 154-2 Inorganic analytical results summary plot for PJ-SMA-5**

Aluminum	Antimony	Arsenic	Boron	Cadmium	Chromium	Cobalt	<b>Copper</b>	Lead	Mercury	Nickel	Selenium	<b>Silver</b>	Thallium	Vanadium	Zinc	Cyanide, weak acid dissociable	Gross alpha	Radium-226 and Radium-228
std used in ratio calculations	MTAL	ATAL	ATAL	ATAL	MQL	MTAL	ATAL	MTAL	MTAL	ATAL	MTAL	ATAL	MQL	ATAL	ATAL	MTAL	MQL	ATAL	ATAL
std value	750	640	9	5000	1	210	1000	4.3	17	0.77	170	5	0.5	6.3	100	42	0.01	15	30
unit	ug/L	ug/L	ug/L	ug/L	ug/L	ug/L	ug/L	ug/L	ug/L	ug/L	ug/L	ug/L	ug/L	ug/L	ug/L	ug/L	mg/L	pCi/L	pCi/L
<b>10/12/2012 result</b>	225	3	5	17.8	0.426	2.37	1.65	<b>75.5</b>	2	0.2	18	5	<b>1</b>	2	5	6.97	0.005	2.72	0.901
result / TAL	0.3	0.005	0.56	0.0036	0.43	0.011	0.0016	<b>18</b>	0.12	0.26	0.11	1	2	0.32	0.05	0.17	0.5	0.18	0.03

Bold font indicates result>TAL/MQL; italic font and hollow symbols indicate undetected results; "-" is used if no analytical results were available.

SWMU 22-015(c) is monitored within PJ-SMA-5. Following the installation of baseline control measures, a baseline storm water sample was collected on October 12, 2012 (Figures 154-2 and 154-3). In Figures 154-2 and 154-3, selenium, silver, and hexachlorobenzene are reported as nondetectable results equal to or greater than their respective TALs. These values are reported at the PQL; however, the MDLs for these analytes are below the TALs. Analytical results from this sample yielded the following TAL exceedance:

TAL exceedances were also evaluated against the appropriate storm water BV, that is, “Bandelier Tuff background” for undisturbed SMAs or “developed background” for urban settings. BVs are expressed as UTLs using the approved EPA method for calculating BVs. UTLs for undisturbed SMAs were derived from storm water runoff containing entrained sediments derived from Bandelier Tuff and are labeled “Bandelier Tuff Background” in Figures 154-2 and 154-3. UTLs developed for urban settings were derived from runoff from developed landscapes on the Pajarito Plateau, including buildings, parking lots, roads, and associated features, and are labeled “Developed Background” in Figures 154-2 and 154-3.

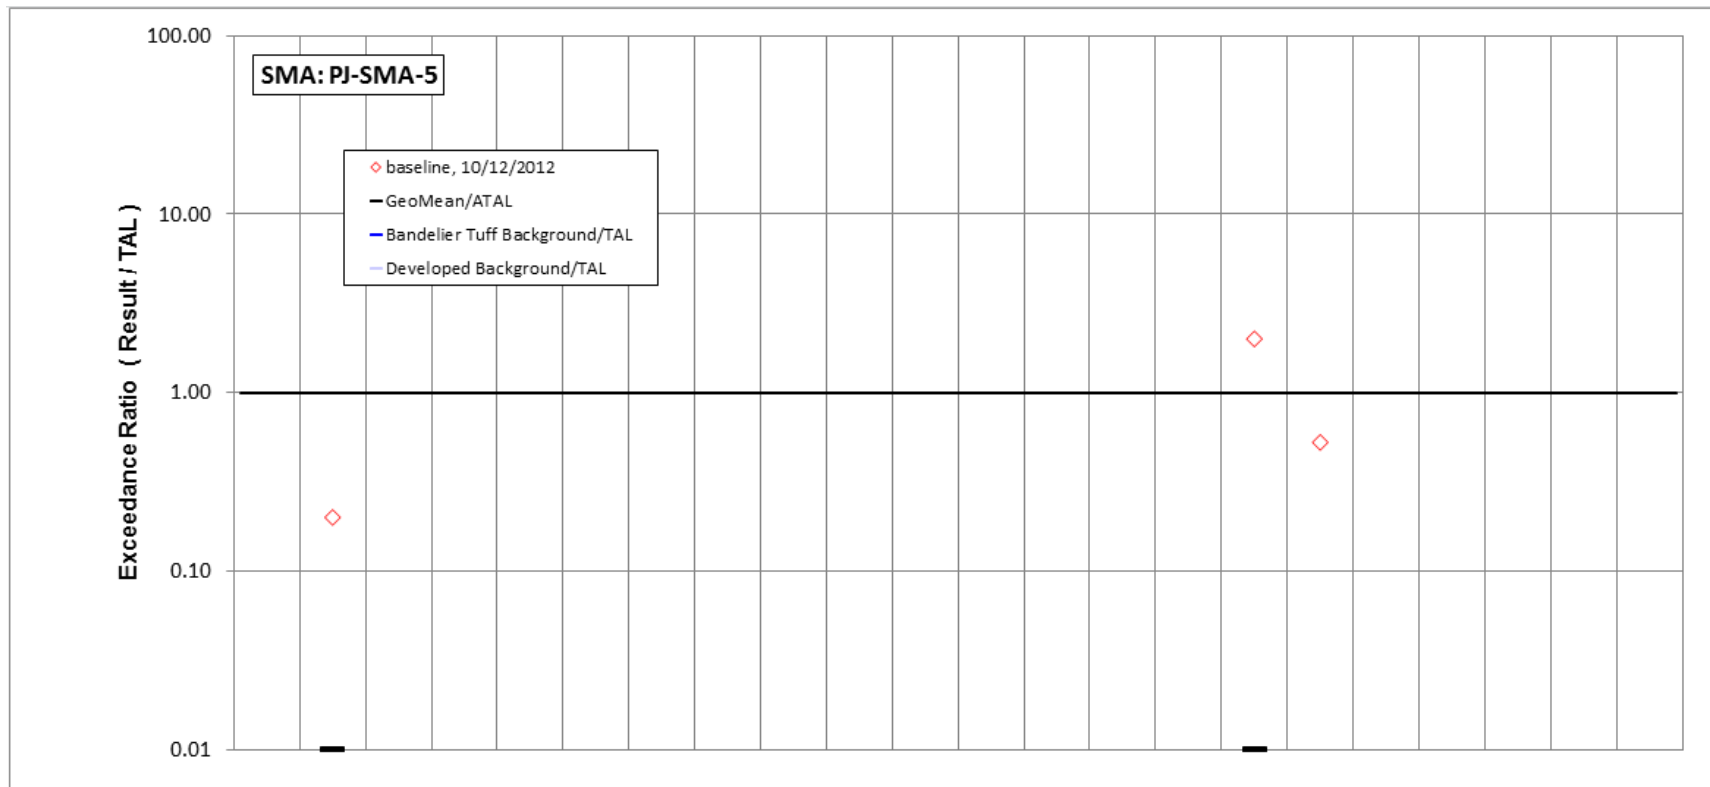
Aldrin	Benzo(a)pyrene	BHC[gamma-]	Chlordane (alpha/gamma)	Chlordane[alpha-]	Chlordane[gamma-]	DDD[4,4'-]	DDE[4,4'-]	DDT[4,4'-]	Dieldrin	Endosulfan I	Endosulfan II	Endrin	Heptachlor	Heptachlor Epoxide	<b>Hexachlorobenzene</b>	Pentachlorophenol	RDX	Tetrachlorodibenzo dioxin[2,3,7,8-]	Total PCB	Toxaphene (Technical Grade)	Trinitrotoluene [2,4,6-]	
std used in ratio calculations	-	MQL	-	-	-	-	-	-	-	-	-	-	-	-	-	MQL	MTAL	-	-	-	-	-	-
std value	-	5	-	-	-	-	-	-	-	-	-	-	-	-	-	5	19	-	-	-	-	-	-
unit	ug/L	ug/L	ug/L	ug/L	ug/L	ug/L	ug/L	ug/L	ug/L	ug/L	ug/L	ug/L	ug/L	ug/L	ug/L	ug/L	ug/L	ug/L	ug/L	ug/L	ug/L	ug/L	ug/L
<b>10/12/2012 result</b>	-	<b>1</b>	-	-	-	-	-	-	-	-	-	-	-	-	-	<b>10</b>	<b>10</b>	-	-	-	-	-	-
result / TAL	-	<b>0.2</b>	-	-	-	-	-	-	-	-	-	-	-	-	-	<b>2</b>	<b>0.53</b>	-	-	-	-	-	-

Bold font indicates result>TAL/MQL; italic font and hollow symbols indicate undetected results; "-" is used if no analytical results were available.

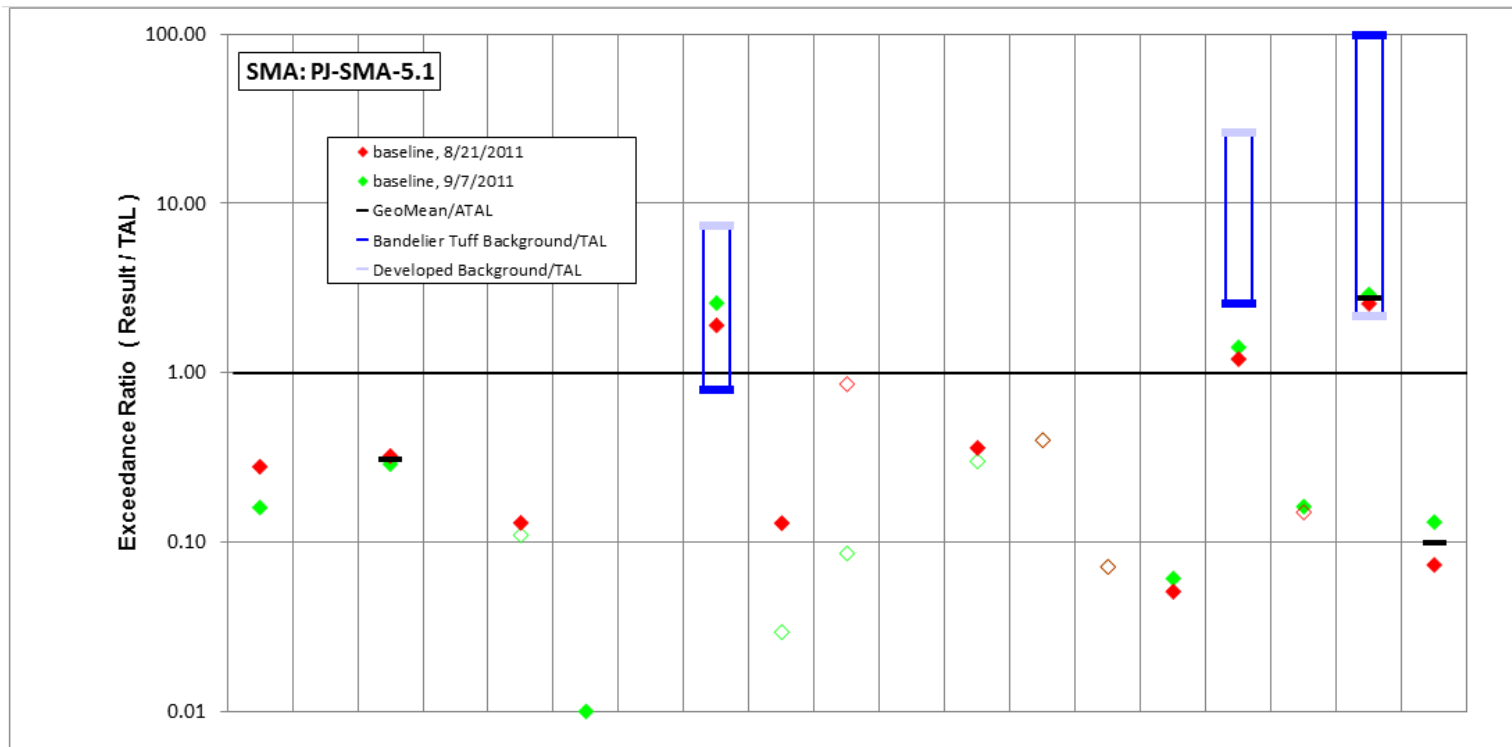
**Figure 155-2 Inorganic analytical results summary plot for PJ-SMA-5.1**

Aluminum	Antimony	Arsenic	Boron	Cadmium	Chromium	Cobalt	<b>Copper</b>	Lead	Mercury	Nickel	Selenium	Silver	Thallium	Vanadium	<b>Zinc</b>	Cyanide, weak acid dissociable	<b>Gross alpha</b>	Radium-226 and Radium-228
std used in ratio calculations	MTAL	ATAL	ATAL	ATAL	MQL	MTAL	ATAL	MTAL	MTAL	ATAL	MTAL	ATAL	MQL	ATAL	ATAL	MTAL	MQL	ATAL	ATAL
std value	750	640	9	5000	1	210	1000	4.3	17	0.77	170	5	0.5	6.3	100	42	0.01	15	30
unit	ug/L	ug/L	ug/L	ug/L	ug/L	ug/L	ug/L	ug/L	ug/L	ug/L	ug/L	ug/L	ug/L	ug/L	ug/L	ug/L	mg/L	pCi/L	pCi/L
<b>9/7/2011 result</b>	120	<i>1</i>	2.6	36.6	<i>0.11</i>	2.1	2.7	<b>11.1</b>	0.5	<i>0.066</i>	1.4	1.5	0.2	0.45	6.1	<b>59.4</b>	0.0016	<b>43.5</b>	3.94
result / TAL	0.16	<i>0.002</i>	0.29	0.0073	<i>0.11</i>	0.01	0.0027	<b>2.6</b>	<i>0.029</i>	<i>0.086</i>	0.0082	0.3	0.4	0.071	0.061	<b>1.4</b>	0.16	<b>2.9</b>	0.13
<b>8/21/2011 result</b>	209	<i>1</i>	2.9	42.3	0.13	2	3.3	<b>8.2</b>	2.2	<i>0.66</i>	1.5	1.8	0.2	0.45	5.1	<b>50.6</b>	0.002	<b>38.4</b>	2.2

result / TAL	0.28	<i>0.002</i>	0.32	0.0085	0.13	<i>0.01</i>	0.0033	<b>1.9</b>	0.13	<i>0.86</i>	0.0088	0.36	0.4	0.071	0.051	<b>1.2</b>	0.15	<b>2.6</b>	0.073

SWMUs 22-010(b) and 22-016 are monitored within PJ-SMA-5.1. Following the installation of baseline control measures, two baseline storm water samples were collected on August 21, 2011, and September 7, 2011 (Figure 155-2). Analytical results from these samples yielded the following TAL exceedances:

“Bandelier Tuff Background” in Figure 155-2. UTLs developed for urban settings were derived from runoff from developed landscapes on the Pajarito Plateau, including buildings, parking lots, roads, and associated features, and are labeled “Developed Background” in Figure 155-2.

- Copper—The copper UTL from background storm water containing sediments derived from Bandelier Tuff is 3.43 µg/L. The copper results from 2011 are greater than this value.
- Zinc—The zinc UTL from background storm water containing sediments derived from Bandelier Tuff is 109 µg/L. The zinc results from 2011 are less than this value.
- Gross alpha—The gross-alpha background UTL for background storm water containing sediment derived from Bandelier Tuff is 1490 pCi/L. The 2011 gross-alpha results are less than this value.

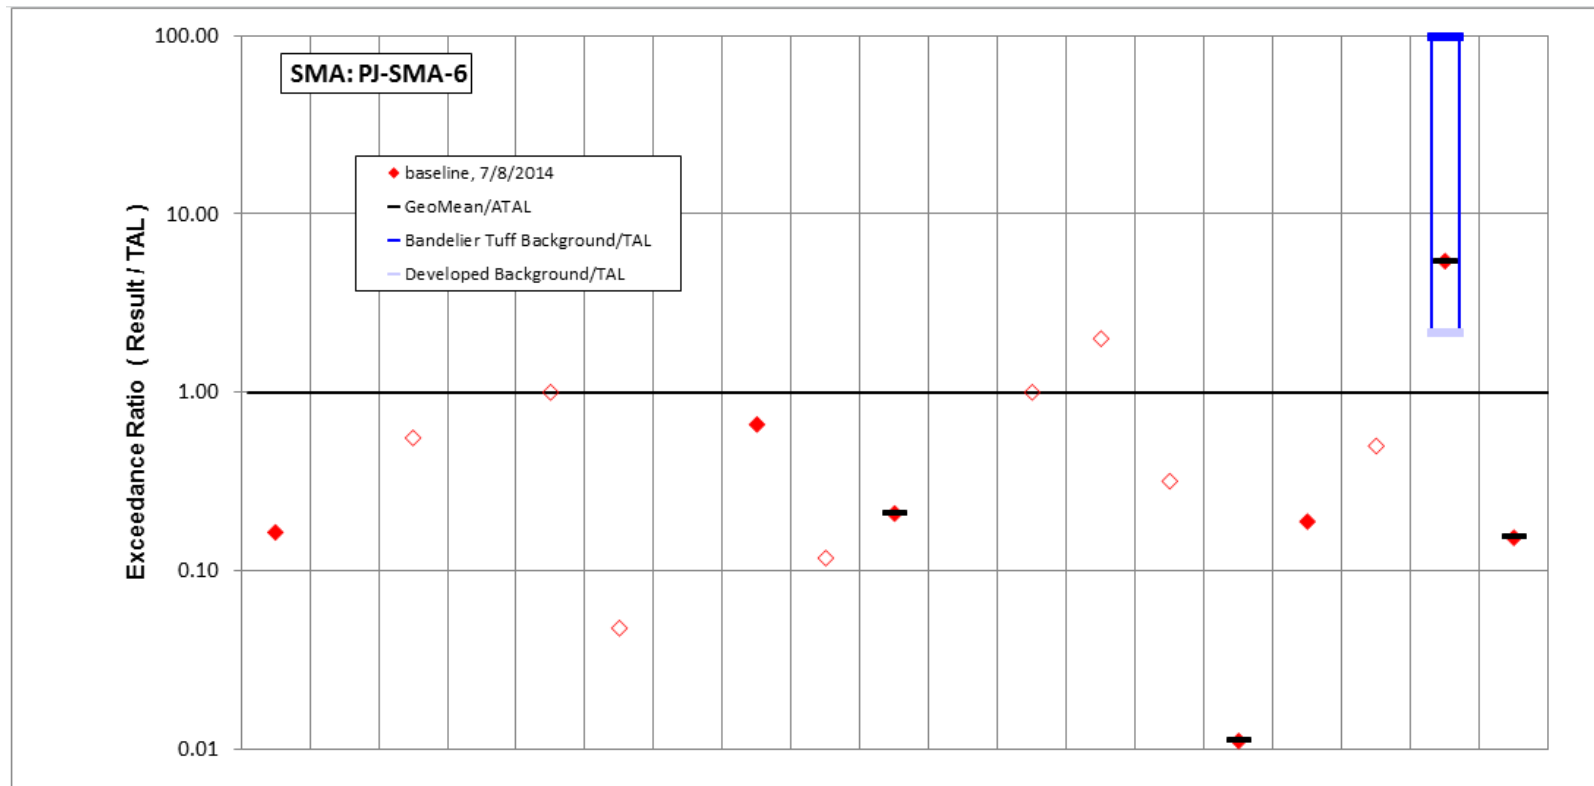
Aluminum	Antimony	Arsenic	Boron	Cadmium	Chromium	Cobalt	Copper	Lead	Mercury	Nickel	Selenium	Silver	Thallium	Vanadium	Zinc	Cyanide, weak acid dissociable	Gross alpha	Radium-226 and Radium-228
std used in ratio calculations	MTAL	ATAL	ATAL	ATAL	MQL	MTAL	ATAL	MTAL	MTAL	ATAL	MTAL	ATAL	MQL	ATAL	ATAL	MTAL	MQL	ATAL	ATAL
std value	750	640	9	5000	1	210	1000	4.3	17	0.77	170	5	0.5	6.3	100	42	0.01	15	30
unit	ug/L	ug/L	ug/L	ug/L	ug/L	ug/L	ug/L	ug/L	ug/L	ug/L	ug/L	ug/L	ug/L	ug/L	ug/L	ug/L	mg/L	pCi/L	pCi/L
<b>7/8/2014 result</b>	123	3	5	18.9	1	10	5	2.84	2	0.161	0.842	5	1	2	1.11	7.92	0.005	<b>81.6</b>	4.59
result / TAL	0.16	0.005	0.56	0.0038	1	0.048	0.005	0.66	0.12	0.21	0.005	1	2	0.32	0.011	0.19	0.5	5.4	0.15

Bold font indicates result>TAL/MQL; italic font and hollow symbols indicate undetected results; "-" is used if no analytical results were available.

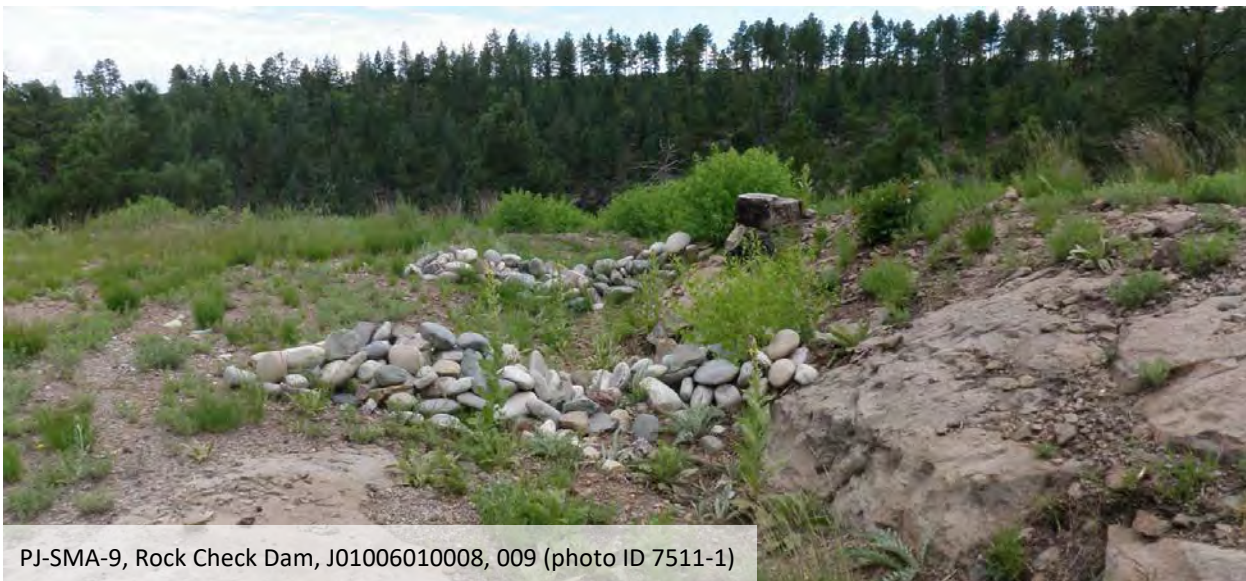
PJ-SMA-9, Rock Check Dam, J01006010008, 009 (photo ID 7511-1)

Enhanced controls were installed and certified on October 28, 2015, and submitted to EPA on October 30, 2015, as part of corrective action. Photographs of the enhanced controls are available at <http://www.lanl.gov/environment/protection/compliance/individual-permit-stormwater/construction-certifications.php>.

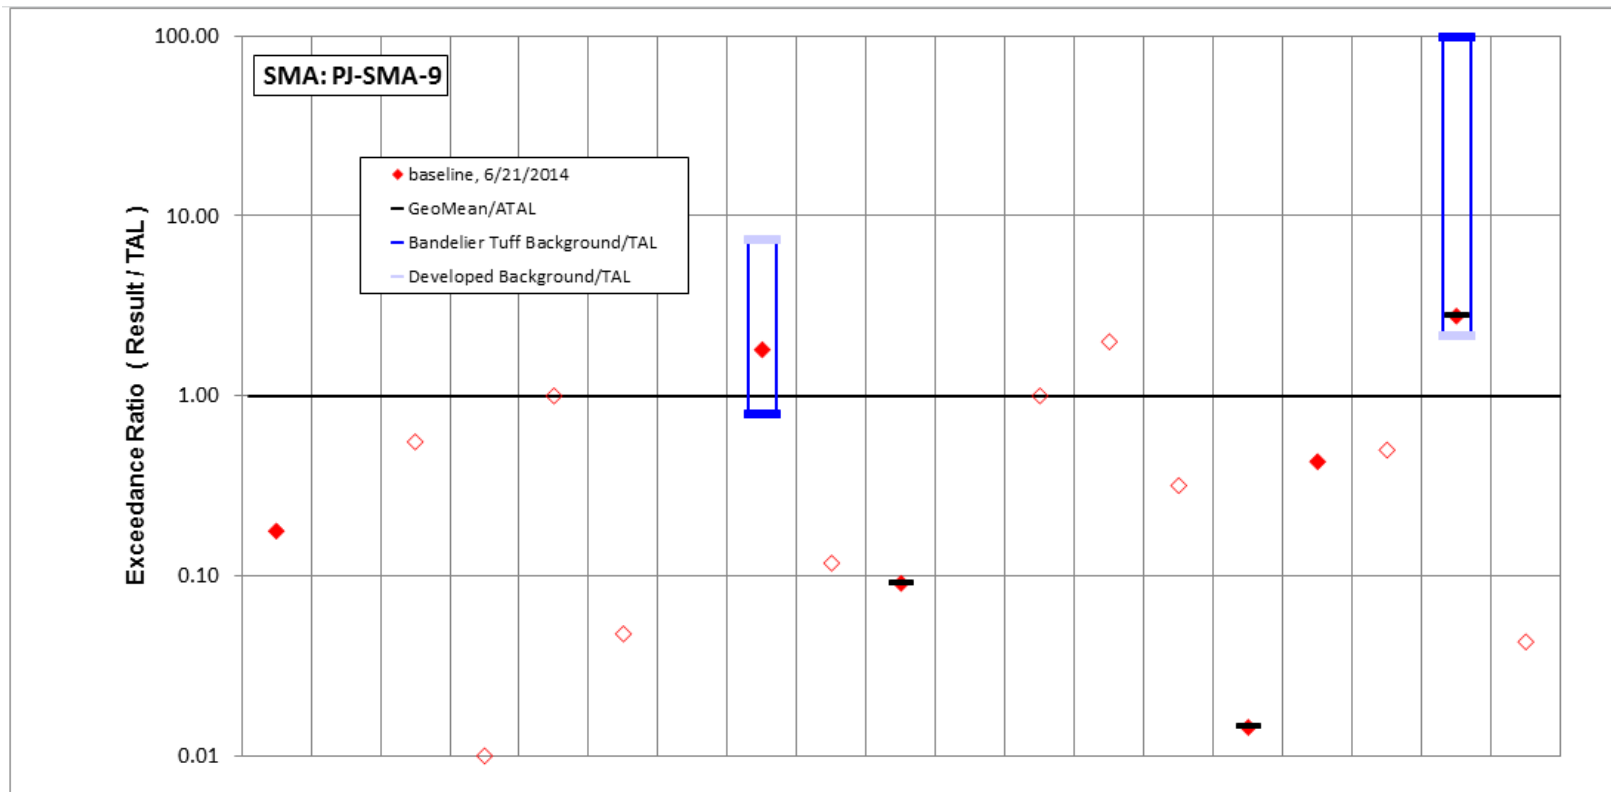
**Figure 159-2 Inorganic analytical results summary plot for PJ-SMA-9**

Aluminum	Antimony	Arsenic	Boron	Cadmium	Chromium	Cobalt	<b>Copper</b>	Lead	Mercury	Nickel	Selenium	<b>Silver</b>	Thallium	Vanadium	Zinc	Cyanide, weak acid dissociable	<b>Gross alpha</b>	Radium-226 and Radium-228
std used in ratio calculations	MTAL	ATAL	ATAL	ATAL	MQL	MTAL	ATAL	MTAL	MTAL	ATAL	MTAL	ATAL	MQL	ATAL	ATAL	MTAL	MQL	ATAL	ATAL
std value	750	640	9	5000	1	210	1000	4.3	17	0.77	170	5	0.5	6.3	100	42	0.01	15	30
unit	ug/L	ug/L	ug/L	ug/L	ug/L	ug/L	ug/L	ug/L	ug/L	ug/L	ug/L	ug/L	ug/L	ug/L	ug/L	ug/L	mg/L	pCi/L	pCi/L
<b>6/21/2014 result</b>	133	3	5	50	1	10	2.22	<b>7.76</b>	2	0.07	0.773	5	<b>1</b>	2	1.44	18.1	<i>0.005</i>	<b>41.6</b>	1.29
result / TAL	0.18	<i>0.005</i>	<i>0.56</i>	<i>0.01</i>	<i>1</i>	<i>0.048</i>	0.0022	<b>1.8</b>	<i>0.12</i>	0.091	0.0045	<i>1</i>	<b>2</b>	0.32	0.014	0.43	0.5	<b>2.8</b>	<i>0.043</i>

Bold font indicates result>TAL/MQL; italic font and hollow symbols indicate undetected results; "-" is used if no analytical results were available.

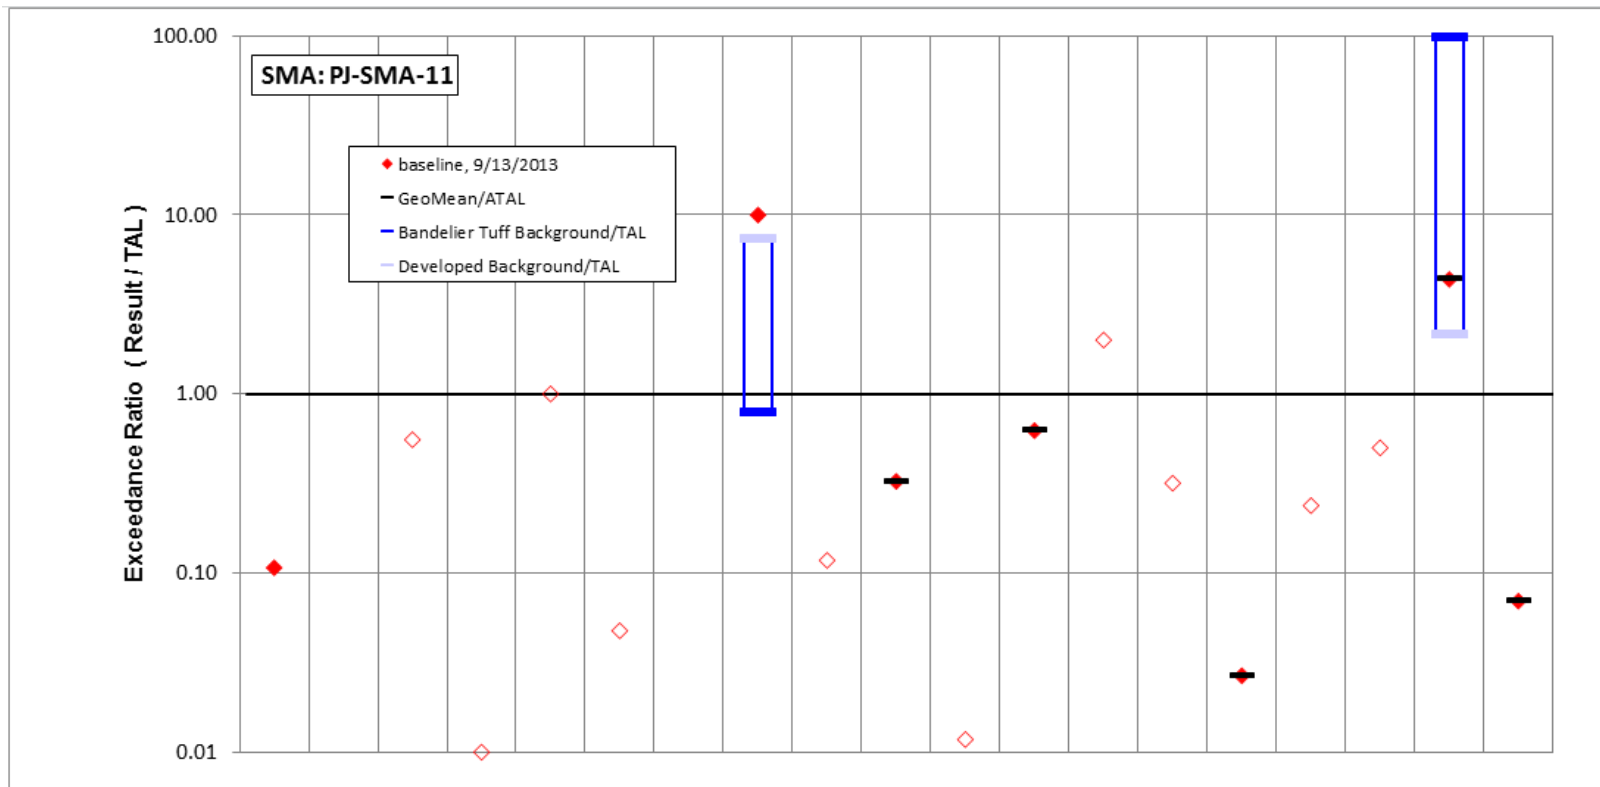
Aluminum	Antimony	Arsenic	Boron	Cadmium	Chromium	Cobalt	<b>Copper</b>	Lead	Mercury	Nickel	Selenium	<b>Silver</b>	Thallium	Vanadium	Zinc	Cyanide, weak acid dissociable	<b>Gross alpha</b>	Radium-226 and Radium-228
std used in ratio calculations	MTAL	ATAL	ATAL	ATAL	MQL	MTAL	ATAL	MTAL	MTAL	ATAL	MTAL	ATAL	MQL	ATAL	ATAL	MTAL	MQL	ATAL	ATAL
std value	750	640	9	5000	1	210	1000	4.3	17	0.77	170	5	0.5	6.3	100	42	0.01	15	30
unit	ug/L	ug/L	ug/L	ug/L	ug/L	ug/L	ug/L	ug/L	ug/L	ug/L	ug/L	ug/L	ug/L	ug/L	ug/L	ug/L	mg/L	pCi/L	pCi/L
<b>9/13/2013 result</b>	80.3	3	5	50	1	10	5	<b>42.9</b>	2	0.25	2	3.12	<b>1</b>	2	2.67	10	0.005	<b>65.4</b>	2.09
result / TAL	0.11	0.005	0.56	0.01	1	0.048	0.005	<b>10</b>	0.12	0.32	0.012	0.62	<b>2</b>	0.32	0.027	0.24	0.5	<b>4.4</b>	0.07

Bold font indicates result>TAL/MQL; italic font and hollow symbols indicate undetected results; "-" is used if no analytical results were available.

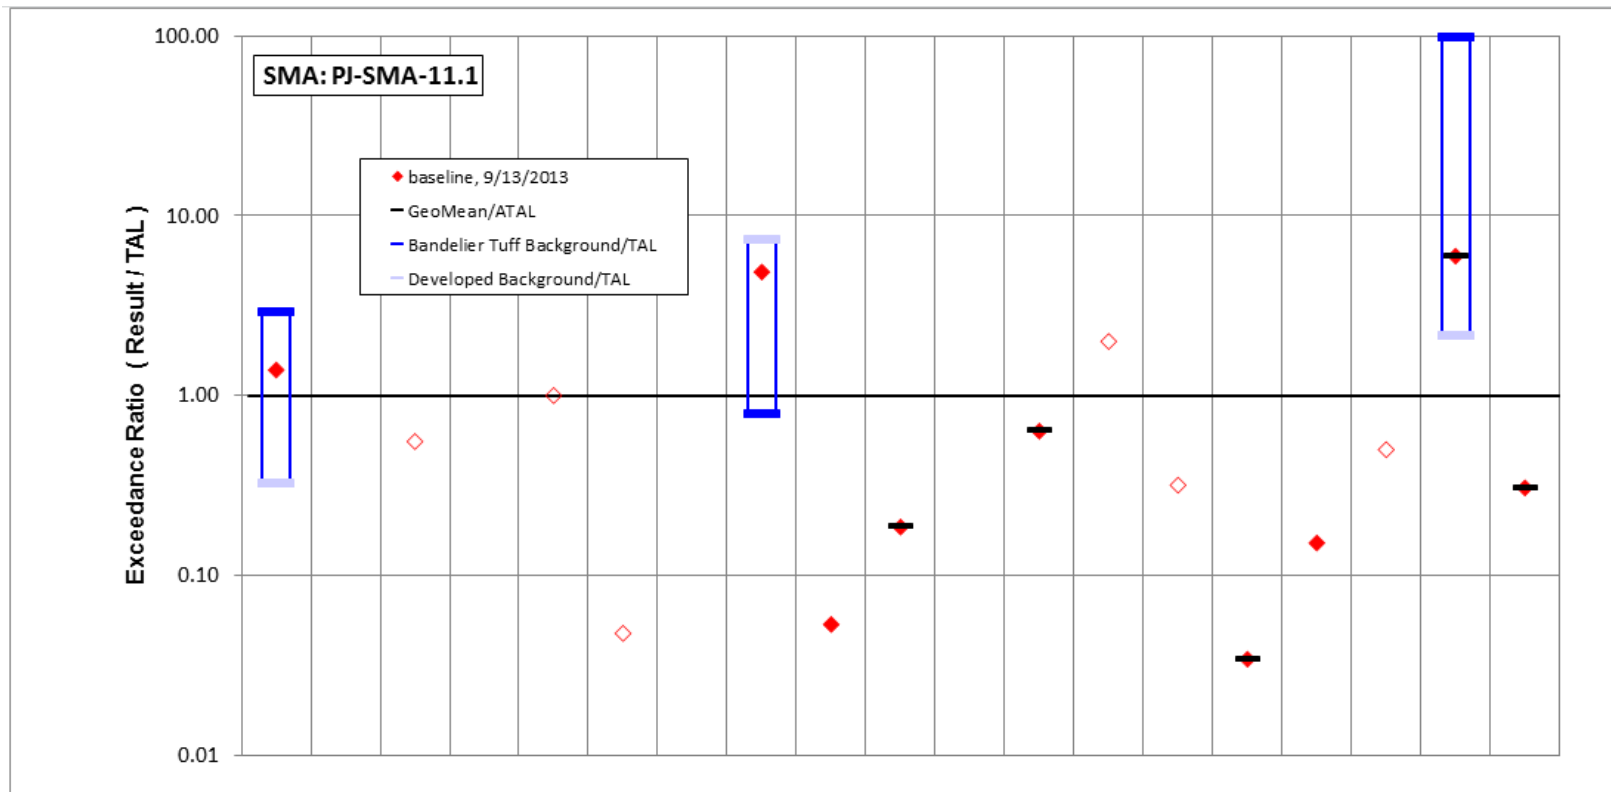
Aluminum	Antimony	Arsenic	Boron	Cadmium	Chromium	Cobalt	Copper	Lead	Mercury	Nickel	Selenium	Silver	Thallium	Vanadium	Zinc	Cyanide, weak acid dissociable	Gross alpha	Radium-226 and Radium-228
std used in ratio calculations	MTAL	ATAL	ATAL	ATAL	MQL	MTAL	ATAL	MTAL	MTAL	ATAL	MTAL	ATAL	MQL	ATAL	ATAL	MTAL	MQL	ATAL	ATAL
std value	750	640	9	5000	1	210	1000	4.3	17	0.77	170	5	0.5	6.3	100	42	0.01	15	30
unit	ug/L	ug/L	ug/L	ug/L	ug/L	ug/L	ug/L	ug/L	ug/L	ug/L	ug/L	ug/L	ug/L	ug/L	ug/L	ug/L	mg/L	pCi/L	pCi/L
9/13/2013 result	<b>1040</b>	3	5	16.2	1	10	1.83	<b>20.9</b>	0.908	0.143	0.832	3.17	1	2	3.42	6.36	0.005	<b>89.4</b>	9.2
result / TAL	<b>1.4</b>	0.005	0.56	0.0032	1	0.048	0.0018	<b>4.9</b>	0.053	0.19	0.0049	0.63	2	0.32	0.034	0.15	0.5	6	0.31

Bold font indicates result>TAL/MQL; italic font and hollow symbols indicate undetected results; "-" is used if no analytical results were available.

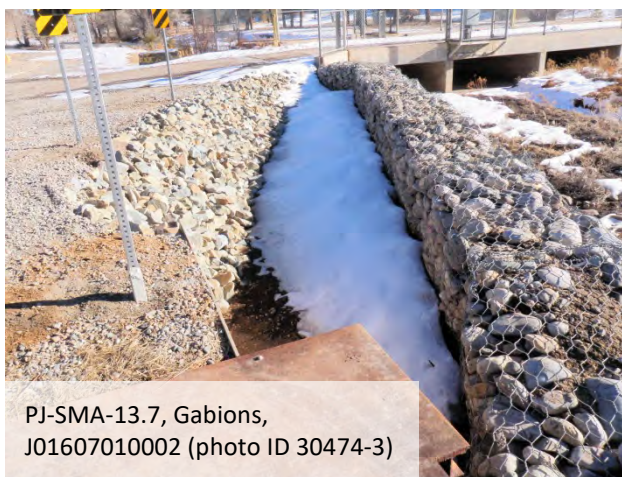
PJ-SMA-13.7, Gabions, J01607010002 (photo ID 30474-3)

Monitoring location PJ-SMA-13.7 receives storm water run-on from landscape containing sediment derived from Bandelier Tuff. Gross alpha in Bandelier Tuff is associated with naturally occurring radioactive uranium- and thorium-bearing minerals.

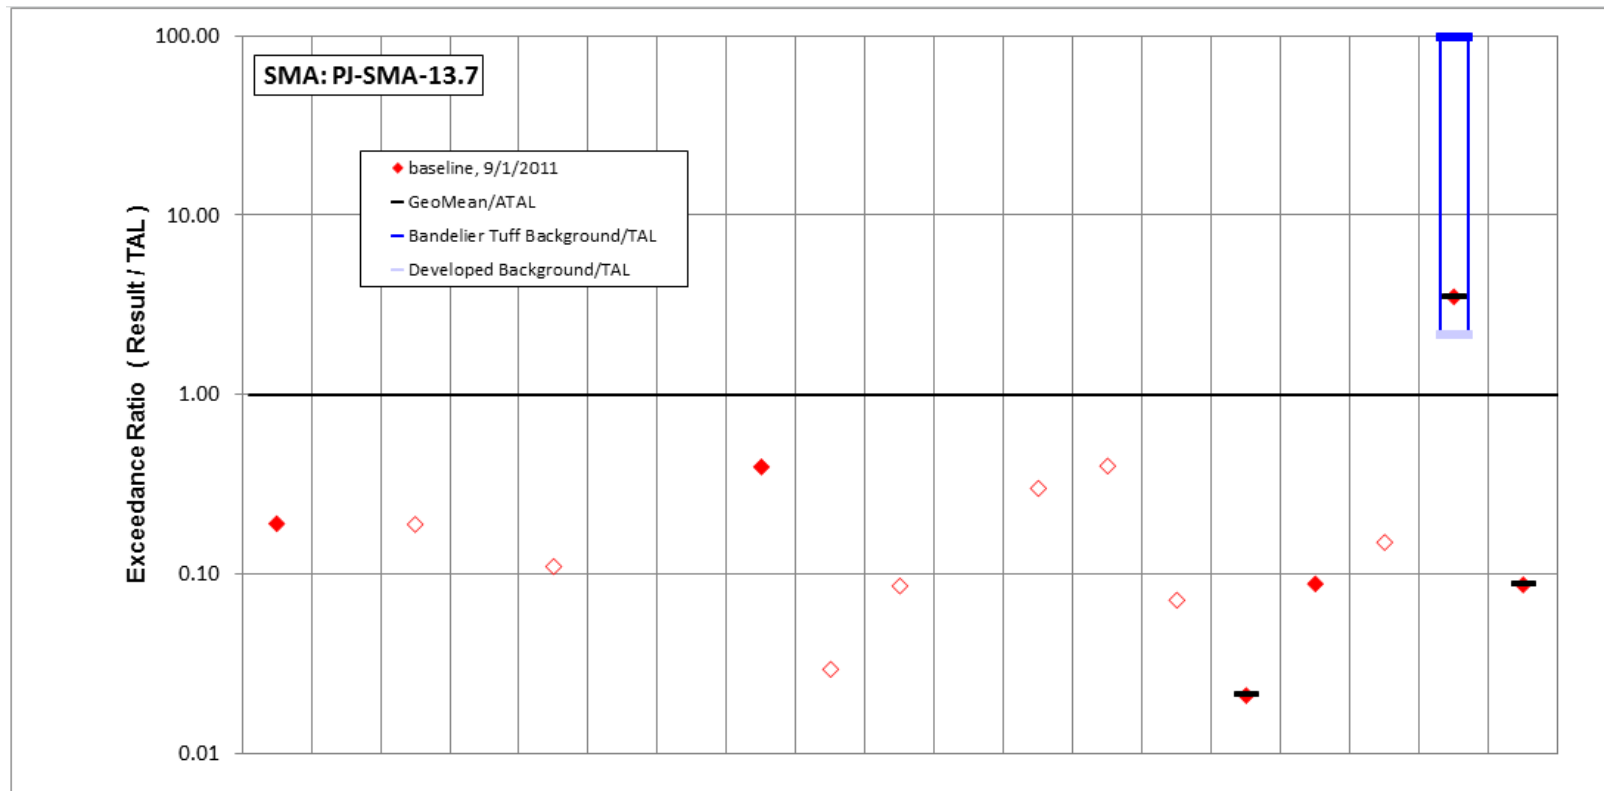
Aluminum	Antimony	Arsenic	Boron	Cadmium	Chromium	Cobalt	Copper	Lead	Mercury	Nickel	Selenium	Silver	Thallium	Vanadium	Zinc	Cyanide, weak acid dissociable	<b>Gross alpha</b>	Radium-226 and Radium-228
std used in ratio calculations	MTAL	ATAL	ATAL	ATAL	MQL	MTAL	ATAL	MTAL	MTAL	ATAL	MTAL	ATAL	MQL	ATAL	ATAL	MTAL	MQL	ATAL	ATAL
std value	750	640	9	5000	1	210	1000	4.3	17	0.77	170	5	0.5	6.3	100	42	0.01	15	30
unit	ug/L	ug/L	ug/L	ug/L	ug/L	ug/L	ug/L	ug/L	ug/L	ug/L	ug/L	ug/L	ug/L	ug/L	ug/L	ug/L	mg/L	pCi/L	pCi/L
<b>9/1/2011 result</b>	143	<b>1</b>	1.7	15	0.11	2	1.8	1.7	0.5	<i>0.066</i>	0.89	1.5	0.2	0.45	2.1	3.7	0.002	<b>52.6</b>	2.61
result / TAL	0.19	<i>0.002</i>	0.19	0.003	0.11	0.01	0.0018	0.4	0.029	0.086	0.0052	0.3	0.4	0.071	0.021	0.088	0.15	3.5	0.087

Bold font indicates result>TAL/MQL; italic font and hollow symbols indicate undetected results; "-" is used if no analytical results were available.

TAL exceedances were also evaluated against the appropriate storm water BV, that is, “Bandelier Tuff background” for undisturbed SMAs or “developed background” for urban settings. BVs are expressed as UTLs using the approved EPA method for calculating BVs. UTLs for undisturbed SMAs were derived from storm water runoff containing entrained sediments derived from Bandelier Tuff and are labeled “Bandelier Tuff Background” in Figure 164-2. UTLs developed for urban settings were derived from runoff from developed landscapes on the Pajarito Plateau, including buildings, parking lots, roads, and associated features, and are labeled “Developed Background” in Figure 164-2.

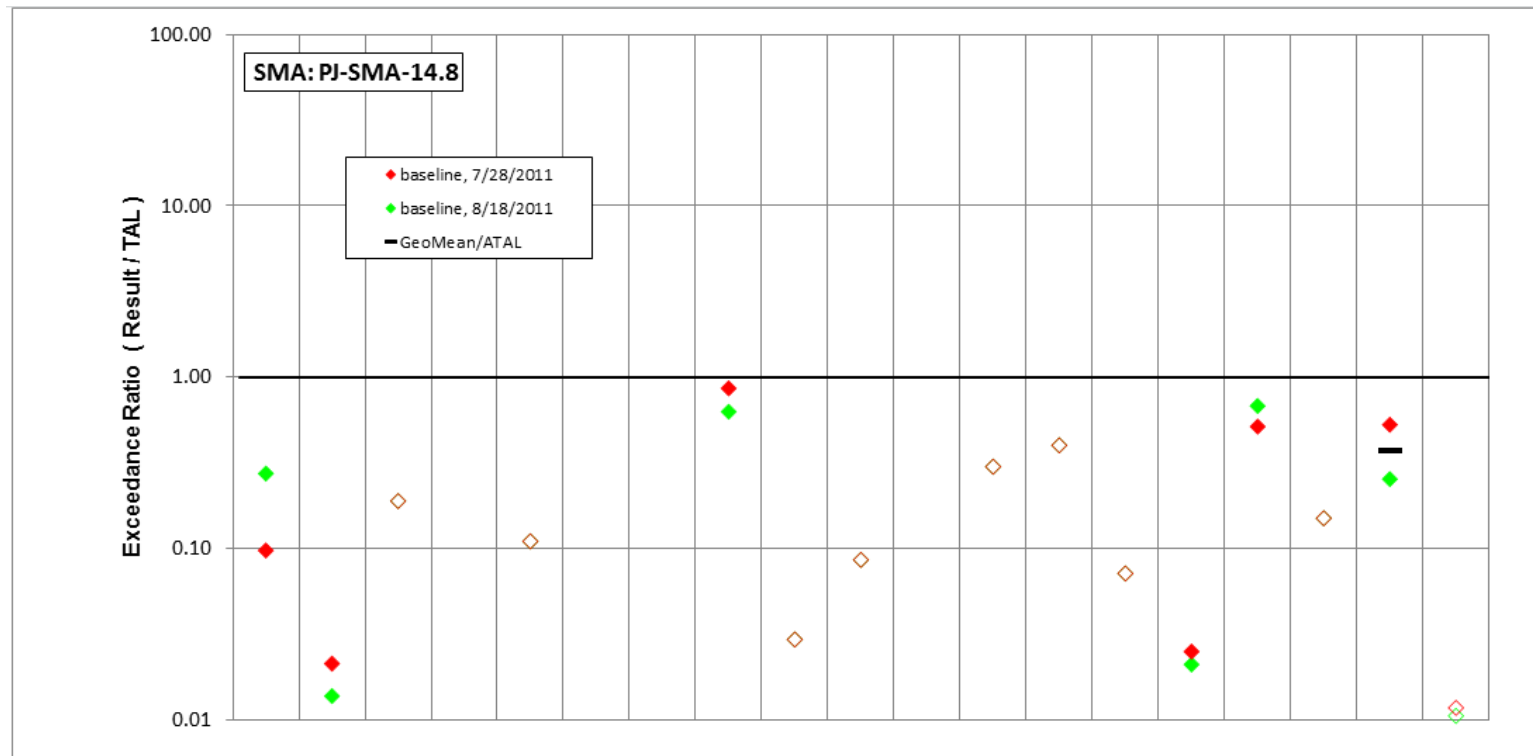
Aluminum	Antimony	Arsenic	Boron	Cadmium	Chromium	Cobalt	Copper	Lead	Mercury	Nickel	Selenium	Silver	Thallium	Vanadium	Zinc	Cyanide, weak acid dissociable	Gross alpha	Radium-226 and Radium-228
std used in ratio calculations	MTAL	ATAL	ATAL	ATAL	MQL	MTAL	ATAL	MTAL	MTAL	ATAL	MTAL	ATAL	MQL	ATAL	ATAL	MTAL	MQL	ATAL	ATAL
std value	750	640	9	5000	1	210	1000	4.3	17	0.77	170	5	0.5	6.3	100	42	0.01	15	30
unit	ug/L	ug/L	ug/L	ug/L	ug/L	ug/L	ug/L	ug/L	ug/L	ug/L	ug/L	ug/L	ug/L	ug/L	ug/L	ug/L	mg/L	pCi/L	pCi/L
8/18/2011 result	205	8.8	1.7	19.1	0.11	2	3.9	2.7	0.5	<i>0.066</i>	1.5	1.5	0.2	0.45	2.1	28.5	0.002	3.81	0.316
result / TAL	0.27	0.014	0.19	0.0038	0.11	0.01	0.0039	0.63	0.029	0.086	0.0088	0.3	0.4	0.071	0.021	0.68	0.15	0.25	0.011
7/28/2011 result	72.9	13.6	1.7	15	0.11	2	1	3.7	0.5	0.066	0.77	1.5	0.2	0.45	2.5	21.6	0.002	7.91	0.352
result / TAL	0.097	0.021	0.19	0.003	0.11	0.01	0.001	0.86	0.029	0.086	0.0045	0.3	0.4	0.071	0.025	0.51	0.15	0.53	0.012

Bold font indicates result>TAL/MQL; italic font and hollow symbols indicate undetected results; "-" is used if no analytical results were available.
