# 2017 Update to the Site Discharge Pollution Prevention Plan, Revision 1

Los Alamos National Laboratory  
NPDES Permit No. NM0030759  
LA-UR-18-22935 • May 1, 2018

## Pajarito Watershed

**Volume 3**

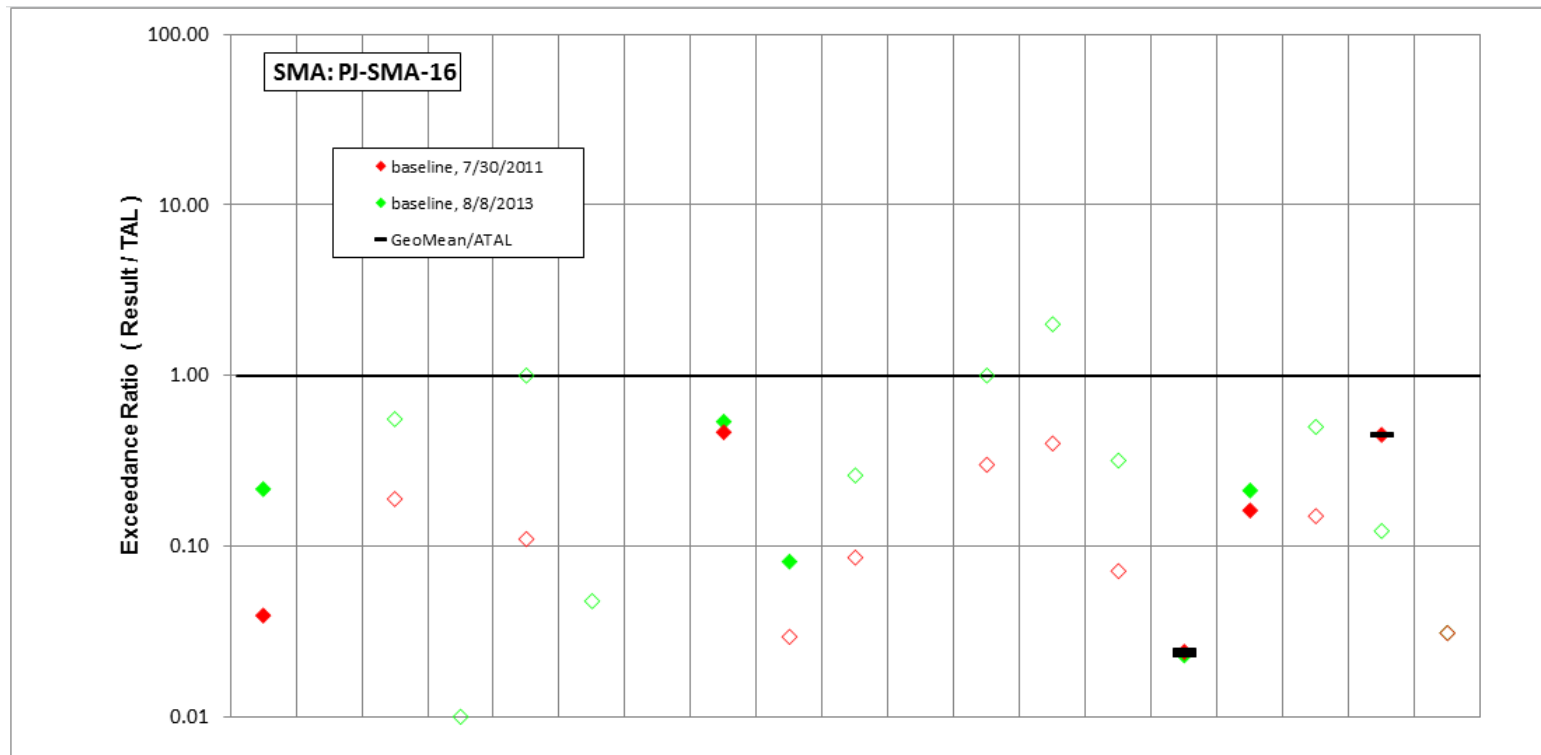
**Figure 171-2 Inorganic analytical results summary plot for PJ-SMA-16**

Aluminum	Antimony	Arsenic	Boron	Cadmium	Chromium	Cobalt	Copper	Lead	Mercury	Nickel	Selenium	Silver	Thallium	Vanadium	Zinc	Cyanide, weak acid dissociable	Gross alpha	Radium-226 and Radium-228
std used in ratio calculations	MTAL	ATAL	ATAL	ATAL	MQL	MTAL	ATAL	MTAL	MTAL	ATAL	MTAL	ATAL	MQL	ATAL	ATAL	MTAL	MQL	ATAL	ATAL
std value	750	640	9	5000	1	210	1000	4.3	17	0.77	170	5	0.5	6.3	100	42	0.01	15	30
unit	ug/L	ug/L	ug/L	ug/L	ug/L	ug/L	ug/L	ug/L	ug/L	ug/L	ug/L	ug/L	ug/L	ug/L	ug/L	ug/L	mg/L	pCi/L	pCi/L
<b>8/8/2013 result</b>	162	3	5	50	1	10	2.49	2.31	1.38	0.2	1.04	5	<b>1</b>	2	2.29	8.9	<i>0.005</i>	<i>1.84</i>	<i>0.93</i>
result / TAL	0.22	0.005	0.56	0.01	1	0.048	0.0025	0.54	0.081	0.26	0.0061	1	2	0.32	0.023	0.21	0.5	0.12	0.031
<b>7/30/2011 result</b>	29.4	1	1.7	15	0.11	2	1.1	2	0.5	0.066	0.96	1.5	0.2	0.45	2.4	6.8	0.002	6.74	0.928
result / TAL	0.039	0.002	0.19	0.003	0.11	0.01	0.0011	0.47	0.029	0.086	0.0056	0.3	0.4	0.071	0.024	0.16	0.15	0.45	0.031

Bold font indicates result>TAL/MQL; italic font and hollow symbols indicate undetected results; "-" is used if no analytical results were available.

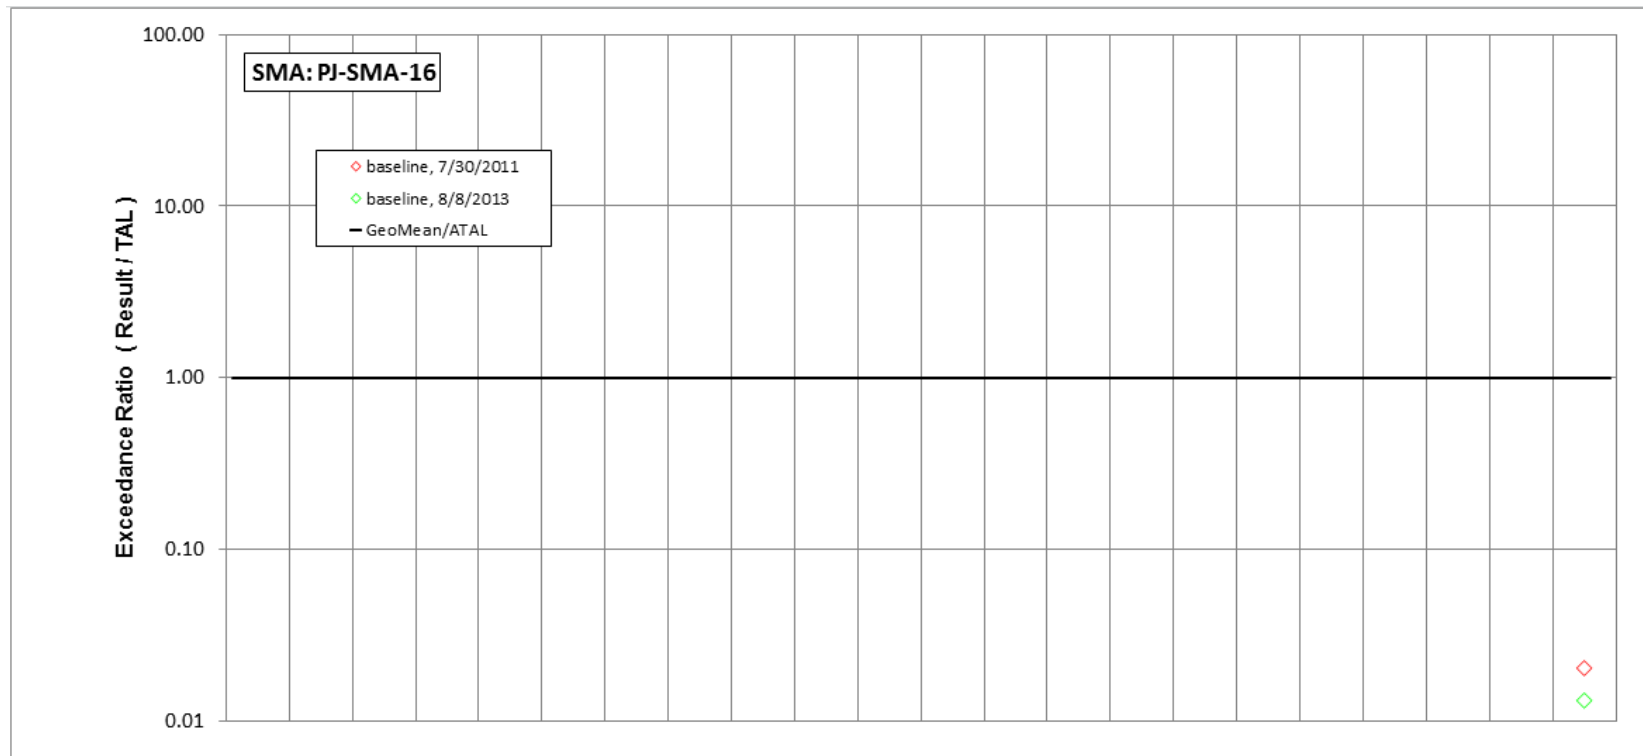
Aldrin	Benzo(a)pyrene	BHC[gamma-]	Chlordane (alpha/gamma)	Chlordane[alpha-]	Chlordane[gamma-]	DDD[4,4'-]	DDE[4,4'-]	DDT[4,4'-]	Dieldrin	Endosulfan I	Endosulfan II	Endrin	Heptachlor	Heptachlor Epoxide	Hexachlorobenzene	Pentachlorophenol	RDX	Tetrachlorodibenzo dioxin[2,3,7,8-]	Total PCB	Toxaphene (Technical Grade)	Trinitrotoluene [2,4,6-]
std used in ratio calculations	-	-	-	-	-	-	-	-	-	-	-	-	-	-	-	-	-	ATAL	-	-	-	ATAL
std value	-	-	-	-	-	-	-	-	-	-	-	-	-	-	-	-	-	200	-	-	-	20
unit	ug/L	ug/L	ug/L	ug/L	ug/L	ug/L	ug/L	ug/L	ug/L	ug/L	ug/L	ug/L	ug/L	ug/L	ug/L	ug/L	ug/L	ug/L	ug/L	ug/L	ug/L	ug/L
8/8/2013 result	-	-	-	-	-	-	-	-	-	-	-	-	-	-	-	-	-	0.263	-	-	-	0.263
result / TAL	-	-	-	-	-	-	-	-	-	-	-	-	-	-	-	-	-	0.001	-	-	-	0.013
7/30/2011 result	-	-	-	-	-	-	-	-	-	-	-	-	-	-	-	-	-	0.406	-	-	-	0.406
result / TAL	-	-	-	-	-	-	-	-	-	-	-	-	-	-	-	-	-	0.002	-	-	-	0.02

Bold font indicates result>TAL/MQL; italic font and hollow symbols indicate undetected results; "-" is used if no analytical results were available.

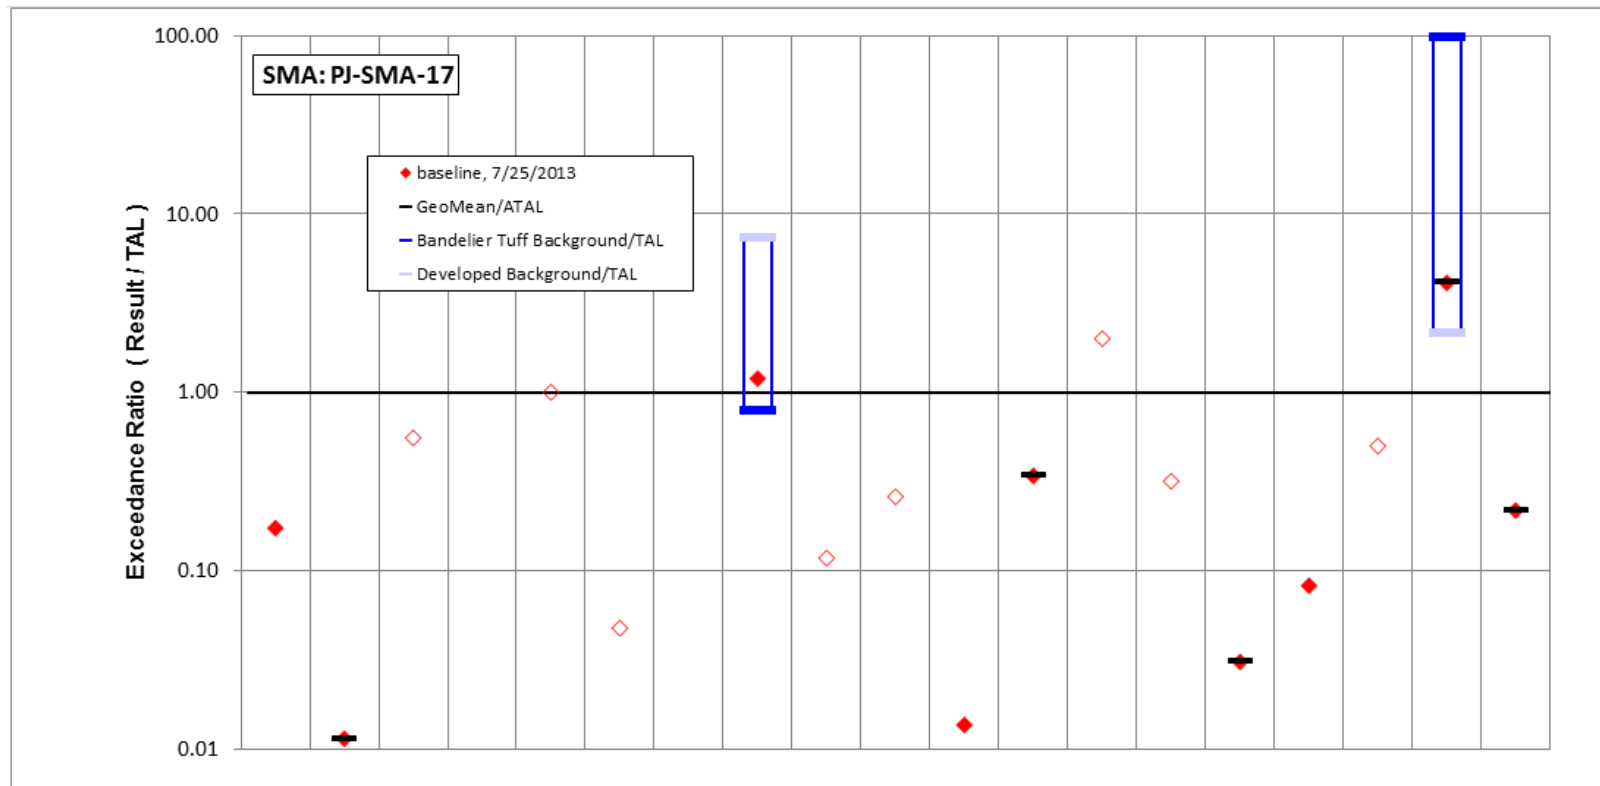
**Figure 172-2 Inorganic analytical results summary plot for PJ-SMA-17**

Aluminum	Antimony	Arsenic	Boron	Cadmium	Chromium	Cobalt	<b>Copper</b>	Lead	Mercury	Nickel	Selenium	<b>Silver</b>	Thallium	Vanadium	Zinc	Cyanide, weak acid dissociable	<b>Gross alpha</b>	Radium-226 and Radium-228
std used in ratio calculations	MTAL	ATAL	ATAL	ATAL	MQL	MTAL	ATAL	MTAL	MTAL	ATAL	MTAL	ATAL	MQL	ATAL	ATAL	MTAL	MQL	ATAL	ATAL
std value	750	640	9	5000	1	210	1000	4.3	17	0.77	170	5	0.5	6.3	100	42	0.01	15	30
unit	ug/L	ug/L	ug/L	ug/L	ug/L	ug/L	ug/L	ug/L	ug/L	ug/L	ug/L	ug/L	ug/L	ug/L	ug/L	ug/L	mg/L	pCi/L	pCi/L
<b>7/25/2013 result</b>	130	7.31	5	28.3	1	10	2.76	<b>5.13</b>	2	0.2	2.32	1.7	<b>1</b>	2	3.08	3.46	0.005	<b>61.6</b>	6.52
result / TAL	0.17	0.011	0.56	0.0057	1	0.048	0.0028	<b>1.2</b>	0.12	0.26	0.014	0.34	<b>2</b>	0.32	0.031	0.082	0.5	<b>4.1</b>	0.22

Bold font indicates result>TAL/MQL; italic font and hollow symbols indicate undetected results; "-" is used if no analytical results were available.

SWMU 54-018 was monitored within PJ-SMA-17. Following the installation of baseline control measures, a baseline storm water sample was collected on July 25, 2013 (Figures 172-2 and 172-3). No exposure was certified and a completion of corrective action for PJ-SMA-17 was submitted on August 27, 2014. This Site is now certified as corrective action complete, and monitoring of storm water discharges has ceased at PJ-SMA-17. No further sampling is required for PJ-SMA-17 for the remainder of the IP. In Figure 172-2, cadmium and silver are reported as nondetectable results equal to or greater than their respective TALs. These values are reported at the PQL; however, the MDLs for these analytes are below the TALs. Analytical results from this sample yielded the following TAL exceedances:

TAL exceedances were also evaluated against the appropriate storm water BVs, that is, “Bandelier Tuff background” for undisturbed SMAs or “developed background” for urban settings. BVs are expressed as UTLs using the approved EPA method for calculating BVs. UTLs for undisturbed SMAs were derived from storm water runoff containing entrained sediments derived from Bandelier Tuff and are labeled “Bandelier Tuff Background” in Figures 172-2 and 172-3. UTLs developed for urban settings were derived from runoff from developed landscapes on the Pajarito Plateau, including buildings, parking lots, roads, and associated features, and are labeled “Developed Background” in Figures 172-2 and 172-3.

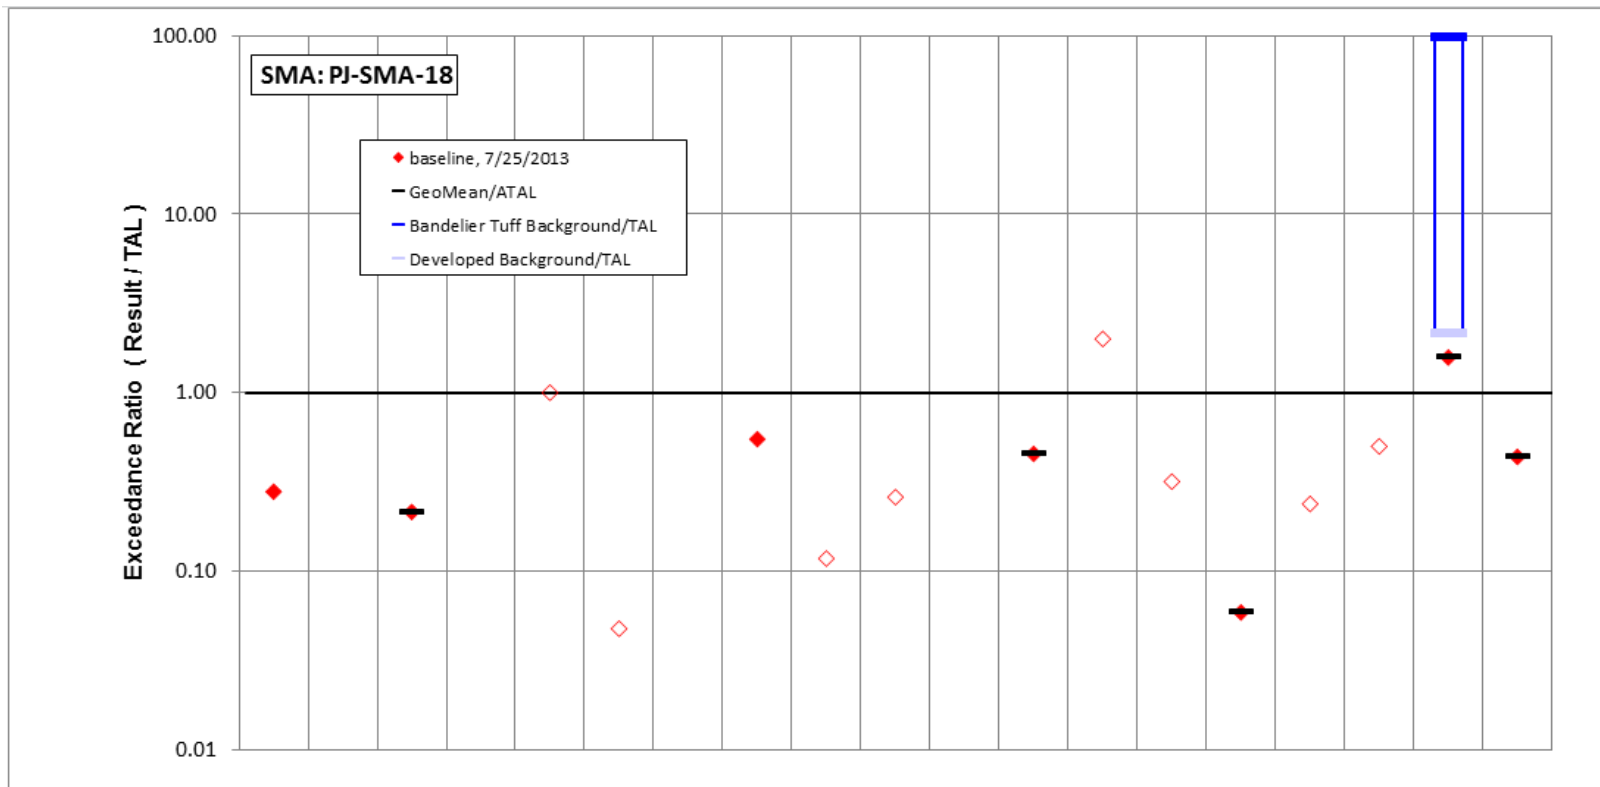
Figure 173-2 Inorganic analytical results summary plot for PJ-SMA-18

Aluminum	Antimony	Arsenic	Boron	Cadmium	Chromium	Cobalt	Copper	Lead	Mercury	Nickel	Selenium	Silver	Thallium	Vanadium	Zinc	Cyanide, weak acid dissociable	Gross alpha	Radium-226 and Radium-228
std used in ratio calculations	MTAL	ATAL	ATAL	ATAL	MQL	MTAL	ATAL	MTAL	MTAL	ATAL	MTAL	ATAL	MQL	ATAL	ATAL	MTAL	MQL	ATAL	ATAL
std value	750	640	9	5000	1	210	1000	4.3	17	0.77	170	5	0.5	6.3	100	42	0.01	15	30
unit	ug/L	ug/L	ug/L	ug/L	ug/L	ug/L	ug/L	ug/L	ug/L	ug/L	ug/L	ug/L	ug/L	ug/L	ug/L	ug/L	mg/L	pCi/L	pCi/L
<b>7/25/2013 result</b>	209	3	1.93	19.7	1	10	2	2.36	2	0.2	1.49	2.27	1	2	5.87	10	0.005	23.6	13.1
result / TAL	0.28	0.005	0.21	0.0039	1	0.048	0.002	0.55	0.12	0.26	0.0088	0.45	2	0.32	0.059	0.24	0.5	1.6	0.44

Bold font indicates result>TAL/MQL; italic font and hollow symbols indicate undetected results; "-" is used if no analytical results were available.

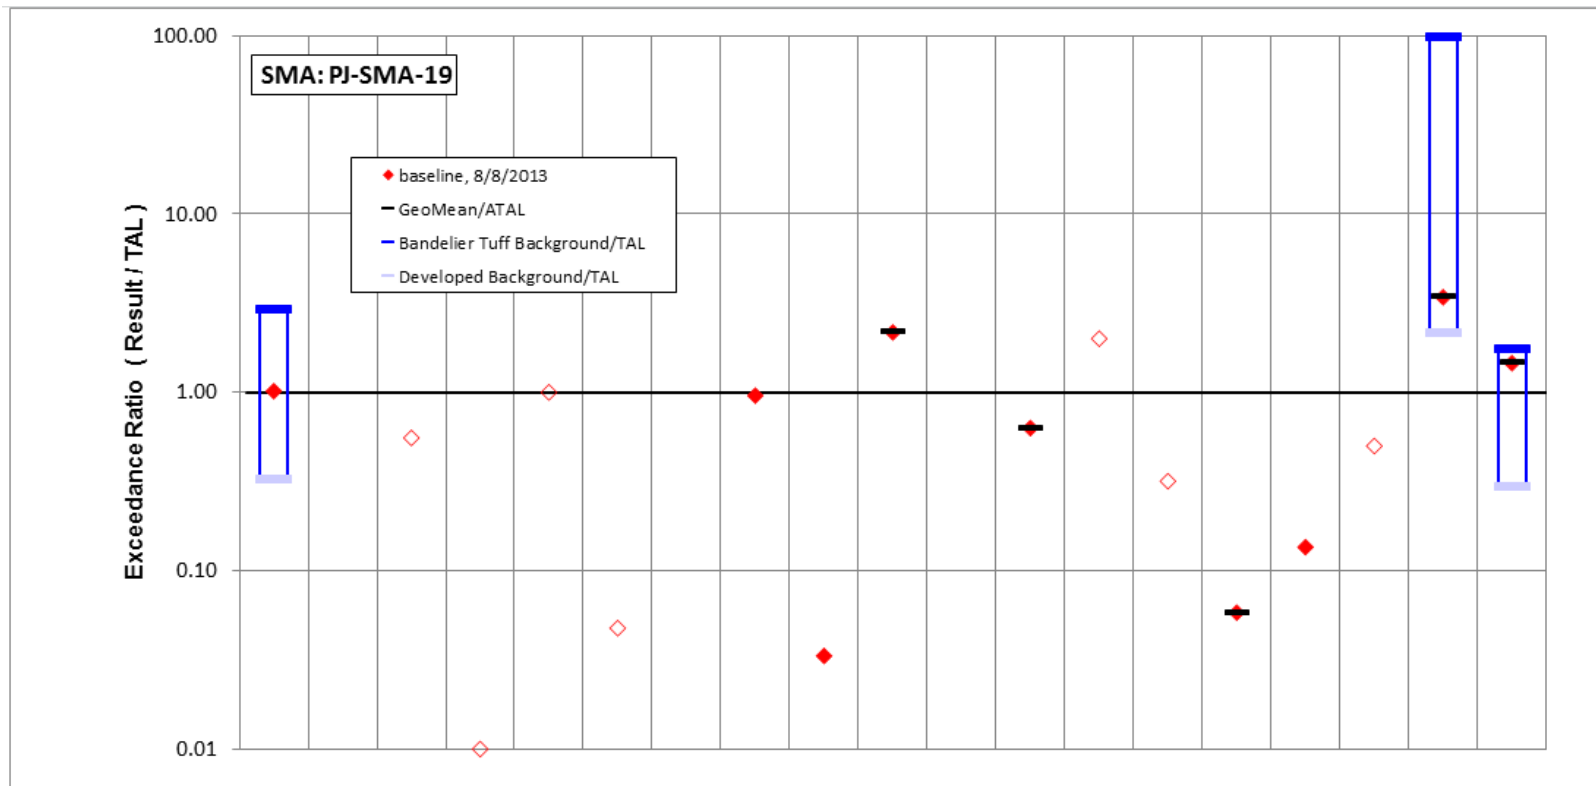
**Figure 174-2 Inorganic analytical results summary plot for PJ-SMA-19**

Aluminum	Antimony	Arsenic	Boron	Cadmium	Chromium	Cobalt	Copper	Lead	Mercury	Nickel	Selenium	Silver	Thallium	Vanadium	Zinc	Cyanide, weak acid dissociable	Gross alpha	Radium-226 and Radium-228
std used in ratio calculations	MTAL	ATAL	ATAL	ATAL	MQL	MTAL	ATAL	MTAL	MTAL	ATAL	MTAL	ATAL	MQL	ATAL	ATAL	MTAL	MQL	ATAL	ATAL
std value	750	640	9	5000	1	210	1000	4.3	17	0.77	170	5	0.5	6.3	100	42	0.01	15	30
unit	ug/L	ug/L	ug/L	ug/L	ug/L	ug/L	ug/L	ug/L	ug/L	ug/L	ug/L	ug/L	ug/L	ug/L	ug/L	ug/L	mg/L	pCi/L	pCi/L
<b>8/8/2013 result</b>	<b>761</b>	3	5	50	1	10	2.94	4.12	0.566	<b>1.67</b>	1.33	3.15	1	2	5.82	5.69	0.005	51.2	43.7
result / TAL	<b>1</b>	0.005	0.56	0.01	1	0.048	0.0029	0.96	0.033	2.2	0.0078	0.63	2	0.32	0.058	0.14	0.5	3.4	1.5

Bold font indicates result>TAL/MQL; italic font and hollow symbols indicate undetected results; "-" is used if no analytical results were available.

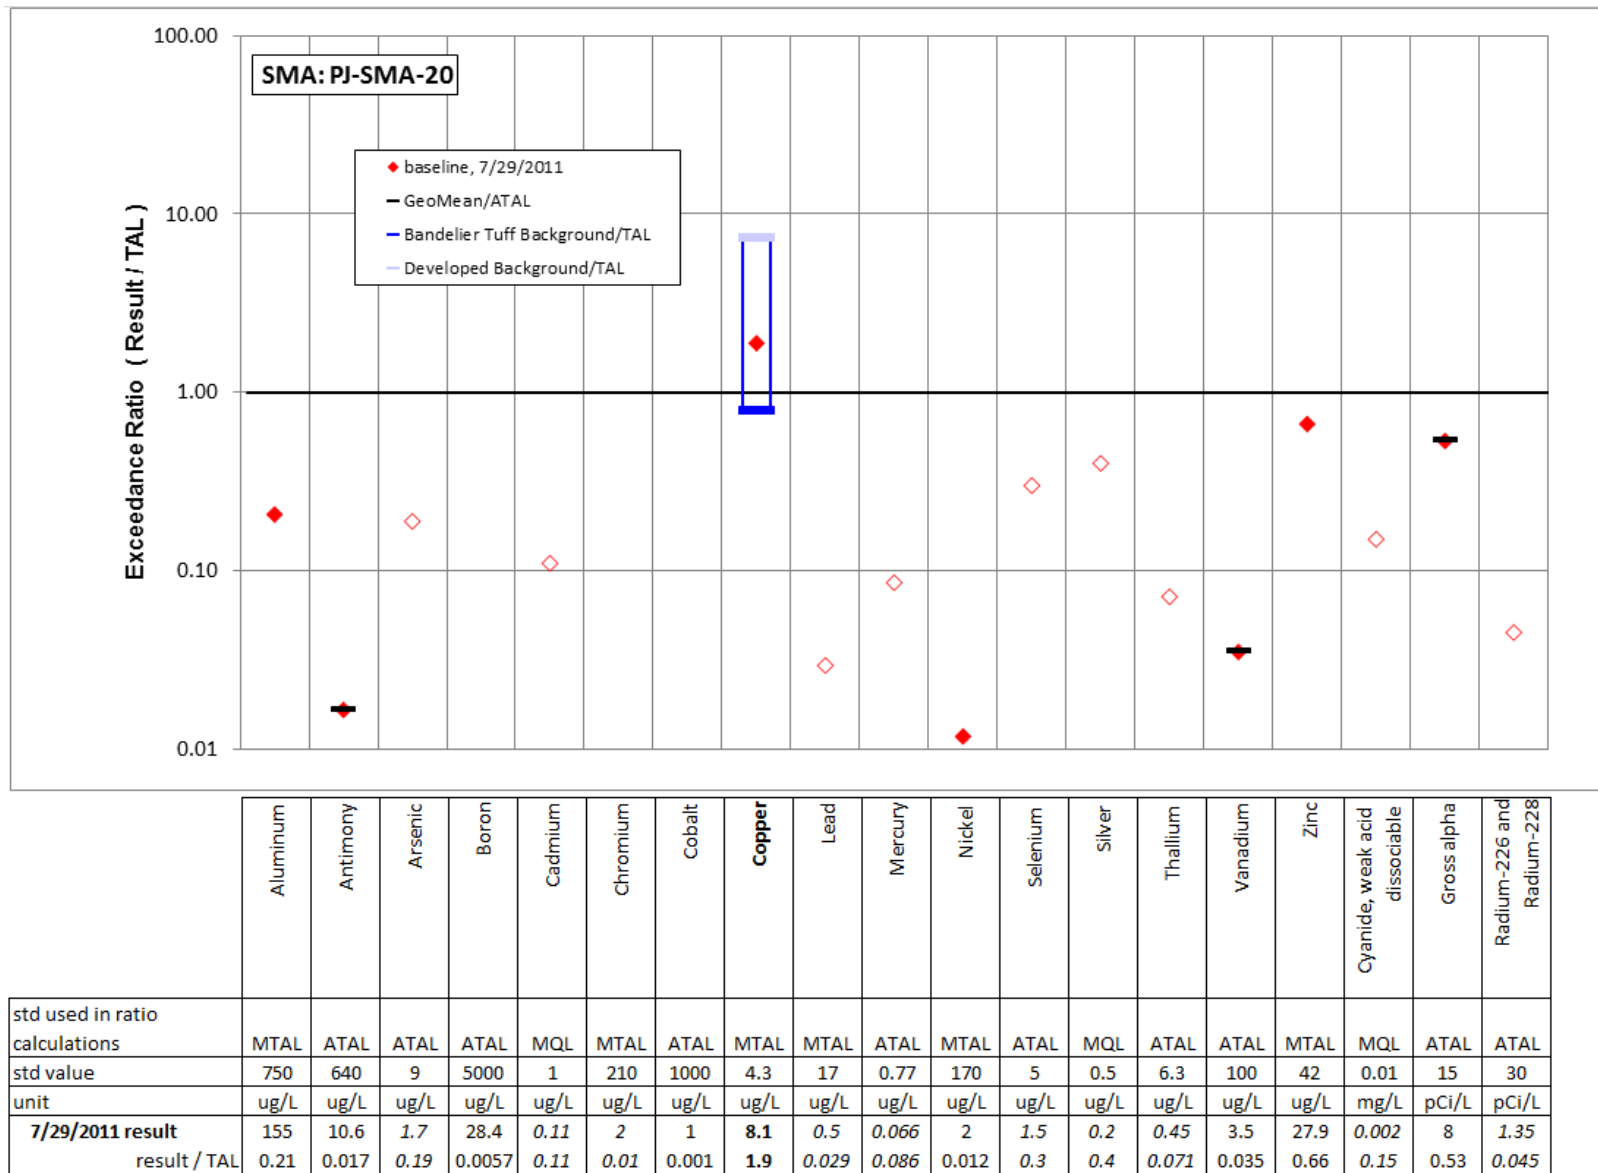
**Figure 175-2 Inorganic analytical results summary plot for PJ-SMA-20**

Bold font indicates result>TAL/MQL; italic font and hollow symbols indicate undetected results; "-" is used if no analytical results were available.

SWMU 54-017 was monitored within PJ-SMA-20. Following the installation of baseline control measures, a baseline storm water sample was collected on July 29, 2011 (Figures 175-2 and 175-3). On October 25, 2013, a document certifying the no exposure condition of SWMU 54-017 was completed and submitted to EPA. This Site is now certified as corrective action complete, and monitoring of storm water discharges has ceased at PJ-SMA-20. No further sampling is required for PJ-SMA-20 for the remainder of the IP. Analytical results from this sample yielded the following TAL exceedances:

The TAL exceedance was also evaluated against the appropriate storm water BV, that is, “Bandelier Tuff background” for undisturbed SMAs or “developed background” for urban settings. BVs are expressed as UTLs using the approved EPA method for calculating BVs. UTLs for undisturbed SMAs were derived from storm water runoff containing entrained sediments derived from Bandelier Tuff and are labeled “Bandelier Tuff Background” in Figures 175-2 and 175-3. UTLs developed for urban settings were derived from runoff from developed landscapes on the Pajarito Plateau, including buildings, parking lots, roads, and associated features, and are labeled “Developed Background” in Figures 175-2 and 175-3.

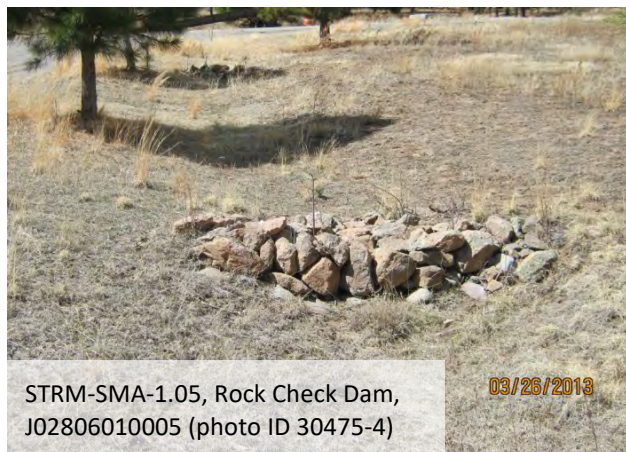
Monitoring location STRM-SMA-1.05 receives storm water run-on from developed environments, including paved parking lots, roads, and buildings, as well as landscape containing sediment derived from Bandelier Tuff. Metals including copper are associated with building materials, parking lots, and automobiles as well as low concentrations in the Bandelier Tuff.

- Copper—The copper UTL from developed landscape storm water run-on is 32.3 µg/L; the copper UTL for storm water containing sediment derived from Bandelier Tuff is 3.43 µg/L. The copper results from 2011 and 2013 are between these values.

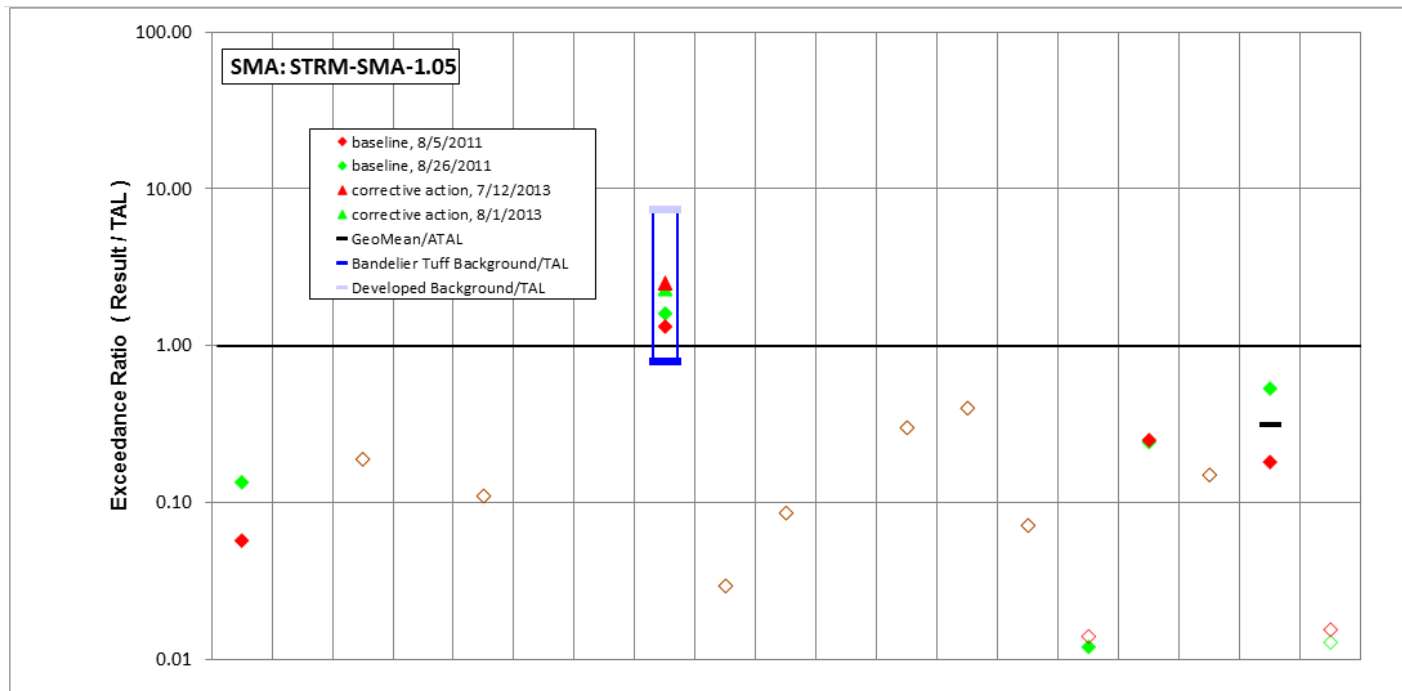
Aluminum	Antimony	Arsenic	Boron	Cadmium	Chromium	Cobalt	<b>Copper</b>	Lead	Mercury	Nickel	Selenium	Silver	Thallium	Vanadium	Zinc	Cyanide, weak acid dissociable	Gross alpha	Radium-226 and Radium-228
std used in ratio calculations	MTAL	ATAL	ATAL	ATAL	MQL	MTAL	ATAL	MTAL	MTAL	ATAL	MTAL	ATAL	MQL	ATAL	ATAL	MTAL	MQL	ATAL	ATAL
std value	750	640	9	5000	1	210	1000	4.3	17	0.77	170	5	0.5	6.3	100	42	0.01	15	30
unit	ug/L	ug/L	ug/L	ug/L	ug/L	ug/L	ug/L	ug/L	ug/L	ug/L	ug/L	ug/L	ug/L	ug/L	ug/L	ug/L	mg/L	pCi/L	pCi/L
8/1/2013 result	-	-	-	-	-	-	-	<b>9.92</b>	-	-	-	-	-	-	-	-	-	-	-
result / TAL	-	-	-	-	-	-	-	<b>2.3</b>	-	-	-	-	-	-	-	-	-	-	-
7/12/2013 result	-	-	-	-	-	-	-	<b>10.8</b>	-	-	-	-	-	-	-	-	-	-	-
result / TAL	-	-	-	-	-	-	-	<b>2.5</b>	-	-	-	-	-	-	-	-	-	-	-
8/26/2011 result	101	3.2	1.7	15	0.11	2	1.3	<b>6.9</b>	0.5	0.066	1	1.5	0.2	0.45	1.2	10.2	0.002	8	0.385
result / TAL	0.13	0.005	0.19	0.003	0.11	0.01	0.0013	<b>1.6</b>	0.029	0.086	0.0059	0.3	0.4	0.071	0.012	0.24	0.15	0.53	0.013

8/5/2011 result	42.9	2.5	1.7	15	0.11	2	1	<b>5.7</b>	0.5	0.066	1.6	1.5	0.2	0.45	1.4	10.5	0.002	2.72	0.464
result / TAL	0.057	0.0039	0.19	0.003	0.11	0.01	0.001	<b>1.3</b>	0.029	0.086	0.0094	0.3	0.4	0.071	0.014	0.25	0.15	0.18	0.015

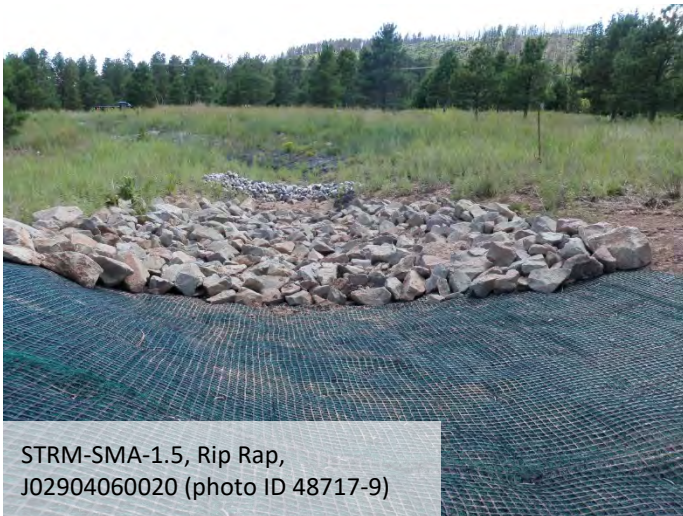
STRM-SMA-1.5, Rip Rap,  
J02904060020 (photo ID 48717-9)

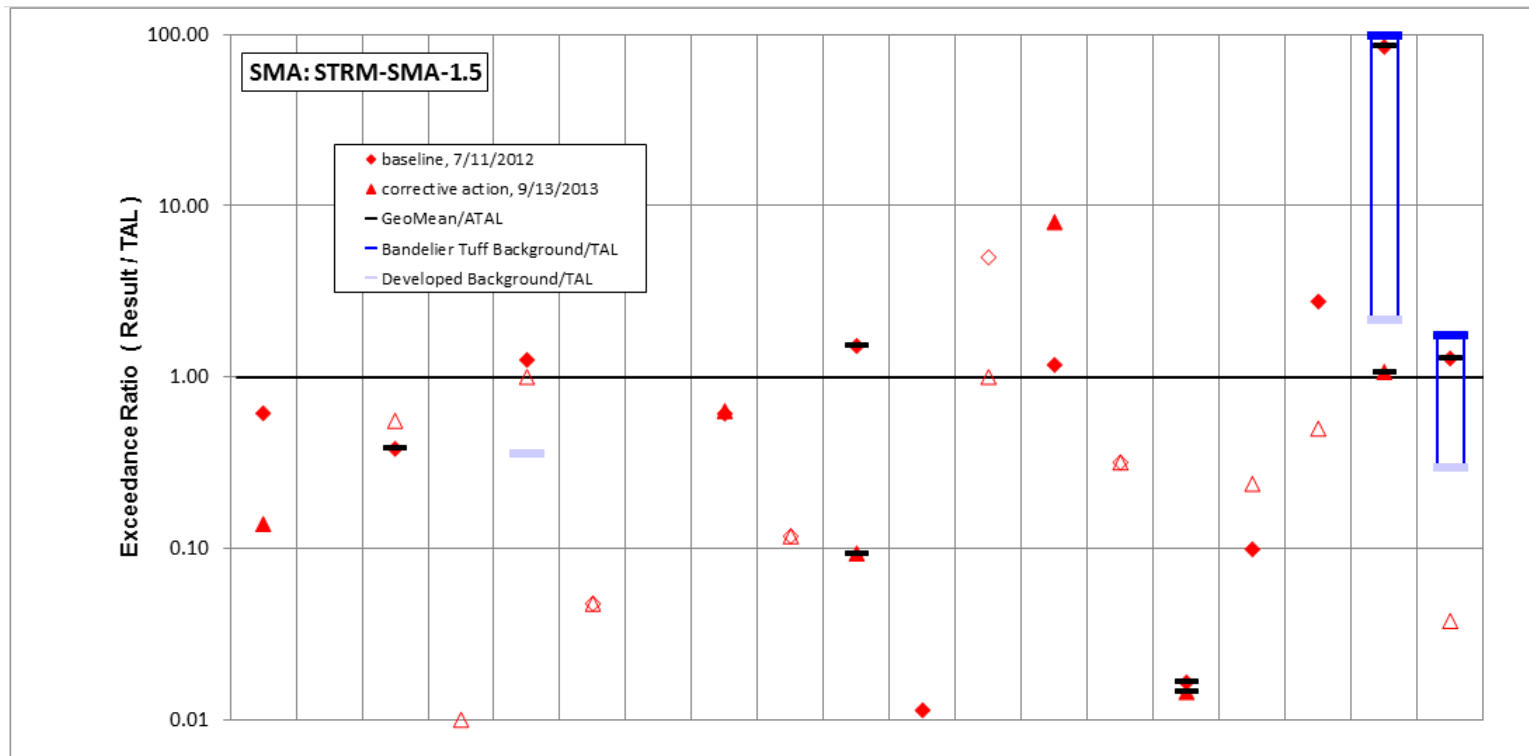
**Figure 177-2 Inorganic analytical results summary plot for STRM-SMA-1.5**

Bold font indicates result>TAL/MQL; italic font and hollow symbols indicate undetected results; "-" is used if no analytical results were available.

Following the installation of enhanced control measures at STRM-SMA-1.5, a corrective action storm water sample was collected on September 13, 2013 (Figures 177-2 and 177-3). Analytical results from this corrective action monitoring sample yielded the following TAL exceedances:

TAL exceedances were also evaluated against the appropriate storm water BV, that is, “Bandelier Tuff background” for undisturbed SMAs or “developed background” for urban settings. BVs are expressed as UTLs using the approved EPA method for calculating BVs. UTLs for undisturbed SMAs were derived from storm water runoff containing entrained sediments derived from Bandelier Tuff and are labeled “Bandelier Tuff Background” in Figures 177-2 and 177-3. UTLs developed for urban settings were derived from runoff from developed landscapes on the

Pajarito Plateau, including buildings, parking lots, roads, and associated features, and are labeled “Developed Background” in Figures 177-2 and 177-3.

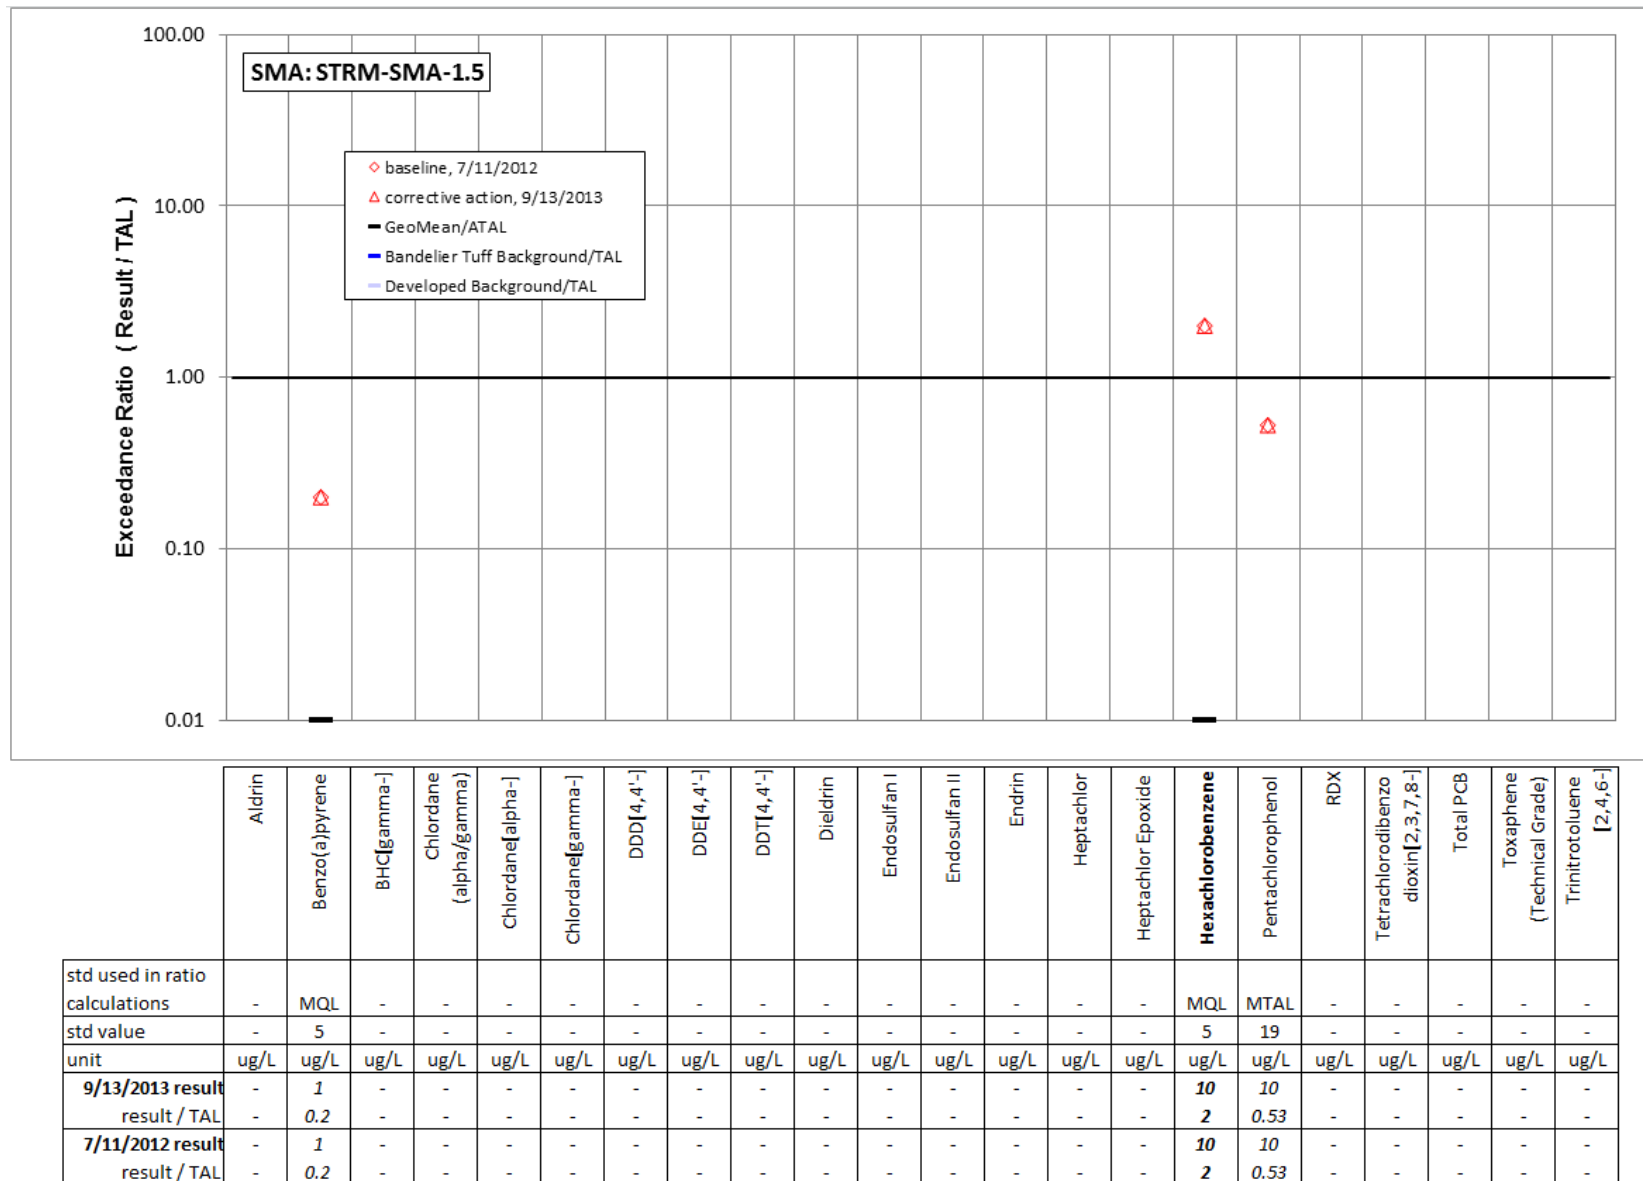
**Figure 177-3 Organic analytical results summary plot for STRM-SMA-1.5**

Bold font indicates result>TAL/MQL; italic font and hollow symbols indicate undetected results; "-" is used if no analytical results were available.

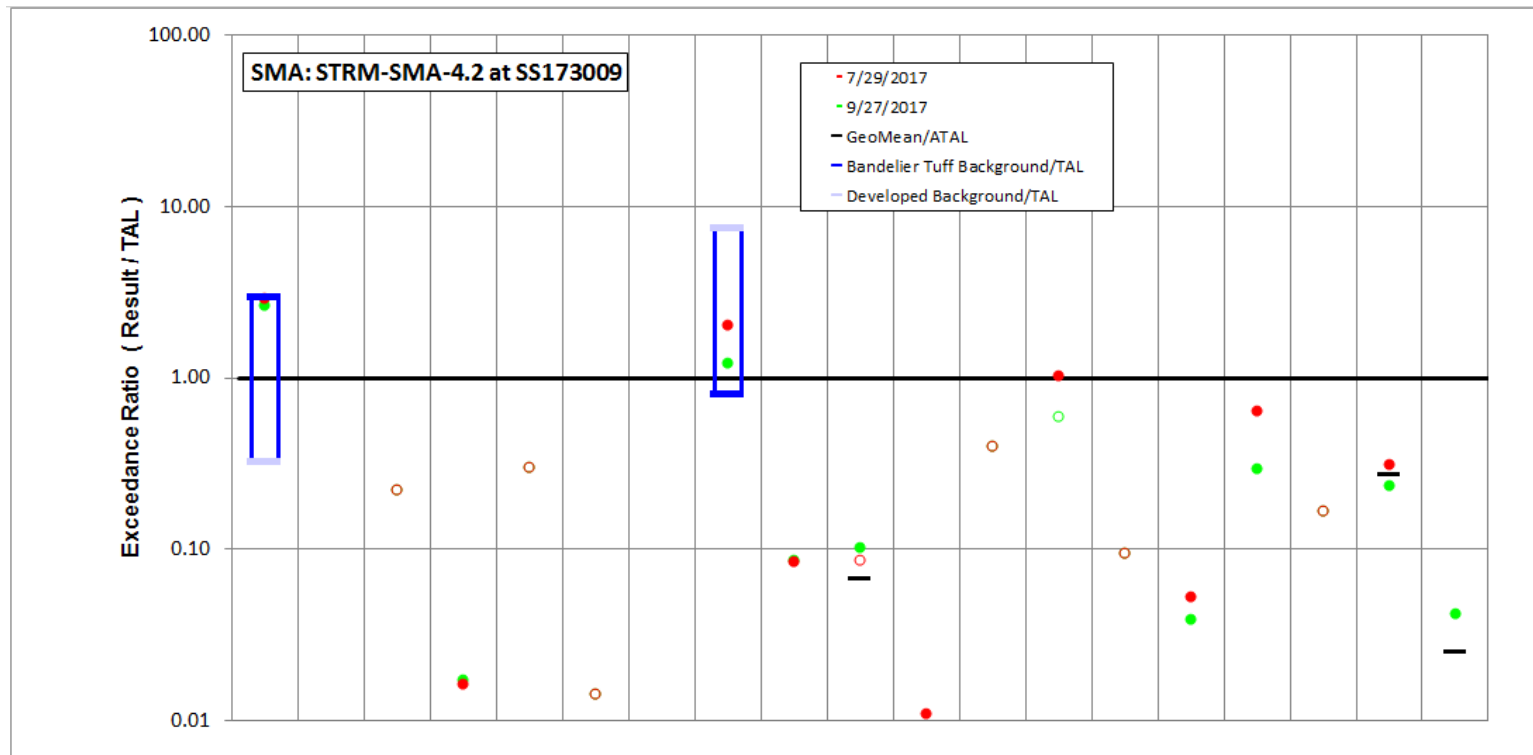
**Figure 178-2a Inorganic analytical results summary plot for STRM-SMA-4.2**

Bold font indicates result>TAL or MQL; italic font and hollow symbols indicate undetected results; "-" is used if no analytical results were available.

SWMU 09-008(b) is monitored within STRM-SMA-4.2. Following the installation of baseline control measures, baseline storm water samples were collected on August 21, 2011, and September 9, 2011 (Figure 178-2). In Figure 178-2, cyanide is reported as a nondetectable result equal to or greater than the TALs. This value is reported at the PQL; however, the MDL for this analyte is below the TAL. Analytical results from this sample yielded the following TAL exceedance:

Enhanced control confirmation storm water samples were collected on July 29, 2017, and September 27, 2017 (Figure 178-2). Analytical results from these samples yielded the following TAL exceedances:

TAL exceedances were also evaluated against the appropriate storm water BV, that is, “Bandelier Tuff background” for undisturbed SMAs or “developed background” for urban settings. BVs are expressed as UTLs using the approved EPA method for calculating BVs. UTLs for undisturbed SMAs were derived from storm water runoff containing entrained sediments derived from Bandelier Tuff and are labeled “Bandelier Tuff Background” in Figure 178-2. UTLs developed for urban settings were derived from runoff from developed landscapes on the Pajarito Plateau, including buildings, parking lots, roads, and associated features, and are labeled “Developed Background” in Figure 178-2.

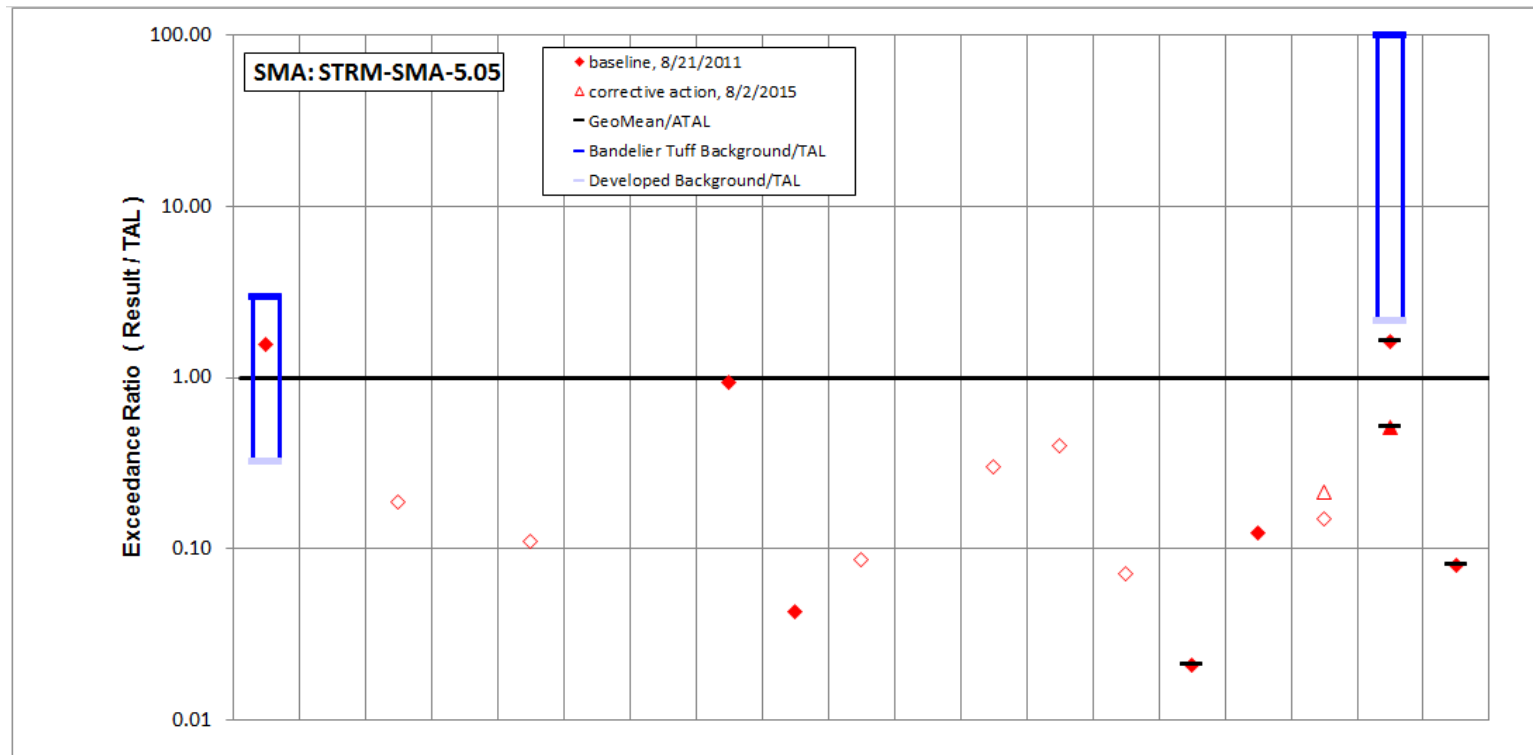
**Figure 179-2 Inorganic analytical results summary plot for STRM-SMA-5.05**

Bold font indicates result>TAL or MQL; italic font and hollow symbols indicate undetected results; "-" is used if no analytical results were available.

SWMU 09-013 is monitored within STRM-SMA-5.05. Following the installation of baseline control measures, a baseline storm water sample was collected on August 21, 2011 (Figures 179-2 and 179-3). Analytical results from this sample yielded the following TAL exceedances:

Following the installation of enhanced control measures at STRM-SMA-5.05, a corrective action storm water sample was collected on August 2, 2015 (Figures 179-2 and 179-3). Analytical results from this corrective action monitoring sample yielded the following TAL exceedance:

TAL exceedances were also evaluated against the appropriate storm water BV, that is, “Bandelier Tuff background” for undisturbed SMAs or “developed background” for urban settings. BVs are expressed as UTLs using the approved EPA method for calculating BVs. UTLs for undisturbed SMAs were derived from storm water runoff containing entrained sediments derived from Bandelier Tuff and are labeled “Bandelier Tuff Background” in Figures 179-2 and 179-3. UTLs developed for urban settings were derived from runoff from developed landscapes on the Pajarito Plateau, including buildings, parking lots, roads, and associated features, and are labeled “Developed Background” in Figures 179-2 and 179-3.
