Historical Investigation Report for Upper Water Canyon Aggregate Area

Prepared by the Environmental Programs Directorate

EXECUTIVE SUMMARY

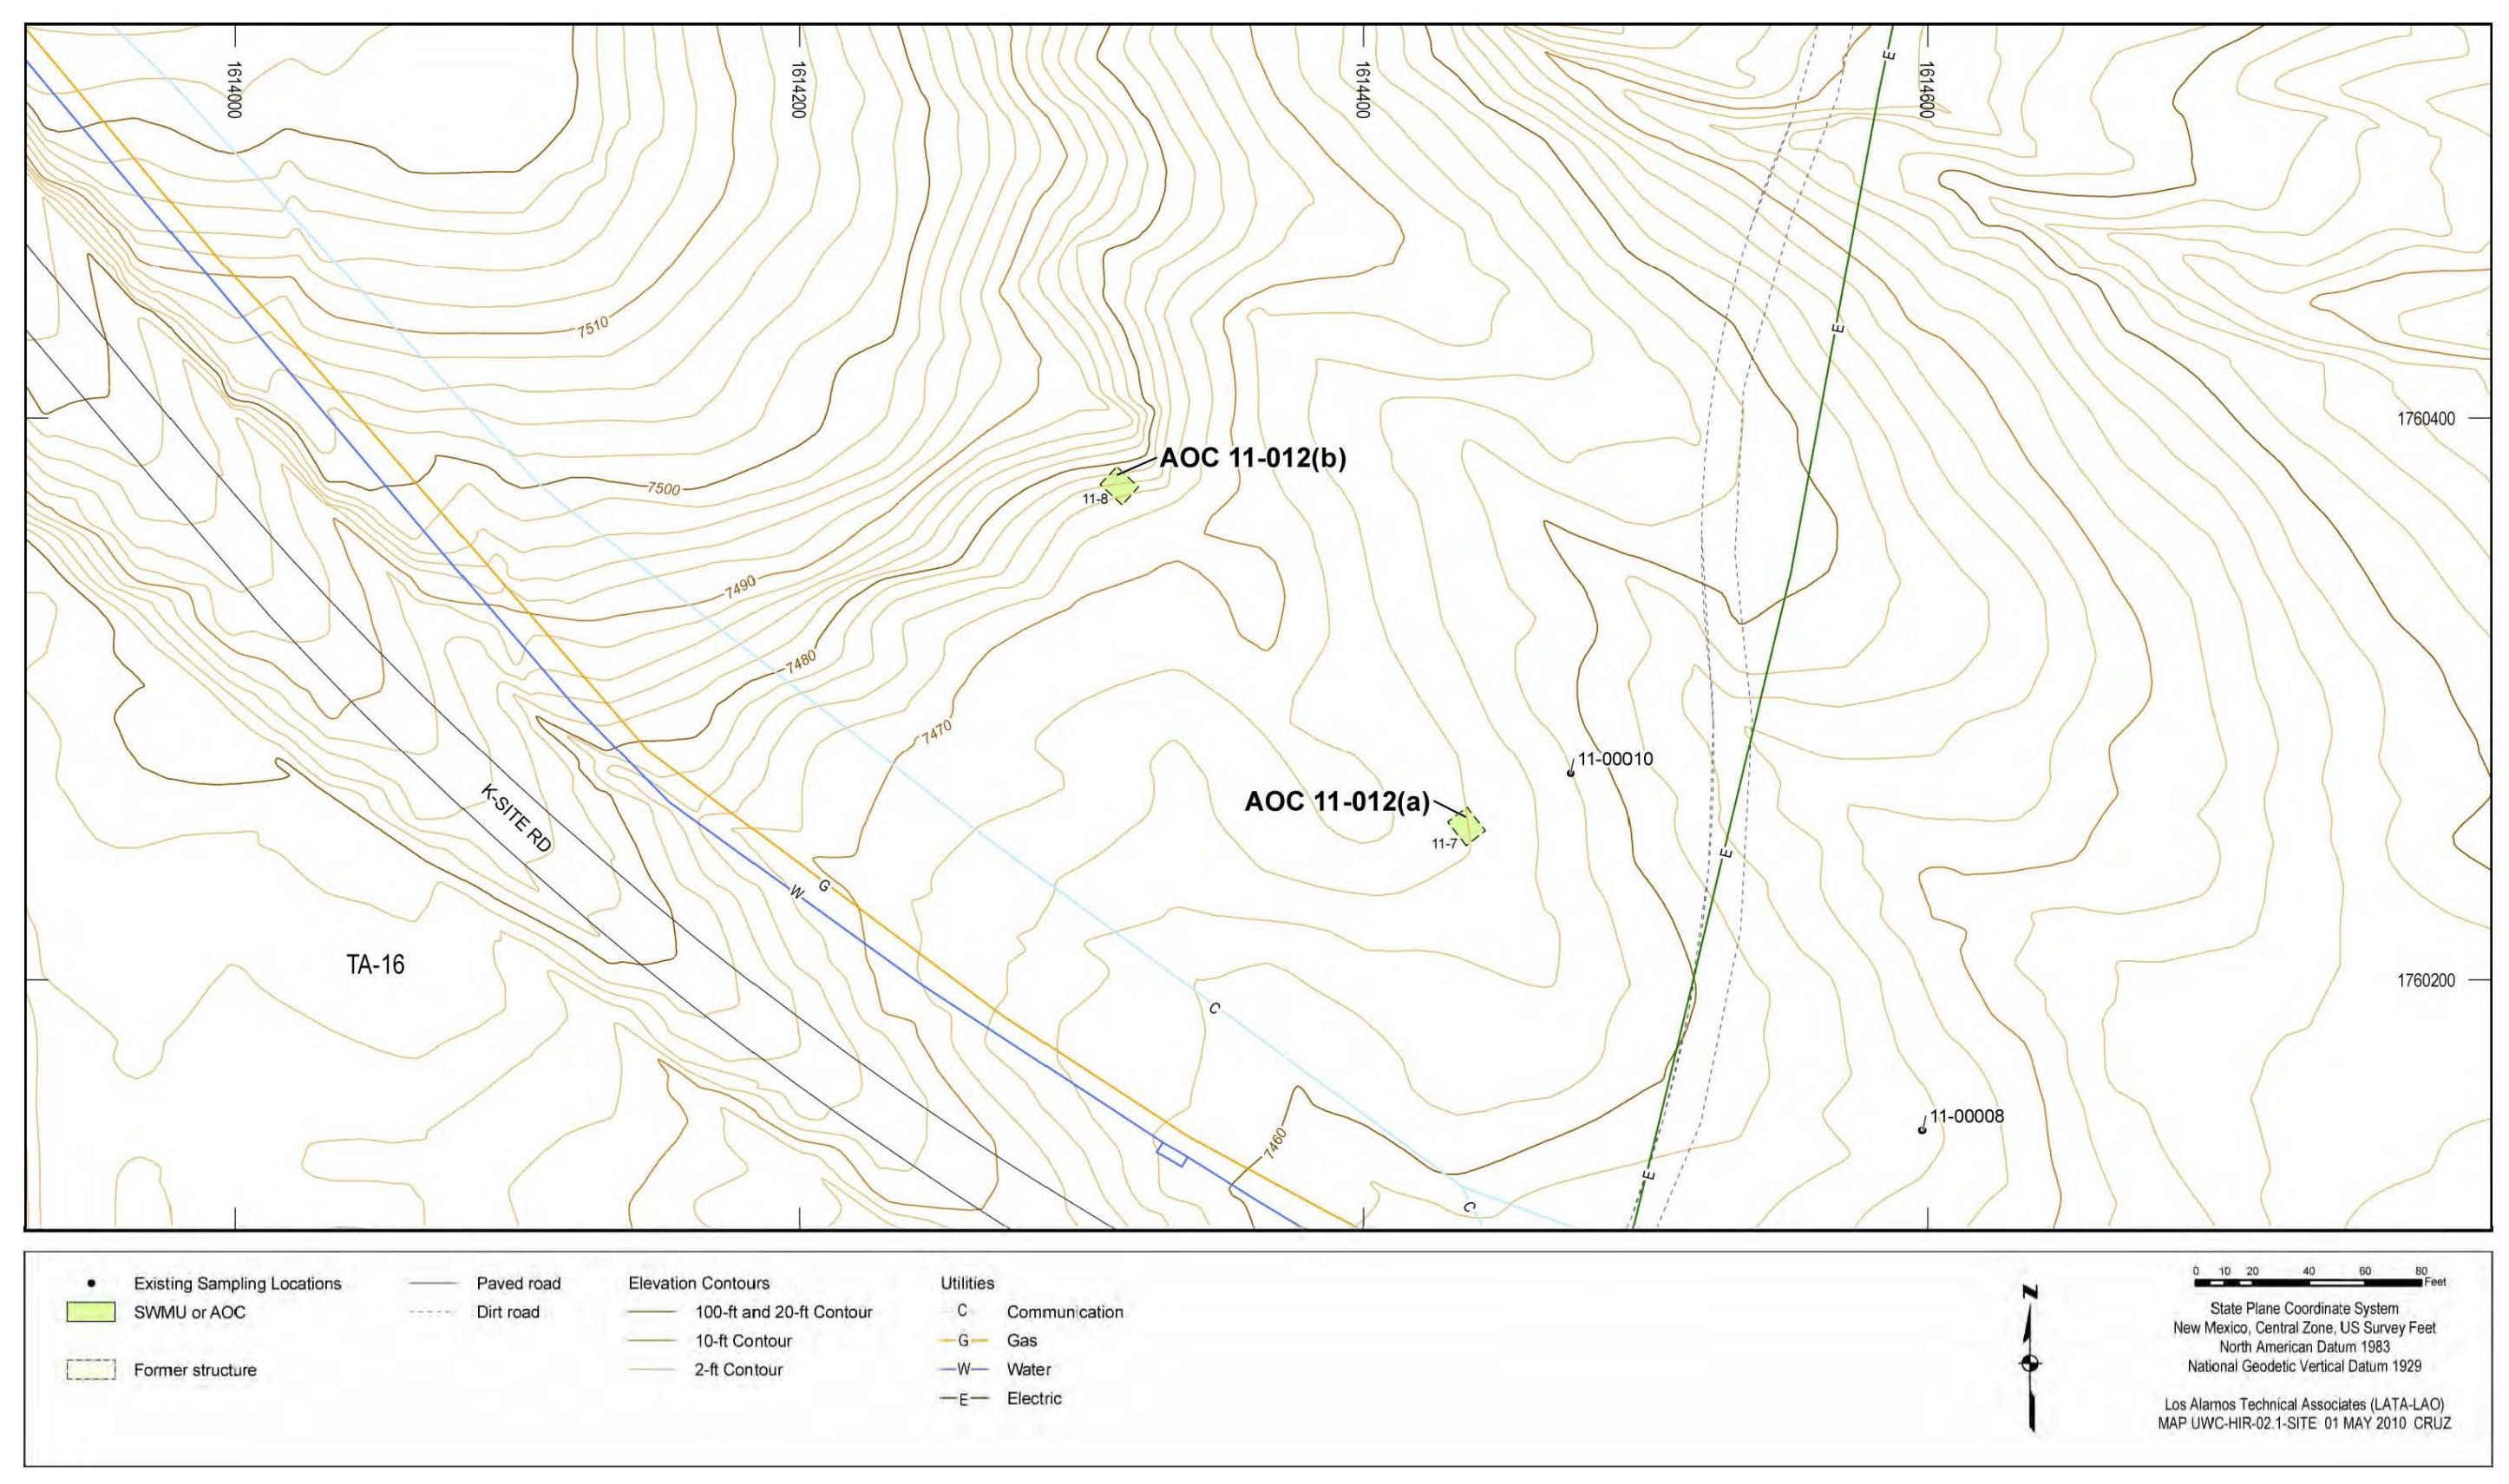
Figure 2.2-1 Site features of AOC 11-012(a) and AOC 11-012(b)

AOC 11-012(a) is an area of potential soil contamination associated with a former HE storage magazine (structure 11-7) at TA-16 (Figure 2.2-1). The magazine was an 11-ft-long \times 9-ft-wide wood structure with earthen berms on three sides. The magazine was built in 1944 and destroyed by intentional burning in 1960 (LANL 1993, 020948, pp. 5 271–5 282).

AOC 11-012(b) is an area of potential soil contamination associated with a former HE storage magazine (structure 11-8) at TA-16 (Figure 2.2-1). The magazine was an 11-ft-long \times 9-ft-wide wood structure with earthen berms on three sides. The magazine was built in 1944 and destroyed by intentional burning in 1960 (LANL 1993, 020948, pp. 5-271–5-282).

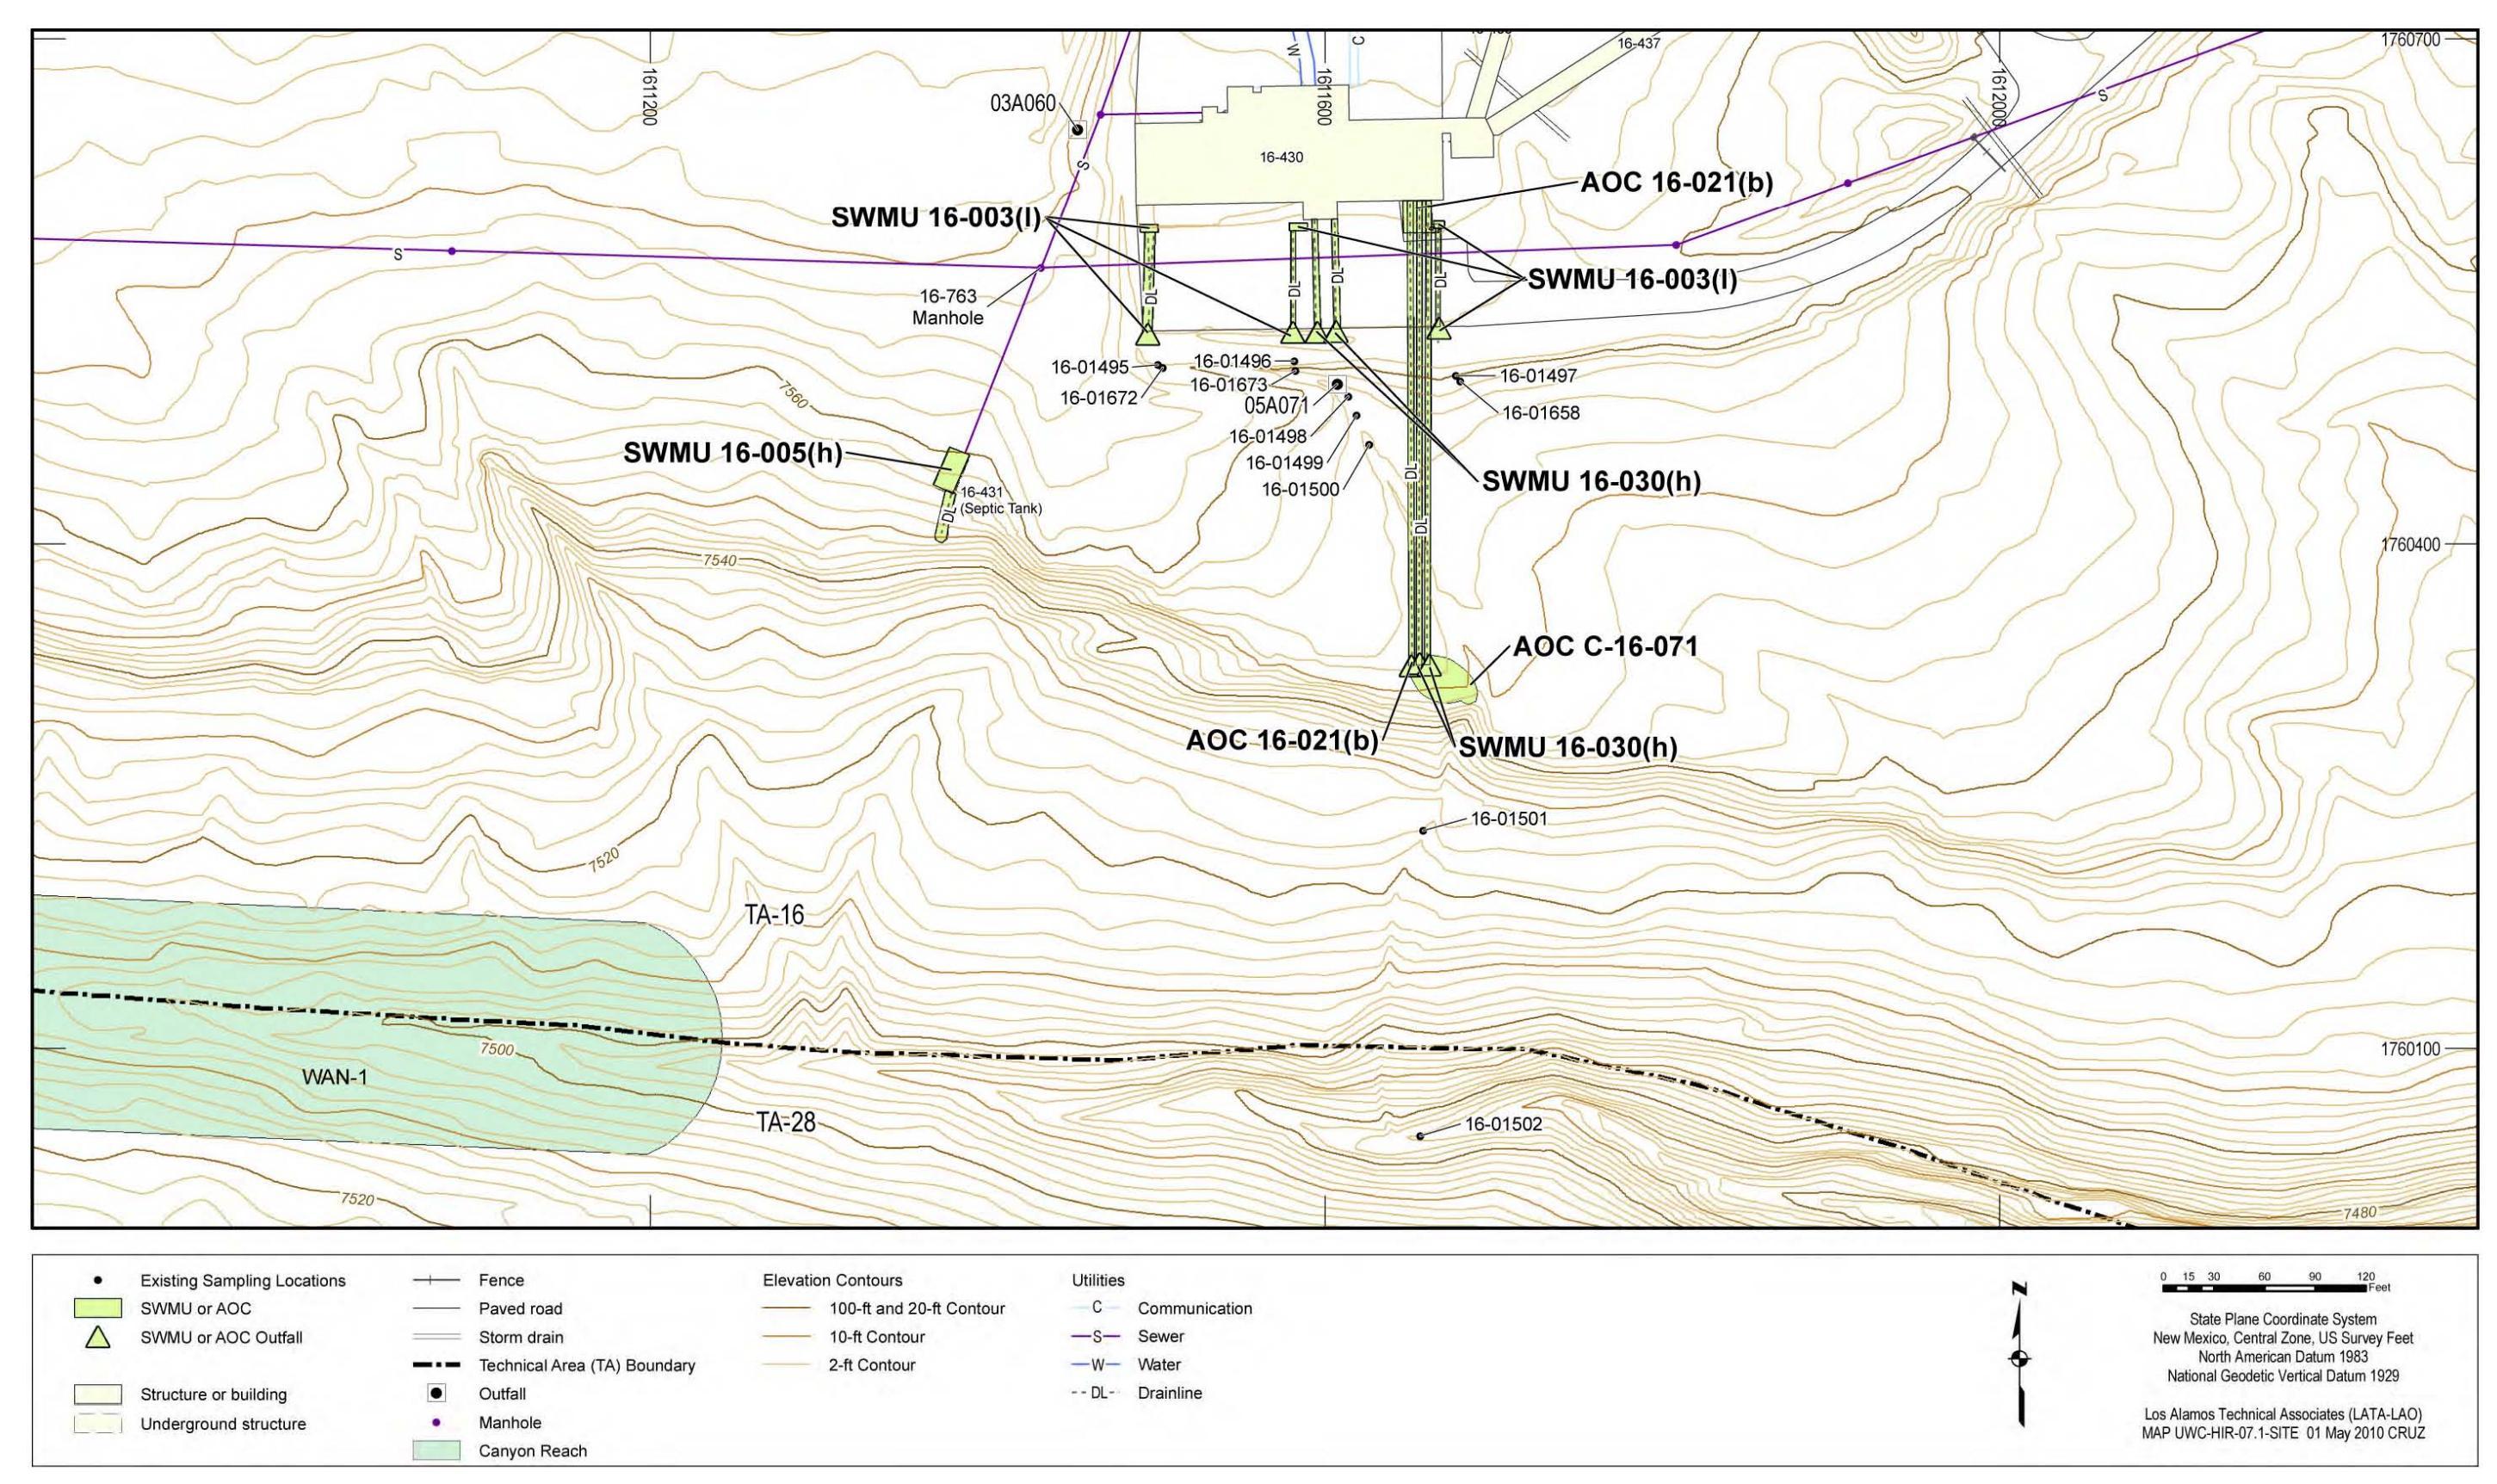
Figure 3.5-1 Site features of Consolidated Unit 16-003(I)-99 [SWMU 16-003(I) and SWMU 16-030(h)], SWMU 16-005(h), AOC 16-021(b), and AOC C-16-071

AOC 16-021(b) is a decommissioned hydraulic press and an associated drain that is located in bay 1 of building 16-430 at TA-16 (Figure 3.5-1). The hydraulic press is located in an equipment pit and is known to have leaked hydraulic fluid (LANL 1990, 007512). A french drain installed around the equipment pit discharged through a drainline south of the building to the same drainage as SWMU 16-030(h). The drain was permanently plugged by 1995 (LANL 1998, 101808, p. 46) and the hydraulic press was decommissioned in 2007.

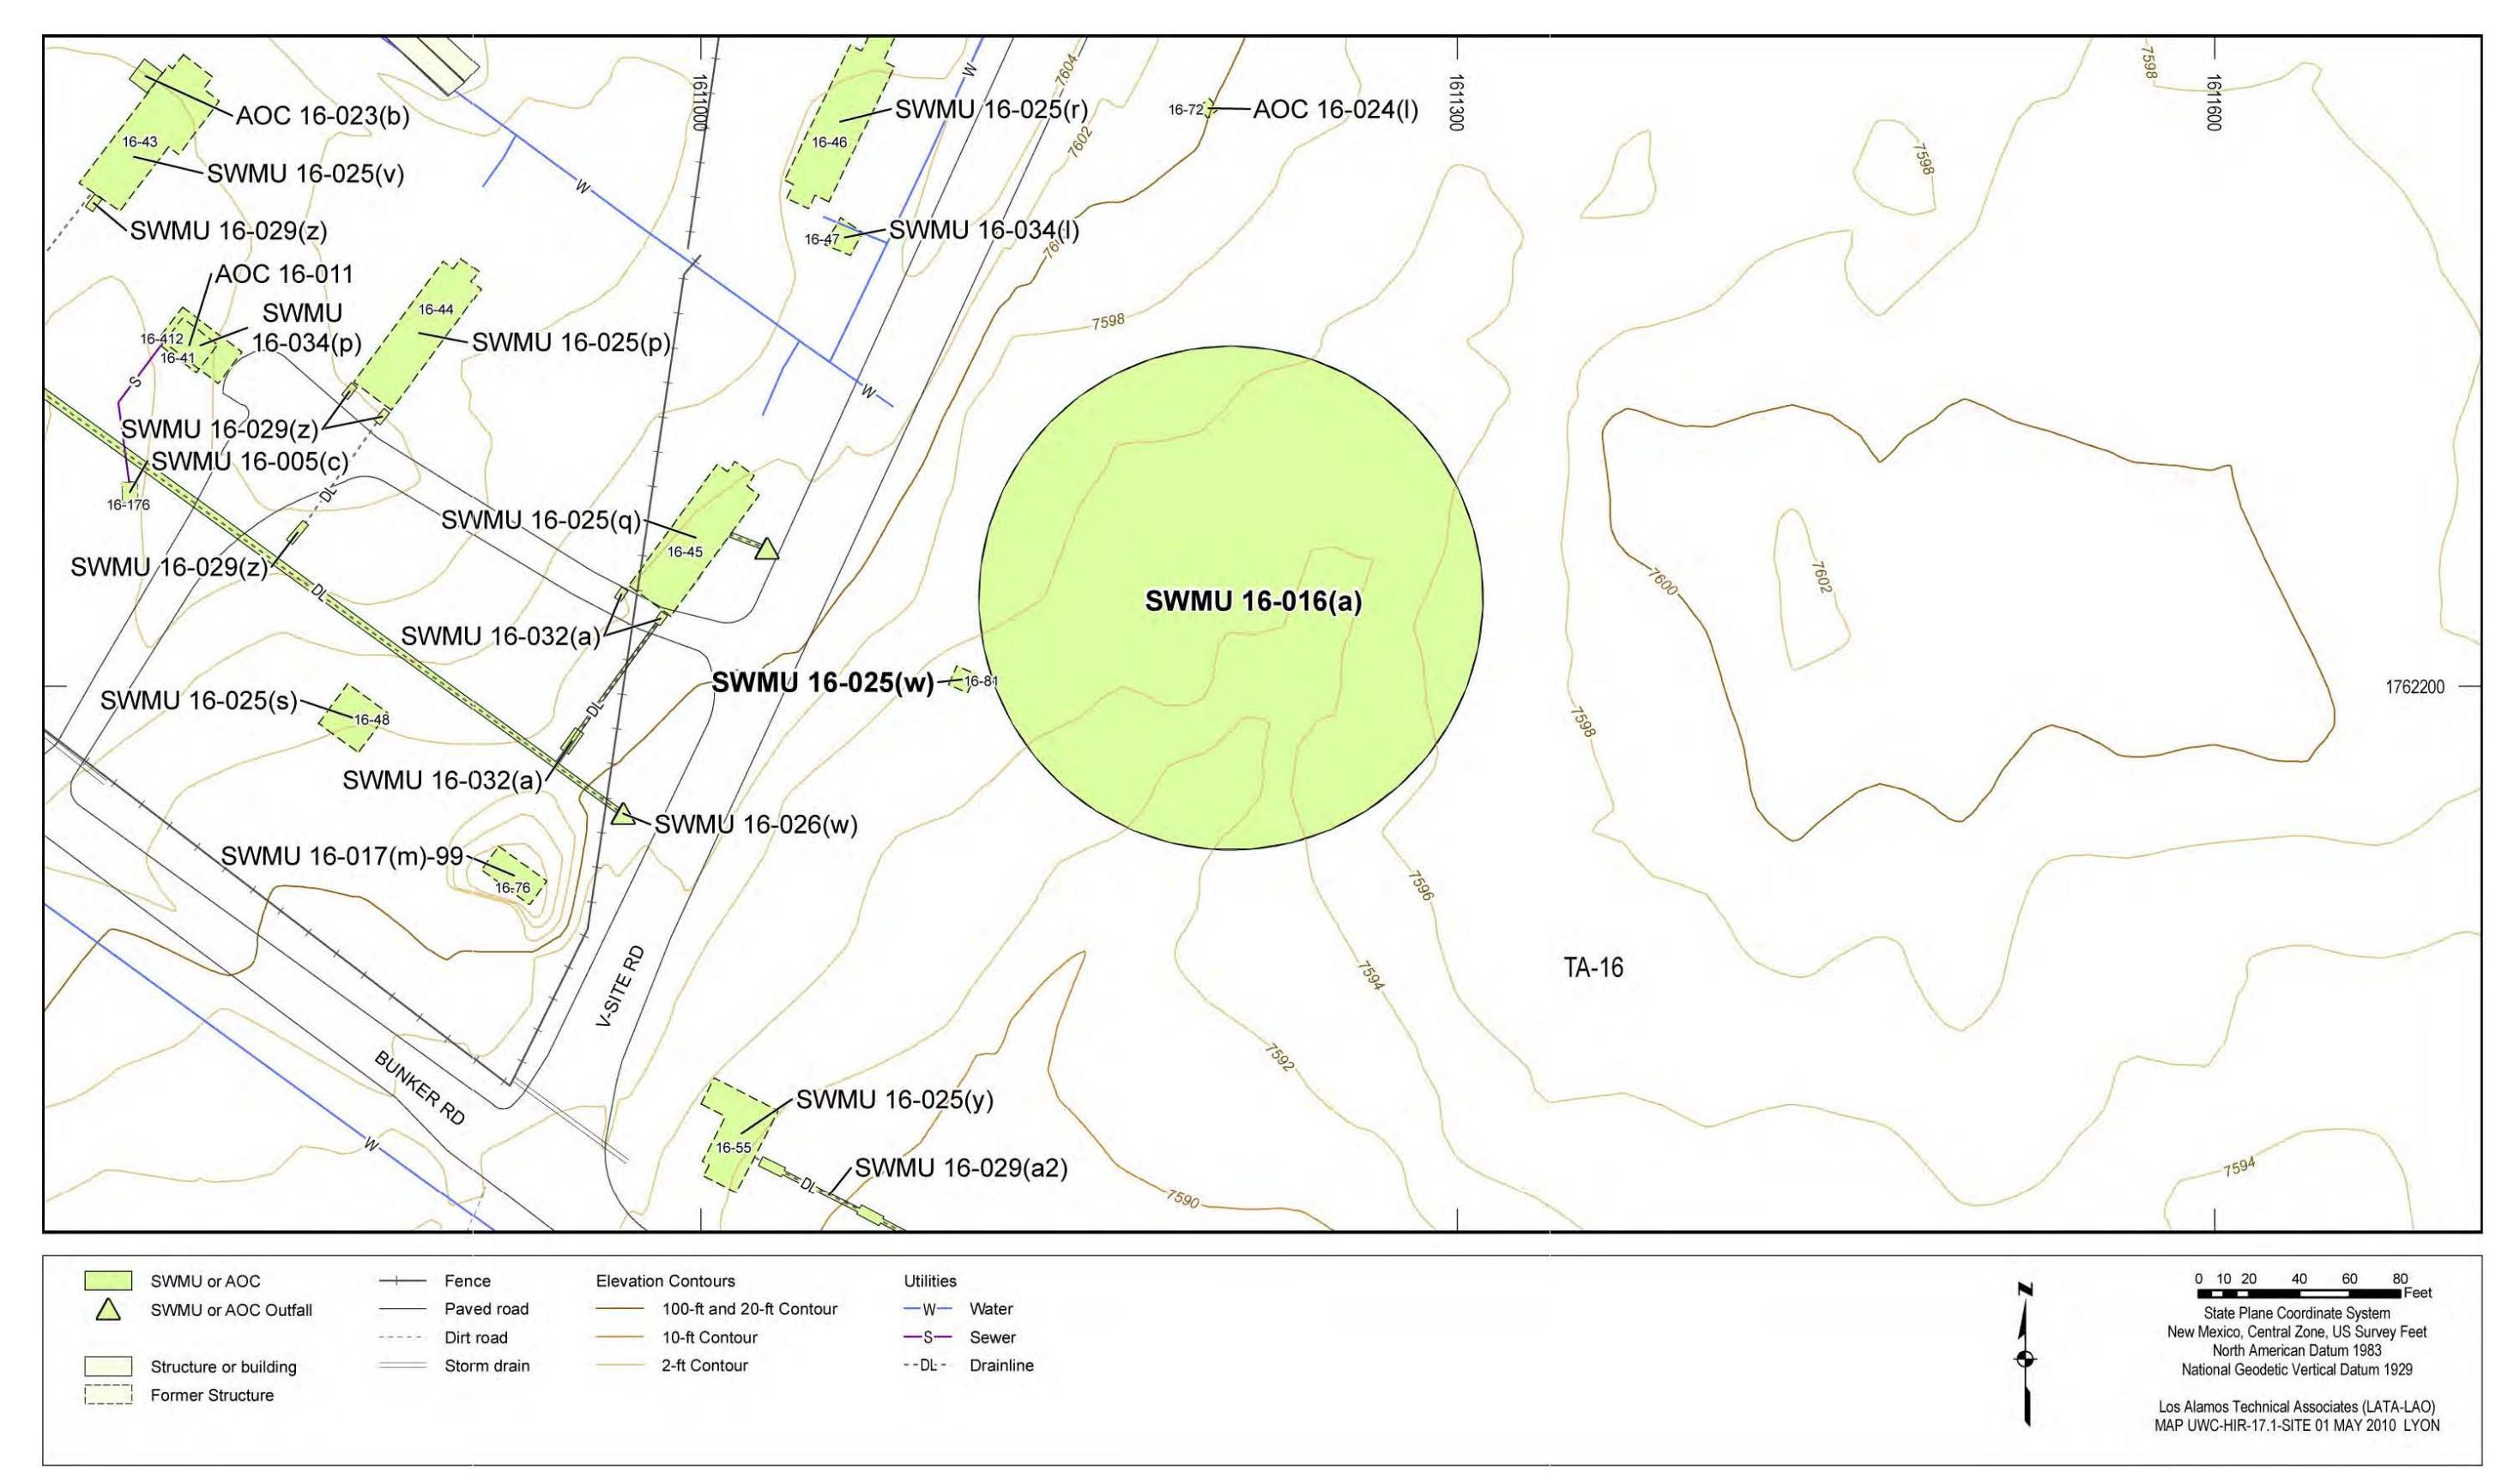
Figure 3.15-1 Site features of SWMU 16-016(a) and SWMU 16-025(w)

SWMU 16-025(w) is an area of potential soil contamination at TA-16 associated with a former nitrocellulose drying building, 16-81 (Figure 3.15-1). Building 16-81 was 8.5 ft \times 8.5 ft \times 8 ft, located northeast of the intersection of V-Site Bunker Road. Nitrocellulose was shipped in alcohol to avoid spontaneous combustion, and the alcohol was evaporated from the nitrocellulose in building 16-81. Building 16-81 was built in 1944 and destroyed by intentional burning in 1960 (LANL 1994, 039440, p. 5-390).

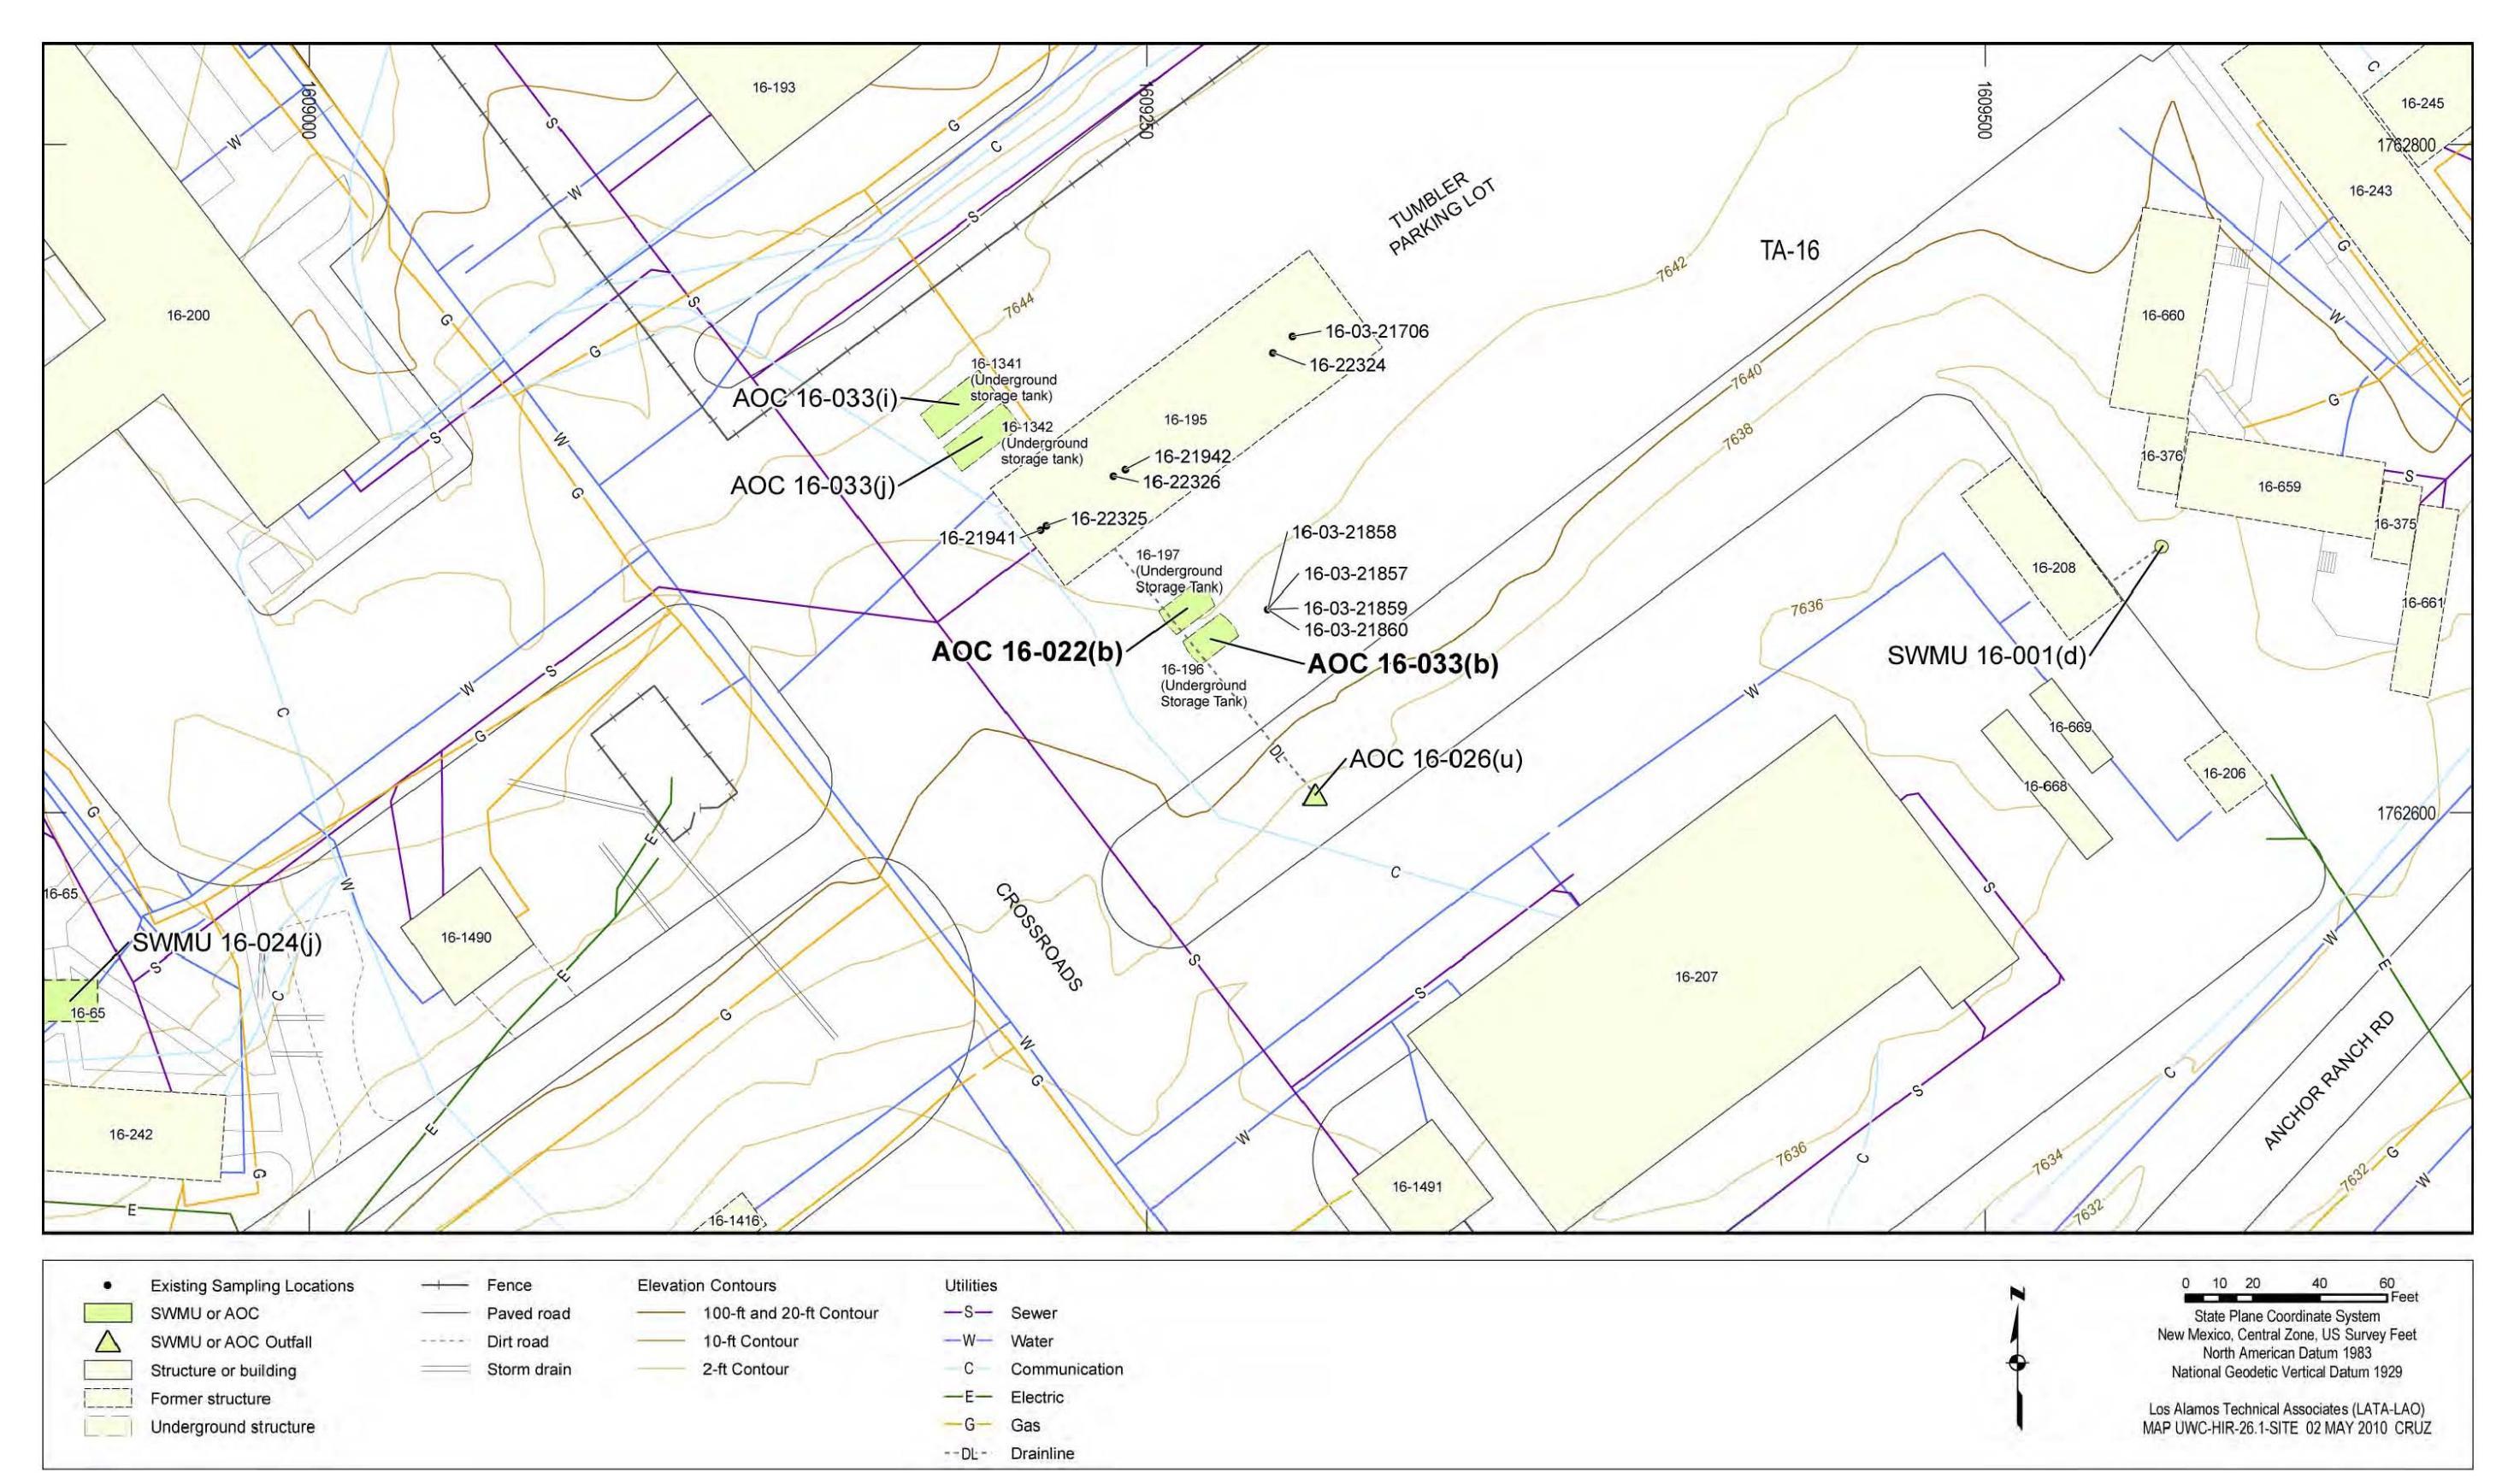
Figure 3.27-1 Site features of AOC 16-022(b) and AOC 16-033(b)

AOC 16-022(b) is a former UST that was located at TA-16, southeast of the former service station (building 16-195) (Figure 3.27-1). The tank (structure 16-197) had a 4000 gal. capacity and was used to store unleaded gasoline. UST 16-197 was installed in 1952 and placed directly adjacent to a second UST (structure 16-196) [AOC 16-033(b)], that stored leaded gasoline. When UST 16–196 was removed in 1987, it was found to have leaked, contaminating the soil surrounding UST 16-197. Contaminated soil was removed from the area surrounding UST 16-197, but the excavation had to be discontinued when

soil removal threatened the integrity of UST 16-197. When UST 16-197 was removed in 1990, the tank was found to be in good shape and not leaking. However, contaminated scale and soil associated with the releases from UST 16-196 were dislodged from the bottom of the tank. The contaminated soil was removed immediately and remediated under the direction of the NMED UST Bureau in compliance with the UST regulations in effect at the time.

After UST 16-197 was removed, a 10,000-gal. tank (structure 16-1465) was installed at the same location of removed USTs 16-196 and 16-197 (LANL 1995, 057225, pp. 6-39–6-41). During UST 16-1465 tank maintenance activities in 1994, gasoline-contaminated soil associated with UST 16-1465 was found at the location of former USTs 16-196 and 16-197. The contaminated area was remediated under the direction of the NMED UST Bureau in compliance with UST regulations. In 2003, UST 16-1465 was removed under the direction of the NMED UST Bureau (Dye 2003, 095409, pp. 1–8).

The 10,000-gal. tank (structure 16-1465) occupied the space that previously contained UST 16-197 [AOC 16-022(b)] and UST 16-196 [AOC 16-033(b)]. UST 16-1465 leaked in 1994 and the site was sampled and remediated. Six sampling locations were selected: five on the east side of the service station (building 16-195) and one on the west side. Samples were collected and analyzed at an on-site laboratory. The analytical results of the samples collected from the sampling locations between the former service station (building 16-195) and UST 16-1465 indicated benzene, toluene, ethylbenzene, xylene (BTEX) at 65 ft bgs (LANL 1995, 057225, pp. 6-40–6-43). NMED requested additional investigation to define the nature and extent of contamination for this site (NMED 1999, 073897).

Following removal of building 16-195 in February 2003, UST 16-1456 was removed. The tank removal and soil sampling were documented in the TA-16-197 Underground Storage Tank Removal report (Dye 2003, 095409, pp. 1–8). It should be noted that this report incorrectly refers to UST 16-1456 (the 10,000-gal. tank) as UST 16-197. Upon removal, the 10,000-gal. tank appeared in very good condition with no visible evidence of any gasoline release from the dispenser, fuel line, or tank. Soil samples were collected under the former locations of the dispenser, fuel line, and at the west and east ends of the tank 16-1456. Five samples were collected from four locations and submitted for laboratory analyses of SVOCs, TPH-GRO, and VOCs. Sample results are presented in section 3.27.2.

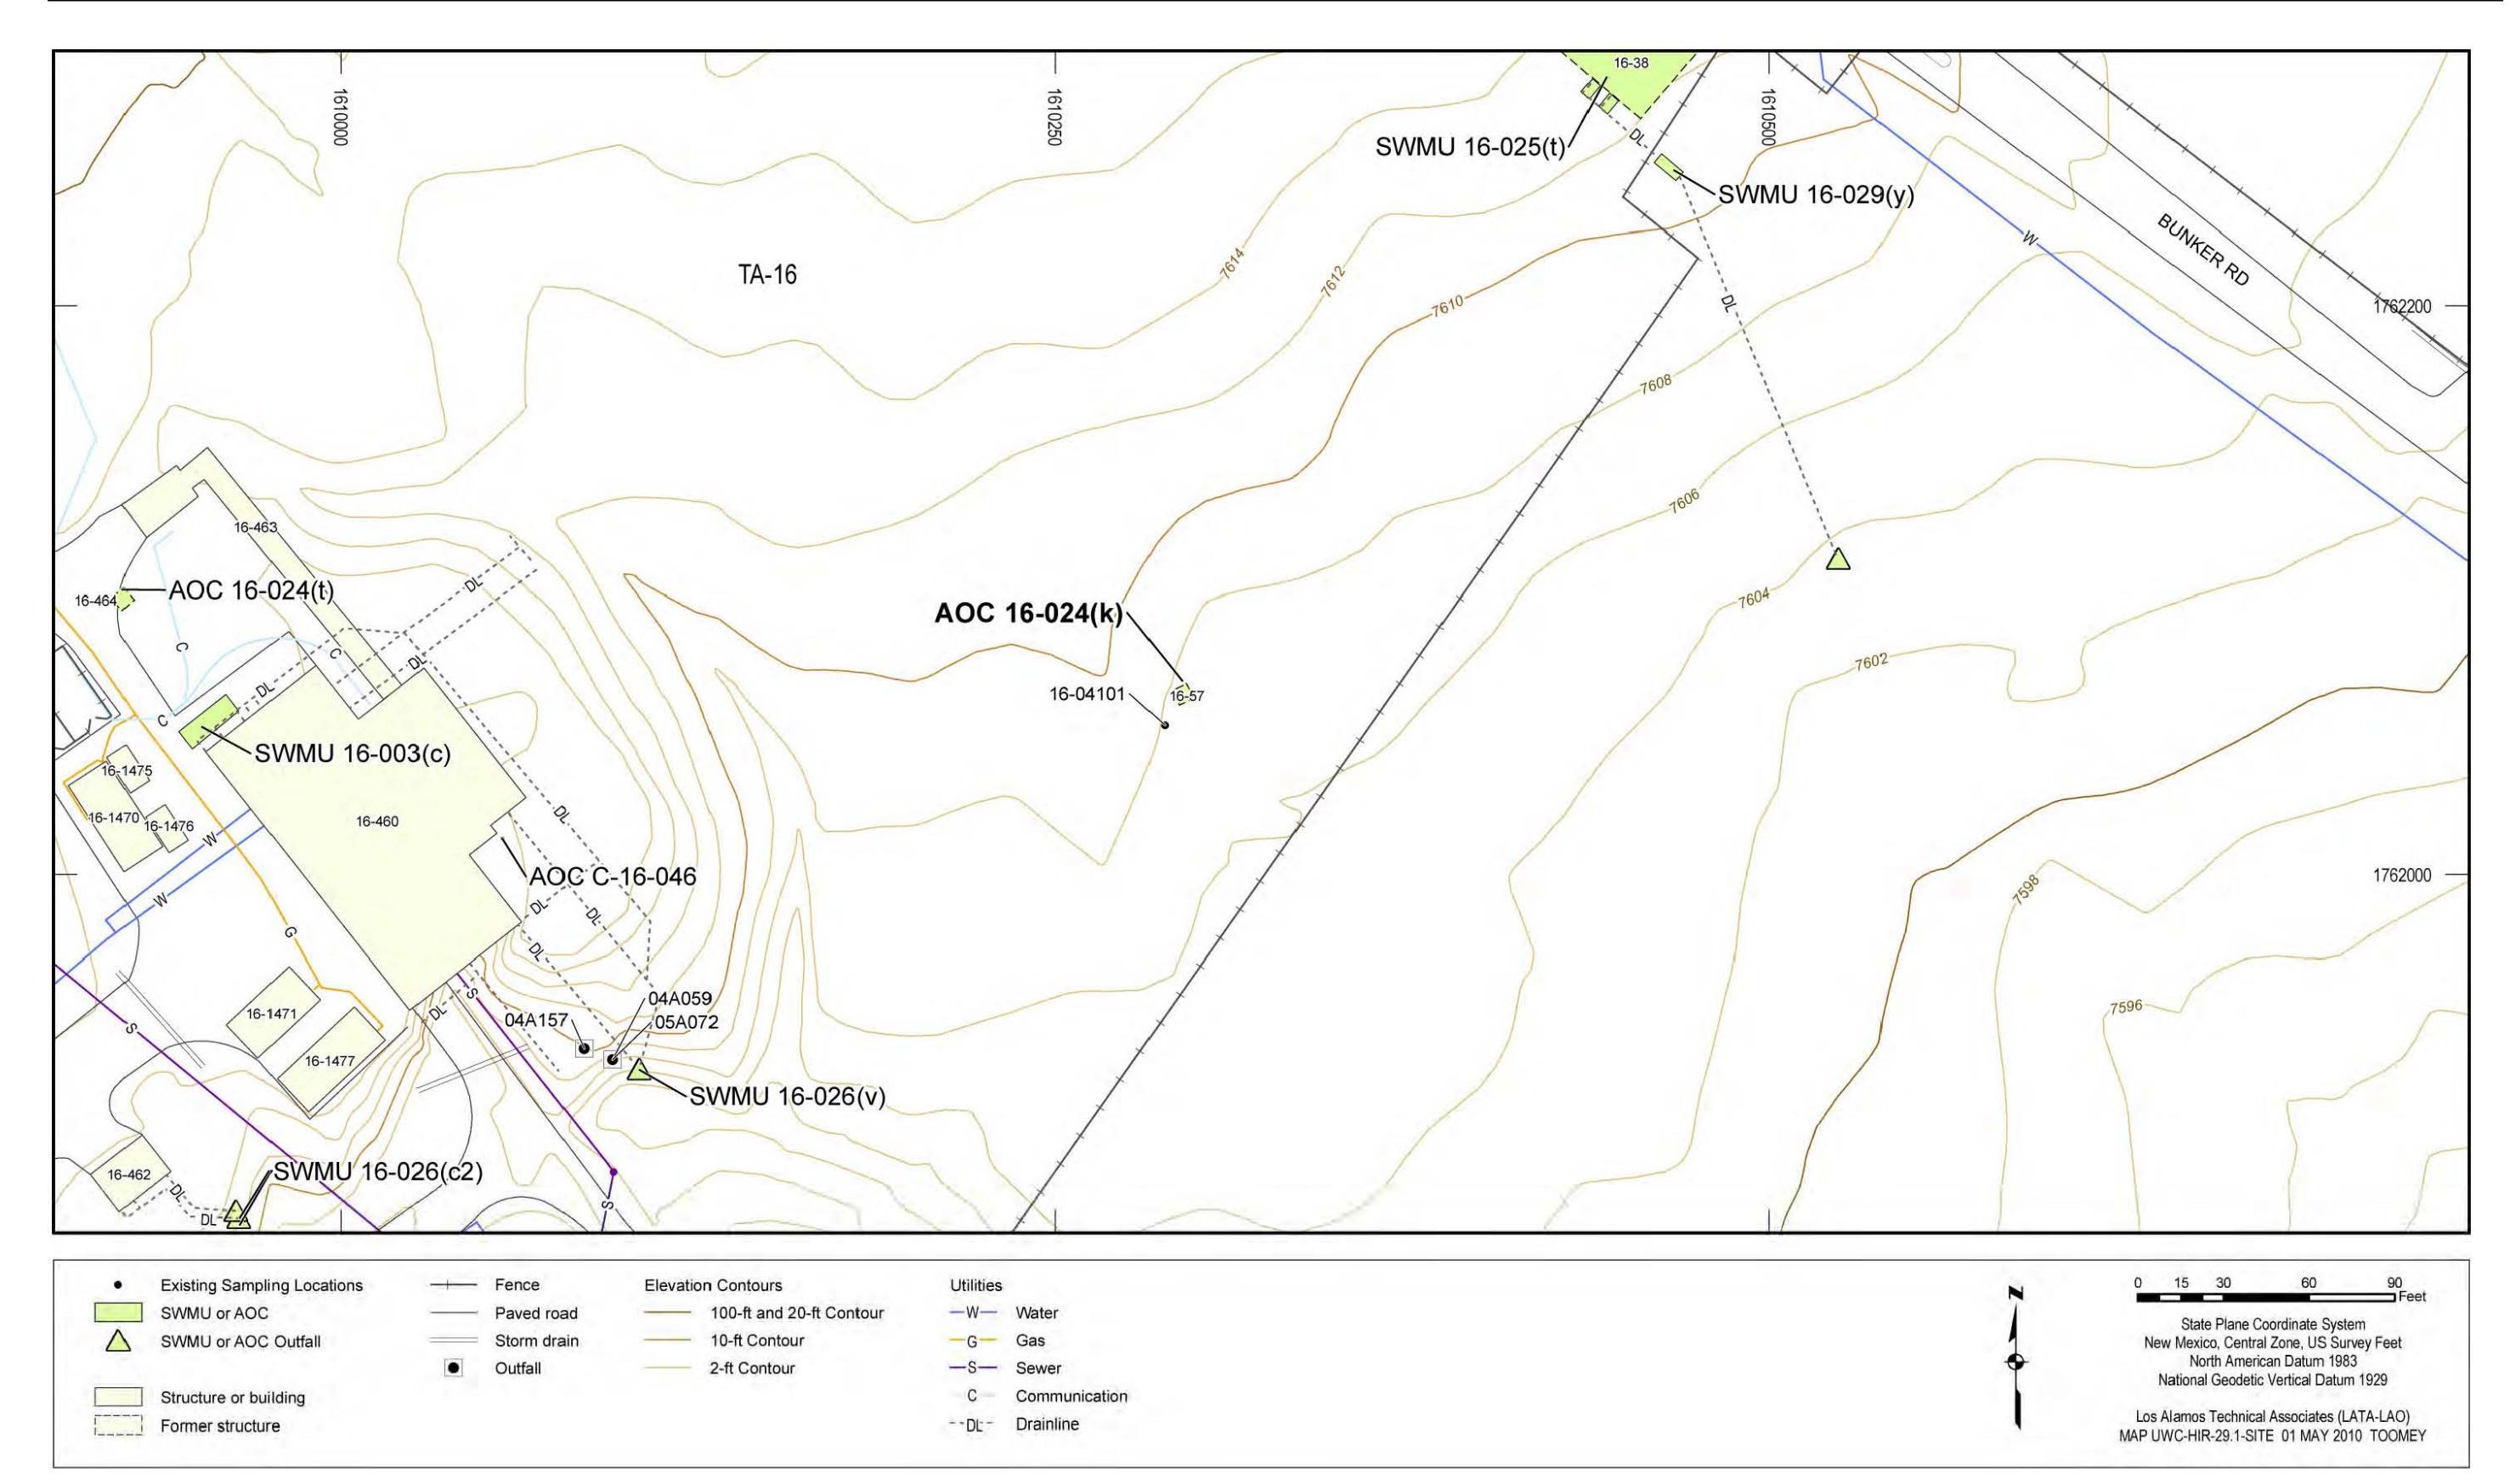
Figure 3.30-1 Site features of AOC 16-024(k)

AOC 16-024(k) is an area of potential soil contamination in TA-16 associated with a former HE magazine (structure 16-57) (Figure 3.30-1). The magazine was a 6 ft x 6 ft x 7 ft wood-framed structure, surrounded on three sides and the top by an earthen berm. The magazine was built in May 1946 and destroyed by intentional burning in 1960 (LANL 1994, 039440, p. 5-388).
