Historical Investigation Report for Upper Water Canyon Aggregate Area

Prepared by the Environmental Programs Directorate

EXECUTIVE SUMMARY

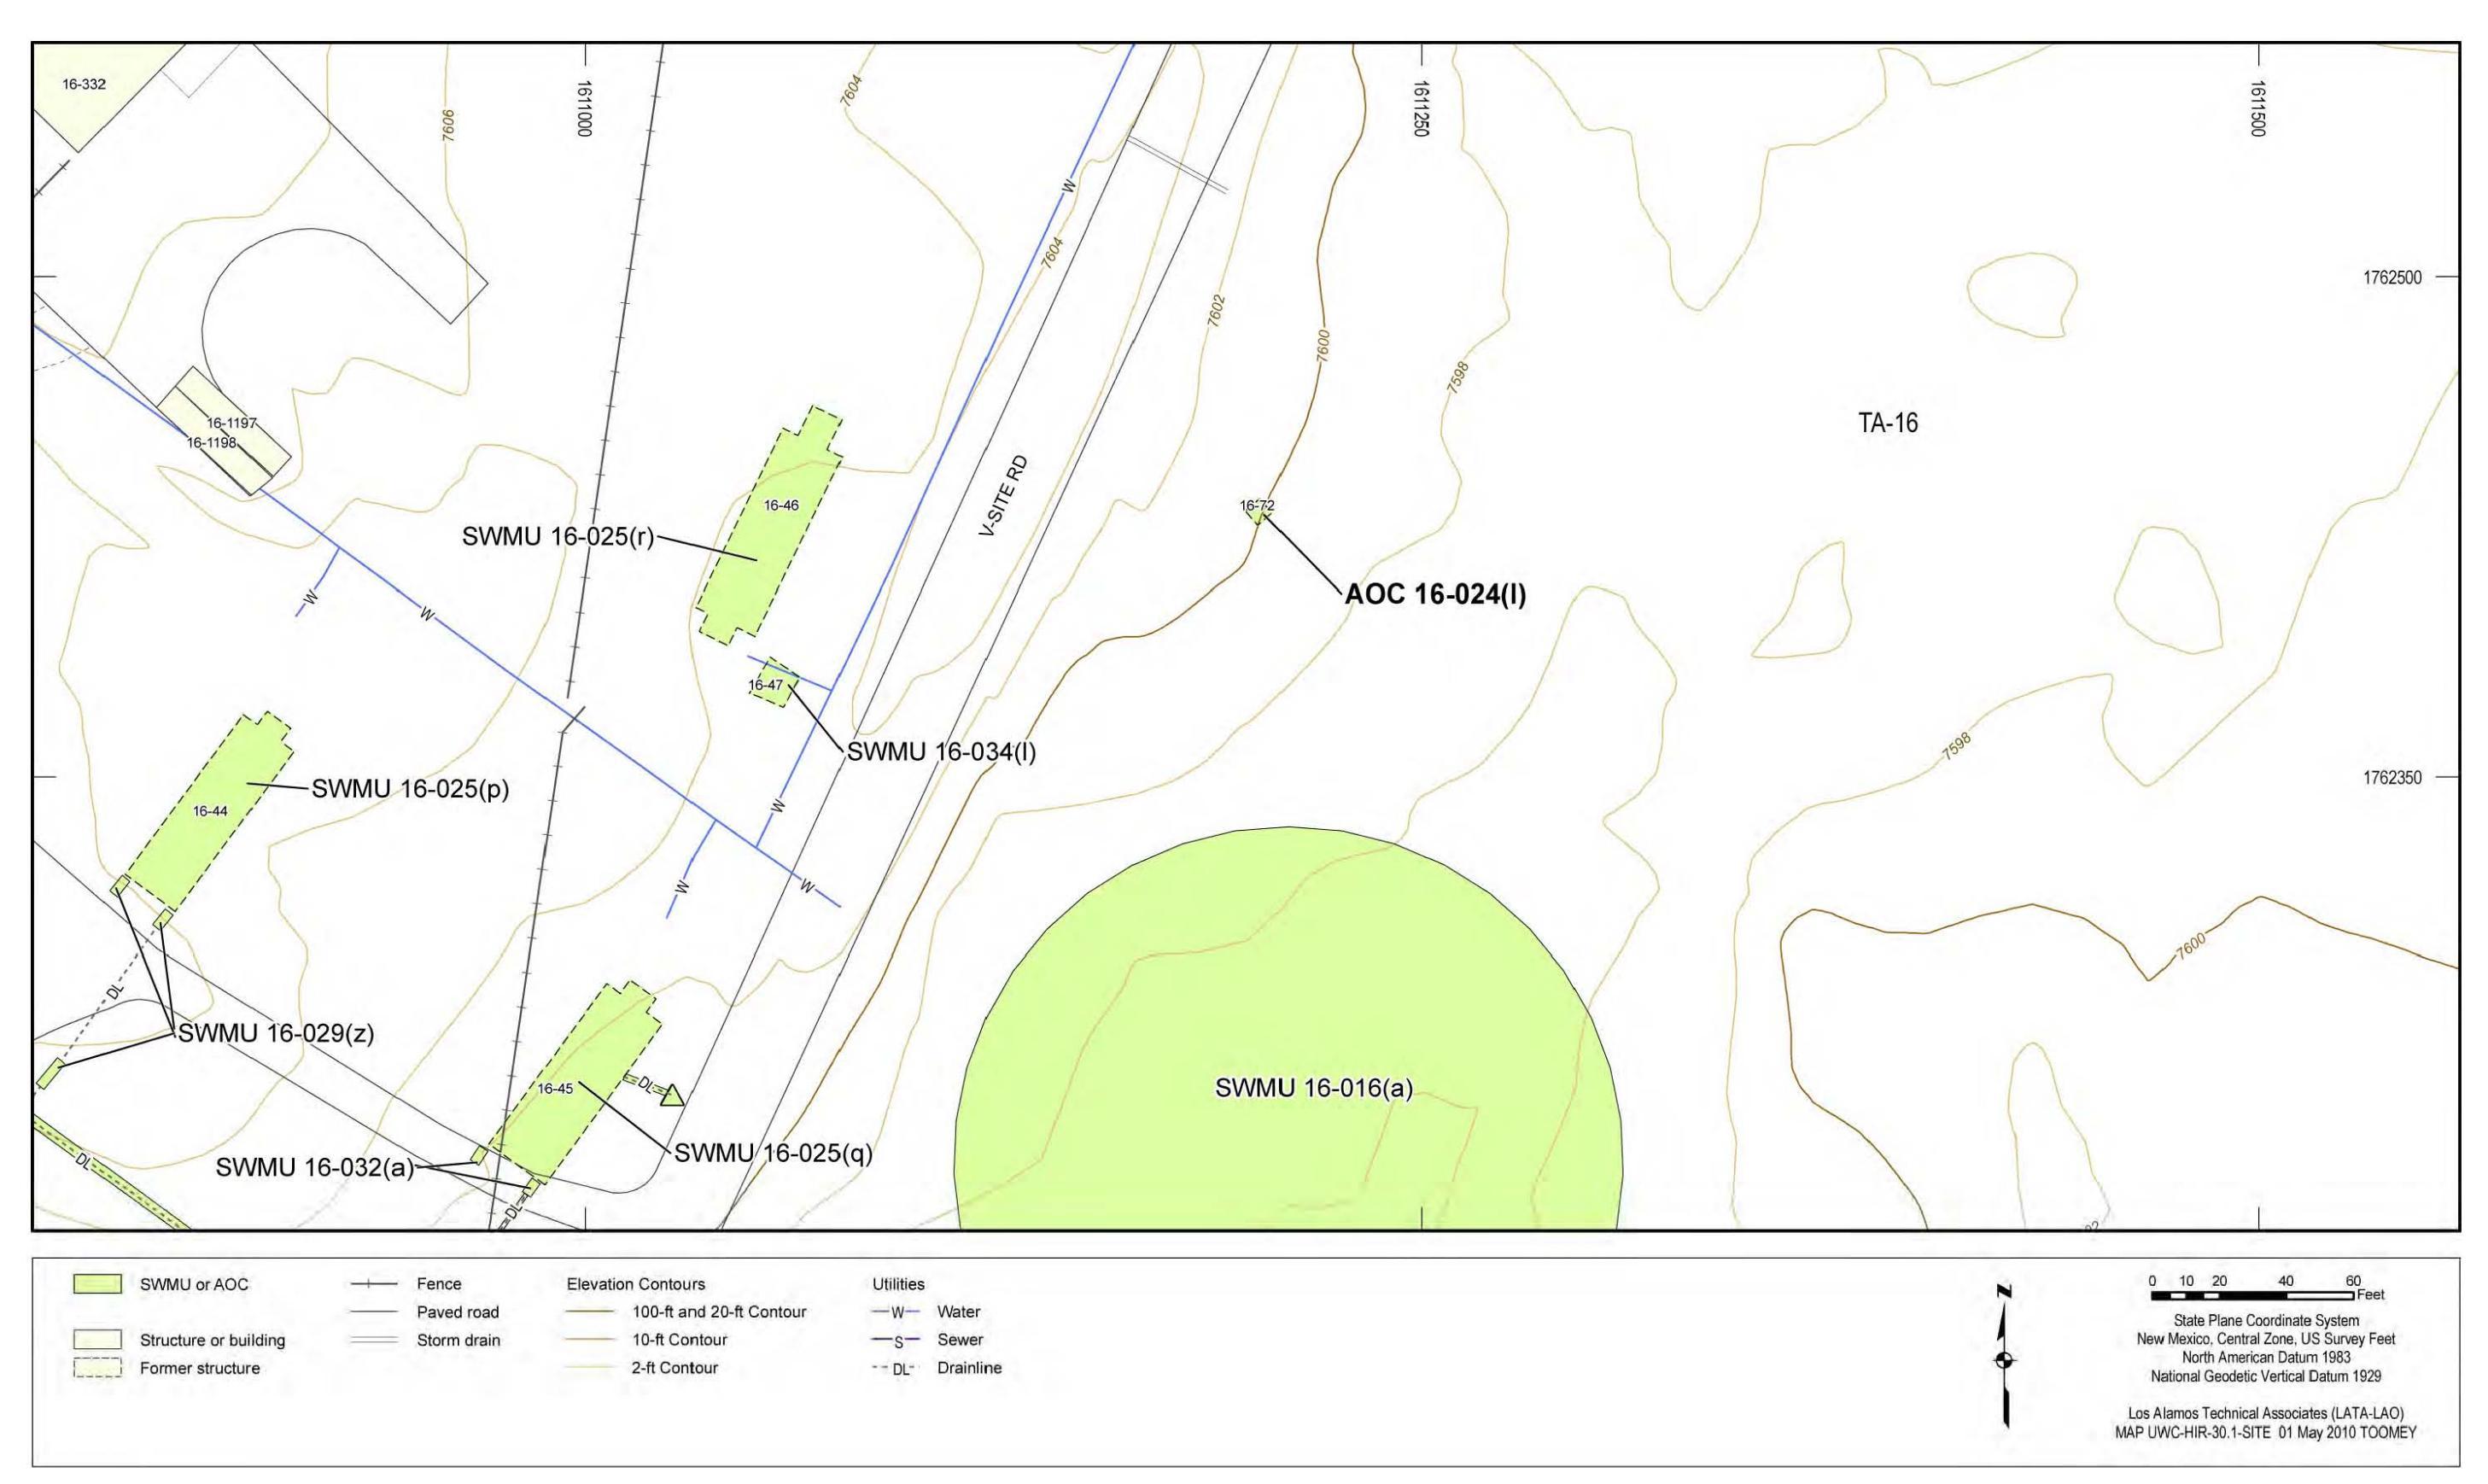
Figure 3.31-1 Site features of AOC 16-024(I)

AOC 16-024(I) is an area of potential soil contamination at TA-16 associated with a former HE magazine (structure 16-72) (Figure 3.31-1). The magazine was a 6 ft \times 6 ft \times 7 ft wood-framed structure, surrounded on three sides and the top by an earthen berm. The magazine was built in 1946 and destroyed by intentional burning in 1960 (LANL 1995, 057225, pp. 5-26-1–5-26-3).

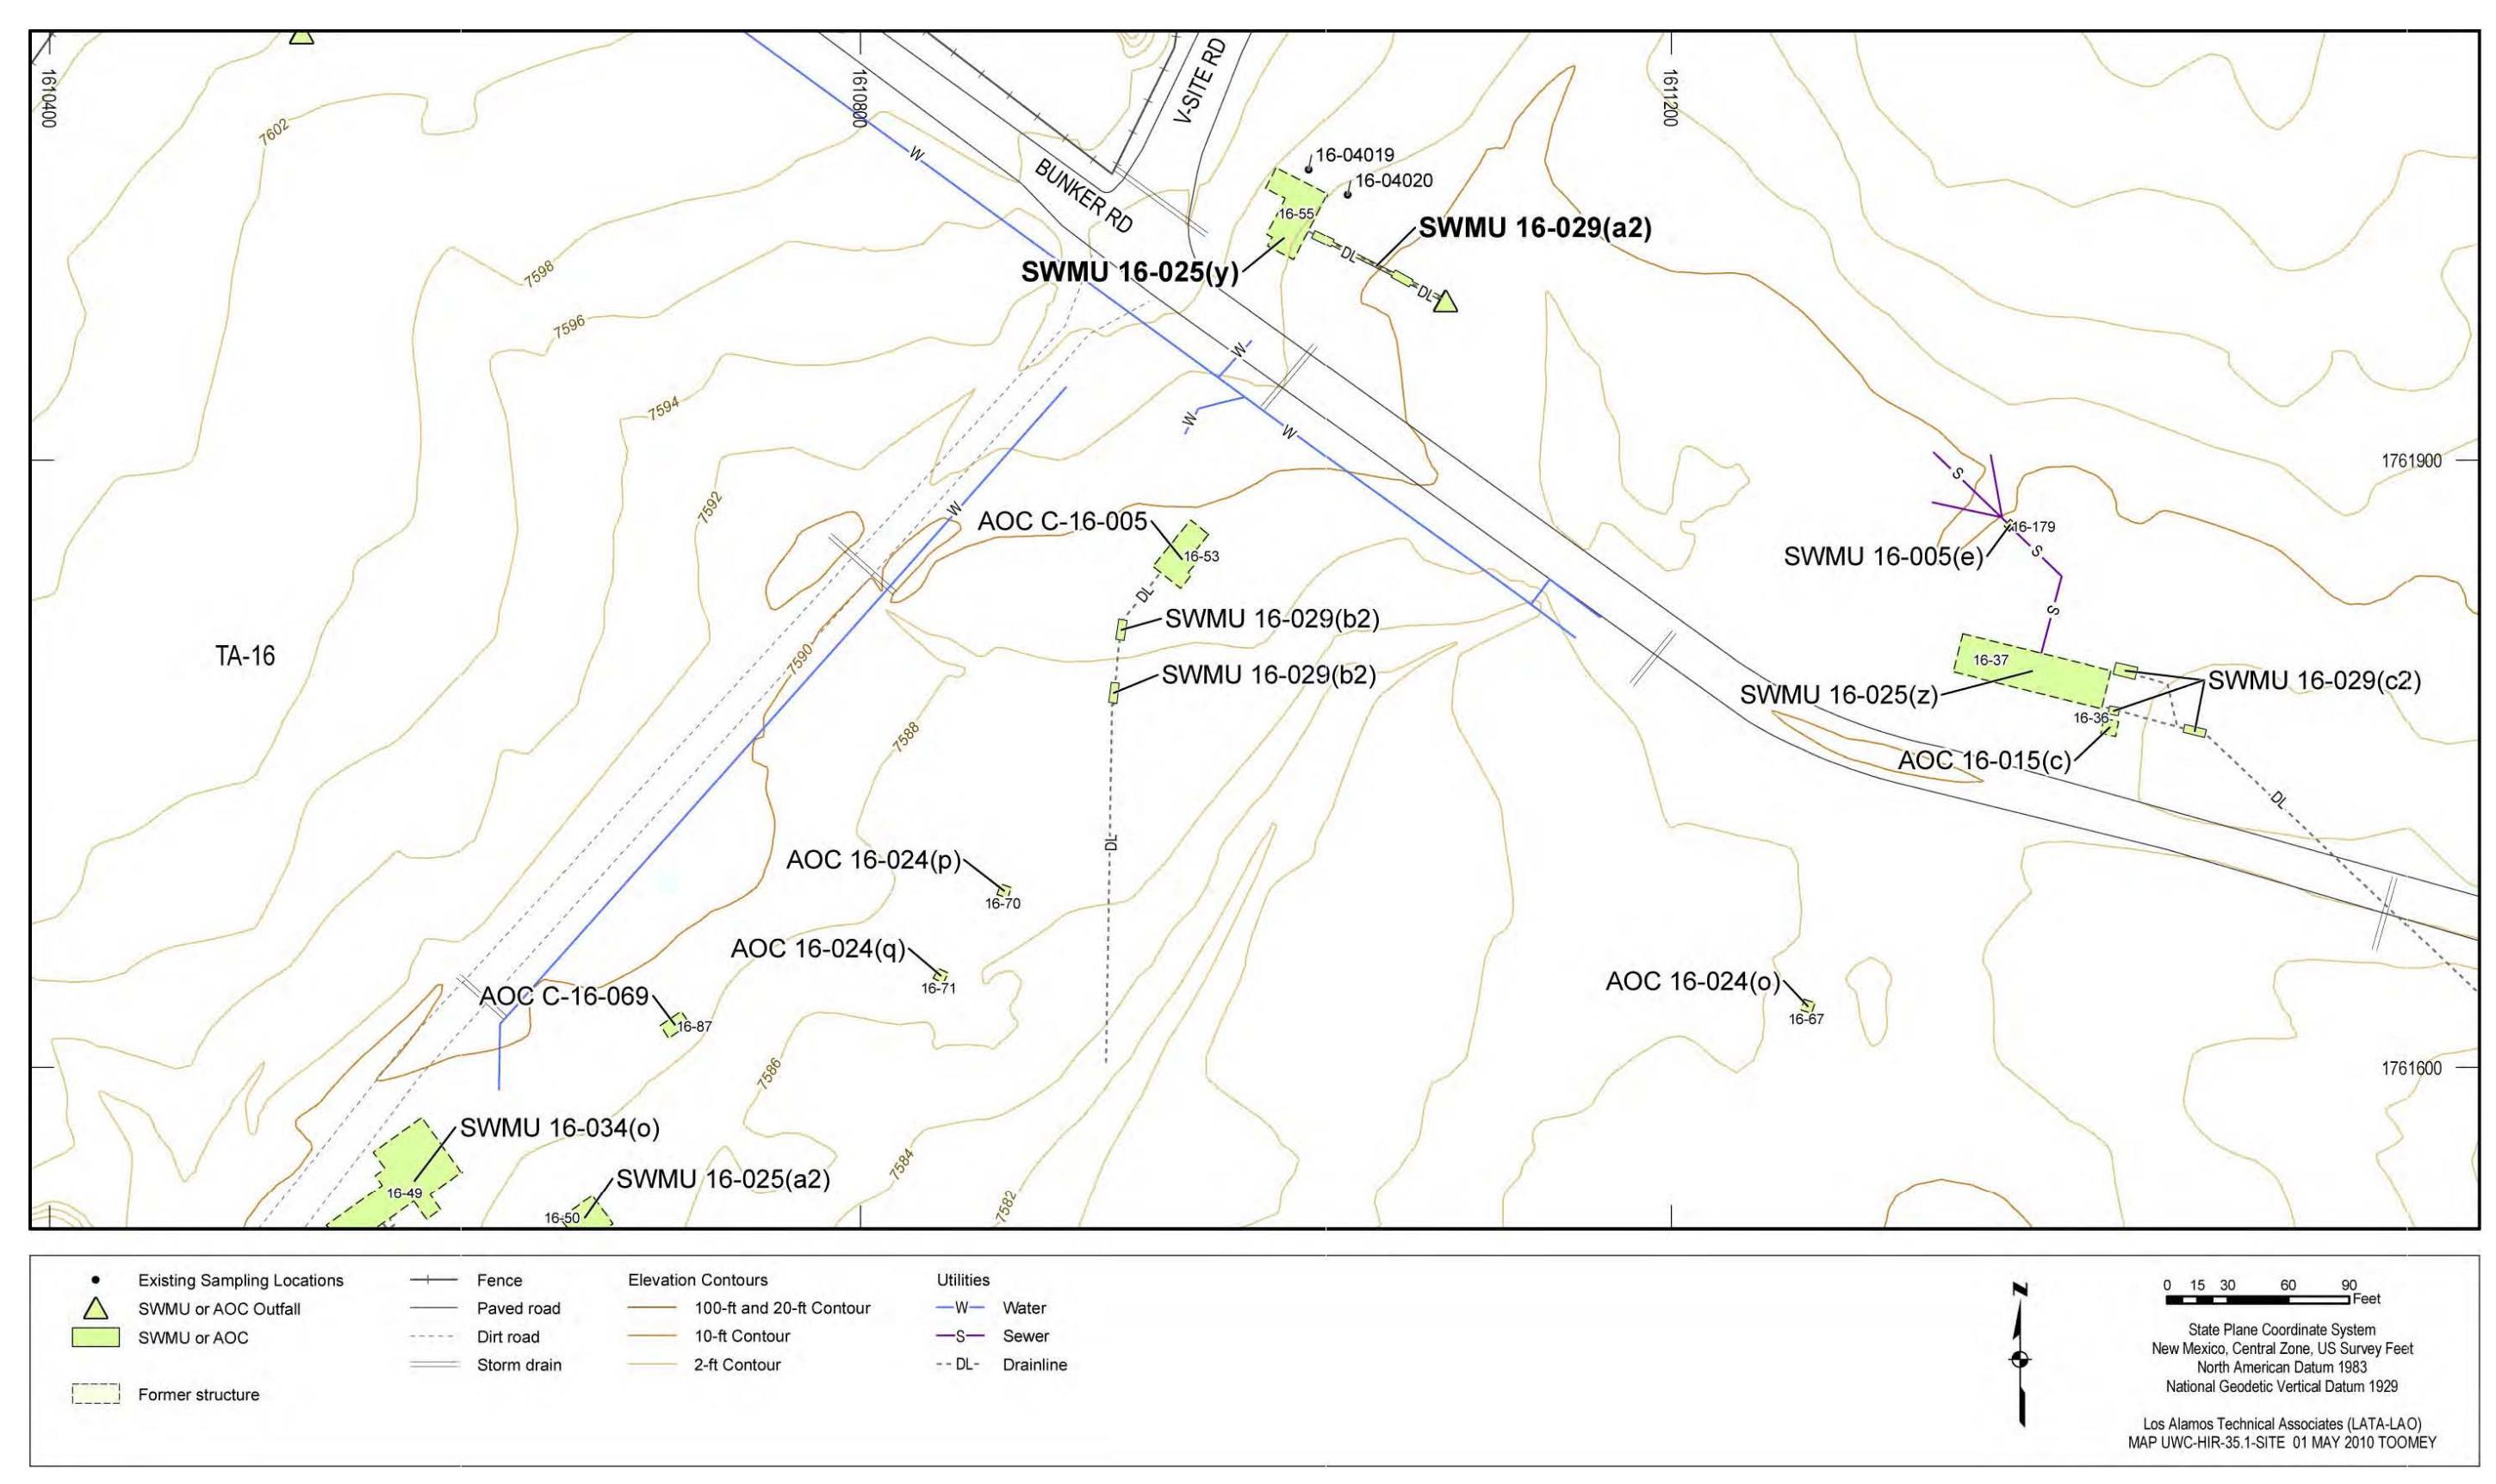
Figure 3.40-1 Site features of Consolidated Unit 16-025(y)-99 [SWMU 16-025(y) and SWMU 16-029(a2)]

SWMU 16-025(y) is an area of potential soil contamination at TA-16 associated with the former barium nitrate grinding building 16-55 (Figure 3.40-1). Building 16-55 consisted of three connected structures: a processing building ($40 \times 20 \times 12$ ft), an equipment room ($11 \times 7 \times 8$ ft), and a storage room ($11 \times 10 \times 8$ ft). Building 16-55 was a wood-frame structure with a concrete floor. Built in 1944, building 16-55 was first used for barium nitrate grinding and then used for storage. The building was destroyed by intentional burning in 1960 (LANL 1994, 039440, pp. 5-382–5-392).

SWMU 16-029(a2) consists of two former HE sumps and an outfall that served former HE grinding building 16-55 at TA-16 (Figure 3.40-1). The sumps were located on the exterior southeast side of building 16-55, connected in series and discharged through a drainline southeast to an outfall that flowed to an outfall in the main TA-16 drainage (LANL 1994, 039440, pp. 5-391–5-392). The sumps were removed from 1966 to 1968 with demolition of building foundations and drainlines, documented by site photos (LANL 1996, 055016). The sumps are visible in a 1965 aerial photograph (LASL 1965, 016396), but are no longer visible in a 1977 aerial photograph (LASL 1977, 017770).

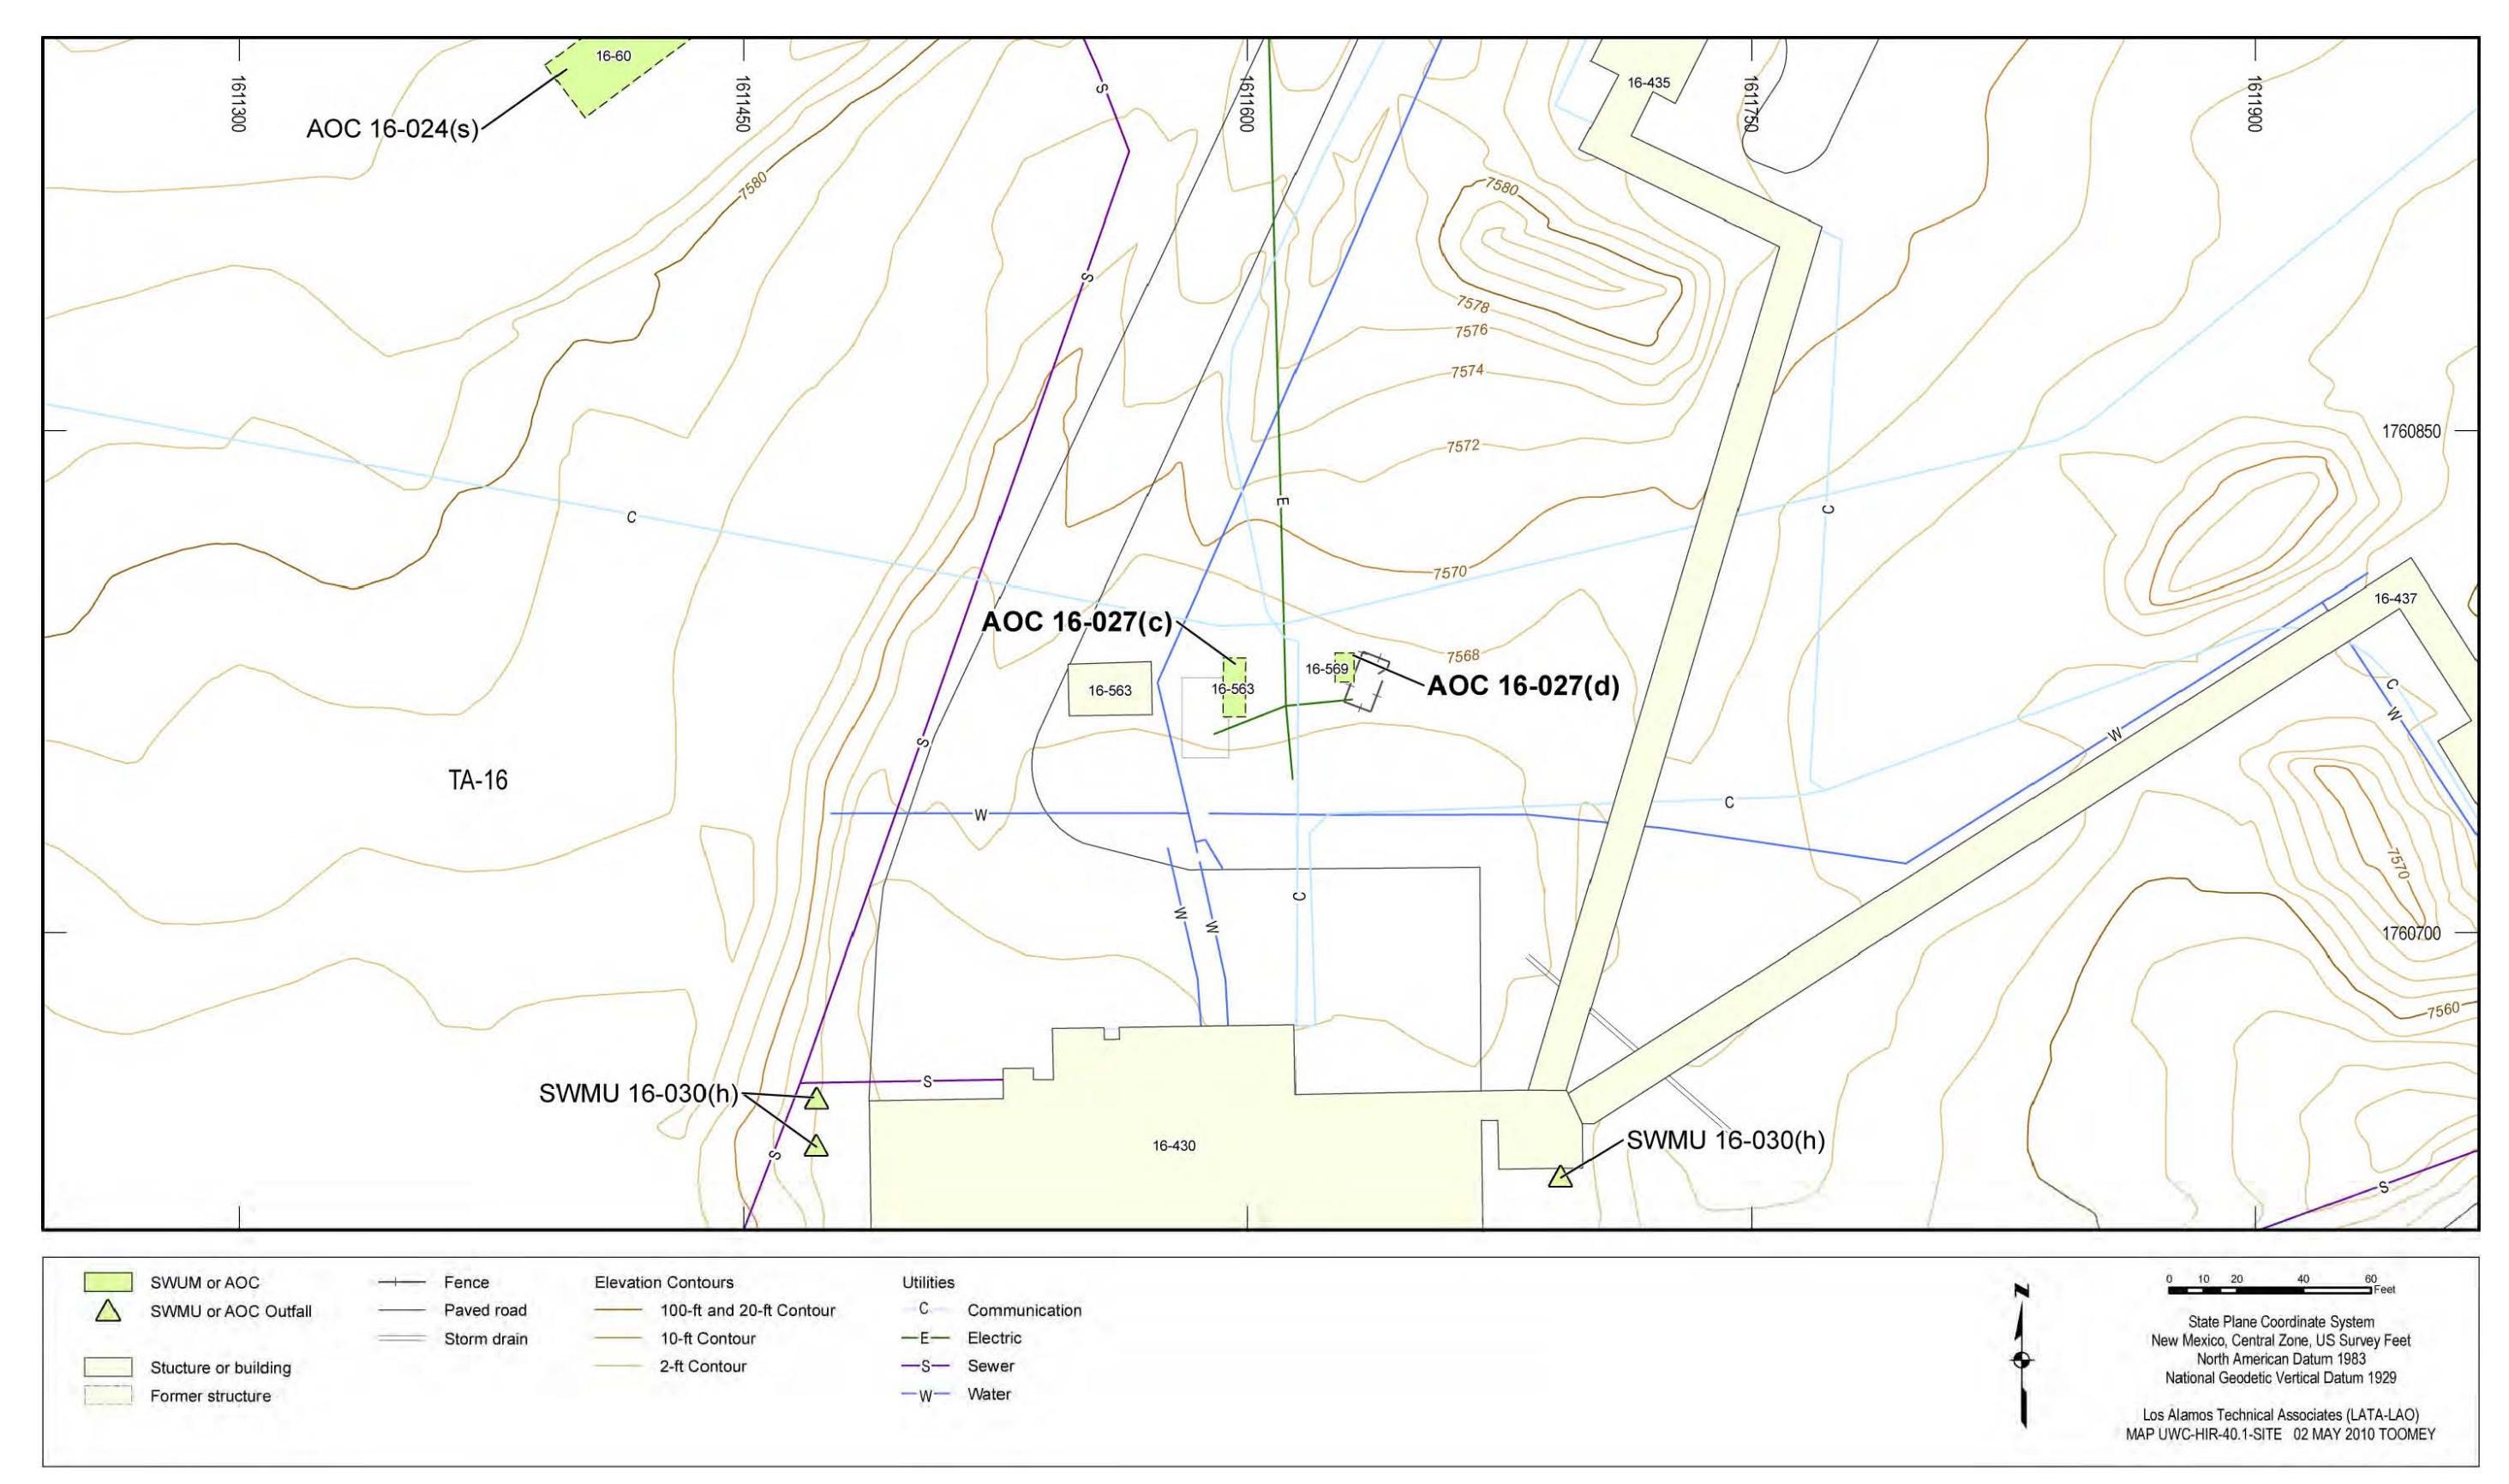
Figure 3.47-1 Site features of AOC 16-027(c) and AOC 16-027(d)

AOC 16-027(c) is a former PCB transformer (structure 16-563) located at TA-16 approximately 100 ft north of building 16-430 in an outdoor fenced area (Figure 3.47-1). The transformer was placed at this site in 1952 and contained 100–500 gal. of dielectric oil with a PCB concentration of 25,000 ppm (LANL 1990, 007512). A leak from the transformer was first reported in 1987. In 1992, the transformer was removed along with its pad and PCB-contaminated soil around and under the pad (Bailey 1993, 052964.489, p. 981). In 1993, a New transformer was placed in the southern portion of the fenced area and remains in place.

The 1995 Addendum 2 to the 1993 RFI work plan reported that a leak of 0.5–1 gal. was detected on July 28, 1987. The concrete pad on which the transformer was mounted and the surrounding soil underwent immediate cleanup. The concrete was cleaned using the double-wash/double-rinse method in accordance with the Toxic Substances Control Act (TSCA) PCB spill-cleanup requirements, and the soil was removed to a depth of approximately 2.5 ft, drummed, and taken to MDA G at TA-54 (LANL 1995, 057225, pp. 6-45–6-46).

In 1989, inspection and sampling revealed a need for additional cleanup. Several sampling and cleanup efforts followed, including removal of the transformer and concrete pad, excavation and removal of the contaminated soil under the pad, and replacement of the transformer and pad with a non-PCB transformer and a New pad. A total of 691 ft³ of soil was removed from the location of the transformer (structure 16-563). The site cleanup was completed November 12, 1992, when samples revealed PCB levels below the 25 ppm TSCA-mandated cleanup levels (LANL 1995, 057225, pp. 6-45–6-46).

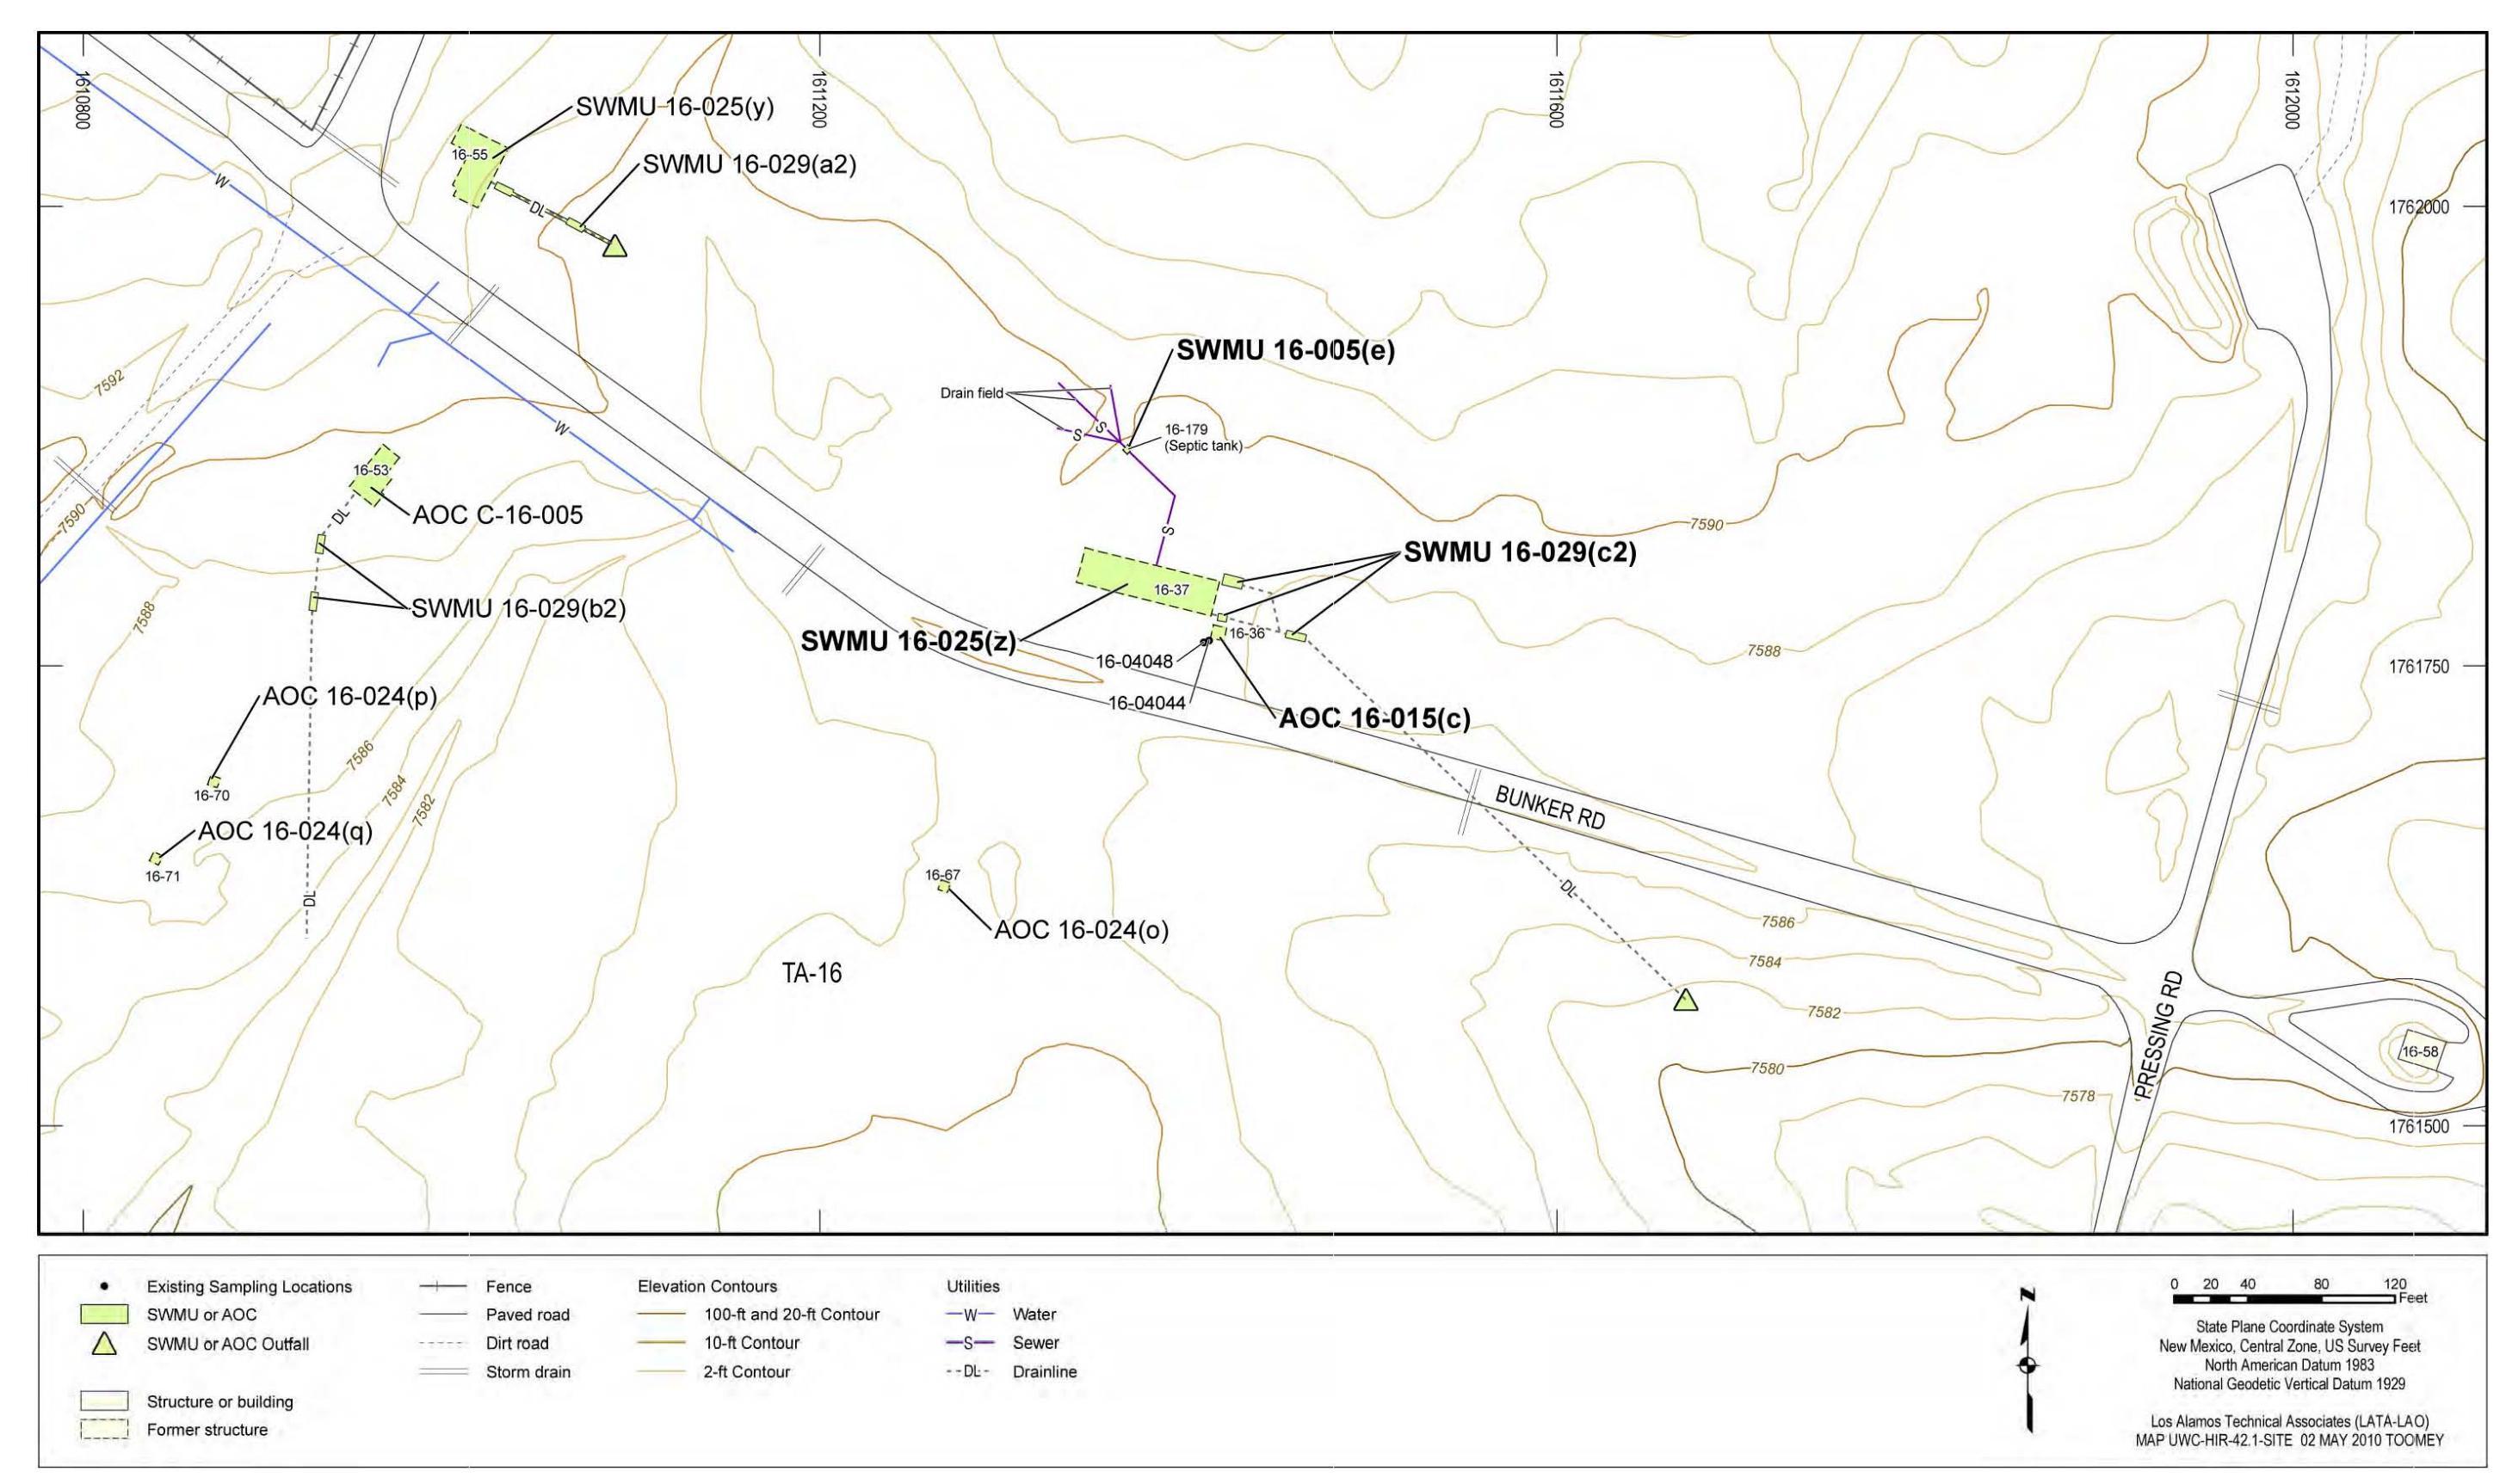
Figure 3.51-1 Site features of Consolidated Unit 16-029(c2)-99 [SWMU 16-005(e), AOC 16-015(c), SWMU 16-025(z), and SWMU 16-029(c2)]

AOC 16-015(c) is a former HE steam-cleaning building 16-36 located at TA-16 approximately 10 ft southeast of former building 16-37 (Figure 3.51-1). Building 16-36 was an 8-ft long \times 8-ft wide \times 10-ft high wood-frame structure with a concrete foundation. Effluent from the building drained to a sump located on the southeast corner of building 16-37 [SWMU 16-029(c2)]. The steam cleaning building was constructed in 1944 and was destroyed by intentional burning in 1960 (LANL 1994, 039440, p. 5-388).

SWMU 16-025(z) is an area of potential soil contamination at TA-16 associated with former HE testing building 16-37 (Figure 3.51-1). Building 16-37 was located approximately 40 ft north of Bunker Road. The building was a $75 \times 20 \times 13$ ft wood-frame structure with concrete floors. Building 16-37 was constructed in 1944 and destroyed by intentional burning in 1960 (LANL 1994, 039440, pp. 5-391–5-392).

SWMU 16-029(c2) consists of three former sumps and an outfall that served former building 16-37 at TA-16 (Figure 3.51-1). Two of the sumps, located on the exterior east side of building 16-37, discharged through a drainline east to a secondary sump. The drainline from the secondary sump discharged to an outfall located approximately 250 ft southeast of building 16-37 (LASL 1959, 024187). Building 16-37 was constructed in 1944 and destroyed by intentional burning in 1960. The sumps were removed from 1966 to 1968 with demolition of building foundations and drainlines, documented by site photos (LANL 1996,
