**Historic Context of Hot Point Site,
Technical Area 33**

Historic Building Report No. 238

Los Alamos National Laboratory

October 31, 2004

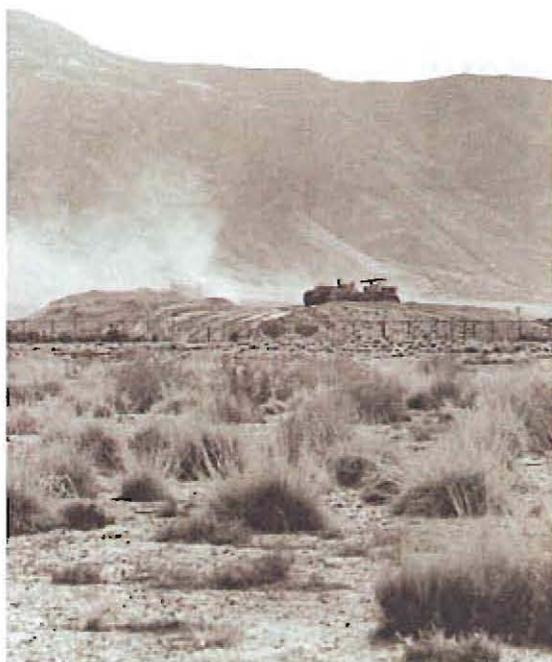
Figure 4. Removal of Overburden

In 1967, Laboratory personnel went to Trinity Site to clean up the Sleeping Beauty shot. After removing the soil overburden, a work crew unearthed the bunker and opened the door of the chamber. The high explosives test package was still intact along with a set of six radiation counters. Workers destroyed the test chamber by using a 100-lb explosive charge. Figures 3 through 6 show the undamaged test chamber during and after the 1967 excavation (WSMR 2004).

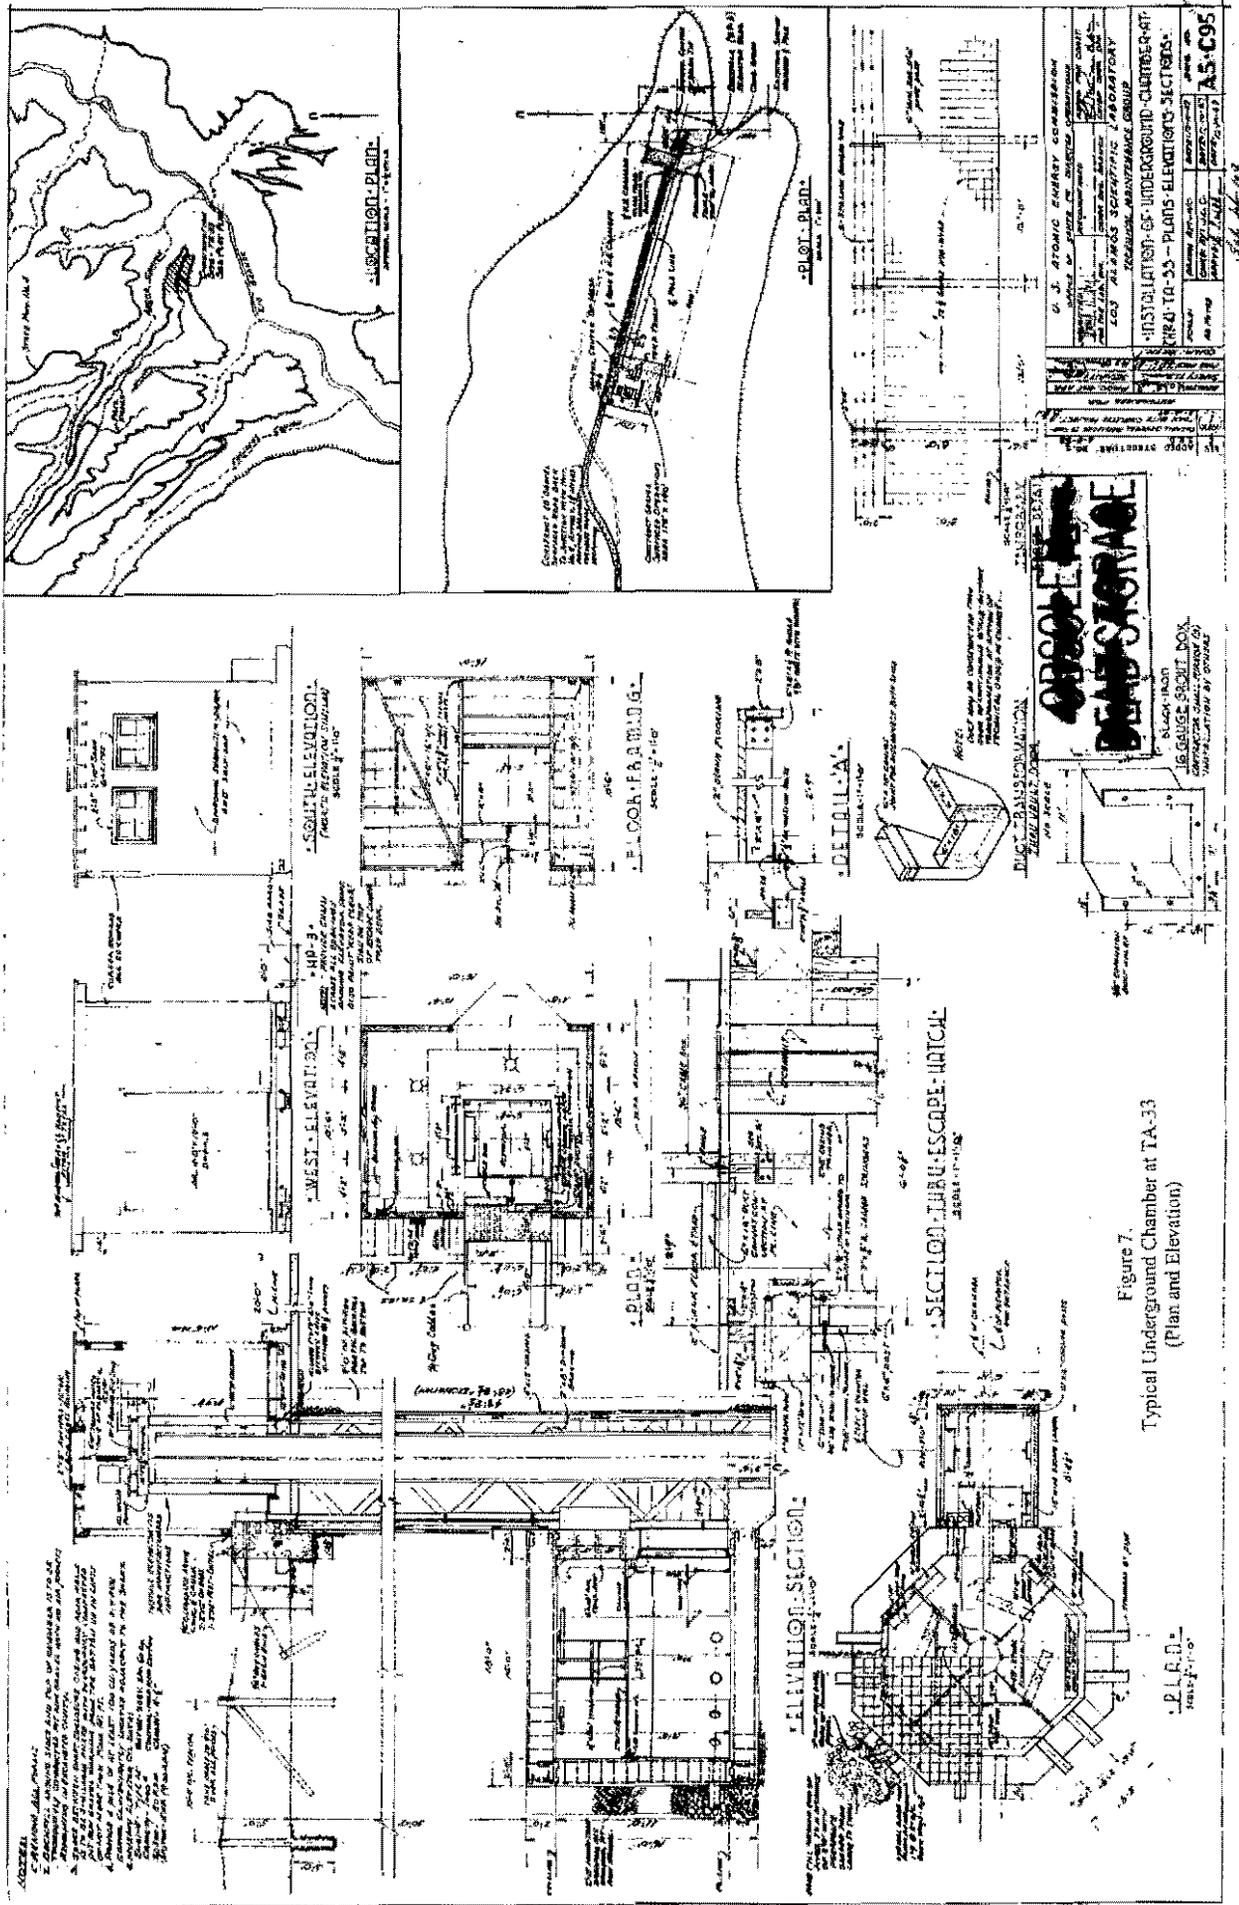
Figure 7.
Typical Underground Chamber at TA-33
(Plan and Elevation)

Like the Trinity Site experiments, the underground initiator tests at Los Alamos were designed to be one-time events, and a new pit facility was dug for each test. Typically, a pit structure and associated entrance shaft were constructed underground. The chambers themselves were octagonal in shape and made of concrete. These chambers were located approximately 30 ft below grade and were accessed by a portable elevator; the elevator building was placed over the shaft until just before the test was conducted (Figures 7 and 8). Scientists placed the initiator experimental apparatus and associated neutron counters in the reinforced concrete pit or “chamber,” and routed electronic cables from the pit structure to a distant control room. Instrumentation in the control room received the completed test data via electronic cables (Los Alamos National Laboratory Archives, U.S. DOE 1986). Known hazardous materials that made up the shots included high explosives and polonium.

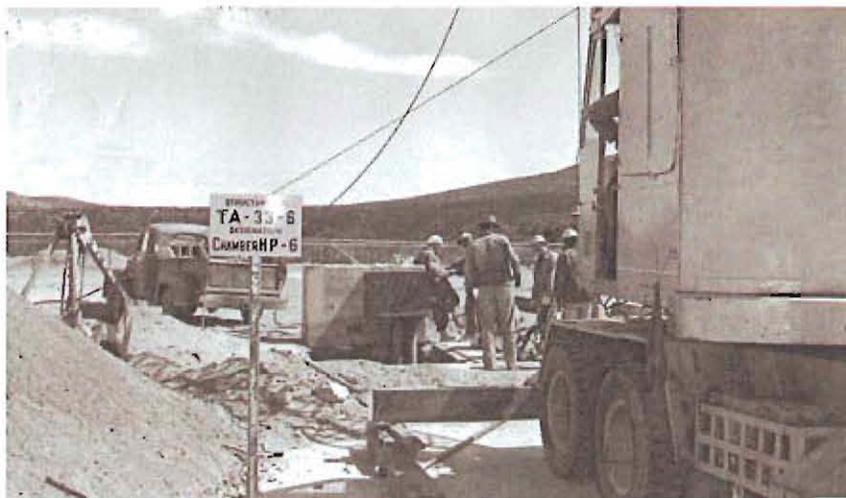
Figure 9. Underground Chamber 2, HP-6

Chamber 2 was larger and situated deeper than the first test chamber, and, as a result, was not completely destroyed during a December 1948 test. Chamber 2 was reopened in 1952 to investigate its condition and stability. The damaged chamber was retested and ultimately destroyed as part of a high-explosives experiment, resulting in the formation of a 10-ft crater (LANL 1992, Los Alamos National Laboratory Archives, U.S. DOE 1986) (Figures 9 through 16).

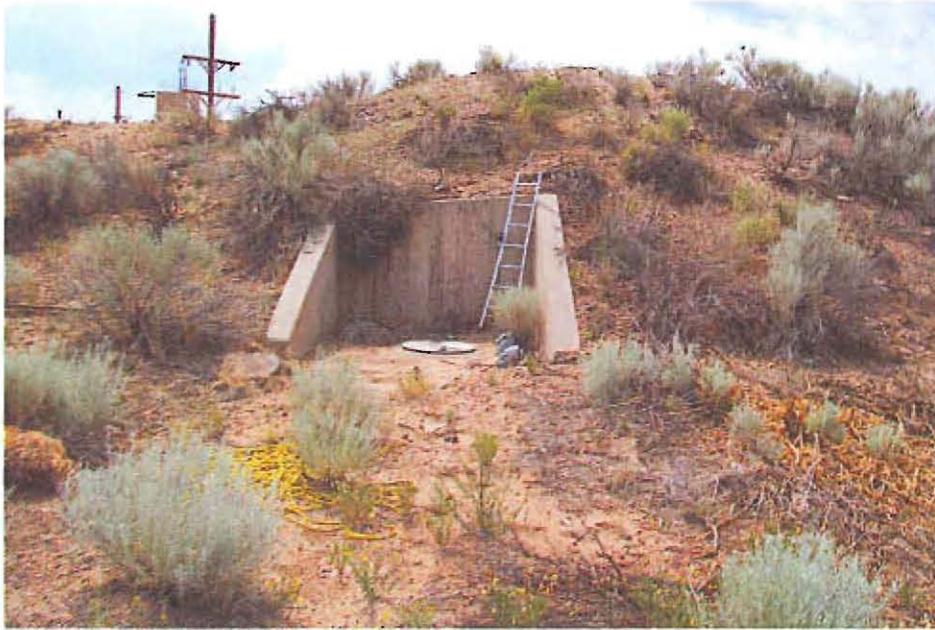
Figure 17. Cable Tunnel Entrance with Manhole, Near TA-33-87

A cable tunnel connected the control room (TA-33-87) to an instrumentation building located further to the east (TA-33-88). Cabling also extended to the X-unit vault (TA-33-89) and to the X-ray shack discussed above. The cables were housed in a 36-in. diameter corrugated metal pipe running along the length of the 6 ft 10 in. high tunnel. The cable tunnel was designed to be accessed through a series of manholes (Hoard 1991).

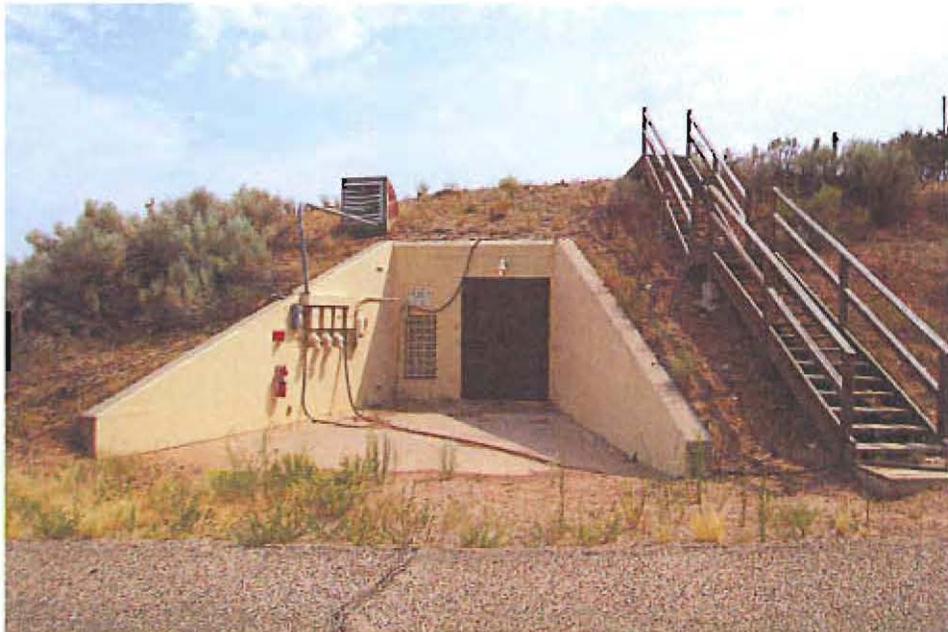
Figure 18. Transformer Vault, TA-33-95

A berm-covered transformer vault, TA-33-95, is also located at East Site. The vault was constructed to withstand explosive blast effects in order to protect the power transformer (LANL 1992).

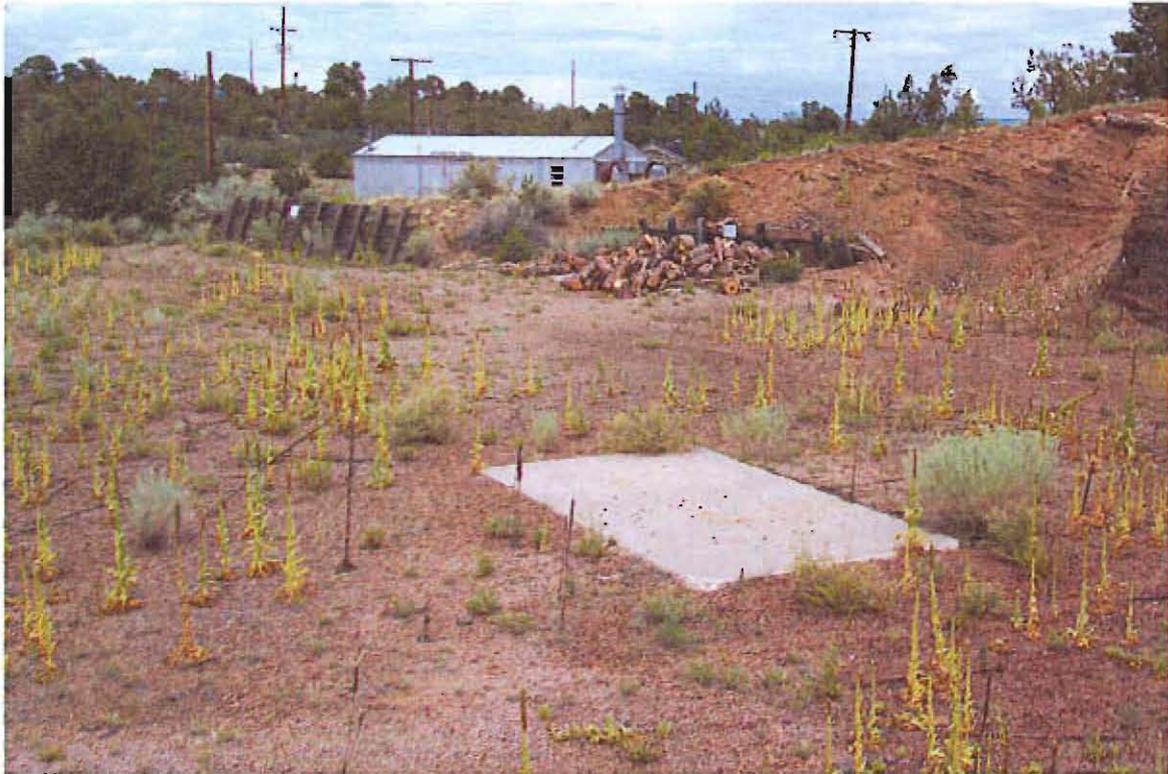
Figure 20. Shot Pad (foreground), Barricades, and TA-33-16 (background)

Work at Area 6 diminished in importance as additional gun testing was carried out at East Site (old Area 1) in the mid-1950s. By 1955, shots were discontinued at Area 6. In 1956, TA-33-16 was being used to make and machine a glass laminated material and other materials such as barium titanate and epoxy resins. TA-33-1 housed experiments to make niobate crystals, and TA-33-2 was being used as a shop (Los Alamos National Laboratory 1992, U.S. DOE 1986).

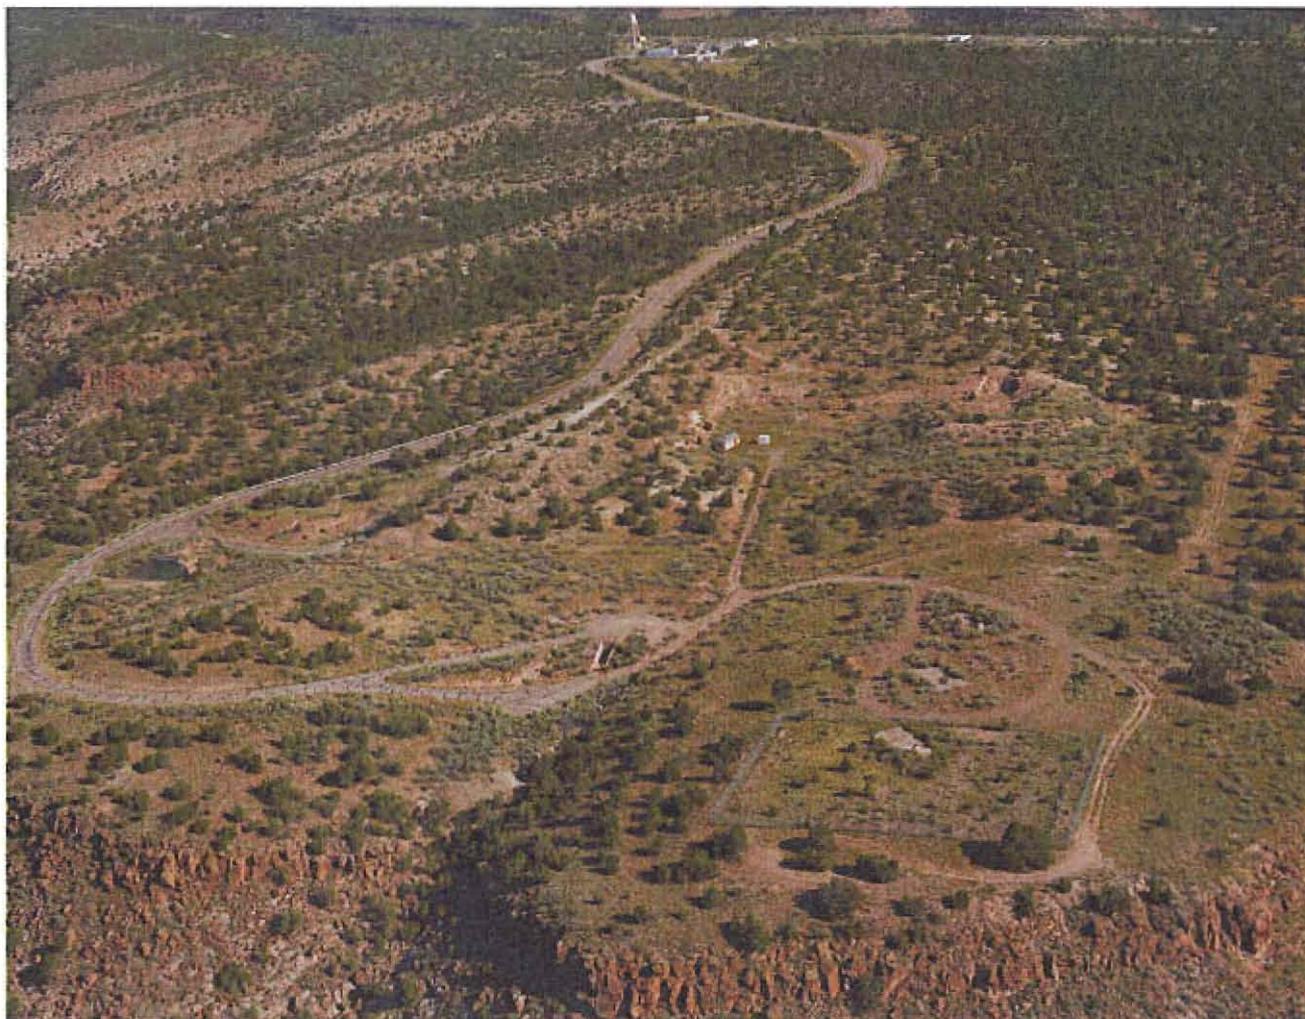
Figure 21. South Site

South Site is located south of the main entrance area at TA-33 (Map 5). The testing area was situated near the edge of White Rock Canyon in a large bowl-shaped depression. Originally developed in 1948 to support underground initiator experiments and ½-scale gun shots, South Site, also known as the tower area, supported the Pacific testing program as well. An additional area at South Site was set aside for leaking tritium reservoirs. The activities at this so called “blivit area” were not related to gun testing; rather, they supported tritium operations conducted at building TA-33-86 and at TA-41 (W Site).

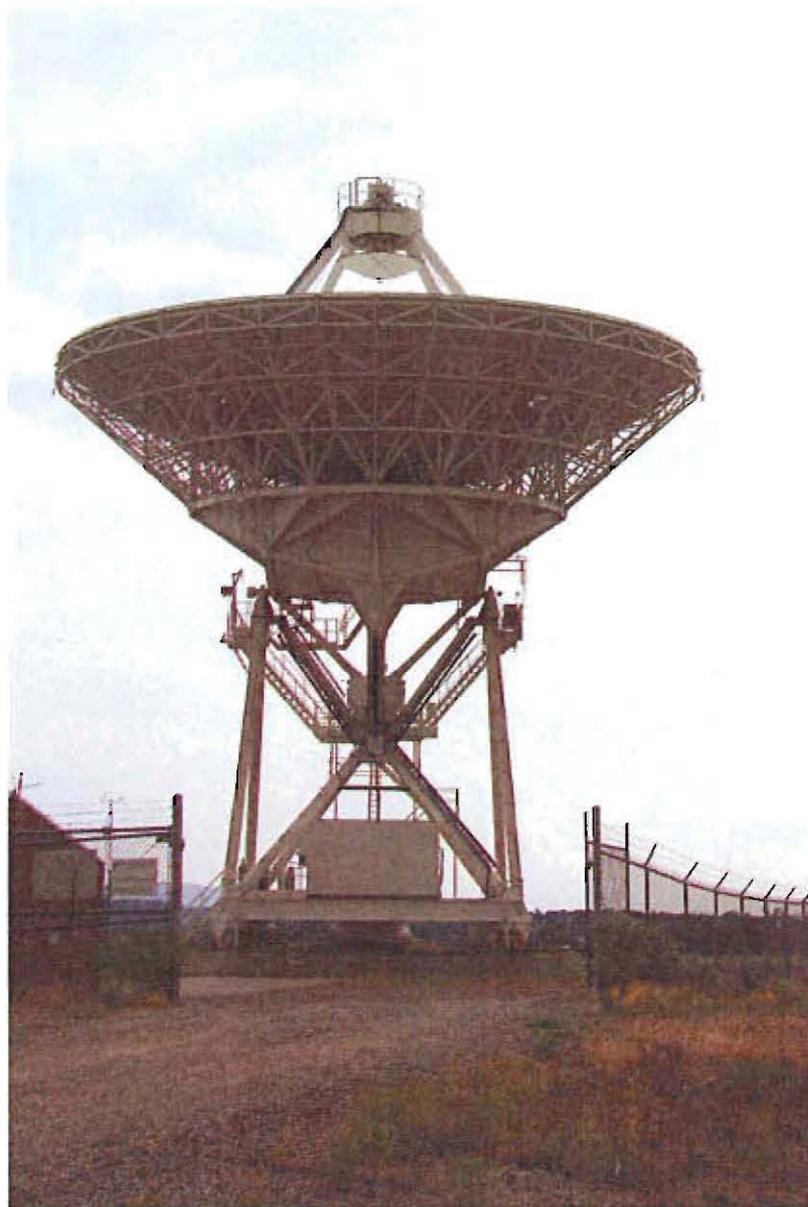
Figure 27. NRAO Antenna

The National Radio Astronomy Observatory (NRAO), one of the world's leading radio astronomy research facilities, operates an 82-ft diameter radio telescope antenna at TA-33's NRAO complex. The radio telescope is located about one mile from TA-33's main entrance, along the East Site Road (Map 7). Completed in 1987, the complex includes a support building and radio telescope. The telescope is controlled remotely from the main NRAO complex near Magdalena, New Mexico, and is part of the Very Long Baseline Array (VLBA), a series of radio antennas located in the United States and its territories, extending from Hawaii to the Virgin Islands. At each antenna site, astronomical information is recorded on digital tape and sent to the main NRAO operations center in New Mexico for correlation. By recording the differing amounts of radio emission from certain areas of the sky, the radio telescopes can produce pictures of celestial bodies. The National Science Foundation operates the NRAO in support of United States and international research in physics and astronomy (LANL 1992, NRAO 2003).

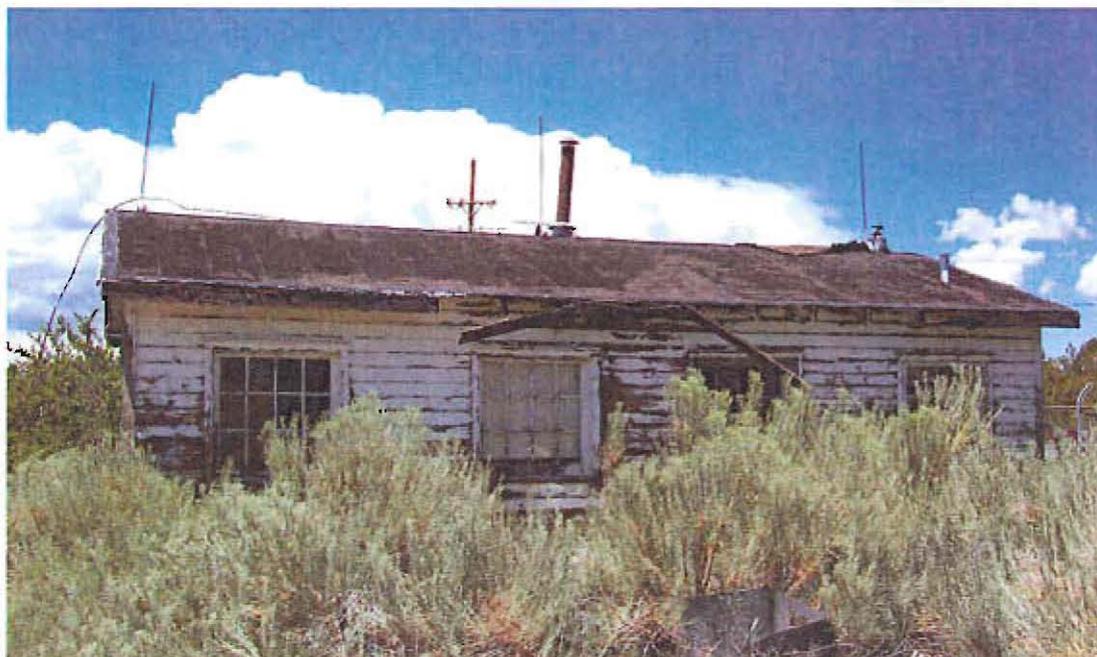
TA-33-1 was originally designed as a laboratory and office space. This small building (450 ft² in size) had wood-frame construction, a pitched roof, and painted wood siding on its exterior. The roof was composed of rolled asphalt over wood framing. The building was designed to be portable and sat on wooden skids. A laboratory sink and workbench were the only notable equipment remaining in the building. Overall, TA-33-1 was in fair condition when it was originally assessed, although it was suffering from the effects of time and from exposure to the elements.

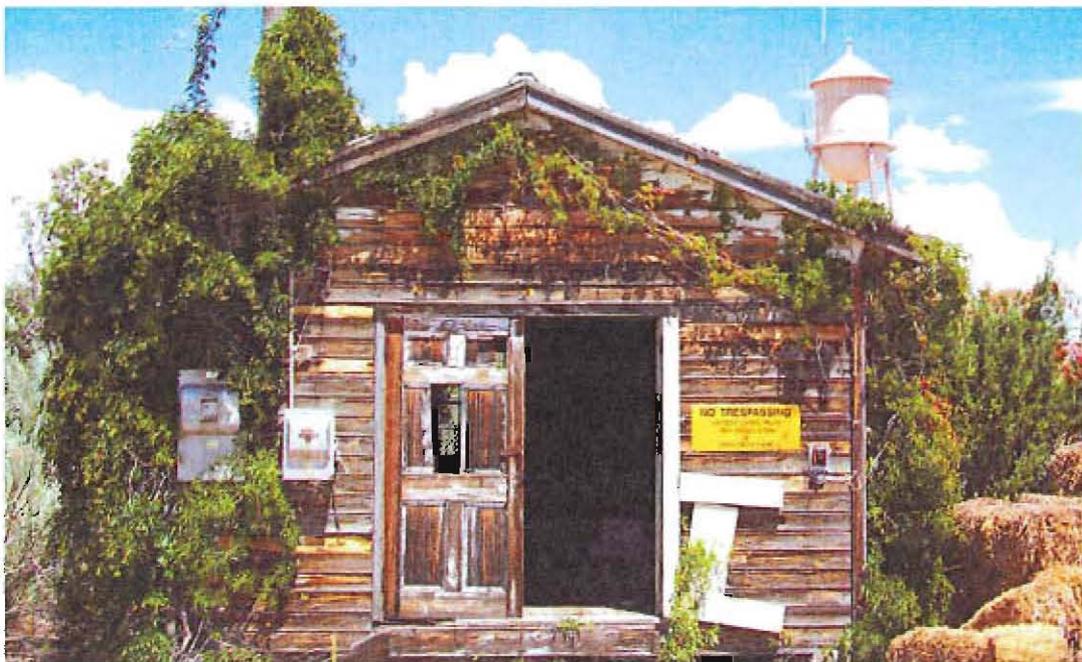
TA-33-2

was a one-story building and was approximately 450 ft² in size. Like TA-33-1, it was of wood-frame construction, sat on wooden skids, had a pitched roof, and had painted wood siding on its exterior. The roof was composed of rolled asphalt over wood framing and was in fair condition. The exterior of the building was deteriorating and was generally in poor condition.

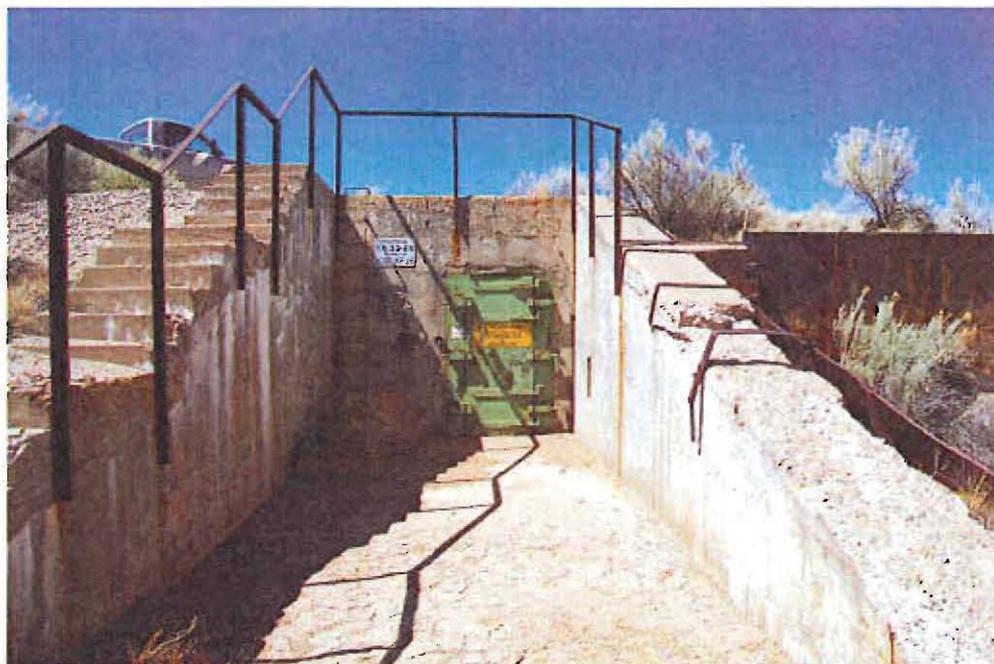
TA-33-26

The high, arched, open bay area is formed from a corrugated iron half section. The end abutments are cast-in-place concrete structures, which support the overhead doors and hold back or abut the earth mound that covers the structure. The roof and wall sections are earth covered and rest on a concrete stem wall 3-ft high on the sides or bearing walls of the structure. The stem wall is penetrated by conduit openings with 6 to 8-in. diameters. Recessed lighting fixtures that shine onto the floor are also evident around the perimeter of the stem wall. Two overhead coiling doors enclosed the openings on each end. The floor is cast-in-place concrete slab with in-floor electrical duct space and sloped perimeter drains around the building at the wall base. A bridge crane with a 5-ton trolley hoist spans the entire building. The interior space is approximately 40 ft by 40 ft, encompassing 1530 ft². The overall sense of the facility is that of a small, robust, and functional hangar.

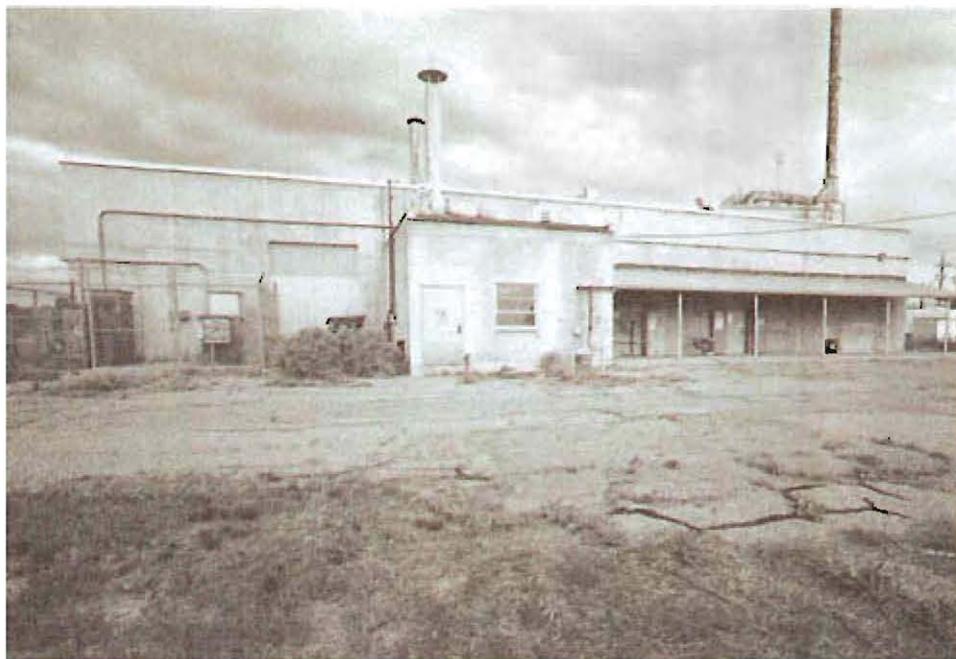
TA-33-86

An equipment room extended east from the east side of the building. The north side of this extension had a double metal pedestrian door. A small cinder (pumice) block addition was constructed on the east side of the utility equipment room in 1958. There were double metal pedestrian doors with single-paned windows located on the north side of the addition. On the east side of the addition there was a single metal pedestrian door and a three-paned, metal frame window. The north side of the building had one metal pedestrian door and a translucent, 144-paned "glass-brick" window. The exhaust stack for the building was located several ft to the north of the north wall. On the west side of the building, at the north end, there were three translucent, 120-paned "glass-brick" windows. Towards the south end of the west side there was one translucent, 144-paned "glass-brick" window. Additionally, there were two metal roll-up garage type doors on the west side. On the south side of the building there was one metal roll-up garage type door. A metal loading dock with a low concrete barrier was adjacent to the south wall. This barrier enabled oxygen trucks to back up and connect hoses to the valves on the barrier, which fed into the building. The walkway allowed an operator to control the valves on the back of the truck. There was a "penthouse" room on the roof of the north end of the building. This room housed additional utility equipment (pump motors for the building's air stack).

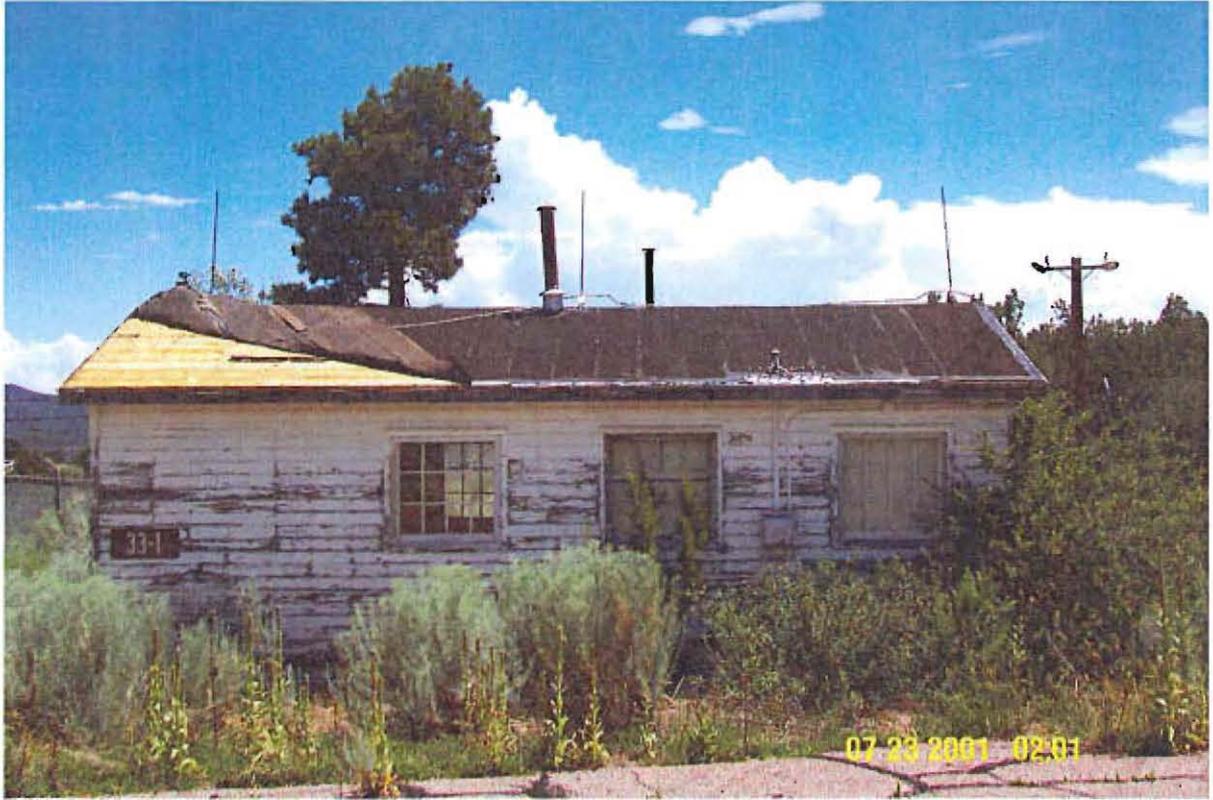
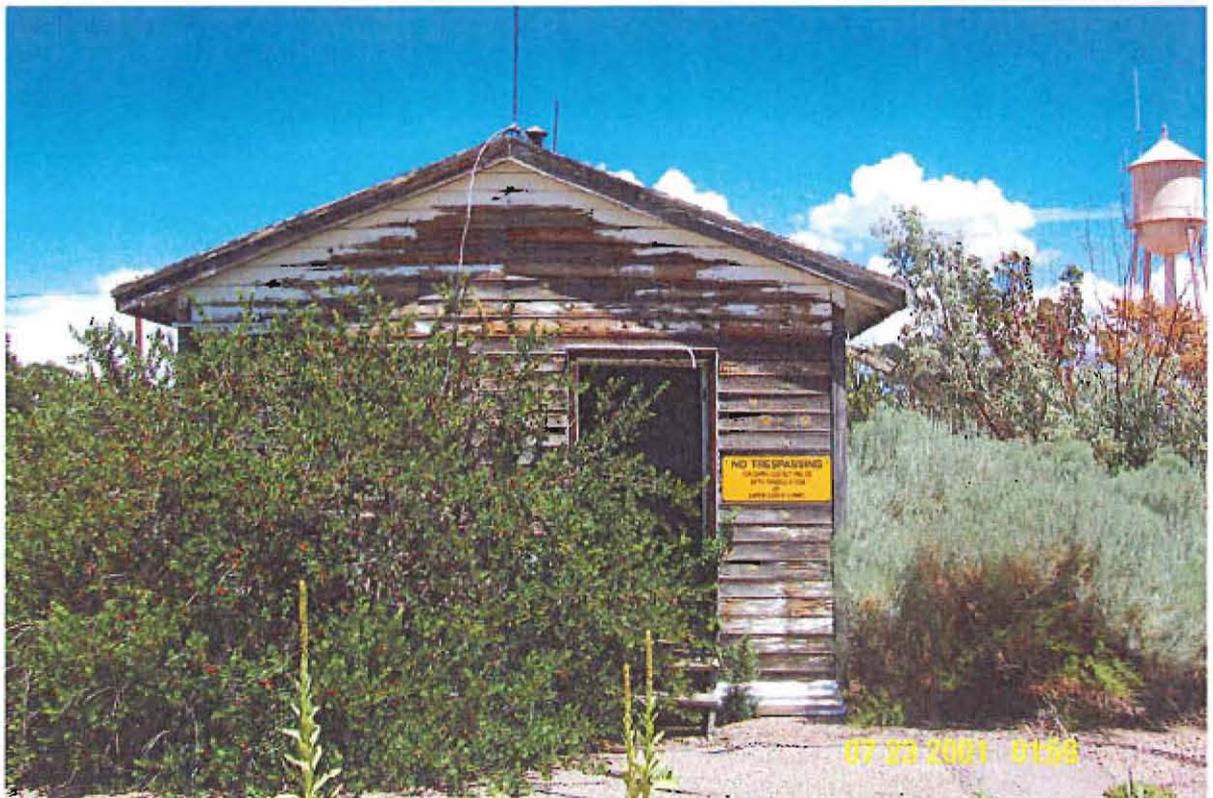
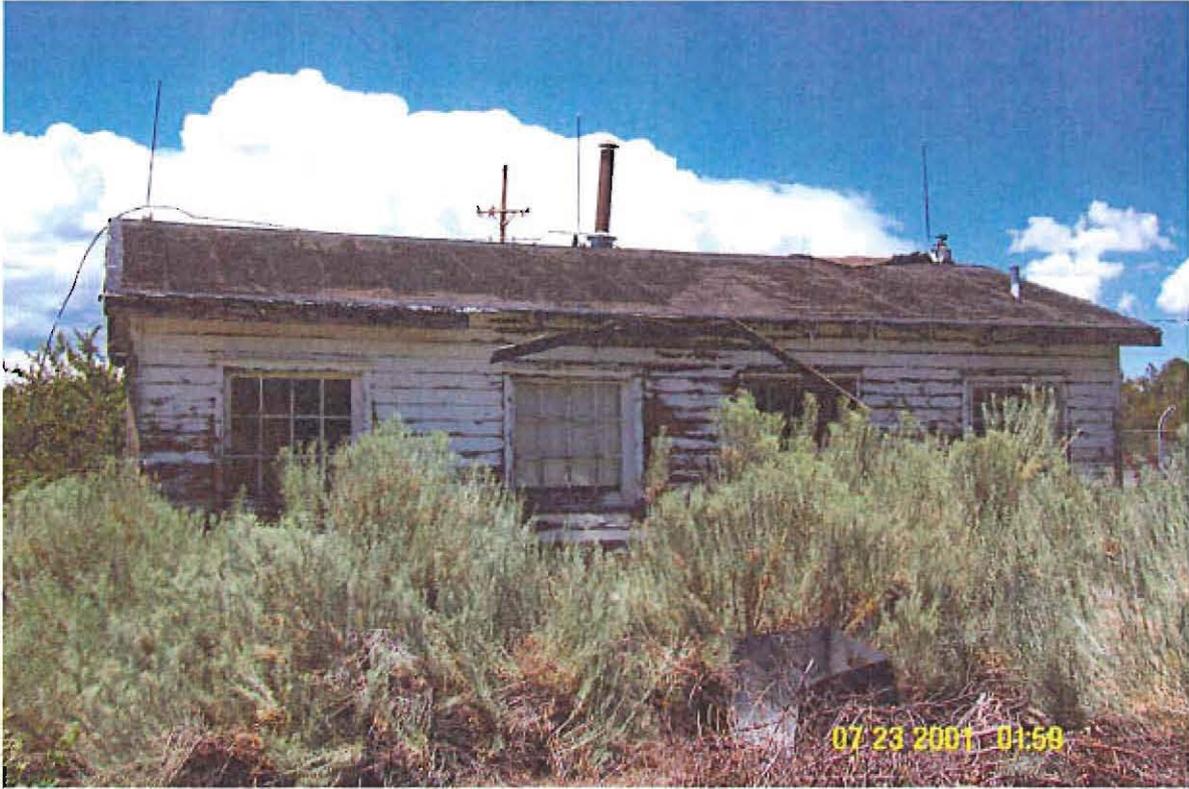
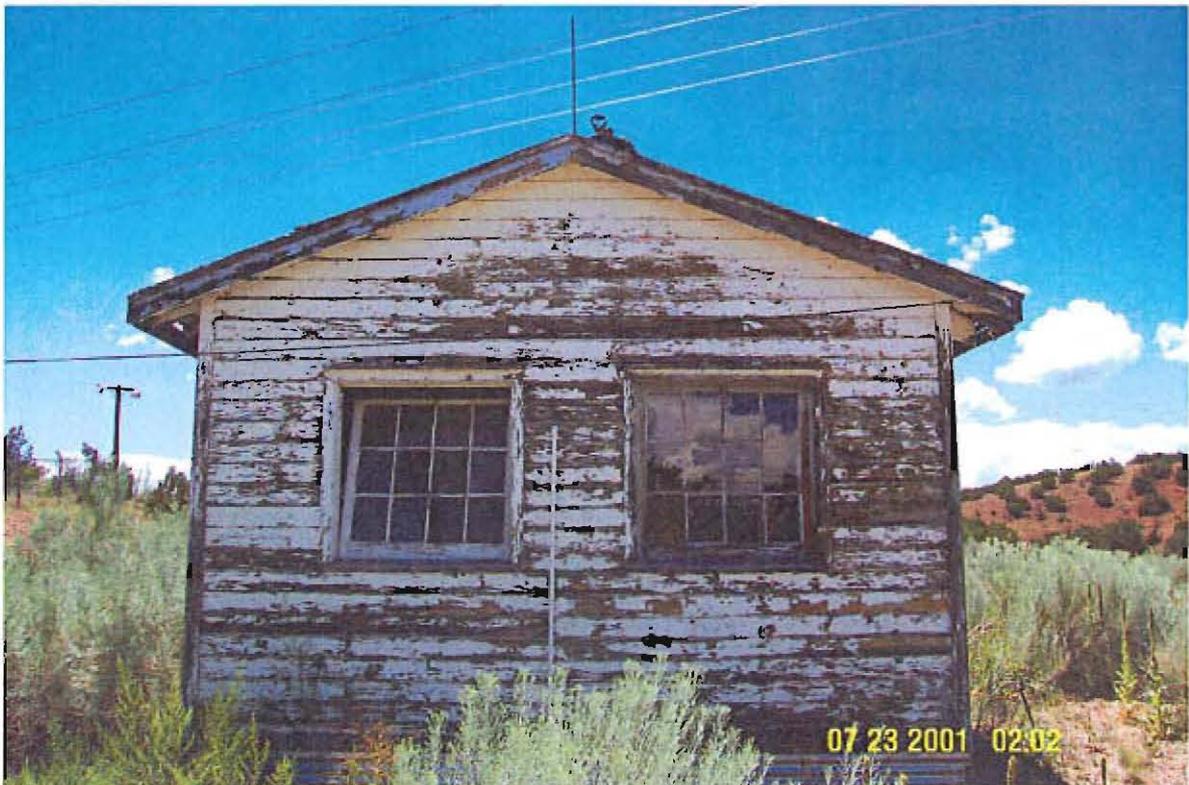
<p>Architectural features TA-33-1 is a free standing, one-story building of approximately 450 gross square feet. It is of wood frame construction, has a pitched roof, and has painted wood siding on the exterior. The roof is composed of rolled asphalt over wood framing and is in an advanced state of deterioration. The building was designed to be portable and sits on wooden skids. On the west elevation, there is one pedestrian door and one hopper-type window with single pane glass. The window has twelve individual panes of clear glass and appears to be of original construction. There are similar windows on the south (4), east (2), and north (3) elevations. The interior walls are in a bad state of deterioration and appear to have been modified at some time with the addition of 1" rigid insulation under 5/8" gypsum board. Today the building stands empty. A laboratory sink and workbench are the only notable equipment remaining in the building. Overall, TA-33-1 is in fair condition although it is suffering from the effects of time and from exposure to the elements.</p>	<p>Comments Built by R.E. McKee. The history of this building is closely linked with that of TA-33-2. Both buildings were moved to Area 6 from Area 1 (now East Site) sometime between July of 1948 and January of 1949.</p> <p>Associated historic theme Cold War Nuclear Weapons Research and Development (specifically initiator testing)</p> <p>Property type: Laboratory/Processing</p> <p>Contamination history Possible hazardous or radioactive materials used in or near the building include barium, lead, uranium, beryllium, high explosives, volatile organics, and photoprocessing chemicals.</p> <p>Integrity Fair</p> <p>Eligibility: Eligible under Criterion A</p>

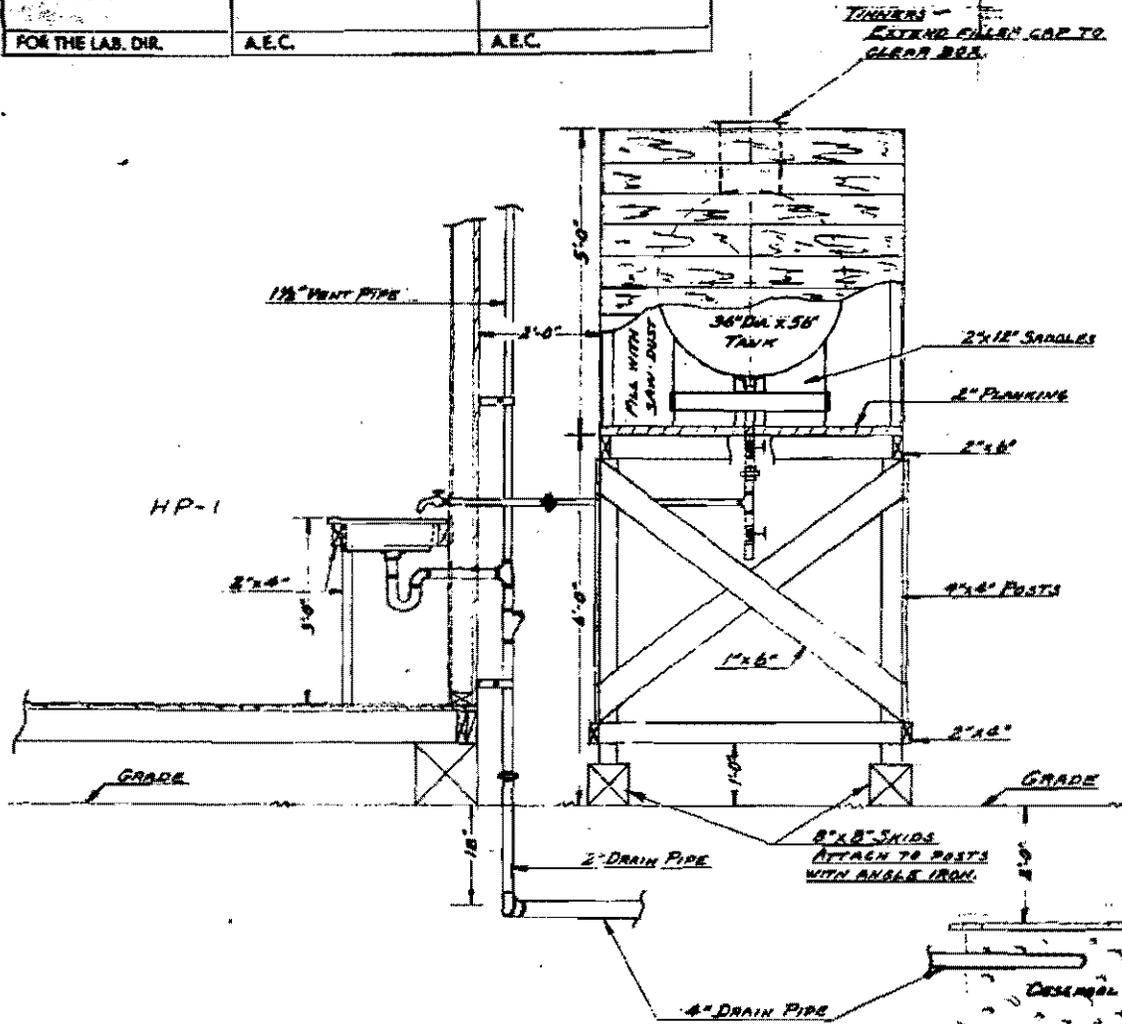
ELEVATION VIEW

FURNISH LADDER FOR ACCESS TO FILLER CAP.

INSTALL. - SINK & C.W. SUPPLY IN HP BLDG. - TA 33 10.151678 GR. M-6
SCALE: H.V.P. 2-16-48
DATE: 2-16-48
APPROV. [Signature] DATE: 2-16-48
MAINTENANCE GROUP
SKETCH No. ENG 4-513

Degree of remodeling <u>X</u> minor _____ moderate _____ major describe: In 1948, a sink and C.W. (cold water?) supply were added to TA-33-1. The raceway, breakers, outlets, and water lines were replaced in 1957 as part of upgrades to the toilet facilities. The interior walls were modified at some time with the addition of 1" rigid insulation under 5/8" gypsum board.			
Surroundings Developed Laboratory Technical Area 33	Relationship to surroundings <u>X</u> similar _____ not similar	District potential _____ yes <u>X</u> no	
Significance <u>X</u> Eligible ___ of interest ___ none if not eligible, why?	Associated building? <u>X</u> yes What type? Laboratory and shop buildings If inventoried, list ID nos. TA-33-2 and TA-33-16	Associated drawings (Photos and copies of the drawings are on following pages.) A5-C96 Installation of Underground Chamber at TA-33, Plan, Sections, Details December 10, 1947 SK No. ENG 4-513 Install Sink and C.W. Supply In HQ Bldg. HP-1, TA-33 February 16, 1948

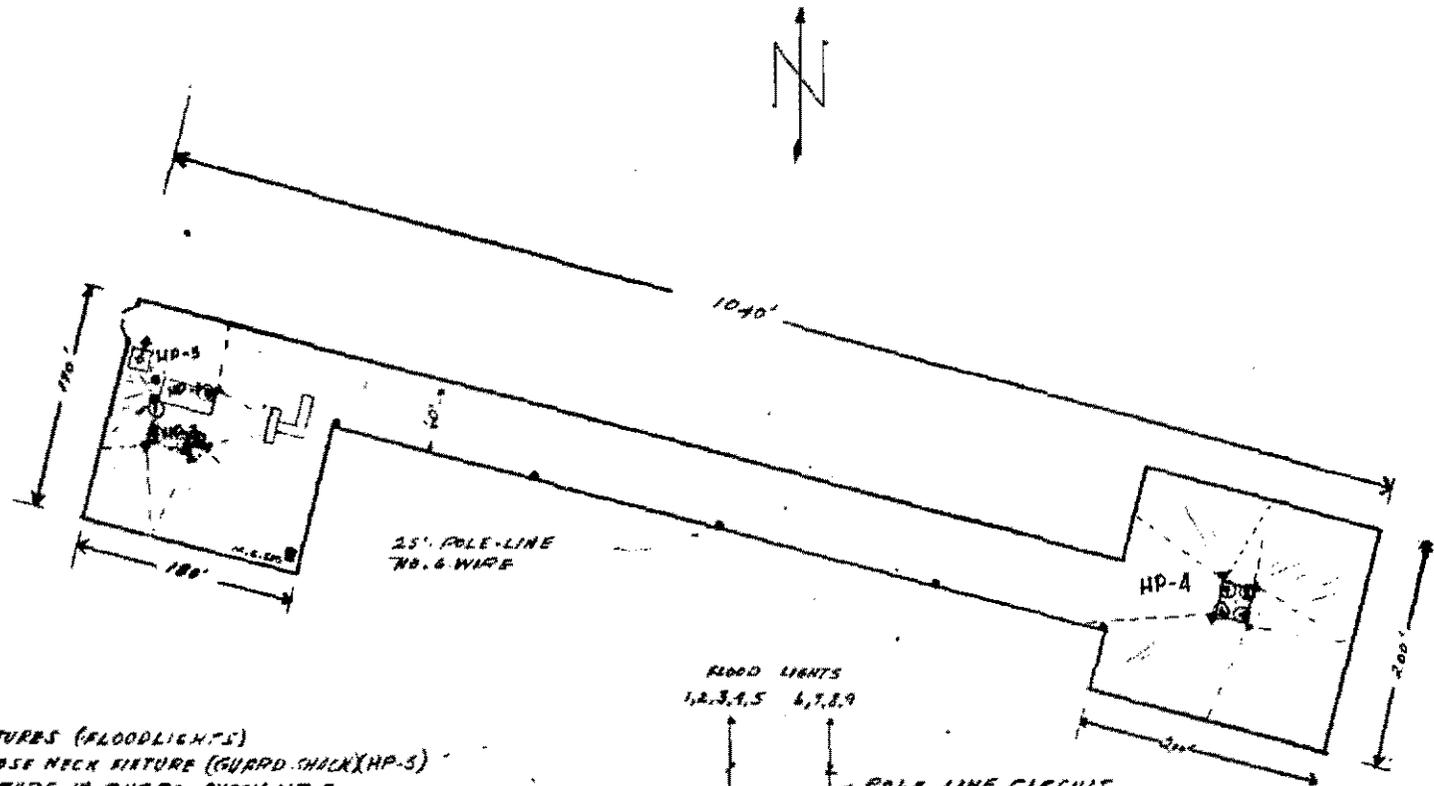
LIGHTING FOR T.A. 33-Area 1		J.O. 153927	SECURITY
SCALE	DWG. CLASS	A 2-25-48	MAINTENANCE GROUP
X	CKD. [Signature]	DATE 3-4-48	
	APP'VD. [Signature]	IA E	
			SKETCH No. ENVA-822

- ▲ 300 W FIXTURES (FLOODLIGHTS)
- ◆ 200 W GOOSE NECK FIXTURE (GUARD SHACK HP-5)
- ◇ 200 W FIXTURE IN GUARD SHACK HP-5
- 3 KW M.G. SET

LOAD - CIR. NO. 1	=	1500 WATTS
" CIR. NO. 2	=	1200 "
" " NO. 3	=	500 "
" " NO. 4	=	400 "
TOTAL LOAD		3600 - WATTS
