**Historic Context of Hot Point Site,
Technical Area 33**

Historic Building Report No. 238

Los Alamos National Laboratory

October 31, 2004

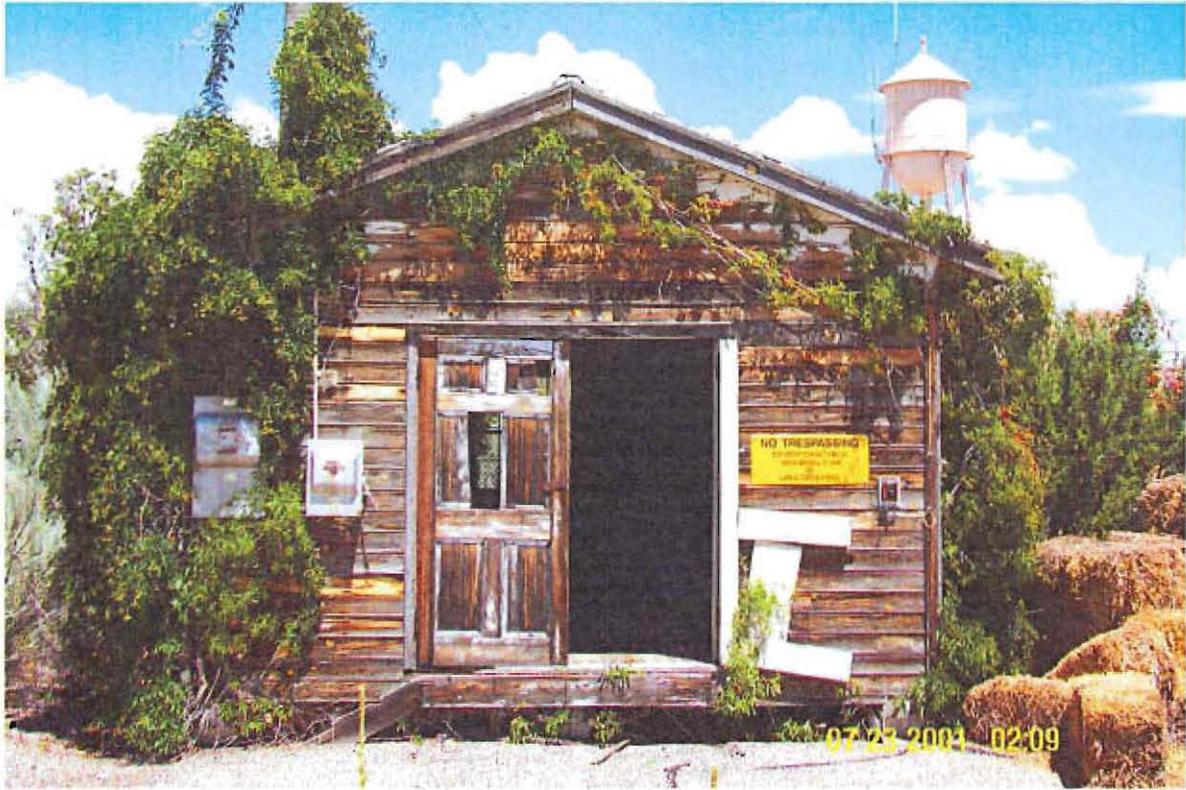
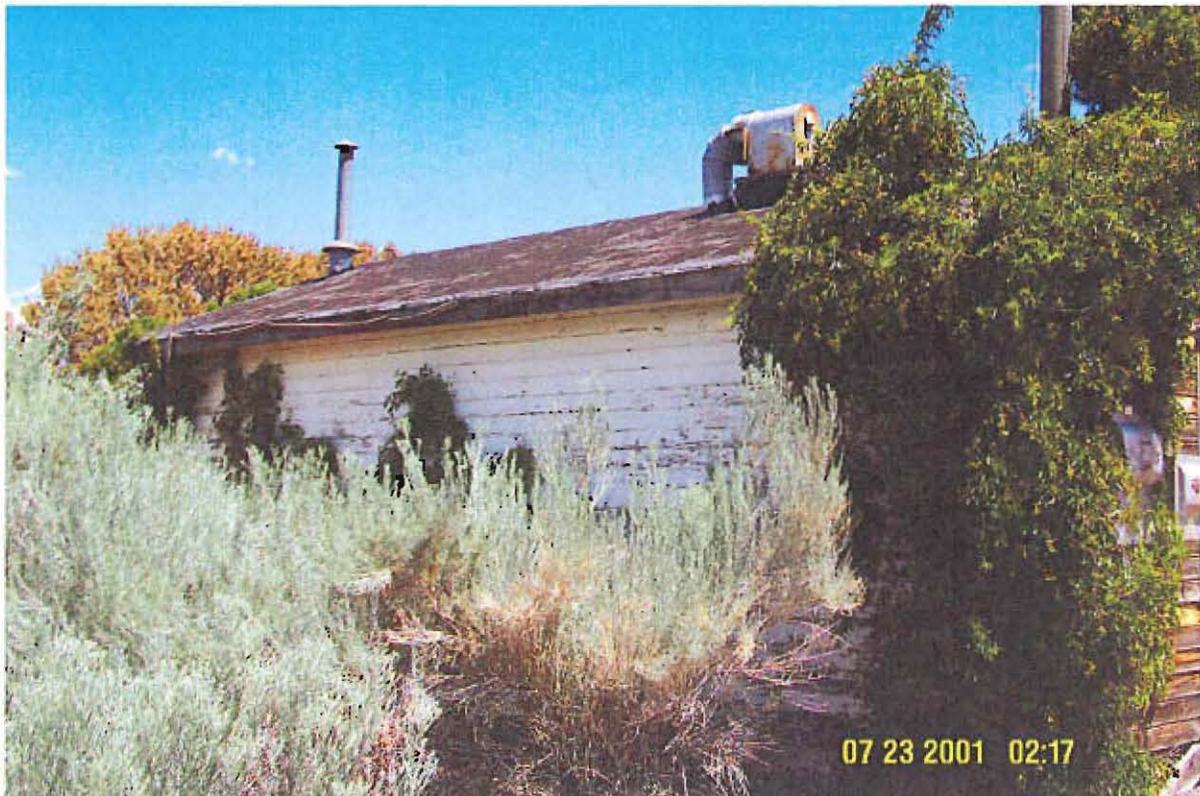
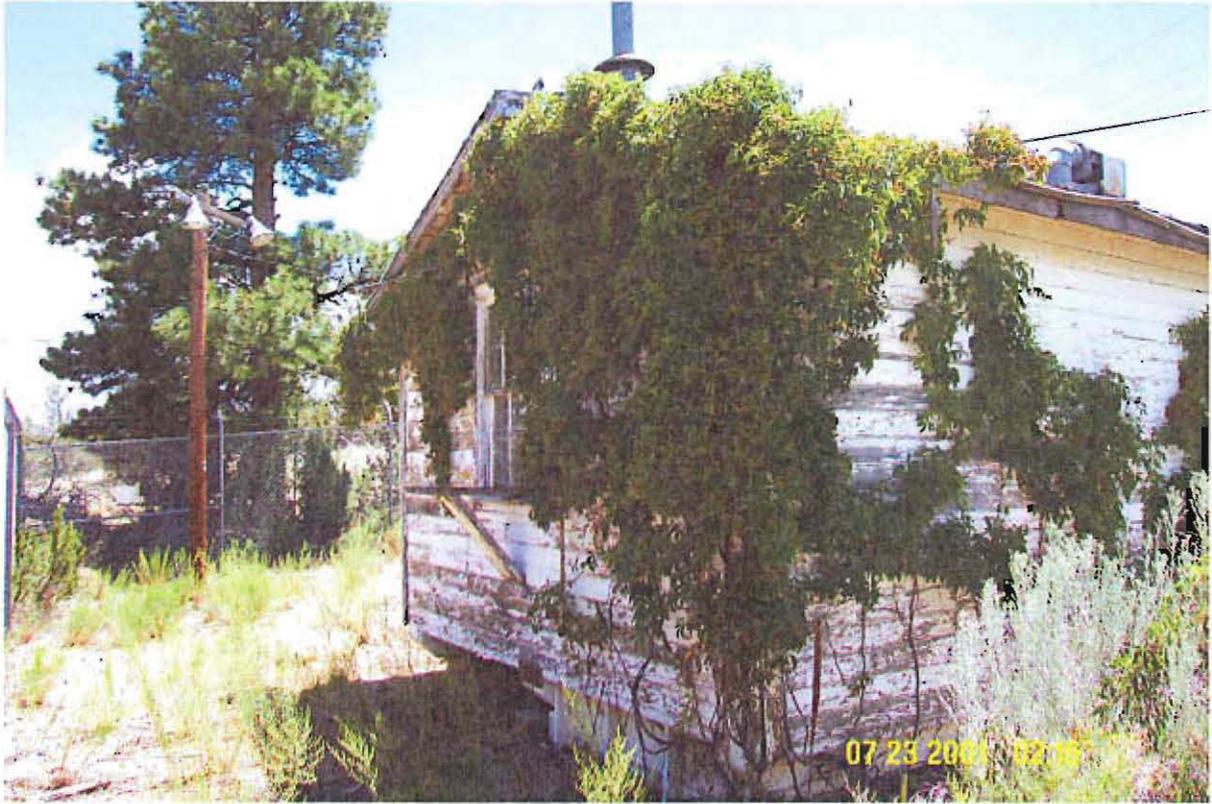
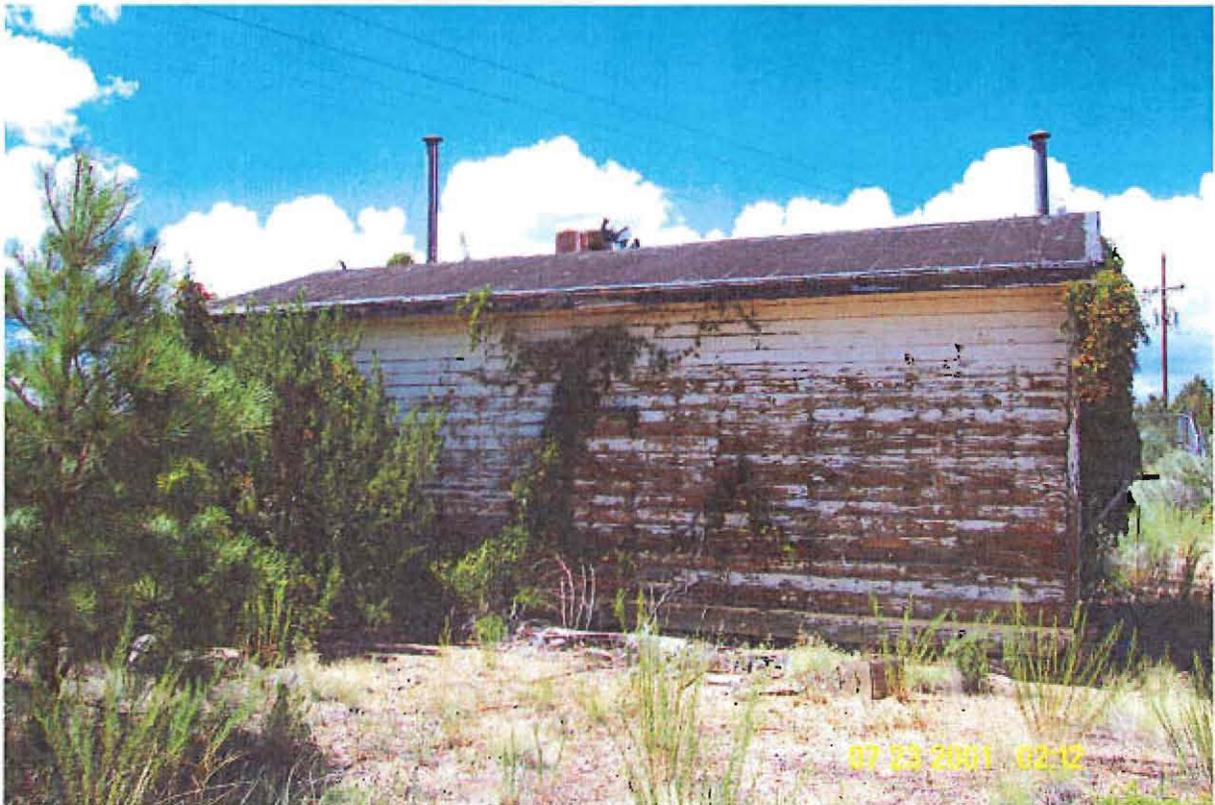
<p>Portable Warehouse Floor Plan Bldg. HP-2, TA-33 June 18, 1964</p> <p>Size 450 gross ft² (406 net ft²)</p>
<p>Architectural features TA-33-2 is a free standing, one-story building of approximately 450 gross square feet. It is of wood frame construction, has a pitched roof, and has painted wood siding on the exterior. The roof is composed of rolled asphalt over wood framing and is in fair condition. The building was designed to be portable and sits on wooden skids. Currently, a portion of the floor is a concrete slab sitting on grade. On the west elevation, there is a wood-paneled, double door and one hopper-type window with single pane glass. The window has sixteen individual panes of clear glass and appears to be of original construction. The exterior of the building is deteriorating and is generally in poor condition. The interior walls appear to be original and are composed of wood framing and either sheet rock or asbestos board material. There is an asphalt drive and parking area west of the building.</p>		<p>Comments Built by R.E. McKee. The history of this building is closely linked with that of TA-33-1. Both buildings were moved to Area 6 from Area 1 (now East Site) sometime between July of 1948 and January of 1949.</p> <p>Associated historic theme Cold War Nuclear Weapons Research and Development (specifically initiator testing)</p> <p>Property type Support and Laboratory/Processing</p> <p>Contamination history Possible hazardous or radioactive materials used in or near the building include barium, lead, uranium, beryllium, and high explosives.</p> <p>Integrity Fair</p> <p>Eligibility Eligible under Criterion A</p>

was a one-story building and was approximately 450 ft² in size. Like TA-33-1, it was of wood-frame construction, sat on wooden skids, had a pitched roof, and had painted wood siding on its exterior. The roof was composed of rolled asphalt over wood framing and was in fair condition. The exterior of the building was deteriorating and was generally in poor condition.

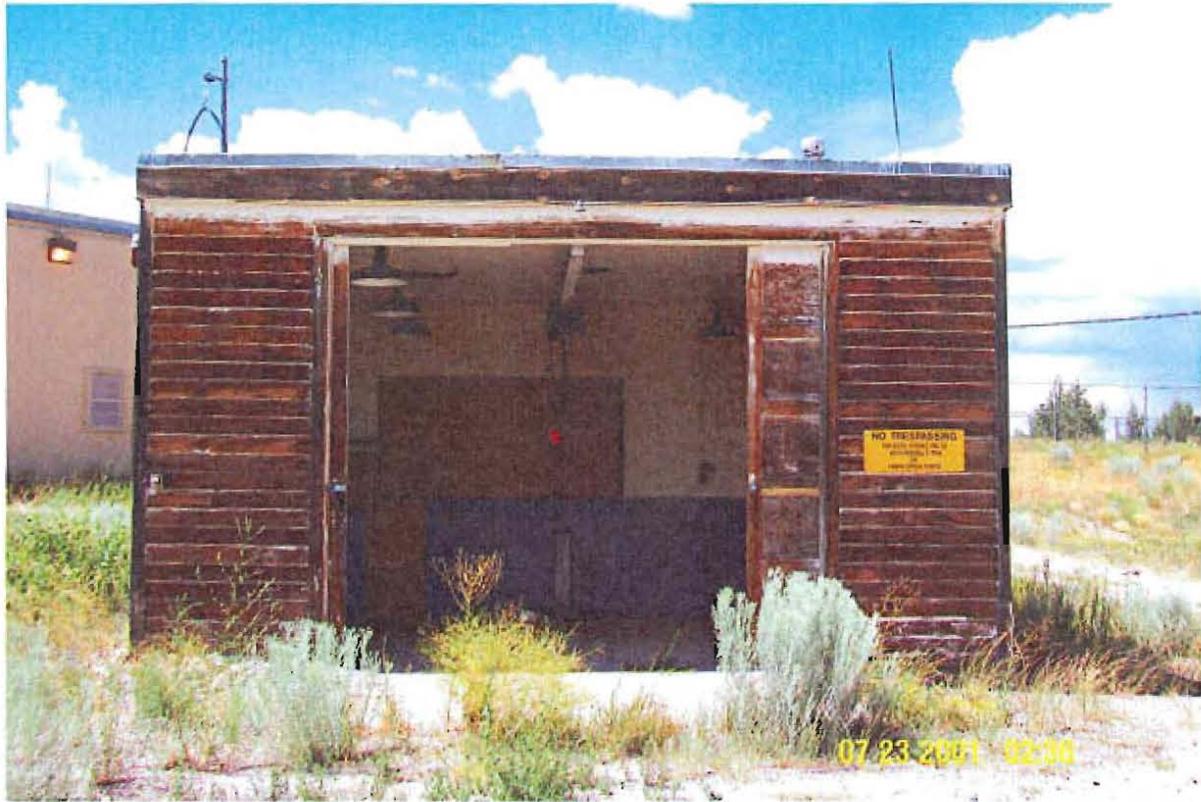
TA-33-40 South Elevation and Interior

<p>Architectural features TA-33-40 is a free standing, windowless, one-story building of approximately 335 gross square feet. It is of wood frame construction and has a slightly pitched, shed-type “built up” roof. The building’s exterior is ship-lapped, tongue and groove wood siding that has been painted. TA-33-40 sits on a reinforced concrete slab that ramps to the east of the building. It also has a sliding sectional wood door. The interior walls and ceiling are finished in masonite panels. There are five overhead pendant lights, a corner wall heater, and an overhead hoist inside the building. TA-33-40 originally housed a 24” saw with self-contained coolant.</p> <p>According to drawing ENG-C2956, a sand bag barricade was situated approximately 4 feet from the building around the east, north and west elevations.</p>	<p>Comments Built by the Zia Company. This building was relocated within the Maiu Site area in 1953 but its original function did not change. A slit saw in the building was used to saw open steel and uranium projectiles after they were retrieved from initiator experiments.</p> <p>Associated historic theme Cold War Nuclear Weapons Research and Development (specifically initiator testing)</p> <p>Property type Laboratory/Processing</p> <p>Contamination history Possible hazardous or radioactive materials used in or near the building include uranium and beryllium. LANL records indicate that a fan was installed in the roof of TA-33-40 because uranium fumes were emanating from saw operations.</p> <p>Integrity Fair</p> <p>Eligibility Eligible under Criterion A</p>

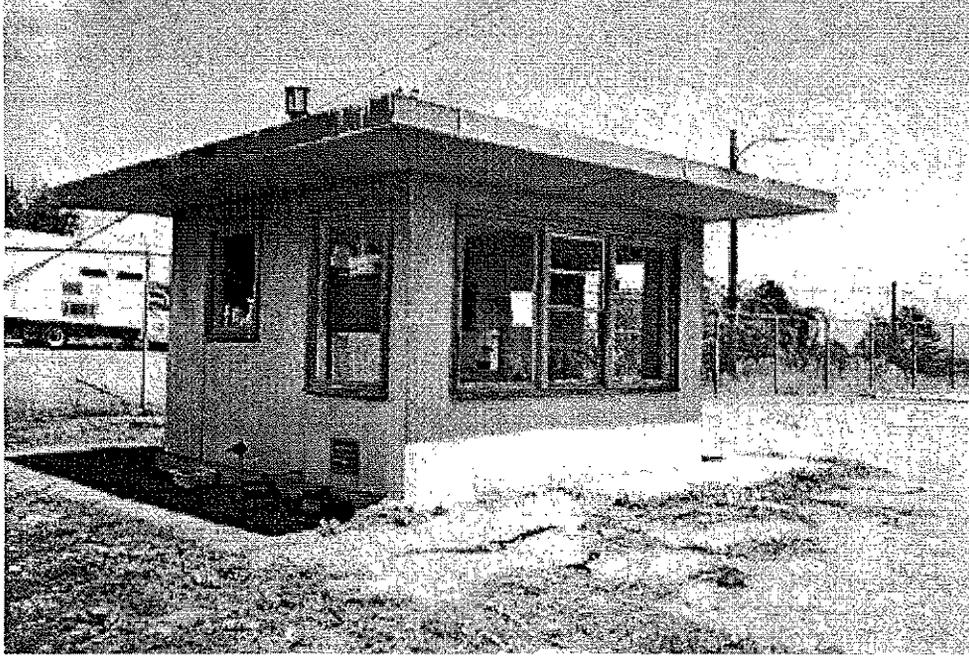
TA-33-90
West and South Sides

<p>architectural features</p> <p>Building 33-90 is a small square, wood frame structure with a flat roof and a concrete foundation. The wood frame is covered with "Transite", a non-friable asbestos siding. The roof of the building extends (overhangs) the building by approximately 2-2 1/2 feet. It is constructed of tarpaper, tar, and gravel and has a metal "flashing" edging along all sides. The 12 by 12 foot building has two rooms, the main room plus a small restroom.</p> <p>On the east side of the building there is a wooden pedestrian door with a large window. There is also a fixed 3' by 4'5½" single-paned window.</p> <p>All windows in the building have wood and metal frames.</p> <p>The north side of the building has two side-by-side windows. One is a fixed 2'8" by 4'5½" single-paned window and the other is a double-hung sash window 2'8" by 4'5½" with four panes.</p> <p>The west side of the building has two single-paned fixed windows. One is 3' by 4'5½" and the other is 2'8" by 3'½".</p> <p>On the south side there are three side-by-side windows. The center window is a double-hung sash window, 2'8" by 4'5½". The two "outside" windows are 3' by 4'5½", single-paned and fixed.</p>	<p>Comments</p>
