**NPDES PERMIT NO. NM0030759  
REQUEST FOR PERMIT MODIFICATION,  
SITE MONITORING REQUIREMENTS FOR SITE 72-001 (S-SMA-6)**

## **1.0 INTRODUCTION**

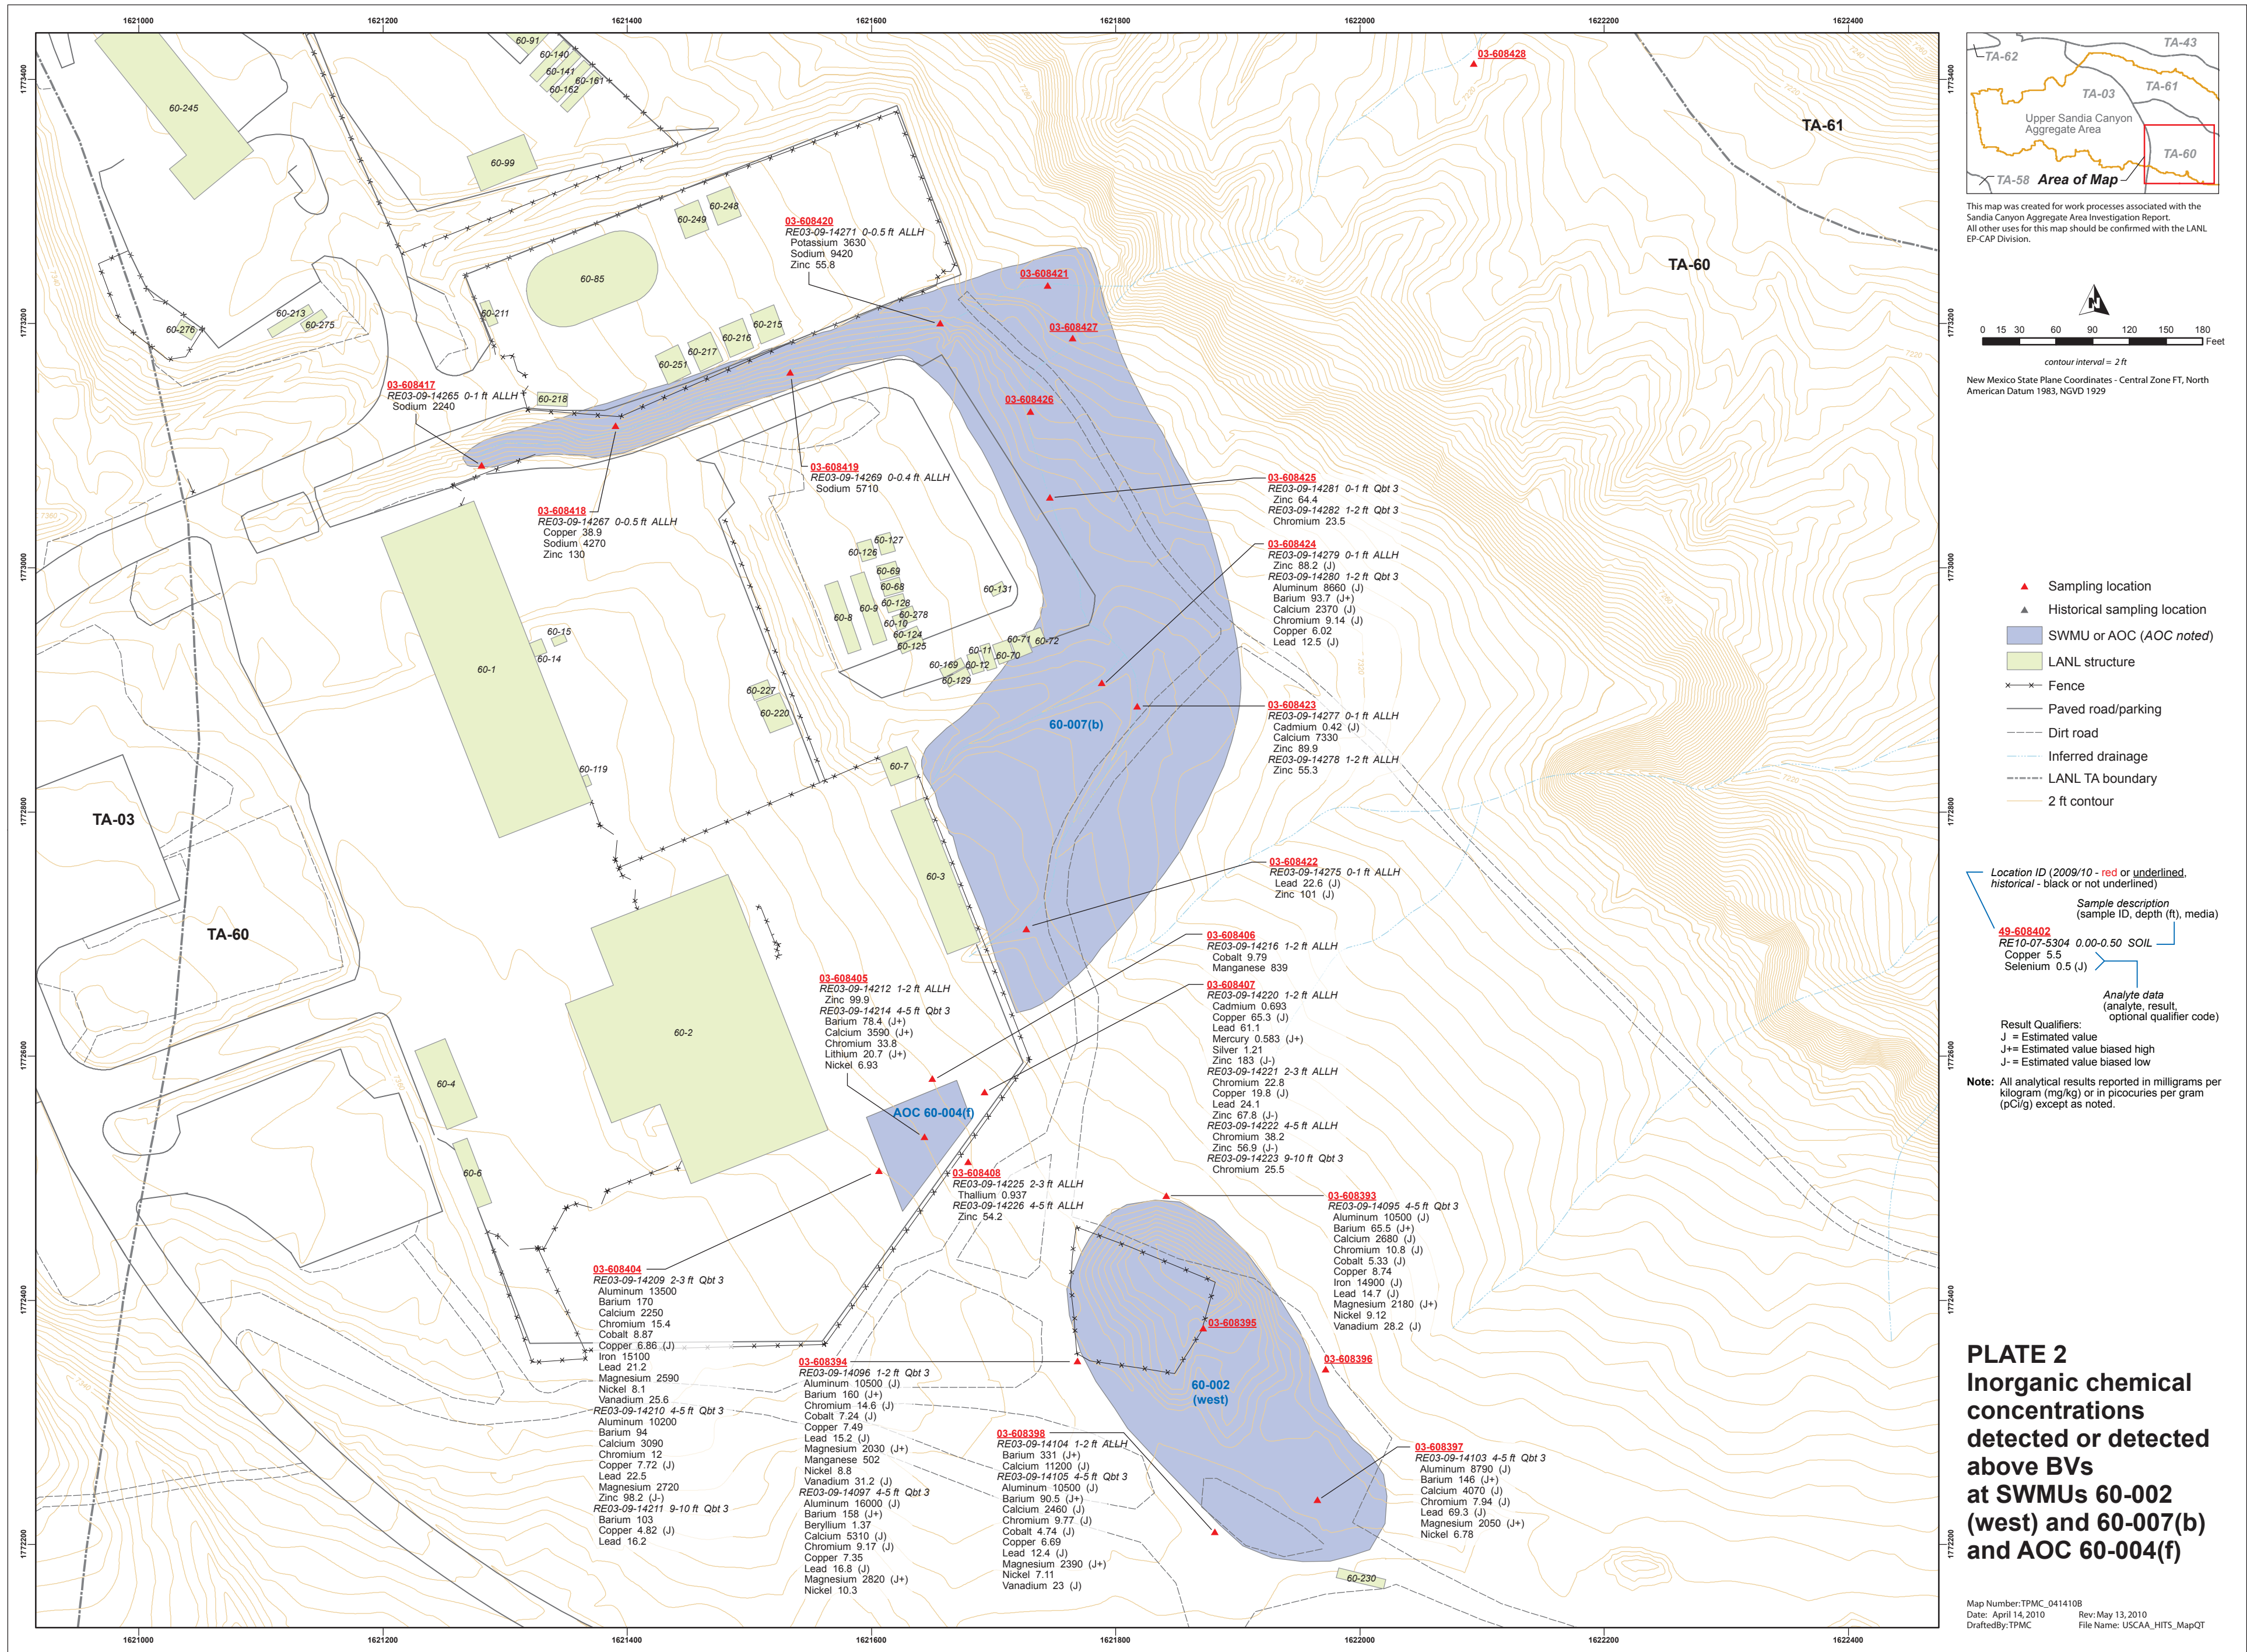
**PLATE 2**  
**Inorganic chemical concentrations detected or detected above BVs at SWMUs 60-002 (west) and 60-007(b) and AOC 60-004(f)**

There are no known or suspected sources of industrial materials containing aluminum exposed to storm water at TA-60 sites. Aluminum metal associated with building materials and containers may be exposed to storm water. Aluminum was detected slightly above the maximum tuff BV in 17 samples at 6 of the 7 SWMUs and AOCs sampled at TA-60 in 2009 under the Consent Order (Plate 2, Figures 25 and 26, and Tables 53 through 58).

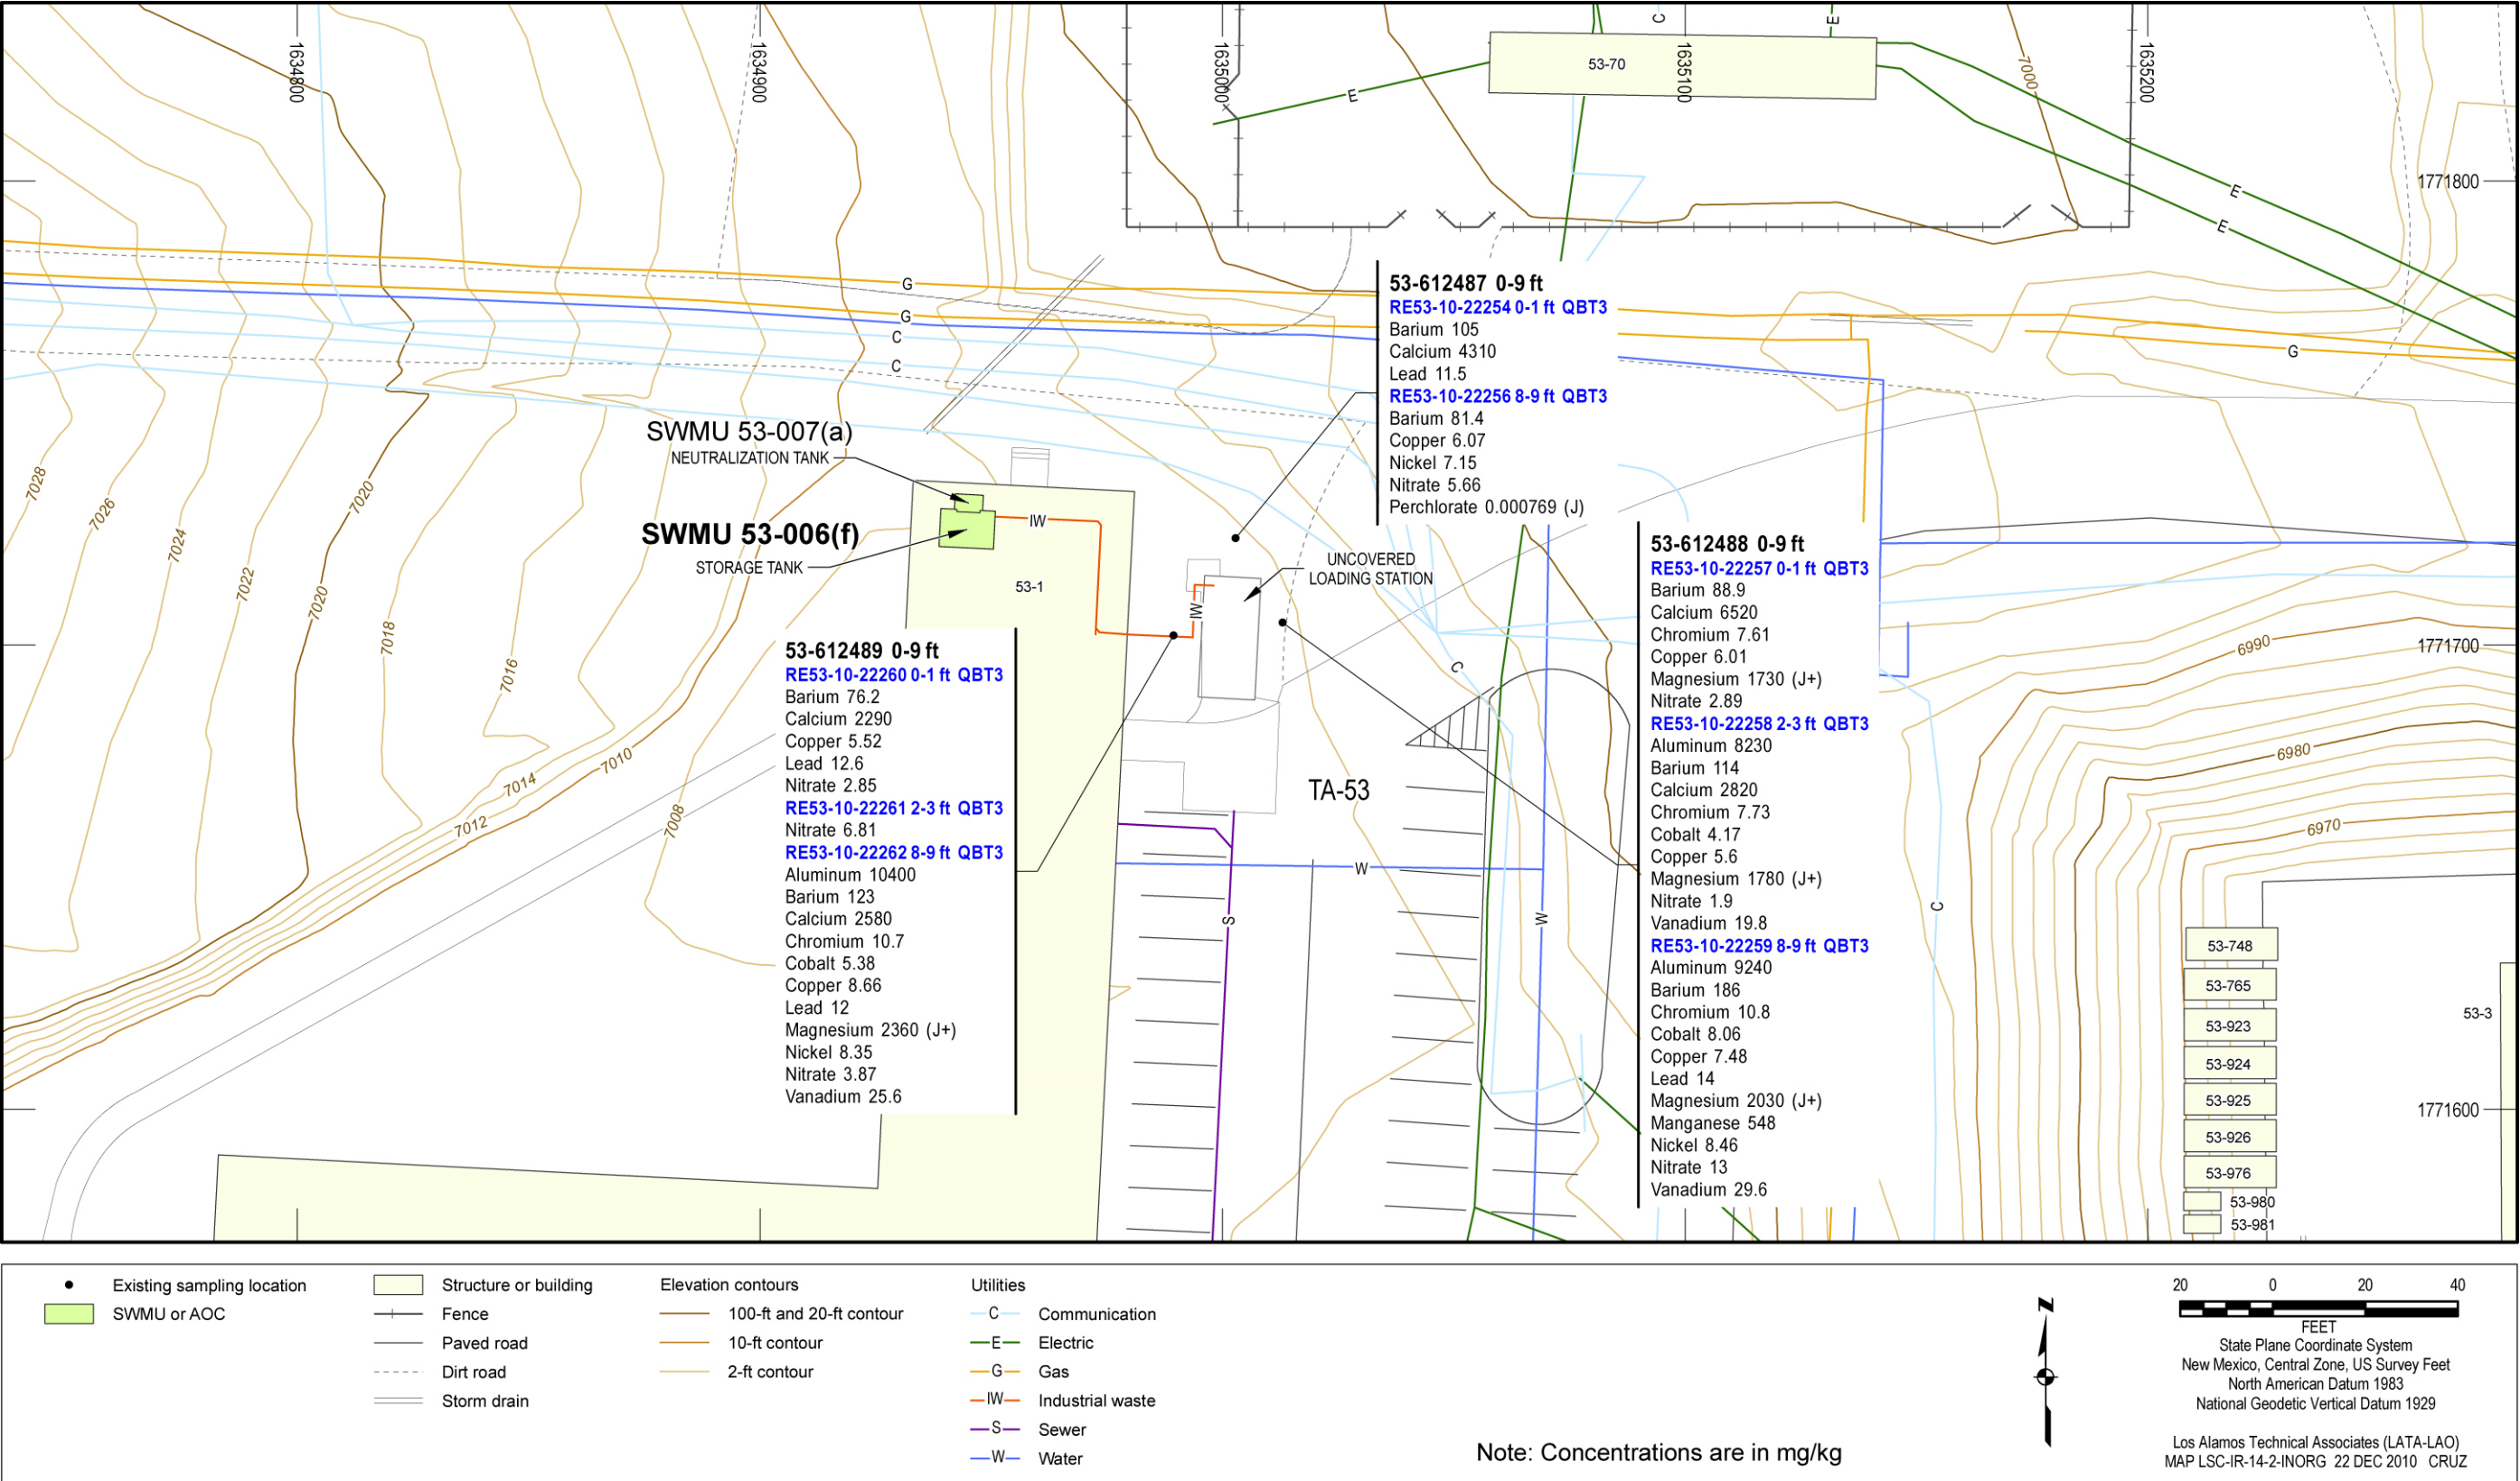
Figure 27 Inorganic chemicals detected or detected above BVs at SWMU 53-006(f)

There are no known or suspected sources of industrial materials containing aluminum exposed to storm water at TA-53. Aluminum metal associated with building materials and containers may be exposed to storm water. Aluminum was detected slightly above the maximum tuff BV in three samples at two of the nine sites sampled at TA-53 in 2010 under the Consent Order (Figures 27 and 28 and Tables 60 and 61).

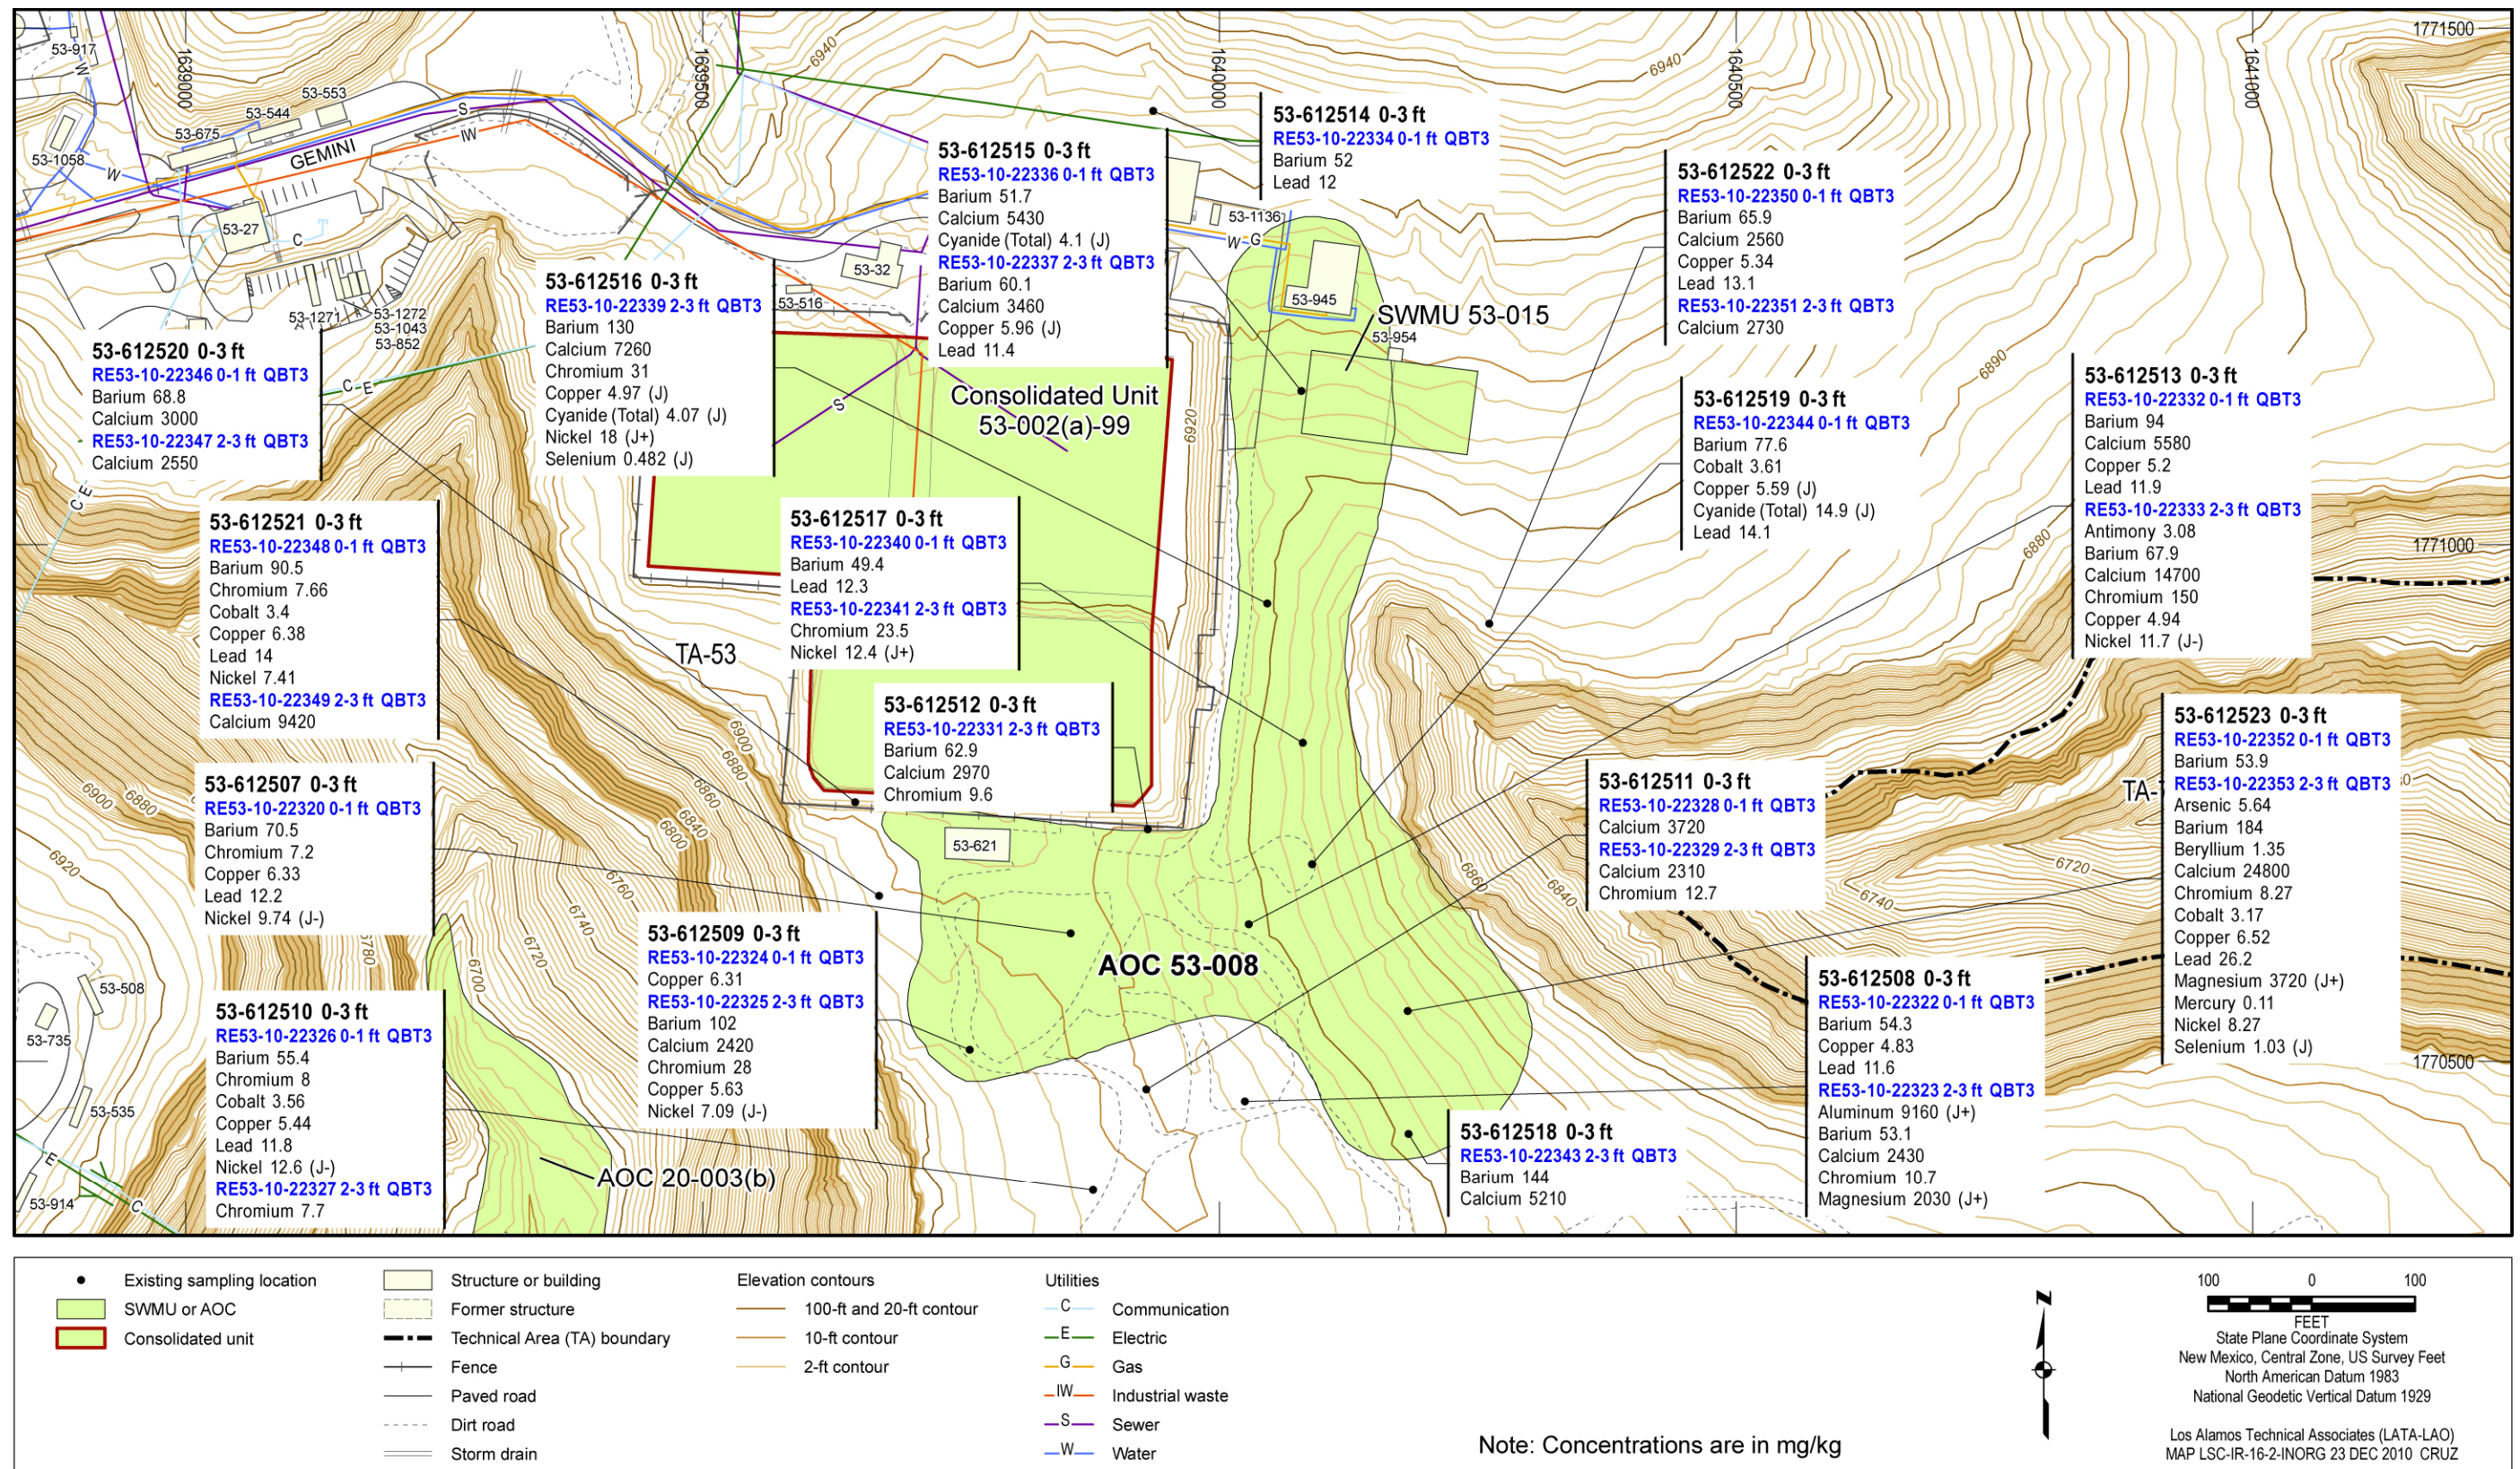
**Figure 28 Inorganic chemicals detected or detected above BVs at AOC 53-008**

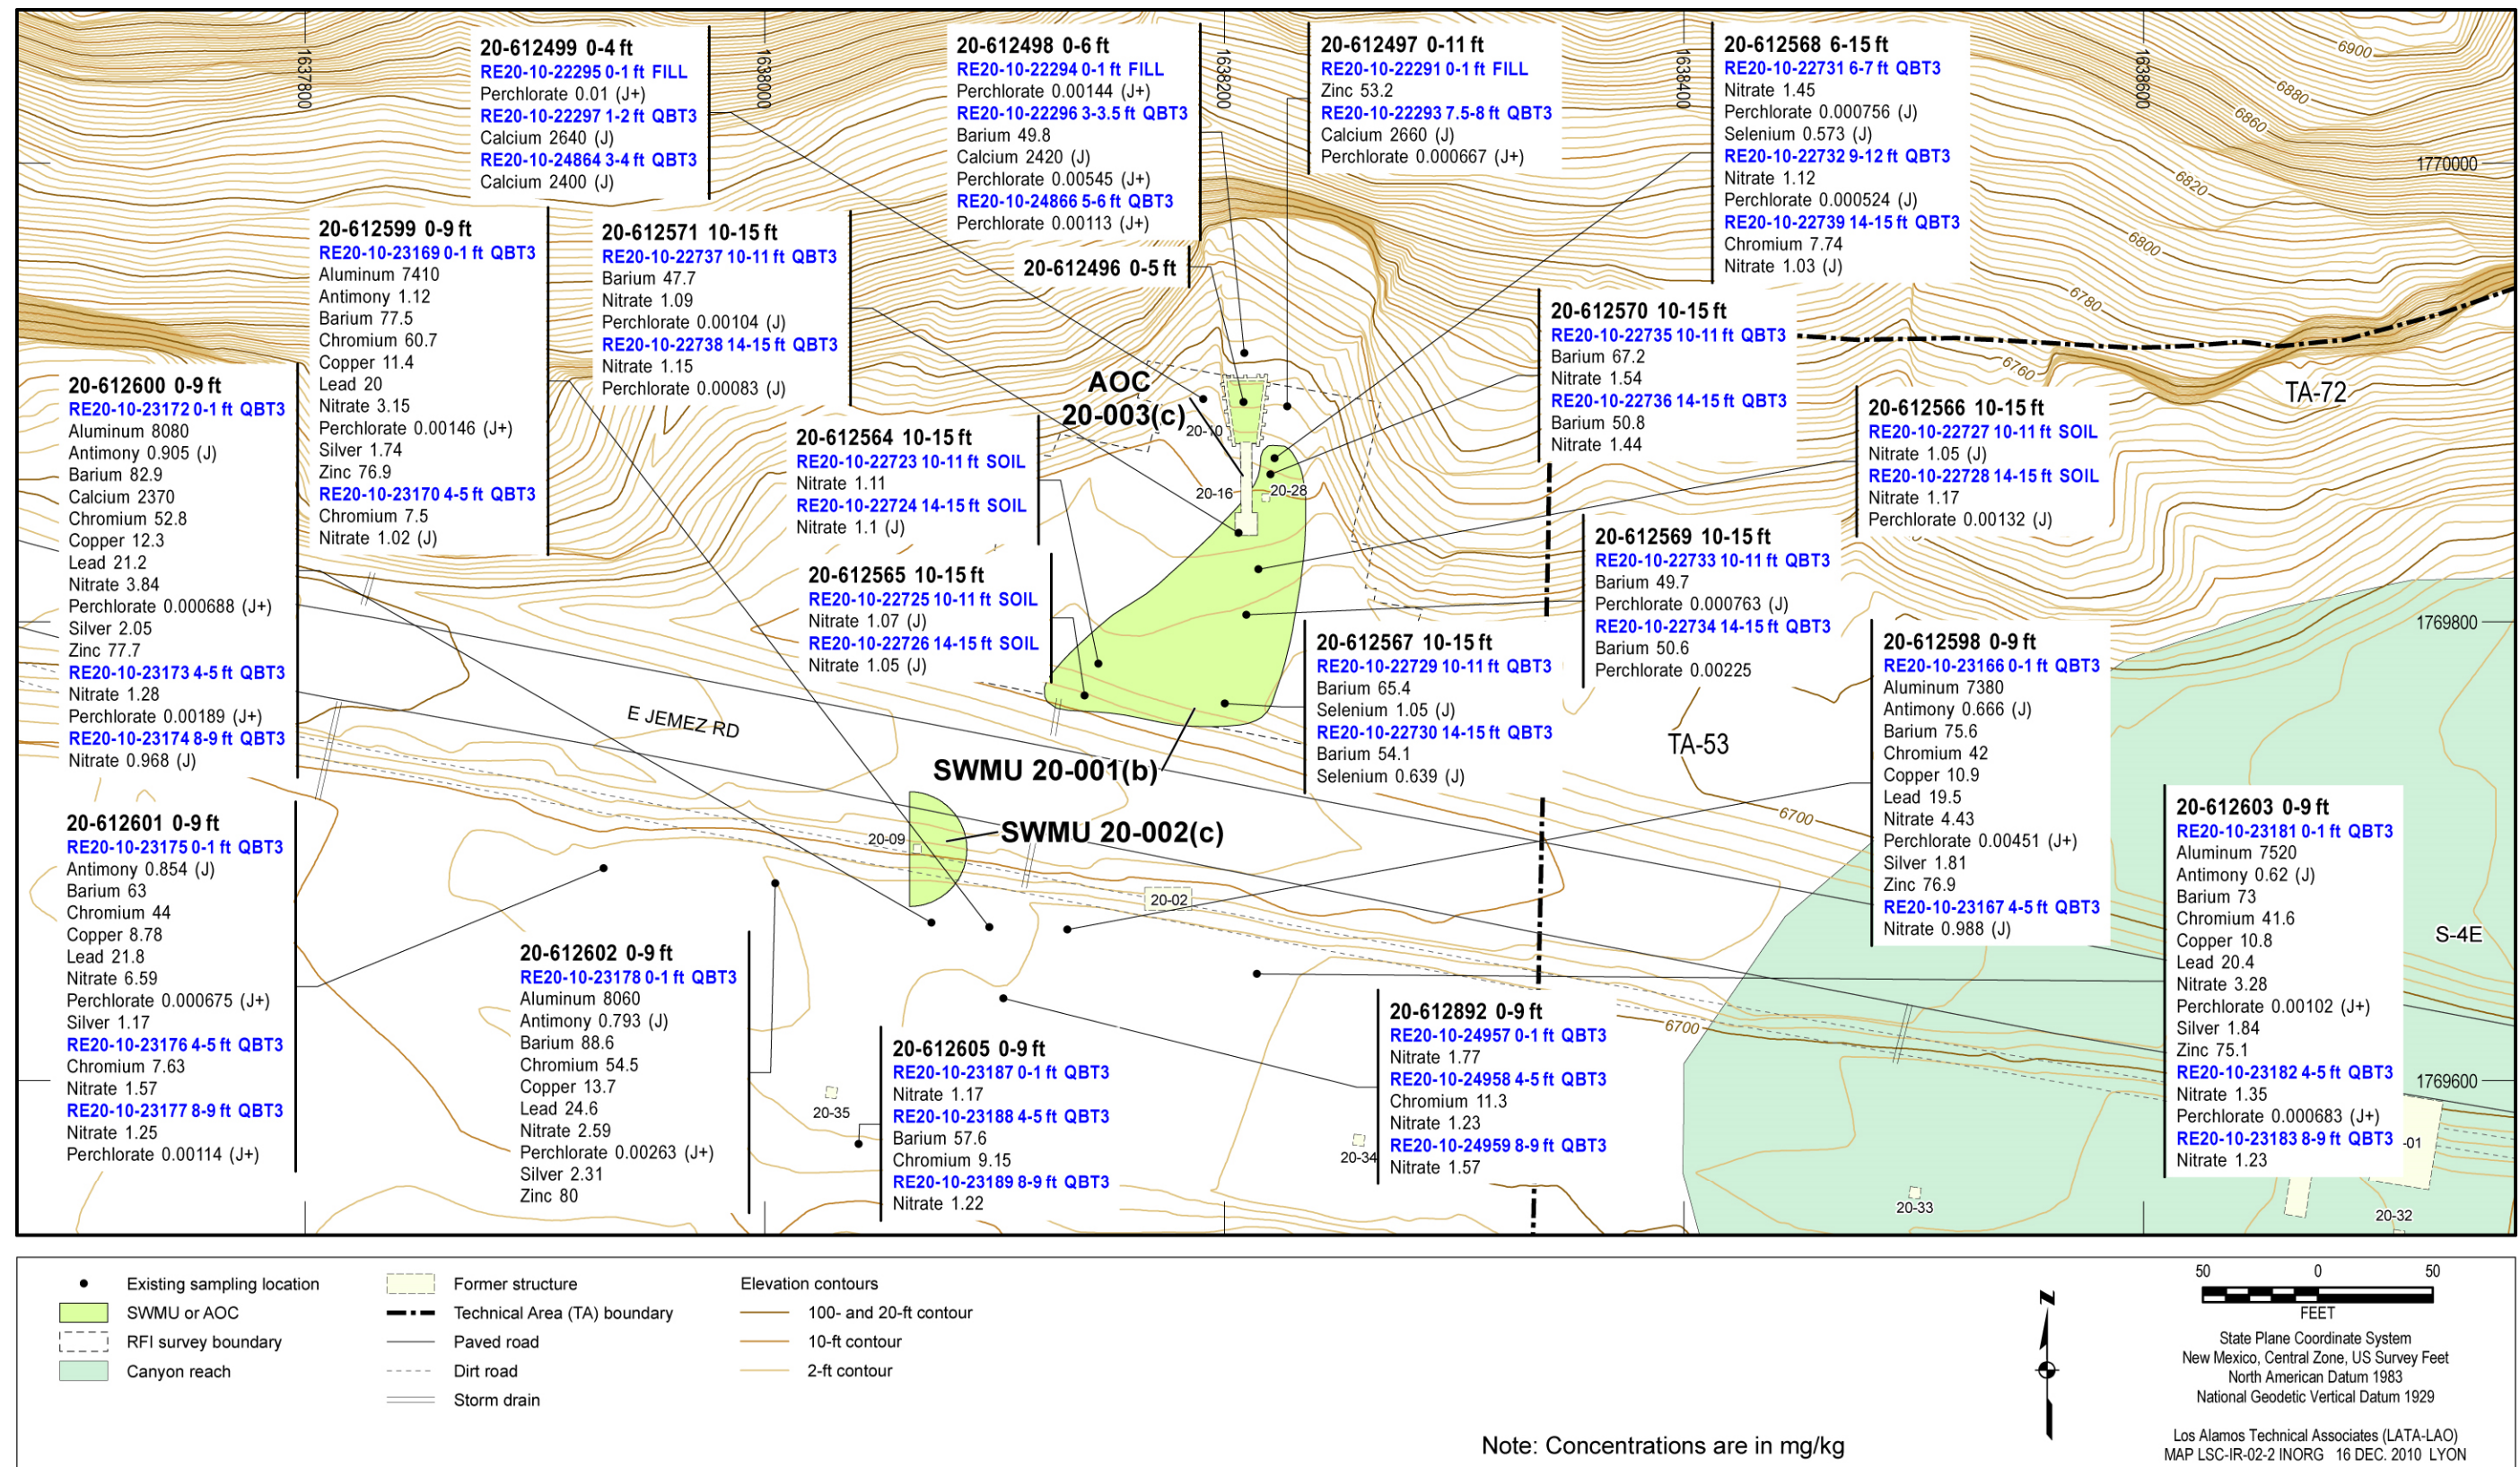
**Figure 29** Inorganic chemicals detected or detected above BVs at SWMUs 20-001(b) and 20-002(c) and AOC 20-003(c)

There are no known or suspected sources of industrial materials containing aluminum exposed to storm water at former TA-20. Aluminum was detected slightly above the maximum tuff BV in four samples at 3 of the 11 sites sampled at former TA-20 in 2010 under the Consent Order (Figures 29 through 32 and Tables 62 through 65).

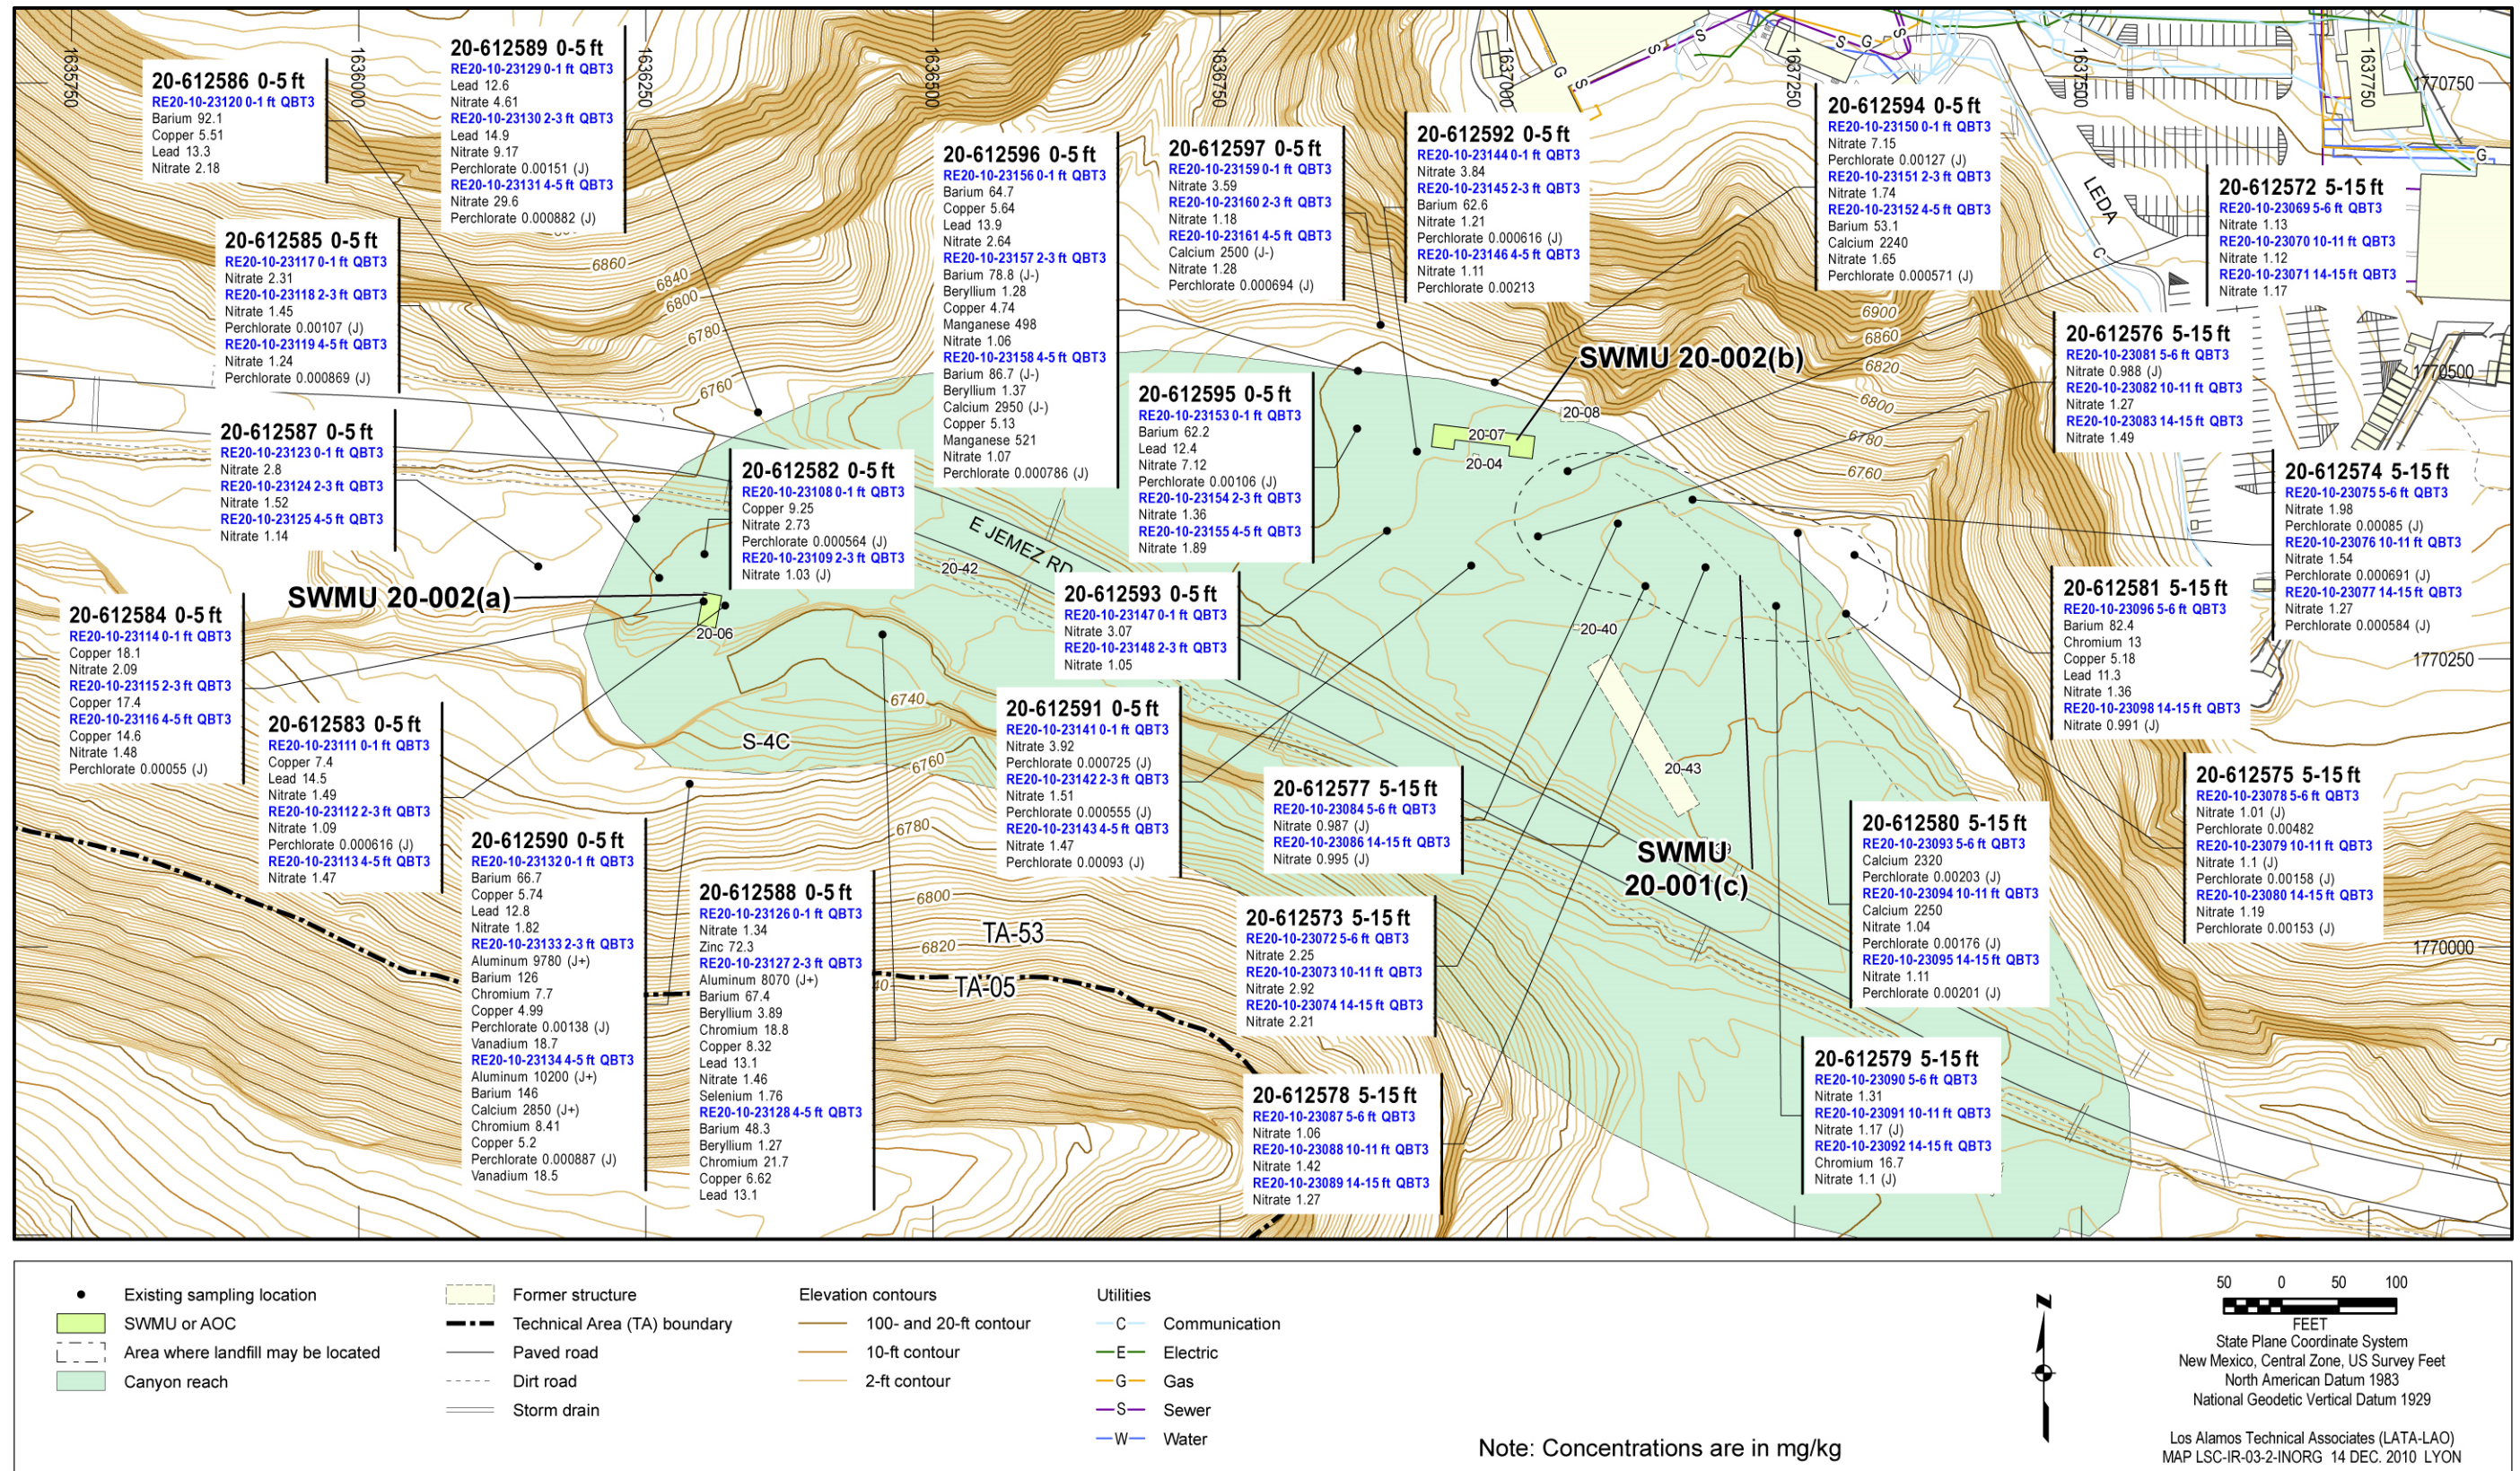
**Figure 30** Inorganic chemicals detected or detected above BVs at SWMUs 20-001(c), 20-002(a), and 20-002(b)

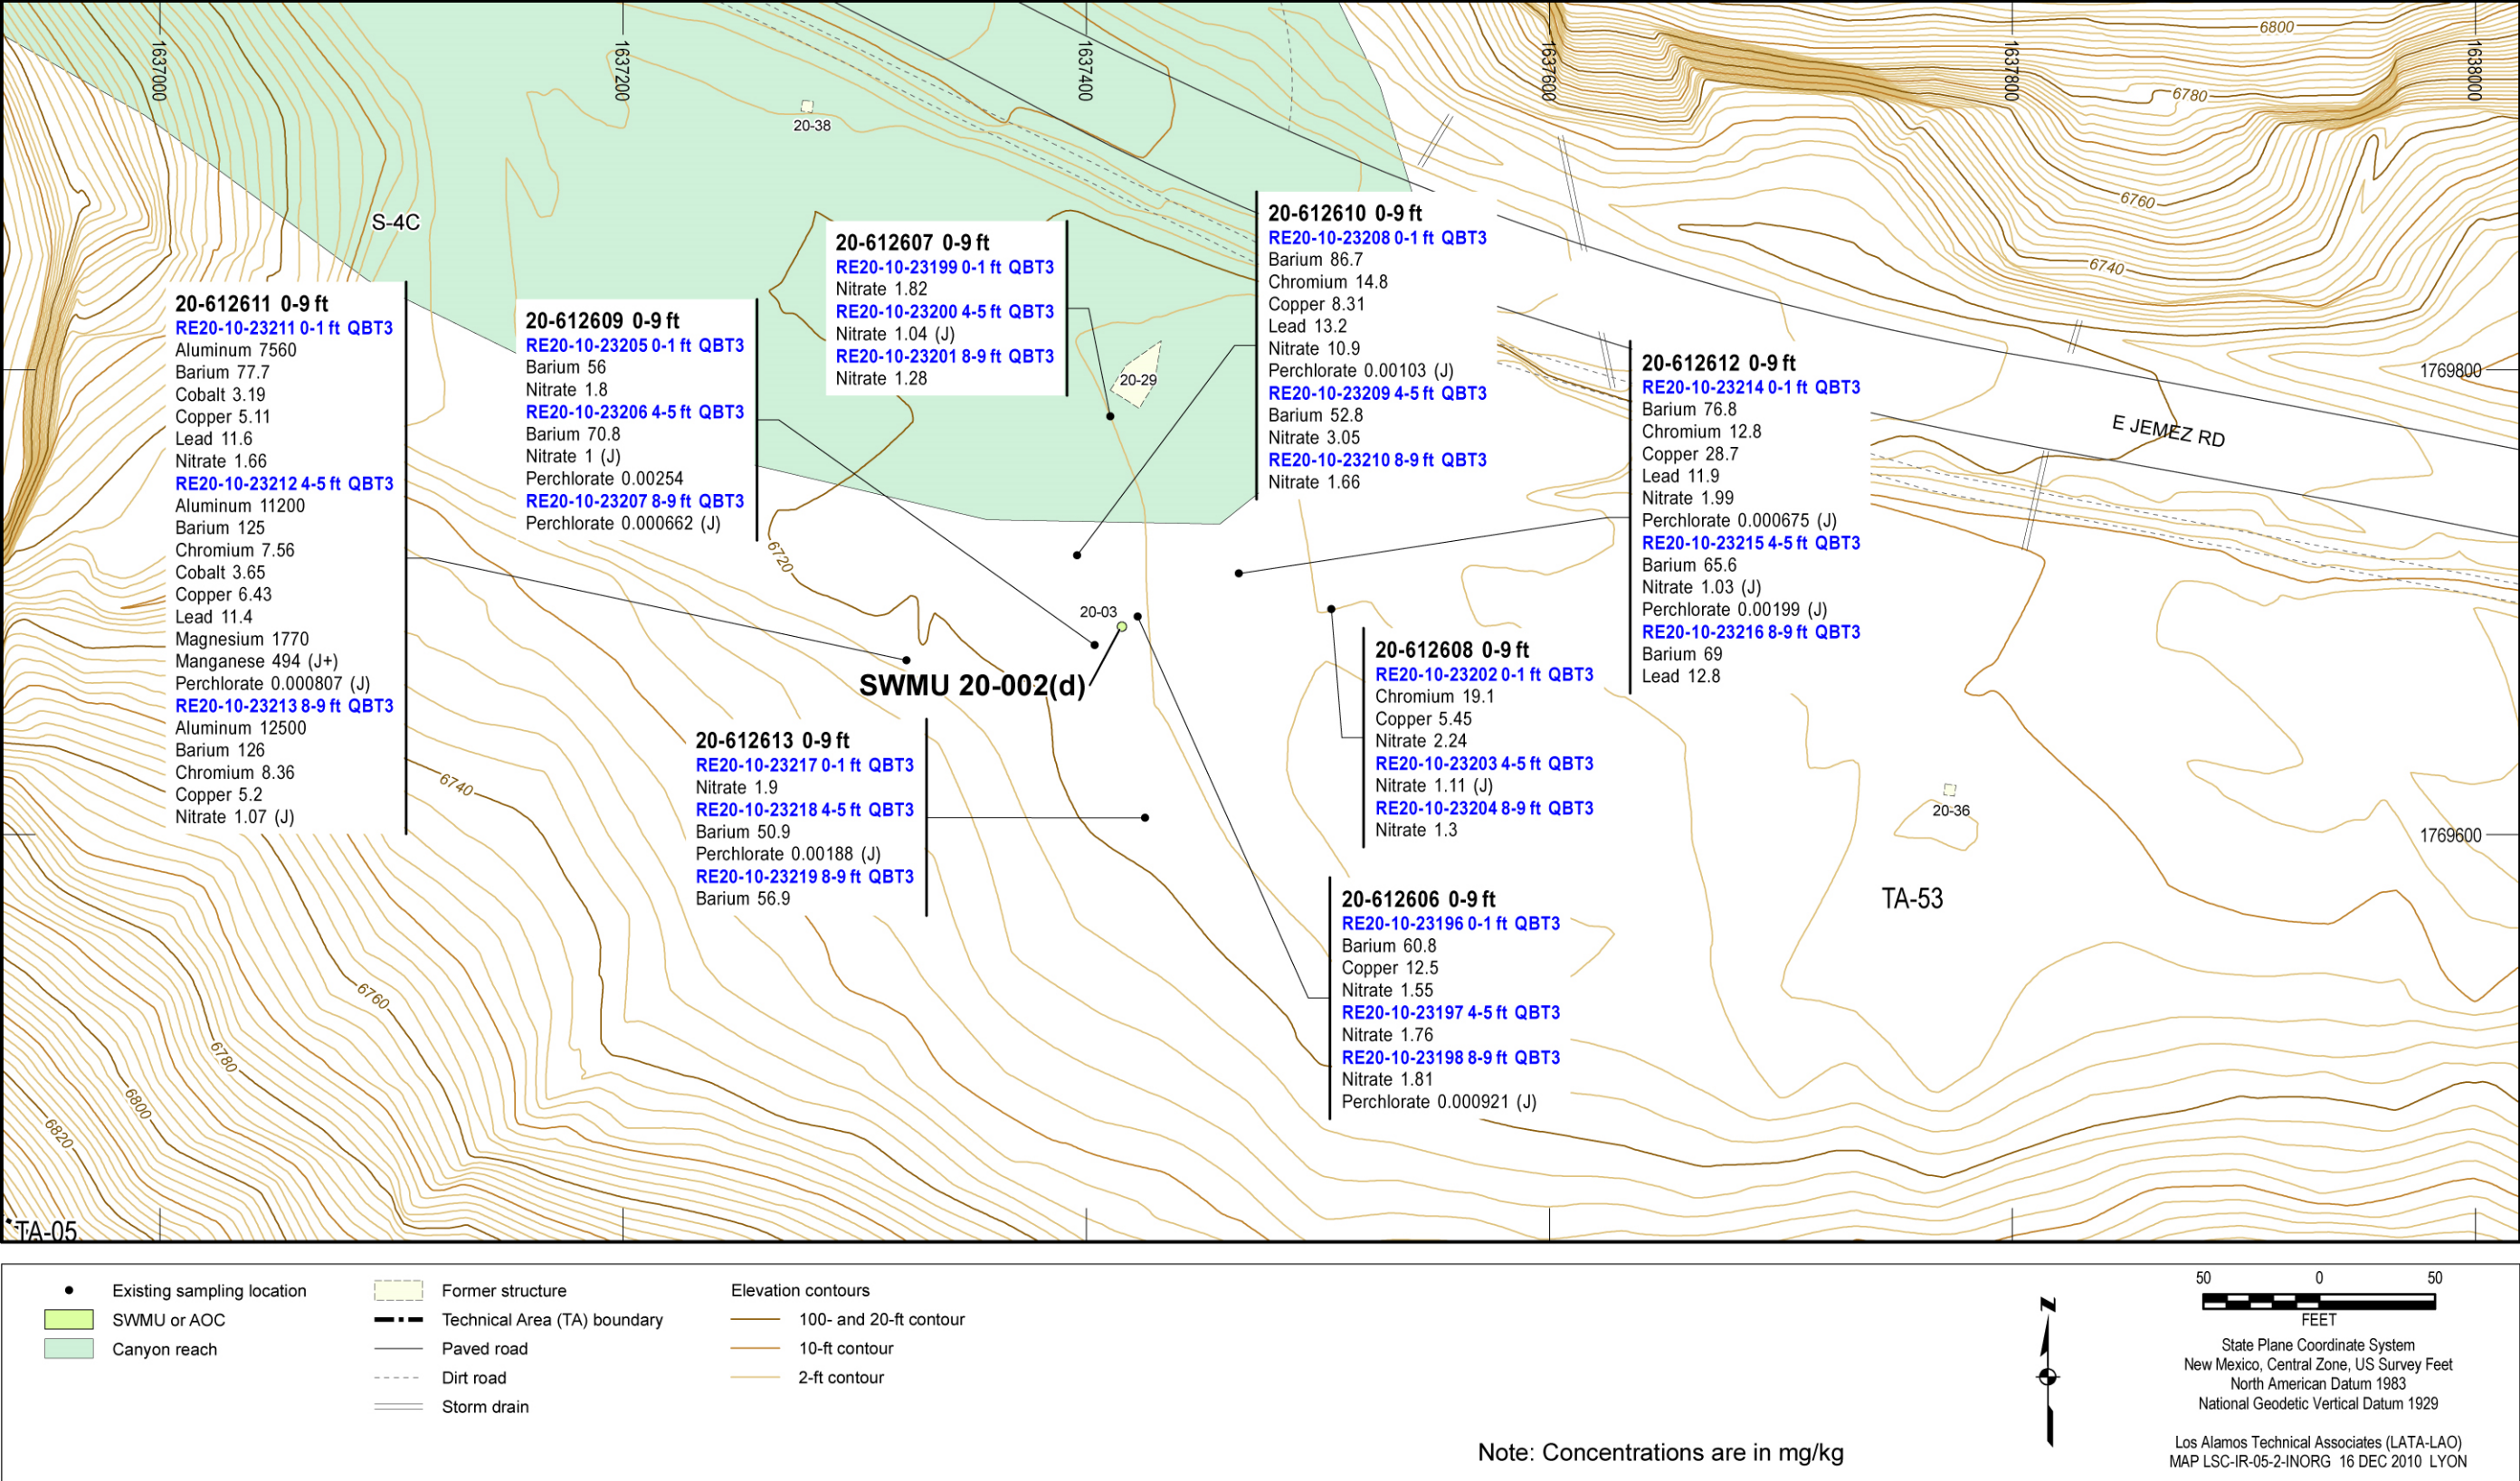
Figure 31 Inorganic chemicals detected or detected above BVs at SWMU 20-002(d)
