**NPDES PERMIT NO. NM0030759  
REQUEST FOR PERMIT MODIFICATION,  
SITE MONITORING REQUIREMENTS FOR SITE 72-001 (S-SMA-6)**

## **1.0 INTRODUCTION**

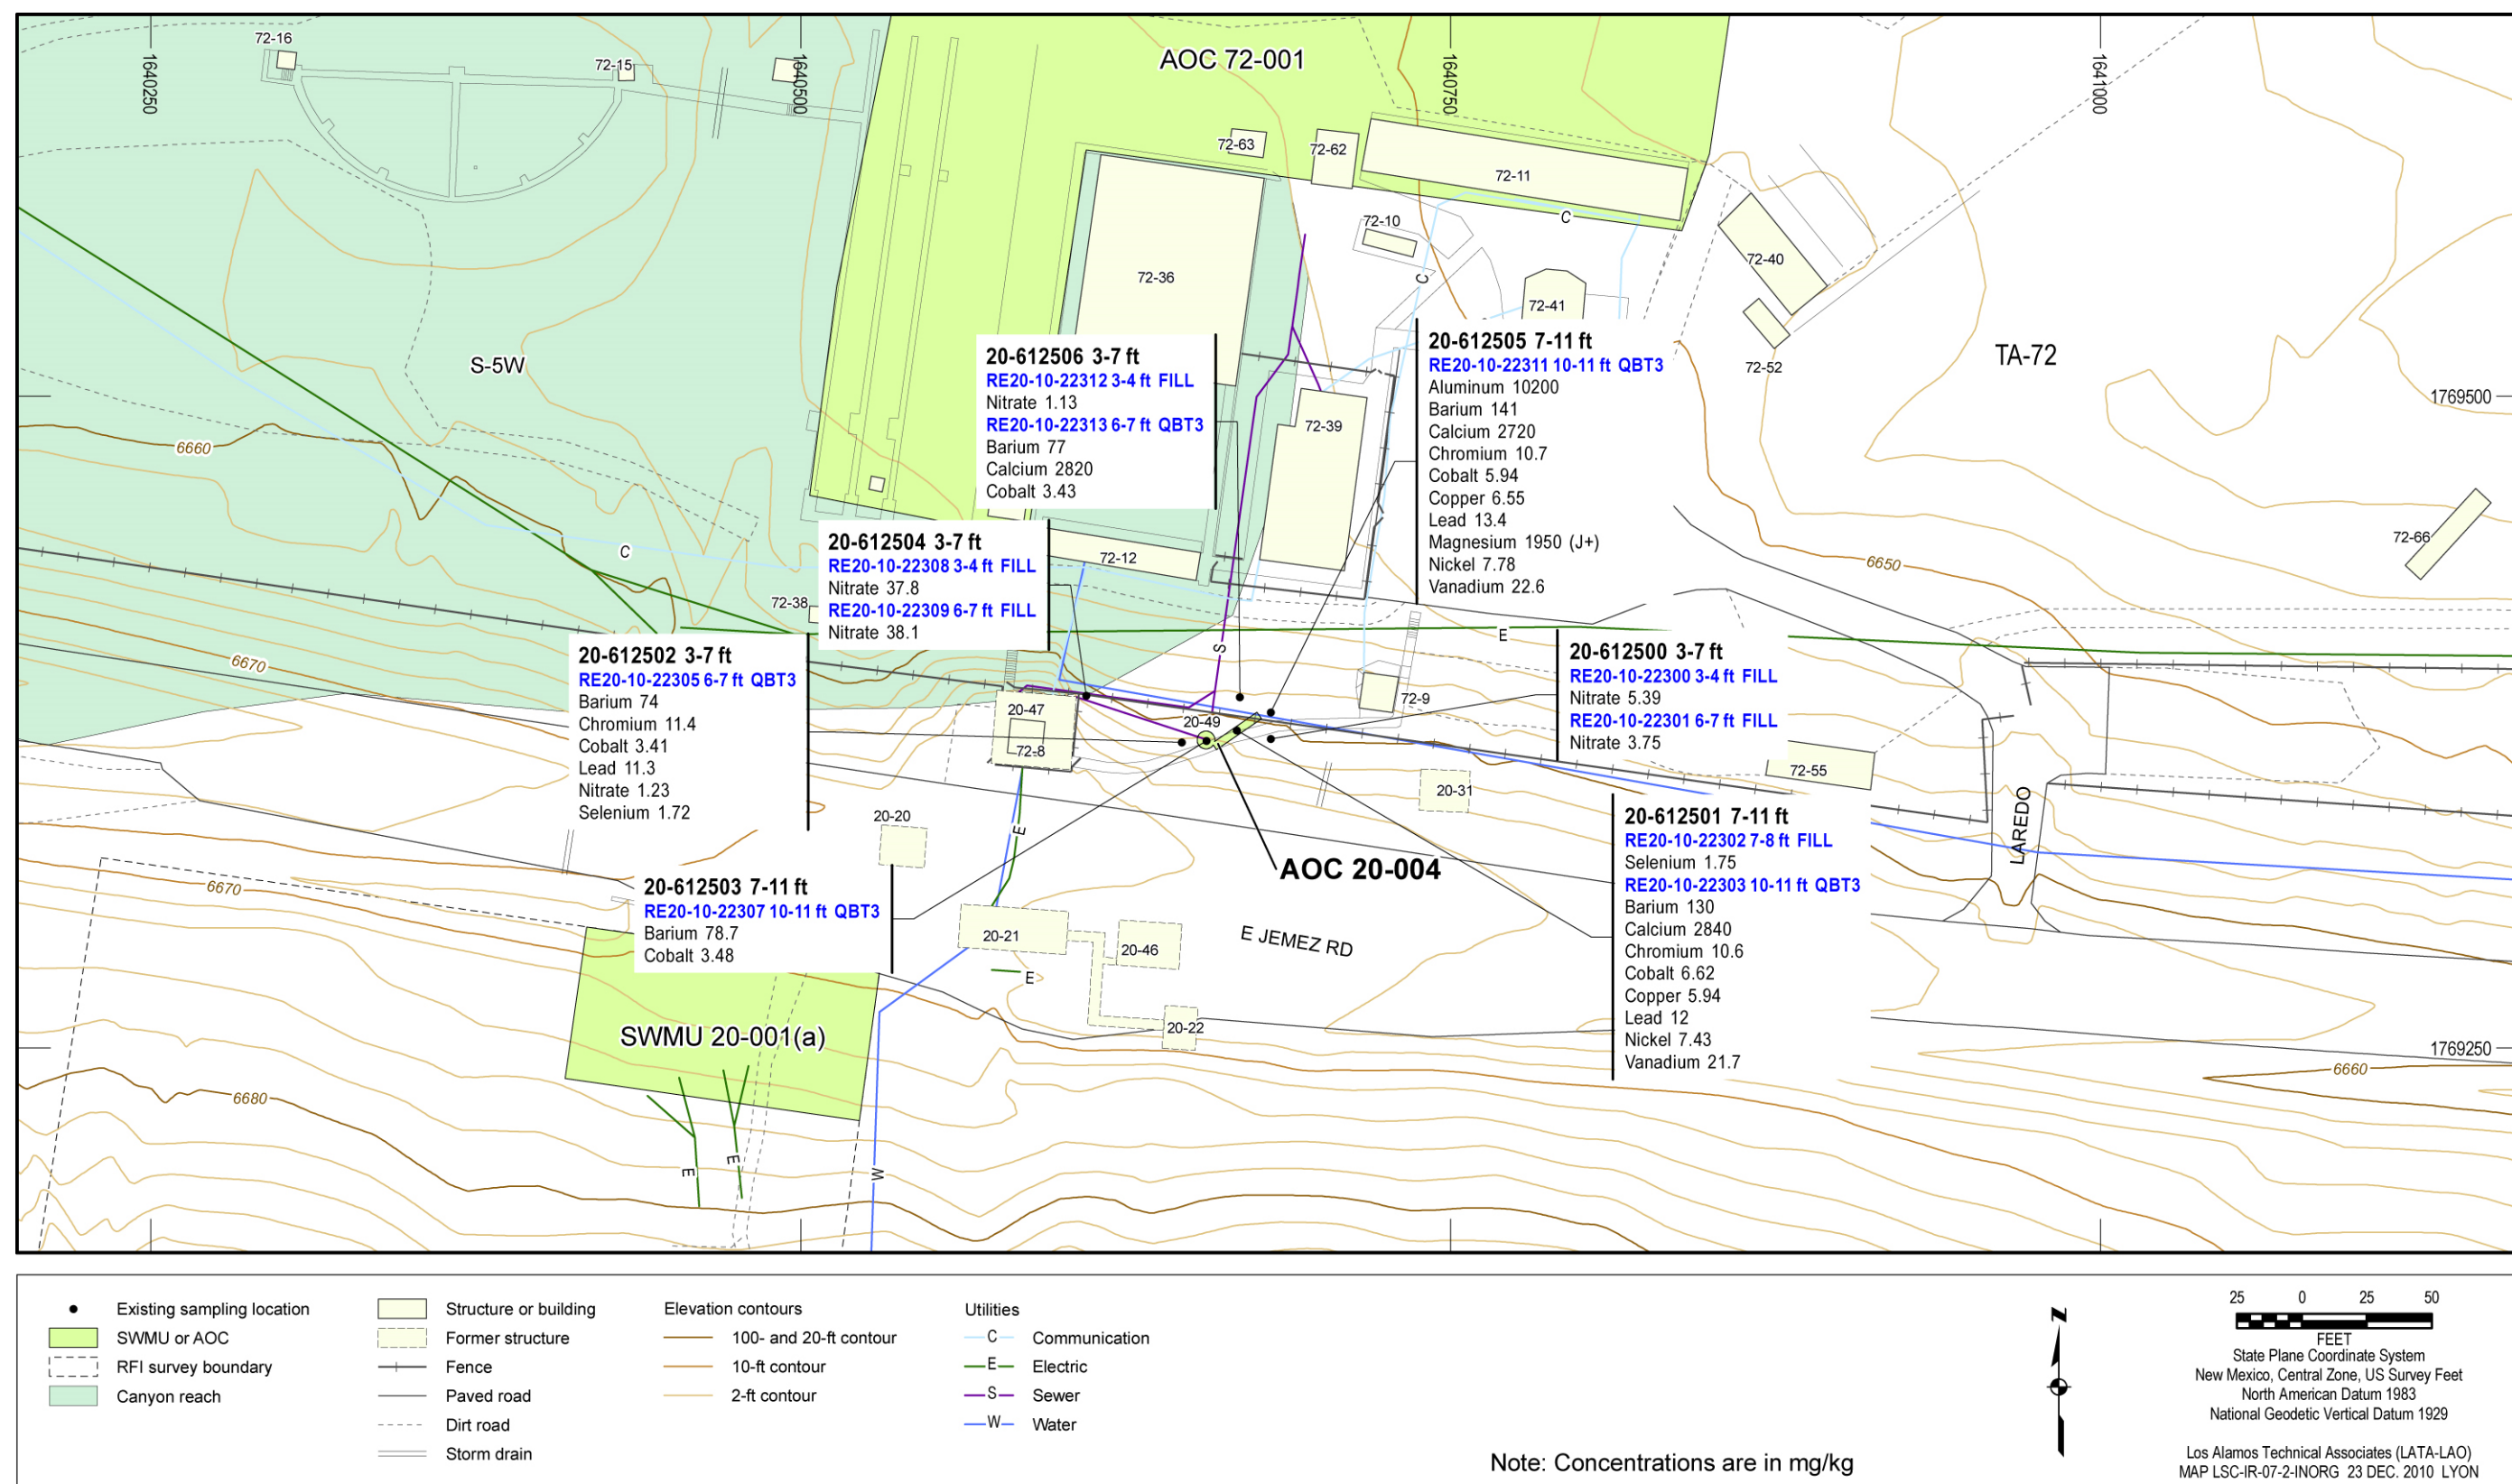
**Figure 32** Inorganic chemicals detected or detected above BVs at AOC 20-004

There are no known or suspected sources of industrial materials containing aluminum exposed to storm water at former TA-20. Aluminum was detected slightly above the maximum tuff BV in four samples at 3 of the 11 sites sampled at former TA-20 in 2010 under the Consent Order (Figures 29 through 32 and Tables 62 through 65).

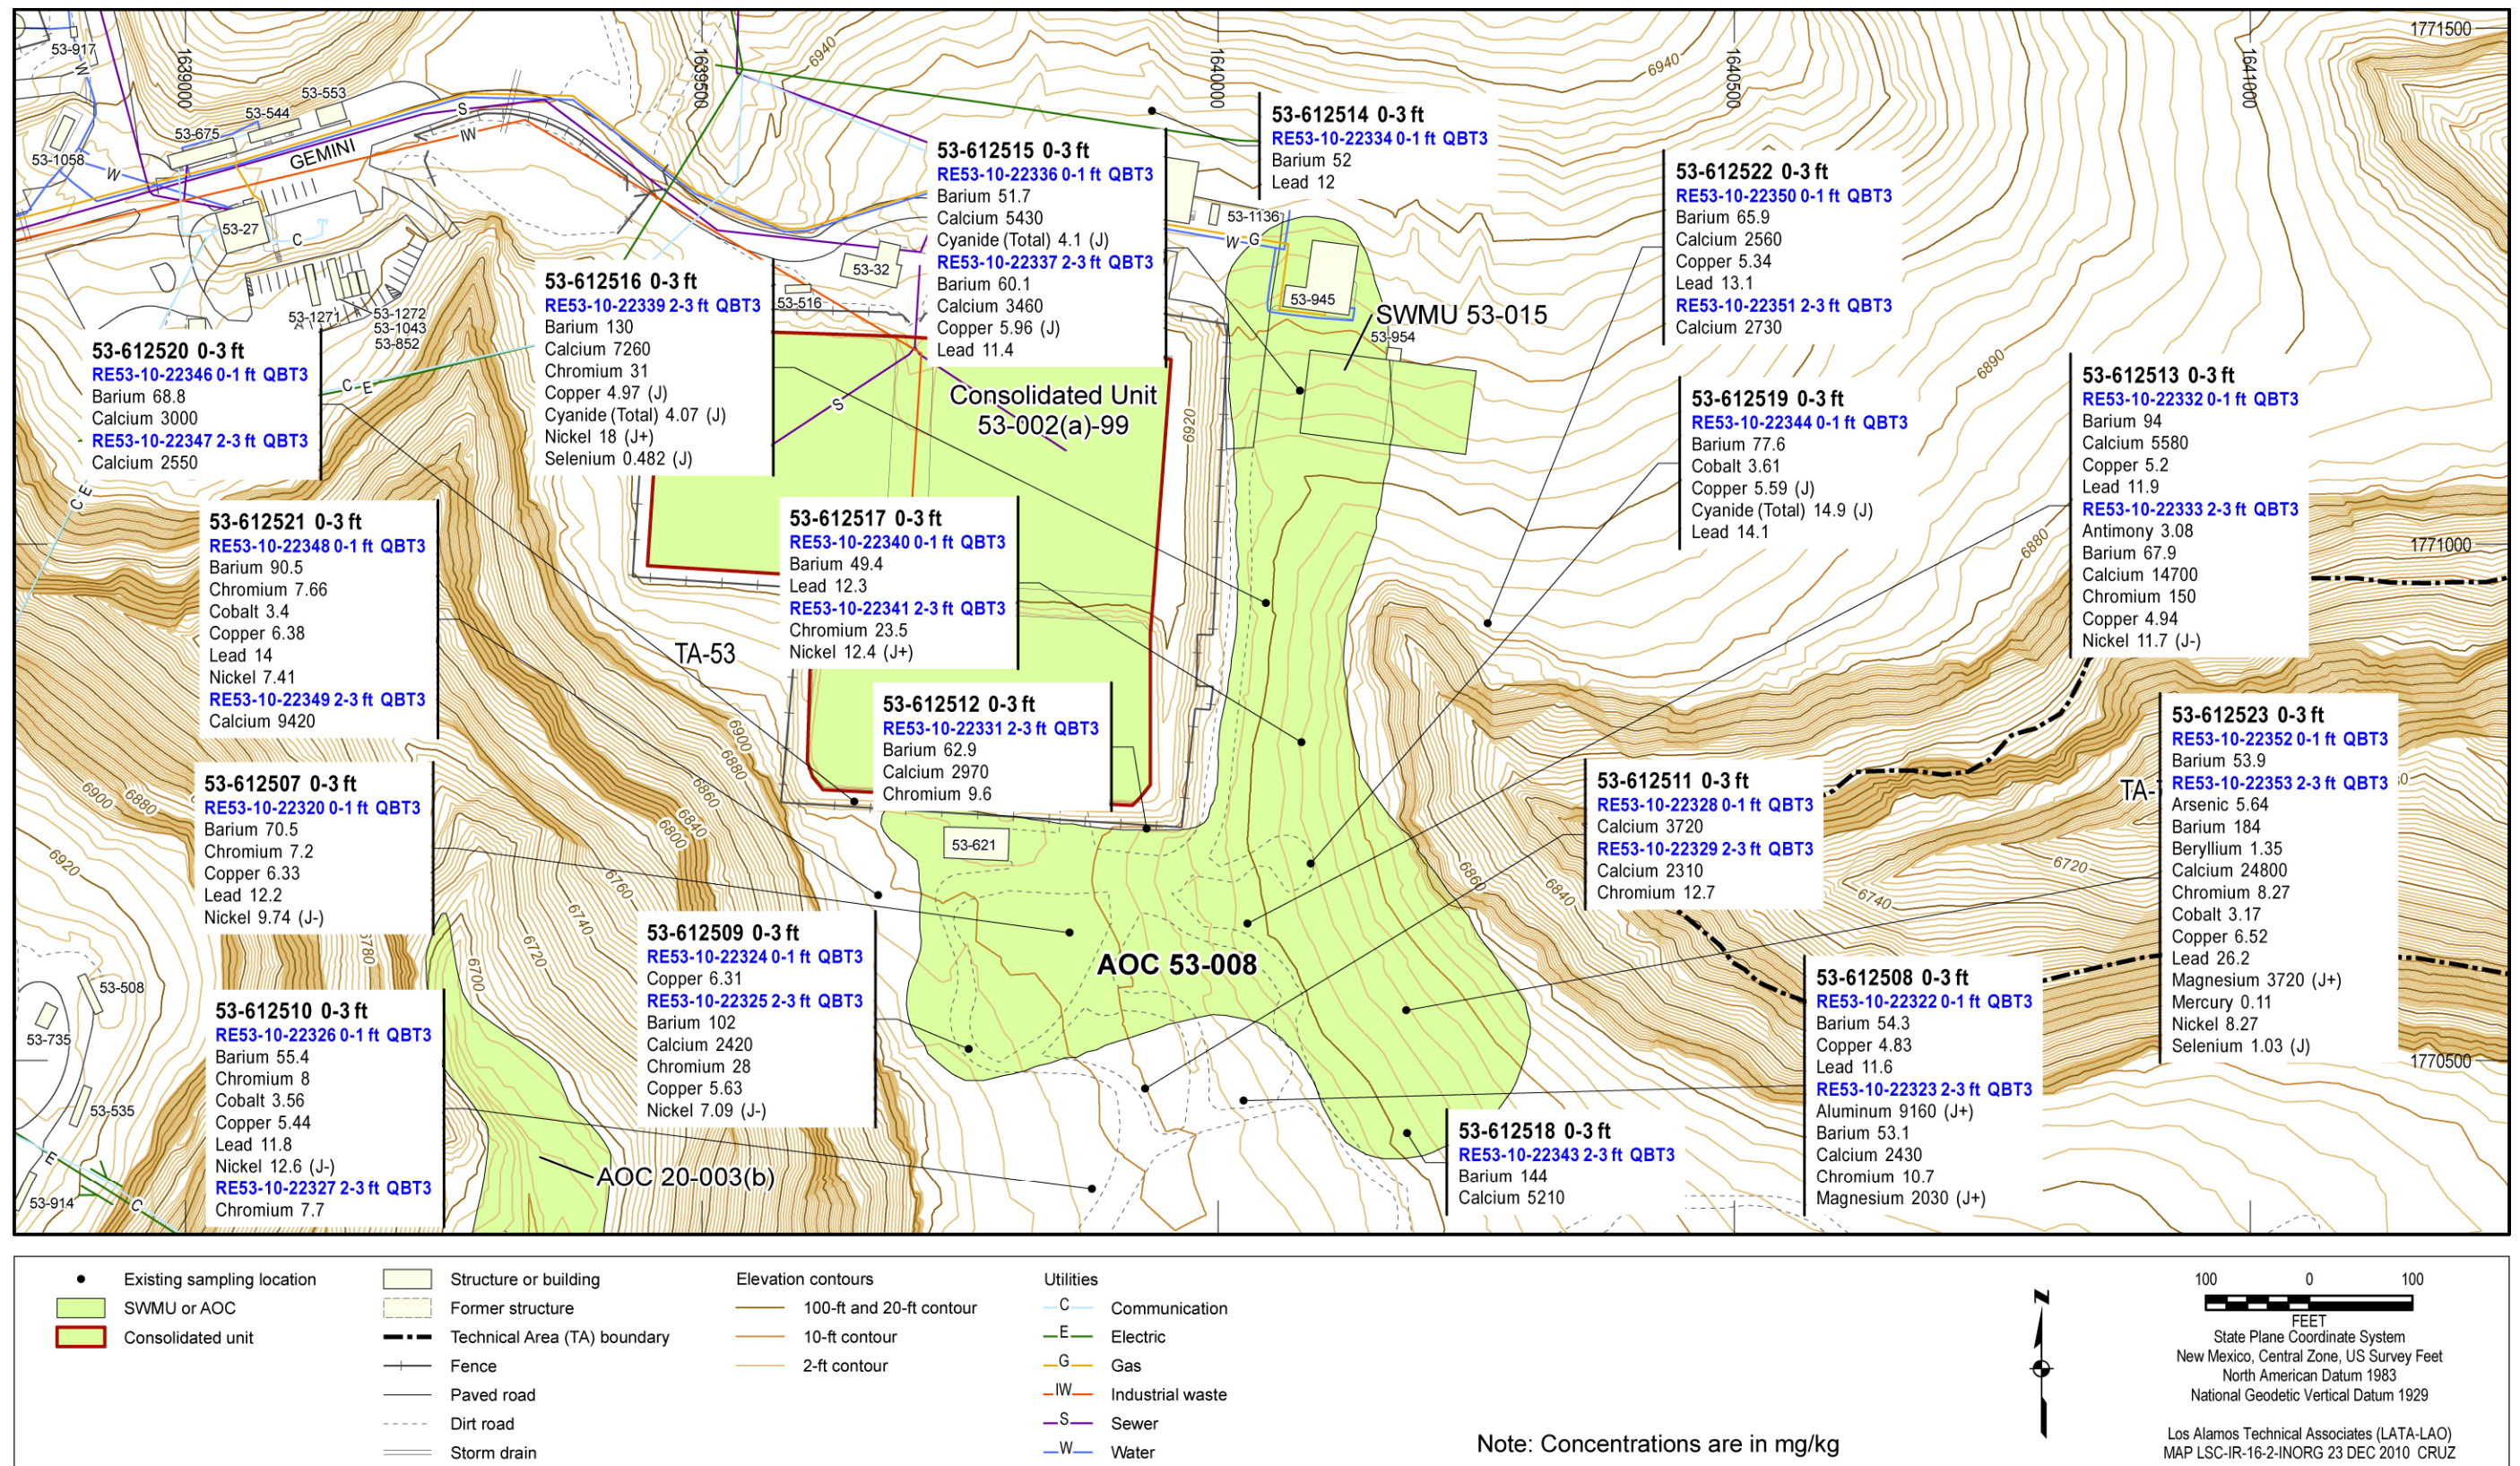
**Figure 33 Inorganic chemicals detected or detected above BVs at AOC 53-008**

There are no known or suspected sources of cyanide at TA-53. Of the nine sites sampled at TA-53 in 2010 under the Consent Order, cyanide was detected above the maximum tuff BV in three samples at one site and above the soil BV in one sample from another site (Figures 33 and 34 and Tables 74 and 75).

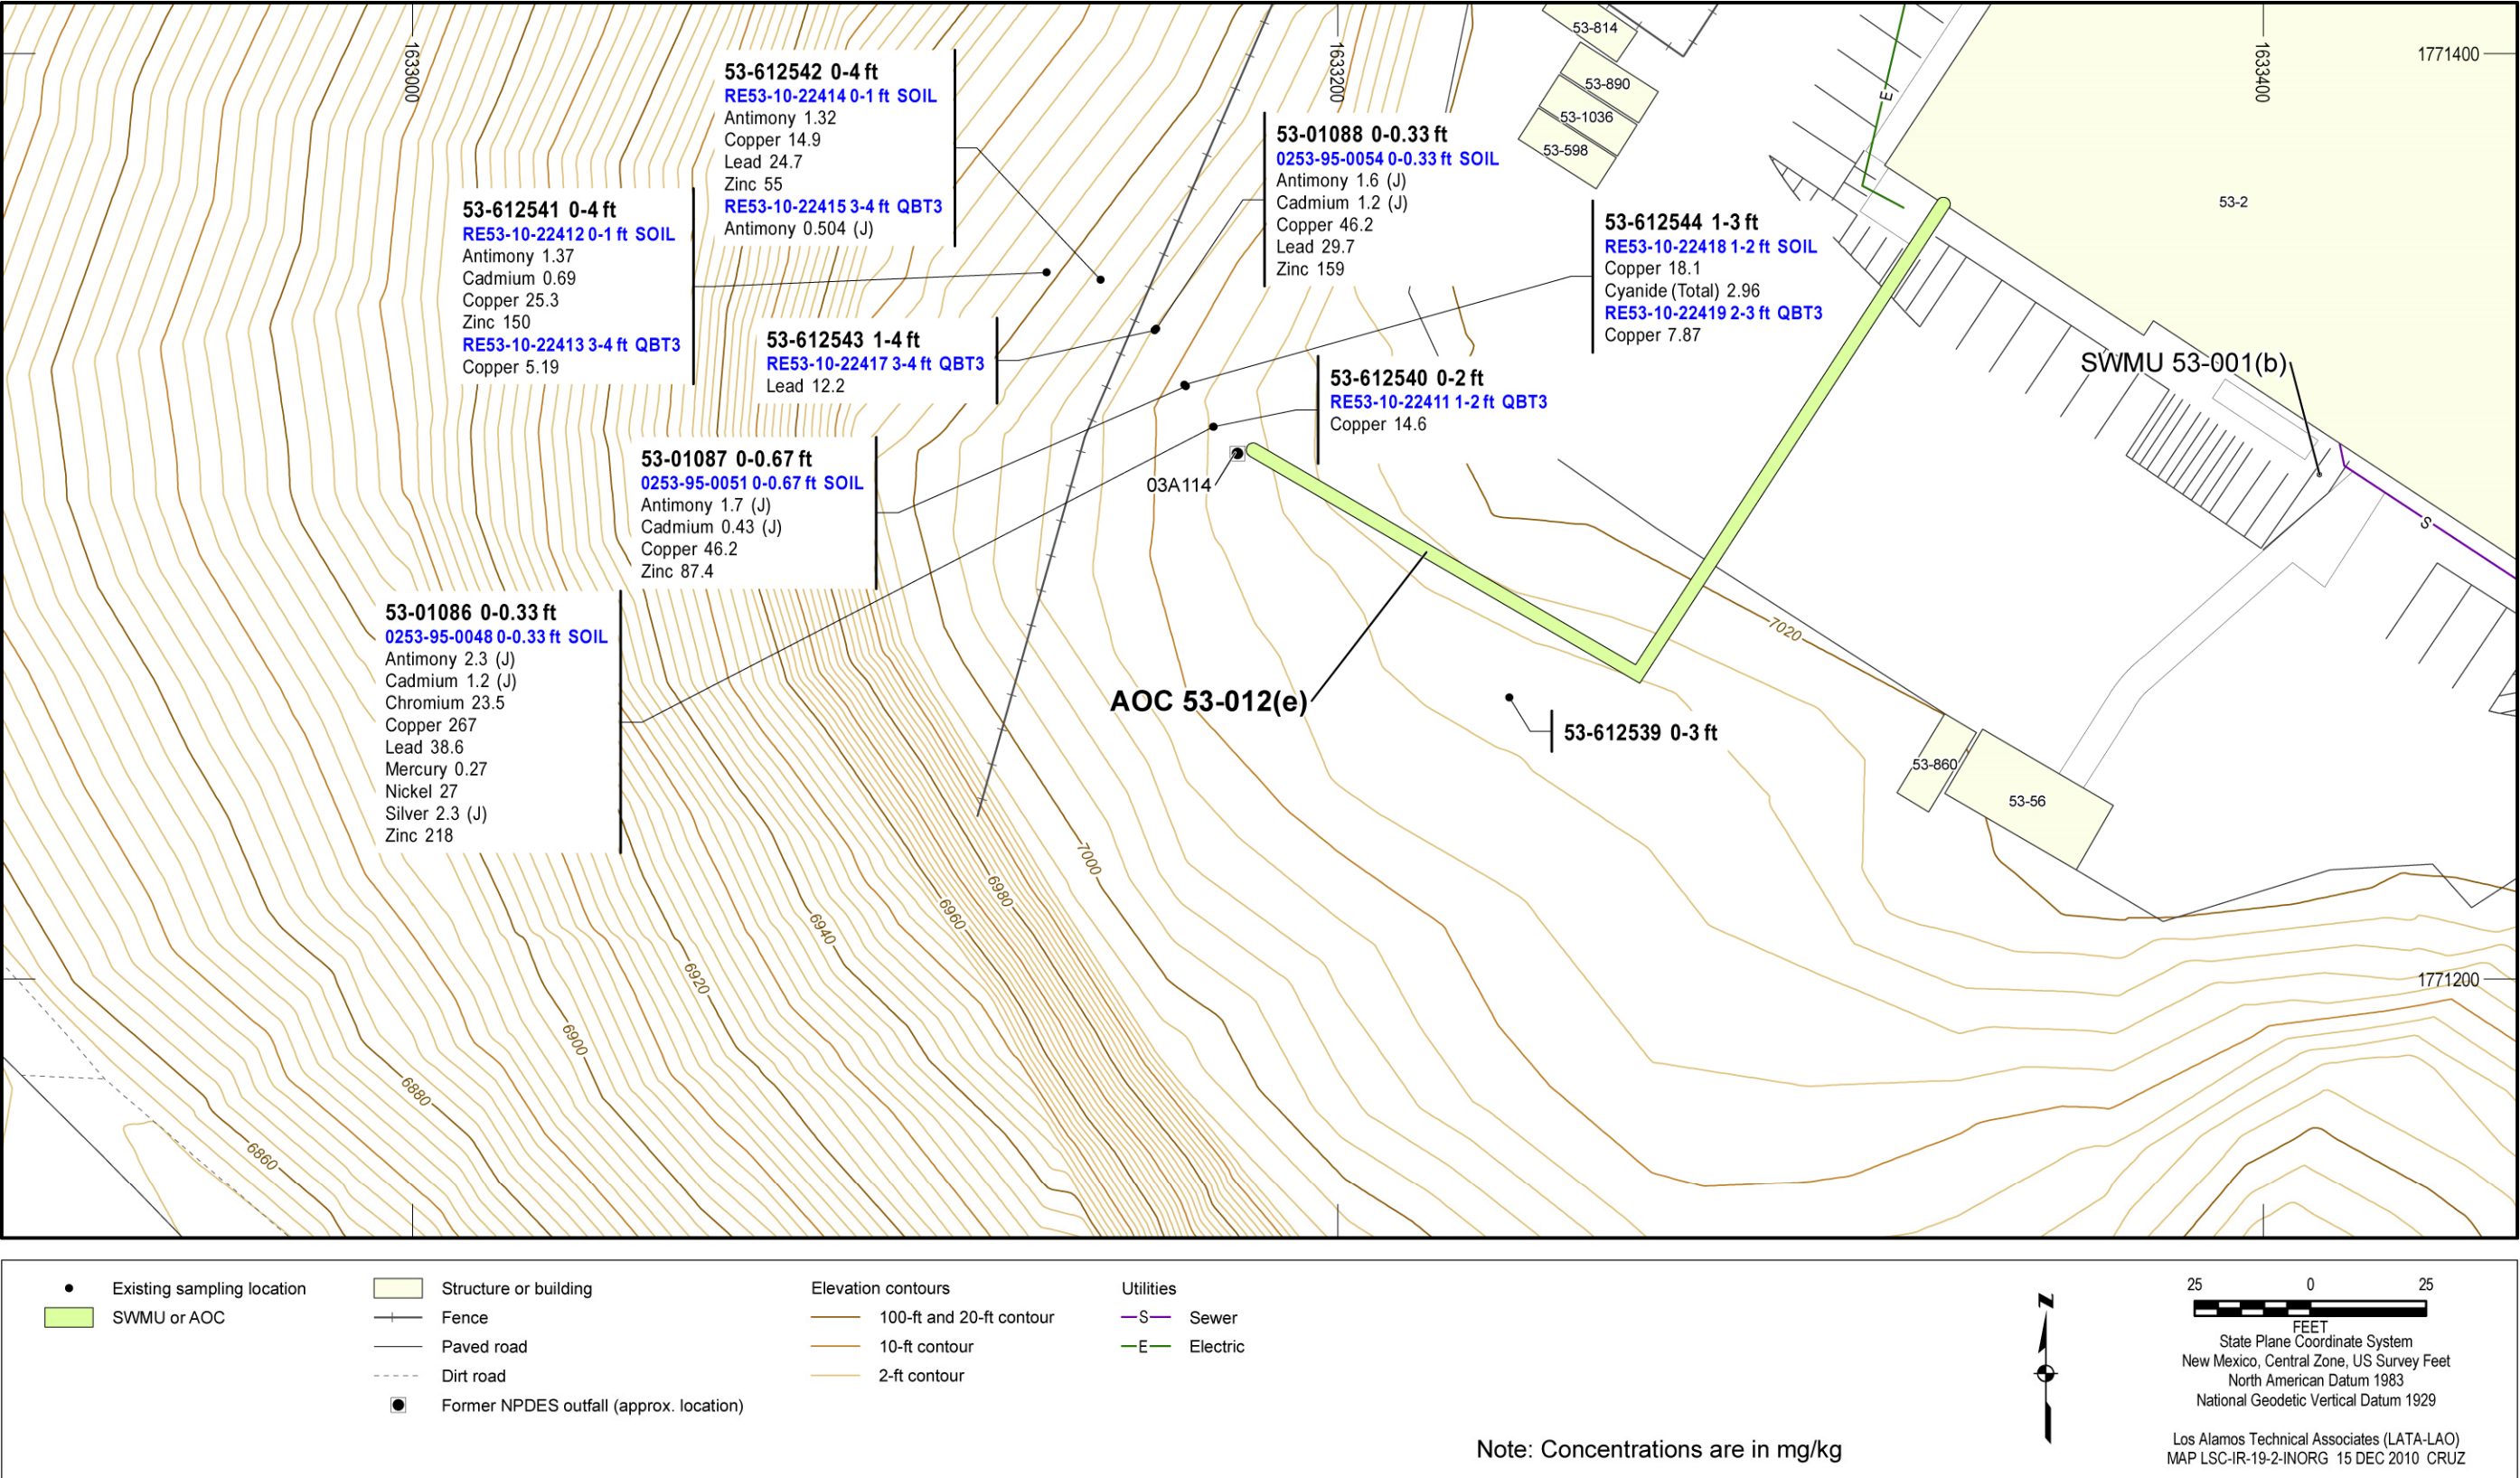
Figure 34 Inorganic chemicals detected or detected above BVs at AOC 53-012(e)
