MSGP Stormwater Pollution Prevention Plan

TA-03-38 Carpentry and Metal Fabrication Shops

Triad National Security, LLC (Triad)
Los Alamos National Laboratory

January 2019

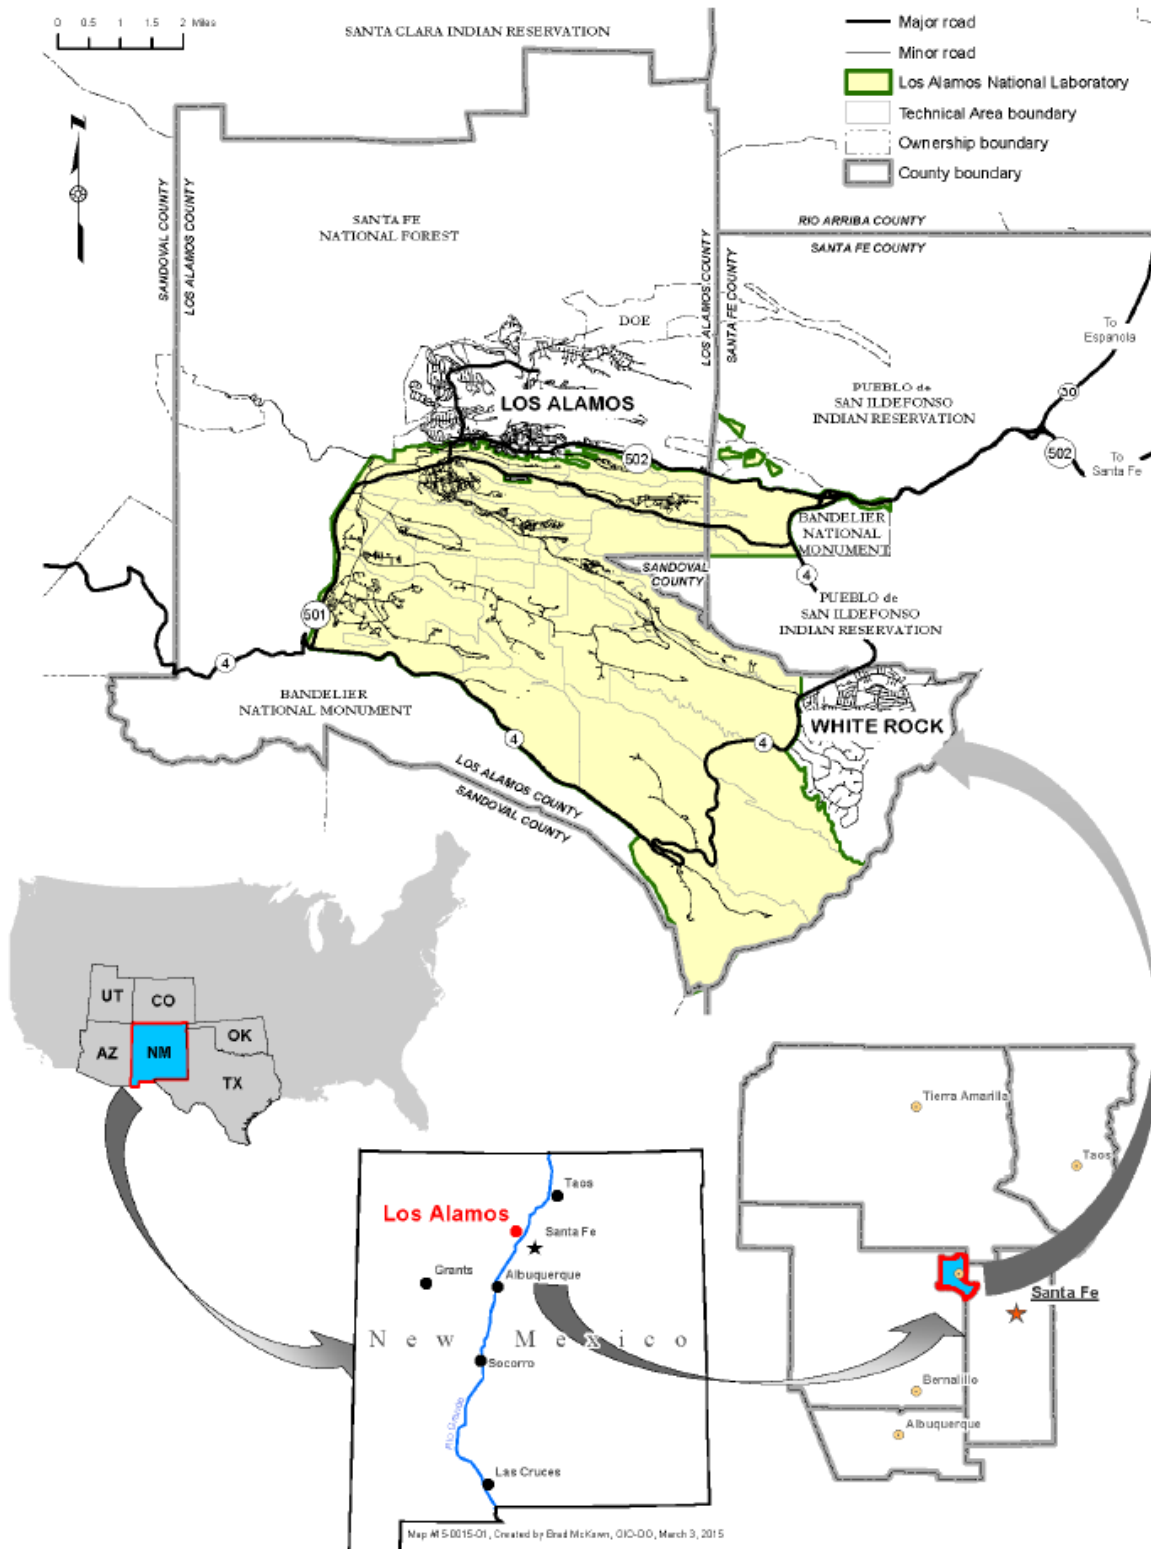
Figure A - General Location Map

The general location map for the facility can be found as Figure A and provides locations of all receiving waters associated with stormwater discharges from the facility. 100% of the site flows to Sandia Canyon. The canyon at this location is a perennial stream and eventually flows into the Rio Grande approximately 10 miles southeast of the site.

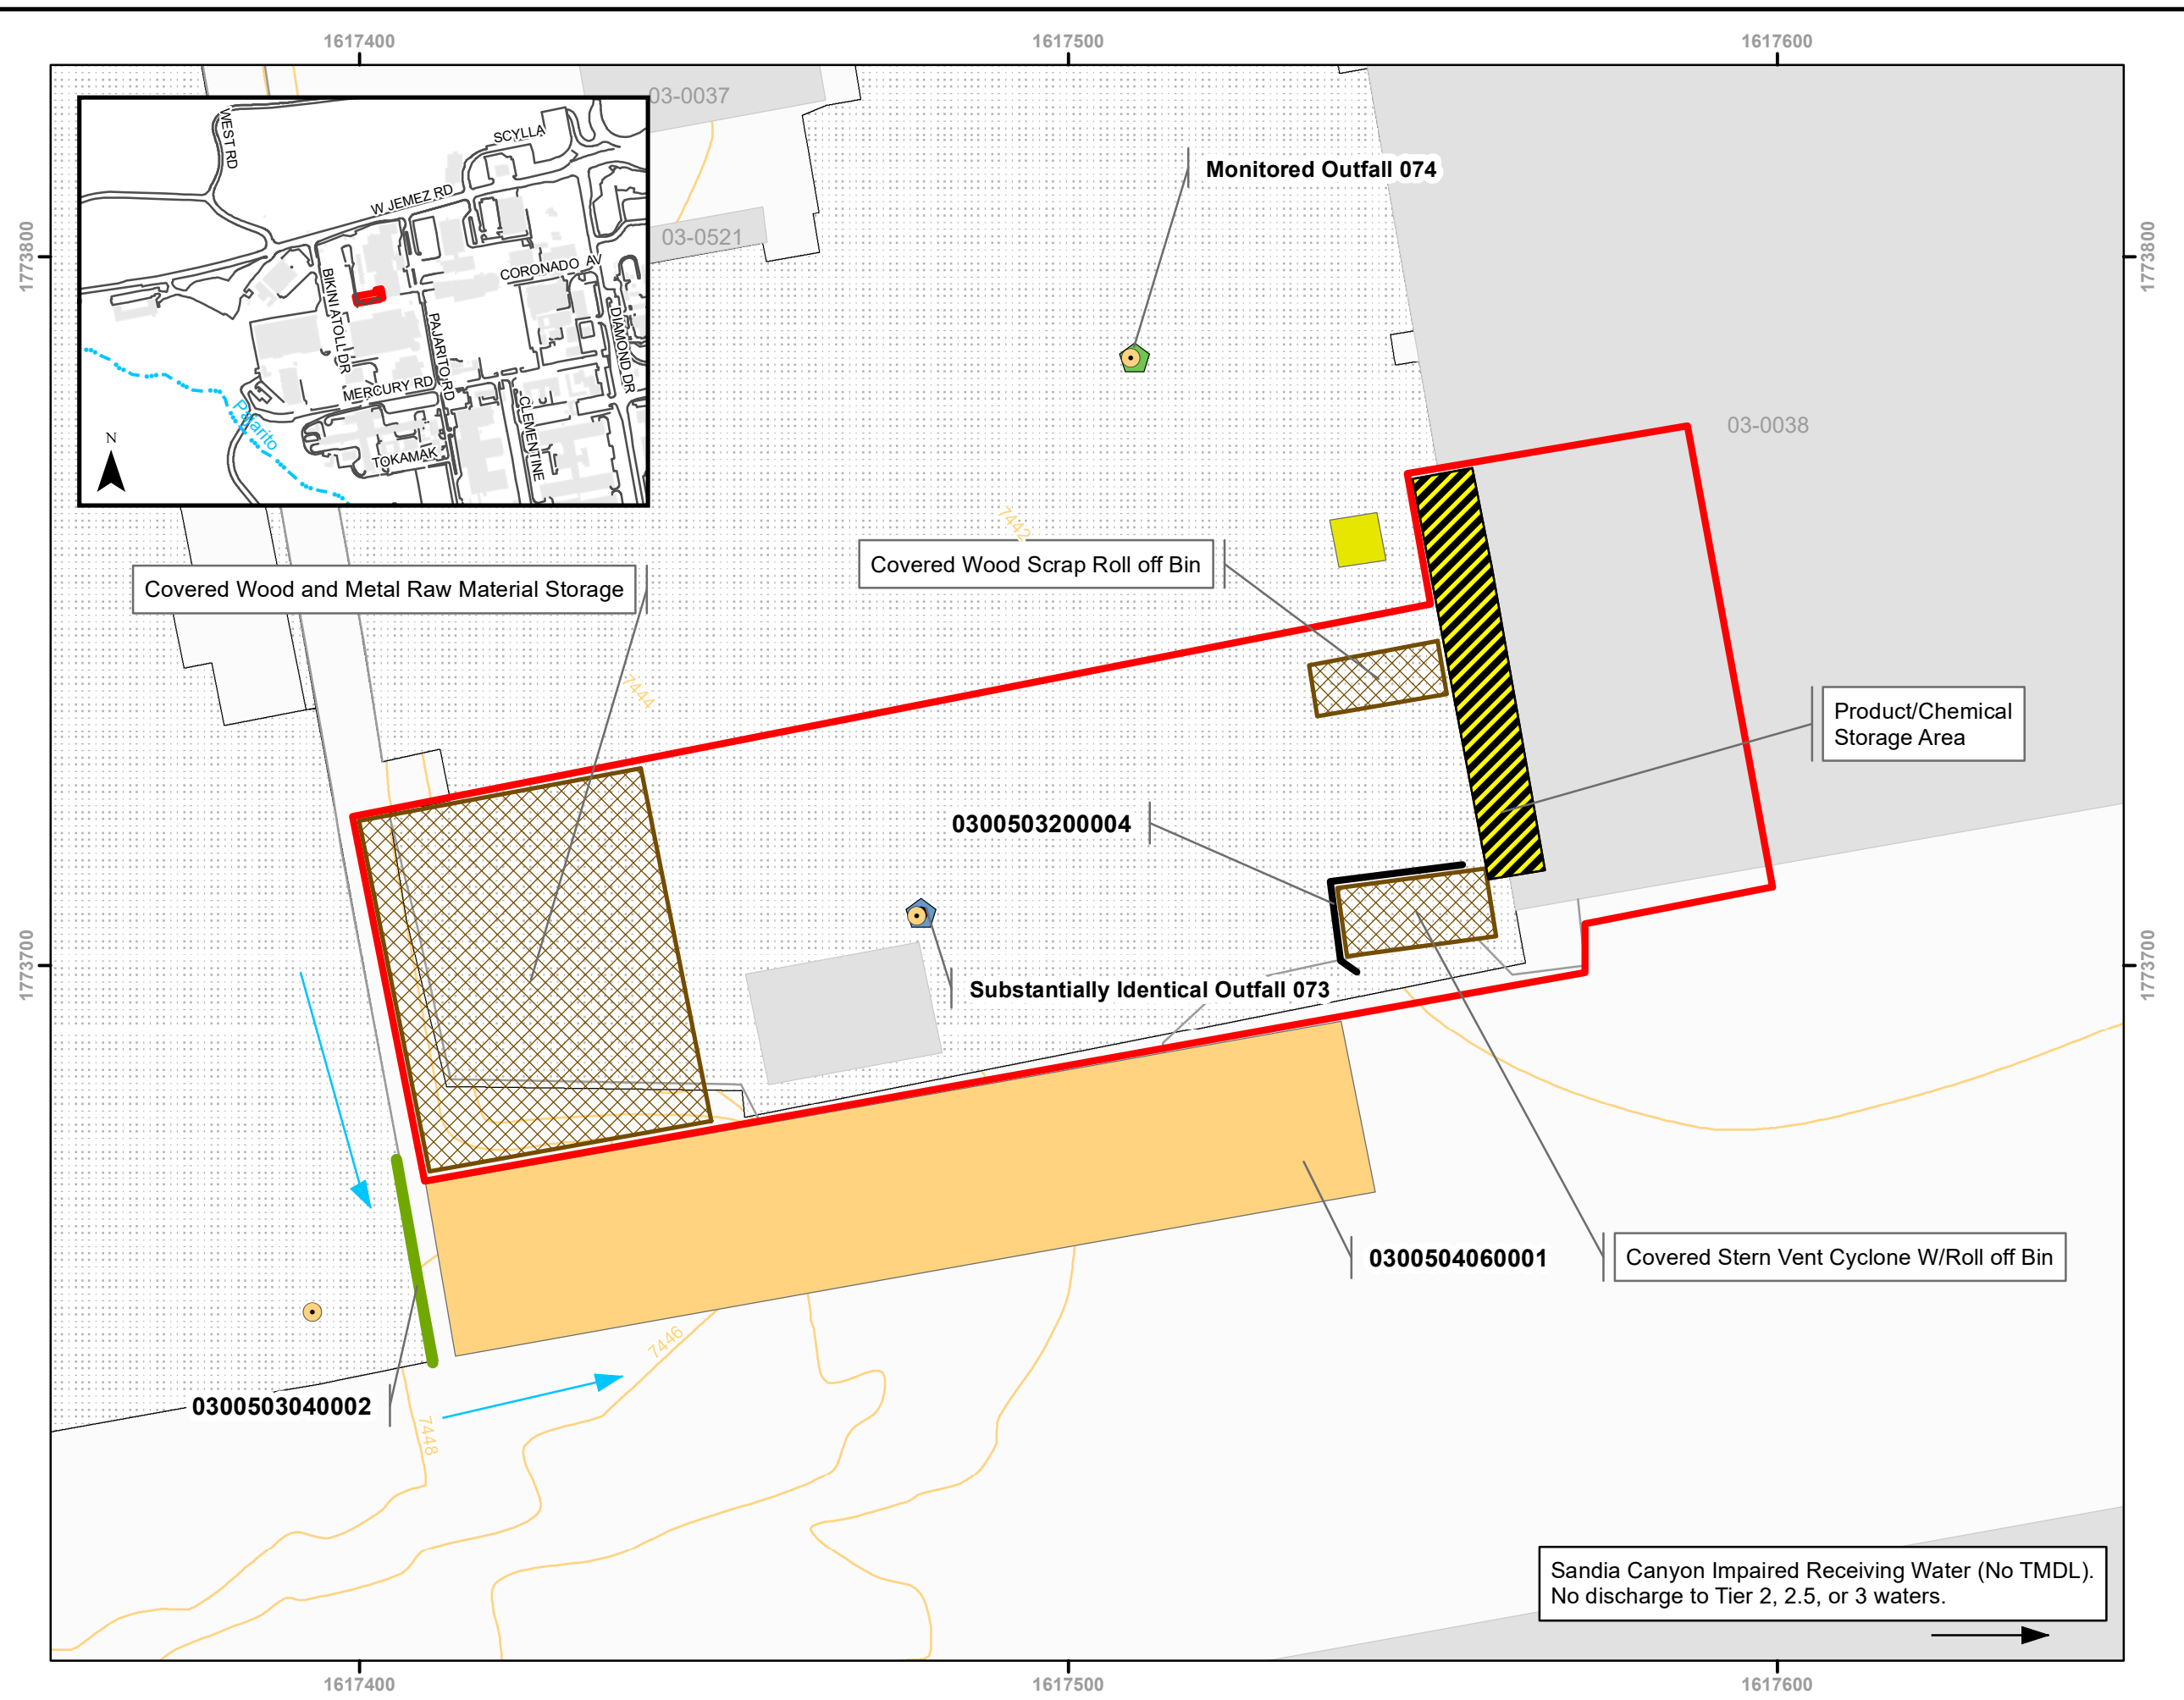
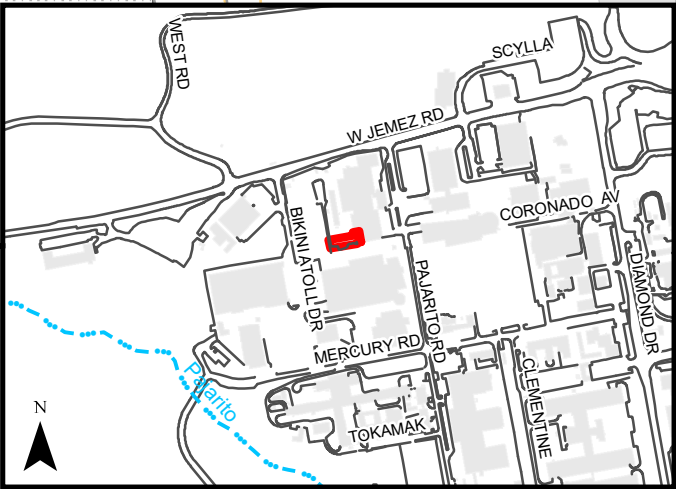
TA-3-38 CARPENTER
SHOP SITE MAP
Figure B-1A

0.25 Acres, 100% Impervious Surface.
Note - No Critical Habitat Areas.

- **Locations of all Stormwater Conveyances.** This includes all ditches, pipes, and swales.
- **Locations of Potential Pollutant Sources.**
- **Locations of Significant Spills or Leaks.**

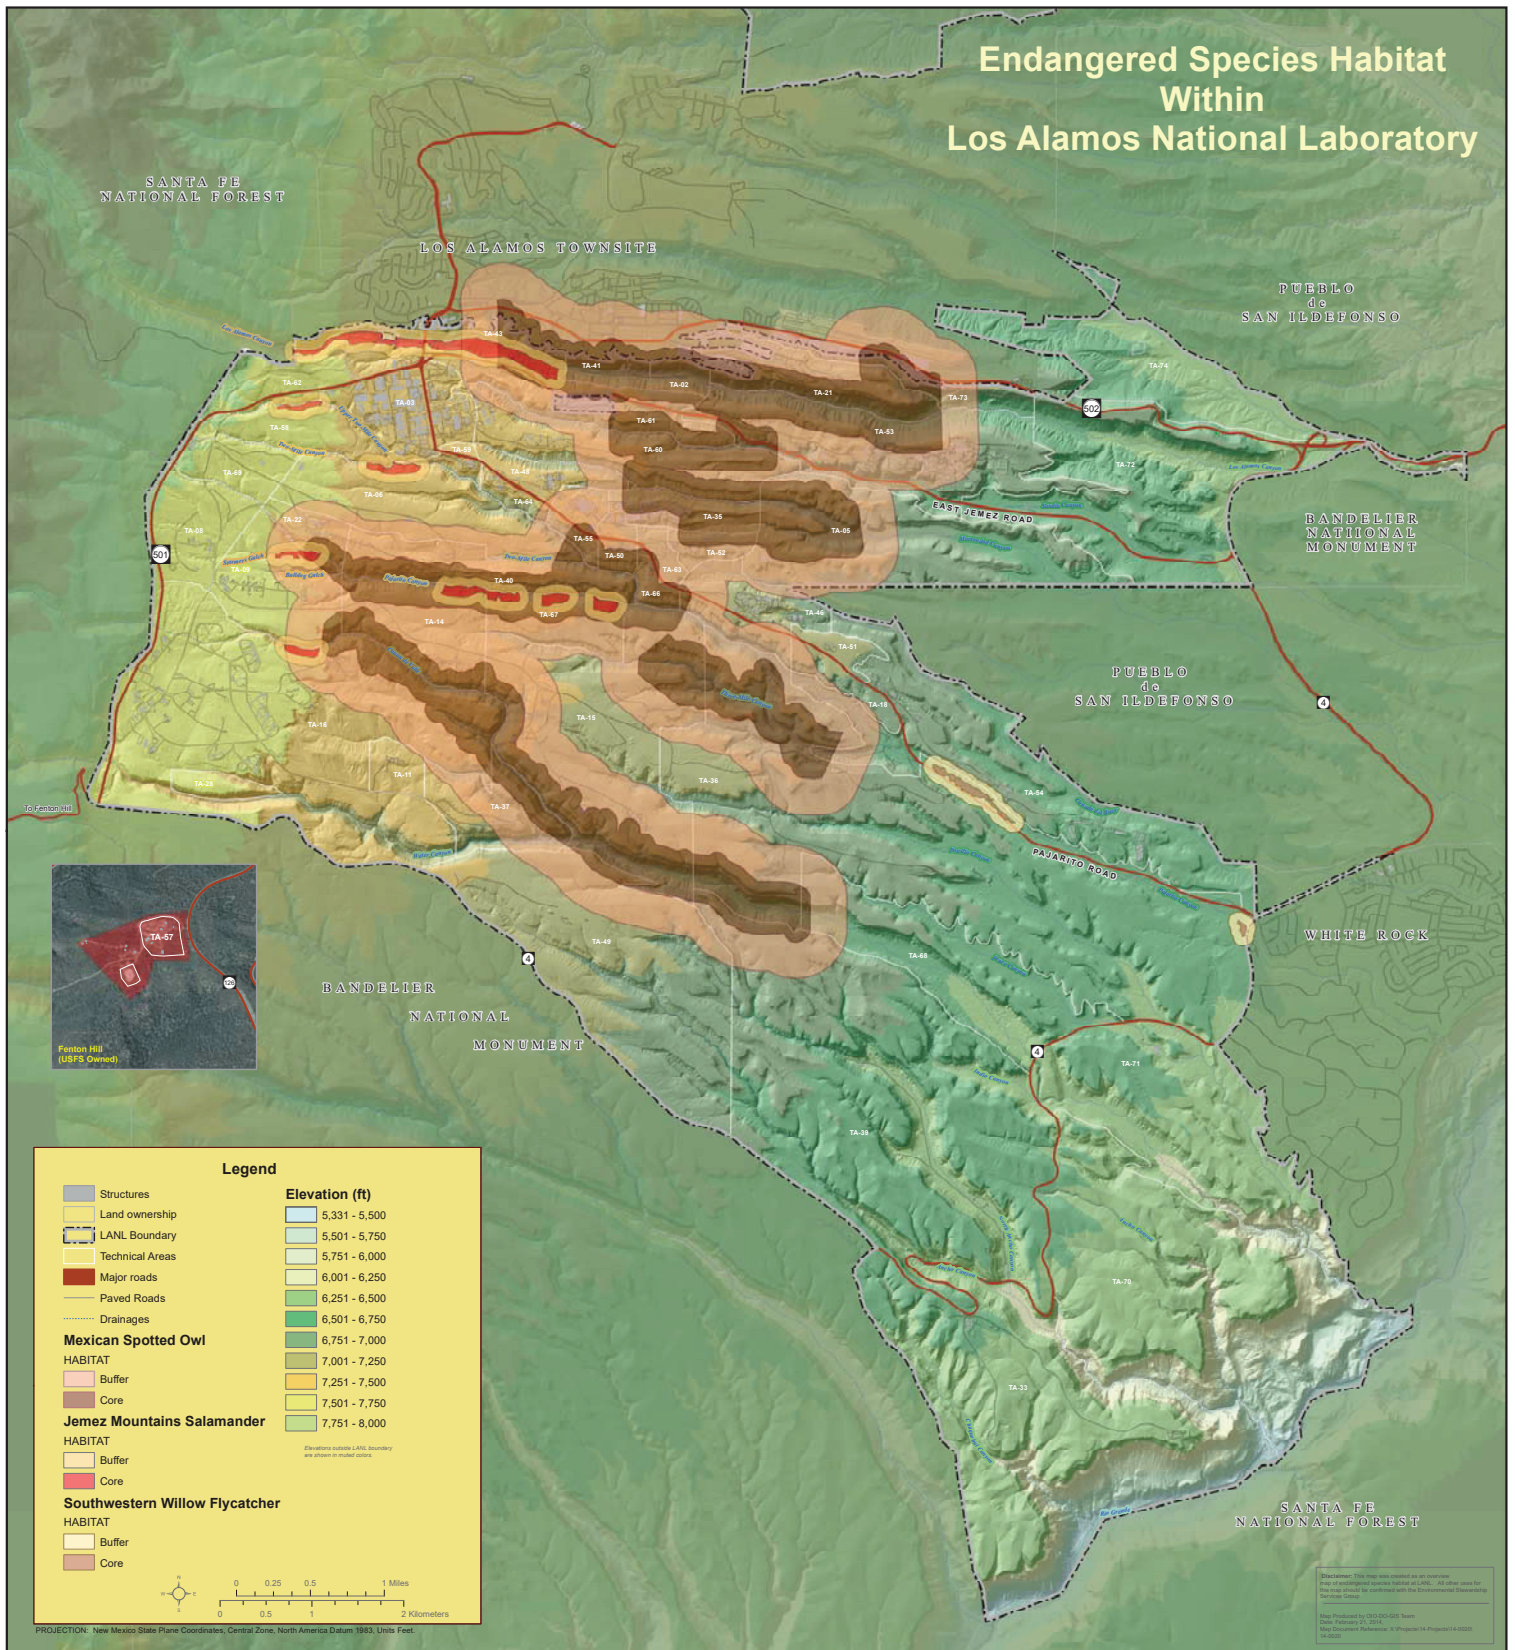
Figure B-3 Endangered Species Map

Peach Layer = Critical Habitat

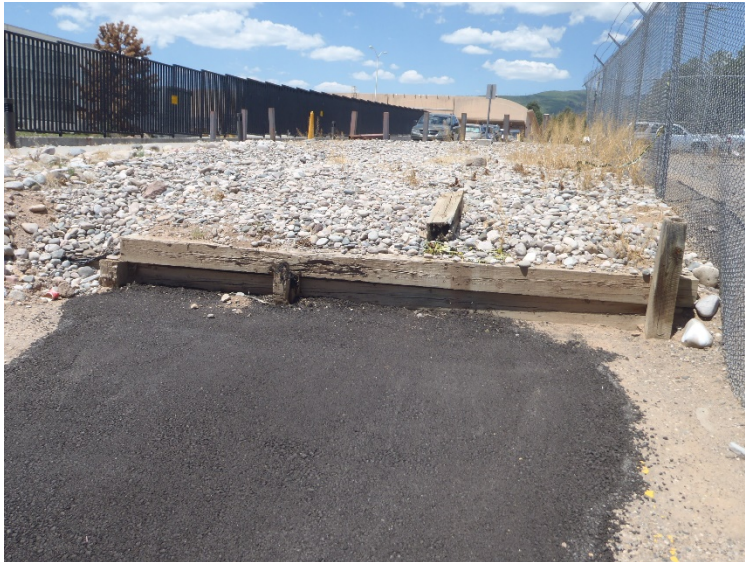
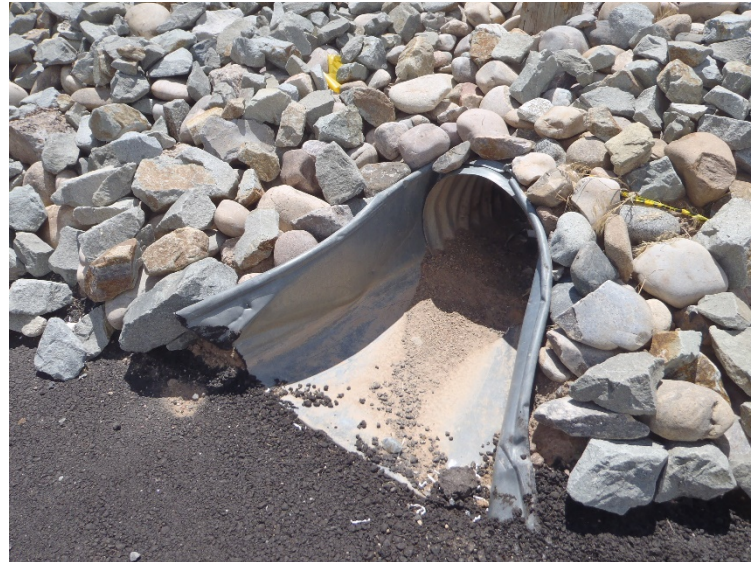
- Run-On Control: The south and west boundary of the site is stabilized with rock and paving to provide run-on control from the west parking lot.

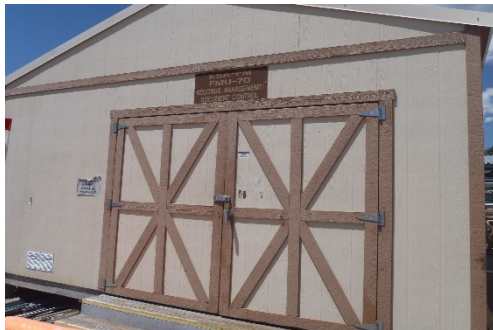
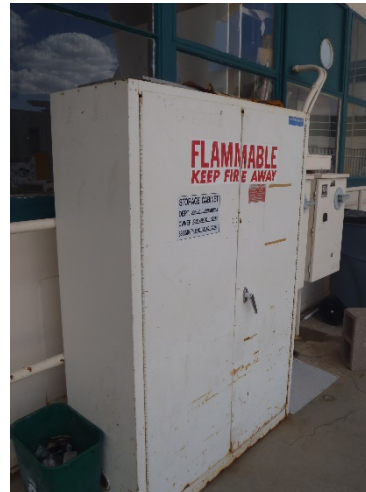
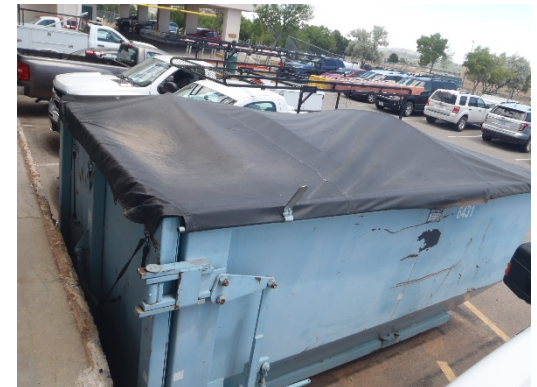
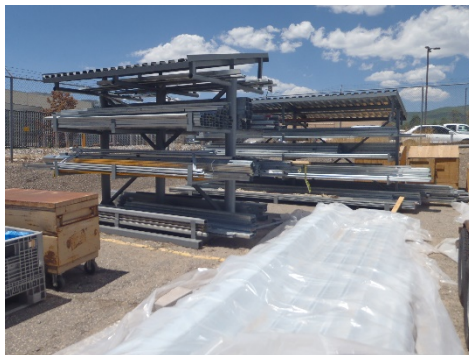
- Covered Metal/Material Storage: Covered storage racks, roll-off bins, enclosed storage sheds, and flam cabinets minimize storm water contact with materials and pollutants.

- **Material storage racks:** Potential pollutants include metal (rust) and wood materials (shavings/dust) exposed to precipitation. The racks were equipped with fabricated covers in February 2016.

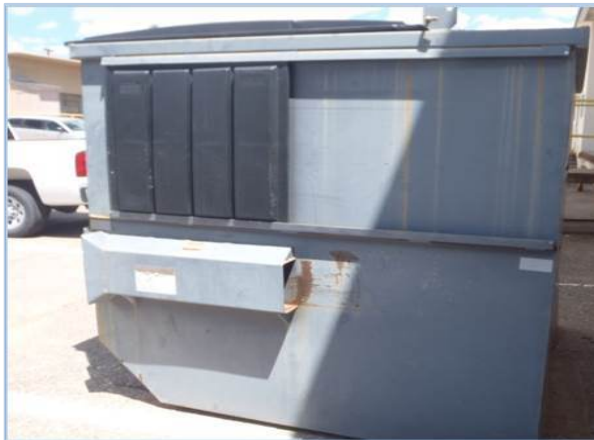
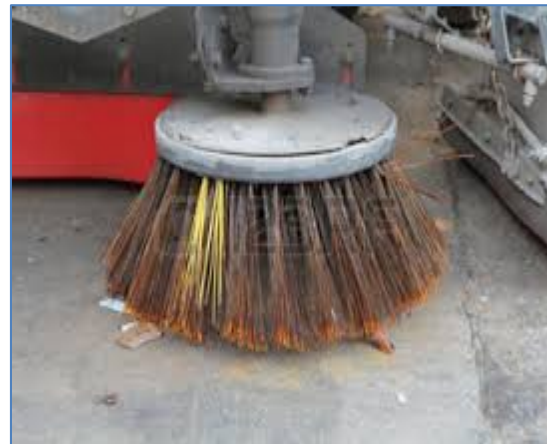
- Good House-Keeping Practices: Covered and enclosed trash bins minimize debris on site. Monthly sweeping of the west lot removes accumulated dust and reduces pollutants.
- YOU can help reduce trash as well: keep truck beds clean, properly dispose of food trash and cigarette butts, keep dumpsters closed. Recycle water bottles, cans, plastic bags, etc..

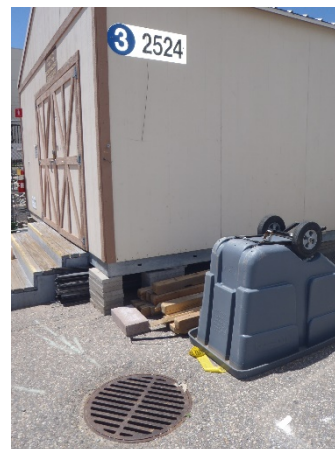
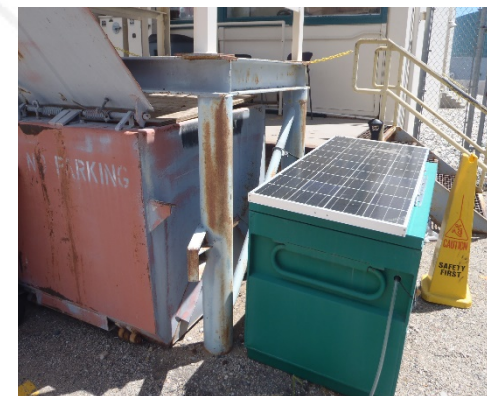
- Automated collection during storm events
- Monitoring for pollutants
 - Benchmark (sector specific limits)
 - Impaired Waters (receiving water)
 - Sandia Canyon

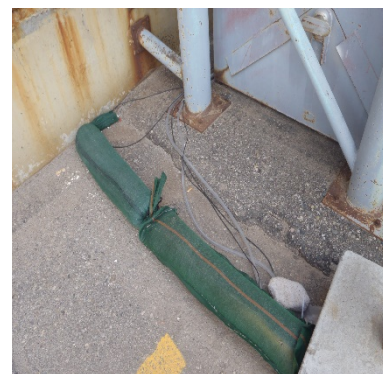
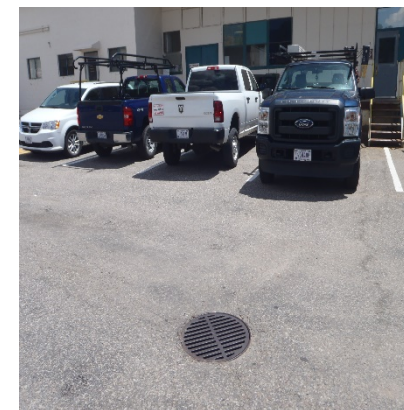
- Sample/discharge points (automated & visual)
- Evaluated during inspections
- Each numbered for site map
- 2 Outfalls on site, Outfalls 073 & 074
- 1 Monitored: Outfall 073 →

Outfall 073 has been determined to be substantially identical to Outfall 074 based on common potential pollutant sources, drainage areas, activities within the drainage areas, and general site topography and characteristics. Outfall 074 also receives a significant amount of drainage from the north parking lot of Building 38, which is outside the CS boundary. Representative samples for the facility will be obtained at monitored Outfall 074 as noted above.

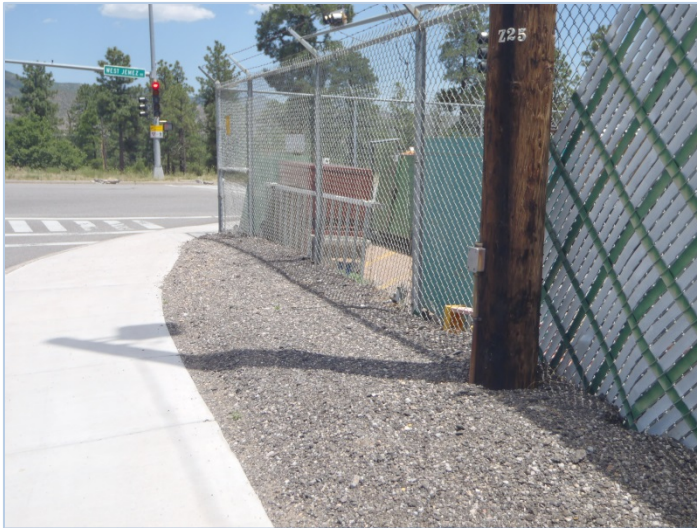
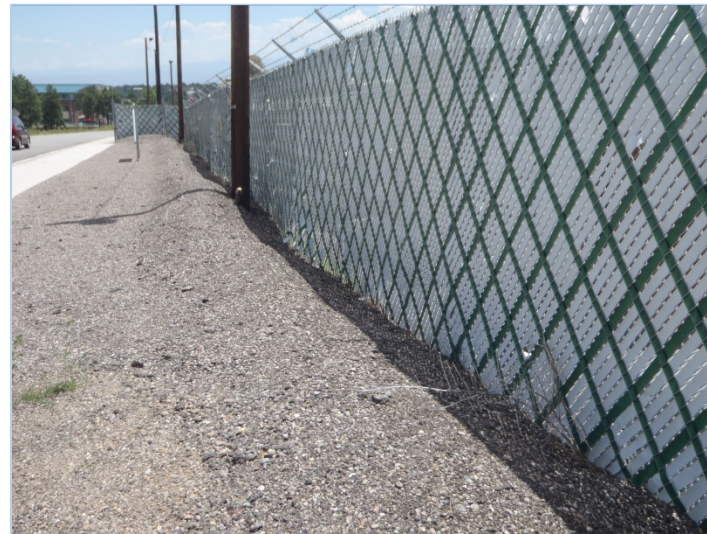
- Asphalt Berming: West & NW boundaries of the facility:
Reduces storm water run-on to the site from roadways and parking areas.

The entire outside surface region associated with the shop, except for small plots of grass adjacent to the buildings, is paved with asphalt and concrete; therefore, erosion and sediment transport is unlikely. An asphalt berm along Bikini Atoll Road and West Jemez Road prevents run-on to the shop’s lot from adjacent roadways. Sweeping of the west lot at the Facility will generally be performed except during winter months when weather conditions do not permit. Regular sweeping reduces sediment accumulation on site and transport of associated pollutants.

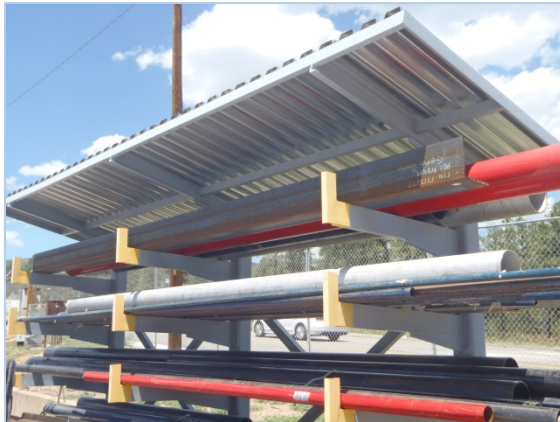
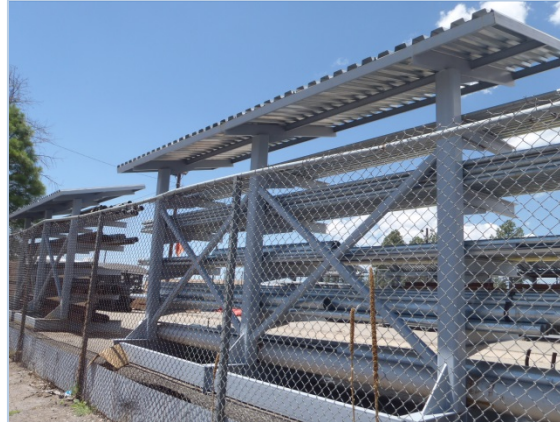
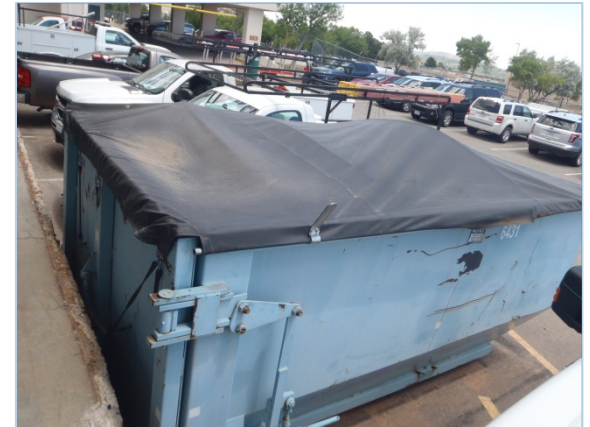
- Covered Metal/Material Storage: Covered storage racks and roll-off bins minimize storm water contact with materials and pollutants.

- **Metal Stockpile/Storage Yards Covered Metal Storage Racks:** Potential pollutants include metals exposed to precipitation (rust).
- **Covered Metal-Recycling Storage Bins:** Potential pollutants include processed metal shavings, turnings, small metal scraps, and cutting oil residues (if leakage occurred from container).
- **Pipe Storage Rack/Covered Metal Storage Rack:** Potential pollutants include metal pipe exposed to precipitation (rust).
- **Vehicle Parking:** Potential pollutants include leakage of fuel, oil, or hydraulic fluids.
- **Forklift Storage:** Potential pollutants include leakage of fuel, oil, or hydraulic fluids.
- **Trash & Cardboard Dumpsters:** Potential pollutants include trash, debris, plastics, food, and cardboard, which can get blown around the parking lot or carried out of the dumpster by birds or other wildlife.
- **Solid Waste Management Unit (SWMU)**

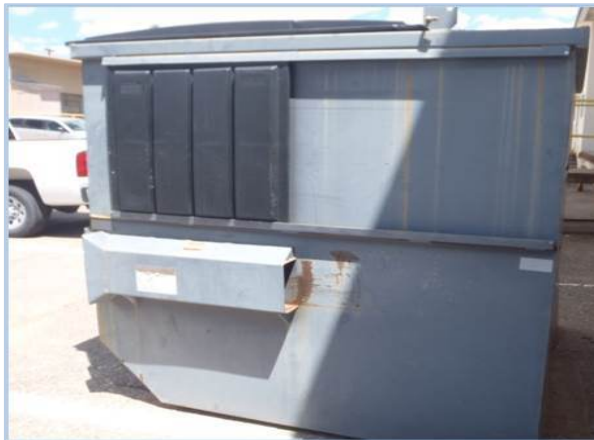
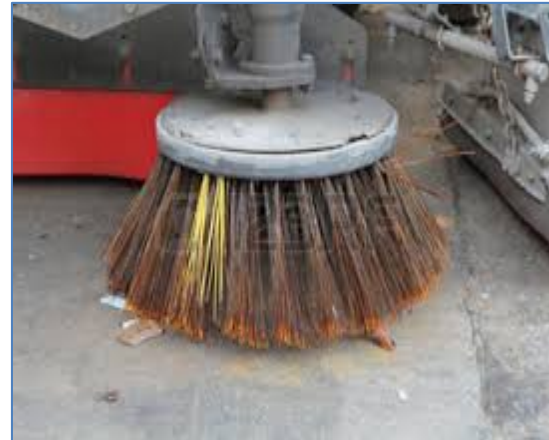
- Good House-Keeping Practices: Covered and enclosed trash bins minimize debris on site. Monthly sweeping of the west lot removes accumulated dust and reduces pollutants. YOU can help reduce trash as well: keep truck beds clean, properly dispose of food trash and cigarette butts, keep dumpsters closed. Recycle water bottles, cans, plastic bags, etc..

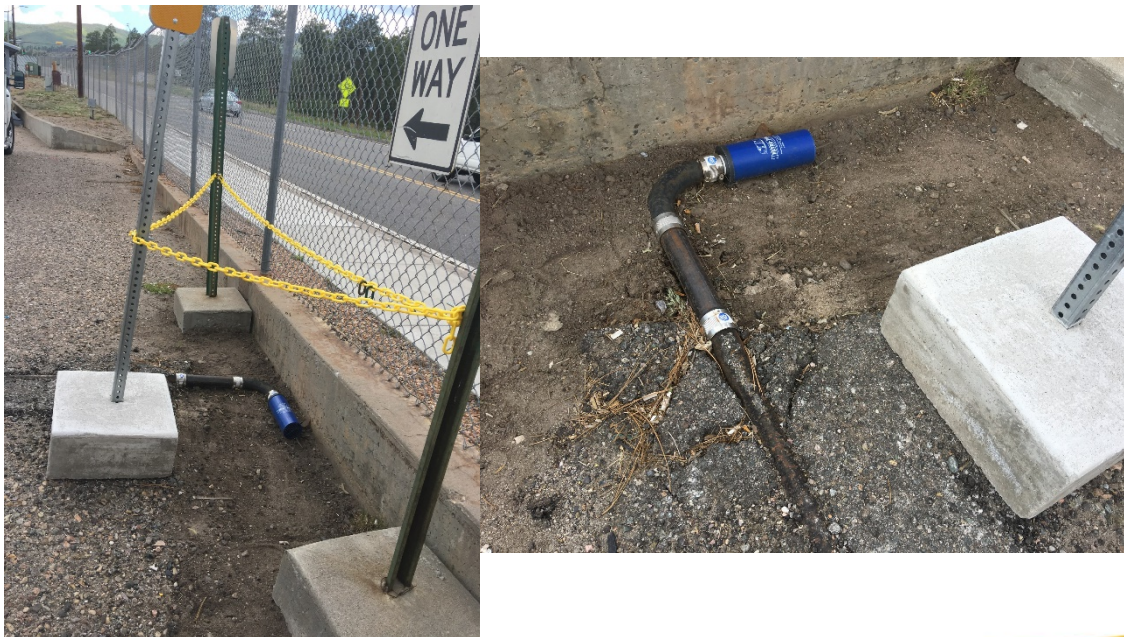
- Petro Pipe Oil Barrier: The Petro Pipe Oil Barrier is used at the end point of the drainage pipe for the trench drain sump (located west of the pipefitter's shop). This allows excess storm water discharge from the trench drain while filtering out oil sheen that accumulates from the parking lot run-off.

- **Petro-Pipe Oil Barrier:** The Petro-Pipe oil barrier is installed at the end of the drain pipe that discharges excess stormwater from the trench drain/sump pump outside the pipefitter's shop. The Petro-Pipe prevents any oil that may accumulate in the trench drain from being discharged to the parking lot. Pumping of the trench drain is required to prevent flooding of the adjacent shop. The Petro-Pipe is removed during winter months to prevent damage from inclement weather, snow removal, and vehicle traffic.

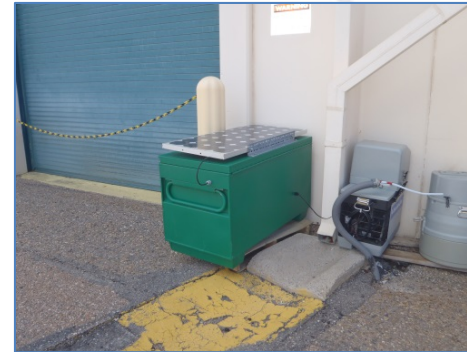
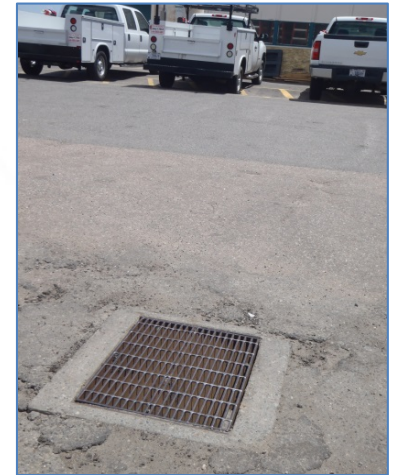
- Automated collection during storm events
- Monitoring for pollutants
 - Benchmark (sector specific limits)
 - Impaired Waters (receiving water)
 - **Sandia Canyon**

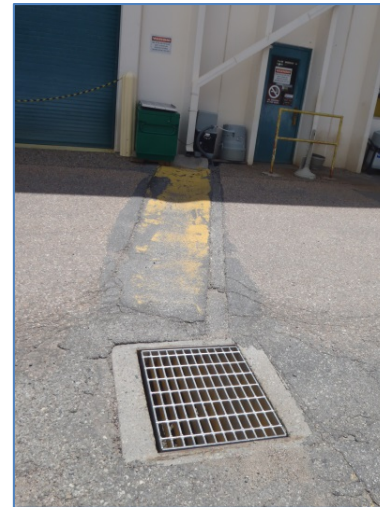
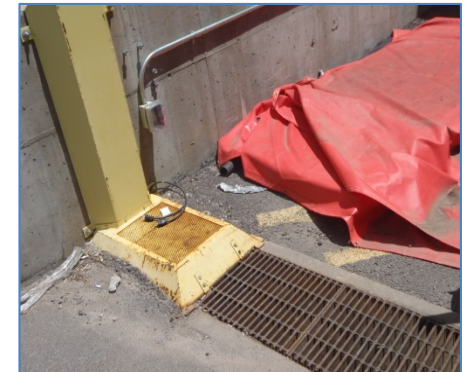
- Sample/discharge points (automated & visual)
- Evaluated during inspections
- Each numbered for site map
- **1 Monitored outfall on site: Outfall 002**
